**REPORT NUMBER: 214-CAL-07-01**

**SAFETY COMPLIANCE TESTING FOR FMVSS 214  
SIDE IMPACT PROTECTION  
INDICANT**

**DAIMLERCHRYSLER CORPORATION  
2007 JEEP COMPASS  
MPV**

**NHTSA NUMBER: C70302**

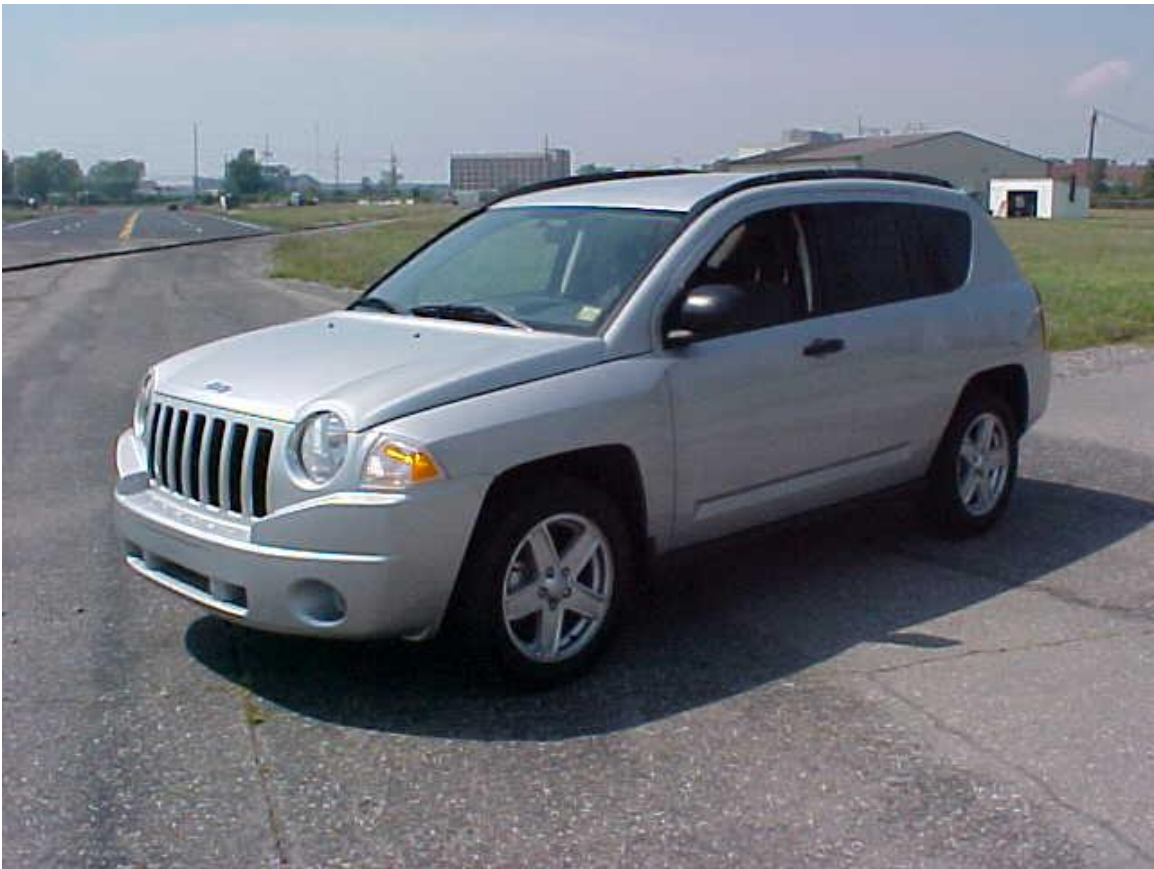
**Figure A-1: As Received Left Front  $\frac{3}{4}$  View**

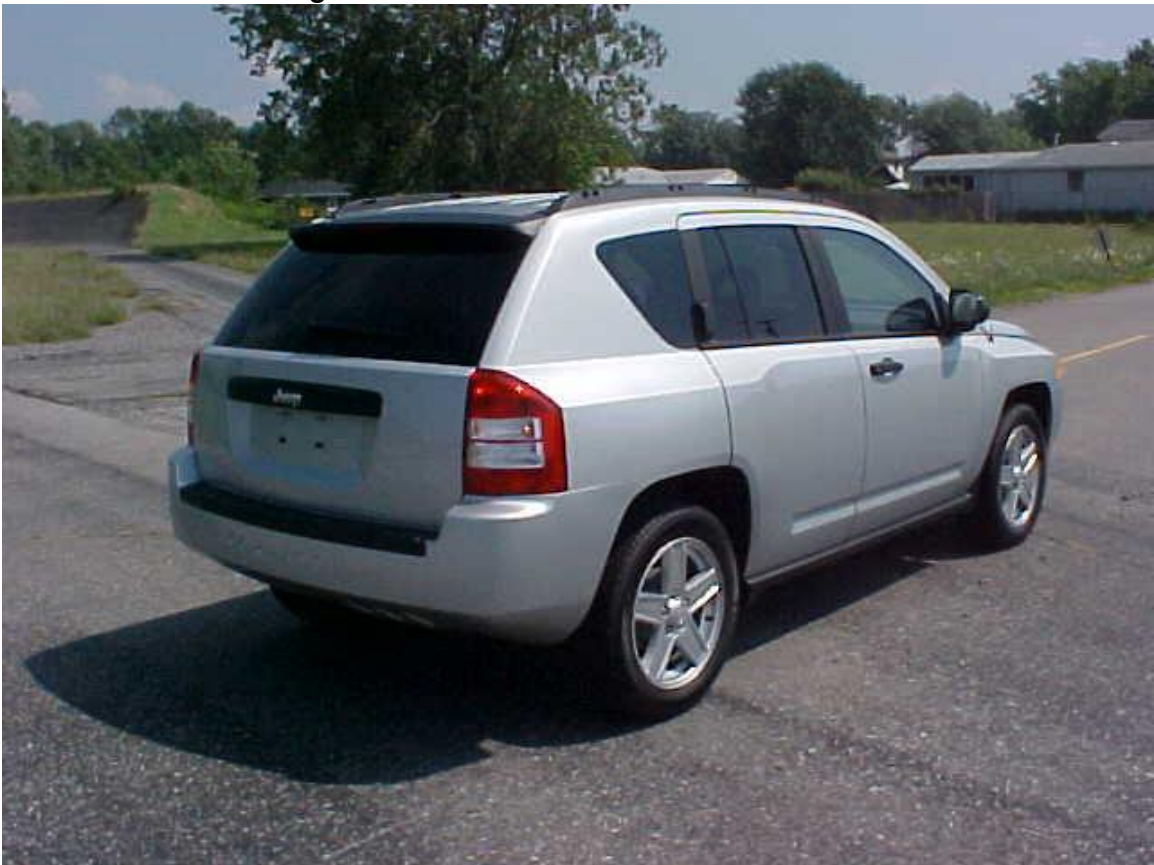
**Figure A-2: As Received Right Rear  $\frac{3}{4}$  View**

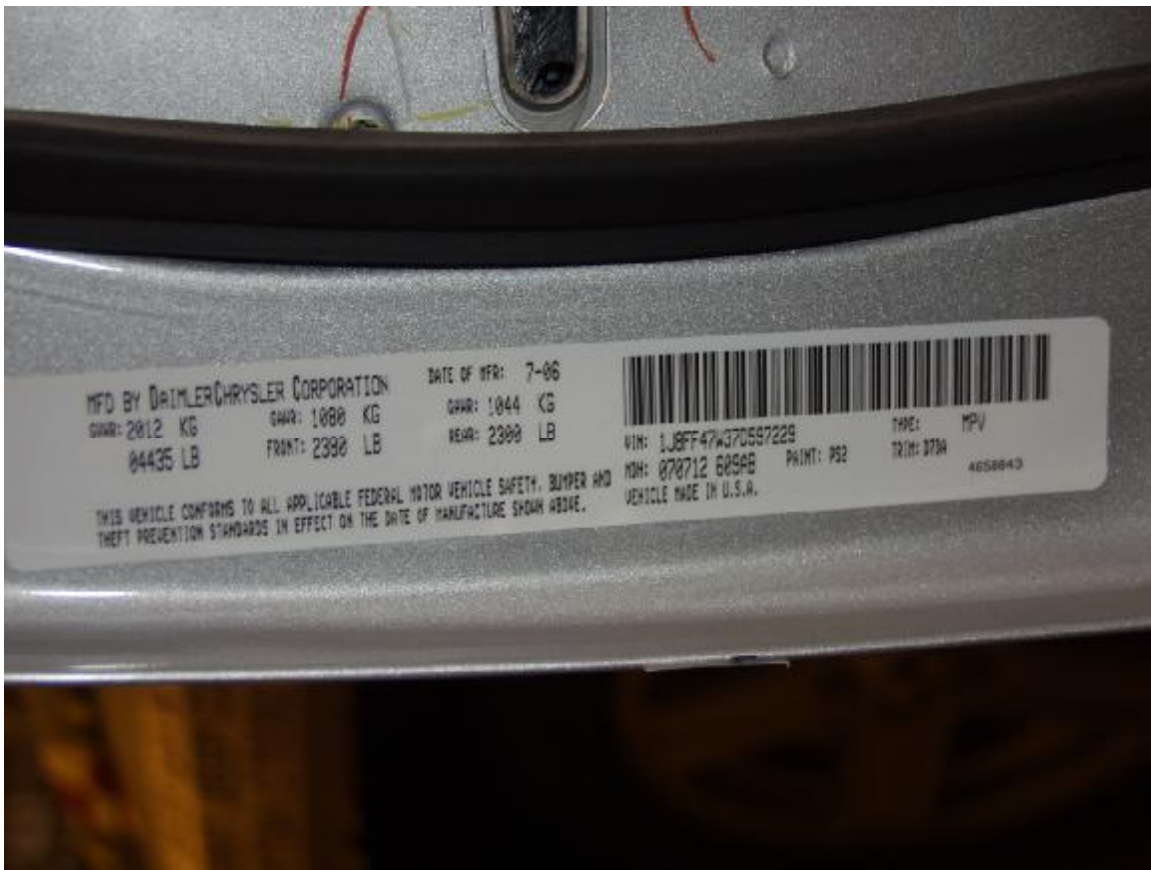
Figure A-3: Vehicle Certification Label

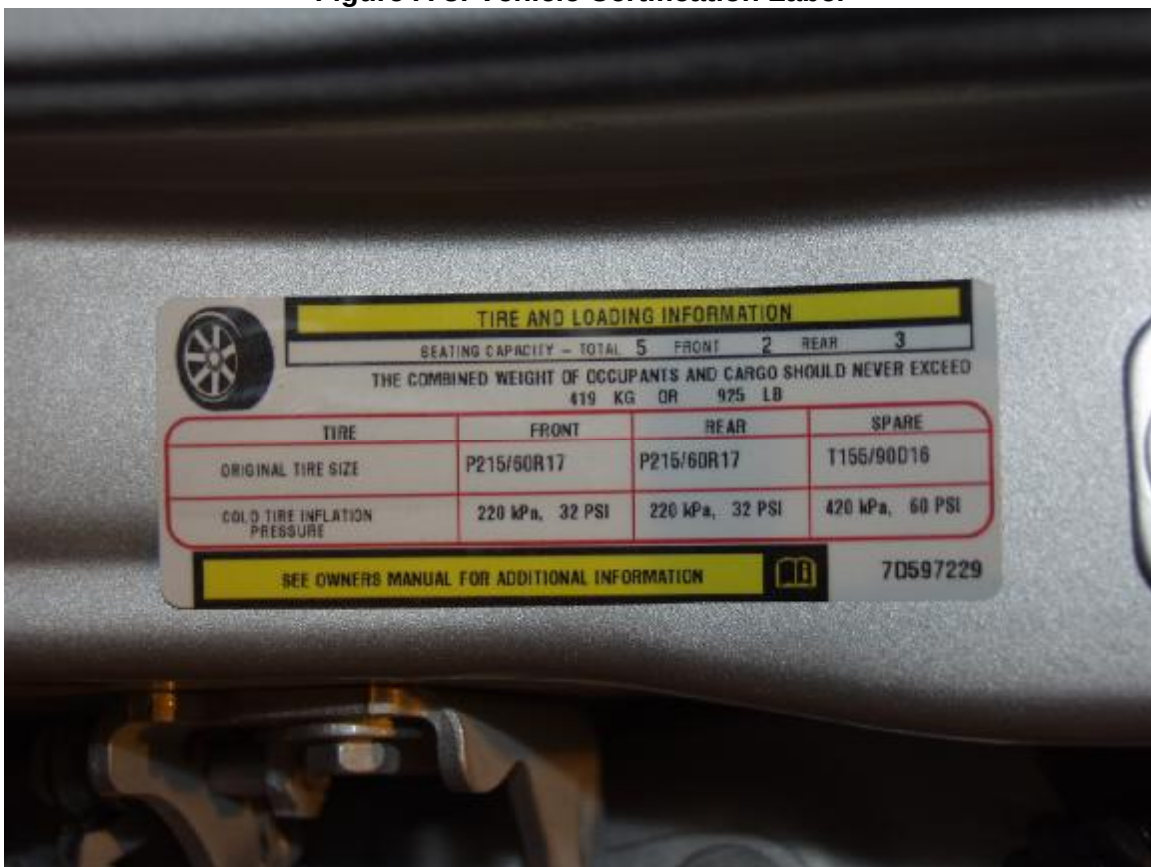
Figure A-4: Vehicle Tire Placard Label

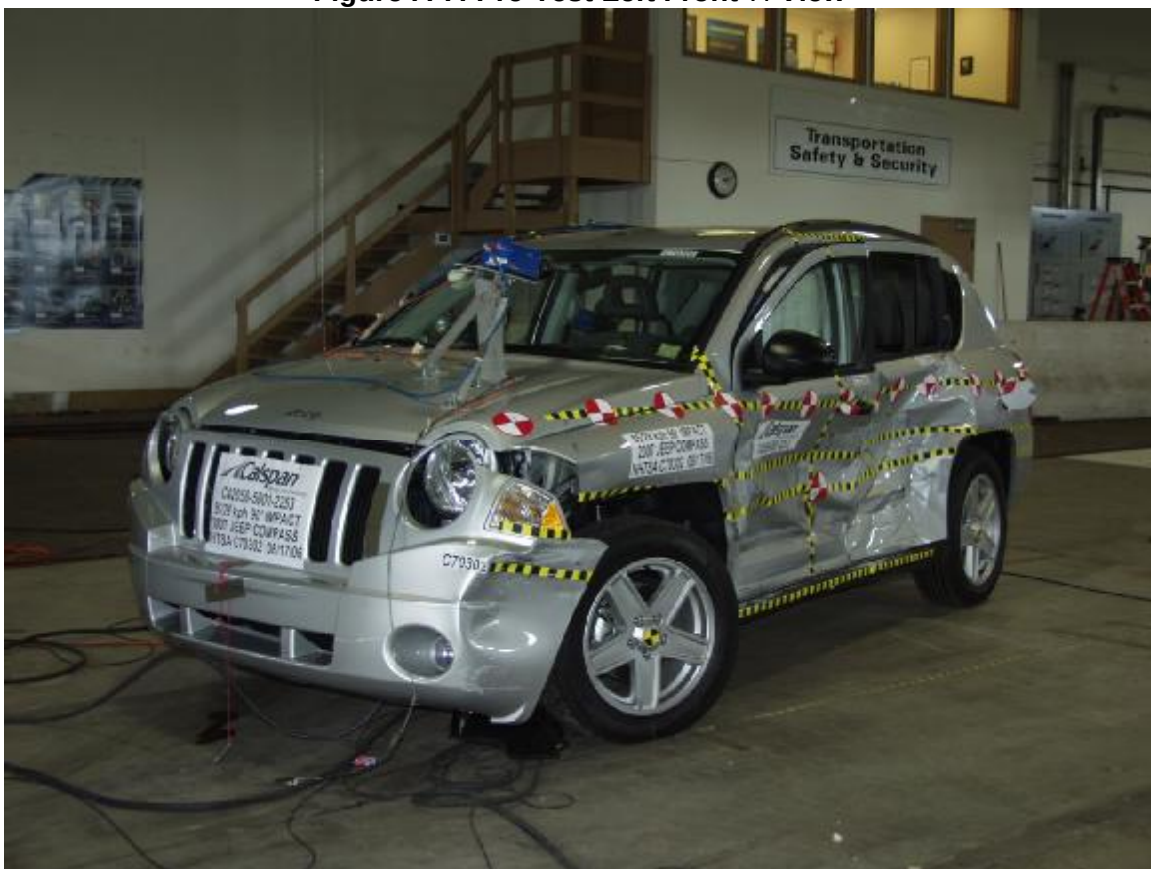
Figure A-8: Post-Test Left Front  $\frac{3}{4}$  View

| Critical Areas of Performance | Observations and Conclusions |
|---|---|
| Windshield Damage | Left lower corner of the windshield cracked |

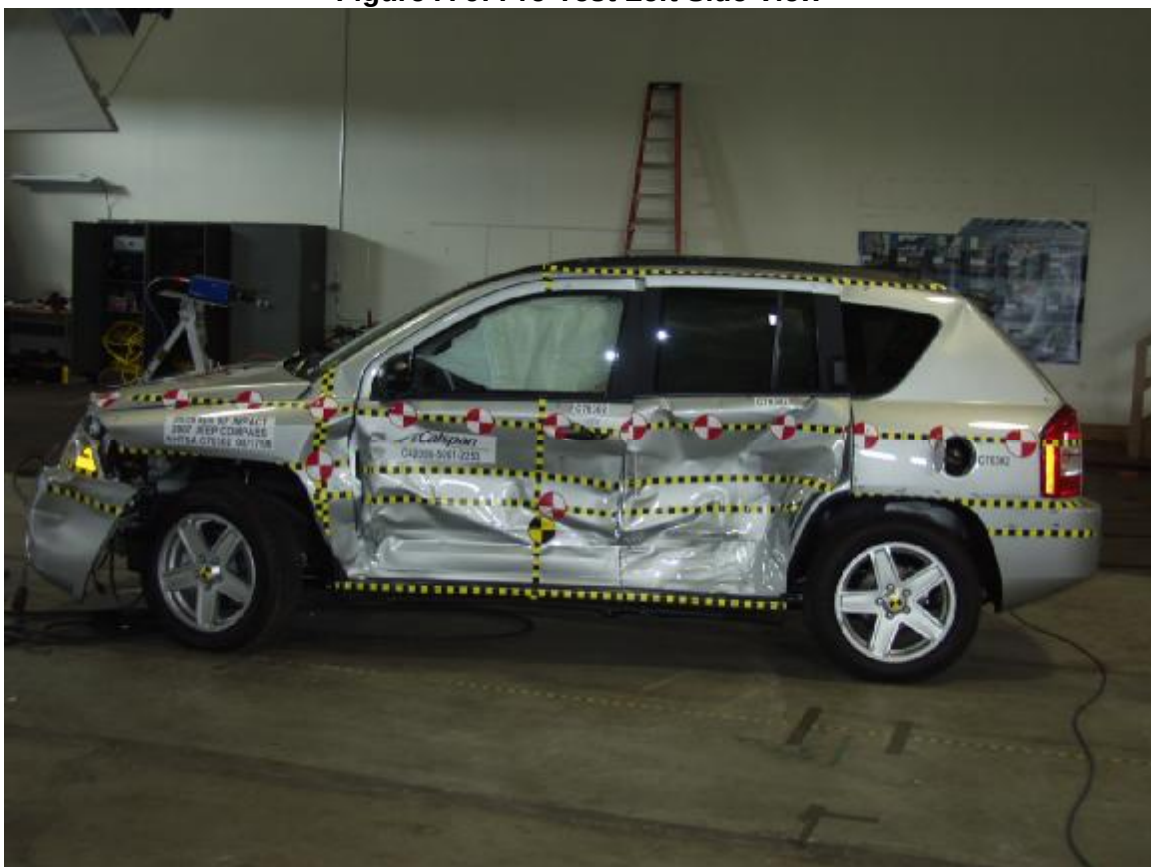
Figure A-10: Post-Test Left Side View

The test vehicle sustained a maximum static crush of 183 mm at level 3, 1500 mm rearward of the left vertical impact point. The driver and passenger SID/HIII's, Serial Nos. 905 and 906 respectively, were calibrated just prior to this test.

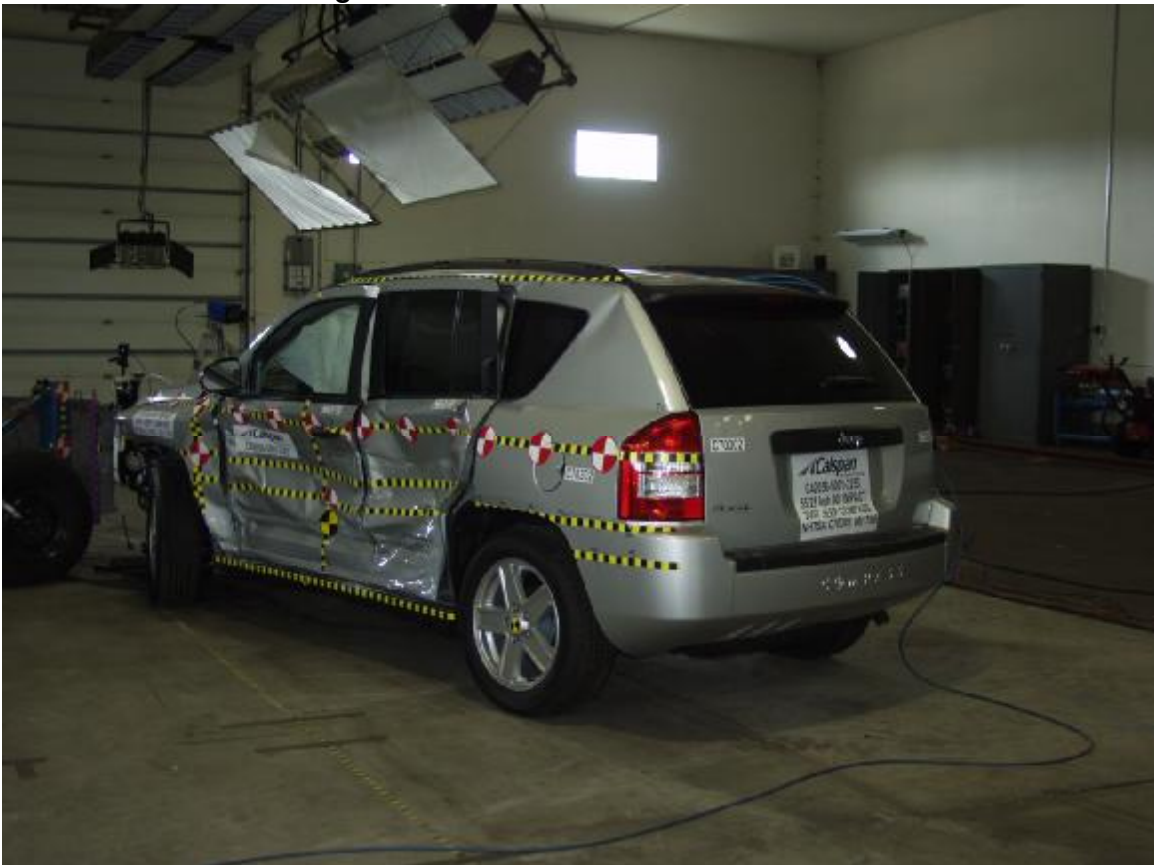
**Figure A-12: Post-Test Left Rear  $\frac{3}{4}$  View**

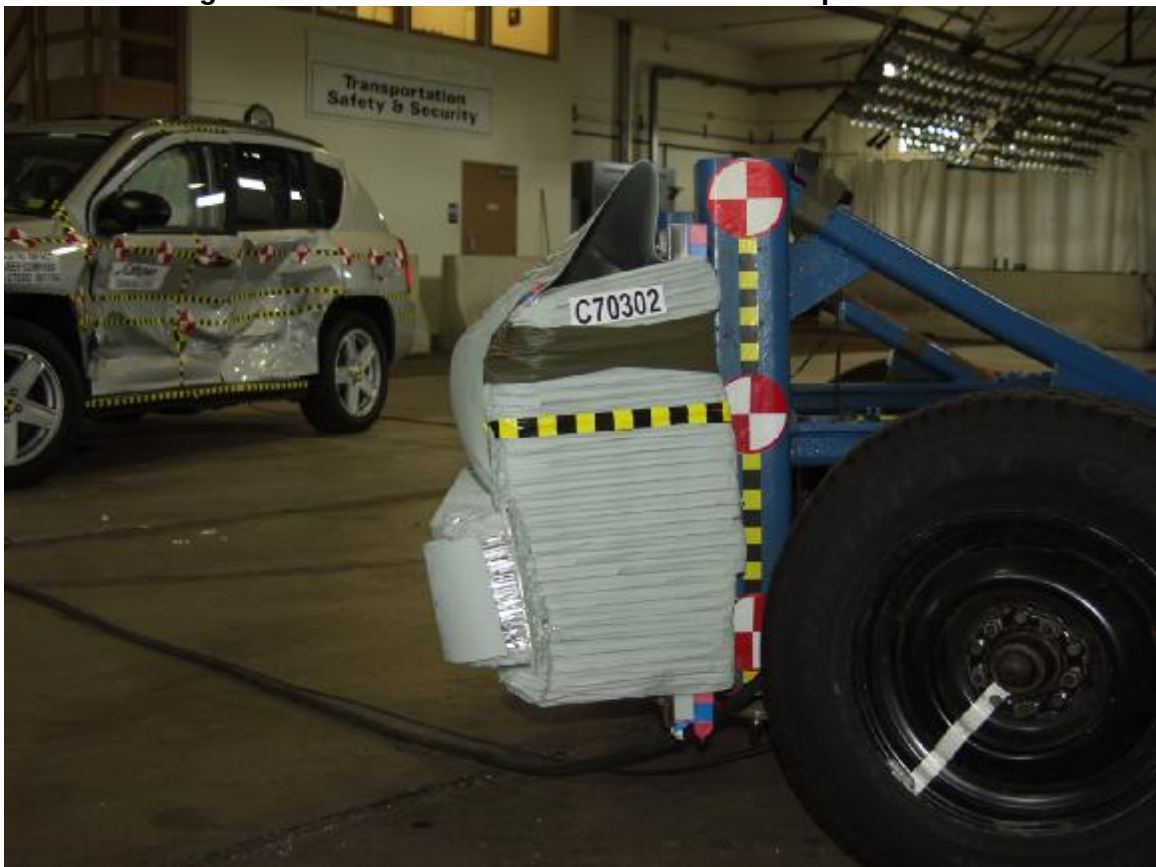
**Figure A-24: Post-Test Left Side View of MDB Impactor Face**

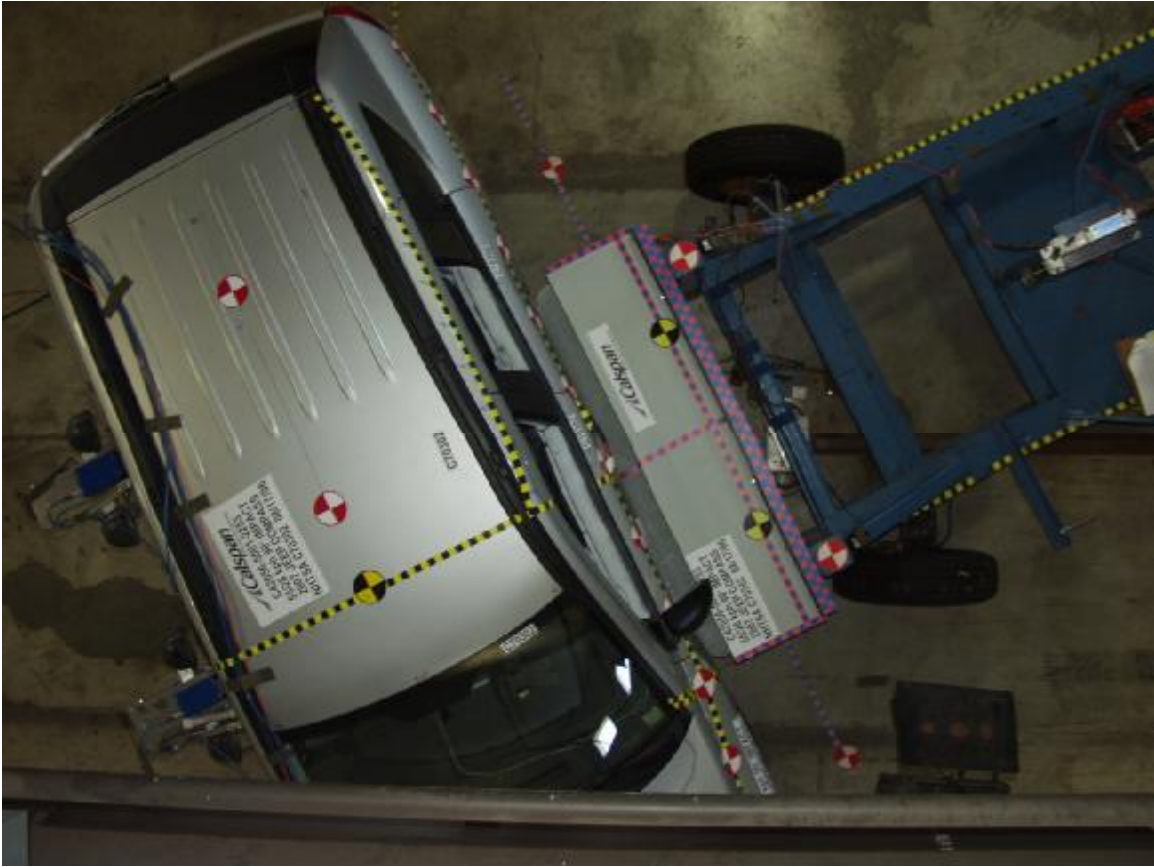
Figure A-31: Pre-Test Overhead View of Aligned MDB and Vehicle

A model year 2007 Jeep Compass MPV was impacted on the left (driver's) side by a Moving Deformable Barrier (MDB) which was moving forward in a 27° crabbed position to the tow road guidance system at a velocity of 62.28 km/h. The specified impact velocity range is from 61.1 to 62.7 km/h. The test (target) vehicle was stationary and positioned 63° to the line of forward motion. The weight of the vehicle as tested was 1738.0 kg and the test weight of the MDB was 1362.5 kg. The test was conducted at the Calspan Corporation Transportation Sciences Center on August 17, 2006.

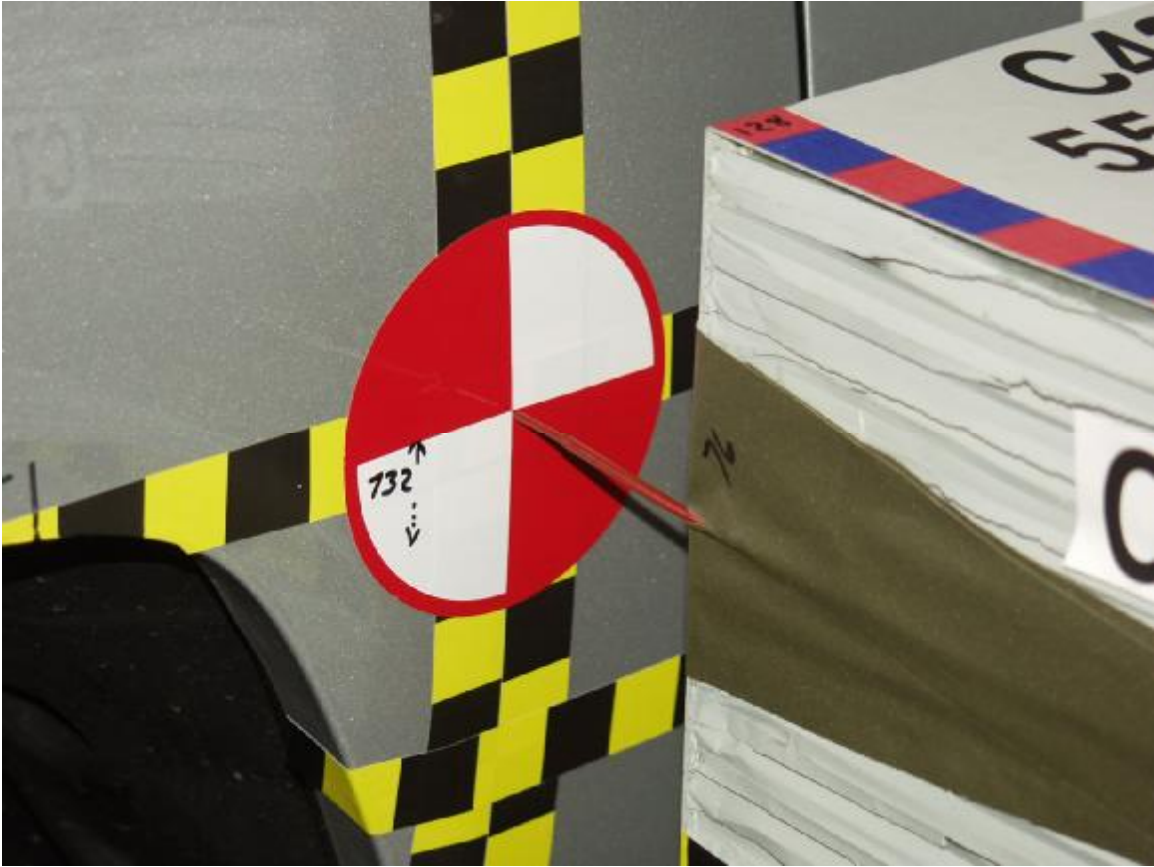
Figure A-33: Pre-Test Close-Up View of Impact Point Target

| Measurement Description | Units | Value |
|---|---|---|
| Actual Impact Point Aft of Front Axle | mm | 377 |

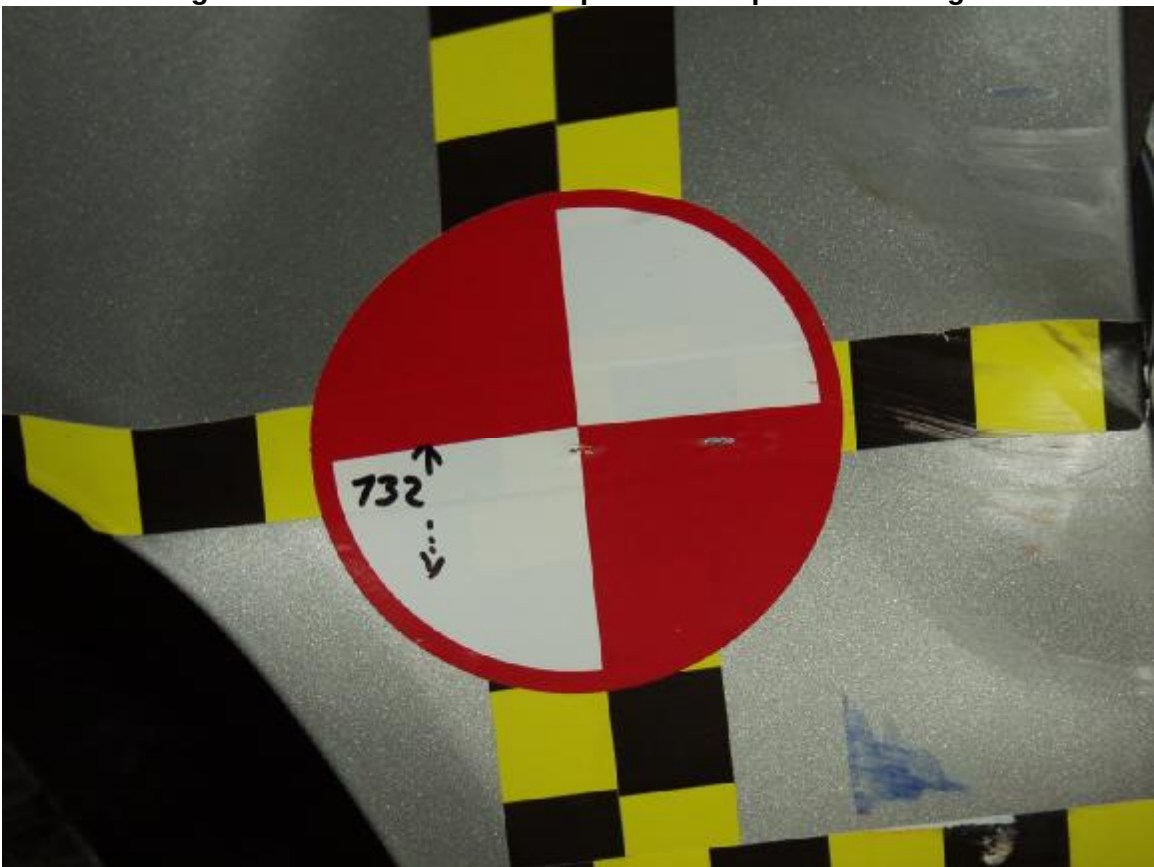
Figure A-34: Post-Test Close-Up View of Impact Point Target

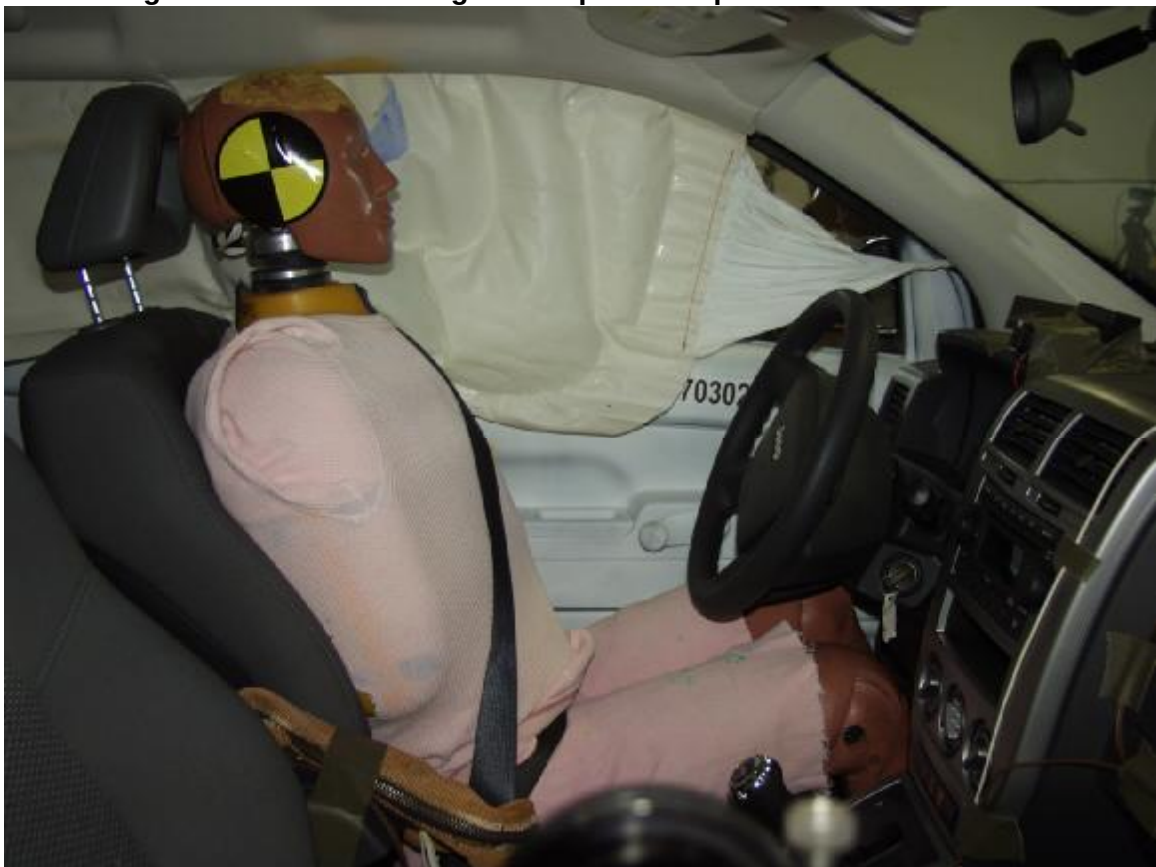
**Figure A-36: Post-Test Right Occupant Compartment View of Driver**

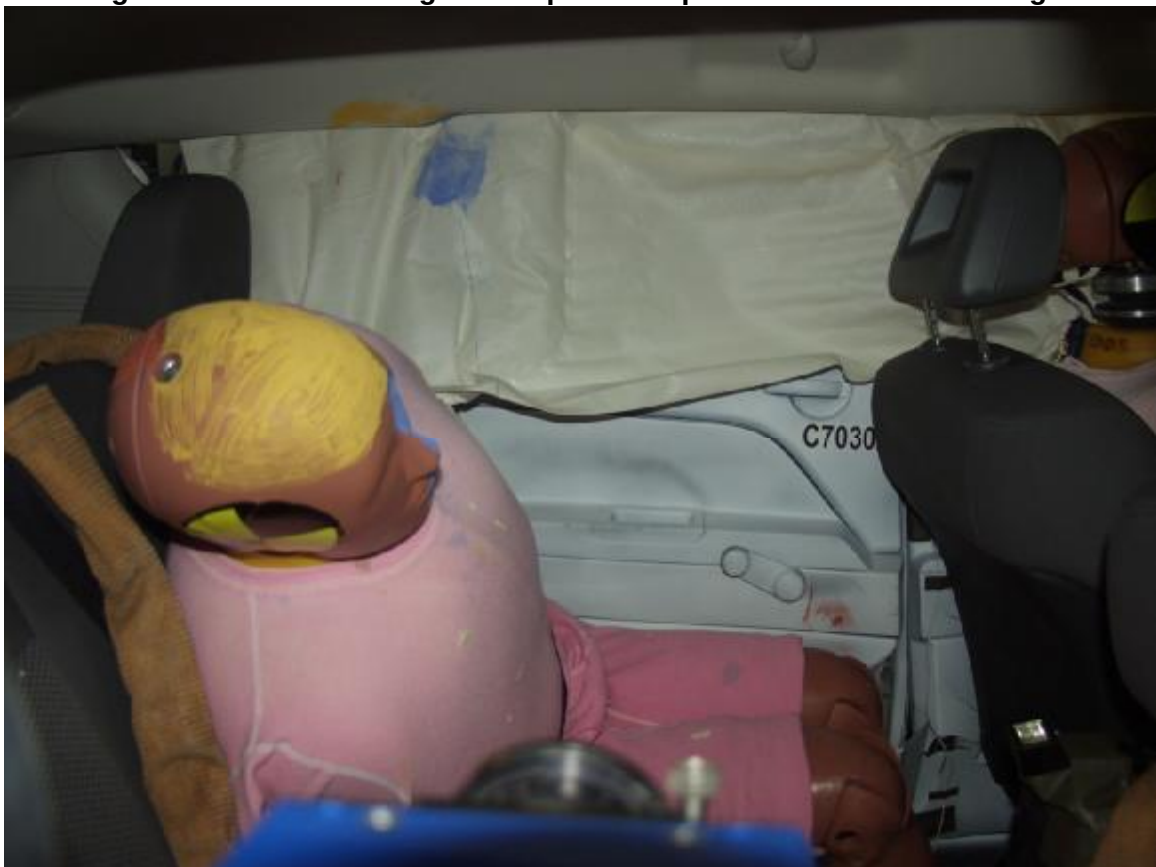
**Figure A-38: Post-Test Right Occupant Compartment View of Passenger**

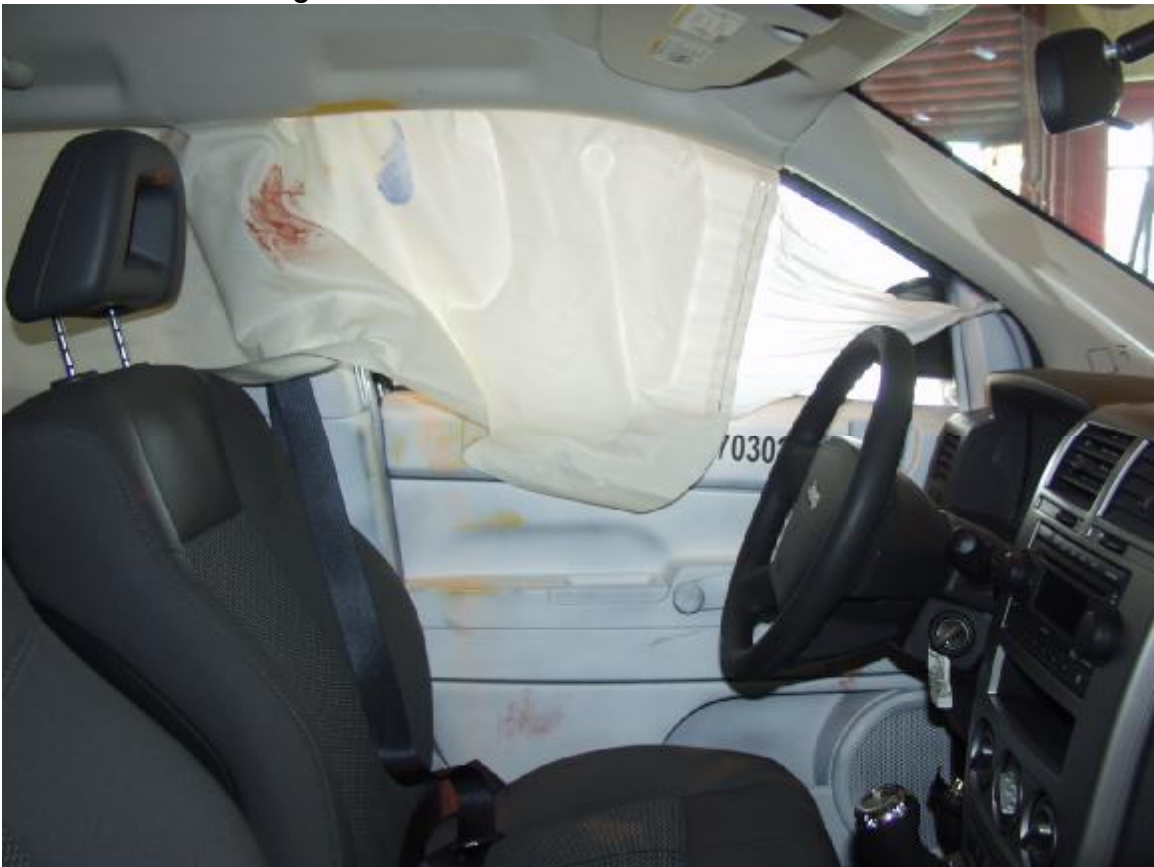
**Figure A-44: Post-Test Left Front Interior Trim**

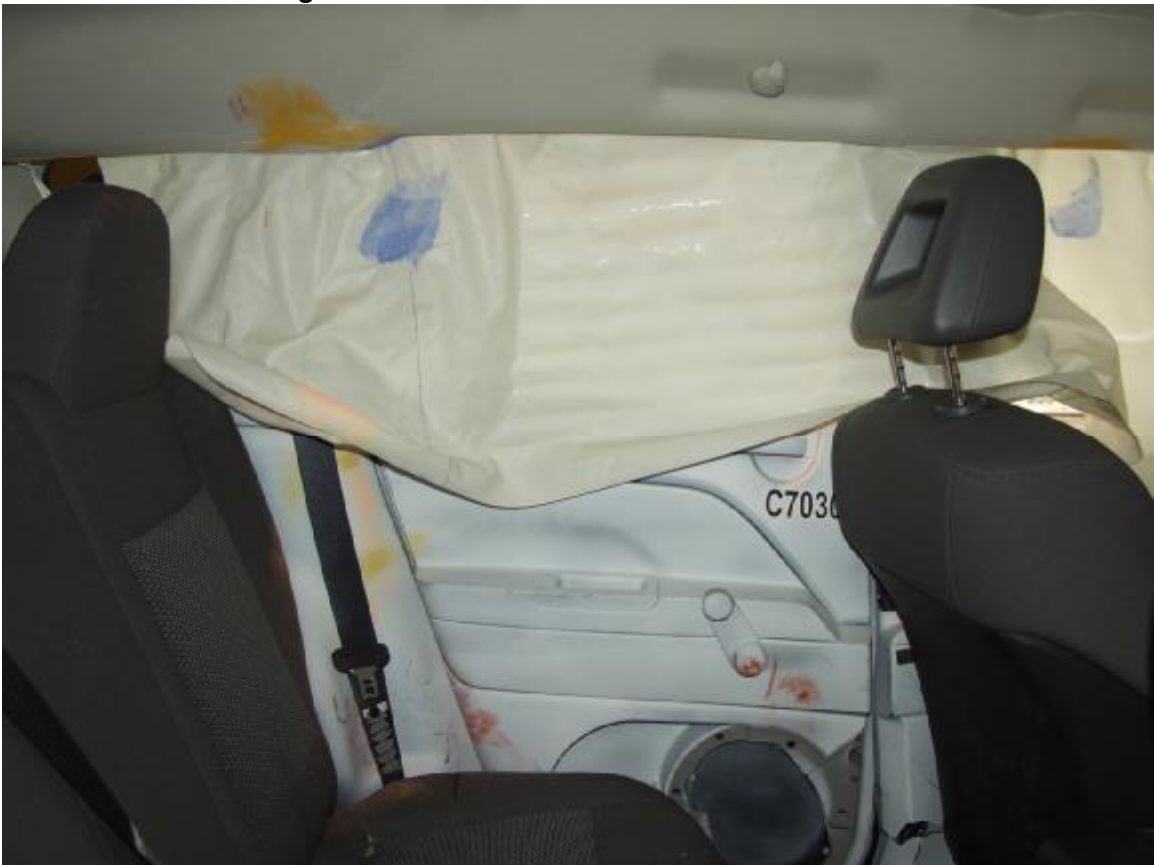
**Figure A-46: Post-Test Left Rear Interior Trim**

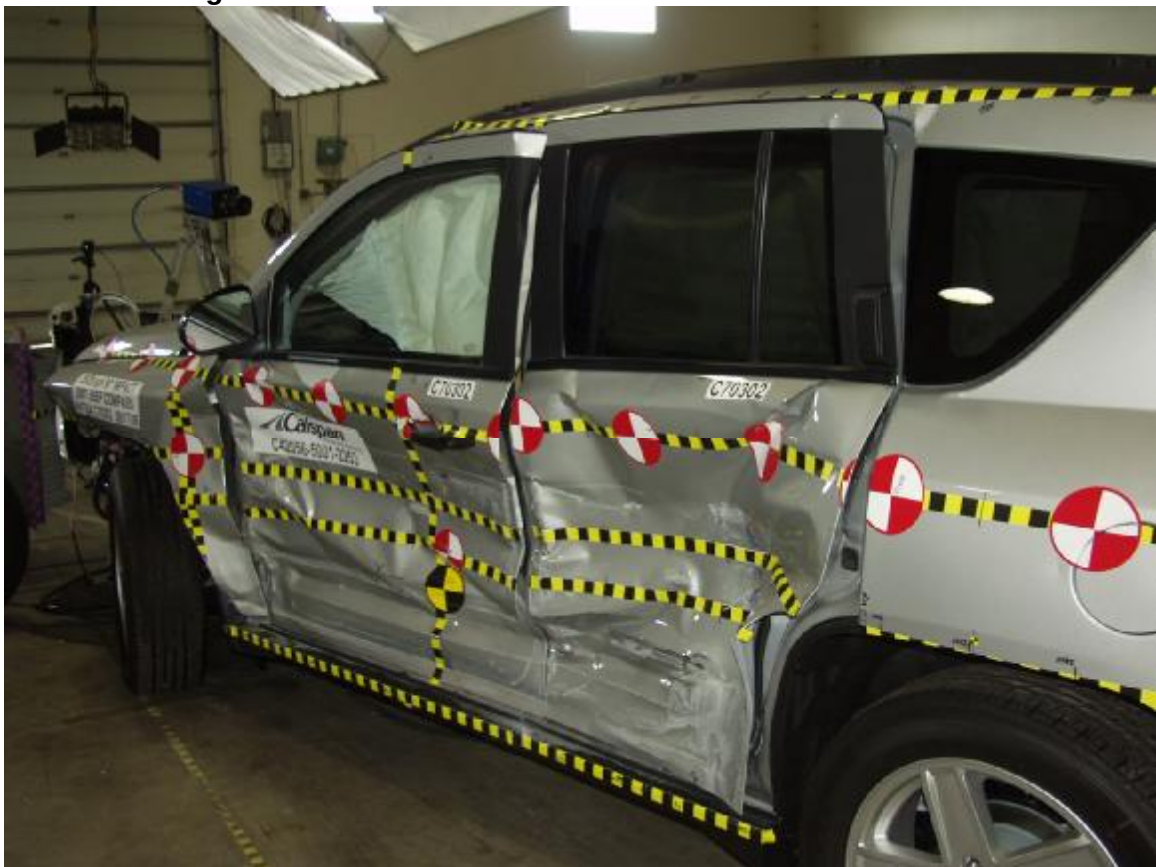
Figure A-50: Post-Test Left Rear  $\frac{3}{4}$  View of Left Side Doors

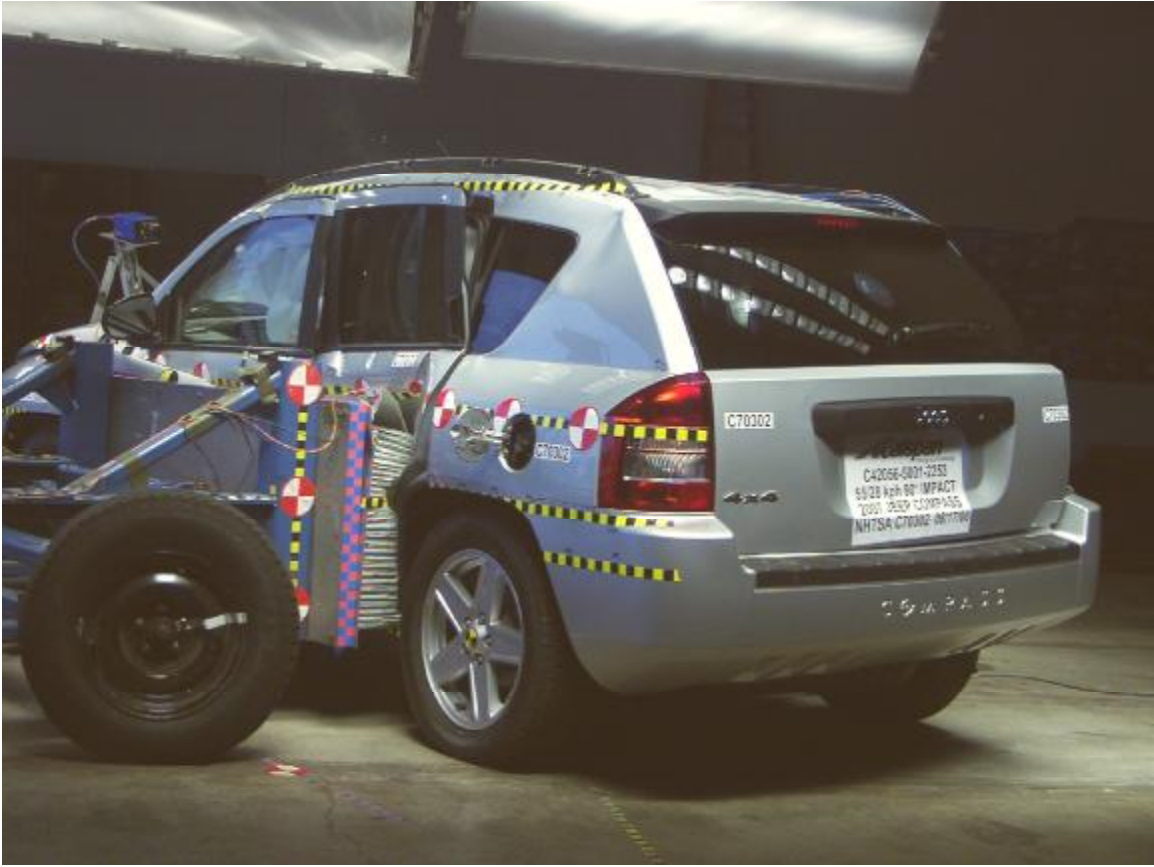
**Figure A-55: Impact Photo**
