**REPORT NUMBER: NCAP-MGA-2007-001**

**NEW CAR ASSESSMENT PROGRAM  
FRONTAL BARRIER IMPACT TEST**

**DAIMLERCHRYSLER CORPORATION  
2007 JEEP COMPASS SPORT 4X4  
NHTSA NUMBER: M70302**

**PREPARED BY:  
MGA RESEARCH CORPORATION  
5000 WARREN ROAD  
BURLINGTON, WI 53105**

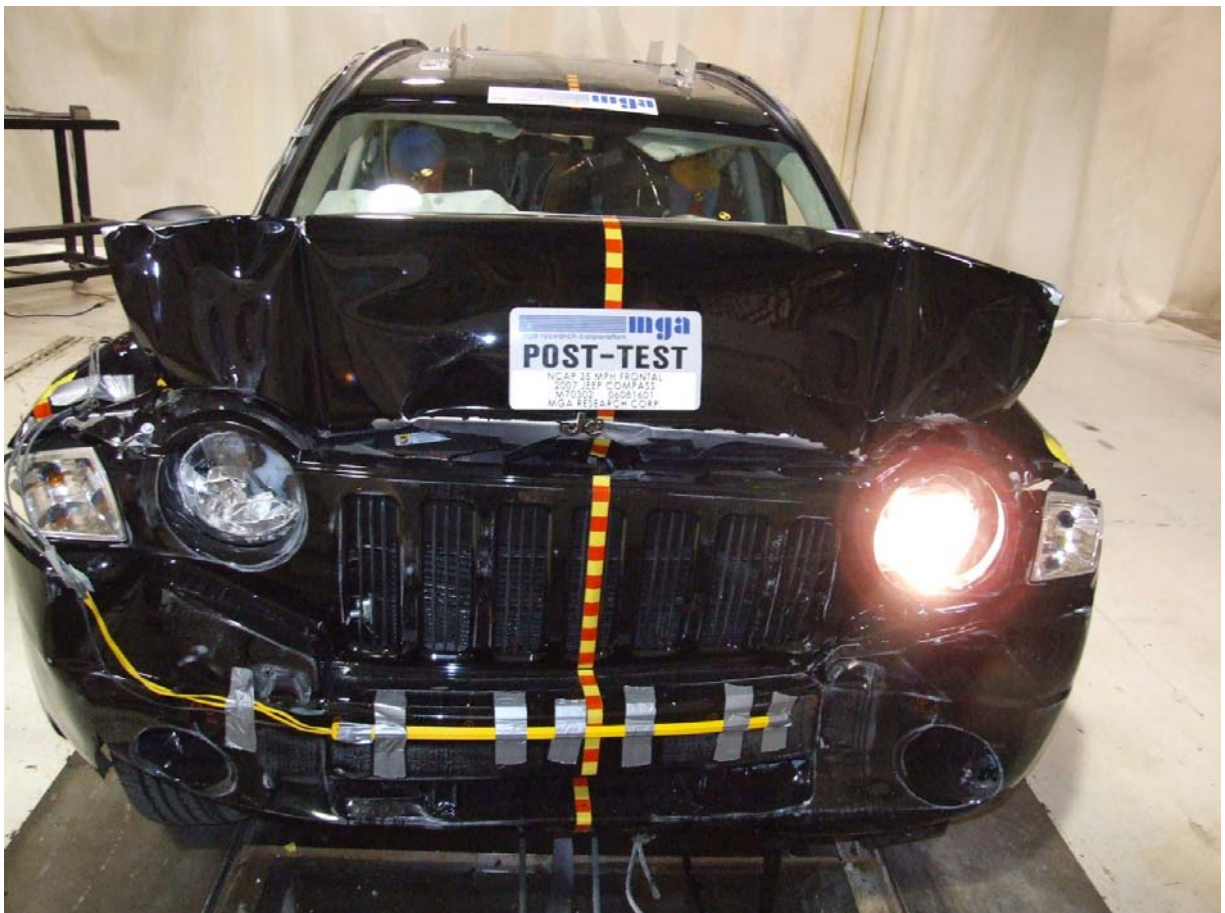
Post-Test Front View

The maximum static crush of the vehicle was 477 mm and both the driver and passenger side doors remained closed and latched during the impact event and were operable after the impact.

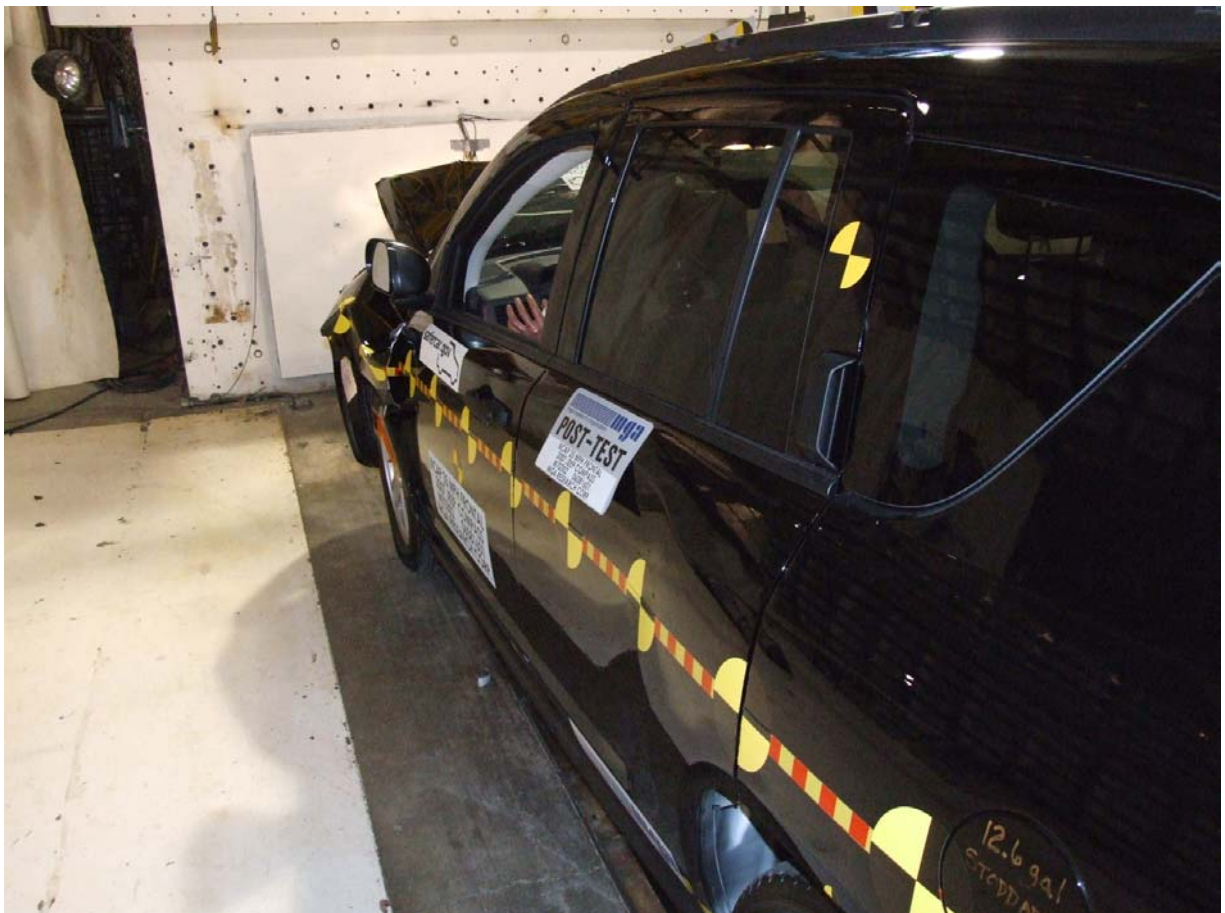
Post-Test Left Side  $\frac{3}{4}$  View of Doors After Impact

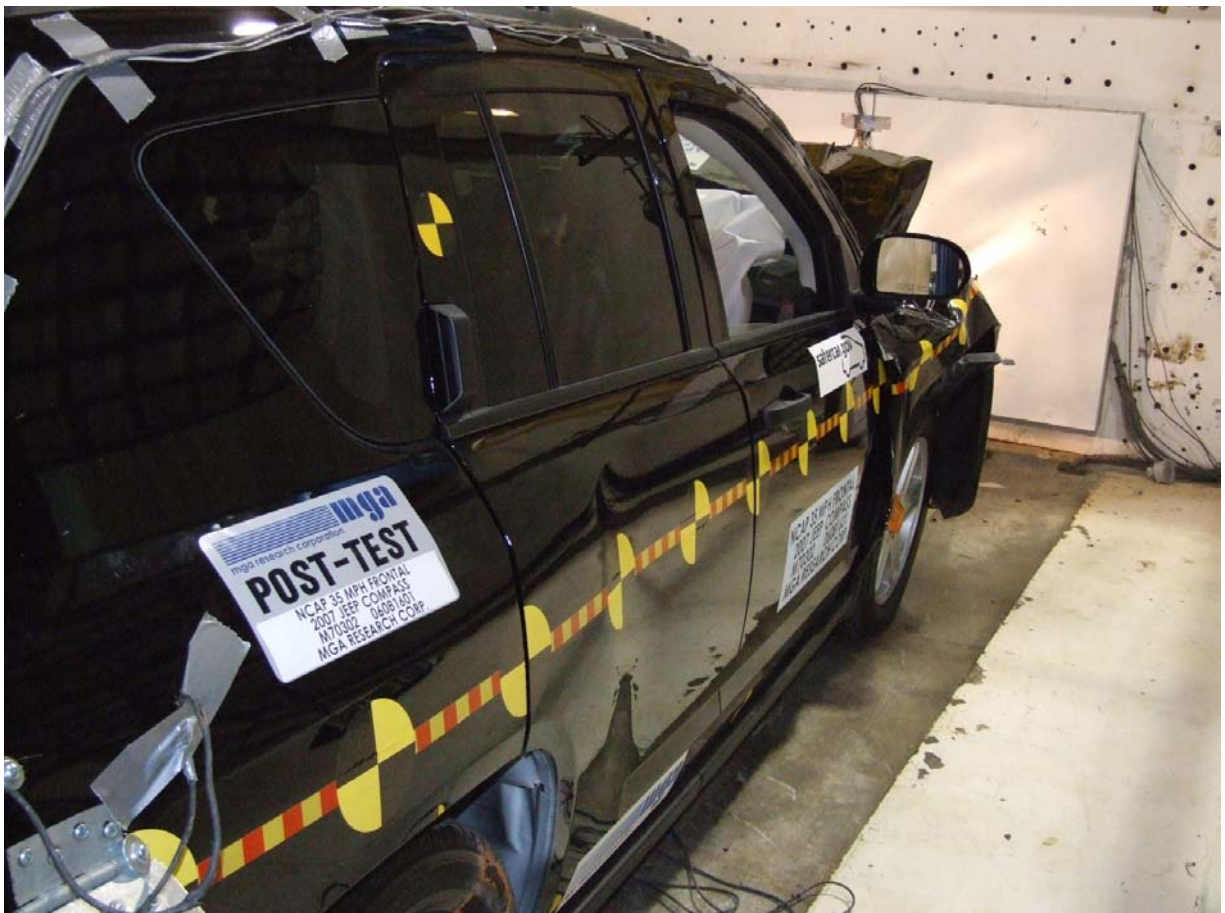
Post-Test Right Side ¾ View of Doors After Impact

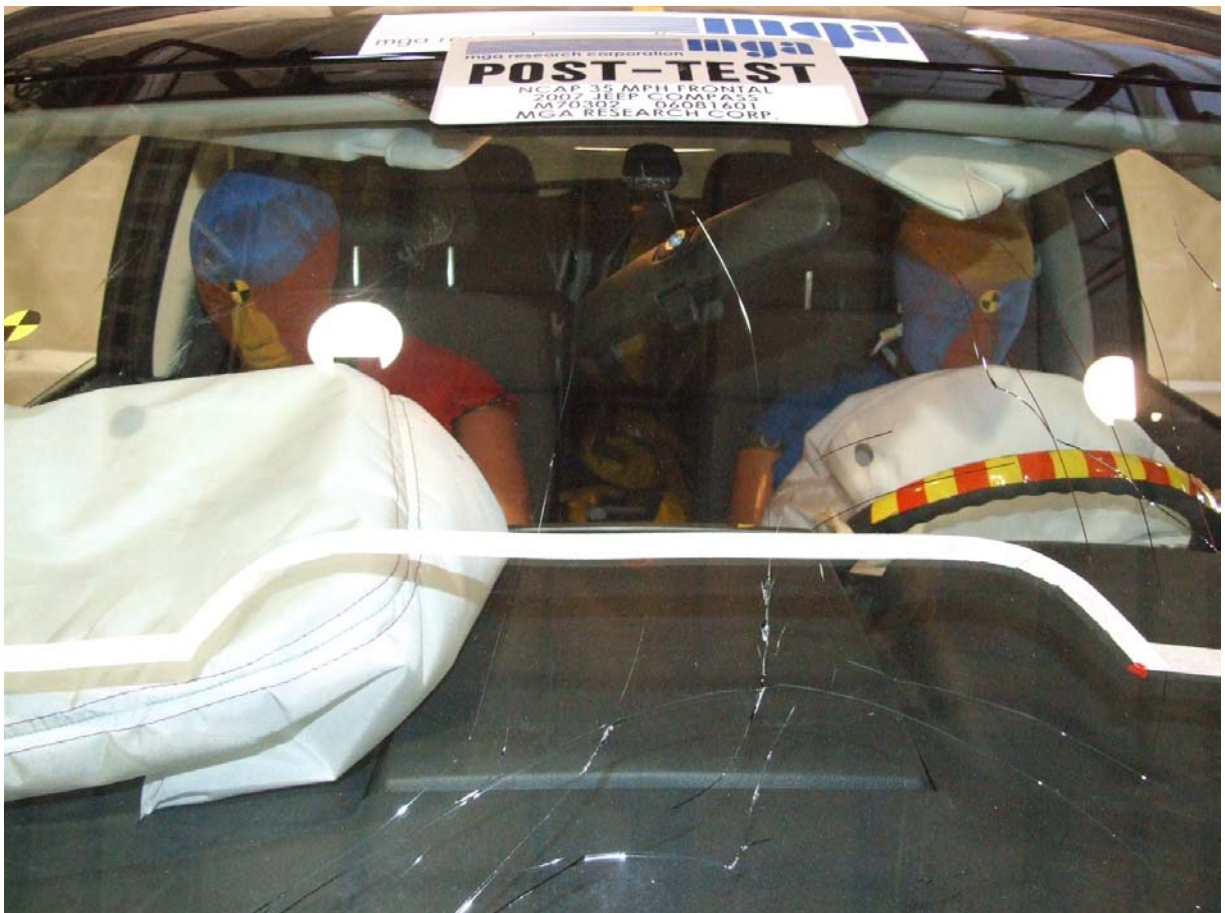
Post-Test Windshield View

There was 100 percent windshield retention and no intrusion into the protected zone of the windshield during the event. There was no Stoddard Solvent leakage after the event or during any phase of the static rollover.

| Description | Driver | Passenger |
|---|---|---|
| Glazing Damage | The windshield was cracked. | |

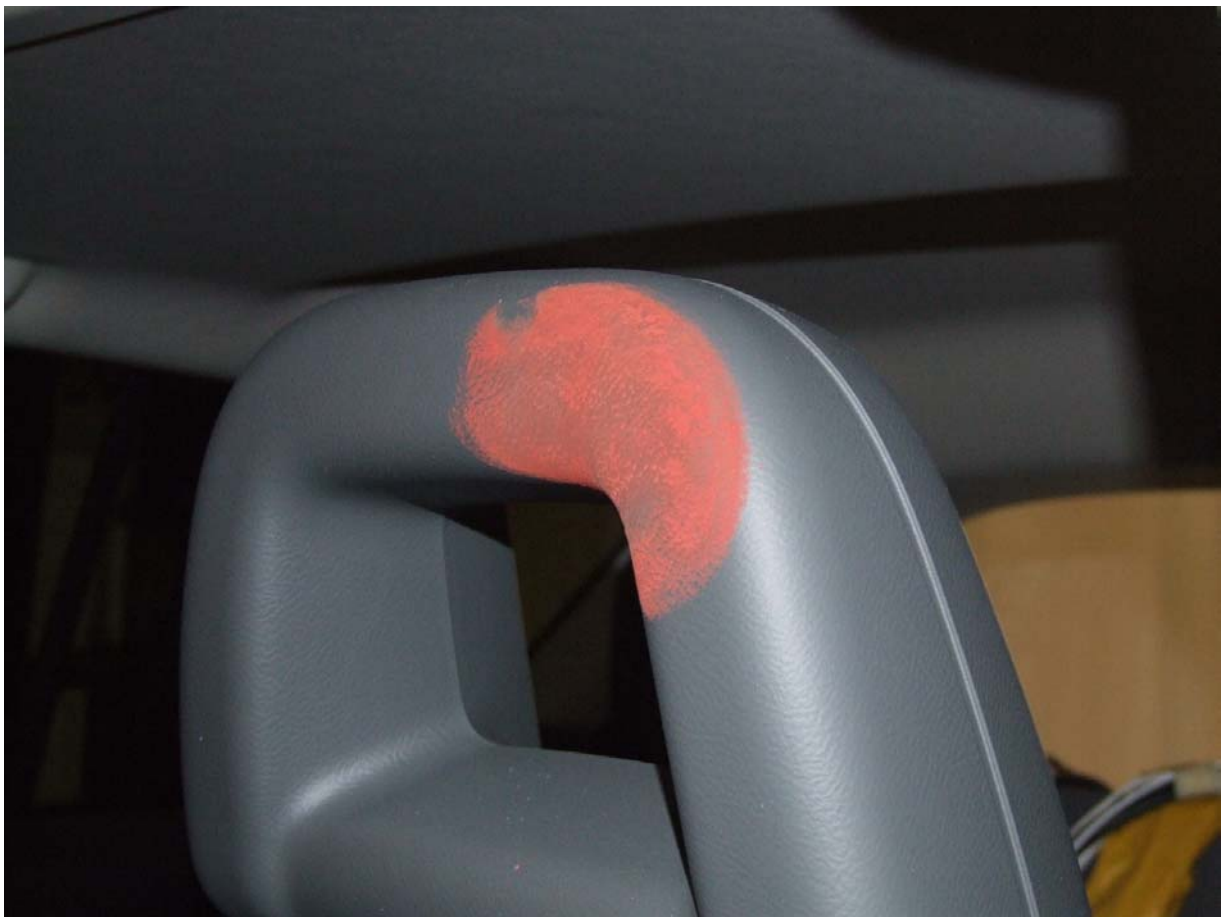
Post-Test Driver Dummy Head Contact

The driver's head and chest contacted the airbag. The driver's head also contacted the headrest. The driver's knees contacted the bolster and steering column. The passenger's head and chest contacted the airbag. The passenger's head also contacted the headrest. The passenger's knees contacted the glove box.

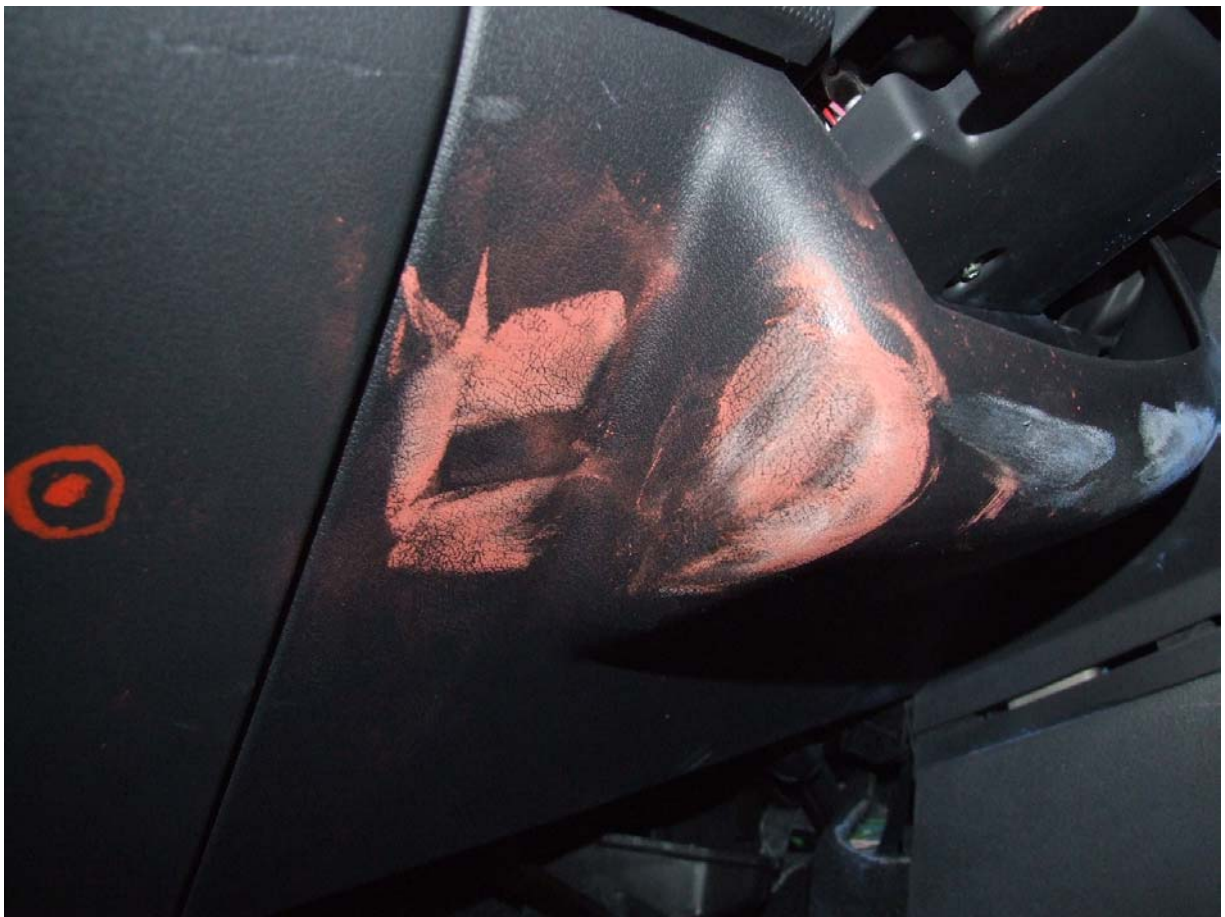
Post-Test Driver Dummy Left Knee Contact

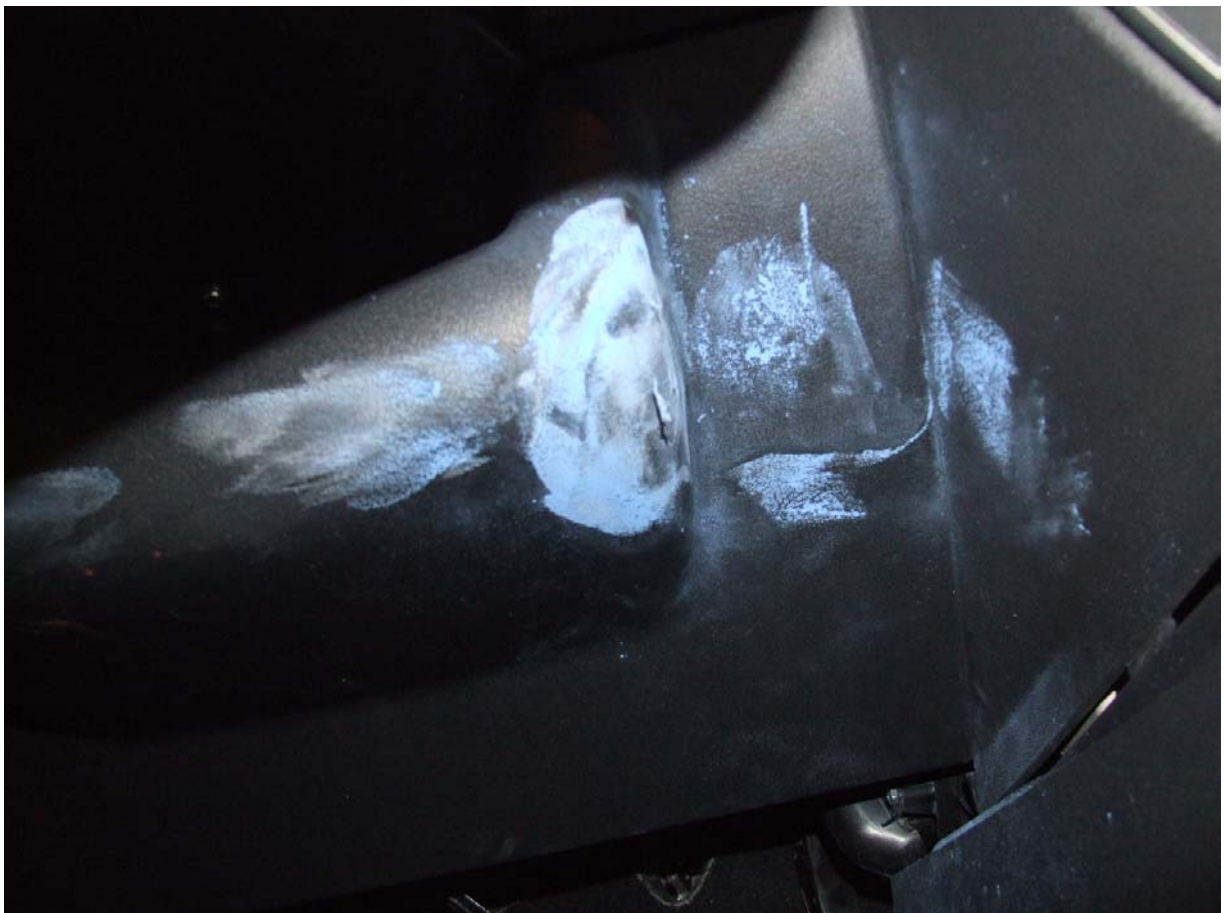
Post-Test Driver Dummy Right Knee Contact

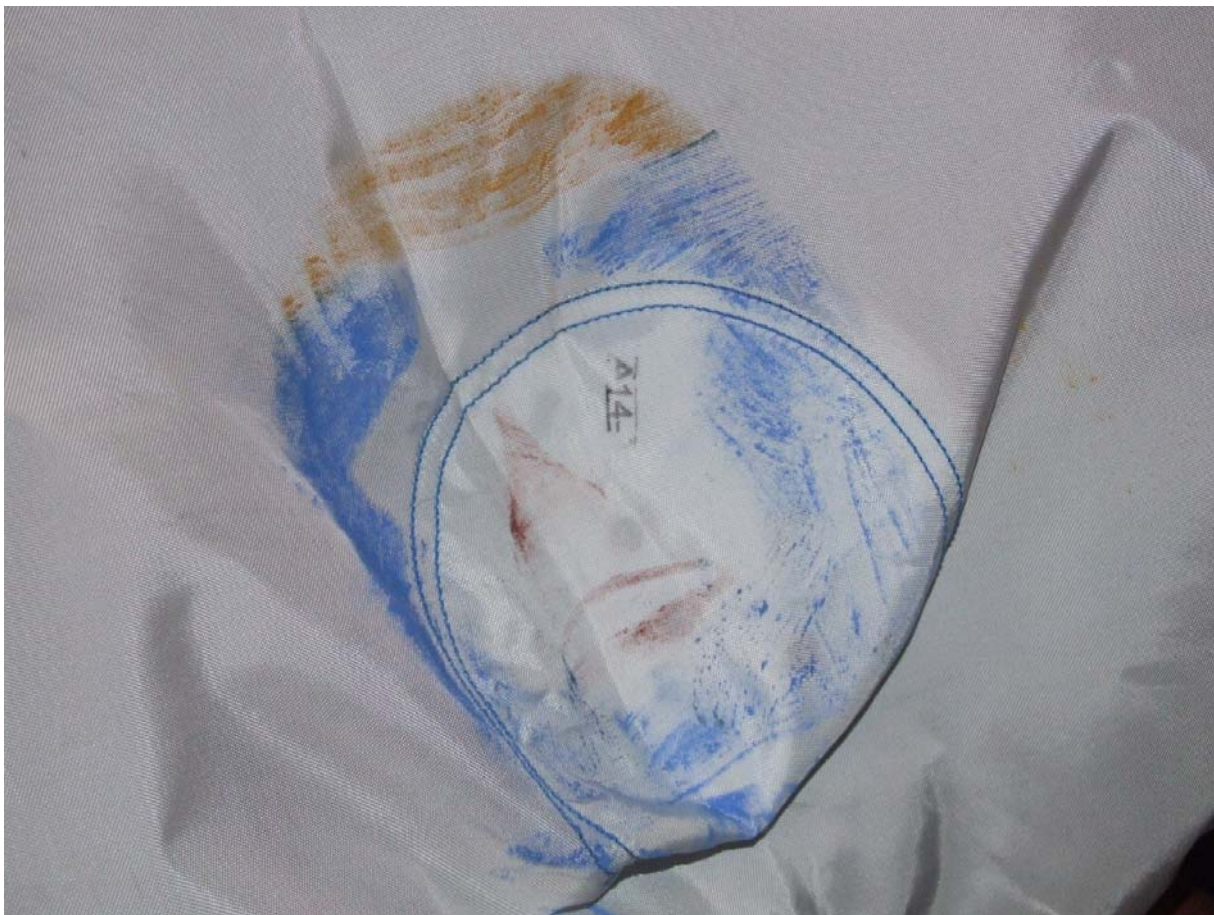
Post-Test Driver Dummy Airbag Contact

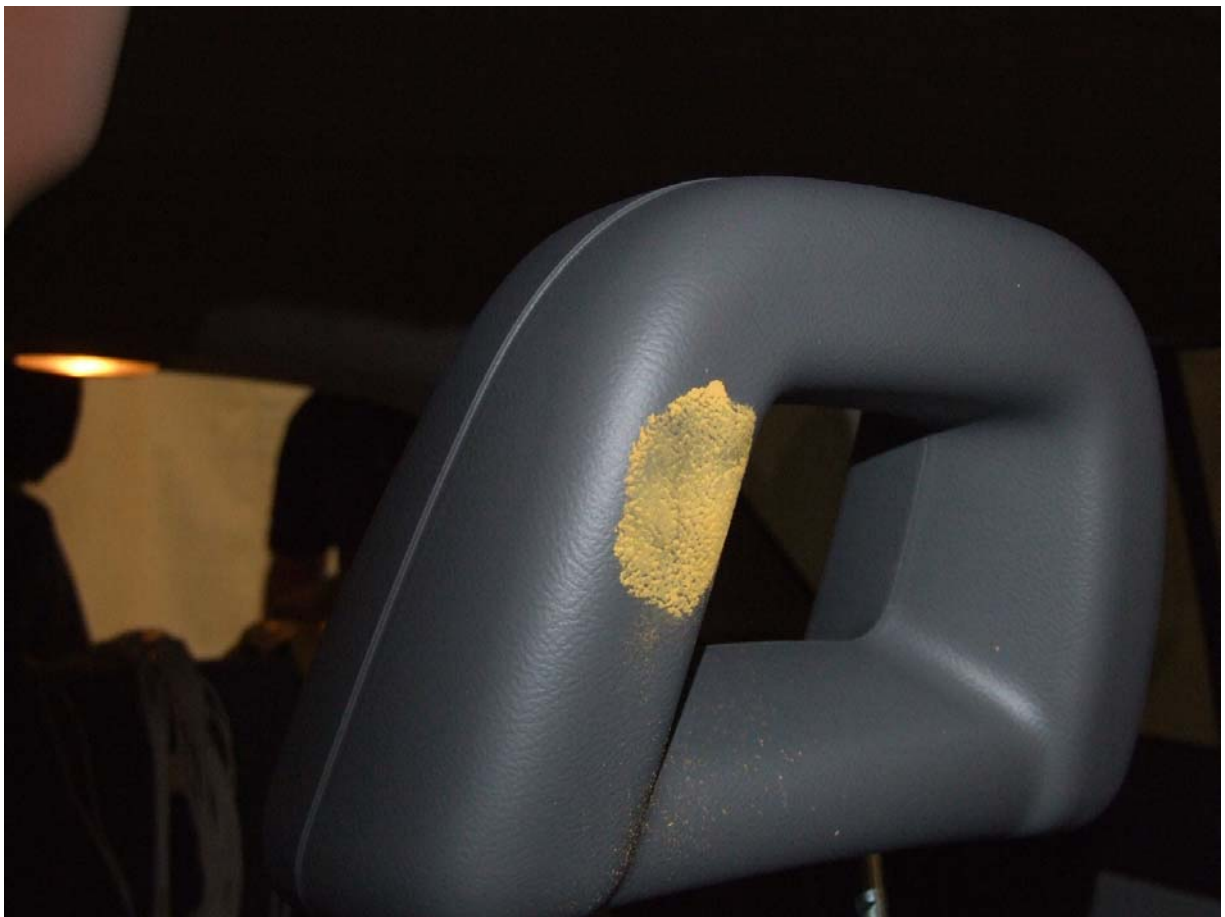
Post-Test Passenger Dummy Head Contact

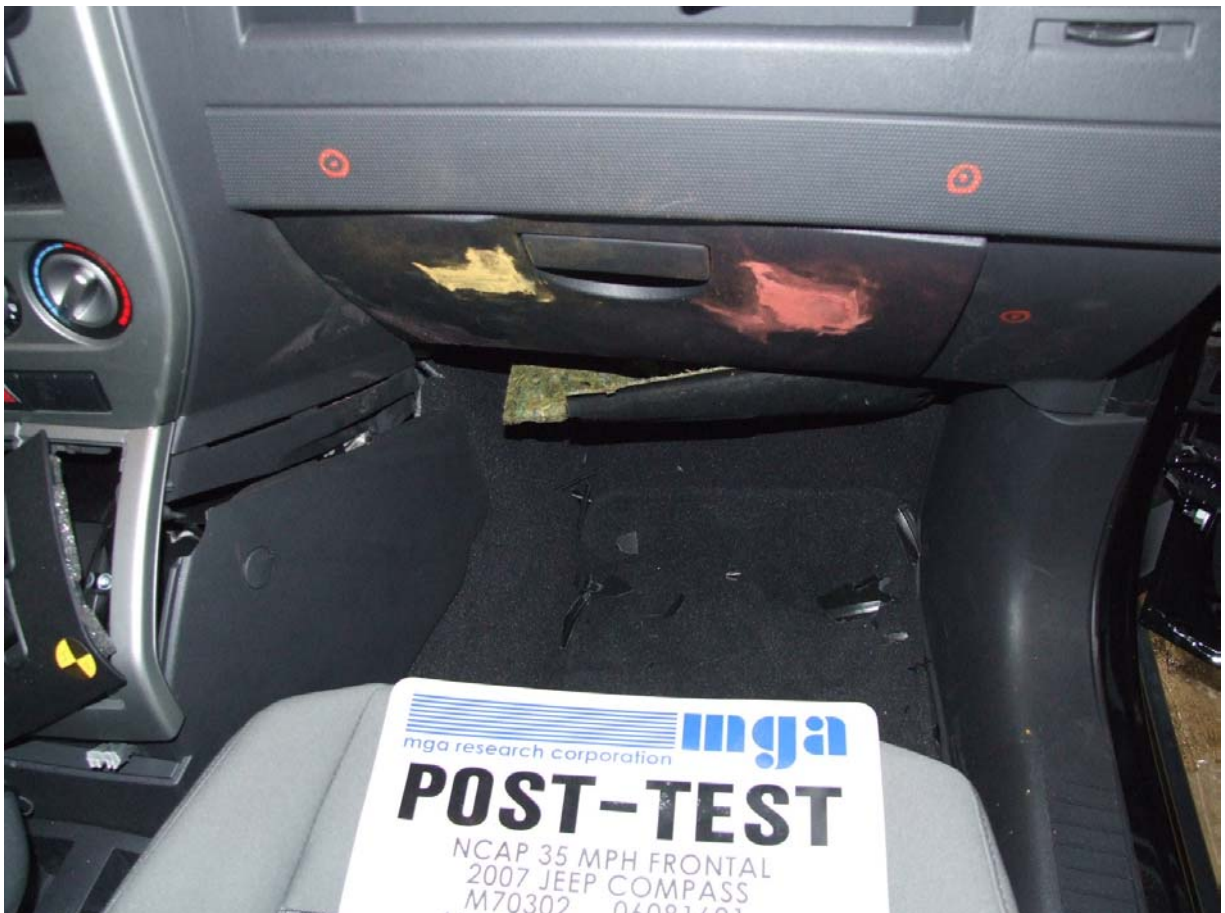
Post-Test Passenger Dummy Knee Contact

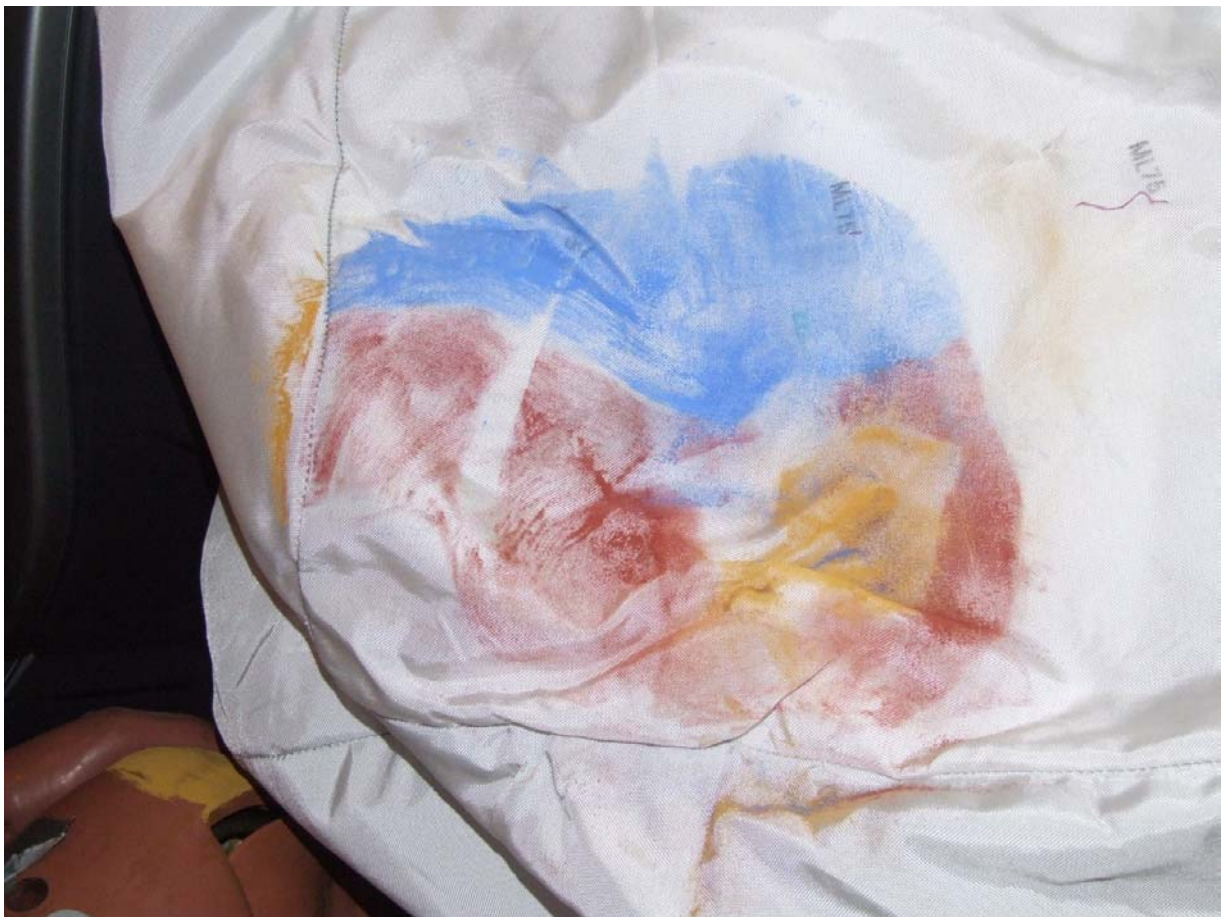
Post-Test Passenger Dummy Airbag Contact

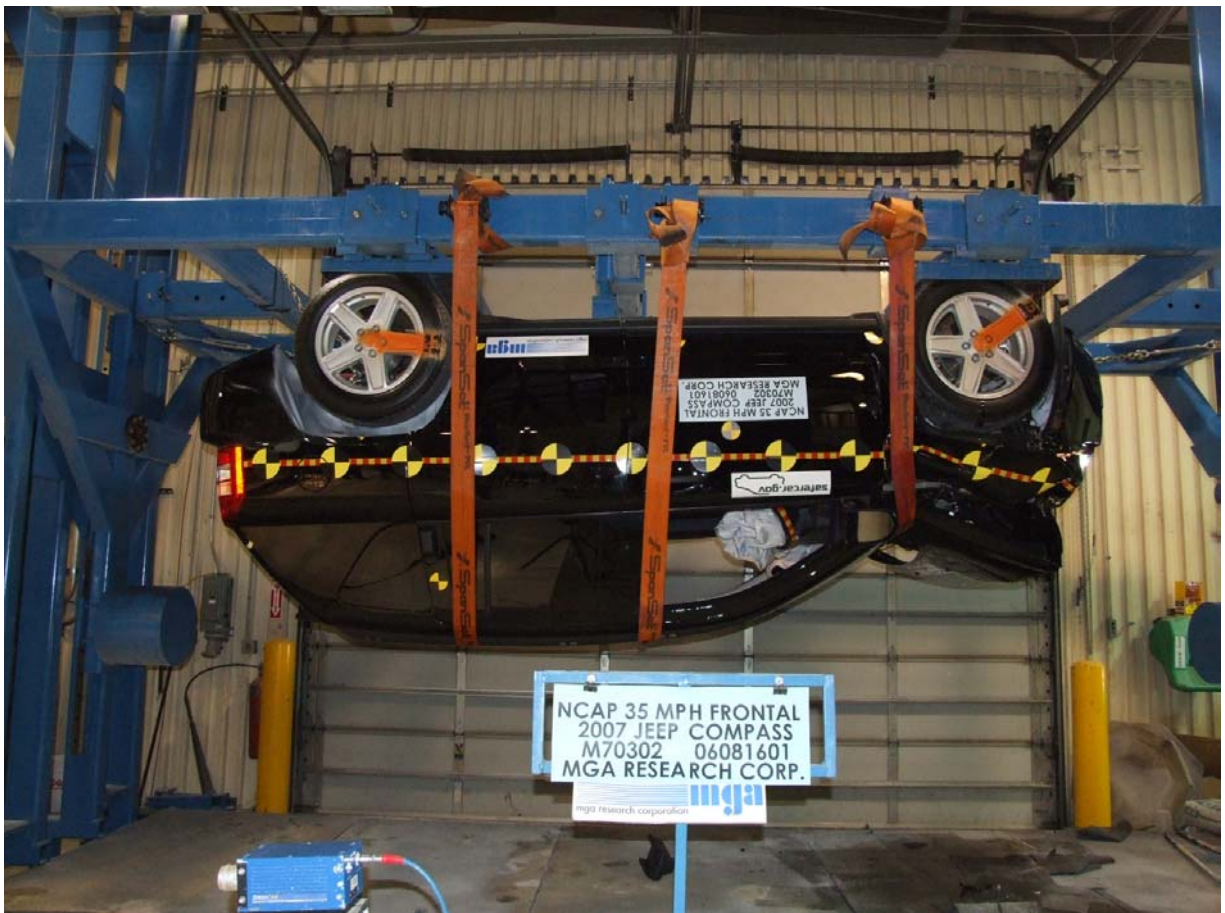
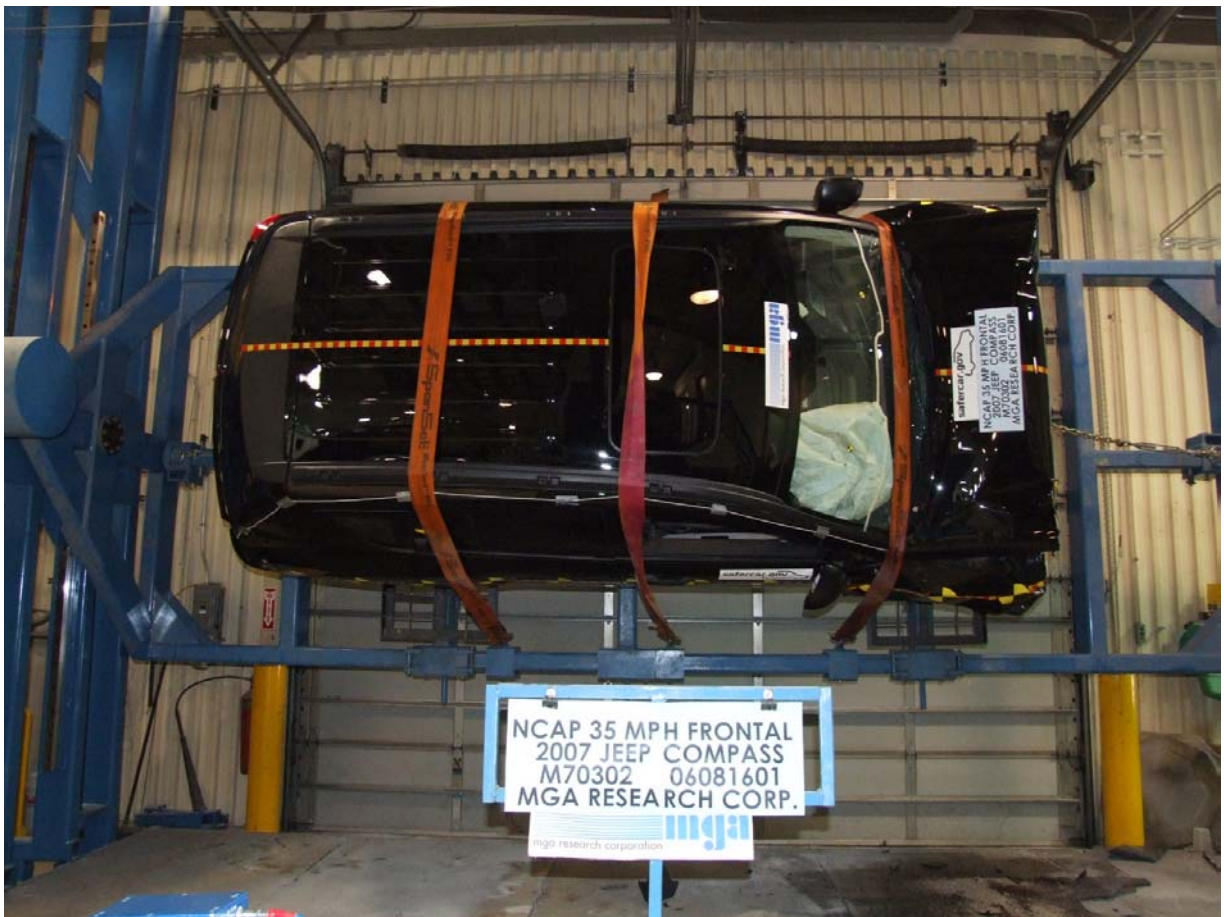
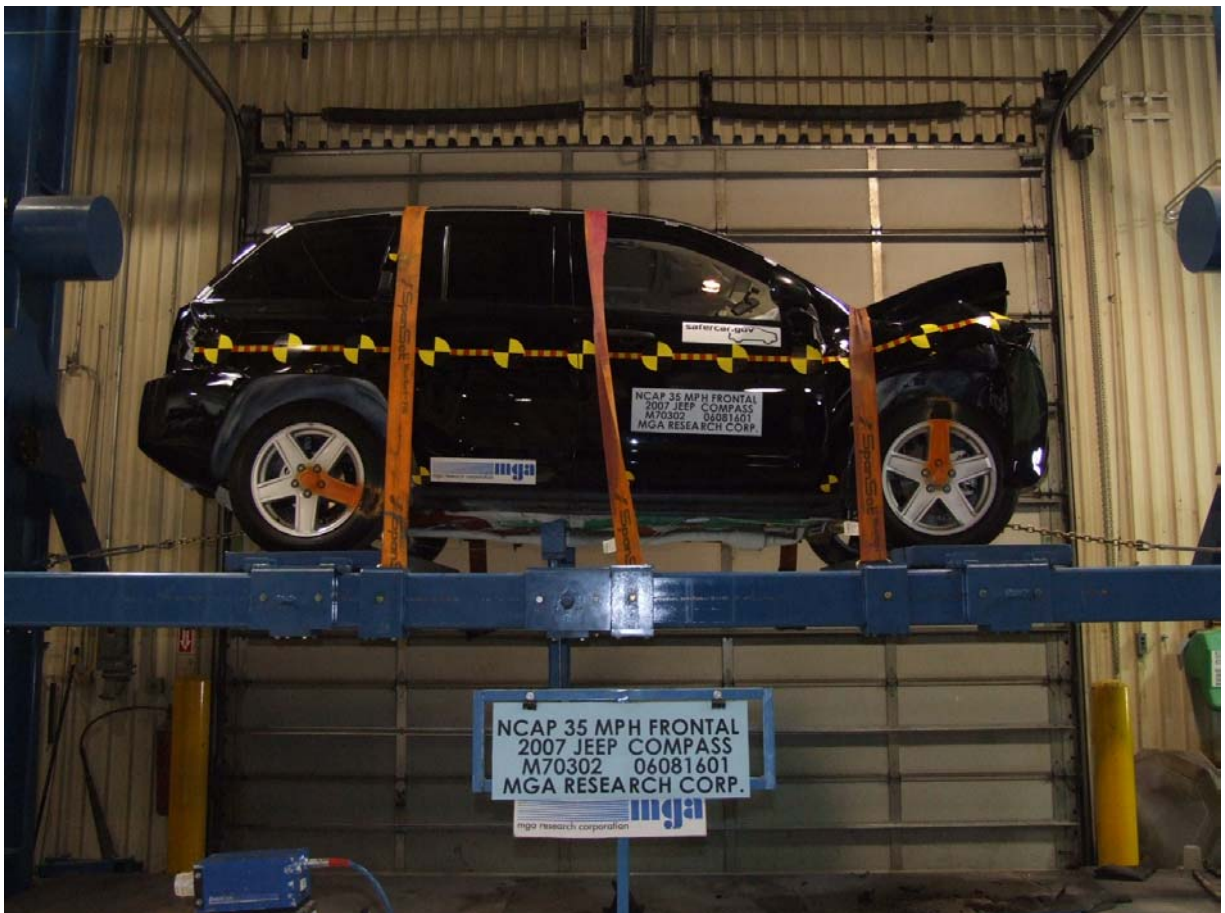
Vehicle on Rollover Device at 90 Degrees

Vehicle on Rollover Device at 180 Degrees

Vehicle on Rollover Device at 270 Degrees

Vehicle on Rollover Device at 360 Degrees

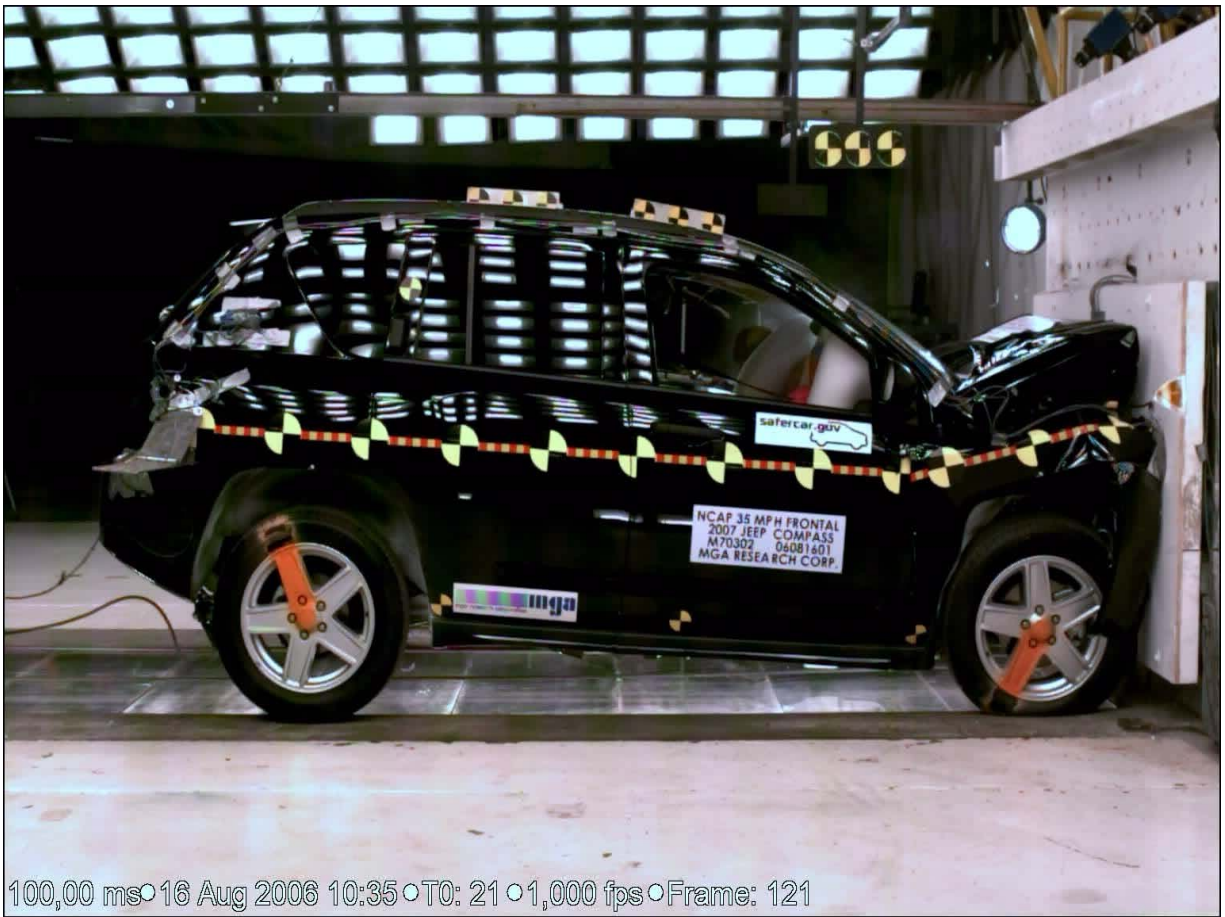
Vehicle Impact

A load cell barrier was impacted by a 2007 Jeep Compass Sport 4x4 at a velocity of 56.5 kph. The test was performed at MGA Research Corporation on August 16, 2006. Pre-and post-test photographs of the vehicle and dummies can be found in Appendix A.
