REPORT NUMBER TR-P26161-01-NC

**NEW CAR ASSESSMENT PROGRAM
SIDE IMPACT TEST**

**FORD MOTOR COMPANY
2006 FORD FREESTYLE
5-DOOR MPV**

FINAL REPORT

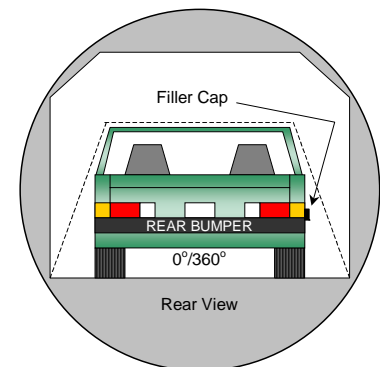
270° to 360°

- A. From impact until vehicle motion ceases: 0.0 oz.
(Maximum Allowable = 1 ounce)
- B. For the 5 minute period after motion ceases: 0.0 oz.
(Maximum Allowable = 5 ounces)
- C. For the following 25 minutes: 0.0 oz.
(Maximum Allowable = 1 oz./minute)
- D. Spillage Details: No leakage occurred

1. The specified fixture rollover rate for each 90° of rotation is 60 to 120 seconds.
 2. The position hold time at each position is 300 seconds (minimum).
 3. Details of Stoddard Solvent spillage locations.
- No solvent leakage occurred during static rollover testing.

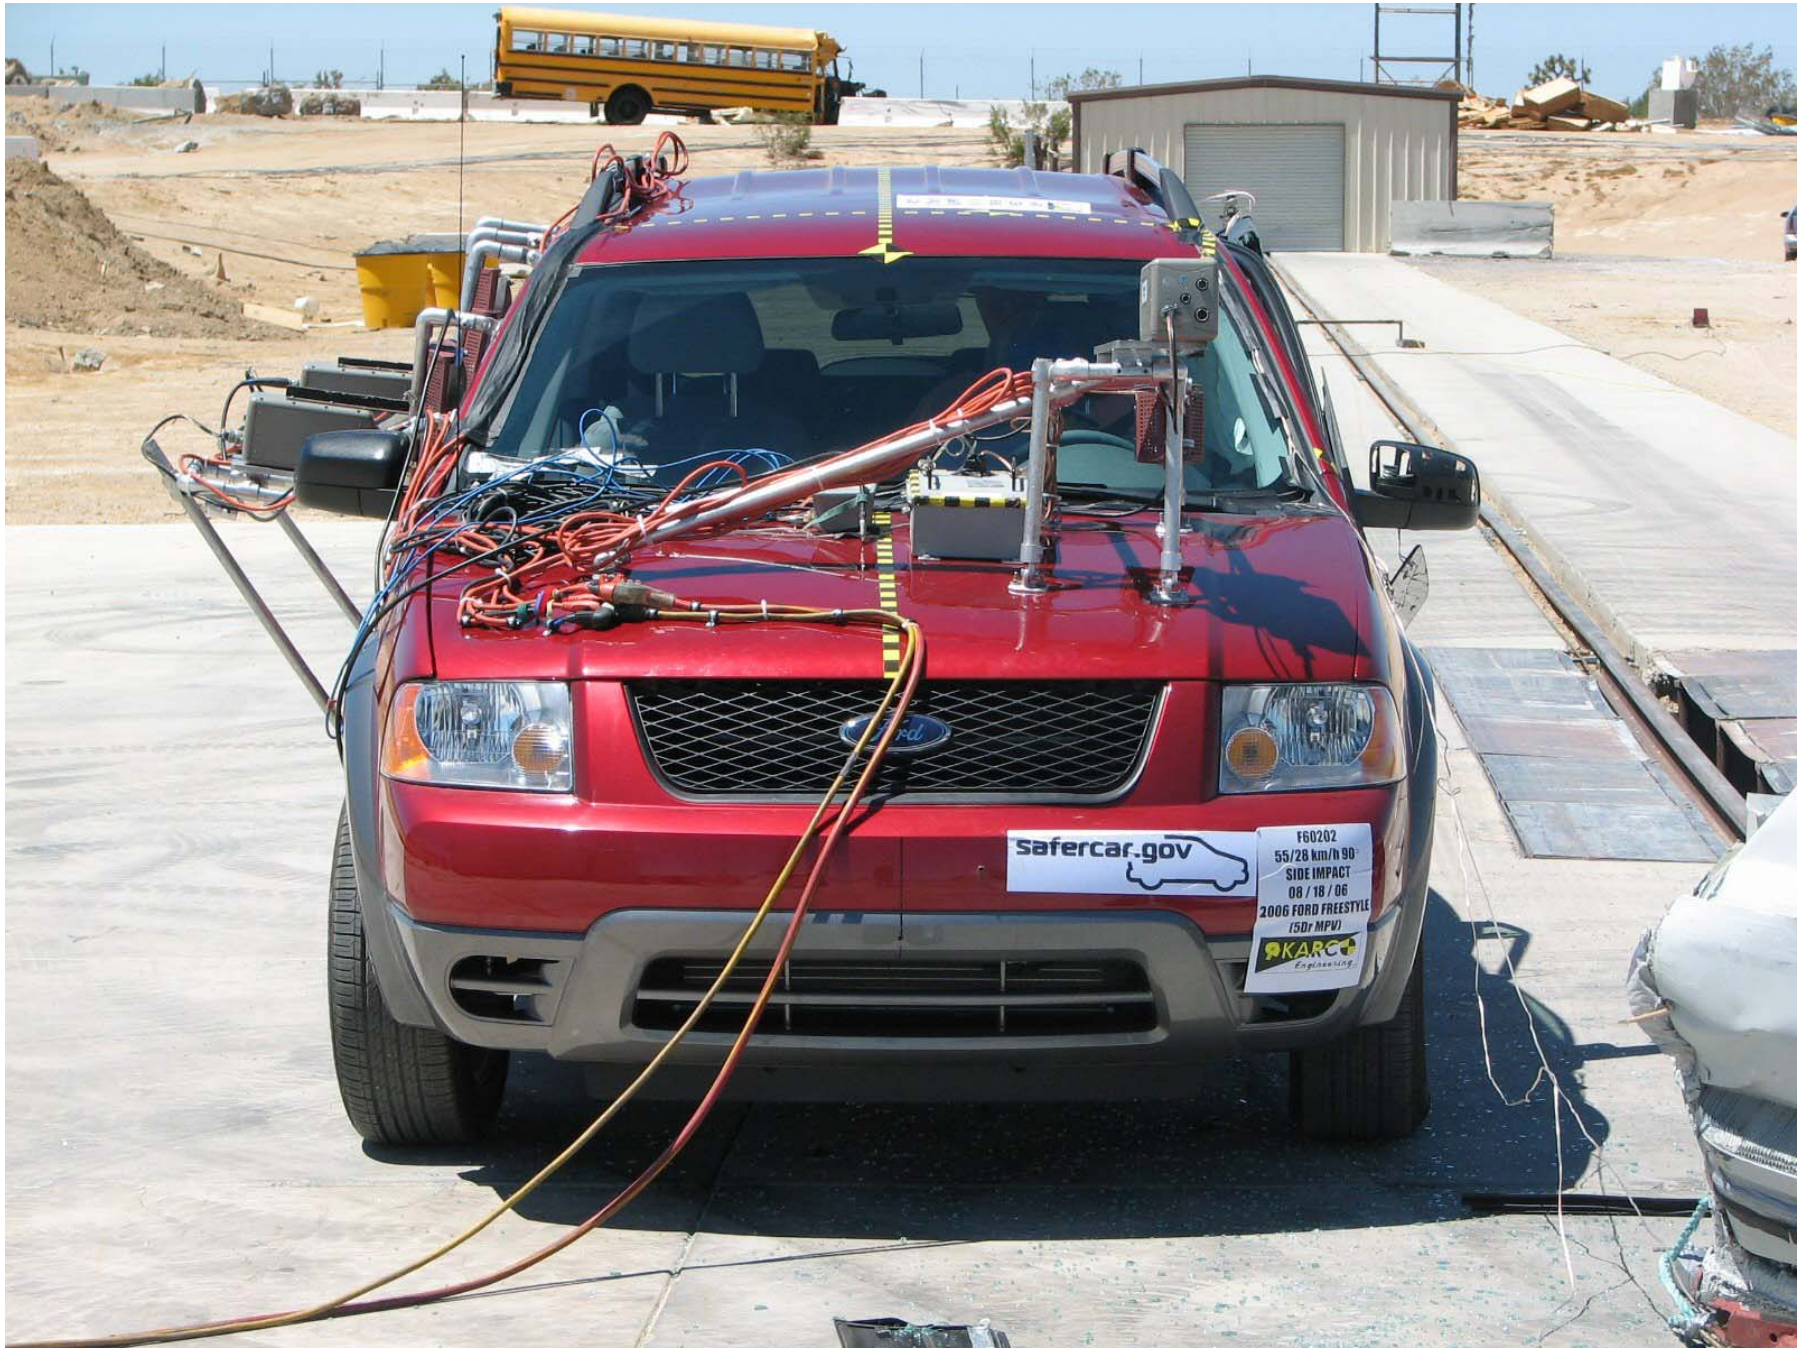
Figure A-6: Post-Test Front View

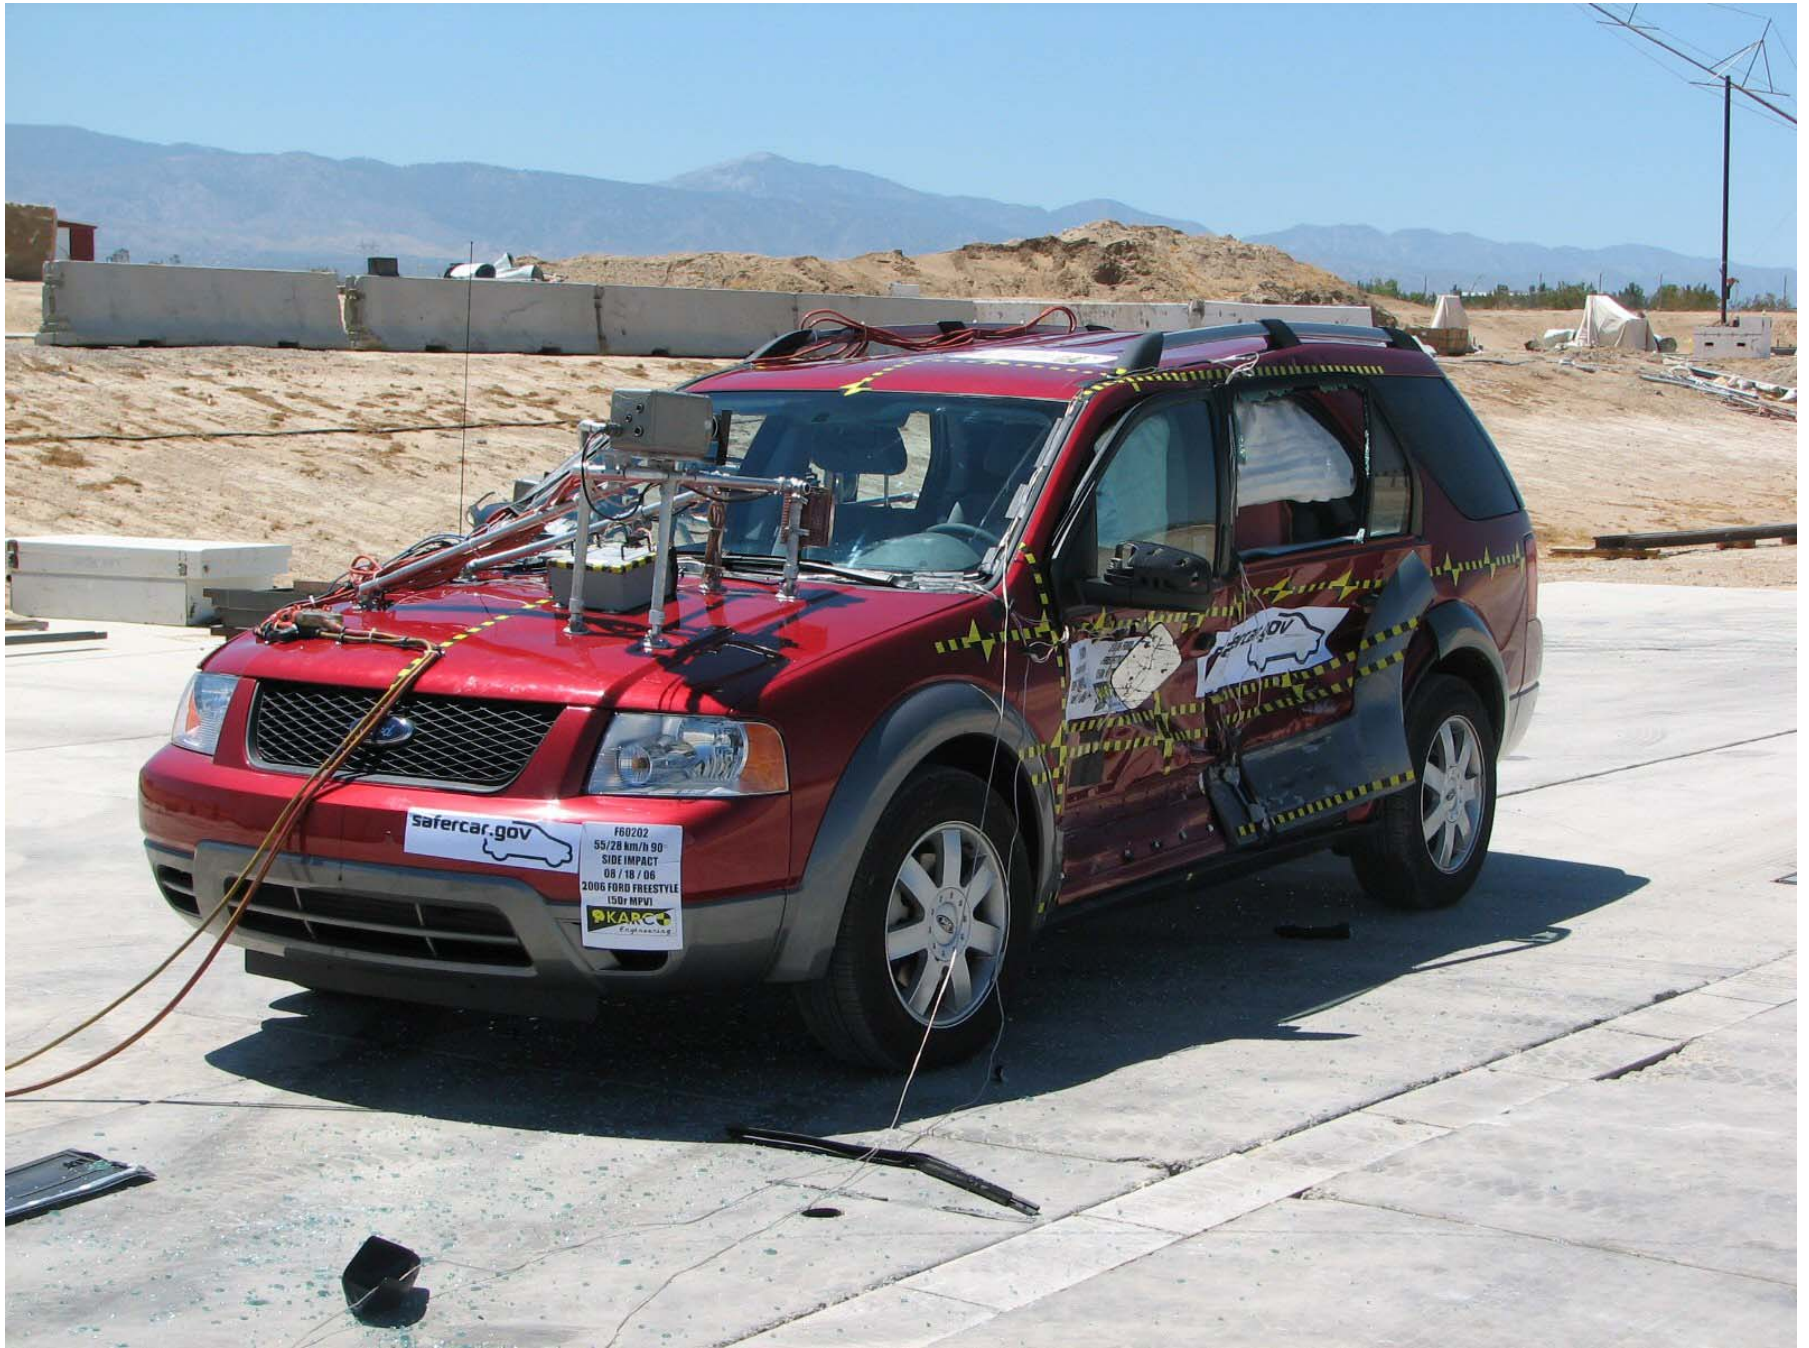
Figure A-8: Post-Test Left Front $\frac{3}{4}$ View

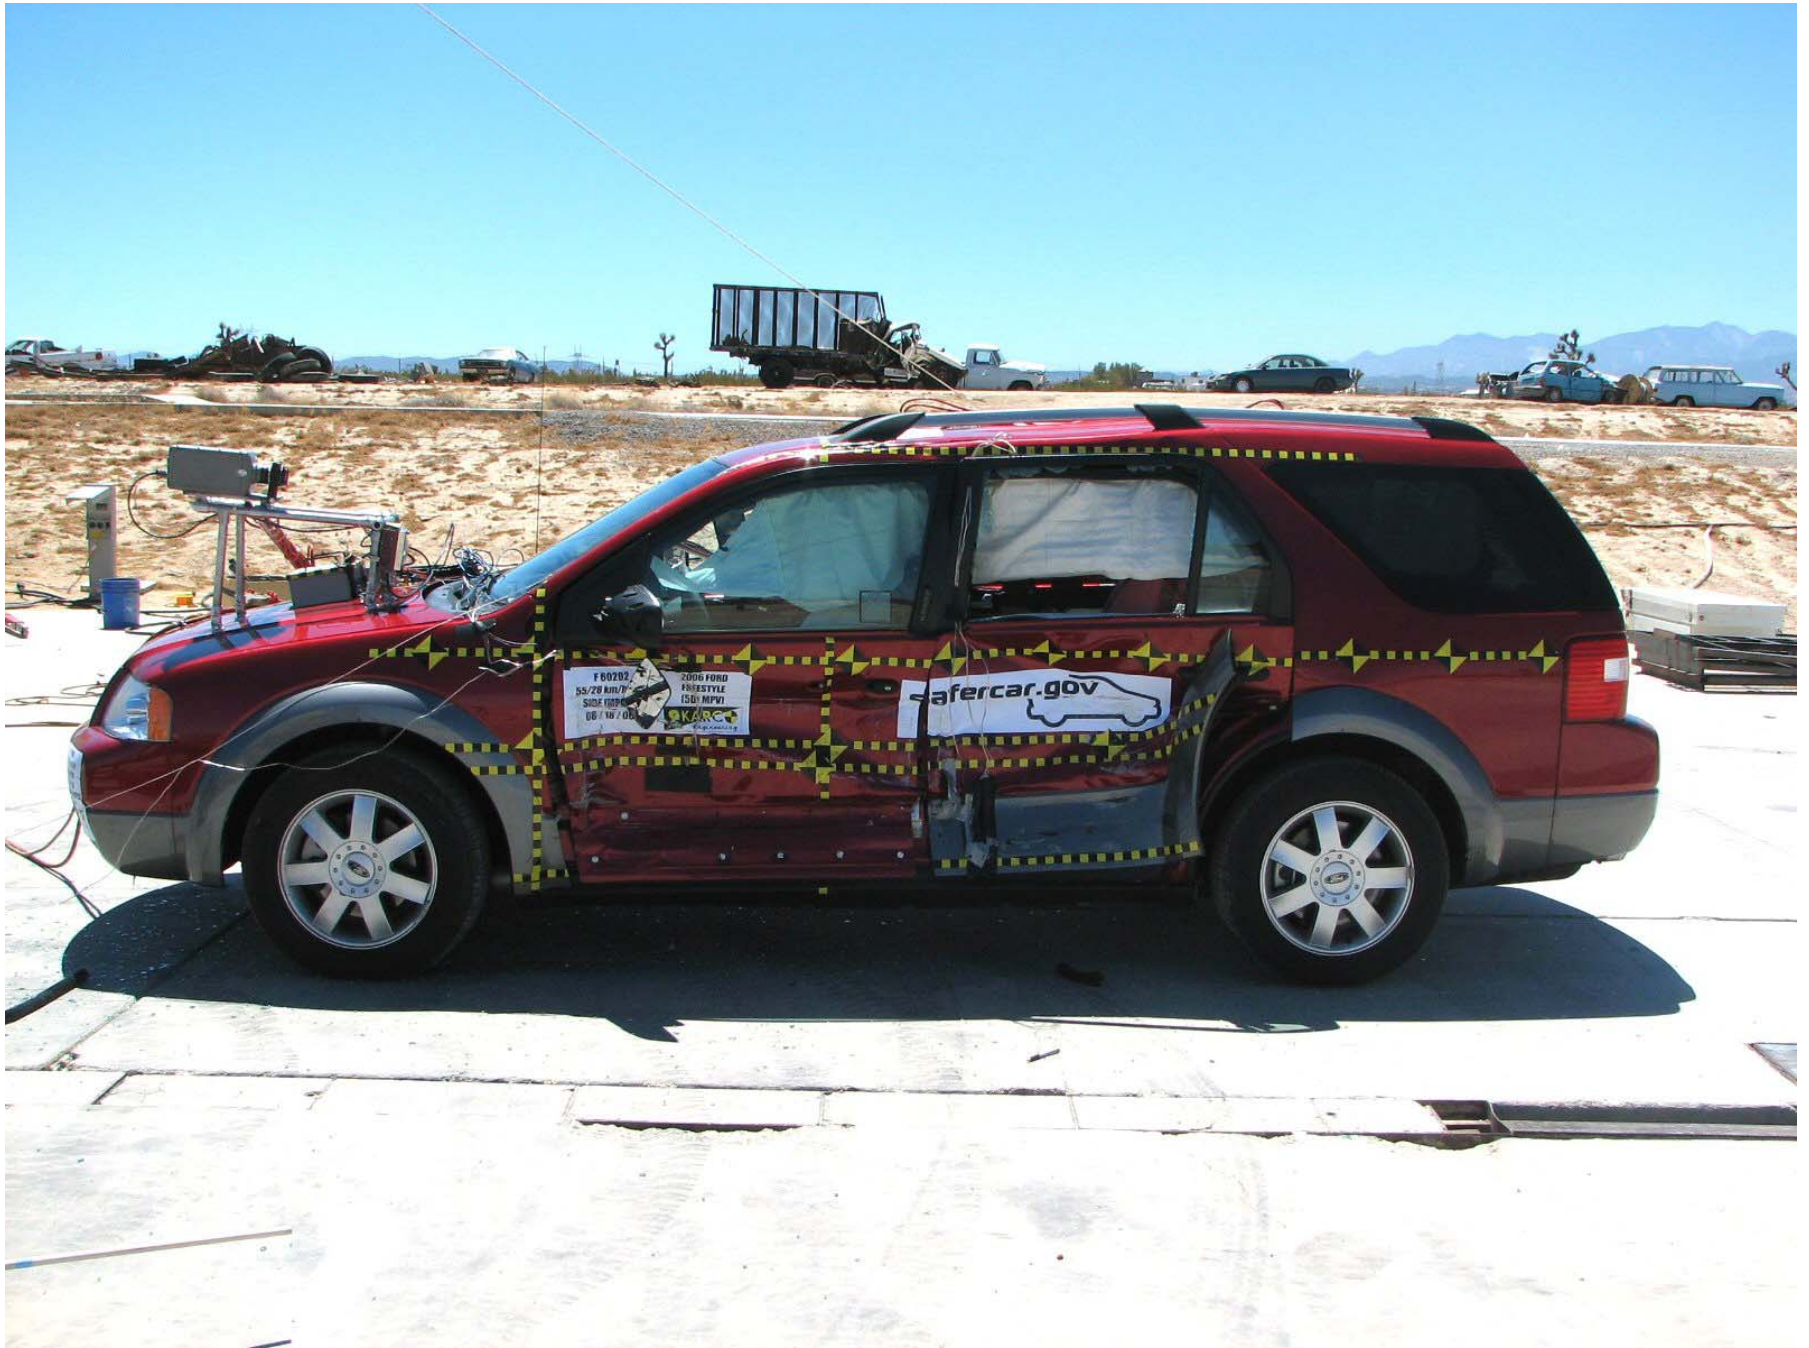
The driver and passenger doors remained closed during impact. The test vehicle sustained a maximum static crush of 240 mm at level 3, 1500 mm rearward of the left vertical impact point. The driver SID/Hybrid III, Serial No. 275 and the passenger SID/Hybrid III, Serial No. 274 were calibrated prior to this test. The SID/Hybrid III injury criteria is summarized as follows:

Figure A-10: Post-Test Left Side View

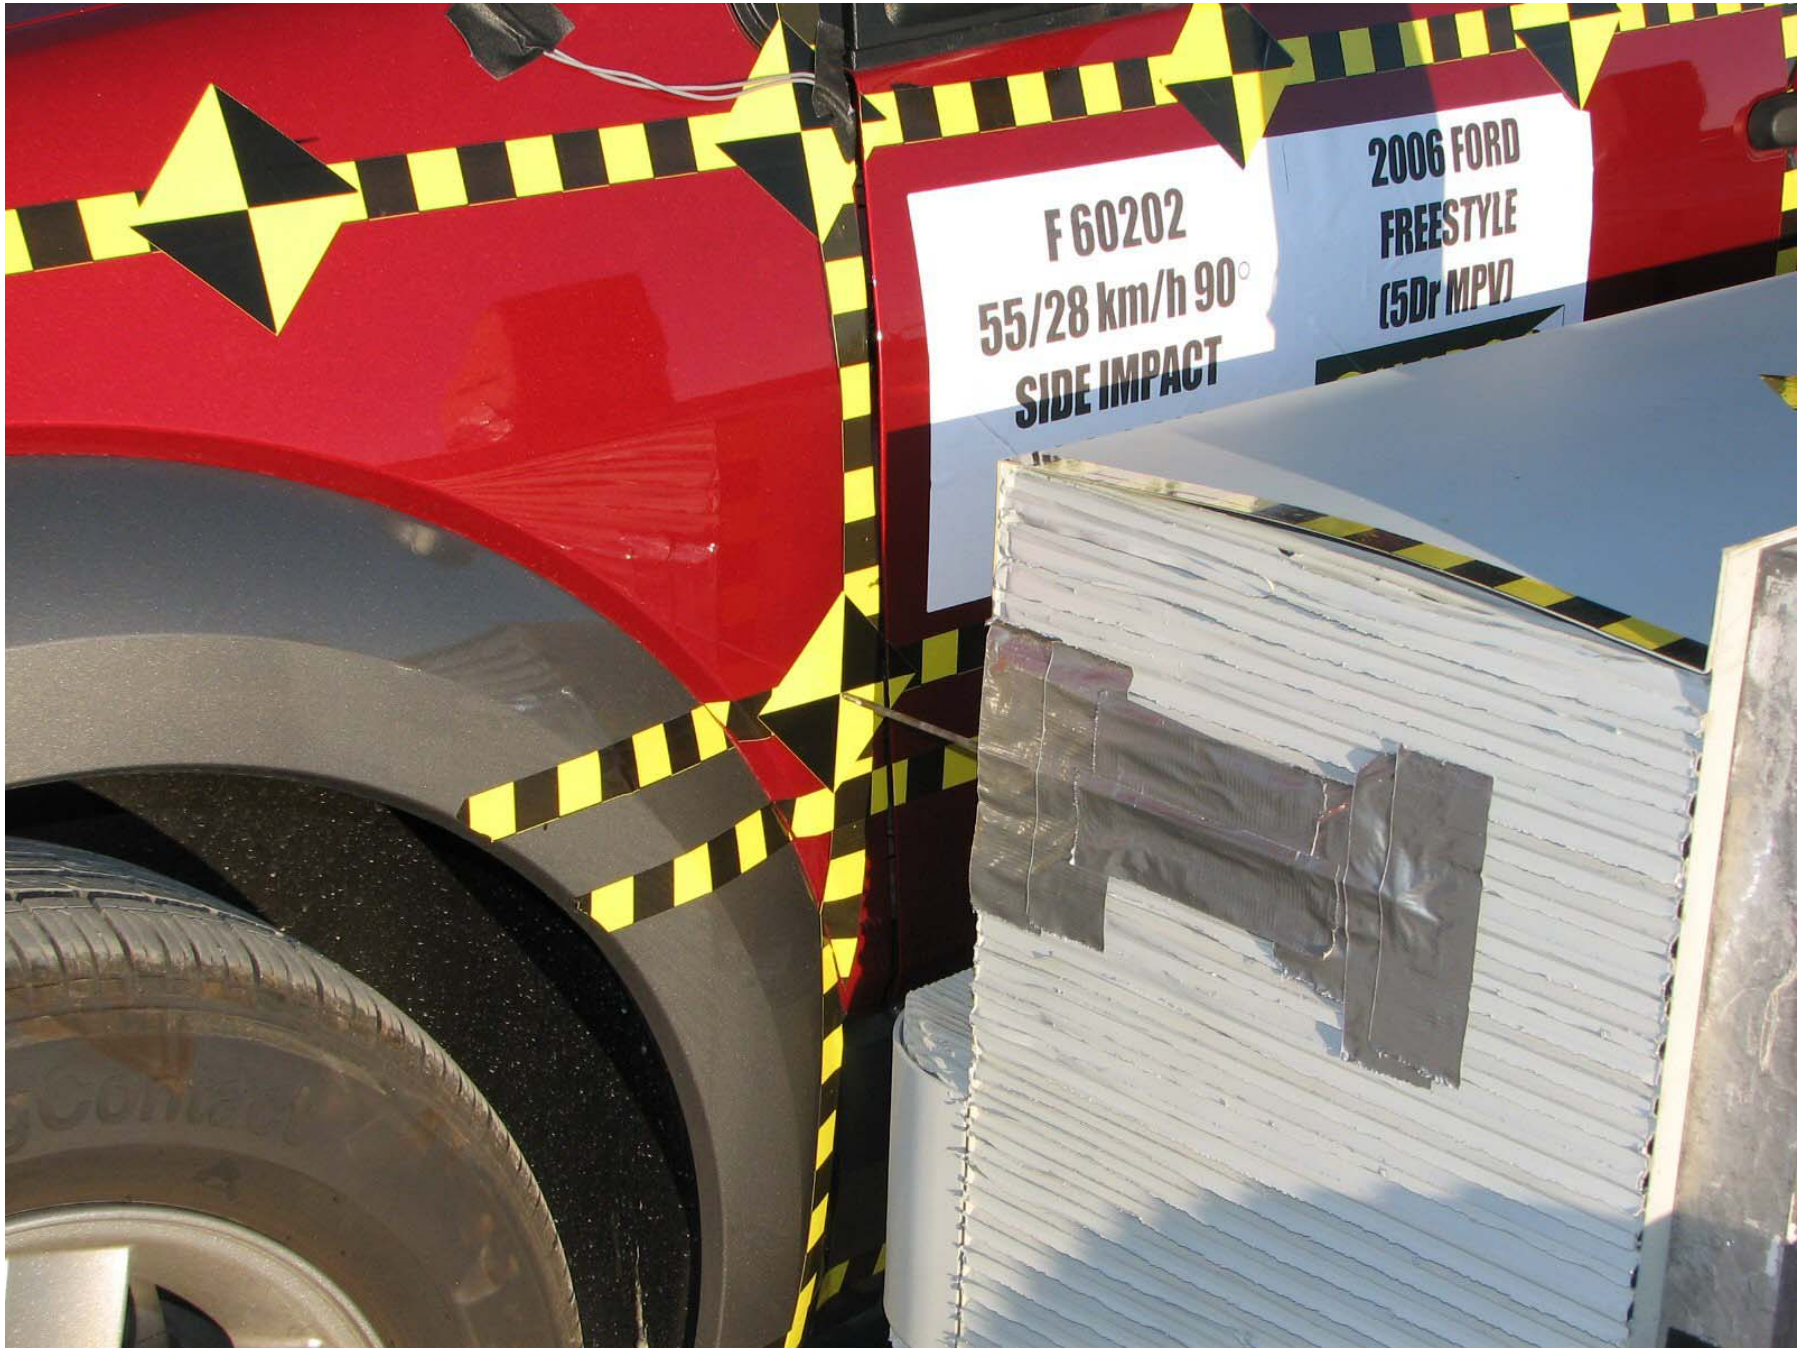
Figure A-25: Pre-Test Left Impact Point

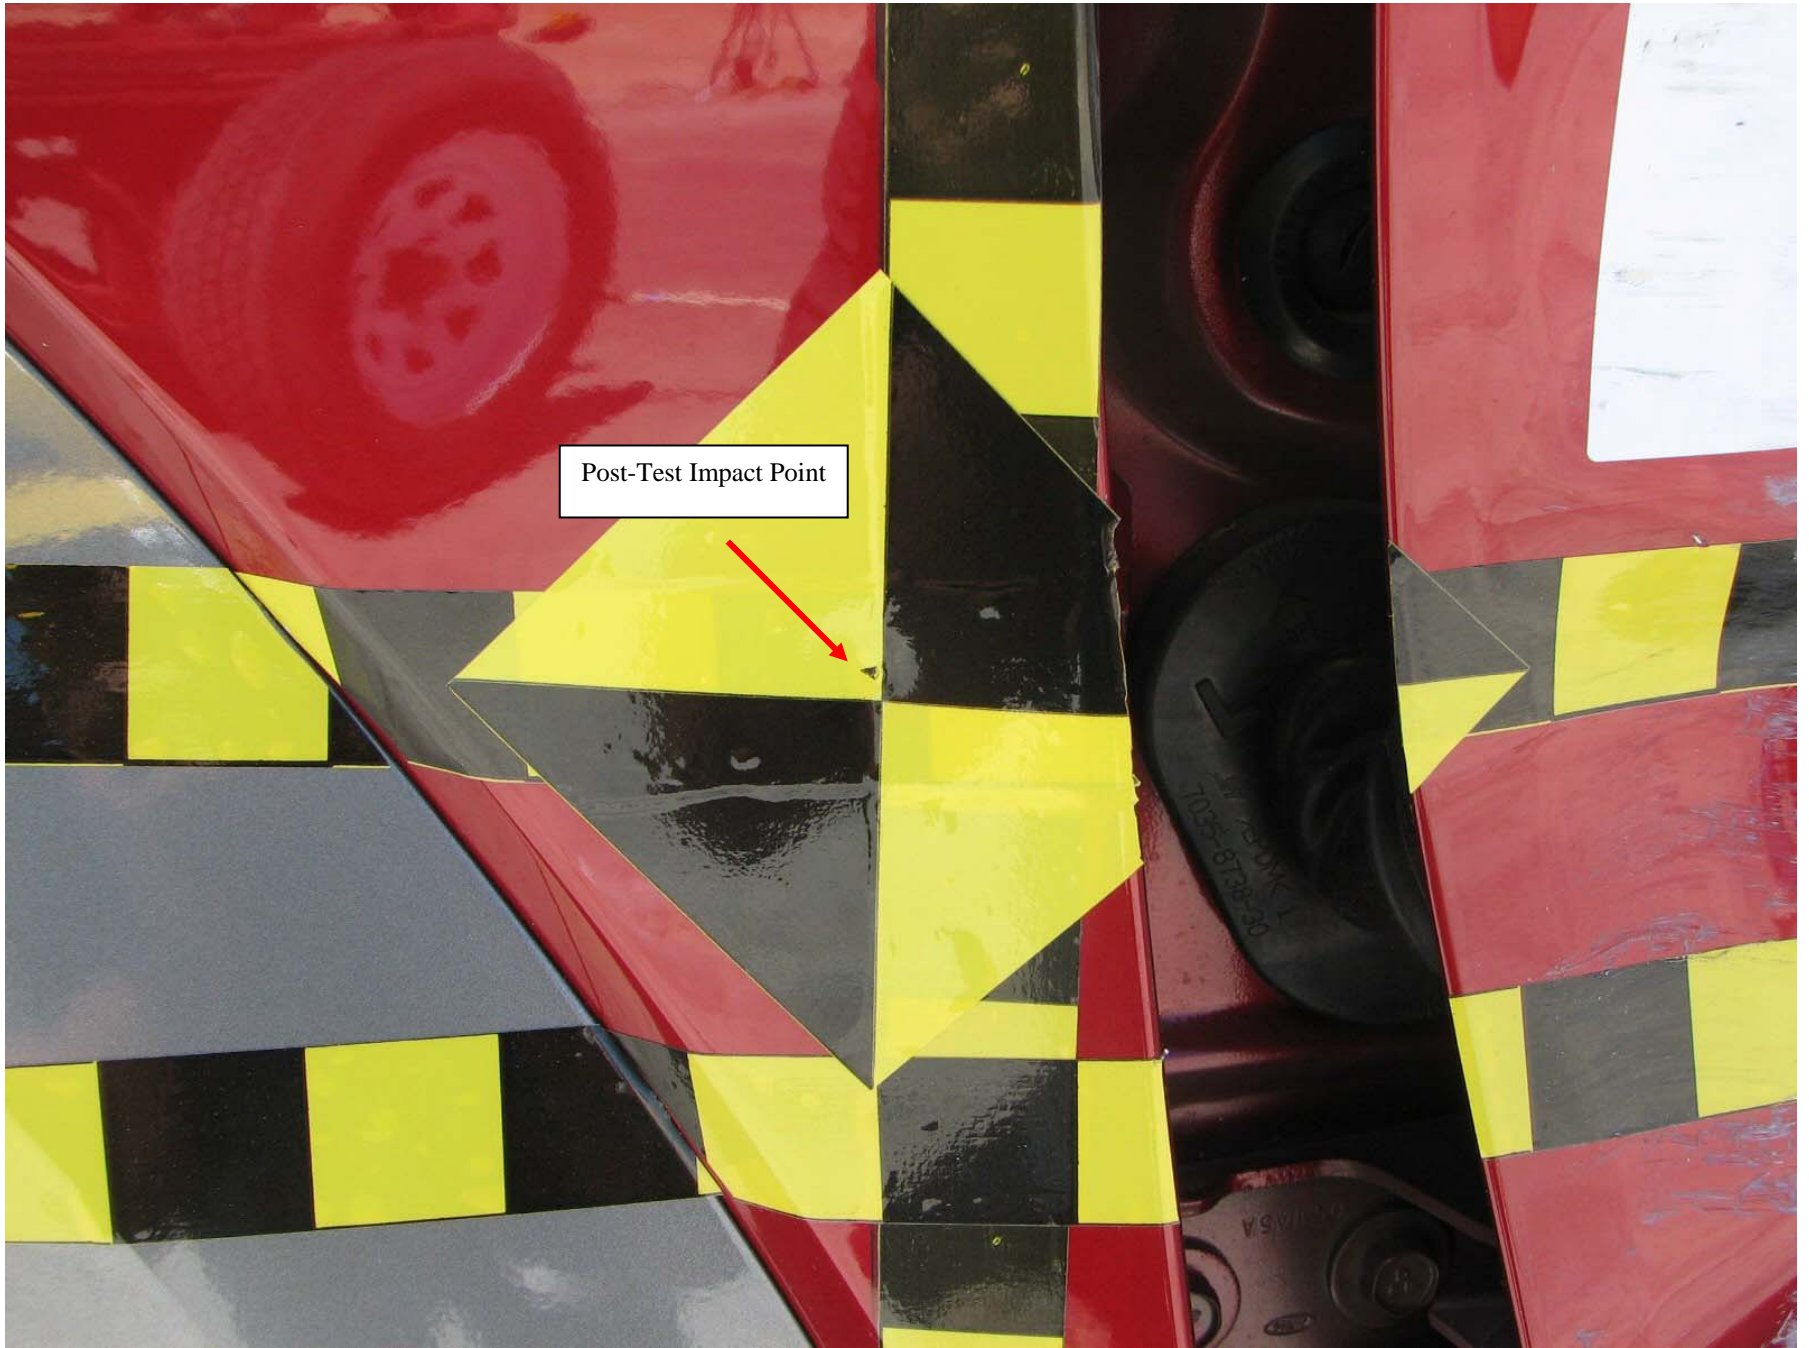
Figure A-26: Post-Test Left Impact Point

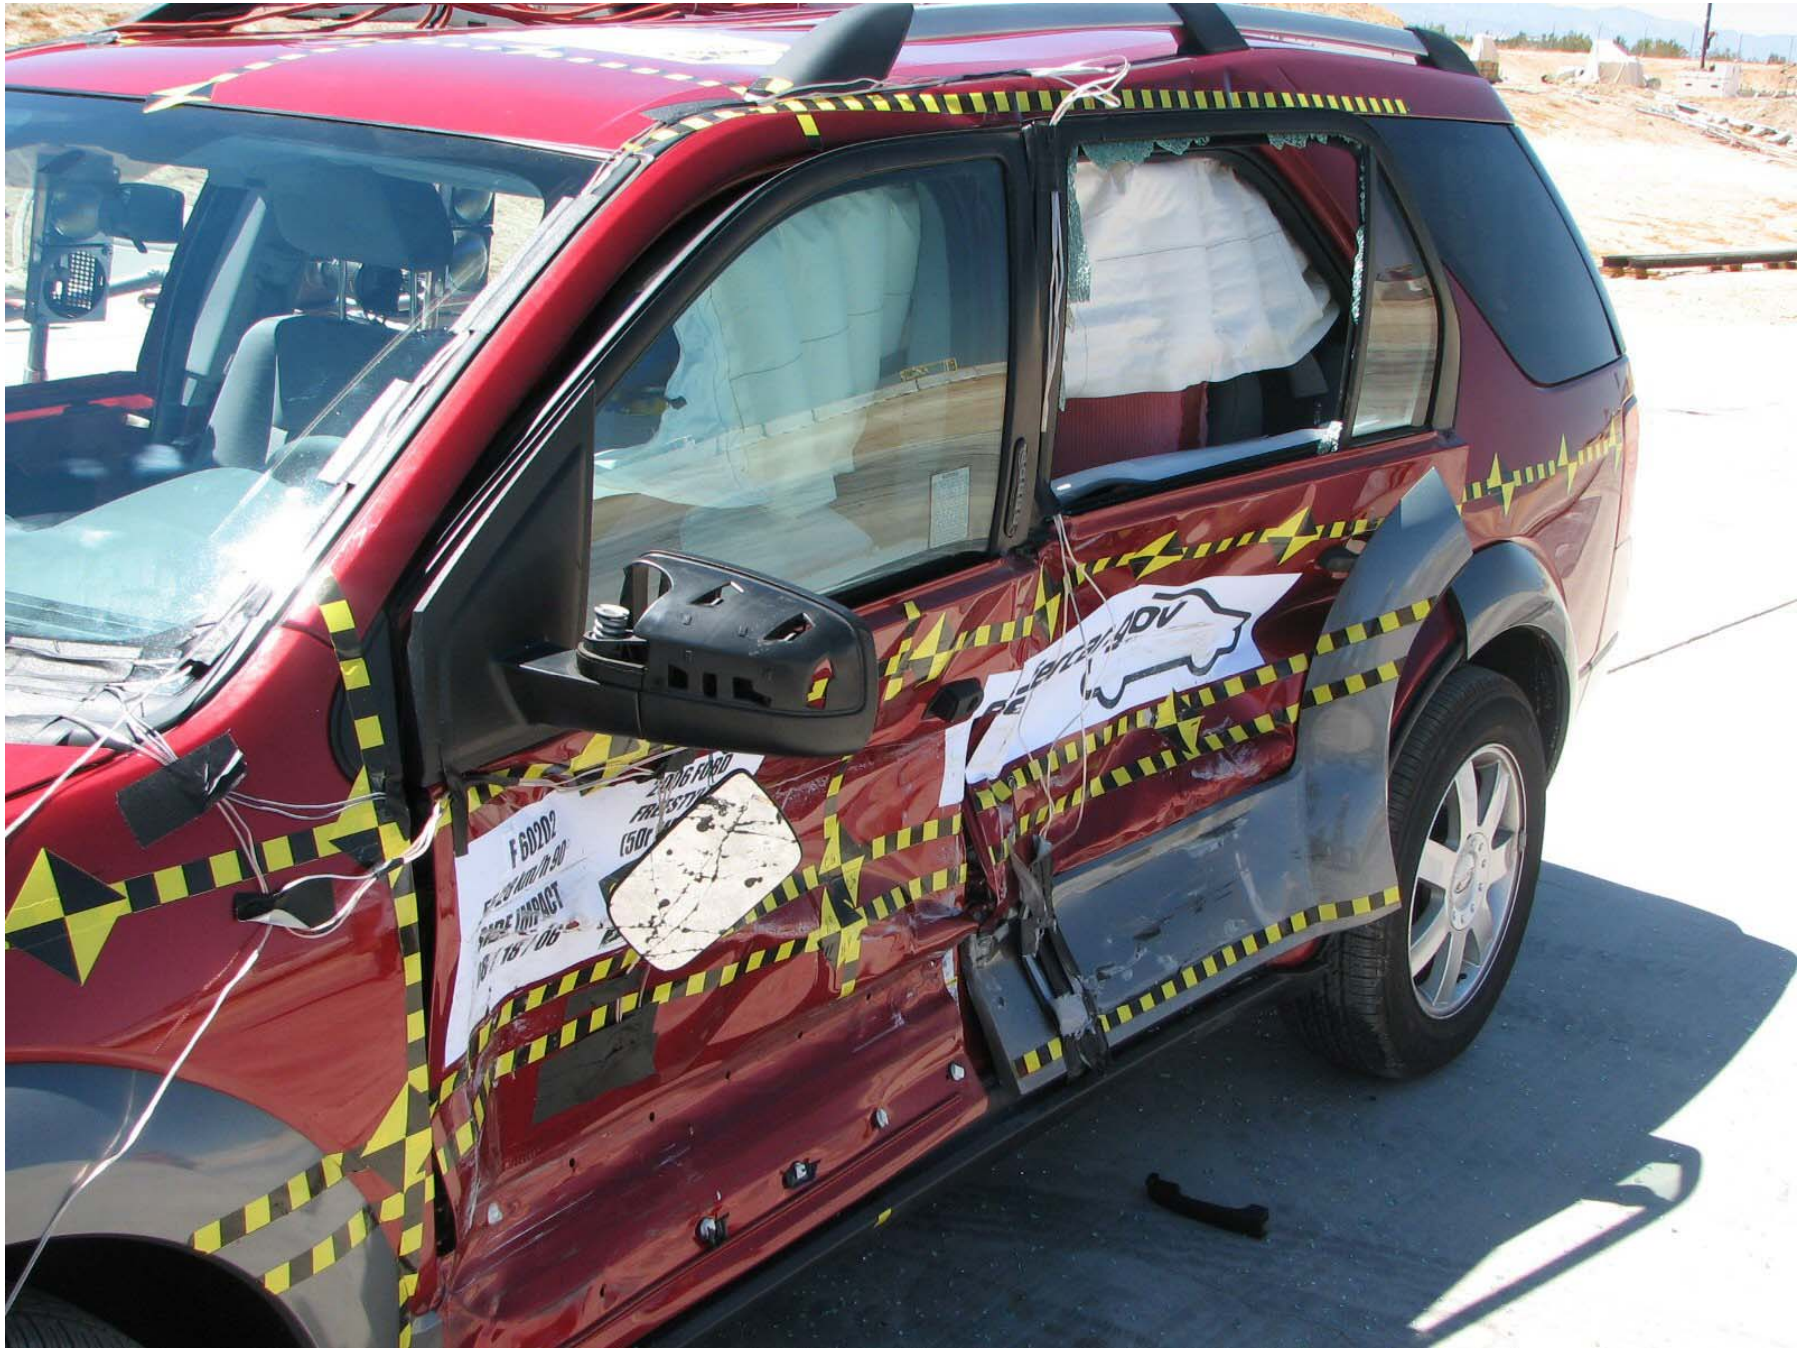
Description	Front	Rear
Left Side Door Opening	Remained closed and latched, jammed	Remained closed and latched, jammed
Right Side Door Opening	Remained closed and latched, operational	Remained closed and latched, operational
Seat Movement	None	None
Seat Back Failure	None	None

Figure A-28: Post-Test Front ¾ View of Left Side Doors

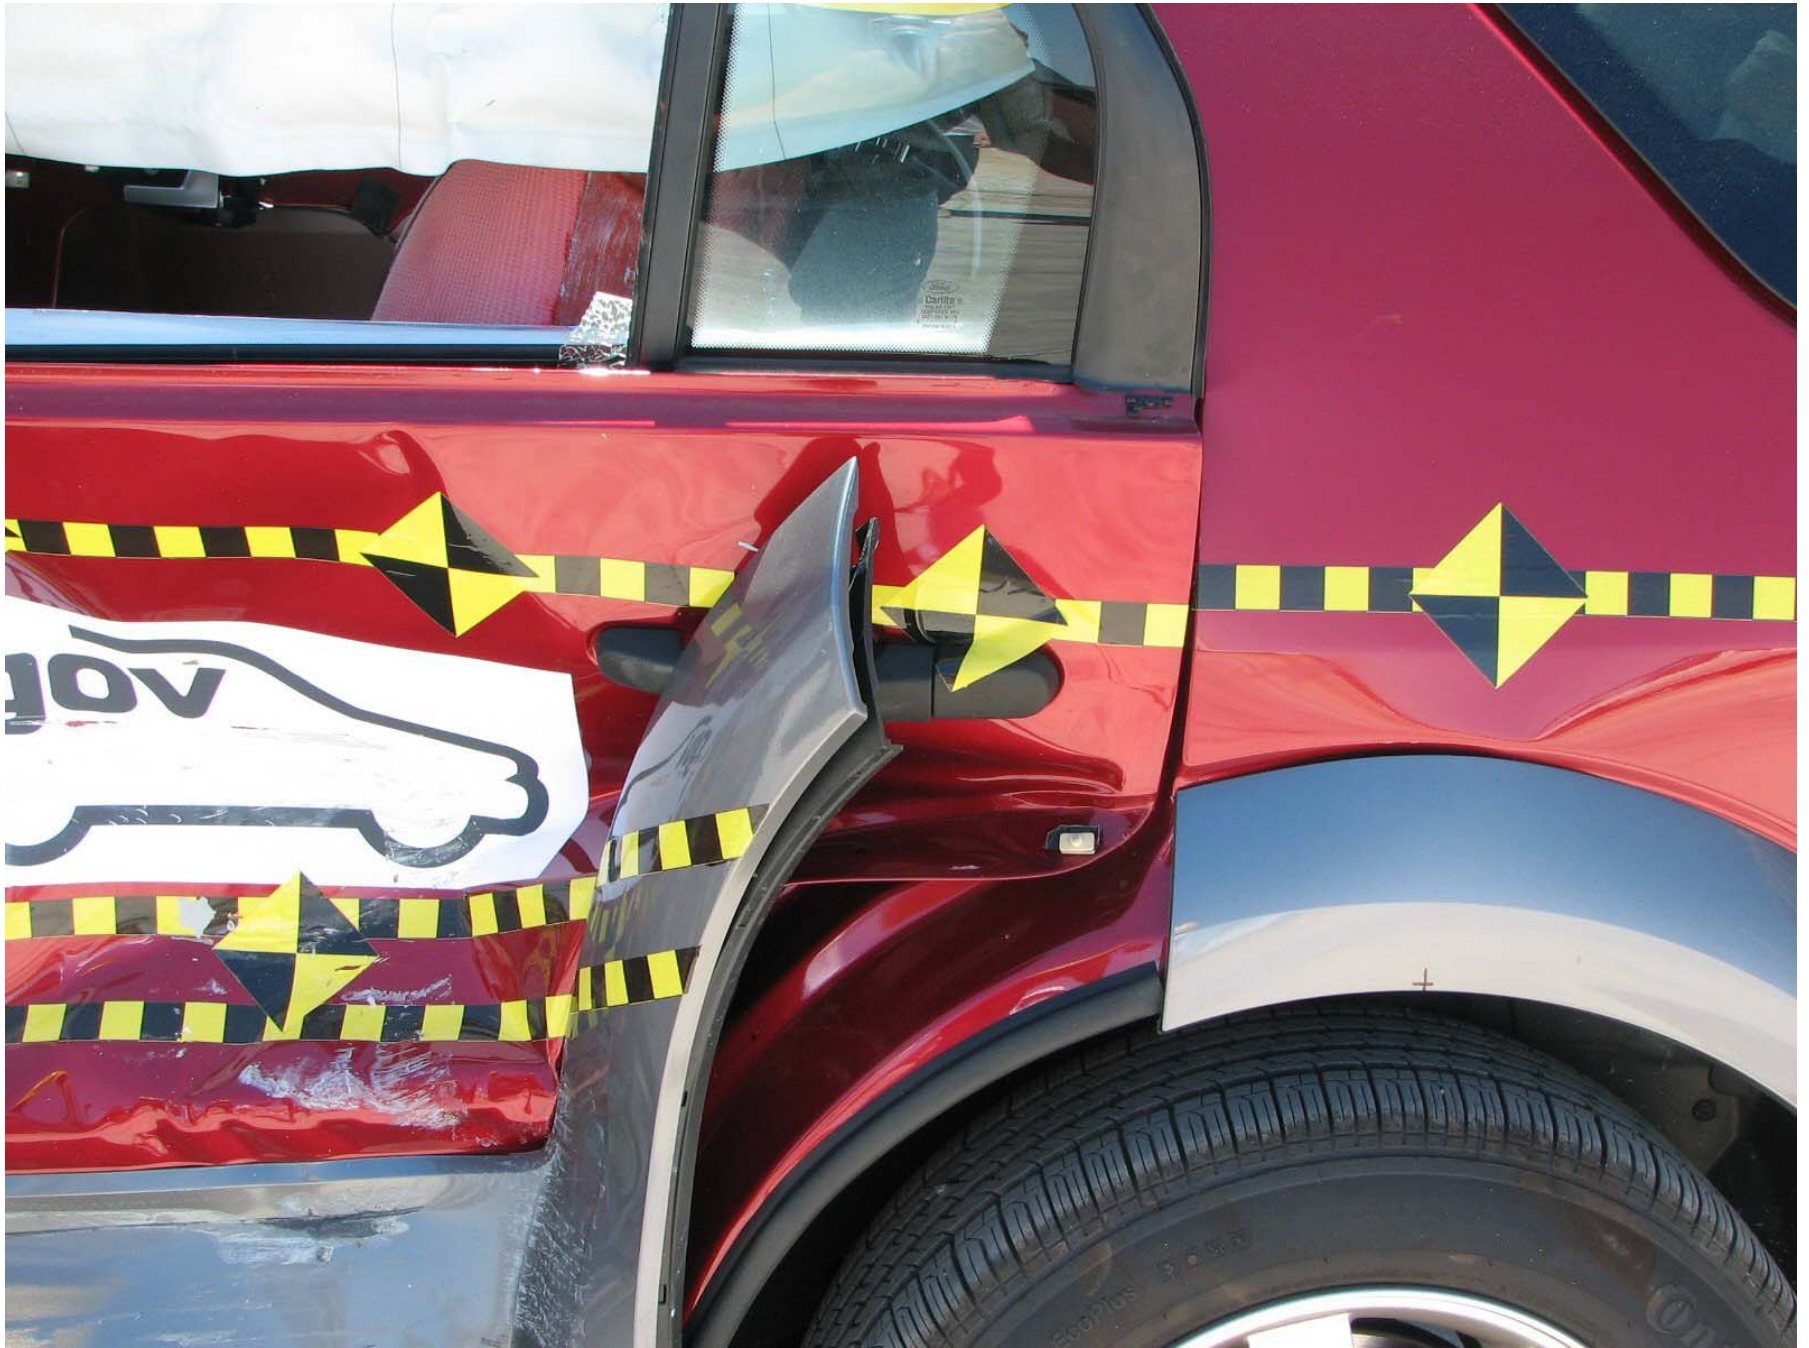
Figure A-34: Post-Test Left Rear Door

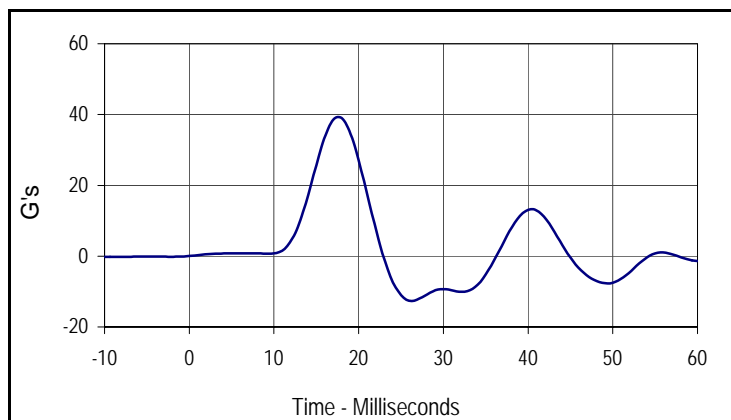
Tested Parameter	Units	Specification	Result	Pass/Fail
Laboratory Temperature	°C	18.9 to 25.6	21.7	Pass
Laboratory Relative Humidity	%	10 to 70	30	Pass
Probe Velocity	m/s	4.21 to 4.33	4.22	Pass
Upper Rib Acceleration	G's	37.0 to 46.0	39.3	Pass
Lower Rib Acceleration	G's	37.0 to 46.0	38.4	Pass
Thoracic Spine Acceleration	G's	15.0 to 22.0	18.6	Pass
Overall Test Results			Pass

Curve Description			
Upper Rib Primary			
CURNO	Type	SAE Class	Units
001	FIL	FIR100	G's
Max	Time	Min	Time
39.3	17.5	-12.7	26.3

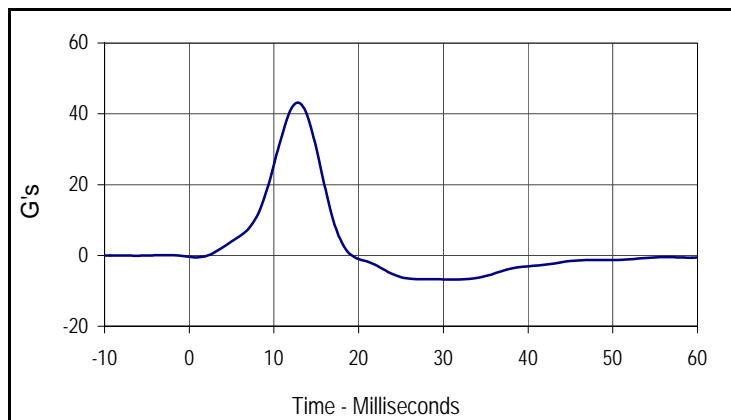
Tested Parameter	Units	Specification	Result	Pass/Fail
Laboratory Temperature	°C	18.9 to 25.6	21.7	Pass
Laboratory Relative Humidity	%	10 to 70	30	Pass
Probe Velocity	m/s	4.21 to 4.33	4.29	Pass
Peak Pelvis Acceleration	G's	40.0 to 60.0	42.9	Pass
Acceleration Time Above 20 G's	Msec.	3.0 to 7.0	6.88	Pass
Overall Test Results				Pass

Curve Description			
Pelvis Primary Y			
CURNO	Type	SAE Class	Units
001	FIL	FIR100	G's
Max	Time	Min	Time
42.9	13.1	-6.8	31.3

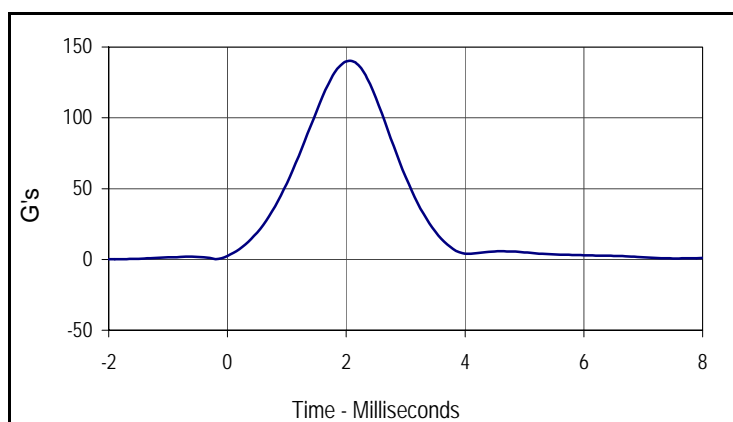
Tested Parameter	Units	Specification	Result	Pass/Fail
Laboratory Temperature	°C	18.9 to 25.6	21.7	Pass
Laboratory Relative Humidity	%	10 to 70	30	Pass
Peak Resultant Acceleration	G's	120.0 to 150.0	140.0	Pass
Peak Longitudinal Acceleration	G's	≤15.0	5.0	Pass
Is Acceleration Unimodal?	Yes/No	Yes	Yes	Pass
Oscillations After Main Pulse	%	<15	3.6	Pass
Overall Test Results			Pass	Pass

Curve Description			
Head Resultant			
CURNO	Type	SAE Class	Units
001	RES	1000	G's
Max	Time	Min	Time
140.0	2.1	0.1	-1.9

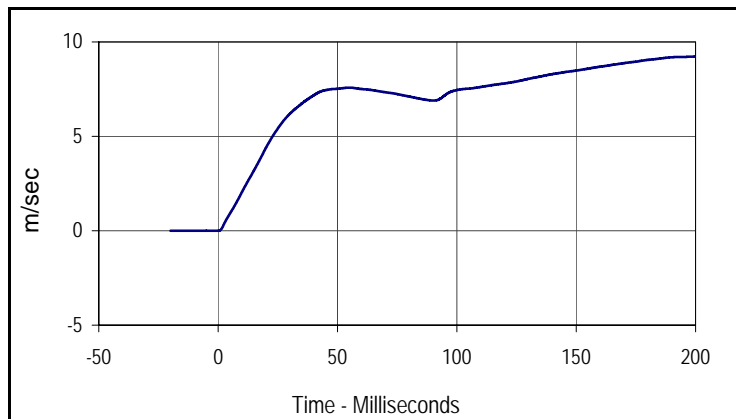
Tested Parameter	Units	Specification	Result	Pass/Fail	
Laboratory Temperature	°C	20.6 to 22.2	21.7	Pass	
Laboratory Relative Humidity	%	10 to 70	30	Pass	
Pendulum Velocity	m/sec	6.89 to 7.13	6.94	Pass	
Pendulum Deceleration	10 Msec.	m/sec	1.96 to 2.55	2.06	Pass
	20 Msec.	m/sec	4.12 to 5.10	4.39	Pass
	30 Msec.	m/sec	5.73 to 7.01	6.20	Pass
	40 to 70	m/sec	6.27 to 7.64	7.58	Pass
"D" Plane Rotation	Max	Degrees	66.0 to 82.0	75.7	Pass
Max Rotation Time After Peak Moment	Msec.	2.0 to 16.0	11.8	Pass	
Rotation Time From Peak to Zero Angle	Msec.	58.0 to 67.0	59.2	Pass	
Moment About Occipital Condyle	Nm	73.0 to 88.0	87.2	Pass	
Positive Moment Decay, Time To 0 Nm	Msec.	49.0 to 64.0	49.8	Pass	
Overall Test Results				Pass

Curve Description			
Pendulum Velocity			
CURNO	Type	SAE Class	Units
001	FIL	180	m/sec
Max	Time	Min	Time
9.2	198.9	0.0	-0.1
