REPORT NUMBER TR-P27003-04-NC

**NEW CAR ASSESSMENT PROGRAM
SIDE IMPACT TEST**

**HYUNDAI MOTOR MANUFACTURING ALABAMA, LLC
2007 HYUNDAI SANTA FE SE 5-DOOR MPV
5-DOOR MPV**

NHTSA NUMBER: M70501

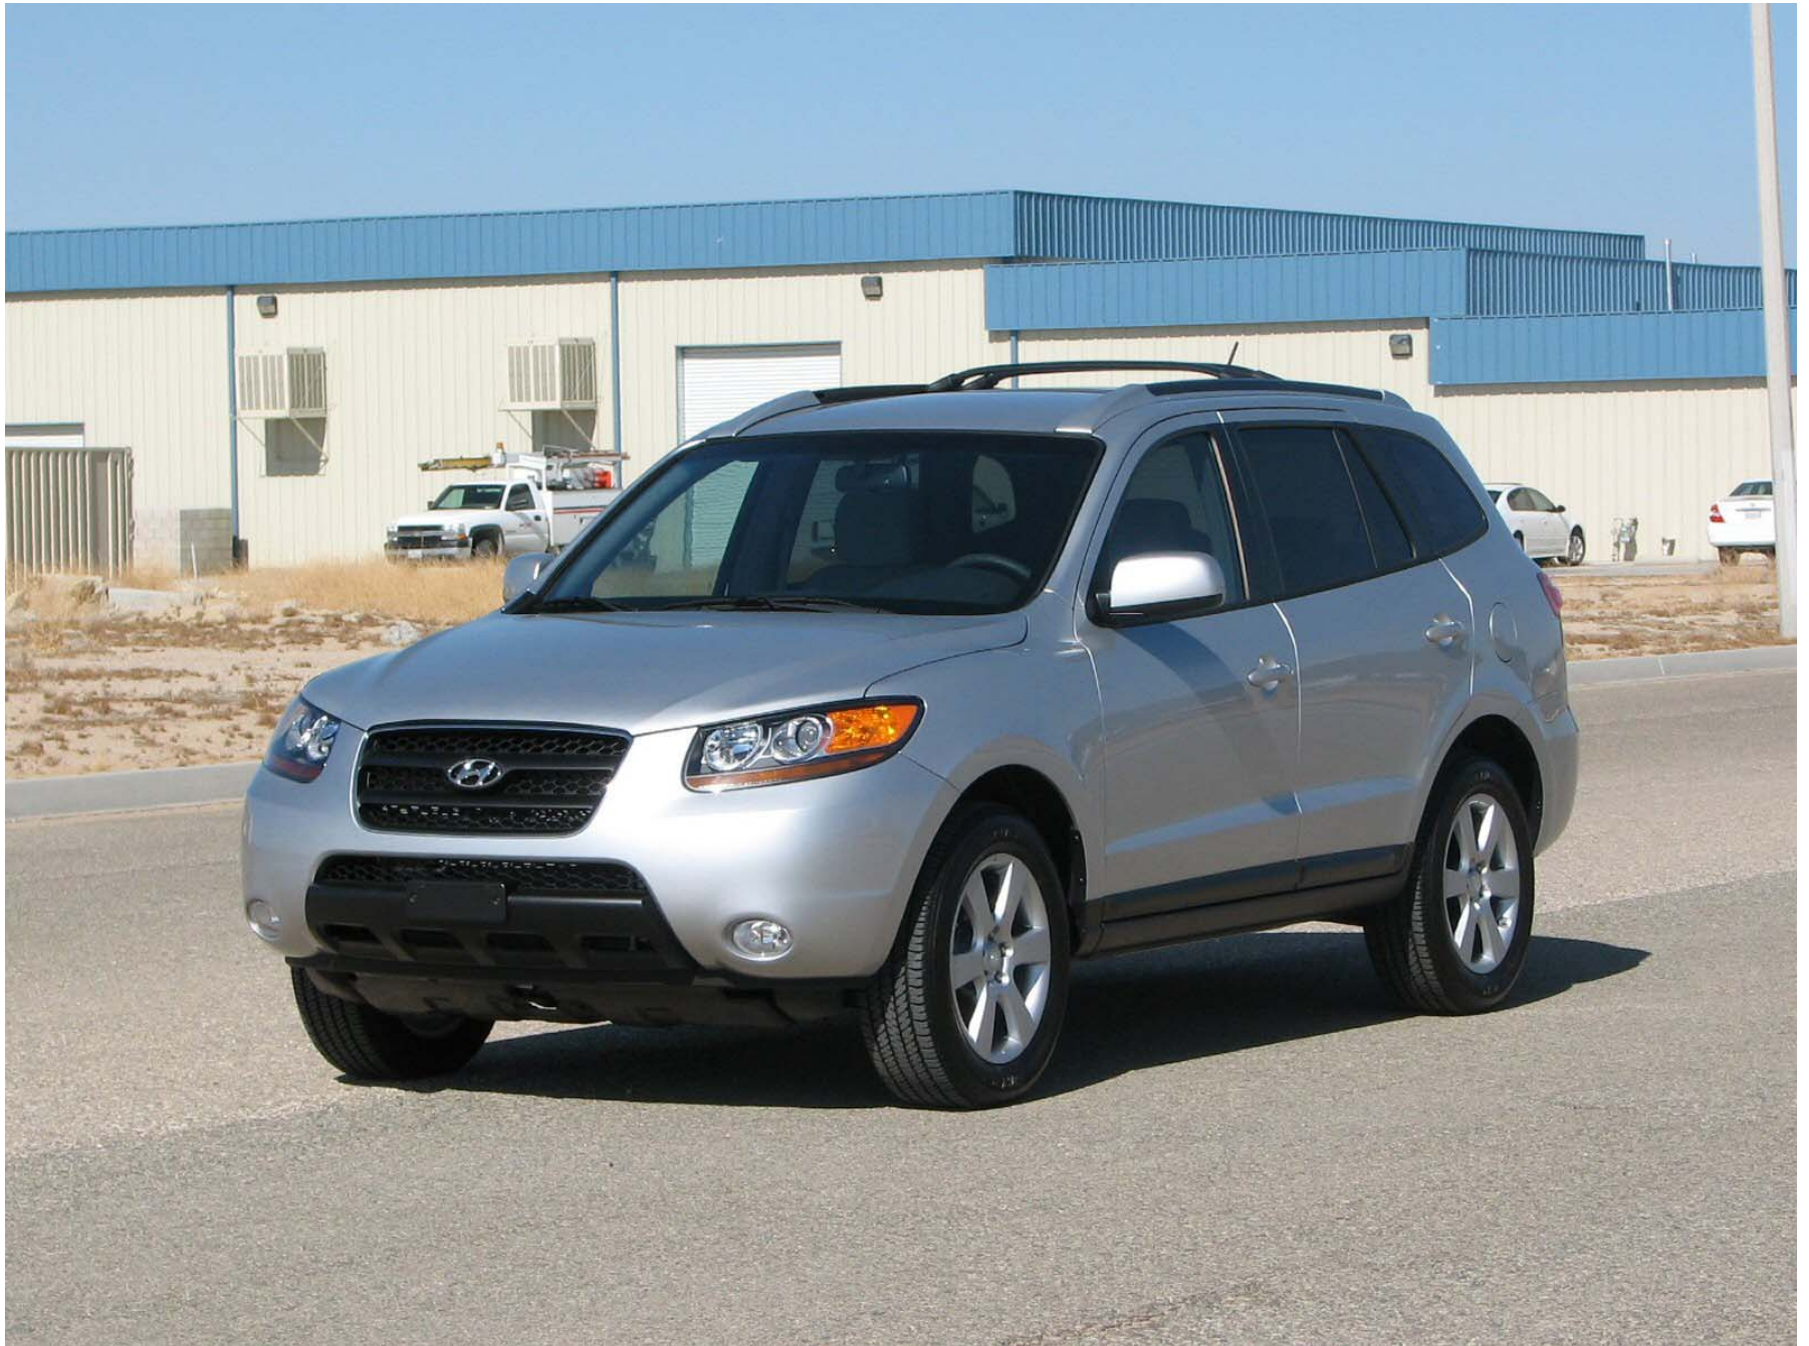
Figure A-1: Left Front $\frac{3}{4}$ View, as Received

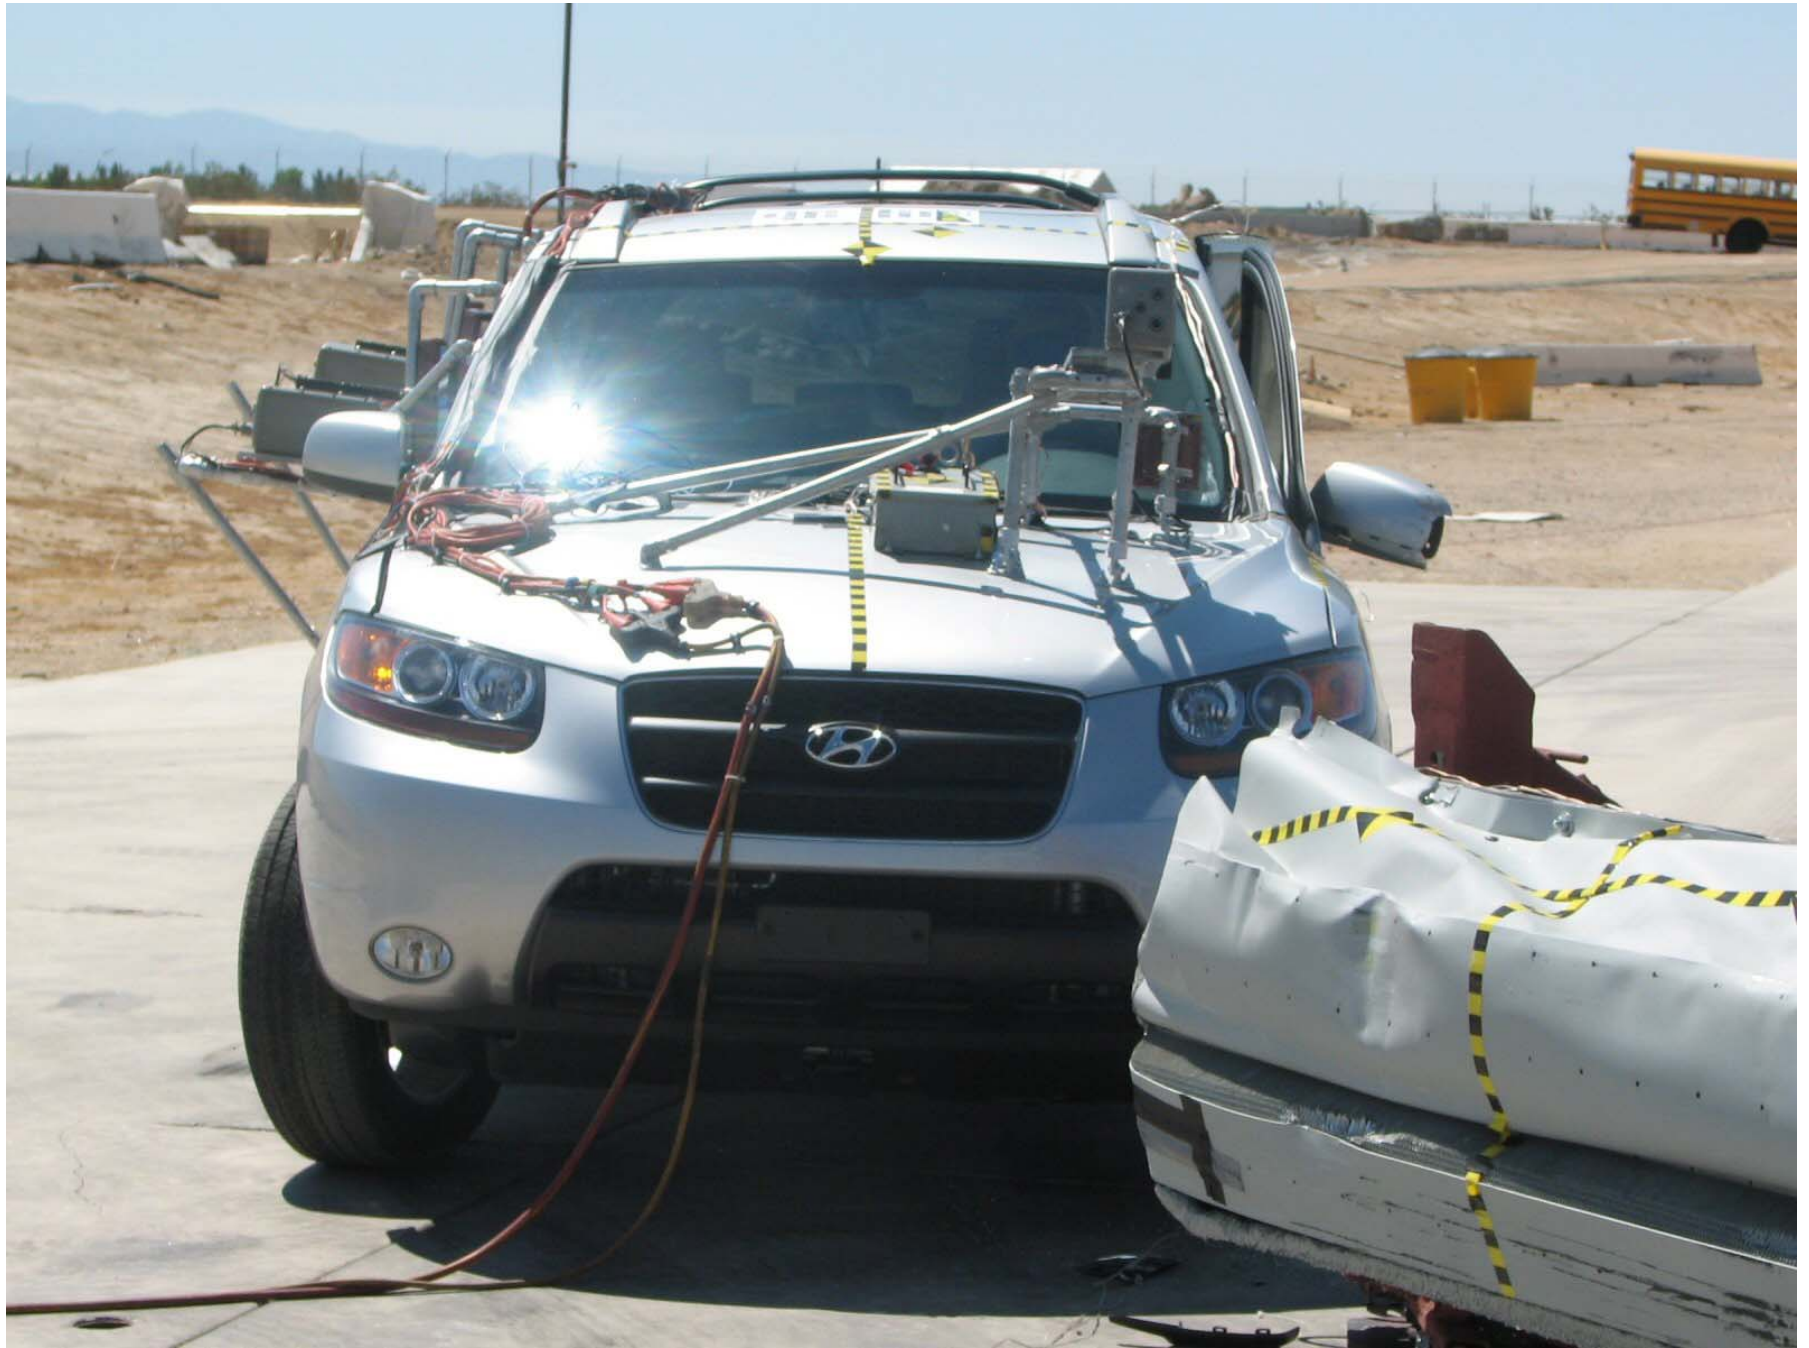
Figure A-6: Post-Test Front View

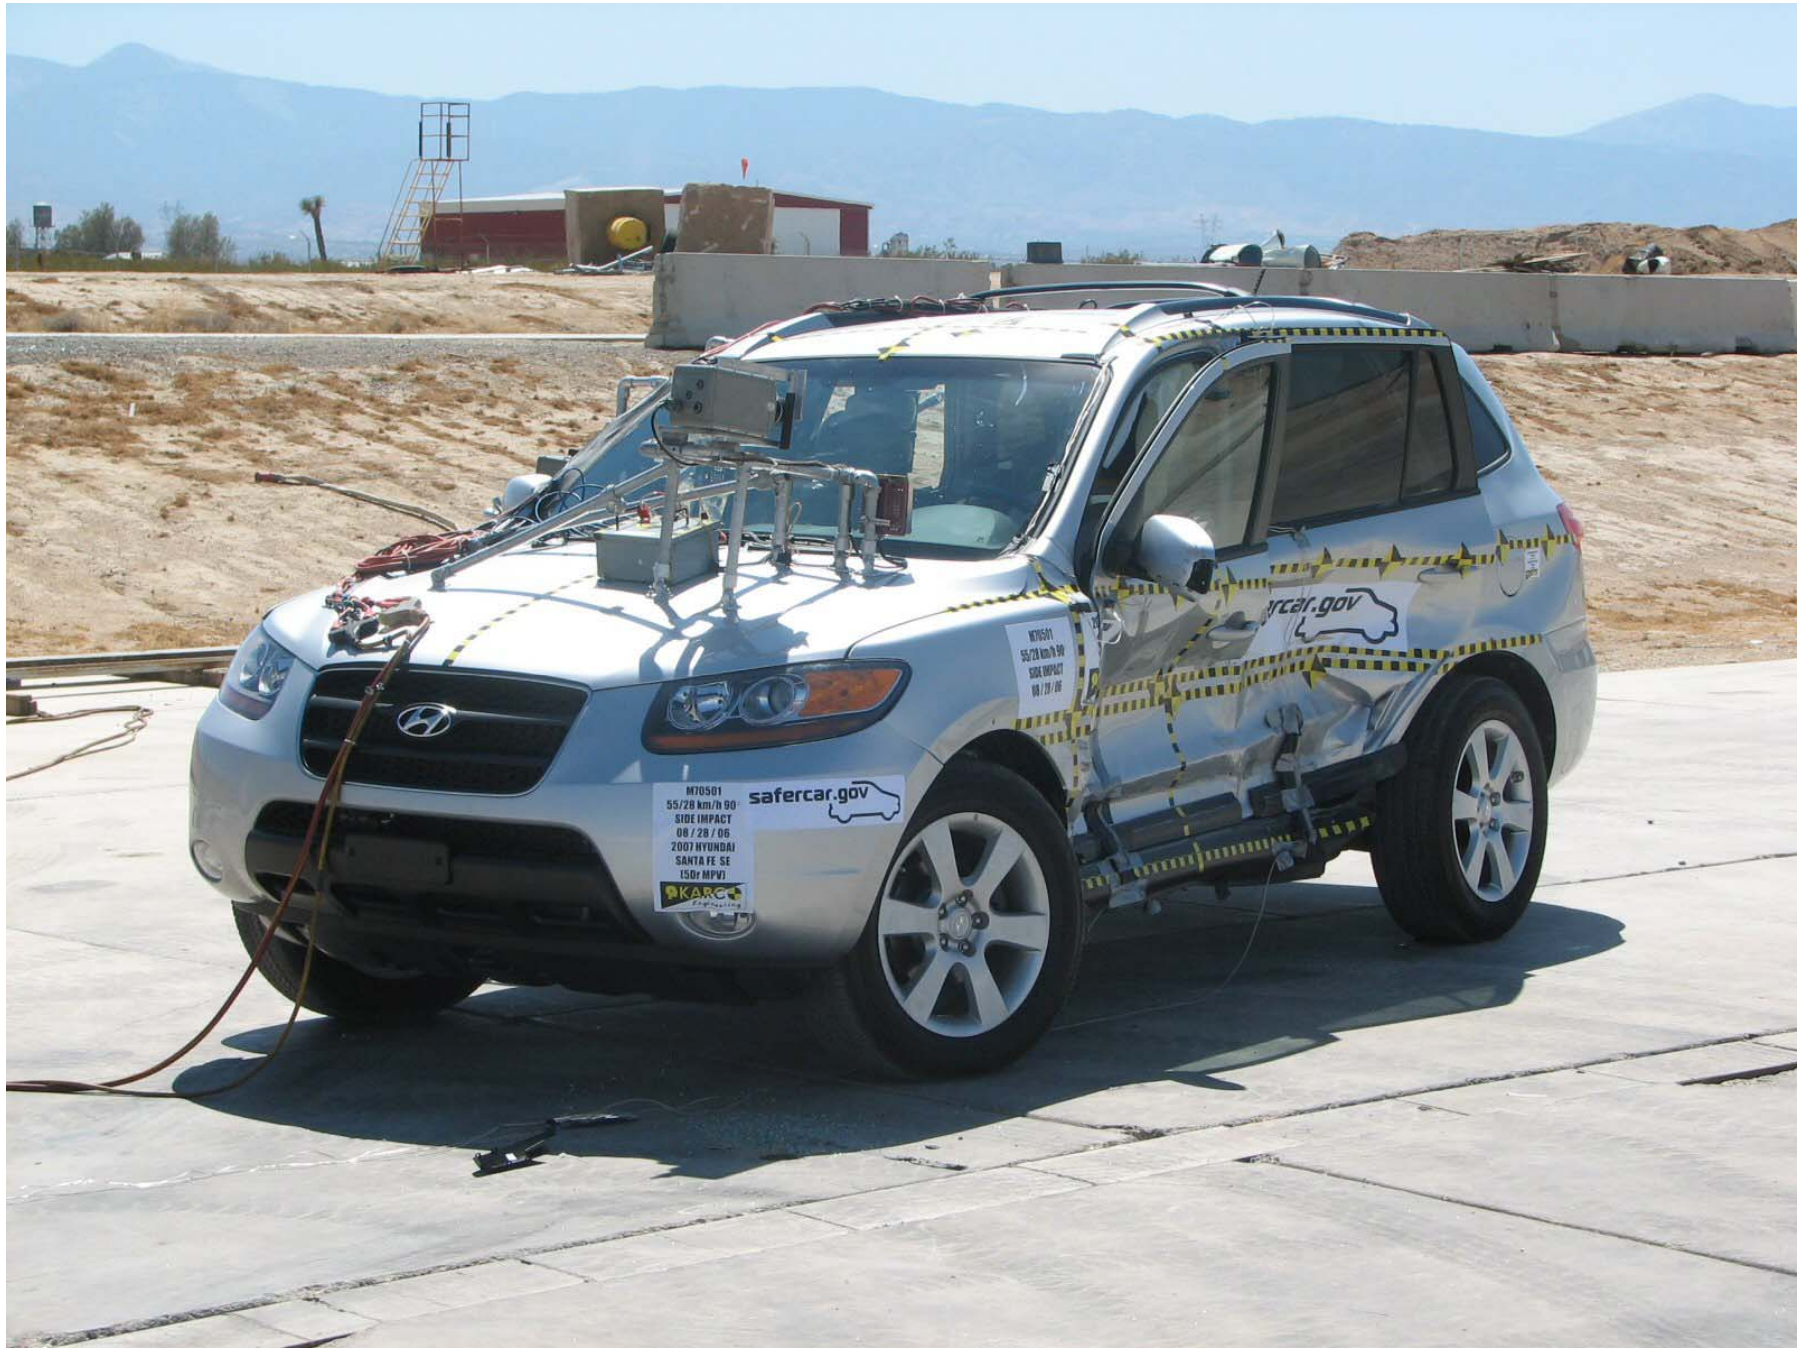
Figure A-8: Post-Test Left Front $\frac{3}{4}$ View

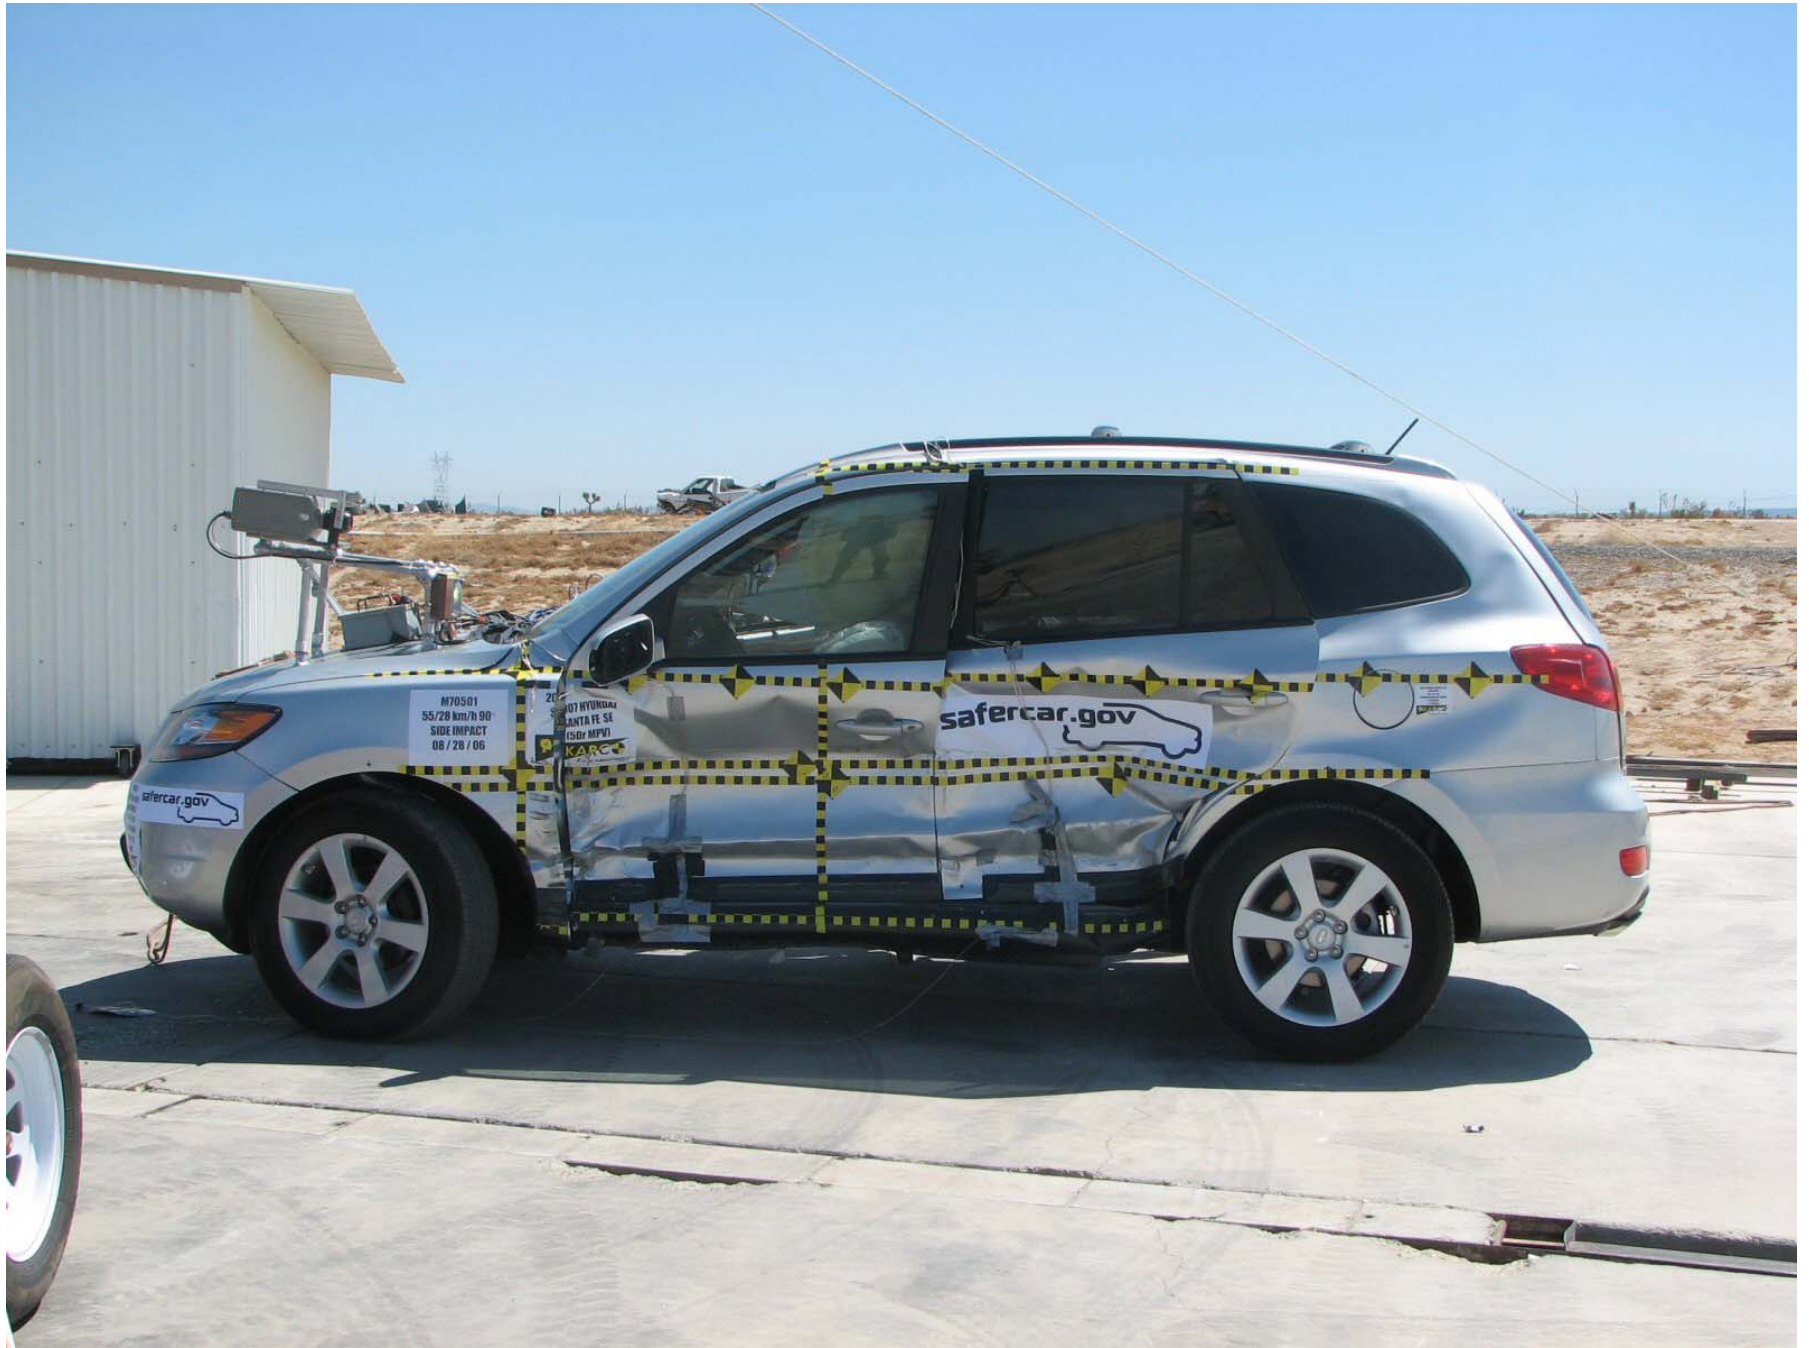
Figure A-10: Post-Test Left Side View

The driver and passenger doors remained closed during impact. The test vehicle sustained a maximum static crush of 302 mm at level 2, 1500 mm rearward of the left vertical impact point. The driver SID/Hybrid III, Serial No. 275 and the passenger SID/Hybrid III, Serial No. 274 were calibrated prior to this test. The SID/Hybrid III injury criteria is summarized as follows:

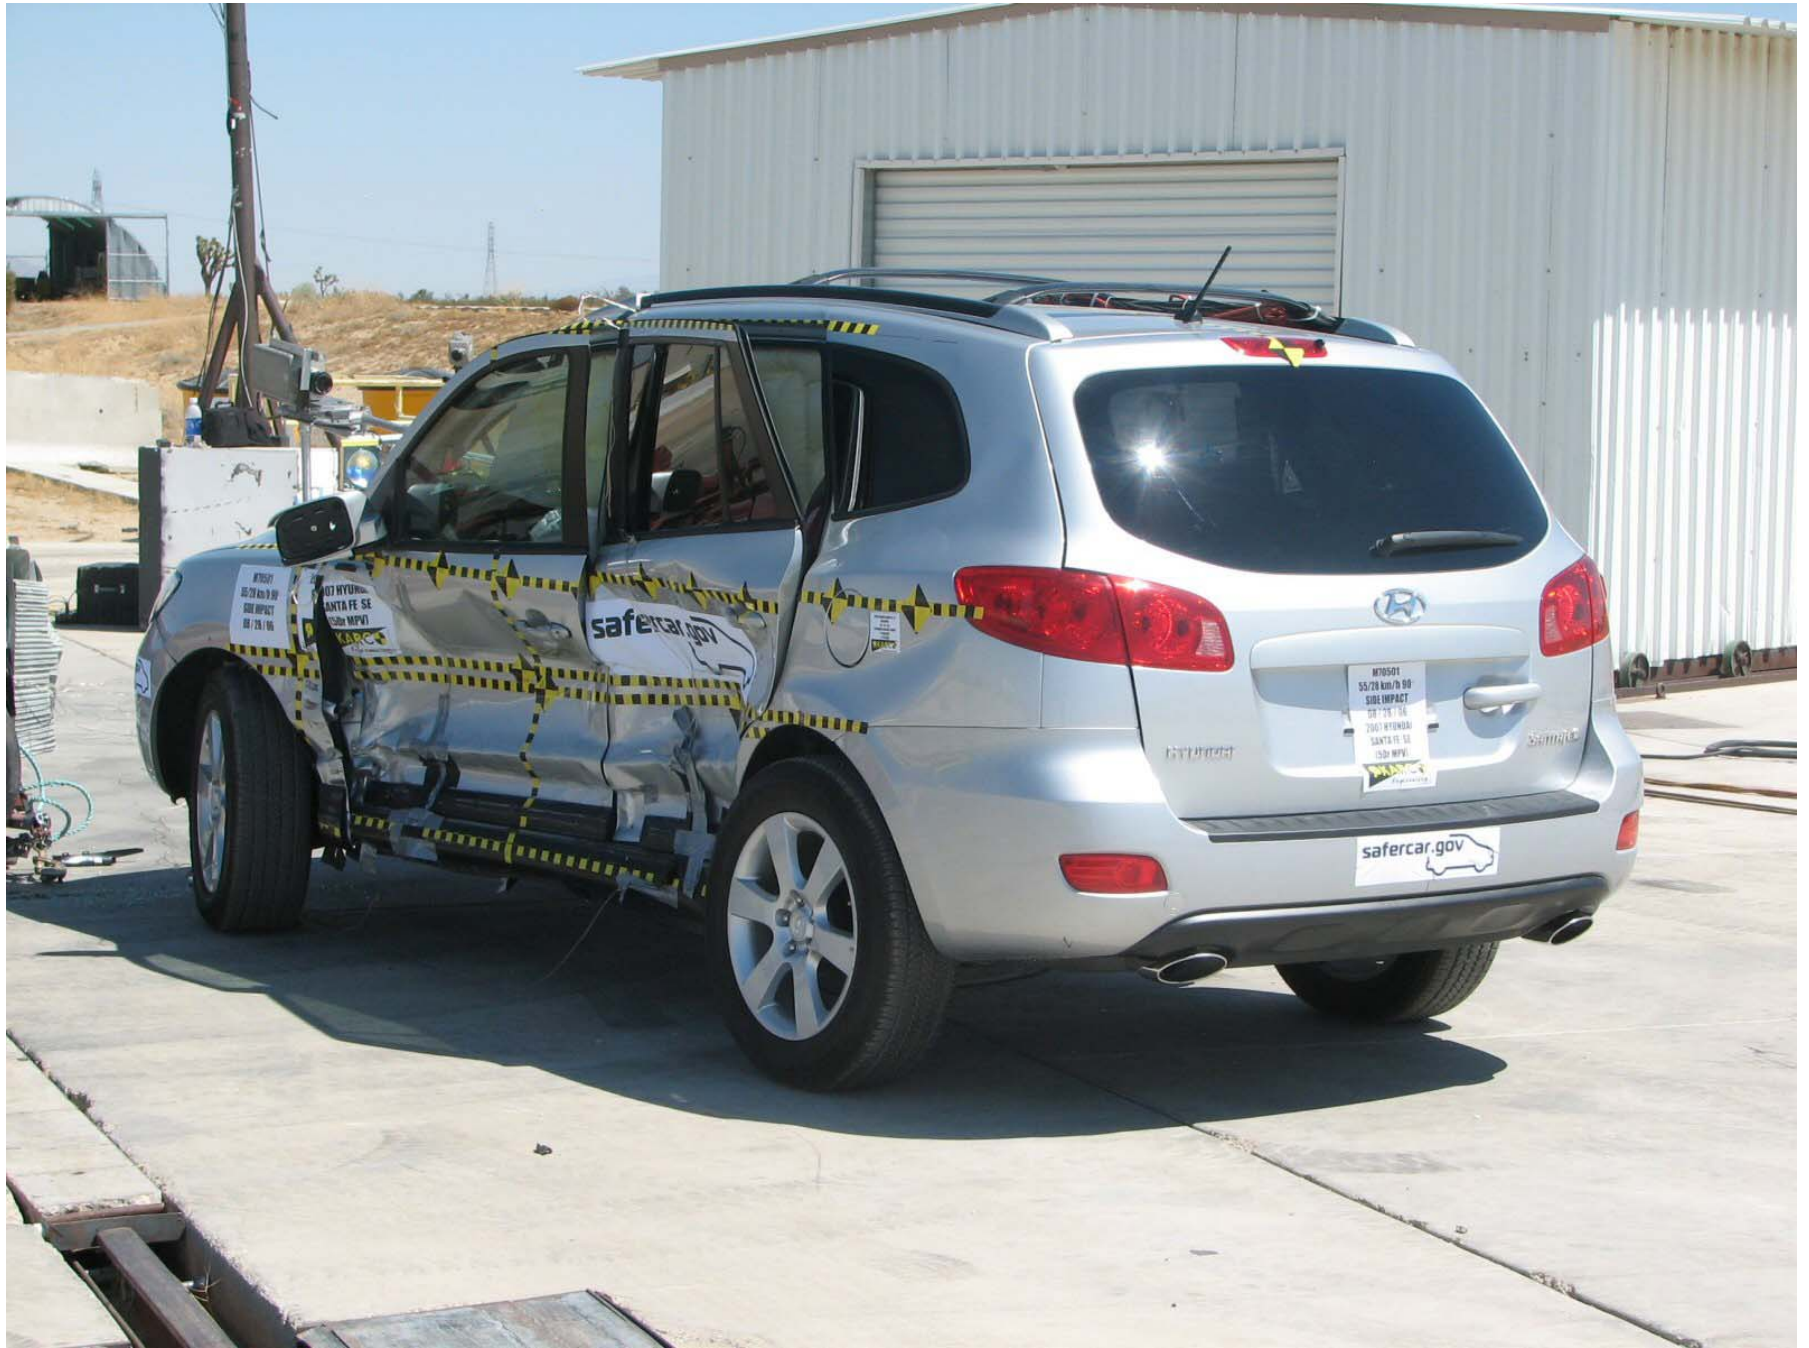
Figure A-12: Post-Test Left Rear 3/4 View

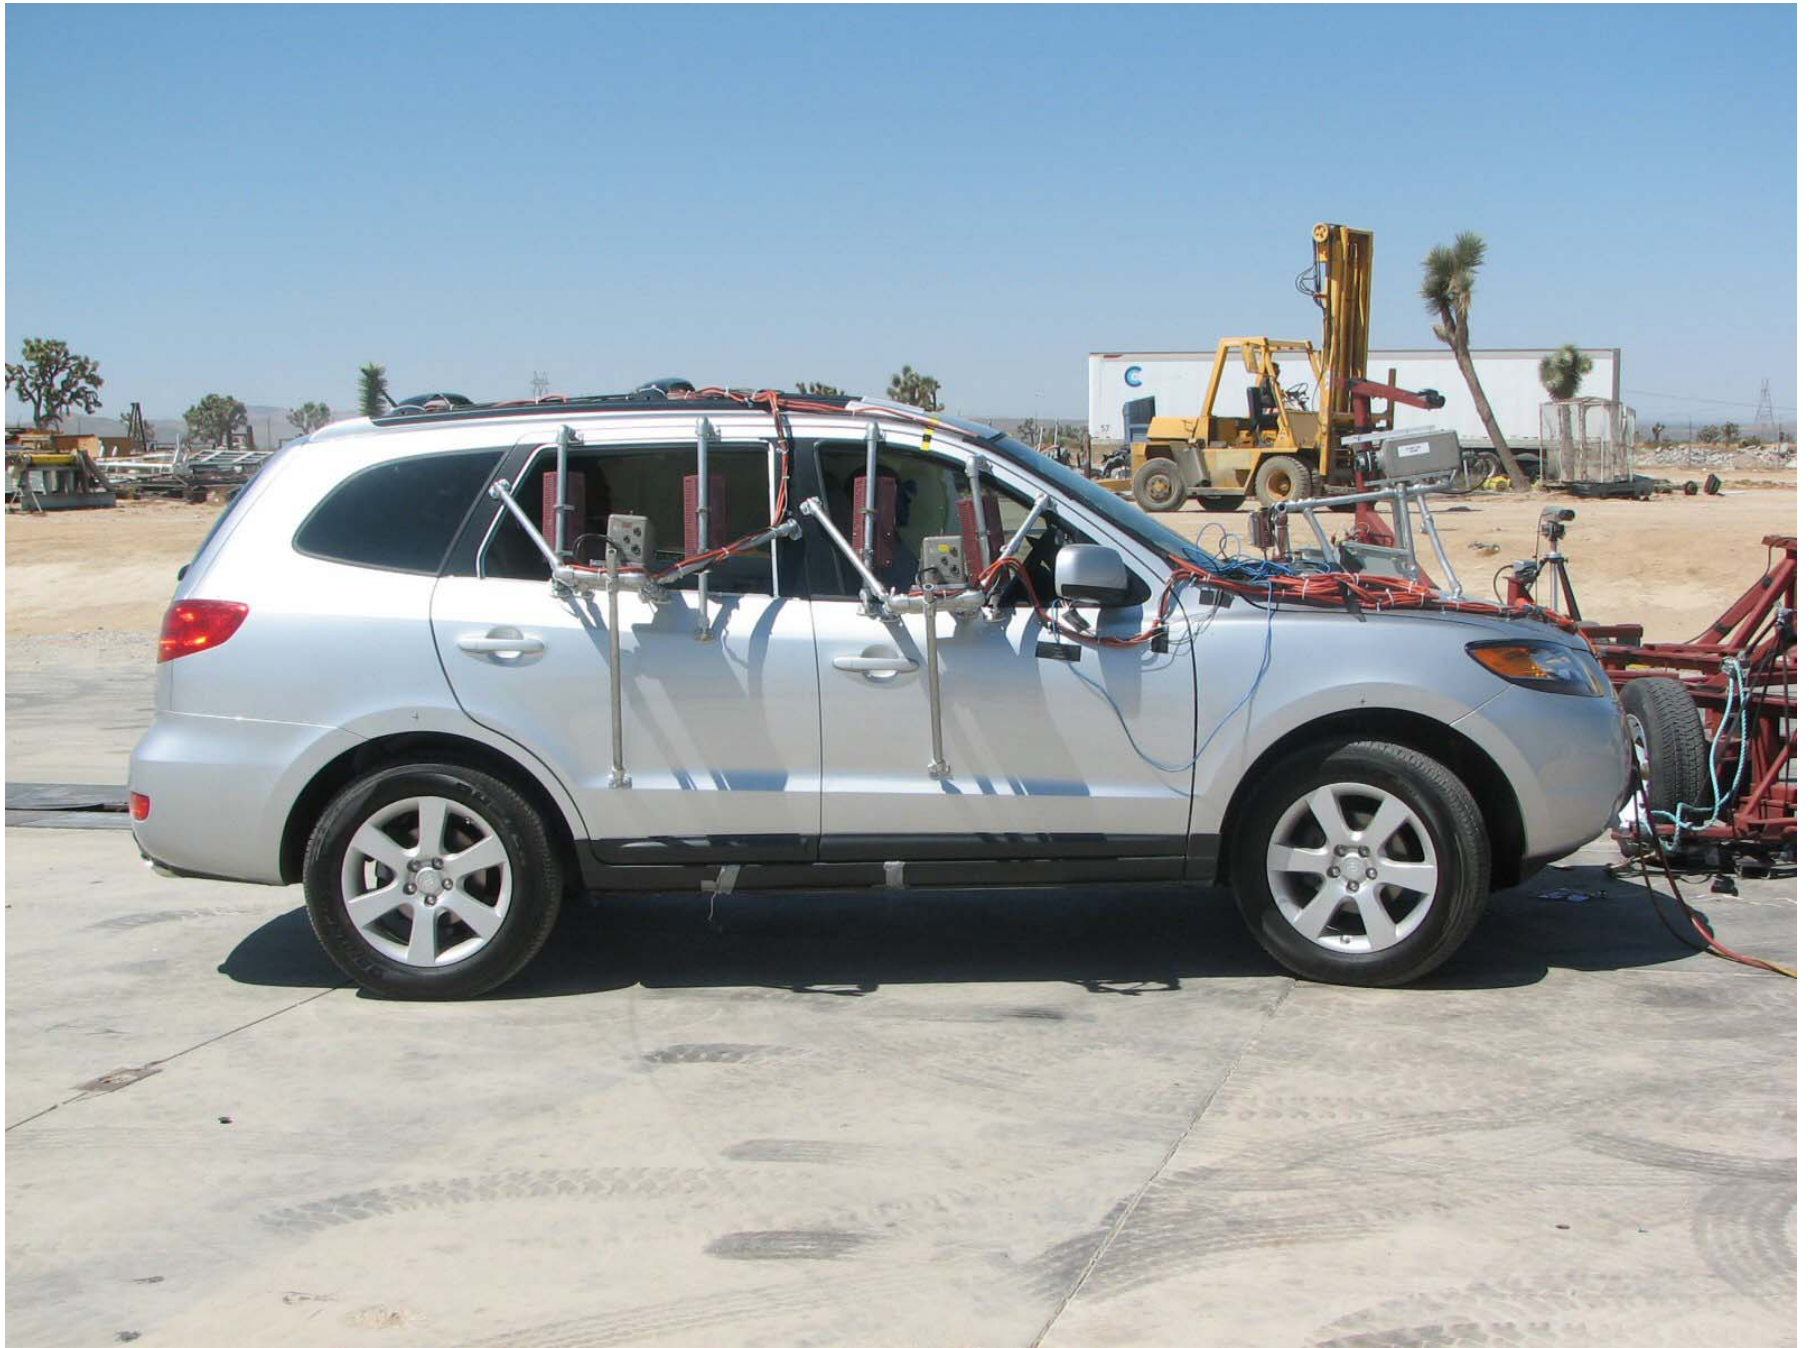
Figure A-18: Post-Test Right Side View

Critical Areas of Performance	Observations and Conclusions
Pillar Performance	No separation
Sill Separation	Front & Rear passenger side sill separated
Windshield Damage	None
Window Damage	None
Other Notable Effects	None

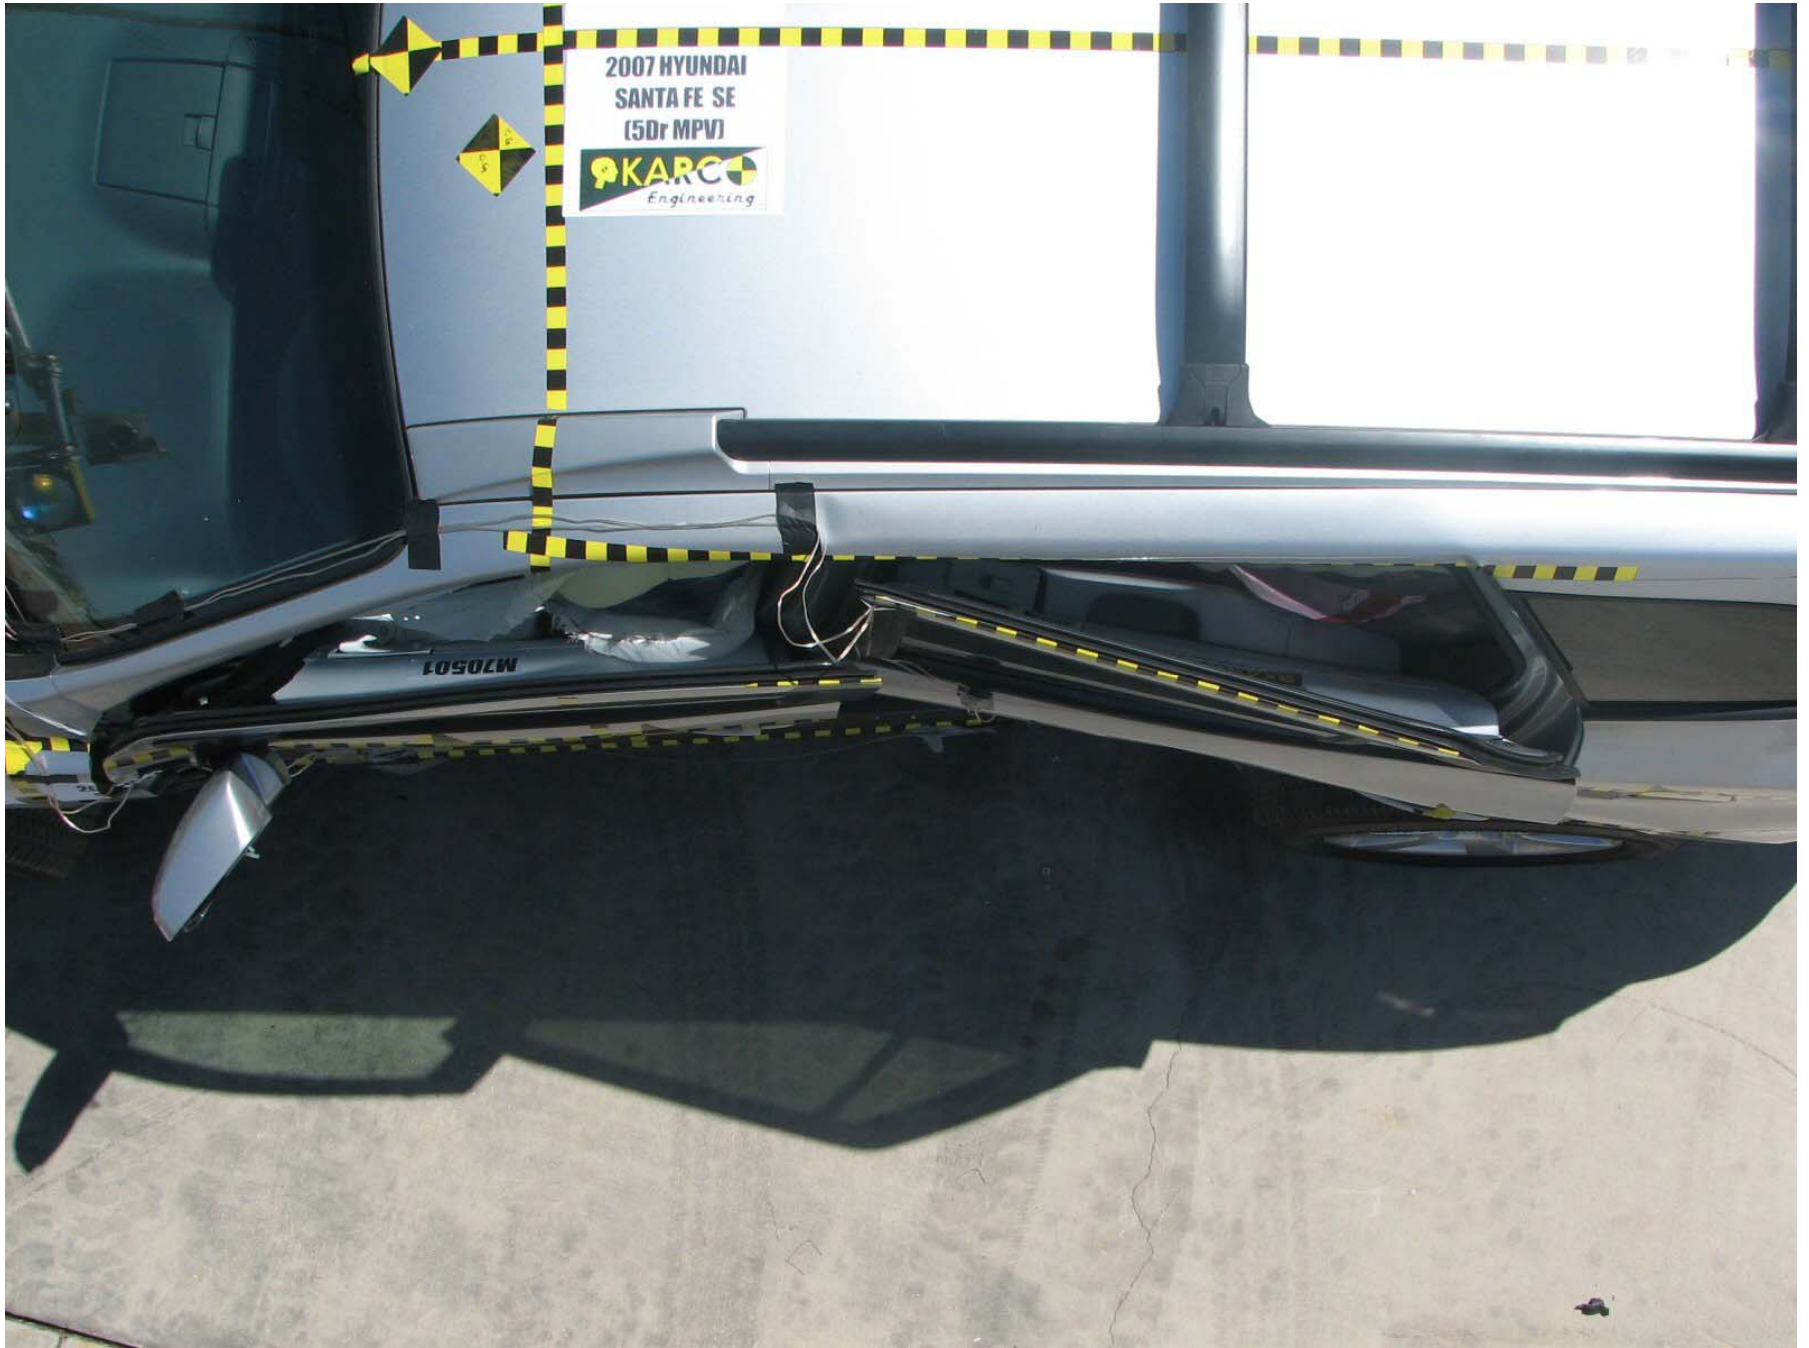
Figure A-24: Post-Test Overhead Close-up View

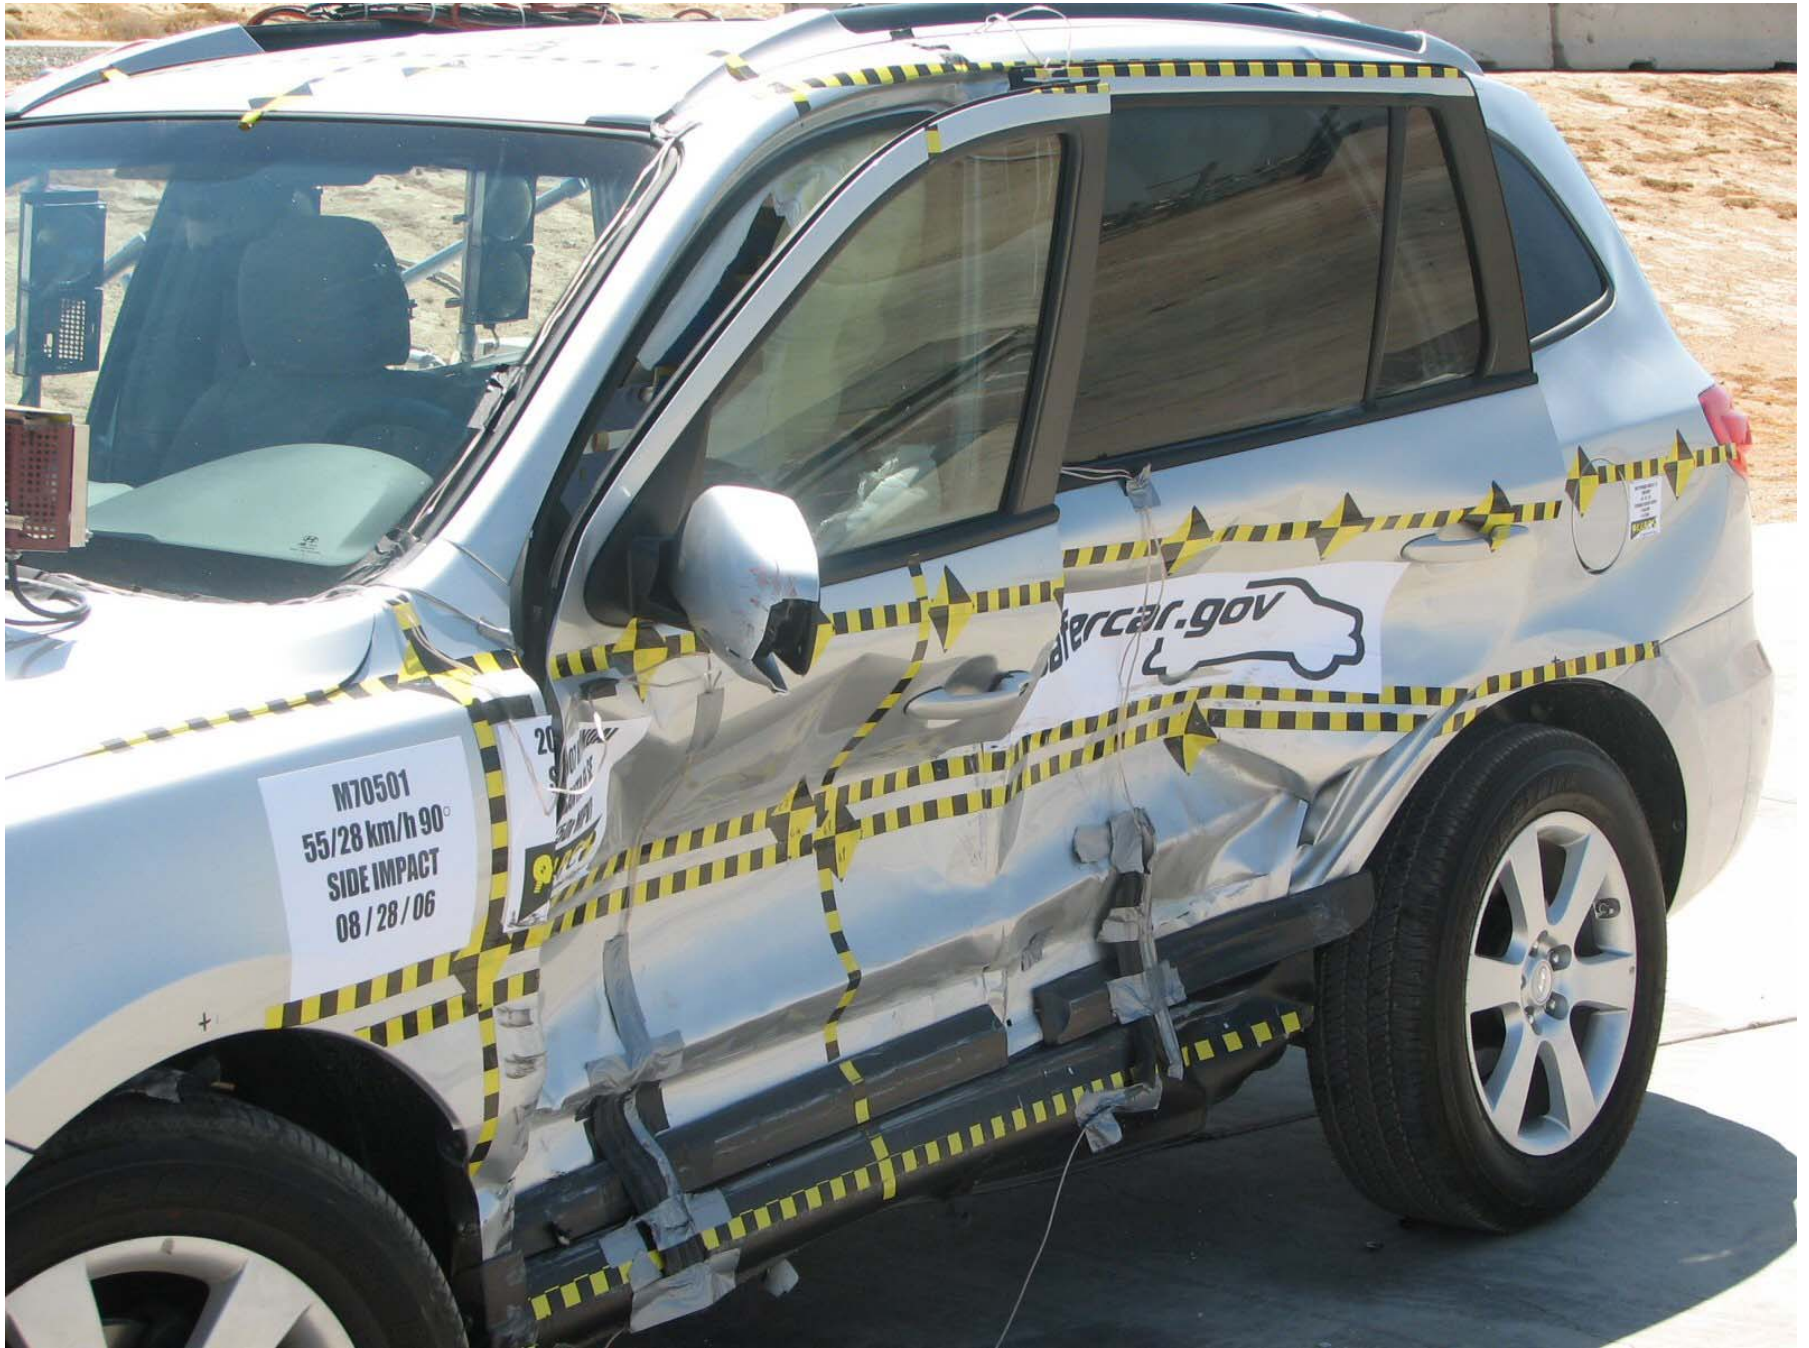
Figure A-28: Post-Test Front ¾ View of Left Side Door

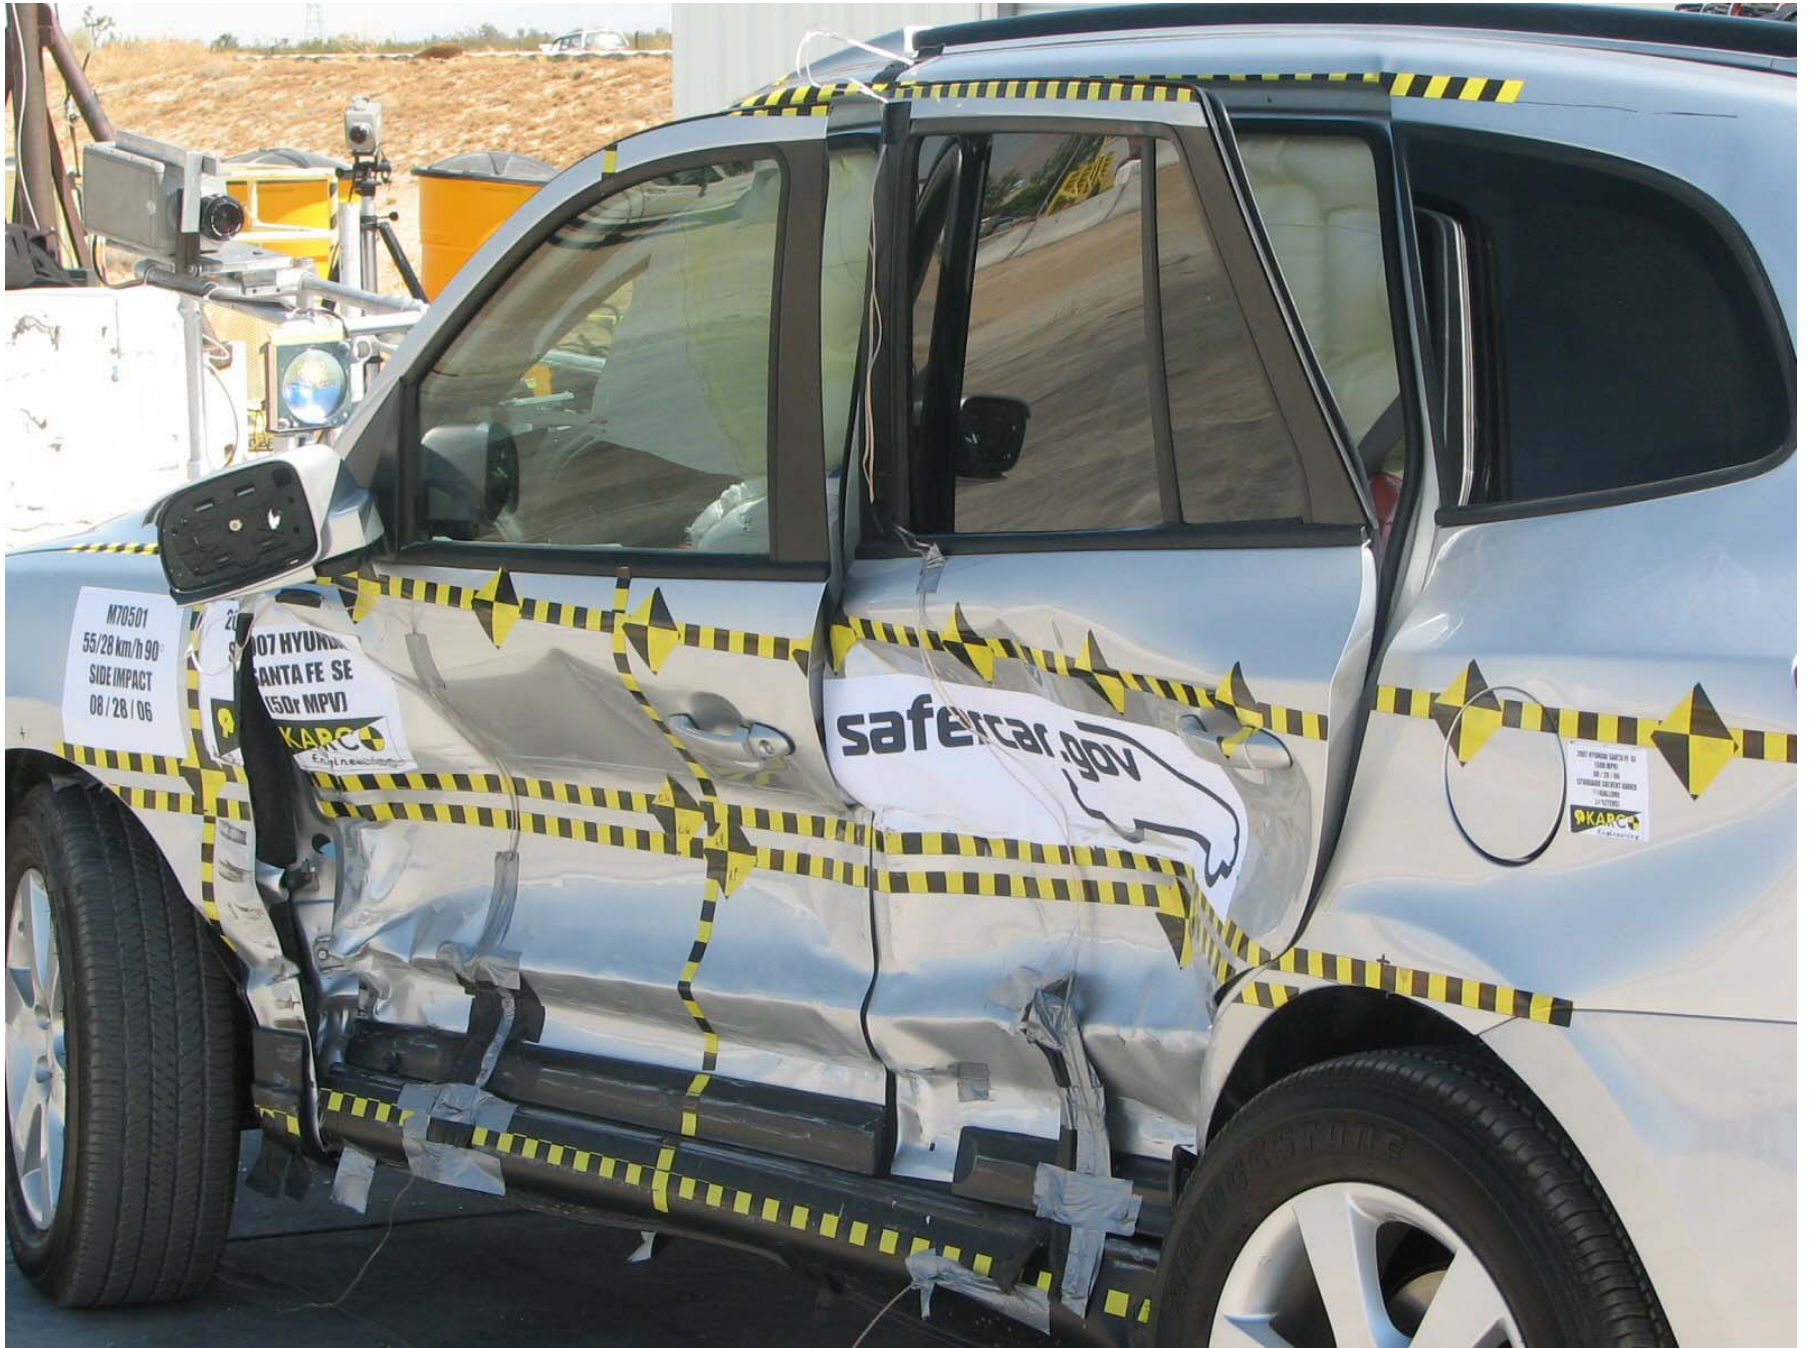
Figure A-30: Post-Test Rear ¾ View of Left Side Door
