REPORT NUMBER TR-P27003-04-NC

**NEW CAR ASSESSMENT PROGRAM
SIDE IMPACT TEST**

**HYUNDAI MOTOR MANUFACTURING ALABAMA, LLC
2007 HYUNDAI SANTA FE SE 5-DOOR MPV
5-DOOR MPV**

NHTSA NUMBER: M70501

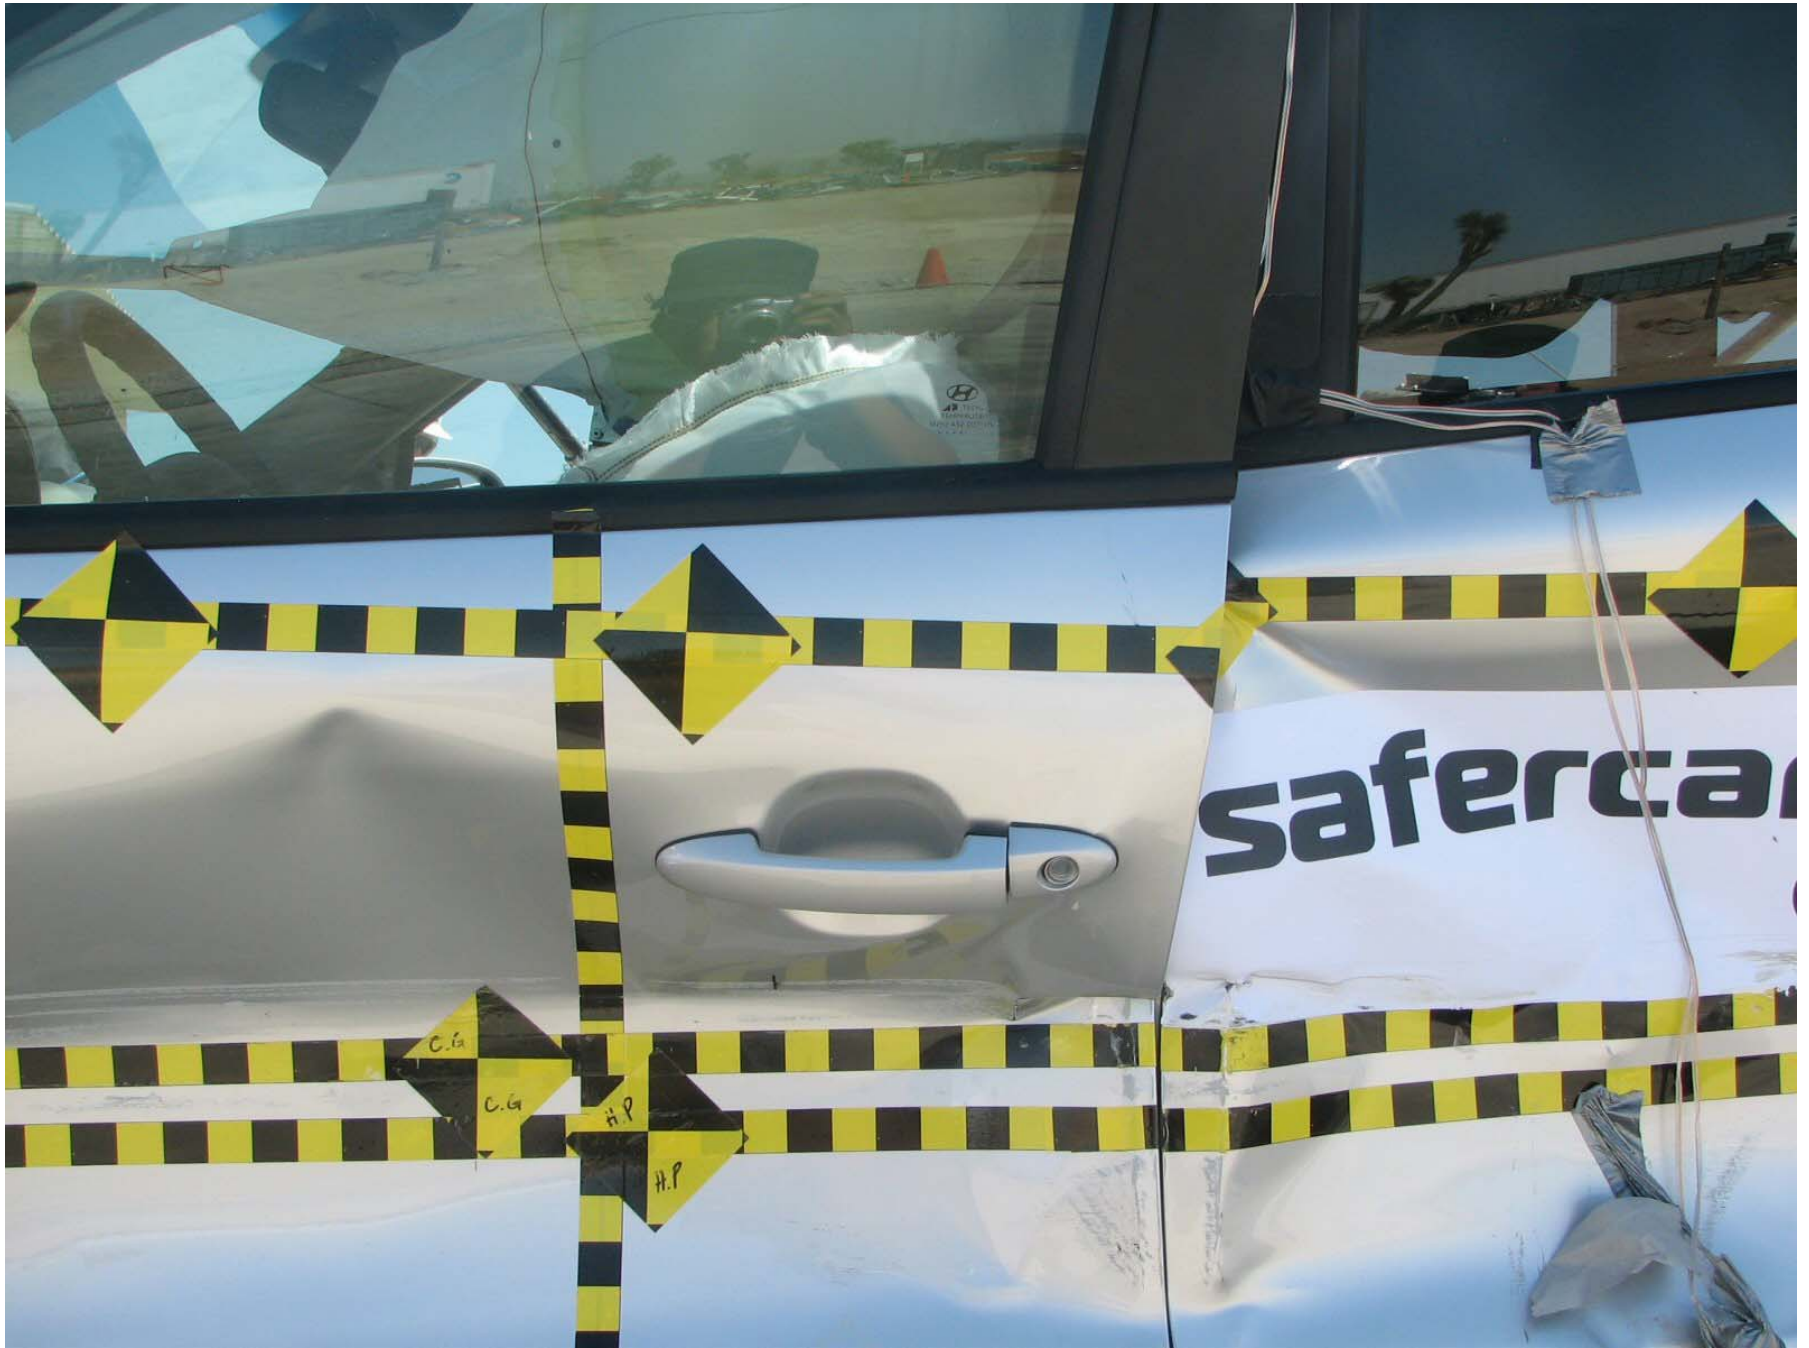
Figure A-32: Post-Test Left Front Door

Description	Front	Rear
Left Side Door Opening	Door remained closed and latched, jammed	Door remained closed and latched, jammed
Right Side Door Opening	Remained closed and latched, operational	Remained closed and latched, operational
Seat Movement	None	None
Seat Back Failure	None	None

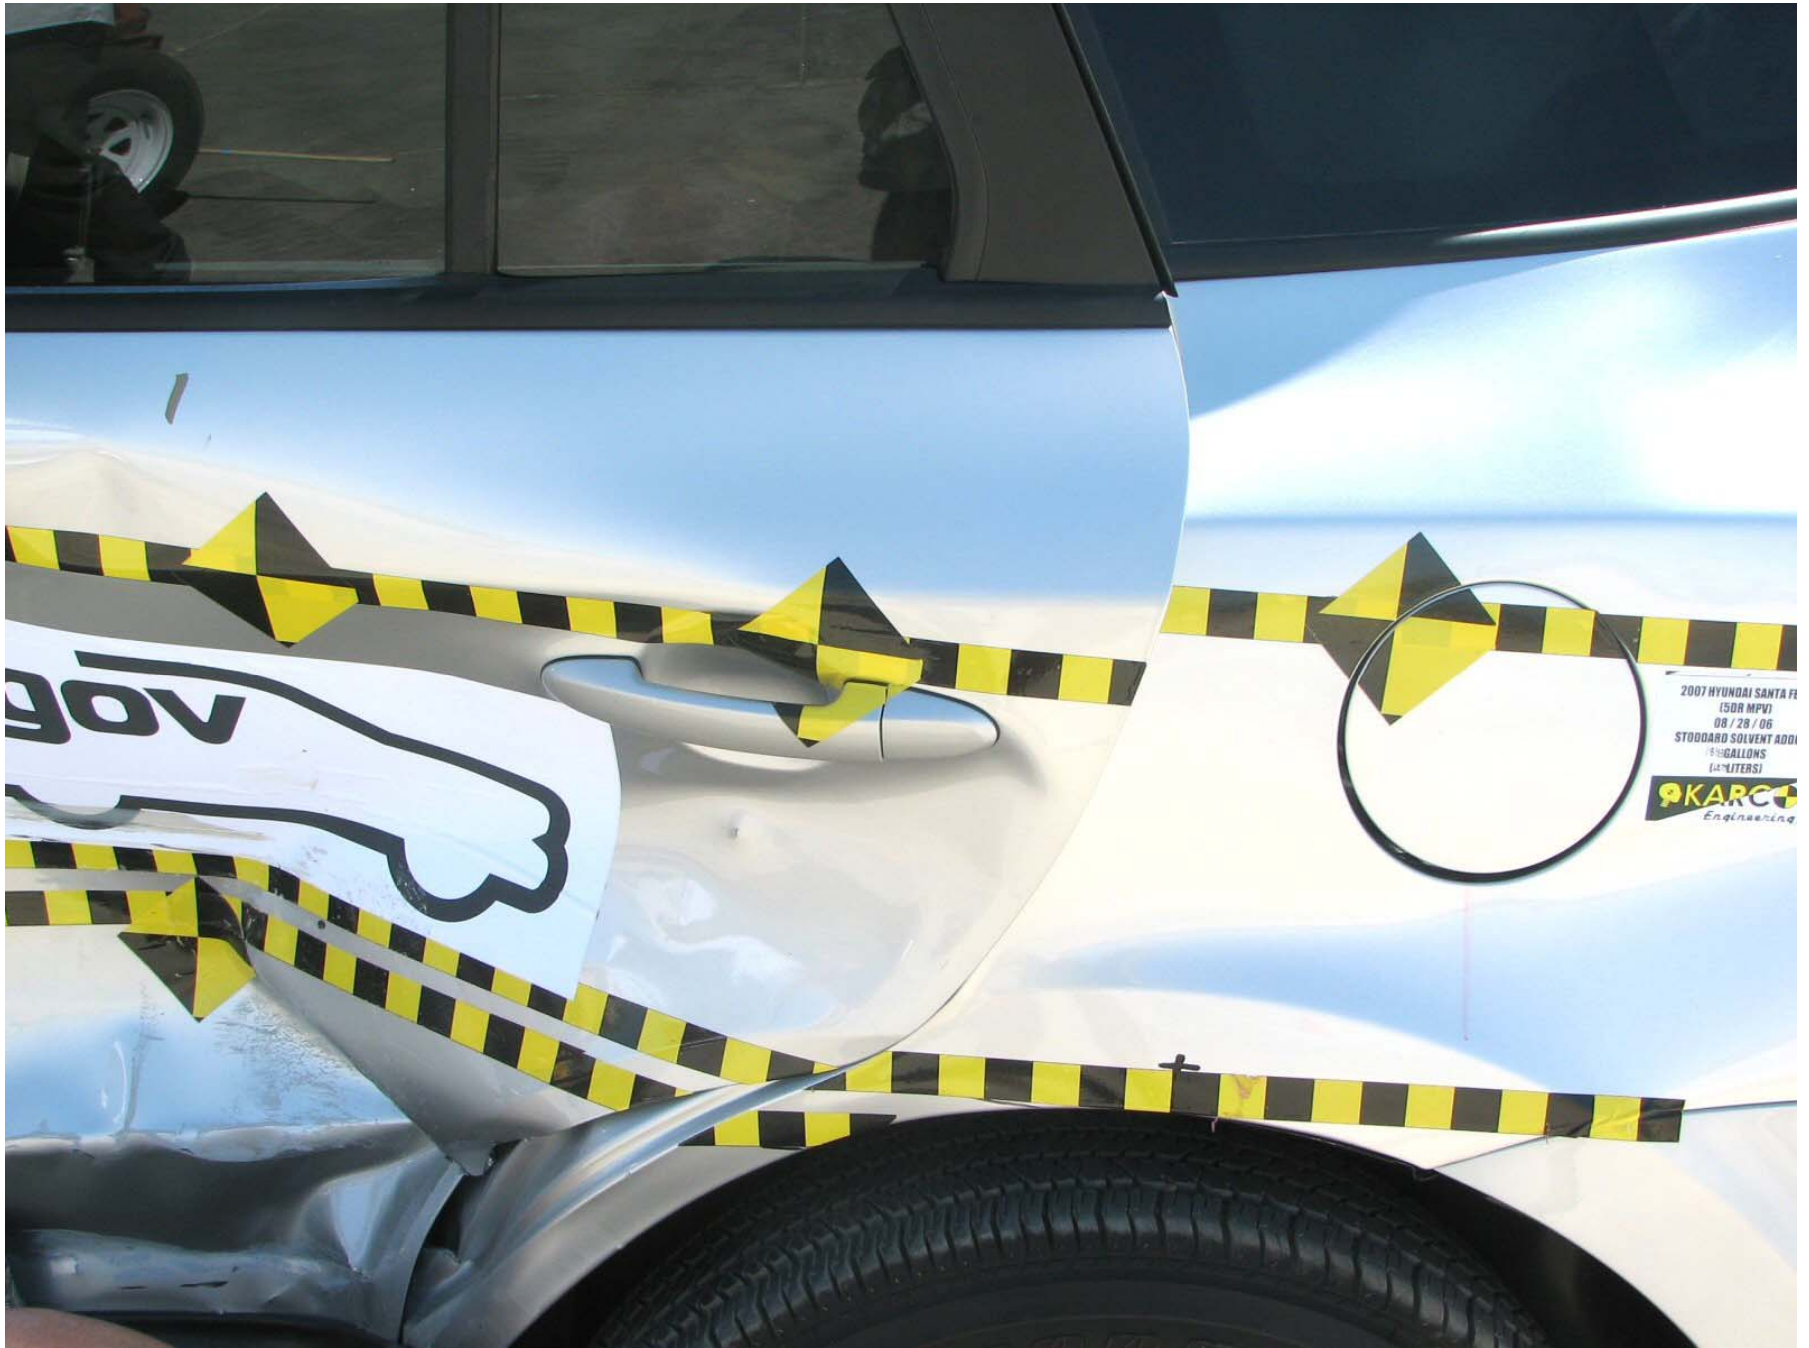
Figure A-34: Post-Test Left Rear Door

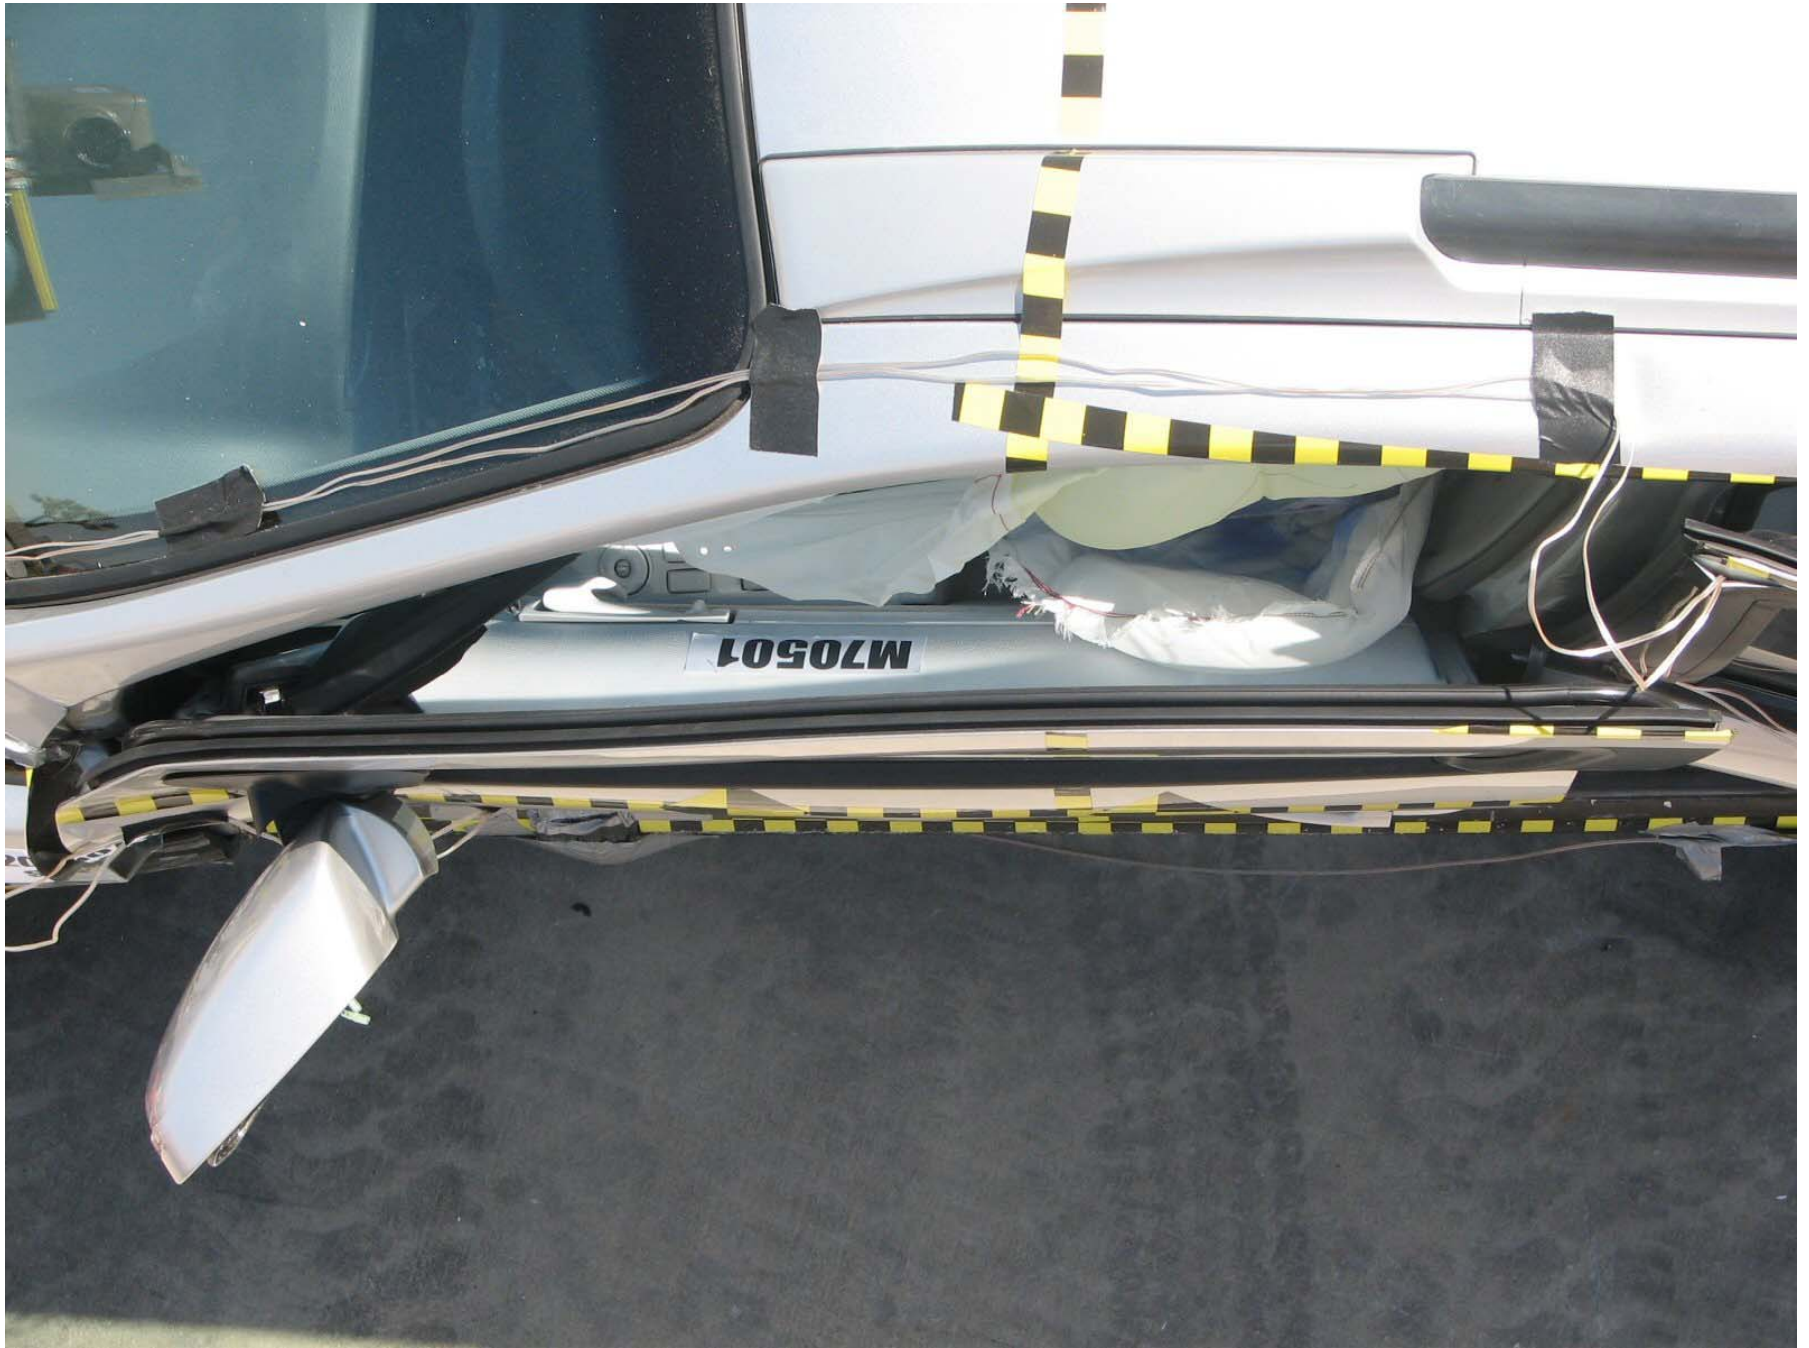
Figure A-39: Post-Test Driver Dummy Clearance From Door

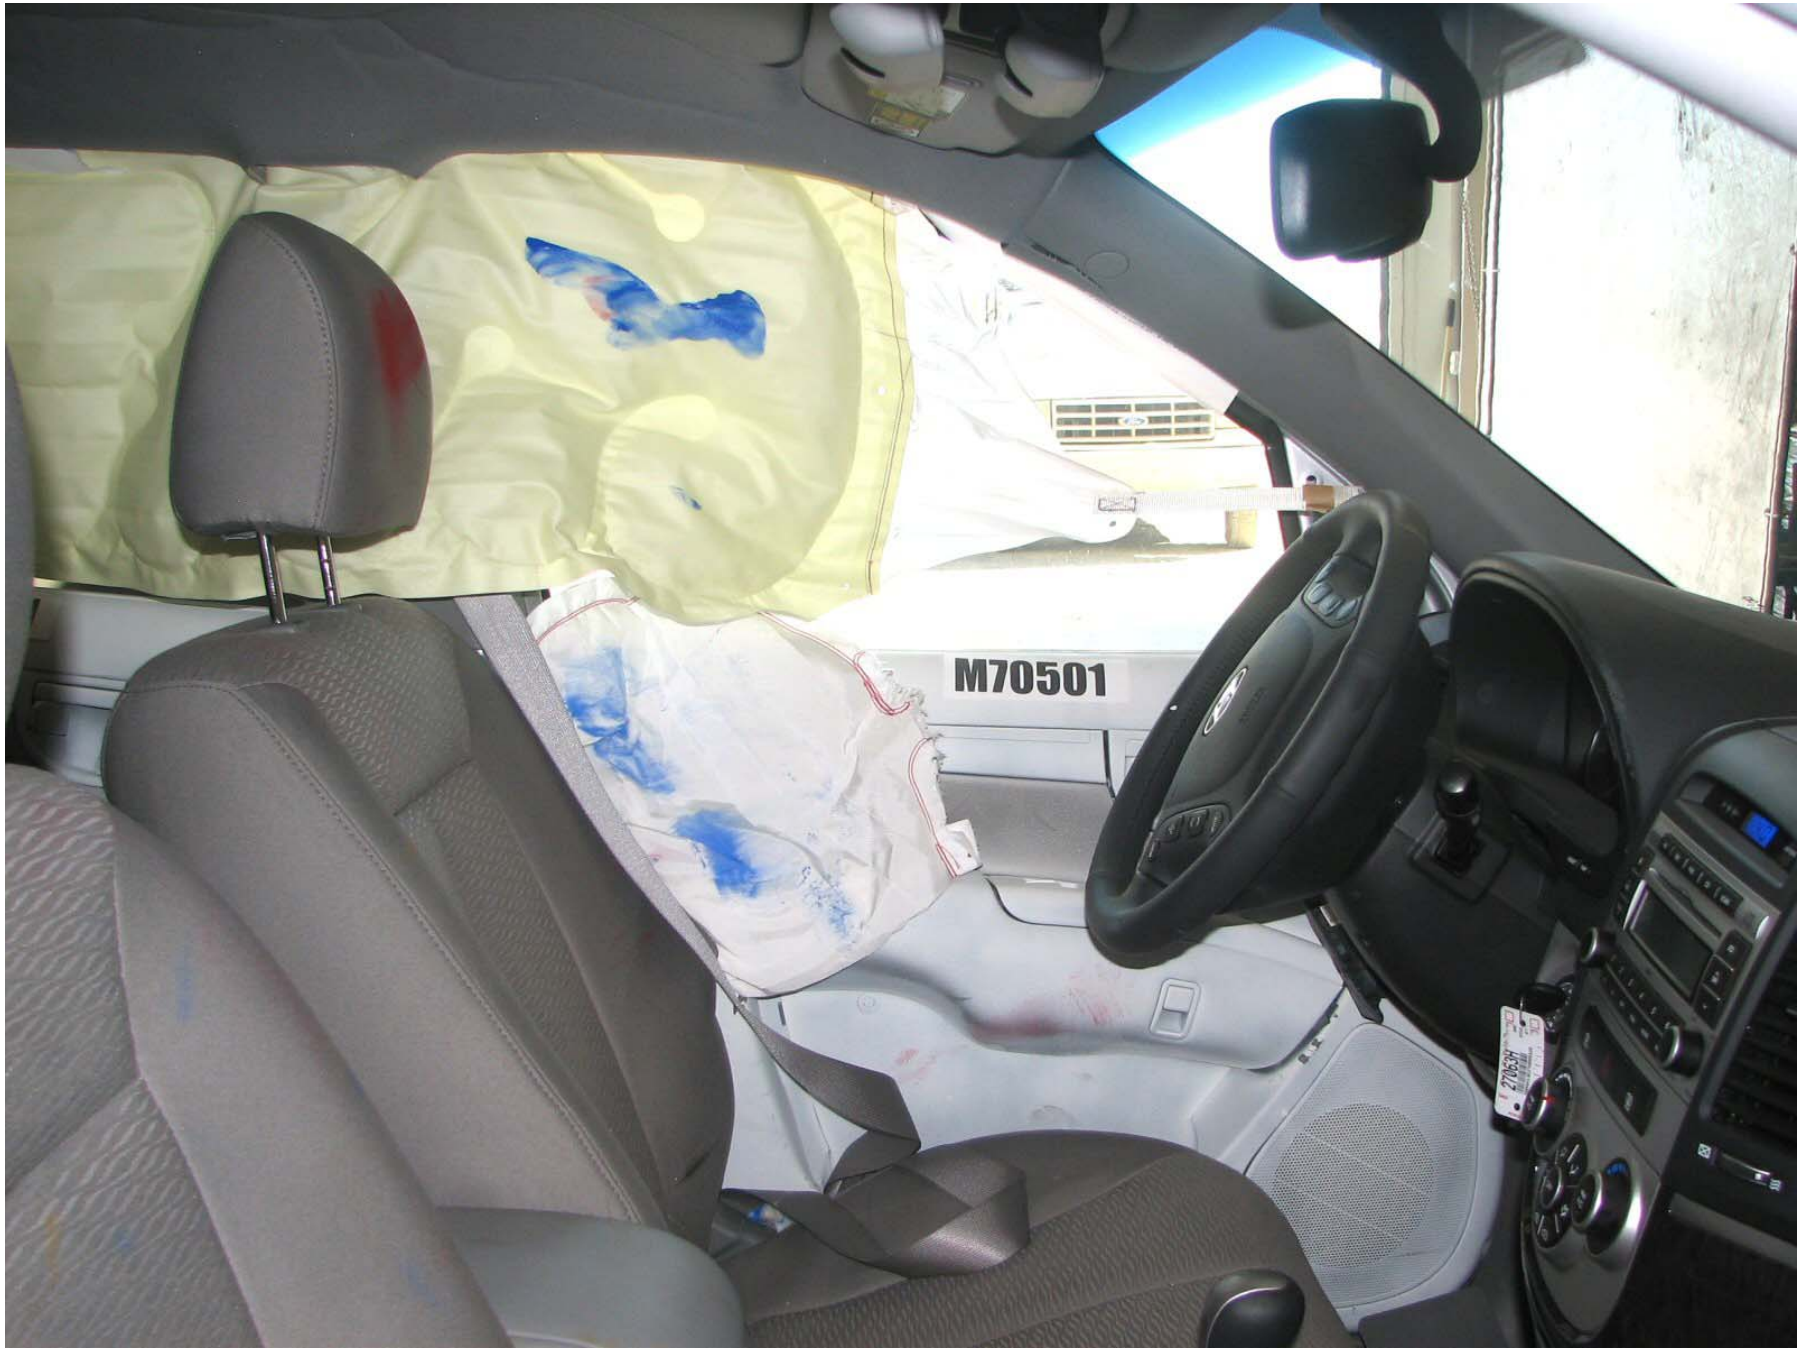
Figure A-43: Post-Test Front Door Panel (Interior)

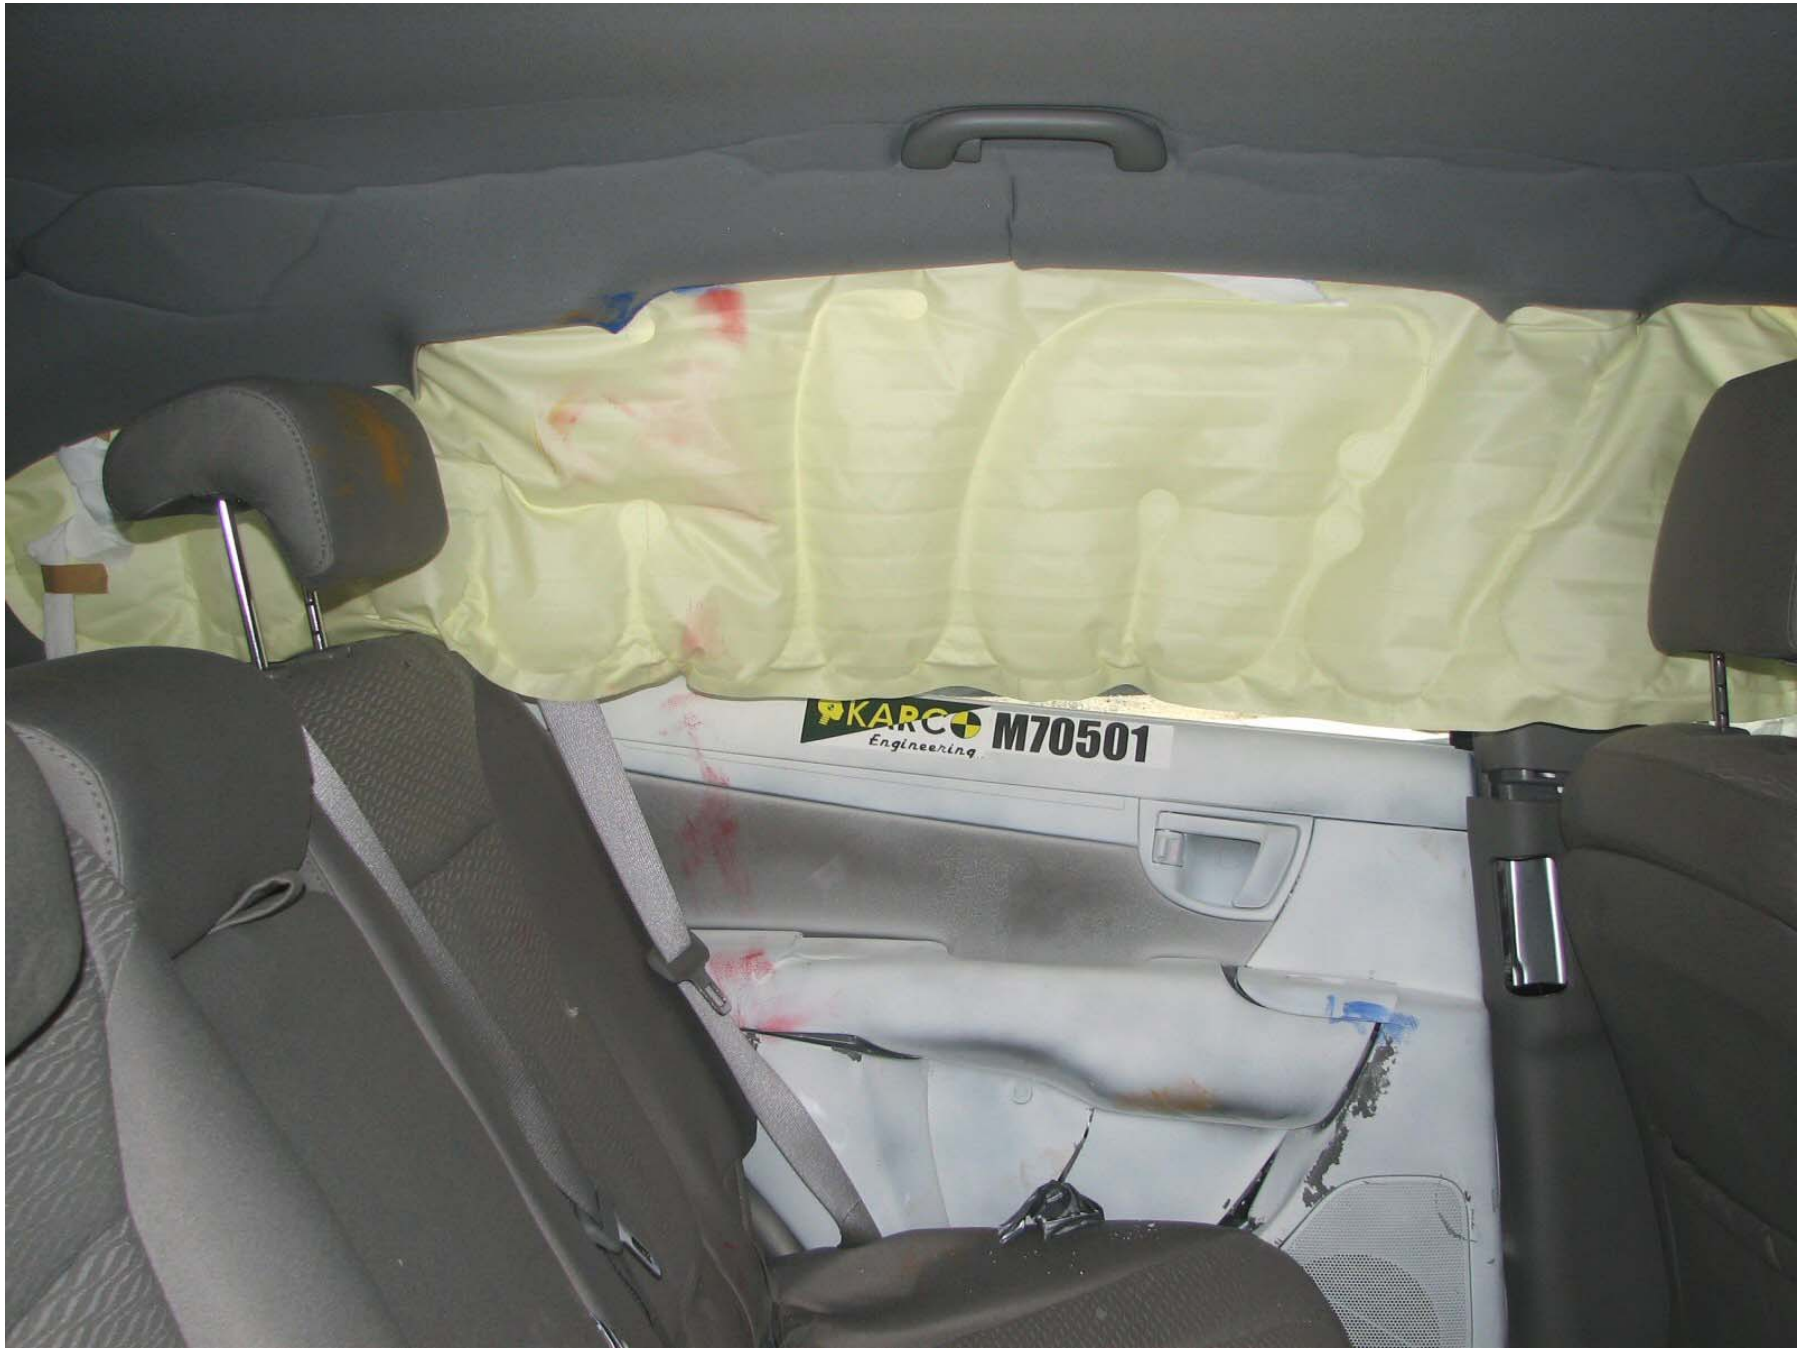
Figure A-52: Post-Test Rear Door Panel (Interior)

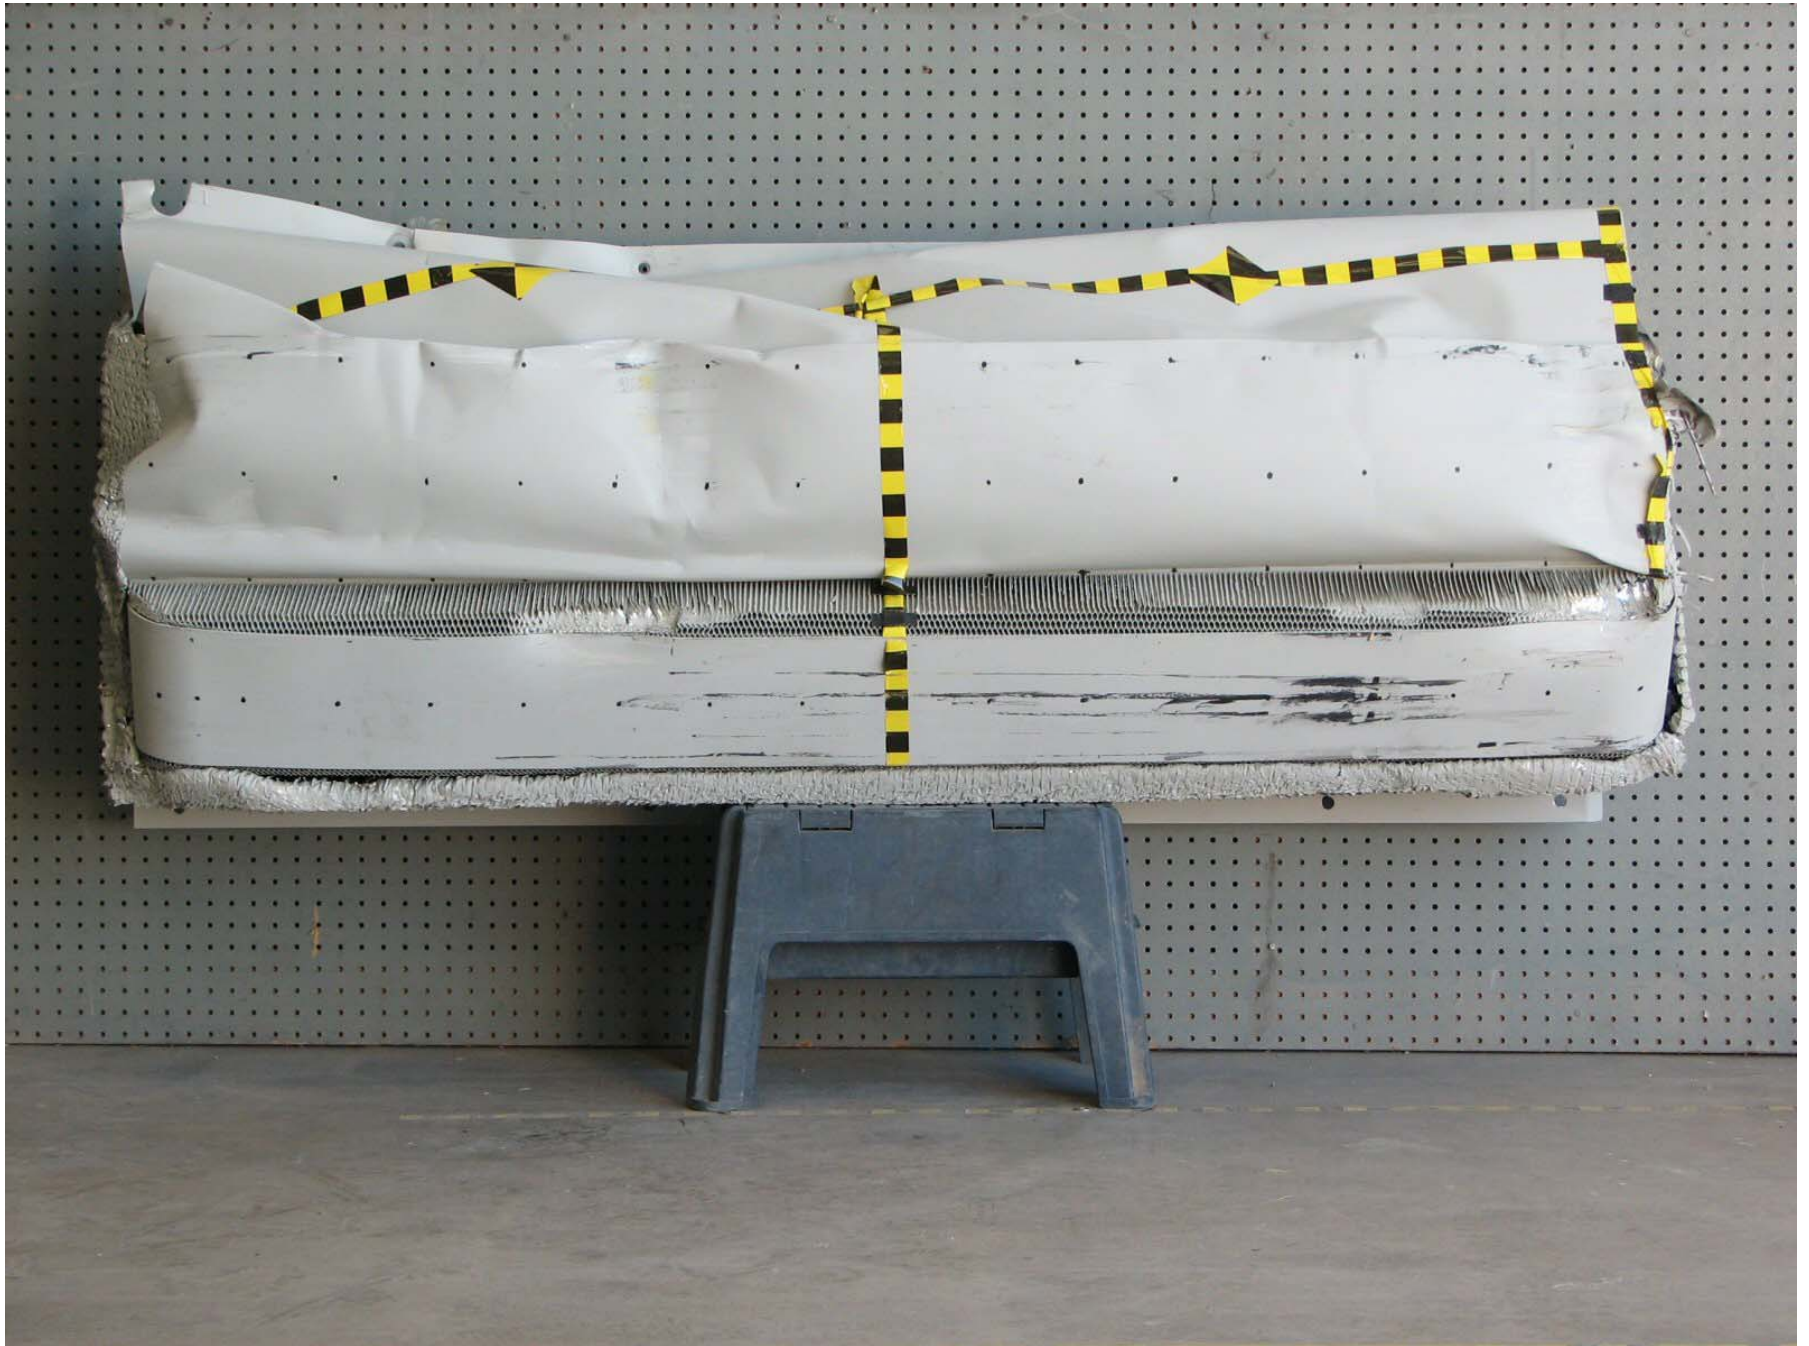
Figure A-54: Post-Test Front View of Deformable Barrier

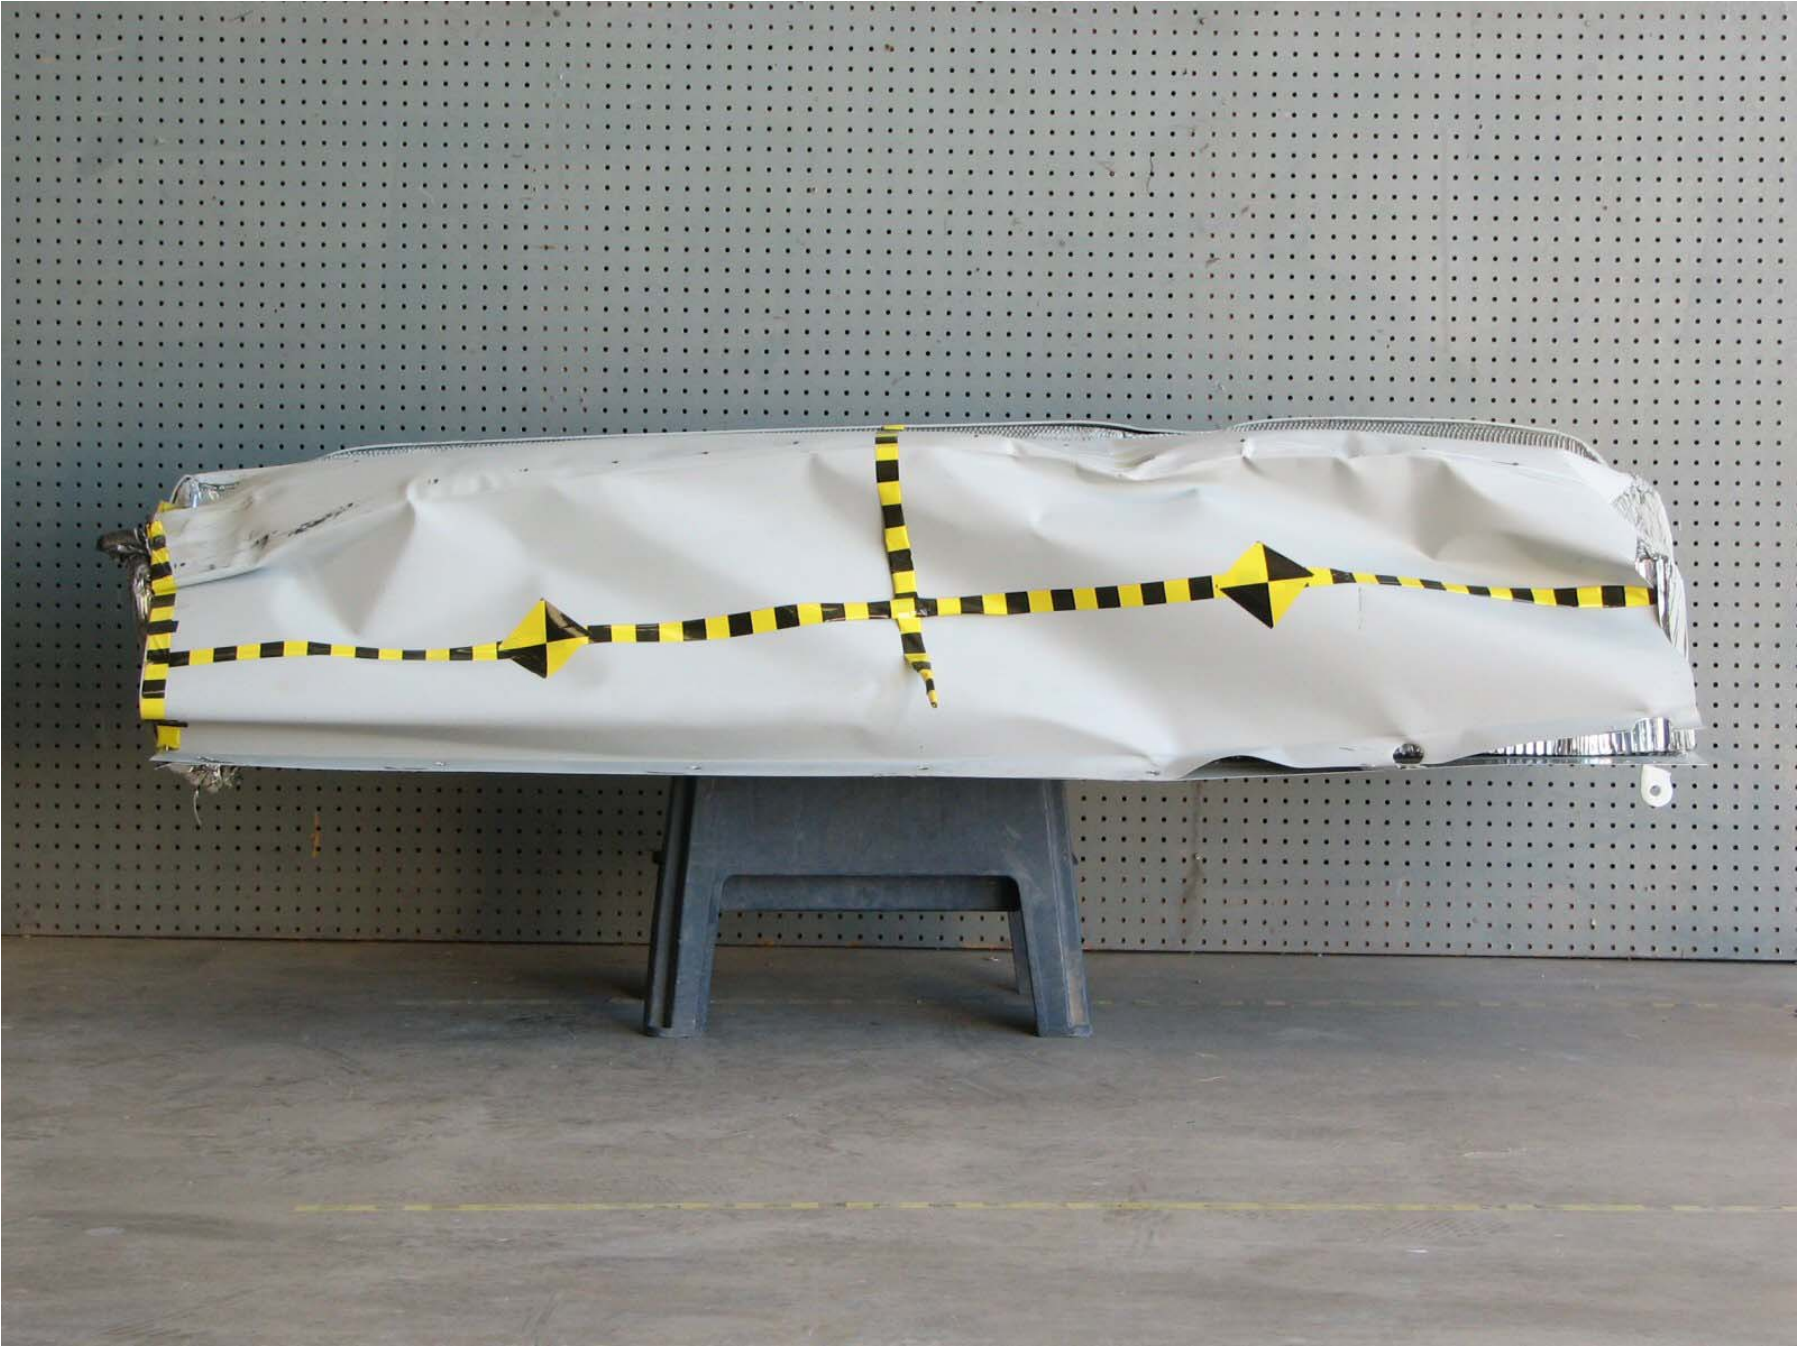
Figure A-56: Post-Test Top View of Deformable Barrier
