REPORT NUMBER: 214-CAL-07-02

**SAFETY COMPLIANCE TESTING FOR FMVSS 214
SIDE IMPACT PROTECTION
INDICANT**

**GENERAL MOTOR CORPORATION
2007 SATURN AURA
4-DOOR SEDAN**

NHTSA NUMBER: C70103

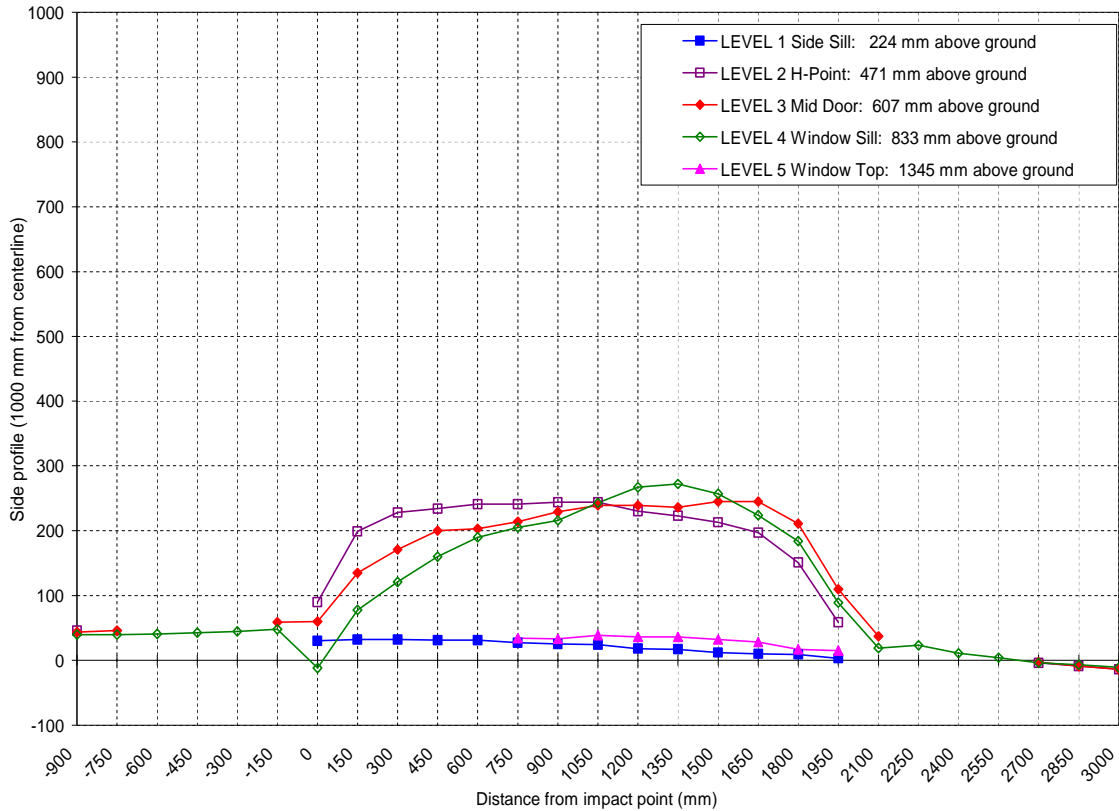
LEVEL	HEIGHT (mm)		DISTANCE IN MILLIMETERS (mm) FROM IMPACT POINT																											
			-900	-750	-600	-450	-300	-150	0	150	300	450	600	750	900	1050	1200	1350	1500	1650	1800	1950	2100	2250	2400	2550	2700	2850	3000	
LEVEL 1 SIDE SILL	224	PRE	-	-	-	-	-	-	150	150	150	149	148	149	149	149	151	151	155	154	151	151	-	-	-	-	-	-	-	-
		POST	-	-	-	-	-	-	180	182	182	180	179	176	174	173	169	168	167	164	160	154	-	-	-	-	-	-	-	-
		CRUSH	N/A	N/A	N/A	N/A	N/A	N/A	30	32	32	31	31	27	25	24	18	17	12	10	9	3	N/A	N/A	N/A	N/A	N/A	N/A	N/A	N/A
LEVEL 2 H POINT	471	PRE	162	-	-	-	-	-	120	120	120	120	120	120	120	121	122	123	124	126	128	127	-	-	-	-	-	147	184	209
		POST	208	-	-	-	-	-	210	319	348	354	361	361	364	365	352	346	337	323	279	186	-	-	-	-	143	175	195	
		CRUSH	46	N/A	N/A	N/A	N/A	N/A	90	199	228	234	241	241	244	244	230	223	213	197	151	59	N/A	N/A	N/A	N/A	-4	-9	-14	
LEVEL 3 MID DOOR	607	PRE	164	125	-	-	-	110	111	111	111	111	111	111	111	113	114	116	118	117	125	116	-	-	-	154	181	205

POST	208	171	-	-	-	169	171	246	282	311	314	325	340	350	352	350	361	363	328	235	153	-	-	-	151	172	191	
		CRUSH	44	46	N/A	N/A	N/A	59	60	135	171	200	203	214	229	239	239	236	245	245	211	110	37	N/A	N/A	N/A	-3	-9	-14	
LEVEL 4 WINDOW SILL	833	PRE	273	221	194	174	161	151	144	138	135	131	128	126	97	123	124	125	126	128	131	136	139	146	154	164	178	196	220	
		POST	313	261	235	217	206	199	132	216	256	291	318	331	313	366	391	397	383	352	315	225	158	169	165	168	174	189	209	
		CRUSH	40	40	41	43	45	48	-12	78	121	160	190	205	216	243	267	272	257	224	184	89	19	23	11	4	-4	-7	-11	
LEVEL 5 WINDOW TOP	1345	PRE	-	-	-	-	-	-	-	-	-	-	-	-	403	399	400	400	401	404	406	418	442	-	-	-	-	-	-	
		POST	-	-	-	-	-	-	-	-	-	-	-	-	-	437	432	439	436	437	436	434	435	457	-	-	-	-	-	-
		CRUSH	N/A	N/A	N/A	N/A	N/A	N/A	N/A	N/A	N/A	N/A	N/A	N/A	N/A	34	33	39	36	36	32	28	17	15	N/A	N/A	N/A	N/A	N/A	N/A

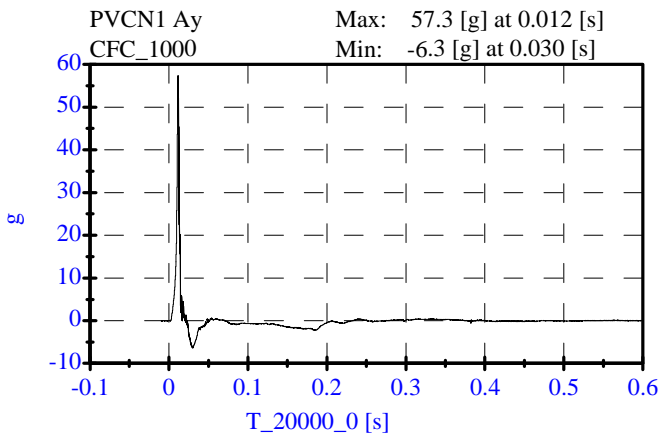
SID Pelvic Test S/N:270

<u>TEST PARAMETER</u>	<u>SPECIFICATION</u>	<u>TEST RESULTS</u>	<u>STATUS</u>
Lab Temperature:	18.9-25.5 C	21.1 C	Passed
Lab Humidity:	10-70 %	30.00 %	Passed
Probe Velocity:	4.27- 4.33 m/s	4.30 m/s	Passed
Pelvis Y Acceleration:	40.00-60.00 g	41.41 g	Passed
Time Above 20 Gs	3.0-7.0 ms	5.3 ms	Passed

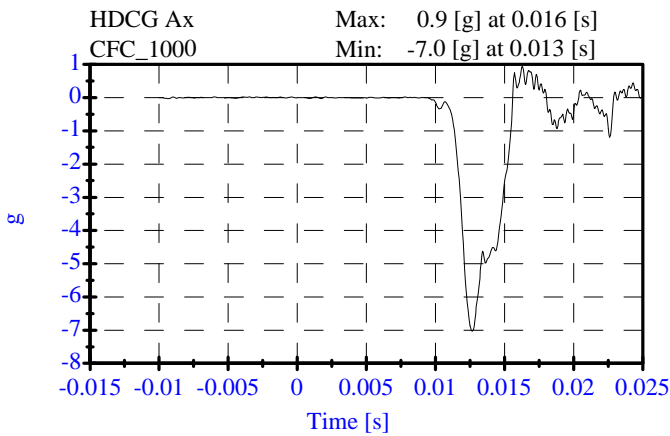
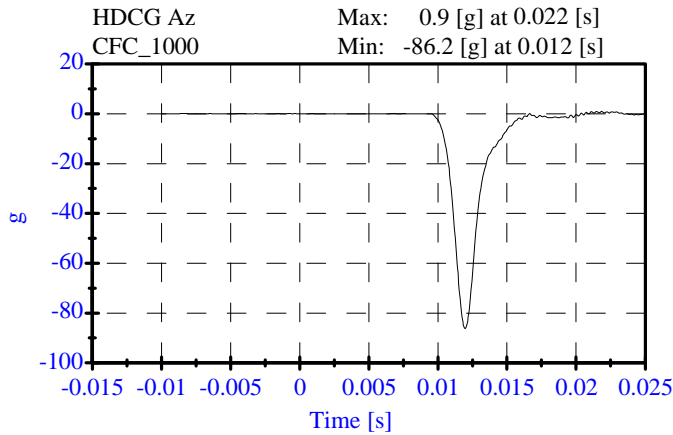
SID HYIII Head Drop Test S/N:270
Pre-Test
CONFIGURED FOR LEFT SIDE IMPACT

<u>TEST PARAMETER</u>	<u>SPECIFICATION</u>	<u>TEST RESULTS</u>	<u>STATUS</u>
Lab Temperature:	18.9-25.6 C	21.1 C	Passed
Lab Humidity:	10-70 %	50.00 %	Passed
Peak Resultant Accel.:	120-150 Gs	136.29 Gs	Passed
Peak Lateral Accel.:	15 Gs Max	0.94 Gs	Passed
Curve PerCent NonModal:	< 15%	2.42 %	Passed

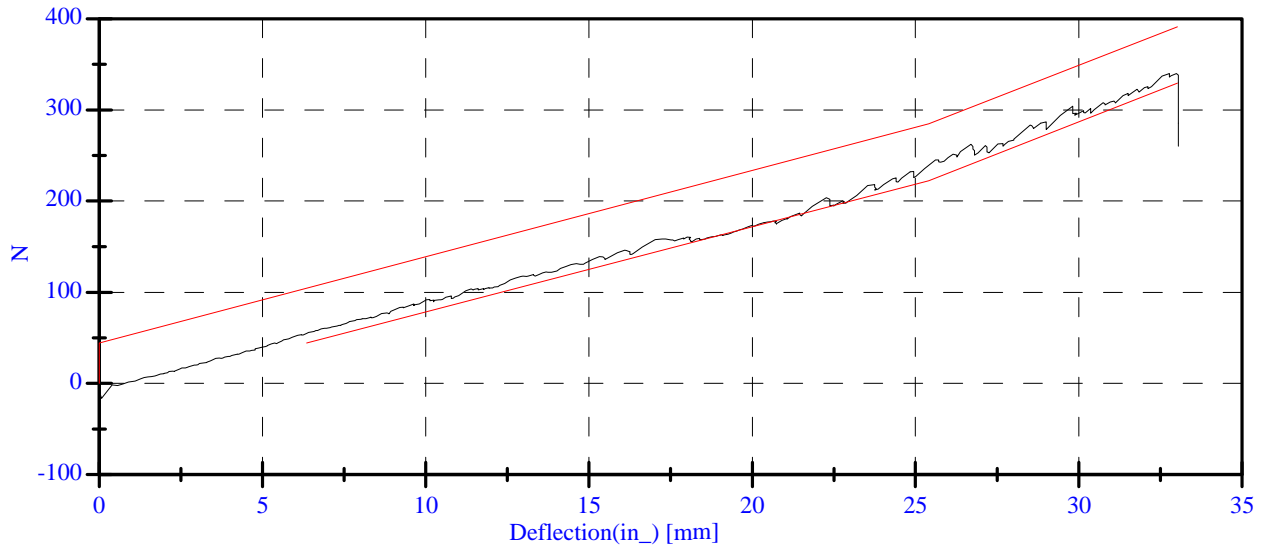
ABDOMINAL COMPRESSION TEST

<u>TEST PARAMETER</u>	<u>SPECIFICATION</u>	<u>TEST RESULTS</u>	<u>STATUS</u>
Lab Temperature:	18.9-25.5 C	21.1 C	Passed
Lab Humidity:	10-70 %	50.00 %	Passed
Force at 12.95 mm :	104.00-162.00 N	117.90 N	Passed
Force at 19.05 mm :	162.98-220.99 N	162.99 N	Passed
Force at 25.40 mm :	221.97-280.02 N	235.73 N	Passed
Force at 33.02 mm :	324.99-391.00 N	338.28 N	Passed

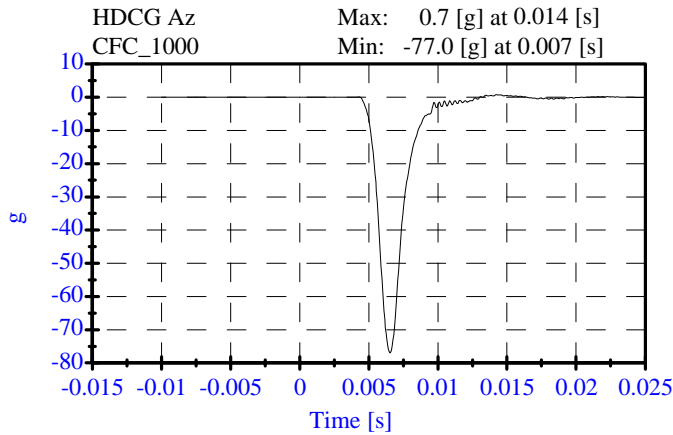
SID HYIII Head Drop Test S/N:269
Pre-Test
CONFIGURED FOR LEFT SIDE IMPACT

<u>TEST PARAMETER</u>	<u>SPECIFICATION</u>	<u>TEST RESULTS</u>	<u>STATUS</u>
Lab Temperature:	18.9-25.6 C	21.1 C	Passed
Lab Humidity:	10-70 %	50.00 %	Passed
Peak Resultant Accel.:	120-150 Gs	143.11 Gs	Passed
Peak Lateral Accel.:	15 Gs Max	9.04 Gs	Passed
Curve PerCent NonModal:	< 15%	2.91 %	Passed

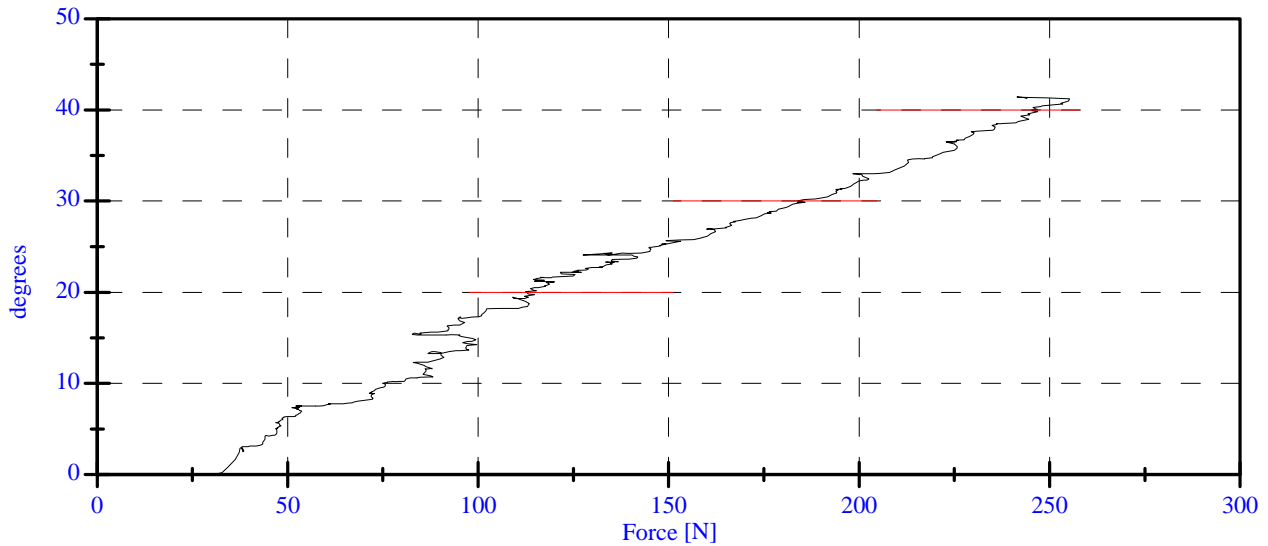
LUMBAR SPINE FLEXION TEST

<u>TEST PARAMETER</u>	<u>SPECIFICATION</u>	<u>TEST RESULTS</u>	<u>STATUS</u>
Lab Temperature:	18.9-25.5 C	21.1 C	Passed
Lab Humidity:	10-70 %	50.00 %	Passed
Force at 0 Deg:	0.00-26.69 N	20.24 N	Passed
Force at 20 Deg:	97.86-151.24 N	112.43 N	Passed
Force at 30 Deg:	151.24-204.62 N	185.29 N	Passed
Force at 40 Deg:	204.62-258.00 N	245.36 N	Passed
Return Angle	12 Deg Max	6.13 deg	Passed

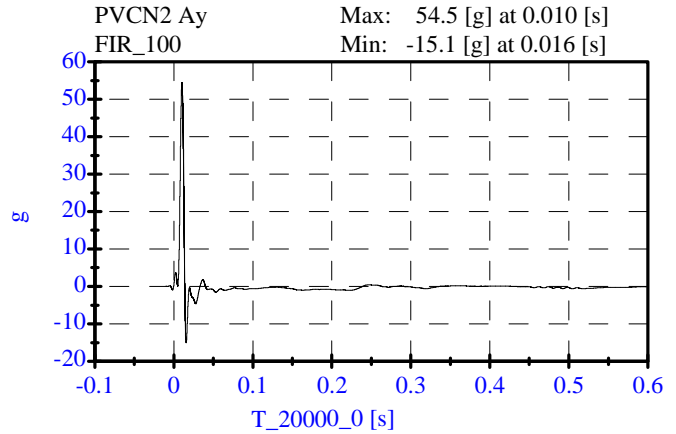
SID Pelvis Test S/N:269

<u>TEST PARAMETER</u>	<u>SPECIFICATION</u>	<u>TEST RESULTS</u>	<u>STATUS</u>
Lab Temperature:	18.9-25.5 C	21.1 C	Passed
Lab Humidity:	10-70 %	50.00 %	Passed
Probe Velocity:	4.27- 4.33 m/s	4.27 m/s	Passed
Pelvis Y Acceleration:	40.00-60.00 g	54.47 g	Passed
Time Above 20 Gs	3.0-7.0 ms	5.4 ms	Passed

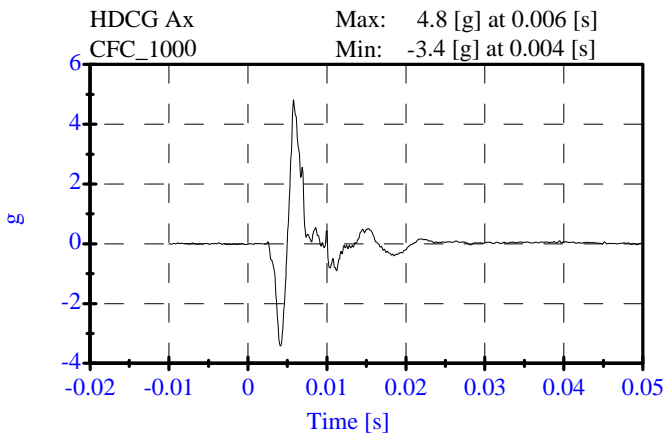
SID HYIII Head Drop Test S/N:269
Post-Test
CONFIGURED FOR LEFT SIDE IMPACT

<u>TEST PARAMETER</u>	<u>SPECIFICATION</u>	<u>TEST RESULTS</u>	<u>STATUS</u>
Lab Temperature:	18.9-25.6 C	21.1 C	Passed
Lab Humidity:	10-70 %	50.00 %	Passed
Peak Resultant Accel.:	120-150 Gs	135.02 Gs	Passed
Peak Lateral Accel.:	15 Gs Max	4.82 Gs	Passed
Curve PerCent NonModal:	< 15%	2.54 %	Passed
