REPORT NUMBER: CAL-07-04

**NEW CAR ASSESSMENT PROGRAM (NCAP)  
FRONTAL BARRIER IMPACT TEST**

GENERAL MOTORS CORPORATION  
2007 SATURN AURA  
4-DOOR SEDAN

NHTSA NUMBER: M70105

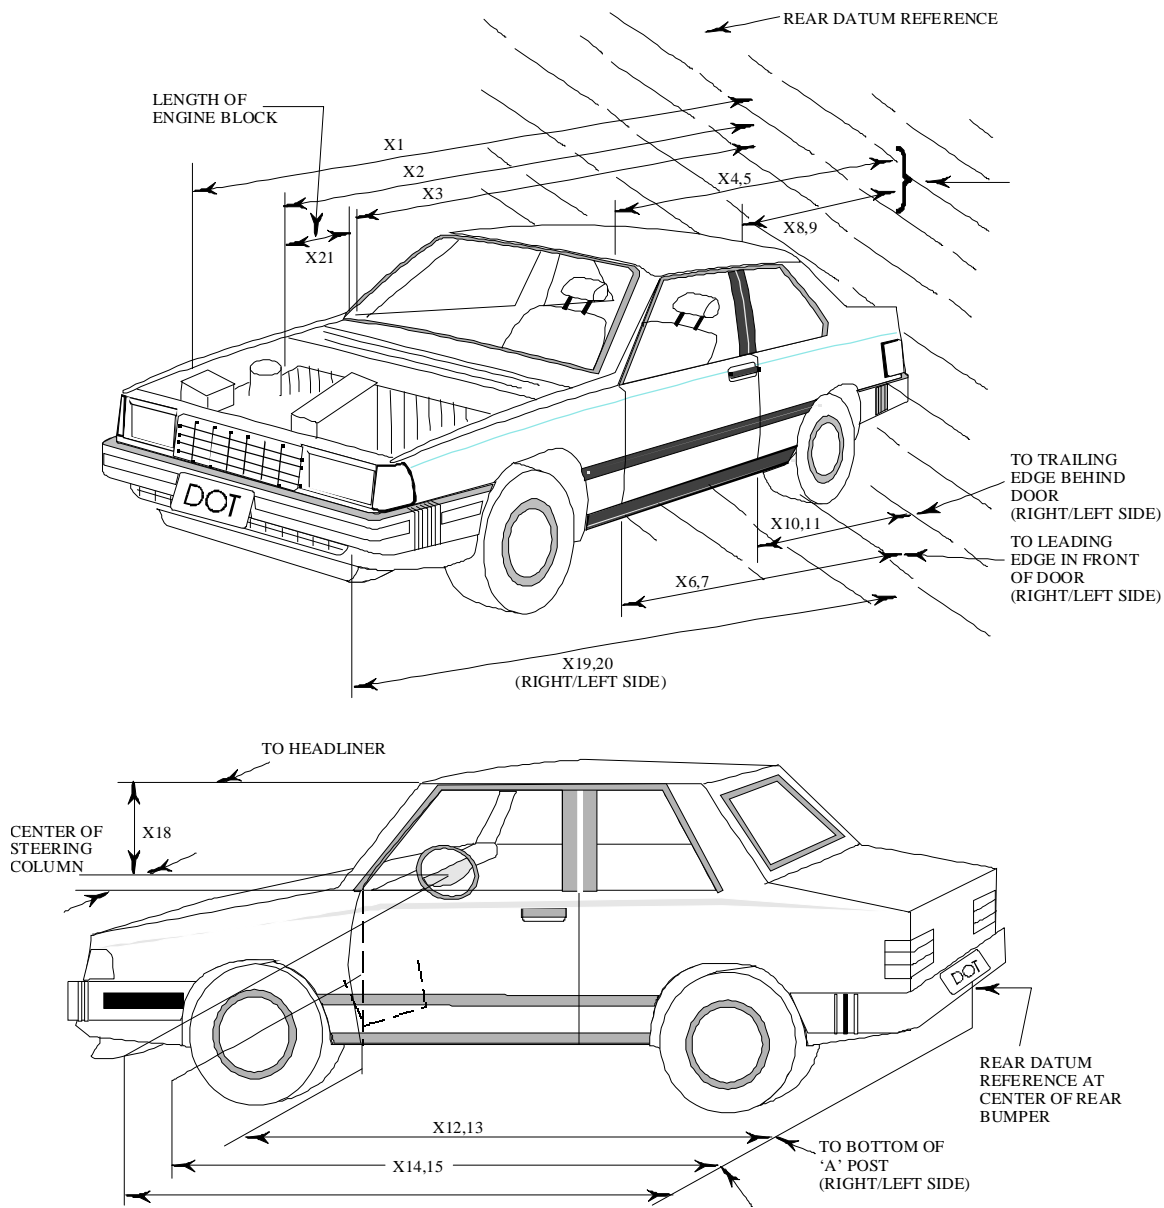
**DATA SHEET NO. 10**  
**TEST VEHICLE MEASUREMENTS**

Elements	Pre-Test (mm)
1	Total length	4839
2	Total Width	1784
3	Bumper Top Height	510
4	Bumper Bottom Height	381
5	Longitudinal Member Top Height	565
6	Distance Between Longitudinal Members	1058
7	Longitudinal Member Width	95
8	Engine top height	880
9	Engine bottom height	211
10	Engine and gearbox width	675
11	Front bumper-engine distance	529
12	Front shock absorber fixing height	863
13	Bonnet leading edge height	728
14	Front shock absorber fixing width	1136
15	Front bumper – front axle distance	972
16	Front axle – a pillar distance	491
17	A-pillar – B pillar distance	1087
18	B-pillar – rear axle distance	1275
19	B-pillar – C Pillar distance	1154
20	Roof sill bottom height	1310
21	Roof sill top height	1407
22	Floor sill bottom height	258
23	Floor sill top height	354

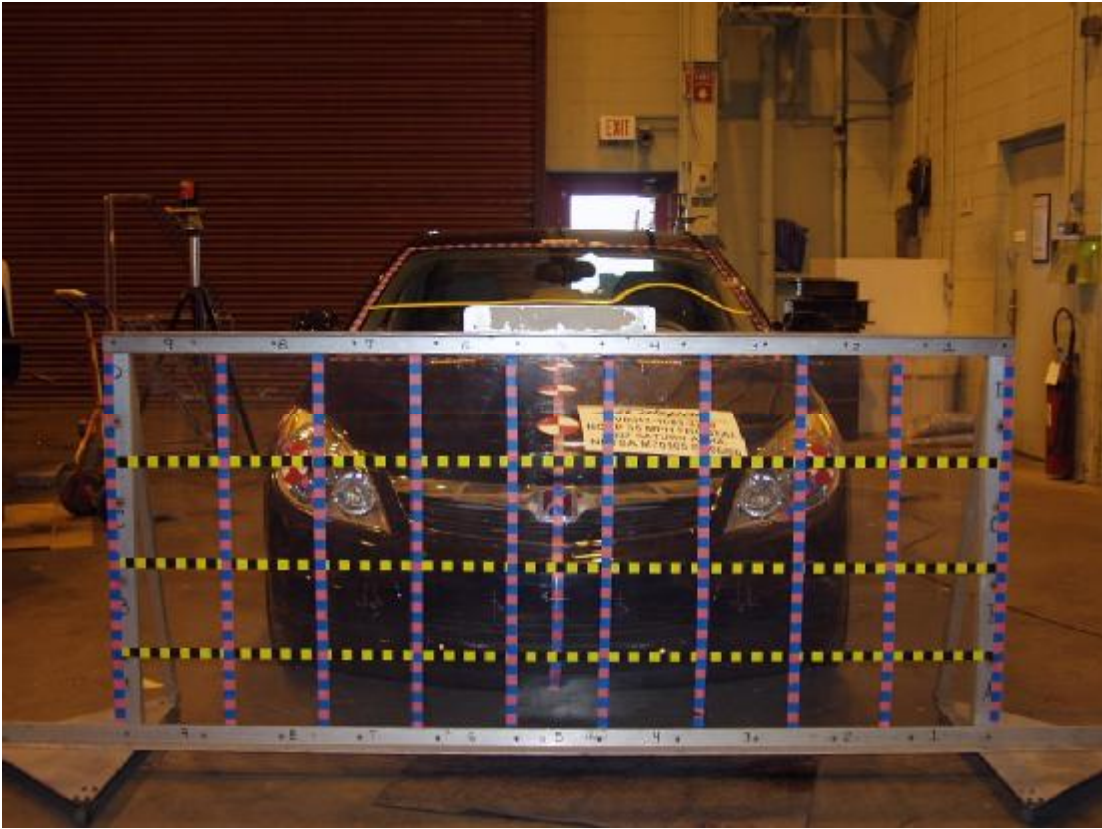
**Figure A-1: Load Cell Locations**

A load cell barrier consisting of 36 load cells was impacted by a 2007 Saturn Aura 4-Door Sedan at a velocity of 56.49 kph. The test was performed at Calspan on September 08, 2006. Pre- and post-test photographs of the vehicle and dummies can be found in Appendix A.

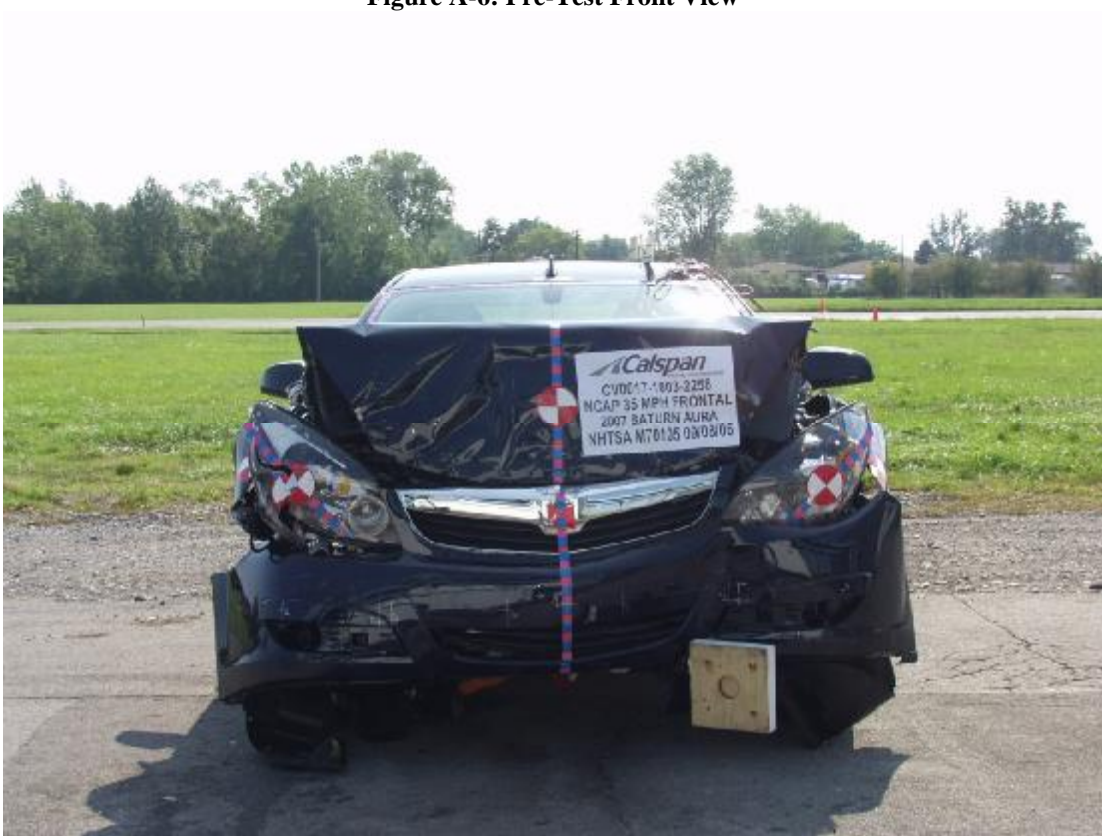
**Figure A-7: Post-Test Front View**

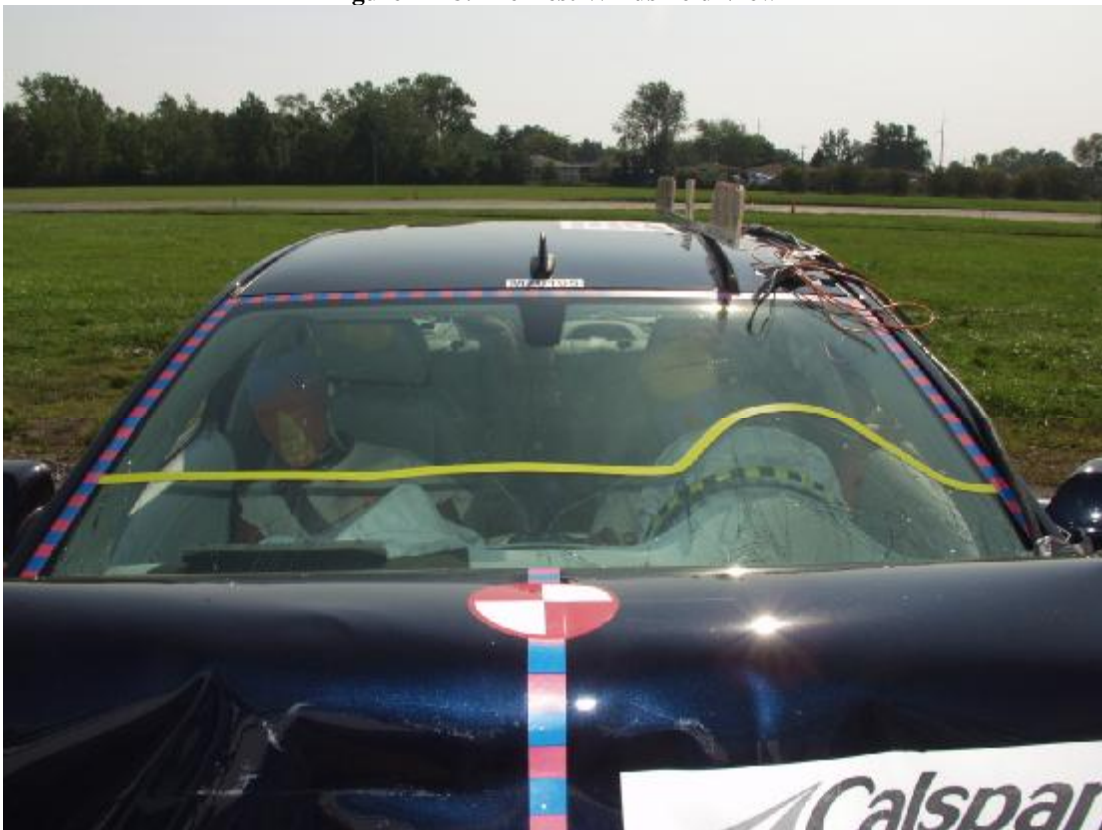
Figure A-19: Post-Test Windshield View

Description	Driver Side	Passenger Side
Door Lock Status	Locked	Locked
Front Door Opening	Closed, latched and operable without tools	Closed, latched and operable without tools
Rear Door Opening	Closed, latched and operable without tools	Closed, latched and operable without tools
Hatch/Other Door Opening	Not Applicable	Not Applicable
Front Seat Track Shift (mm)	16 mm forward	18 mm forward
Front Seat Back Failure	None	None
Glazing Damage	Windshield cracked along its lower edge

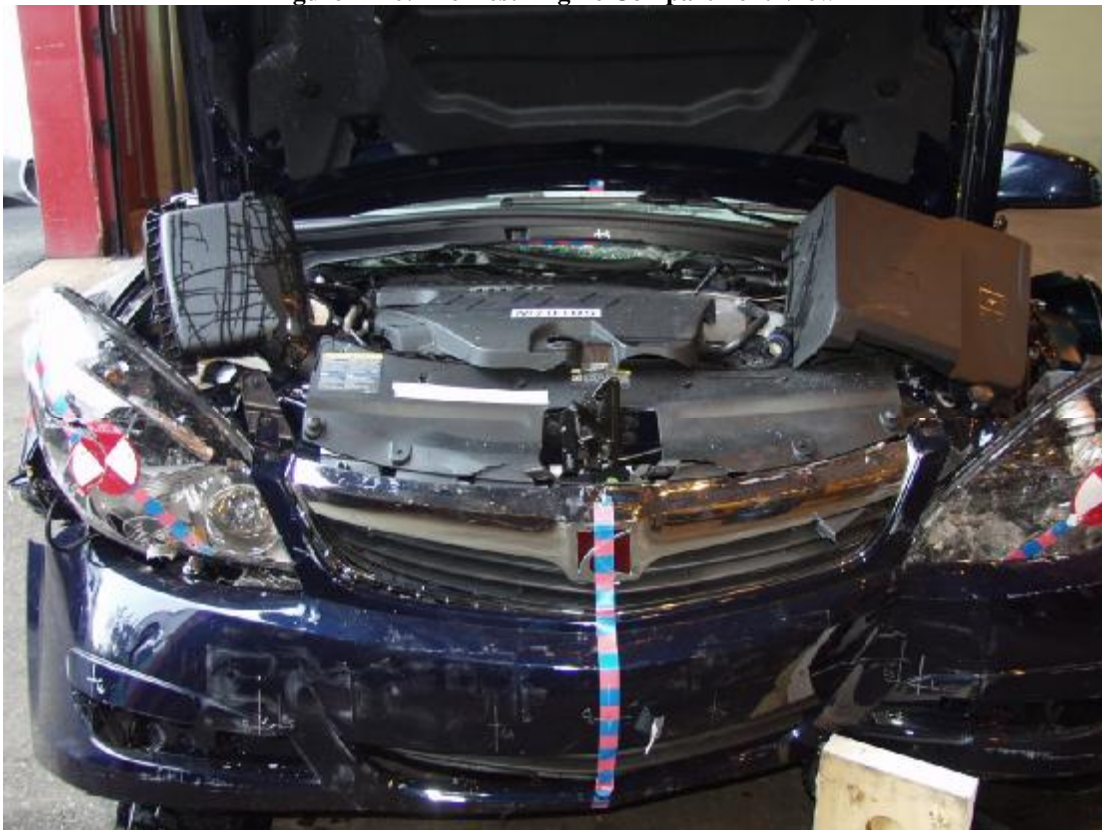
**Figure A-21: Post-Test Engine Compartment View**

TEST NOTES	
Data Channel	Anomalies
V1P1 Head CG Red y	Transducer failed
V1P1 Left Upper Tibia Mx	Connector damaged at 124 ms
V1P2 Left Foot Aft Ax	Connector damaged
V1P2 RFP Lap Belt	Questionable data after 84 ms
V1 Engine Top #3x	Wire cut at 35 ms
V1 Engine Bottom #4x	Wire cut at 36 ms

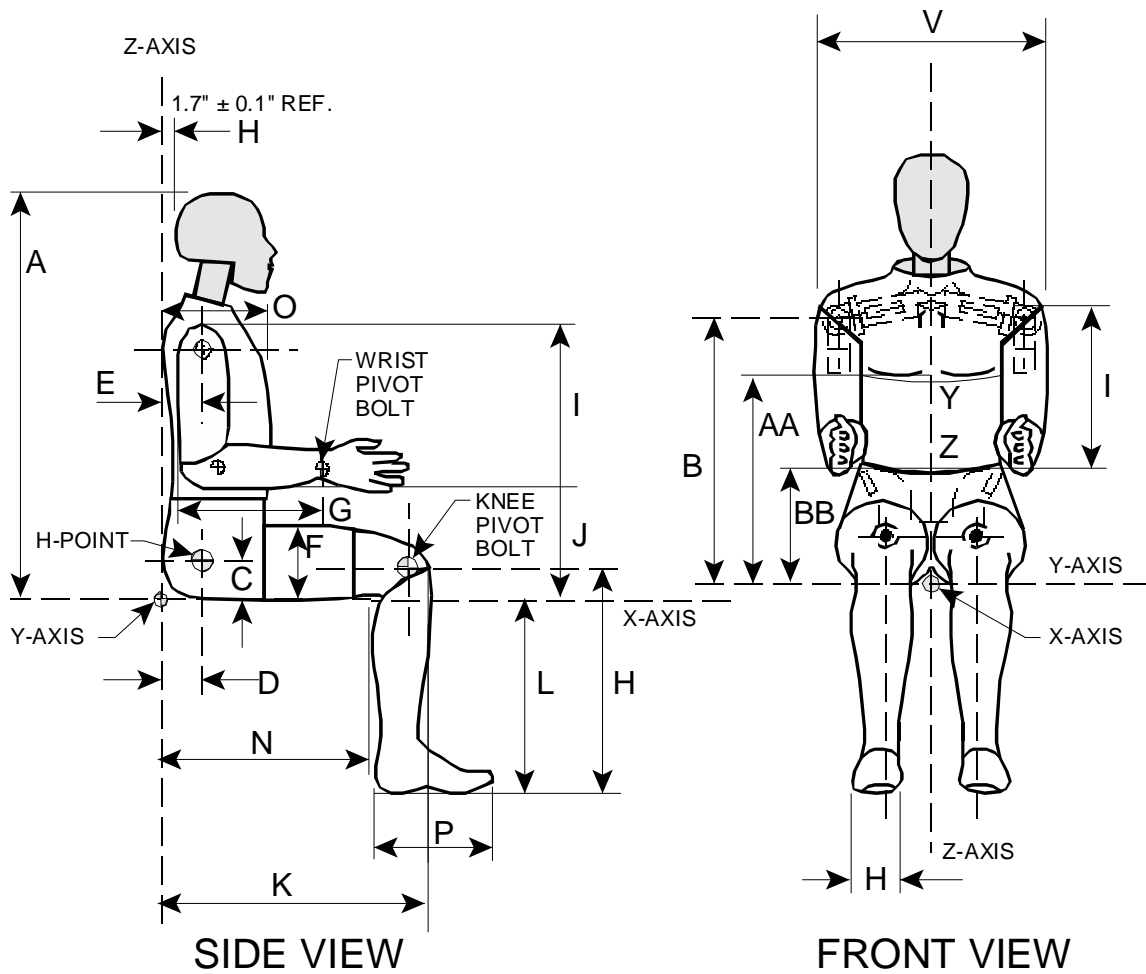
# EXTERNAL DIMENSIONS SPECIFICATIONS

NOTE: Figure is referenced to the erect seated position. The curved lumbar does not allow the Hybrid III to be positioned in a perfect erect attitude. (REF: S572.31(A)(6))

TEST PARAMETER		SPECIFICATION	TEST RESULTS
Temperature			21.1
Relative Humidity			50.0
Location for Chest Circumference	AA	16.9 - 17.1 in	17.0
Location for Waist Circumference	BB	8.9 - 9.1 in	9.0
Total Sitting Height	A	34.6 - 35.0 in	34.9
Shoulder Pivot Height	B	19.9 - 20.5 in	20.3
H-Point Height	C	3.3 - 3.5 in	3.4
H-Point from Backline	D	5.3 - 5.5 in	5.4
Shoulder Pivot from Backline	E	3.3 - 3.7 in	3.6
Thigh Clearance	F	5.5 - 6.1 in	6.0
Back of Elbow to Wrist Pivot	G	11.4 - 12.0 in	11.5
Skull Cap to Backline	H	1.6 - 1.8 in	1.7
Shoulder - Elbow Length	I	13.0 - 13.6 in	13.5
Elbow Rest Height	J	7.5 - 8.3 in	8.1
Buttock Knee Length	K	22.8 - 23.8 in	23.5
Popliteal Height	L	16.9 - 17.9 in	17.7
Knee Pivot Height	M	19.1 - 19.7 in	19.2
Buttock Popliteal Length	N	17.8 - 18.8 in	18.6
Chest Depth	O	8.4 - 9.0 in	8.9
Foot Length	P	9.9 - 10.5 in	10.3
Shoulder Breadth	V	16.6 - 17.2 in	16.9
Foot Breadth	W	3.6 - 4.2 in	4.0
Chest Circumference (With Jacket)	Y	38.2 - 39.4 in	38.9
