**NEW CAR ASSESSMENT PROGRAM  
FRONTAL BARRIER IMPACT TEST**

**AUDI AG  
2007 AUDI Q7  
5-DOOR MPV**

**NHTSA NUMBER: V75801**

**FINAL REPORT**

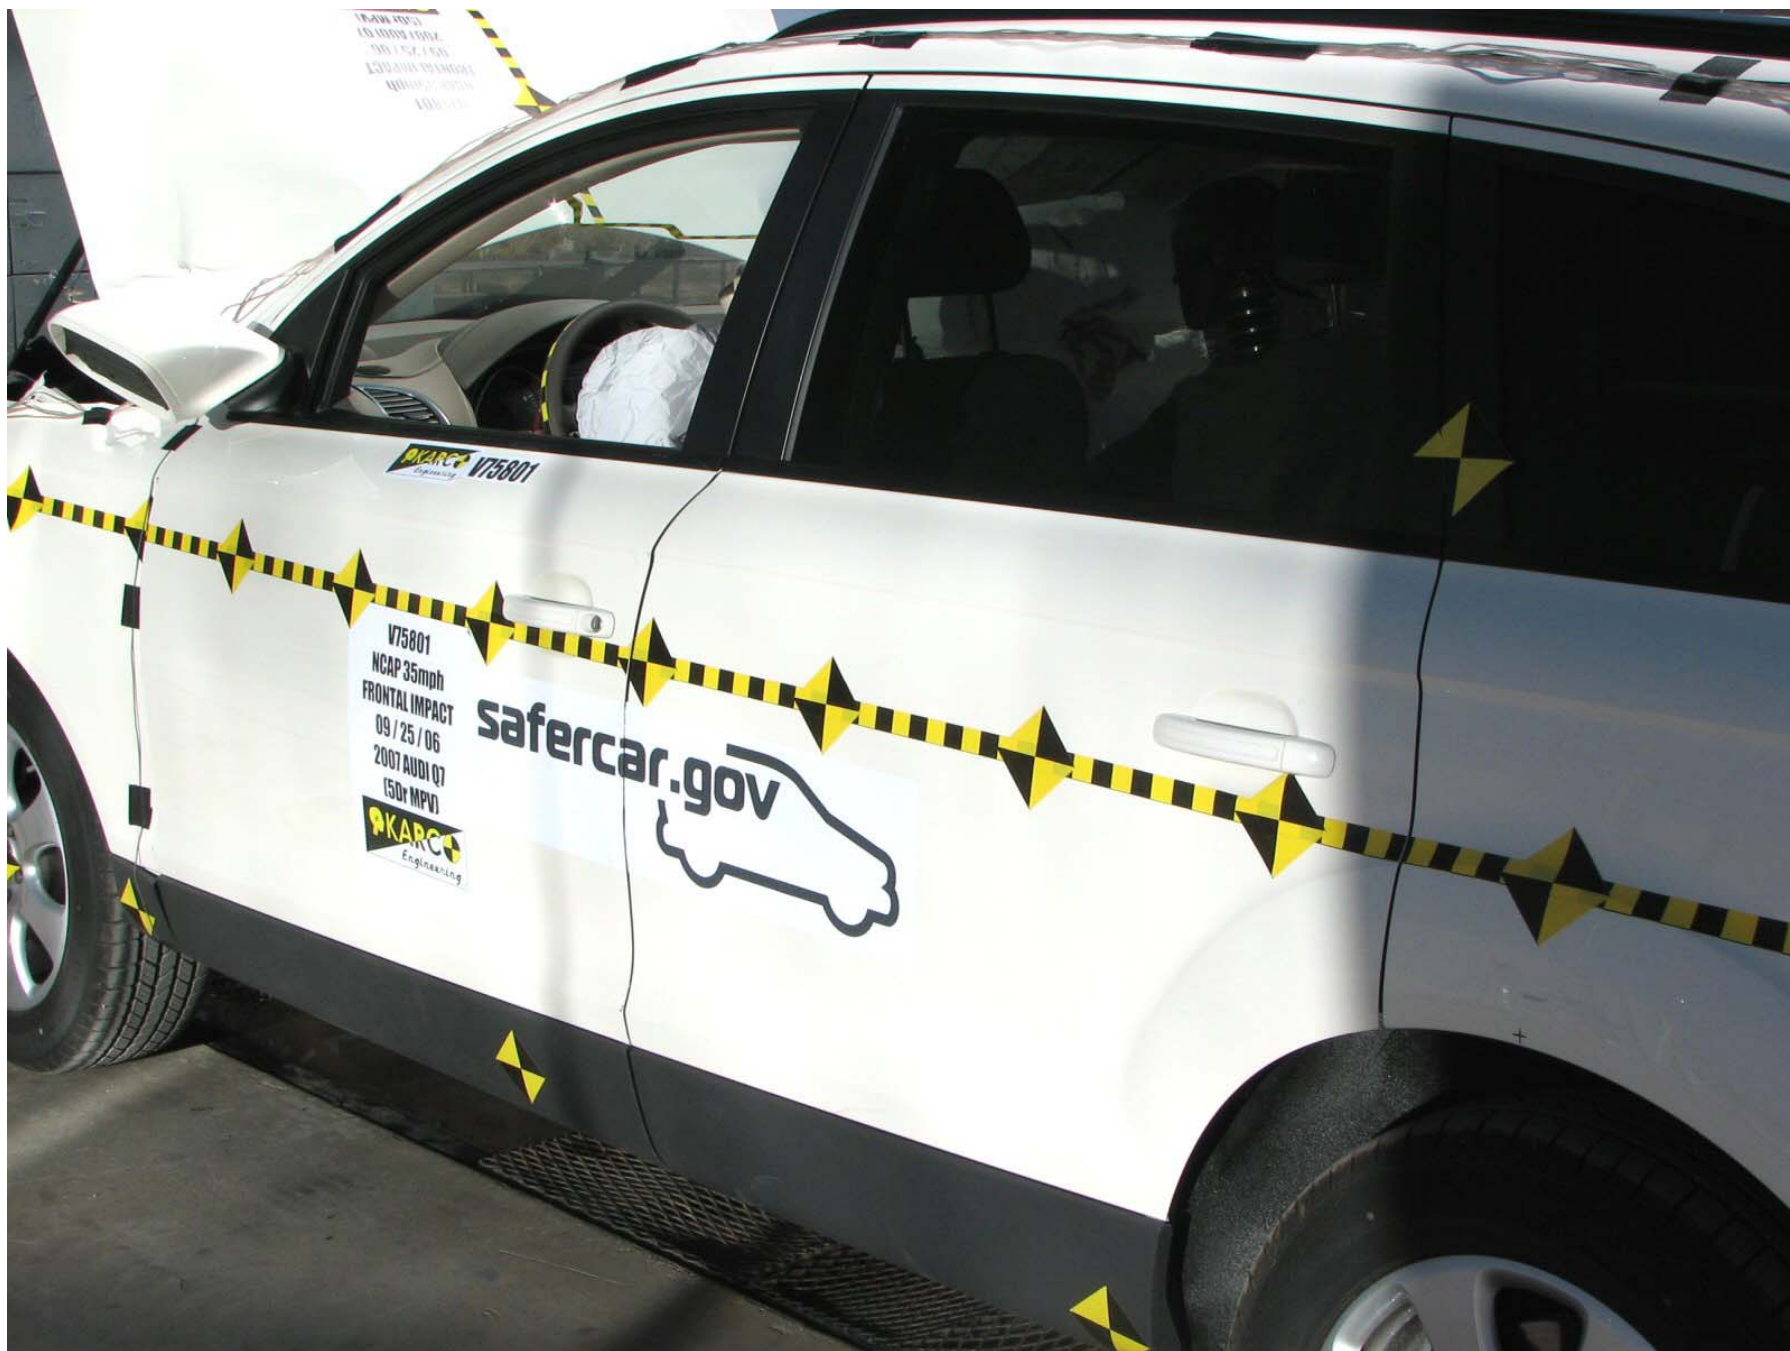
Figure A-16: Post-Test Left Side ¾ View of Doors After Impact

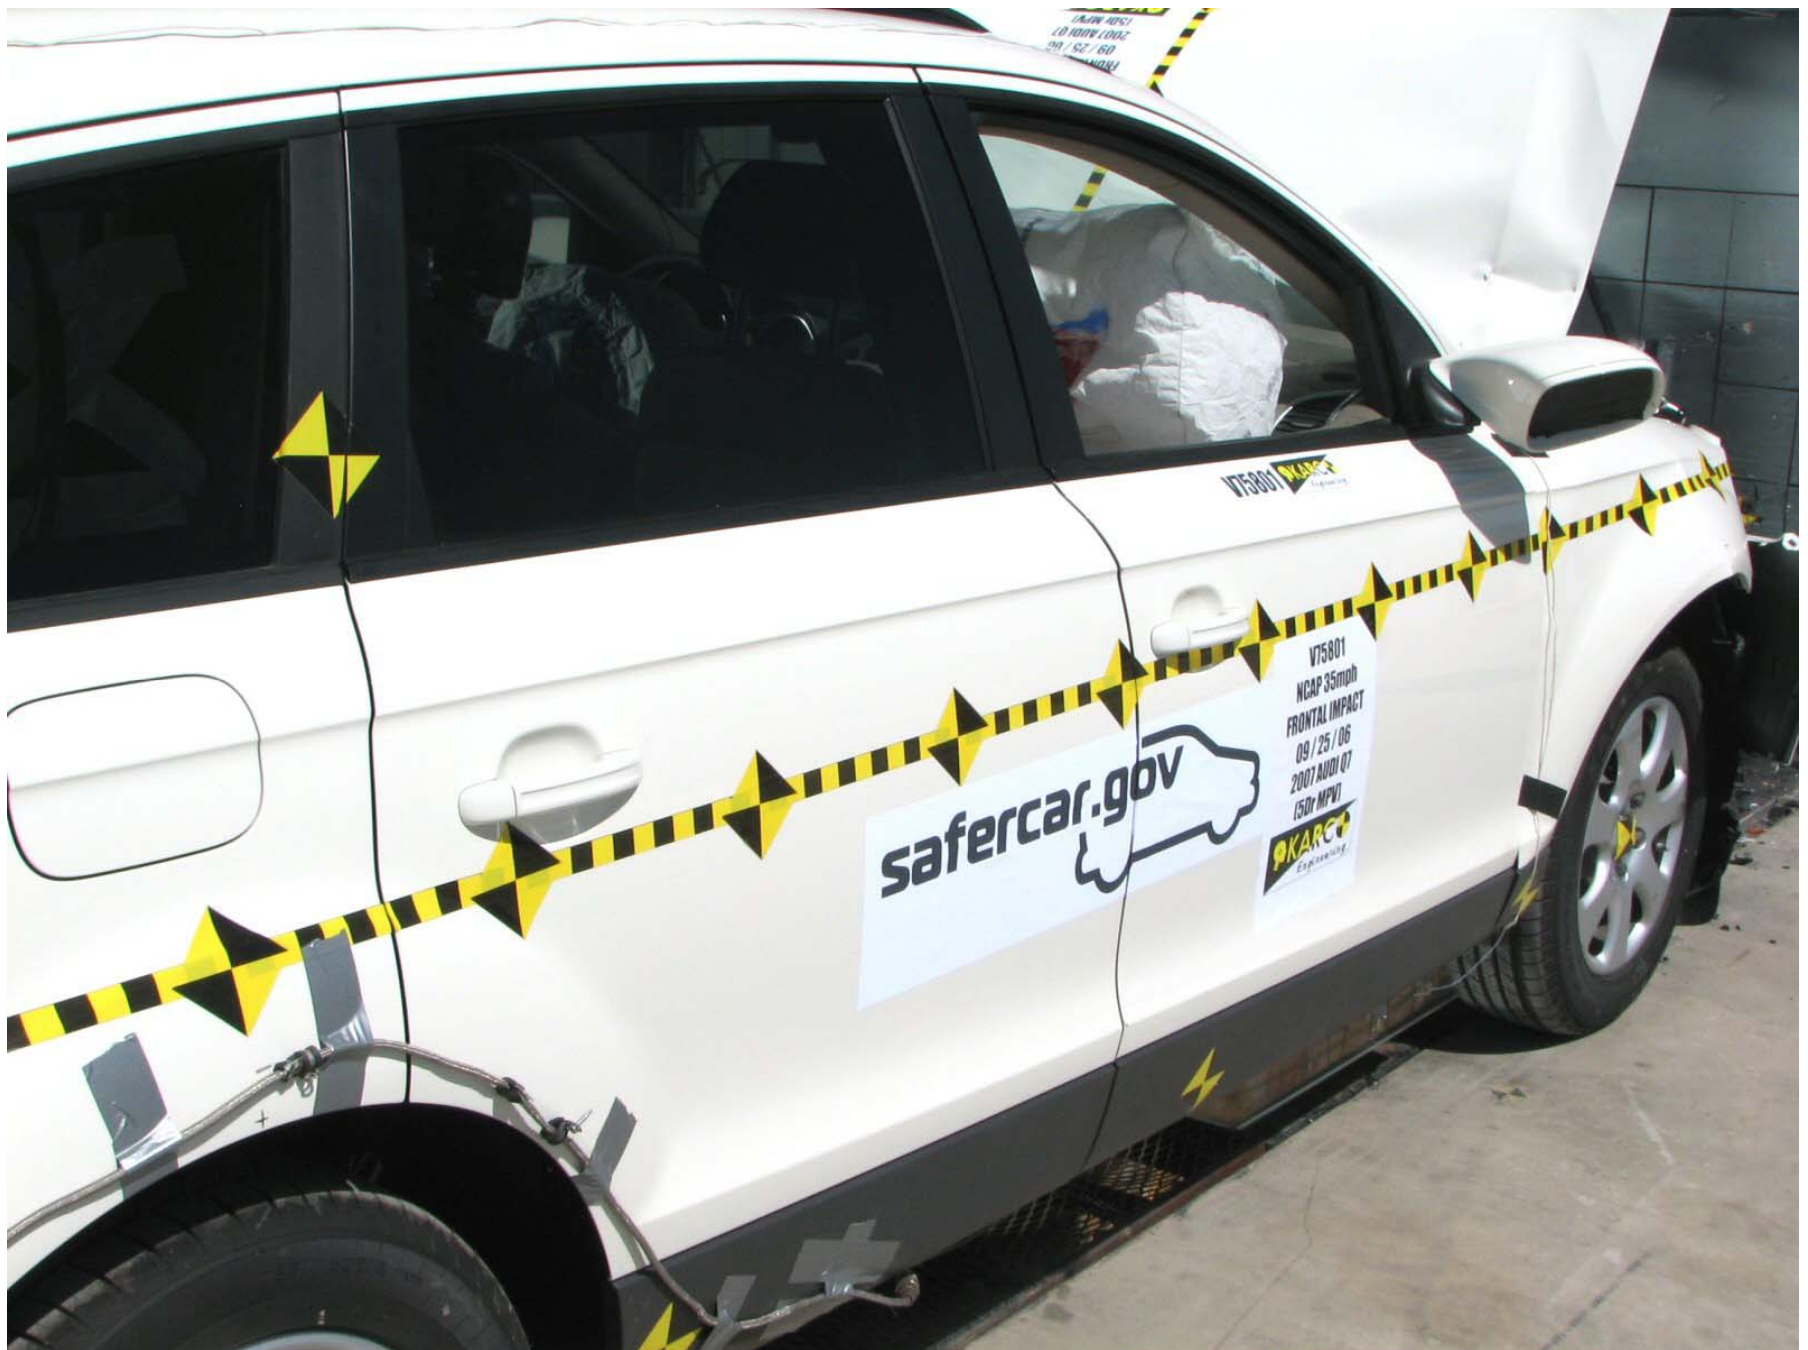
Figure A-17: Post-Test Right Side  $\frac{3}{4}$  View of Doors After Impact

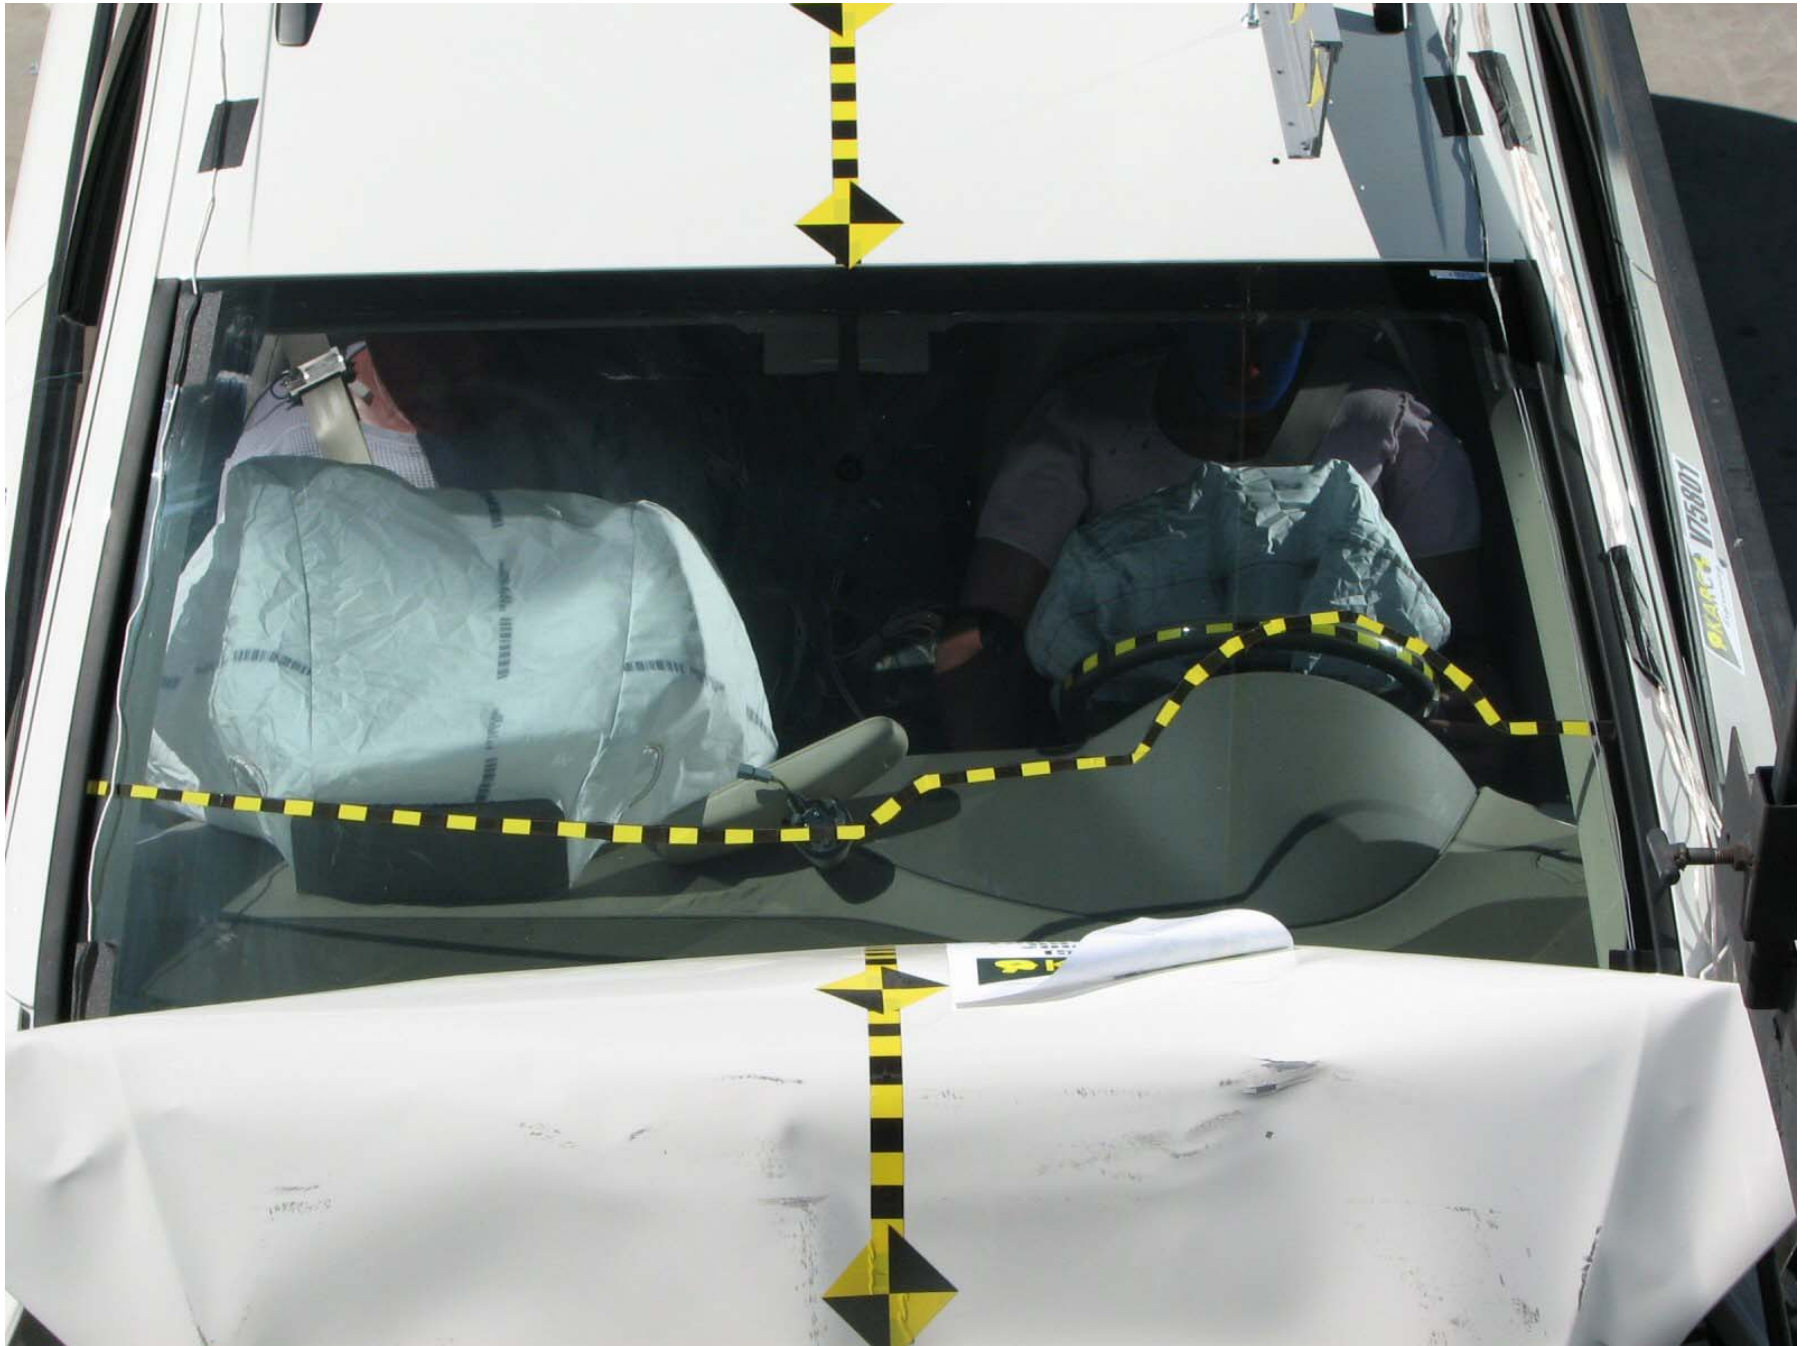
Figure A-19: Post-Test Windshield

There was 100 percent windshield retention and there was no intrusion into the protected zone of the windshield during the impact event. There was no stoddard solvent leakage after the event or during any phase of the static rollover.

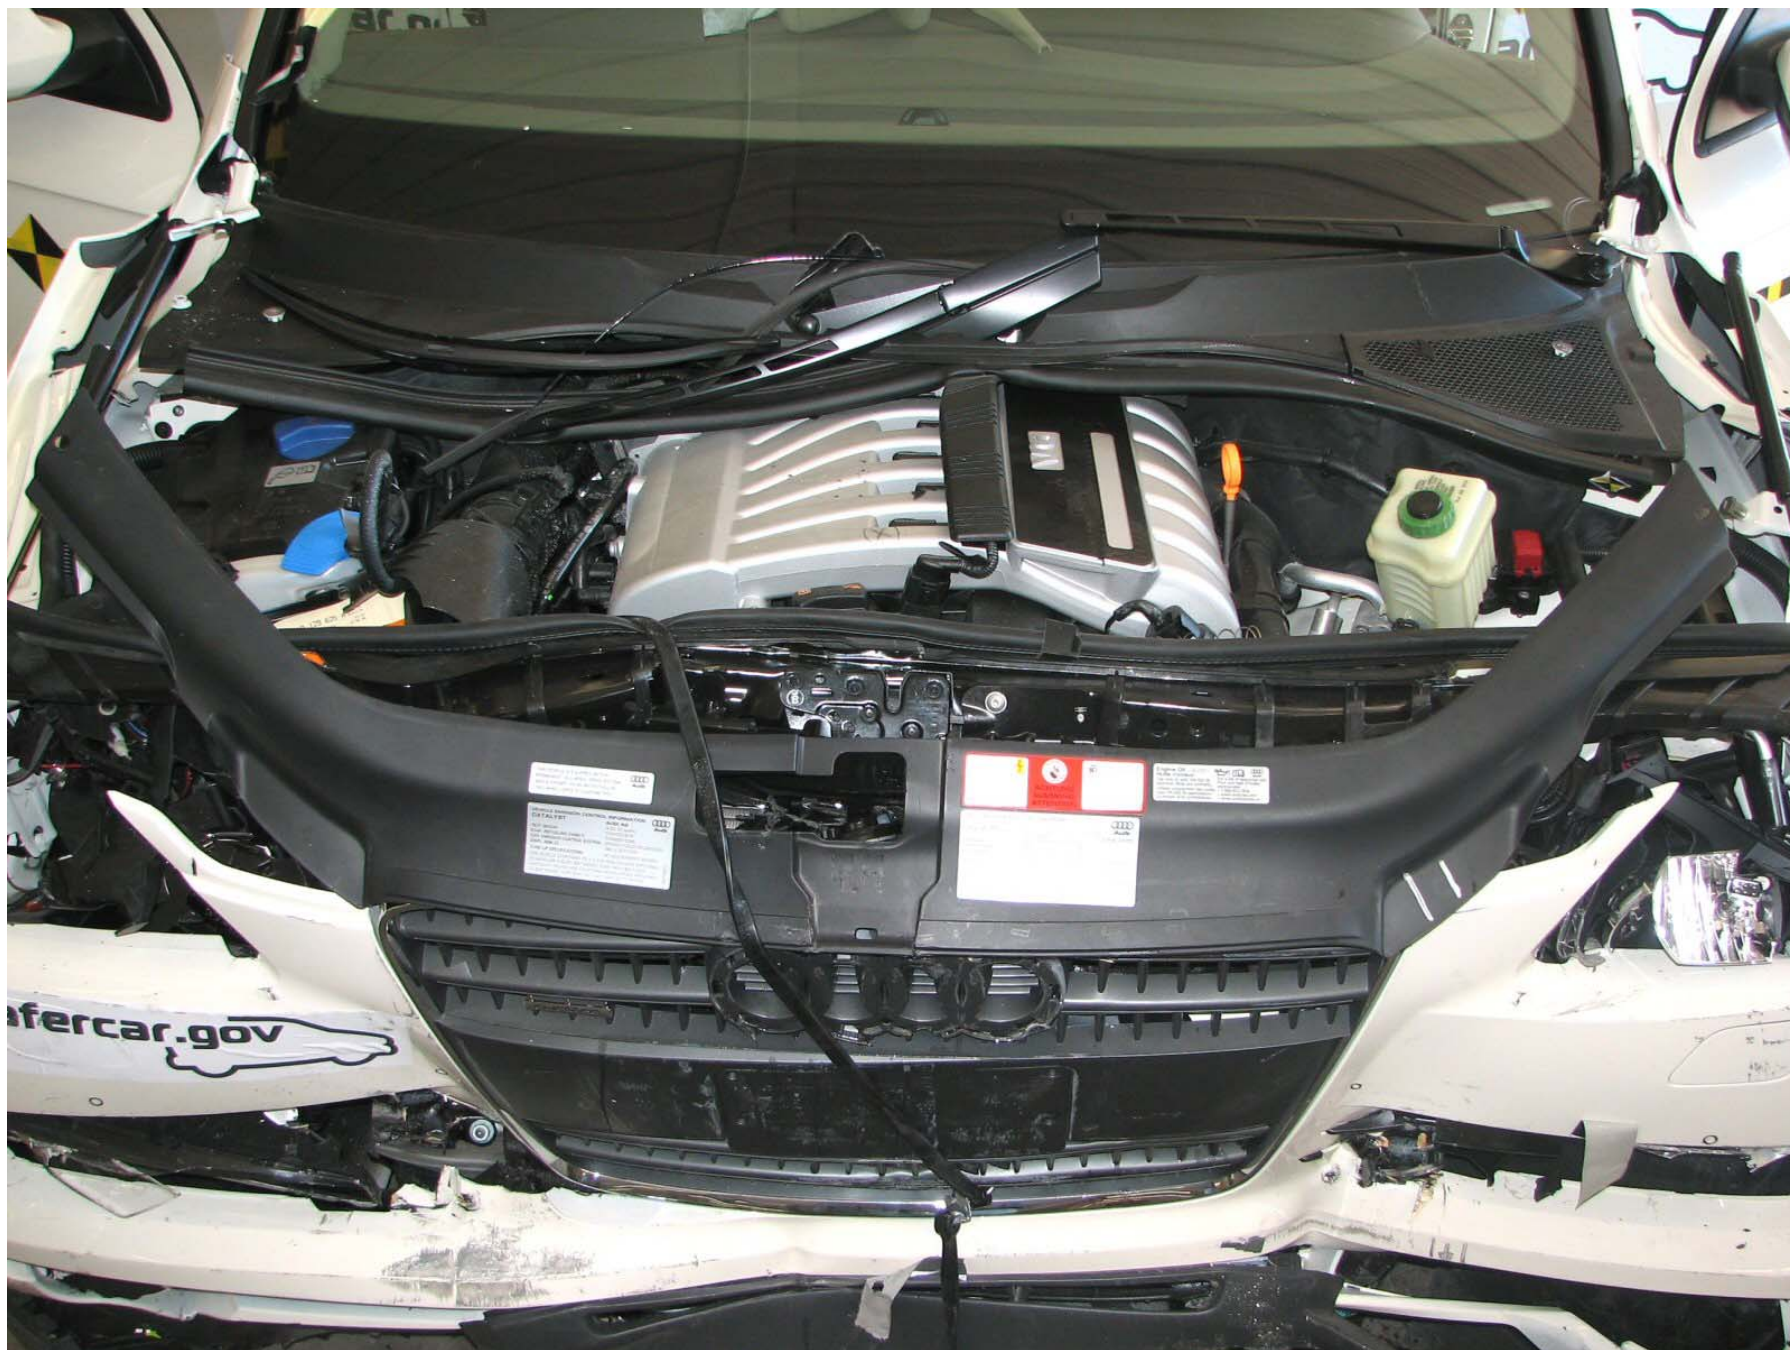
Figure A-21: Post-Test Engine Compartment (Vehicle Moved)

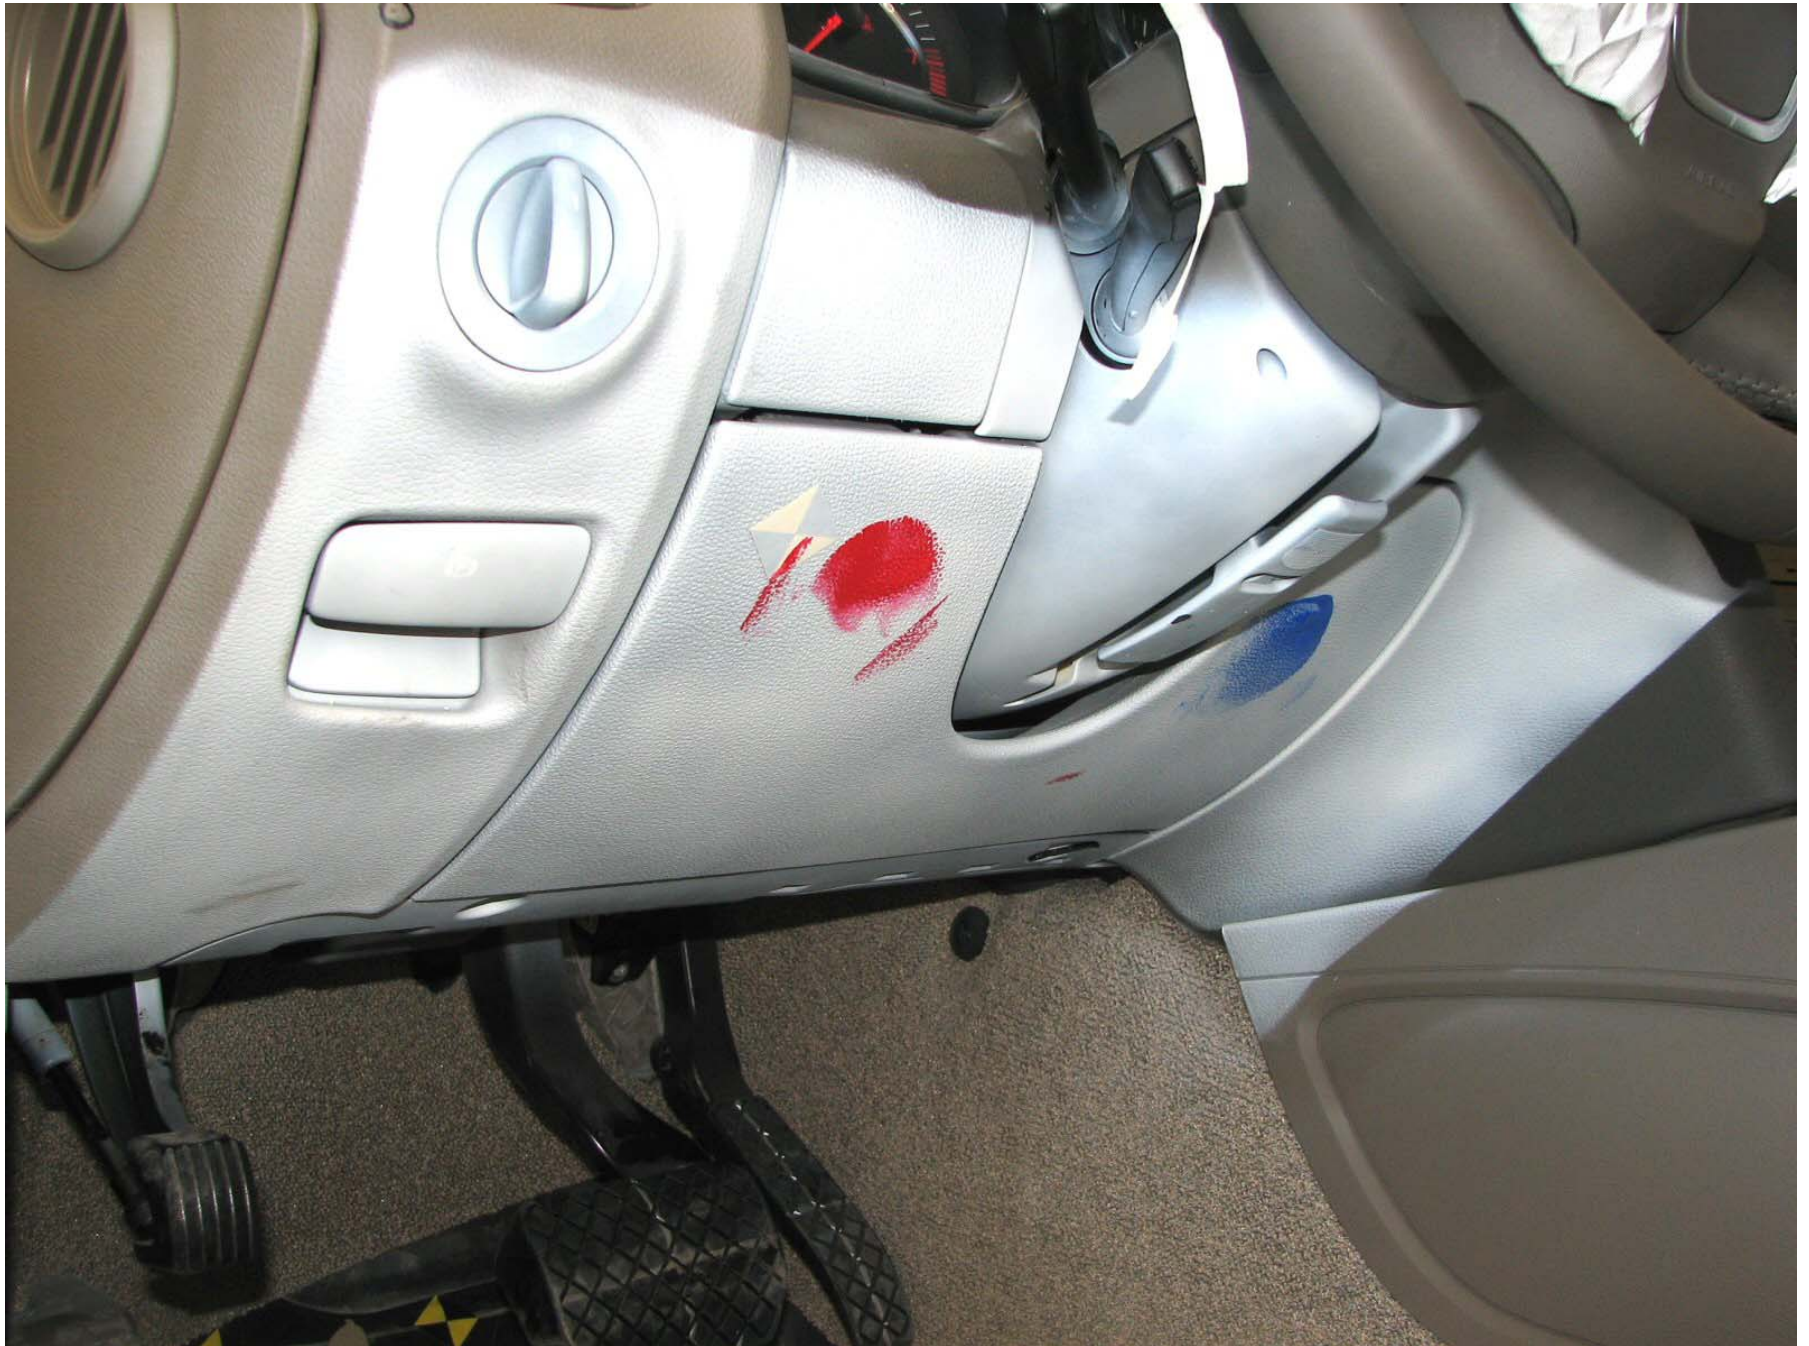
Figure A-39: Post-Test Driver Side Knee Bolster

The driver's visible contact points were as follows: The driver ATD's head and chest contacted the airbag and the abdomen had no contact. Both knees contacted the knee bolster.

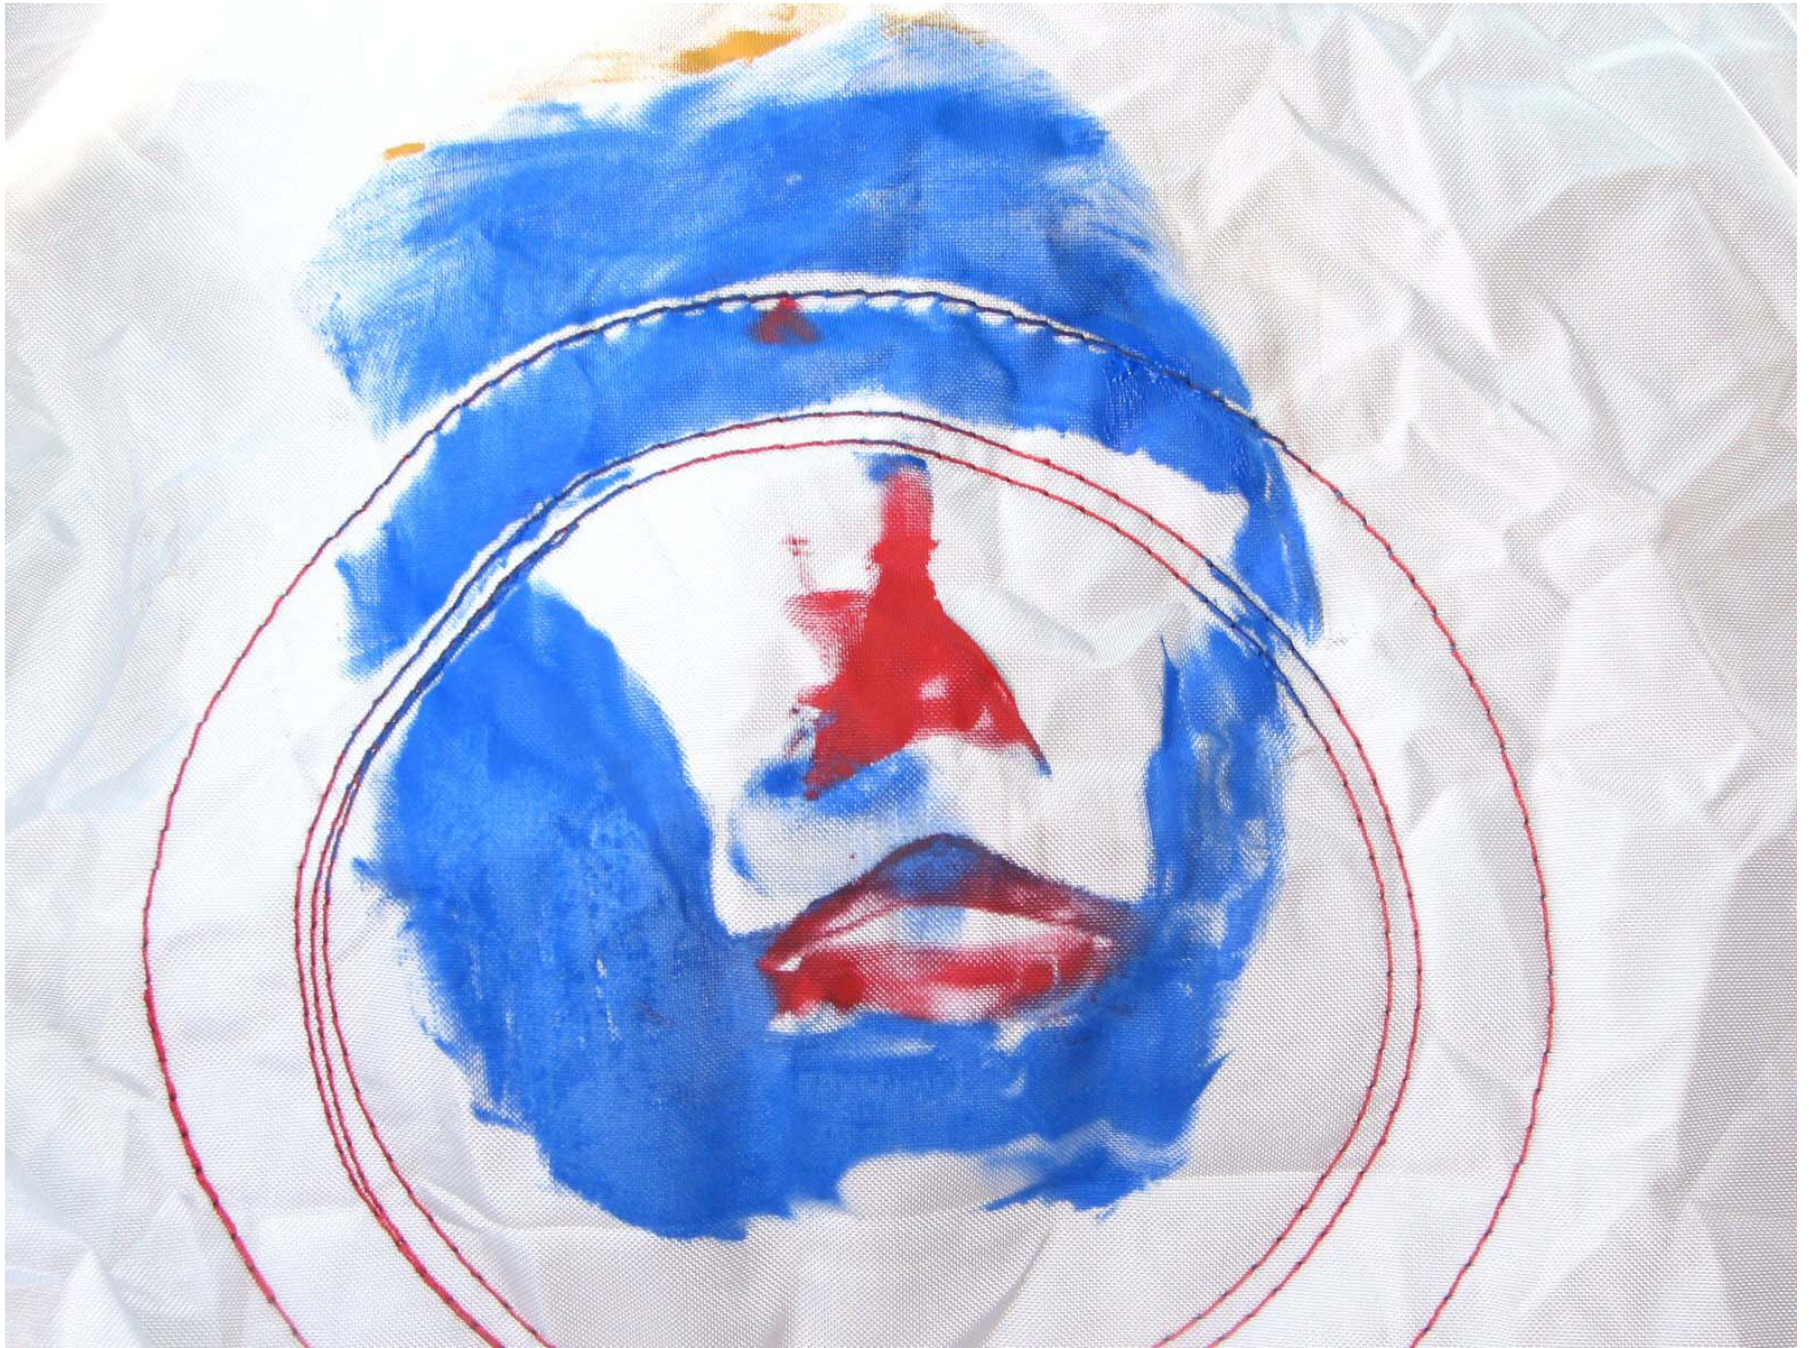
Figure A-43: Post-Test Driver Dummy Airbag Contact

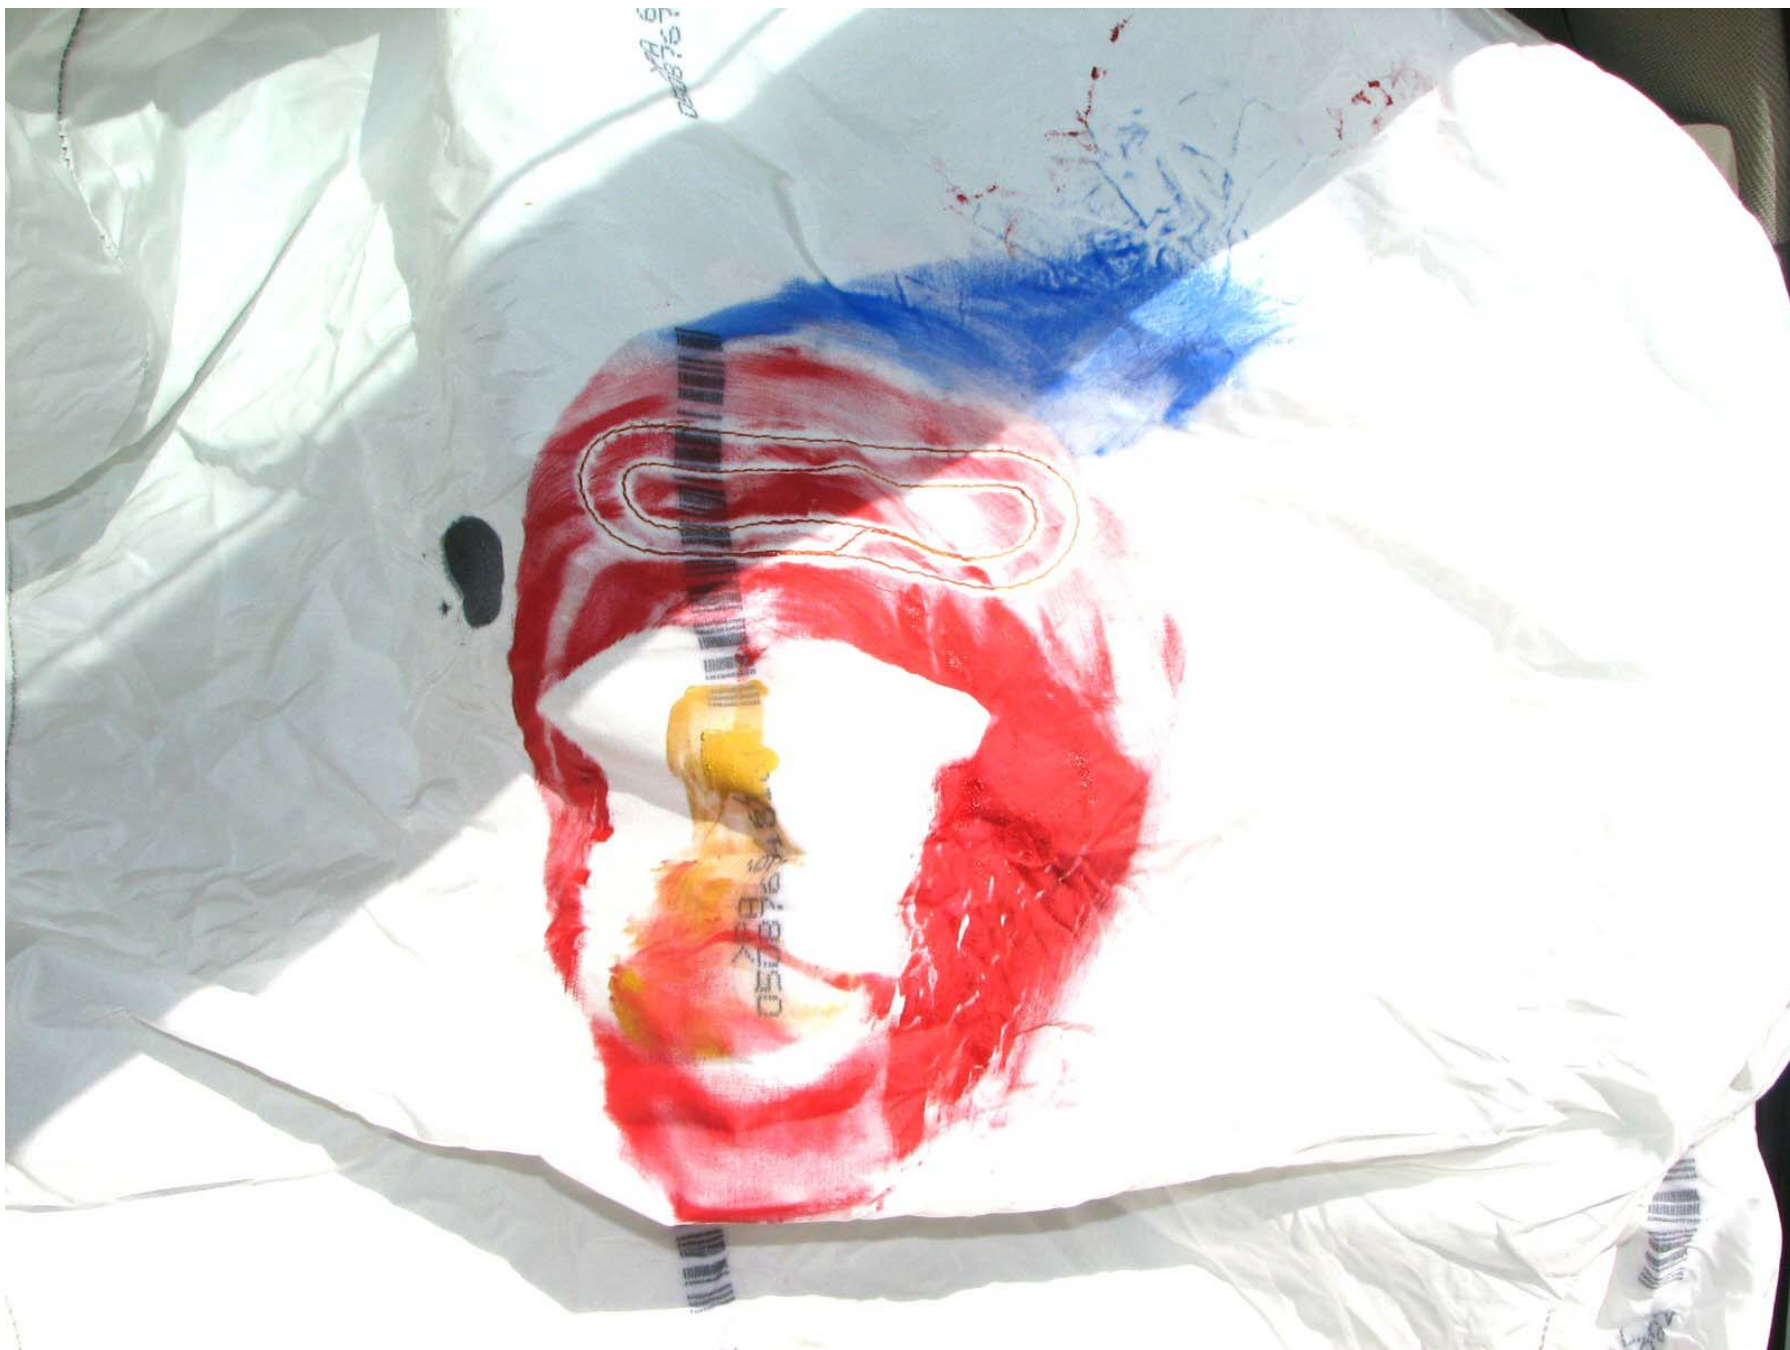
Figure A-57: Post-Test Passenger Dummy Airbag Contact

The passenger's visible contact points were as follows: The passenger ATD's head, chest and abdomen contacted the airbag. Both knees contacted the knee bolster.

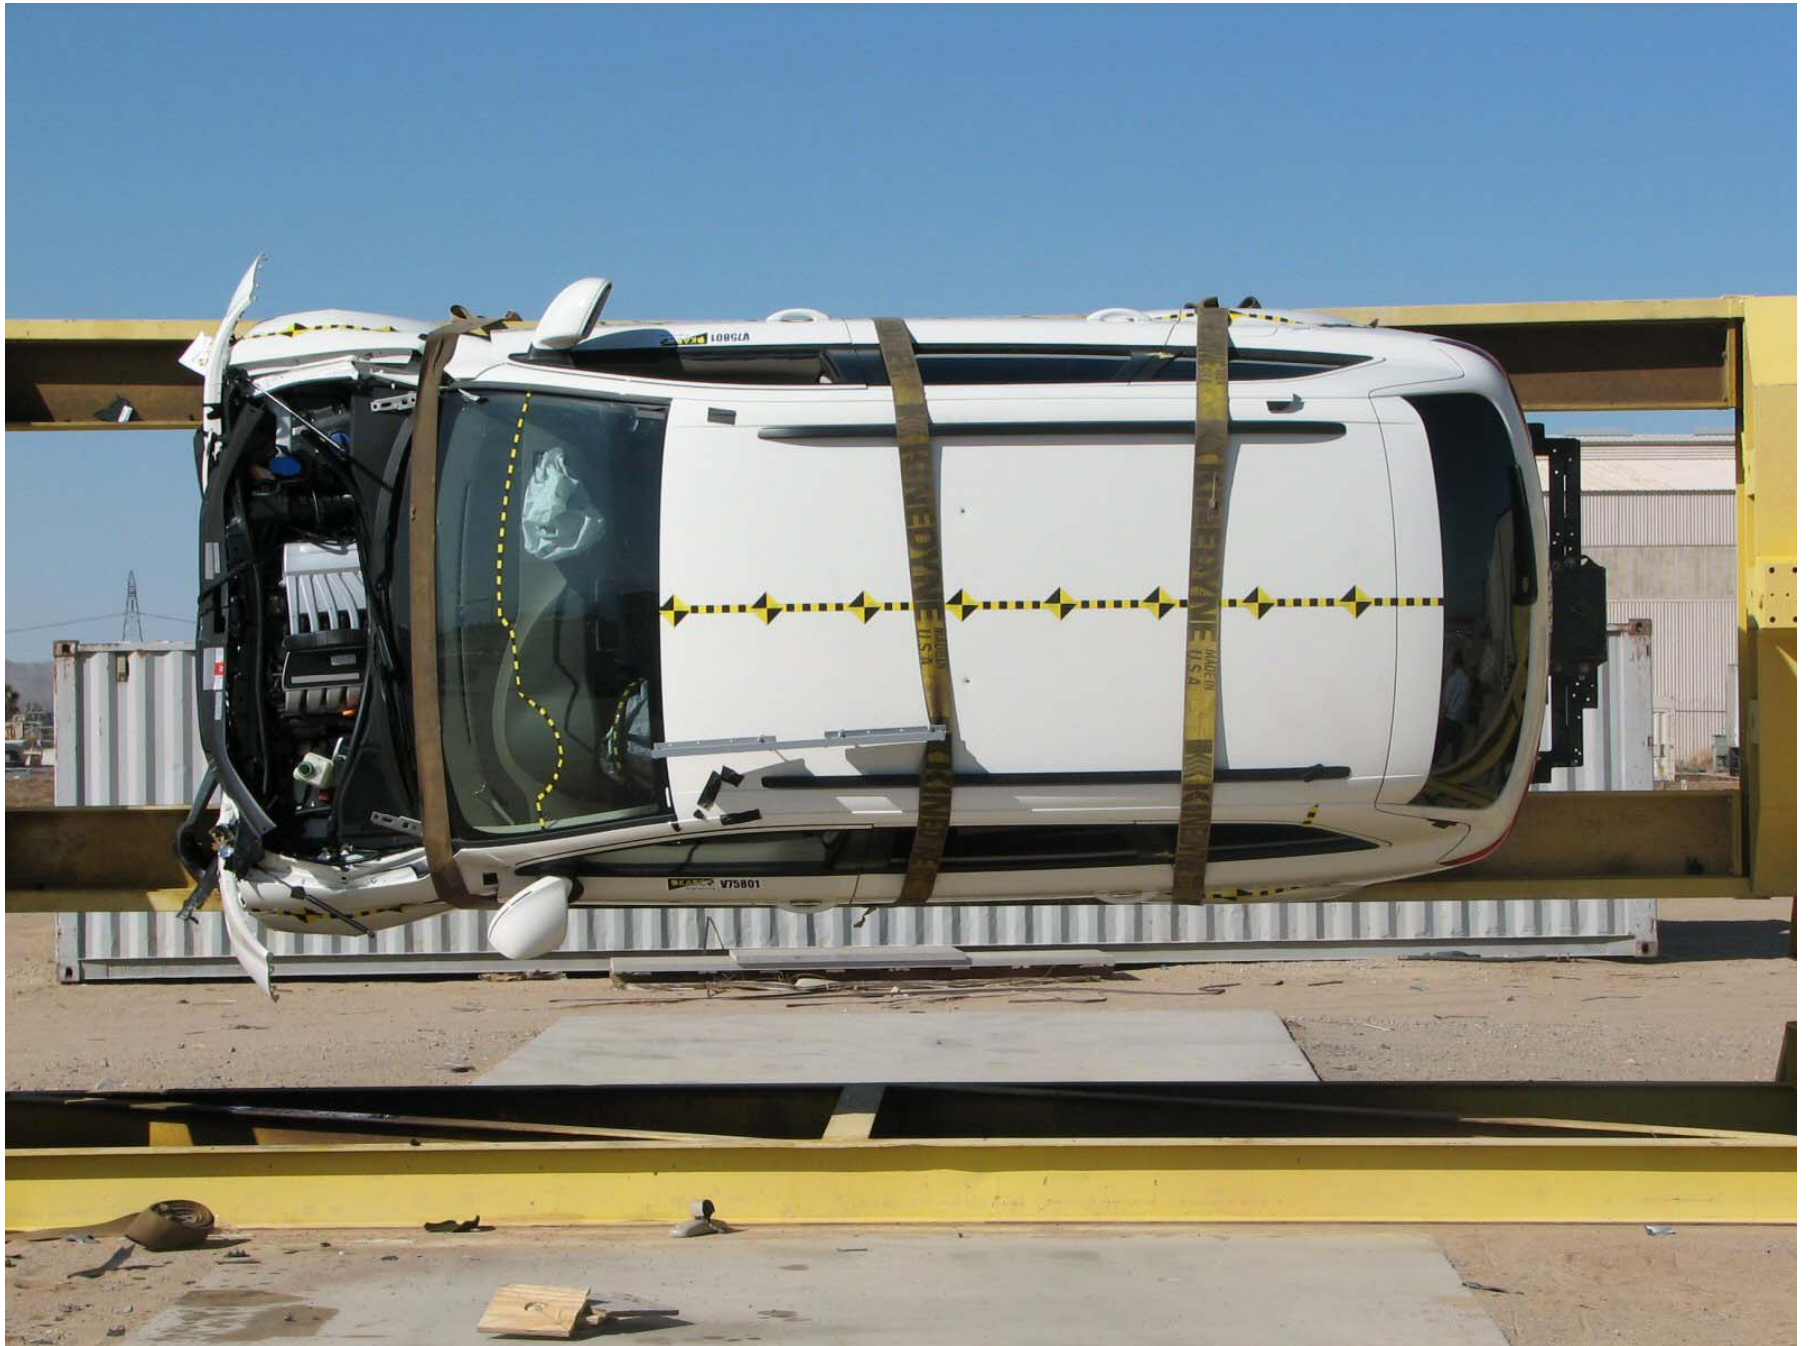
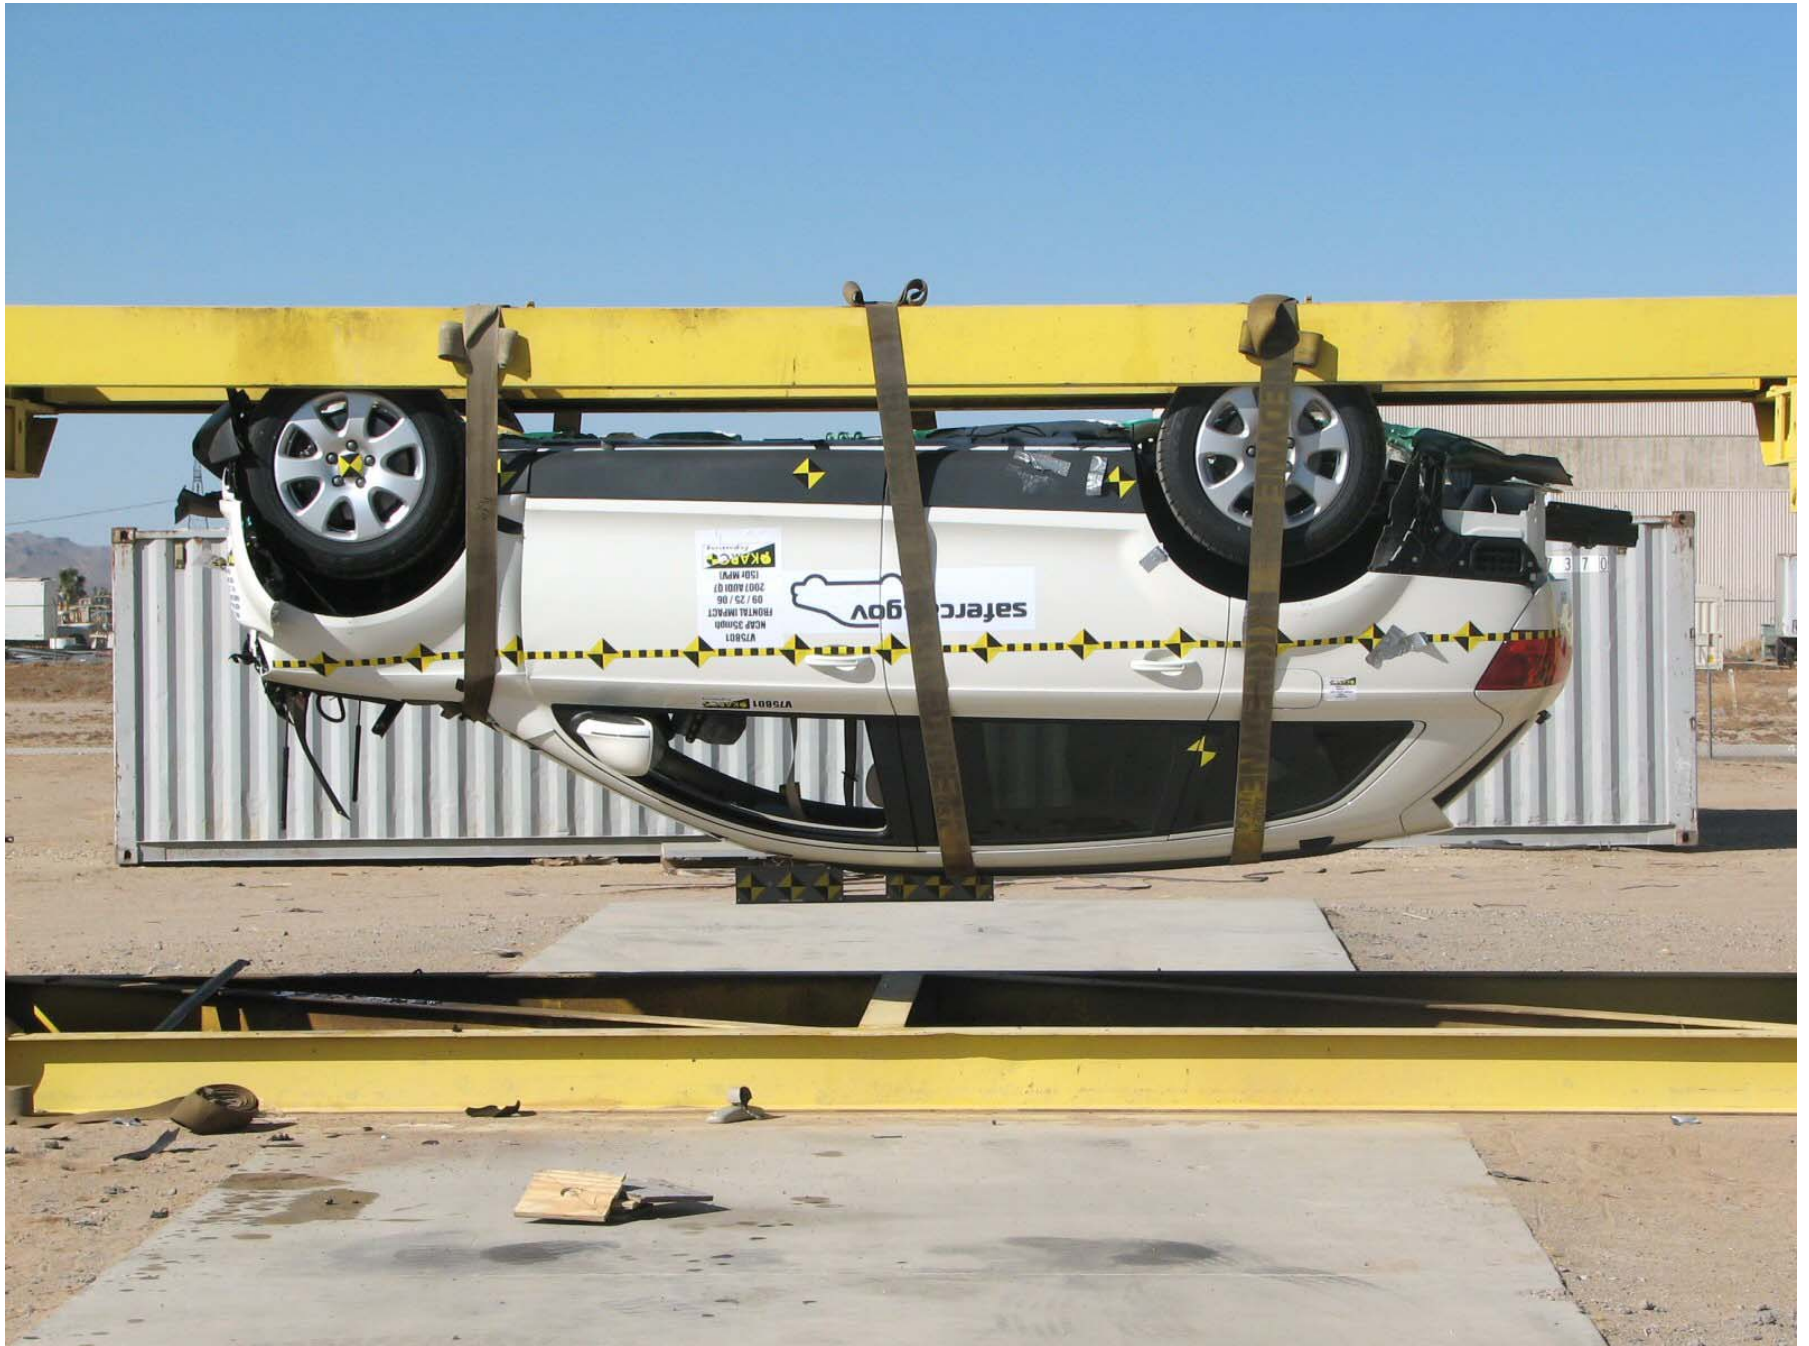
Figure A-58: Vehicle on Rollover Device (0°)

Figure A-59: Vehicle on Rollover Device (90°)

Figure A-60: Vehicle on Rollover Device (180°)

Figure A-61: Vehicle on Rollover Device (270°)

1. The specified fixture rollover rate for each 90° of rotation is 60 to 120 seconds.
2. The position hold time at each position is 300 seconds (minimum).
3. No solvent leakage occurred during rollover.
