**NEW CAR ASSESSMENT PROGRAM  
FRONTAL BARRIER IMPACT TEST**

**AUDI AG  
2007 AUDI Q7  
5-DOOR MPV**

**NHTSA NUMBER: V75801**

**FINAL REPORT**

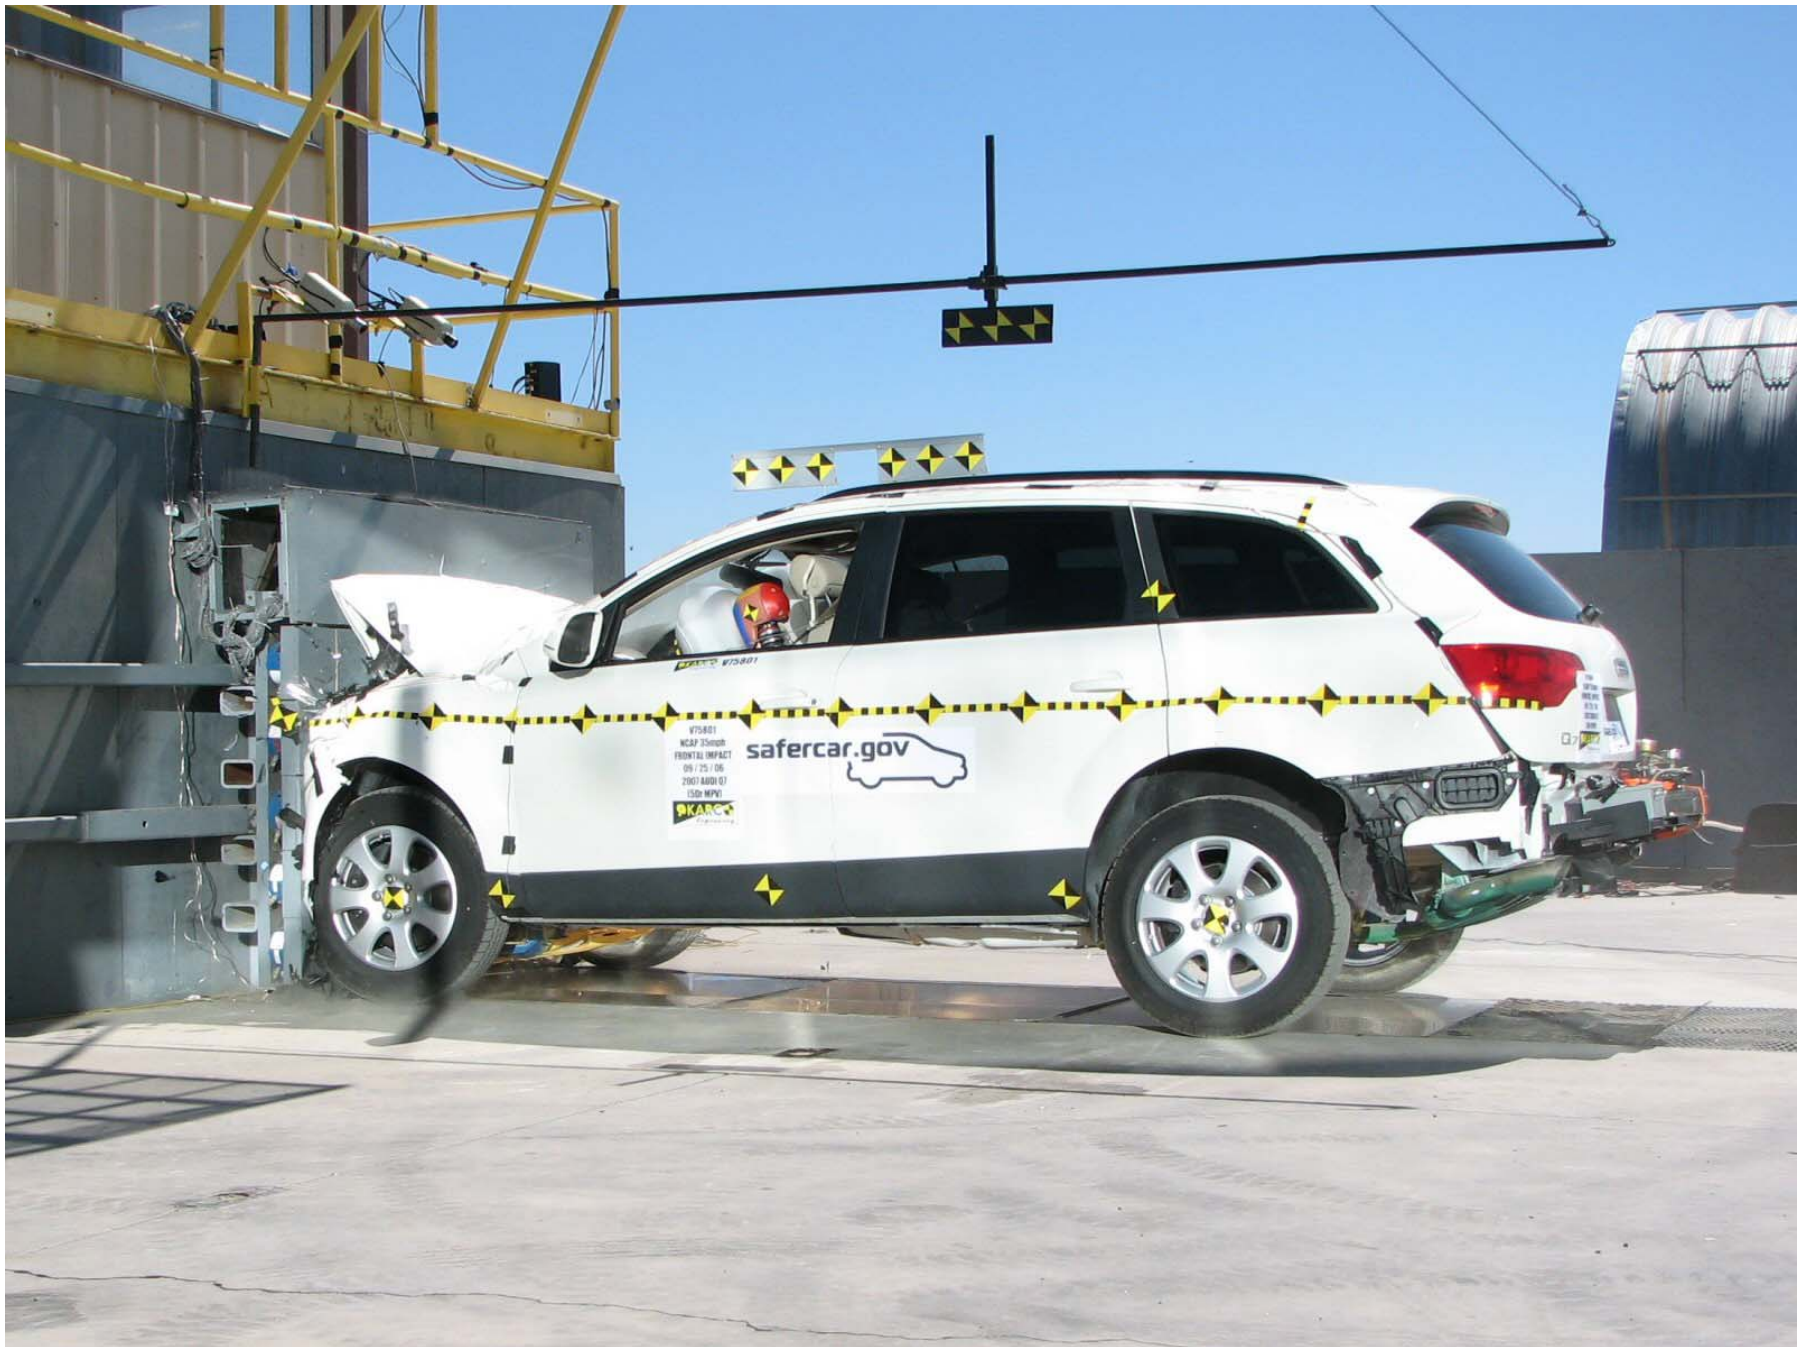
Figure A-62: Vehicle Impact

A load cell barrier was impacted by a 2007 Audi Q7 5-Door MPV at a velocity of 56.14 km/h. The test was performed at Karco Engineering, LLC on September 25, 2006.
