**REPORT NUMBER TR-P26168-01-NC**

**NEW CAR ASSESSMENT PROGRAM  
SIDE IMPACT TEST**

**AUDI AG  
2007 AUDI Q7  
5-DOOR MPV**

**Prepared By:  
KARCO ENGINEERING, LLC  
9270 HOLLY ROAD  
ADELANTO, CALIFORNIA 92301**

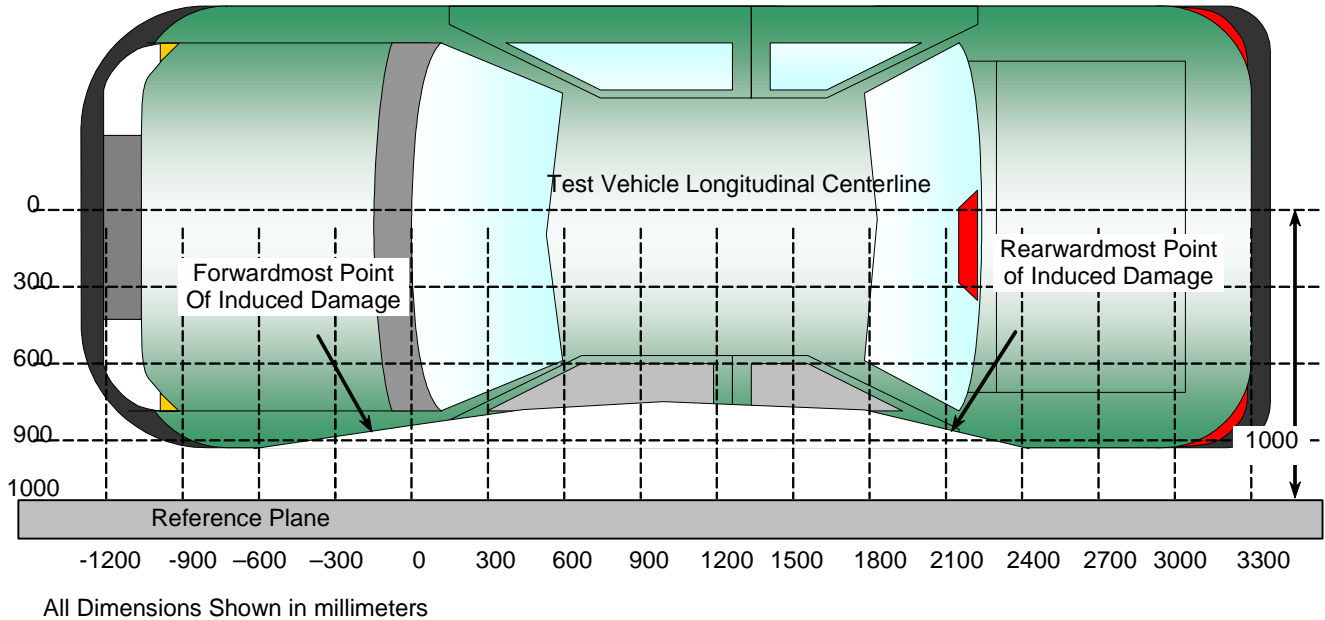
**VEHICLE DAMAGE PROFILE DISTANCES**

**TOP VIEW**

**DAMAGE PROFILE DISTANCES**

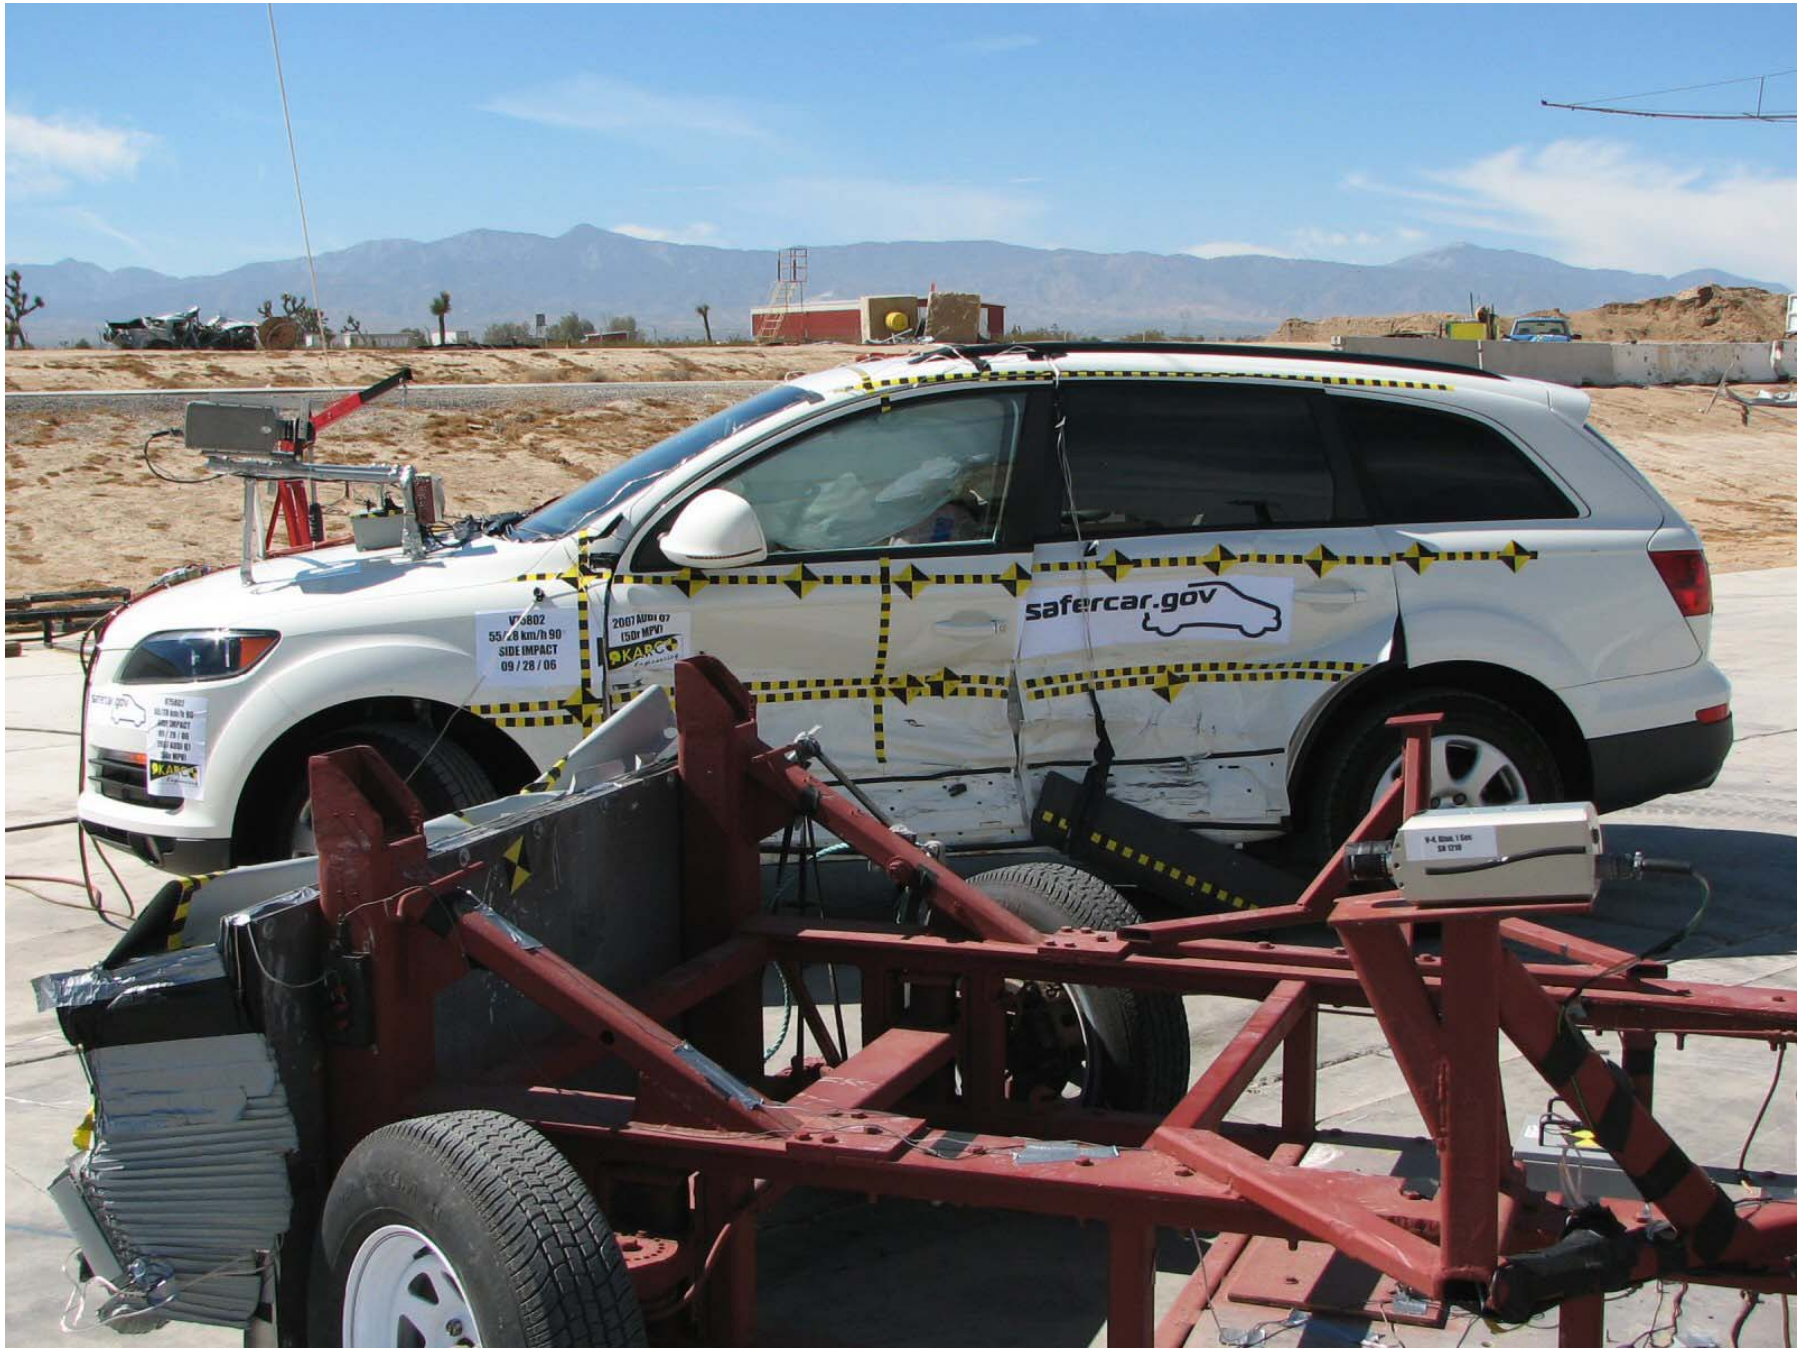
Figure A-10: Post-Test Left Side View

The driver and passenger doors remained closed during impact. The test vehicle sustained a maximum static crush of 237 mm at level 2, 900 mm rearward of the left vertical impact point. The driver SID/Hybrid III, Serial No. 274 and the passenger SID/Hybrid III, Serial No. 275 were calibrated prior to this test. The SID/Hybrid III injury criteria is summarized as follows:

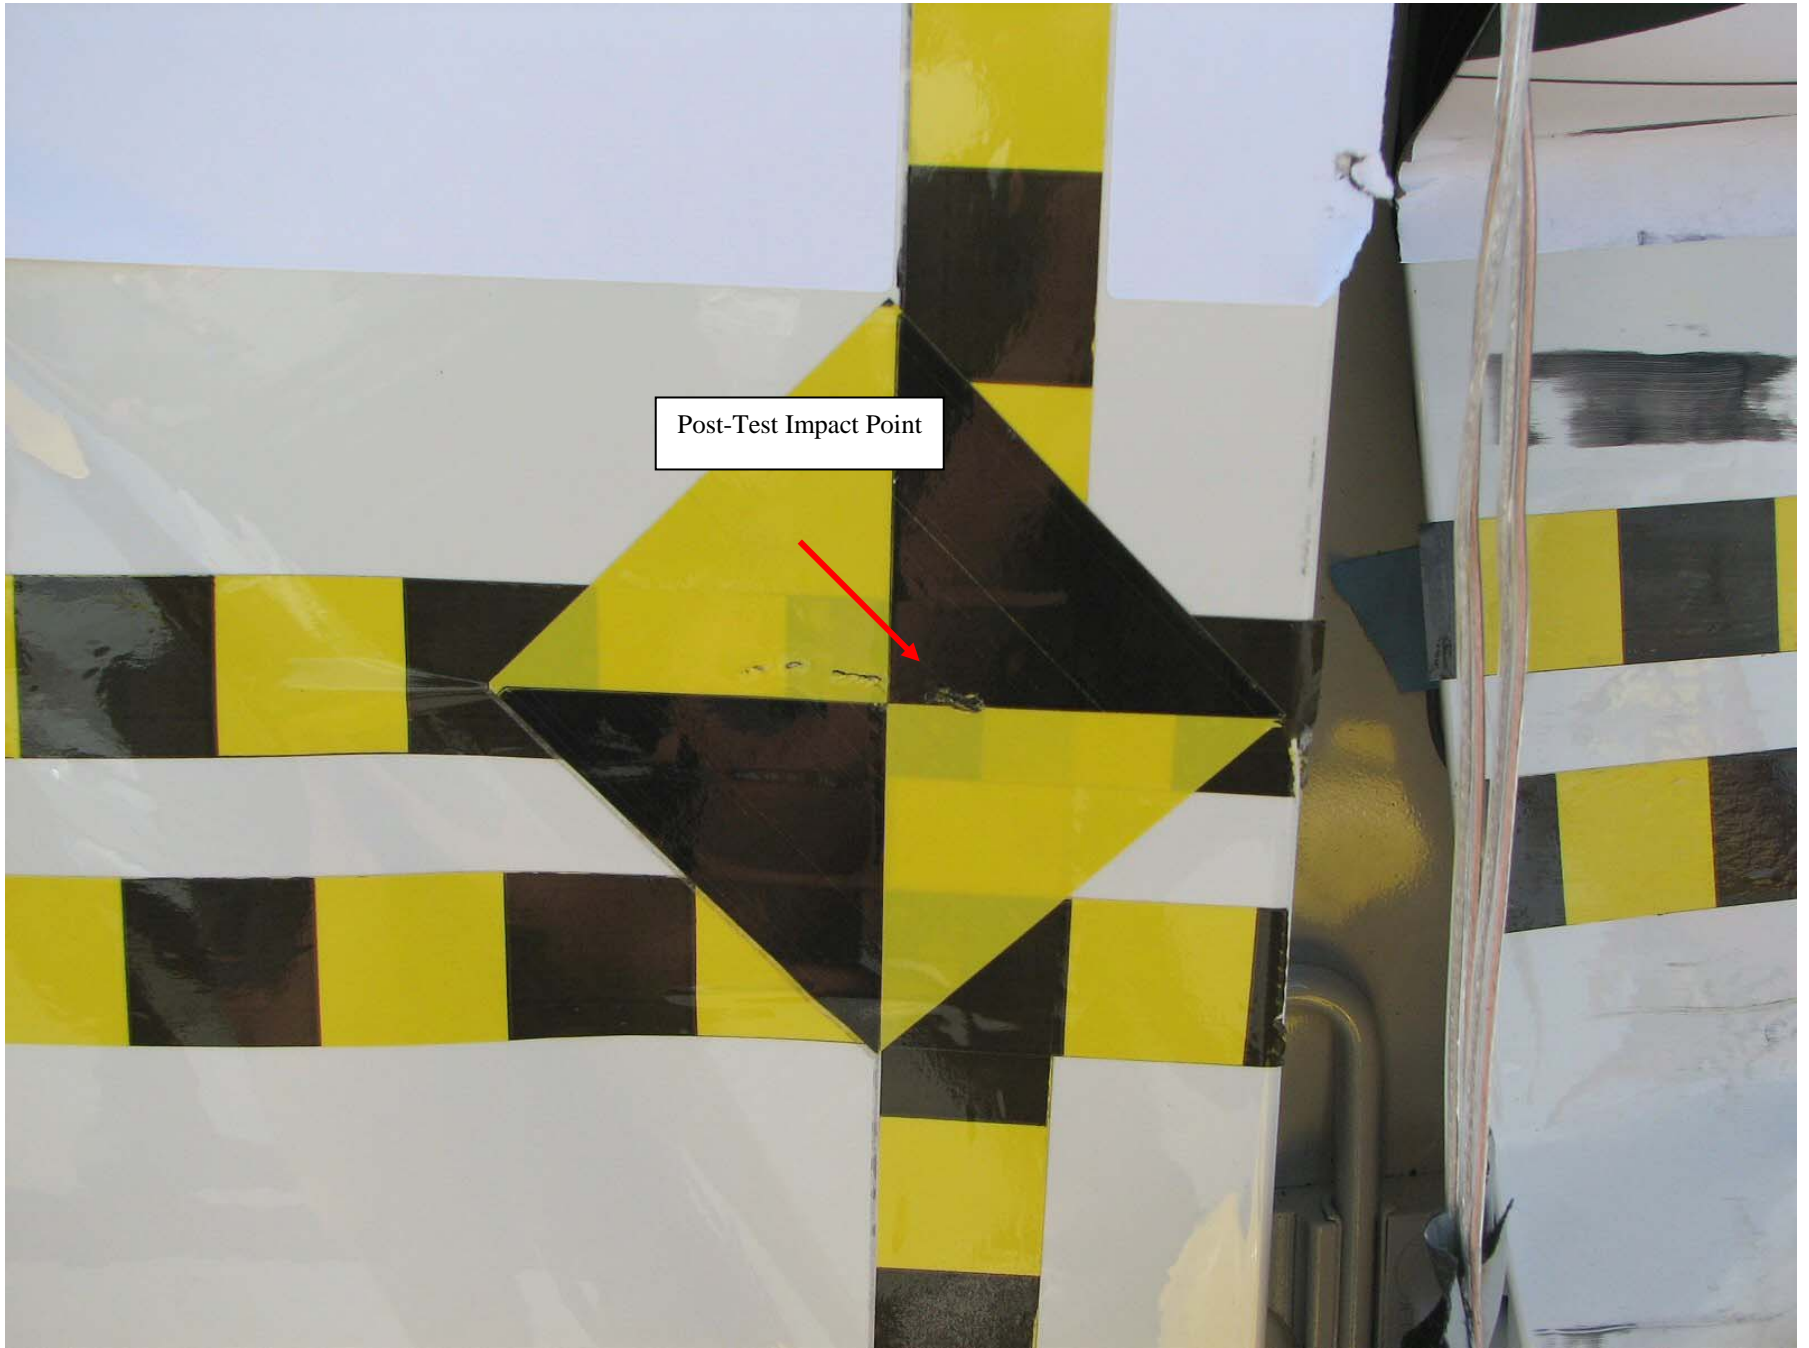
Figure A-26: Post-Test Left Impact Point

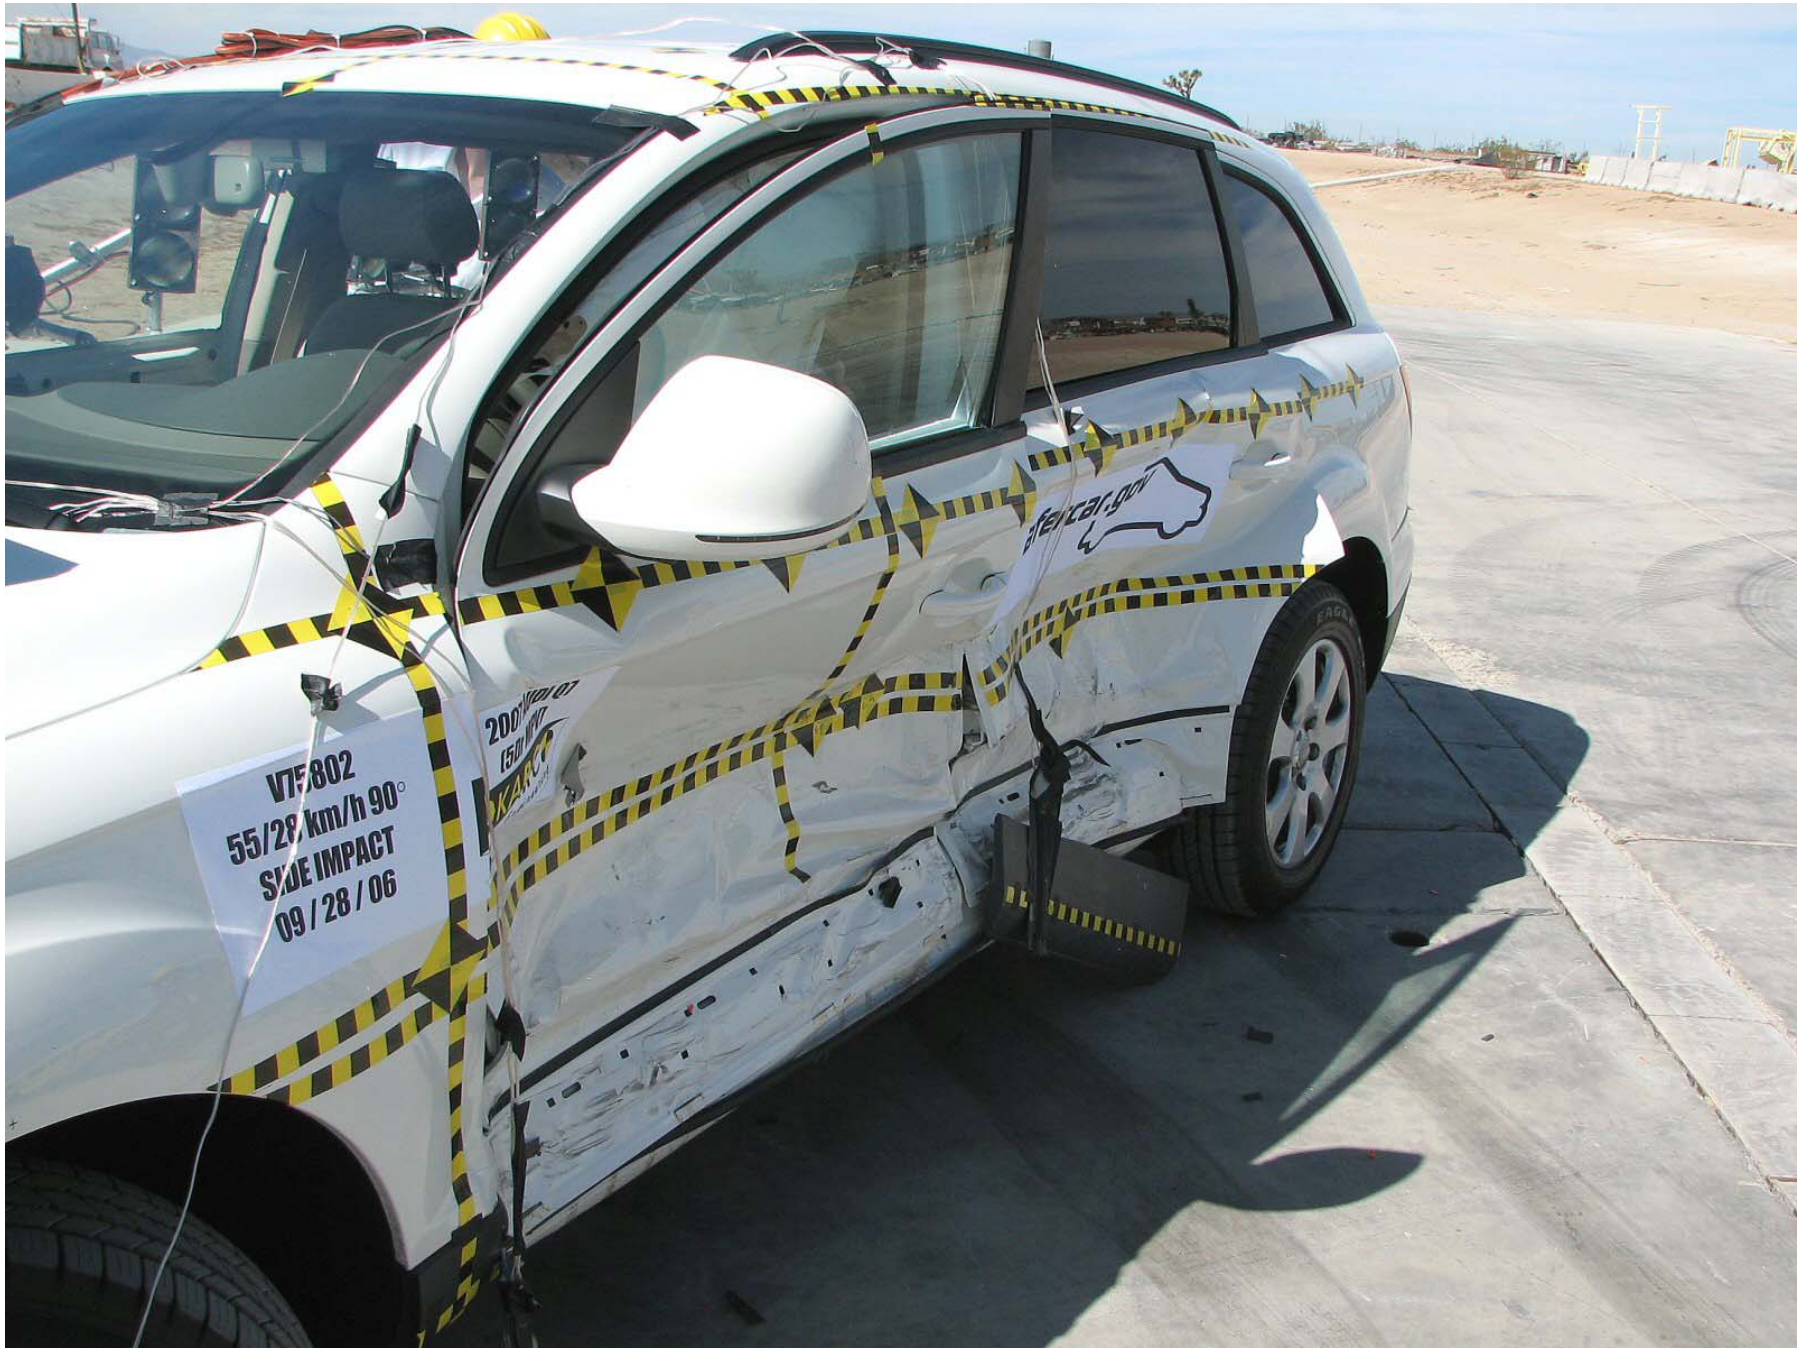
Figure A-28: Post-Test Front ¾ View of Left Side Door

Description	Front	Rear
Left Side Door Opening	Door remained closed and latched, jammed	Door remained closed and latched, jammed
Right Side Door Opening	Remained closed and latched, operational	Remained closed and latched, operational
Seat Movement	None	None
Seat Back Failure	None	None

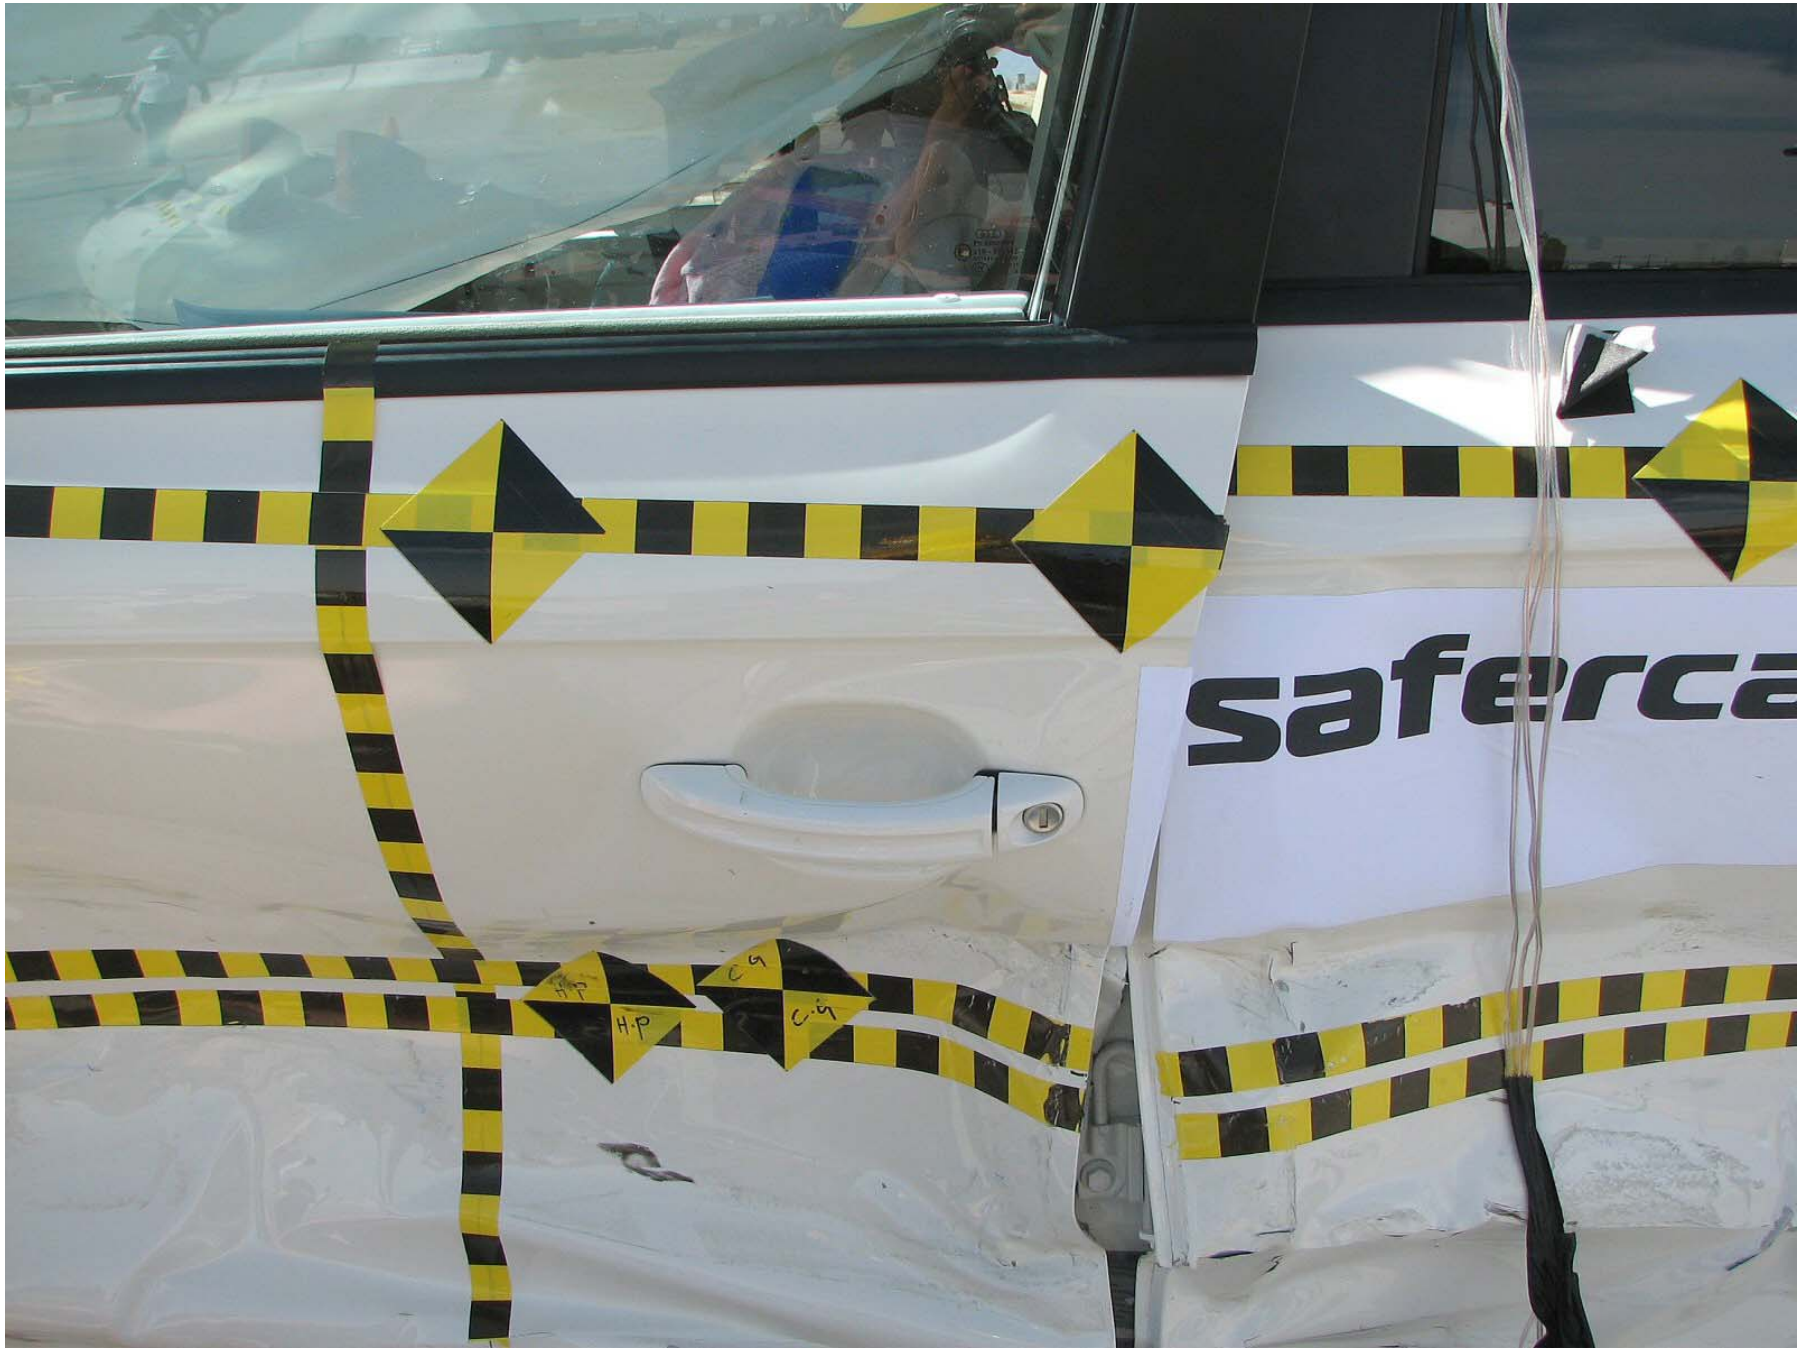
Figure A-32: Post-Test Left Front Door

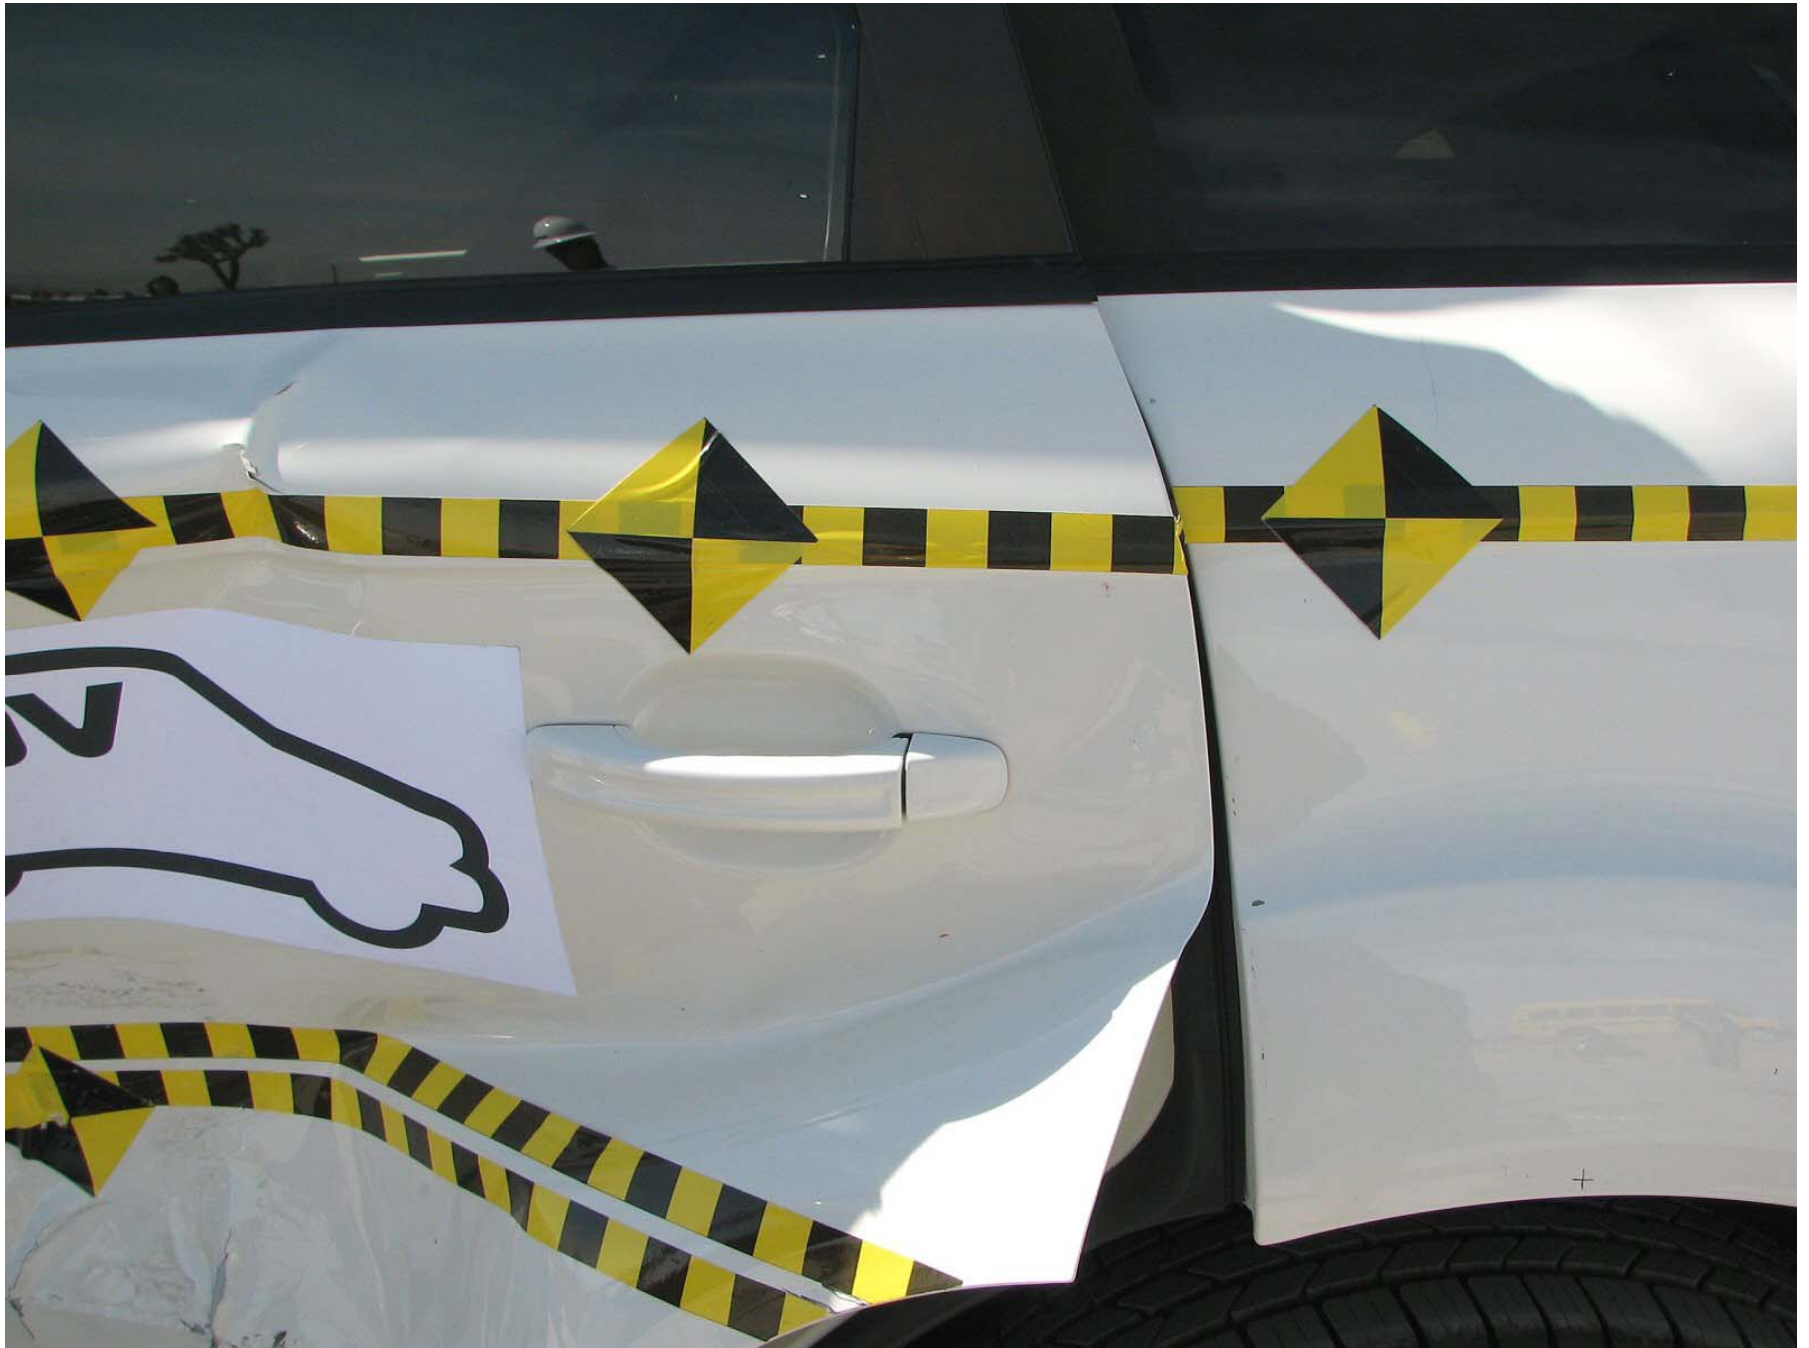
Figure A-34: Post-Test Left Rear Door

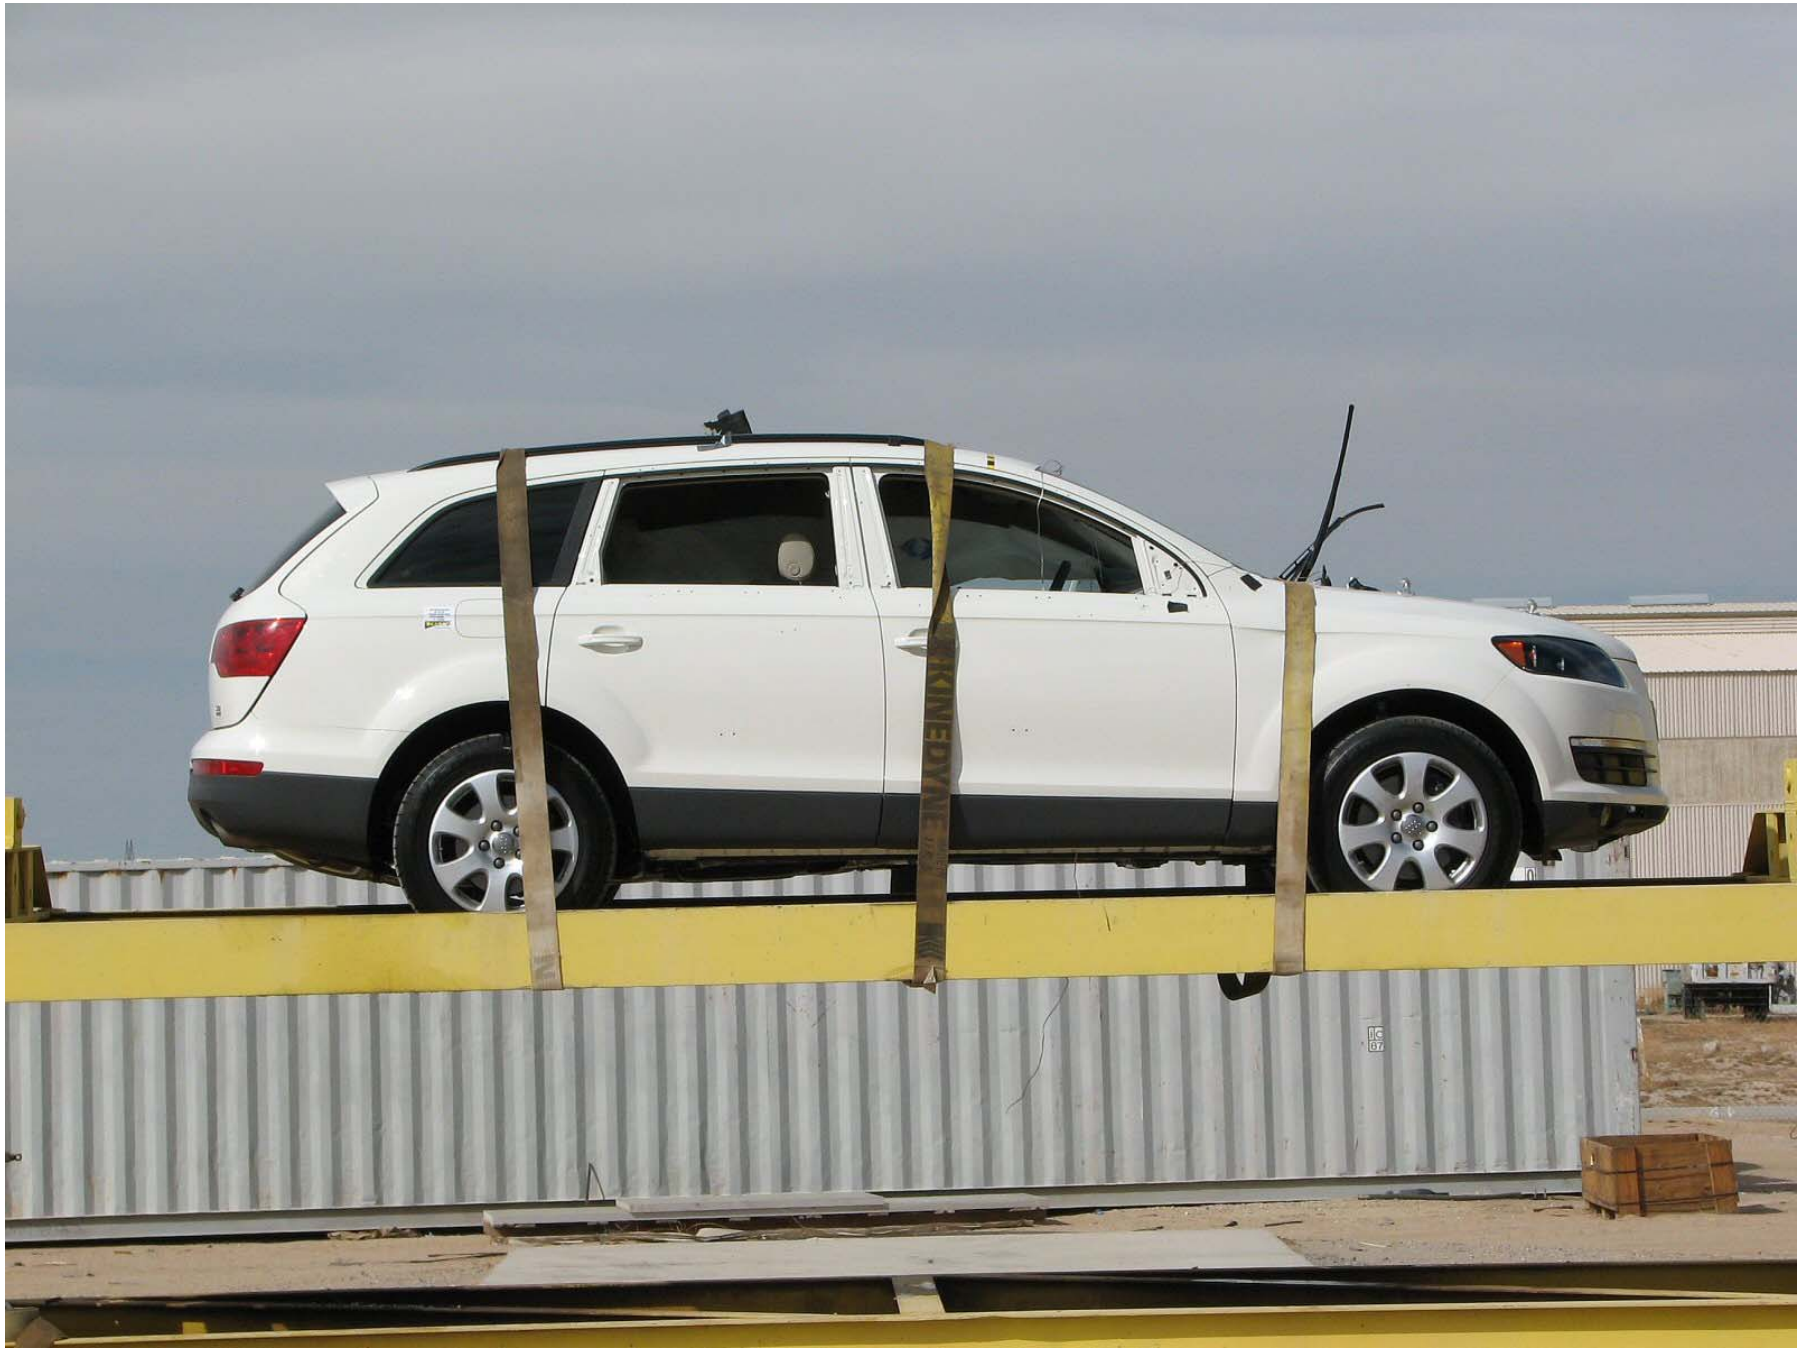
Figure A-61: Vehicle on Rollover Device (0°)

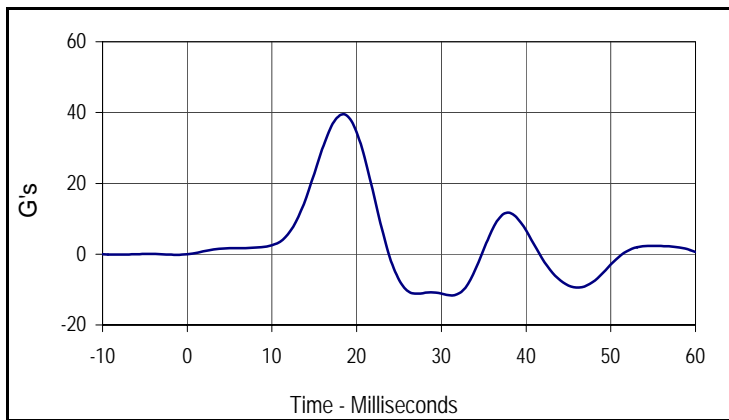
Curve Description			
Upper Rib Primary Y			
CURNO	Type	SAE Class	Units
001	FIL	FIR100	G's
Max	Time	Min	Time
39.4	18.1	-11.7	31.3

Tested Parameter	Units	Specification	Result	Pass/Fail
Laboratory Temperature	°C	18.9 to 25.6	21.1	Pass
Laboratory Relative Humidity	%	10 to 70	30	Pass
Probe Velocity	m/s	4.21 to 4.33	4.27	Pass
Upper Rib Acceleration	G's	37.0 to 46.0	39.4	Pass
Lower Rib Acceleration	G's	37.0 to 46.0	38.3	Pass
Thoracic Spine Acceleration	G's	15.0 to 22.0	16.9	Pass
Overall Test Results			Pass

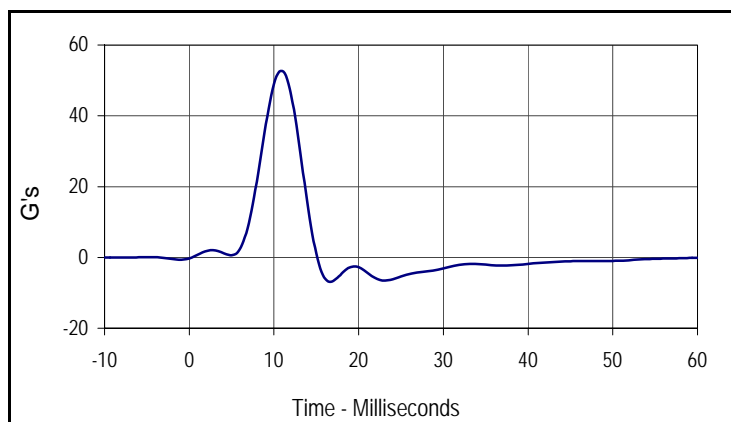
Curve Description			
Pelvis Primary Y			
CURNO	Type	SAE Class	Units
001	FIL	FIR100	G's
Max	Time	Min	Time
52.5	10.6	-6.8	16.9

Tested Parameter	Units	Specification	Result	Pass/Fail
Laboratory Temperature	°C	18.9 to 25.6	21.1	Pass
Laboratory Relative Humidity	%	10 to 70	30	Pass
Probe Velocity	m/s	4.21 to 4.33	4.29	Pass
Peak Pelvis Acceleration	G's	40.0 to 60.0	52.5	Pass
Acceleration Time Above 20 G's	Msec.	3.0 to 7.0	5.63	Pass
Overall Test Results				Pass

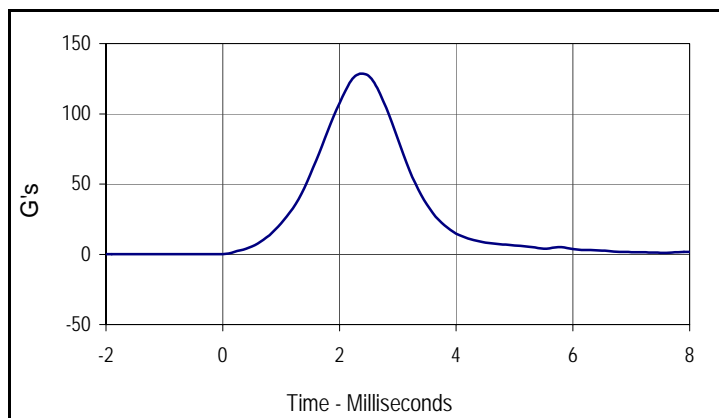
Curve Description			
Head Resultant			
CURNO	Type	SAE Class	Units
001	RES	1000	G's
Max	Time	Min	Time
128.6	2.4	0.1	-1.3

Tested Parameter	Units	Specification	Result	Pass/Fail
Laboratory Temperature	°C	18.9 to 25.6	21.9	Pass
Laboratory Relative Humidity	%	10 to 70	30	Pass
Peak Resultant Acceleration	G's	120.0 to 150.0	128.6	Pass
Peak Longitudinal Acceleration	G's	≤15.0	8.3	Pass
Is Acceleration Unimodal?	Yes/No	Yes	Yes	Pass
Oscillations After Main Pulse	%	<15	4.9	Pass
Overall Test Results				Pass

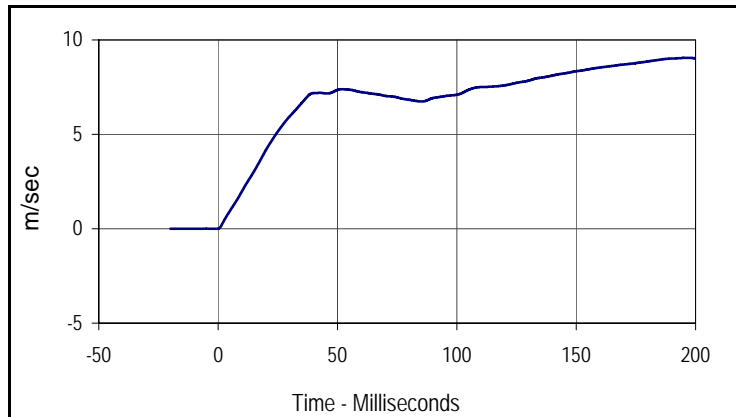
Curve Description			
Pendulum Velocity			
CURNO	Type	SAE Class	Units
001	FIL	180	m/sec
Max	Time	Min	Time
9.1	196.2	0.0	-0.4

Tested Parameter	Units	Specification	Result	Pass/Fail	
Laboratory Temperature	°C	20.6 to 22.2	21.9	Pass	
Laboratory Relative Humidity	%	10 to 70	30	Pass	
Pendulum Velocity	m/sec	6.89 to 7.13	6.97	Pass	
Pendulum Deceleration	10 Msec.	m/sec	1.96 to 2.55	1.99	Pass
	20 Msec.	m/sec	4.12 to 5.10	4.17	Pass
	30 Msec.	m/sec	5.73 to 7.01	5.96	Pass
	40 to 70	m/sec	6.27 to 7.64	7.39	Pass
"D" Plane Rotation	Max	Degrees	66.0 to 82.0	74.2	Pass
Max Rotation Time After Peak Moment	Msec.	2.0 to 16.0	9.7	Pass	
Rotation Time From Peak to Zero Angle	Msec.	58.0 to 67.0	58.4	Pass	
Moment About Occipital Condyle	Nm	73.0 to 88.0	85.6	Pass	
Positive Moment Decay, Time To 0 Nm	Msec.	49.0 to 64.0	52.6	Pass	
Overall Test Results				Pass

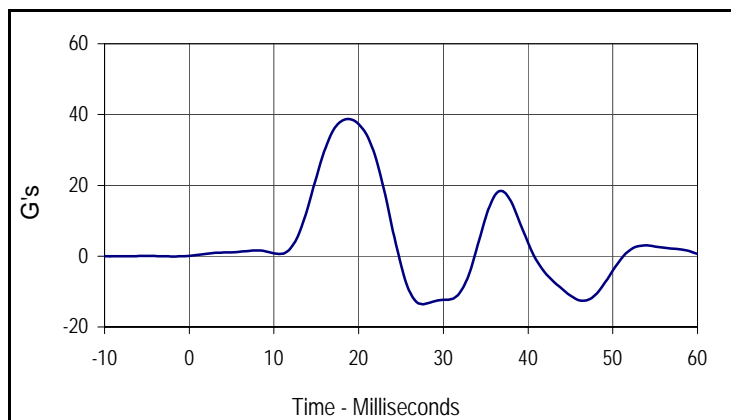
Curve Description			
Upper Rib Primary			
CURNO	Type	SAE Class	Units
001	FIL	FIR100	G's
Max	Time	Min	Time
38.7	18.8	-13.6	27.5

Tested Parameter	Units	Specification	Result	Pass/Fail
Laboratory Temperature	°C	18.9 to 25.6	21.1	Pass
Laboratory Relative Humidity	%	10 to 70	30	Pass
Probe Velocity	m/s	4.21 to 4.33	4.27	Pass
Upper Rib Acceleration	G's	37.0 to 46.0	38.7	Pass
Lower Rib Acceleration	G's	37.0 to 46.0	37.4	Pass
Thoracic Spine Acceleration	G's	15.0 to 22.0	21.2	Pass
Overall Test Results			Pass

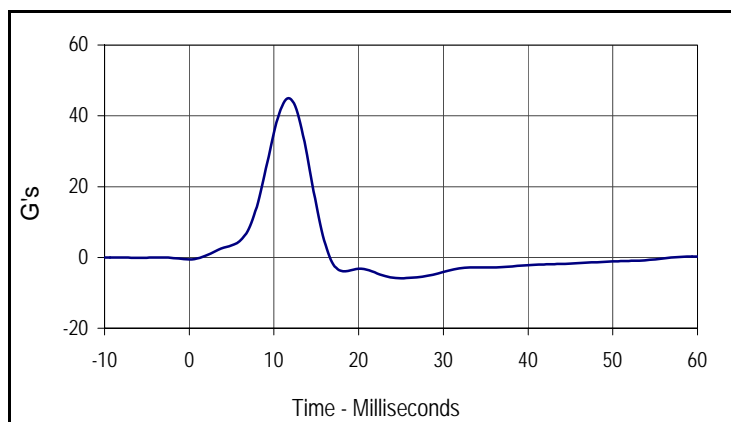
Curve Description			
Pelvis Primary Y			
CURNO	Type	SAE Class	Units
001	FIL	FIR100	G's
Max	Time	Min	Time
44.9	11.9	-5.9	25.0

Tested Parameter	Units	Specification	Result	Pass/Fail
Laboratory Temperature	°C	18.9 to 25.6	21.9	Pass
Laboratory Relative Humidity	%	10 to 70	30	Pass
Probe Velocity	m/s	4.21 to 4.33	4.27	Pass
Peak Pelvis Acceleration	G's	40.0 to 60.0	44.9	Pass
Acceleration Time Above 20 G's	Msec.	3.0 to 7.0	6.25	Pass
Overall Test Results				Pass

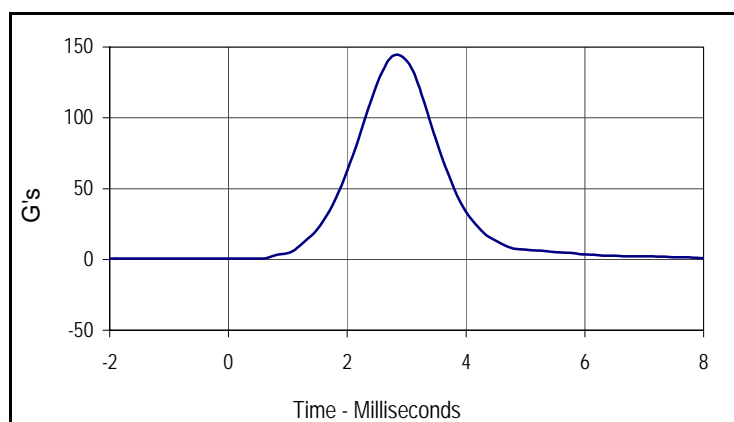
Curve Description			
Head Resultant			
CURNO	Type	SAE Class	Units
001	RES	1000	G's
Max	Time	Min	Time
144.5	2.8	0.5	0.5

Tested Parameter	Units	Specification	Result	Pass/Fail
Laboratory Temperature	°C	18.9 to 25.6	21.1	Pass
Laboratory Relative Humidity	%	10 to 70	30	Pass
Peak Resultant Acceleration	G's	120.0 to 150.0	144.5	Pass
Peak Longitudinal Acceleration	G's	≤15.0	5.3	Pass
Is Acceleration Unimodal?	Yes/No	Yes	Yes	Pass
Oscillations After Main Pulse	%	<15	4.8	Pass
Overall Test Results			Pass	Pass

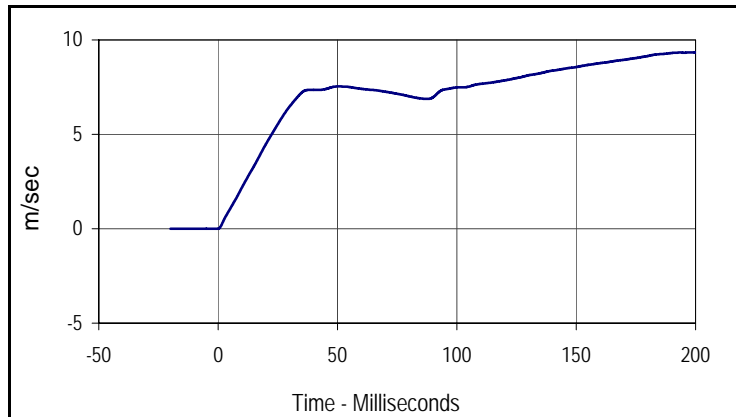
Curve Description			
Pendulum Velocity			
CURNO	Type	SAE Class	Units
001	FIL	180	m/sec
Max	Time	Min	Time
9.3	198.8	0.0	-0.5

Tested Parameter	Units	Specification	Result	Pass/Fail	
Laboratory Temperature	°C	20.6 to 22.2	21.9	Pass	
Laboratory Relative Humidity	%	10 to 70	30	Pass	
Pendulum Velocity	m/sec	6.89 to 7.13	6.97	Pass	
Pendulum Deceleration	10 Msec.	m/sec	1.96 to 2.55	2.20	Pass
	20 Msec.	m/sec	4.12 to 5.10	4.48	Pass
	30 Msec.	m/sec	5.73 to 7.01	6.49	Pass
	40 to 70	m/sec	6.27 to 7.64	7.54	Pass
"D" Plane Rotation	Max	Degrees	66.0 to 82.0	77.5	Pass
Max Rotation Time After Peak Moment	Msec.	2.0 to 16.0	9.4	Pass	
Rotation Time From Peak to Zero Angle	Msec.	58.0 to 67.0	59.4	Pass	
Moment About Occipital Condyle	Nm	73.0 to 88.0	75.8	Pass	
Positive Moment Decay, Time To 0 Nm	Msec.	49.0 to 64.0	50.4	Pass	
Overall Test Results				Pass

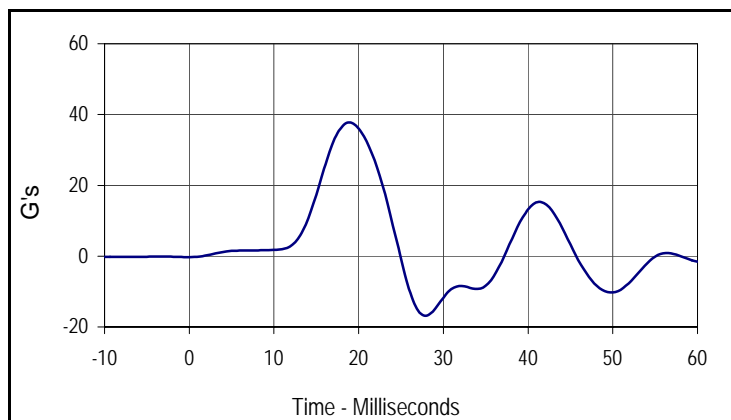
Curve Description			
Upper Rib Primary			
CURNO	Type	SAE Class	Units
001	FIL	FIR100	G's
Max	Time	Min	Time
37.7	18.8	-16.7	28.1

Tested Parameter	Units	Specification	Result	Pass/Fail
Laboratory Temperature	°C	18.9 to 25.6	21.1	Pass
Laboratory Relative Humidity	%	10 to 70	30	Pass
Probe Velocity	m/s	4.21 to 4.33	4.31	Pass
Upper Rib Acceleration	G's	37.0 to 46.0	37.7	Pass
Lower Rib Acceleration	G's	37.0 to 46.0	37.3	Pass
Thoracic Spine Acceleration	G's	15.0 to 22.0	20.8	Pass
Overall Test Results			Pass

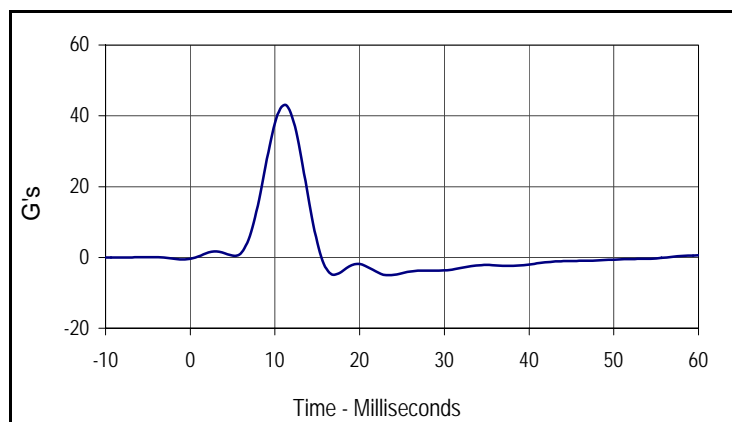
Curve Description			
Pelvis Primary Y			
CURNO	Type	SAE Class	Units
001	FIL	FIR100	G's
Max	Time	Min	Time
43.1	11.3	-5.0	23.8

Tested Parameter	Units	Specification	Result	Pass/Fail
Laboratory Temperature	°C	18.9 to 25.6	21.1	Pass
Laboratory Relative Humidity	%	10 to 70	30	Pass
Probe Velocity	m/s	4.21 to 4.33	4.29	Pass
Peak Pelvis Acceleration	G's	40.0 to 60.0	43.1	Pass
Acceleration Time Above 20 G's	Msec.	3.0 to 7.0	5.00	Pass
Overall Test Results				Pass

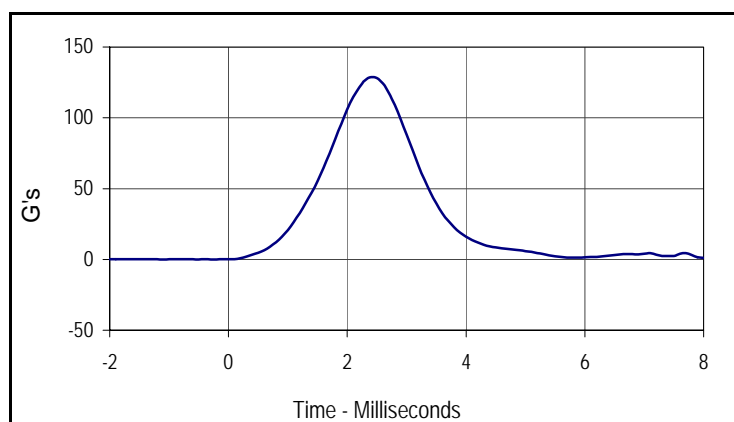
Curve Description			
Head Resultant			
CURNO	Type	SAE Class	Units
001	RES	1000	G's
Max	Time	Min	Time
128.7	2.4	0.0	-0.2

Tested Parameter	Units	Specification	Result	Pass/Fail
Laboratory Temperature	°C	18.9 to 25.6	21.1	Pass
Laboratory Relative Humidity	%	10 to 70	30	Pass
Peak Resultant Acceleration	G's	120.0 to 150.0	128.7	Pass
Peak Longitudinal Acceleration	G's	≤15.0	6.9	Pass
Is Acceleration Unimodal?	Yes/No	Yes	Yes	Pass
Oscillations After Main Pulse	%	<15	4.6	Pass
Overall Test Results				Pass

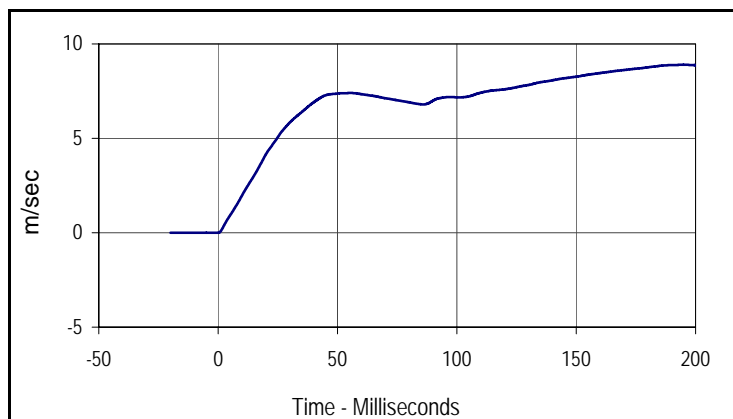
Curve Description			
Pendulum Velocity			
CURNO	Type	SAE Class	Units
001	FIL	180	m/sec
Max	Time	Min	Time
8.9	195.0	0.0	-0.2

Tested Parameter	Units	Specification	Result	Pass/Fail	
Laboratory Temperature	°C	20.6 to 22.2	21.1	Pass	
Laboratory Relative Humidity	%	10 to 70	30	Pass	
Pendulum Velocity	m/sec	6.89 to 7.13	6.98	Pass	
Pendulum Deceleration	10 Msec.	m/sec	1.96 to 2.55	1.98	Pass
	20 Msec.	m/sec	4.12 to 5.10	4.15	Pass
	30 Msec.	m/sec	5.73 to 7.01	5.84	Pass
	40 to 70	m/sec	6.27 to 7.64	7.40	Pass
"D" Plane Rotation	Max	Degrees	66.0 to 82.0	78.6	Pass
Max Rotation Time After Peak Moment	Msec.	2.0 to 16.0	6.9	Pass	
Rotation Time From Peak to Zero Angle	Msec.	58.0 to 67.0	58.9	Pass	
Moment About Occipital Condyle	Nm	73.0 to 88.0	87.1	Pass	
Positive Moment Decay, Time To 0 Nm	Msec.	49.0 to 64.0	55.5	Pass	
Overall Test Results				Pass

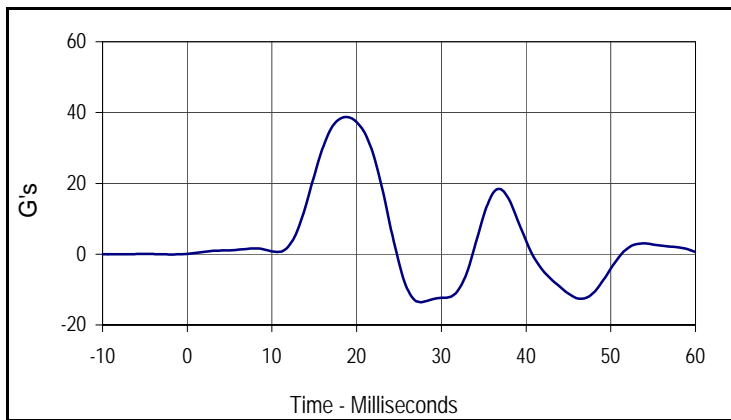
Curve Description			
Upper Rib Primary			
CURNO	Type	SAE Class	Units
001	FIL	FIR100	G's
Max	Time	Min	Time
38.7	18.8	-13.6	27.5

Tested Parameter	Units	Specification	Result	Pass/Fail
Laboratory Temperature	°C	18.9 to 25.6	21.1	Pass
Laboratory Relative Humidity	%	10 to 70	30	Pass
Probe Velocity	m/s	4.21 to 4.33	4.27	Pass
Upper Rib Acceleration	G's	37.0 to 46.0	38.7	Pass
Lower Rib Acceleration	G's	37.0 to 46.0	37.4	Pass
Thoracic Spine Acceleration	G's	15.0 to 22.0	21.2	Pass
Overall Test Results			Pass

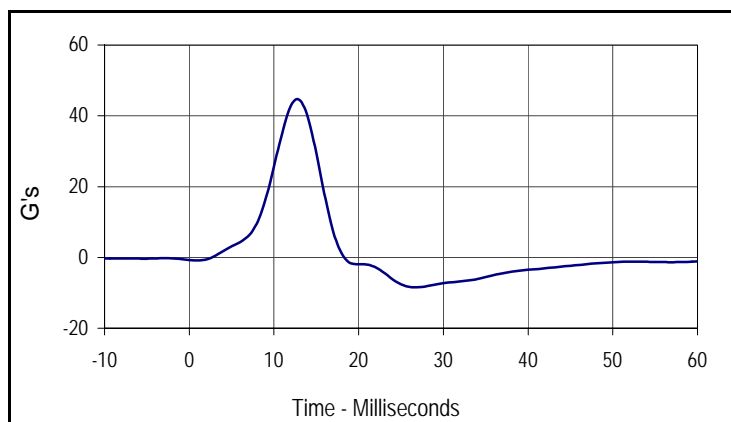
Curve Description			
Pelvis Primary Y			
CURNO	Type	SAE Class	Units
001	FIL	FIR100	G's
Max	Time	Min	Time
44.5	12.5	-8.5	26.9

Tested Parameter	Units	Specification	Result	Pass/Fail
Laboratory Temperature	°C	18.9 to 25.6	21.1	Pass
Laboratory Relative Humidity	%	10 to 70	30	Pass
Probe Velocity	m/s	4.21 to 4.33	4.31	Pass
Peak Pelvis Acceleration	G's	40.0 to 60.0	44.5	Pass
Acceleration Time Above 20 G's	Msec.	3.0 to 7.0	6.88	Pass
Overall Test Results				Pass

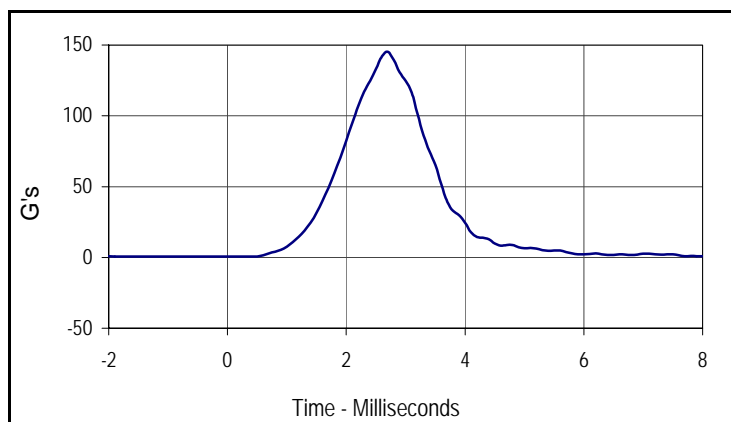
Curve Description			
Head Resultant			
CURNO	Type	SAE Class	Units
001	RES	1000	G's
Max	Time	Min	Time
145.2	2.7	0.5	0.4

Tested Parameter	Units	Specification	Result	Pass/Fail
Laboratory Temperature	°C	18.9 to 25.6	21.1	Pass
Laboratory Relative Humidity	%	10 to 70	30	Pass
Peak Resultant Acceleration	G's	120.0 to 150.0	145.2	Pass
Peak Longitudinal Acceleration	G's	≤15.0	6.9	Pass
Is Acceleration Unimodal?	Yes/No	Yes	Yes	Pass
Oscillations After Main Pulse	%	<15	4.6	Pass
Overall Test Results				Pass
