**REPORT NUMBER TR-P26168-01-NC**

**NEW CAR ASSESSMENT PROGRAM  
SIDE IMPACT TEST**

**AUDI AG  
2007 AUDI Q7  
5-DOOR MPV**

**Prepared By:  
KARCO ENGINEERING, LLC  
9270 HOLLY ROAD  
ADELANTO, CALIFORNIA 92301**

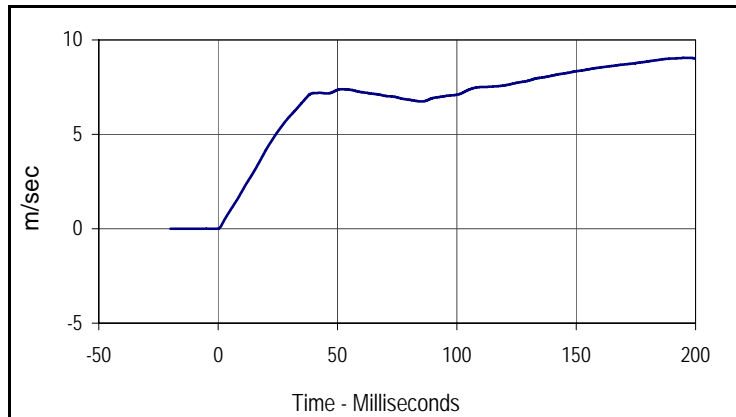
Curve Description			
Pendulum Velocity			
CURNO	Type	SAE Class	Units
001	FIL	180	m/sec
Max	Time	Min	Time
9.1	196.2	0.0	-0.4

Tested Parameter	Units	Specification	Result	Pass/Fail	
Laboratory Temperature	°C	20.6 to 22.2	21.1	Pass	
Laboratory Relative Humidity	%	10 to 70	30	Pass	
Pendulum Velocity	m/sec	6.89 to 7.13	7.13	Pass	
Pendulum Deceleration	10 Msec.	m/sec	1.96 to 2.55	1.99	Pass
	20 Msec.	m/sec	4.12 to 5.10	4.17	Pass
	30 Msec.	m/sec	5.73 to 7.01	5.96	Pass
	40 to 70	m/sec	6.27 to 7.64	7.39	Pass
"D" Plane Rotation	Max	Degrees	66.0 to 82.0	74.2	Pass
Max Rotation Time After Peak Moment	Msec.	2.0 to 16.0	9.7	Pass	
Rotation Time From Peak to Zero Angle	Msec.	58.0 to 67.0	58.4	Pass	
Moment About Occipital Condyle	Nm	73.0 to 88.0	85.6	Pass	
Positive Moment Decay, Time To 0 Nm	Msec.	49.0 to 64.0	52.6	Pass	
Overall Test Results				Pass
