**Report Number: NCAP-TRC-06-001**

**New Car Assessment Program**

**Frontal Barrier Impact Test**

**Kia Motors America, Inc.  
2006 Kia Optima LX 4-door sedan**

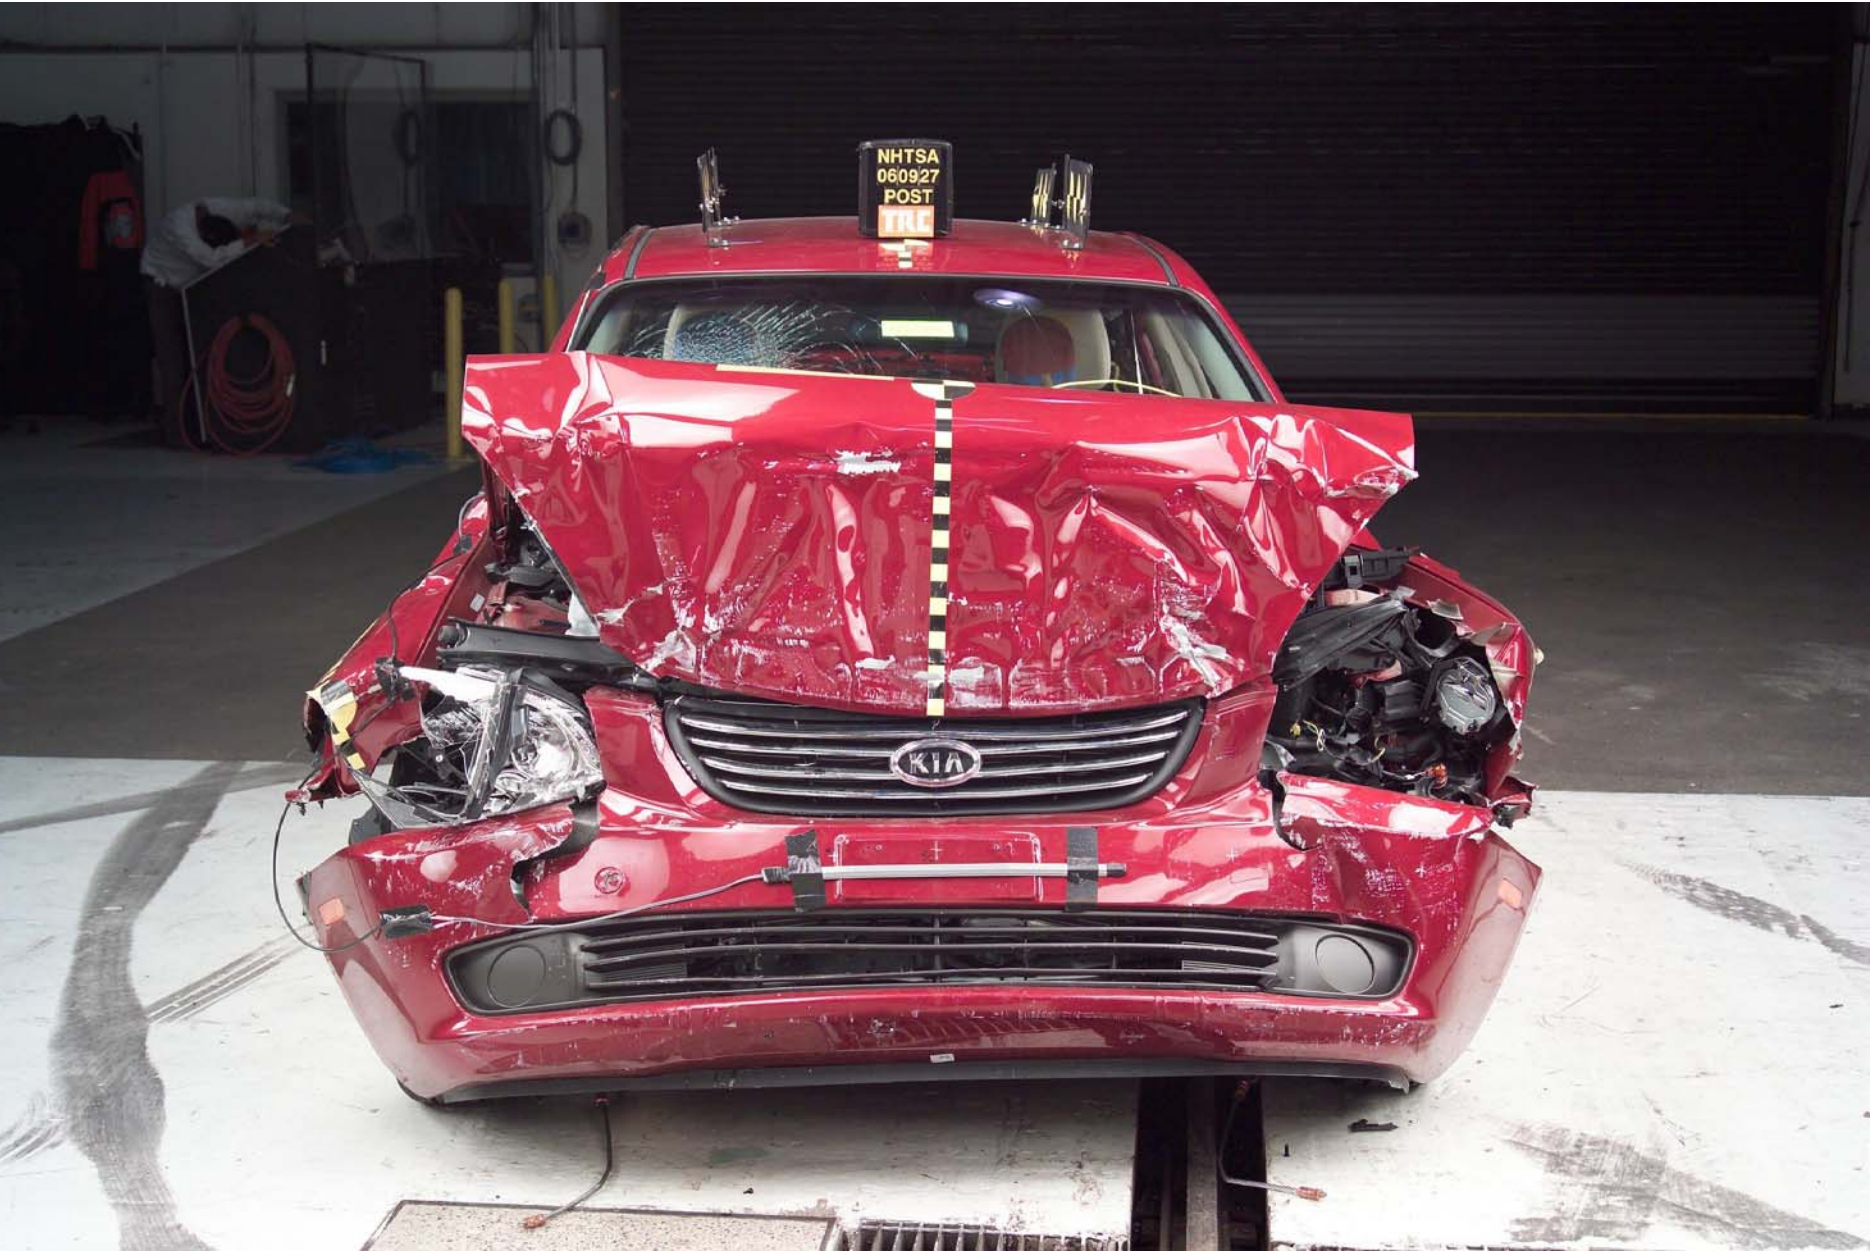
Figure A-2 Post-Test Front View

The maximum static crush of the vehicle was 444 mm and both the driver and passenger side doors remained closed during the impact event and were operable after the impact.

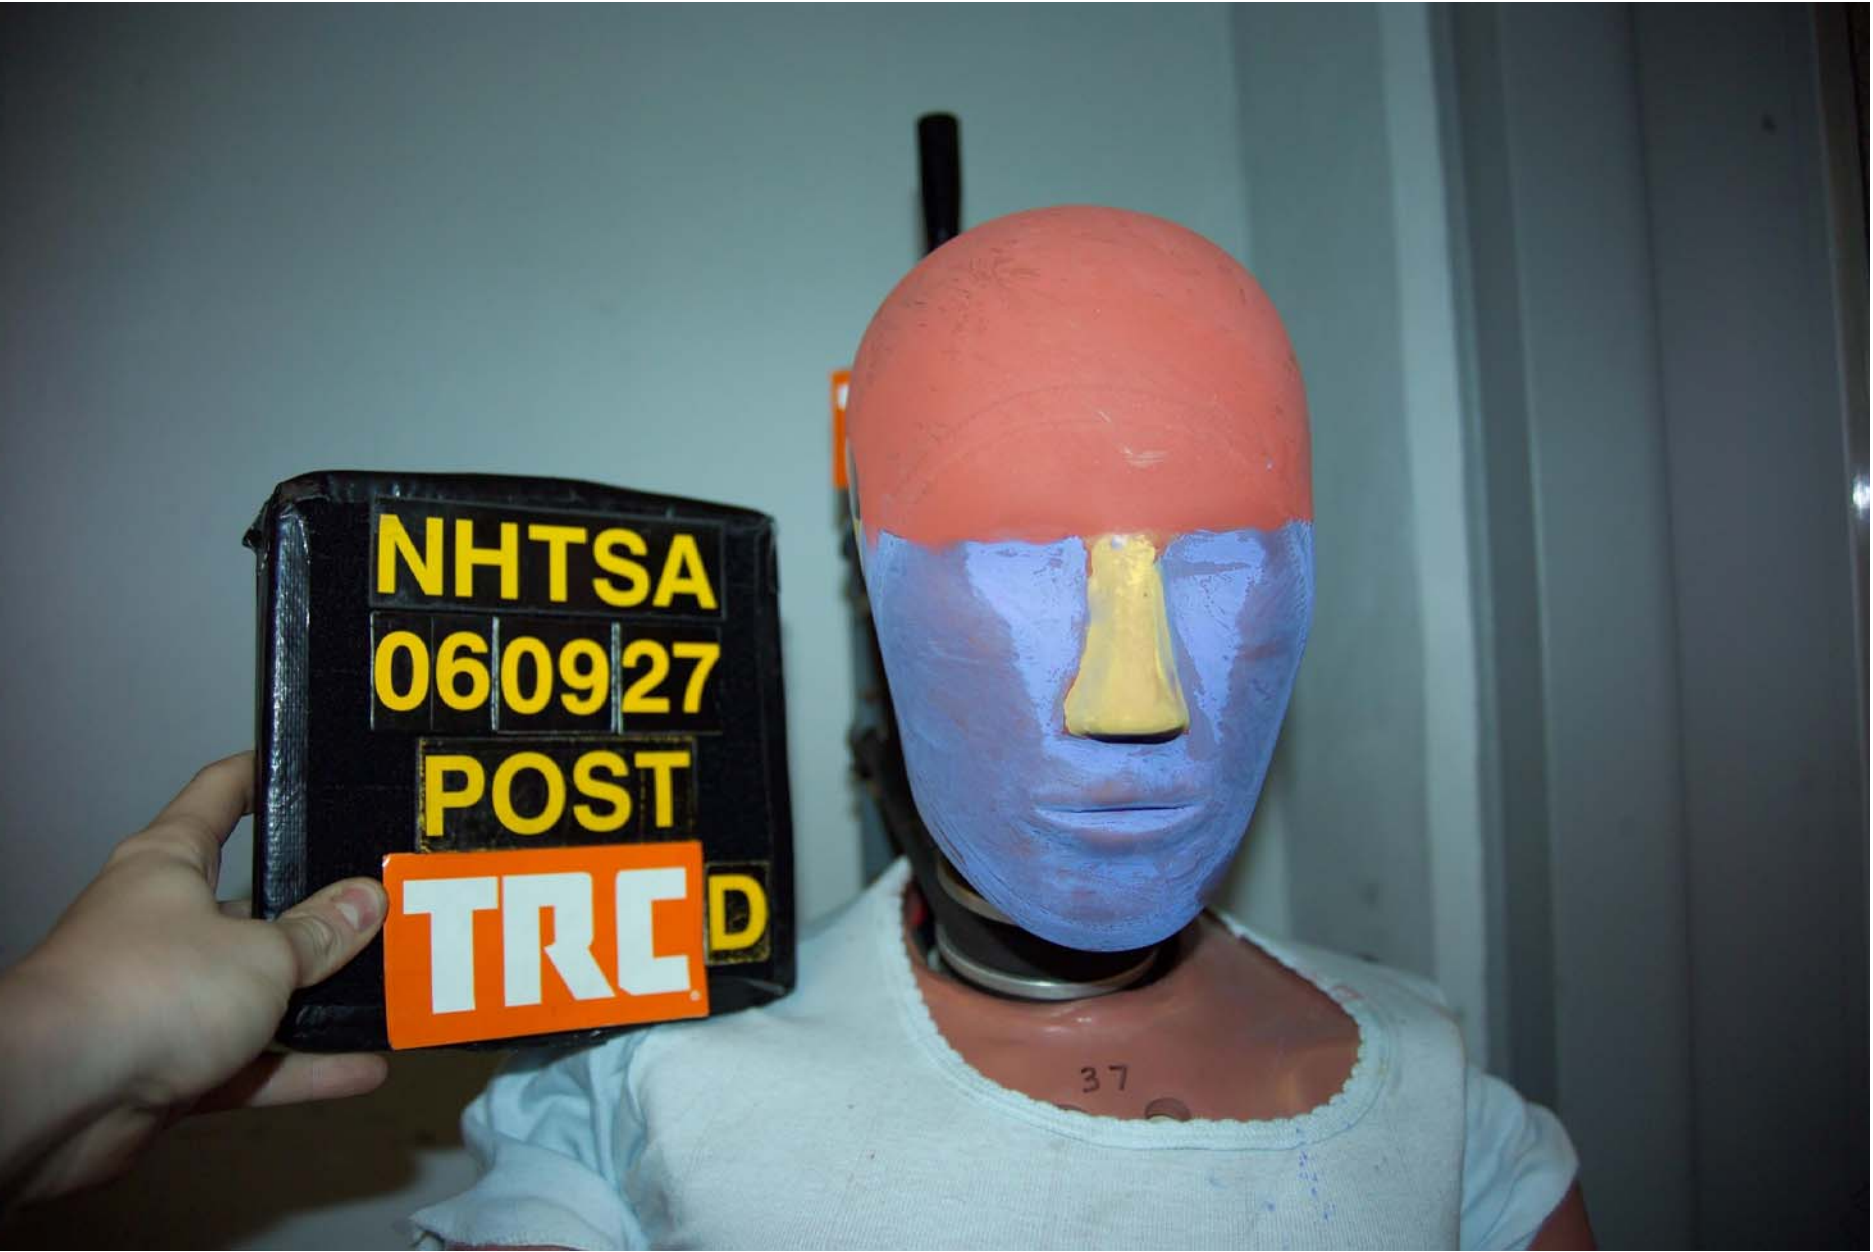
Figure A-54 Post-Test Driver Dummy Head Contact - View 1

The driver's visible contact points were as follows: airbag, head restraint, and dash panel. The passenger's visible contact points were as follows: airbag, head restraint, and dash panel.

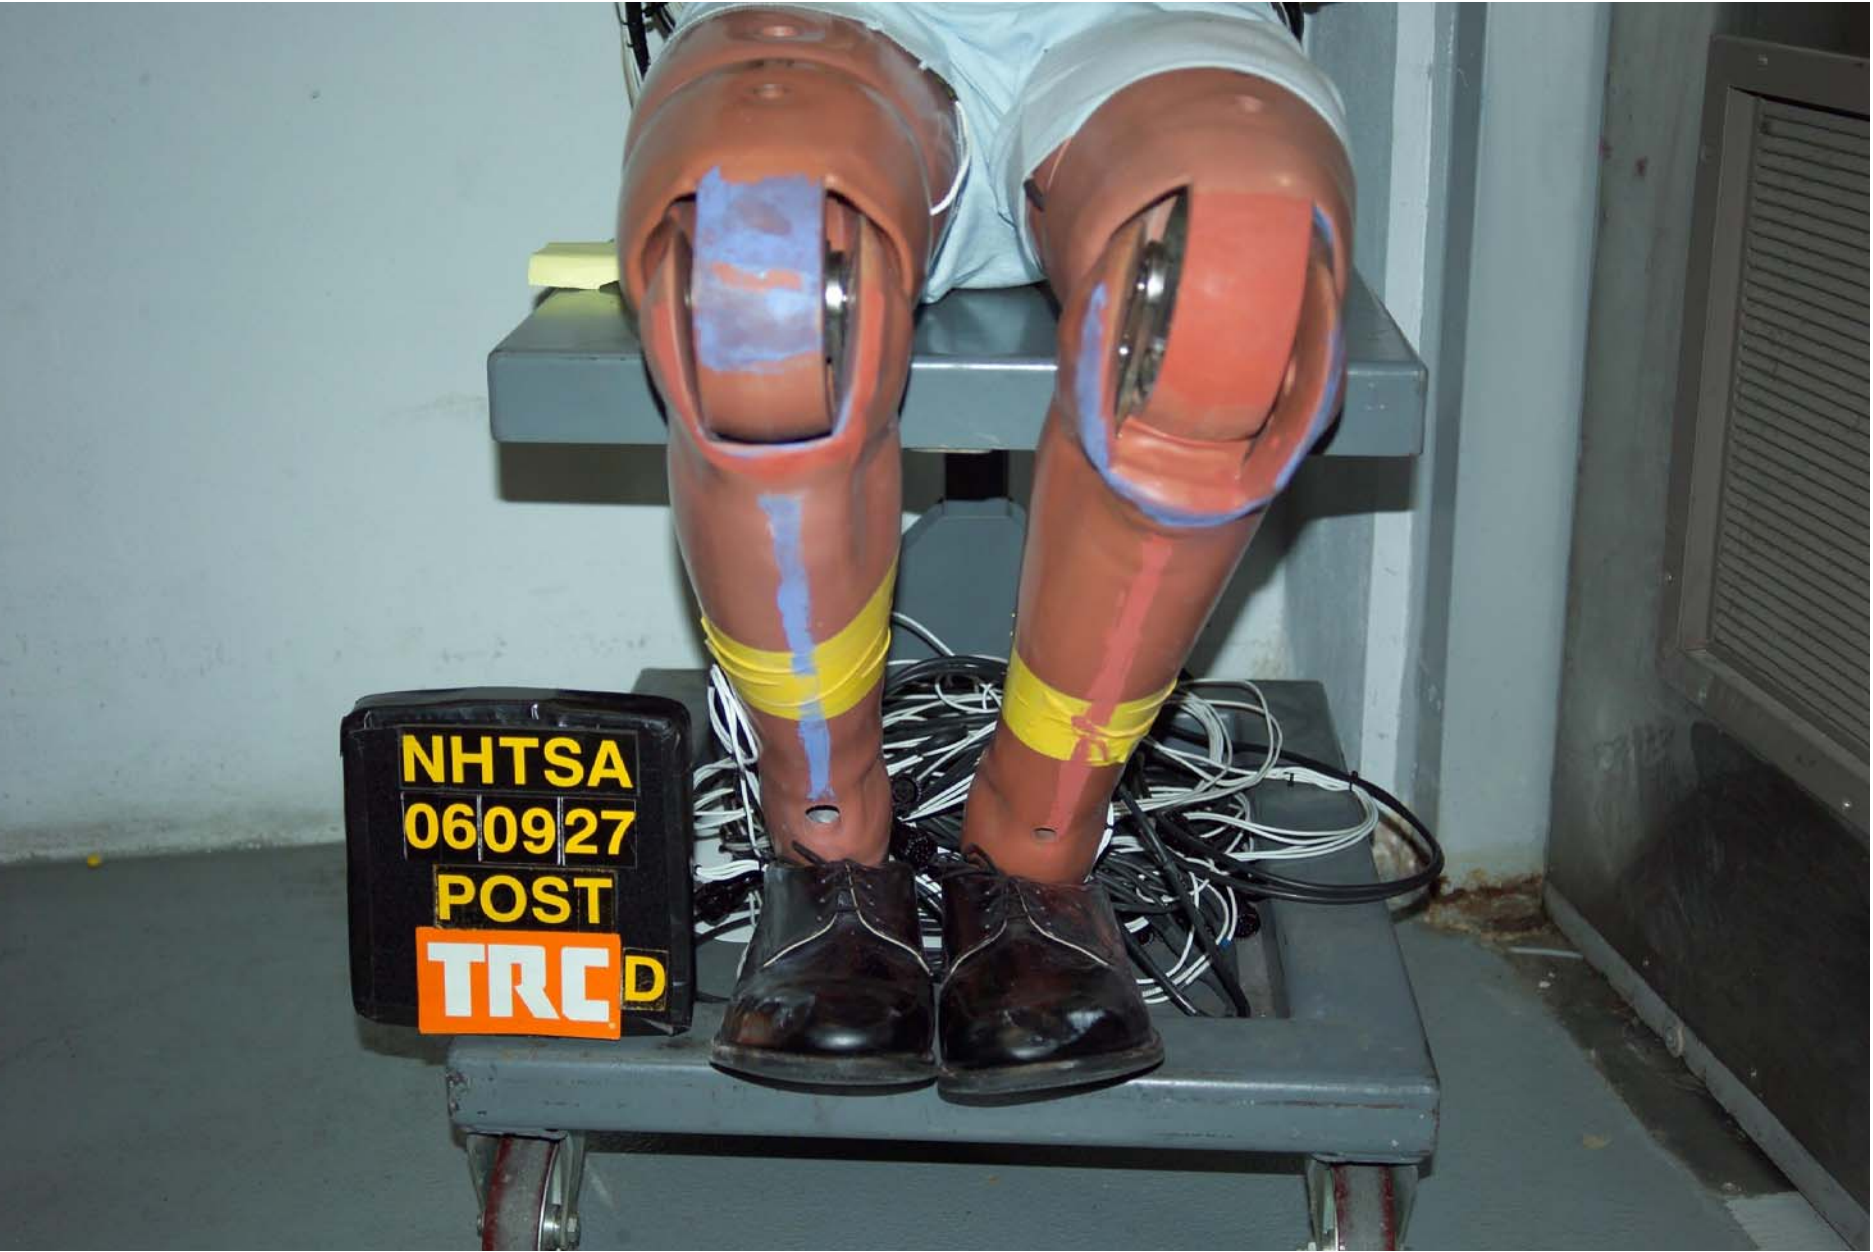
Figure A-57 Post-Test Driver Dummy Knee Contact - View 1

| Left Knee: | Knee bolster | Knee bolster |

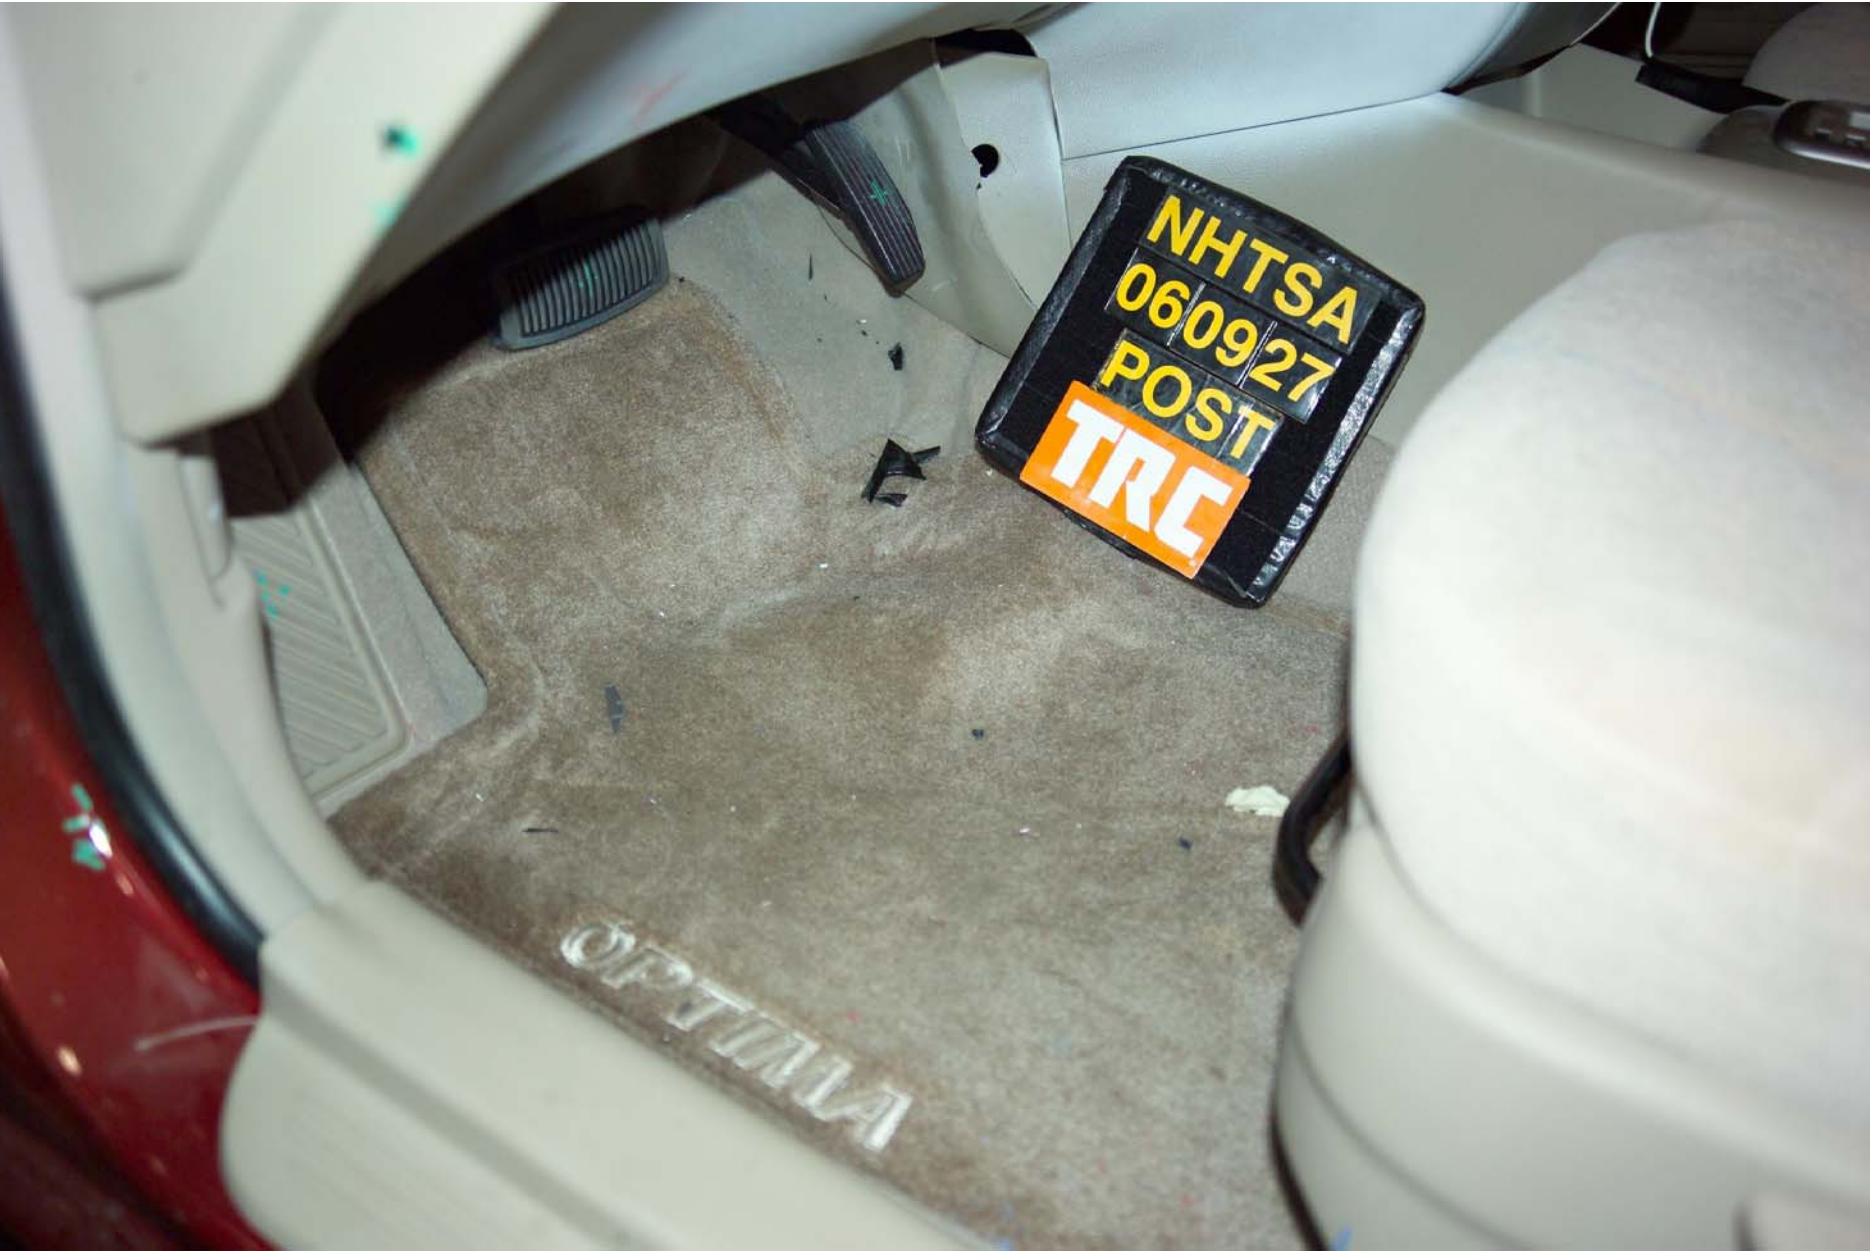
Figure A-59 Post-Test Driver Floorboard Deformation View

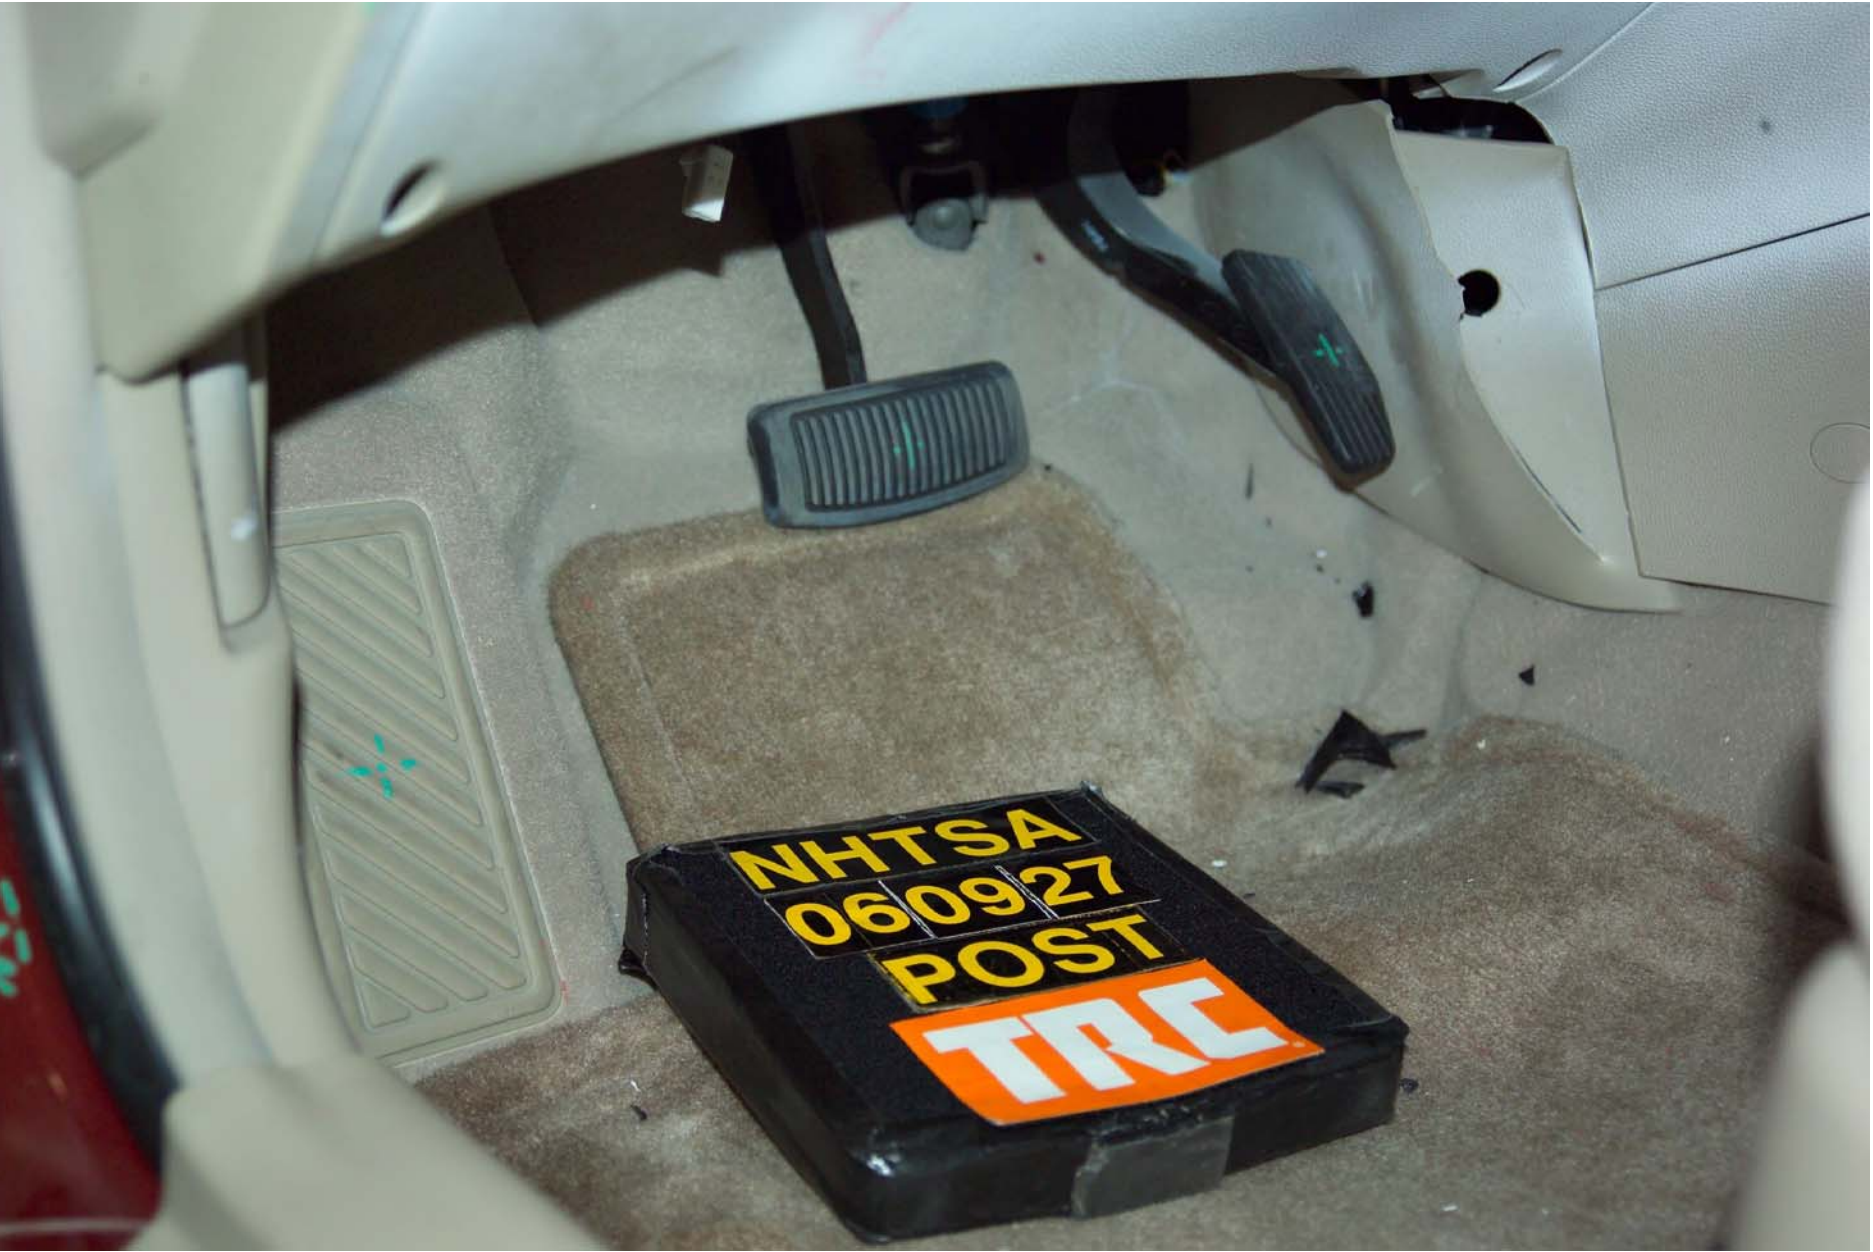
Figure A-60 Post-Test Driver Toeboard Deformation View

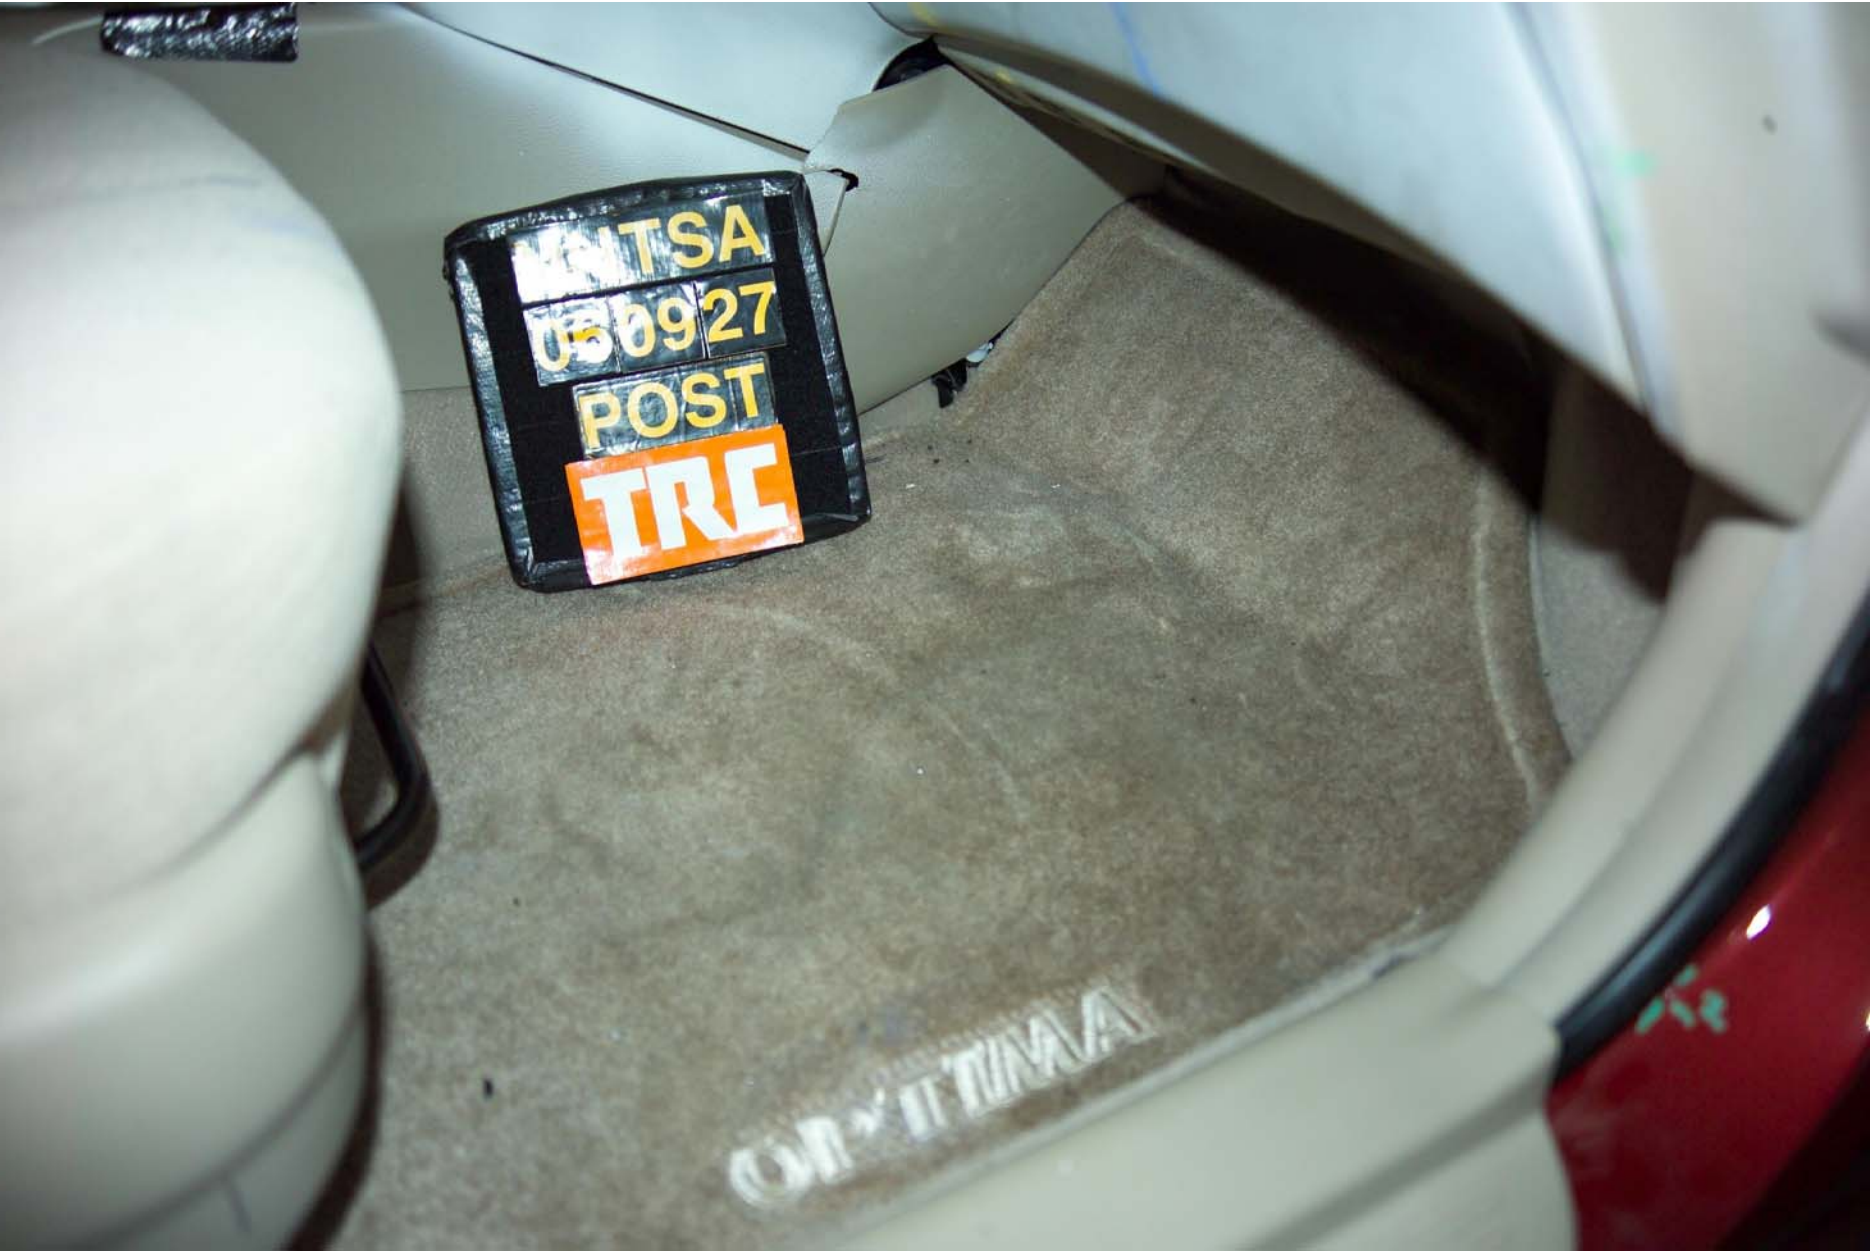
Figure A-77 Post-Test Right Front Passenger Floorboard Deformation View

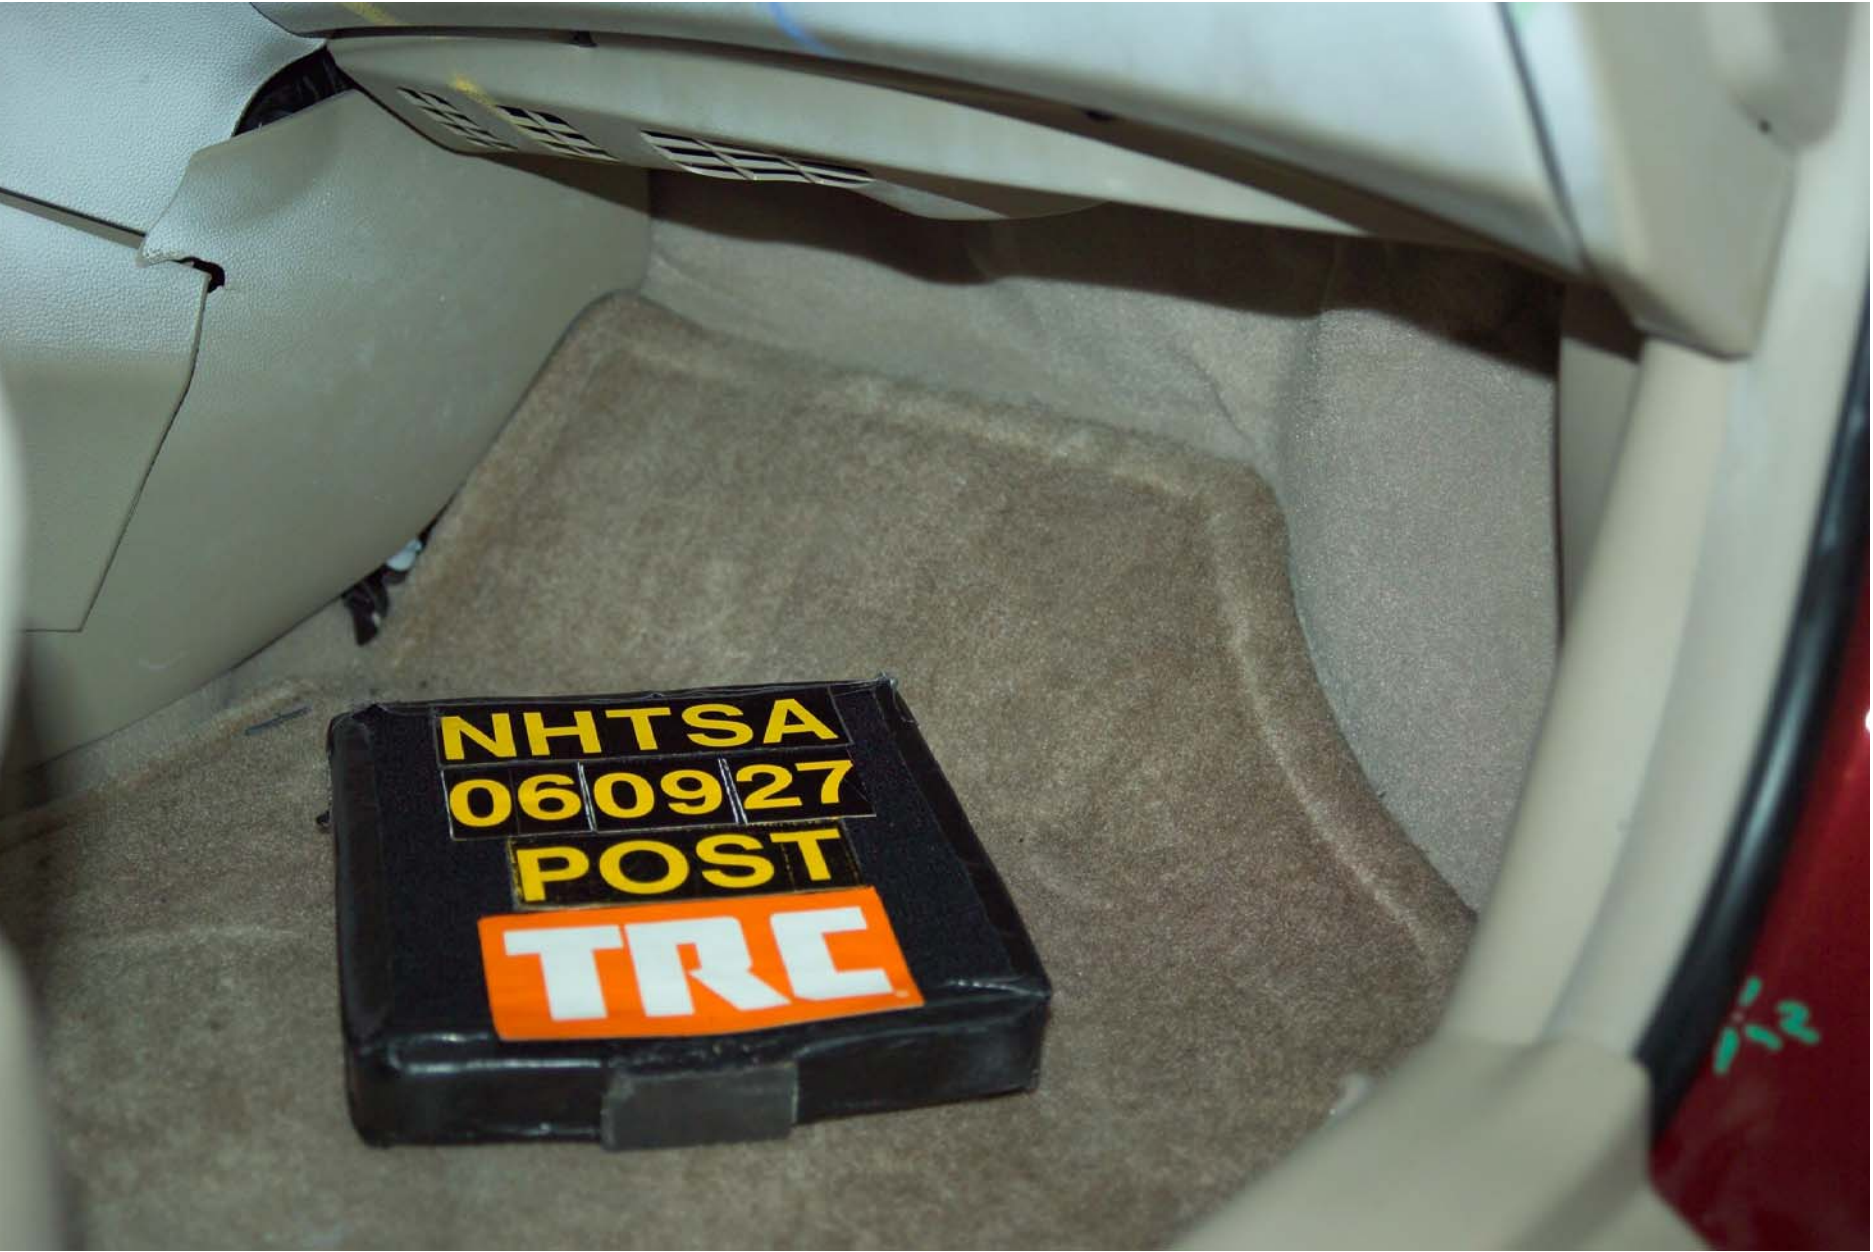
Figure A-78 Post-Test Right Front Passenger Toeboard Deformation View

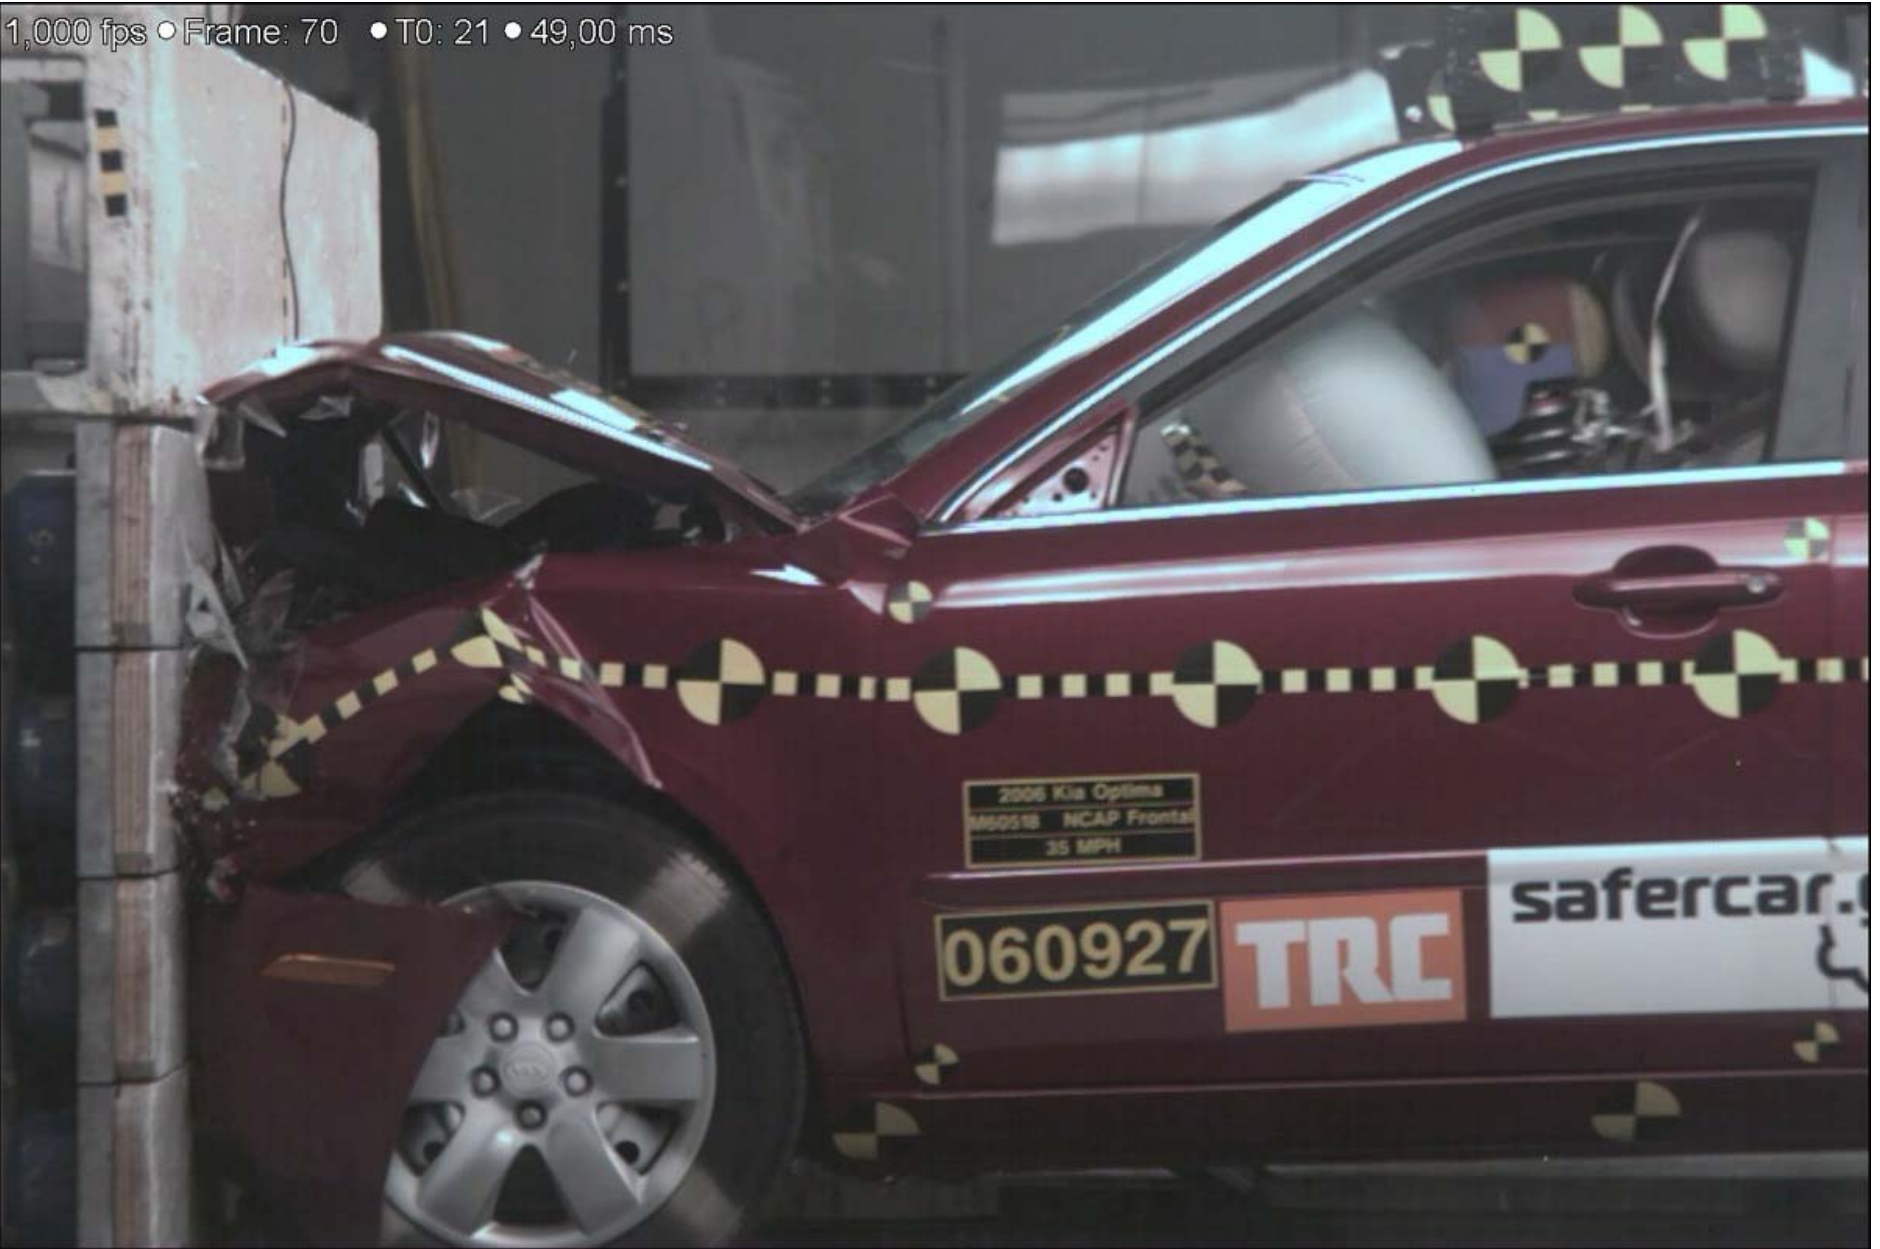
Figure A-87 Impact Event
