REPORT NUMBER: CAL-07-05

**NEW CAR ASSESSMENT PROGRAM (NCAP)  
FRONTAL BARRIER IMPACT TEST**

GENERAL MOTORS DE MEXICO  
2007 CHEVROLET AVALANCHE  
MPV

FINAL REPORT

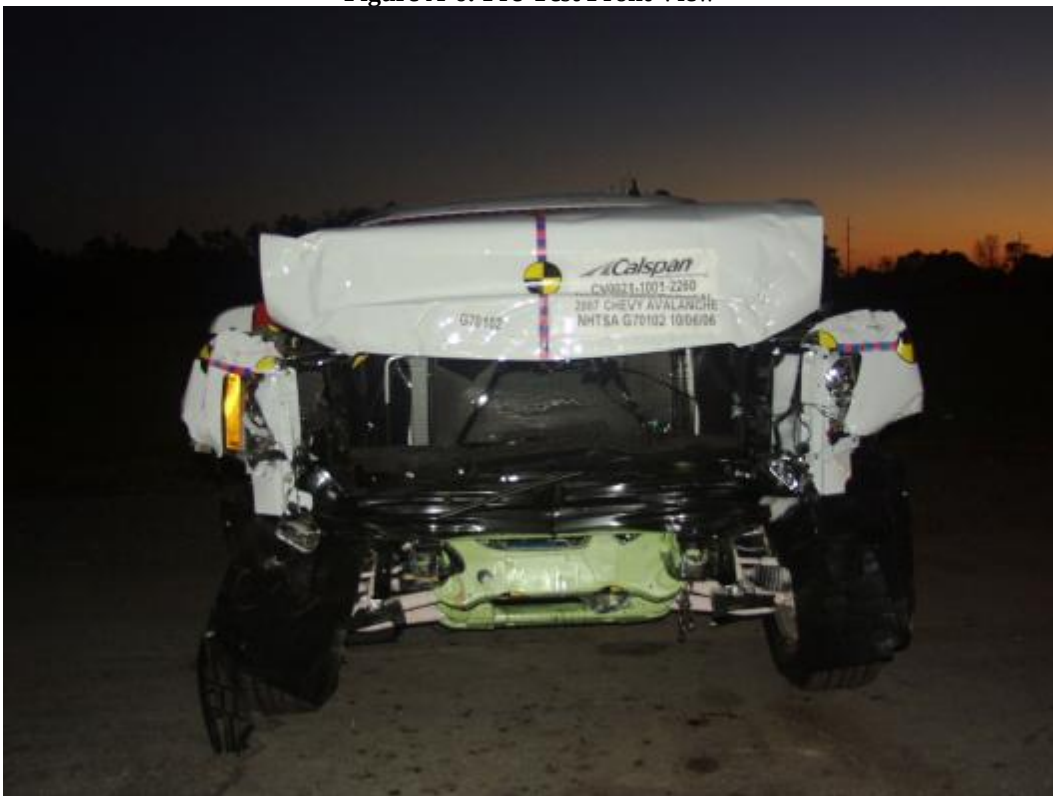
**Figure A-7: Post-Test Front View**

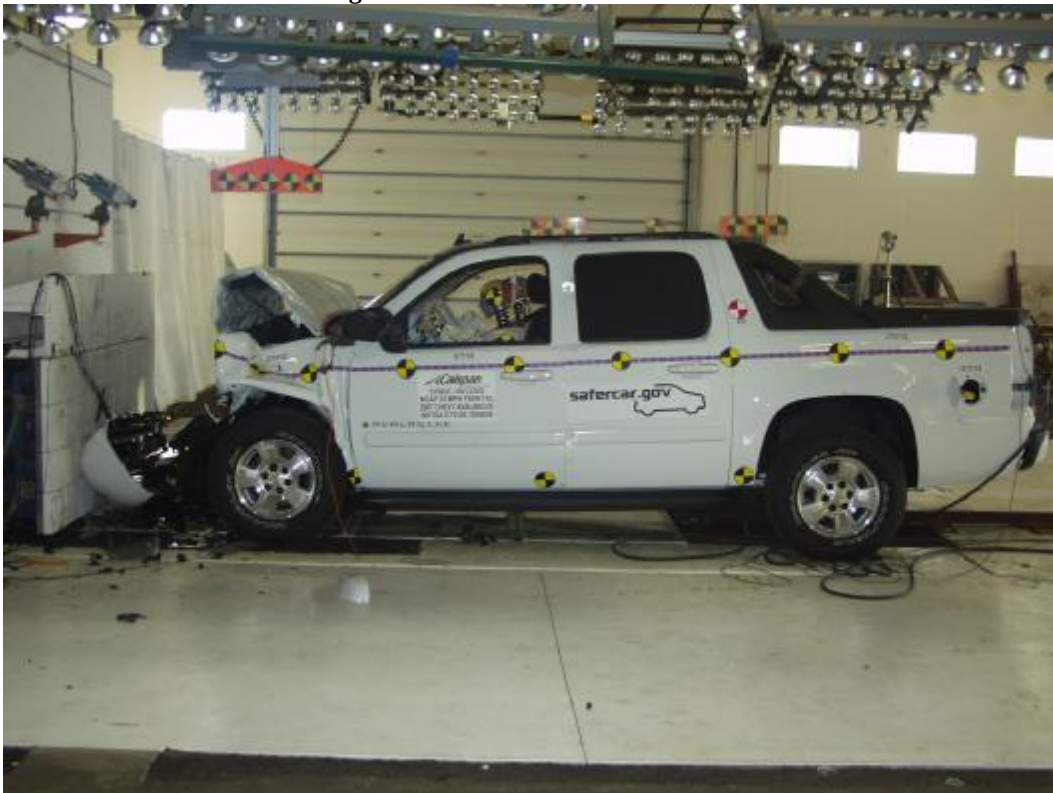
Figure A-9: Post-Test Left Side View

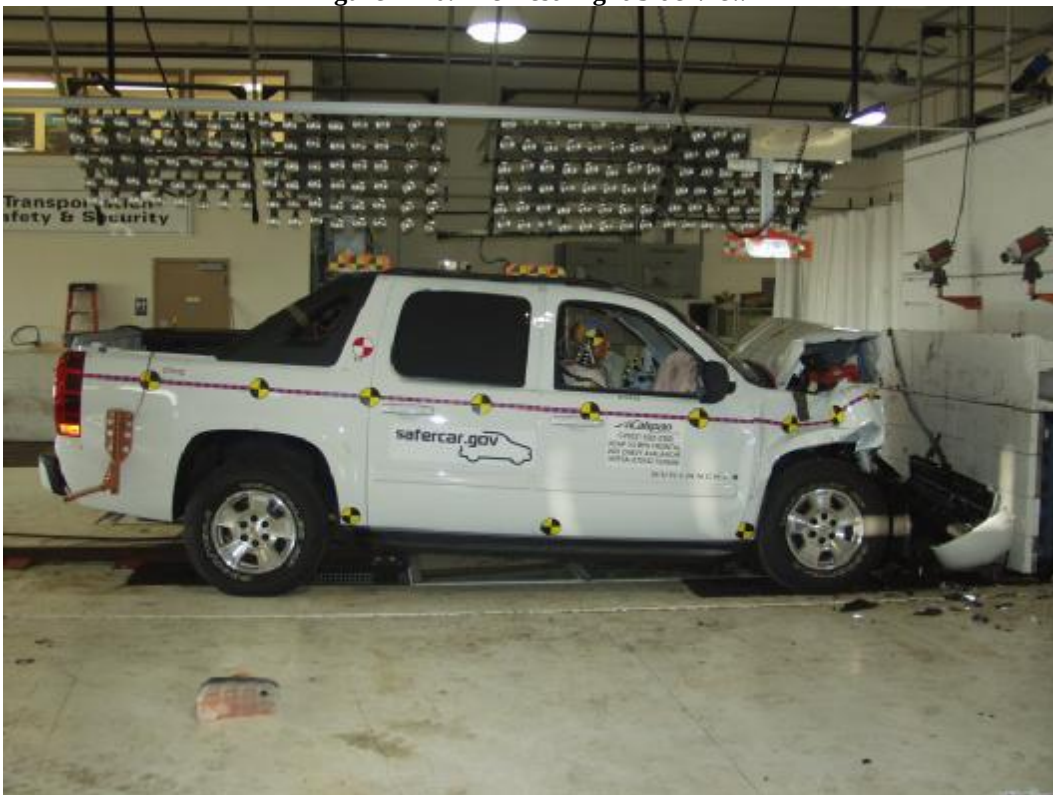
Figure A-11: Post-Test Right Side View

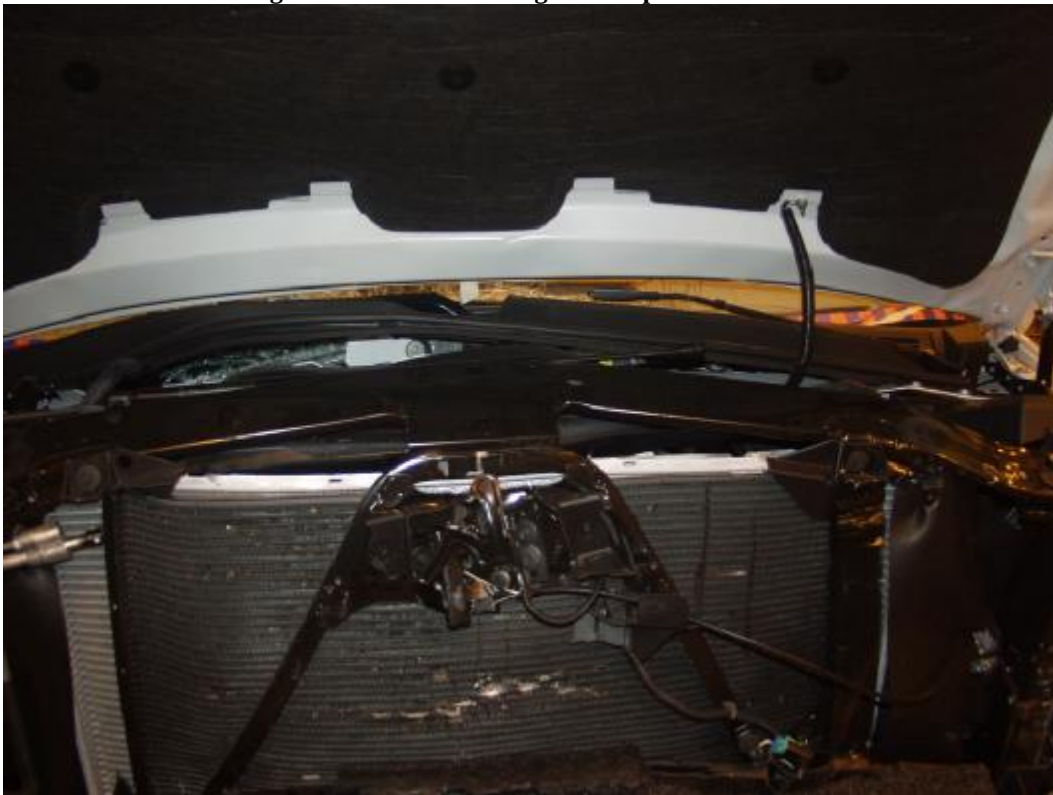
**Figure A-21: Post-Test Engine Compartment View**

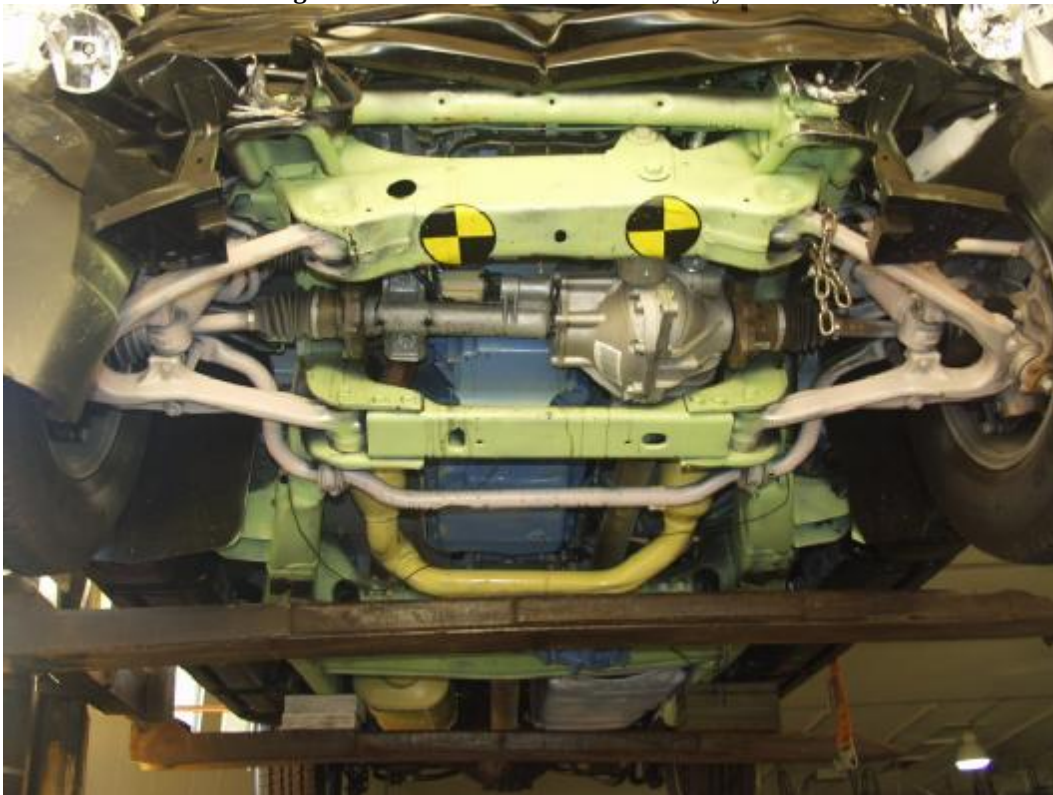
**Figure A-25: Post-Test Front Underbody View**

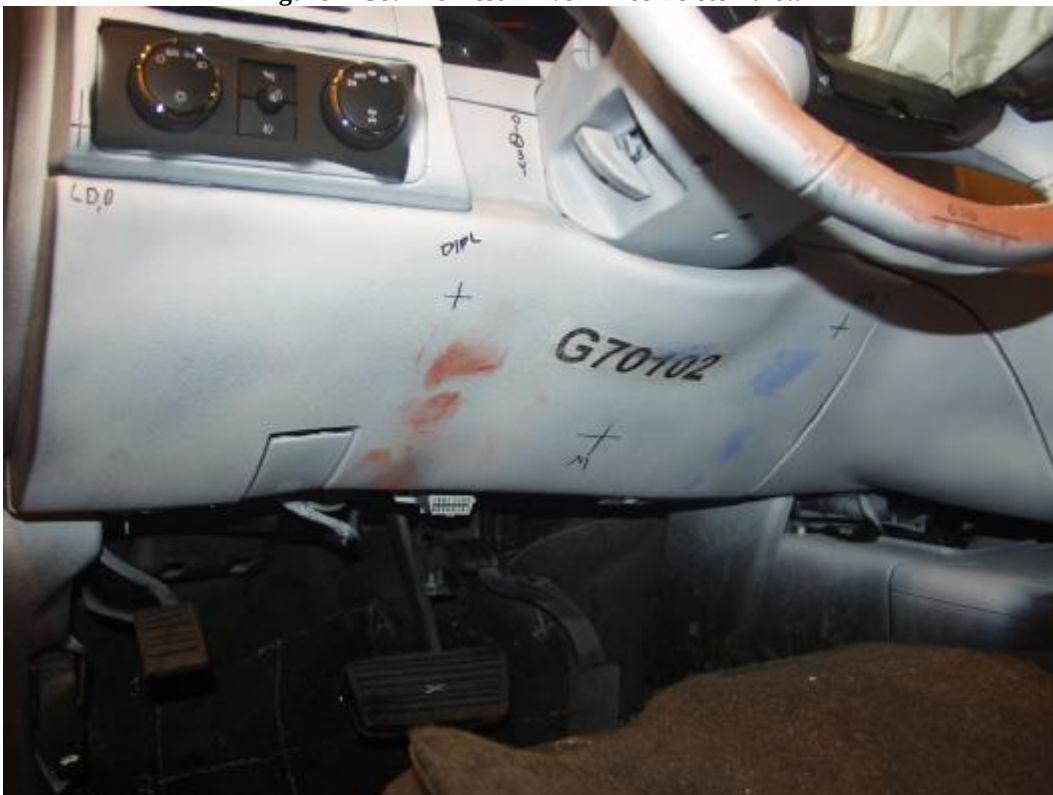
**Figure A-39: Post-Test Driver Knee Bolster View**

| | DRIVER | PASSENGER |
|---|---|---|
| Left Knee Contact: | Knee bolster | Glove compartment door |

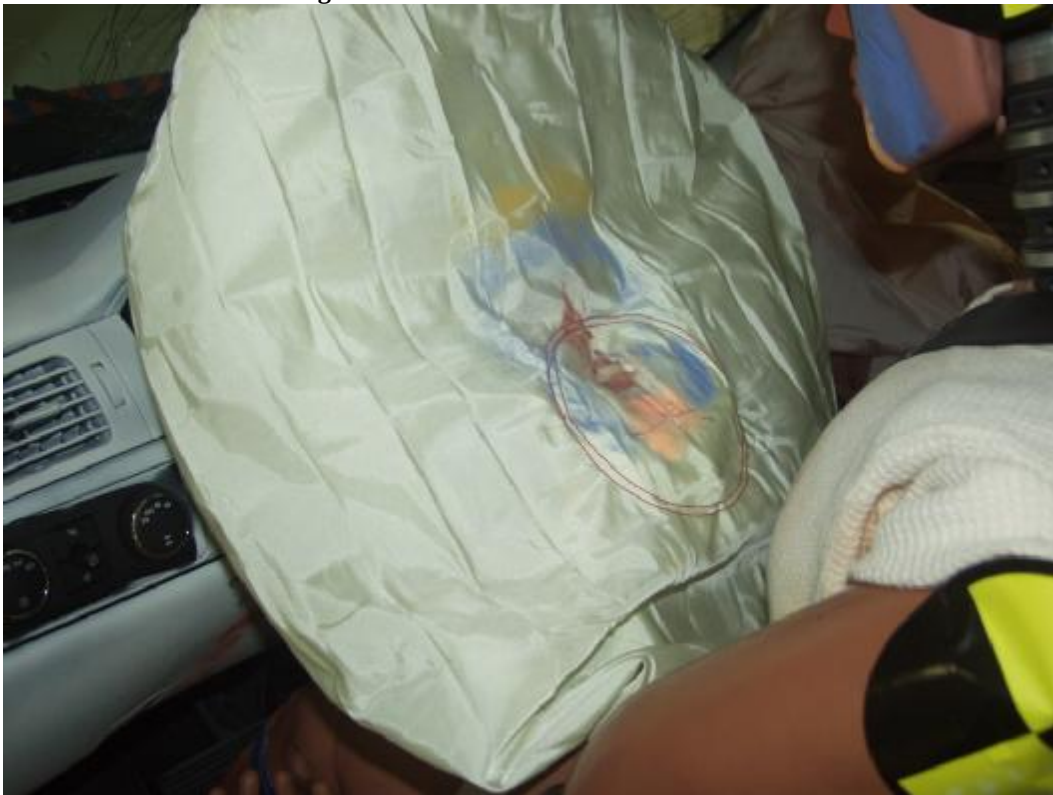
**Figure A-43: Post-Test Driver Contact to Airbag**

| | DRIVER | PASSENGER |
|---|---|---|
| Head Contact: | The face to the center of the airbag, the back of the head to the outboard half of the head restraint. | The face to the center of the airbag, the back of the head to the center of the head restraint. |
| Chest Contact: | Airbag | Airbag |

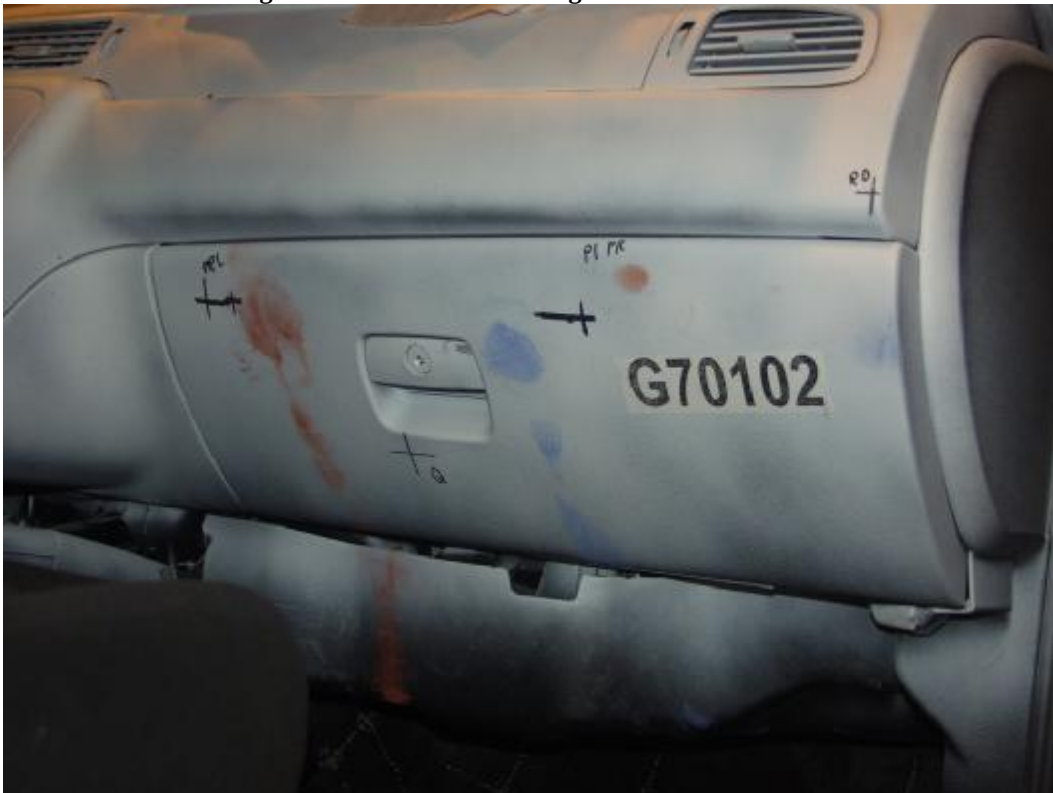
**Figure A-53: Post-Test Passenger Knee Bolster View**

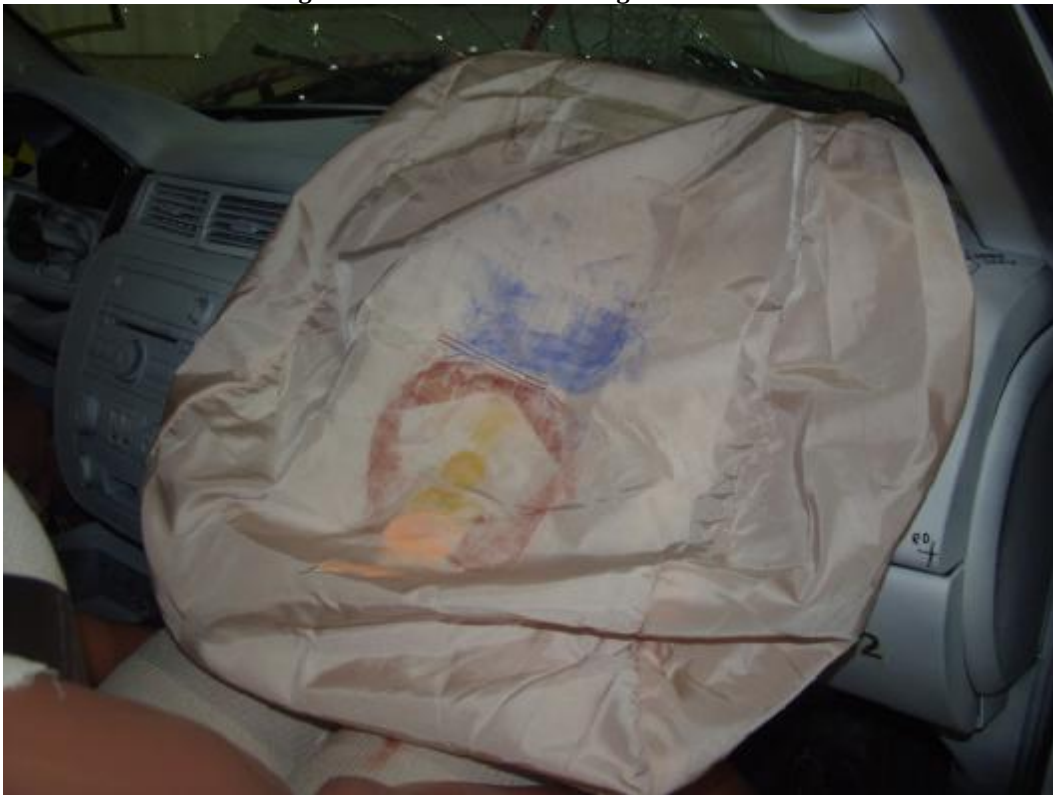
**Figure A-57: Post-Test Passenger Contact to Airbag**
