REPORT NUMBER TR-P26174-01-NC

**NEW CAR ASSESSMENT PROGRAM
FRONTAL BARRIER IMPACT TEST**

**HONDA OF AMERICA MFG., INC.
2007 ACURA RDX
5-DOOR MPV**

NHTSA NUMBER: H75301

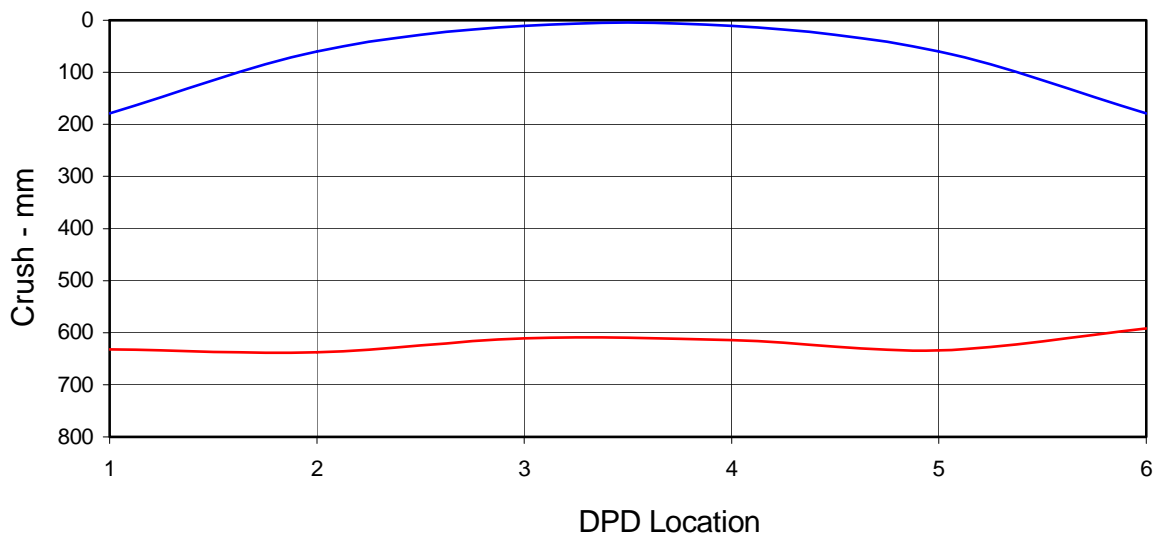
Collision Deformation Classification: 12FDEW6 Midpoint of Damage: Vehicle Centerline
Damage Region Length (mm): 1458 Impact Mode: Full Frontal

No.	Measurement Description	Units	Pre-Test	Post-Test	Difference
C1	Crush zone 1 at left side	mm	179	632	-453
C2	Crush zone 2 on left side	mm	60	638	-578
C3	Crush zone 3 on left side	mm	11	611	-600
C4	Crush zone 4 on right side	mm	11	614	-603
C5	Crush zone 5 on right side	mm	60	634	-574
C6	Crush zone 6 at right side	mm	179	592	-413

The maximum static crush of the vehicle was 604 mm at the vehicle's centerline and both the driver and the passenger side doors remained closed and latched during the impact event and were operable after the impact.

Measured Parameter	Units	Pre-Test	Post-Test	Difference
Left Side	mm	4412	3959	-453
Center	mm	4591	3987	-604
Right Side	mm	4412	3998	-414

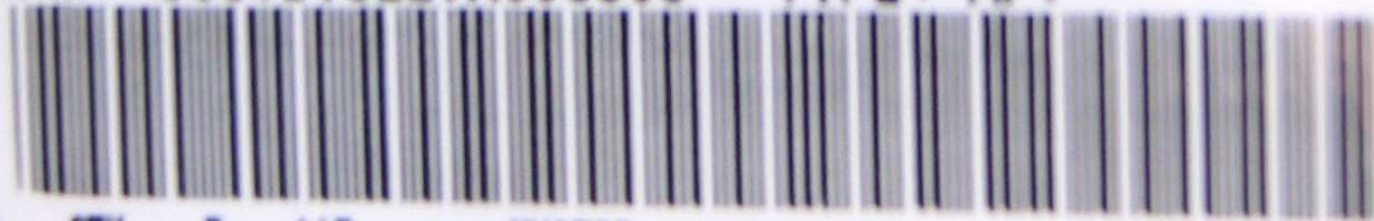
Figure A-2: Manufacturer's Label

MFD. BY HONDA OF AMERICA MFG., INC. 08/06
GVWR 2220KG (4894LBS) TIRE SIZE RIM SIZE
GAWR F 1155KG (2546LBS) P235/55R18 99V 18X7 1/2J
GAWR R 1080KG (2381LBS) P235/55R18 99V 18X7 1/2J
THIS VEHICLE CONFORMS TO ALL APPLICABLE
FEDERAL MOTOR VEHICLE SAFETY
AND THEFT PREVENTION STANDARDS IN EFFECT
ON THE DATE OF MANUFACTURE SHOWN ABOVE.
V.I.N.: 5J8TB18227A003863 TYPE: MPV

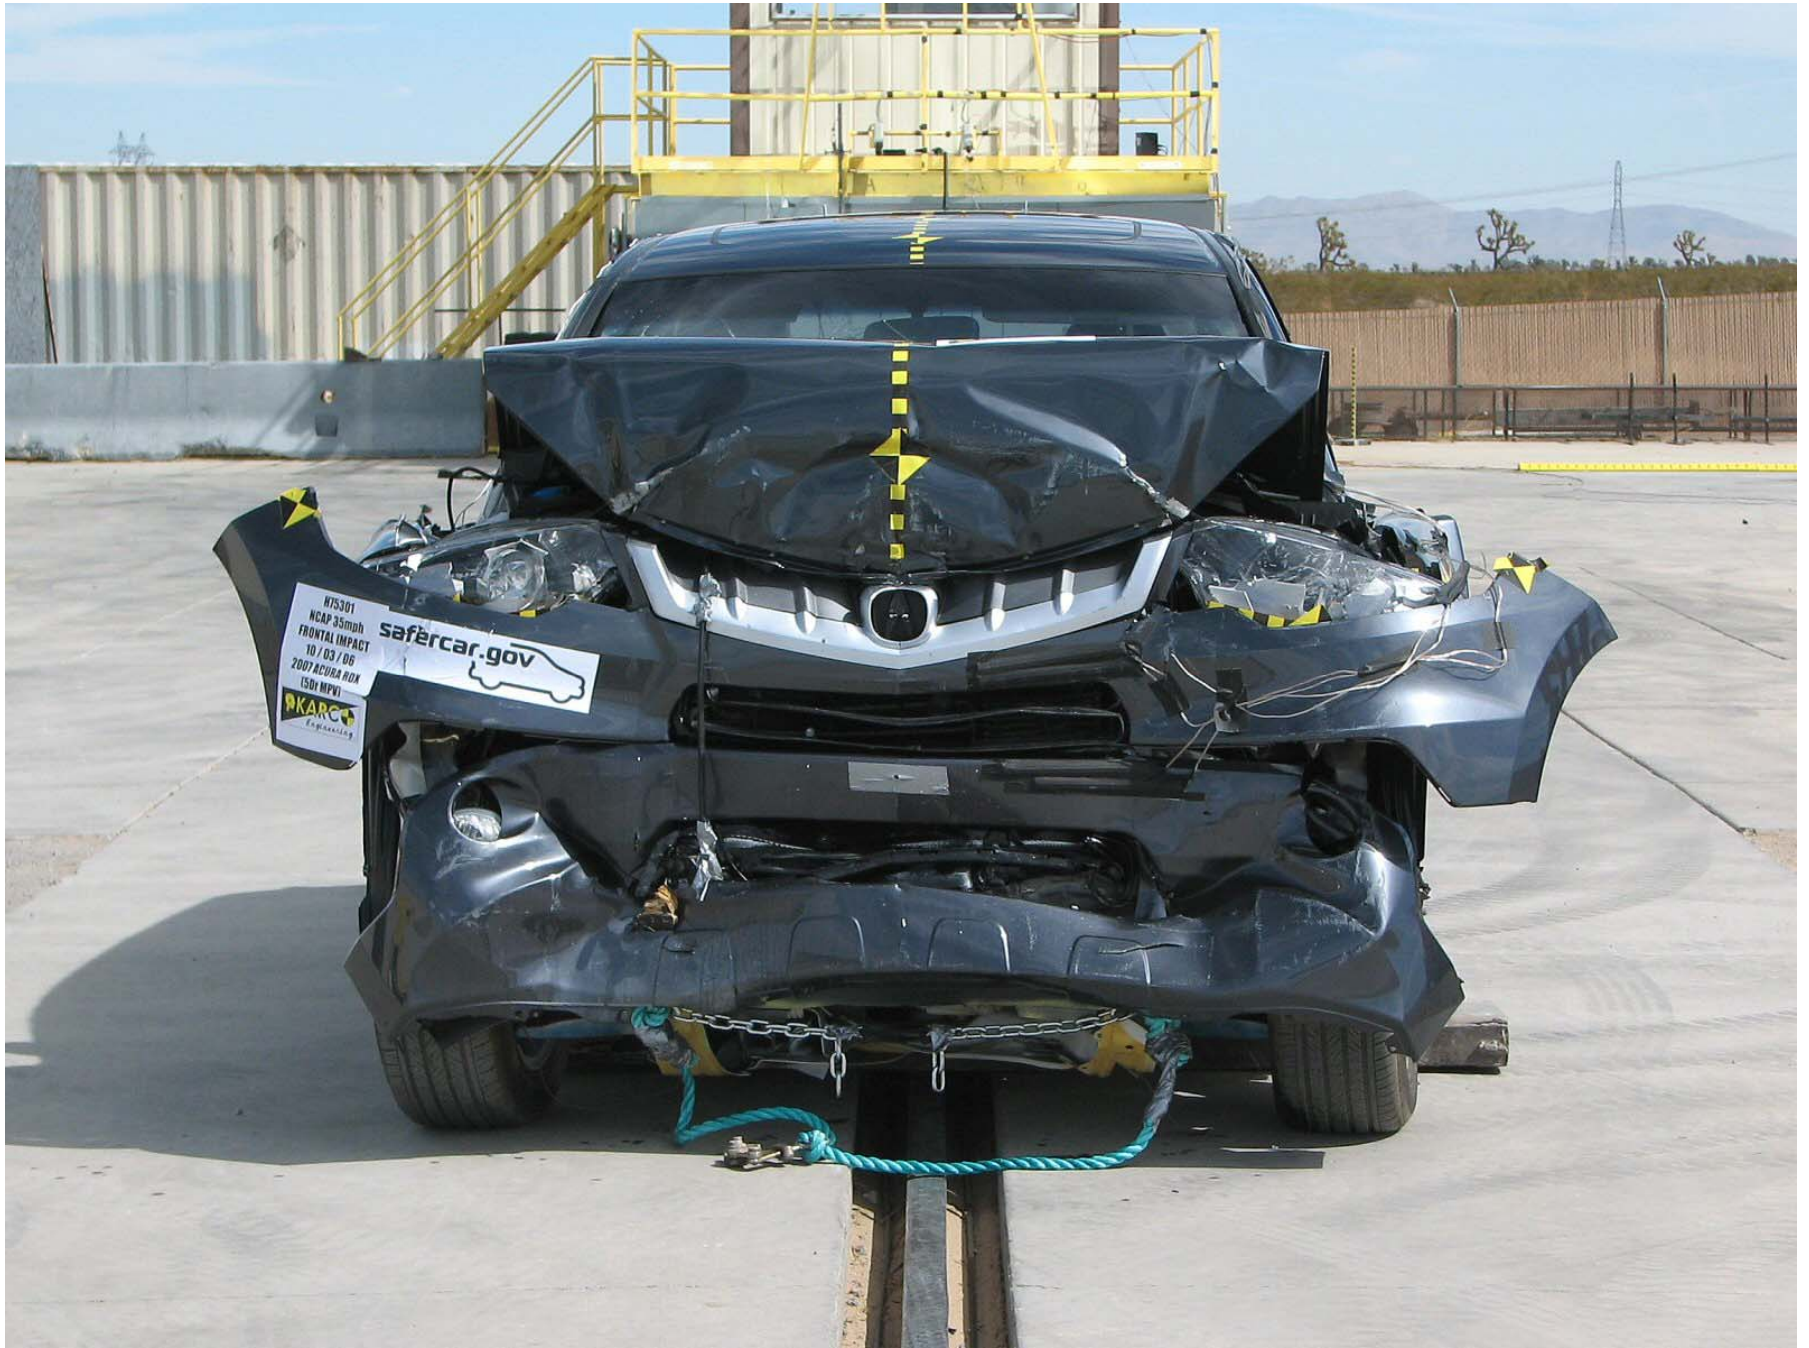
Figure A-7: Post-Test Front View (Vehicle Moved)

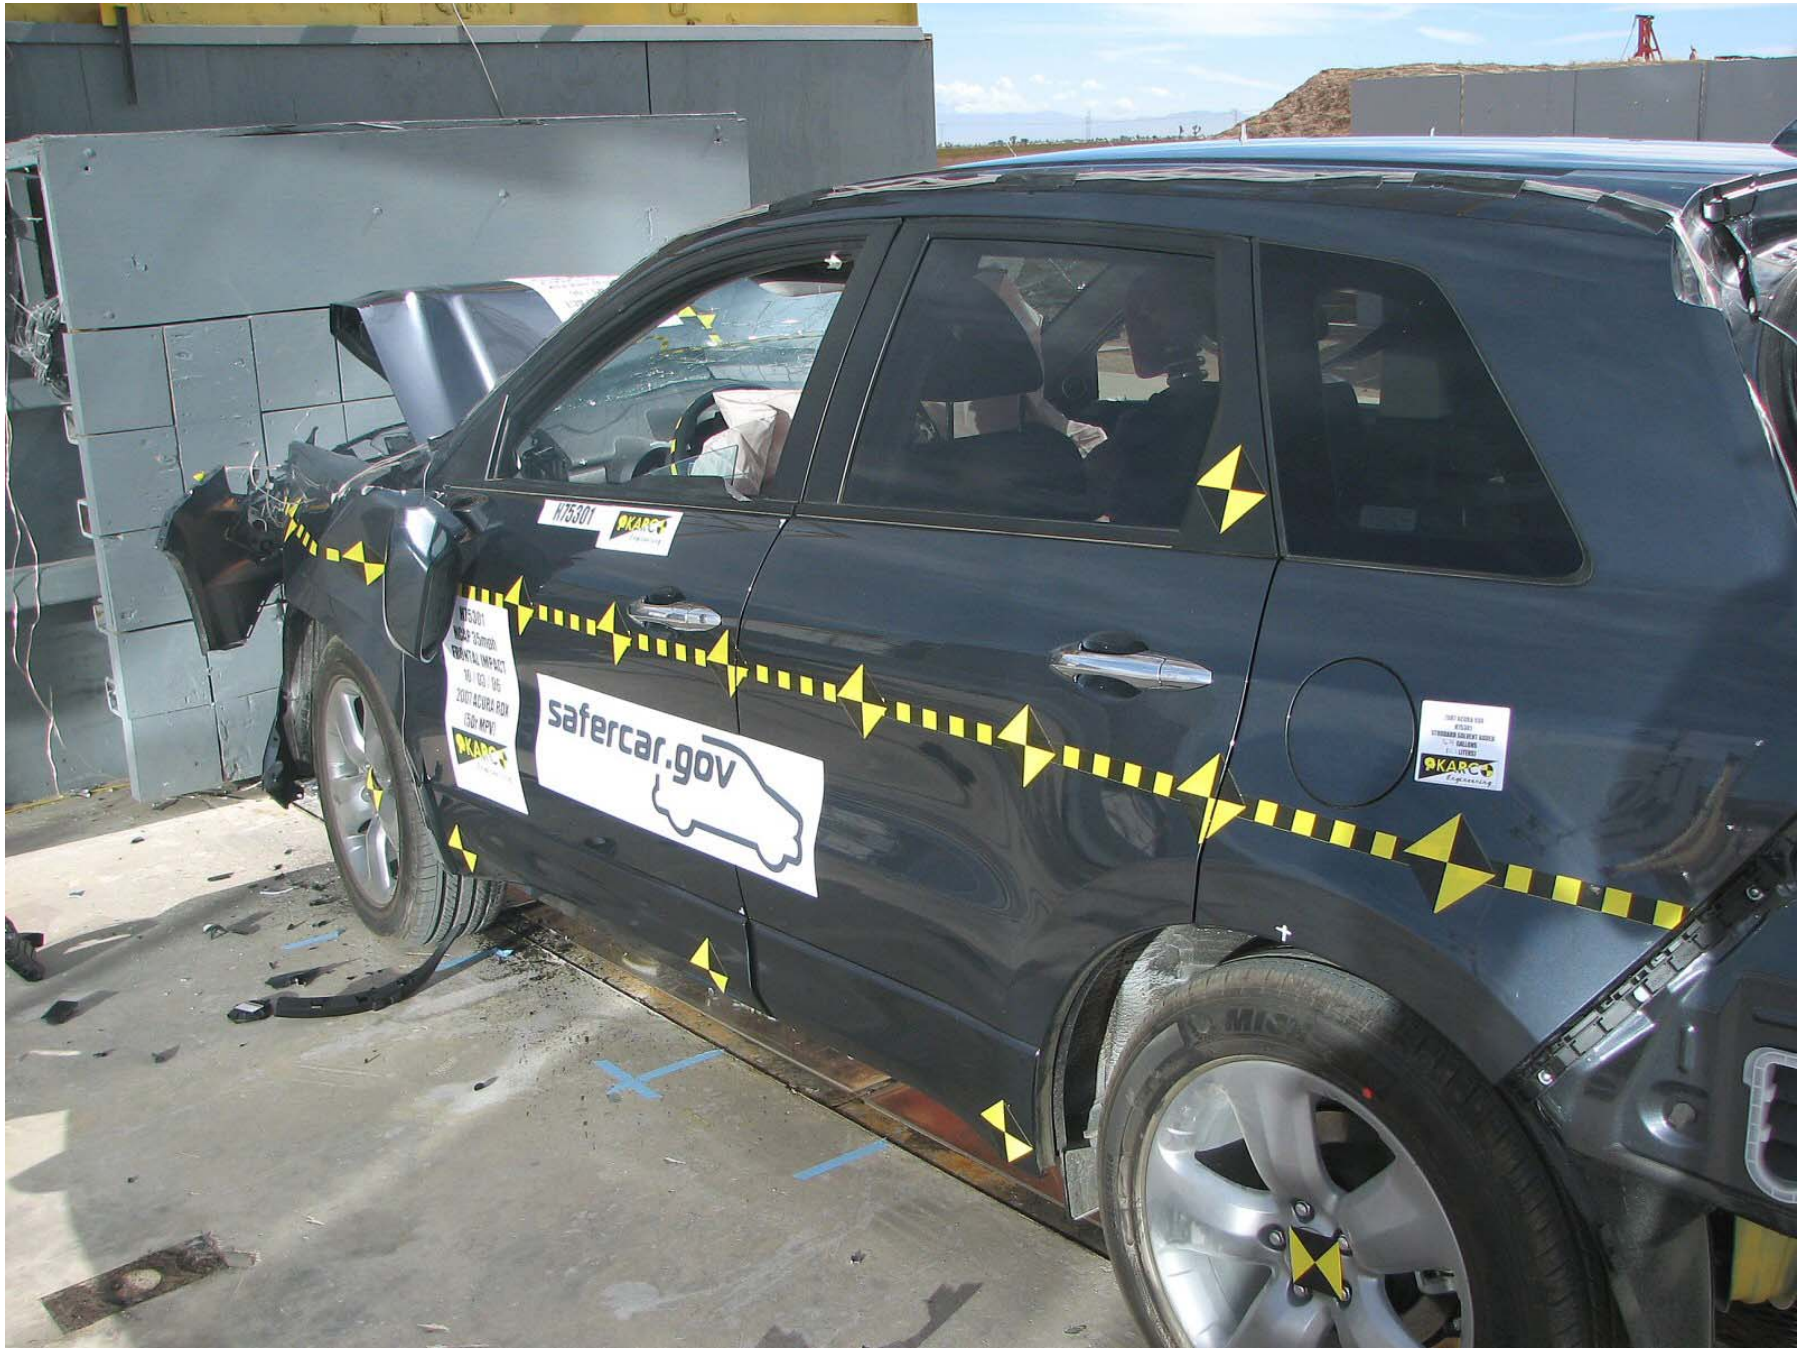
Figure A-16: Post-Test Left Side ¾ View of Doors After Impact

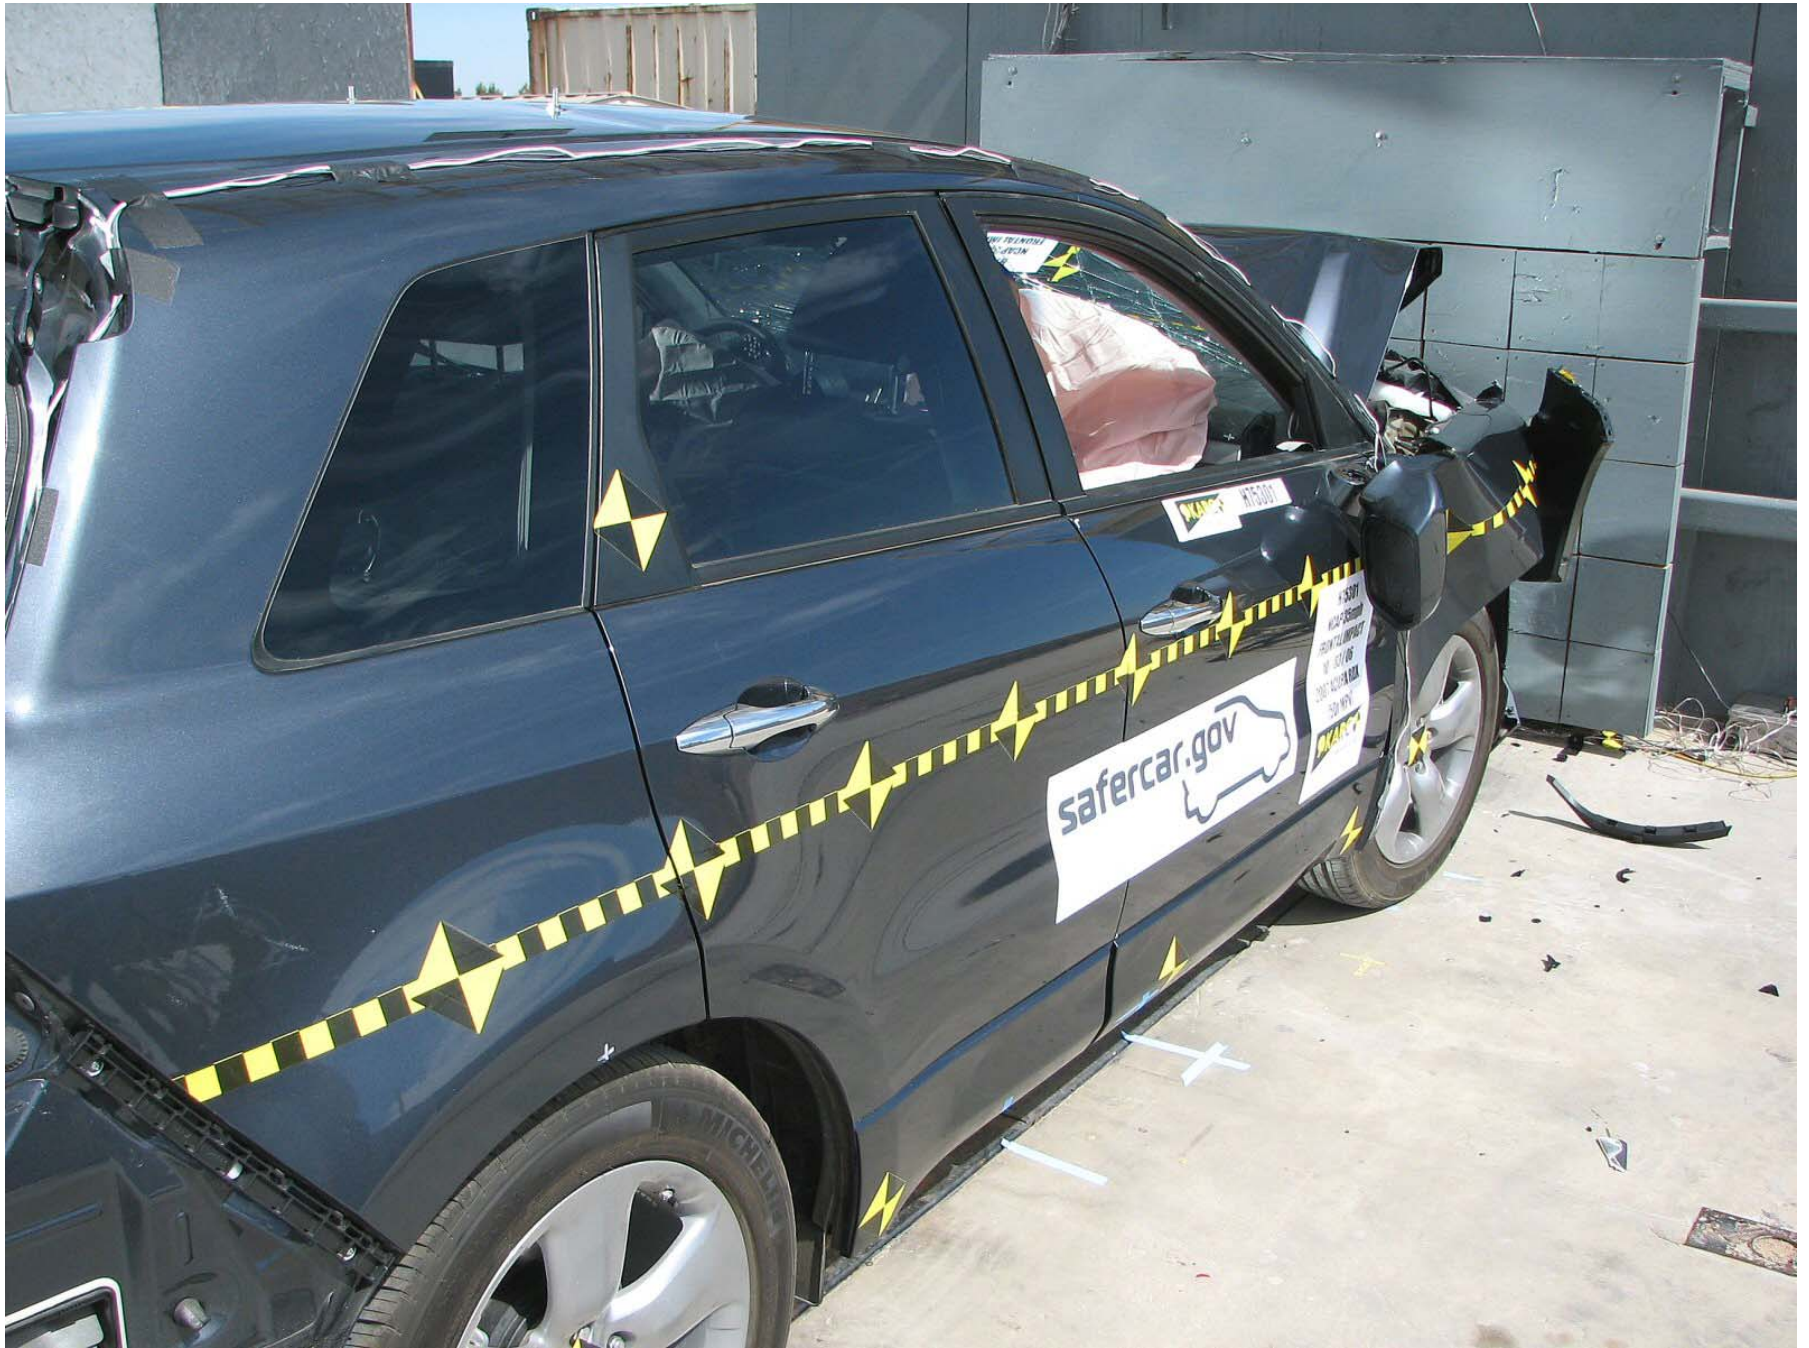
Figure A-17: Post-Test Right Side ¾ View of Doors After Impact

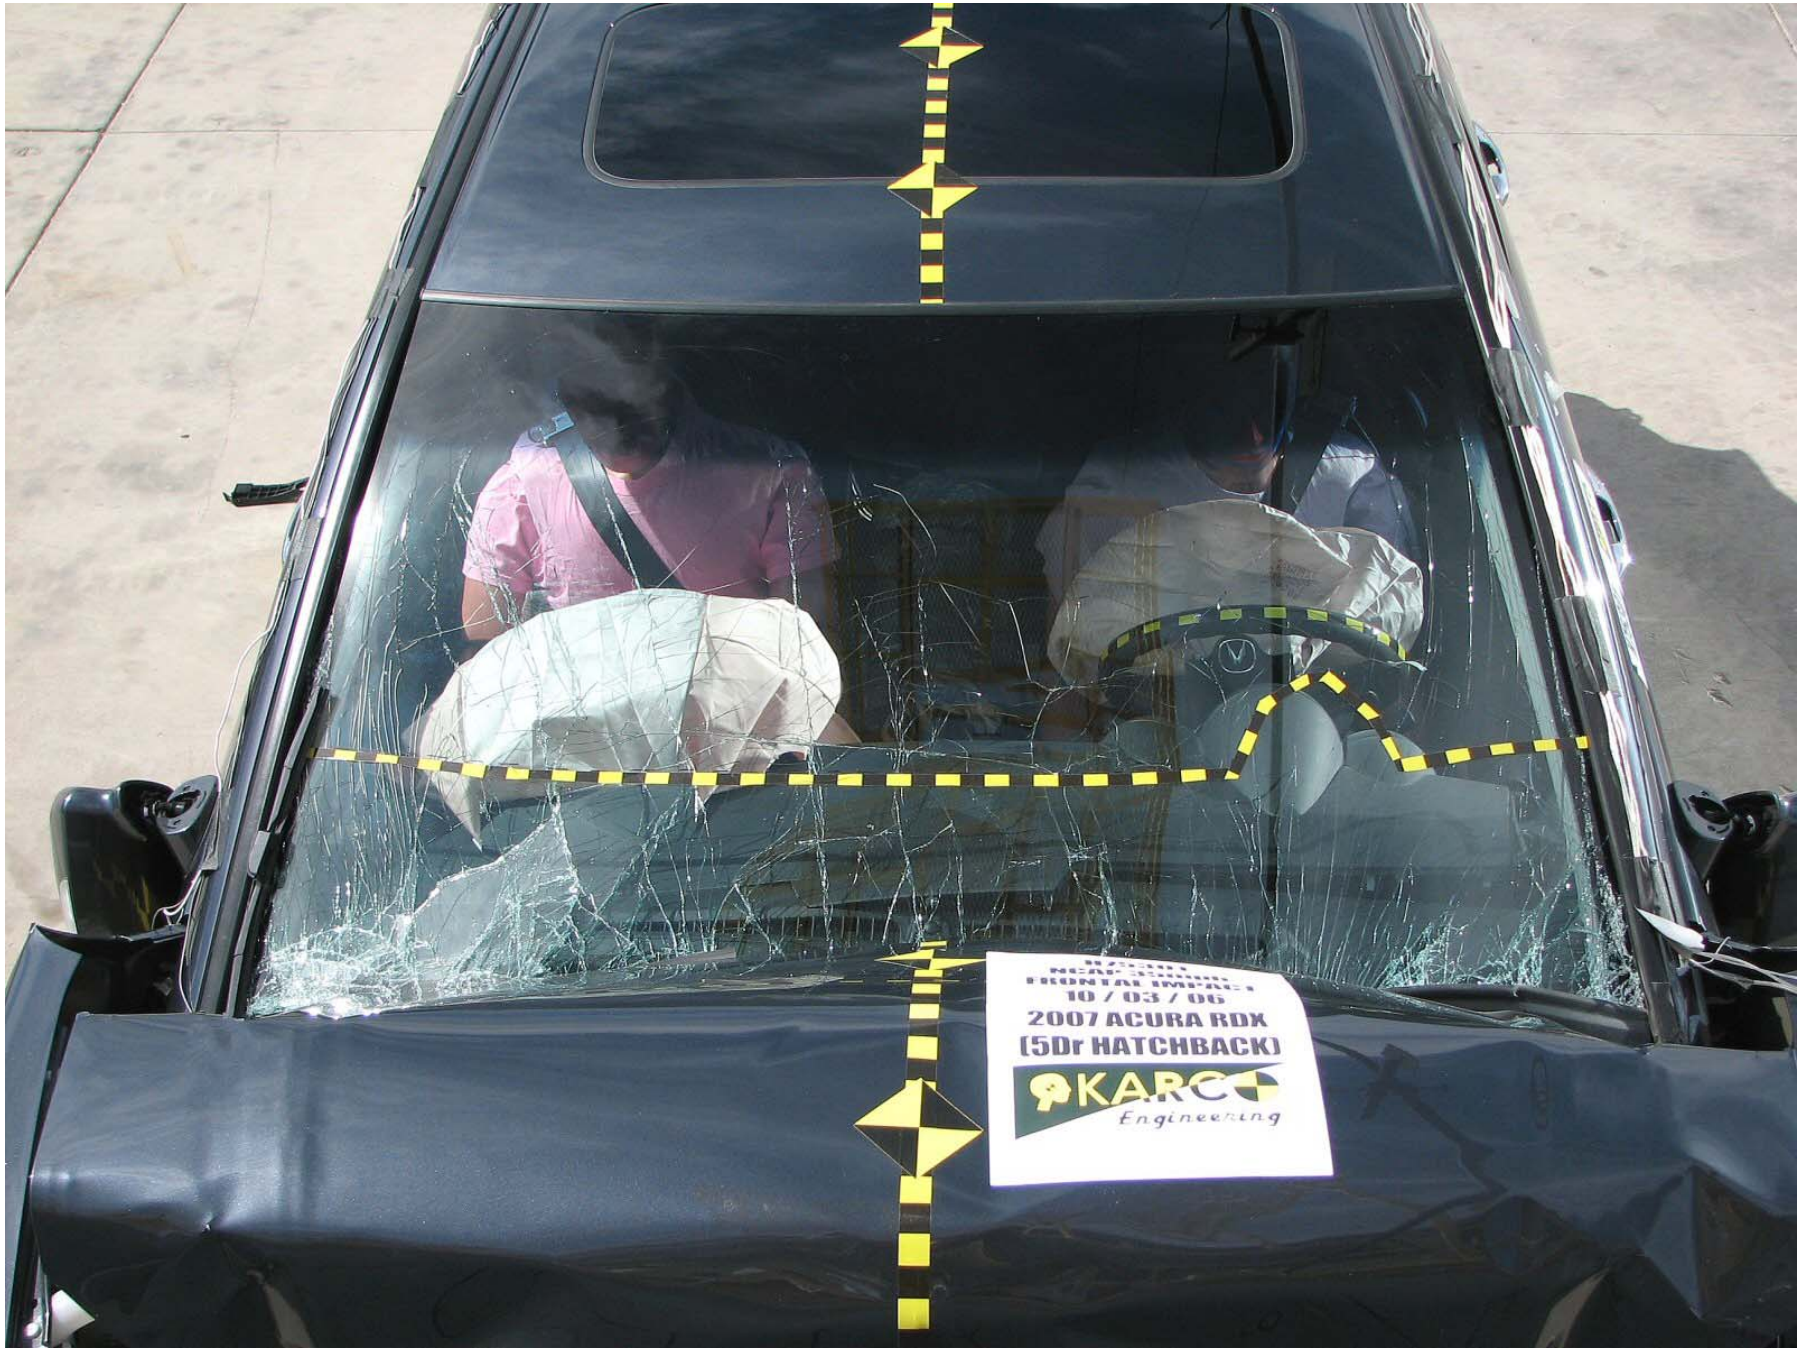
Figure A-19: Post-Test Windshield

There was 100 percent windshield retention and there was no intrusion into the protected zone of the windshield during the impact event. There was no stoddard solvent leakage after the event or during any phase of the static rollover.

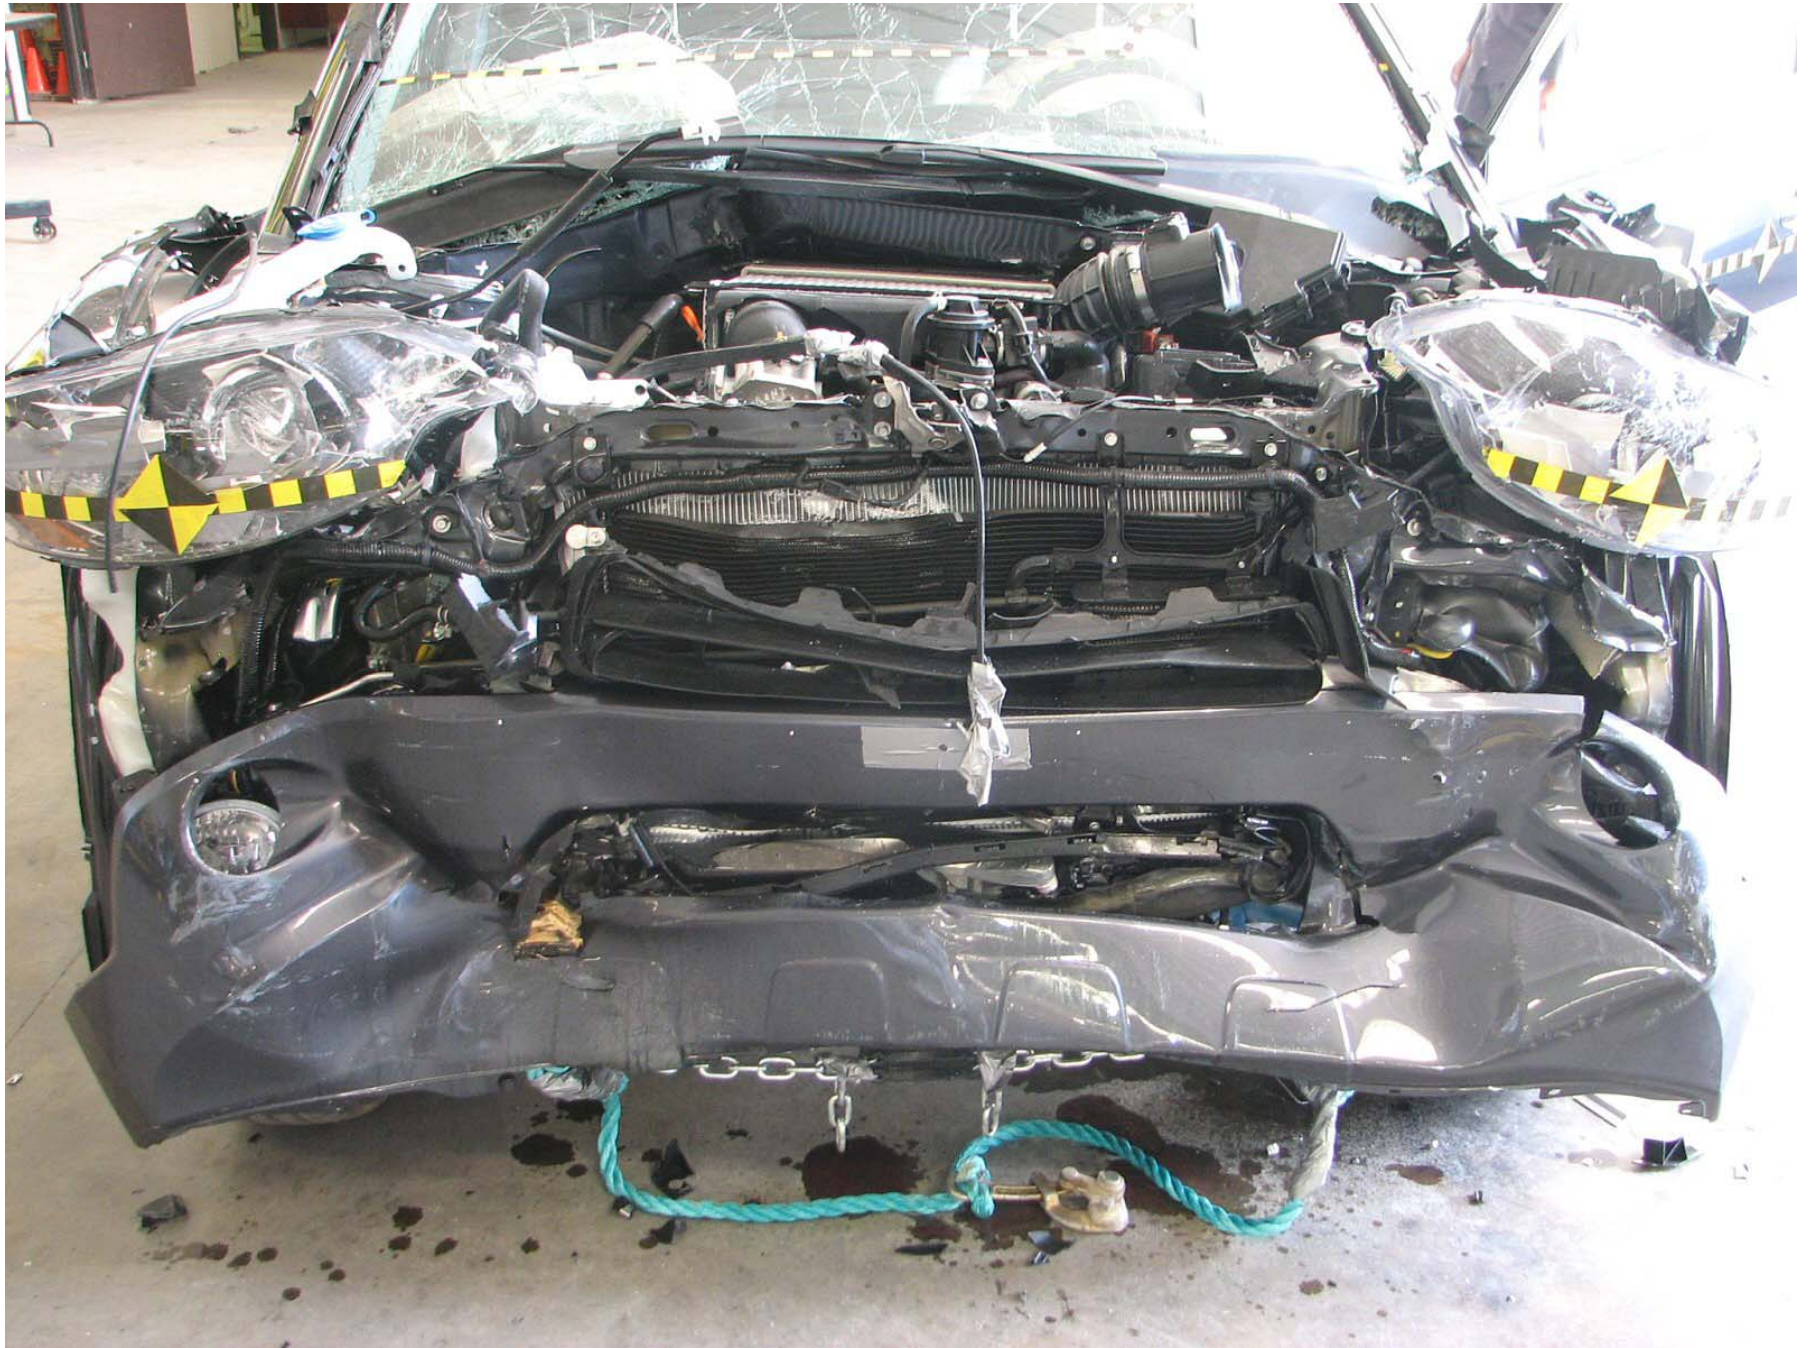
Figure A-21: Post-Test Engine Compartment (Vehicle Moved)

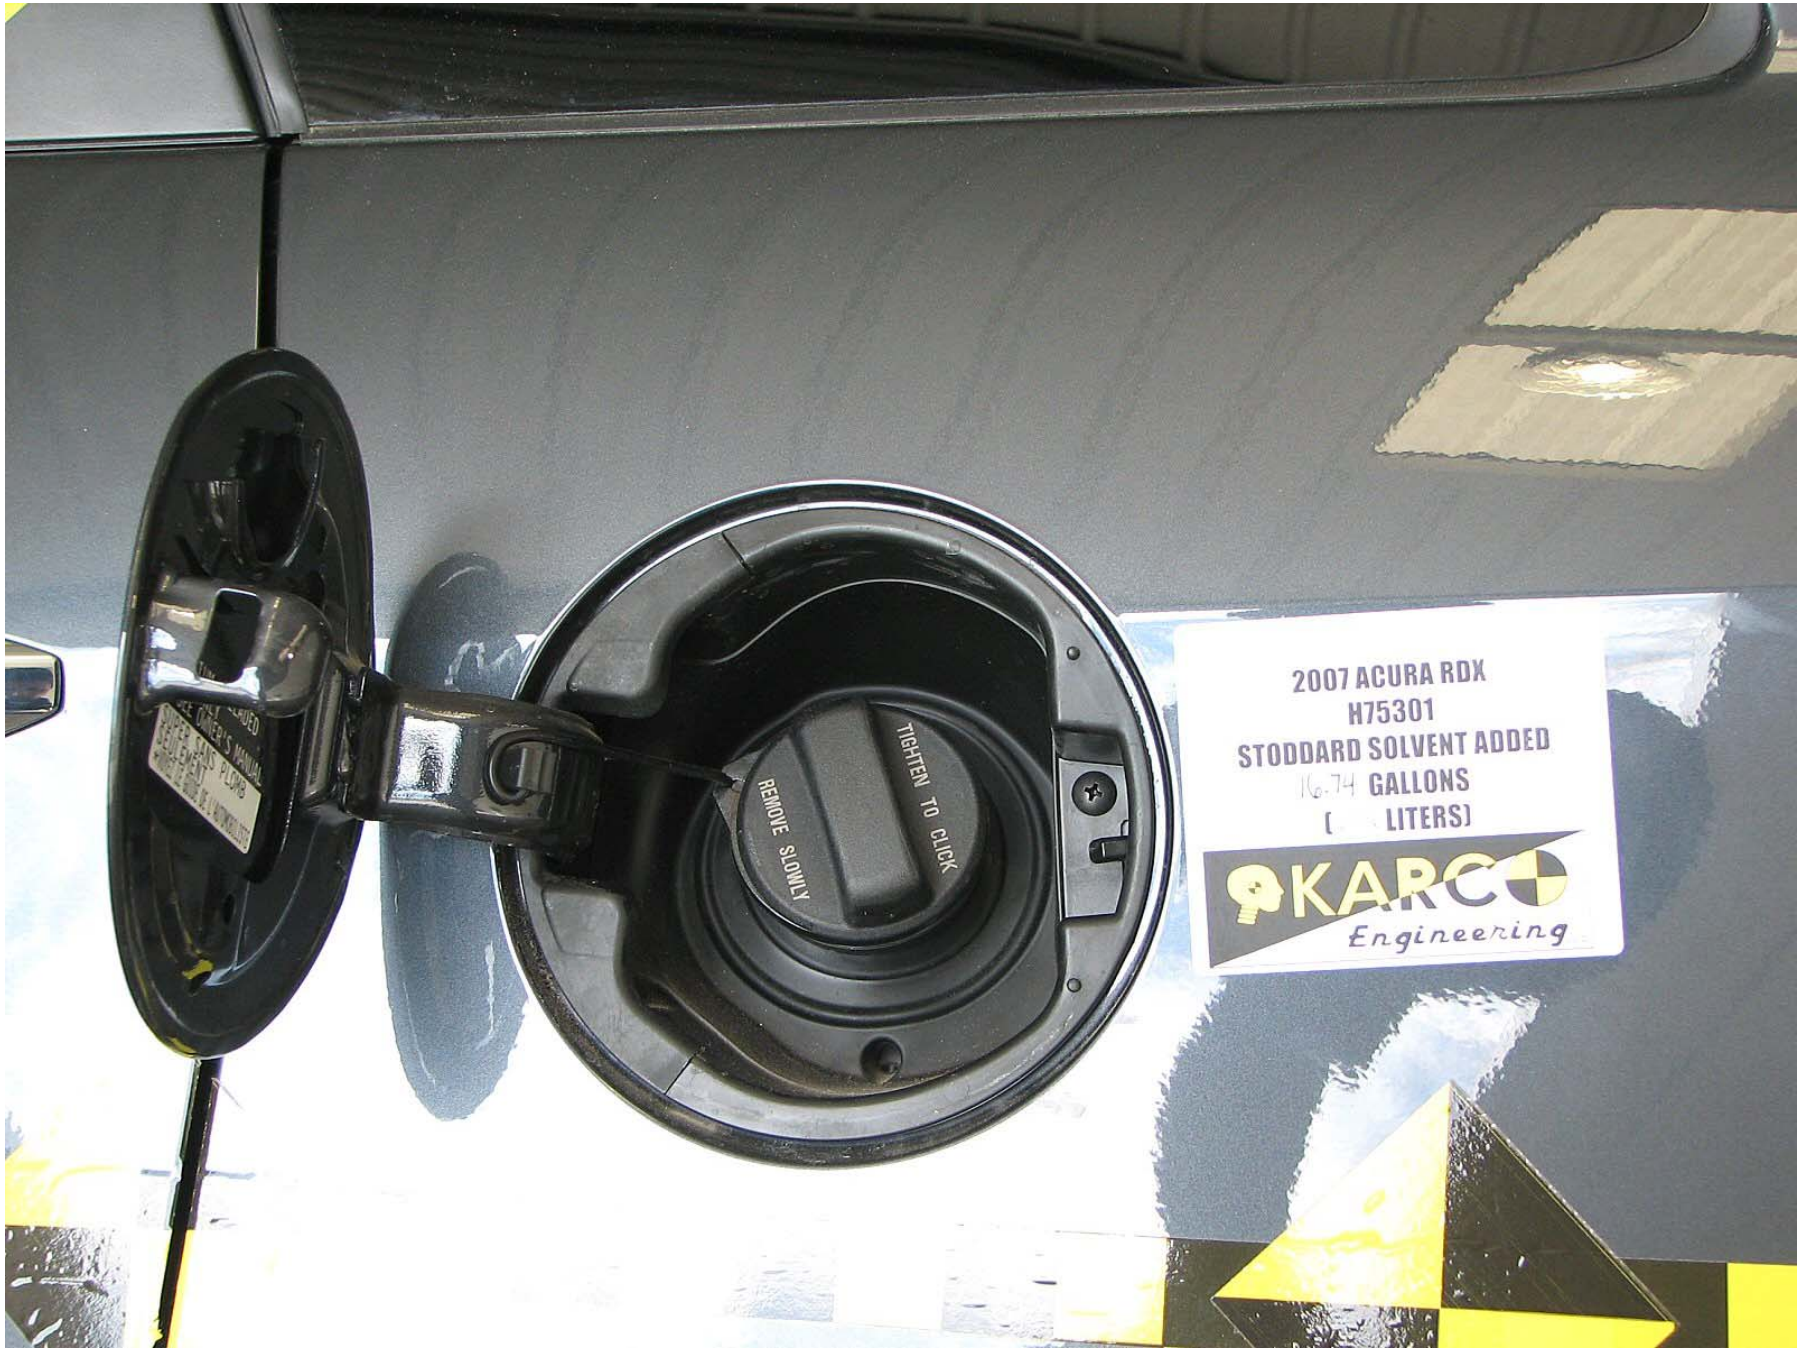
Figure A-23: Post-Test Fuel Cap

D. Spillage Location Details: No leakage occurred

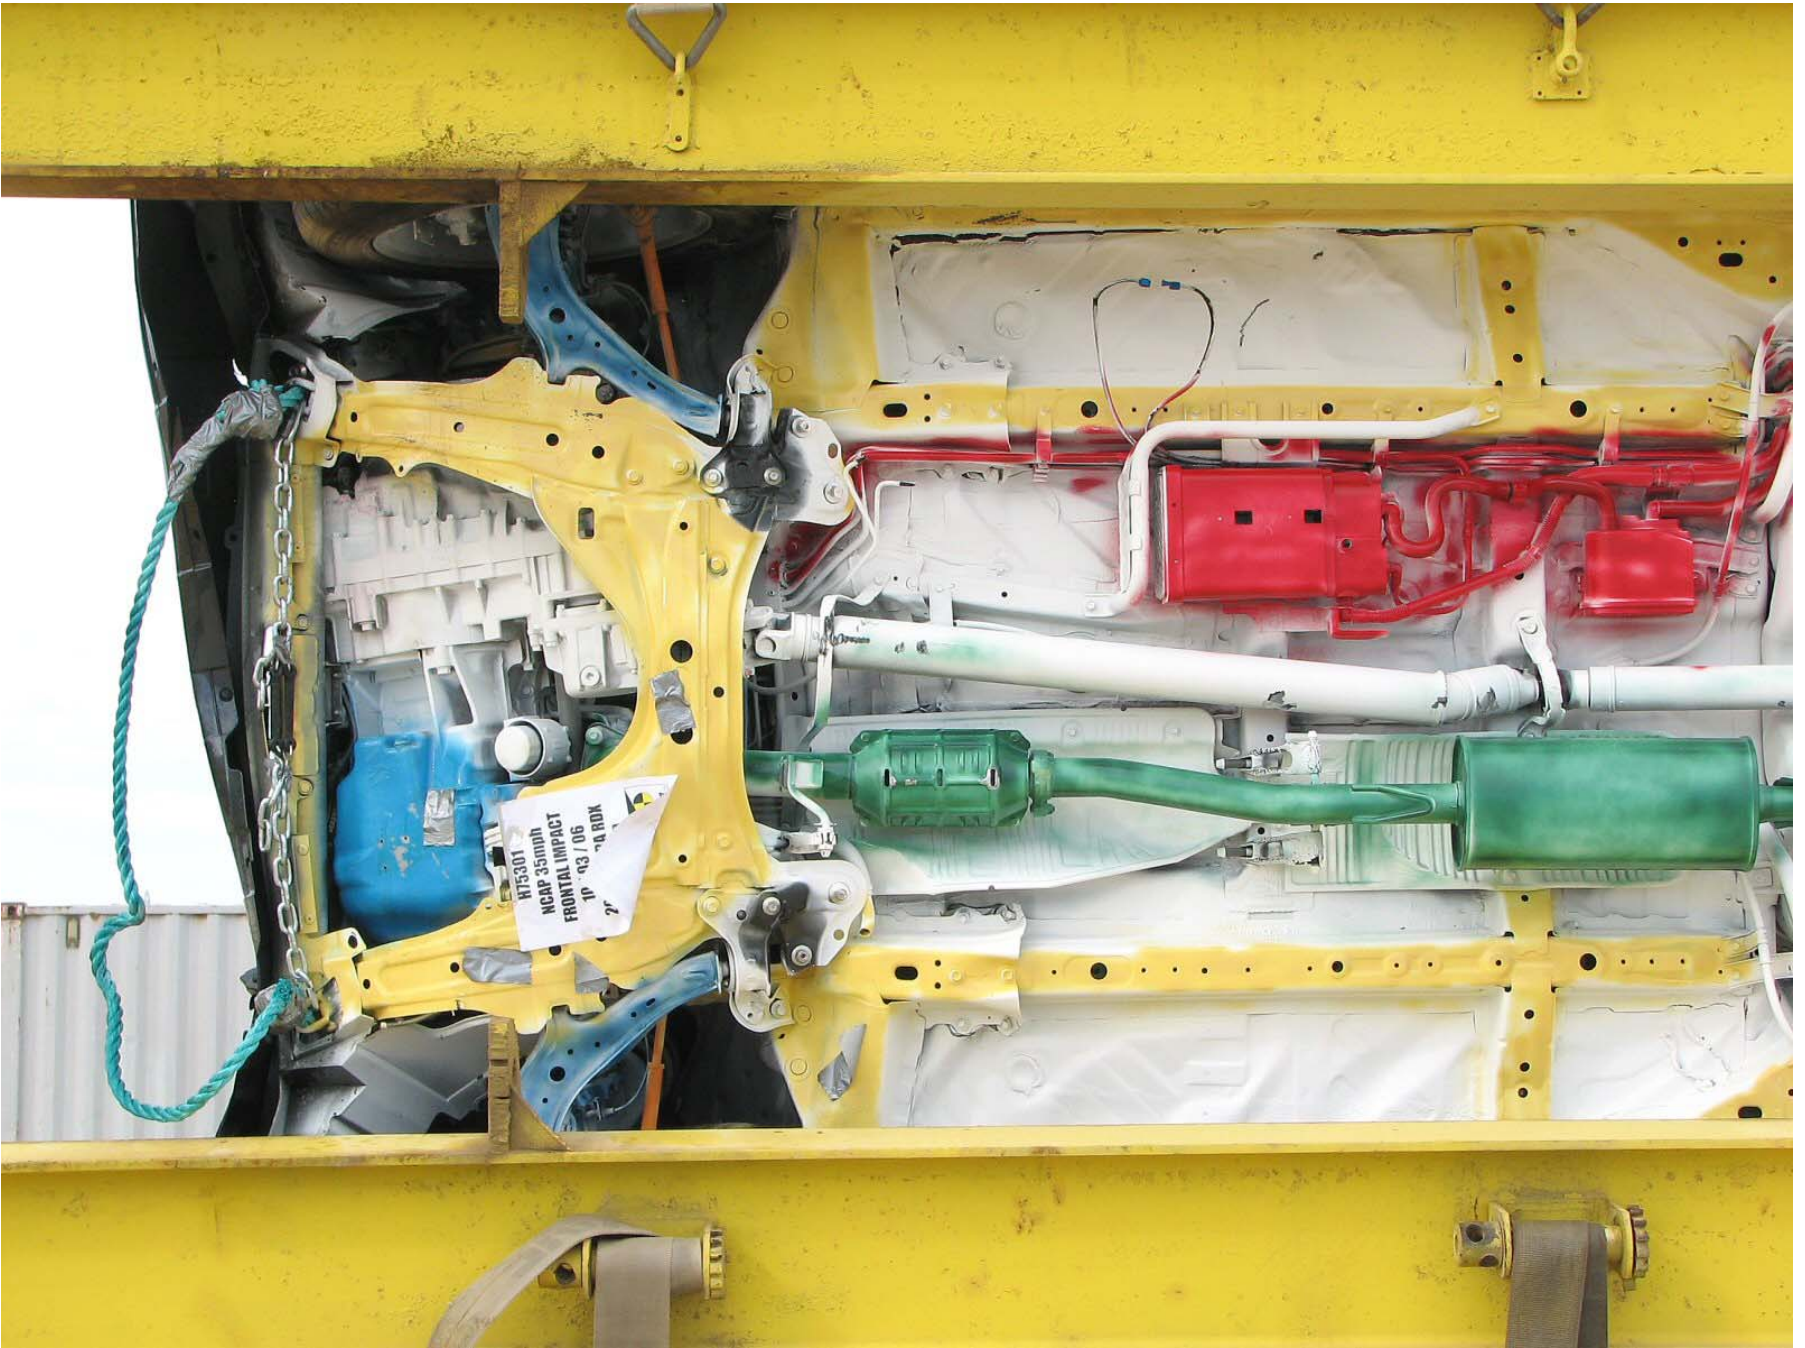
Figure A-25: Post-Test Front Underbody

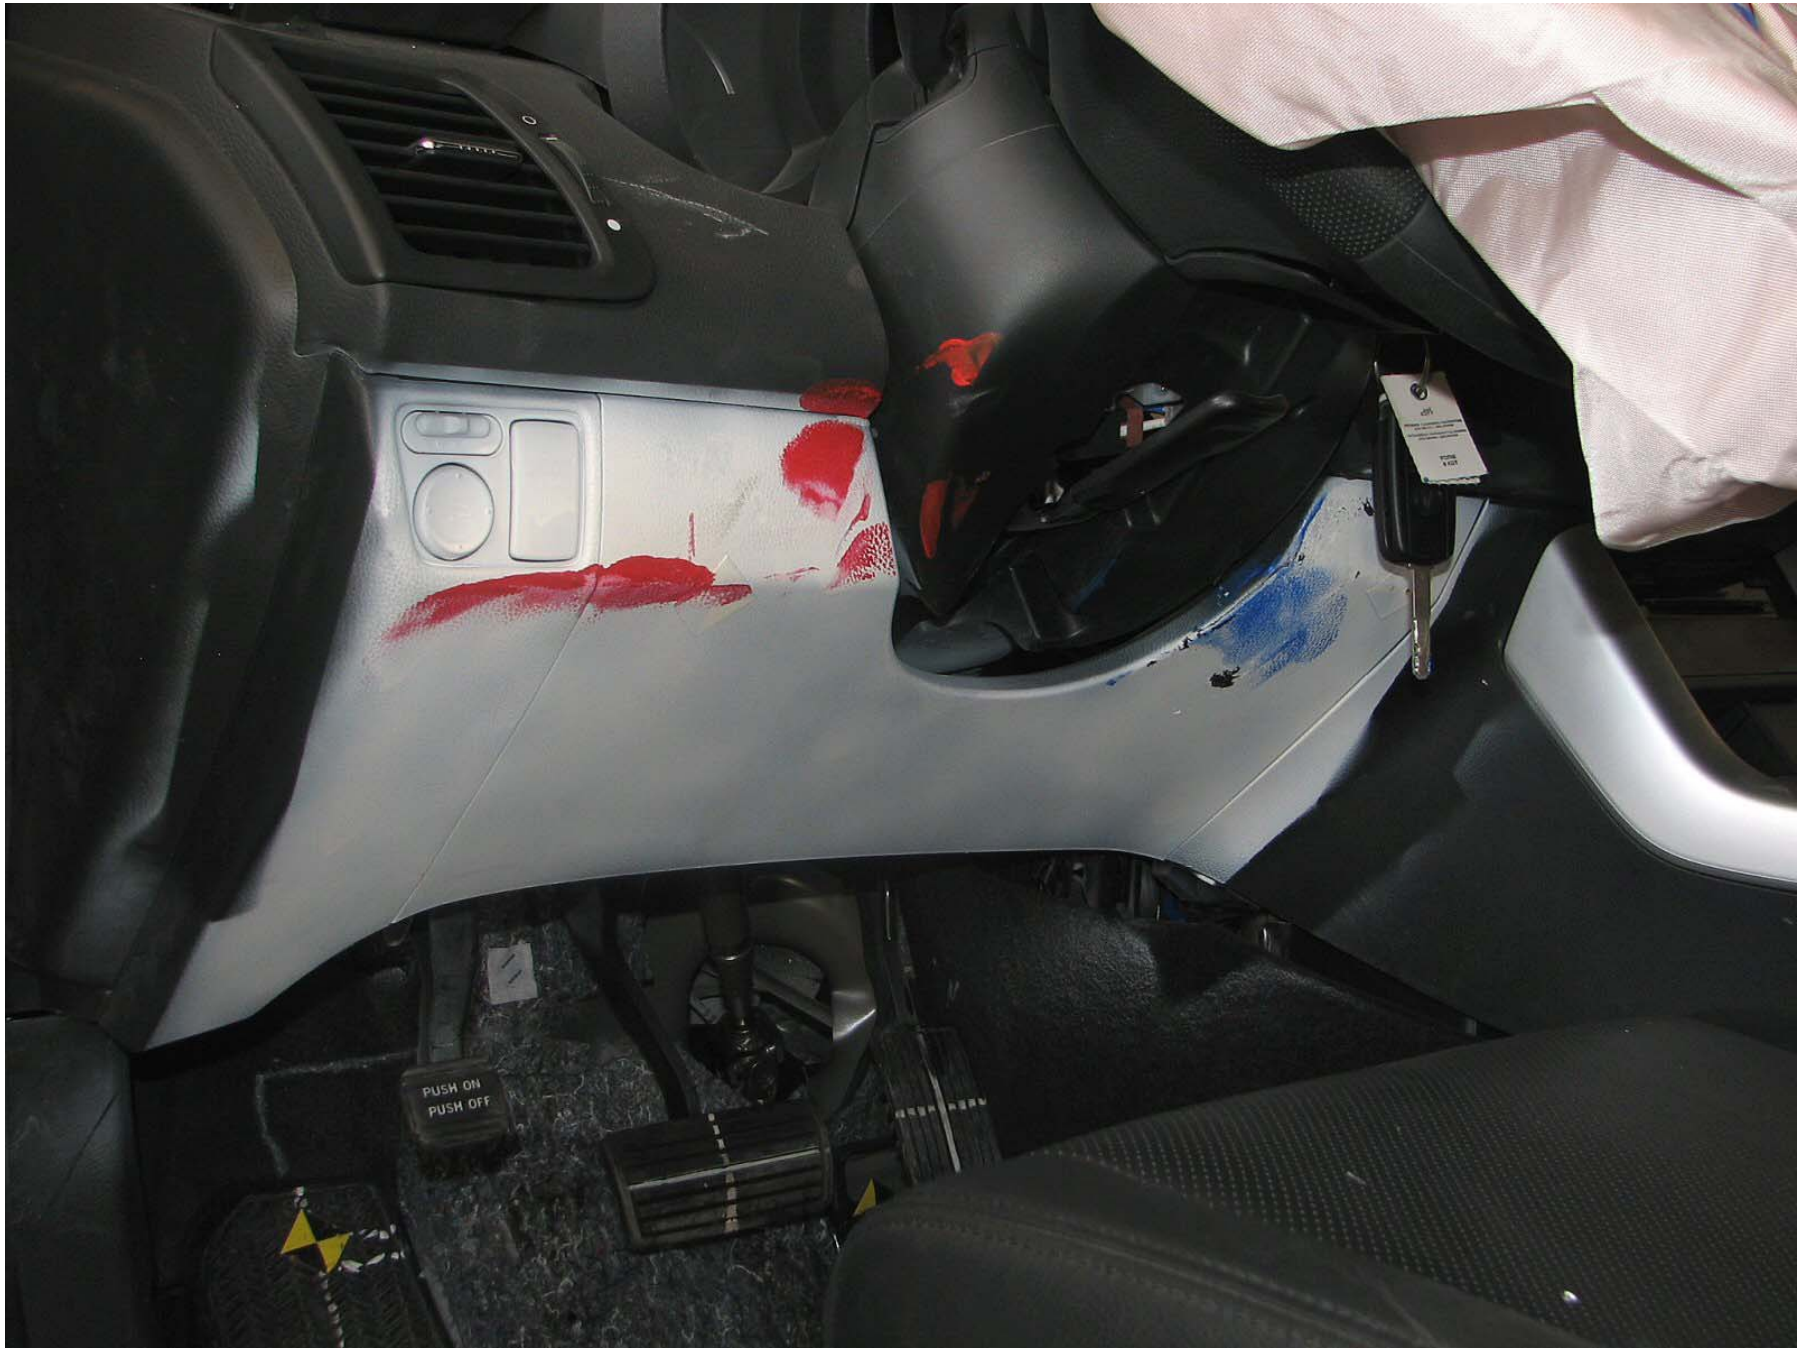
Figure A-39: Post-Test Driver Side Knee Bolster

The driver's visible contact points were as follows: The driver ATD's head and chest contacted the airbag and the abdomen had no contact. Both knees contacted the knee bolster.
