REPORT NUMBER TR-P26174-01-NC

**NEW CAR ASSESSMENT PROGRAM
FRONTAL BARRIER IMPACT TEST**

**HONDA OF AMERICA MFG., INC.
2007 ACURA RDX
5-DOOR MPV**

NHTSA NUMBER: H75301

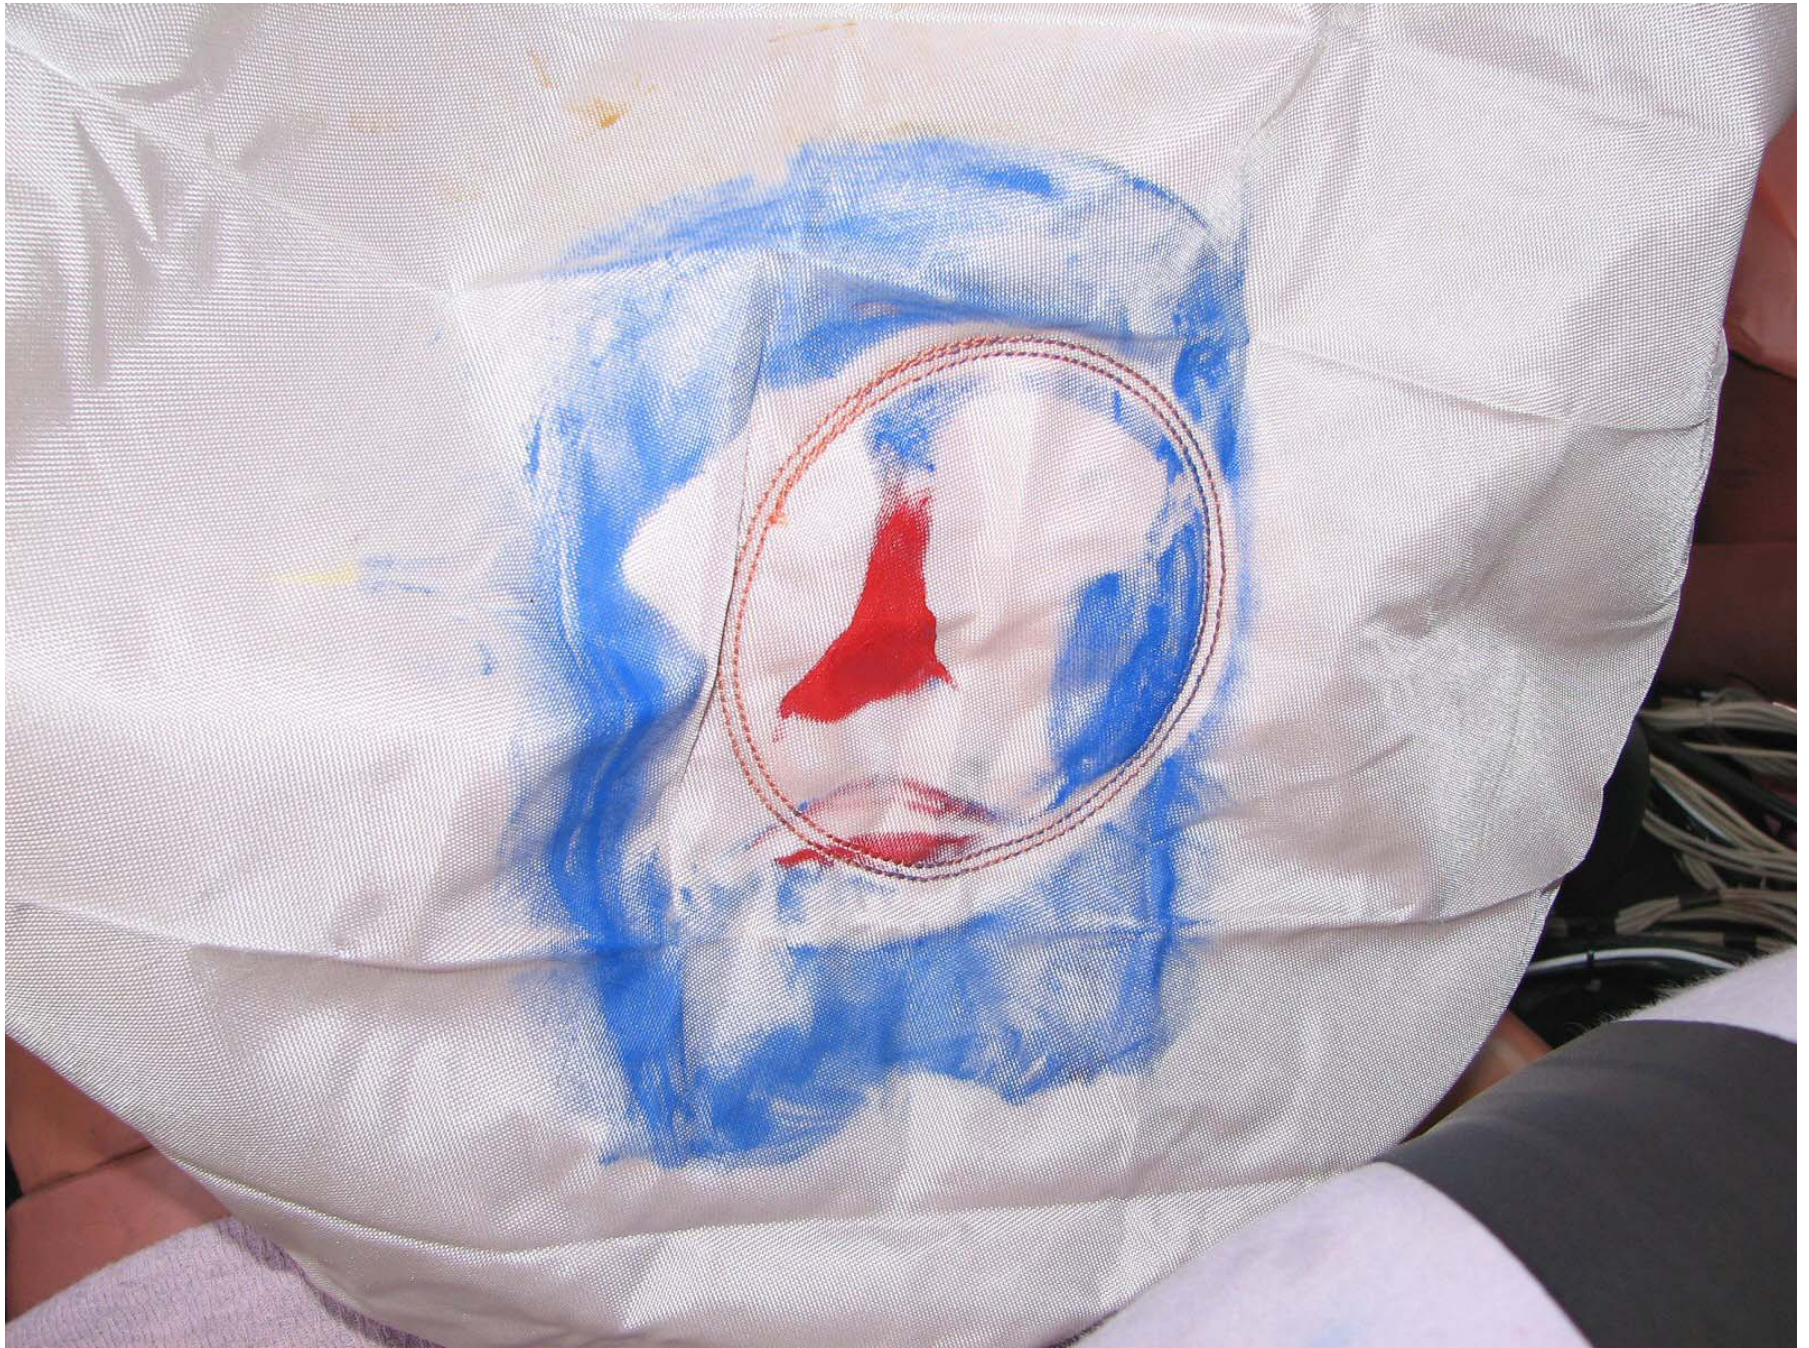
Figure A-43: Post-Test Driver Dummy Airbag Contact

The driver's visible contact points were as follows: The driver ATD's head and chest contacted the airbag and the abdomen had no contact. Both knees contacted the knee bolster.

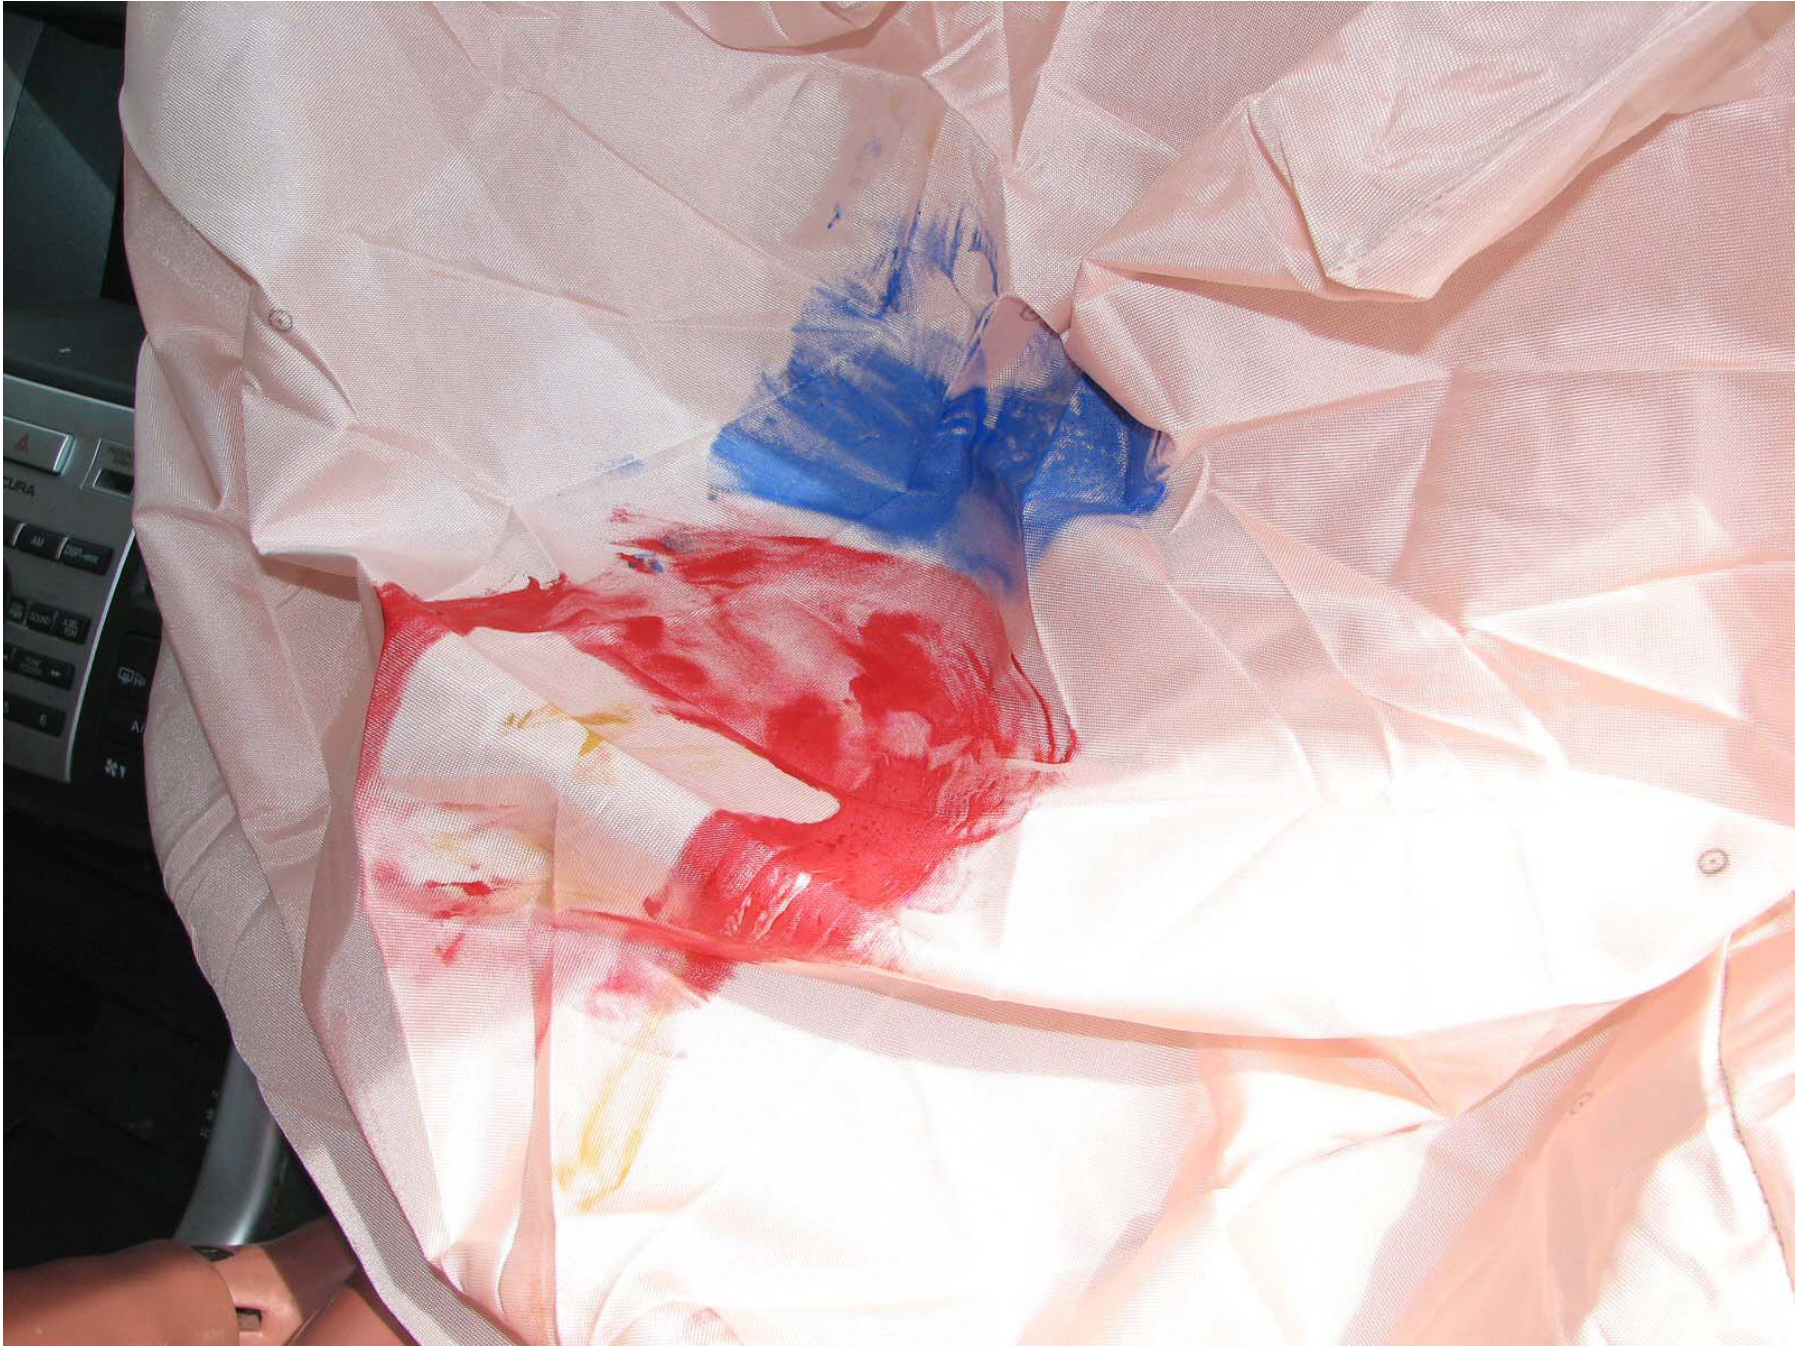
Figure A-57: Post-Test Passenger Dummy Airbag Contact

The passenger's visible contact points were as follows: The passenger ATD's head, chest and abdomen contacted the airbag. Both knees contacted the knee bolster.

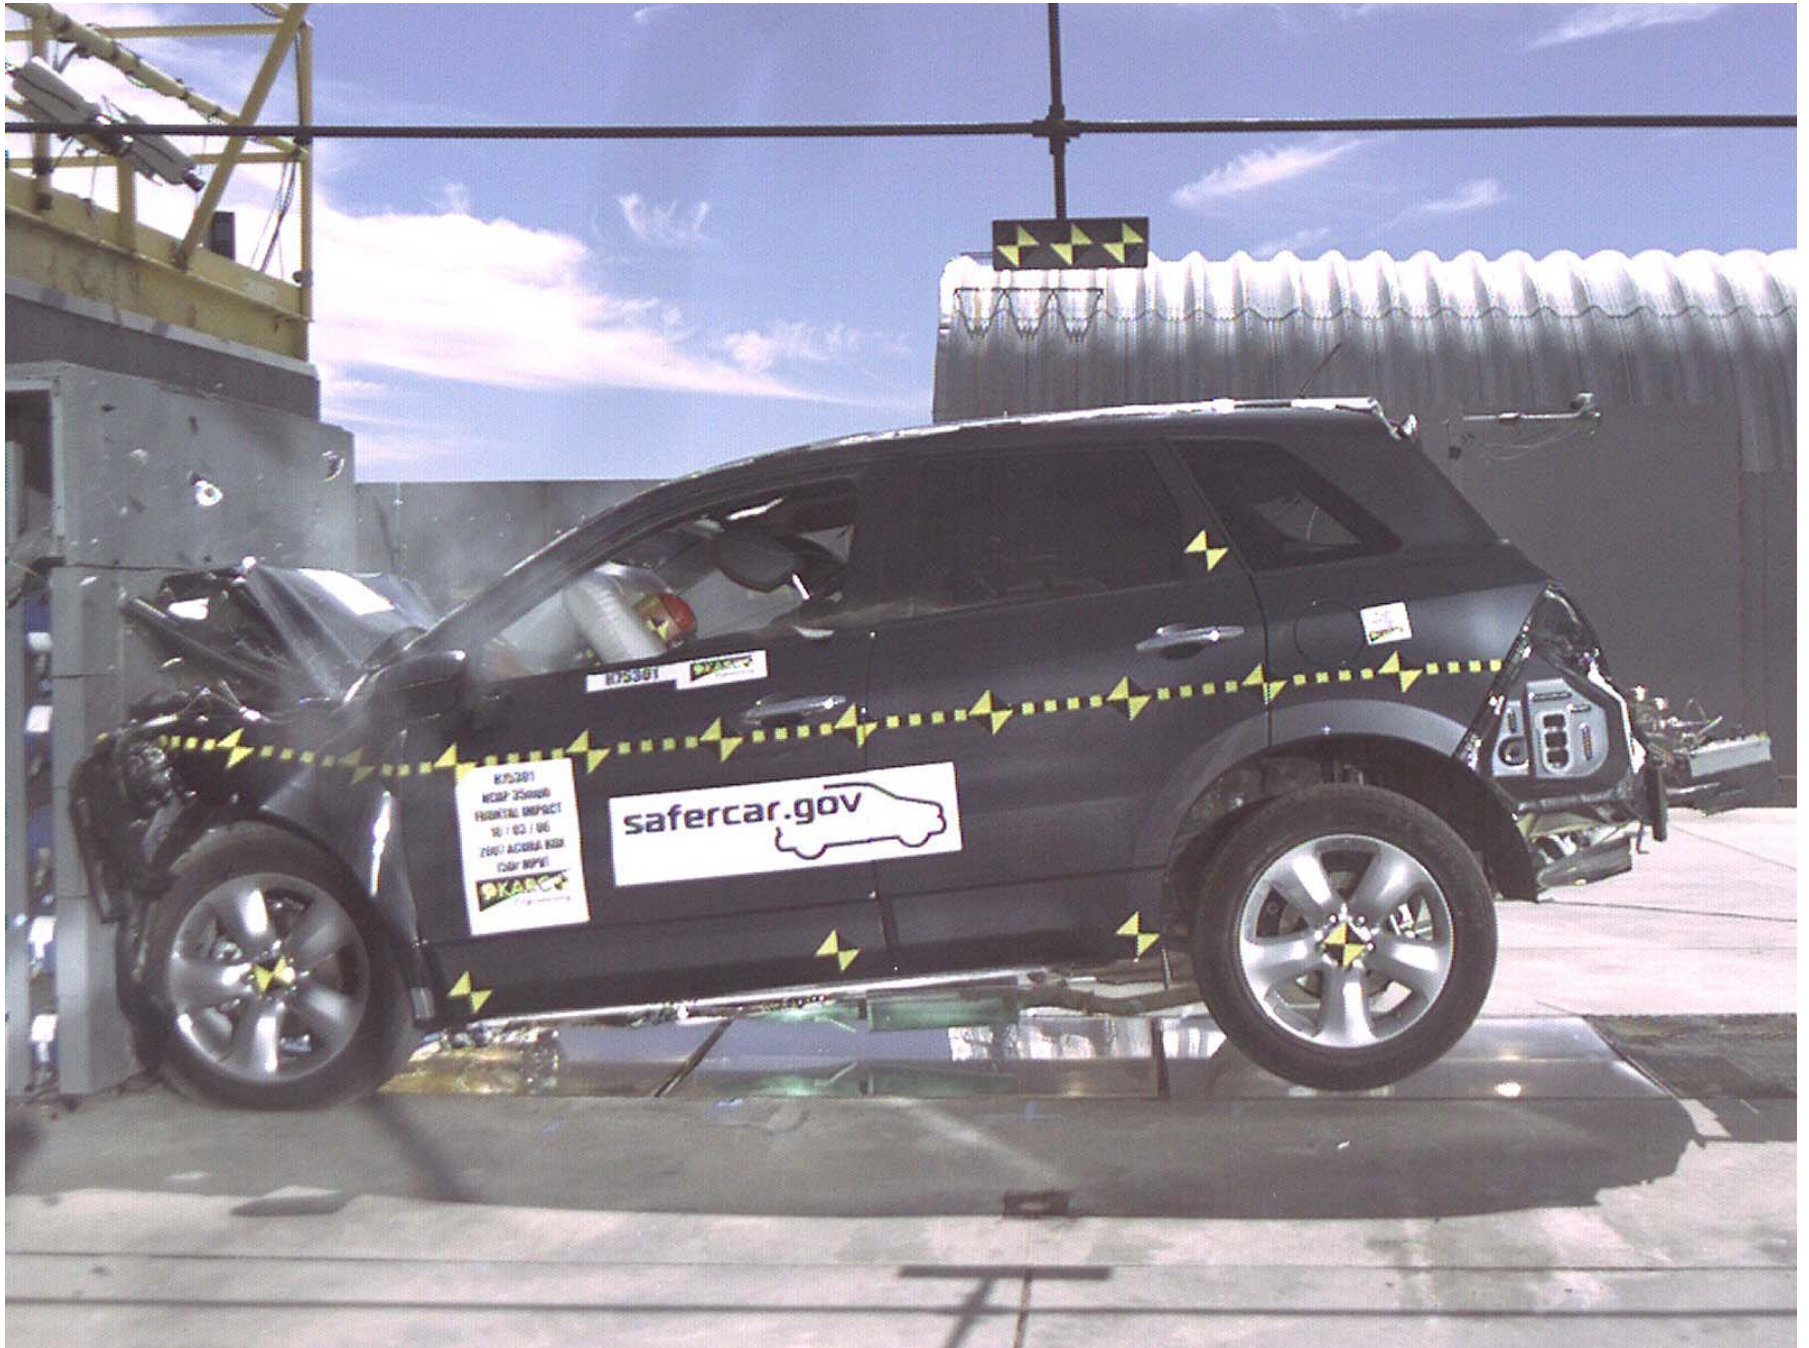
Figure A-62: Vehicle Impact

A load cell barrier was impacted by a 2007 Acura RDX 5-Door MPV at a velocity of 55.63 km/h. The test was performed at Karco Engineering, LLC on October 3, 2006.

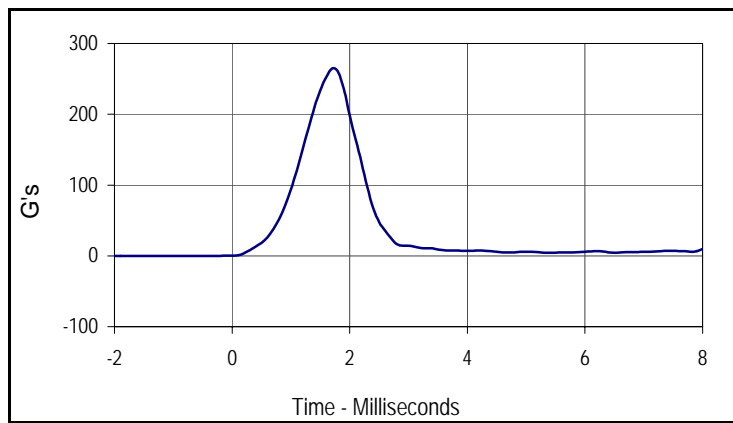
Tested Parameter	Units	Specification	Result	Pass/Fail
Laboratory Temperature	°C	18.9 to 25.6	21.1	Pass
Laboratory Relative Humidity	%	10 to 70	30	Pass
Peak Resultant Acceleration	G's	225.0 to 275.0	264.5	Pass
Peak Lateral Acceleration	G's	≤15.0	4.6	Pass
Is Acceleration Unimodal?	Yes/No	Yes	Yes	Pass
Overall Test Results				Pass

Curve Description			
Head Resultant			
CURNO	Type	SAE Class	Units
001	RES	1000	G's
Max	Time	Min	Time
264.5	1.7	0.0	-1.6

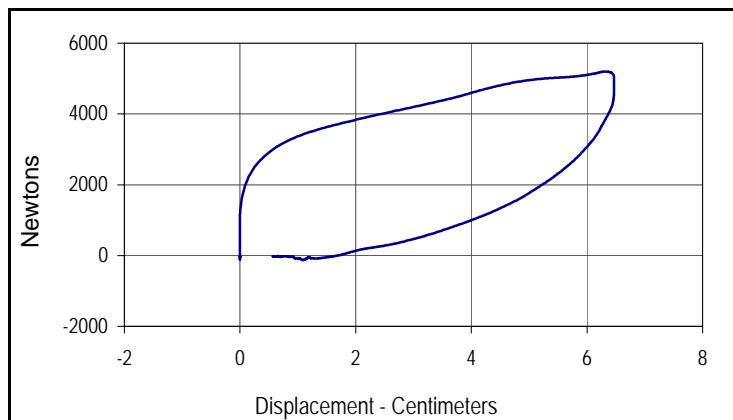
Tested Parameter	Units	Specification	Result	Pass/Fail
Laboratory Temperature	°C	20.6 to 22.2	21.1	Pass
Laboratory Relative Humidity	%	10 to 70	30	Pass
Probe Velocity	m/s	6.58 to 6.82	6.66	Pass
Peak Probe Force	Newtons	5159 to 5893	5198	Pass
Peak Sternum Deflection	CM	6.35 to 7.26	6.47	Pass
Internal Hysteresis	%	69 to 85	76.2	Pass
Overall Test Results				Pass

Curve Description			
Probe Force vs. Chest Deflection			
CURNO	Type	SAE Class	Hysteresis
001	FIL	180	76.2
Peak Probe Force		Peak Chest Deflection	
5198		6.47

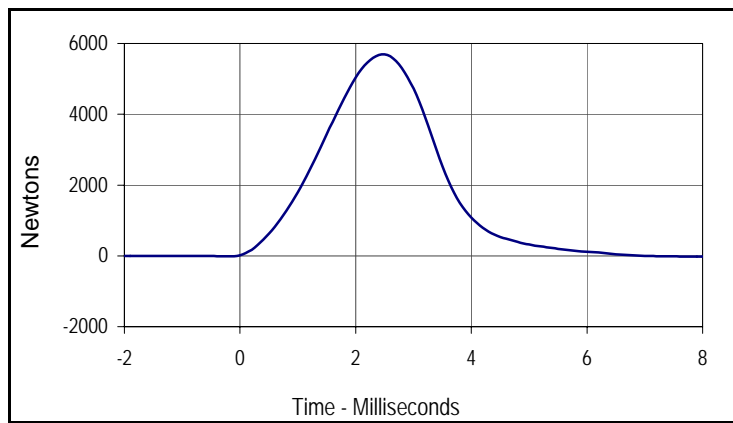
Pendulum Velocity at T=0	m/sec	2.07 to 2.13	2.08	Pass
Peak Probe Force	Newtons	4715 to 5782	5724	Pass
Overall Test Results				Pass

Curve Description			
Left Knee Probe Force			
CURNO	Type	SAE Class	Units
001	FIL	600	Newtons
Max	Time	Min	Time
5691.0	2.5	-25.0	8.8

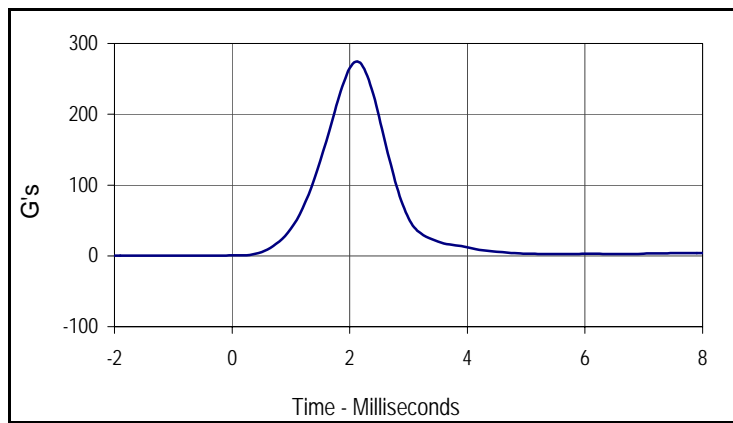
Tested Parameter	Units	Specification	Result	Pass/Fail
Laboratory Temperature	°C	18.9 to 25.6	21.7	Pass
Laboratory Relative Humidity	%	10 to 70	30	Pass
Peak Resultant Acceleration	G's	225.0 to 275.0	274.4	Pass
Peak Lateral Acceleration	G's	≤15.0	4.9	Pass
Is Acceleration Unimodal?	Yes/No	Yes	Yes	Pass
Overall Test Results				Pass

Curve Description			
Head Resultant			
CURNO	Type	SAE Class	Units
001	RES	1000	G's
Max	Time	Min	Time
274.4	2.1	0.5	-1.9

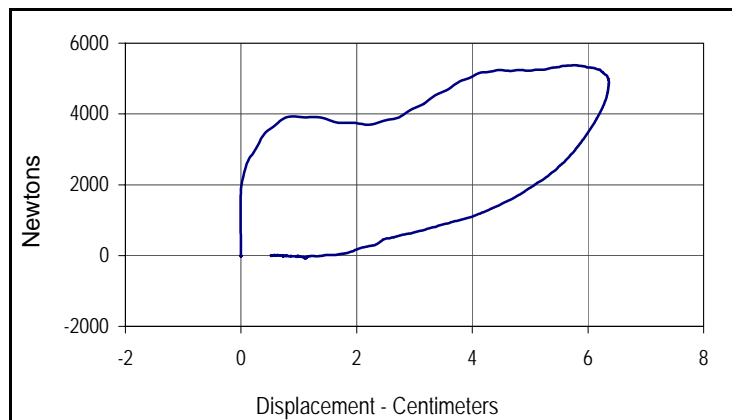
Tested Parameter	Units	Specification	Result	Pass/Fail
Laboratory Temperature	°C	20.6 to 22.2	21.1	Pass
Laboratory Relative Humidity	%	10 to 70	30	Pass
Probe Velocity	m/s	6.58 to 6.82	6.73	Pass
Peak Probe Force	Newtons	5159 to 5893	5376	Pass
Peak Sternum Deflection	CM	6.35 to 7.26	6.36	Pass
Internal Hysteresis	%	69 to 85	75.8	Pass
Overall Test Results				Pass

Curve Description			
Probe Force vs. Chest Deflection			
CURNO	Type	SAE Class	Hysteresis
001	FIL	180	75.8
Peak Probe Force		Peak Chest Deflection	
5376		6.36
