REPORT NUMBER: CAL-07-05

**NEW CAR ASSESSMENT PROGRAM (NCAP)  
FRONTAL BARRIER IMPACT TEST**

GENERAL MOTORS CORPORATION  
2007 PONTIAC SOLSTICE  
2-DOOR CONVERTIBLE

CALSPAN TEST NUMBER: 8806-NCAP-04

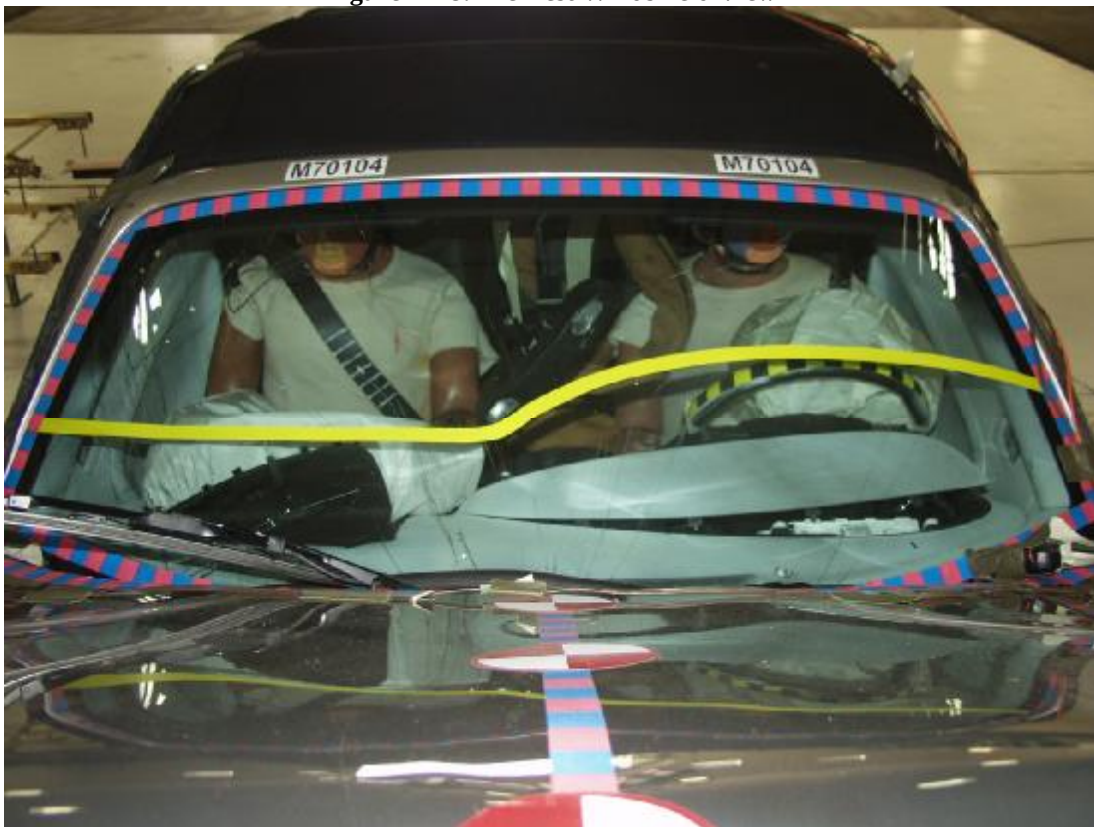
**Figure A-19: Post-Test Windshield View**

| Description | Driver Side | Passenger Side |
|---|---|---|
| Glazing Damage | Windshield cracked along its lower edge | |

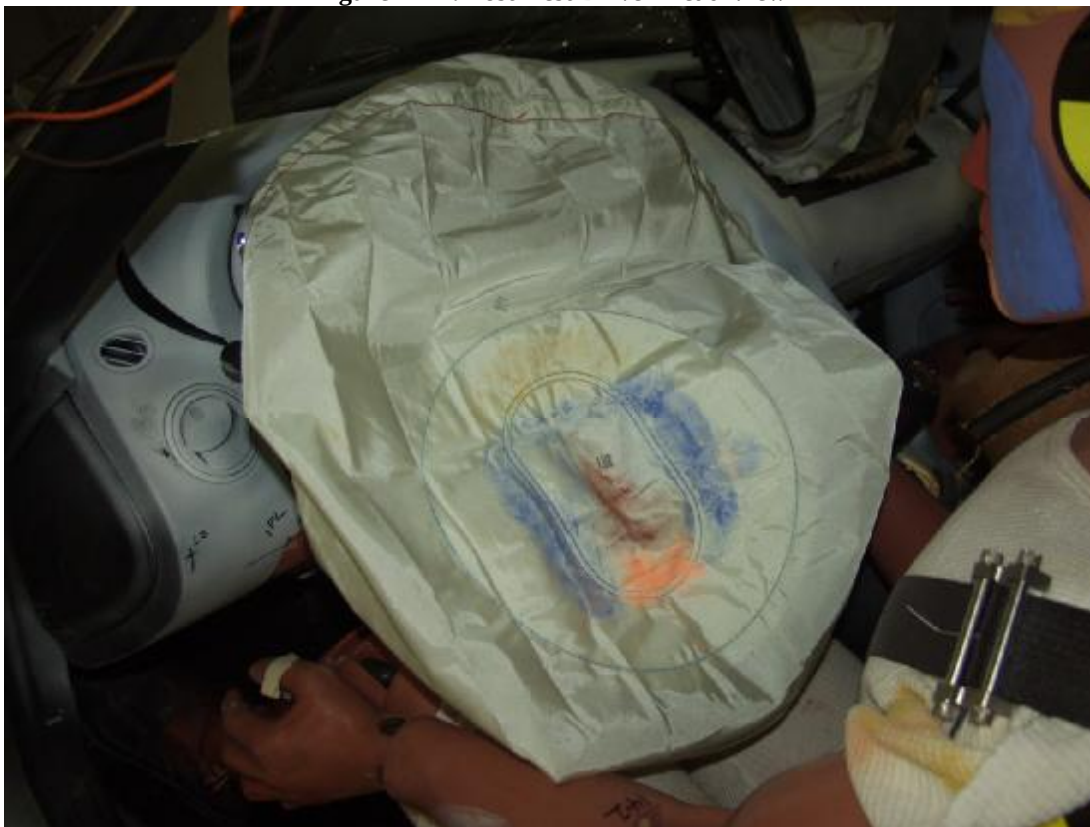
**Figure A-43: Post-Test Driver Contact to Airbag**

| | DRIVER | PASSENGER |
|---|---|---|
| Head Contact: | Face to the center of the airbag; Back of the head to the inboard half of the head restraint | Face to the upper right of the airbag; Back of the head to the outboard half of the head restraint |
| Chest Contact: | Airbag | None |
