**REPORT NUMBER: NCAPSIDE-MGA-2007-002**

**NEW CAR ASSESSMENT PROGRAM  
SIDE IMPACT TEST**

**GM DAEWOO AUTO & TECHNOLOGY COMPANY  
2007 SUZUKI FORENZA 4-DR.  
NHTSA NUMBER: M70511**

**PREPARED BY:  
MGA RESEARCH CORPORATION  
5000 WARREN ROAD  
BURLINGTON, WI 53105**

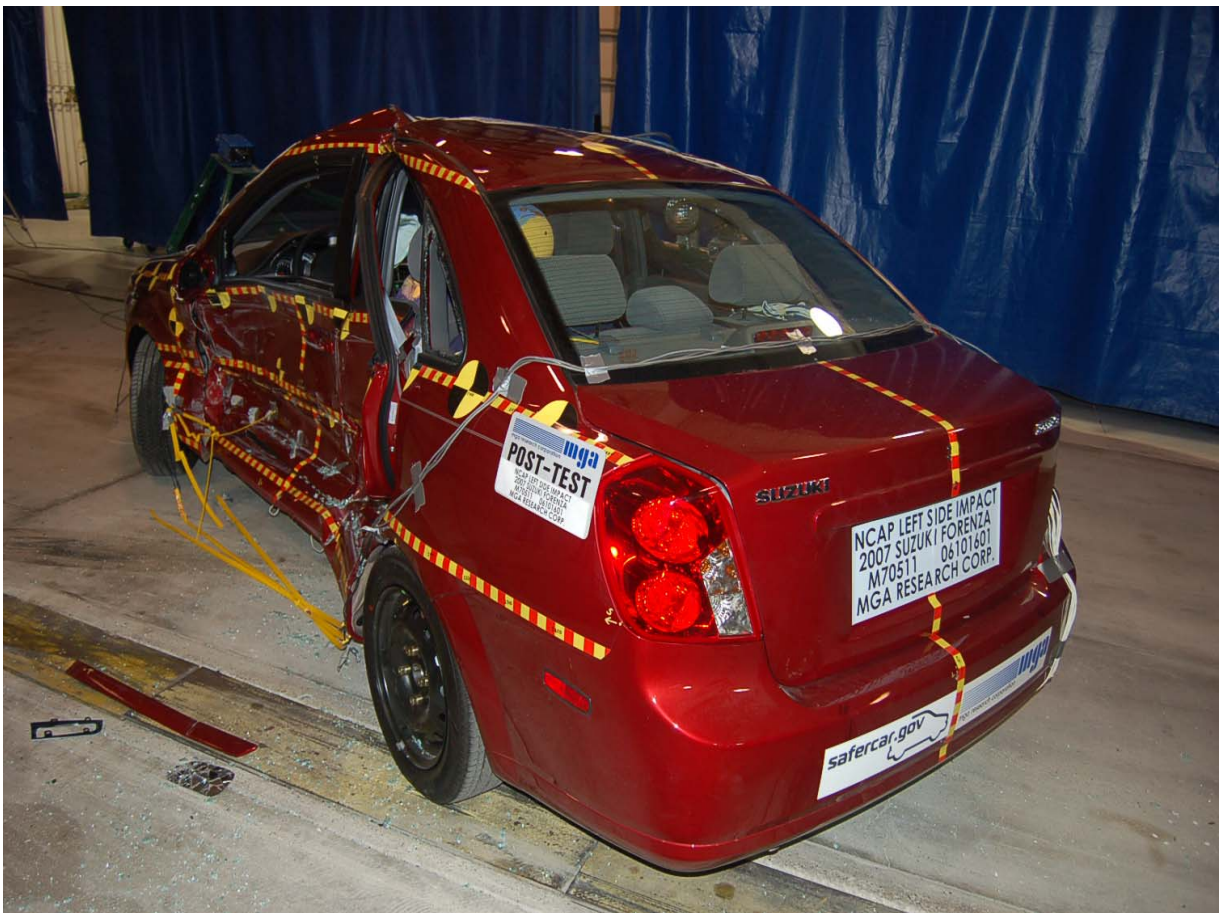
Post-Test Left Rear  $\frac{3}{4}$  View

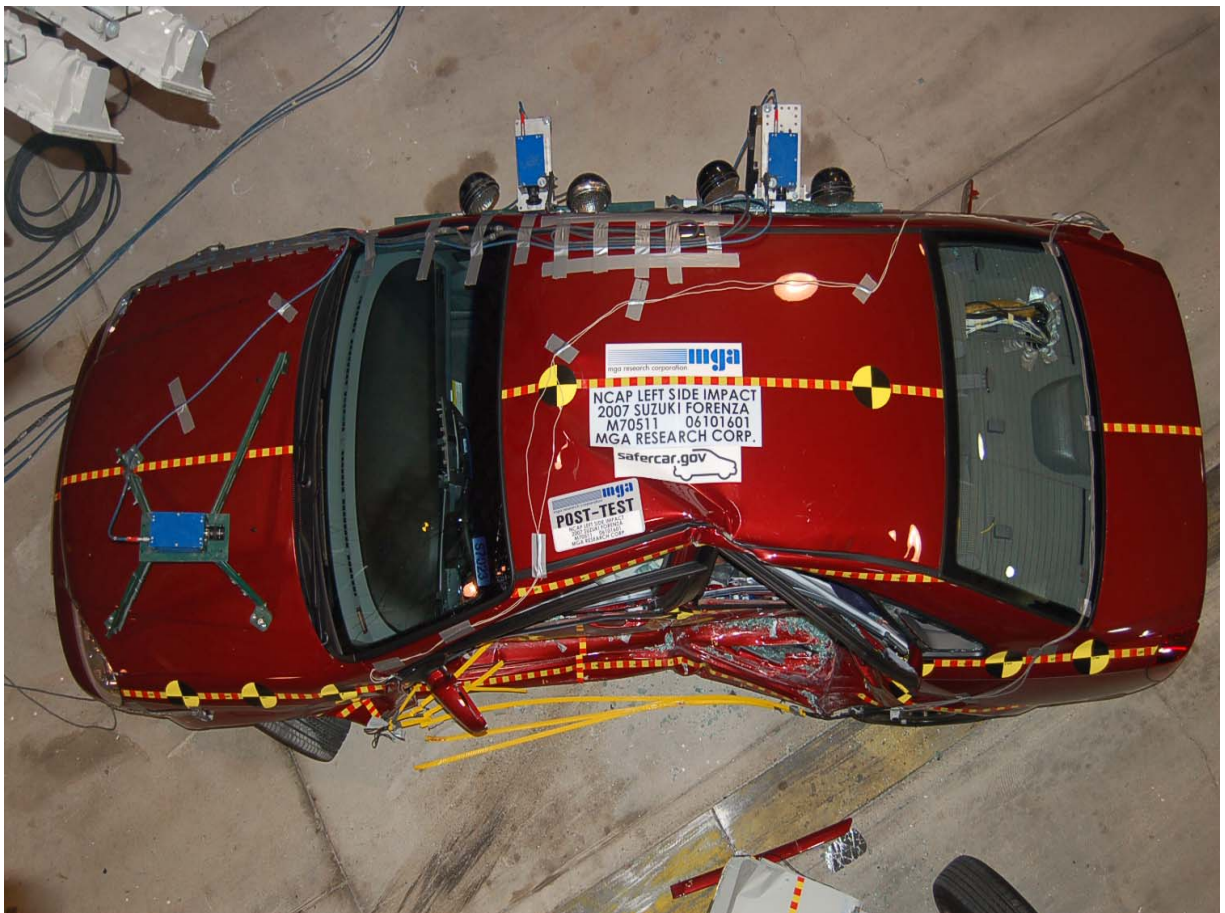
Post-Test Overhead View

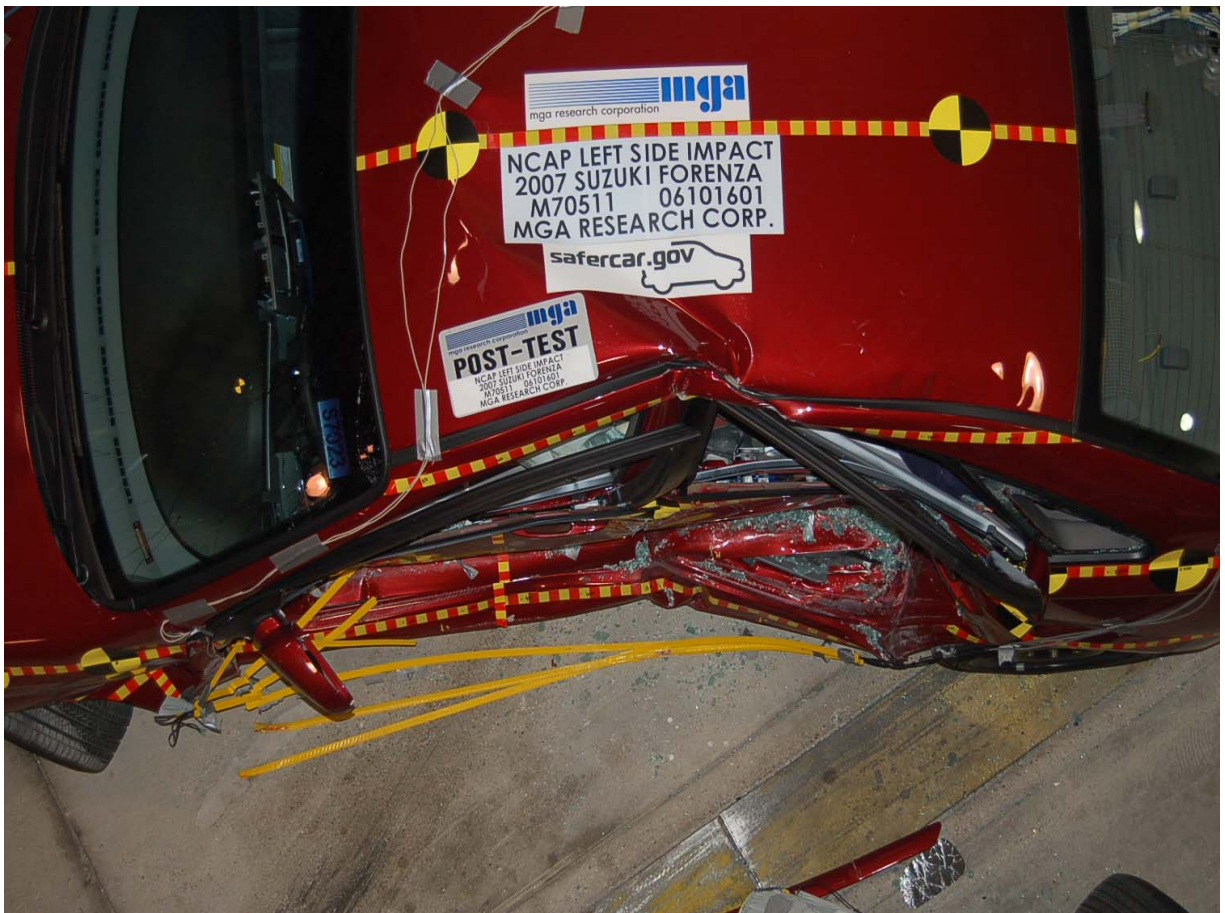
Post-Test Overhead Close-up View

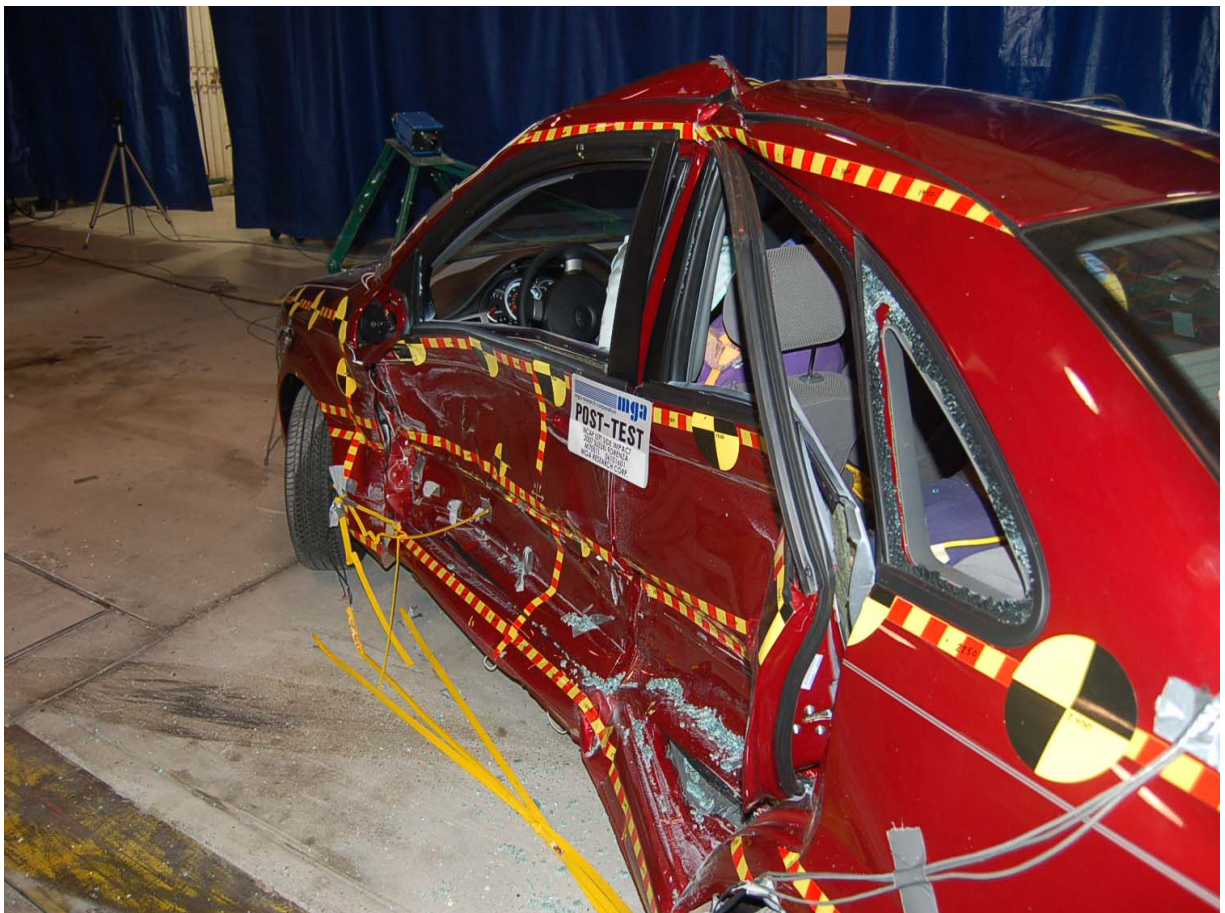
Post-Test Rear  $\frac{3}{4}$  View of Left Side Door

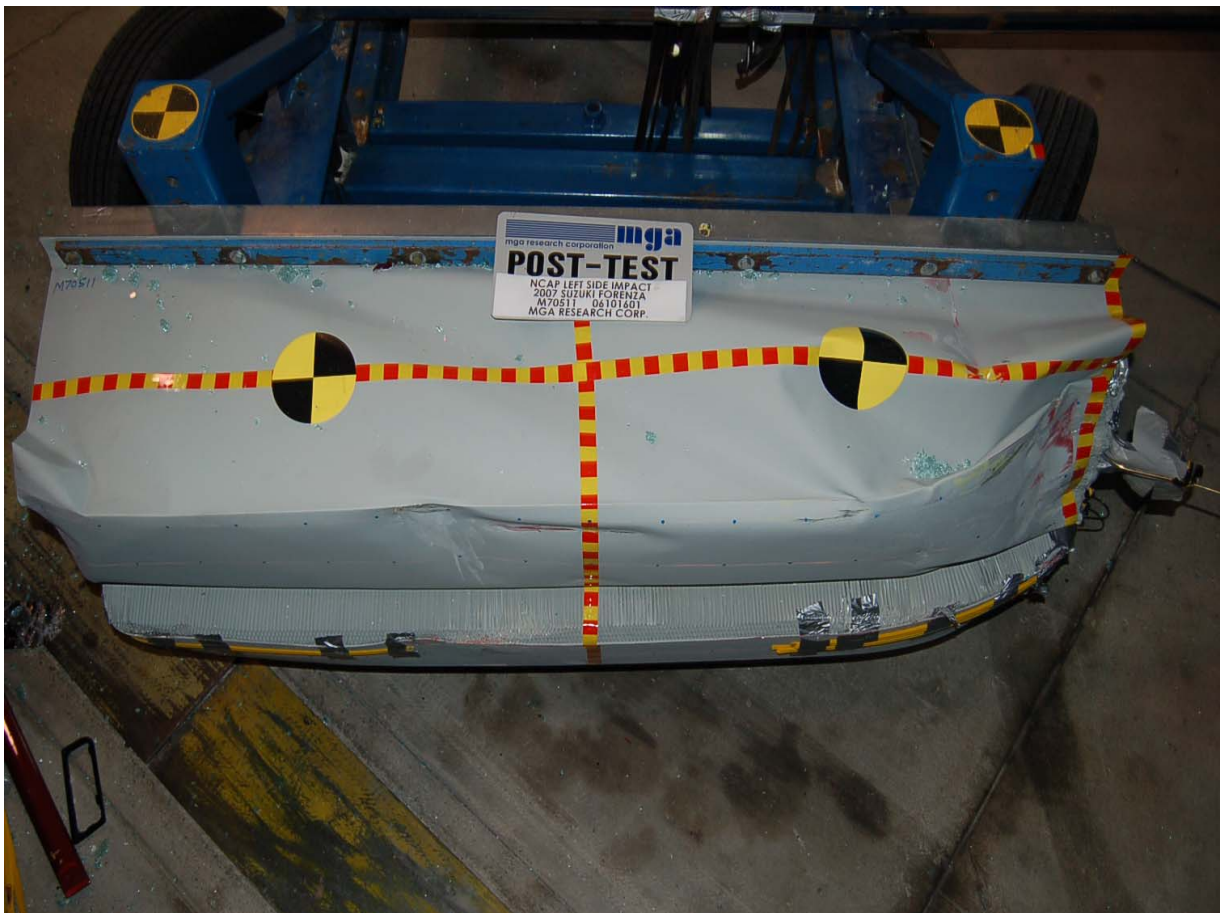
Post-Test Top View of Deformable Barrier

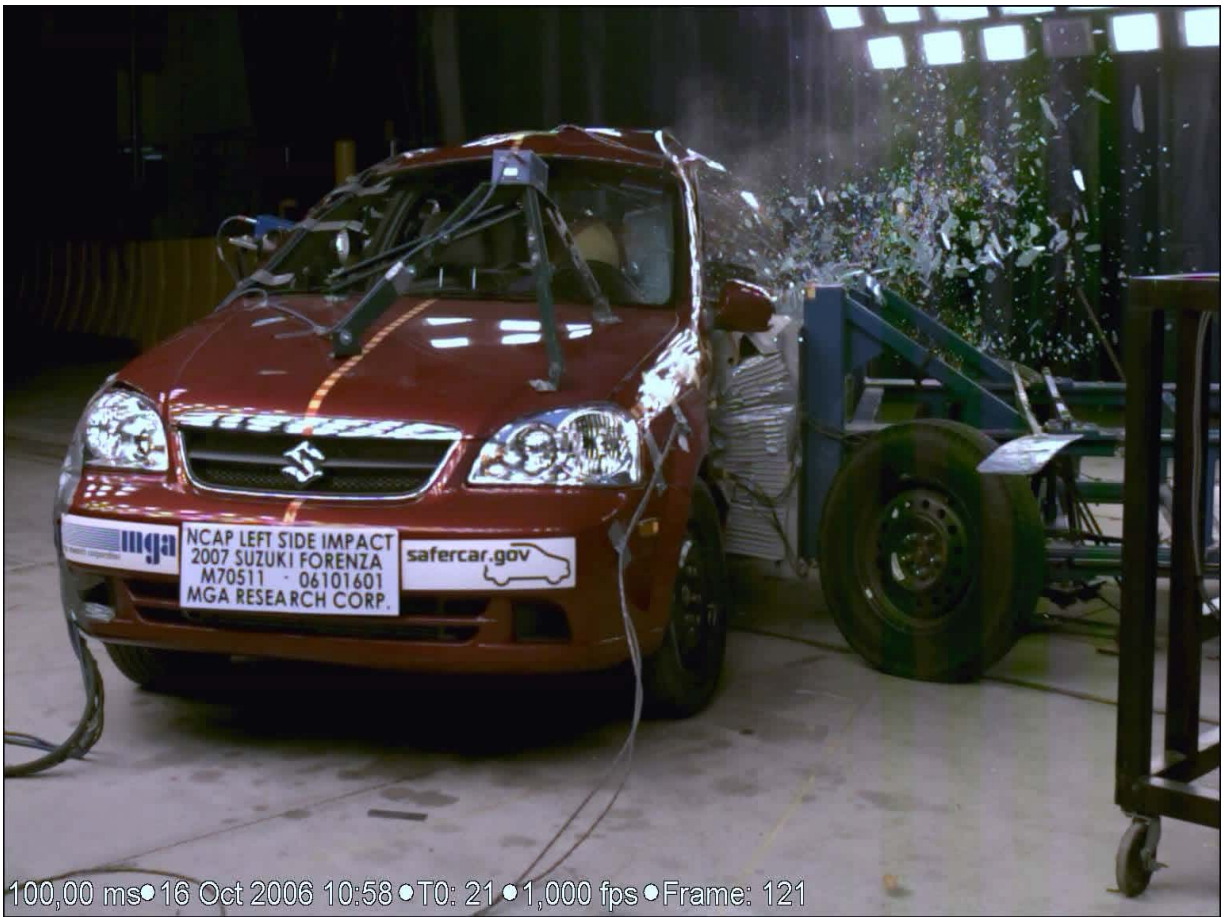
100,00 ms • 16 Oct 2006 10:58 • T0: 21 • 1,000 fps • Frame: 121

Vehicle Impact
