REPORT NUMBER: 214-CAL-07-03

**SAFETY COMPLIANCE TESTING FOR FMVSS 214
SIDE IMPACT PROTECTION
INDICANT**

**GENERAL MOTORS CORPORATION
2007 PONTIAC SOLSTICE
2-DOOR CONVERTIBLE**

NHTSA NUMBER: C70101

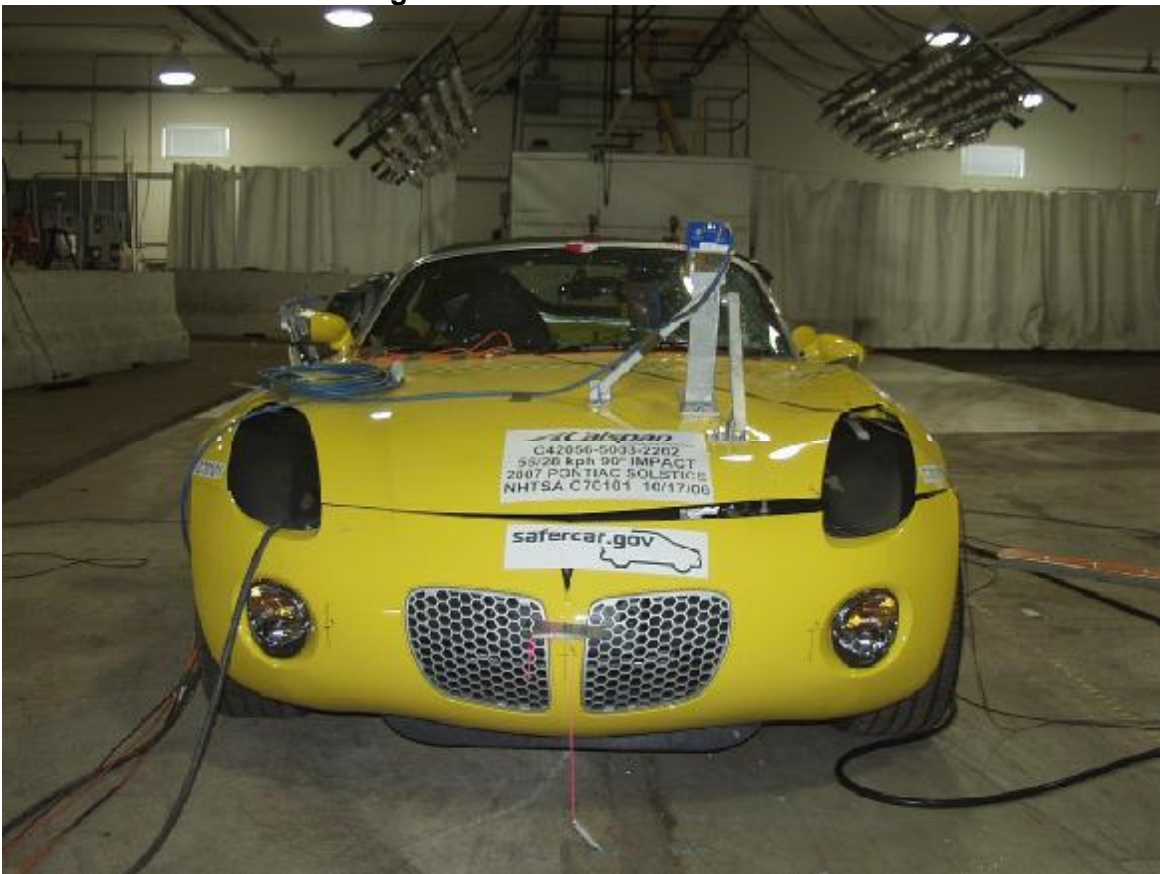
Figure A-6: Post-Test Front View

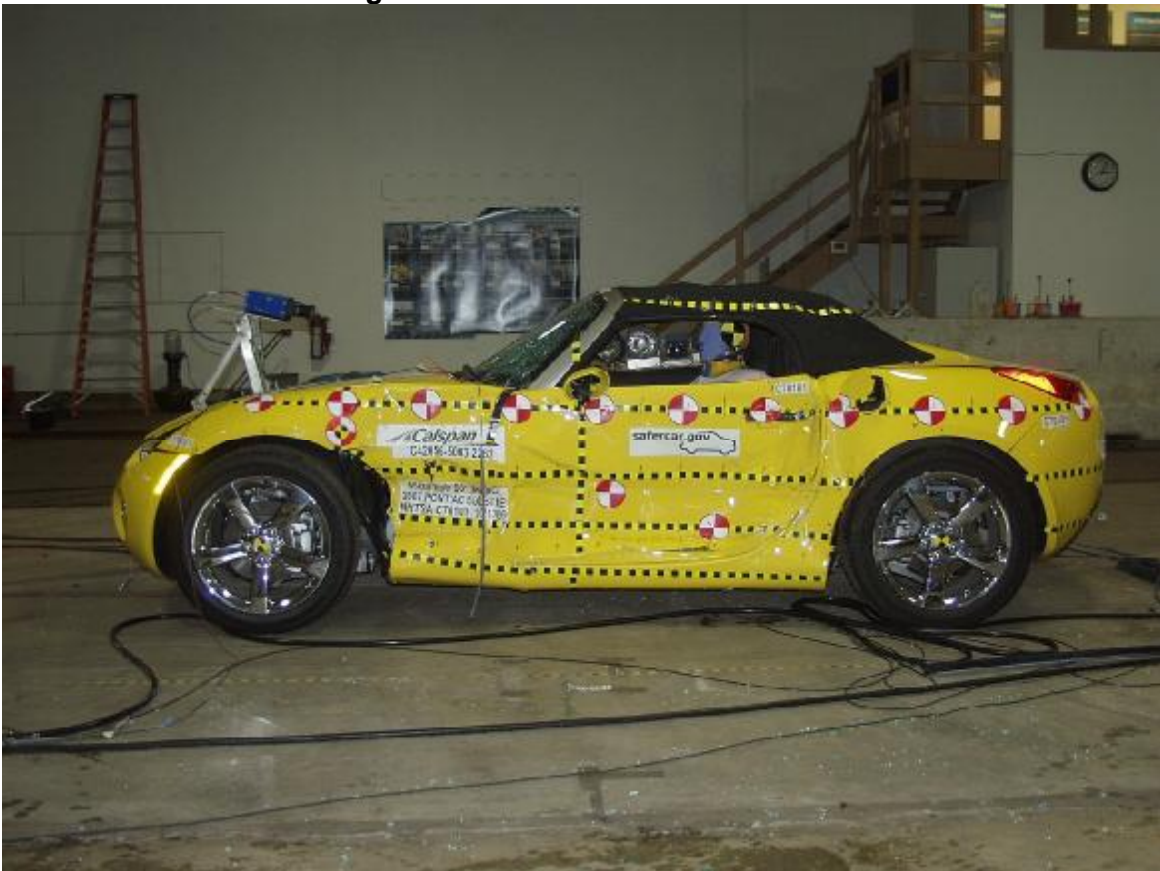
Figure A-10: Post-Test Left Side View

Critical Areas of Performance	Observations and Conclusions
Pillar Performance	No Separation
Sill Separation	None
Windshield Damage	Windshield cracked along the left edge
Window Damage	Left window shattered during the impact
Other Notable Effects	None

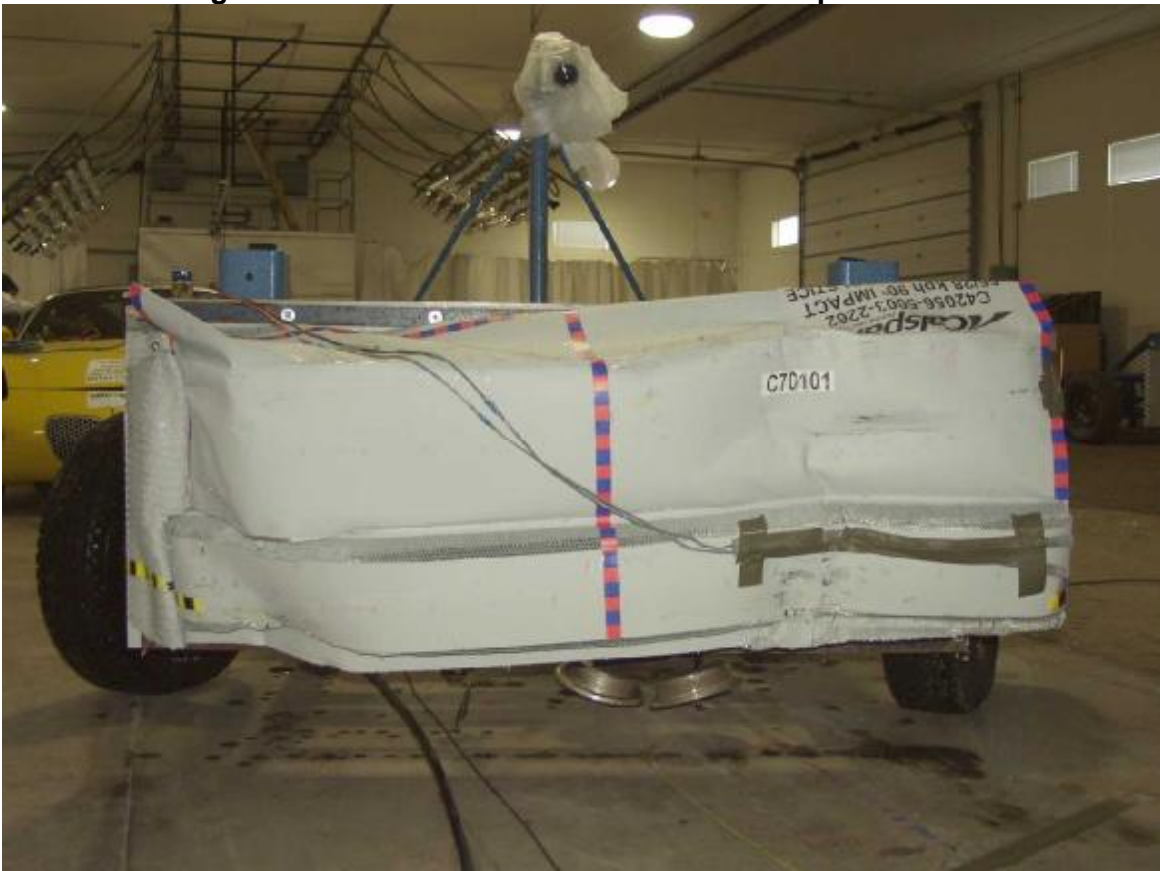
Figure A-22: Post-Test Frontal View of MDB Impactor Face

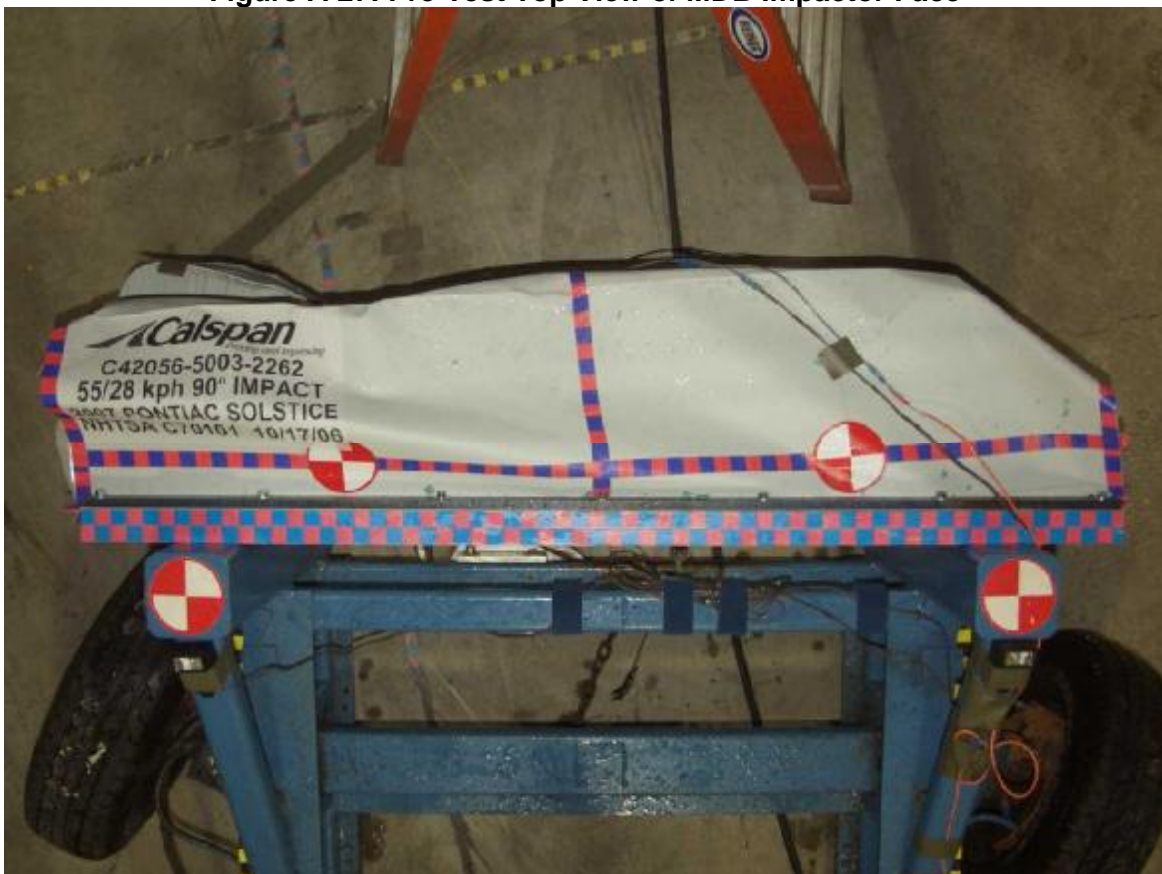
Figure A-28: Post-Test Top View of MDB Impactor Face

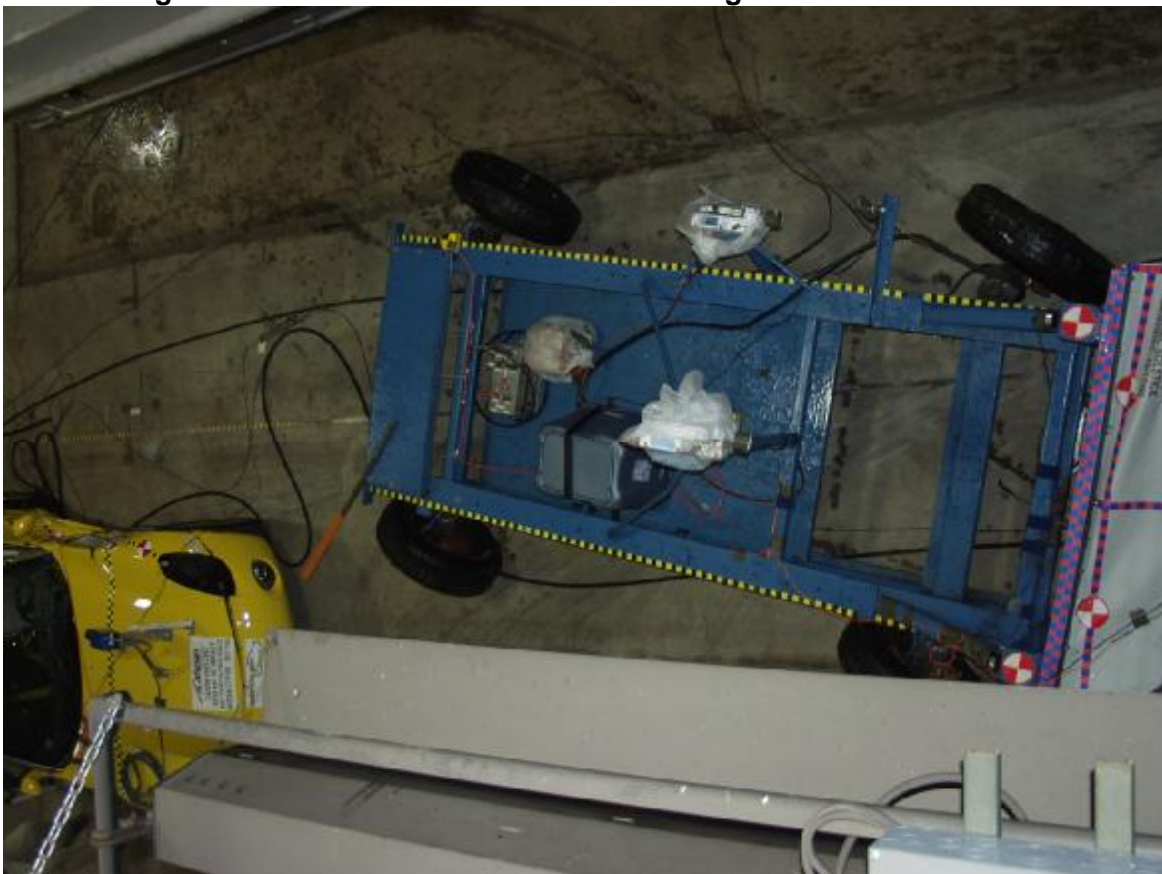
Figure A-32: Post-Test Overhead View of MDB and Vehicle

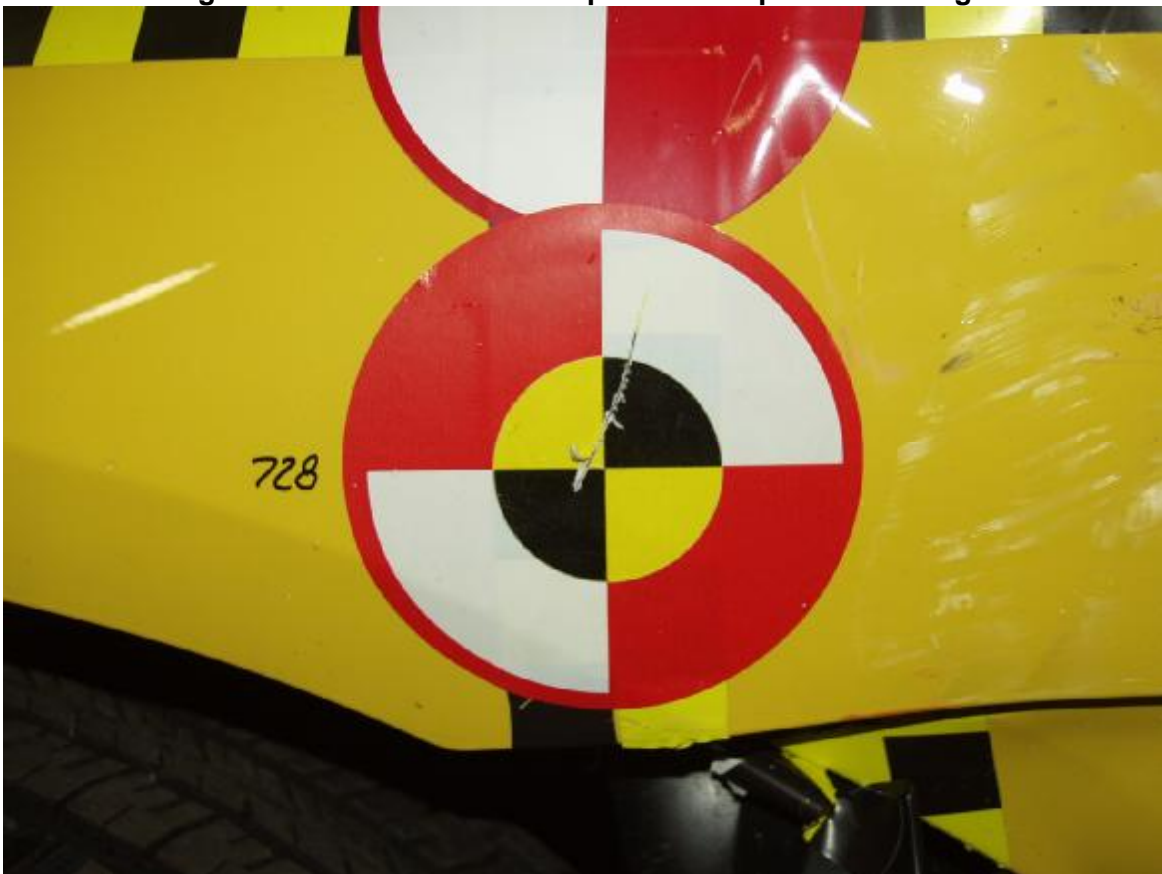
Figure A-34: Post-Test Close-Up View of Impact Point Target

Measured Parameter	Units	Requirement	Value
Horizontal Offset	mm	+/- 50	6 mm forward
Vertical Offset	mm	+/-20	5 mm below

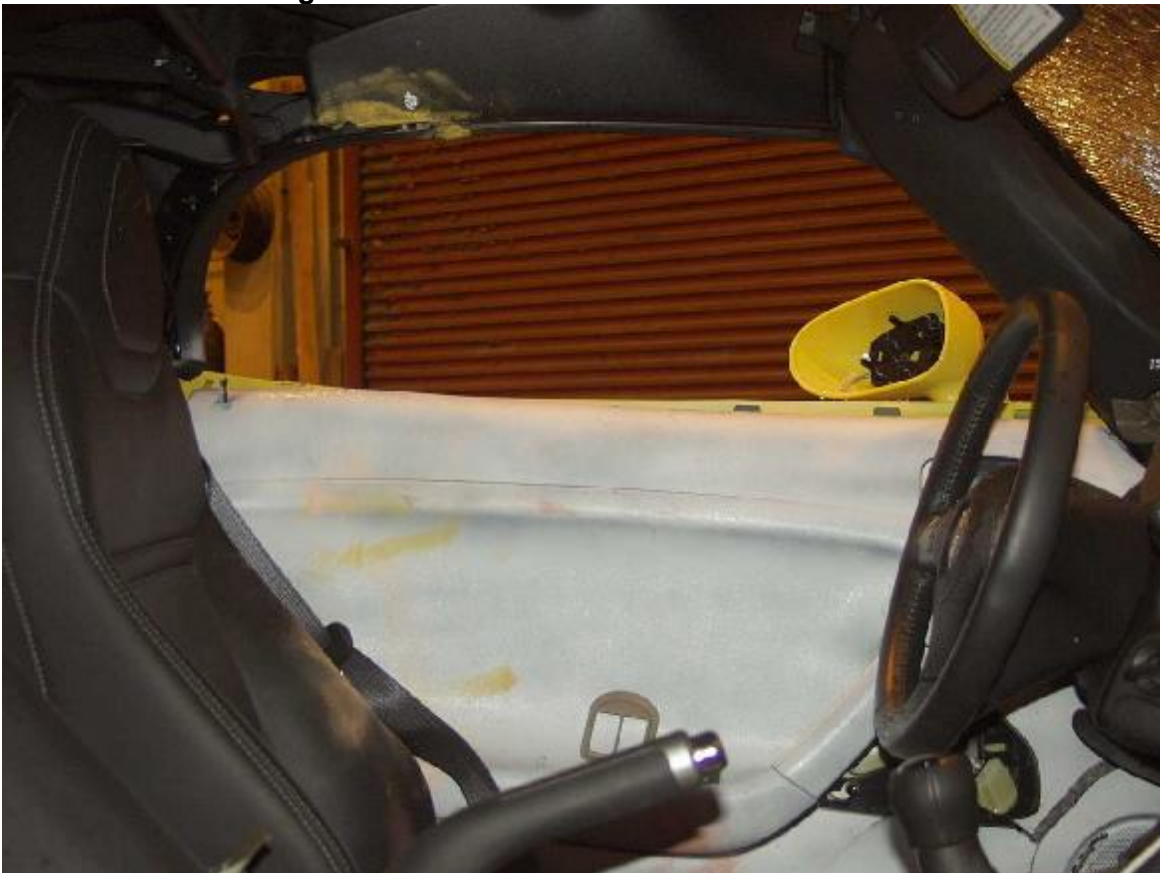
Figure A-40: Post-Test Left Front Interior Trim

Description	Front Seat SID/HIII	Rear Seat SID/HIII*
Dummy Type / Serial No.	SID/HIII / 906	SID/HIII / -
Head Contact	Top of head to side header	-
Upper Torso Contact	Left arm to door trim above arm rest	-
Lower Torso Contact	Pelvis to door trim below arm rest	-
Left Knee Contact	Left knee to door trim	-
Right Knee Contact	Right knee to left knee	-

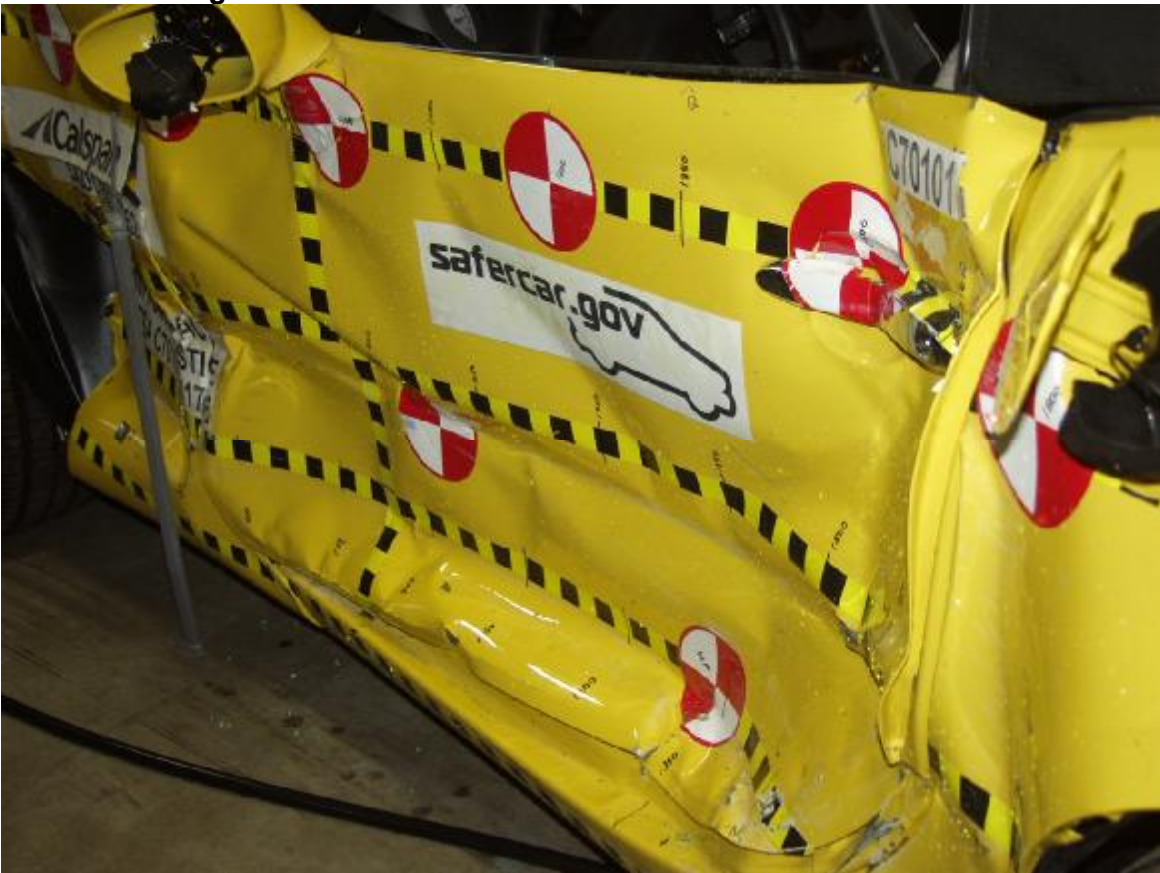
Figure A-44: Post-Test Left Rear $\frac{3}{4}$ View of Left Side Doors

Description	Front	Rear*
Locked/Unlocked Doors	Doors were unlocked	-
Left Side Door Opening	Door remained closed and latched	-
Right Side Door Opening	Door remained closed and latched; Door opened without tools	-
Seat Movement	0	-
Seat Back Failure	None	-

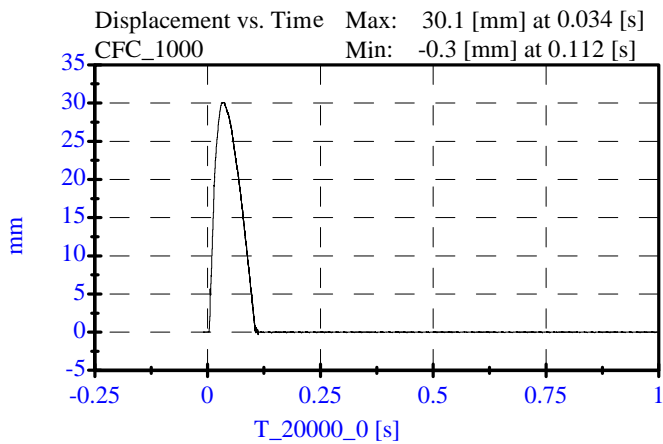
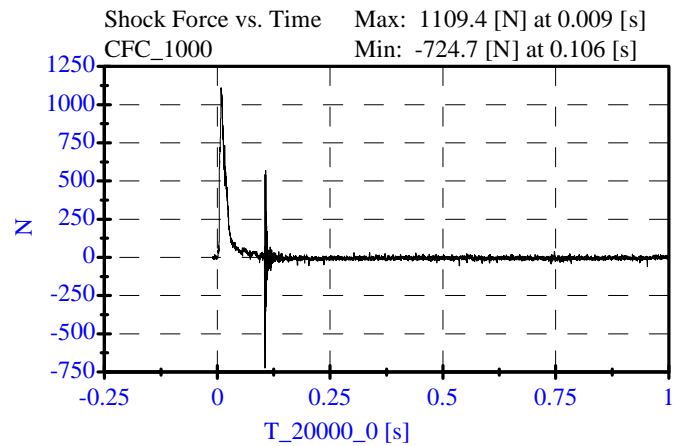
<u>TEST PARAMETER</u>	<u>SPECIFICATION</u>	<u>TEST RESULTS</u>	<u>STATUS</u>
Lab Temperature:	18.9-25.5 C	21.1 C	Passed
Lab Humidity:	10-70 %	50.00 %	Passed
Displacement:	30.00-35.00 mm	30.05 mm	Passed
Maximum Force:	836.00-1125.00 N	1109.43 N	Passed
Impact Test Velocity:	3.05 m/s		
Damper Identification:	906		
Damper Setting:	5

SID Mid Speed Shock Test S/N:906 (4.27 m/s)

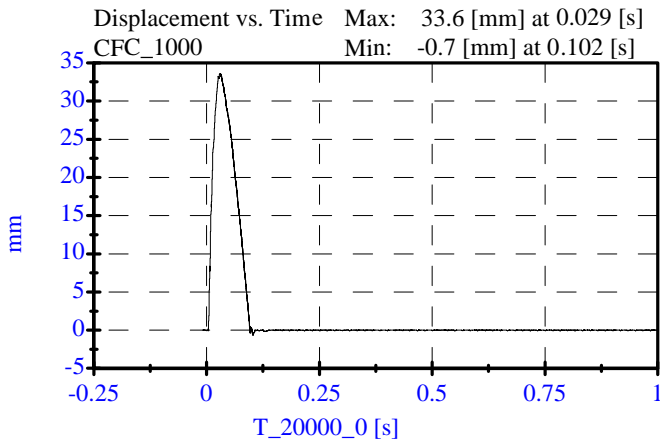
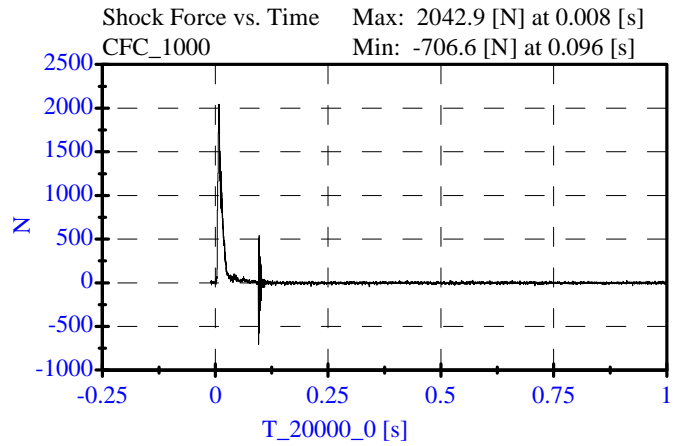
<u>TEST PARAMETER</u>	<u>SPECIFICATION</u>	<u>TEST RESULTS</u>	<u>STATUS</u>
Lab Temperature:	18.9-25.5 C	21.1 C	Passed
Lab Humidity:	10-70 %	50.00 %	Passed
Displacement:	32.00-37.00 mm	33.58 mm	Passed
Maximum Force:	1730.00-2099.00 N	2042.90 N	Passed

Impact Test Velocity: 4.27 m/s
Damper Identification: 906
Damper Setting: 5

SID High Speed Shock Test S/N:906 (6.10 m/s)

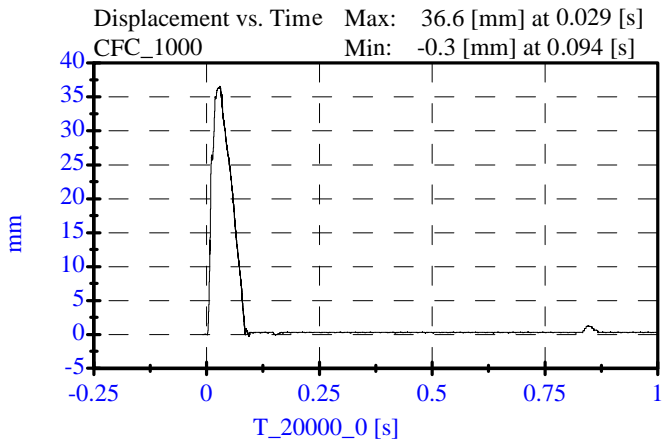
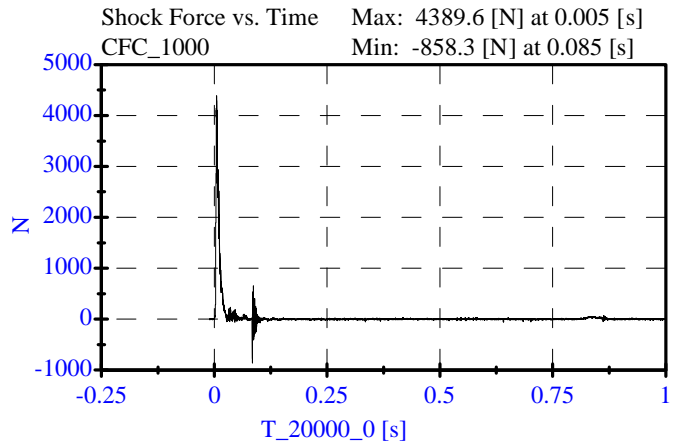
<u>TEST PARAMETER</u>	<u>SPECIFICATION</u>	<u>TEST RESULTS</u>	<u>STATUS</u>
Lab Temperature:	18.9-25.5 C	21.1 C	Passed
Lab Humidity:	10-70 %	50.00 %	Passed
Displacement:	33.00-40.00 mm	36.58 mm	Passed
Maximum Force:	3741.00-4448.00 N	4389.60 N	Passed

Impact Test Velocity: 6.10 m/s
Damper Identification: 906
Damper Setting: 5

SID Thorax Test S/N:906
Pre-Test
CONFIGURED FOR LEFT SIDE IMPACT

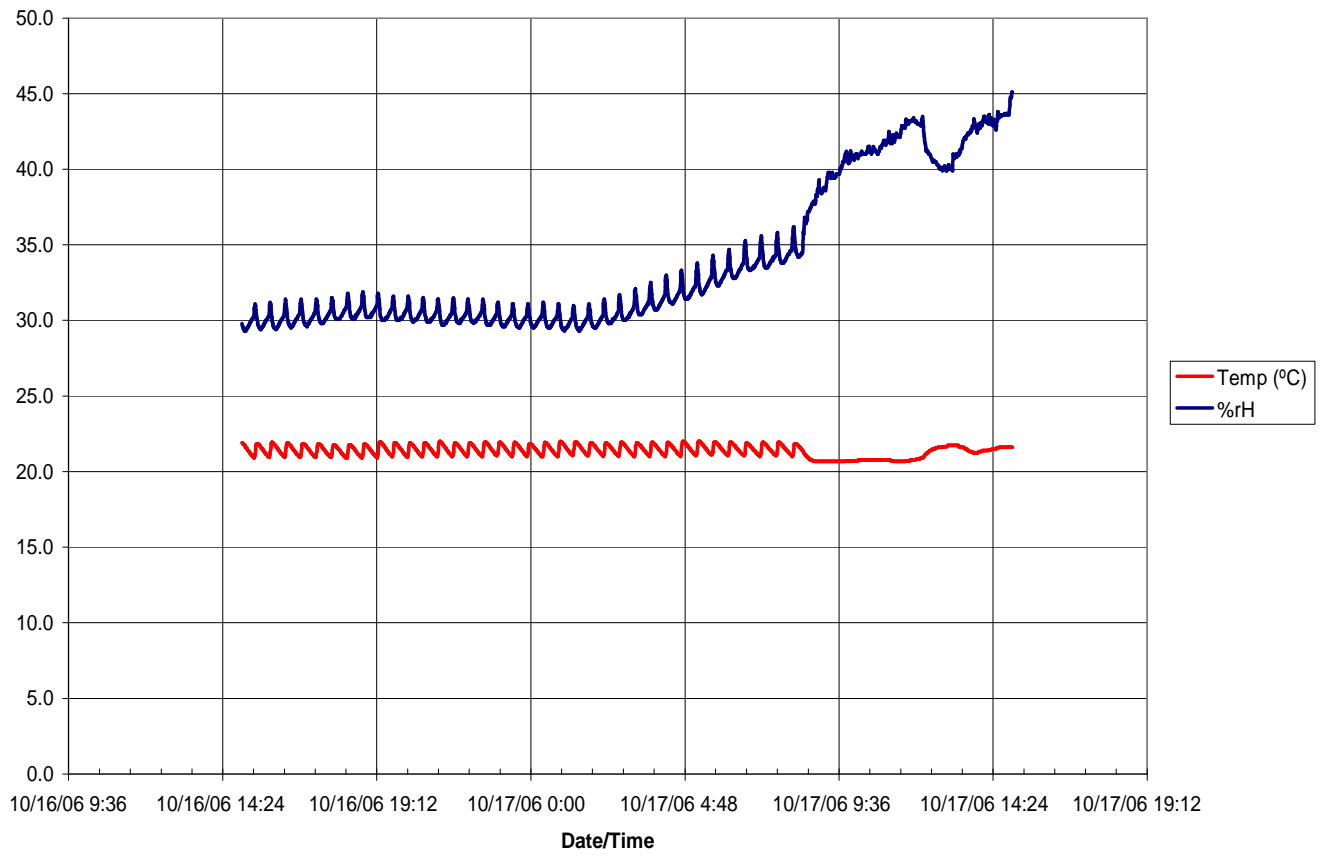
TEMPERATURE TRACE

2007 Pontiac Solstice C70101 Environmental Conditions
