**REPORT NUMBER: SNCAP-CAL-07-04**

**NEW CAR ASSESSMENT PROGRAM  
SIDE IMPACT TEST**

**GENERAL MOTORS OF CANADA, LTD.  
2007 BUICK LACROSSE  
FOUR-DOOR SEDAN**

**FINAL REPORT**

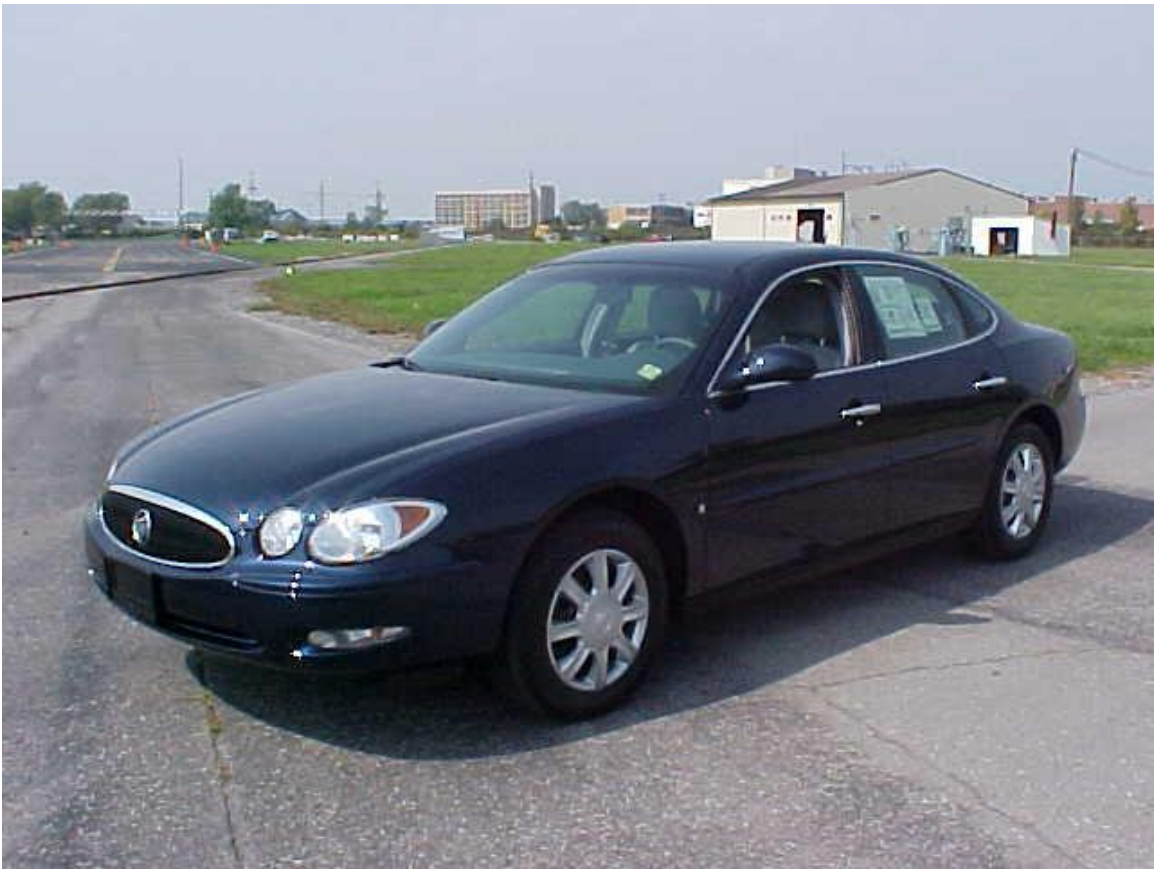
**Figure A-1: As Received Left Front  $\frac{3}{4}$  View**

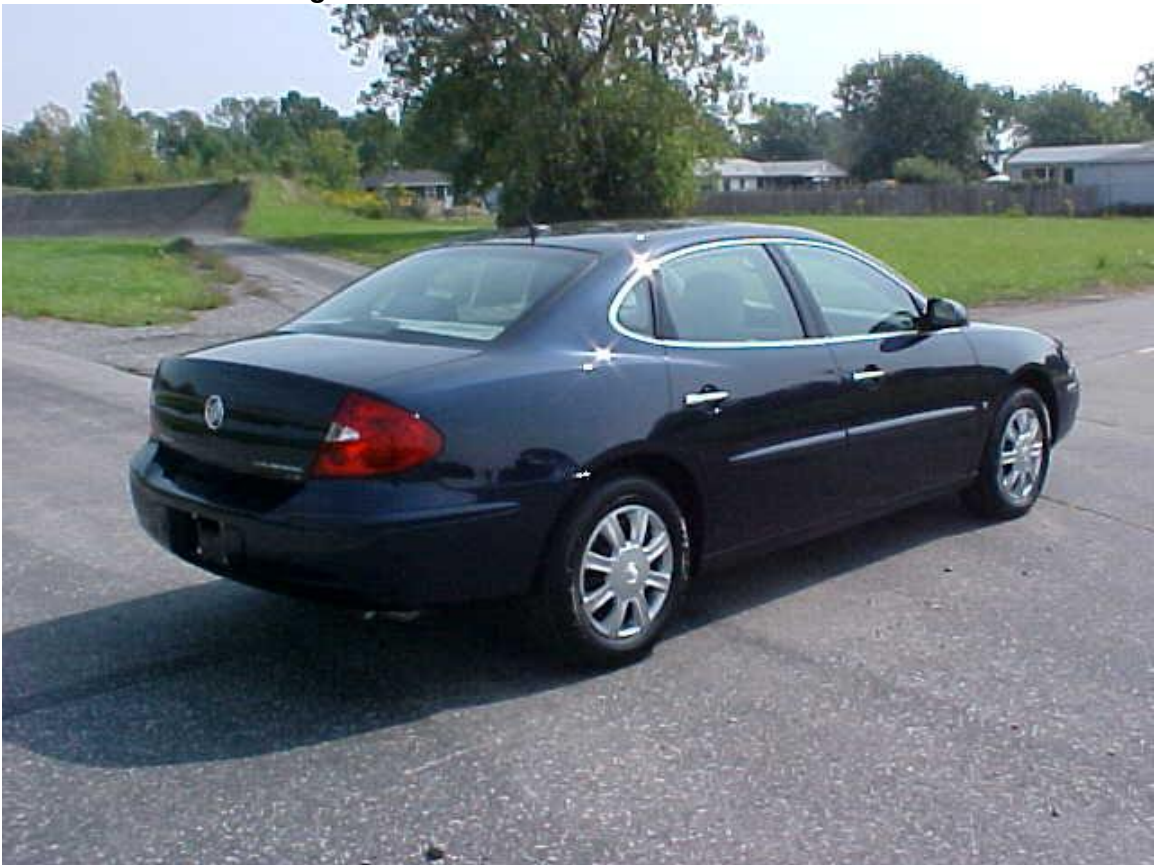
**Figure A-2: As Received Right Rear  $\frac{3}{4}$  View**

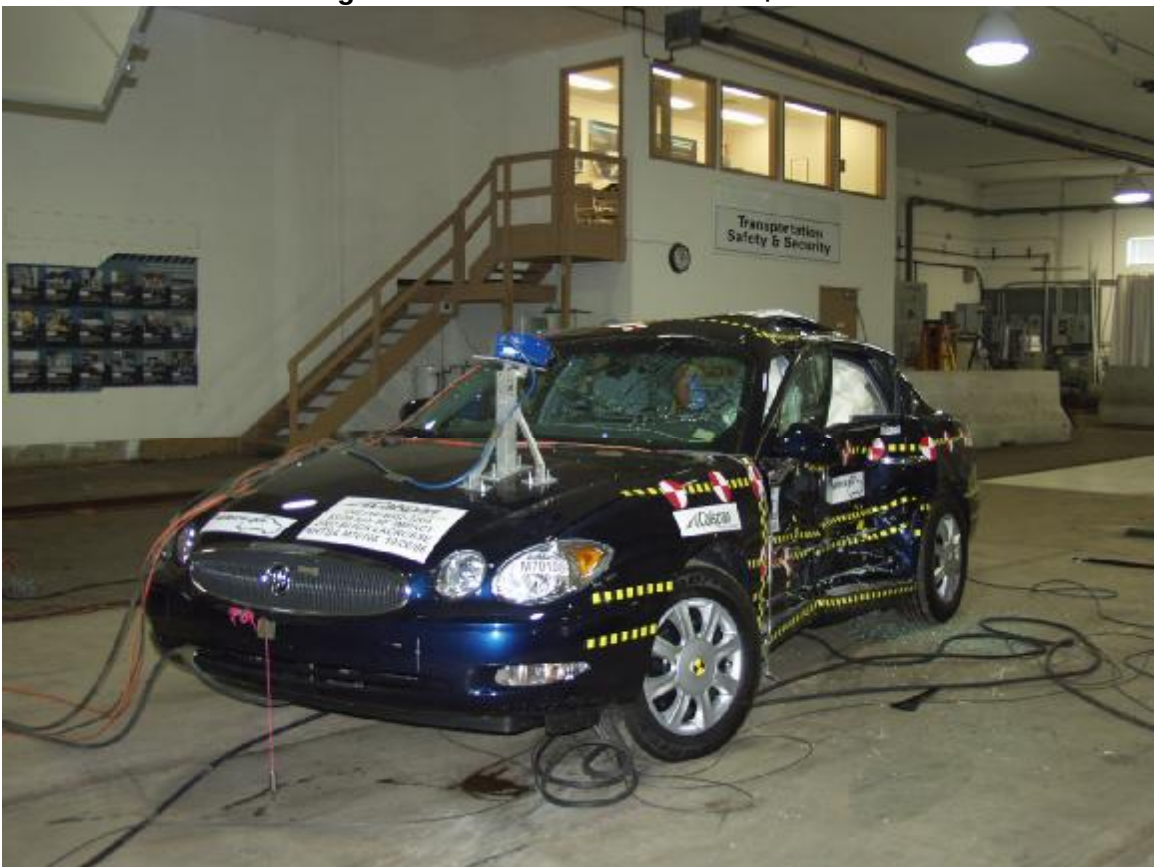
**Figure A-8: Post-Test Left Front  $\frac{3}{4}$  View**

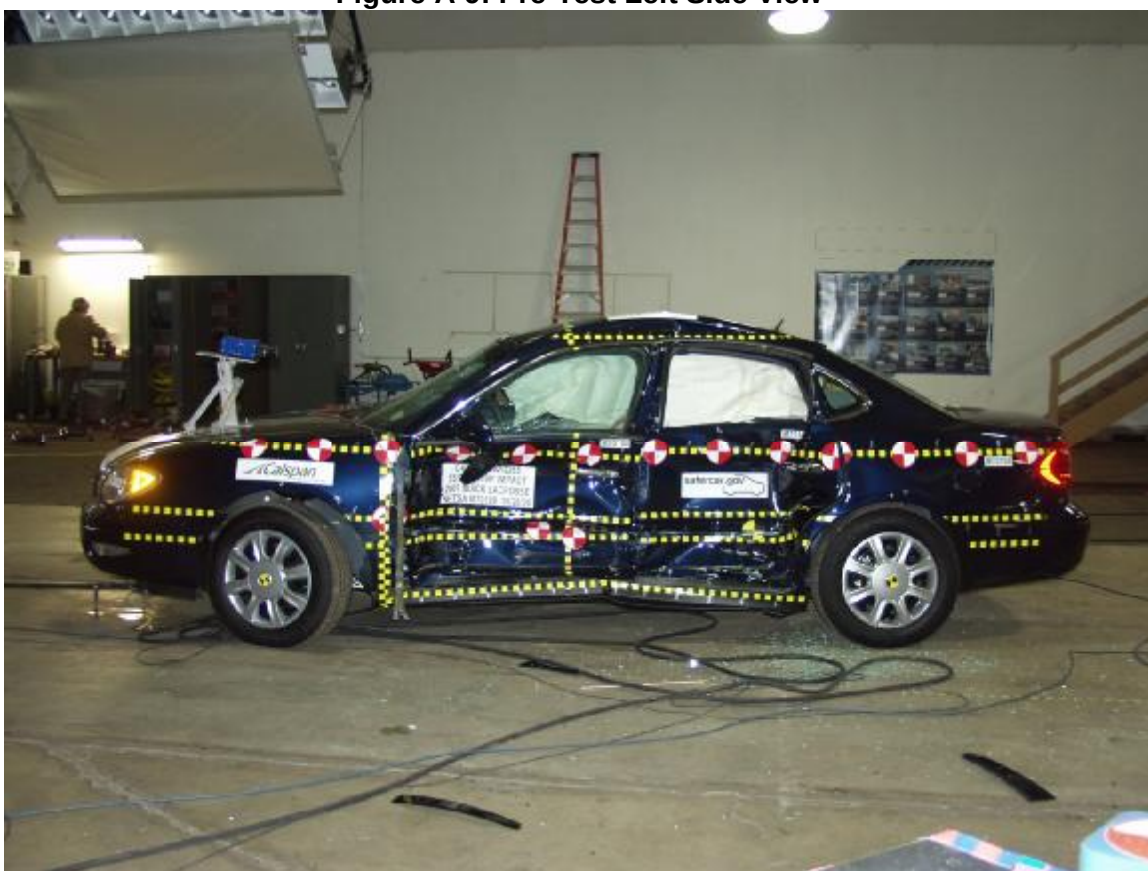
Figure A-10: Post-Test Left Side View

The test vehicle sustained a maximum static crush of 299 mm at level 2, 1050 mm rearward of the left vertical impact point. The driver and passenger SID/HIII's, Serial Nos. 270 and 269 respectively, were calibrated just prior to this test.

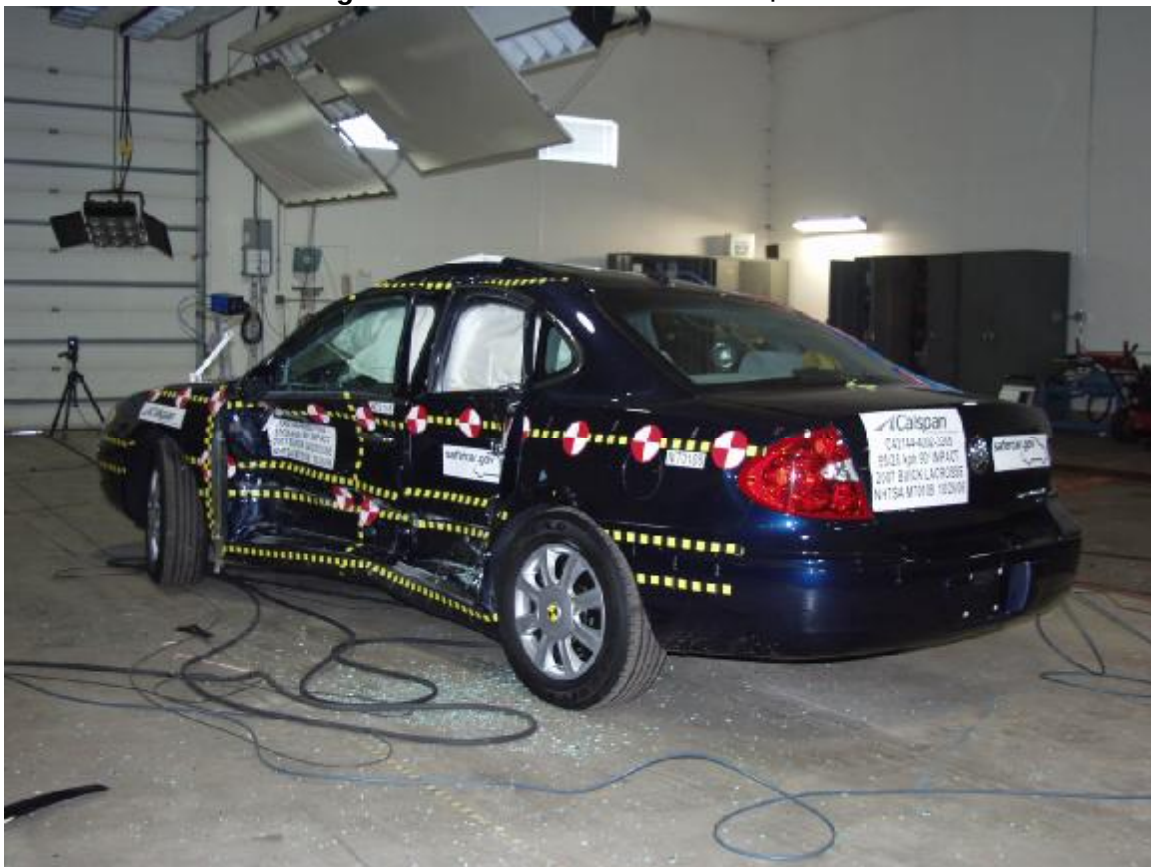
**Figure A-12: Post-Test Left Rear  $\frac{3}{4}$  View**

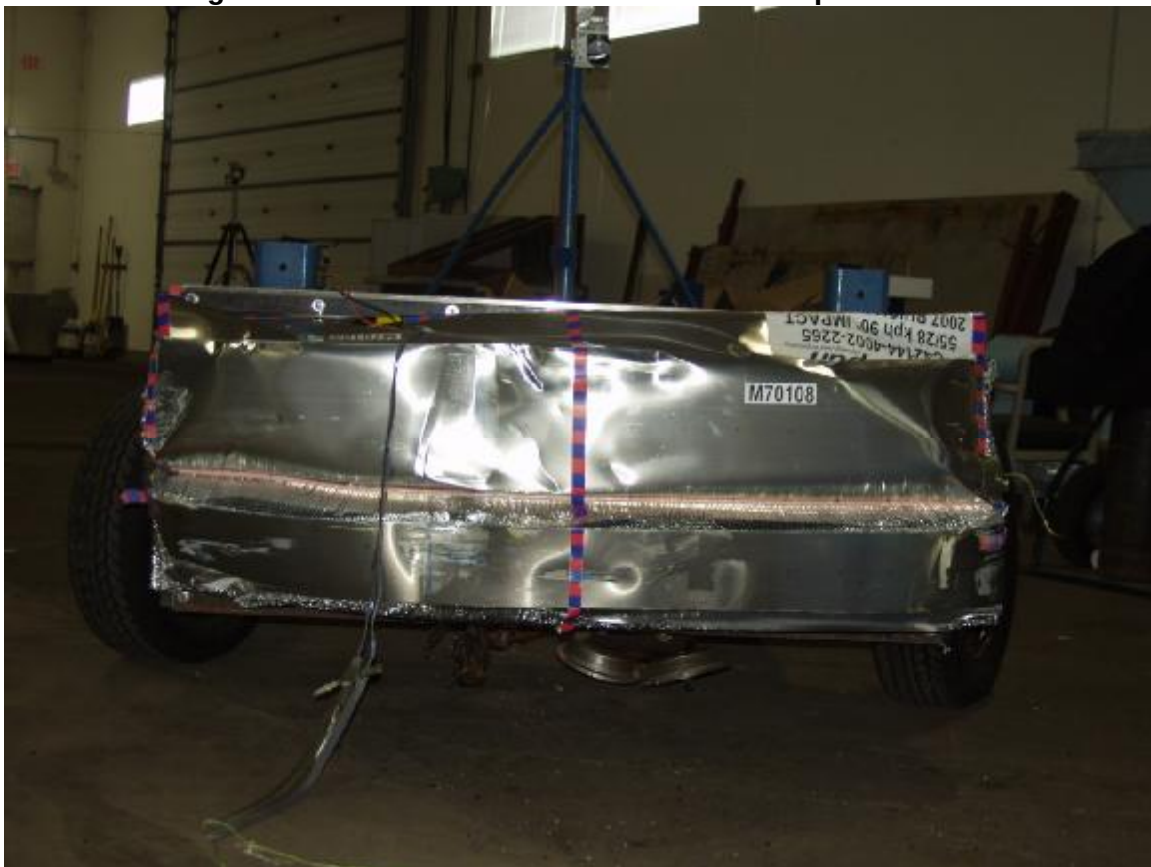
**Figure A-22: Post-Test Frontal View of MDB Impactor Face**

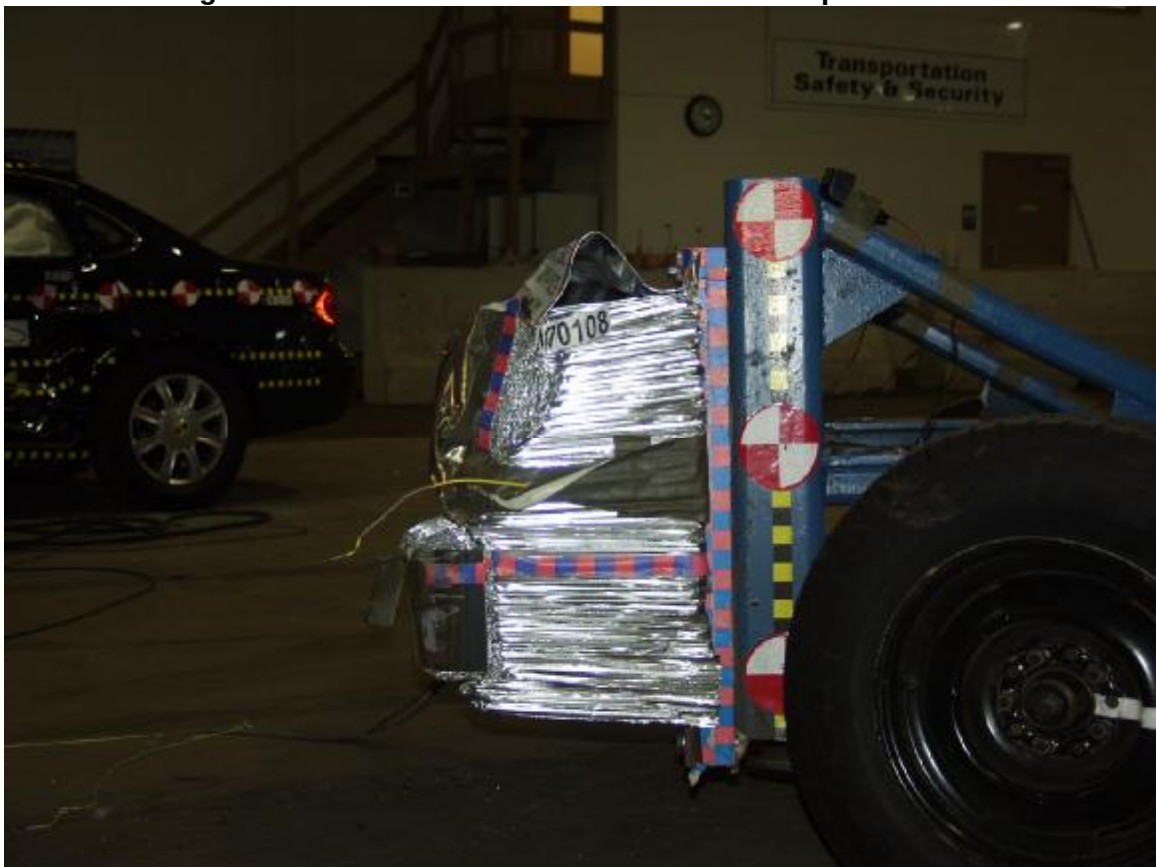
**Figure A-24: Post-Test Left Side View of MDB Impactor Face**

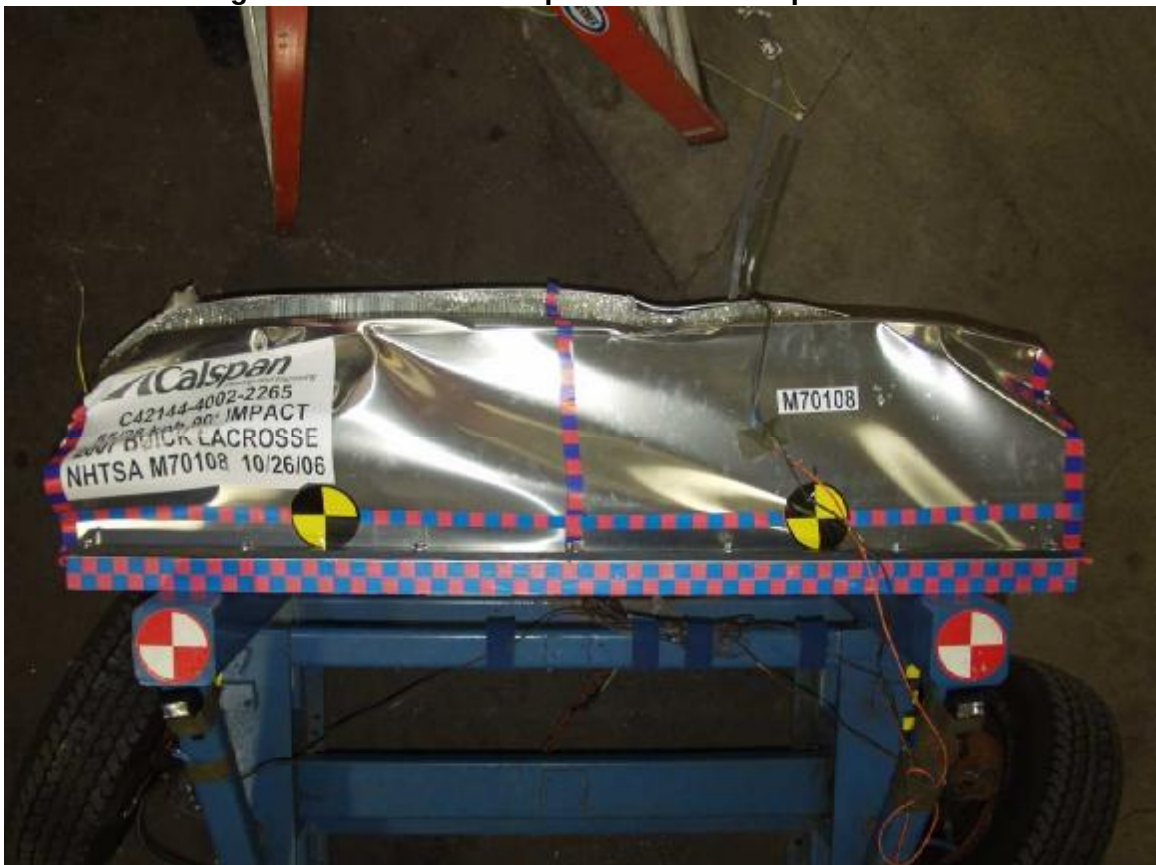
Figure A-28: Post-Test Top View of MDB Impactor Face

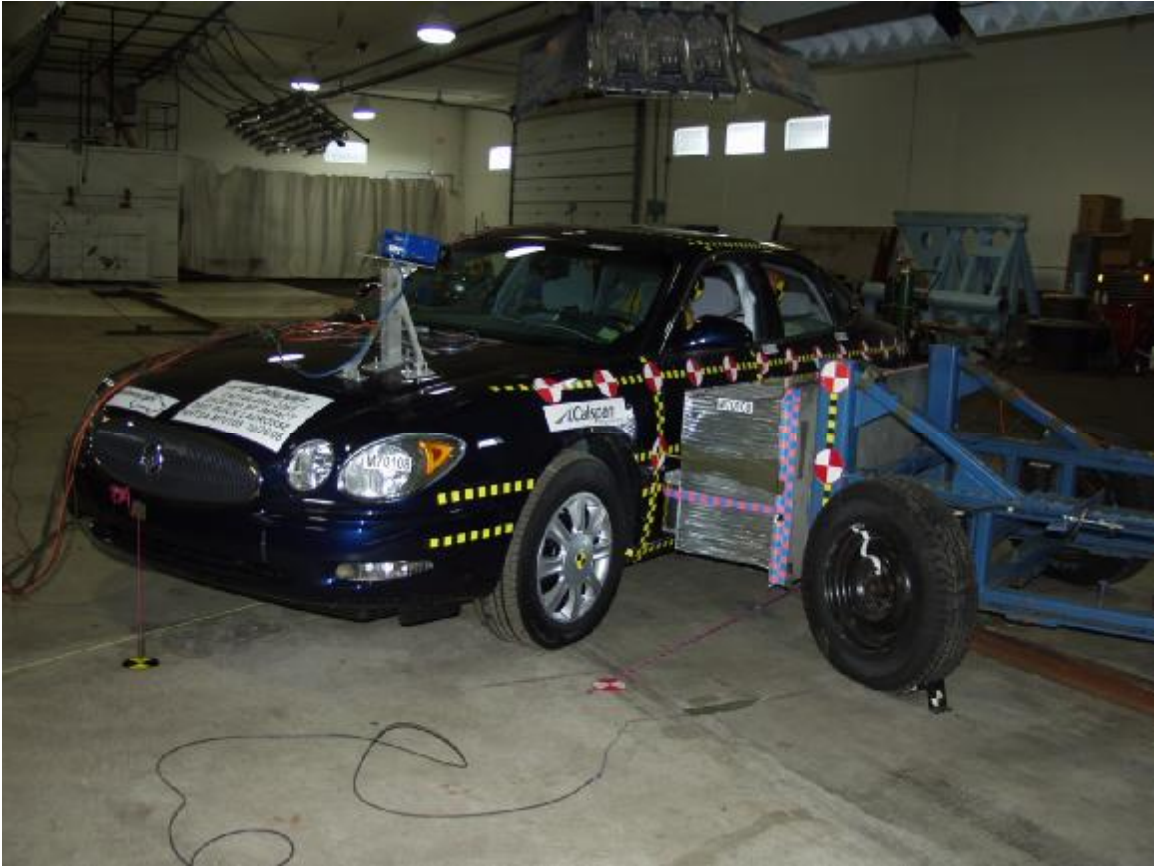
**Figure A-29: Pre-Test Left Side View of Aligned MDB and Vehicle**

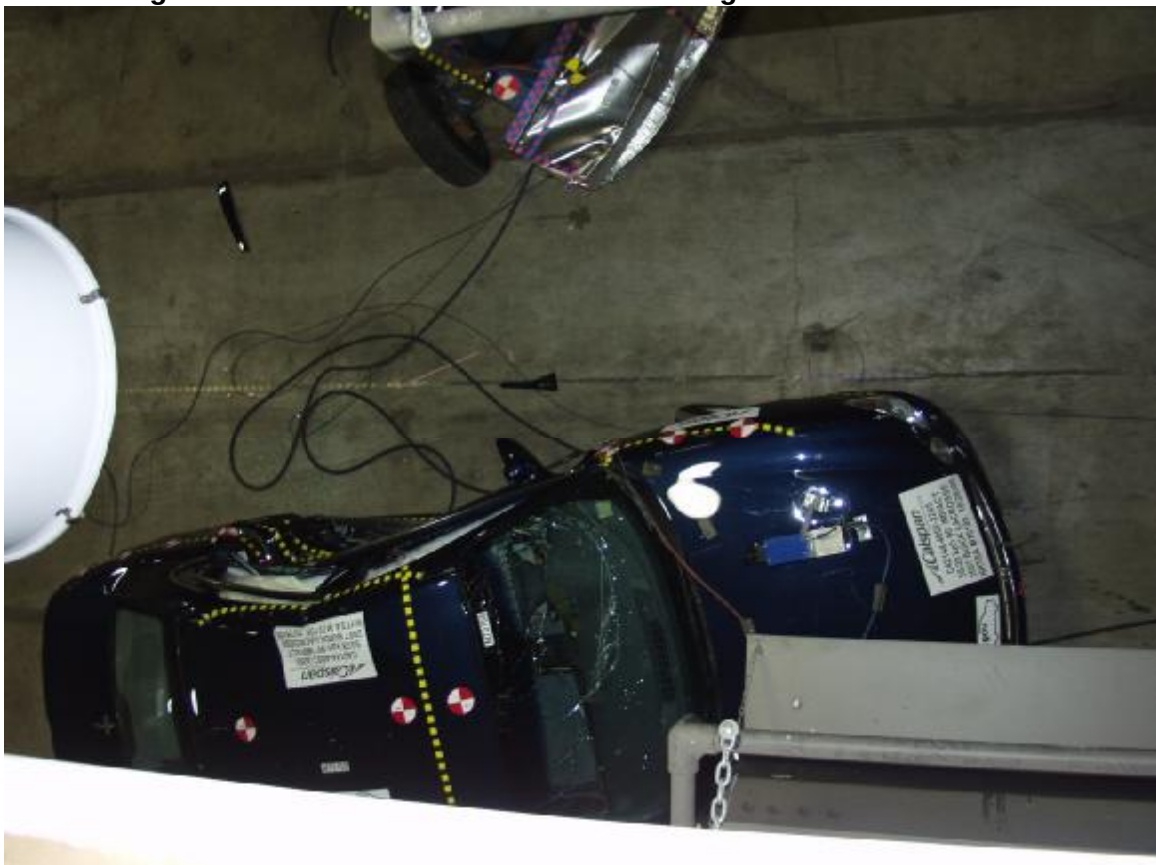
**Figure A-32: Post-Test Overhead View of MDB and Vehicle**

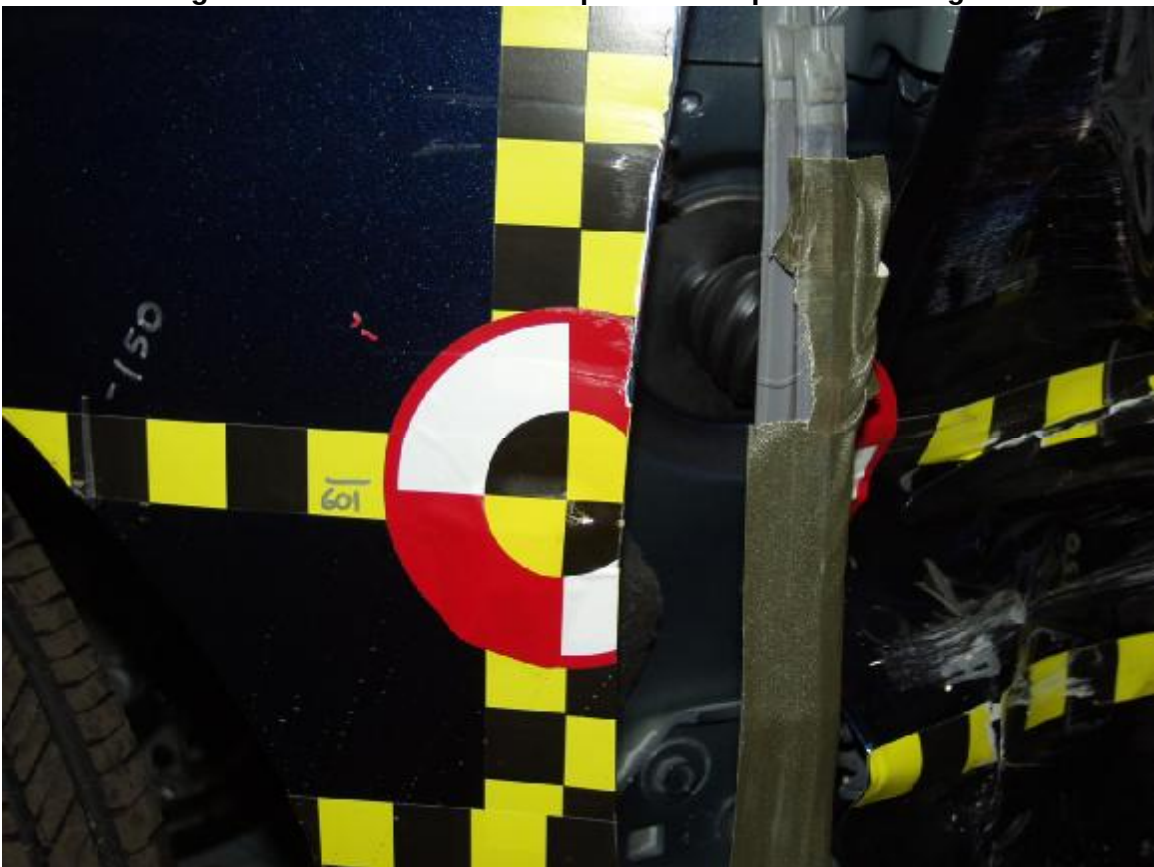
**Figure A-34: Post-Test Close-Up View of Impact Point Target**

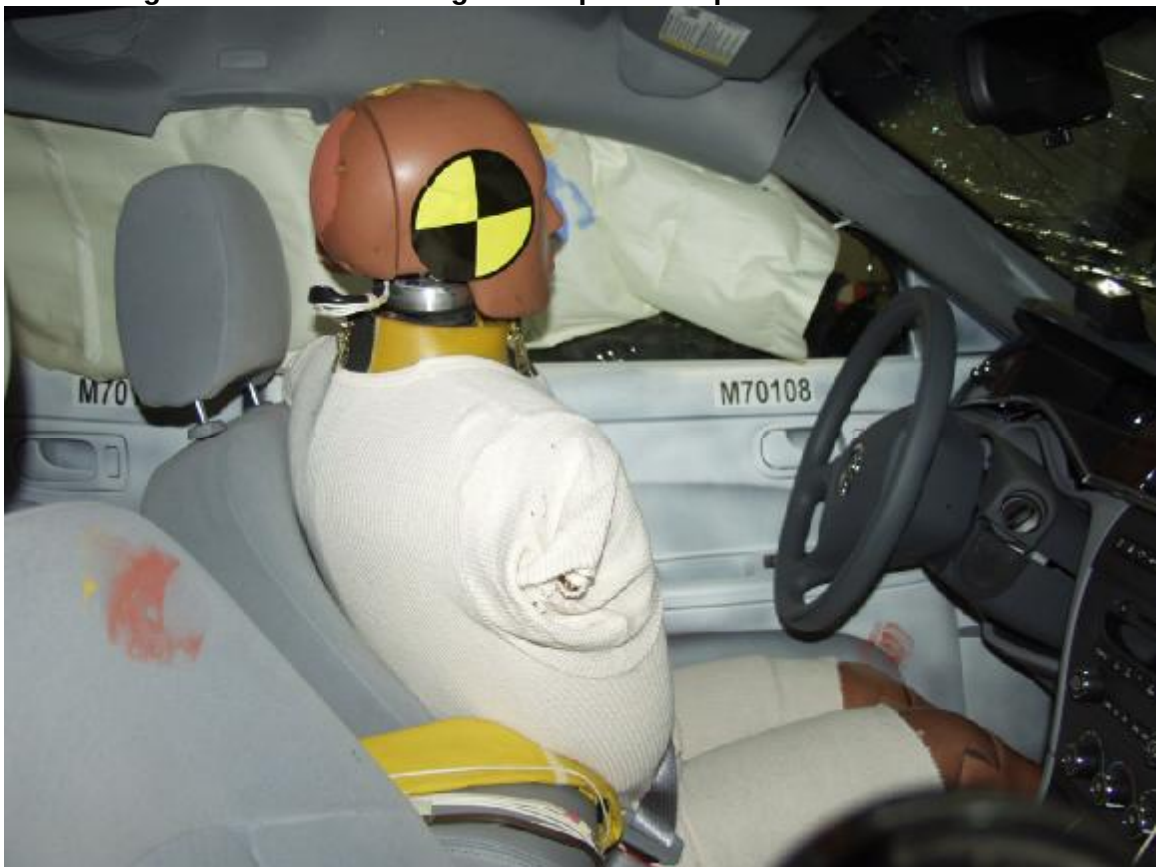
**Figure A-36: Post-Test Right Occupant Compartment View of Driver**

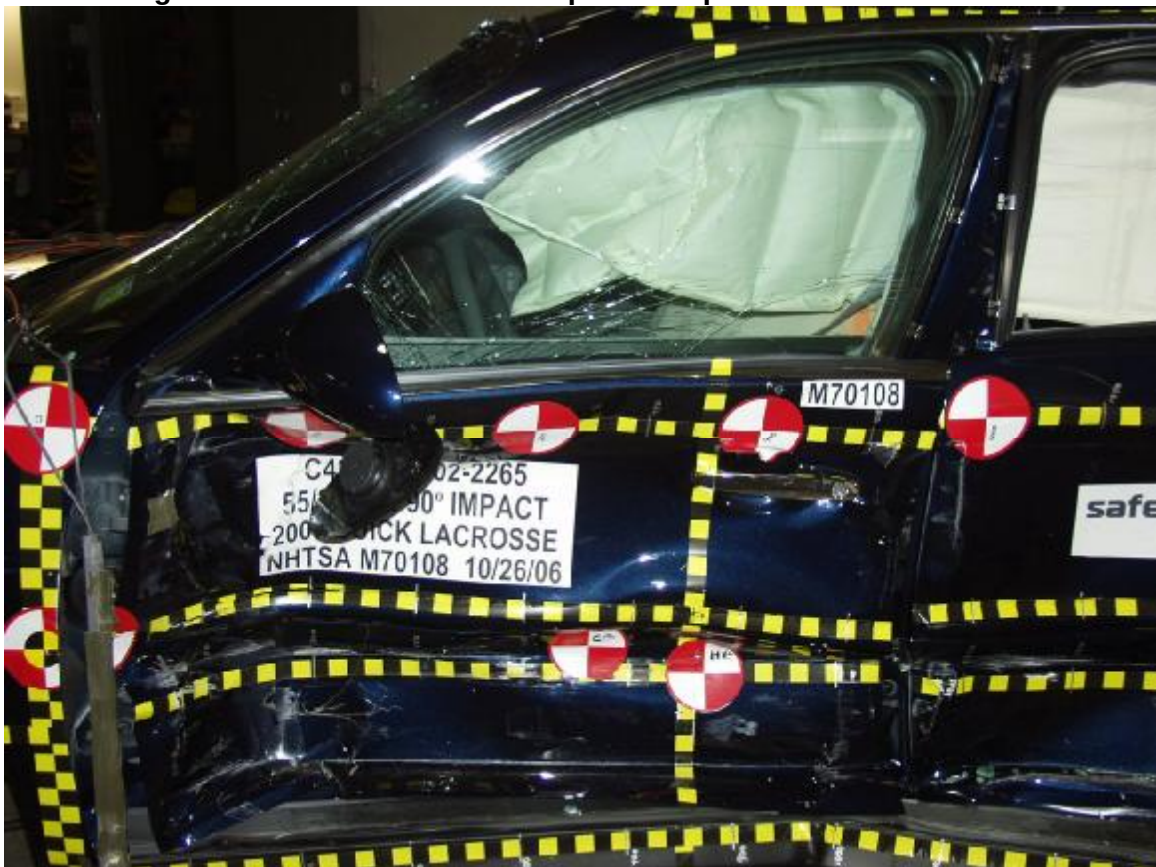
Figure A-40: Post-Test Left Occupant Compartment View of Driver

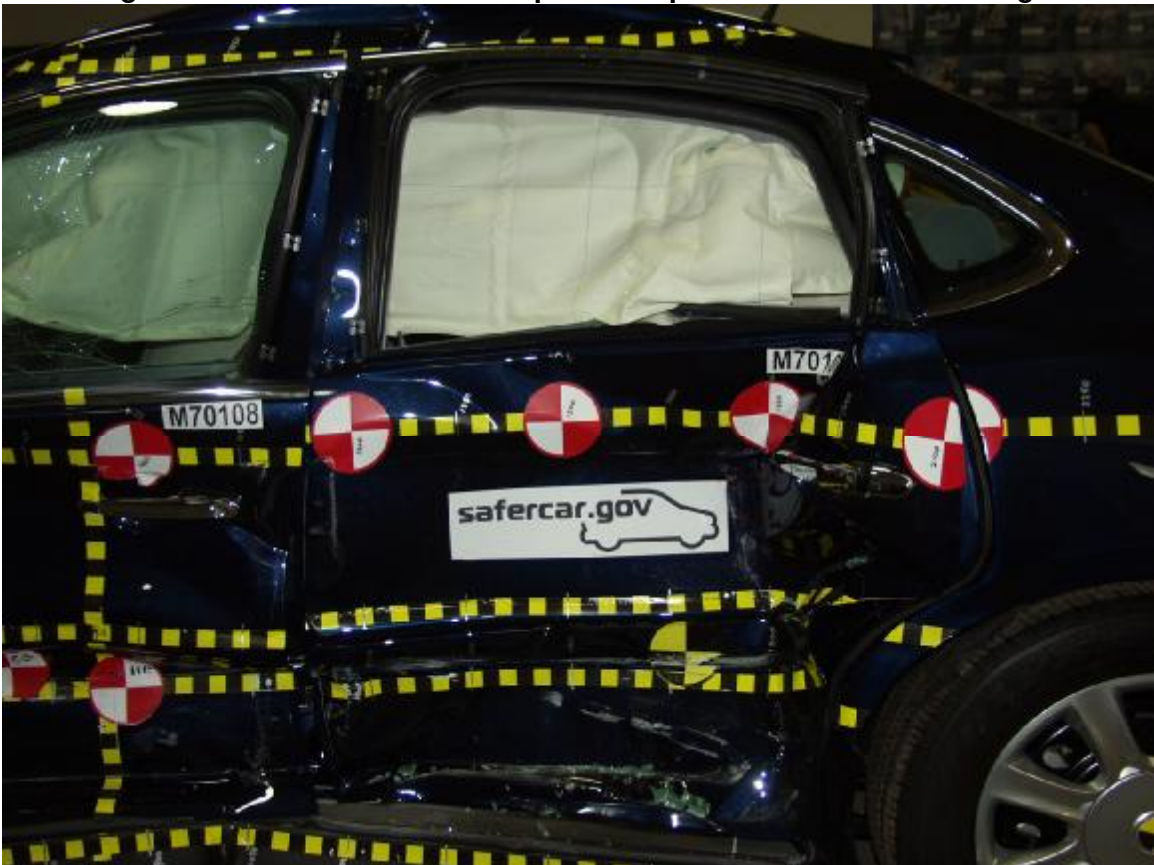
**Figure A-42: Post-Test Left Occupant Compartment View of Passenger**

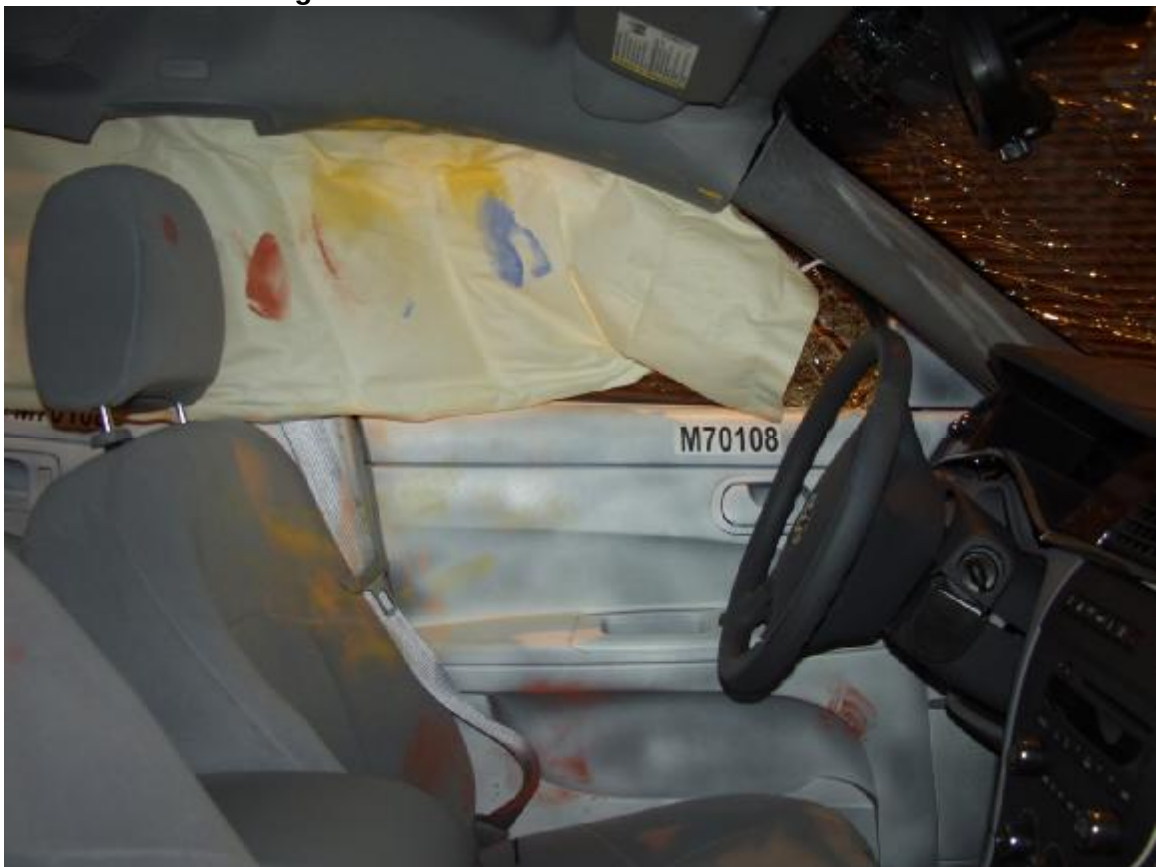
**Figure A-44: Post-Test Left Front Interior Trim**

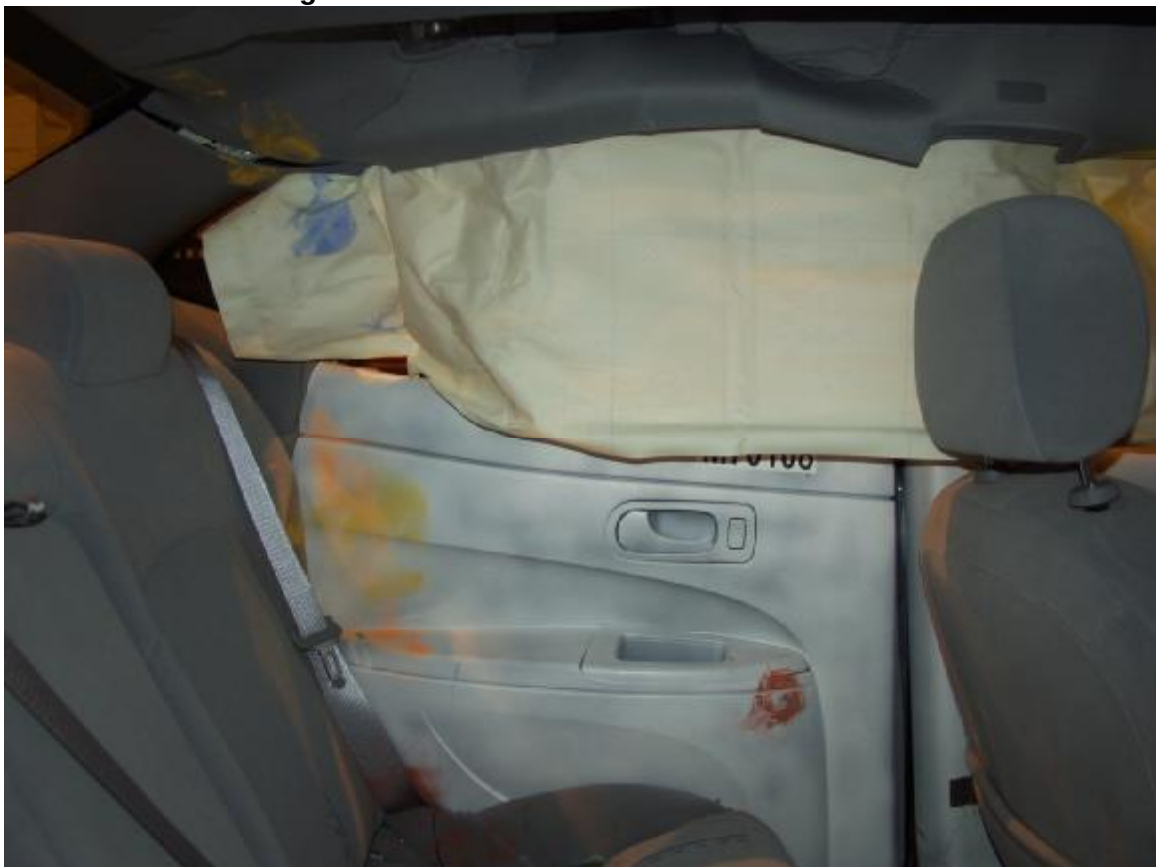
**Figure A-46: Post-Test Left Rear Interior Trim**

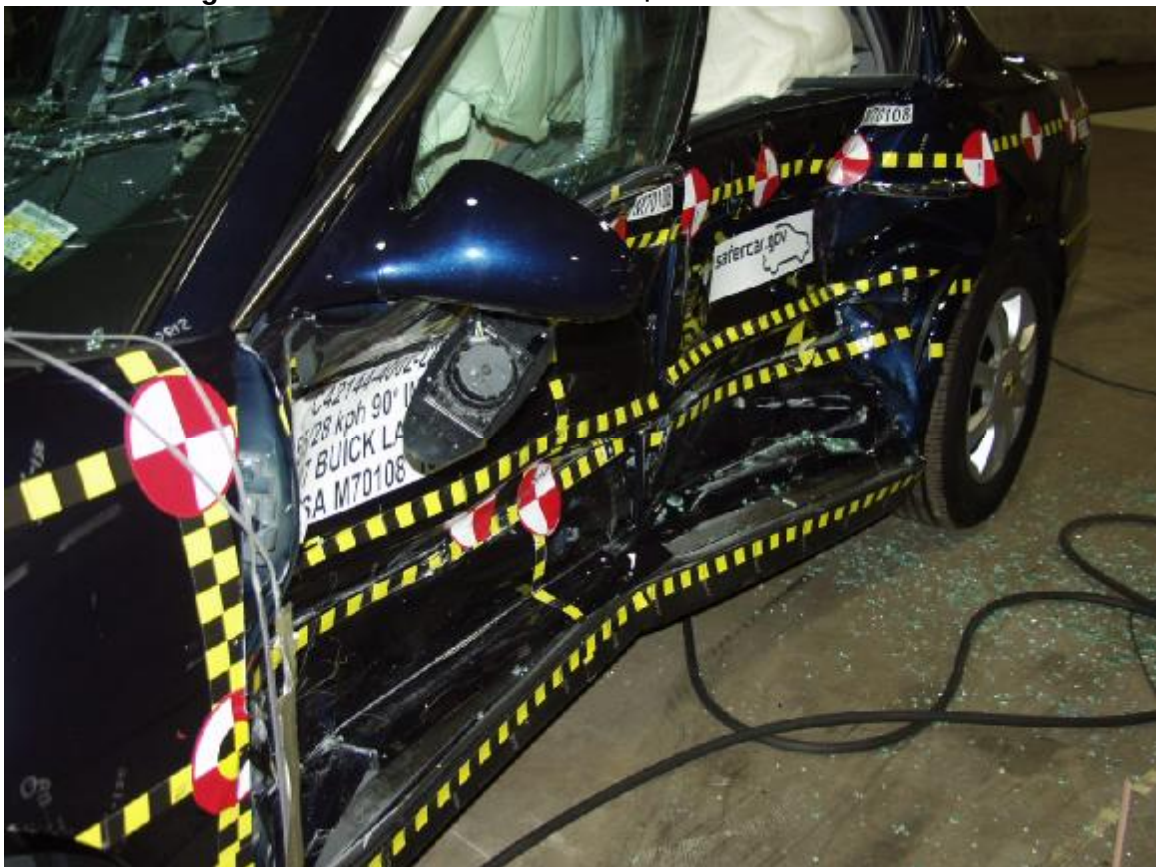
**Figure A-48: Post-Test Left Front  $\frac{3}{4}$  View of Left Side Doors**

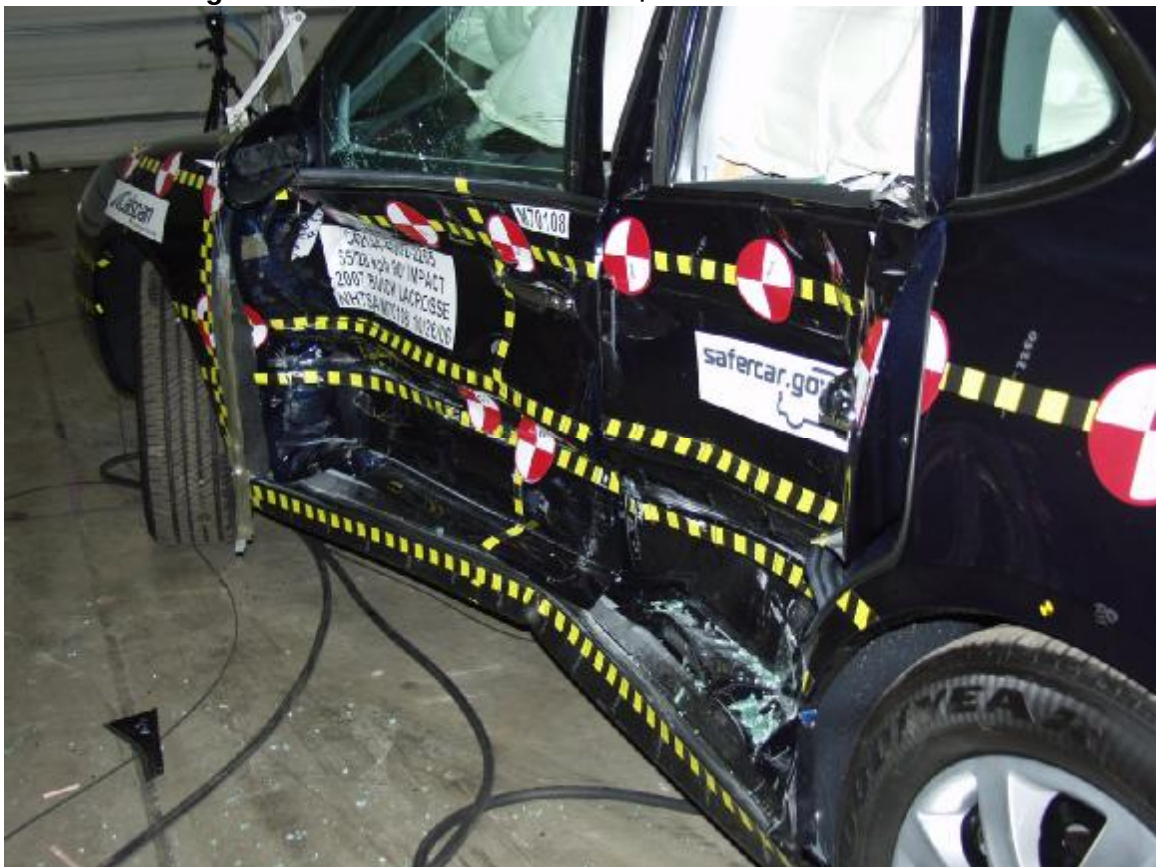
**Figure A-50: Post-Test Left Rear  $\frac{3}{4}$  View of Left Side Doors**

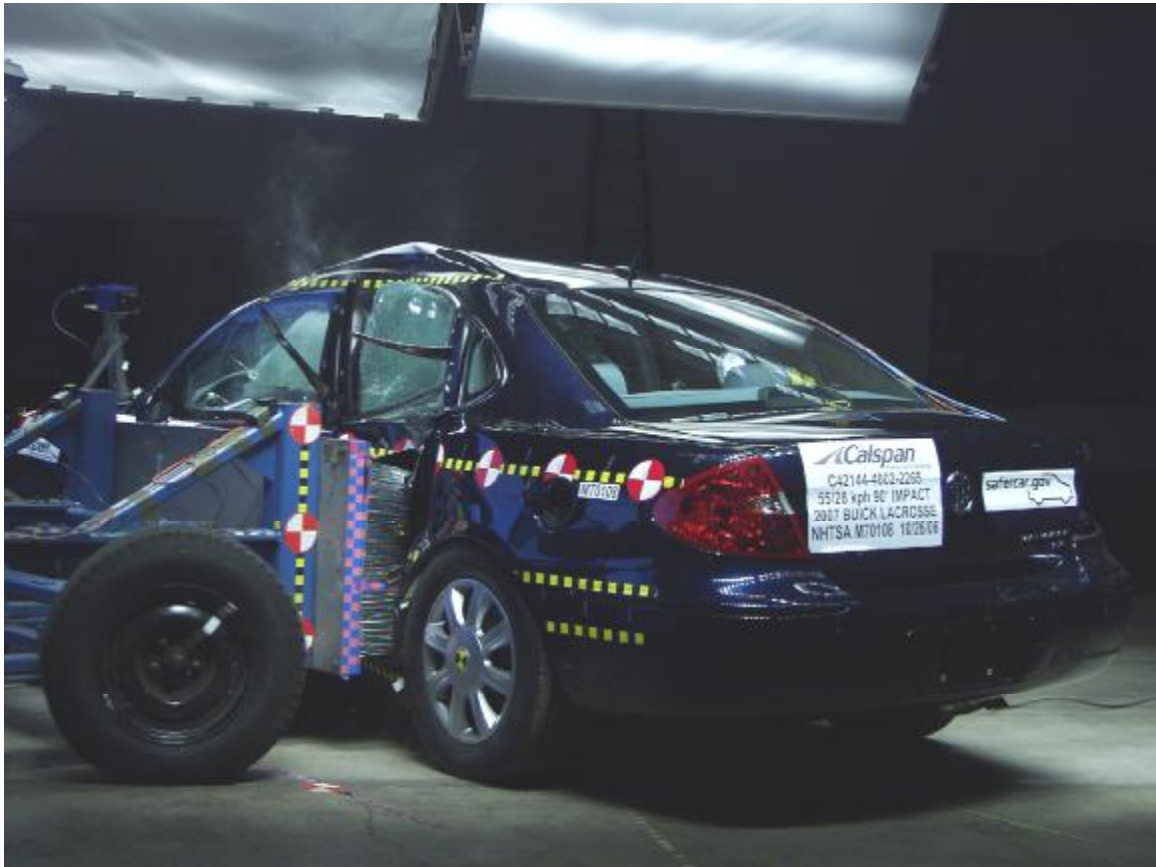
**Figure A-55: Impact Photo**
