**REPORT NUMBER: SNCAP-CAL-07-03**

**NEW CAR ASSESSMENT PROGRAM  
SIDE IMPACT TEST**

**HONDA OF AMERICA MFG.  
2007 HONDA ELEMENT  
MPV**

**NHTSA NUMBER: M75306**

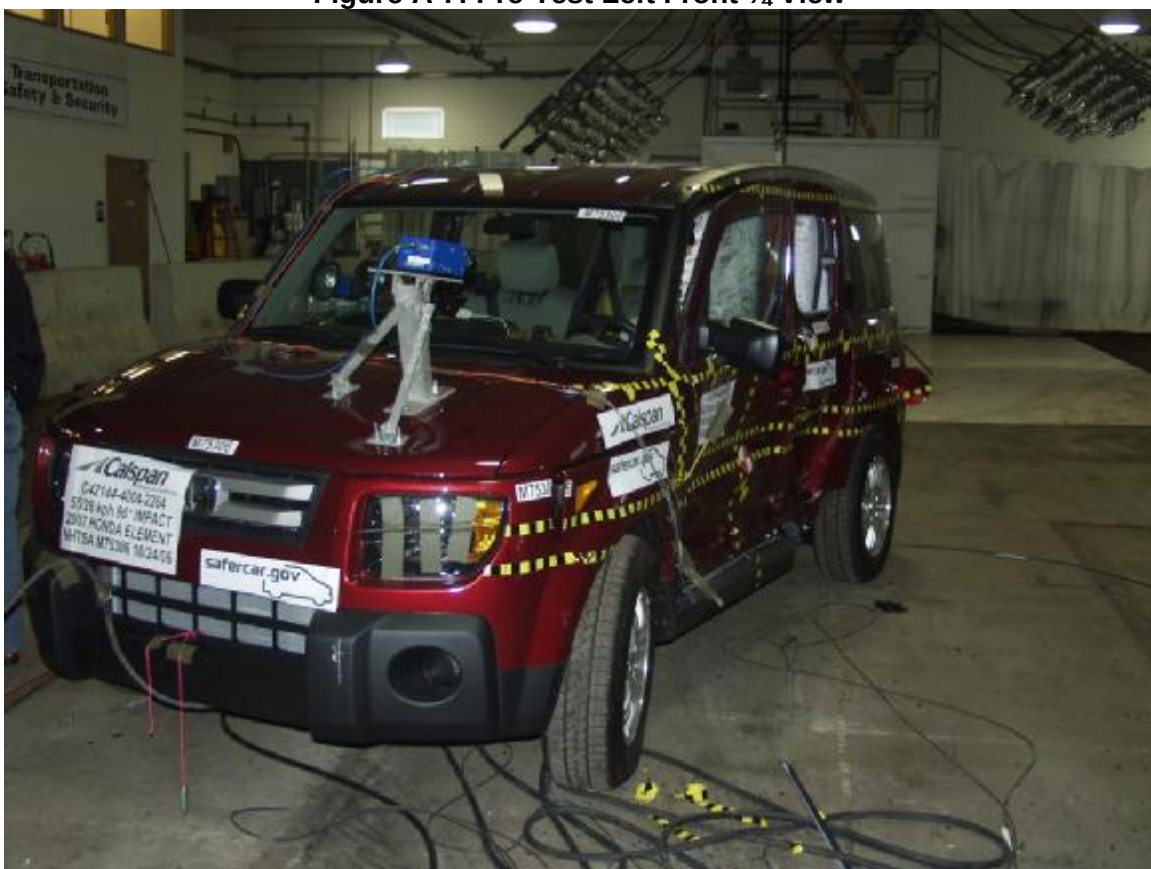
Figure A-8: Post-Test Left Front  $\frac{3}{4}$  View

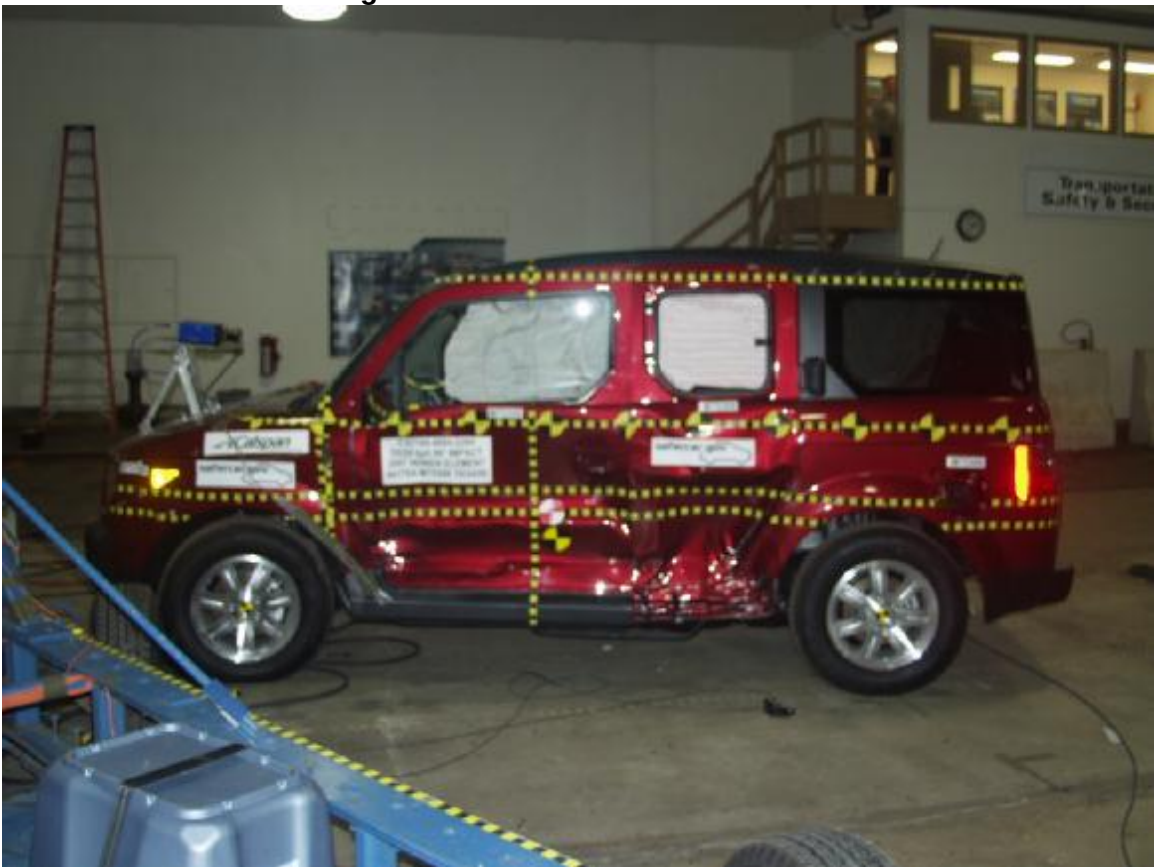
Figure A-10: Post-Test Left Side View

The test vehicle sustained a maximum static crush of 161 mm at level 3, 1050 mm rearward of the left vertical impact point. The driver and passenger SID/HIII's, Serial Nos. and respectively, were calibrated just prior to this test.

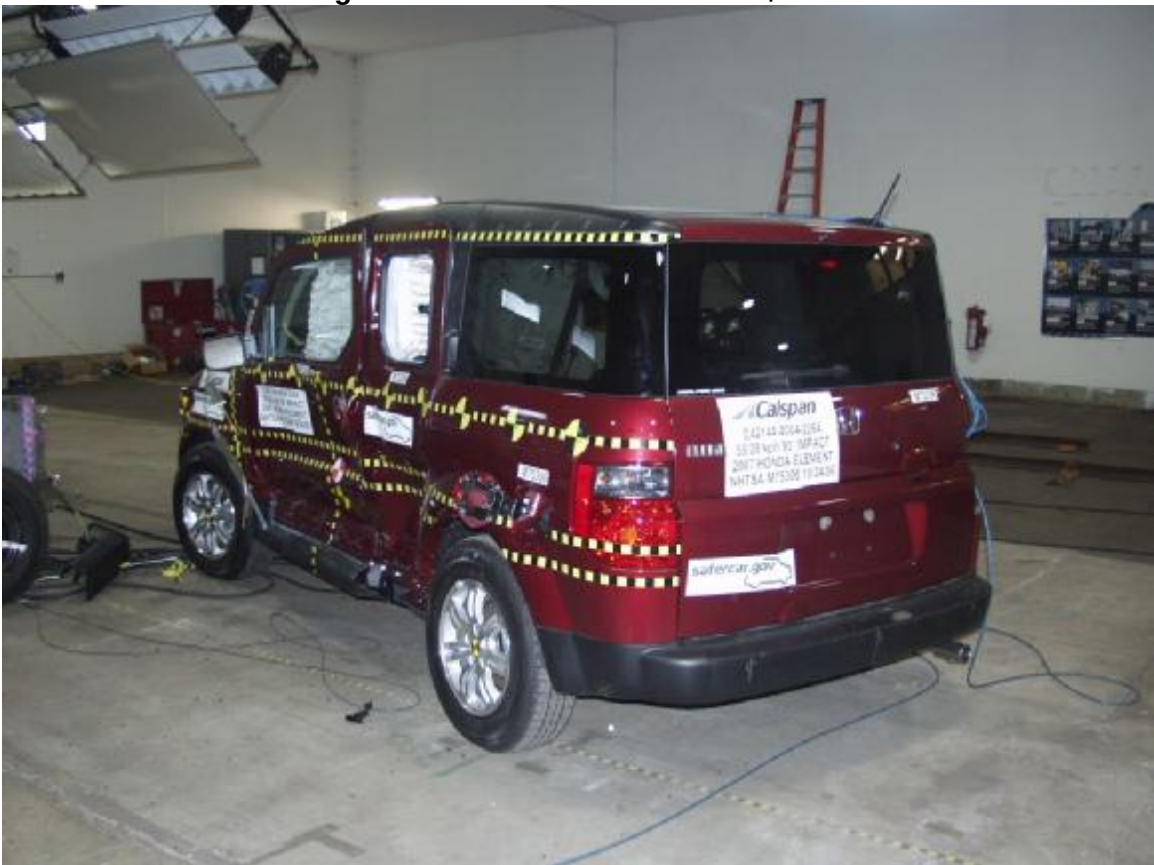
**Figure A-12: Post-Test Left Rear  $\frac{3}{4}$  View**

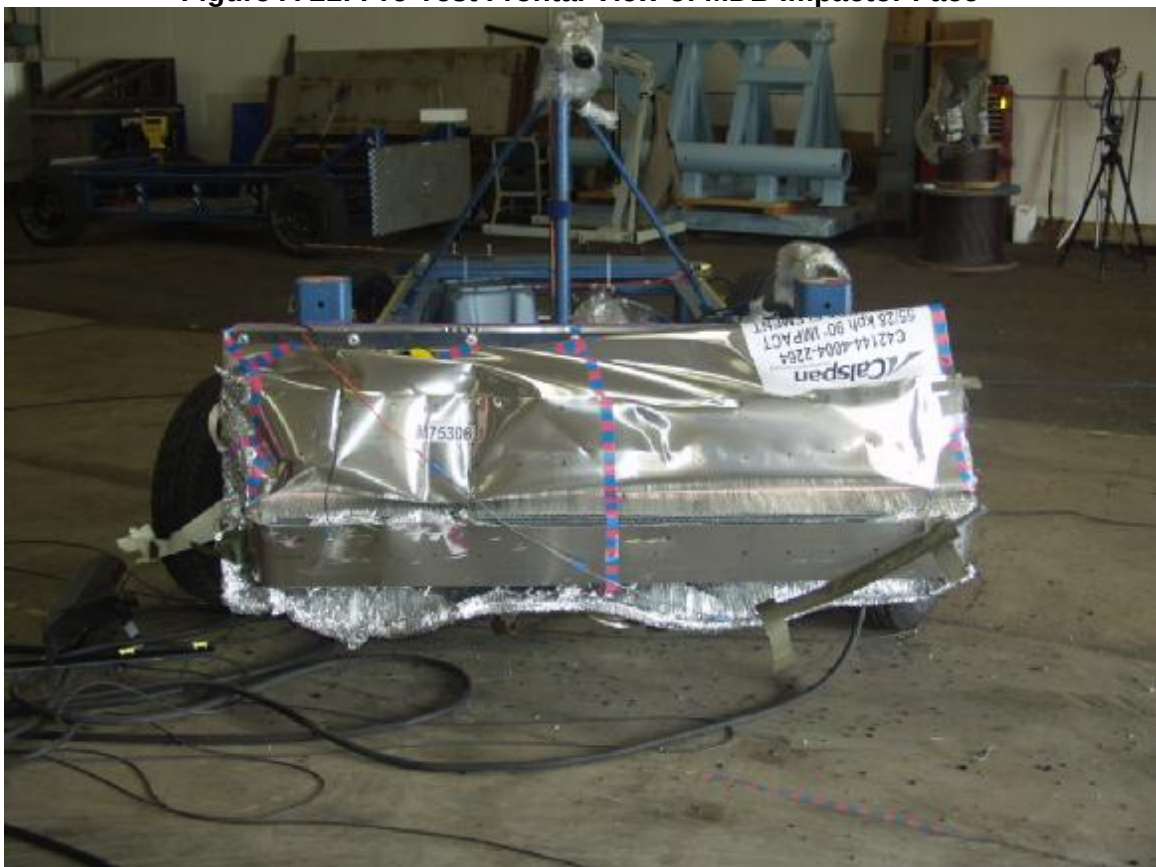
**Figure A-22: Post-Test Frontal View of MDB Impactor Face**

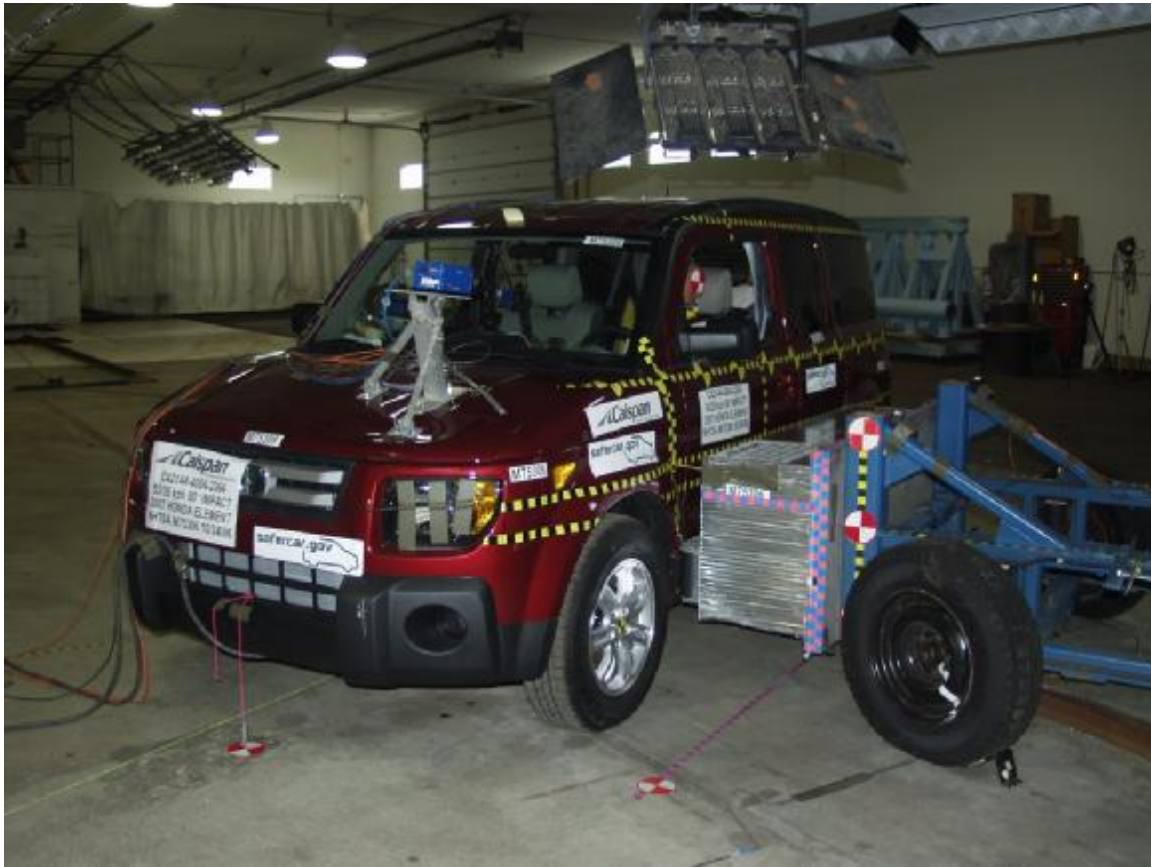
Figure A-29: Pre-Test Left Side View of Aligned MDB and Vehicle

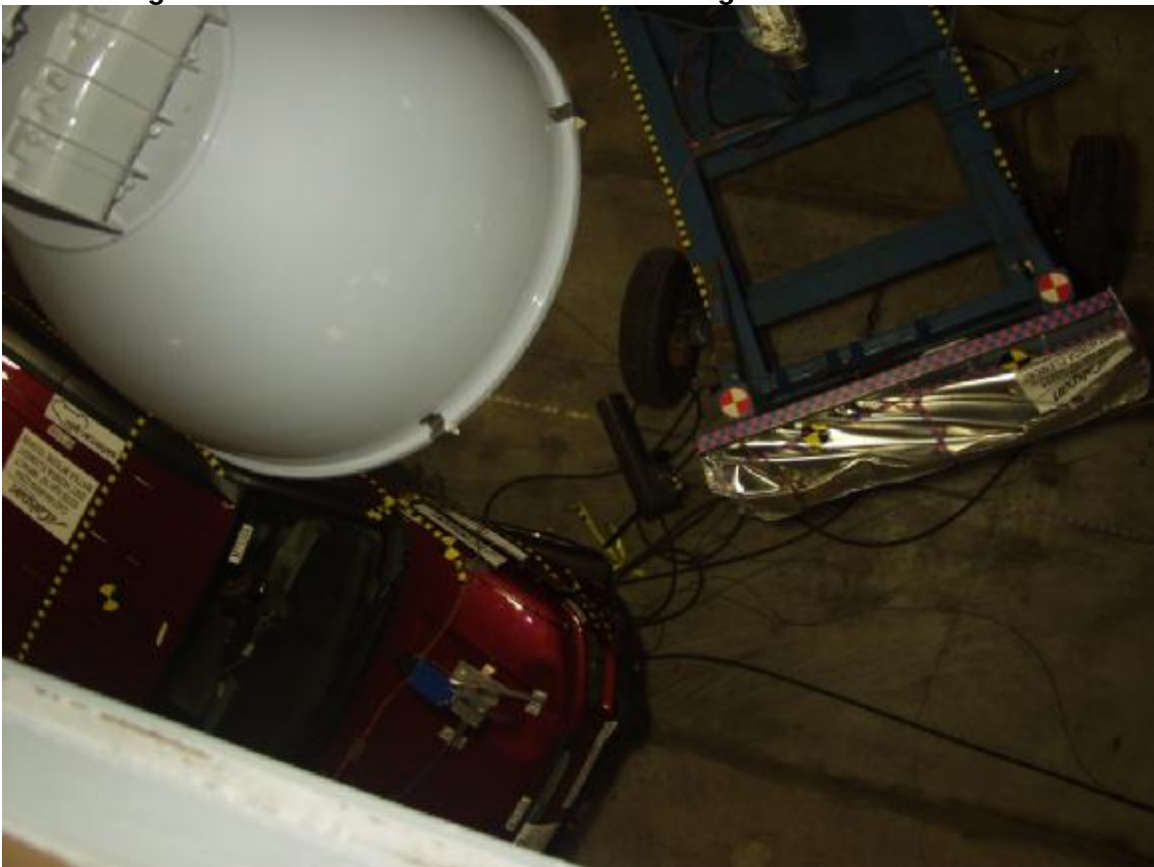
**Figure A-32: Post-Test Overhead View of MDB and Vehicle**

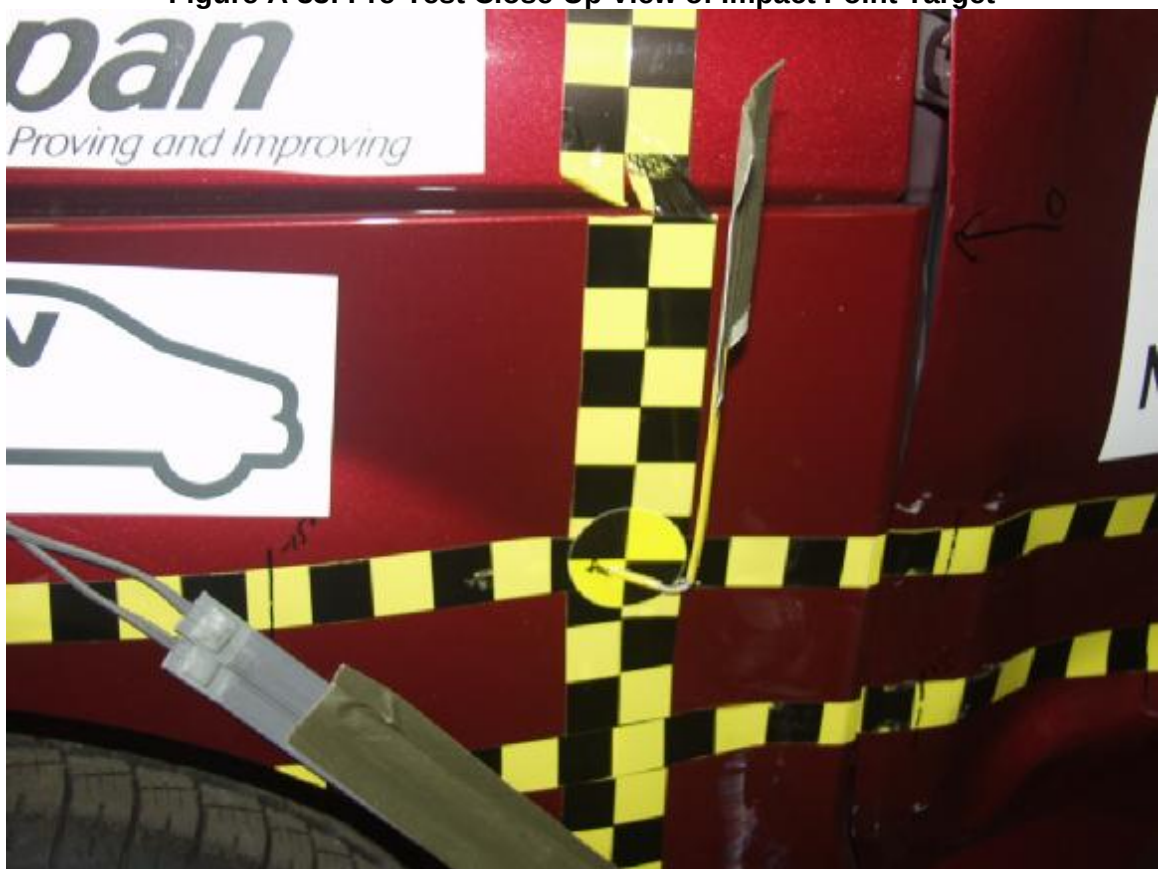
Figure A-34: Post-Test Close-Up View of Impact Point Target

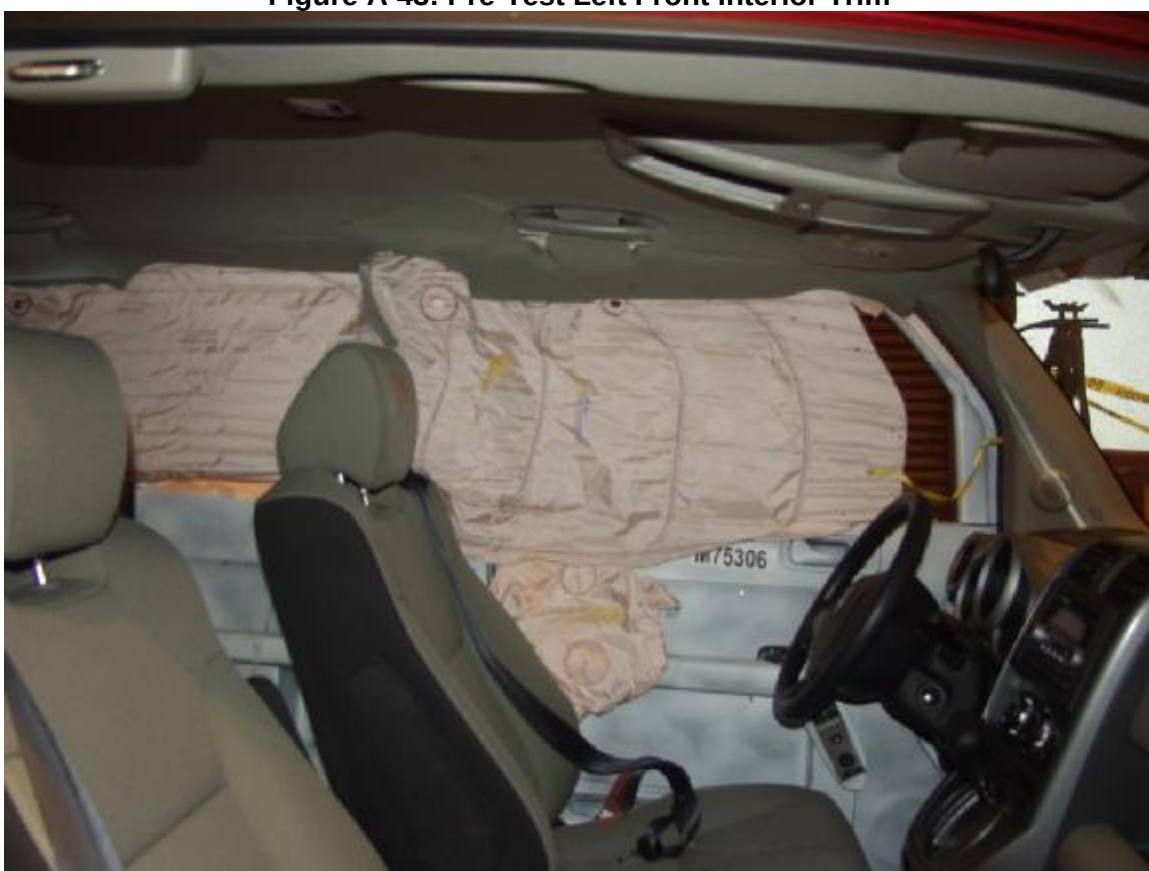
**Figure A-44: Post-Test Left Front Interior Trim**

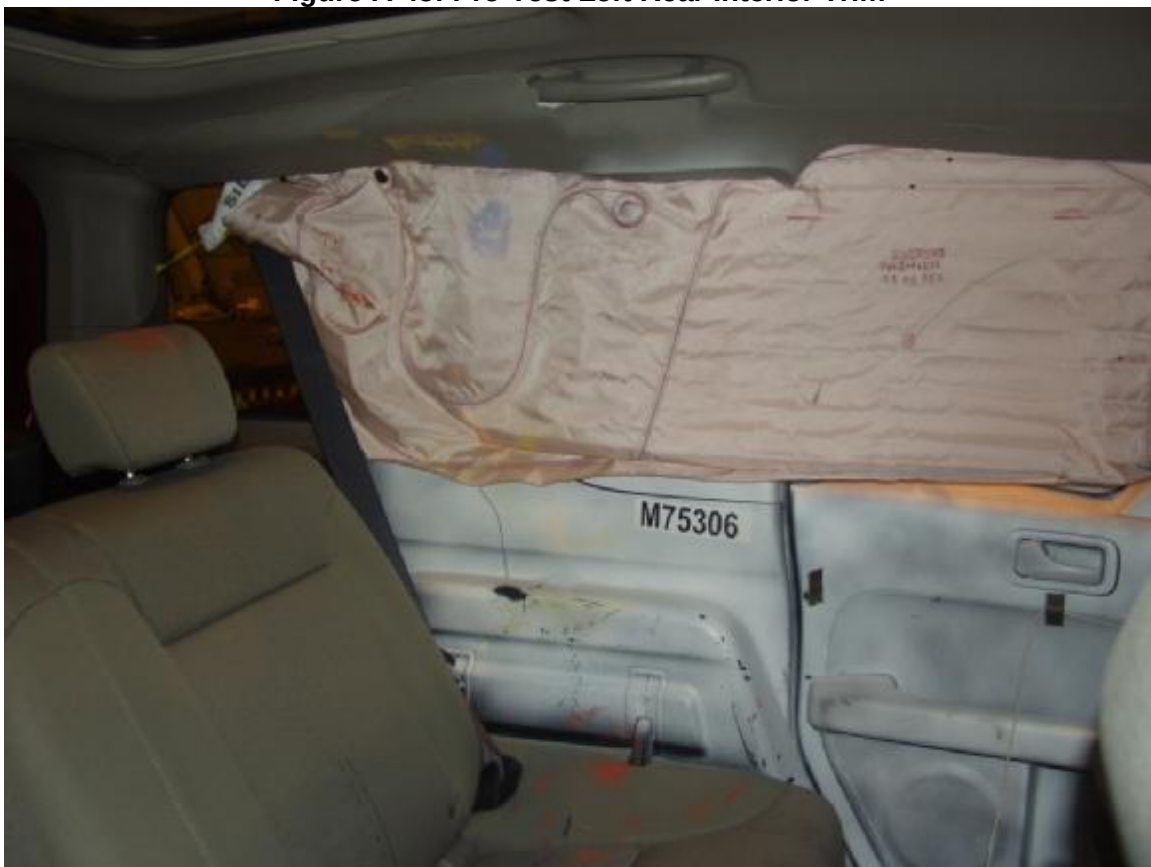
**Figure A-46: Post-Test Left Rear Interior Trim**

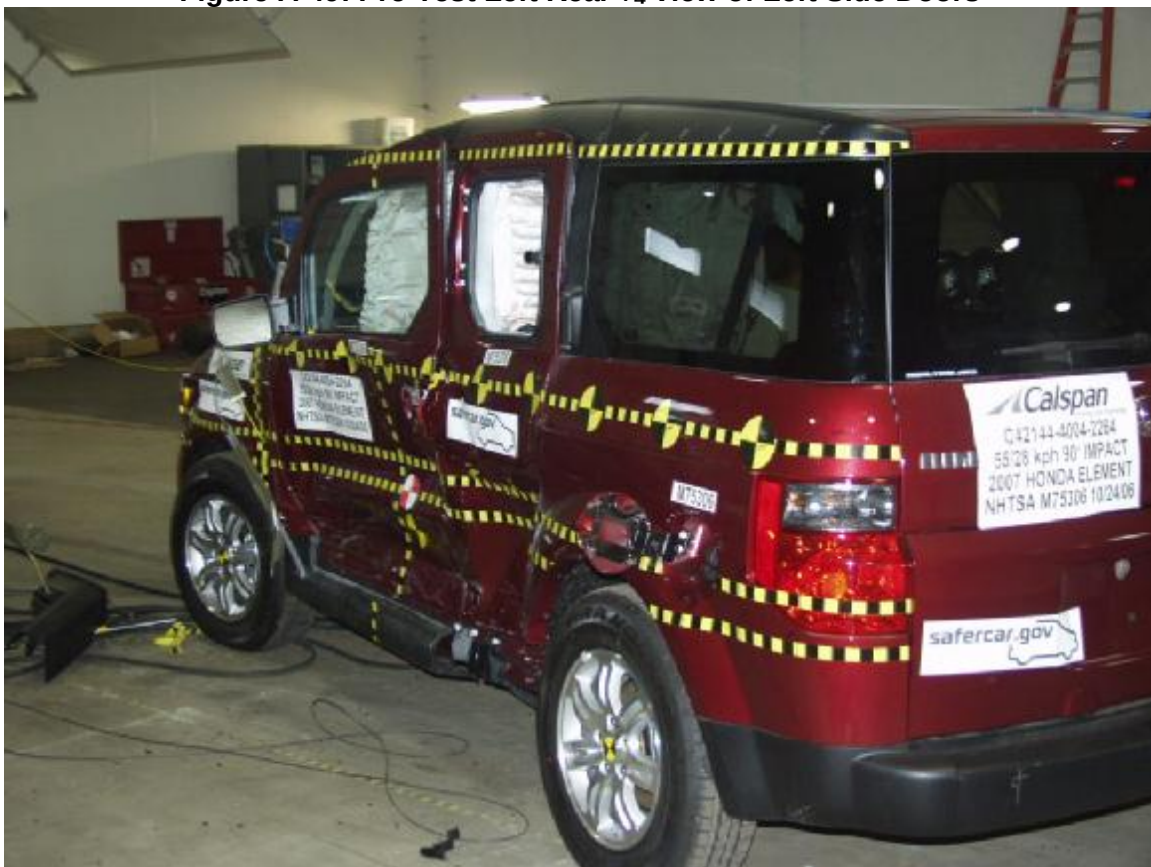
**Figure A-50: Post-Test Left Rear  $\frac{3}{4}$  View of Left Side Doors**

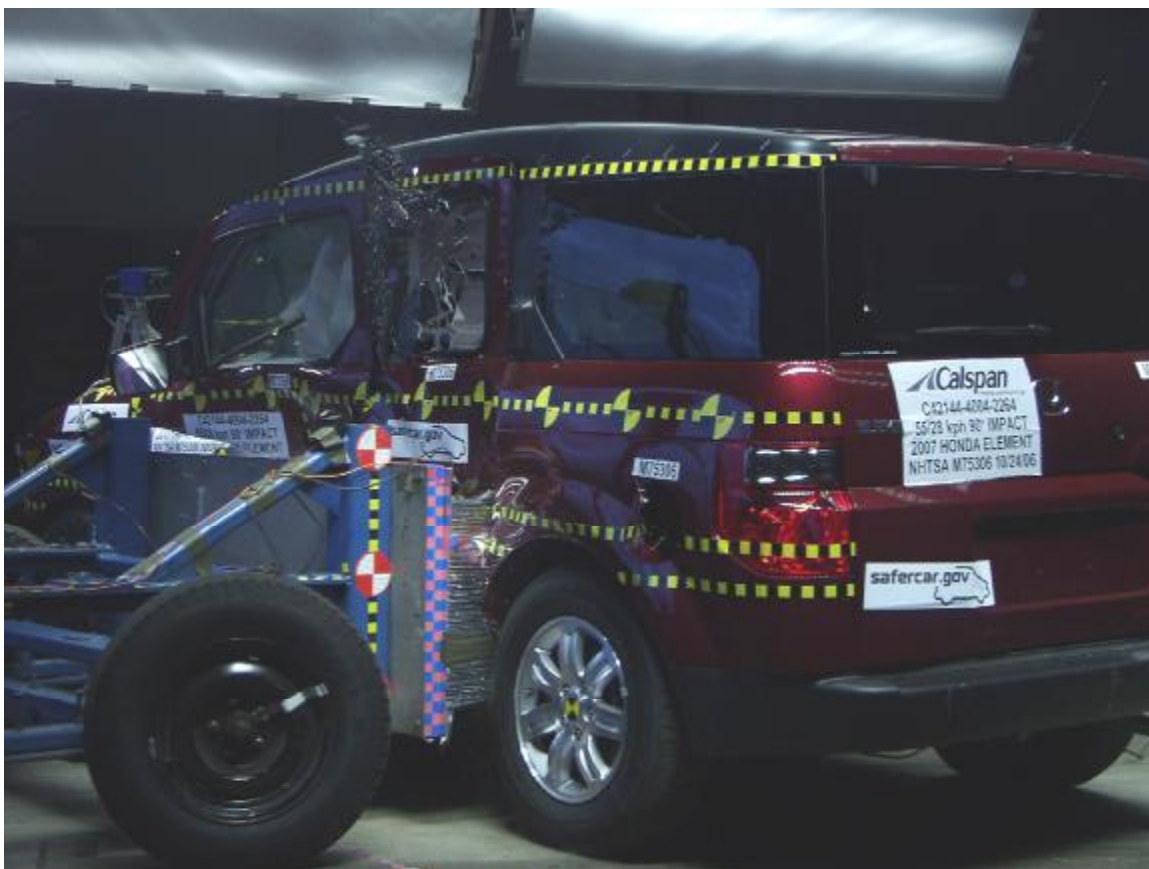
**Figure A-55: Impact Photo**
