**REPORT NUMBER: NCAP-MGA-2007-004**

**NEW CAR ASSESSMENT PROGRAM  
FRONTAL BARRIER IMPACT TEST**

**NISSAN MOTOR CO., LTD.  
2007 NISSAN SENTRA 4-DOOR  
NHTSA NUMBER: M75204**

**PREPARED BY:  
MGA RESEARCH CORPORATION  
5000 WARREN ROAD  
BURLINGTON, WI 53105**

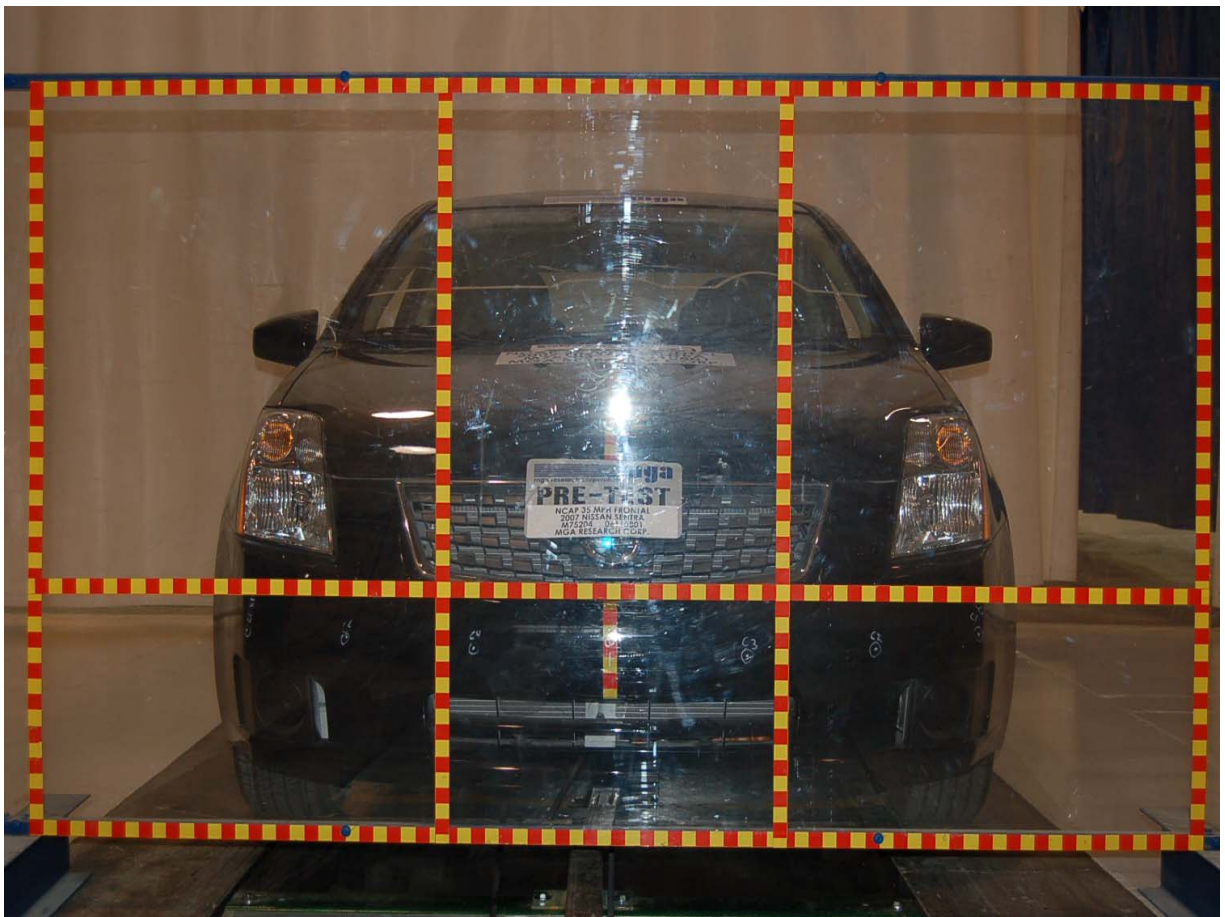
Load Cell Location

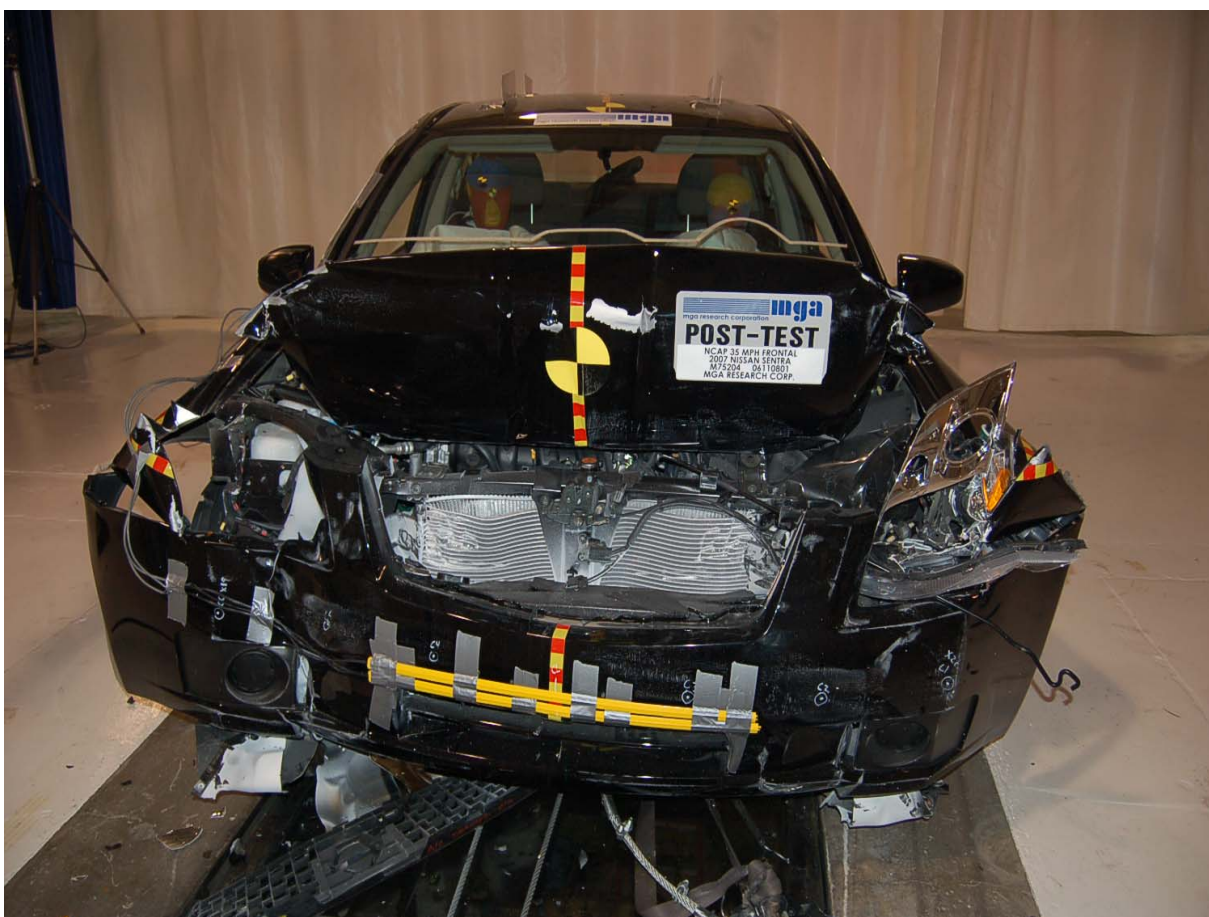
Post-Test Front View

The maximum static crush of the vehicle was 507 mm and both the driver and passenger side doors remained closed and latched during the impact event and were operable after the impact.

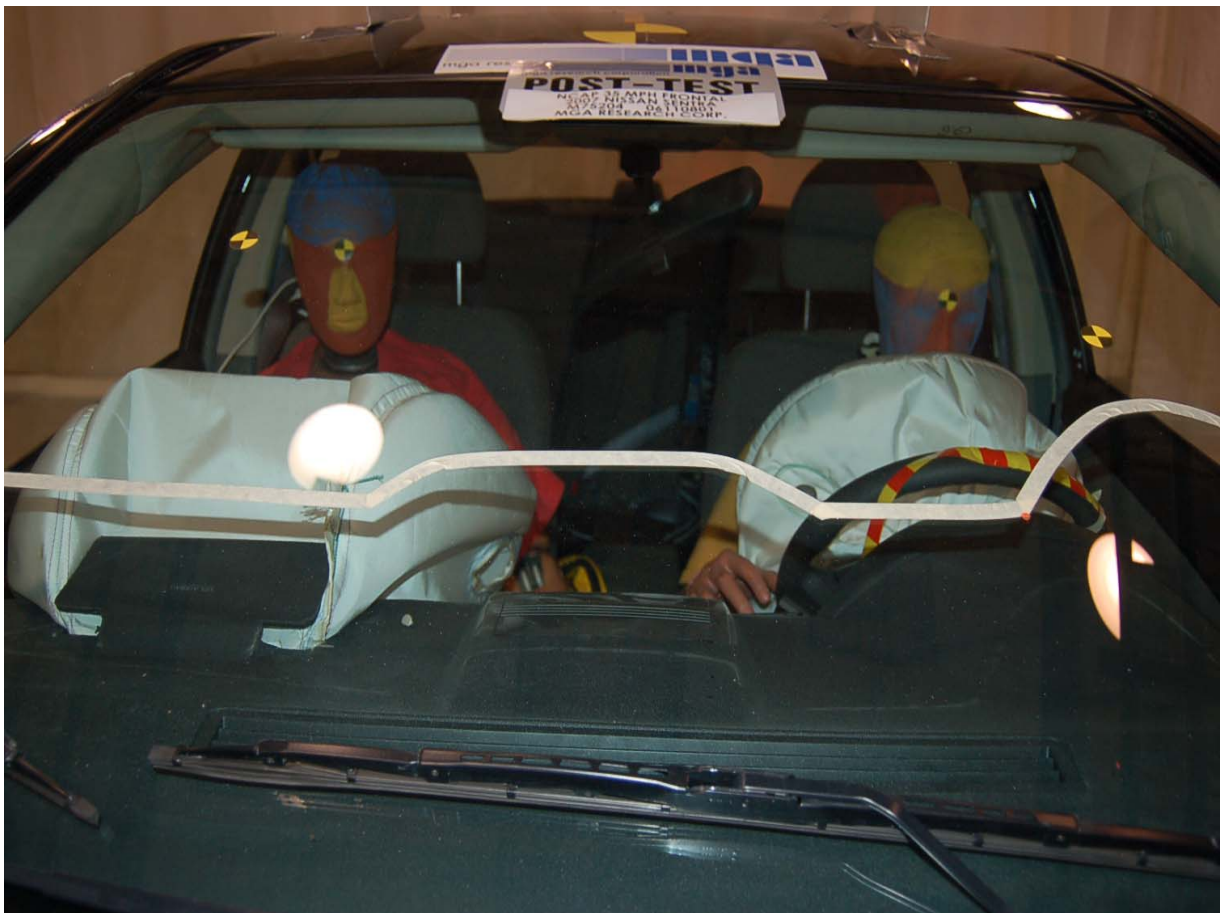
Post-Test Windshield View

There was 100 percent windshield retention and no intrusion into the protected zone of the windshield during the event. There was no Stoddard Solvent leakage after the event or during any phase of the static rollover.

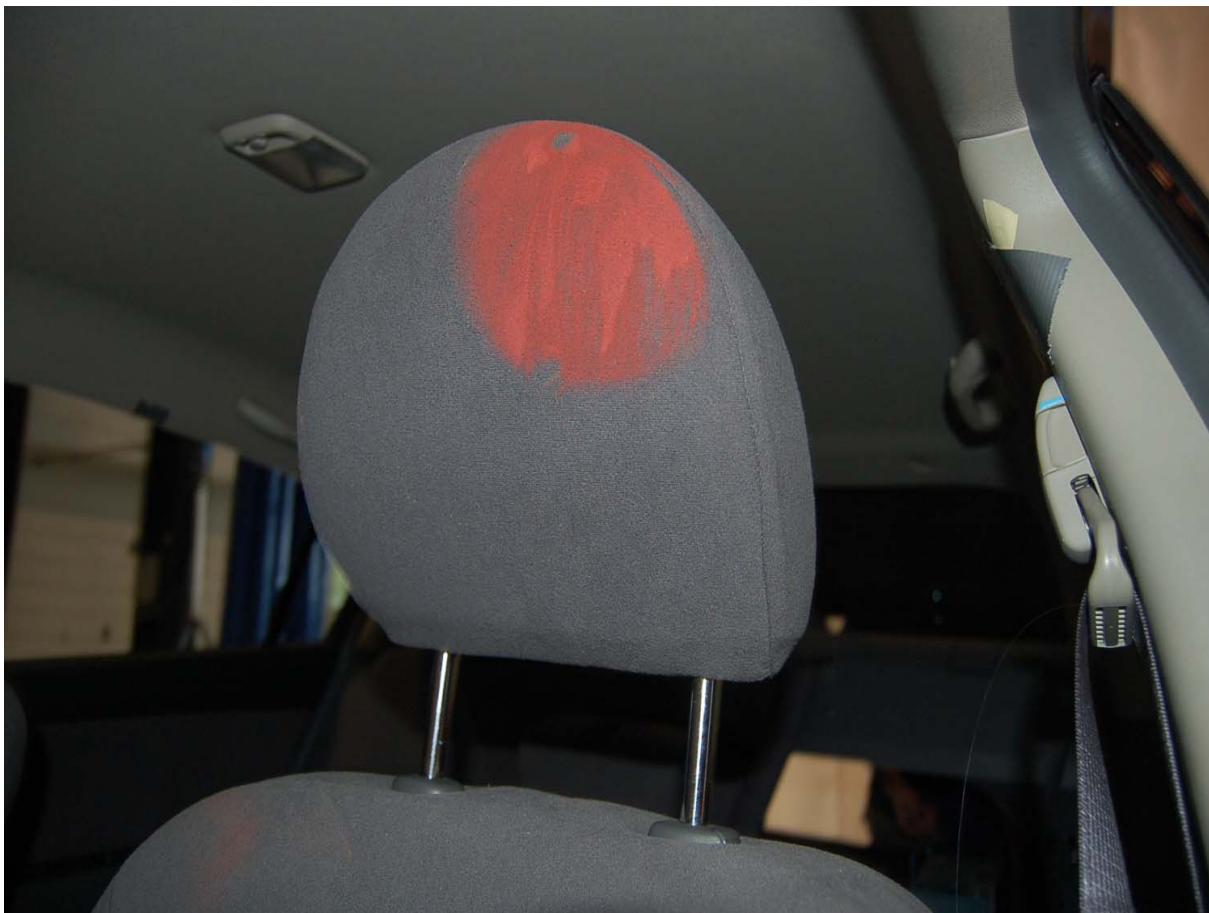
Post-Test Driver Dummy Head Contact (headrest)

The driver's head and chest contacted the airbag. The driver's head also contacted the headrest. The driver's knees contacted the bolster. The passenger's head and chest contacted the airbag. The passenger's head also contacted the headrest and grab handle. The passenger's knees contacted the glove box.

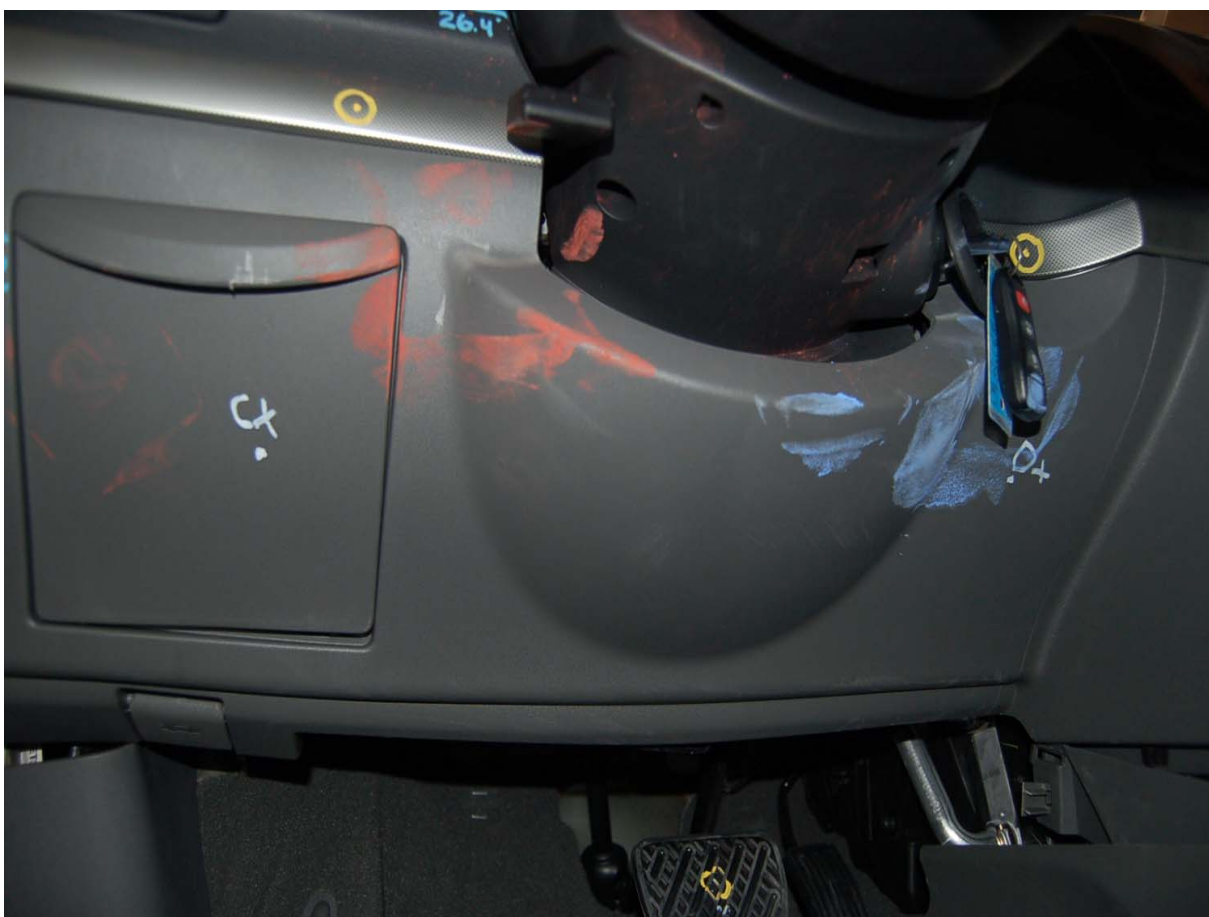
Post-Test Driver Dummy Knee Contact

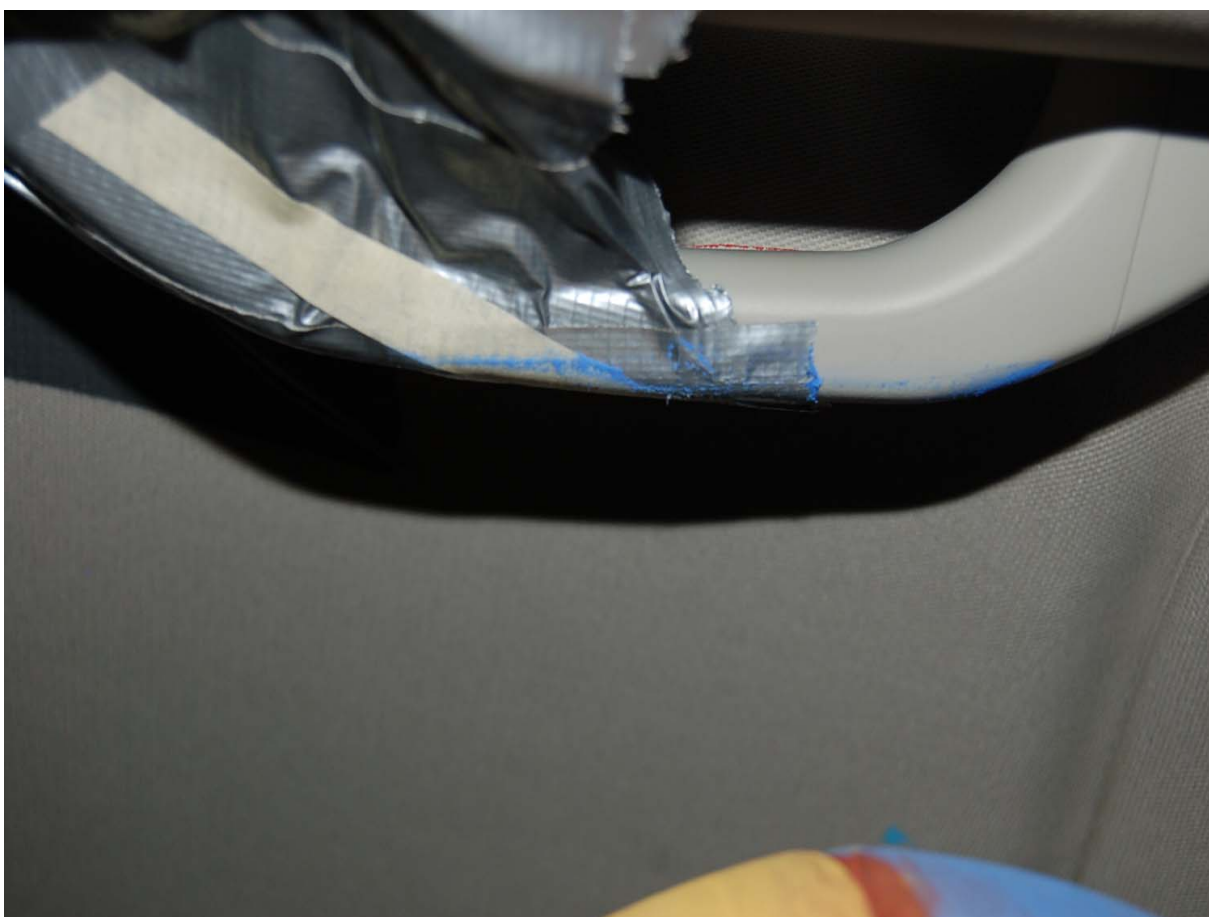
Post-Test Passenger Dummy Head Contact (grab handle)

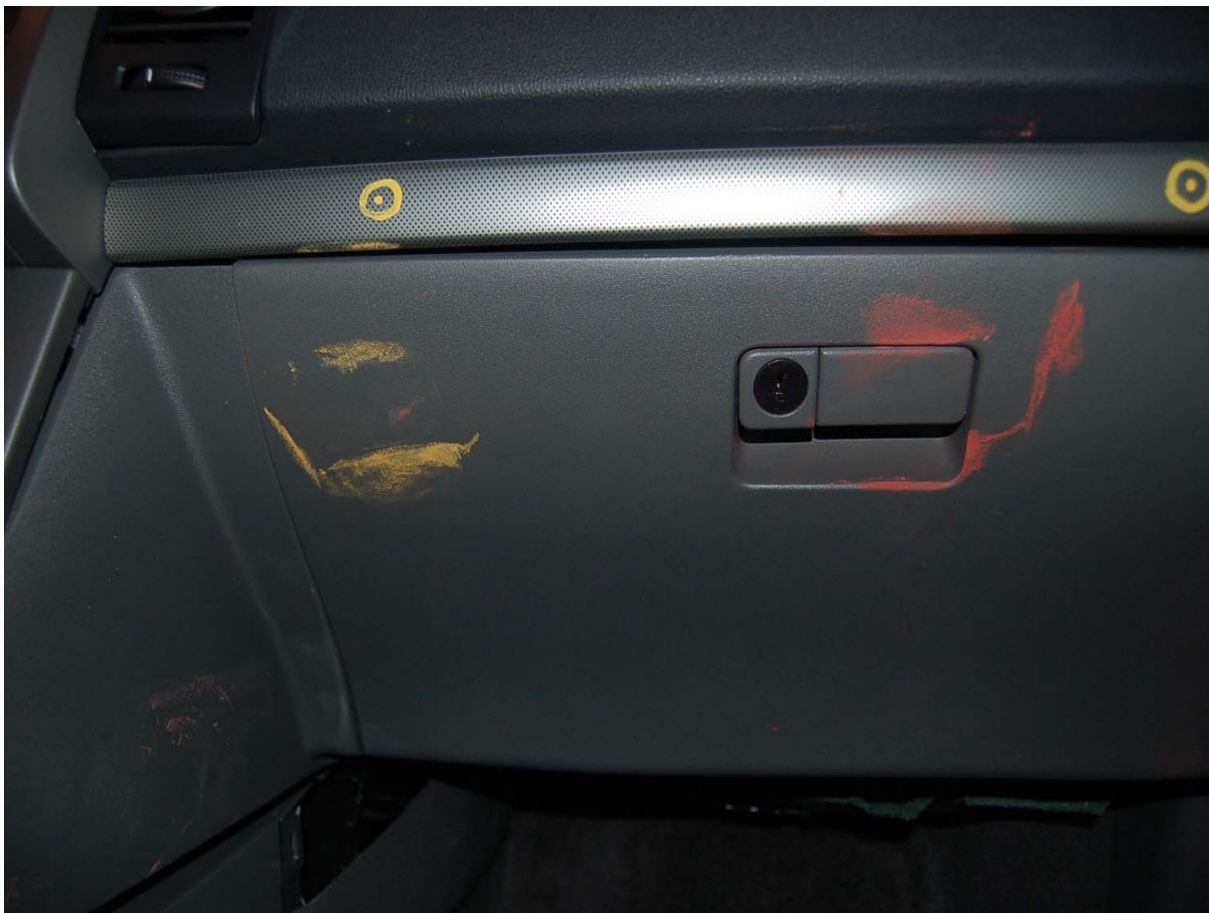
Post-Test Passenger Dummy Knee Contact

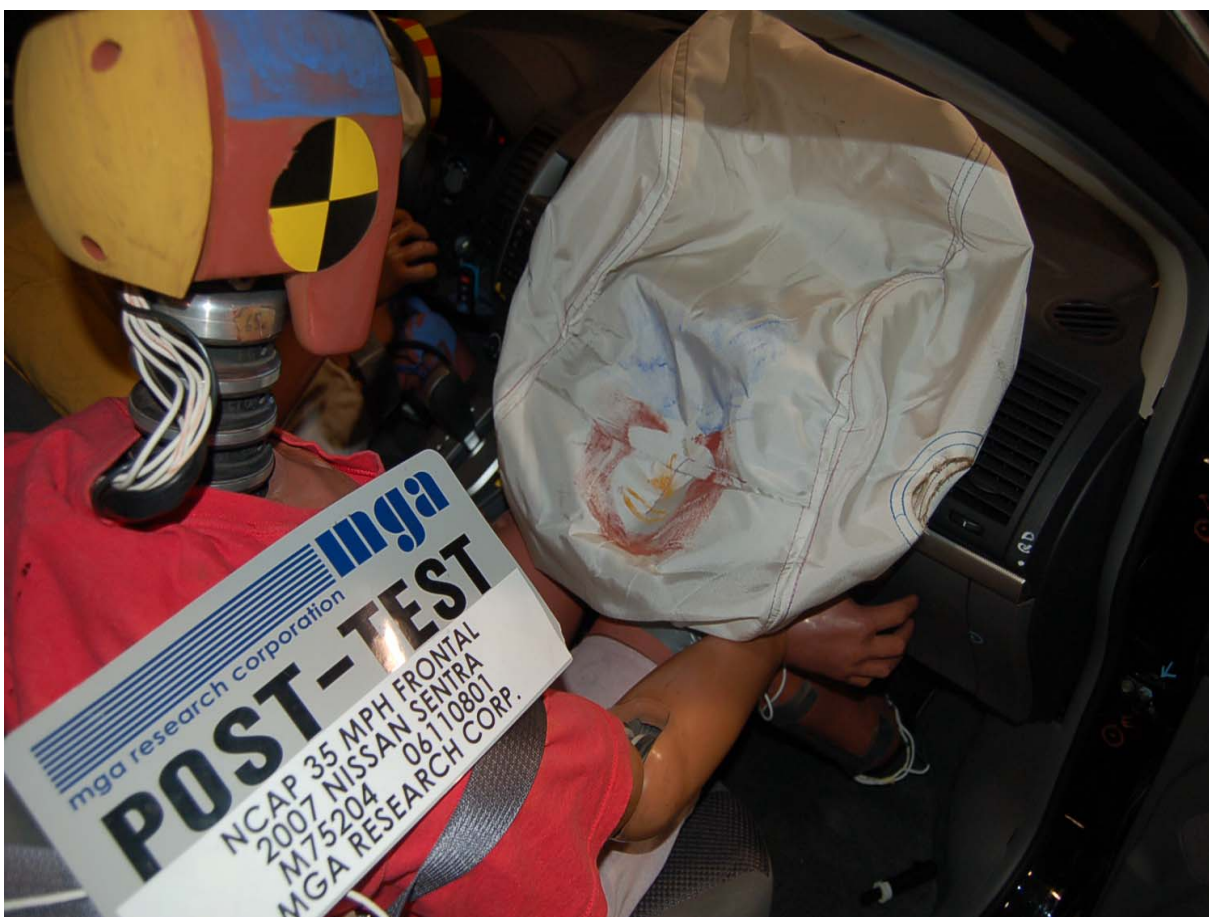
Post-Test Passenger Dummy Airbag Contact
