**REPORT NUMBER: SNCAP-CAL-07-05**

**NEW CAR ASSESSMENT PROGRAM  
SIDE IMPACT TEST**

**HONDA MOTOR CO., LTD.  
2007 HONDA CR-V  
MPV**

**FINAL REPORT**

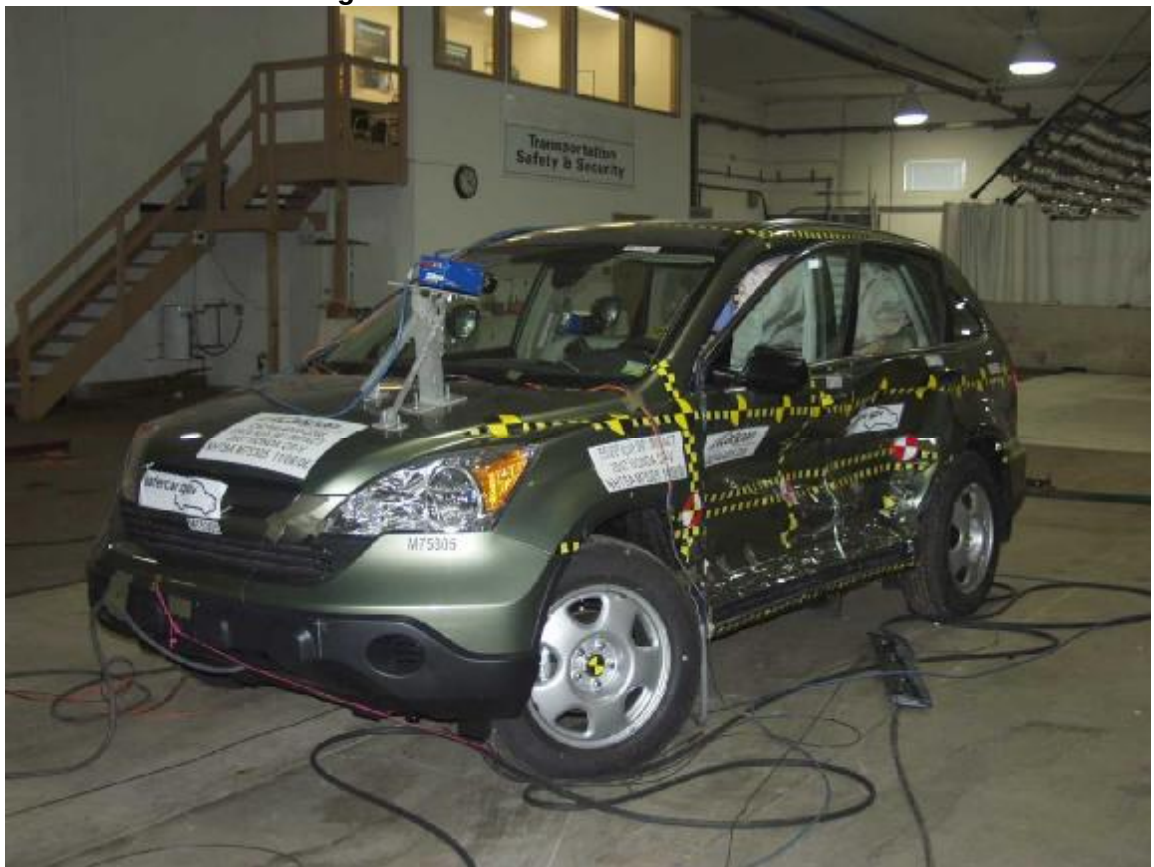
Figure A-8: Post-Test Left Front  $\frac{3}{4}$  View

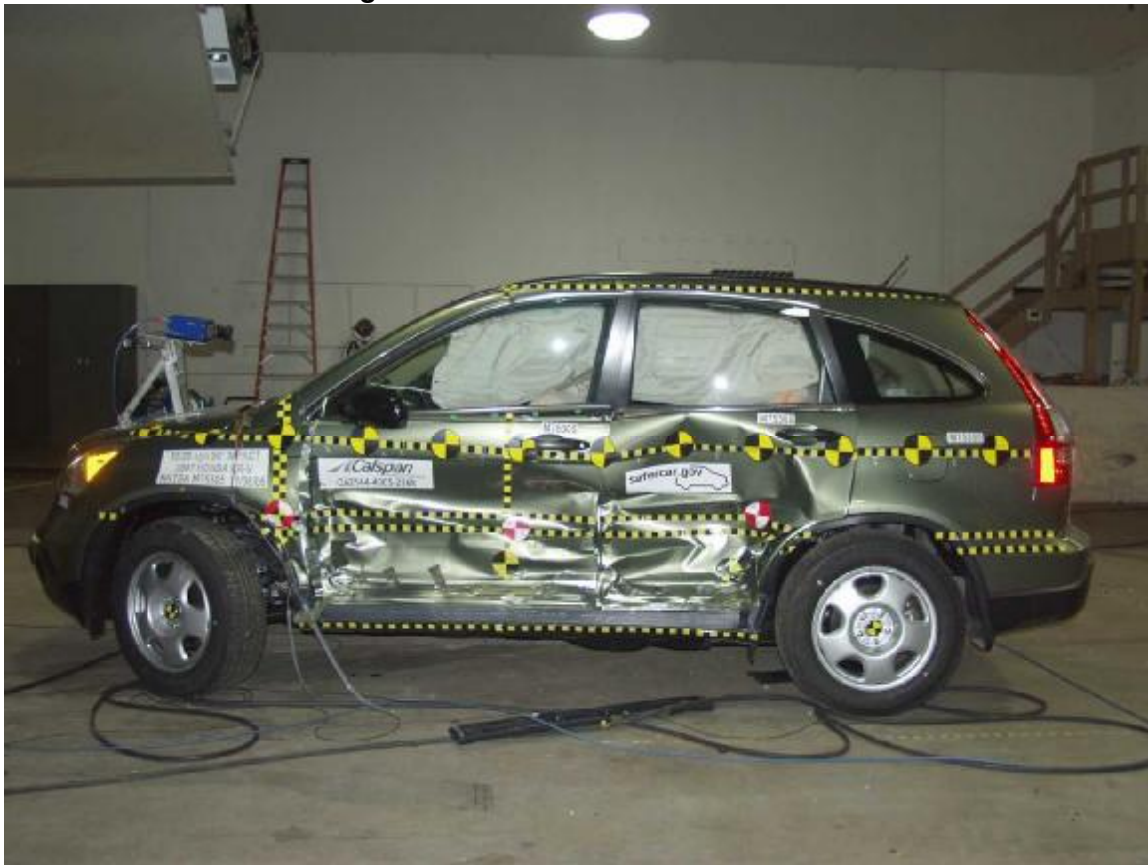
**Figure A-10: Post-Test Left Side View**

The test vehicle sustained a maximum static crush of 210 mm at level 3, 1350 mm rearward of the left vertical impact point. The driver and passenger SID/HIII's, Serial Nos. 269 and 270 respectively, were calibrated just prior to this test.

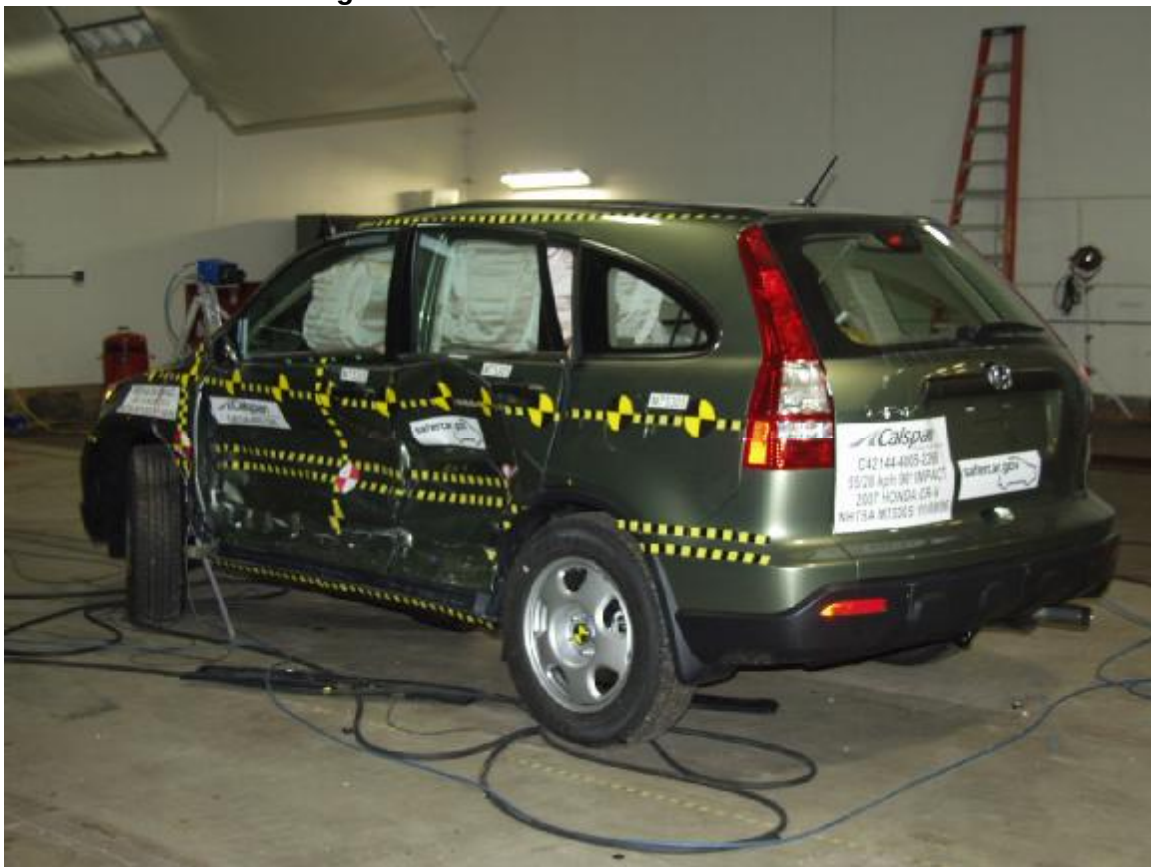
**Figure A-12: Post-Test Left Rear  $\frac{3}{4}$  View**

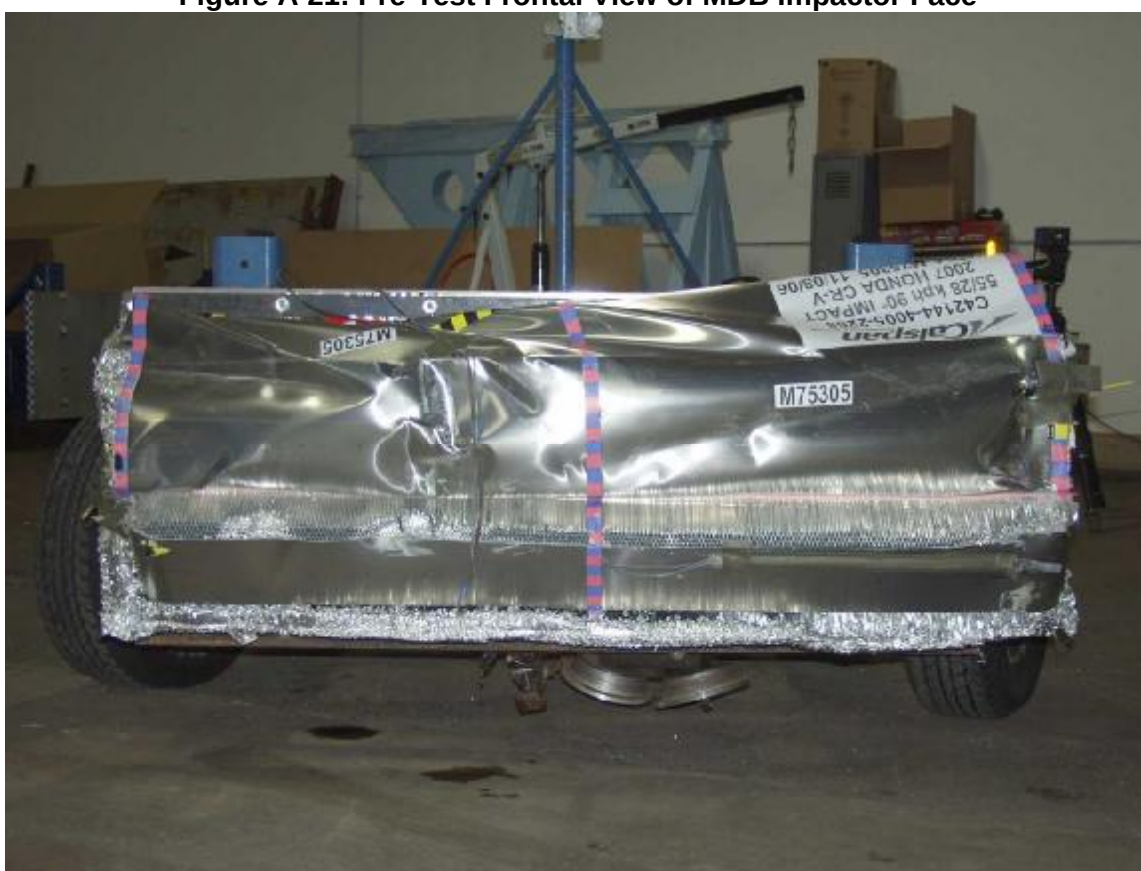
**Figure A-22: Post-Test Frontal View of MDB Impactor Face**

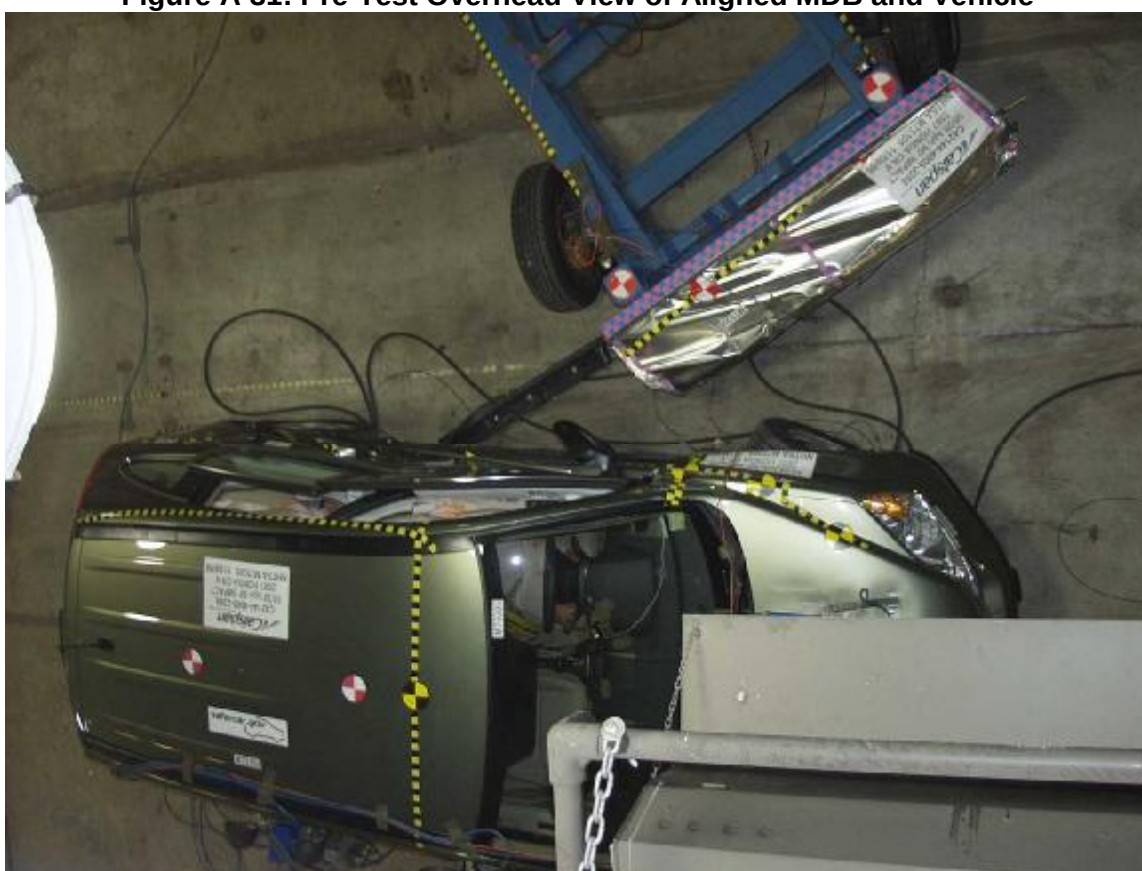
**Figure A-32: Post-Test Overhead View of MDB and Vehicle**

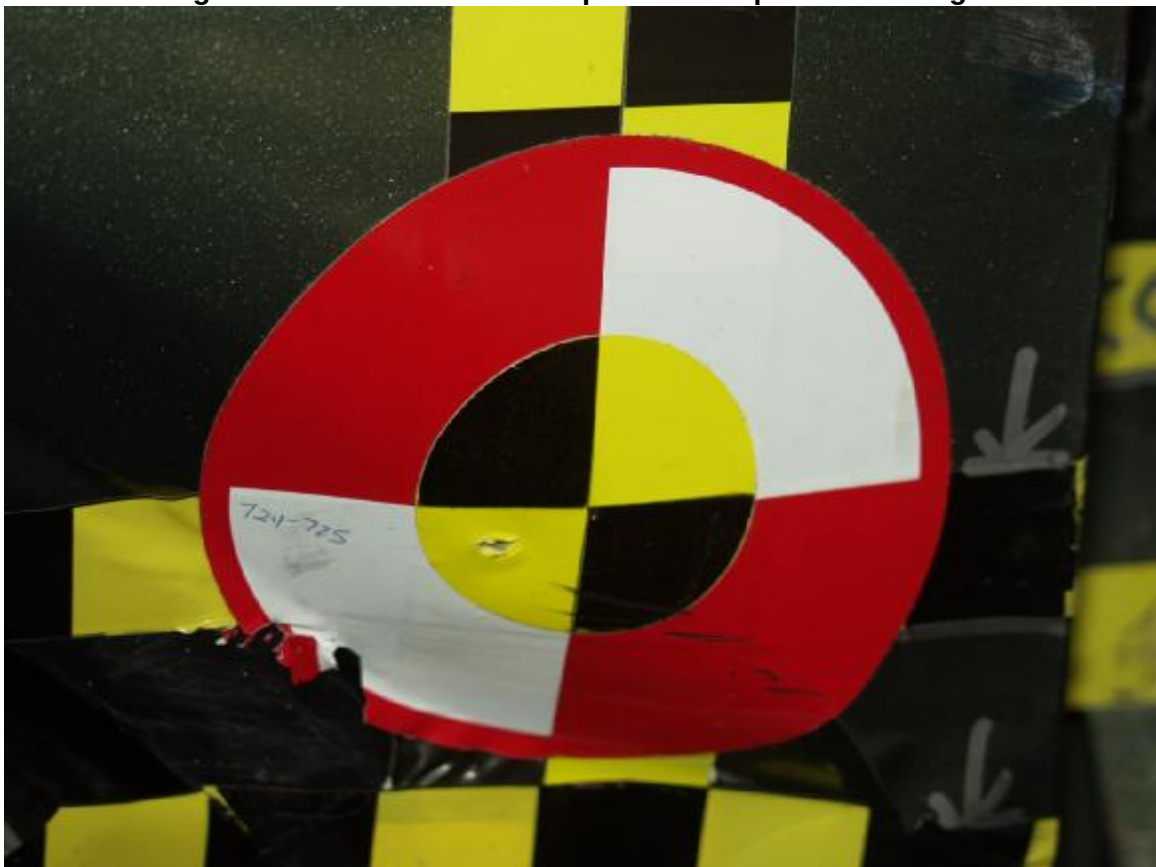
**Figure A-34: Post-Test Close-Up View of Impact Point Target**

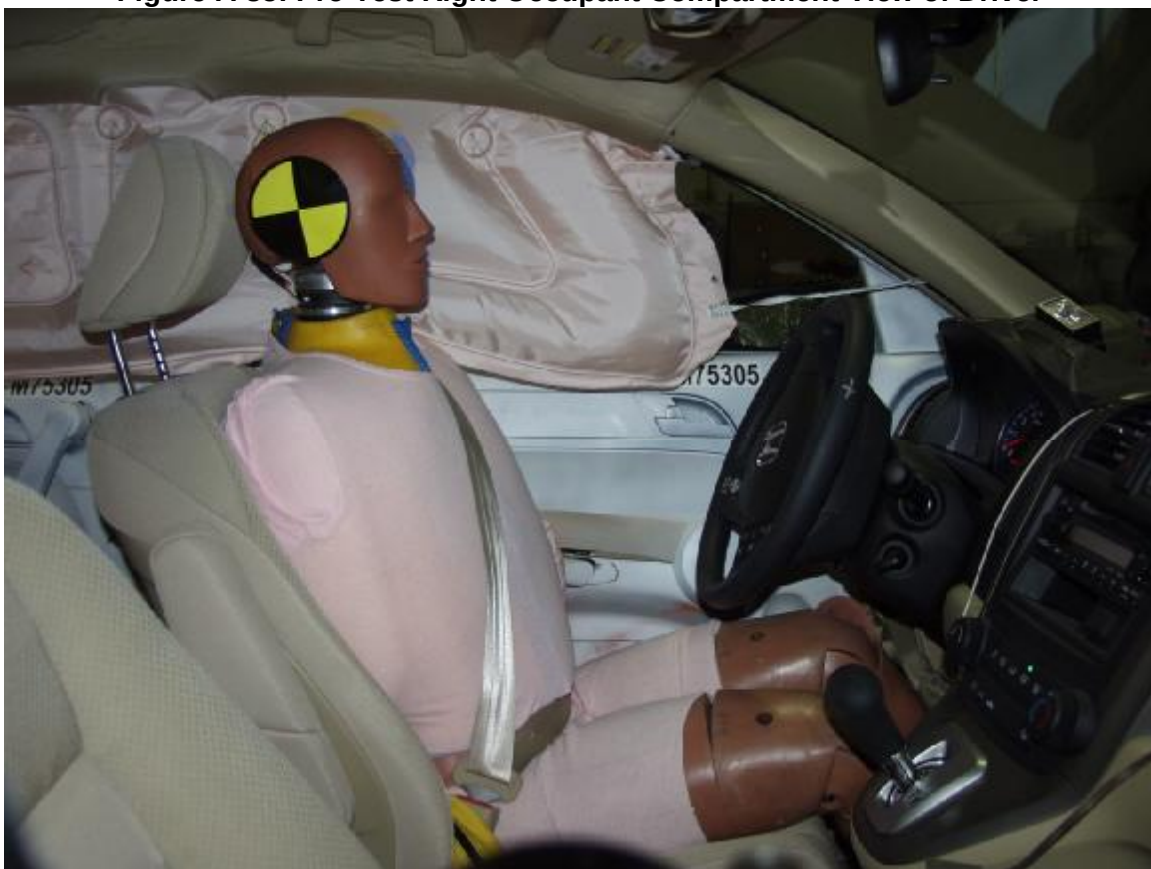
**Figure A-36: Post-Test Right Occupant Compartment View of Driver**

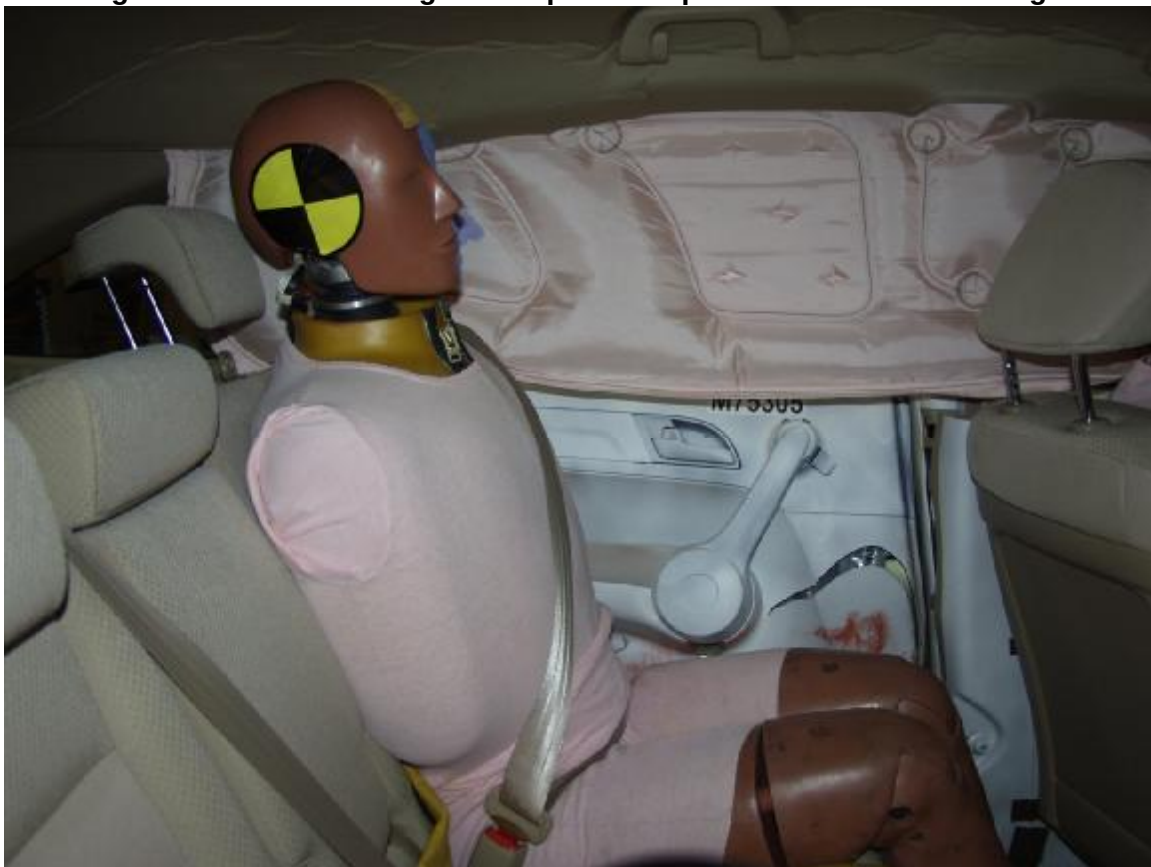
**Figure A-38: Post-Test Right Occupant Compartment View of Passenger**

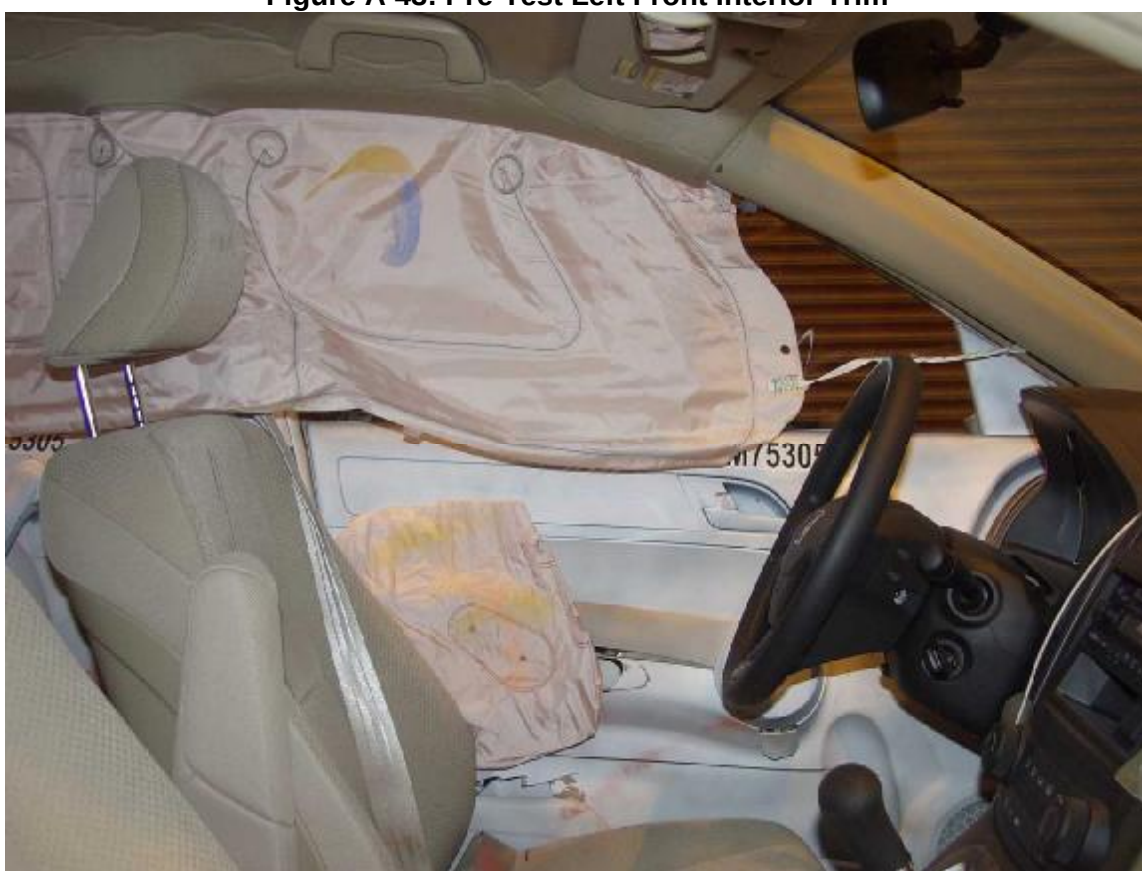
**Figure A-44: Post-Test Left Front Interior Trim**

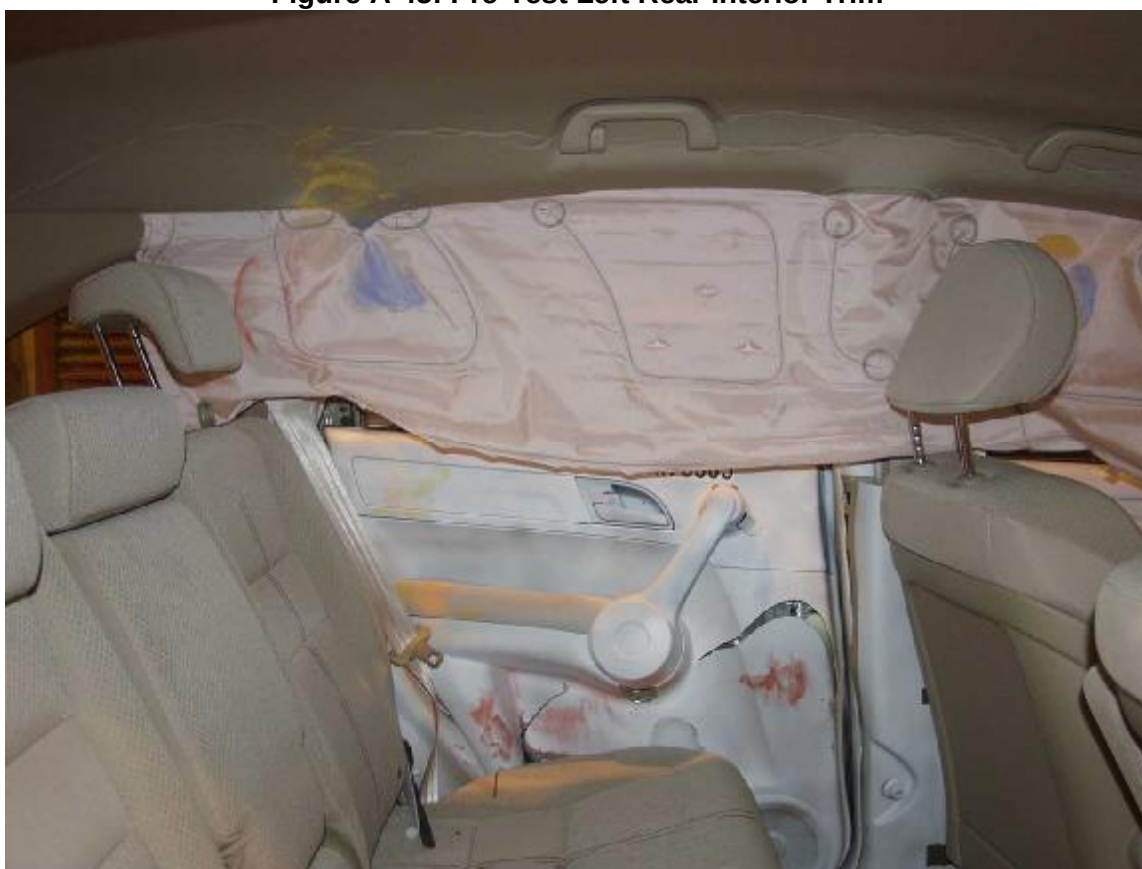
**Figure A-46: Post-Test Left Rear Interior Trim**

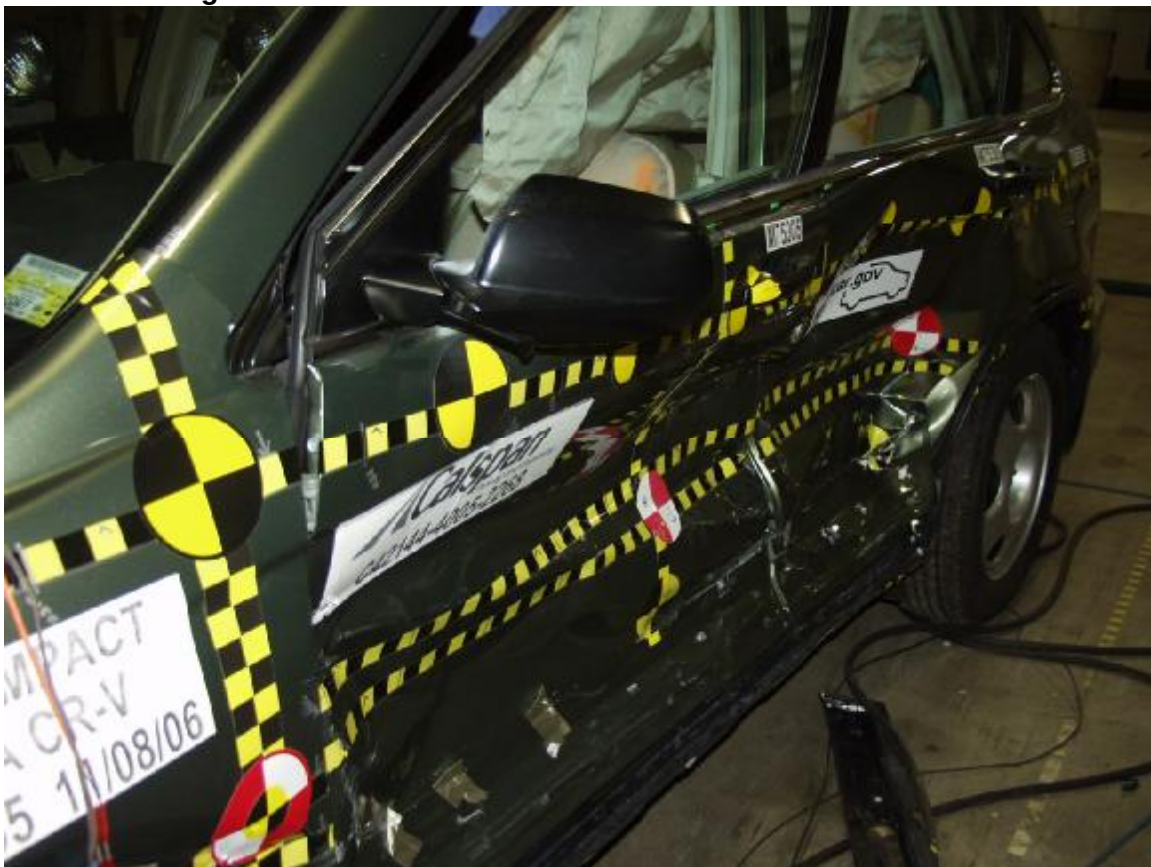
Figure A-48: Post-Test Left Front  $\frac{3}{4}$  View of Left Side Doors

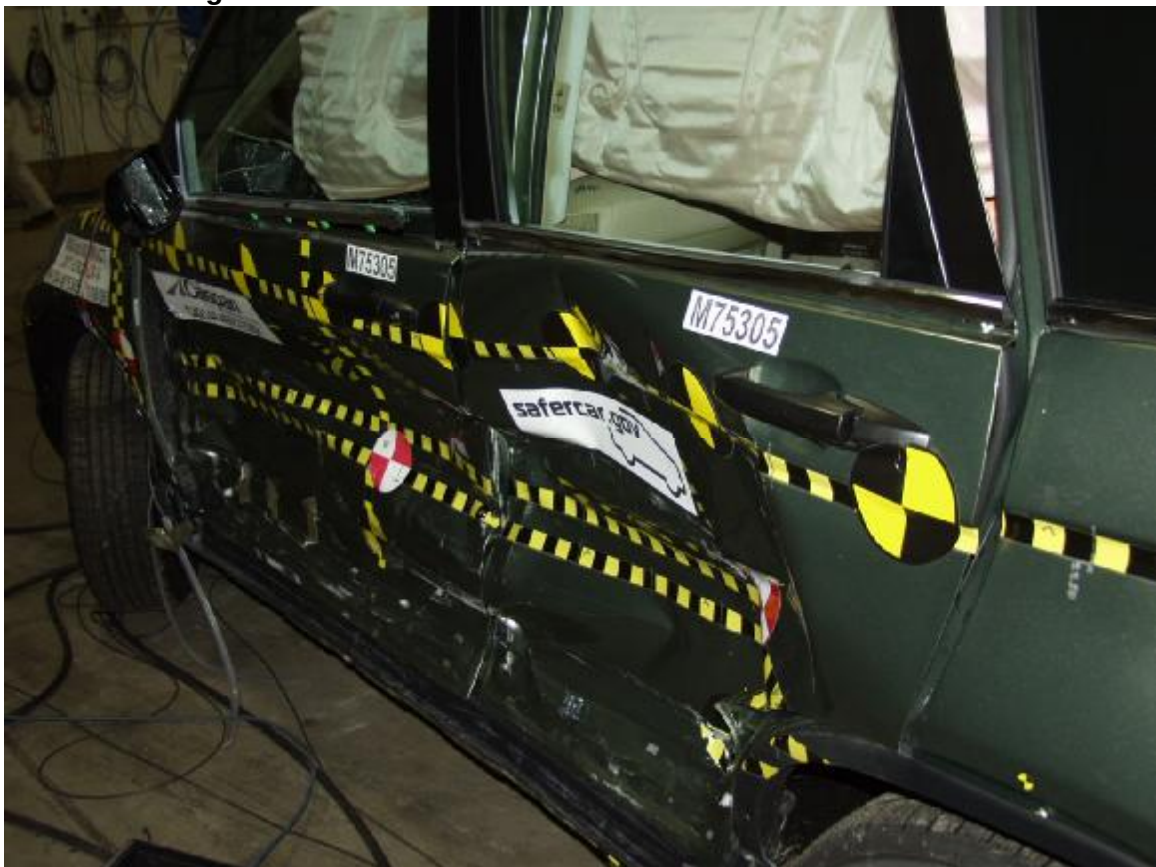
Figure A-50: Post-Test Left Rear  $\frac{3}{4}$  View of Left Side Doors
