**REPORT NUMBER: NCAPSIDE-MGA-2007-003**

**NEW CAR ASSESSMENT PROGRAM  
SIDE IMPACT TEST**

**KIA MOTORS CORPORATION  
2007 KIA SPORTAGE 4X2  
NHTSA NUMBER: M70510**

**PREPARED BY:  
MGA RESEARCH CORPORATION  
5000 WARREN ROAD  
BURLINGTON, WI 53105**

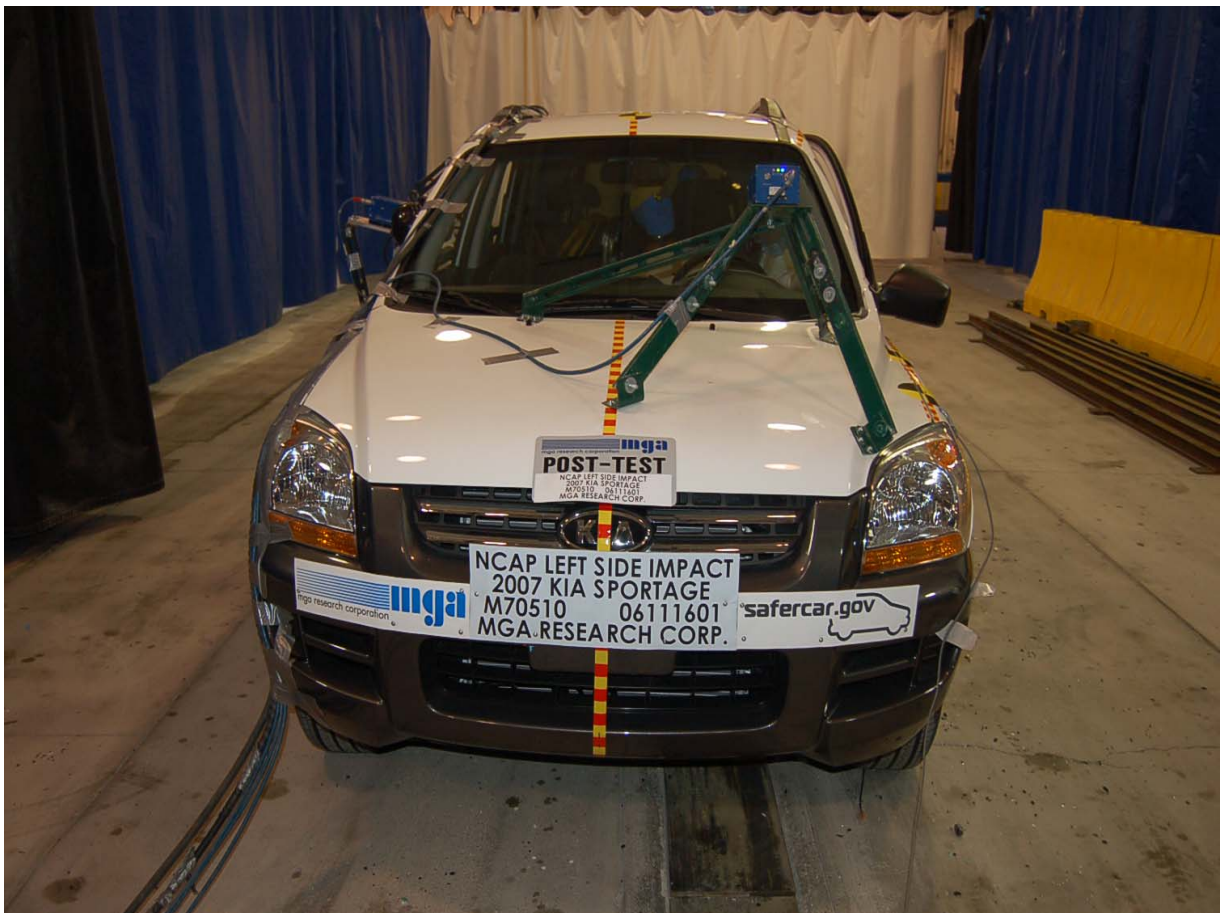
Post-Test Front View

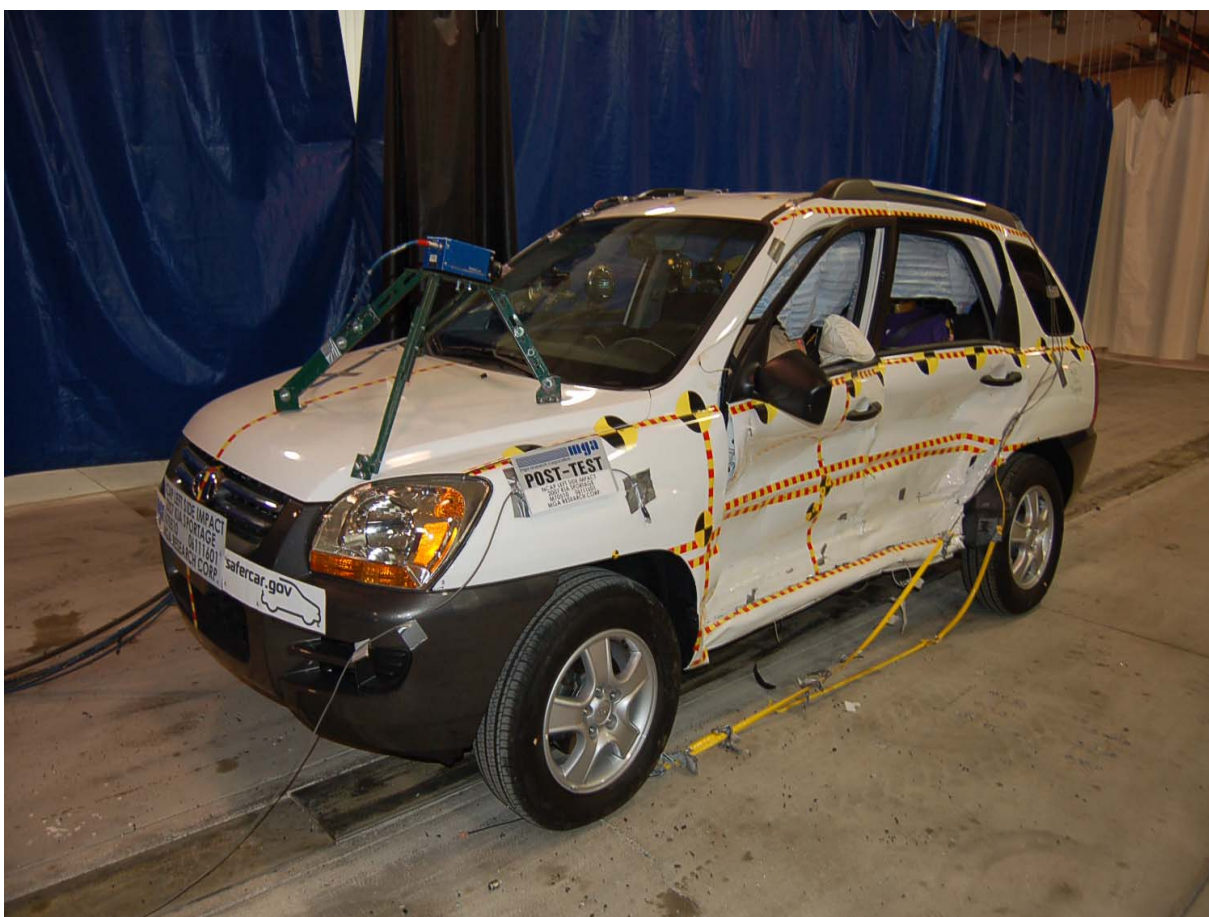
Post-Test Left Front  $\frac{3}{4}$  View

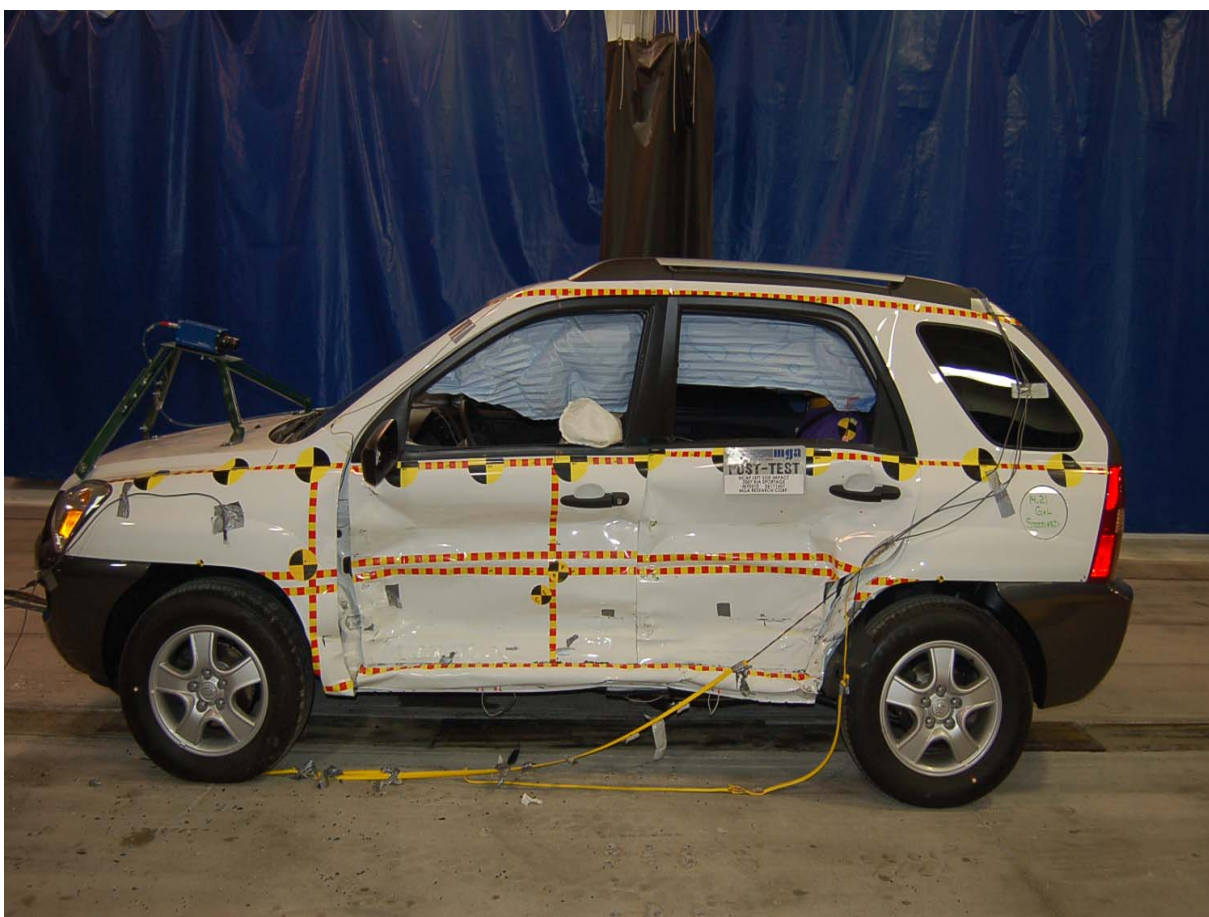
Post-Test Left Side View

The test vehicle sustained a maximum static crush of 280 mm at level 2, 1200 mm rearward of the left vertical impact point. The driver and passenger SID/HIIIs, Serial Nos. 904 and 272 respectively, were calibrated just prior to this test.

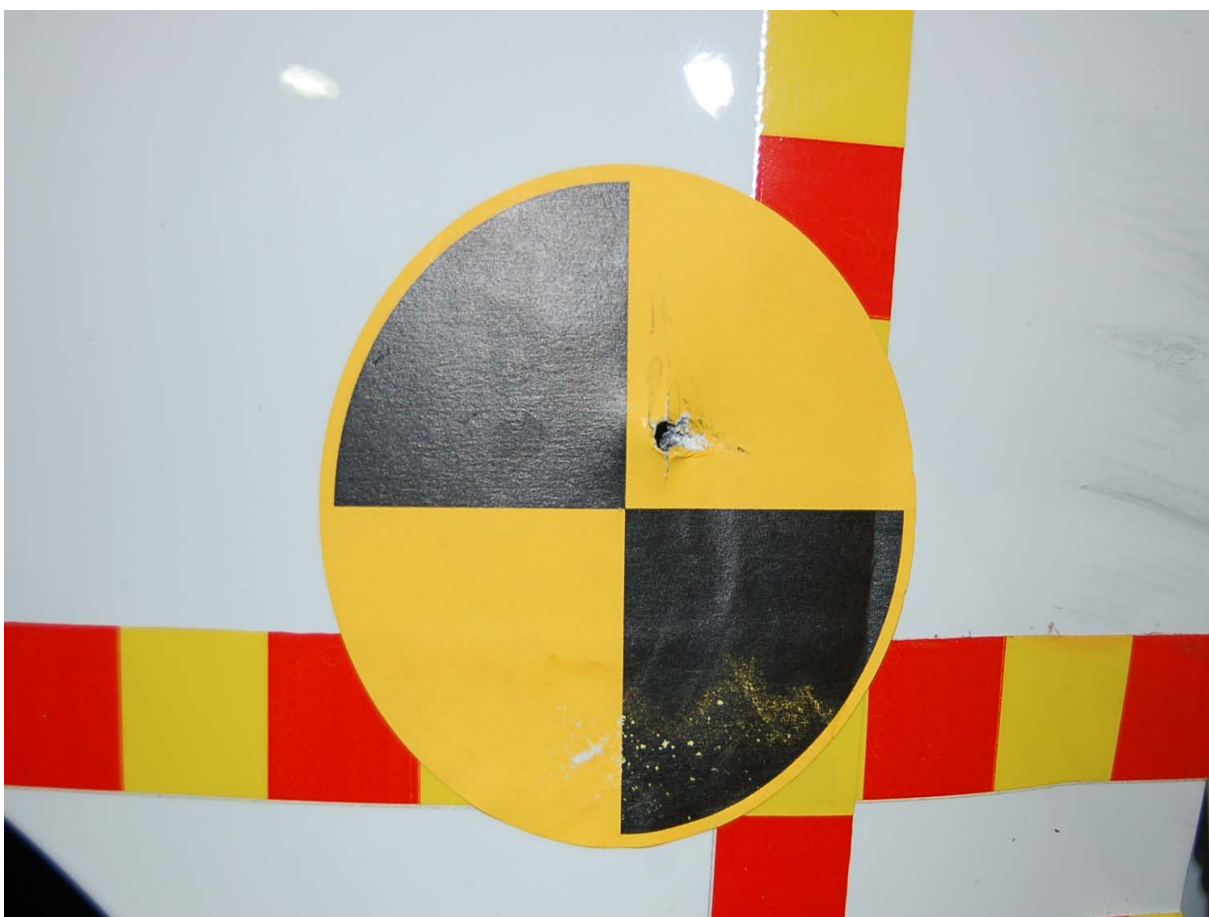
Post-Test Left Impact Point

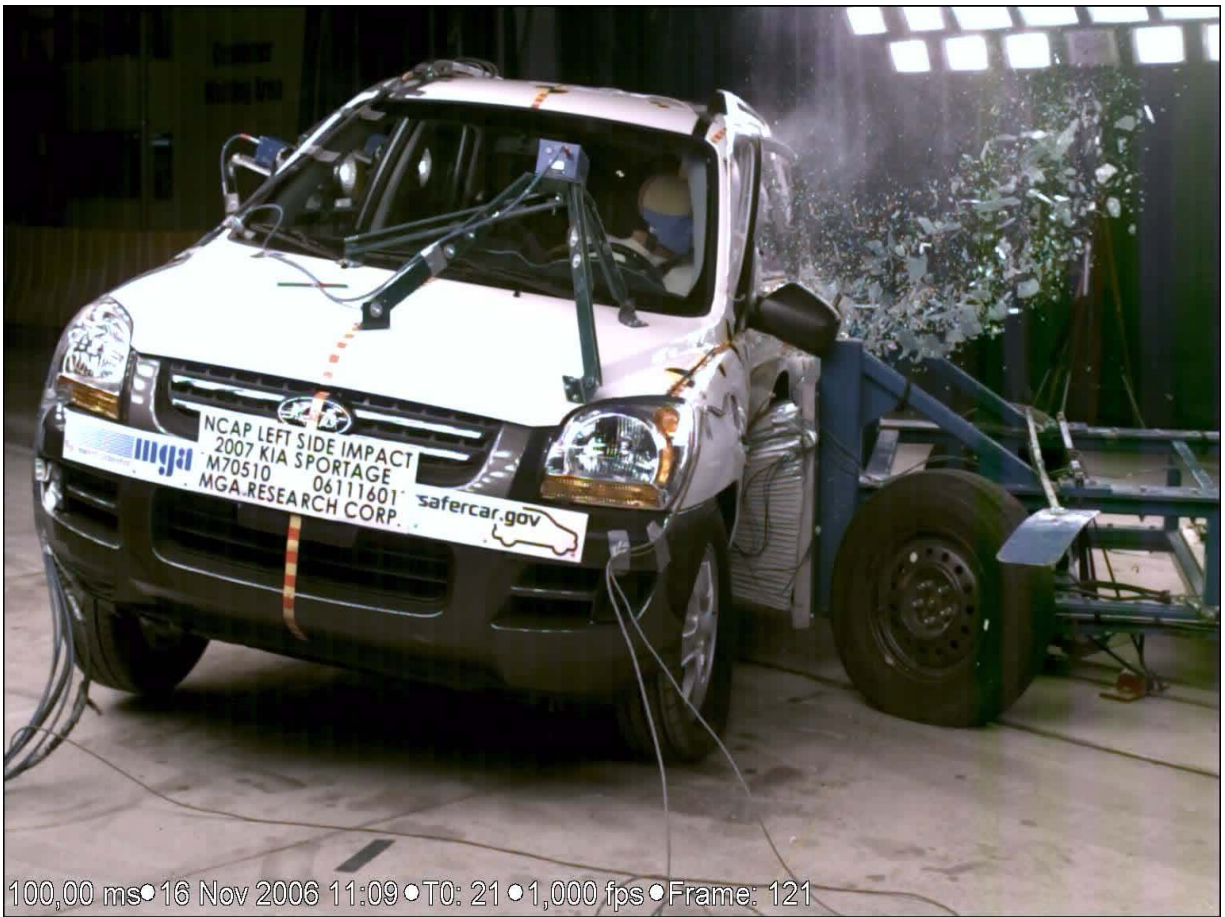
Vehicle Impact

A model year 2007 Kia Sportage 4x2 was impacted on the left (driver's) side by a Moving Deformable Barrier (MDB) which was moving forward in a 27° crabbed position to the tow road guidance system at a velocity of 62.3 km/h. The specified impact velocity range is from 61.1 to 62.7 km/h. The test (target) vehicle was stationary and positioned 63° to the line of forward motion. The weight of the vehicle as tested was 1742.3 kg and the test weight of the MDB was 1360.8 kg. The test was conducted at MGA Research Corporation in Burlington, Wisconsin, on November 16, 2006.

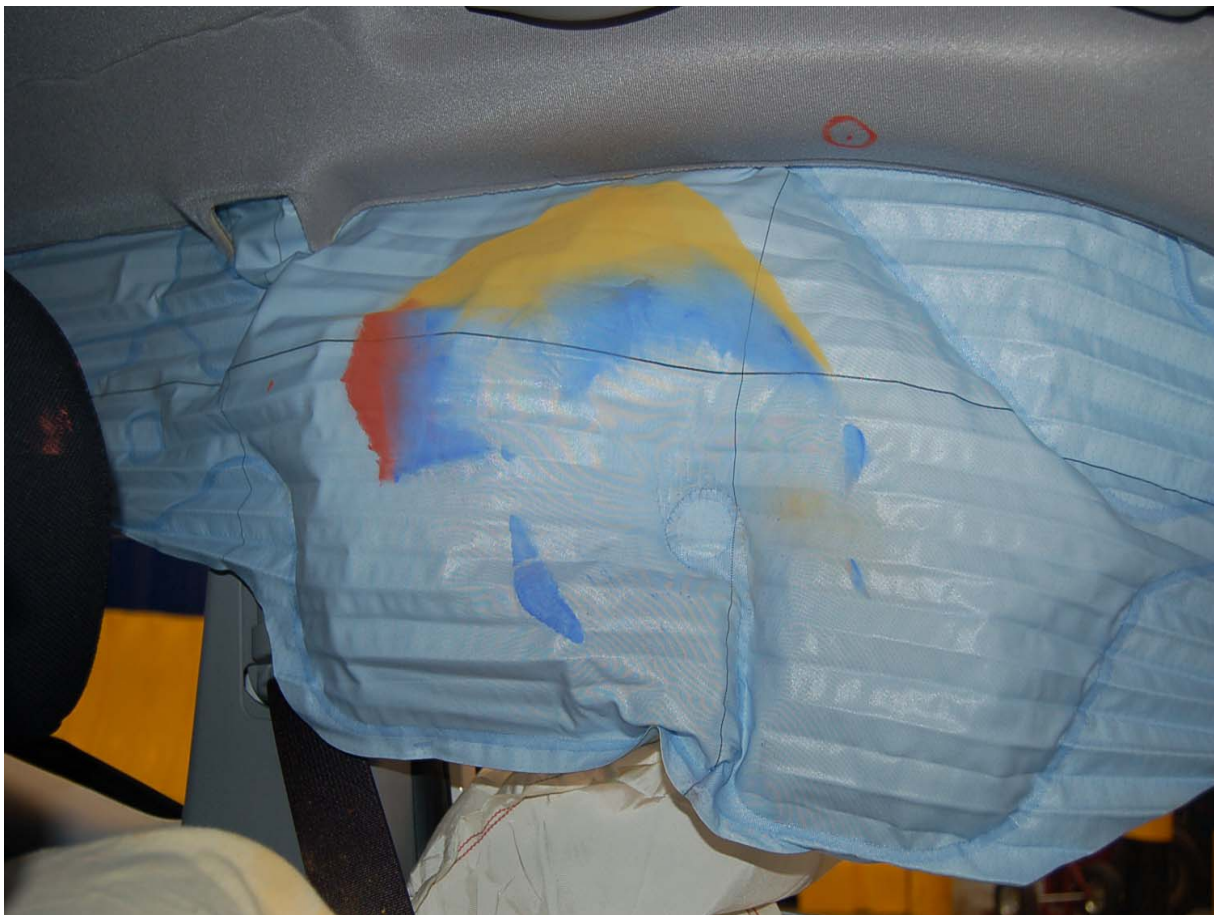
Post-Test Driver Dummy Head Contact
