Report Number: 214-TRC-06-006

Safety Compliance Testing For FMVSS 214

Side Impact Protection

2007 Nissan Sentra 4-door

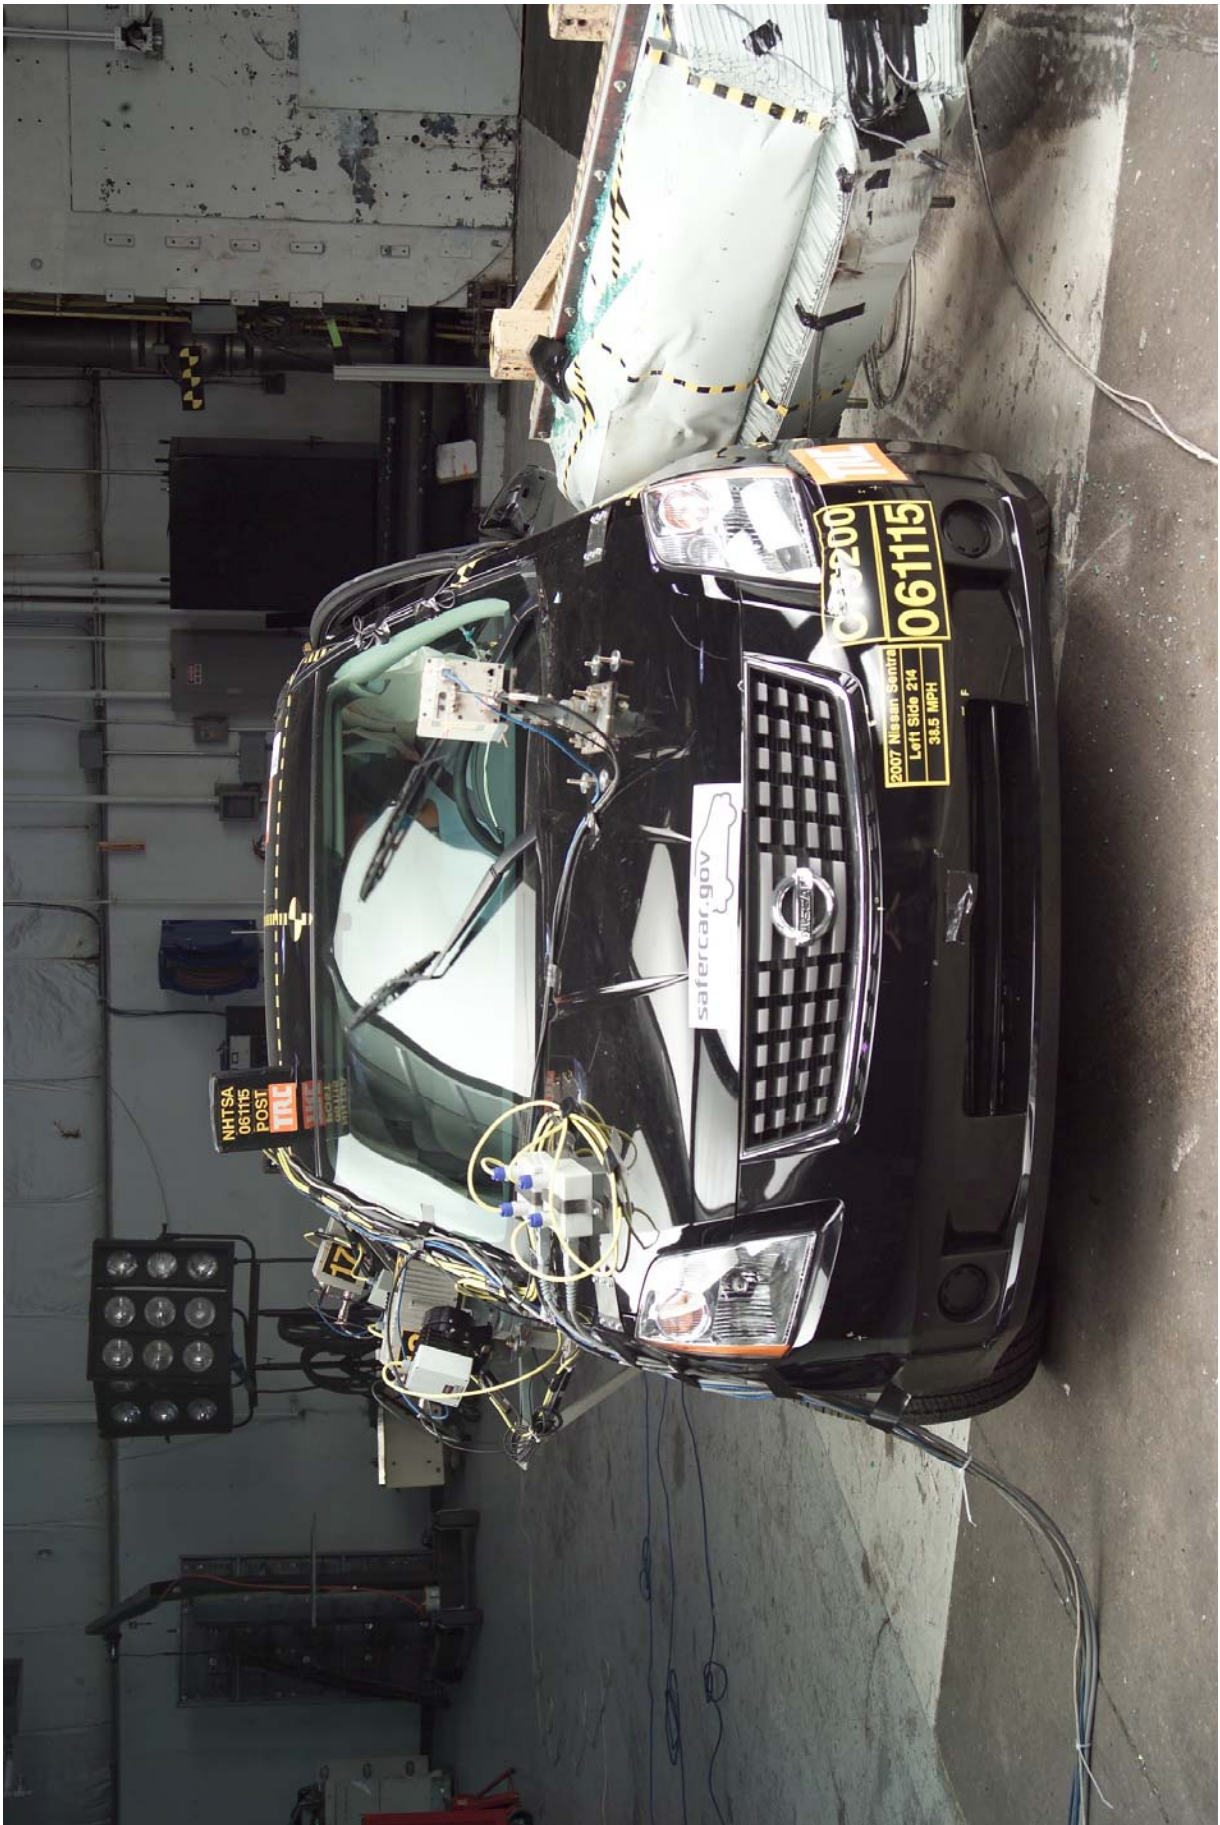
Figure A-2 Post-Test Front View of Test Vehicle

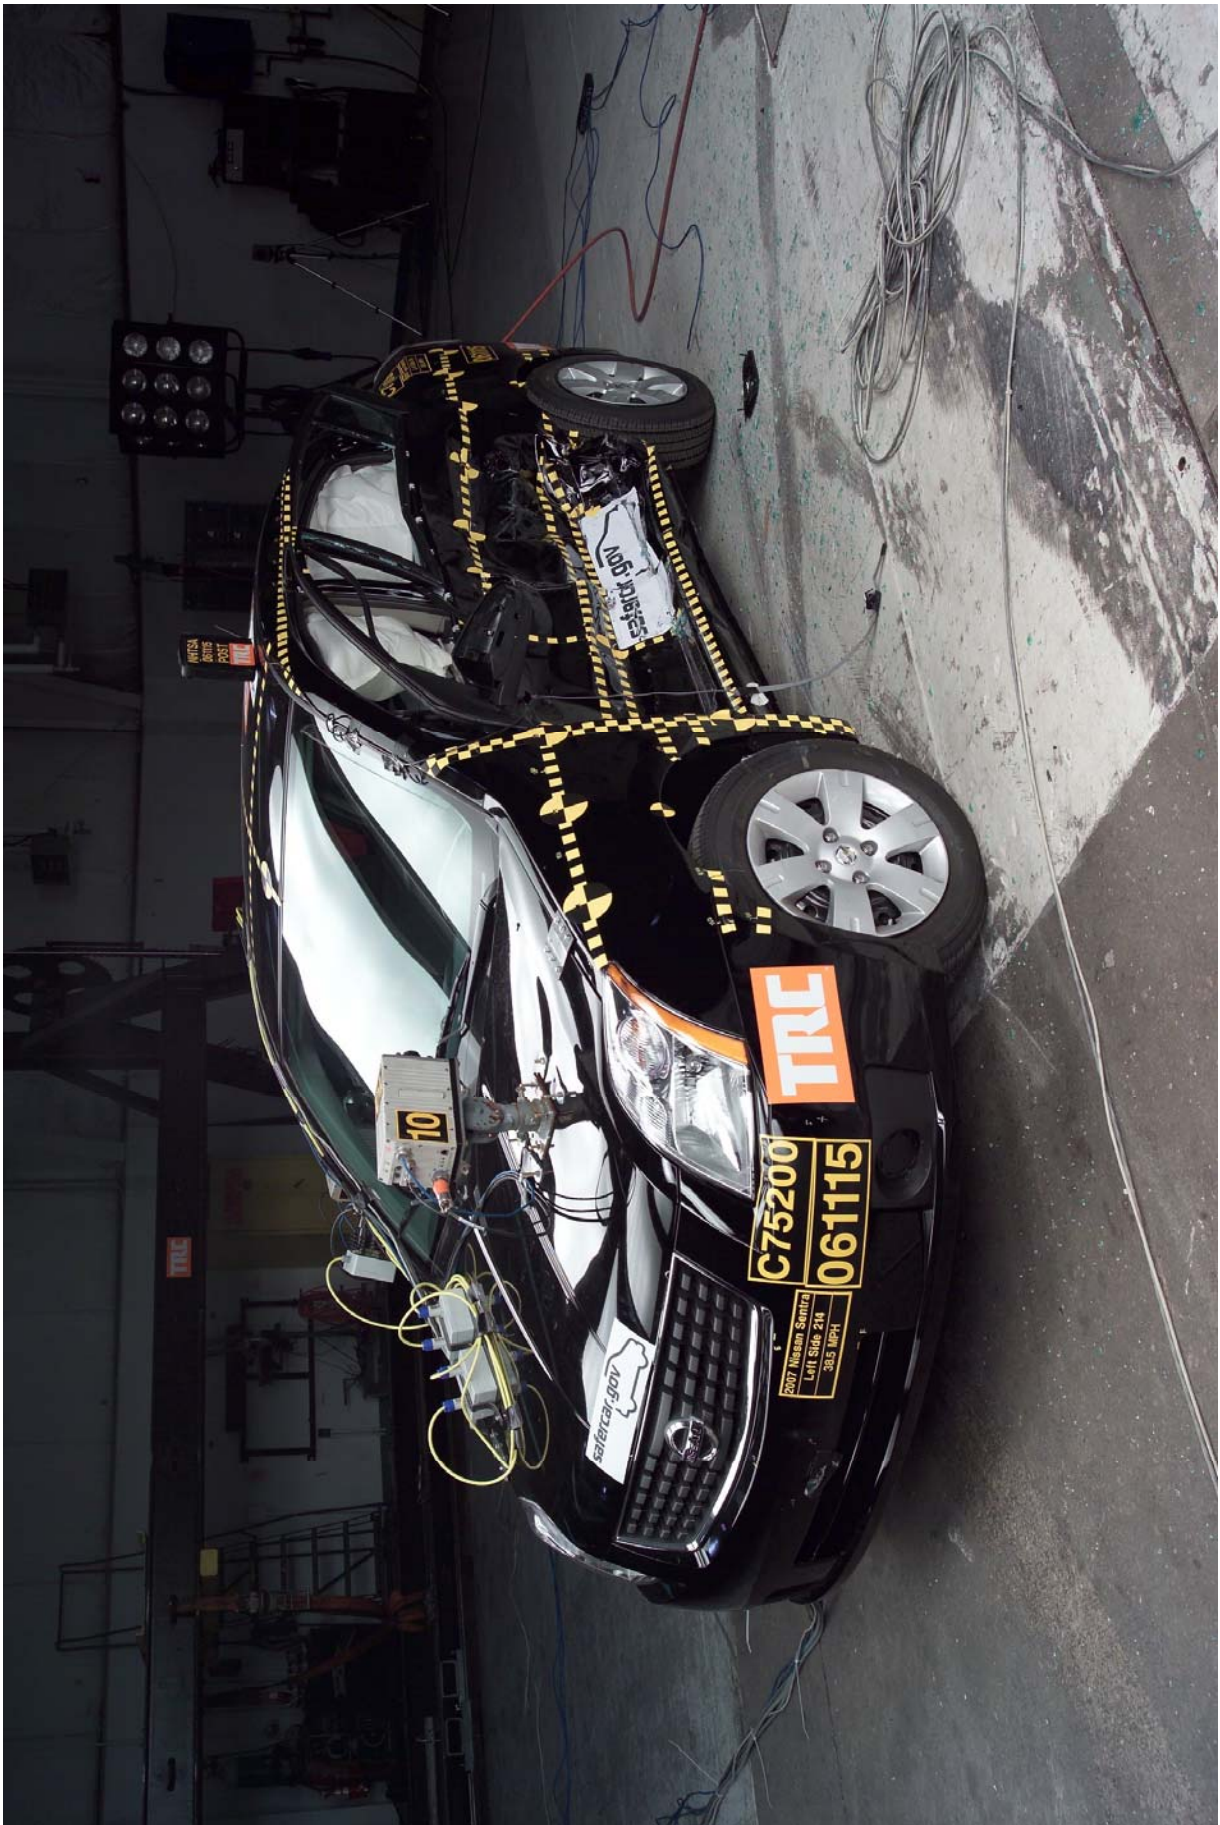
Figure A-4 Post-Test Left Front View of Test Vehicle

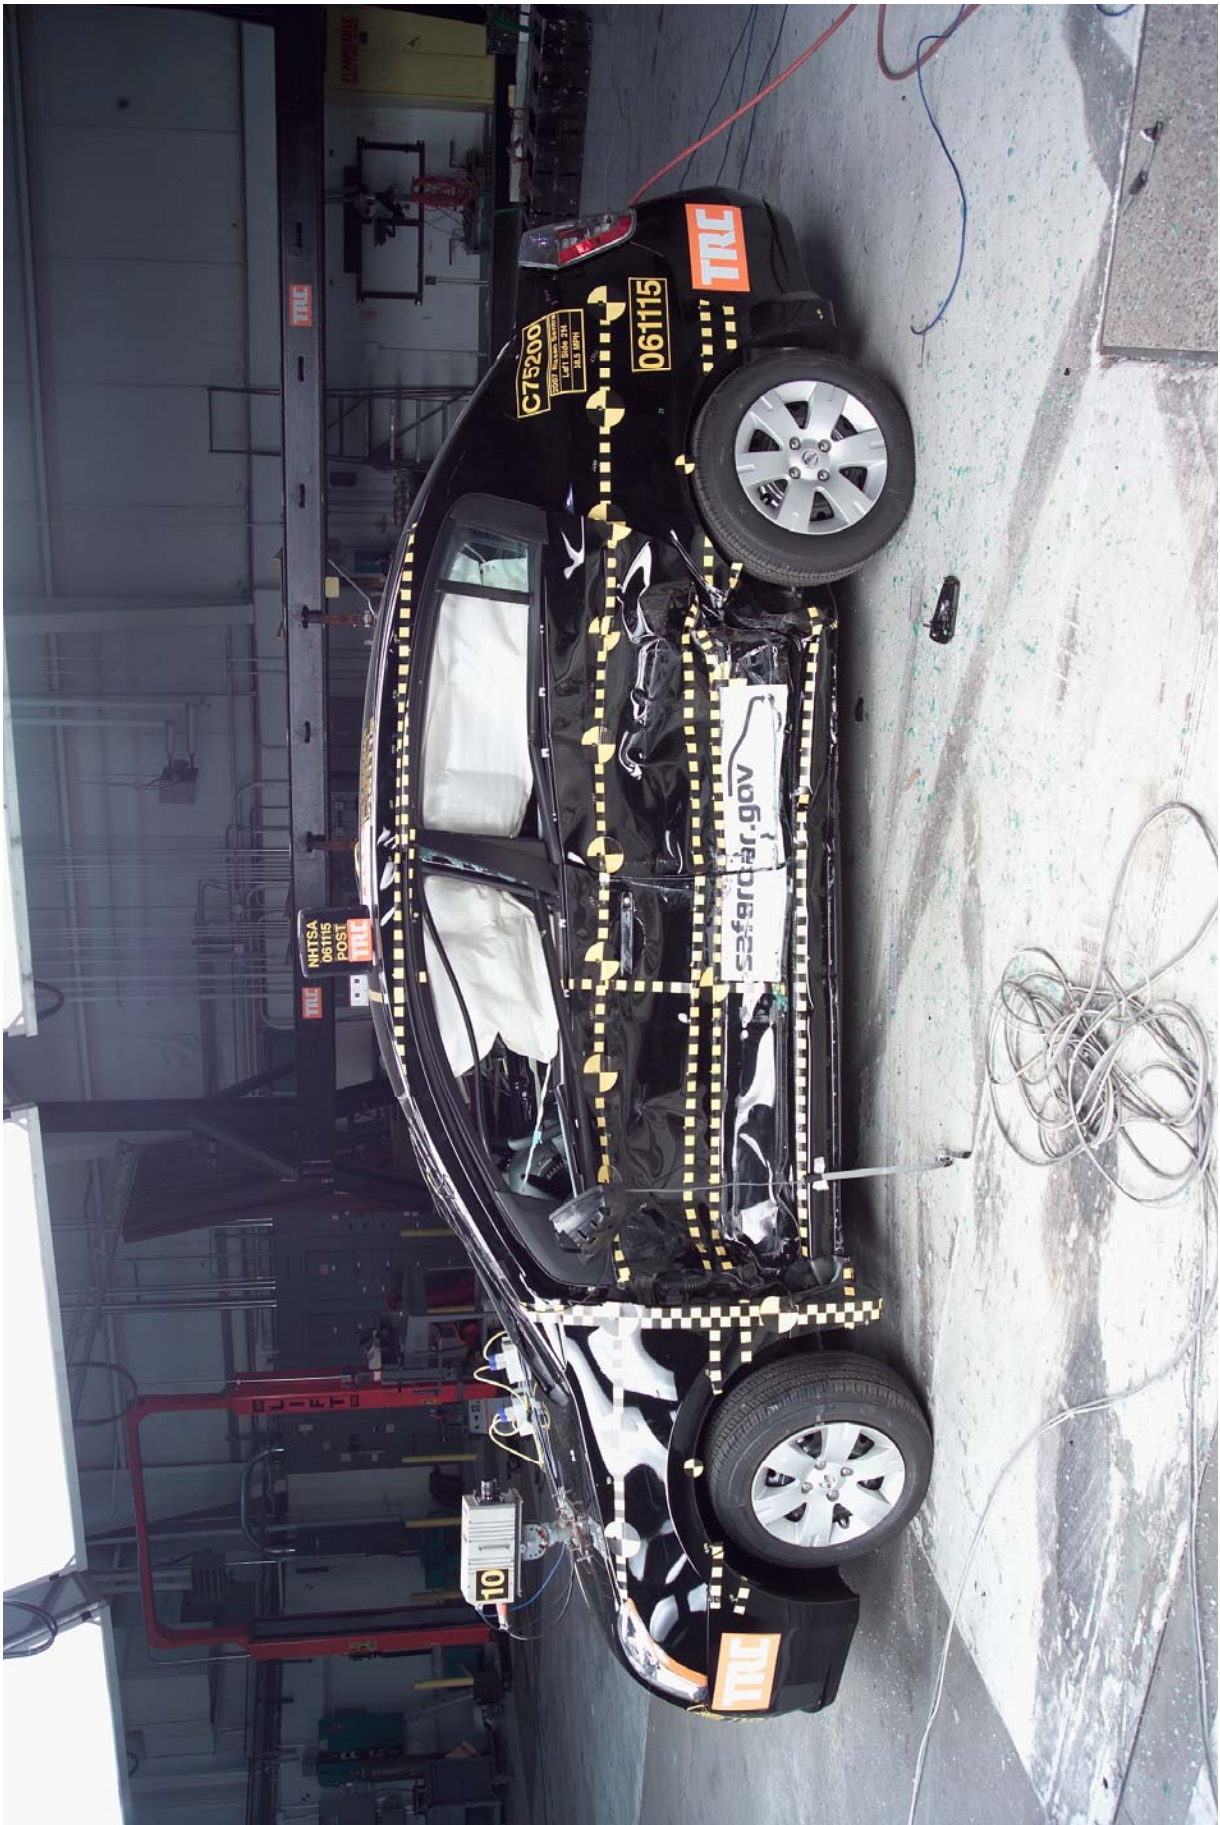
Figure A-6 Post-Test Impacted Side View of Test Vehicle

Full length of induced damage was 1950 mm.

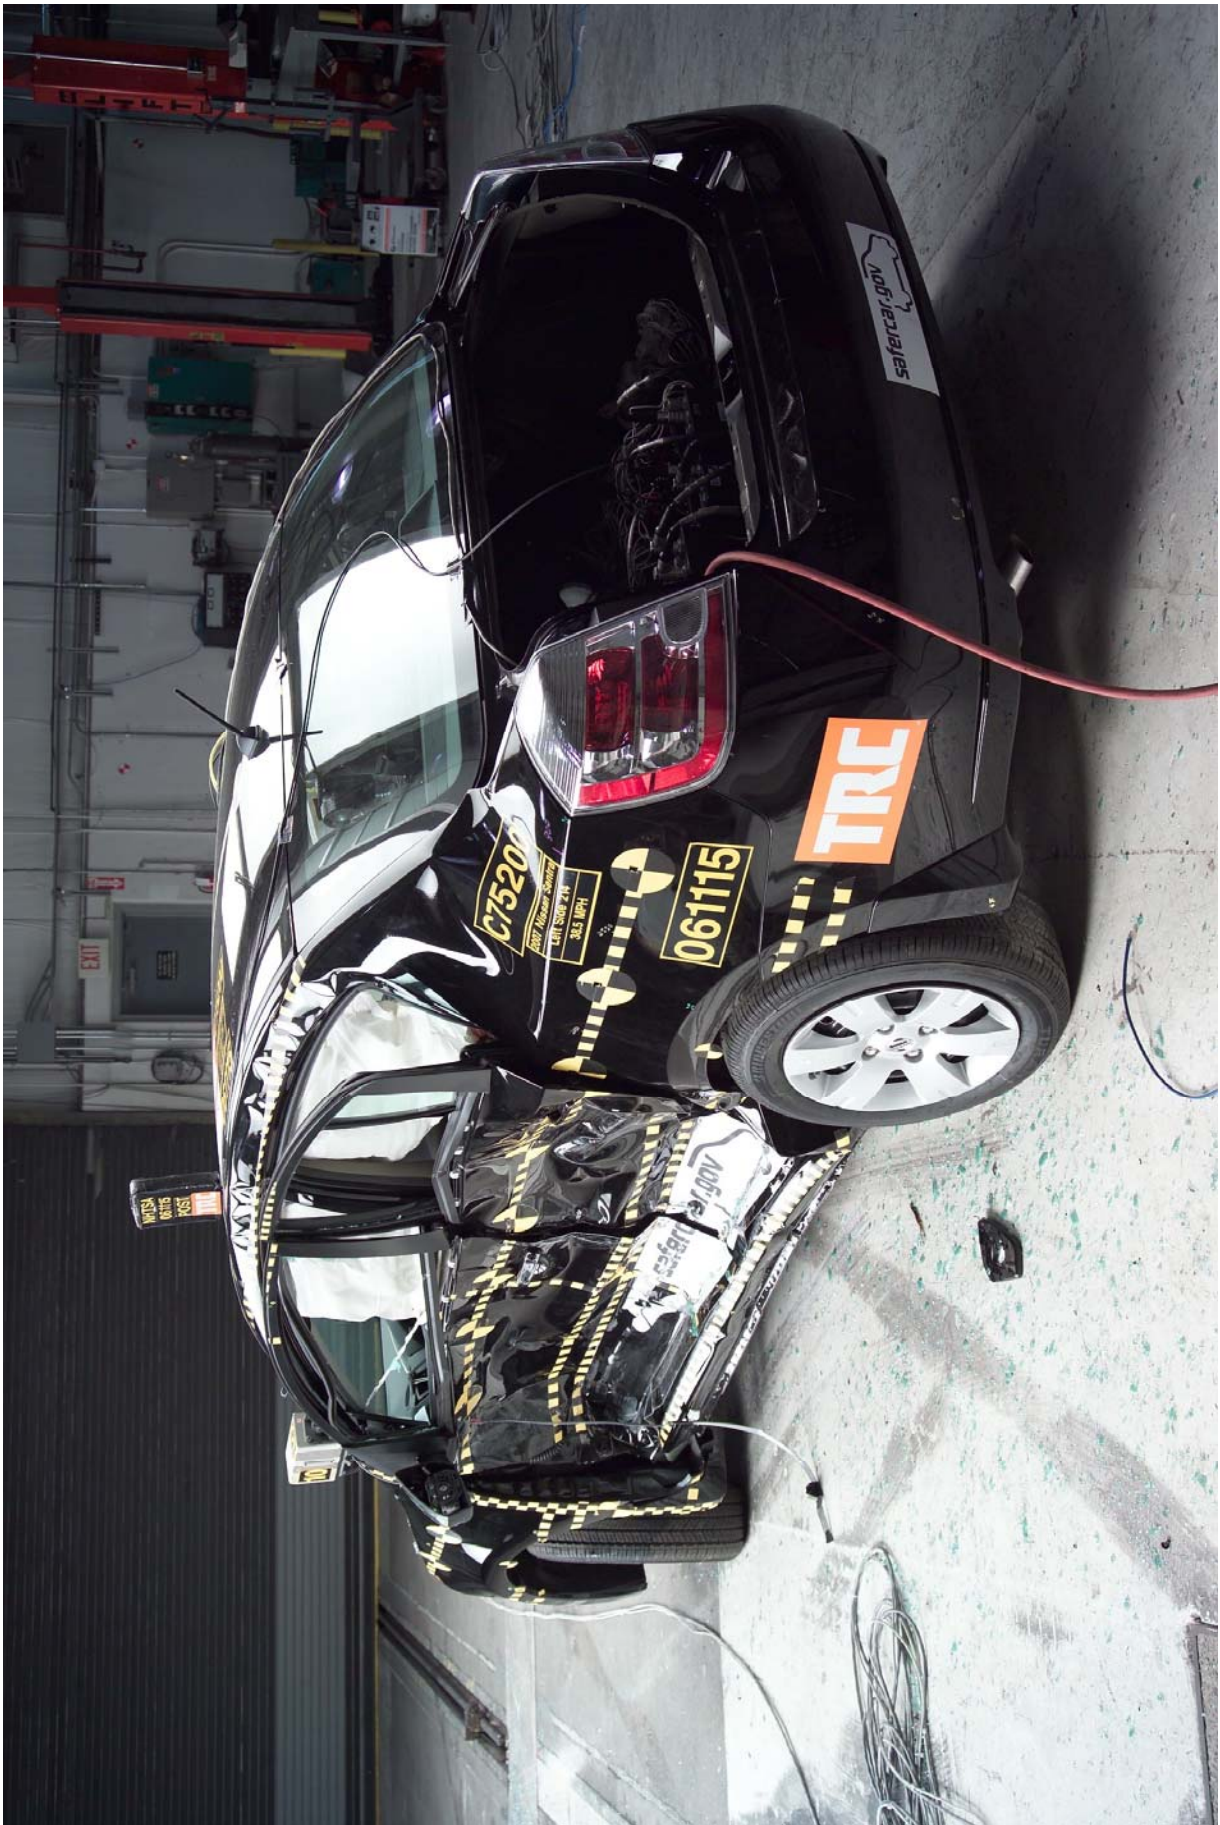
Figure A-8 Post-Test Left Rear View of Test Vehicle

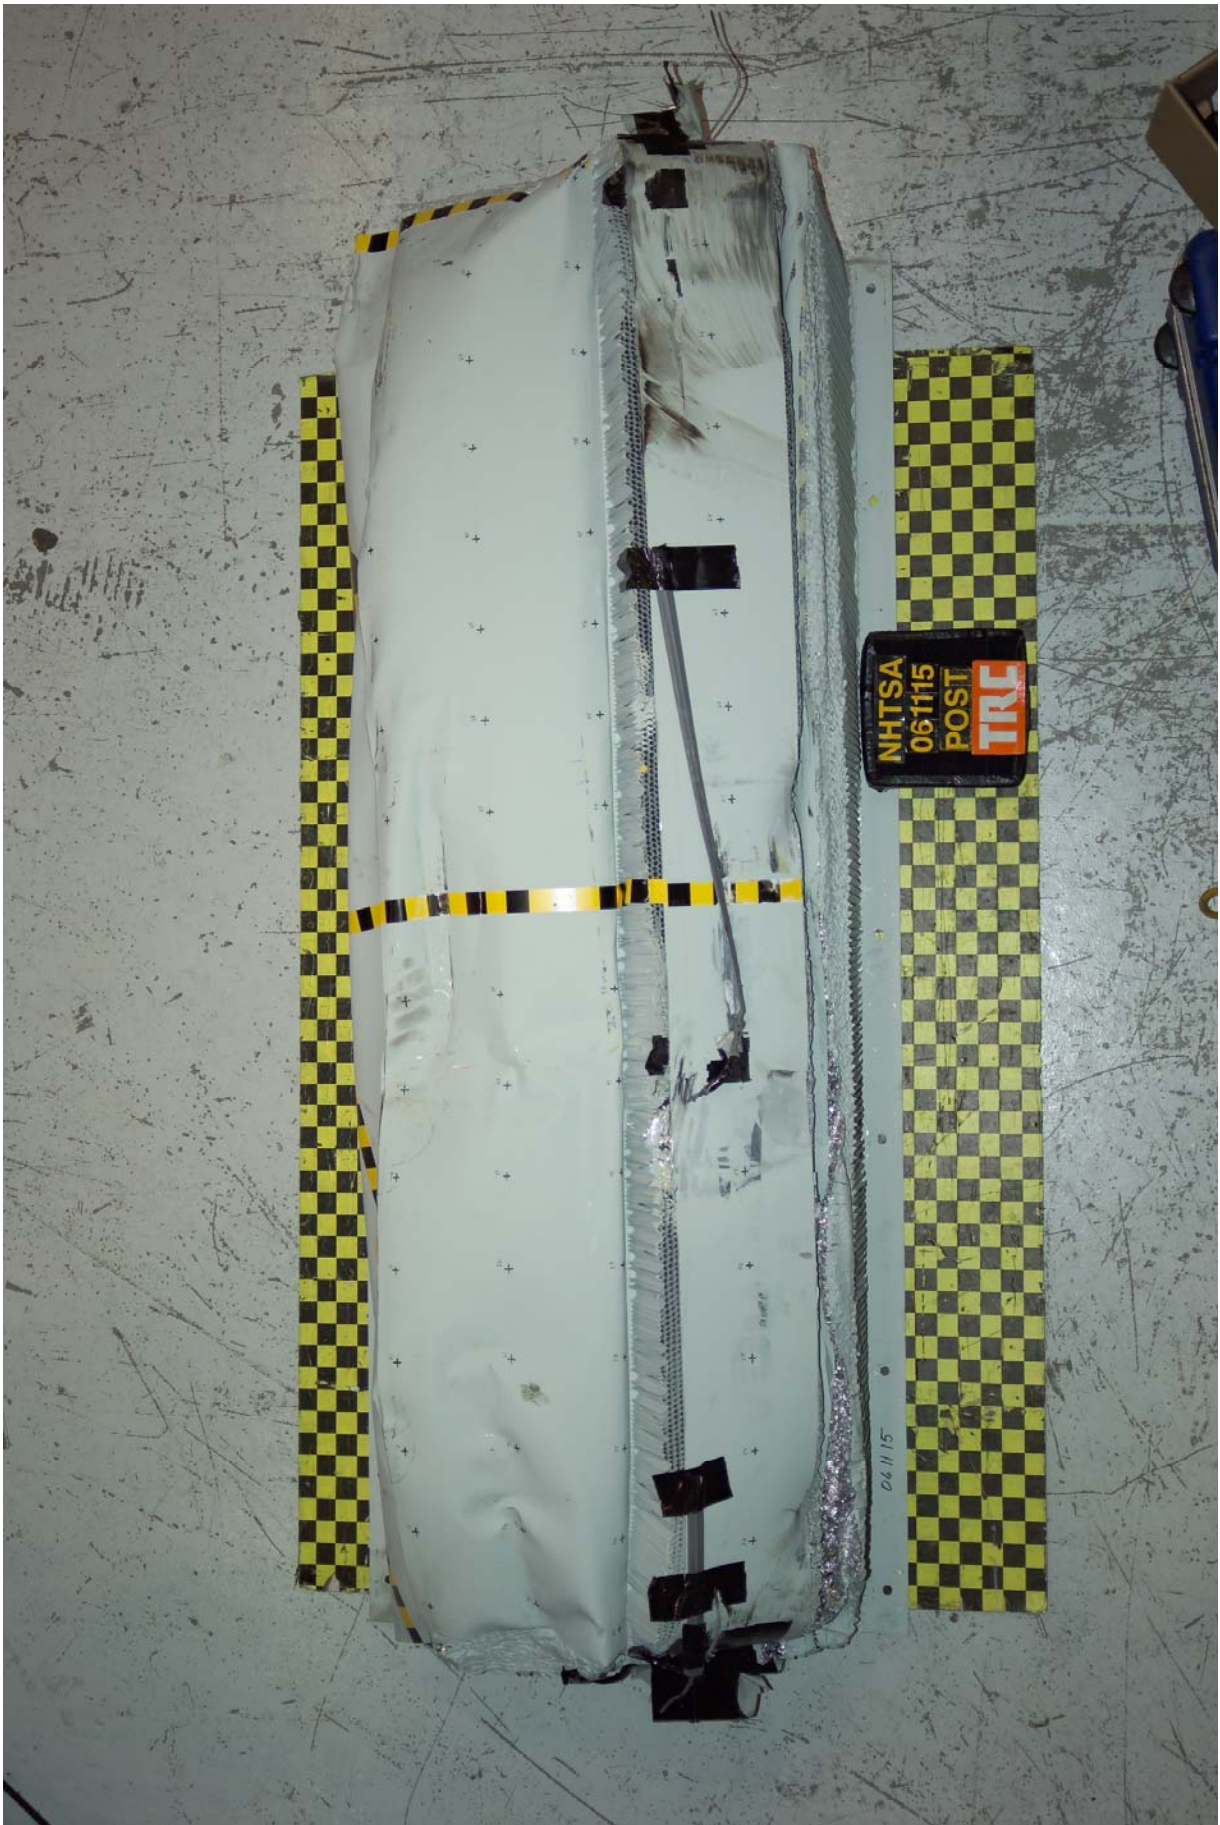
Figure A-18 Post-Test Frontal View of Impactor Face

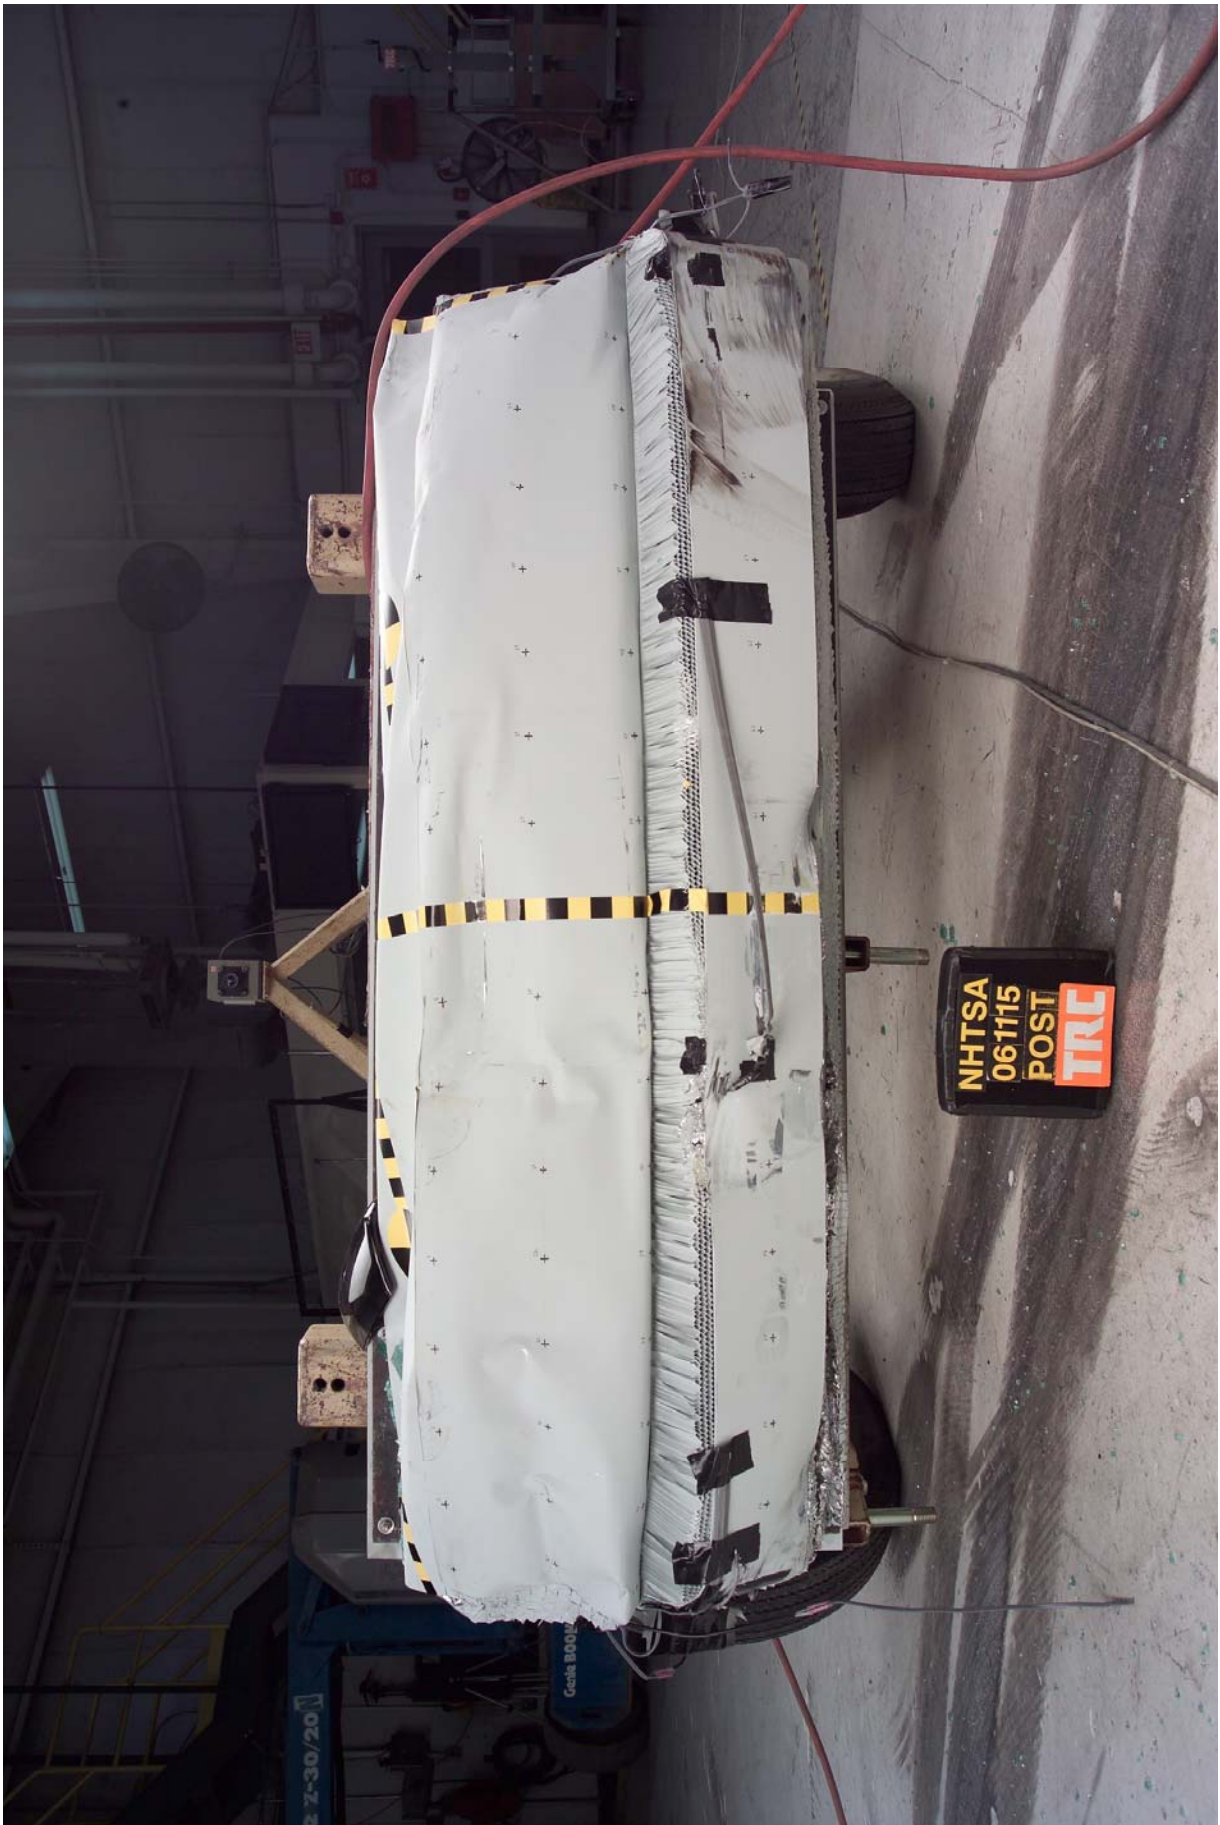
Figure A-42 Post-Test View of MDB Showing Contact Switches in Place

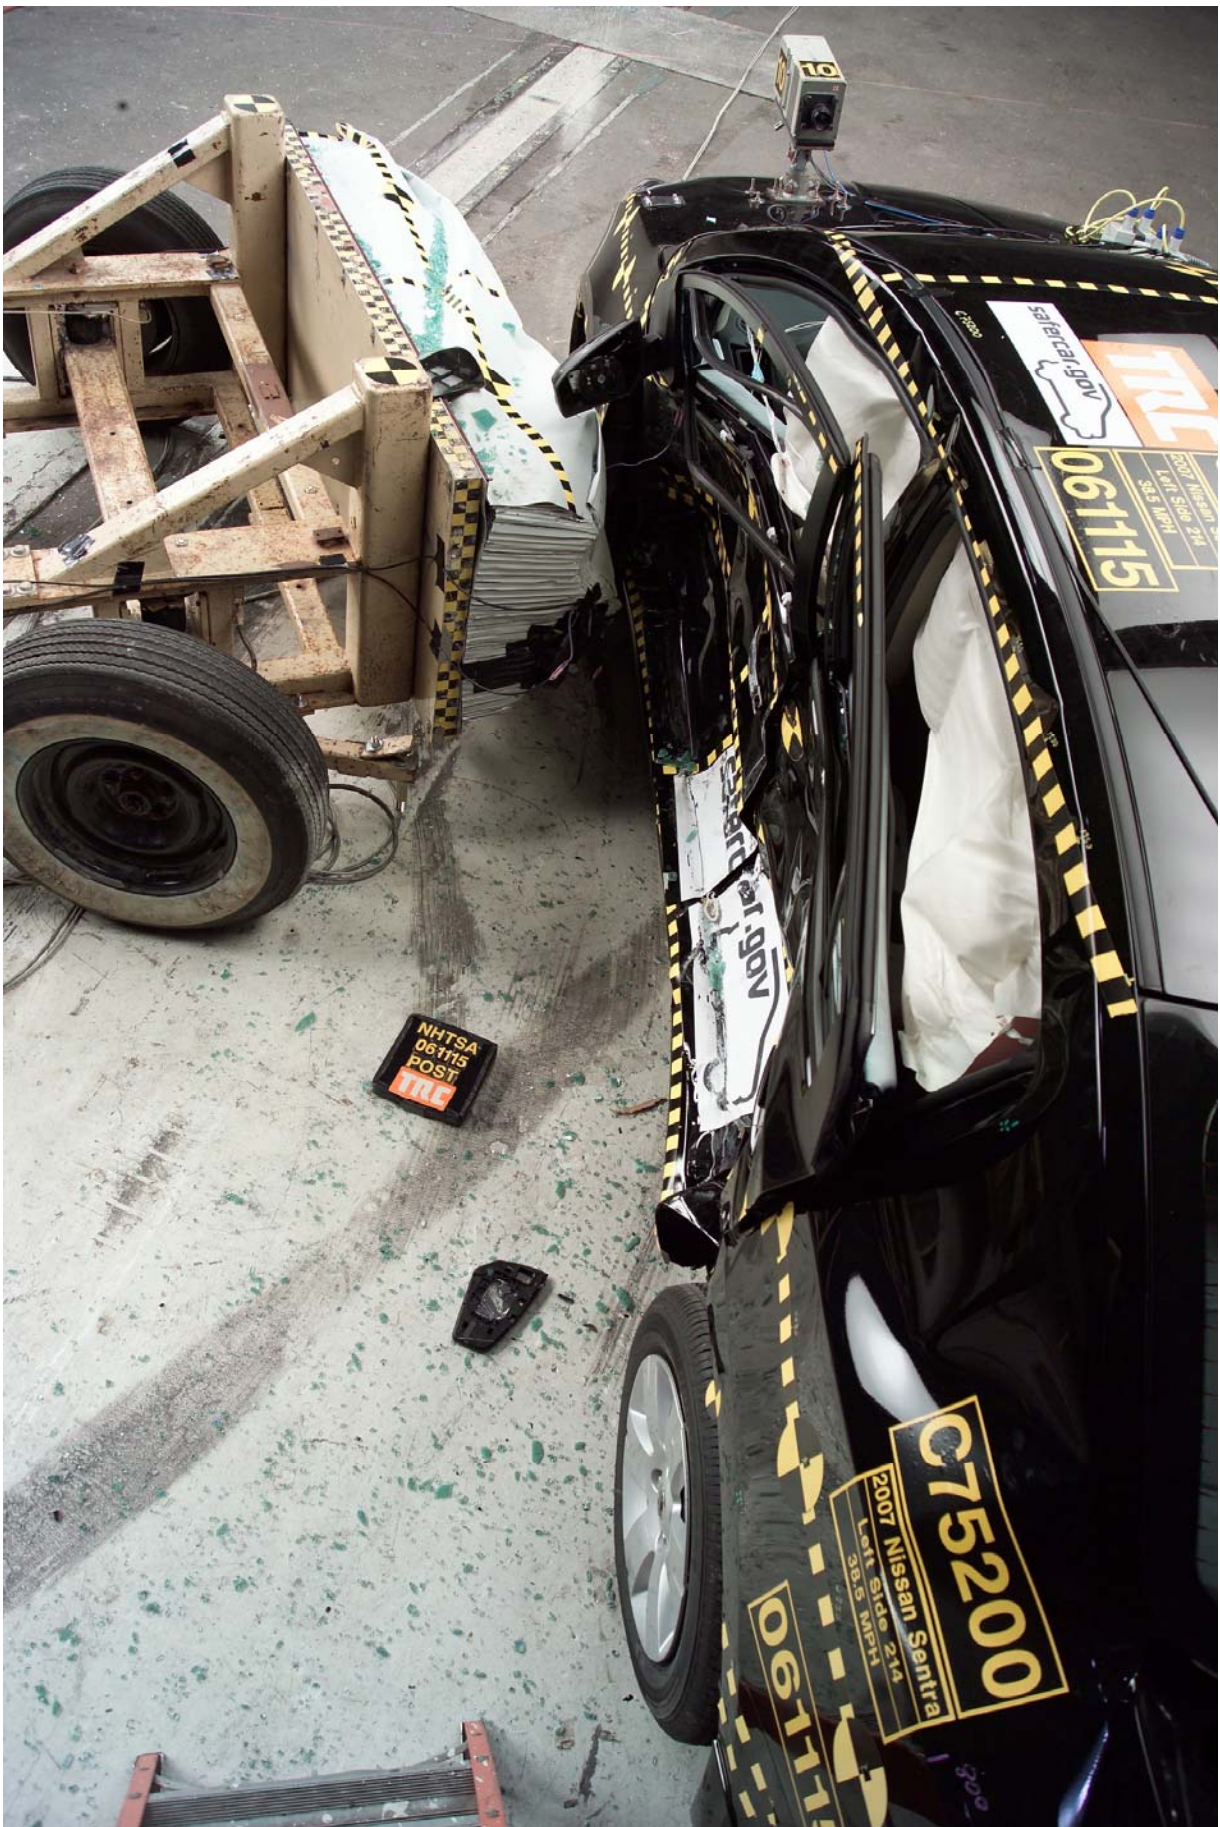
Figure A-44 Post-Test Overhead View of MDB and Vehicle

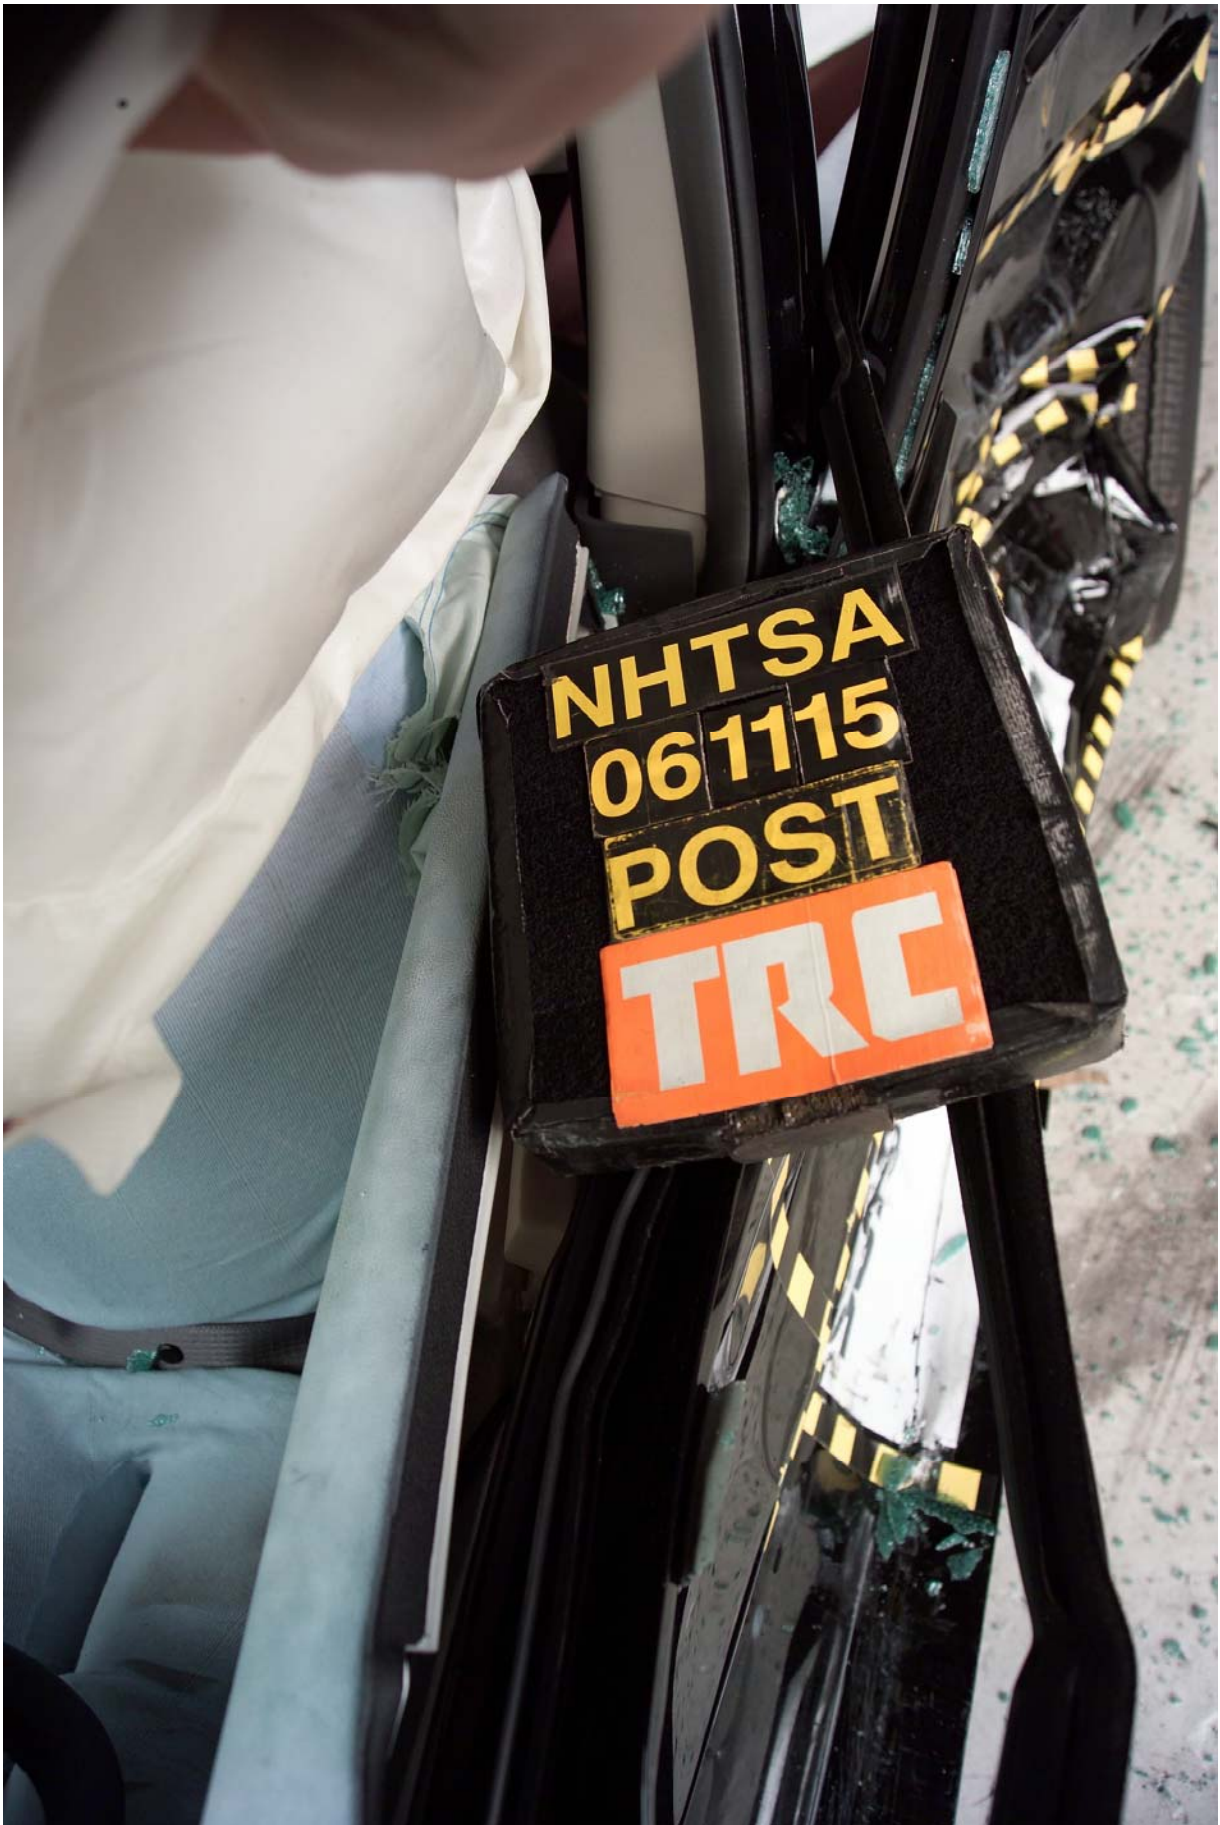
Figure A-53 Post-Test Left View of Front SID HIII and Door Clearance

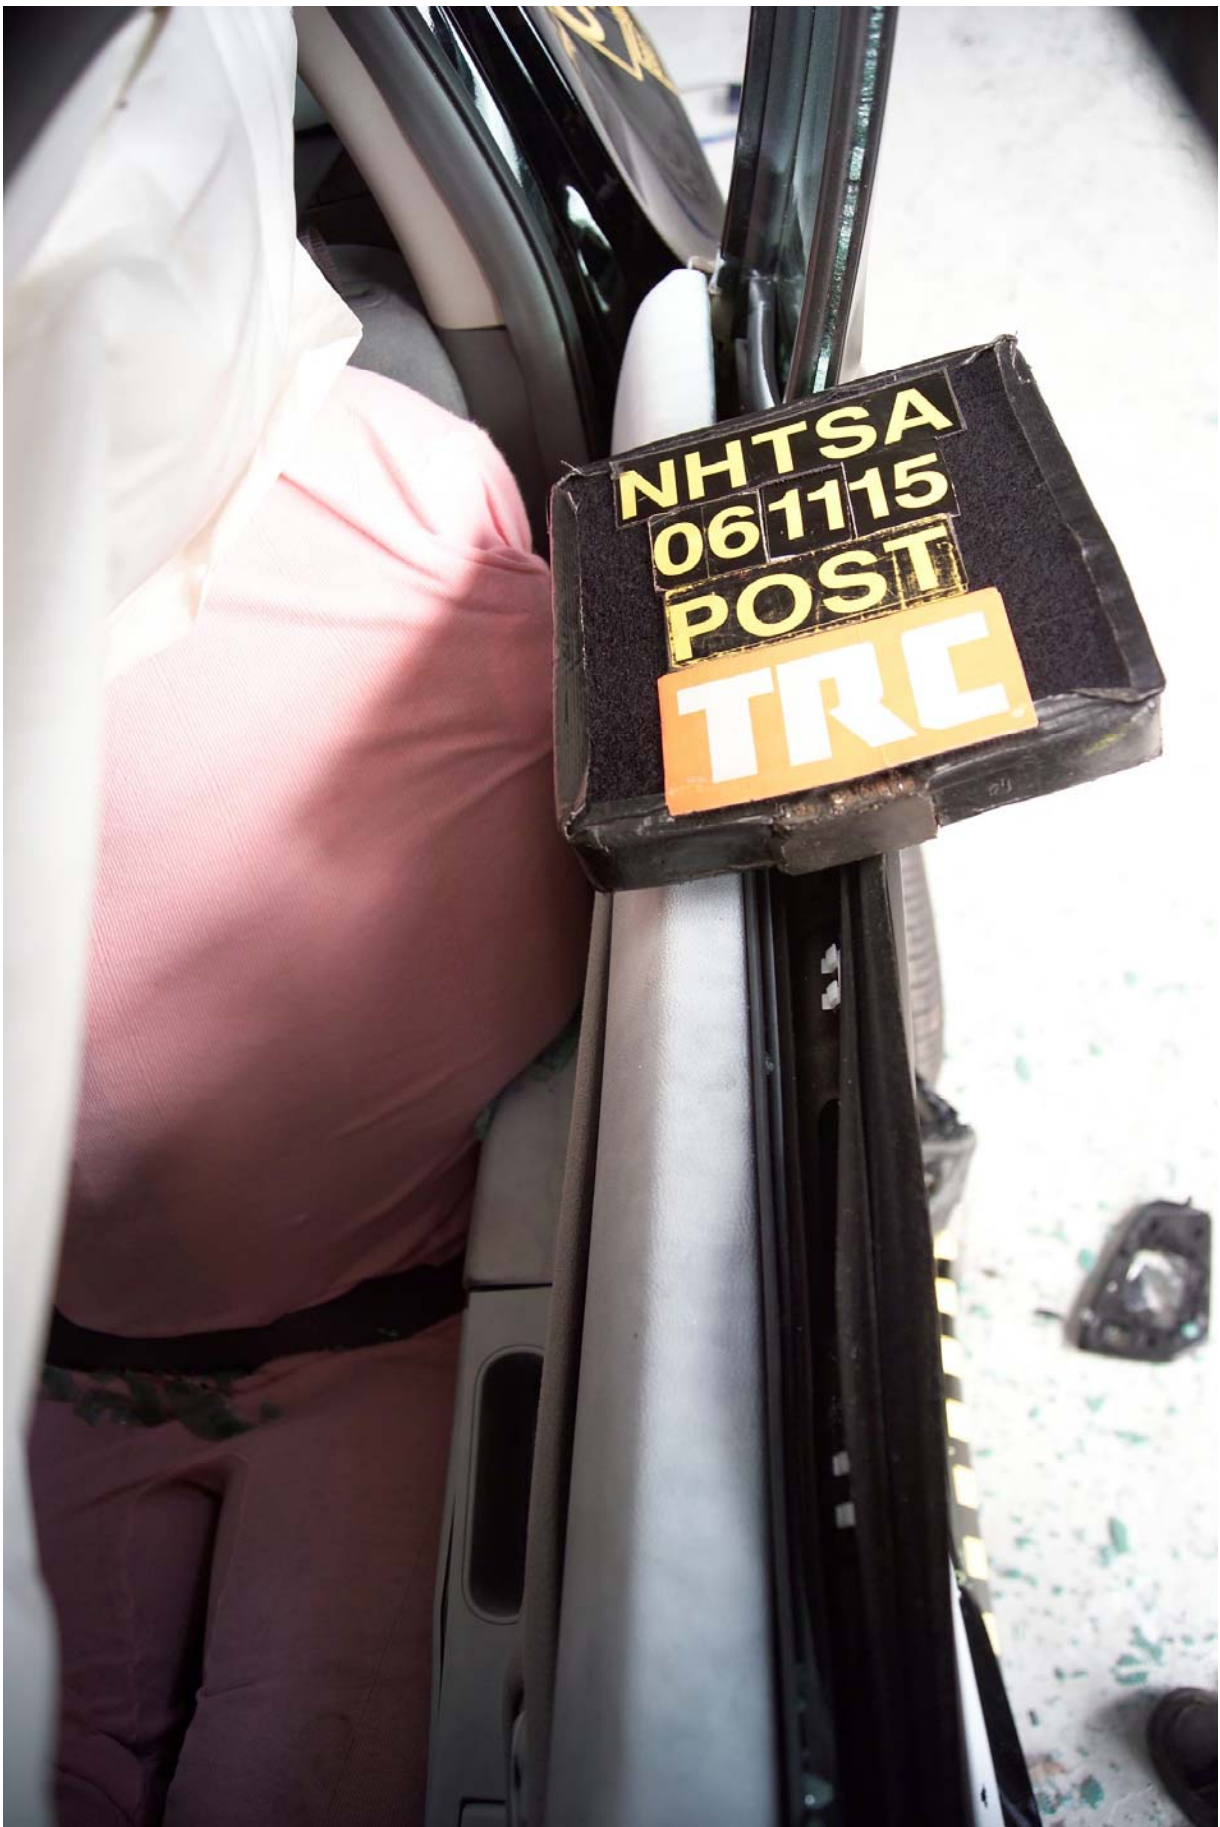
Figure A-58 Post-Test Left View of Rear SID HIII and Door Clearance

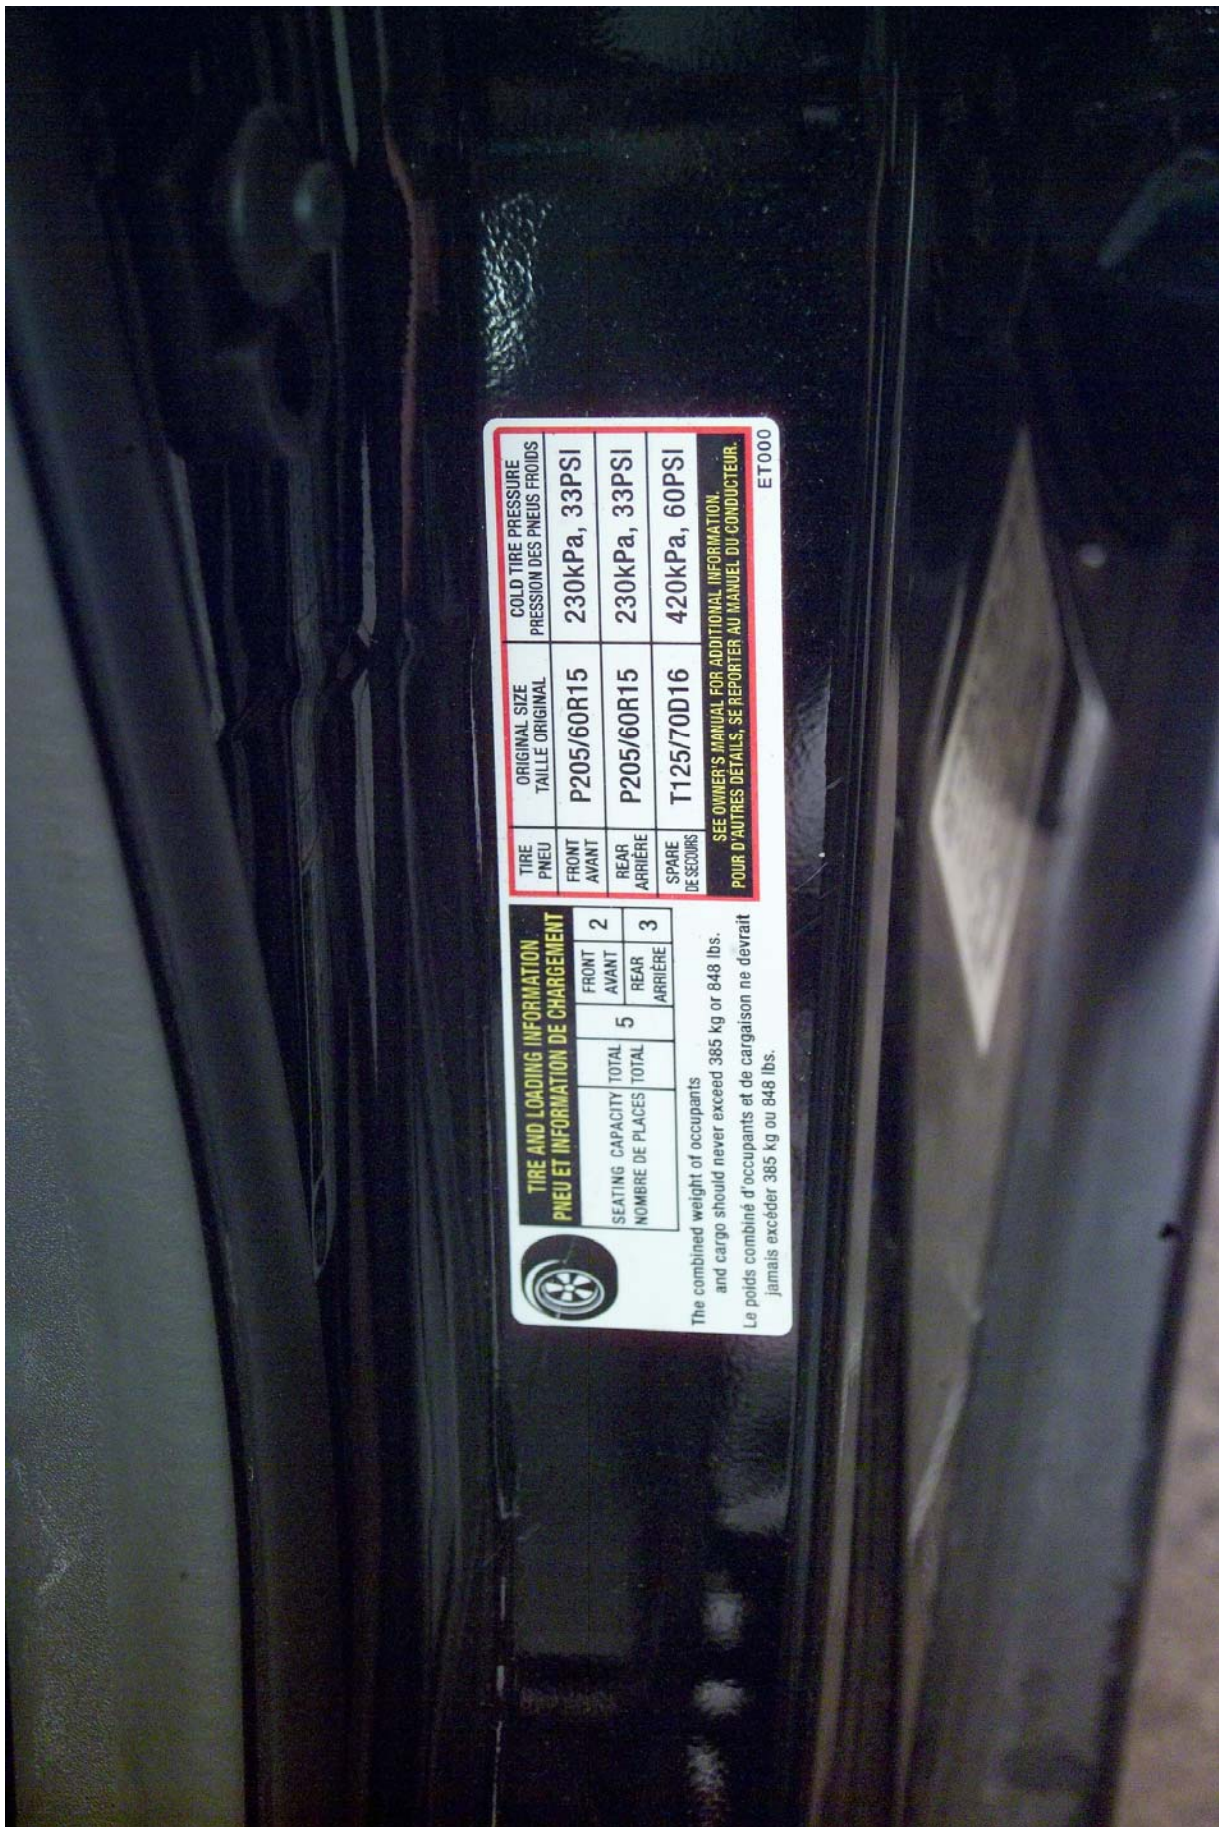
TIRE PNEU	ORIGINAL SIZE TAILLE ORIGINAL	COLD TIRE PRESSURE PRESSION DES PNEUS FROIDS
FRONT AVANT	P205/60R15	230kPa, 33PSI
REAR ARRIERE	P205/60R15	230kPa, 33PSI
SPARE DE SECOURS	T125/70D16	420kPa, 60PSI

Figure A-80 Pre-Test Vehicle Recommended Tire Pressure Label View
