Report Number: 214-TRC-06-006

Safety Compliance Testing For FMVSS 214

Side Impact Protection

2007 Nissan Sentra 4-door

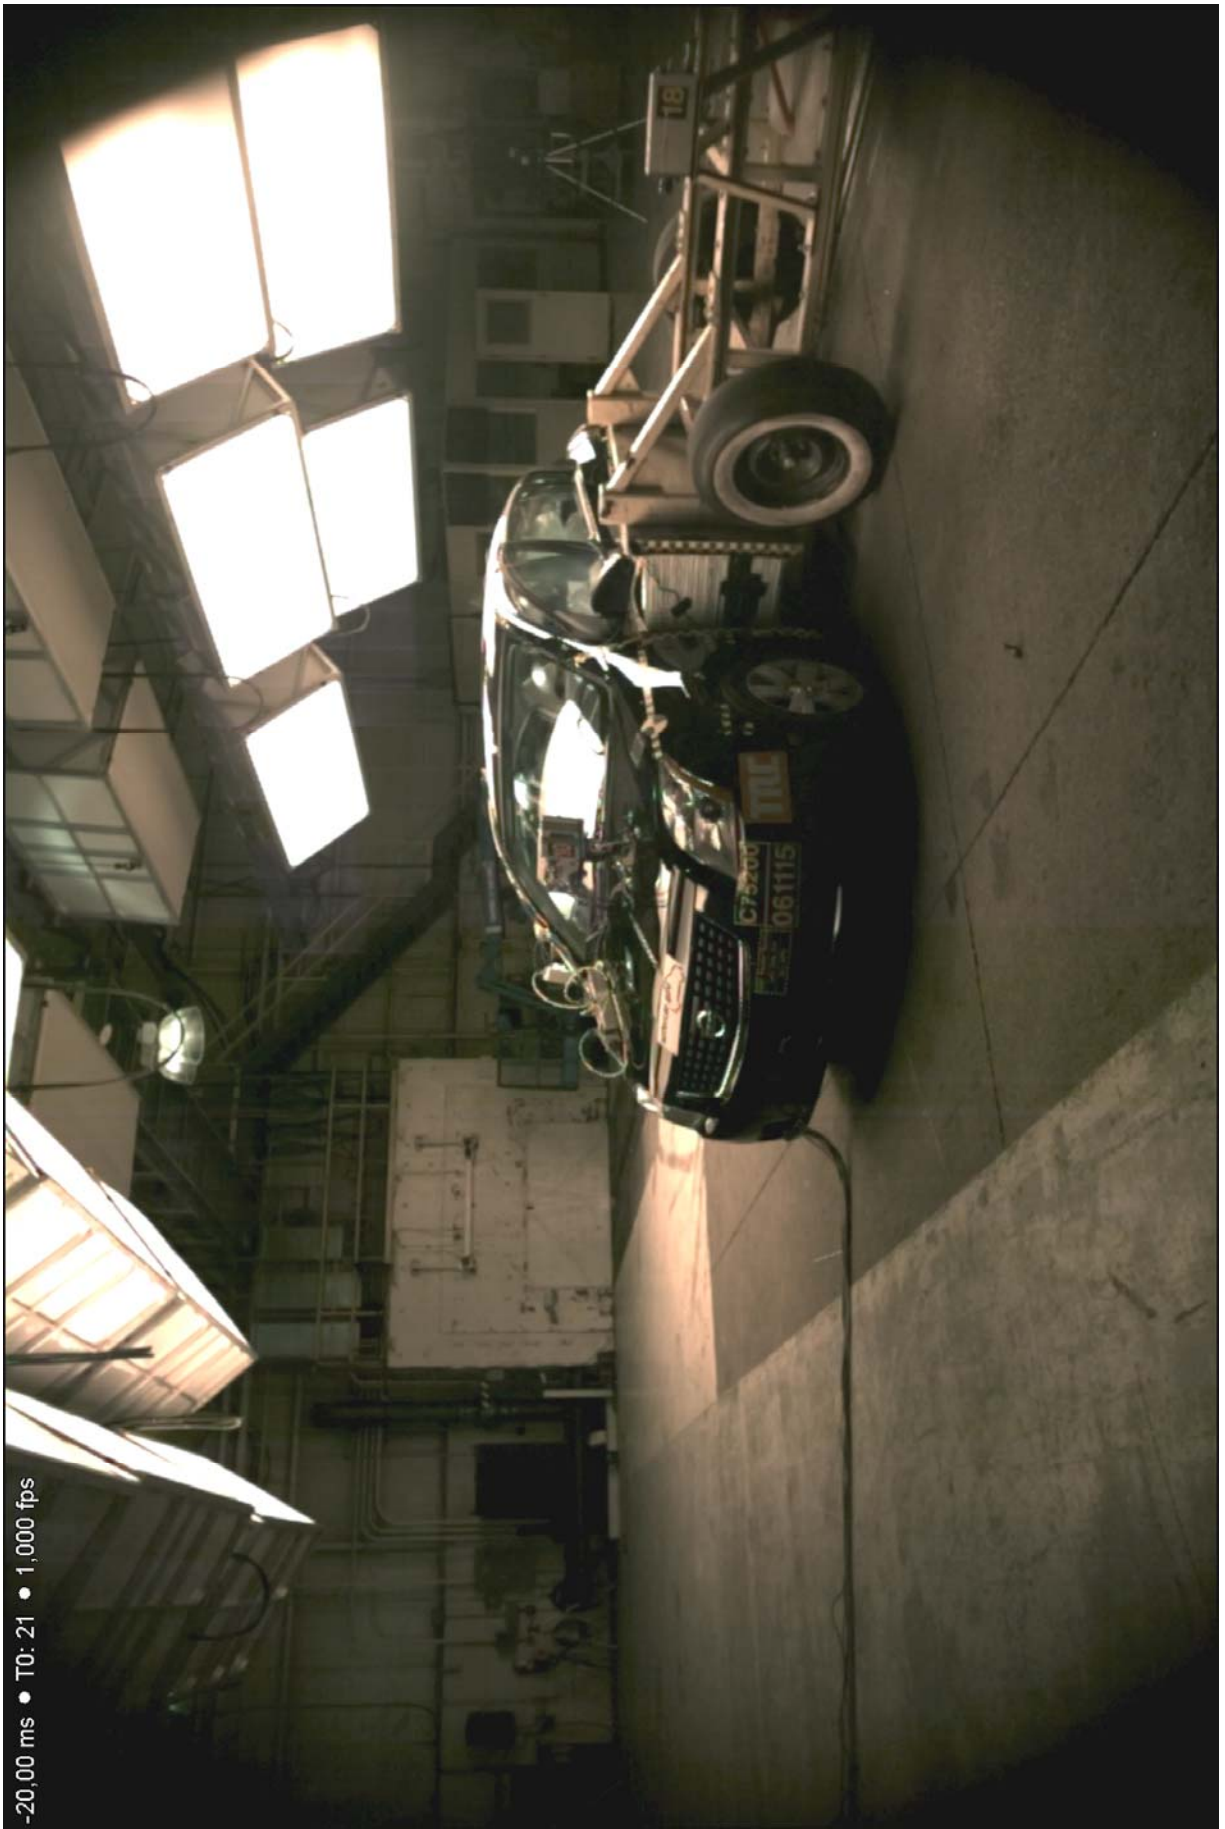
Figure A-83 Impact Event
