**REPORT NUMBER: NCAP-MGA-2007-009**

**NEW CAR ASSESSMENT PROGRAM  
FRONTAL BARRIER IMPACT TEST**

**NISSAN MOTOR CO., LTD.  
2007 NISSAN ALTIMA  
NHTSA NUMBER: M75202**

**PREPARED BY:  
MGA RESEARCH CORPORATION  
5000 WARREN ROAD  
BURLINGTON, WI 53105**

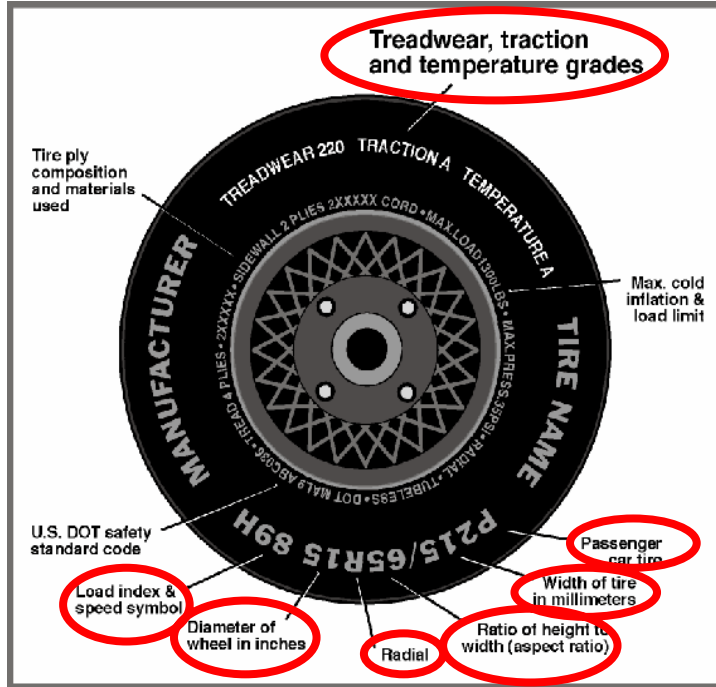
**DATA SHEET NO. 3**  
**TEST VEHICLE TIRE INFORMATION**

Measured Parameter	Front	Rear
Maximum Tire Pressure (kPa)	300	300
Cold Pressure (kPa)	220	220
Recommended Tire Size	P215/60R16	P215/60R16
Tire Size on Vehicle	P215/60R16	P215/60R16
Tire Manufacturer	Continental	Continental
Tire Name	Conti Pro Contact	Conti Pro Contact
Tire Type	Passenger	Passenger
Tire Width (mm)	215	215
Ratio of Height to Width (aspect ratio)	60	60
Radial	R	R
Wheel Diameter	16	16
Load Index & Speed Symbol	94T	94T
Treadwear	400	400
Traction Grade	AA	AA
Temperature Grade	A	A

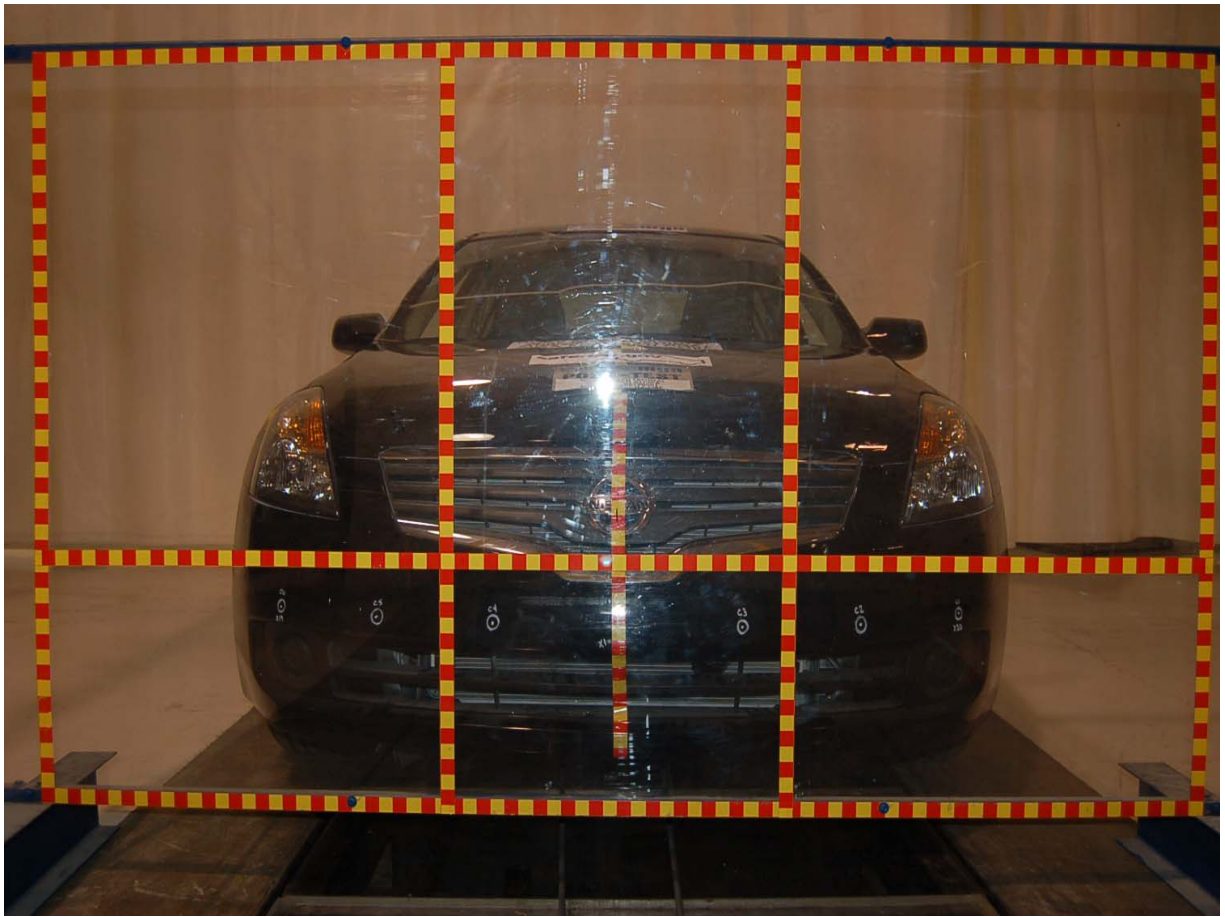
Load Cell Location

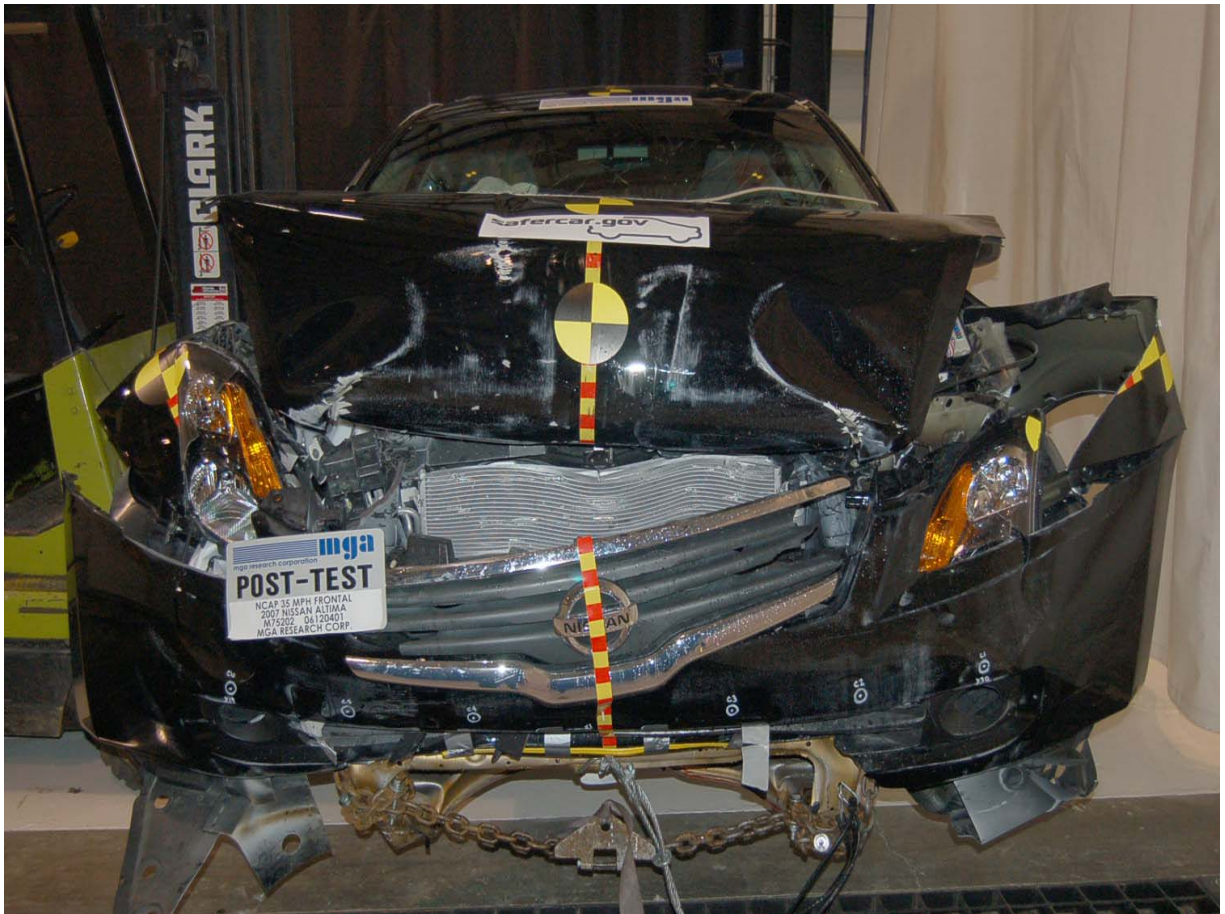
Post-Test Front View

The maximum static crush of the vehicle was 591 mm and both the driver and passenger side doors remained closed and latched during the impact event and were operable after the impact.

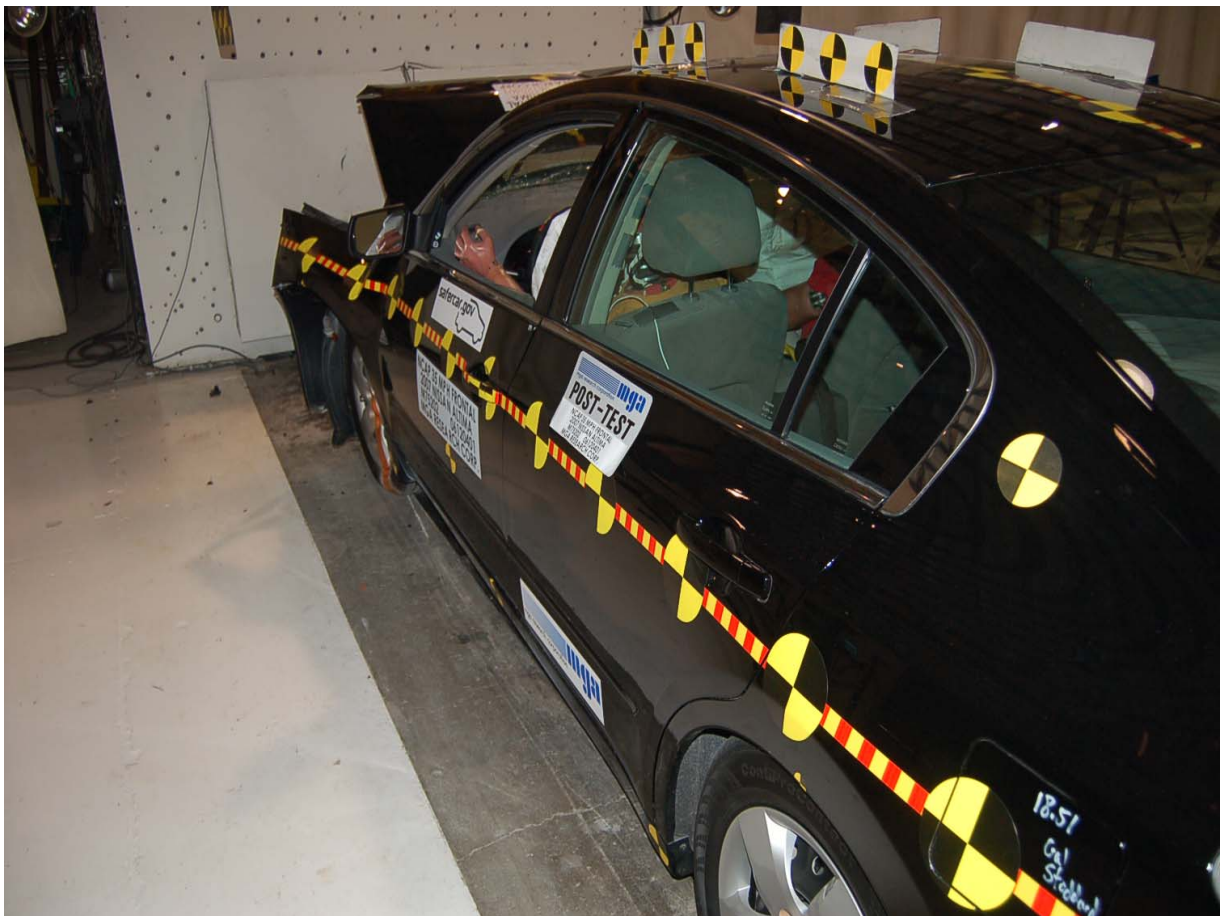
Post-Test Left Side 3/4 View of Doors After Impact

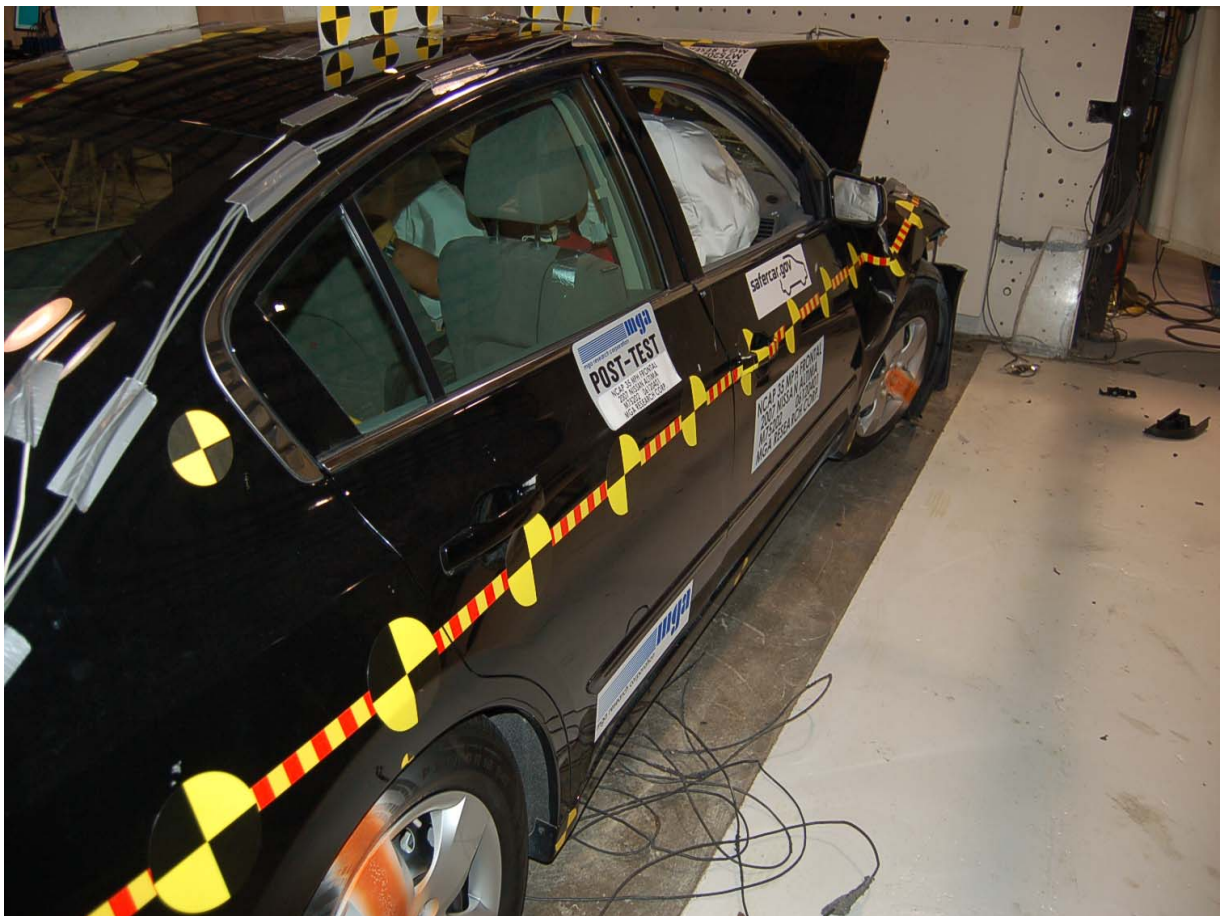
Post-Test Right Side ¾ View of Doors After Impact

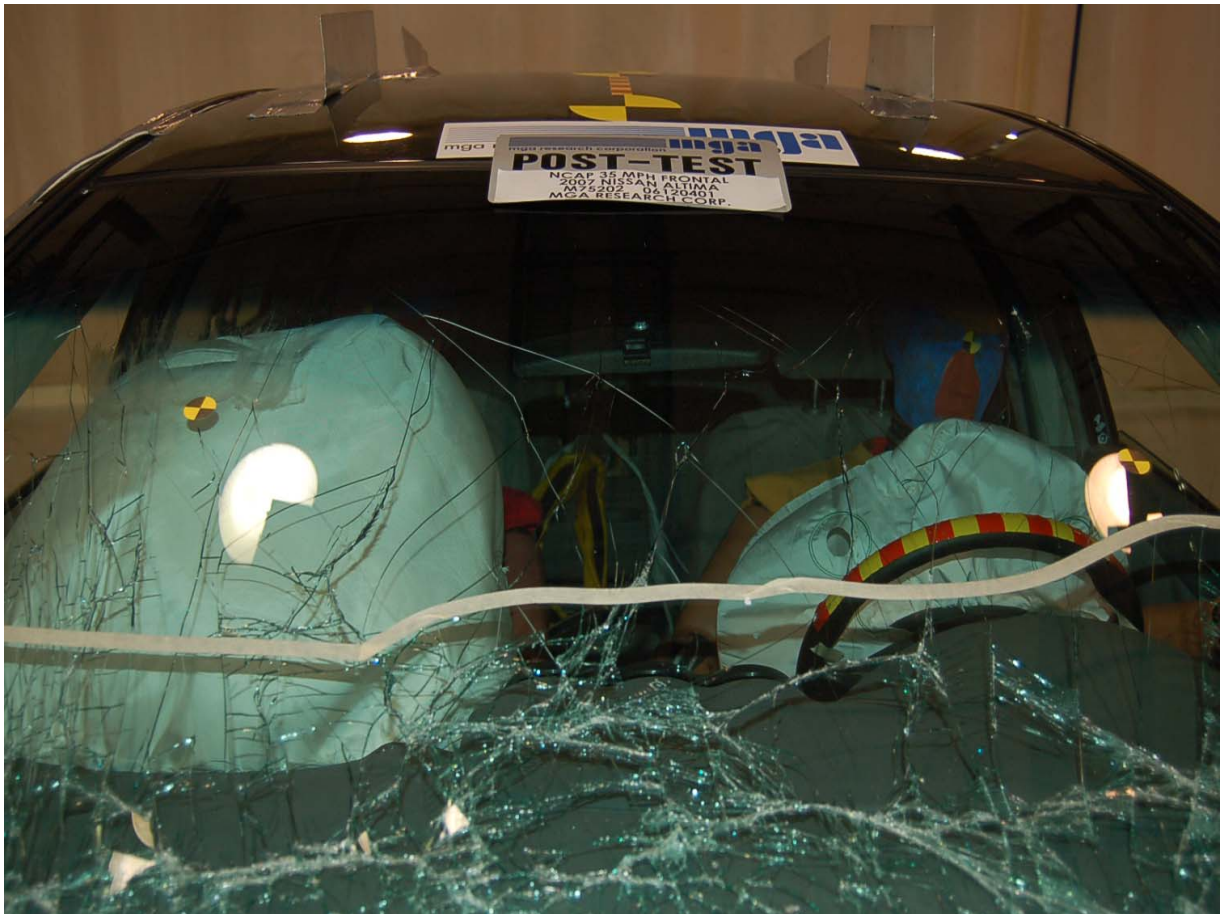
Post-Test Windshield View

There was 100 percent windshield retention and no intrusion into the protected zone of the windshield during the event. There was no Stoddard Solvent leakage after the event. There was a trace of leakage during the last phase of the static rollover.

Description	Driver	Passenger
Locked/Unlocked Doors	Doors were unlocked	Doors were unlocked
Front Door Opening	Door remained closed and latched; Door opened without tools	Door remained closed and latched; Door opened without tools
Rear Door Opening	Door remained closed and latched; Door opened without tools	Door remained closed and latched; Door opened without tools
Seat Track Shift (mm)	0	0
Seat Back Failure	None	None
Glazing Damage	The windshield cracked.

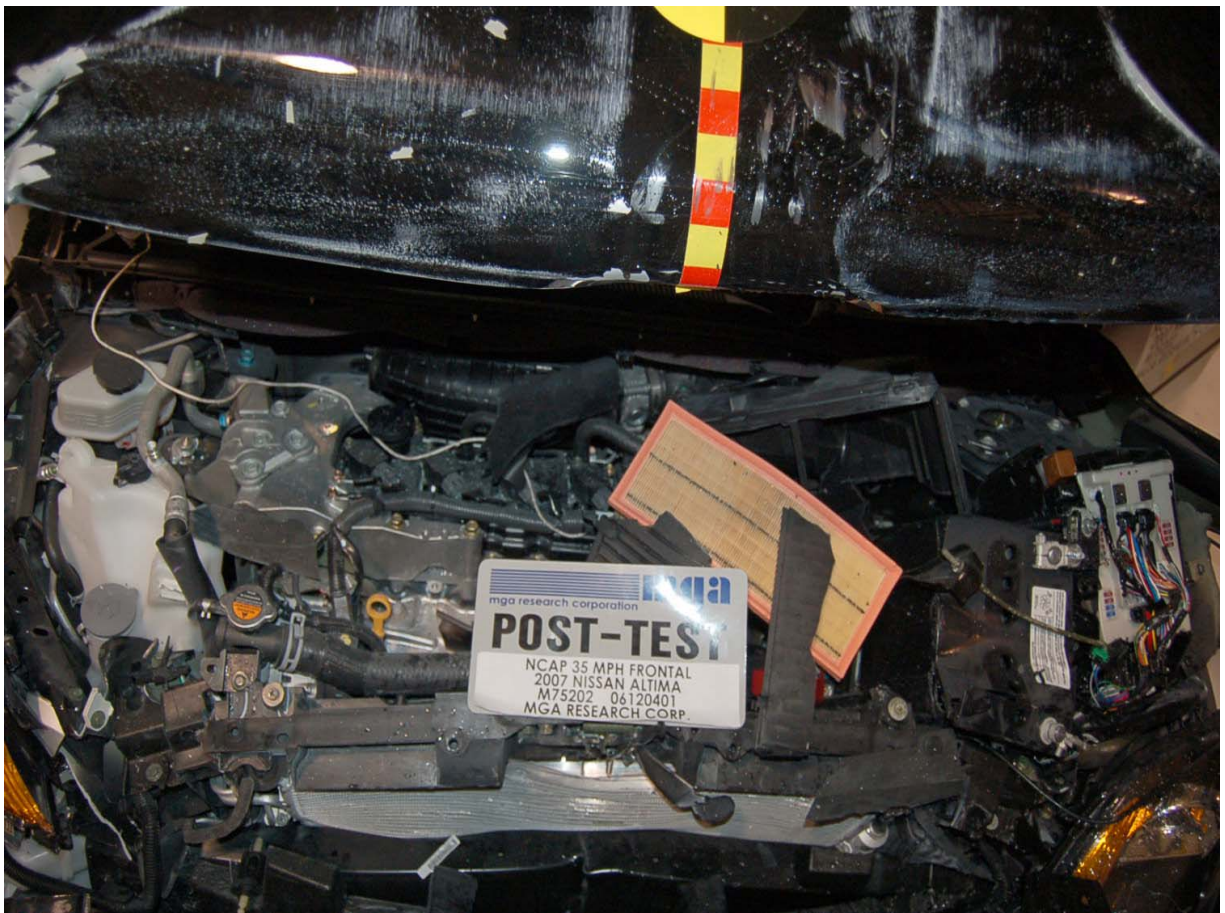
Post-Test Engine Compartment View

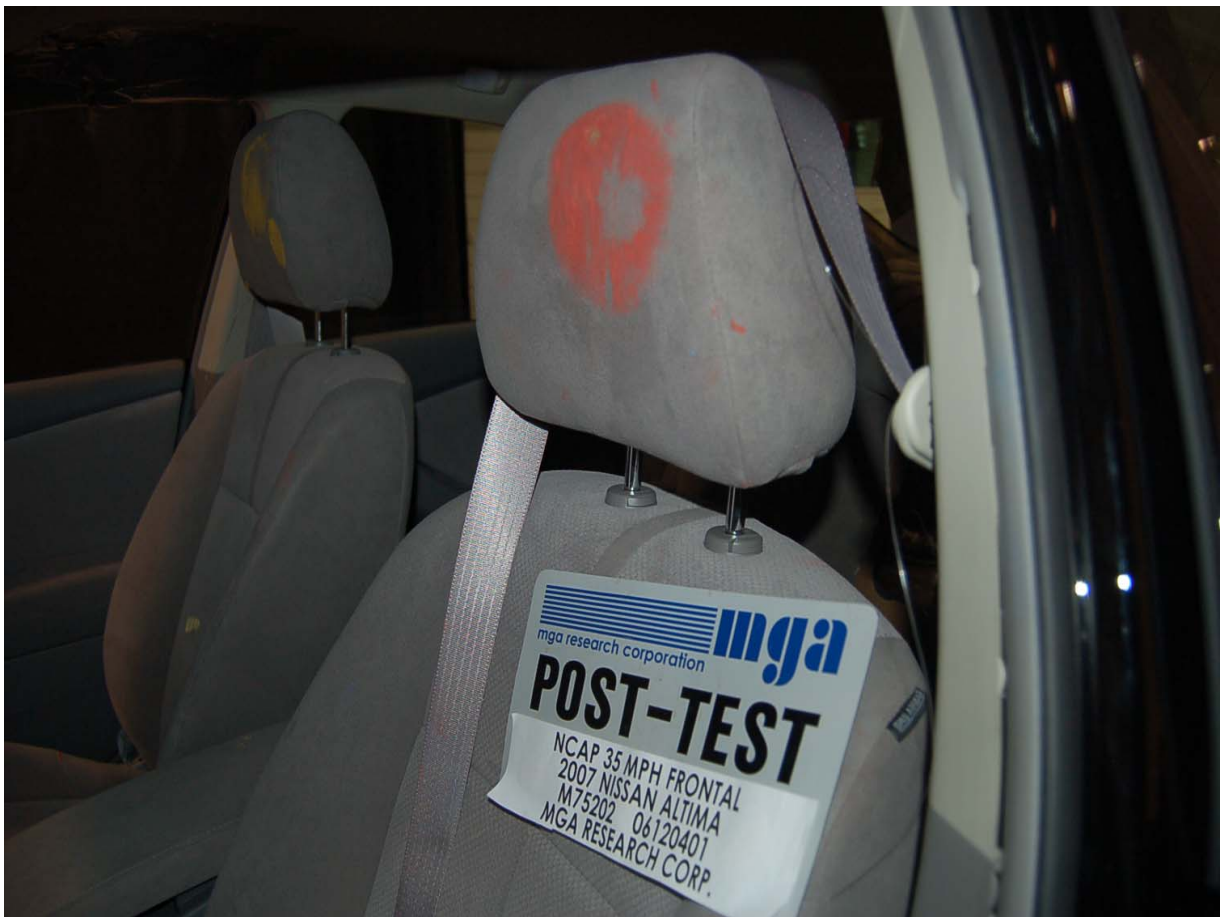
Post-Test Driver Dummy Head Contact (headrest)

The driver's head and chest contacted the airbag. The driver's head also contacted the headrest. The driver's knees contacted the bolster. The passenger's head and chest contacted the airbag. The passenger's head also contacted the headrest. The passenger's knees contacted the glove box.

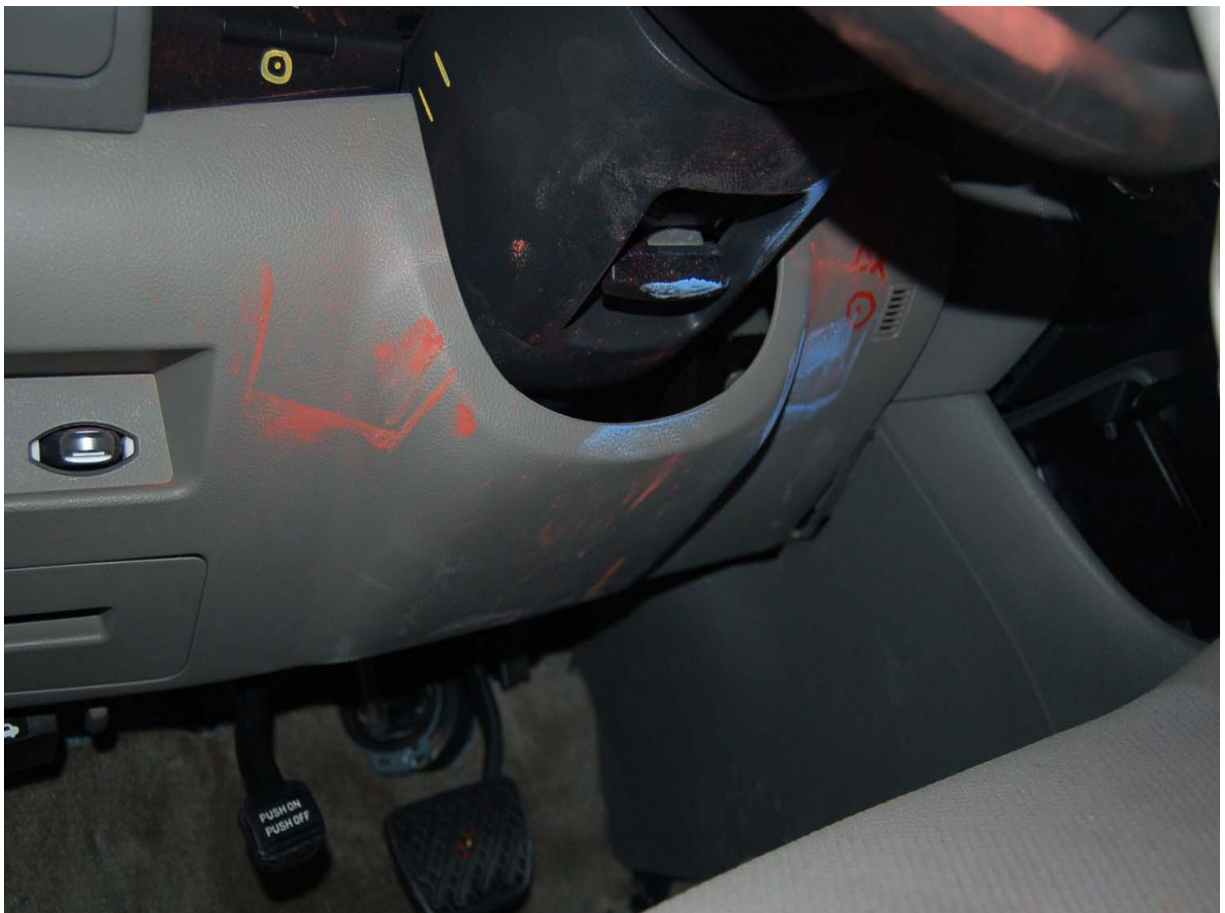
Post-Test Driver Dummy Knee Contact

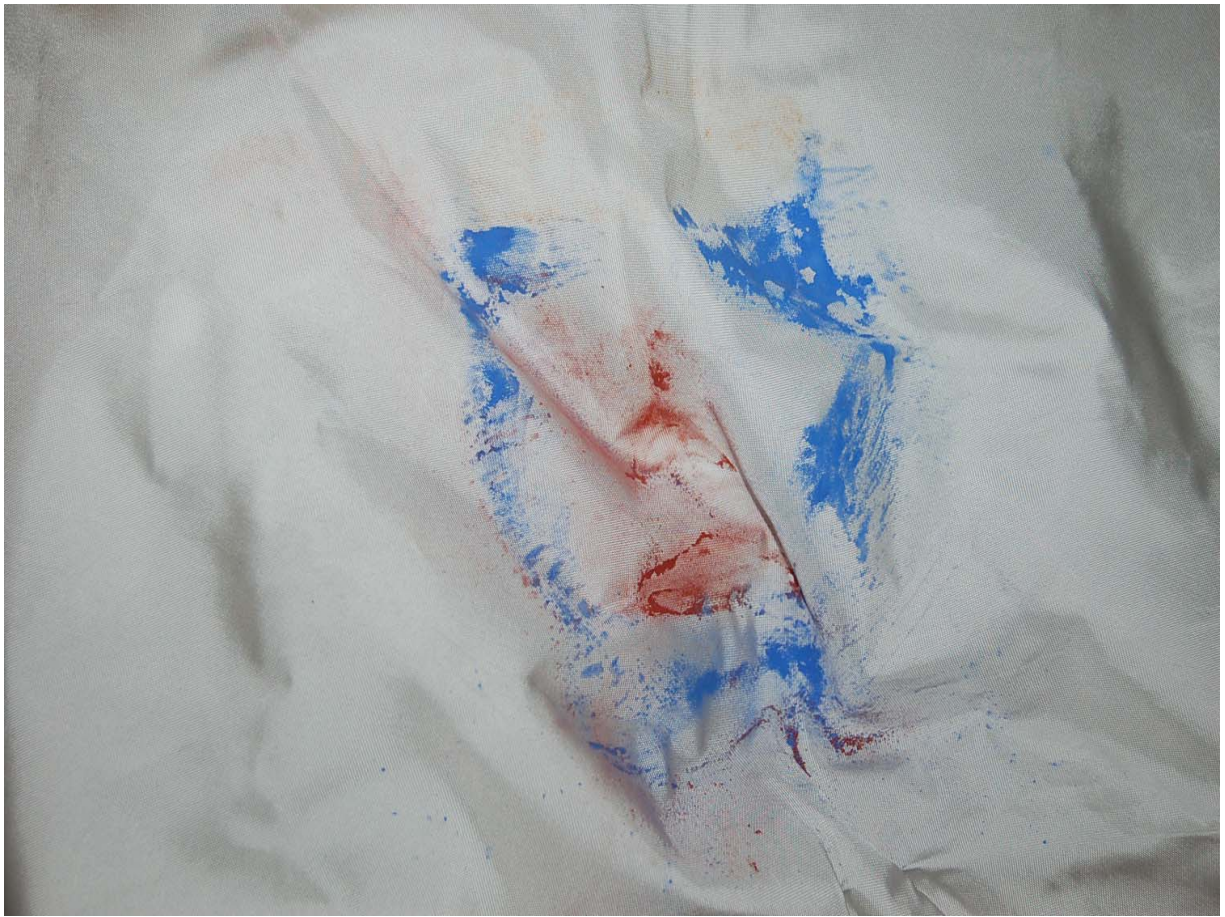
Post-Test Driver Dummy Airbag Contact

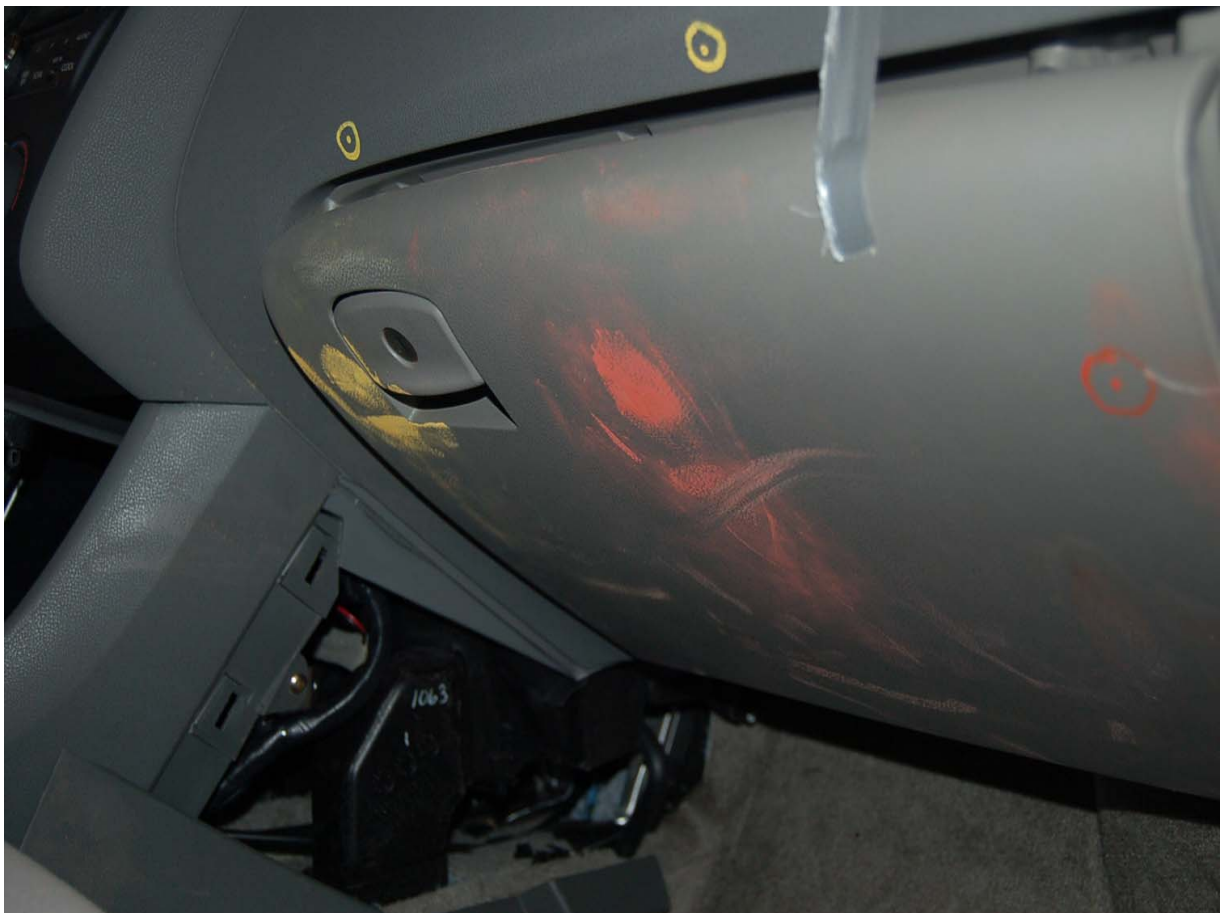
Post-Test Passenger Dummy Knee Contact

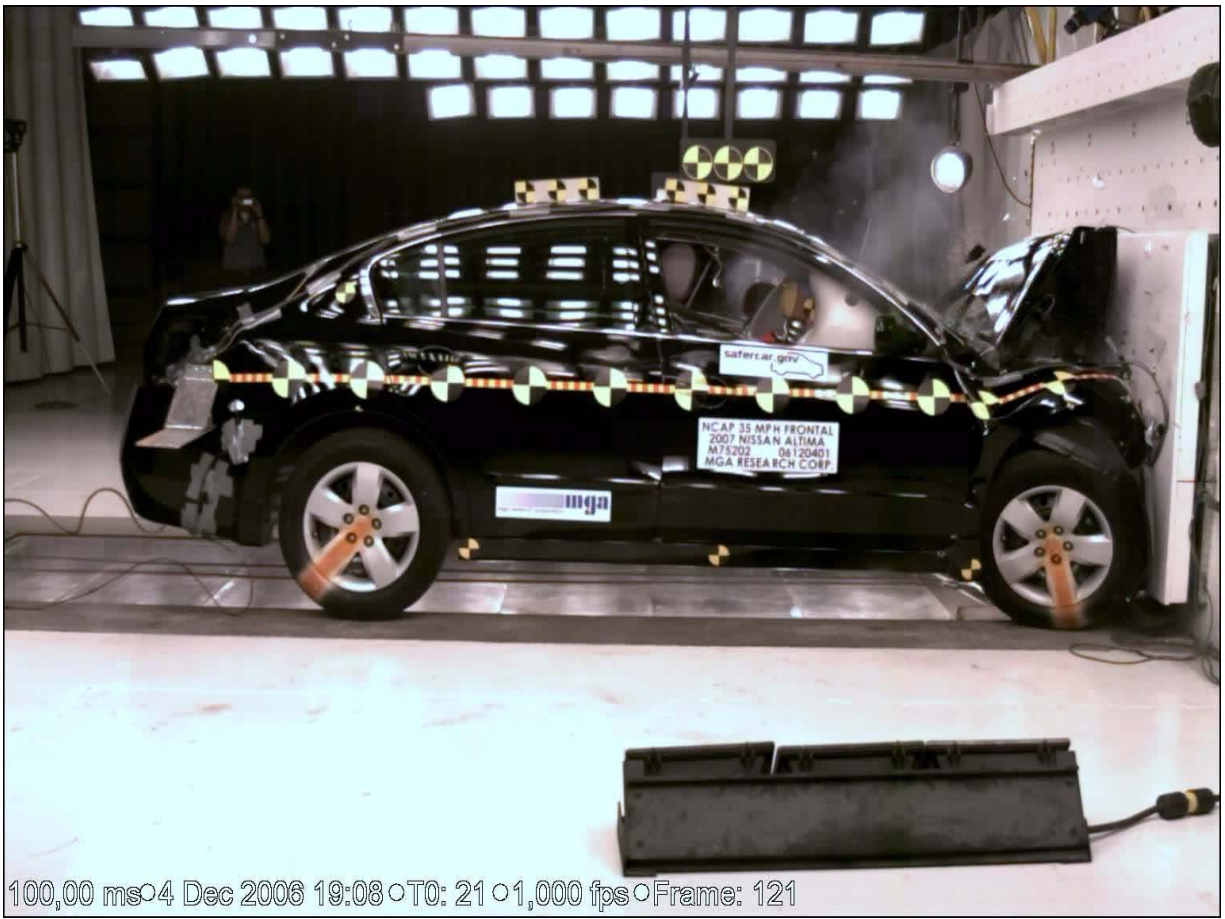
100,00 ms 4 Dec 2006 19:08 TO: 21 1,000 fps Frame: 121

Vehicle Impact

A load cell barrier was impacted by a 2007 Nissan Altima at a velocity of 56.5 kph. The test was performed at MGA Research Corporation on December 4, 2006. Pre-and post-test photographs of the vehicle and dummies can be found in Appendix A.
