**REPORT NUMBER: NCAPSIDE-MGA-2007-004**

**NEW CAR ASSESSMENT PROGRAM  
SIDE IMPACT TEST**

**NISSAN MOTOR CO., LTD.  
2007 NISSAN ALTIMA  
NHTSA NUMBER: M75203**

**PREPARED BY:  
MGA RESEARCH CORPORATION  
5000 WARREN ROAD  
BURLINGTON, WI 53105**

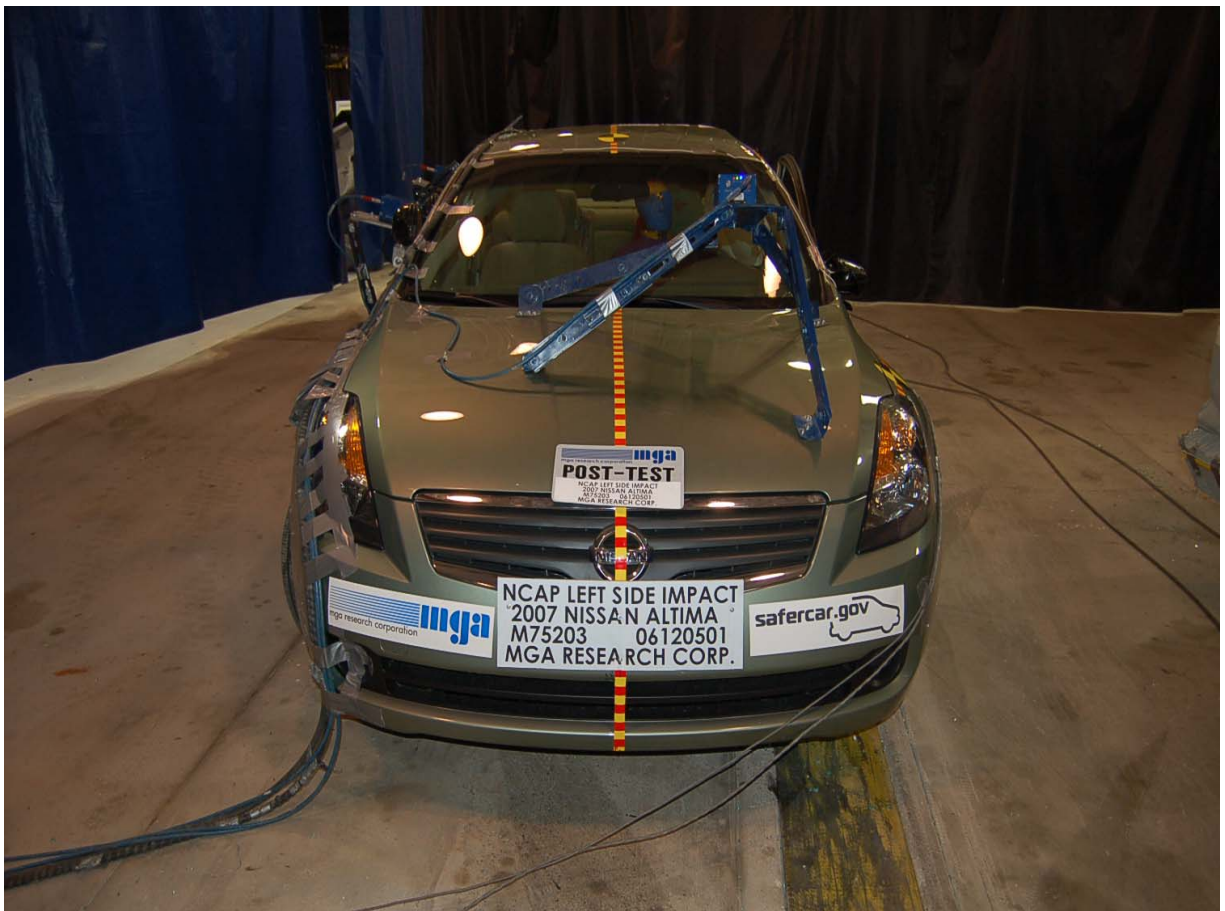
Post-Test Front View

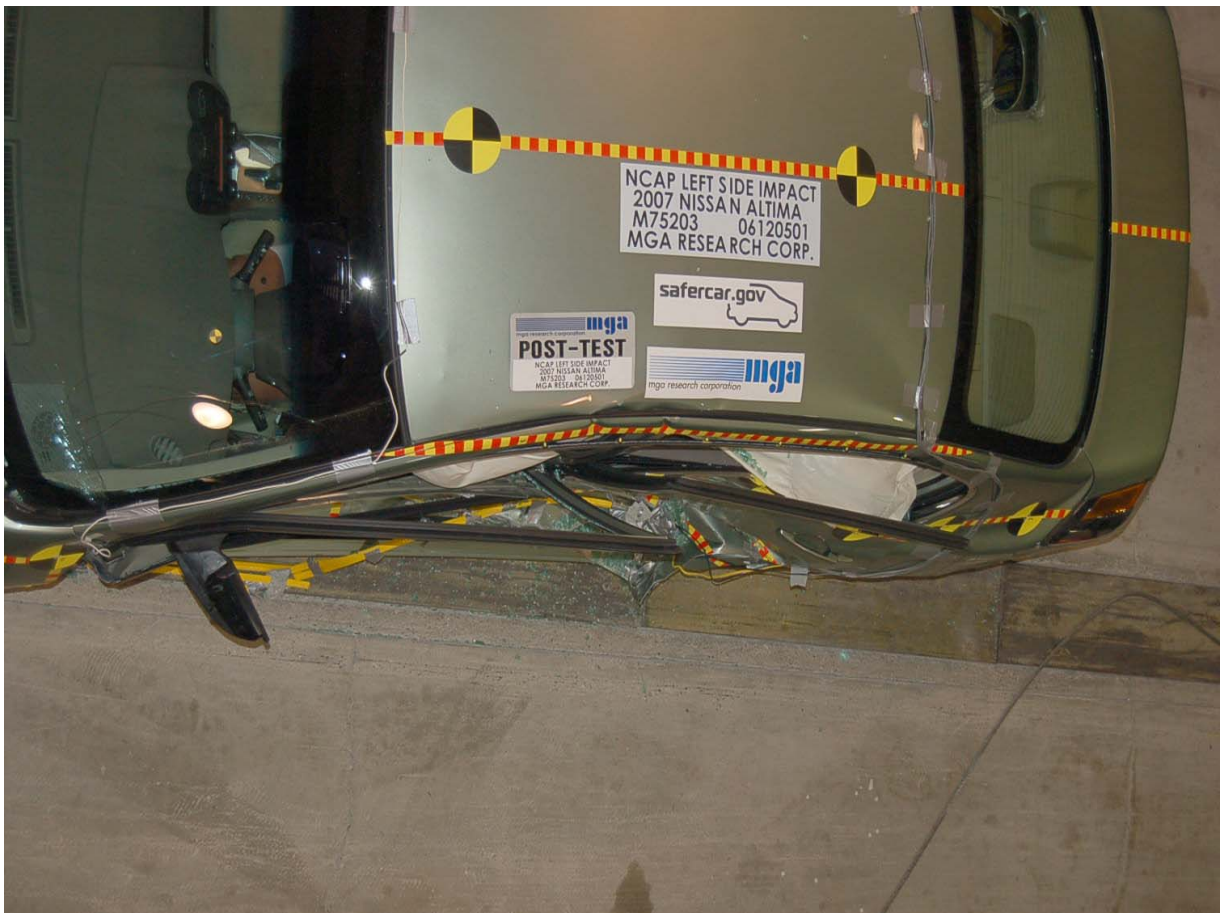
Post-Test Overhead Close-up View

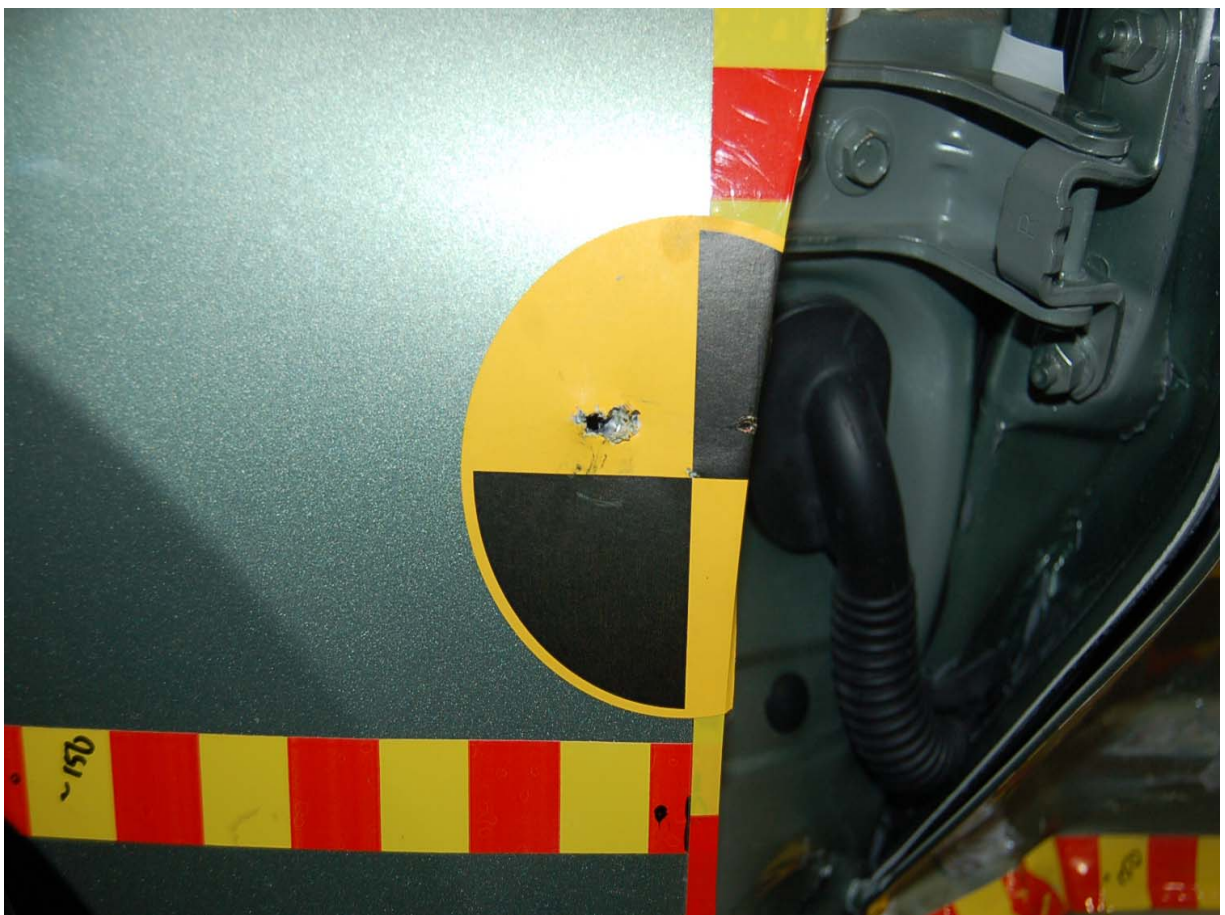
Post-Test Left Impact Point

The test vehicle sustained a maximum static crush of 308 mm at level 3, 750 mm rearward of the vertical impact point. The driver and passenger SID/HIIIs, Serial Nos. 272 and 904 respectively, were calibrated just prior to this test.

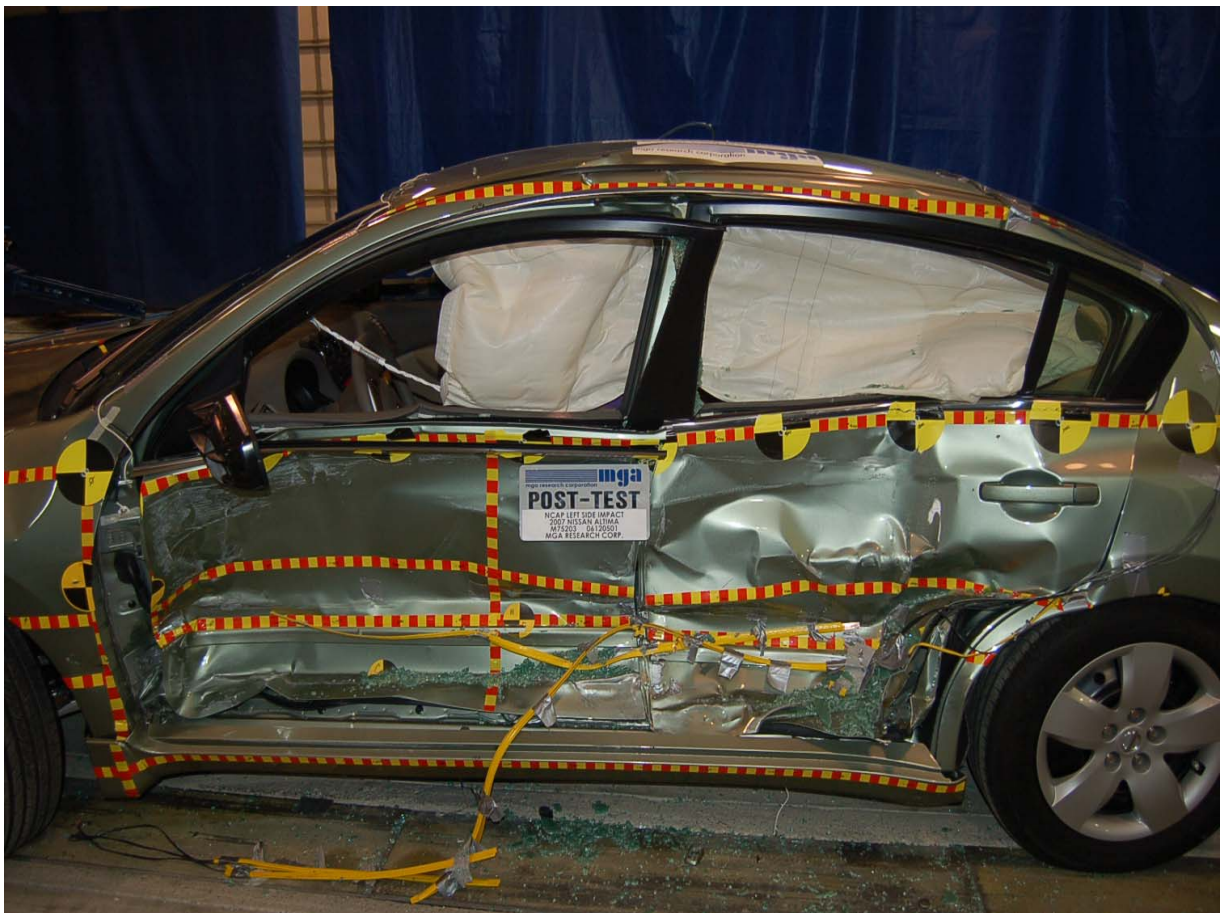
Post-Test Left Side Impact Close-up

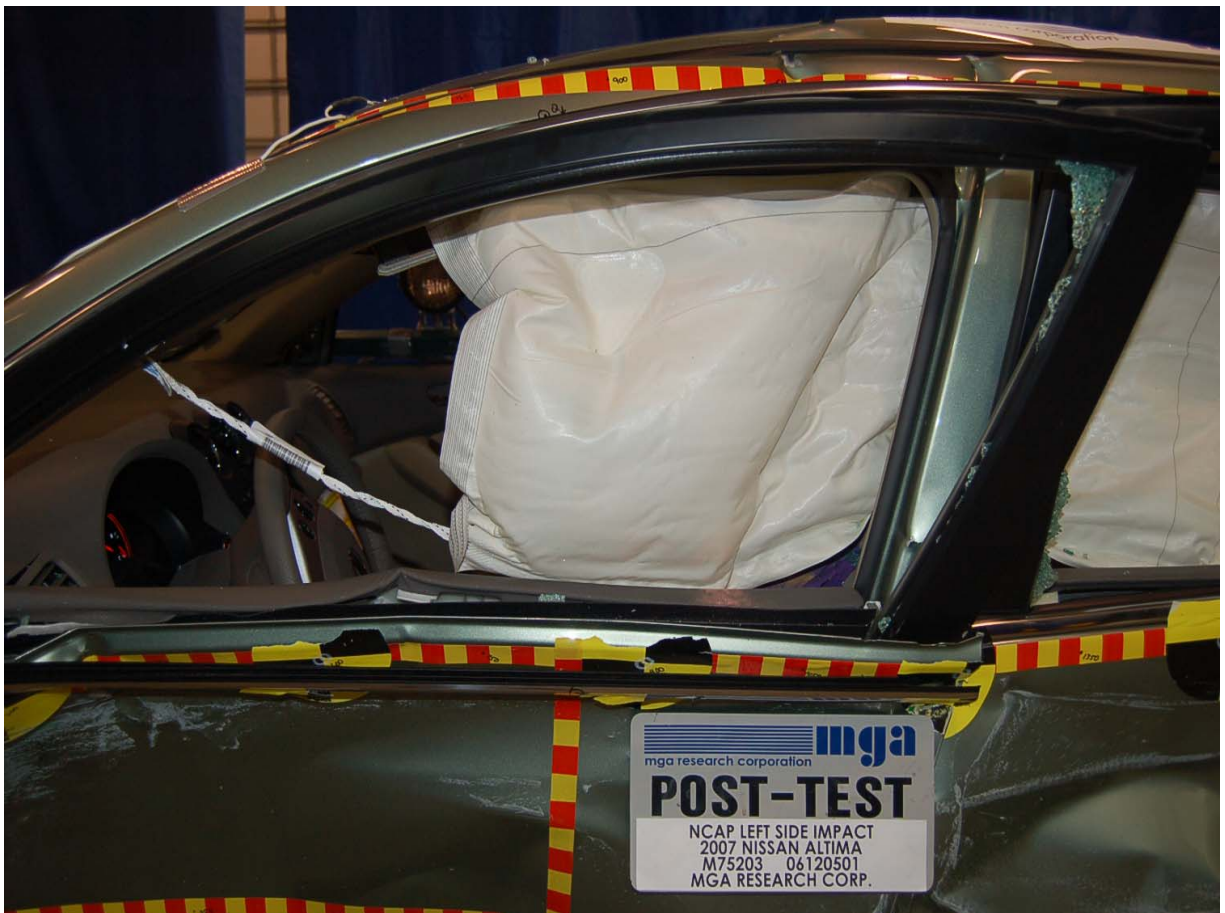
Post-Test Driver Dummy (Through Window)

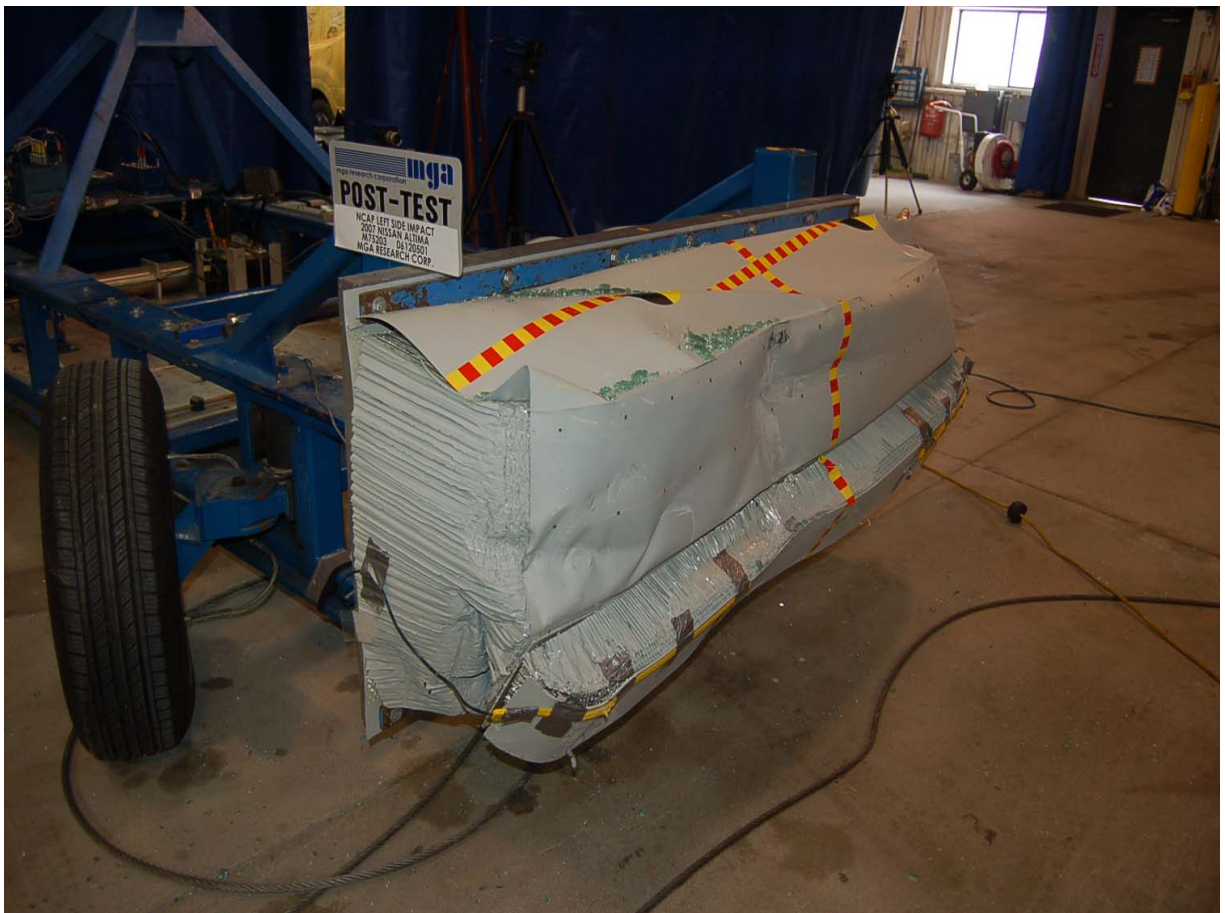
Post-Test Right Side View of Deformable Barrier

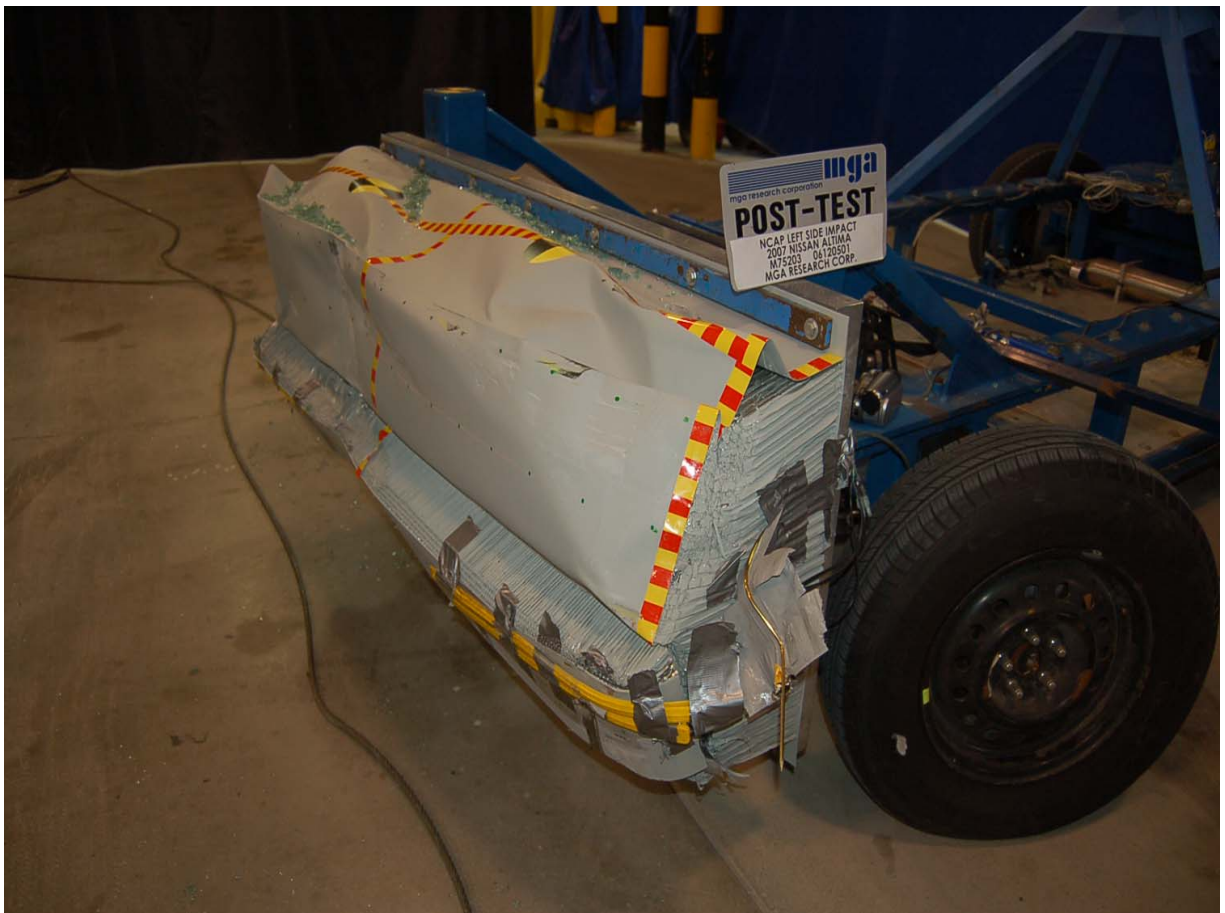
Post-Test Left Side View of Deformable Barrier
