**REPORT NUMBER: NCAP-MGA-2007-010**

**NEW CAR ASSESSMENT PROGRAM  
FRONTAL BARRIER IMPACT TEST**

**KIA MOTORS CORPORATION  
2007 KIA SORENTO LX 4X2  
NHTSA NUMBER: M70506**

**PREPARED BY:  
MGA RESEARCH CORPORATION  
5000 WARREN ROAD  
BURLINGTON, WI 53105**

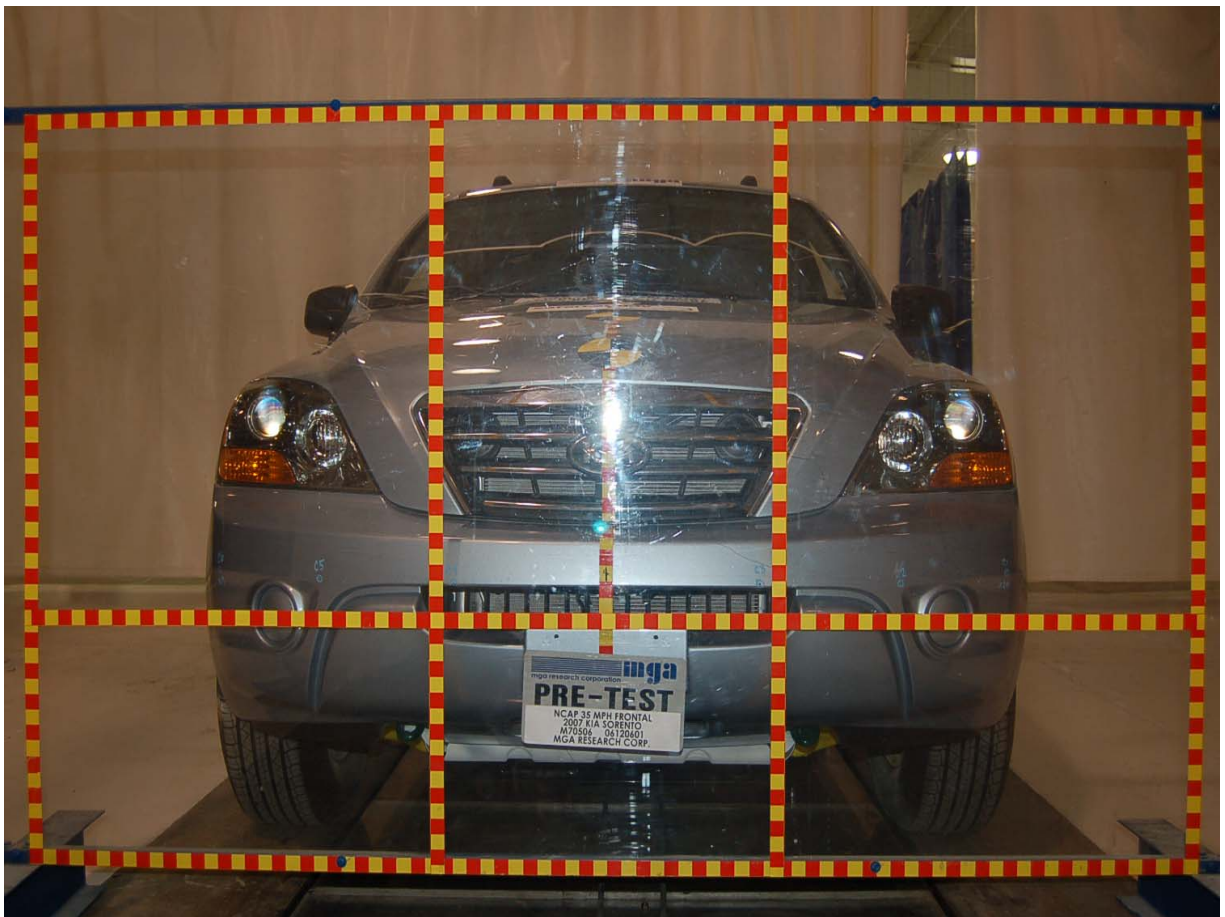
Load Cell Location

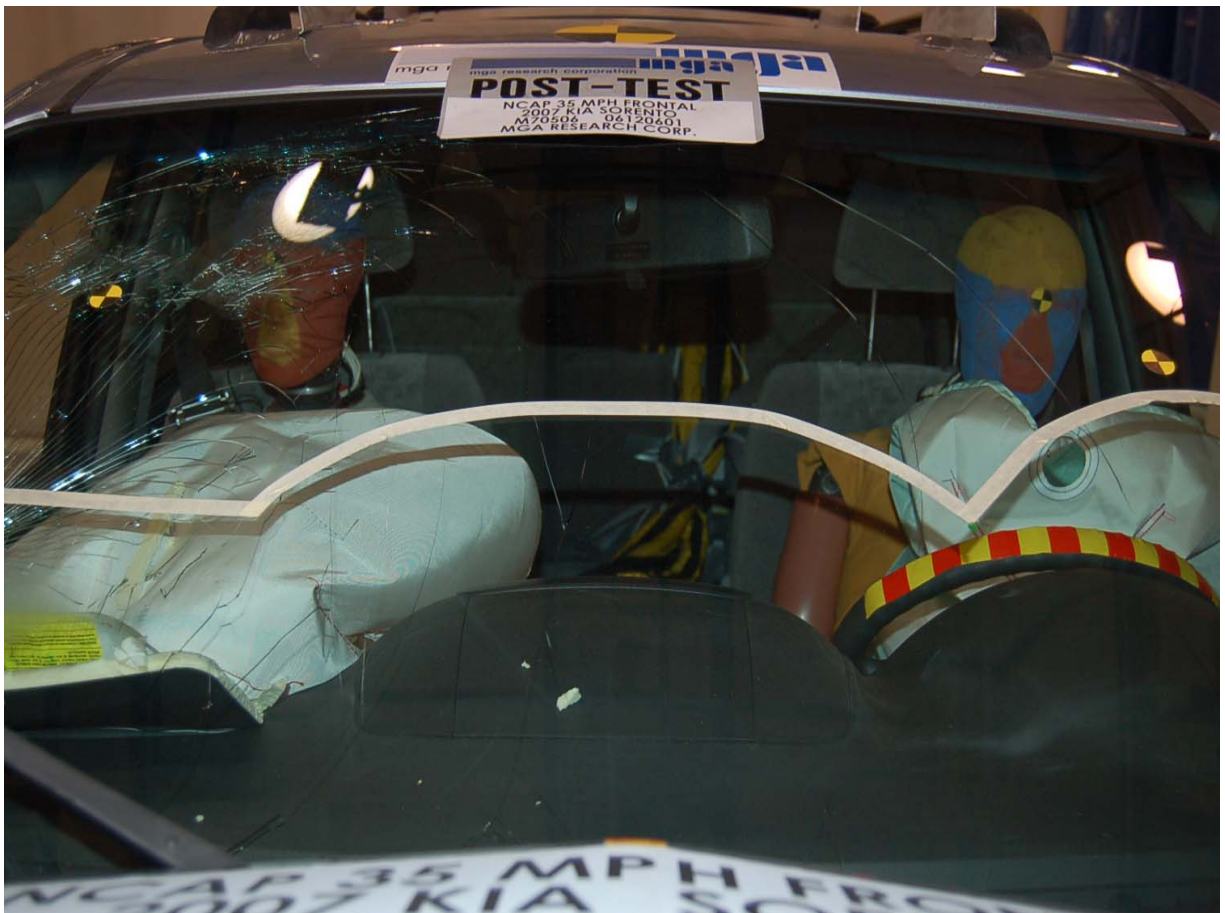
Post-Test Windshield View

There was 100 percent windshield retention and no intrusion into the protected zone of the windshield during the event. There was no Stoddard Solvent leakage after the event or during any phase of the static rollover.

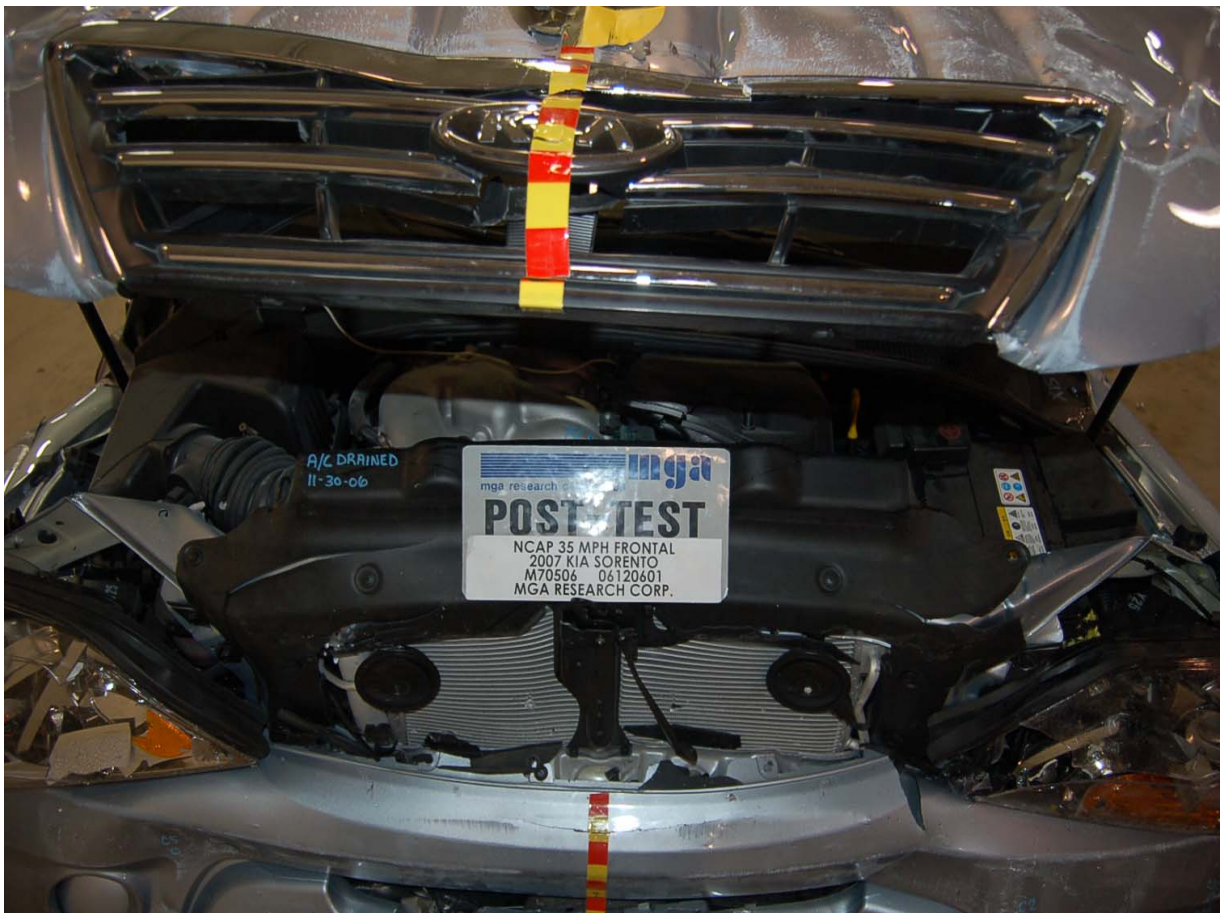
Post-Test Engine Compartment View

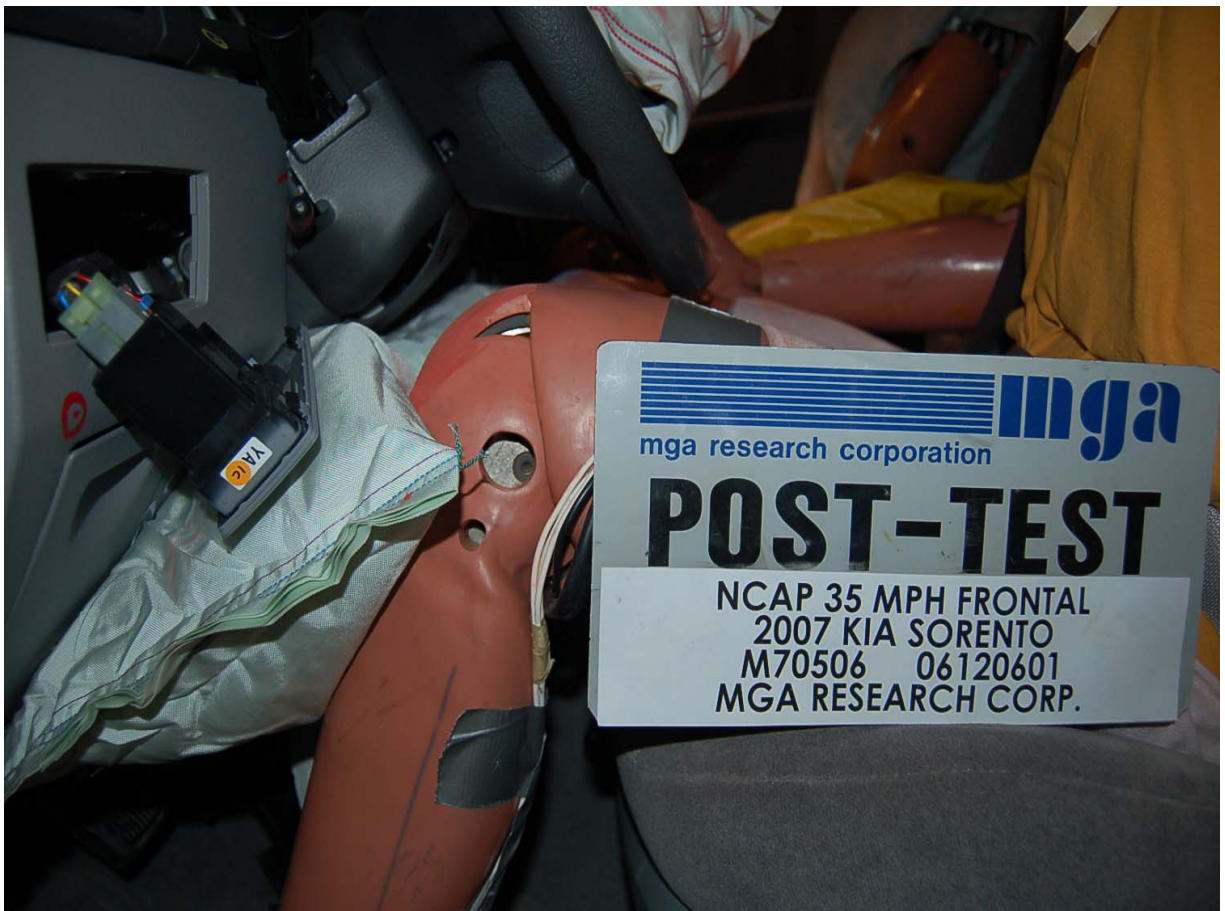
Post-Test Driver Side Knee Bolster

The driver's head and chest contacted the airbag. The driver's head also contacted the headrest. The driver's knees contacted the knee bag and bolster. The passenger's head and chest contacted the airbag. The passenger's head also contacted the headrest. The passenger's knees contacted the glove box.

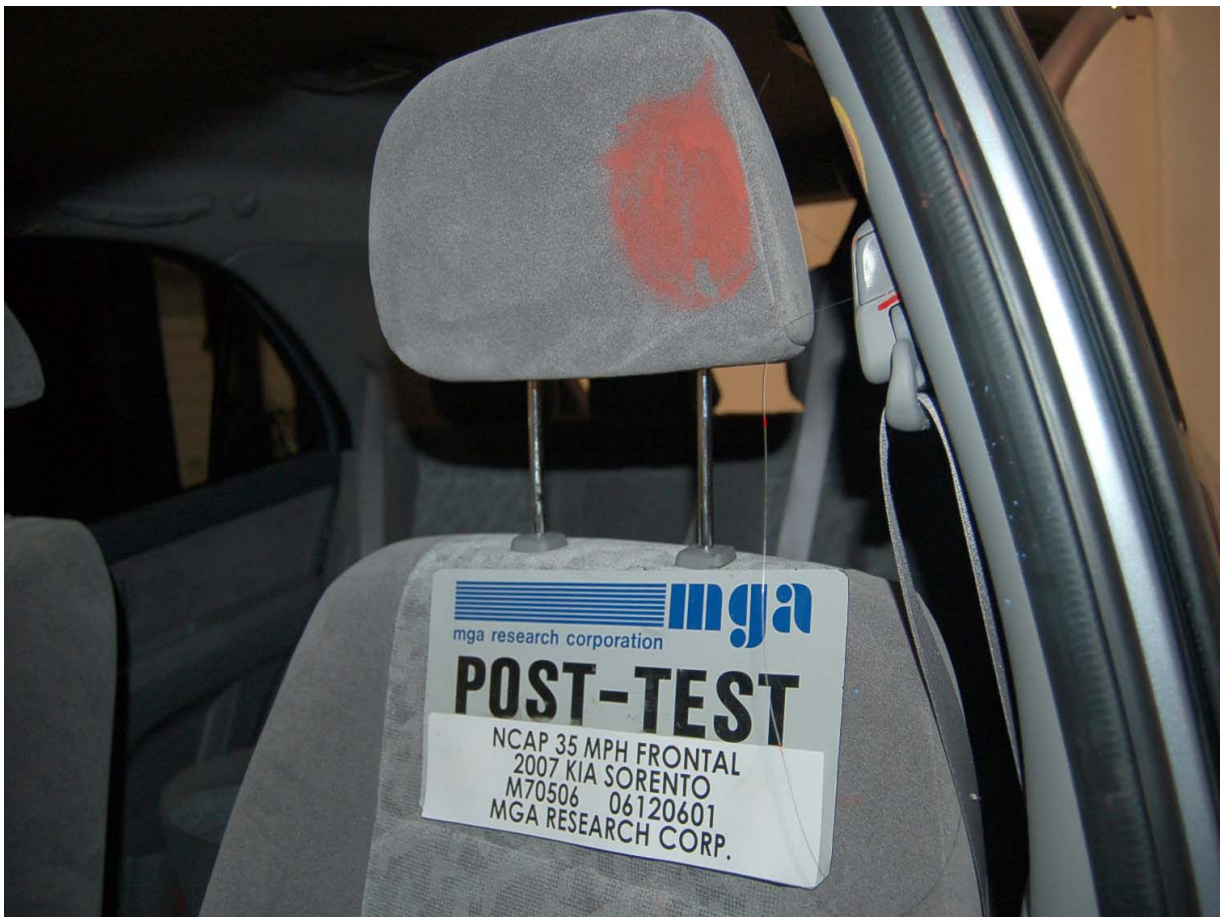
Post-Test Driver Dummy Head Contact (headrest)

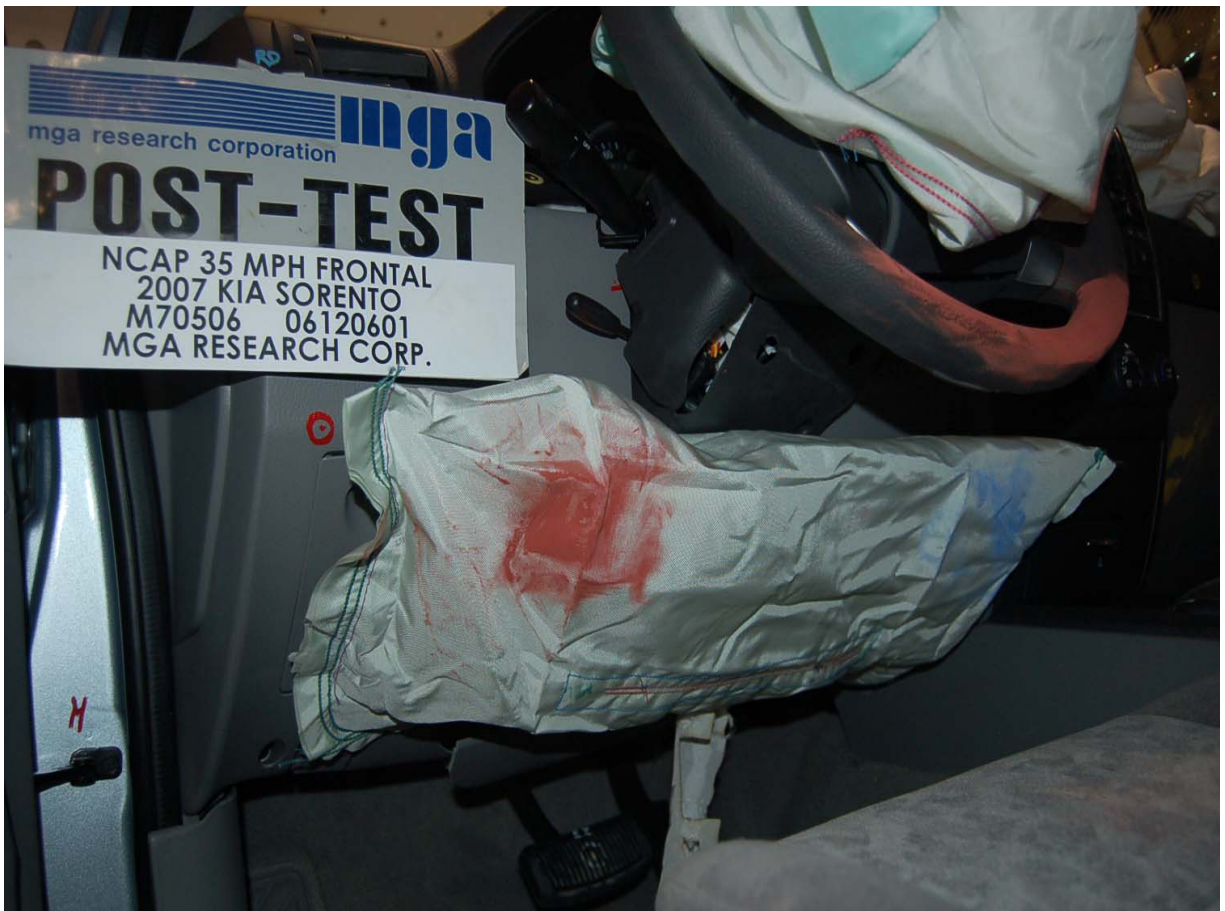
Post-Test Driver Dummy Knee Contact

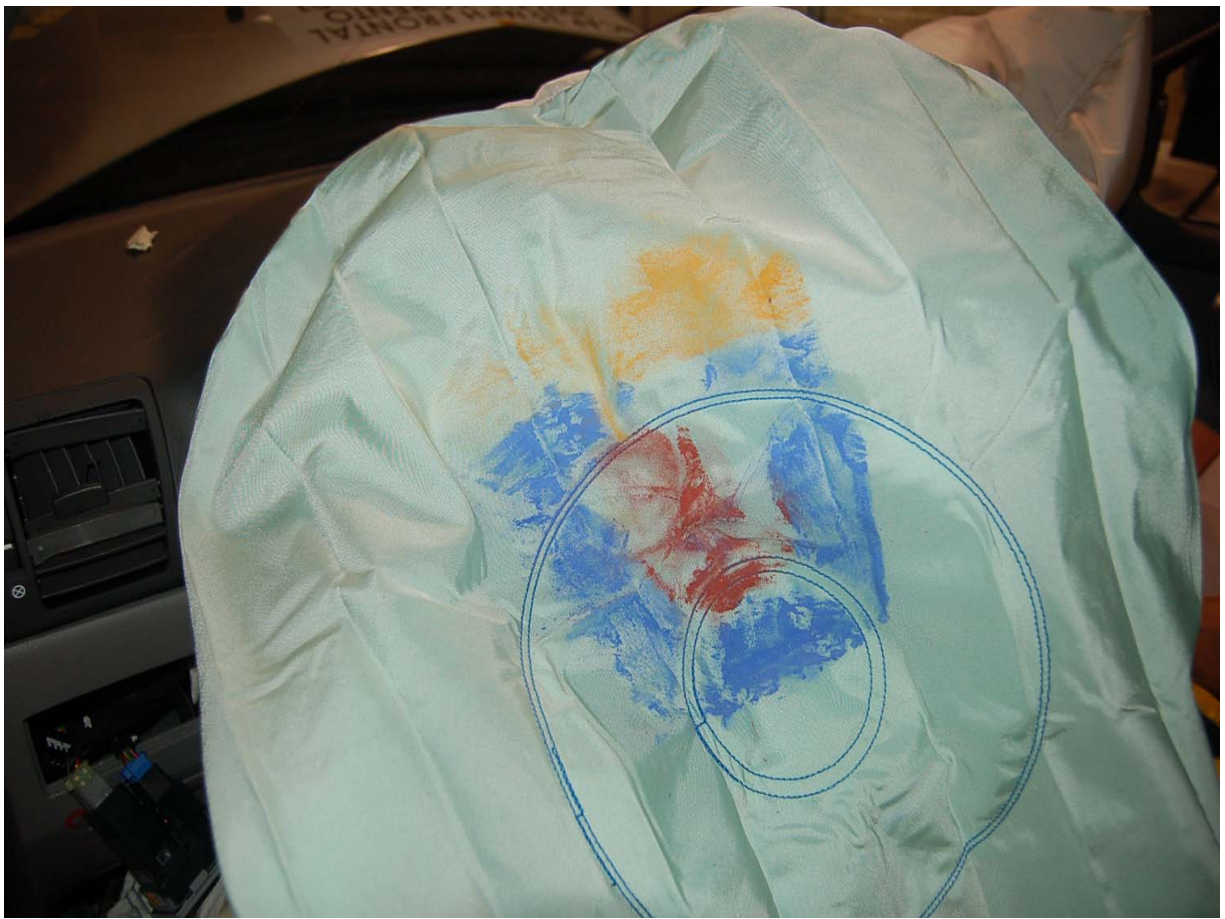
Post-Test Driver Dummy Airbag Contact

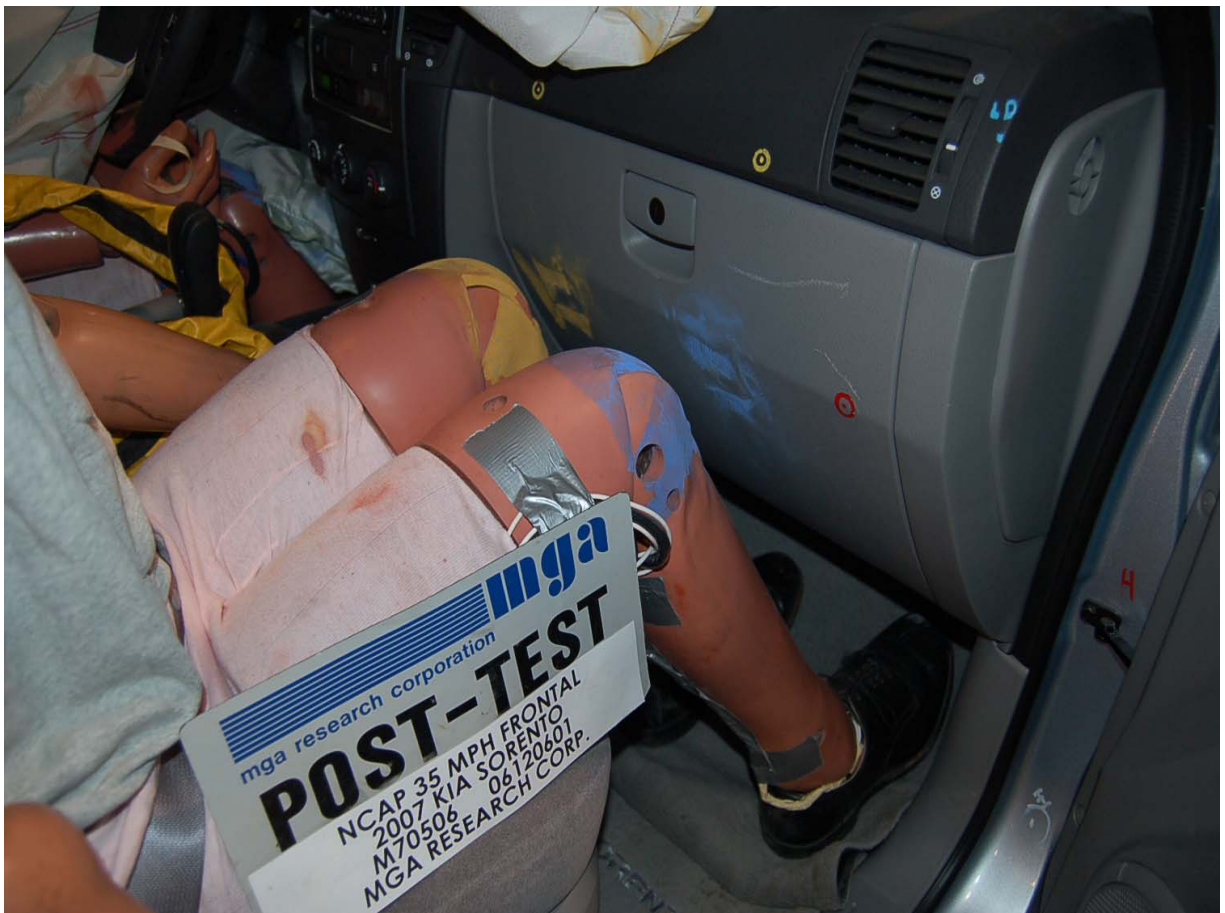
Post-Test Passenger Side Glove Box

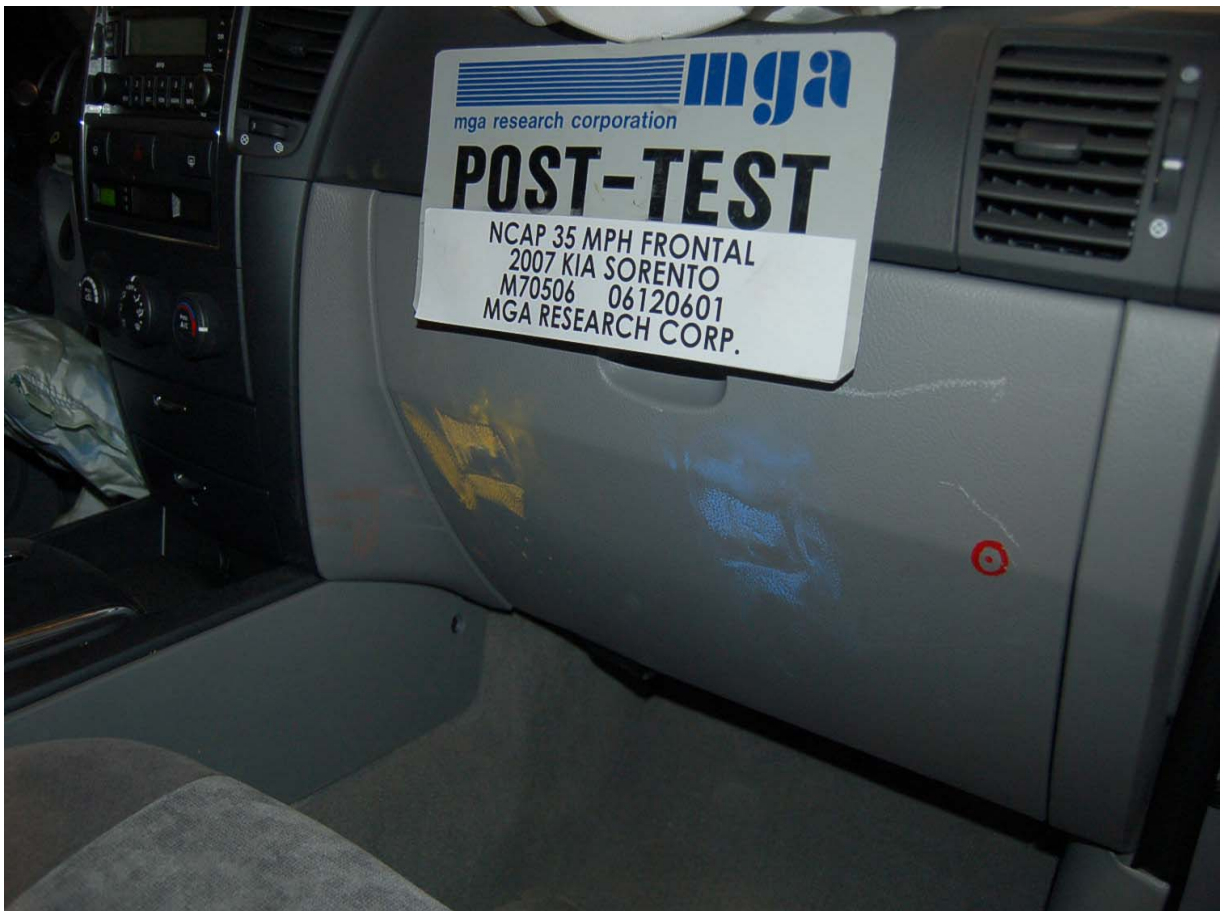
Post-Test Passenger Dummy Knee Contact

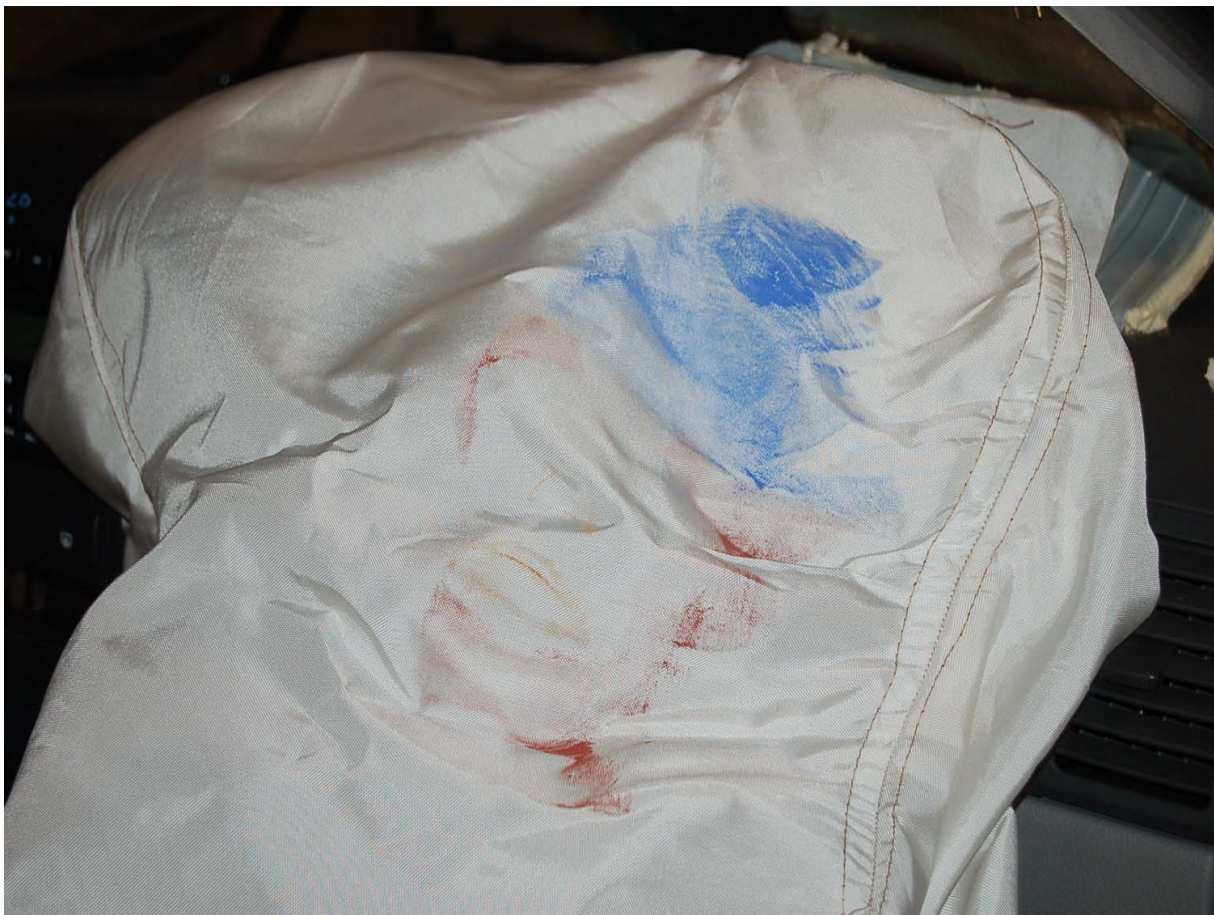
Post-Test Passenger Dummy Airbag Contact

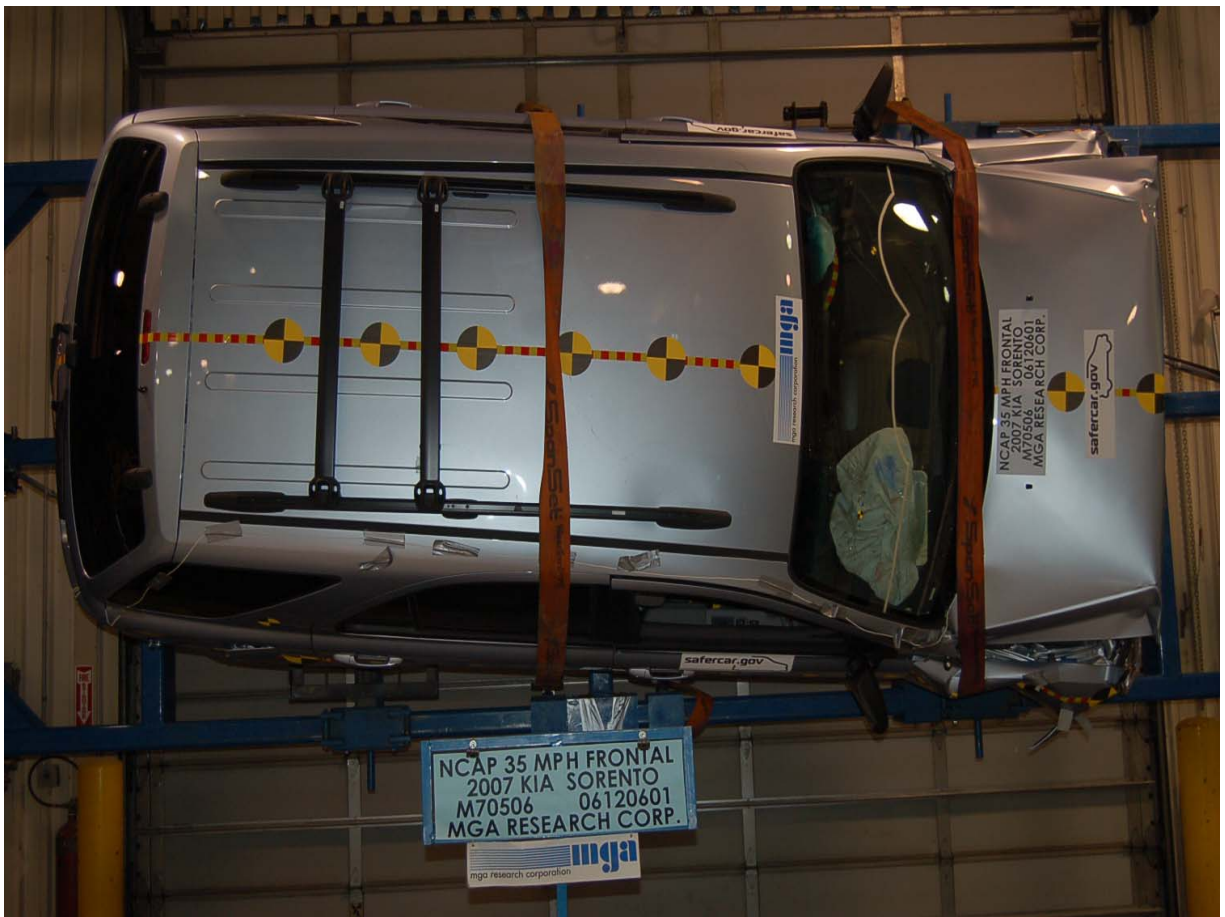
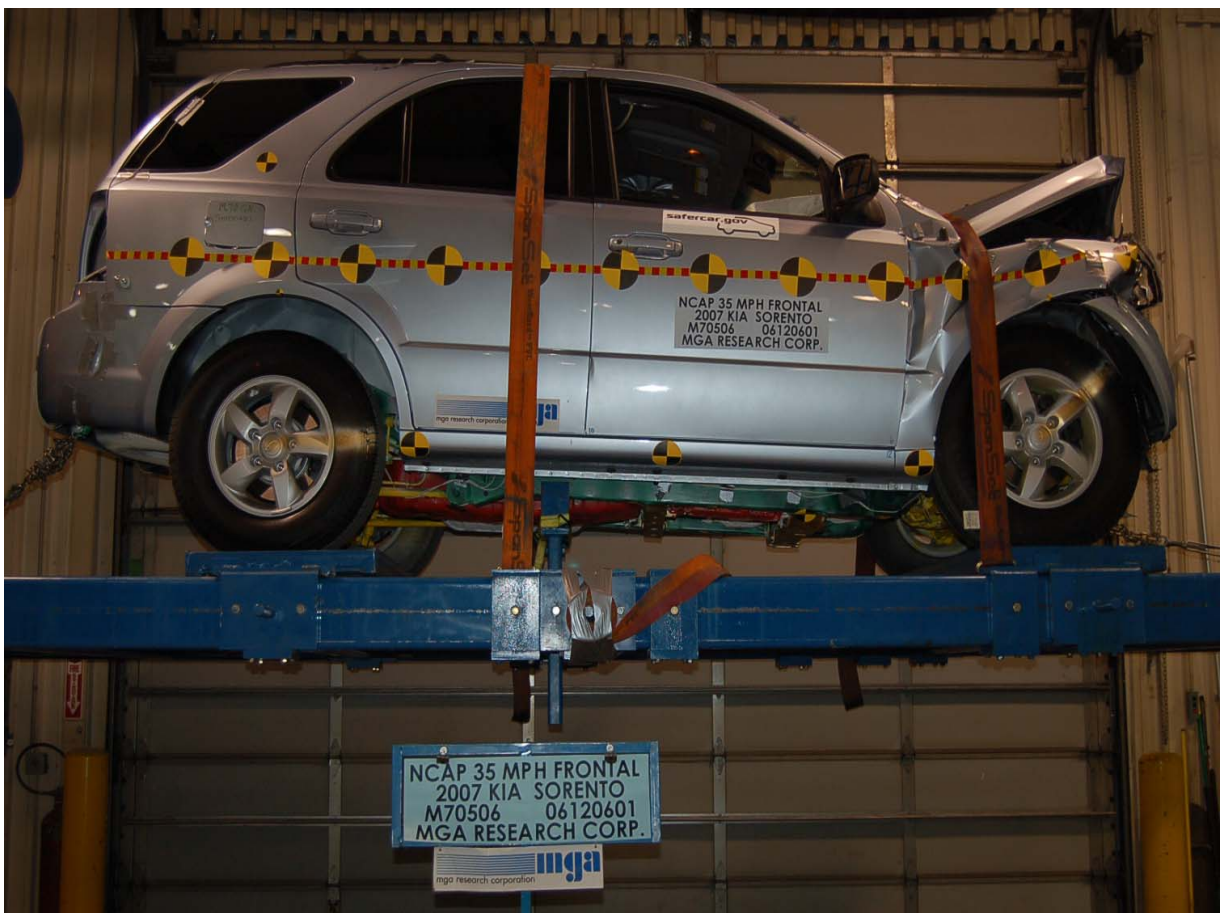
Rollover 90 Degrees

Rollover 180 Degrees

Rollover 270 Degrees

Rollover 360 Degrees

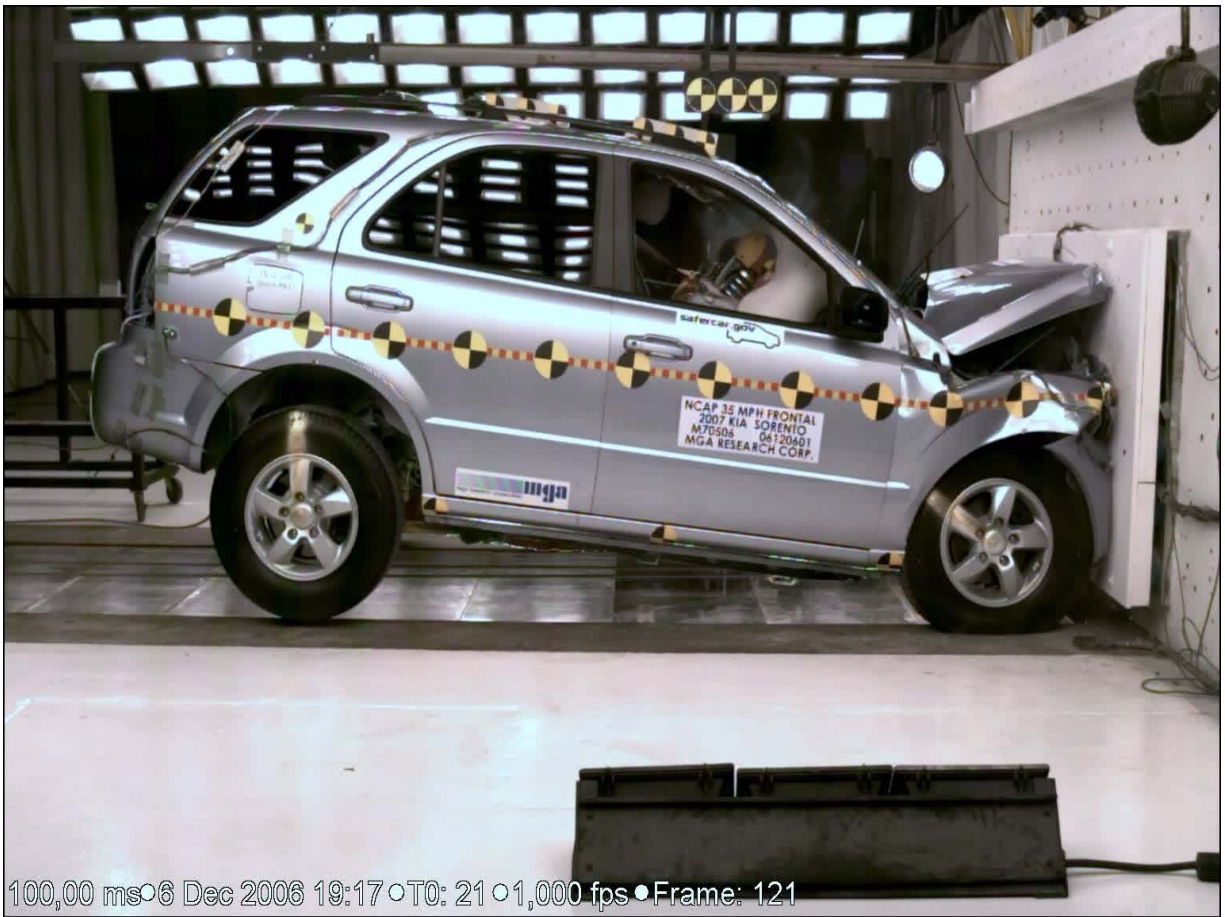
Vehicle Impact

A load cell barrier was impacted by a 2007 Kia Sorento at a velocity of 56.2 kph. The test was performed at MGA Research Corporation on December 6, 2006. Pre-and post-test photographs of the vehicle and dummies can be found in Appendix A.
