**REPORT NUMBER: NCAPSIDE-MGA-2007-005**

**NEW CAR ASSESSMENT PROGRAM  
SIDE IMPACT TEST**

**HONDA OF CANADA MFG.  
2007 ACURA MDX  
NHTSA NUMBER: M75303**

**PREPARED BY:  
MGA RESEARCH CORPORATION  
5000 WARREN ROAD  
BURLINGTON, WI 53105**

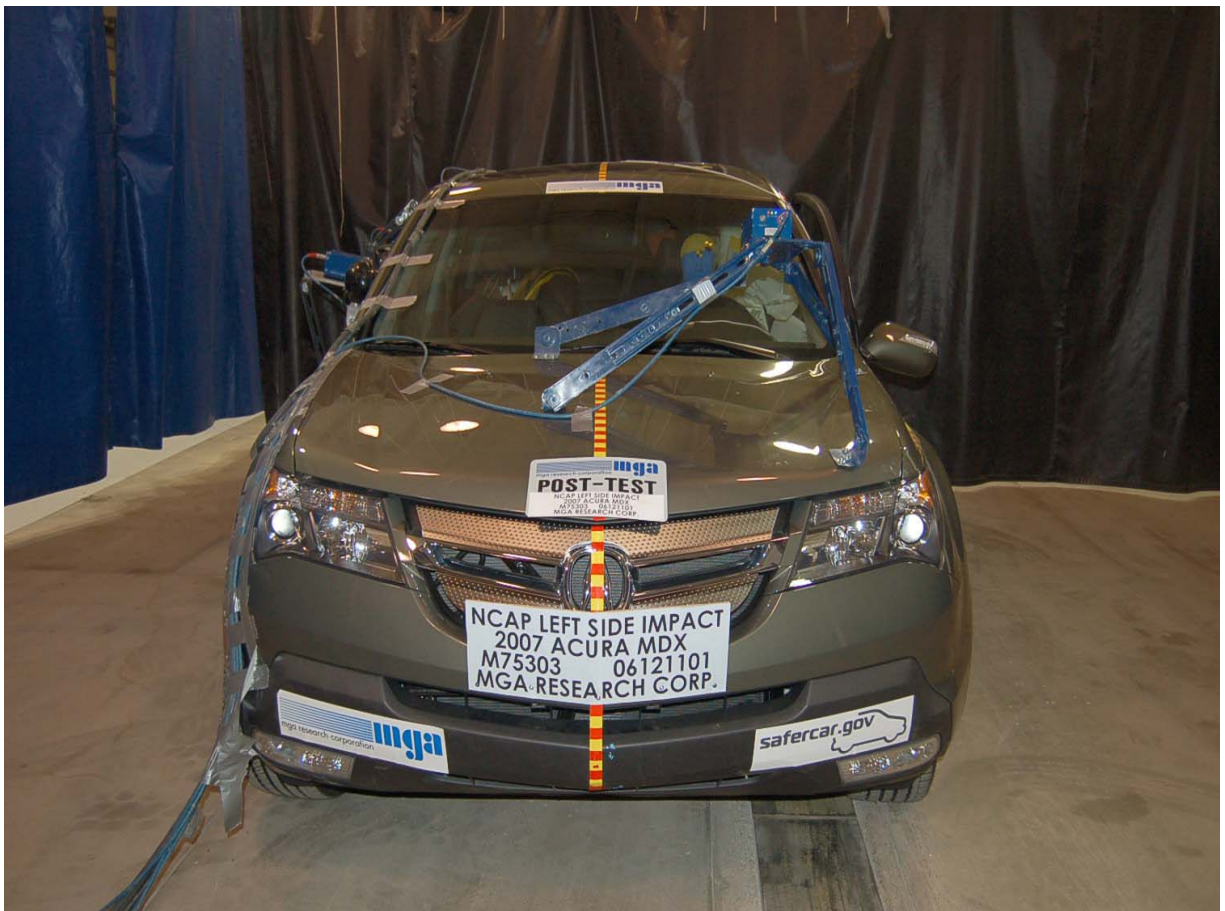
Post-Test Front View

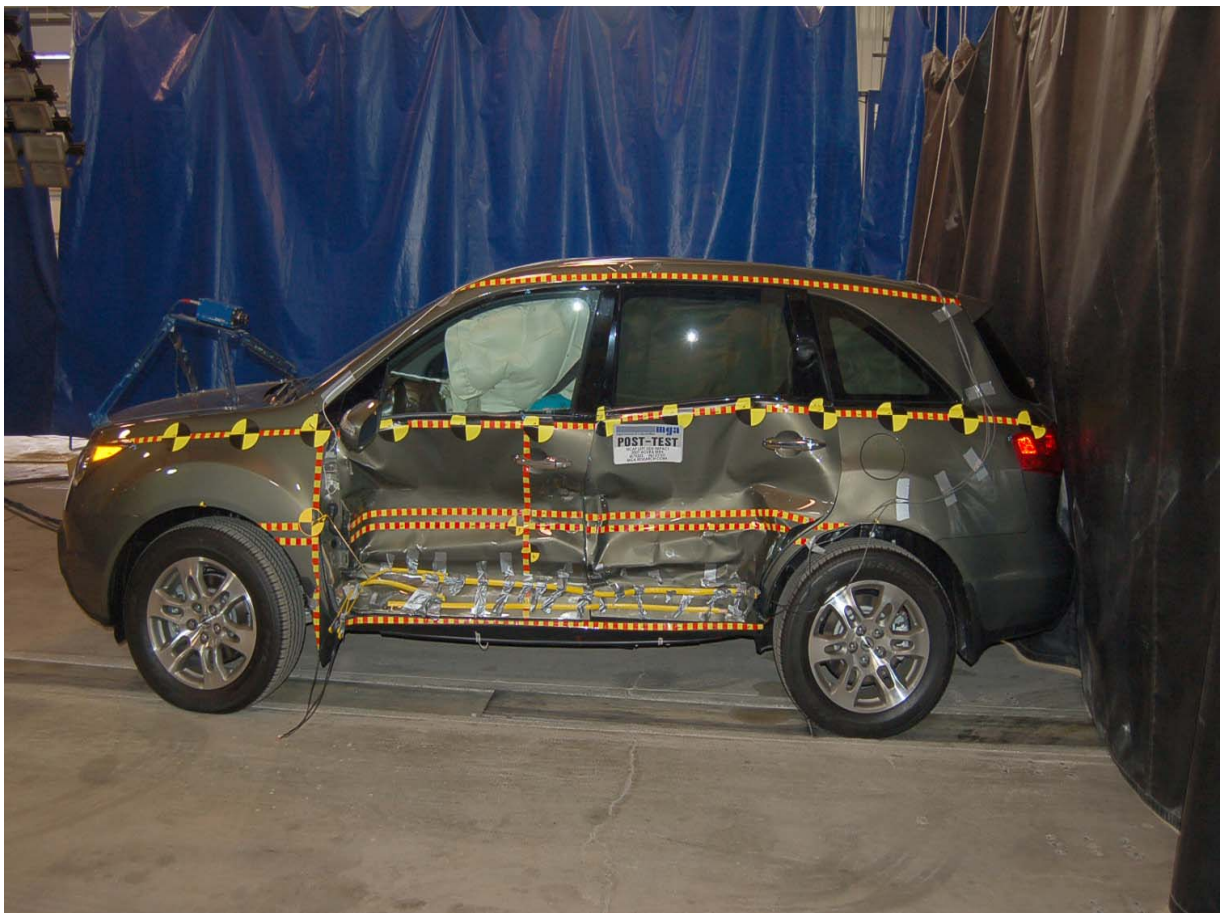
Post-Test Left Side View

The test vehicle sustained a maximum static crush of 261 mm at level 3, 1350 mm rearward of the vertical impact point. The driver and passenger SID/HIIs, Serial Nos. 904 and 272 respectively, were calibrated just prior to this test.

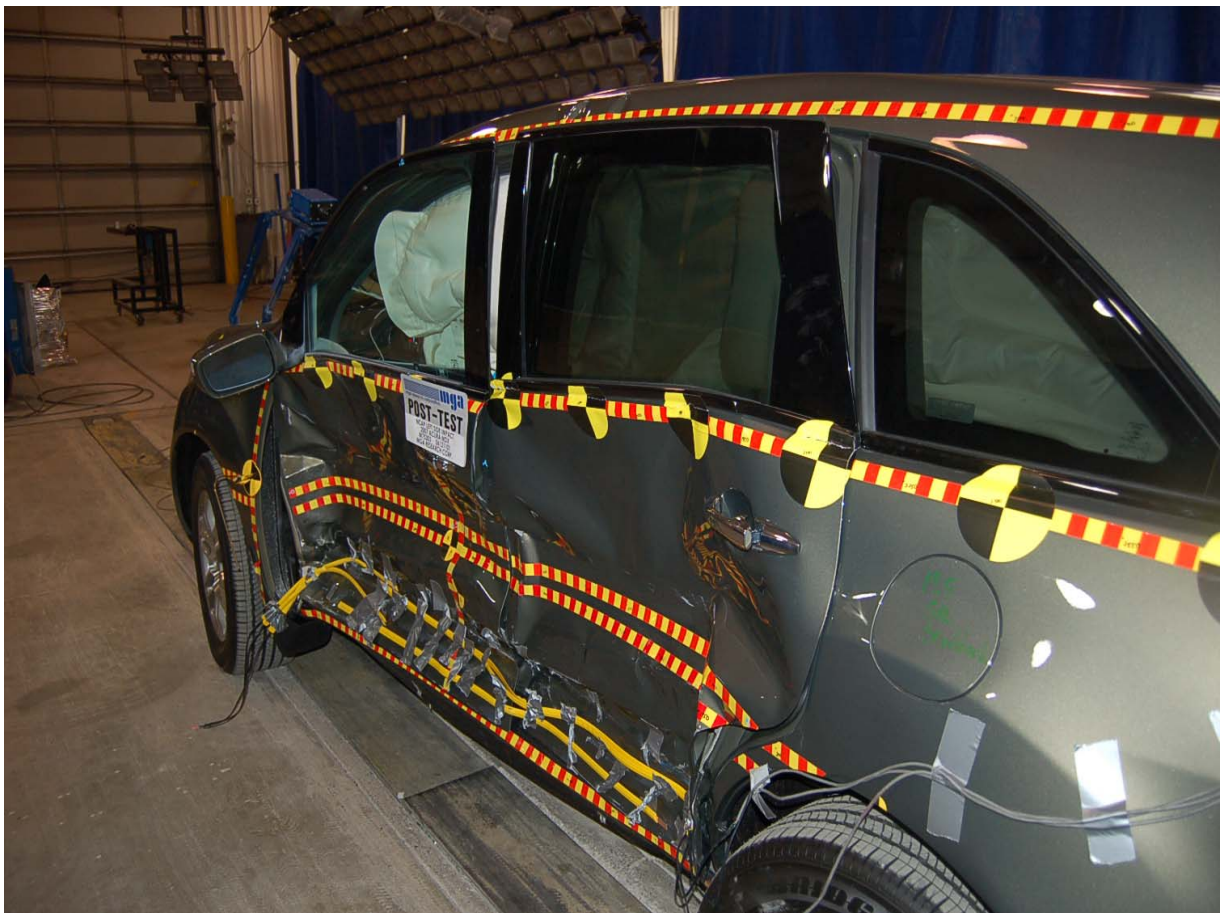
Post-Test Rear  $\frac{3}{4}$  View of Left Side Door

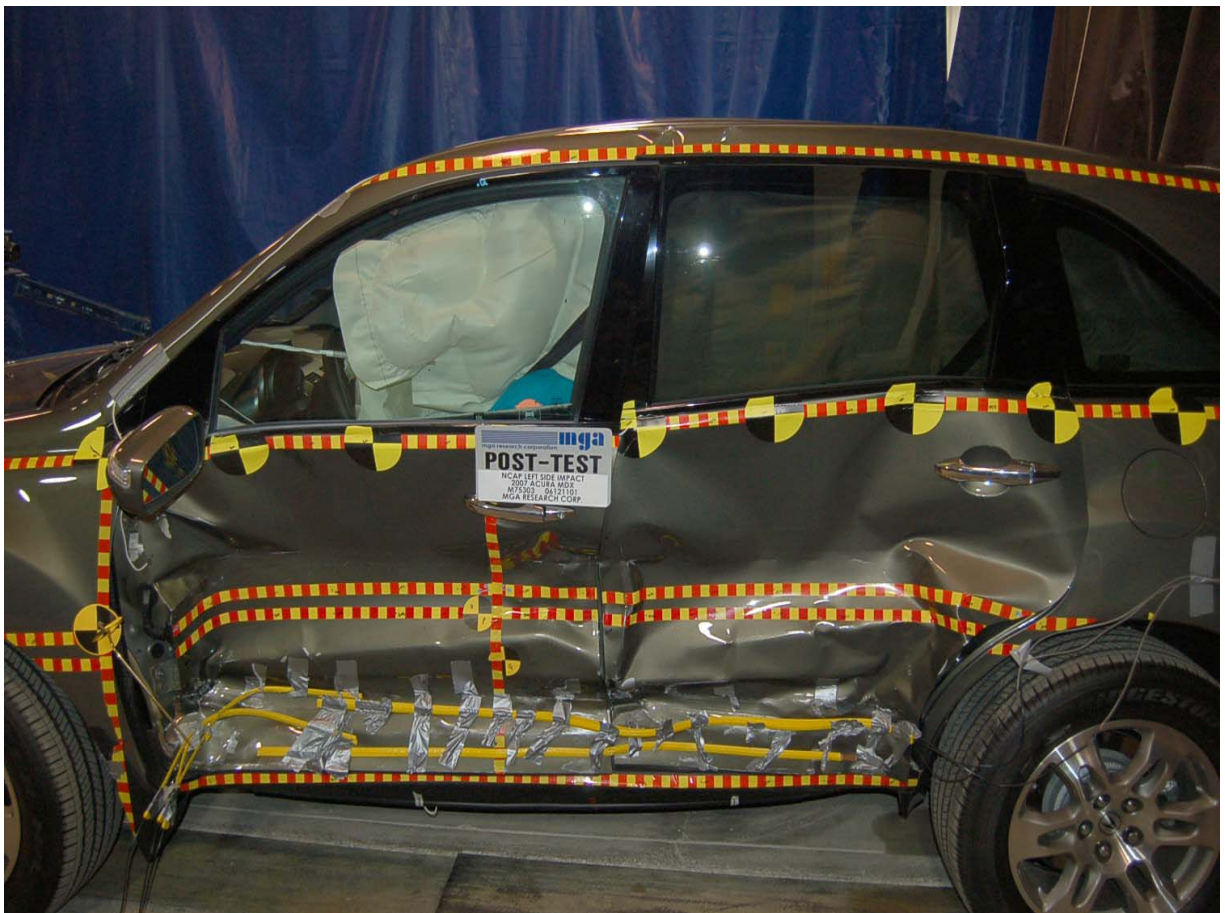
Post-Test Left Side Impact Close-up

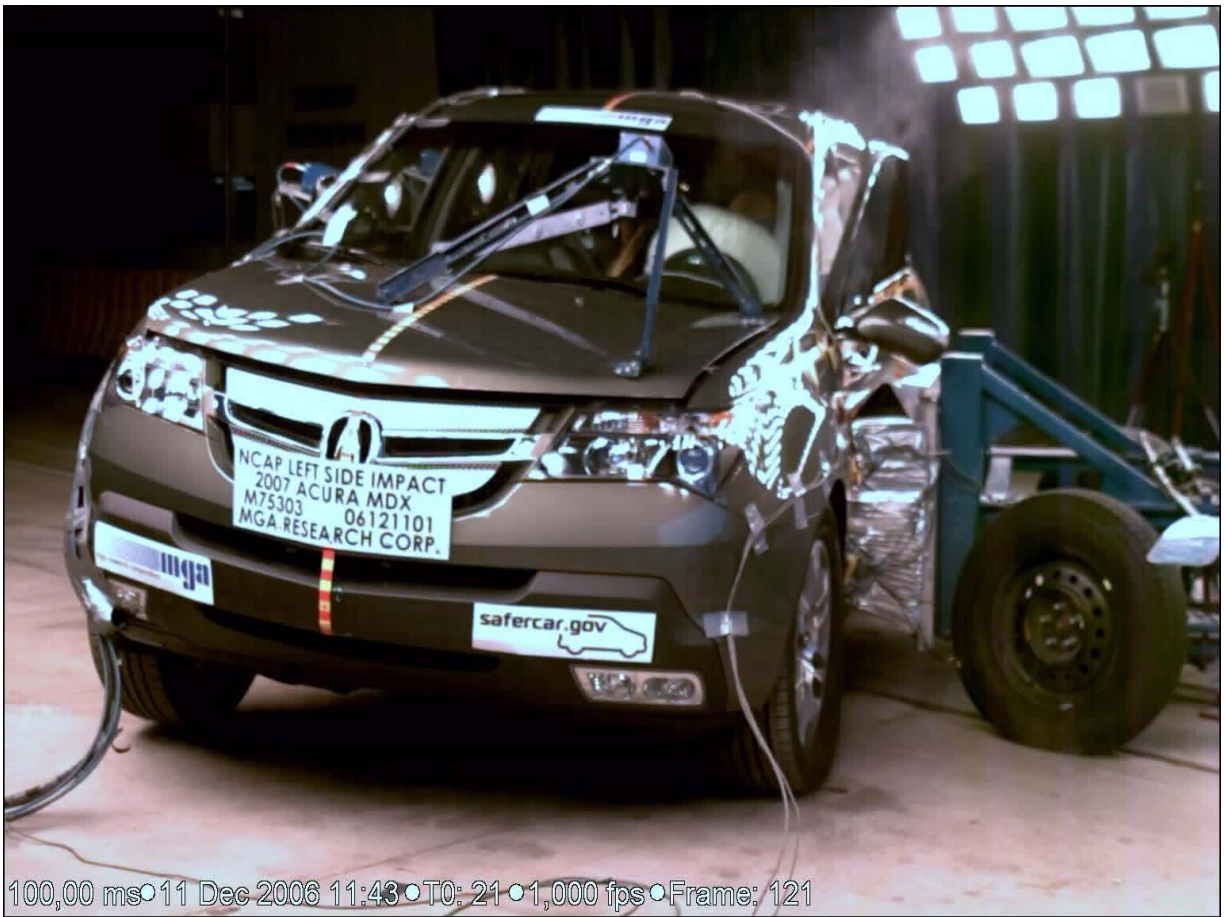
Vehicle Impact

A model year 2007 Acura MDX was impacted on the left (driver's) side by a Moving Deformable Barrier (MDB) which was moving forward in a 27° crabbed position to the tow road guidance system at a velocity of 62.3 km/h. The specified impact velocity range is from 61.1 to 62.7 km/h. The test (target) vehicle was stationary and positioned 63° to the line of forward motion. The weight of the vehicle as tested was 2272.9 kg and the test weight of the MDB was 1360.8 kg. The test was conducted at MGA Research Corporation in Burlington, Wisconsin, on December 11, 2006.

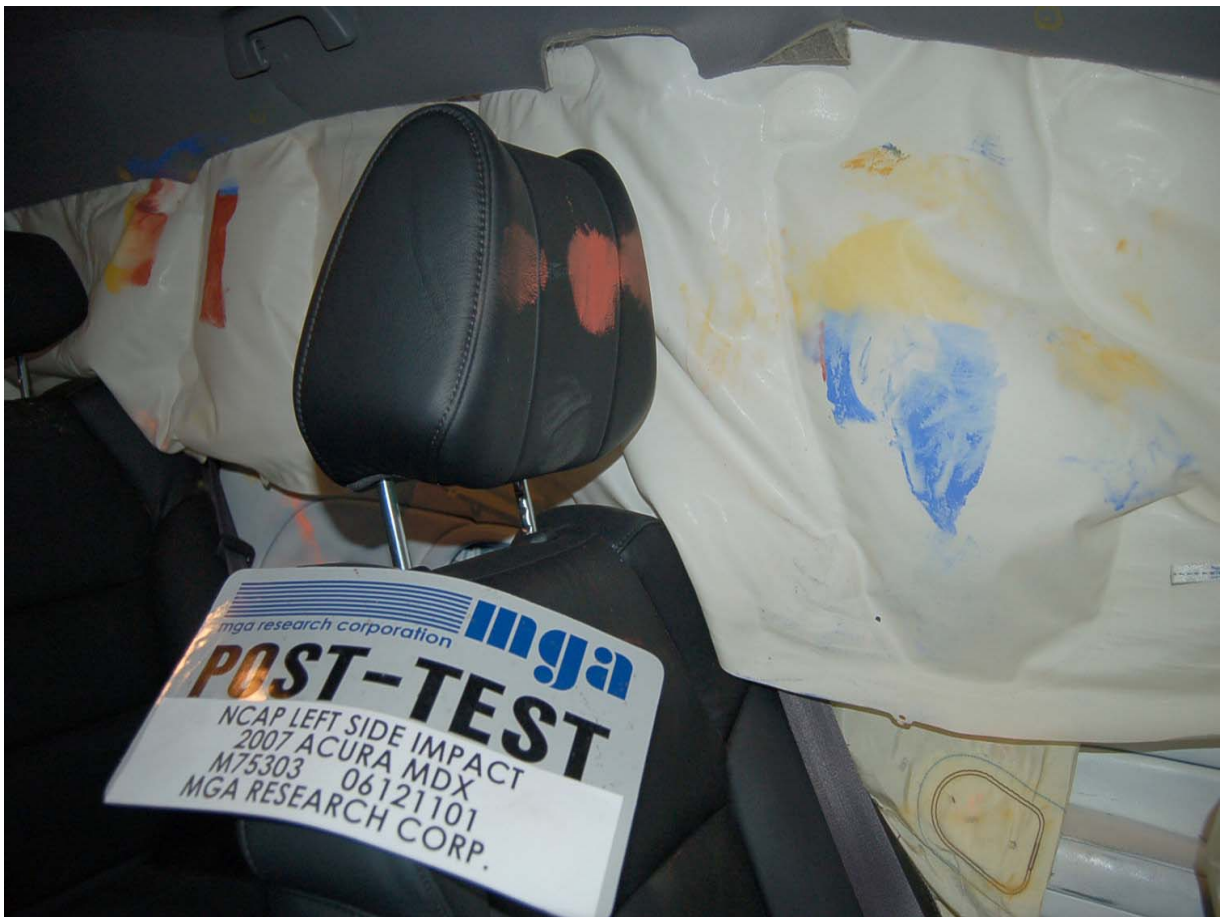
Post-Test Driver Dummy Head Contact

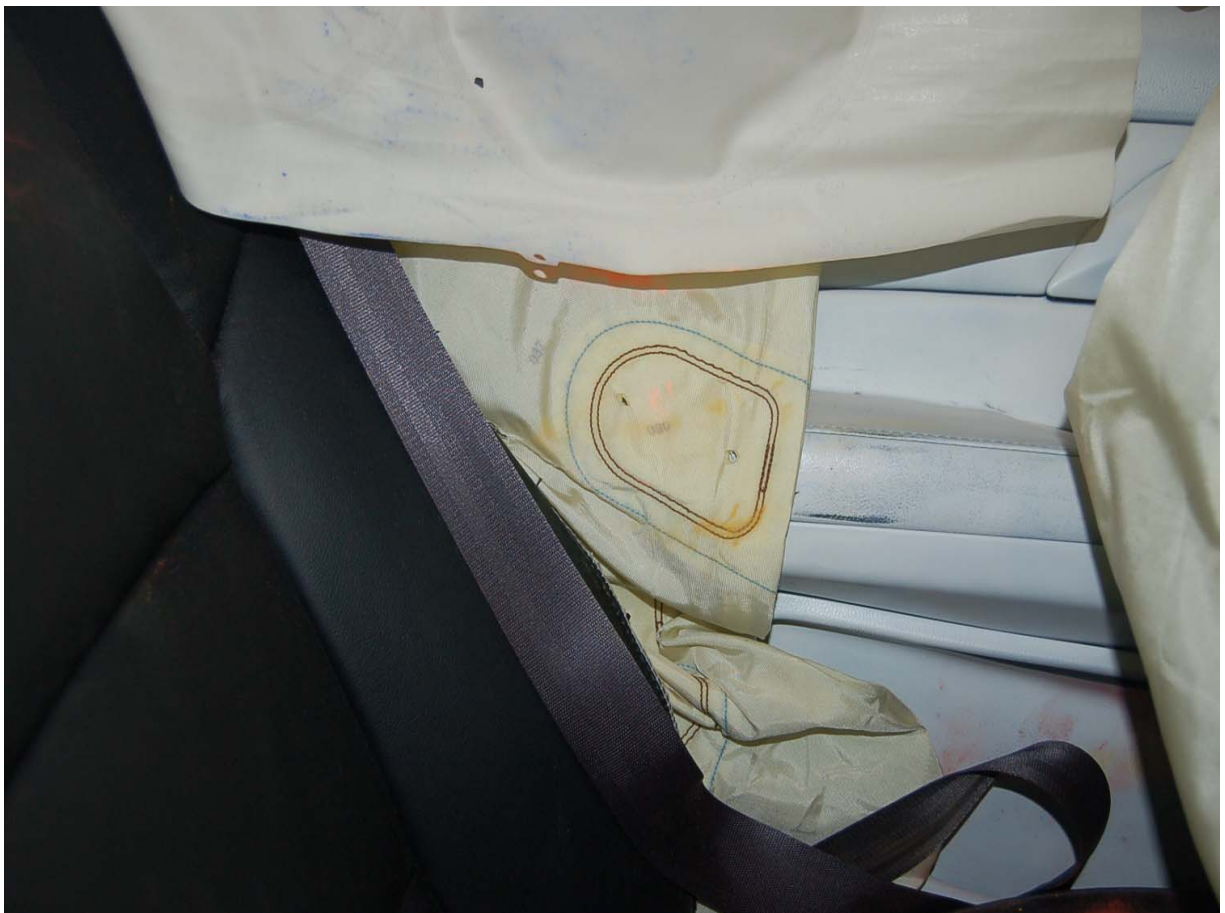
Post-Test Driver Dummy Torso Contact

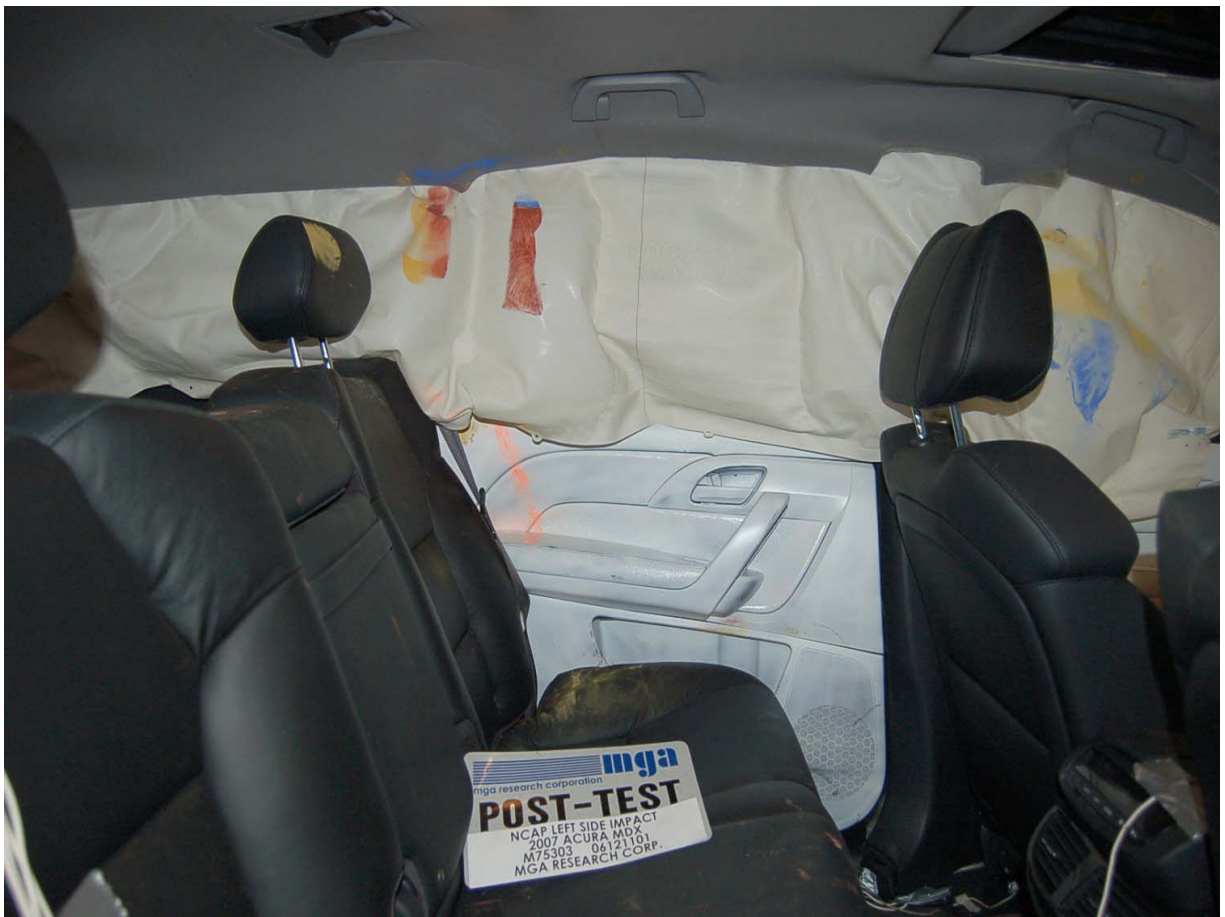
Post-Test Passenger Dummy Contact
