REPORT NUMBER: SNCAP-CAL-07-06

**NEW CAR ASSESSMENT PROGRAM
SIDE IMPACT TEST**

**KIA MOTORS CORPORATION
2007 KIA SPECTRA
4-DOOR SEDAN**

FINAL REPORT

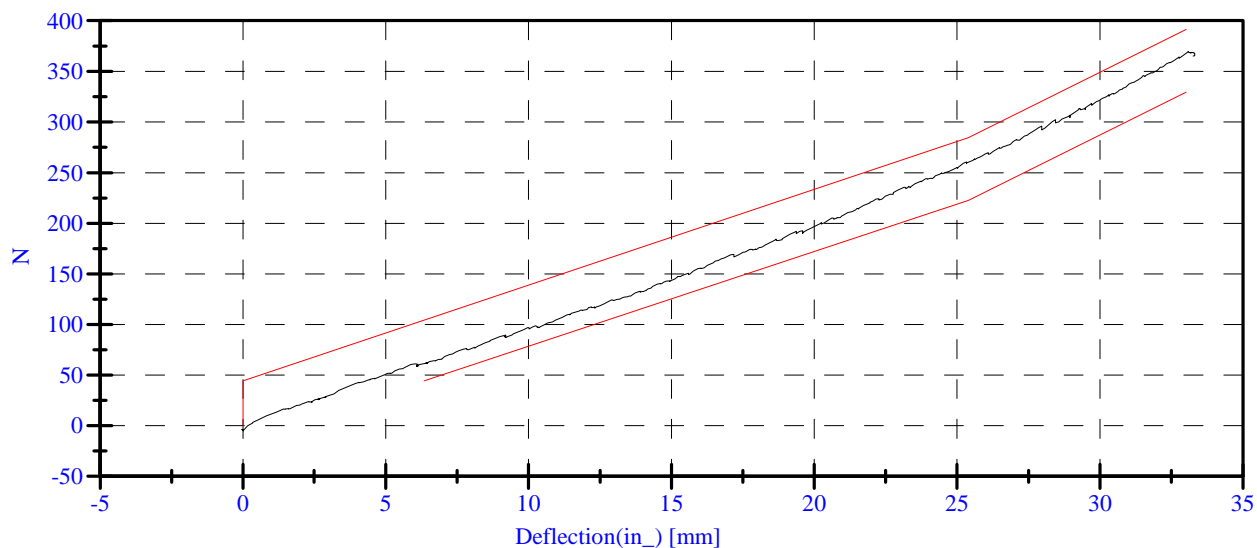
ABDOMINAL COMPRESSION TEST

<u>TEST PARAMETER</u>	<u>SPECIFICATION</u>	<u>TEST RESULTS</u>	<u>STATUS</u>
Lab Temperature:	18.9-25.5 C	21.1 C	Passed
Lab Humidity:	10-70 %	37.00 %	Passed
Force at 12.95 mm :	104.00-162.00 N	124.04 N	Passed
Force at 19.05 mm :	162.98-220.99 N	188.93 N	Passed
Force at 25.40 mm :	221.97-280.02 N	260.70 N	Passed
Force at 33.02 mm :	324.99-391.00 N	368.35 N	Passed
