REPORT NUMBER: CAL-07-06

**NEW CAR ASSESSMENT PROGRAM (NCAP)  
FRONTAL BARRIER IMPACT TEST**

KIA MOTORS CORPORATION  
2007 KIA SPECTRA  
4-DOOR SEDAN

CALSPAN TEST NUMBER: 8806-NCAP-06

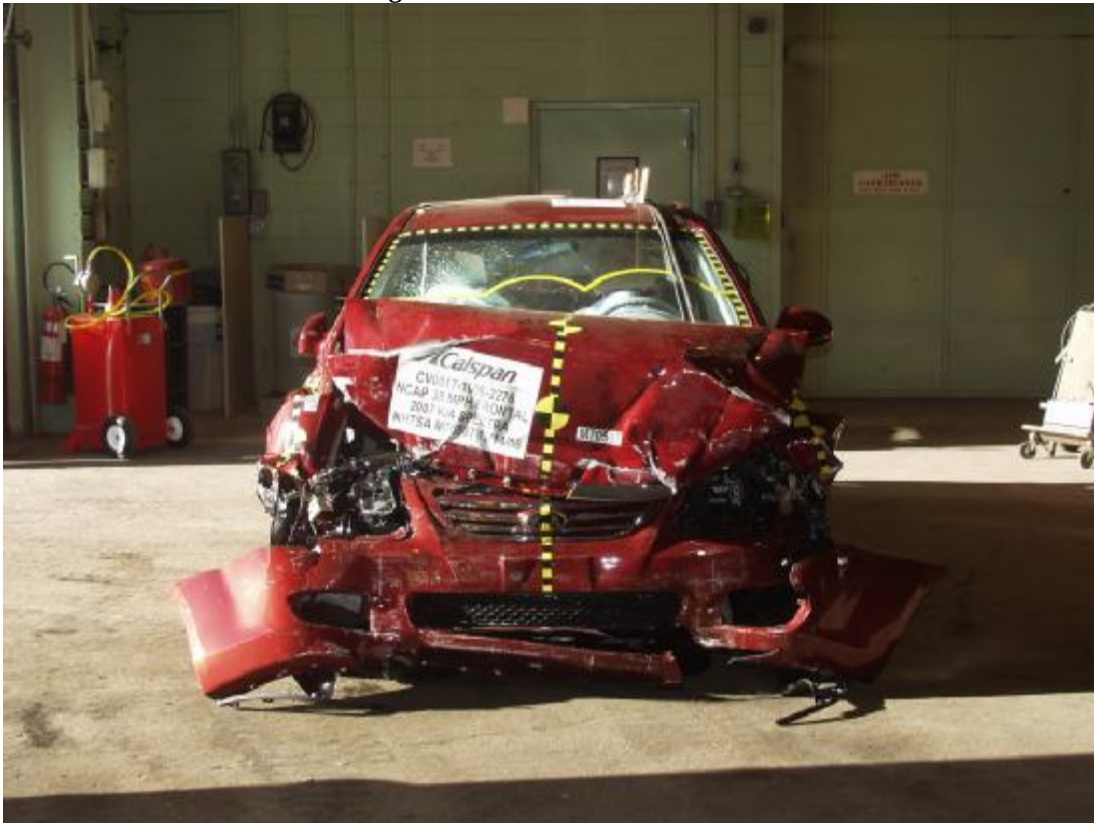
**Figure A-7: Post-Test Front View**

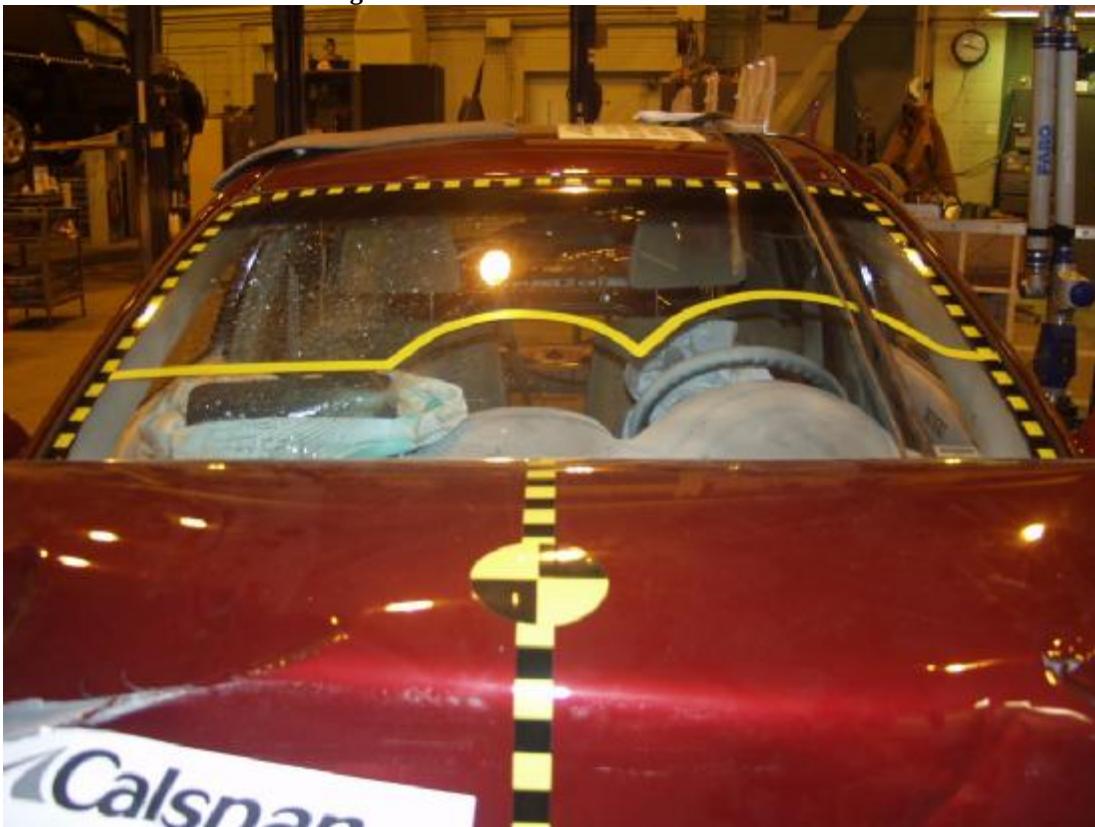
Figure A-19: Post-Test Windshield View

| Description | Driver Side | Passenger Side |
|---|---|---|
| Glazing Damage | Cracks on passenger side from airbag deployment | |

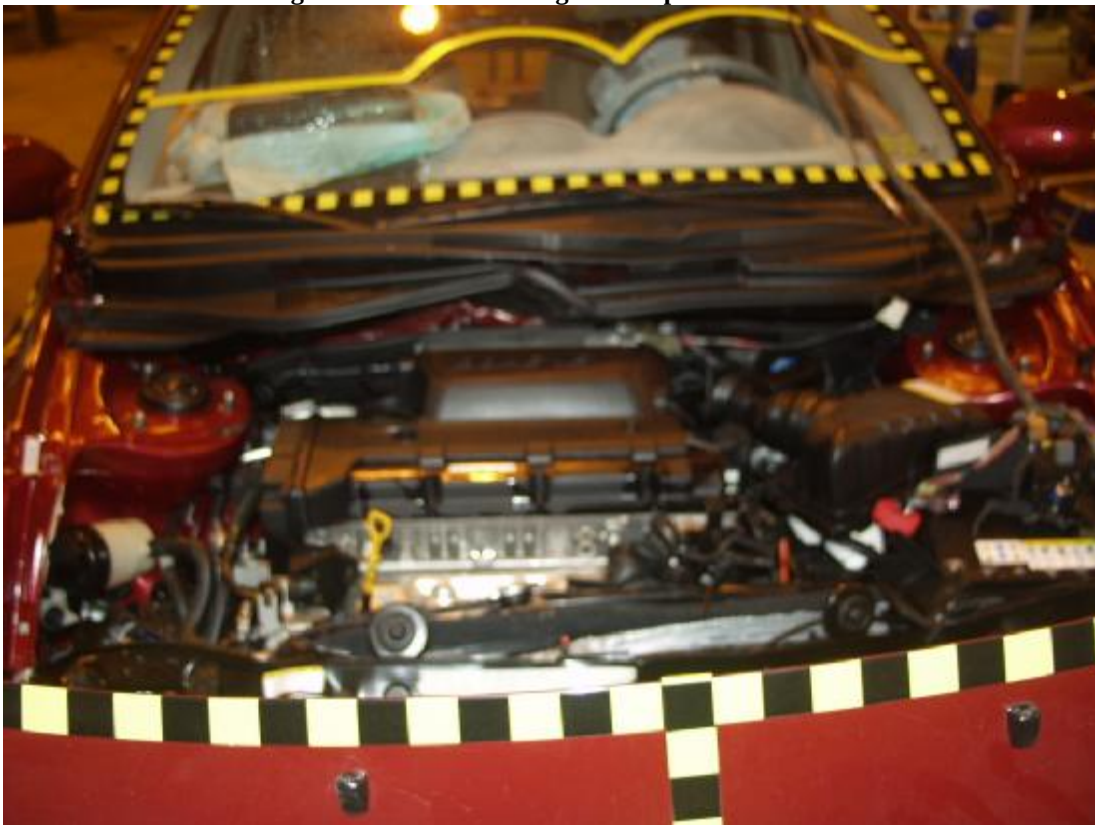
**Figure A-21: Post-Test Engine Compartment View**

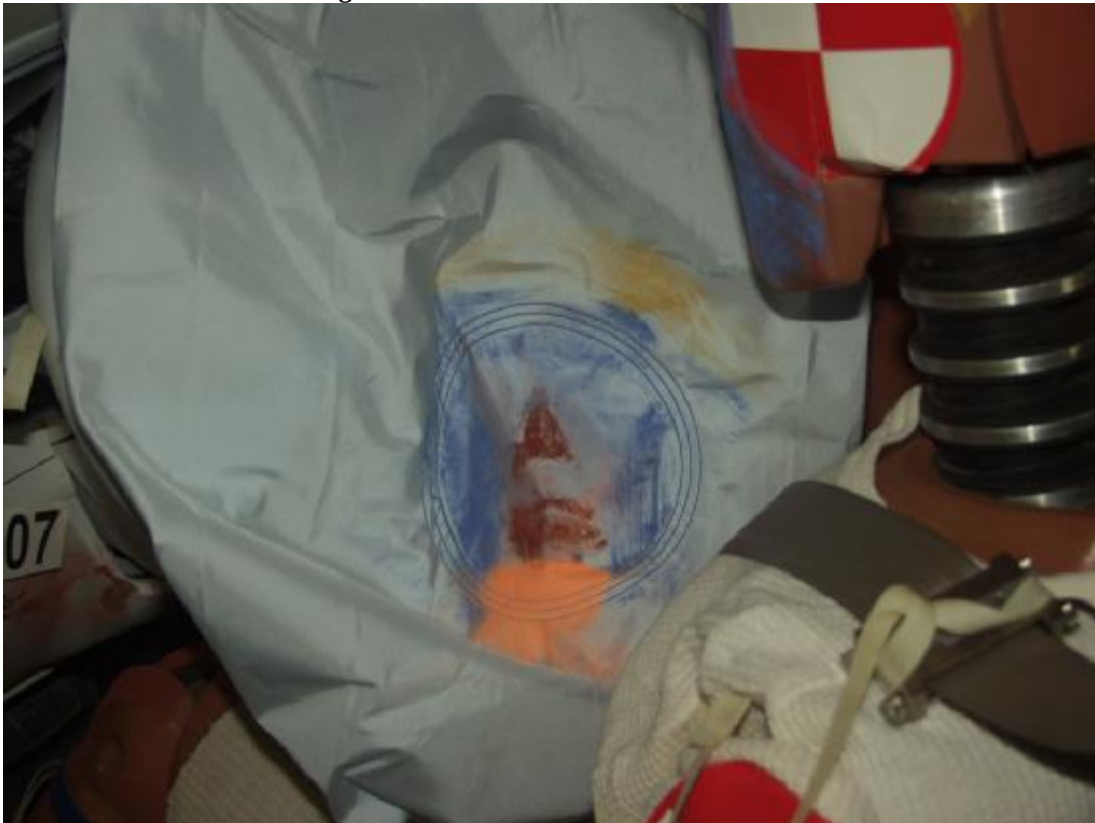
**Figure A-43: Post-Test Driver Contact to Airbag**

| | DRIVER | PASSENGER |
|---|---|---|
| Chest Contact: | Airbag | Airbag |

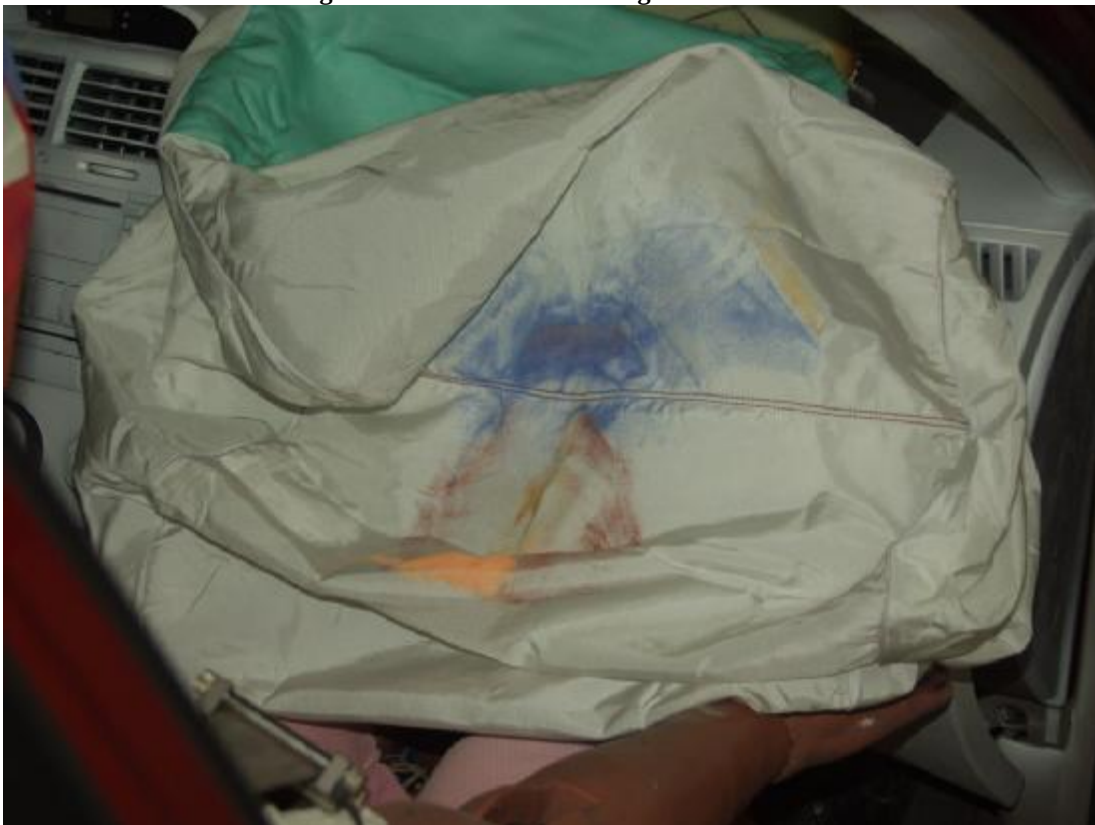
**Figure A-57: Post-Test Passenger Contact to Airbag**
