**NEW CAR ASSESSMENT PROGRAM  
FRONTAL BARRIER IMPACT TEST**

**CAMI AUTOMOTIVE INC. CANADA  
2007 SUZUKI XL7  
5-DOOR MPV**

**NHTSA NUMBER: M70512**

**FINAL REPORT**

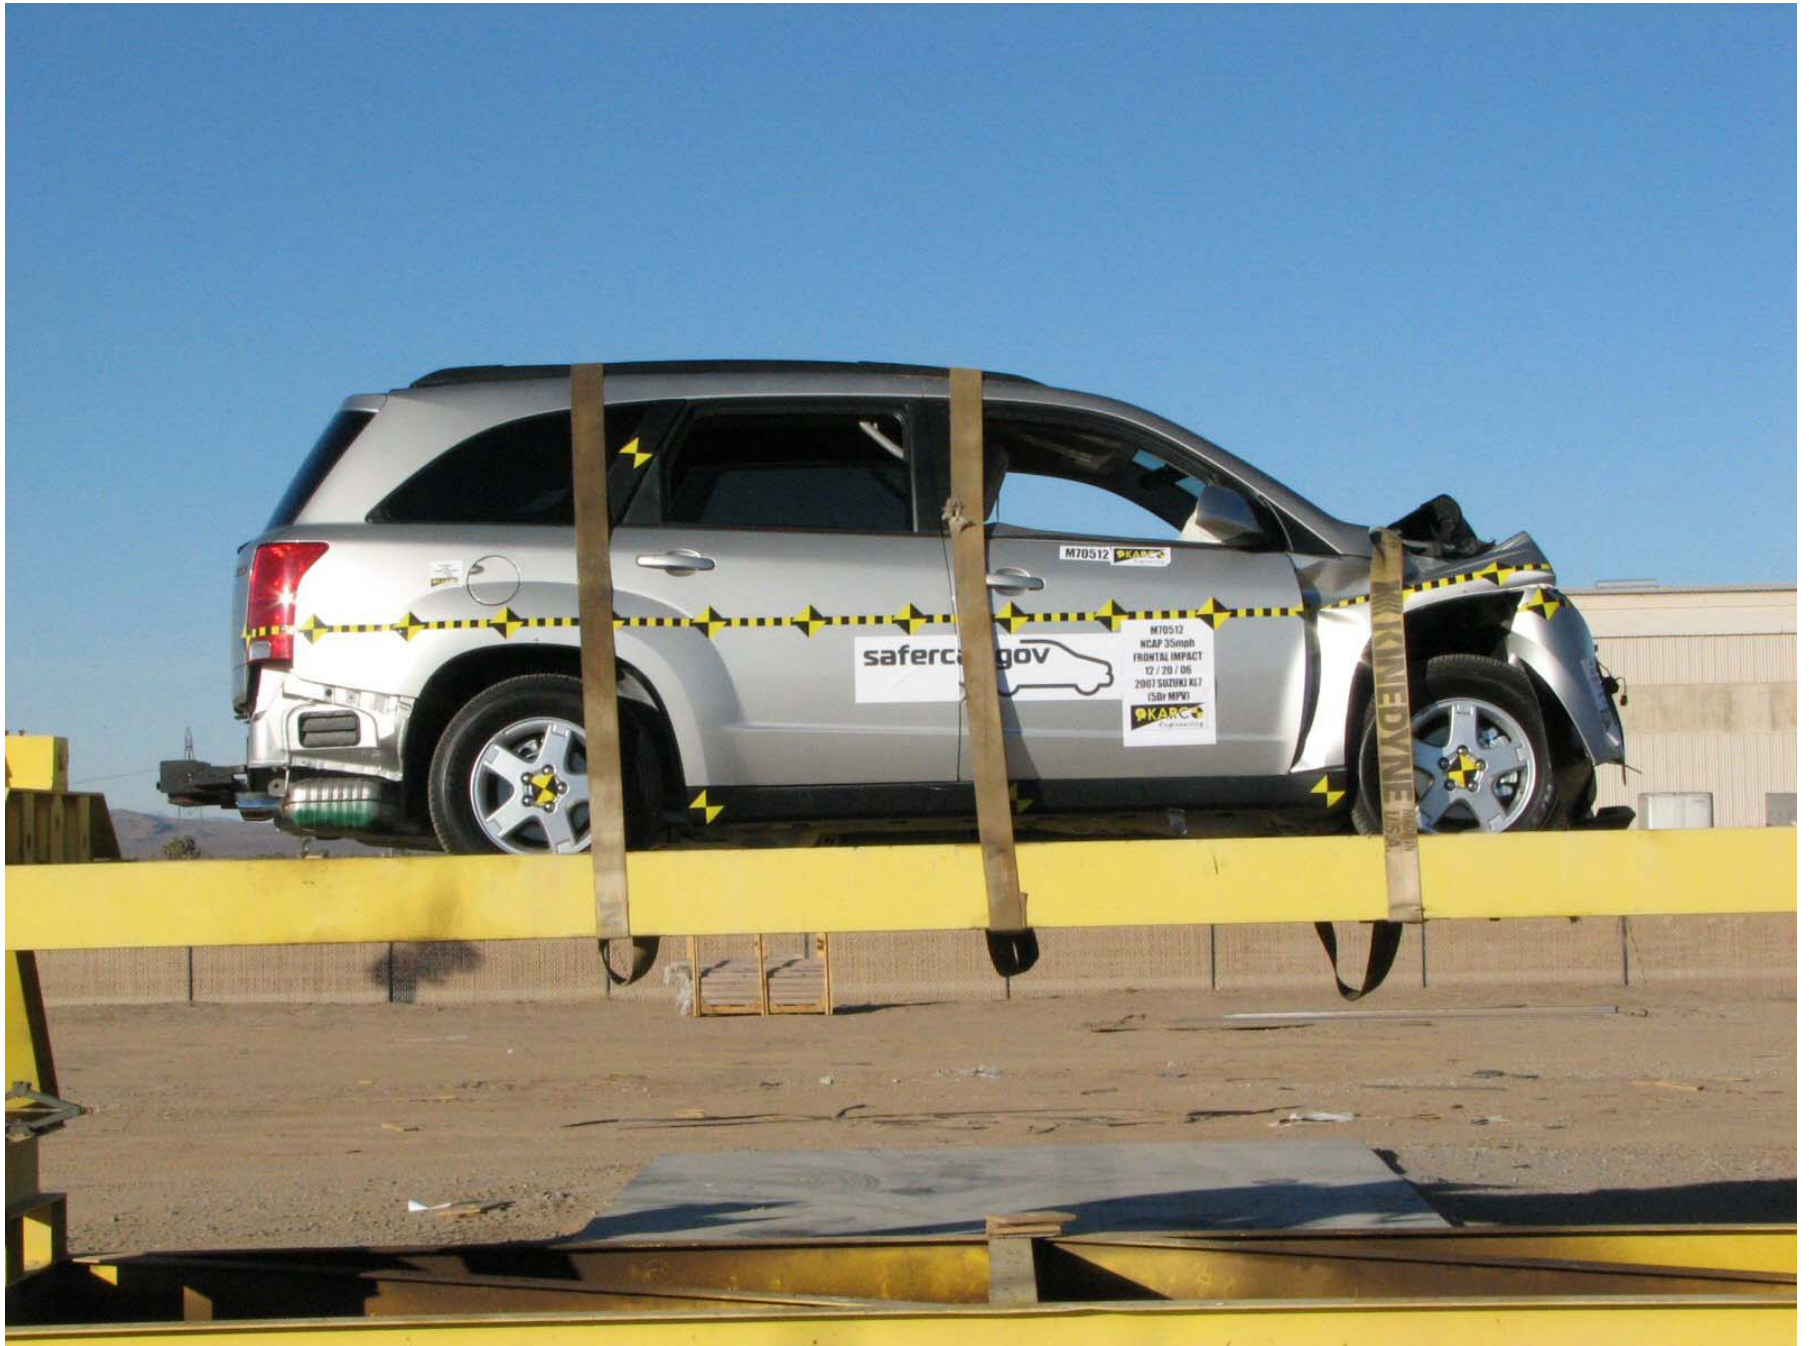
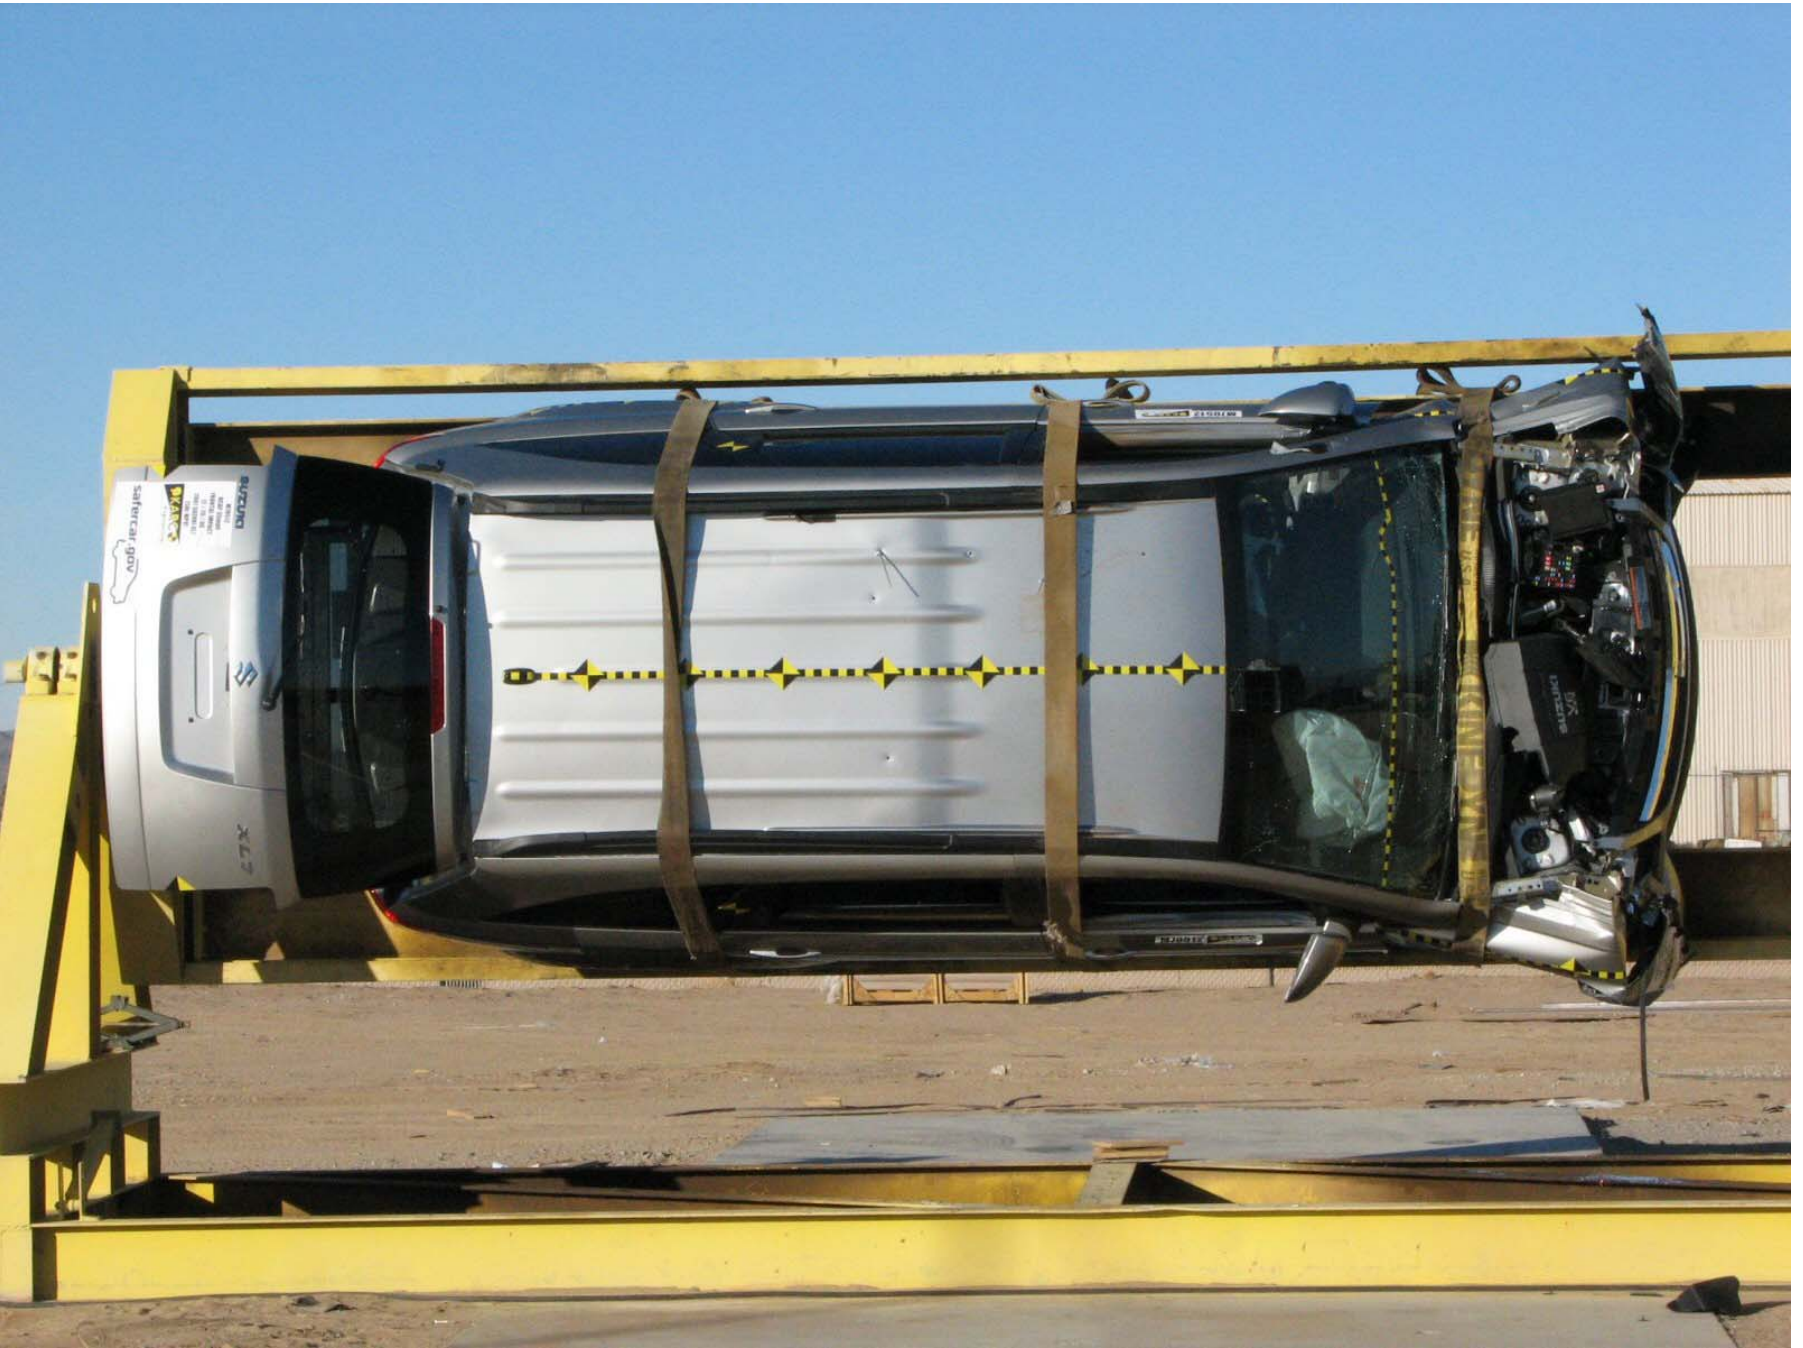
1. The specified fixture rollover rate for each 90° of rotation is 60 to 120 seconds.
2. The position hold time at each position is 300 seconds (minimum).
3. Details of Stoddard Solvent spillage locations.  
No solvent leakage occurred during static rollover testing.

There was 100 percent windshield retention and there was no intrusion into the protected zone of the windshield during the impact event. There was no stoddard solvent leakage after the event or during any phase of the static rollover.
