**REPORT NUMBER TR-P27003-07-NC**

**NEW CAR ASSESSMENT PROGRAM  
SIDE IMPACT TEST**

**CAMI AUTOMOTIVE INC. CANADA  
2007 SUZUKI XL7  
5-DOOR MPV**

**NHTSA NUMBER: M70513**

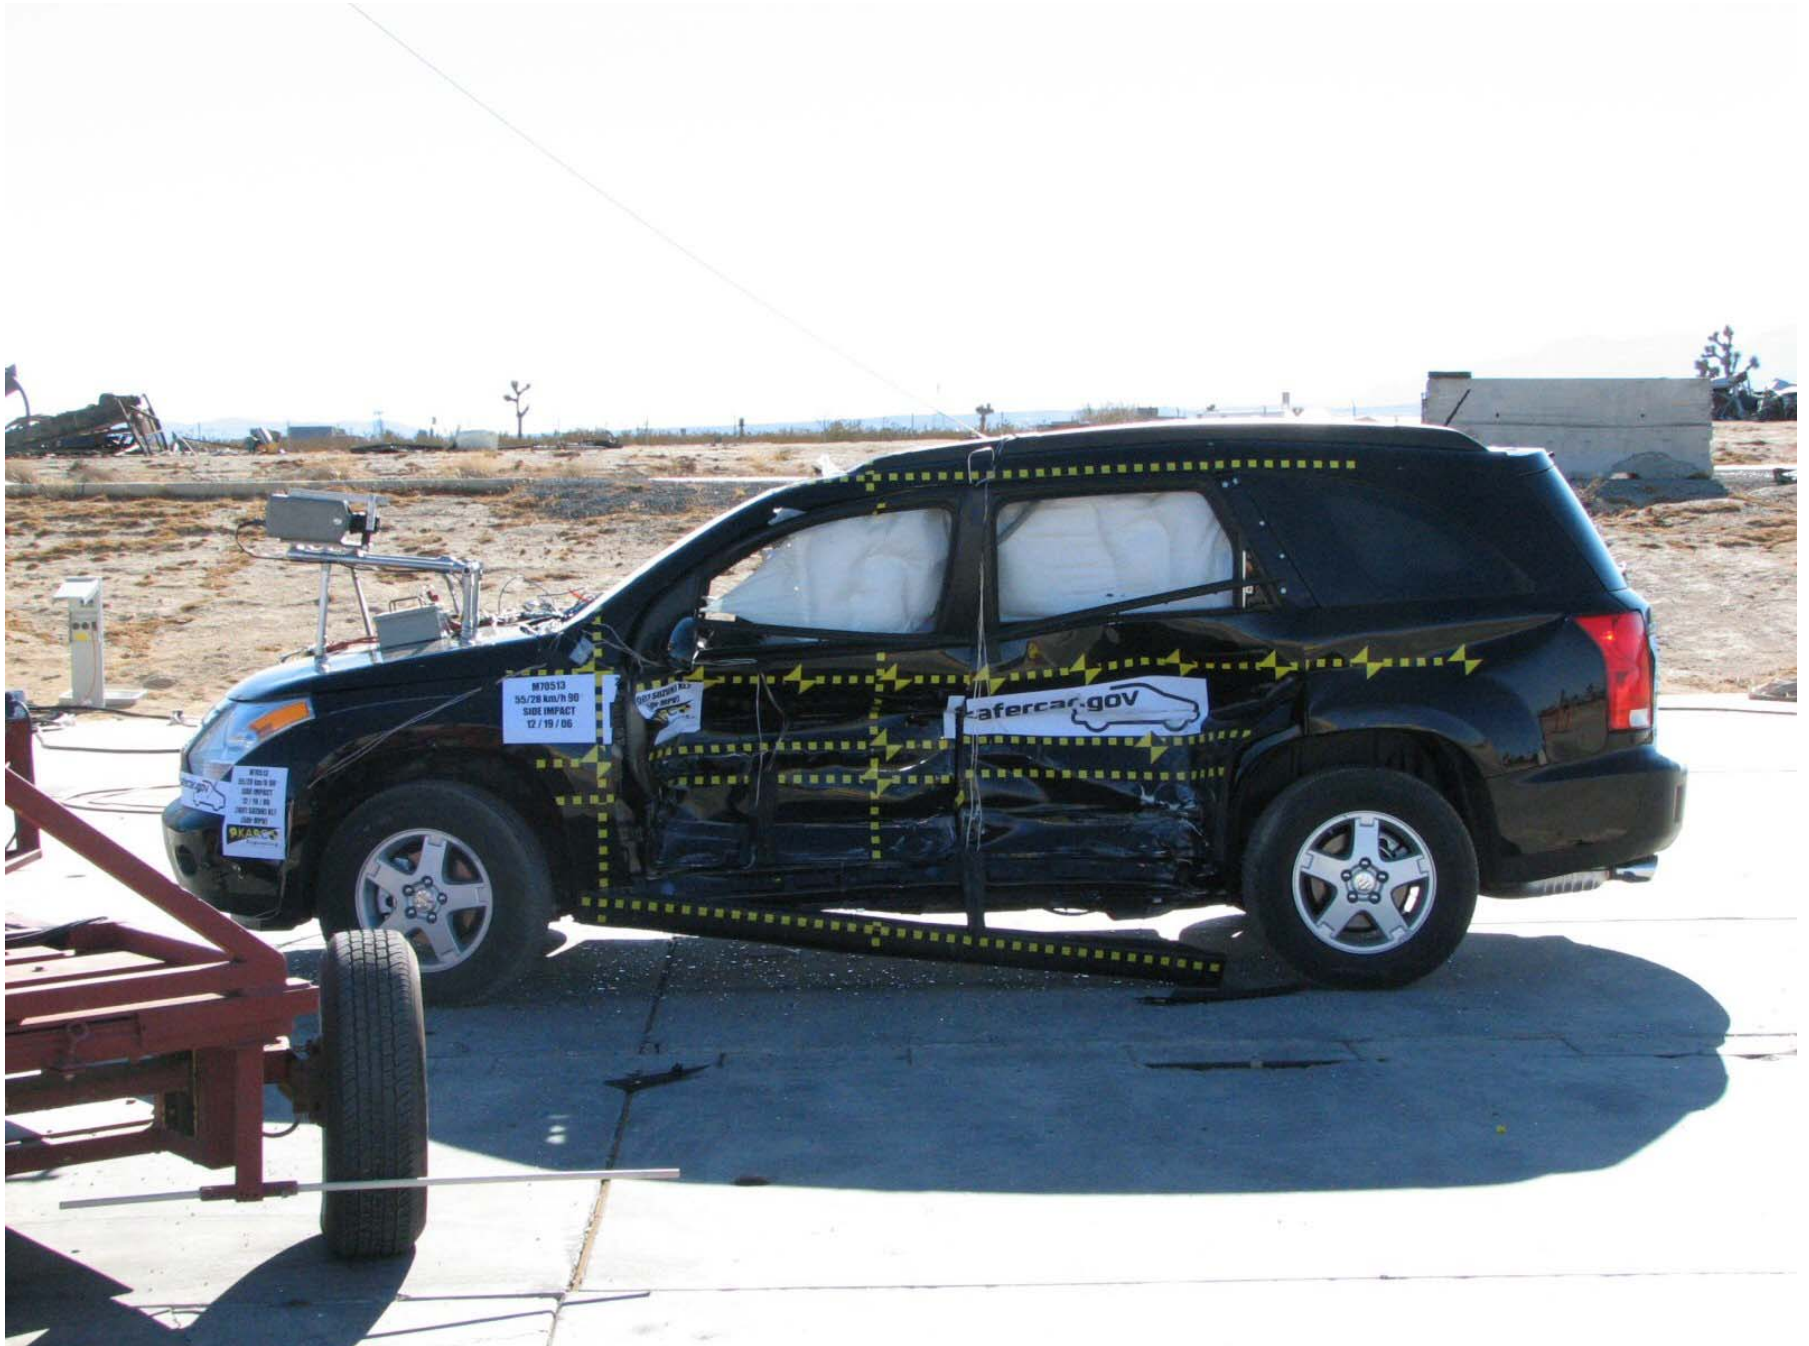
Figure A-10: Post-Test Left Side View

The driver and passenger doors remained closed during impact. The test vehicle sustained a maximum static crush of 326 mm at level 3, 1500 mm rearward of the left vertical impact point. The driver SID/Hybrid III, Serial No. 275 and the passenger SID/Hybrid III, Serial No. 274 were calibrated prior to this test. The SID/Hybrid III injury criteria are summarized as follows:

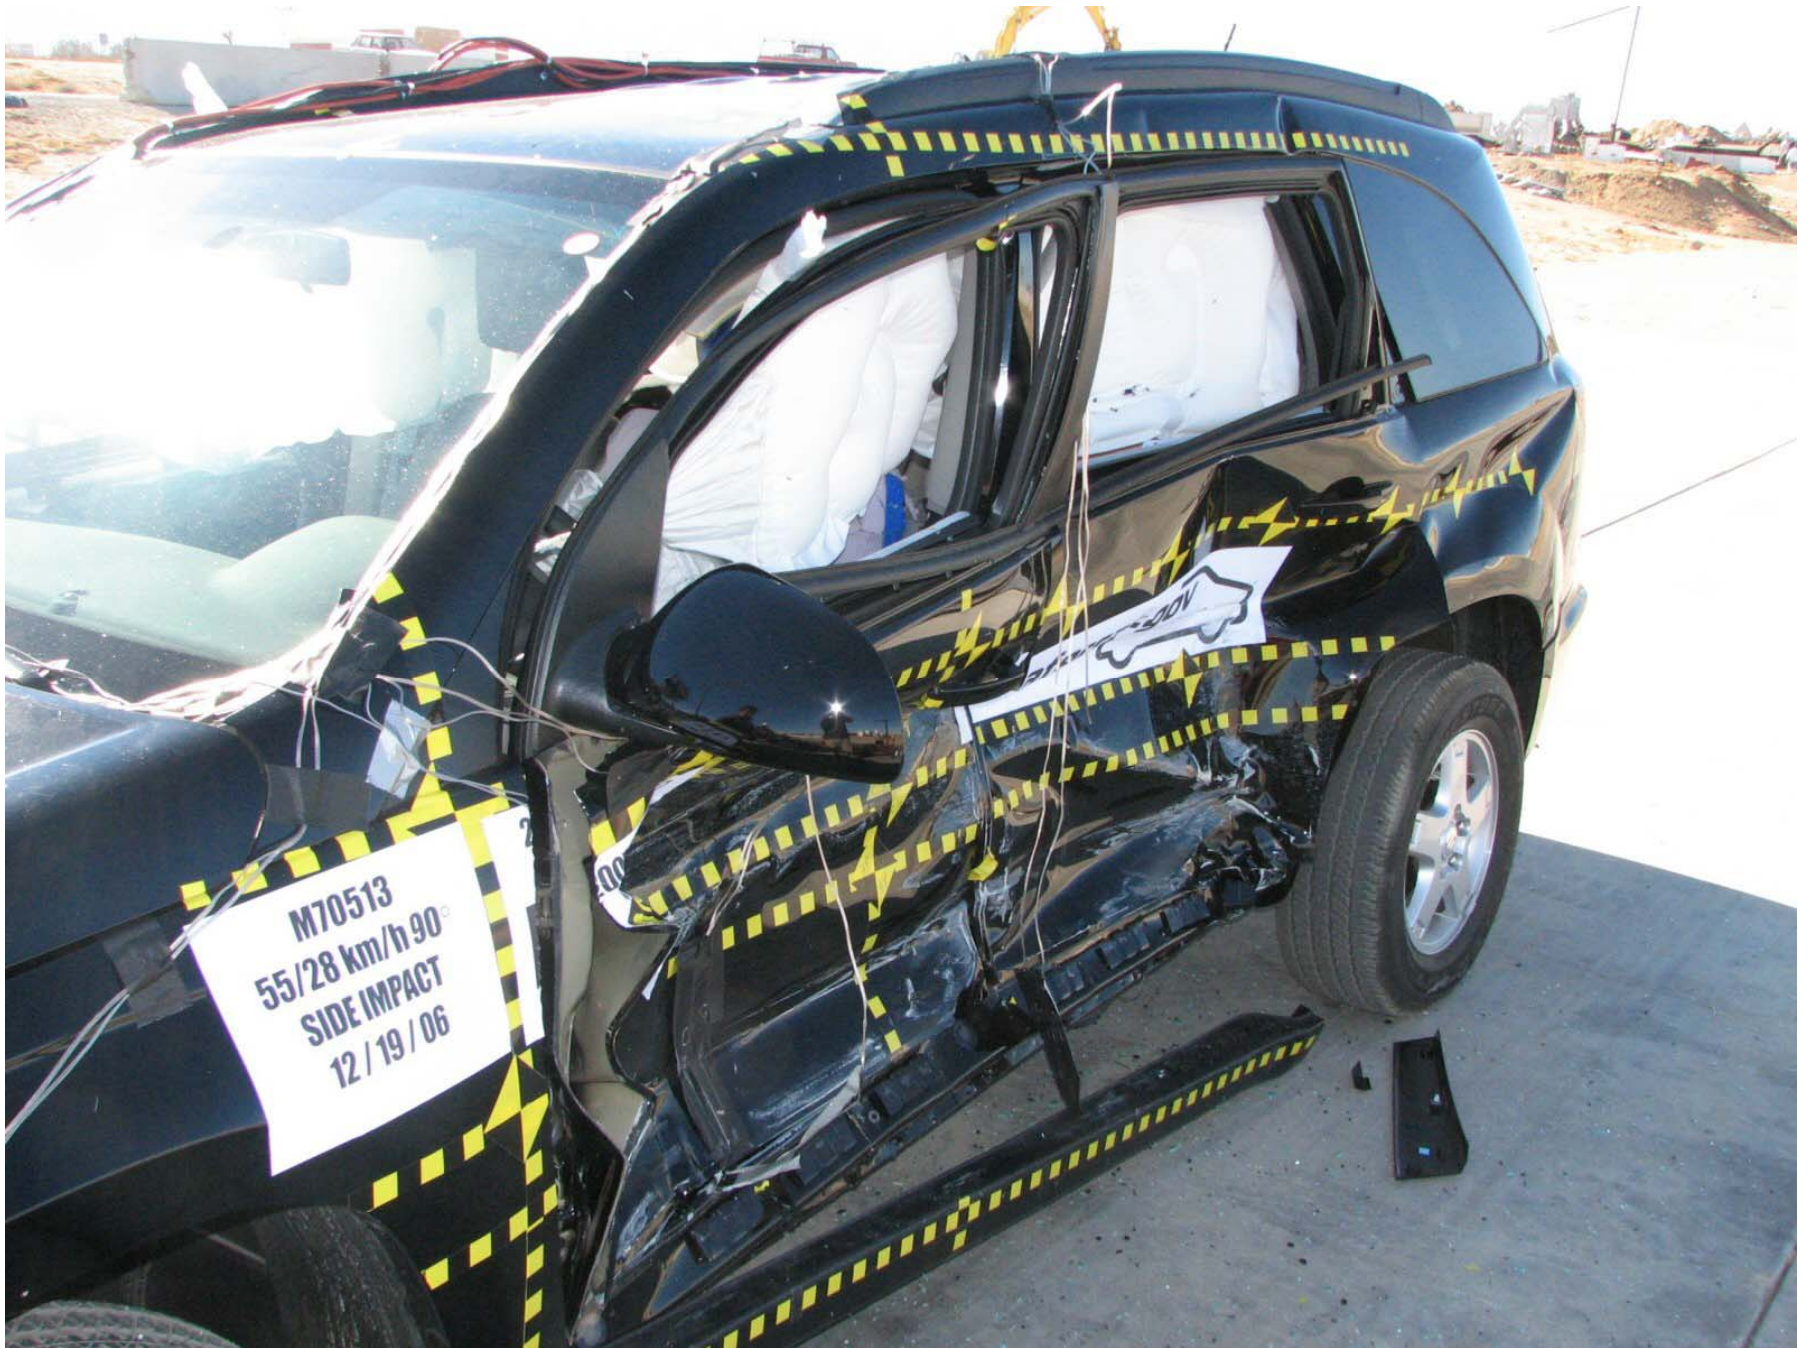
Figure A-28: Post-Test Front  $\frac{3}{4}$  View of Left Side Door

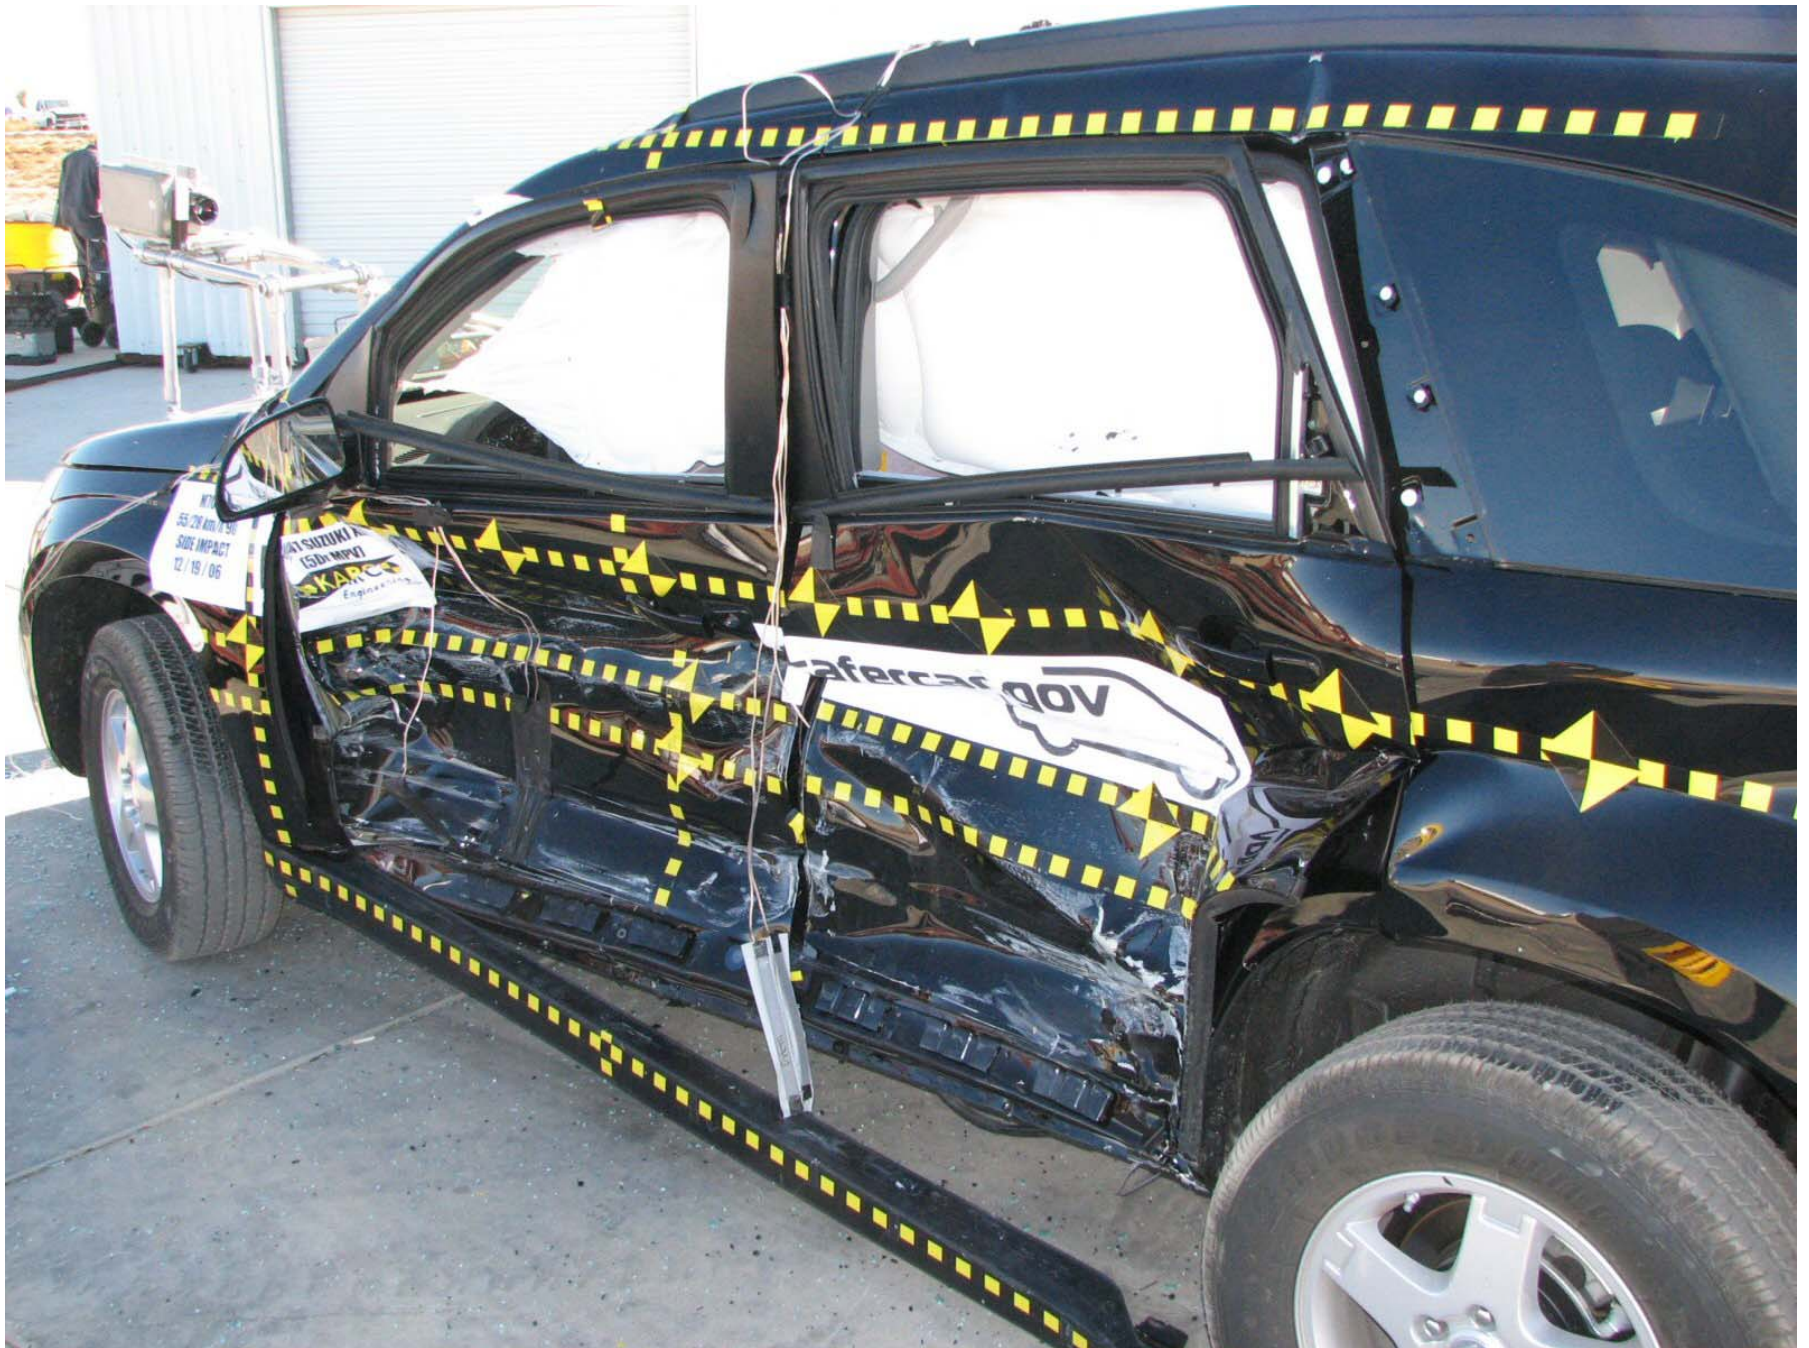
Figure A-30: Post-Test Rear  $\frac{3}{4}$  View of Left Side Door

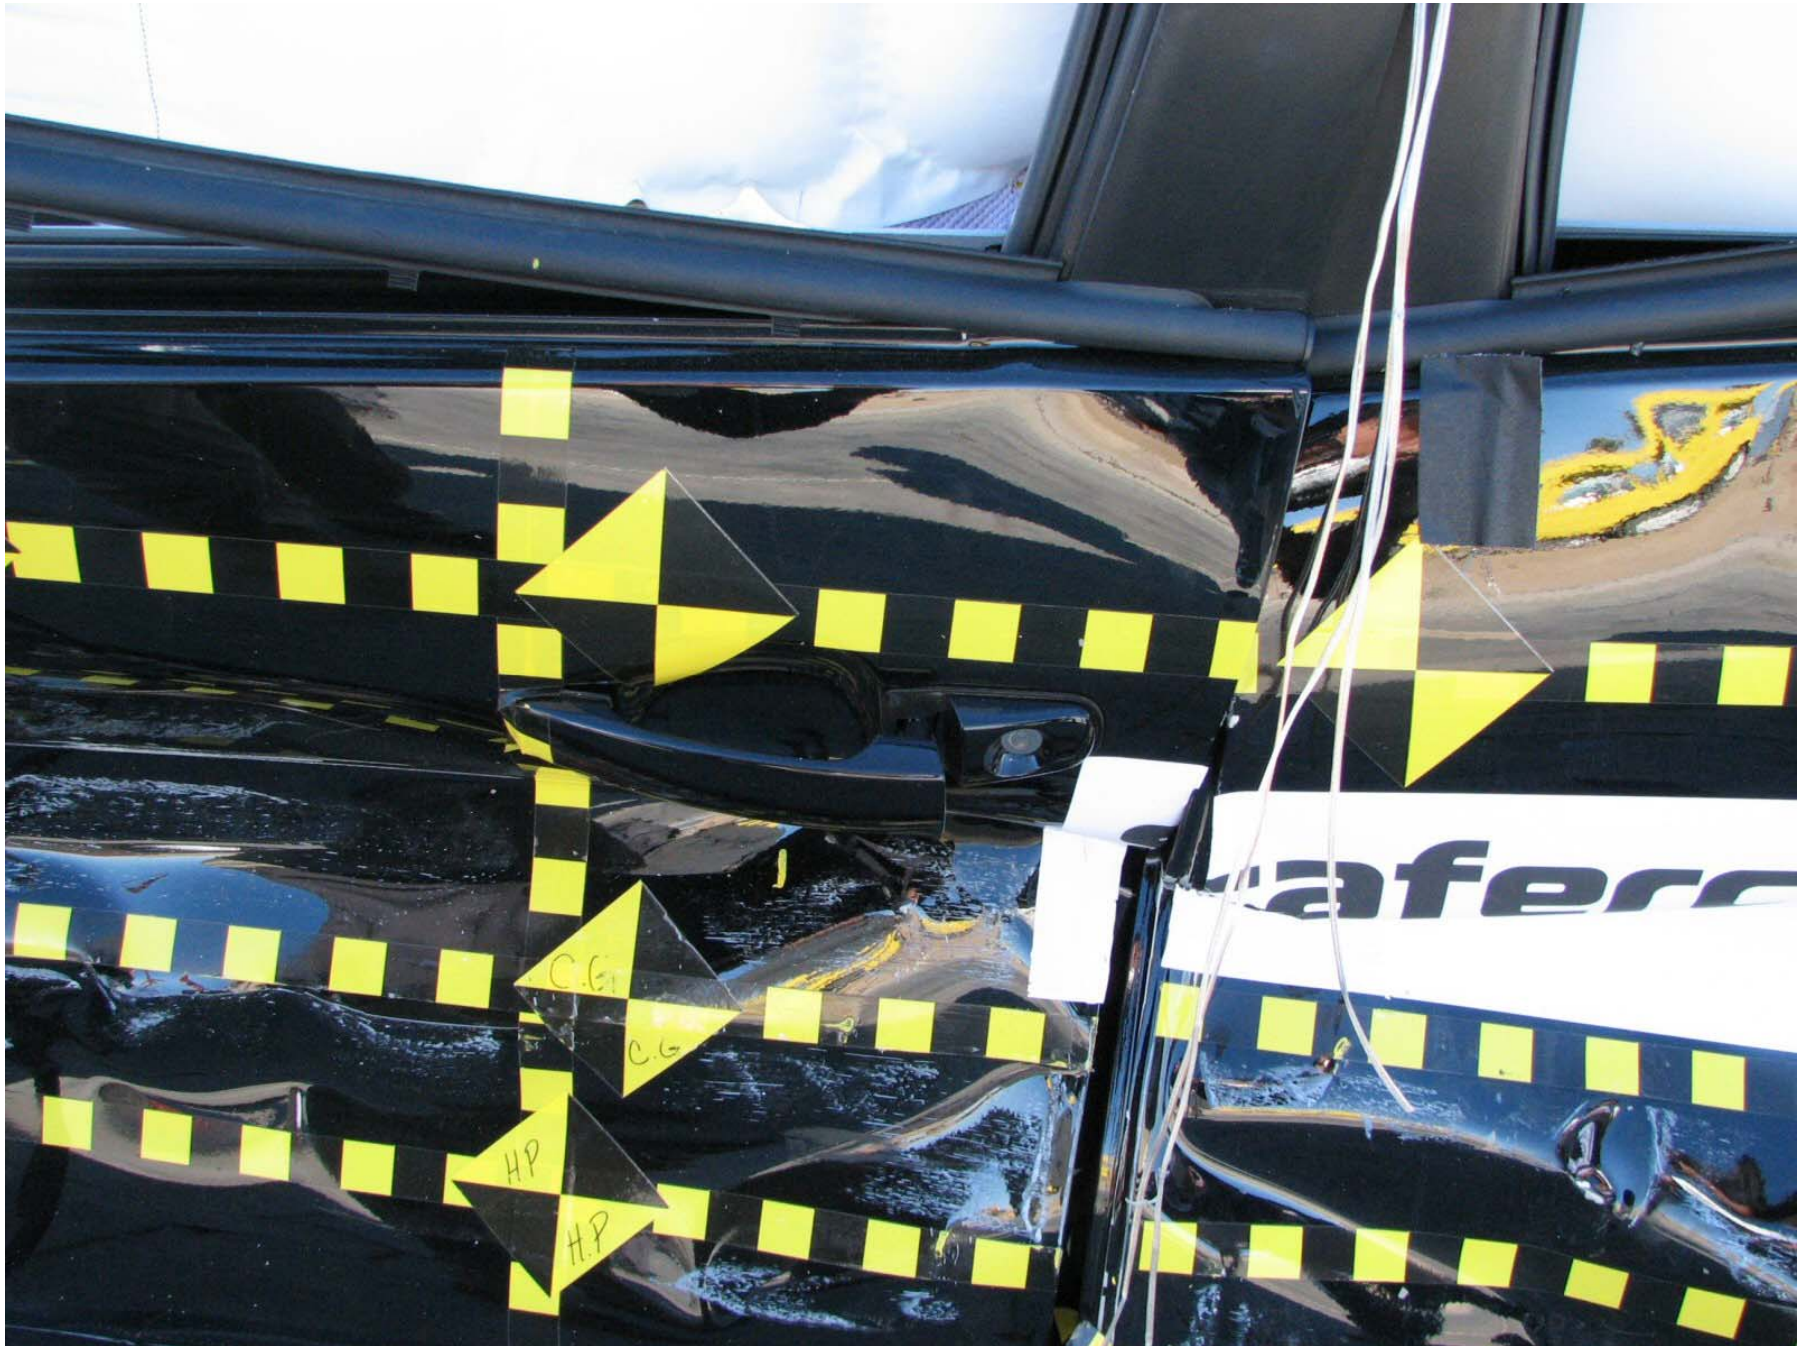
Figure A-32: Post-Test Left Front Door

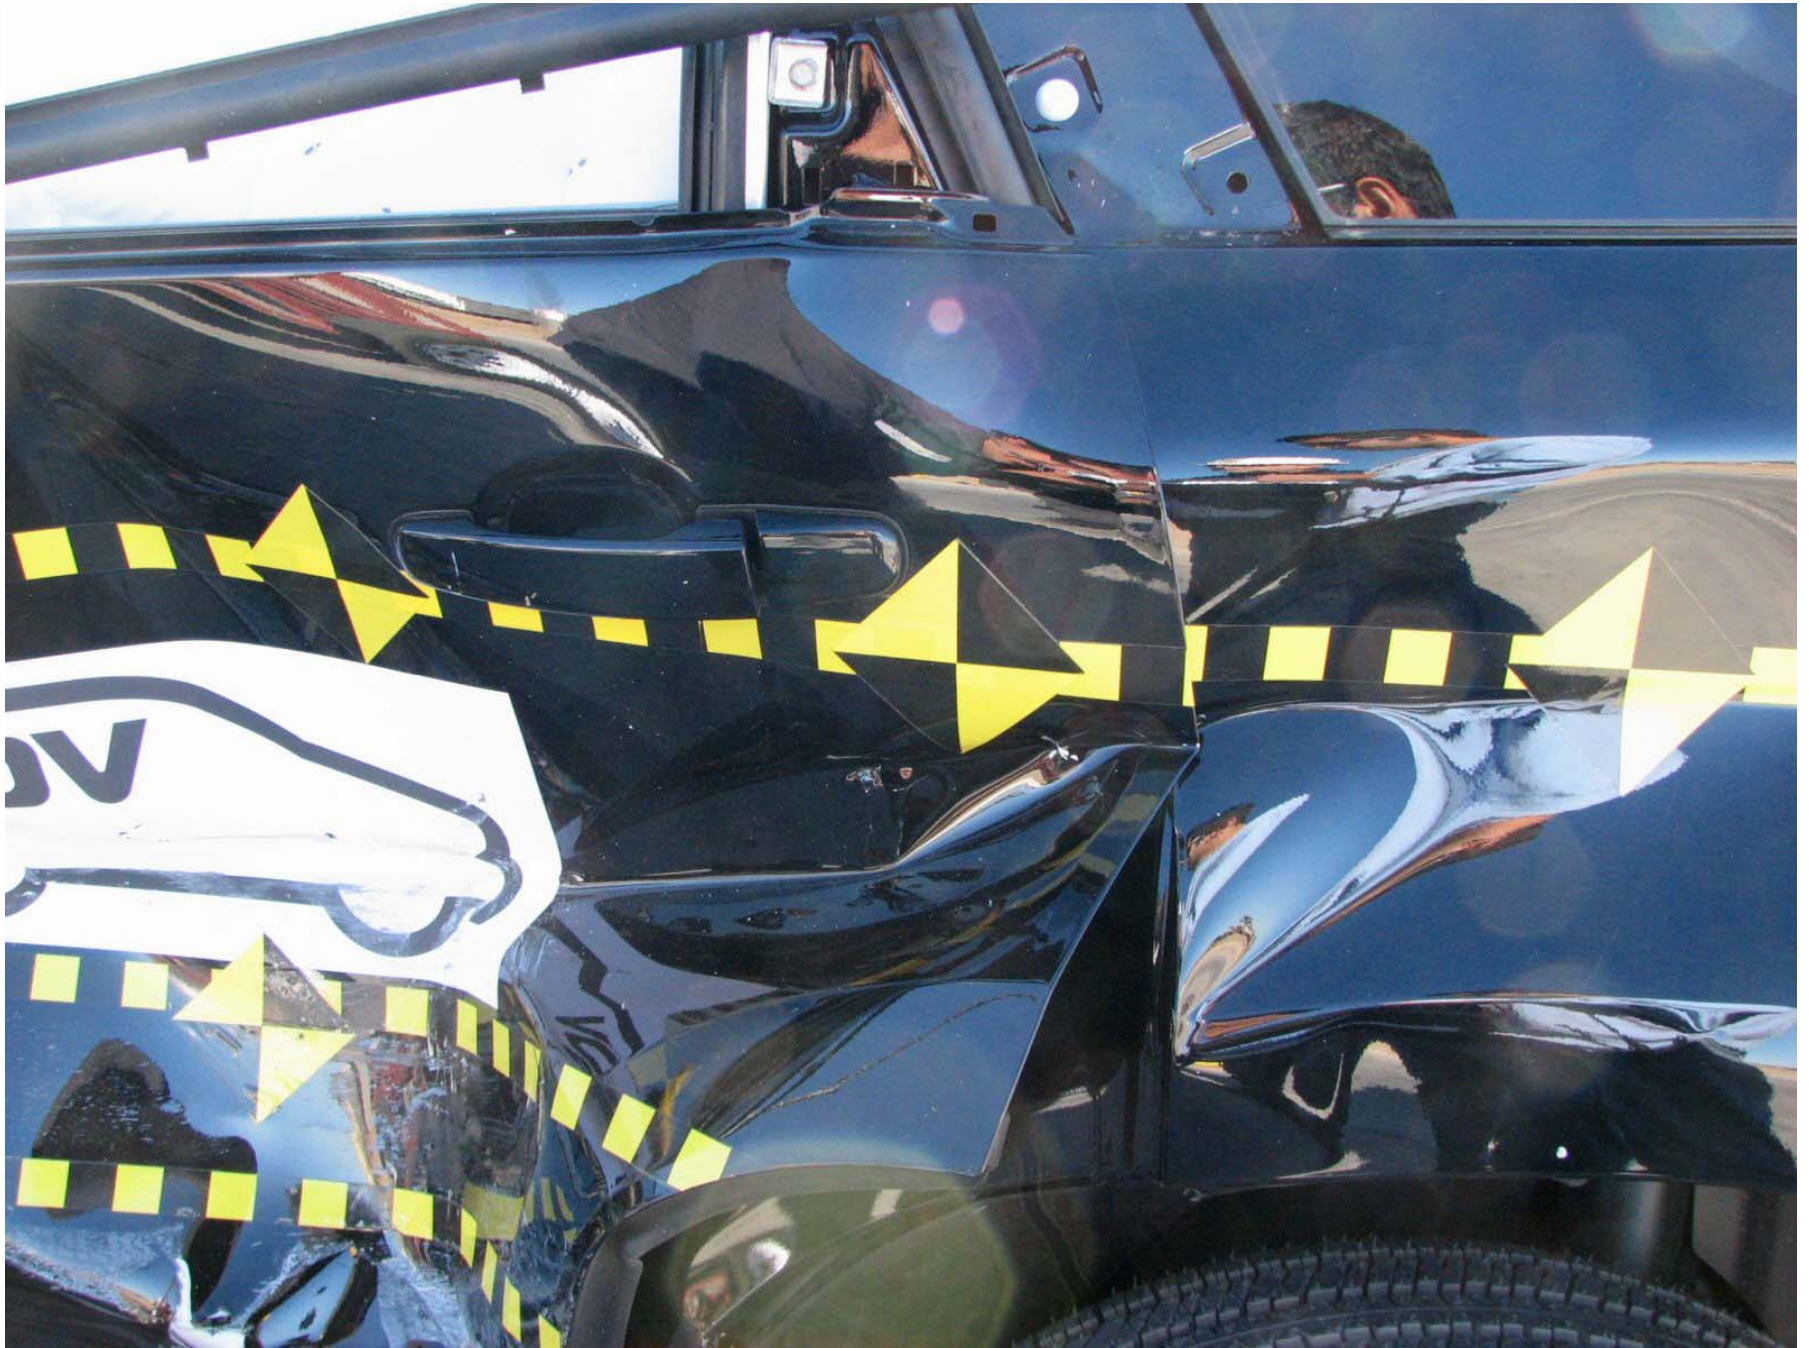
Figure A-34: Post-Test Left Rear Door

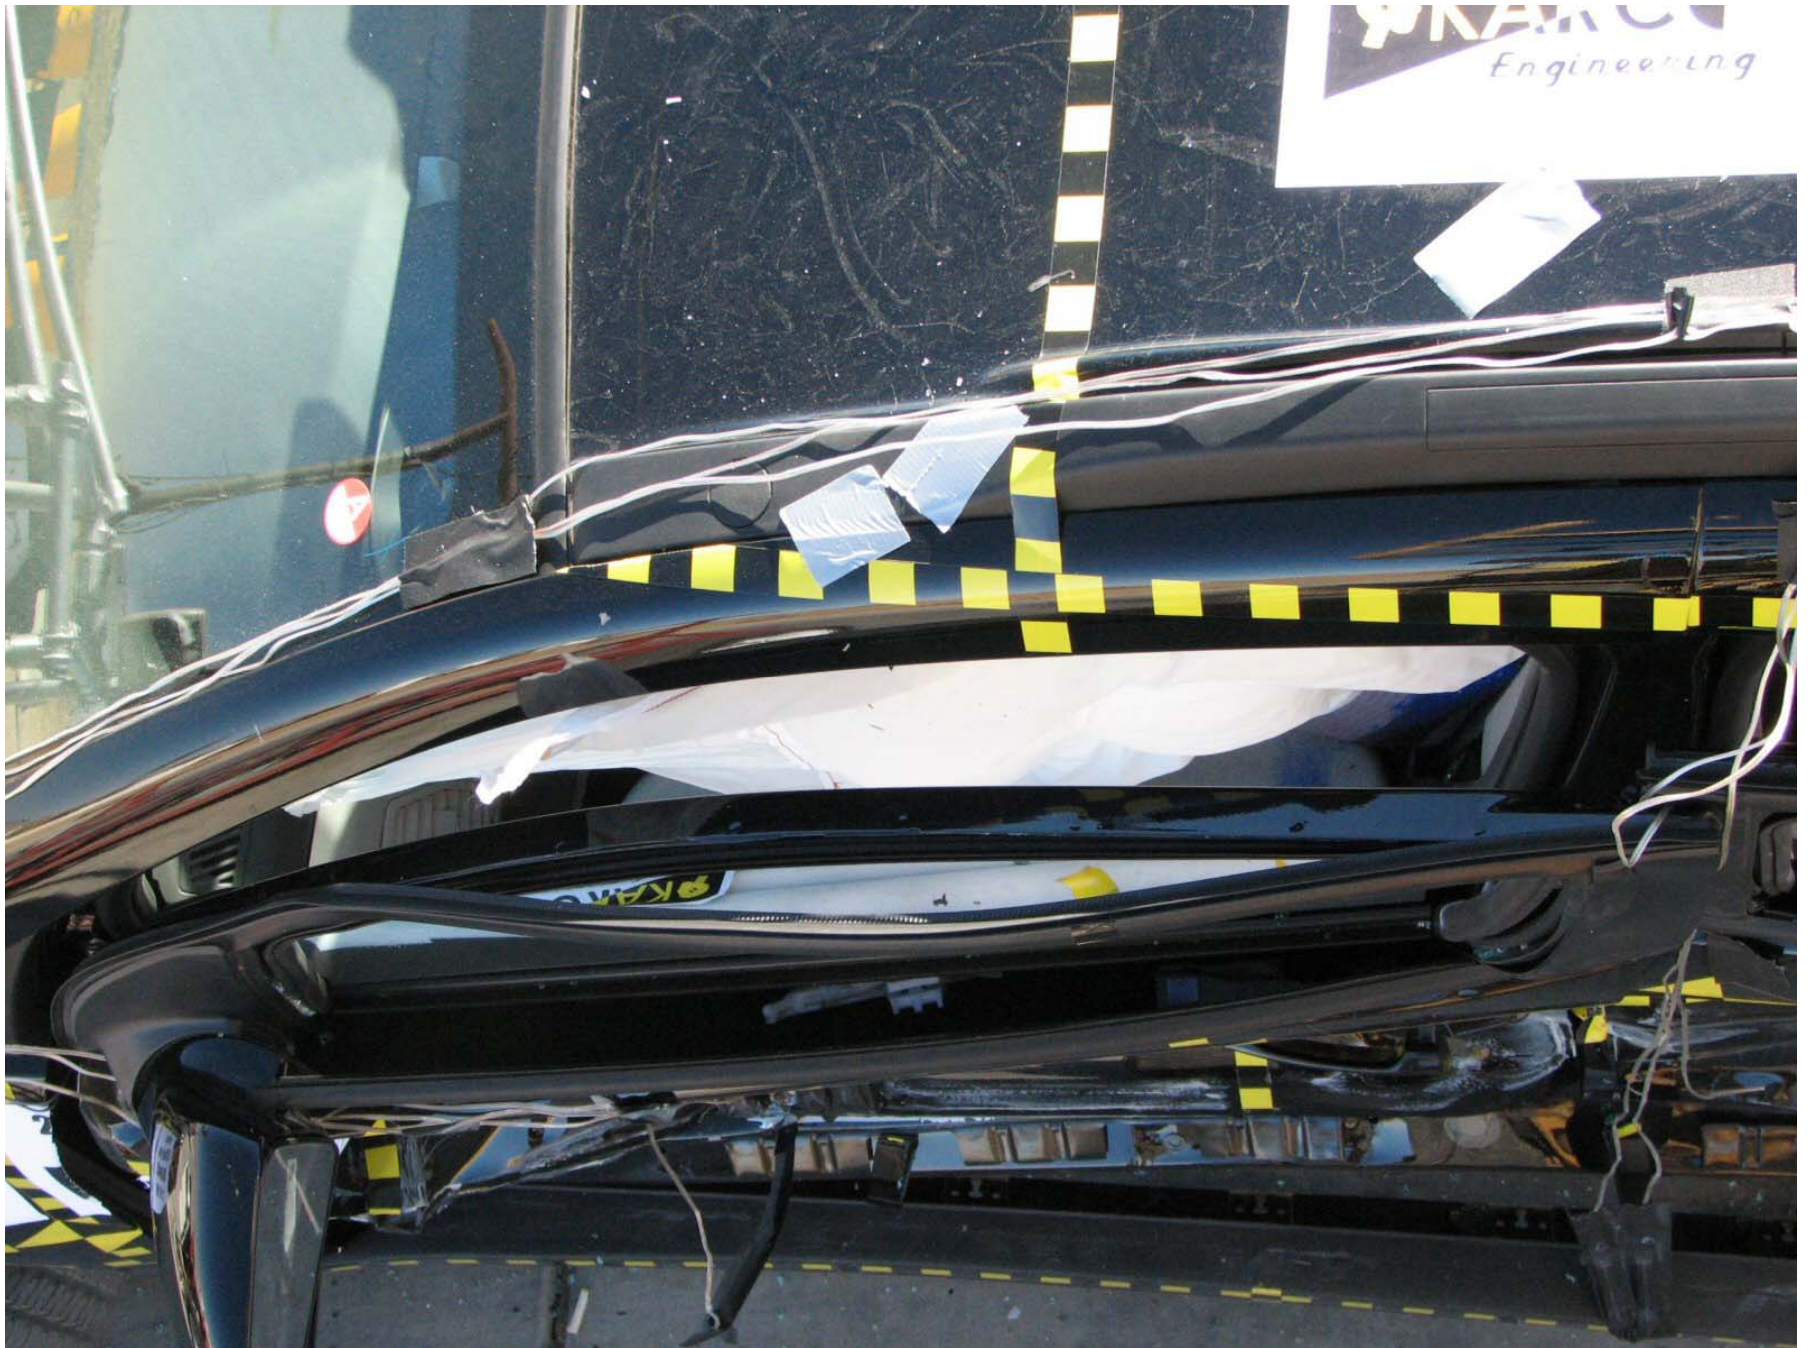
Figure A-39: Post-Test Driver Dummy Clearance From Door

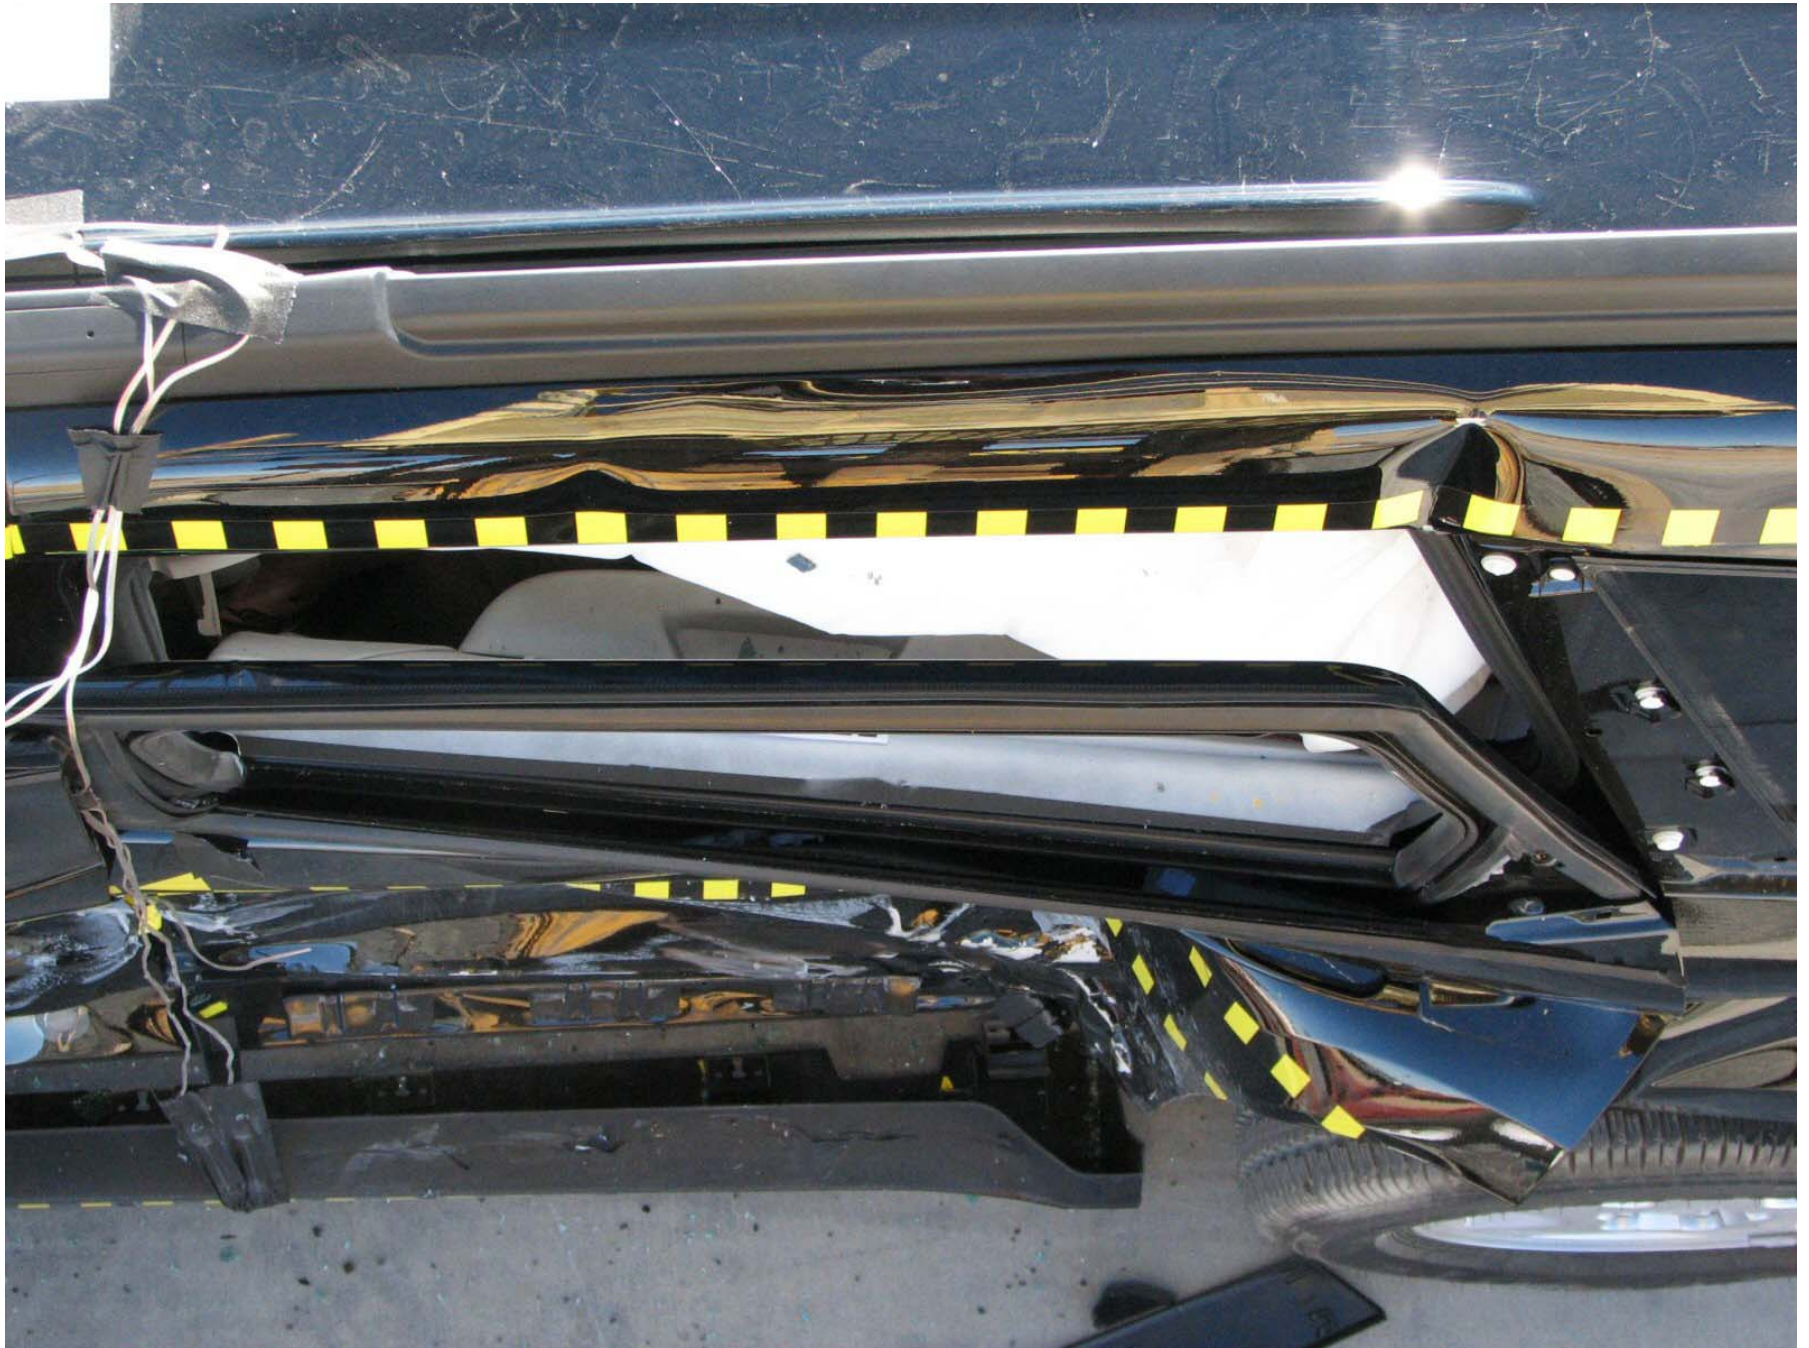
Figure A-48: Post-Test Passenger Dummy Clearance From Door

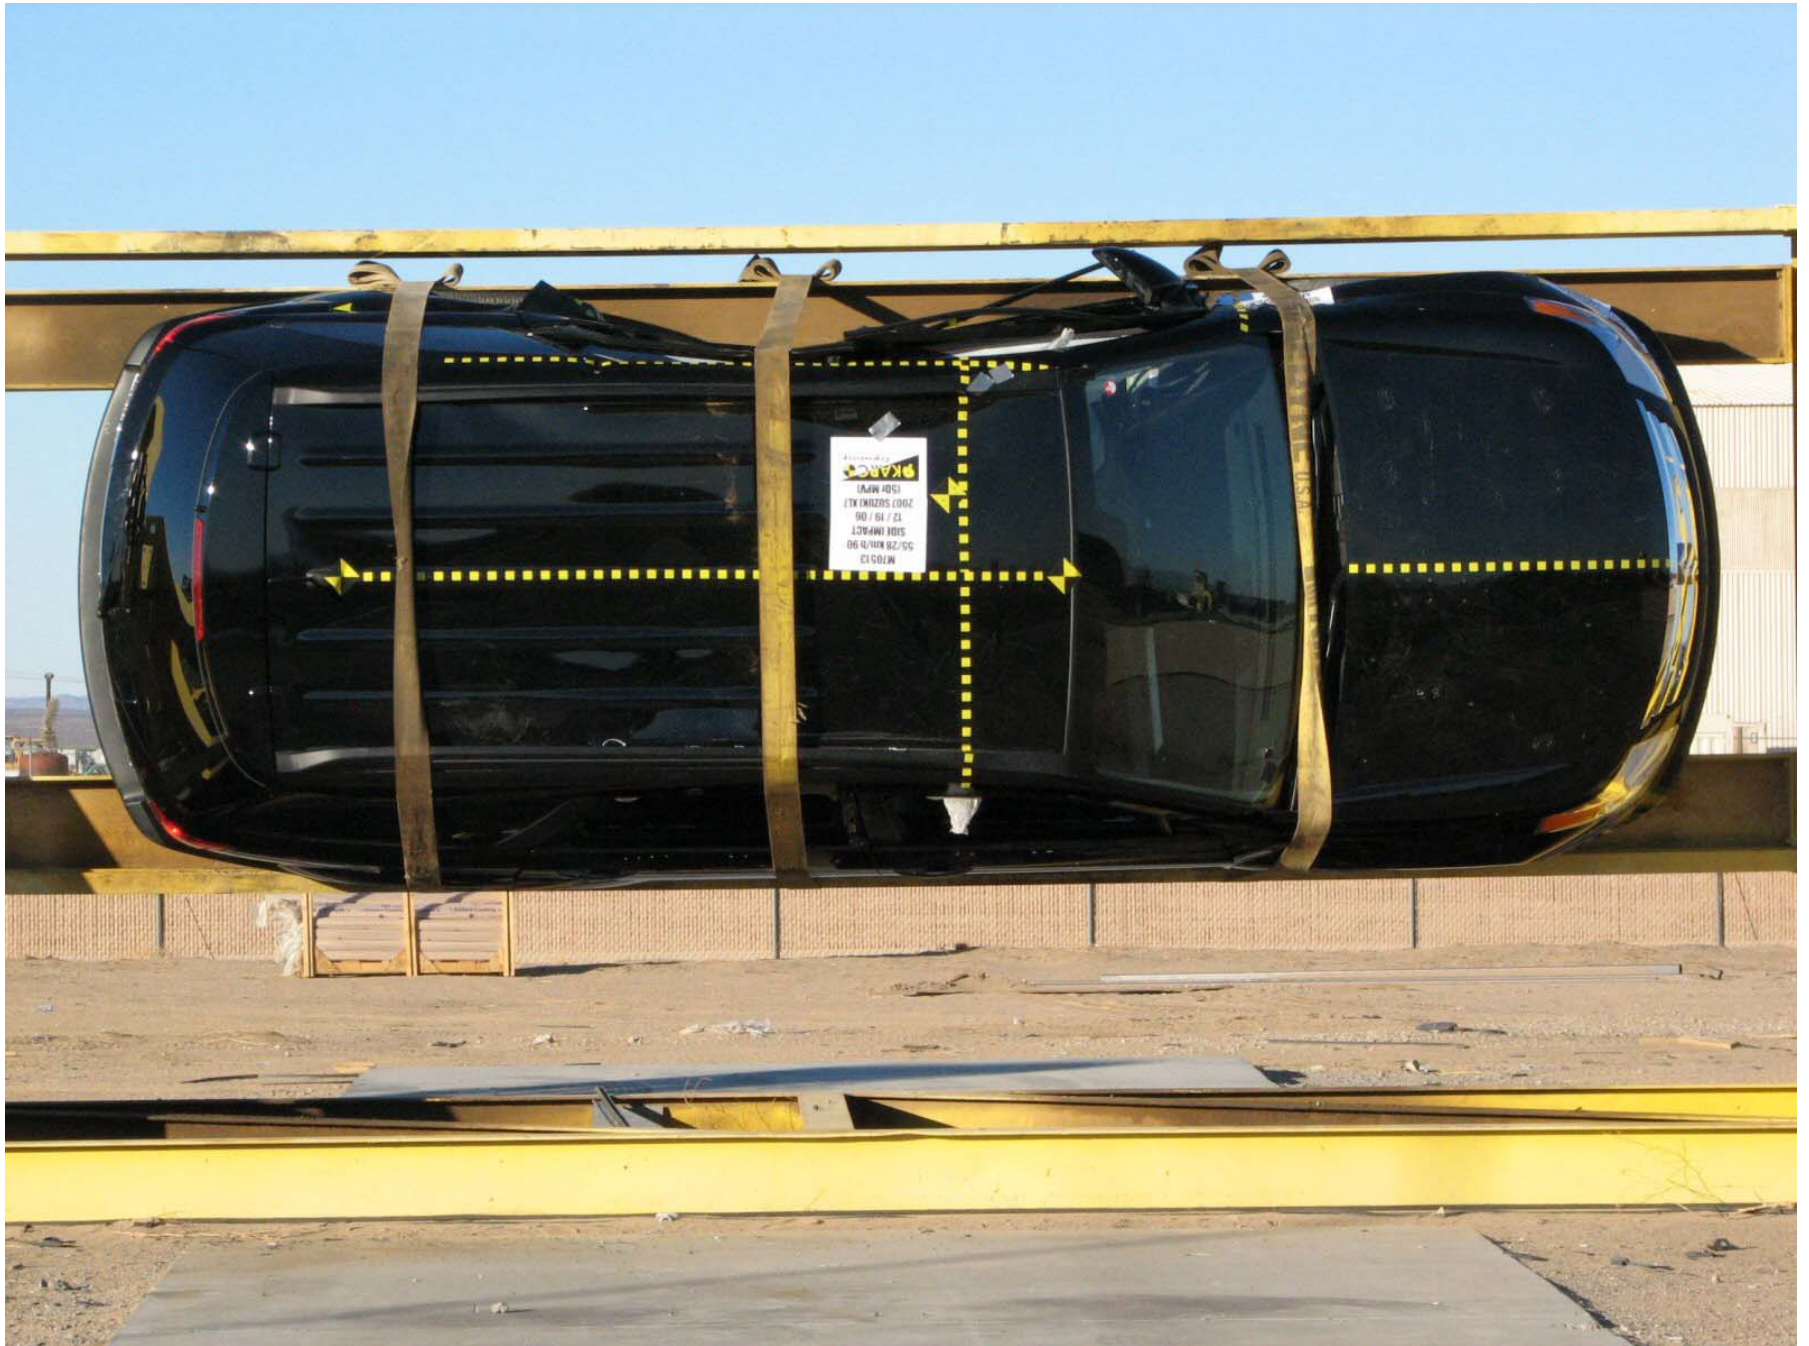
Figure A-62: Vehicle on Rollover Device (90°)

1. The specified fixture rollover rate for each 90° of rotation is 60 to 120 seconds.
2. The position hold time at each position is 300 seconds (minimum).
3. Details of Stoddard Solvent spillage locations.  
No solvent leakage occurred during static rollover testing.

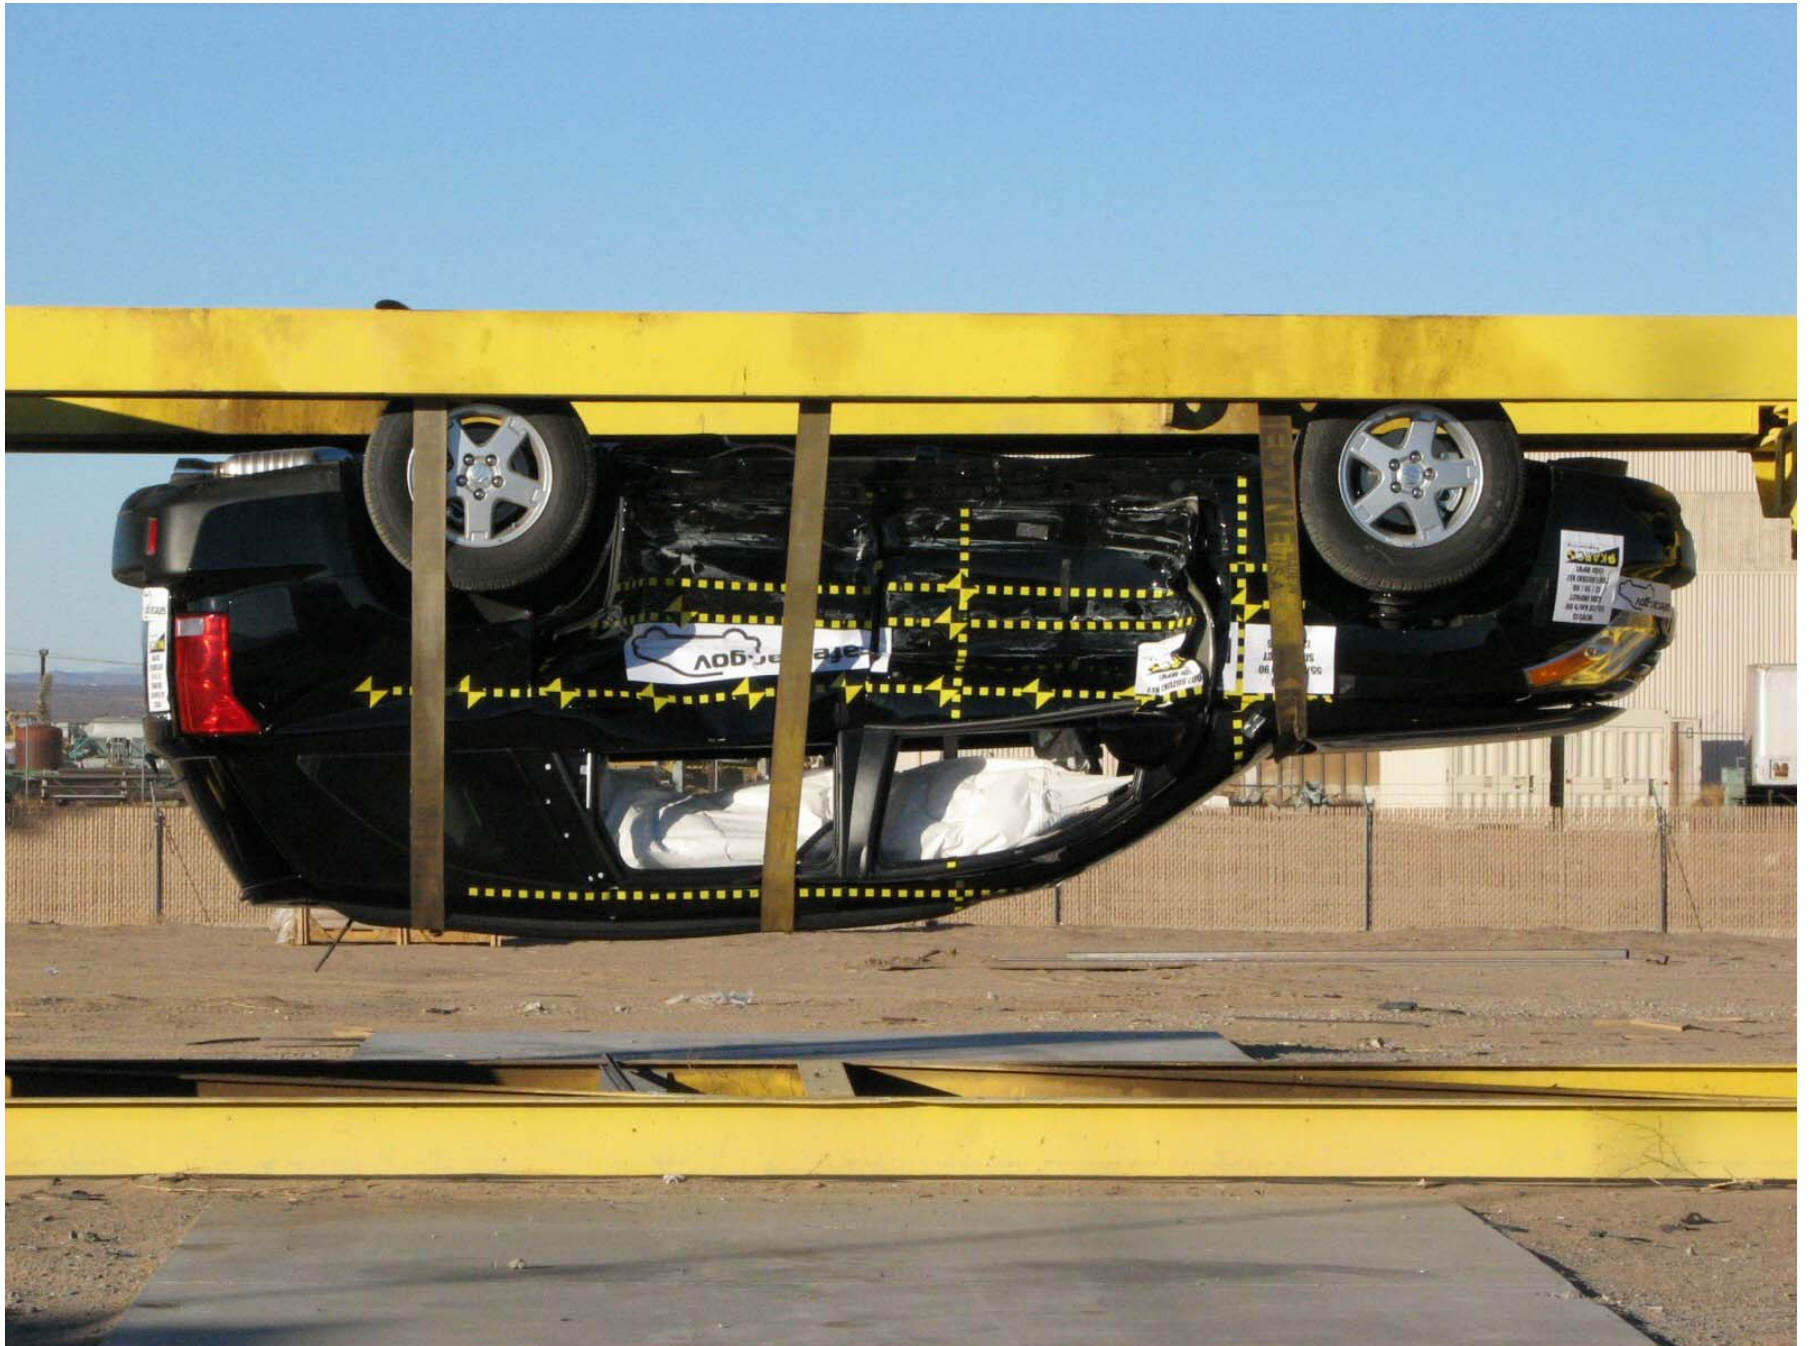
Figure A-63: Vehicle on Rollover Device (180°)
