**REPORT NUMBER TR-P27003-07-NC**

**NEW CAR ASSESSMENT PROGRAM  
SIDE IMPACT TEST**

**CAMI AUTOMOTIVE INC. CANADA  
2007 SUZUKI XL7  
5-DOOR MPV**

**NHTSA NUMBER: M70513**

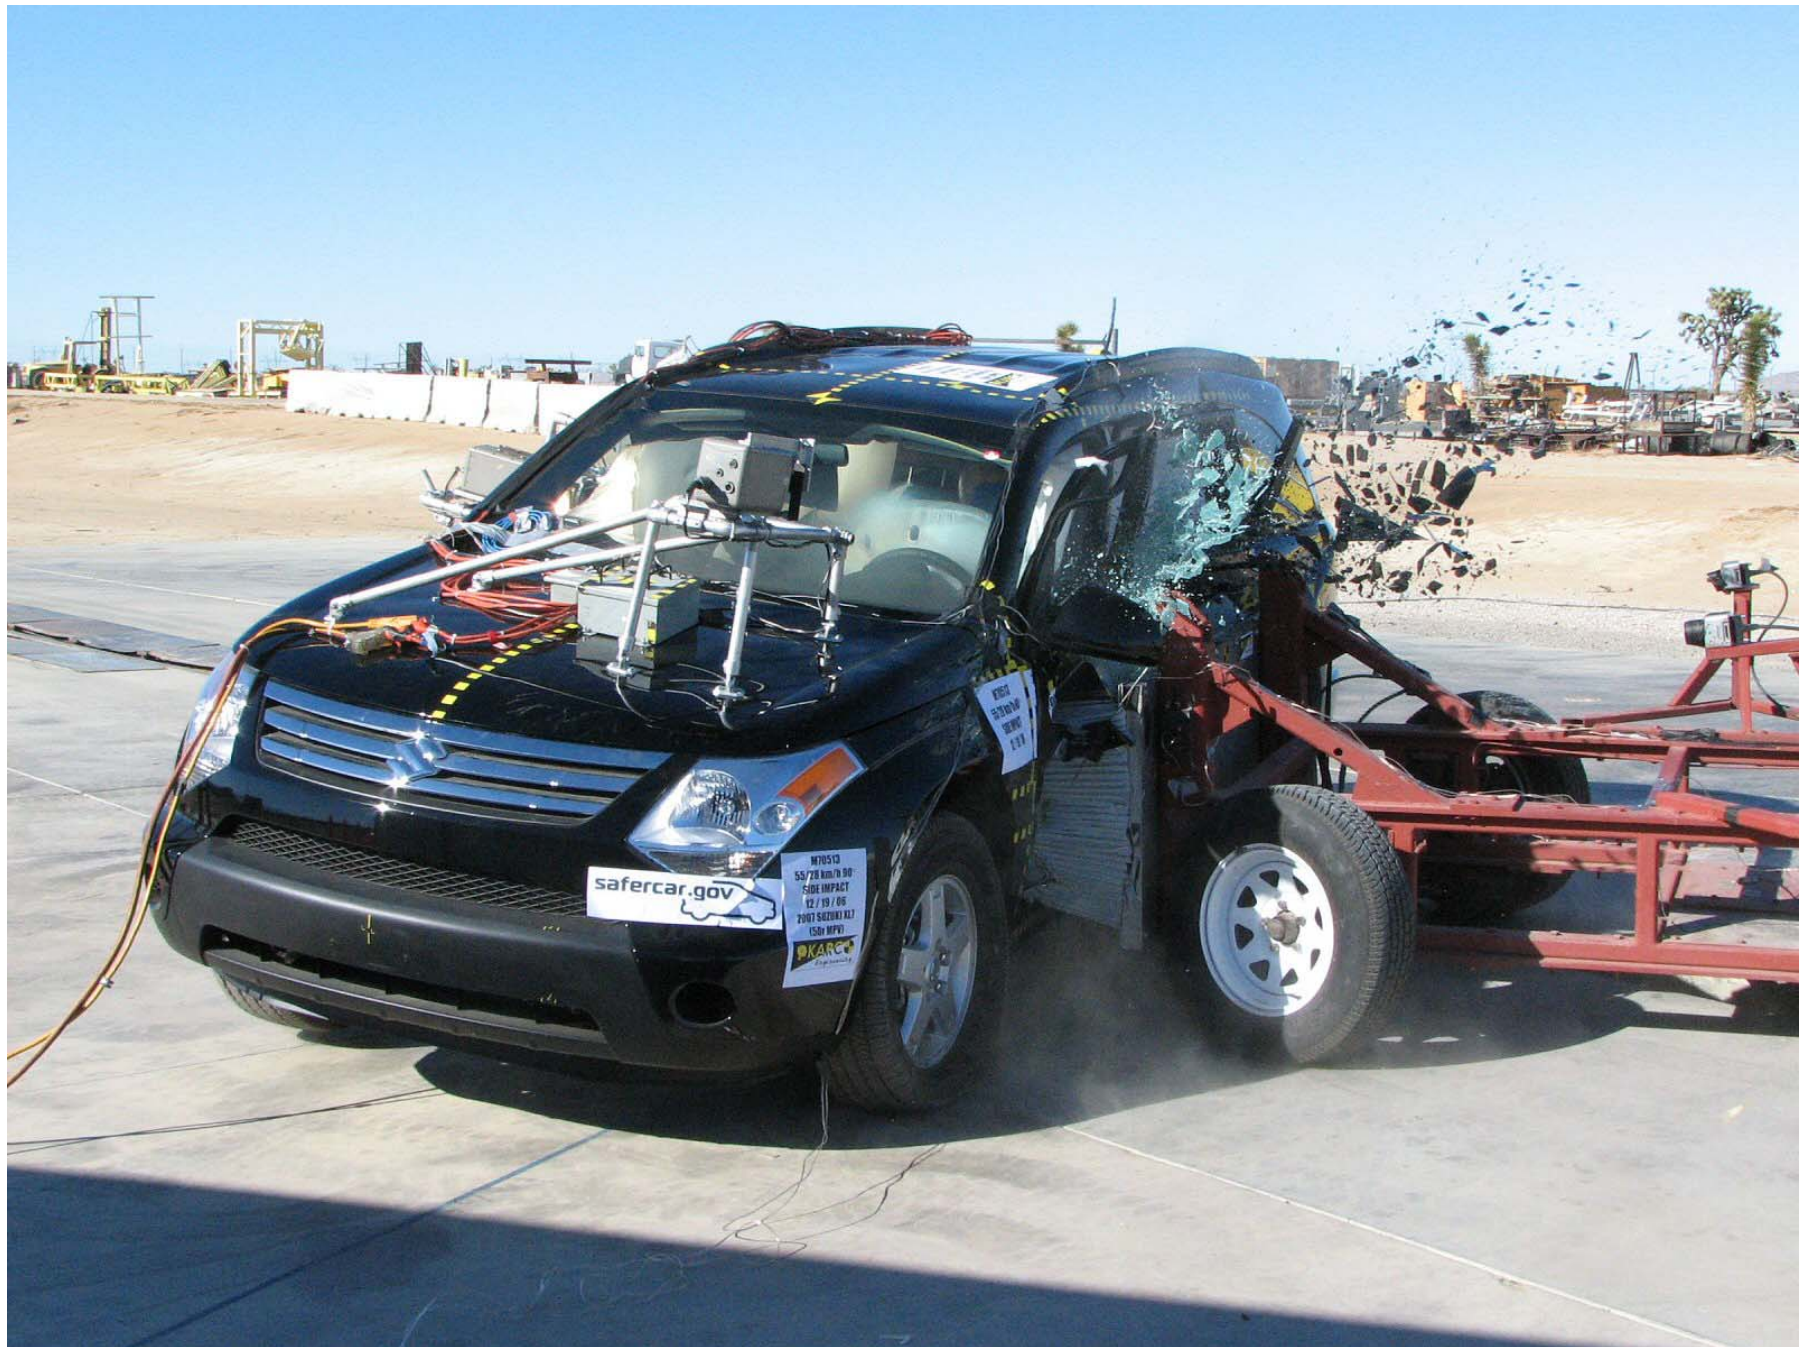
Figure A-65: Vehicle Impact

A model year 2007 Suzuki XL7 5-Door MPV was impacted on the left (driver's) side by a Moving Deformable Barrier (MDB) which was moving forward in a 27° crabbed position to the tow road guidance system at a velocity of 62.05 km/h. The specified impact velocity range is from 61.14 to 62.75 km/h. The test (target) vehicle was stationary and positioned 63° to the line of forward motion. The weight of the vehicle as tested was 2099 kg and the test weight of the MDB was 1361 kg. The test was conducted at KARCO Engineering, LLC in Adelanto, California, on December 19, 2006.
