REPORT NUMBER: CAL-07-08

**NEW CAR ASSESSMENT PROGRAM (NCAP)  
FRONTAL BARRIER IMPACT TEST**

KIA MOTORS CORPORATION  
2007 KIA RIO  
4-DOOR SEDAN

FINAL REPORT

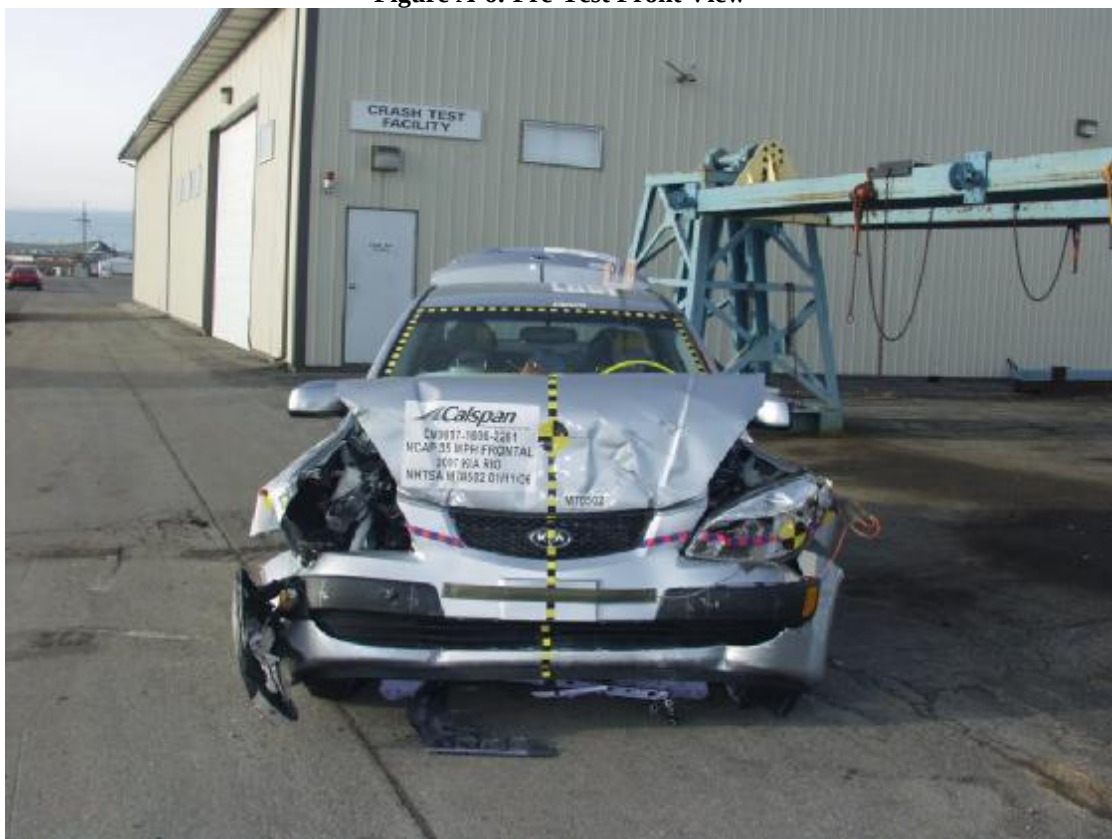
**Figure A-7: Post-Test Front View**

Vehicle NHTSA No.: M70502 Test Mode: 56.3 kph Frontal Barrier  
 Test Date: January 11, 2007 Time: 14:00 Temperature: 21 °C  
 Vehicle Make/Model/Body Style: 2007 Kia Rio 4-door Sedan  
 Vehicle Test Weight: 1352 kg Impact Velocity: 56.01 kph (55.5 – 57.1 kph)  
 Vehicle/Barrier Impact Angle: 0 ° Max Static Crush: 377 mm

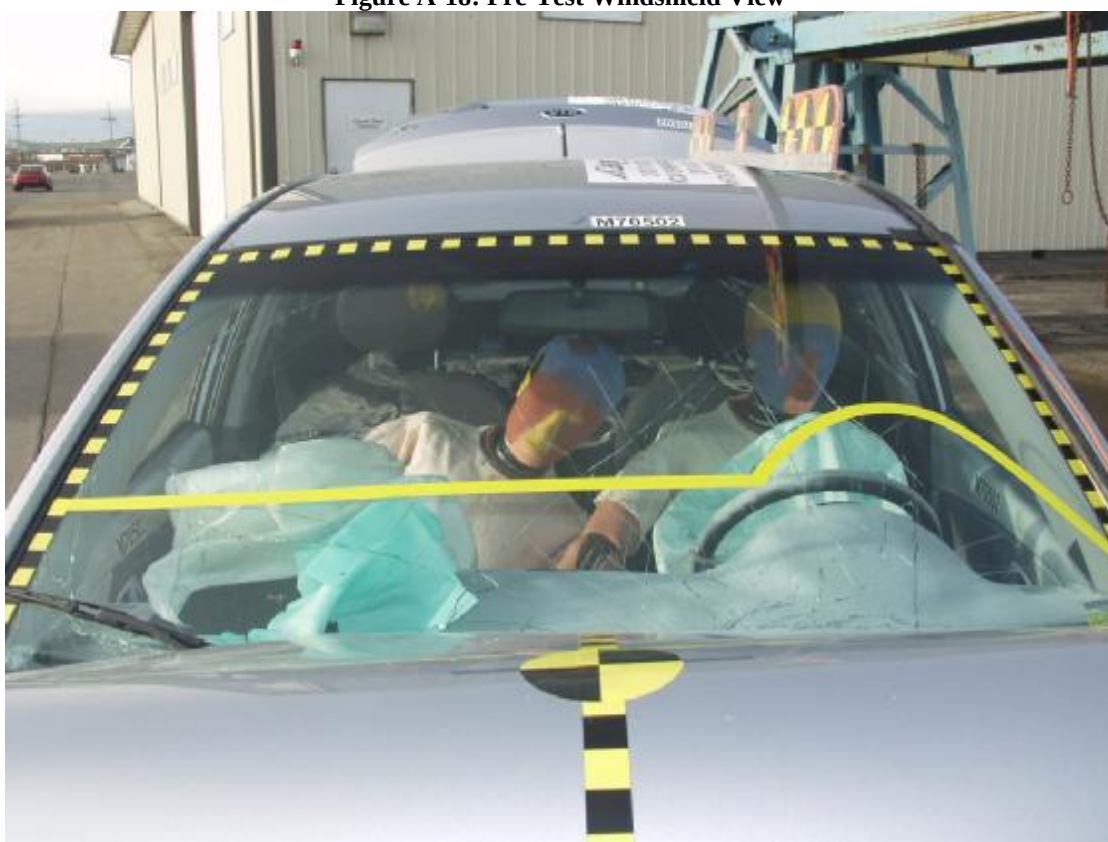
**Figure A-19: Post-Test Windshield View**

| Description | Driver Side | Passenger Side |
|---|---|---|
| Glazing Damage | Windshield sustained cracks in front of the passenger dummy seating position from airbag cover | |

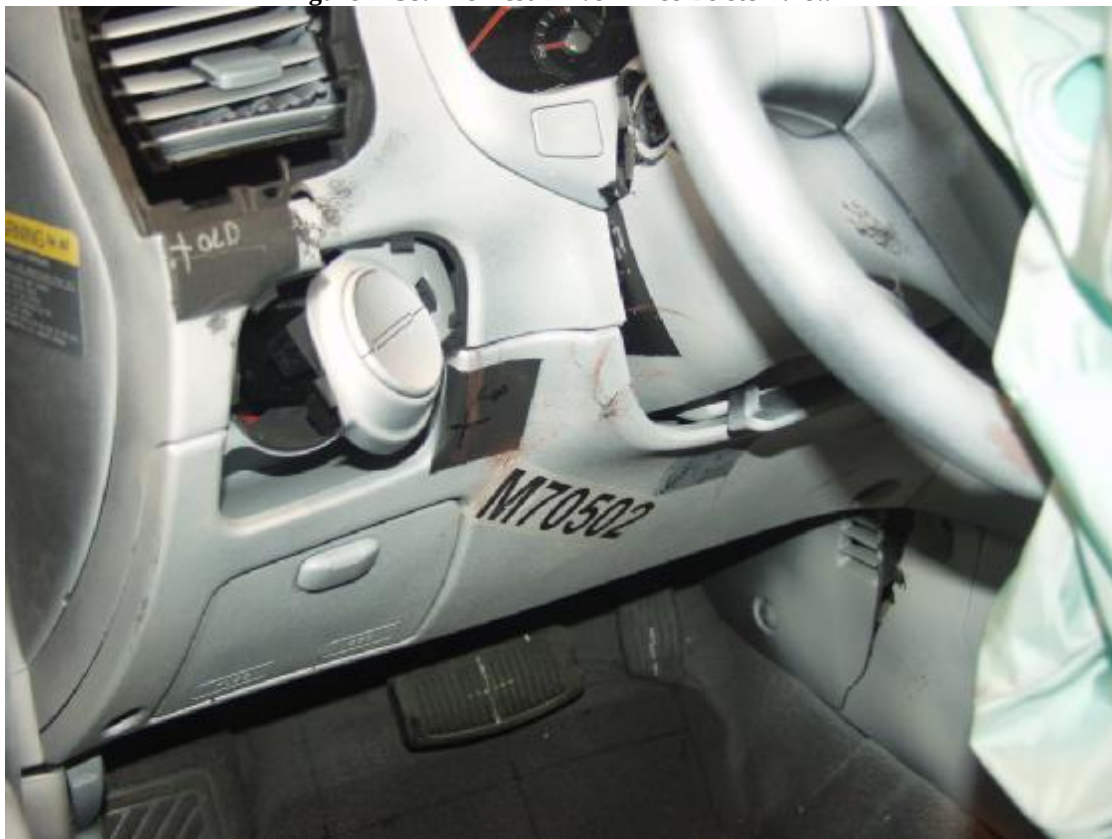
**Figure A-39: Post-Test Driver Knee Bolster View**

| | DRIVER | PASSENGER |
|---|---|---|
| Left Knee Contact: | Knee Bolster | Knee Bolster |
| Right Knee Contact: | Knee Bolster | Knee Bolster |

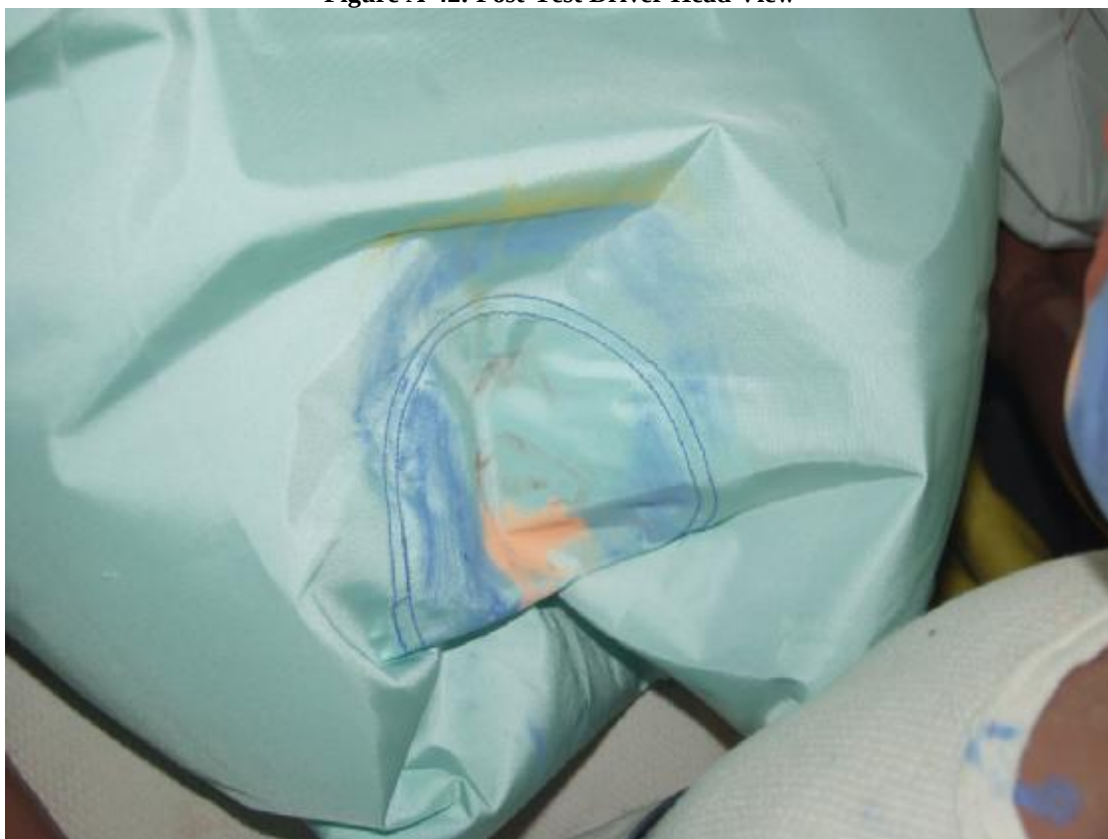
**Figure A-43: Post-Test Driver Contact to Airbag**

| | DRIVER | PASSENGER |
|---|---|---|
| Head Contact: | Airbag / Back of head to headrest | Airbag / Back of head to headrest |
| Abdomen Contact: | Airbag | Airbag |
