REPORT NUMBER: CAL-07-09

**NEW CAR ASSESSMENT PROGRAM (NCAP)  
FRONTAL BARRIER IMPACT TEST**

GENERAL MOTORS CORPORATION  
2007 SATURN OUTLOOK  
MPV

NHTSA NUMBER: M70106

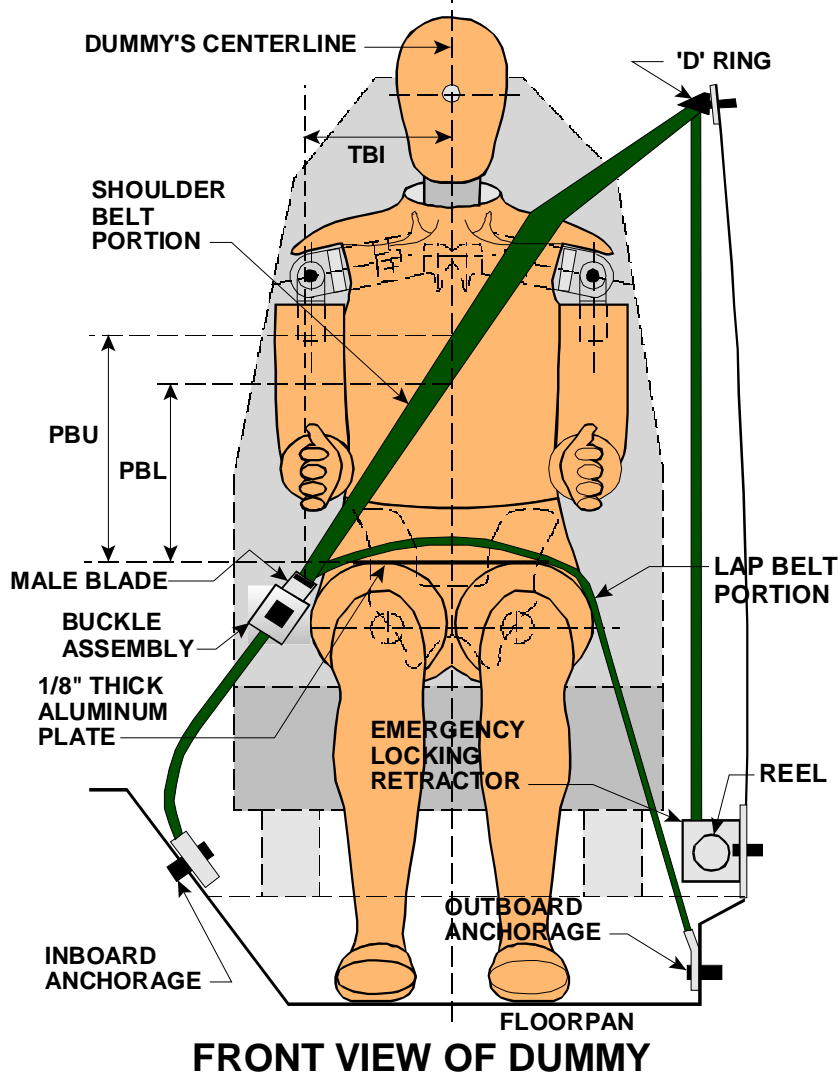
**SEAT BELT POSITIONING DATA**

DRIVER DUMMY (mm)	PASSENGER DUMMY (mm)
PBU -- Top surface of alum. plate to upper edge	340	200
PBL-- Top surface of alum. plate to belt lower edge	260	230
LAP BELT TENSION	10 N	10 N
SHOULDER BELT TENSION	Retractor	Retractor

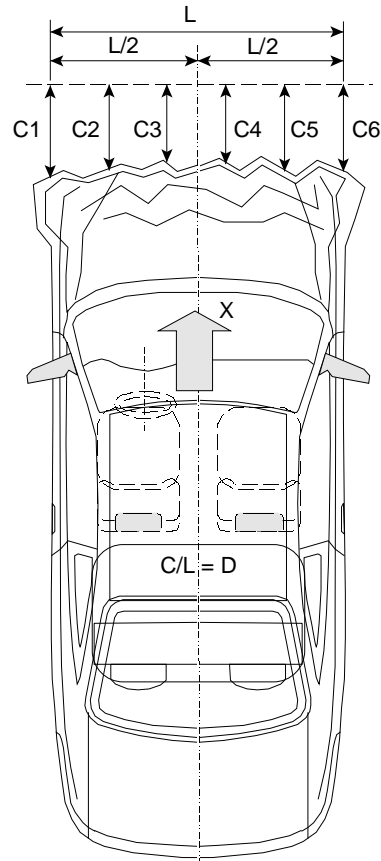
Crush Depth Dimensions

PRE (mm)	POST (mm)	DIFF (mm)
C1 =	4852	4611	241
C2 =	5001	4543	458
C3 =	5083	4596	487
C4 =	5083	4598	485
C5 =	5002	4547	455
C6 =	4853	4588	265

Midpoint of Damage: D = Vehicle Centerline (Longitudinal)

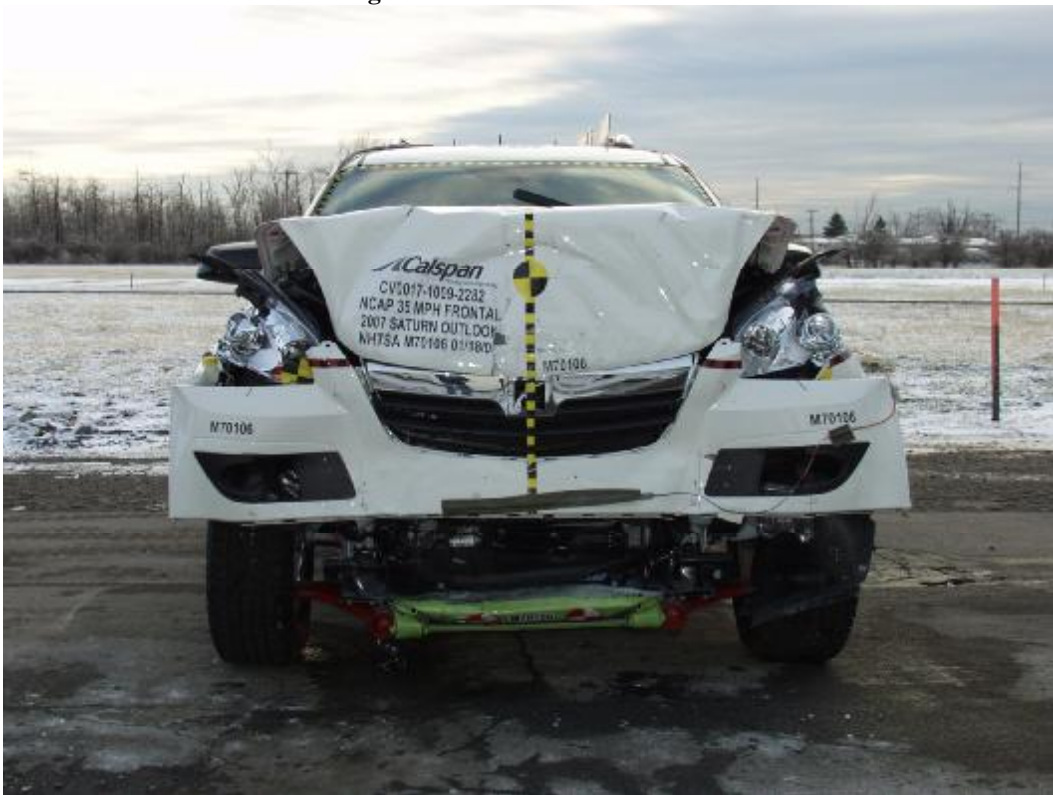
Figure A-7: Post-Test Front View

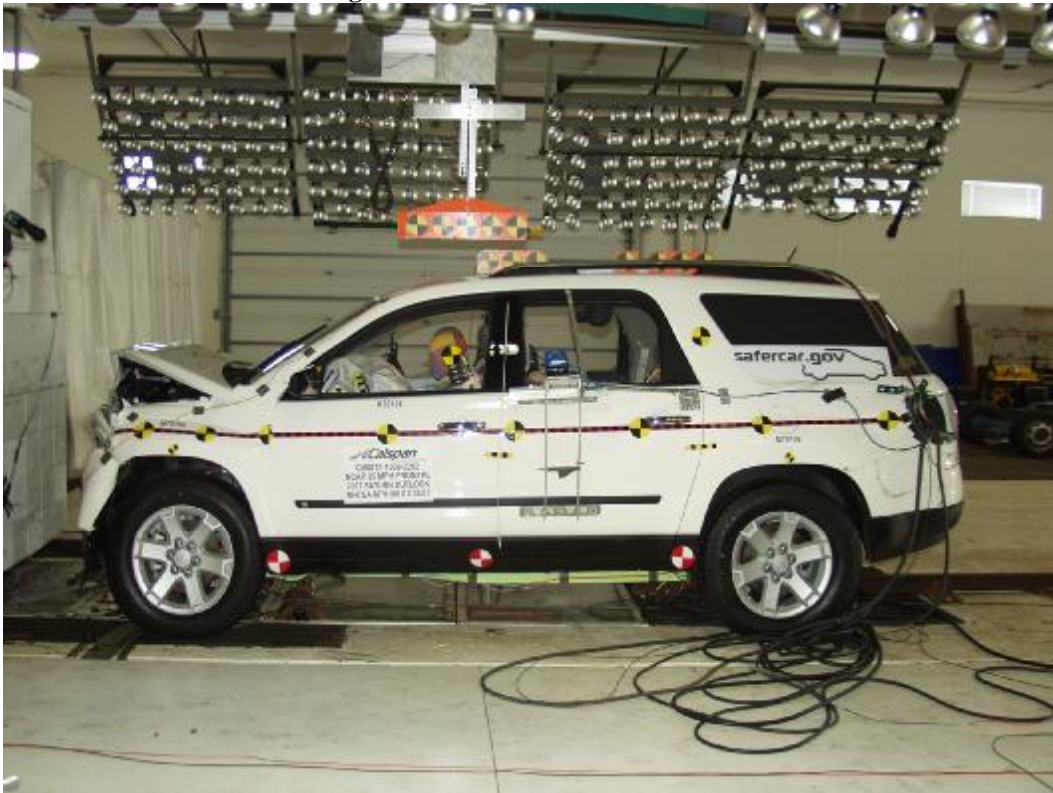
Figure A-9: Post-Test Left Side View

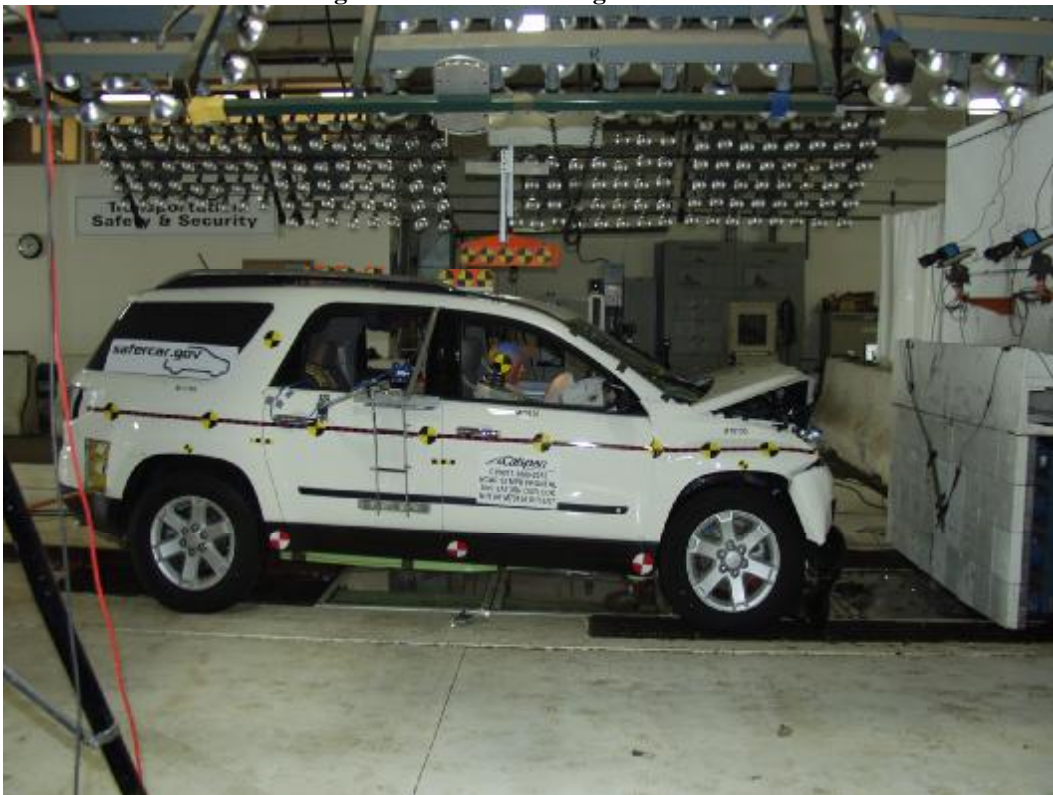
Figure A-11: Post-Test Right Side View

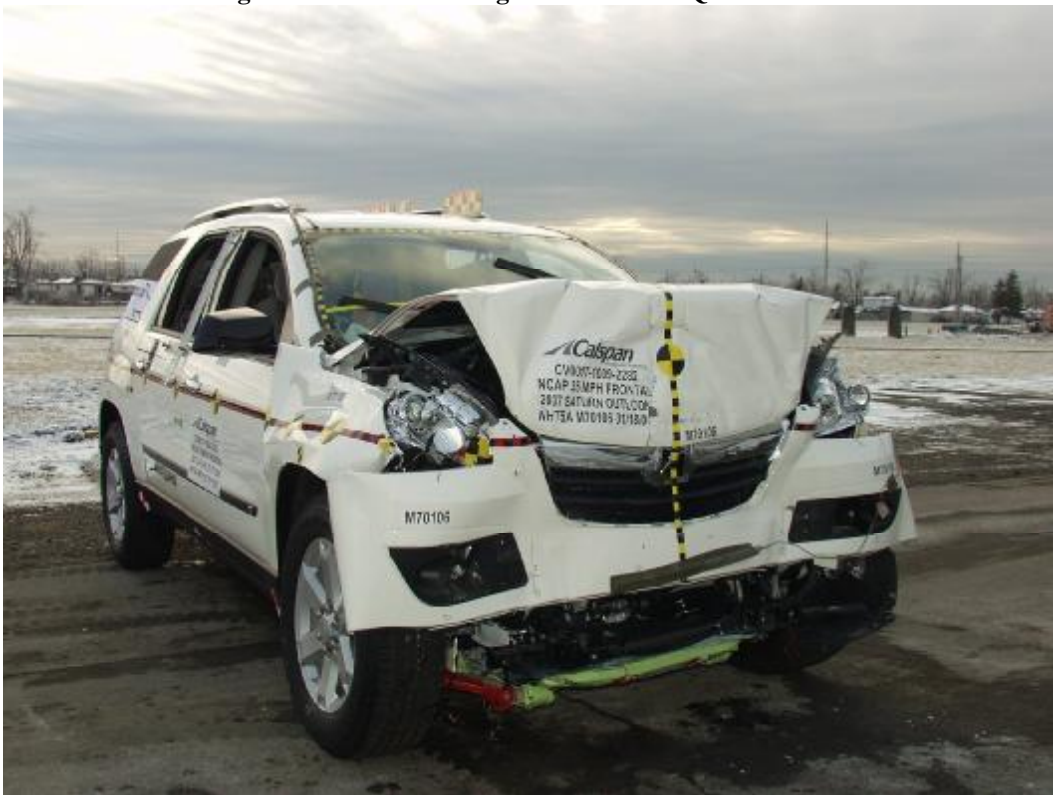
Figure A-13: Post-Test Right Front Three-Quarter View

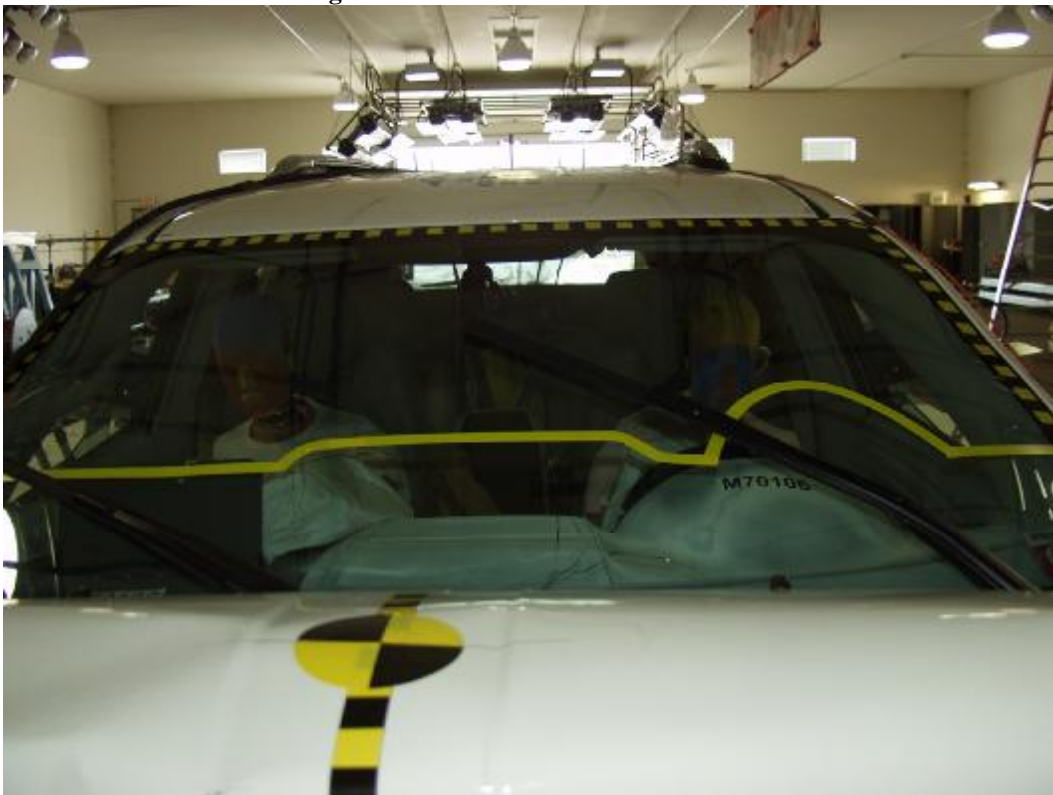
**Figure A-19: Post-Test Windshield View**

Description	Driver Side	Passenger Side
Door Lock Status	Locked	Locked
Front Door Opening	Closed, latched and operable without tools	Closed, latched and operable without tools
Rear Door Opening	Closed, latched and operable without tools	Closed, latched and operable without tools
Hatch/Other Door Opening	Closed, latched and operable without tools	Closed, latched and operable without tools
Front Seat Track Shift (mm)	0	0
Front Seat Back Failure	None	None
Glazing Damage	The windshield was cracked from bottom to top to the left of center

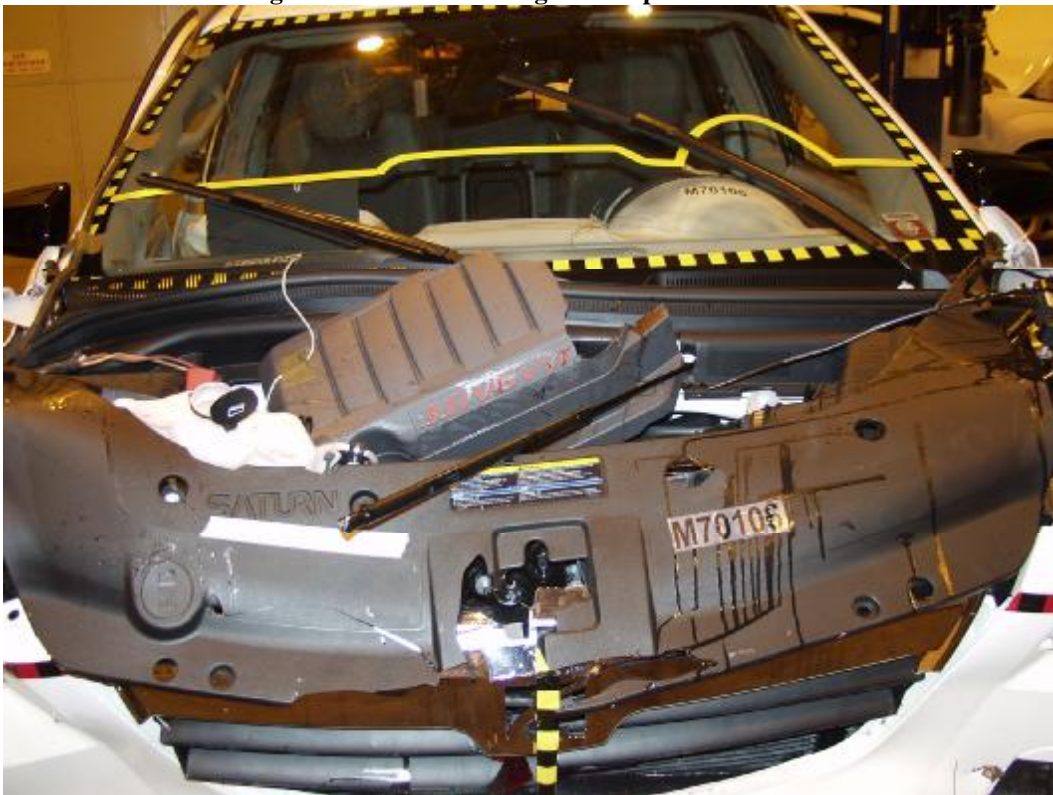
**Figure A-21: Post-Test Engine Compartment View**

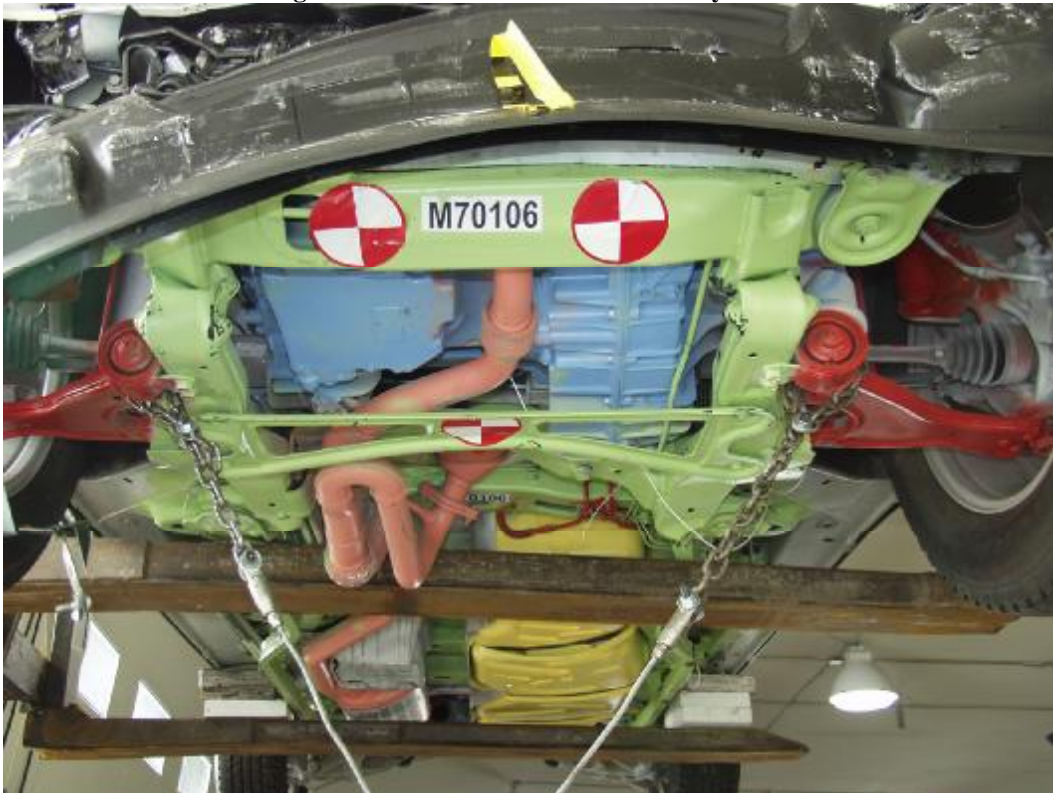
**Figure A-25: Post-Test Front Underbody View**

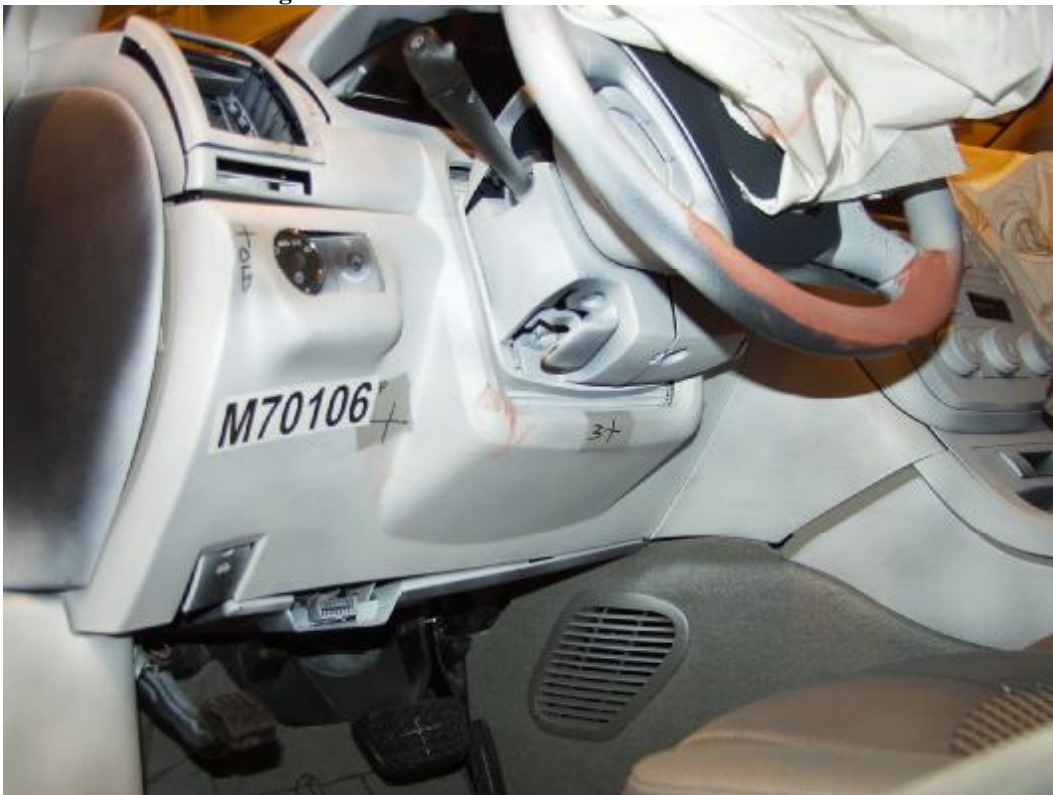
**Figure A-39: Post-Test Driver Knee Bolster View**

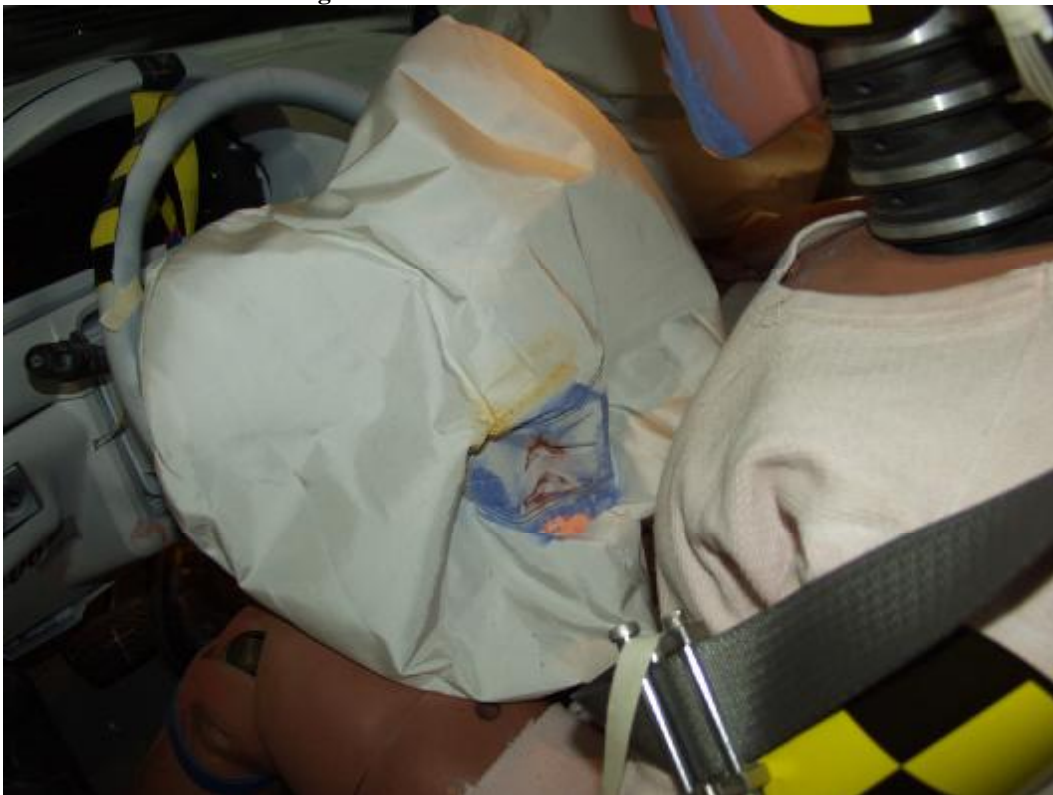
**Figure A-43: Post-Test Driver Contact to Airbag**

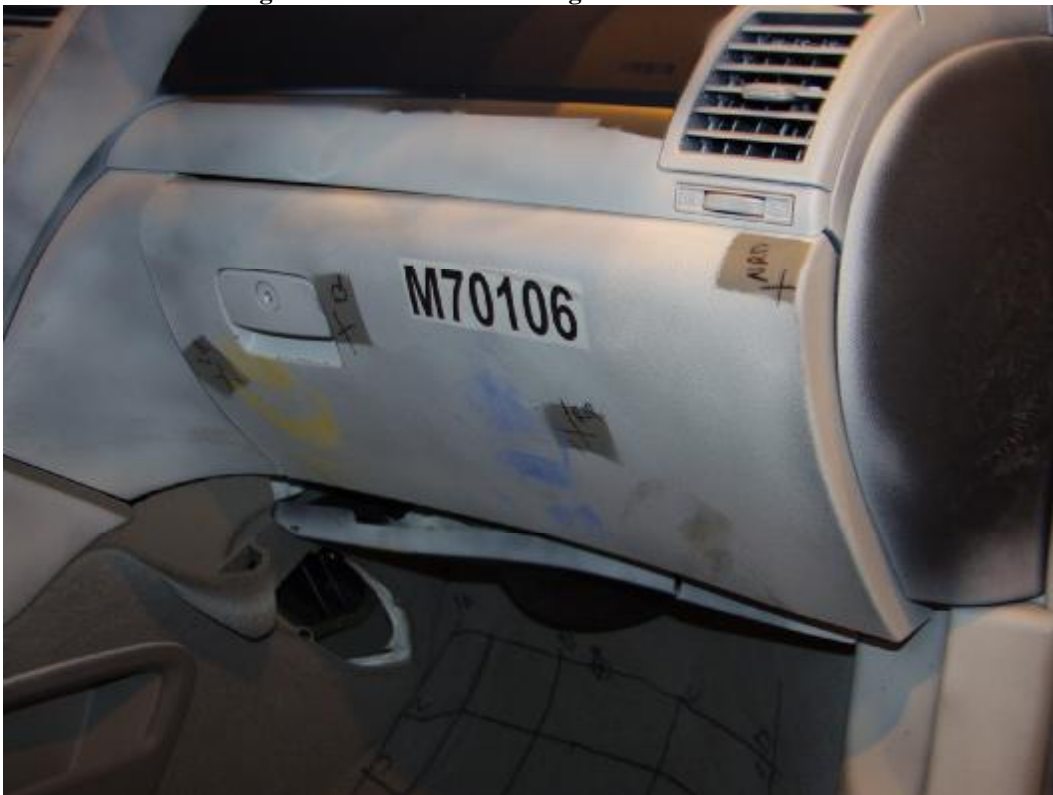
**Figure A-53: Post-Test Passenger Knee Bolster View**

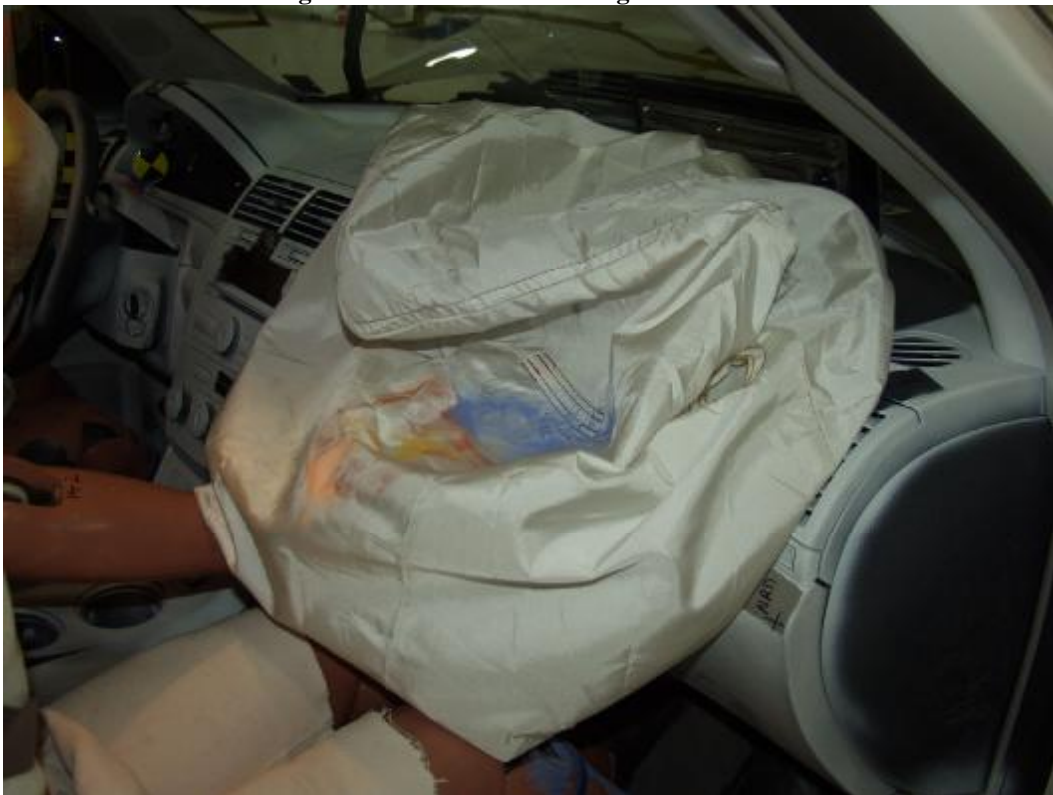
**Figure A-57: Post-Test Passenger Contact to Airbag**
