**NEW CAR ASSESSMENT PROGRAM  
FRONTAL BARRIER IMPACT TEST**

**FORD MOTOR COMPANY  
2007 FORD EDGE SE AWD  
5-DOOR MPV**

**NHTSA NUMBER: M70201**

**FINAL REPORT**

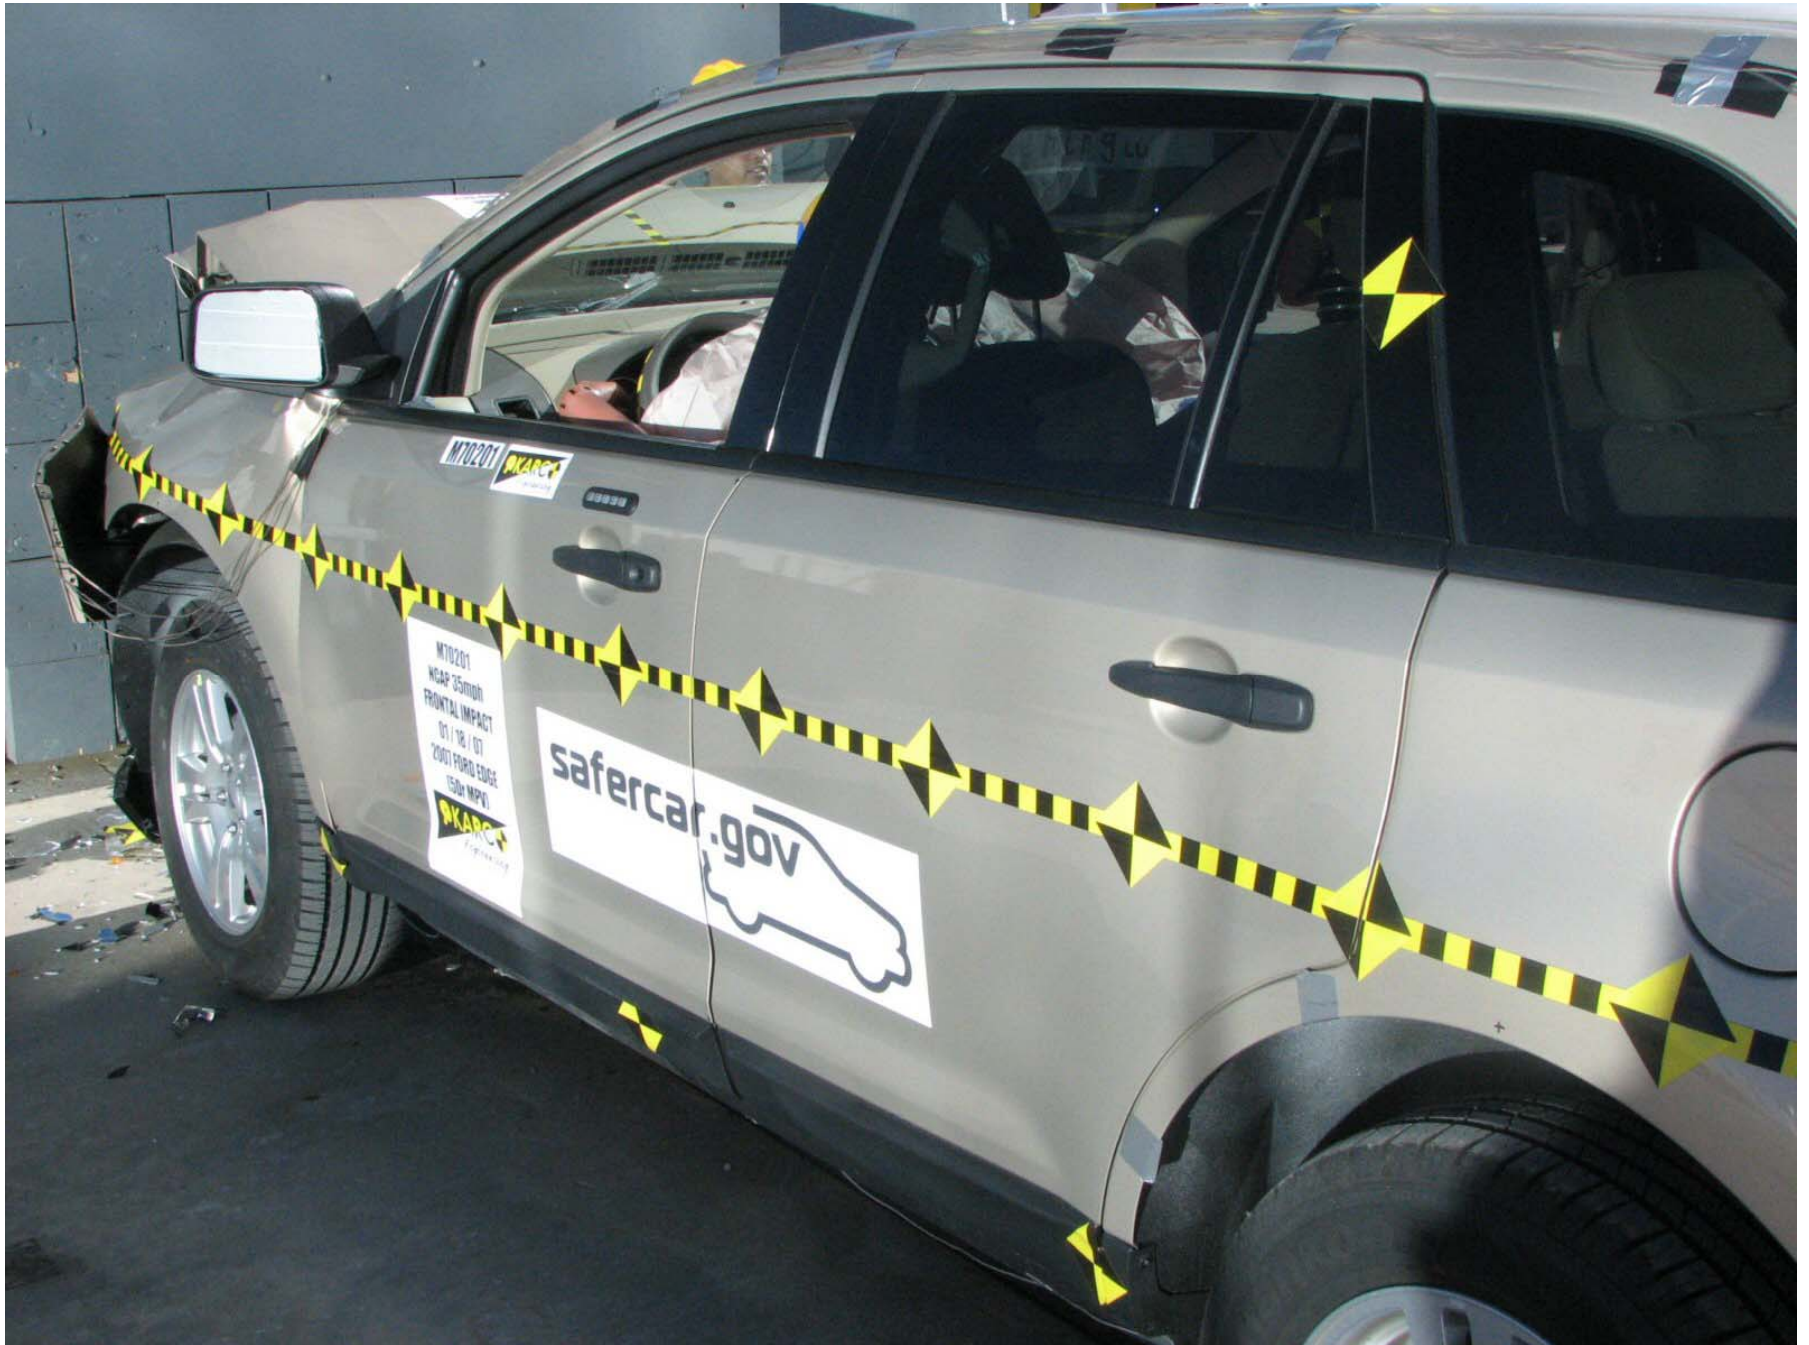
Figure A-16: Post-Test Left Side  $\frac{3}{4}$  View of Doors After Impact

The maximum static crush of the vehicle was 432 mm at the vehicle's centerline and both the driver and the passenger side doors remained closed and latched during the impact event and were operable after the impact.

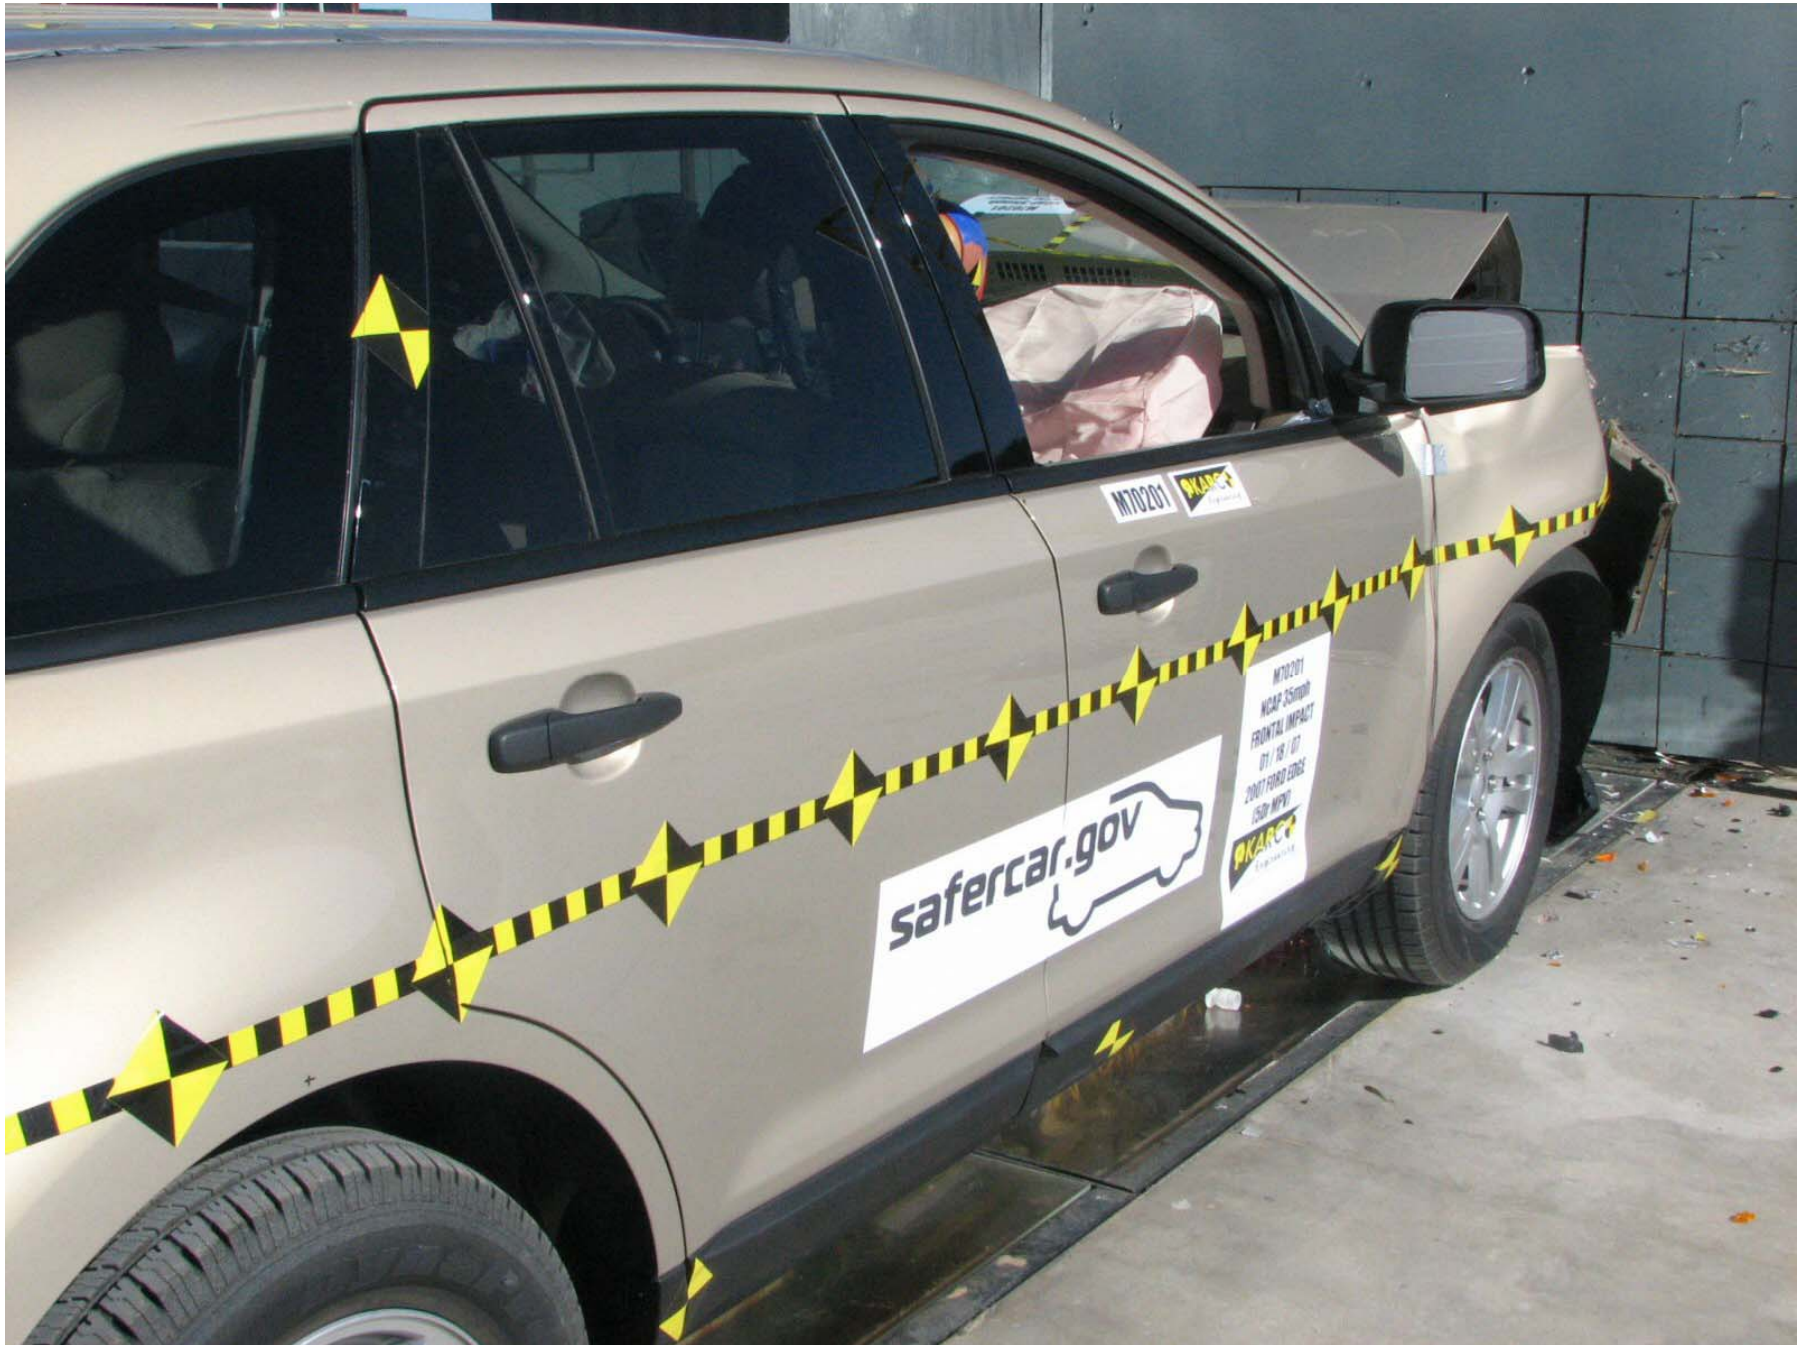
Figure A-17: Post-Test Right Side  $\frac{3}{4}$  View of Doors After Impact

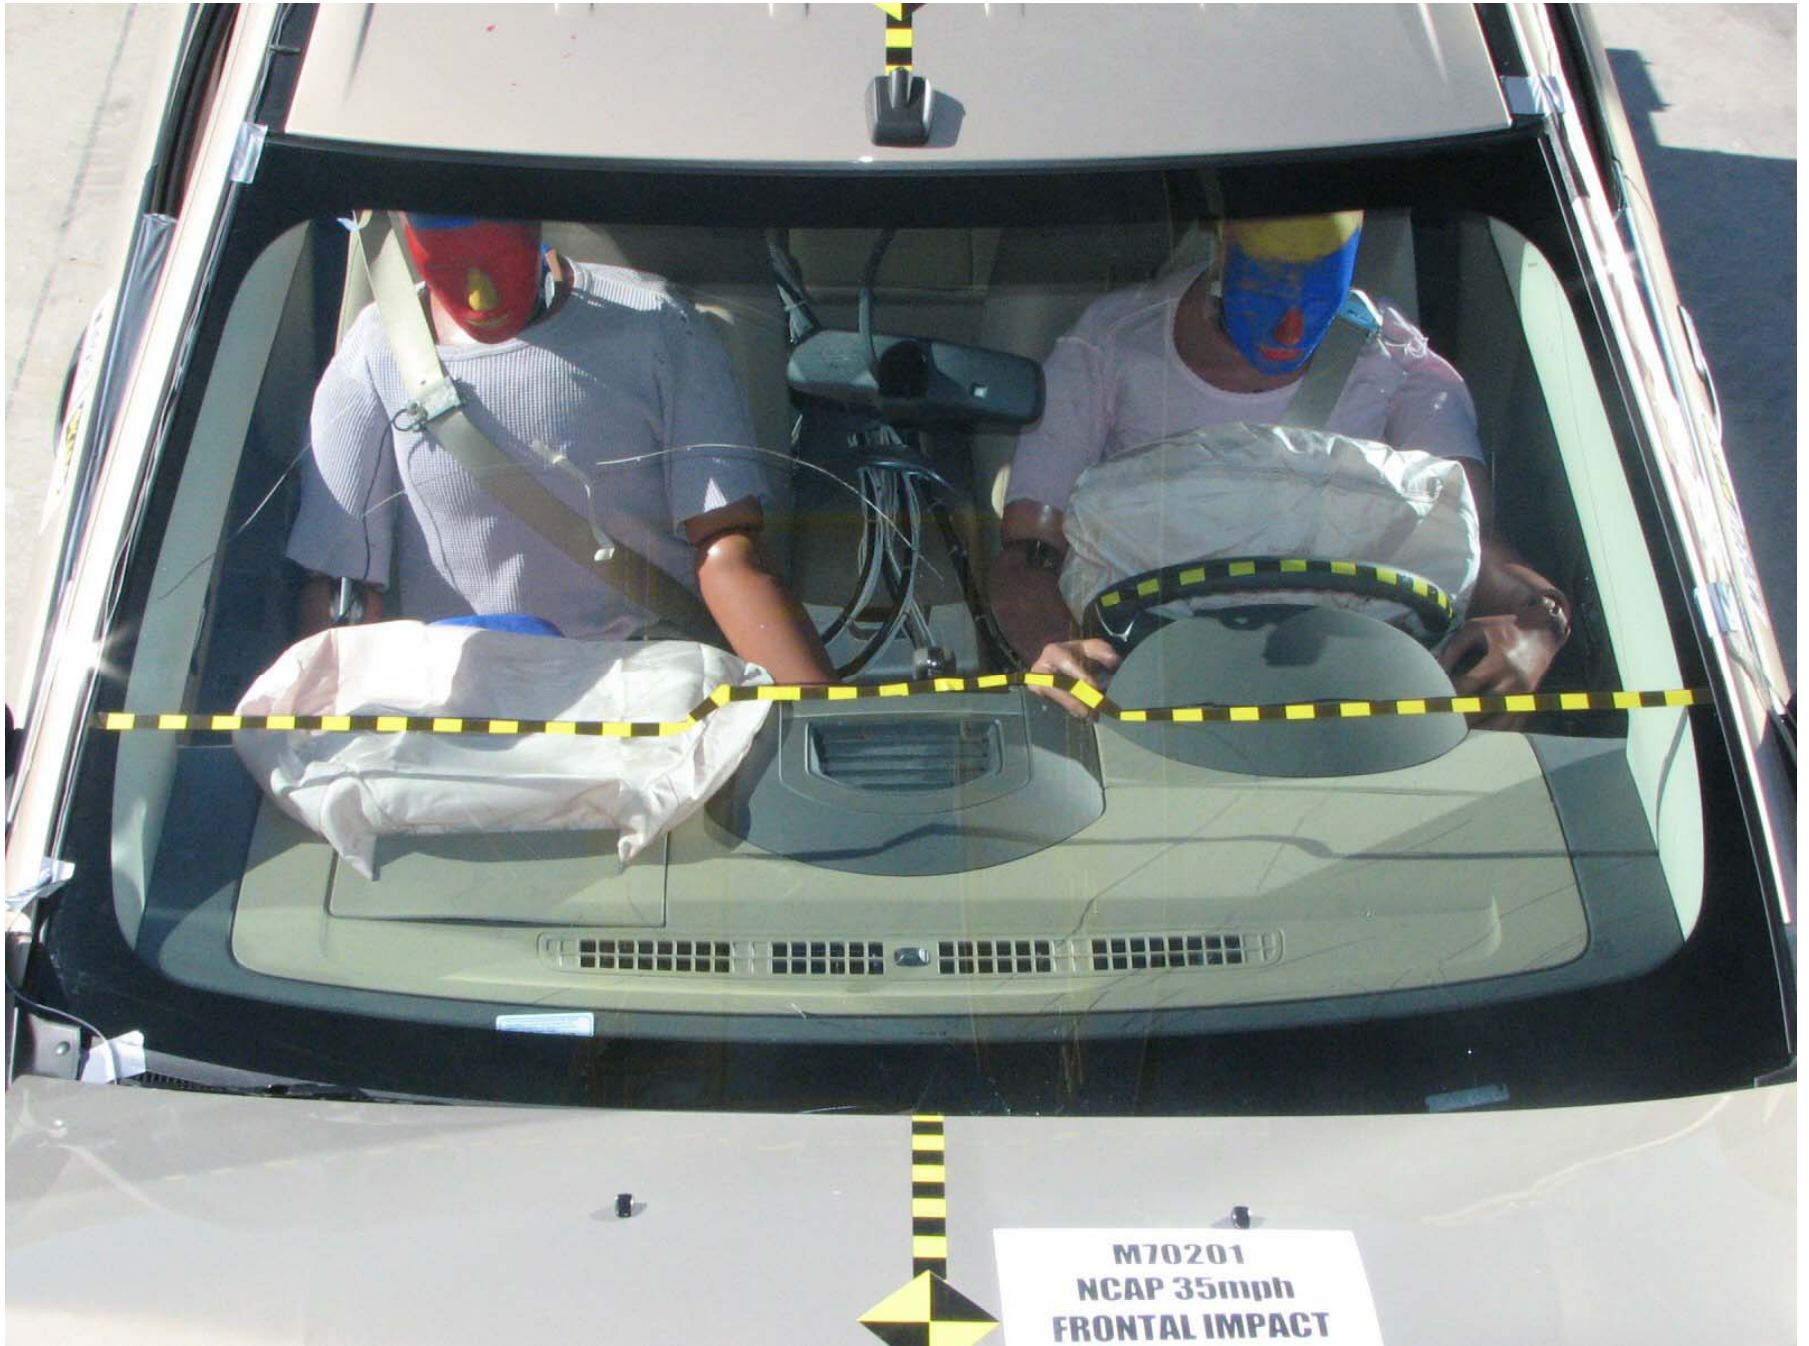
Figure A-19: Post-Test Windshield

There was 100 percent windshield retention and there was no intrusion into the protected zone of the windshield during the impact event. There was no stoddard solvent leakage after the event or during any phase of the static rollover.

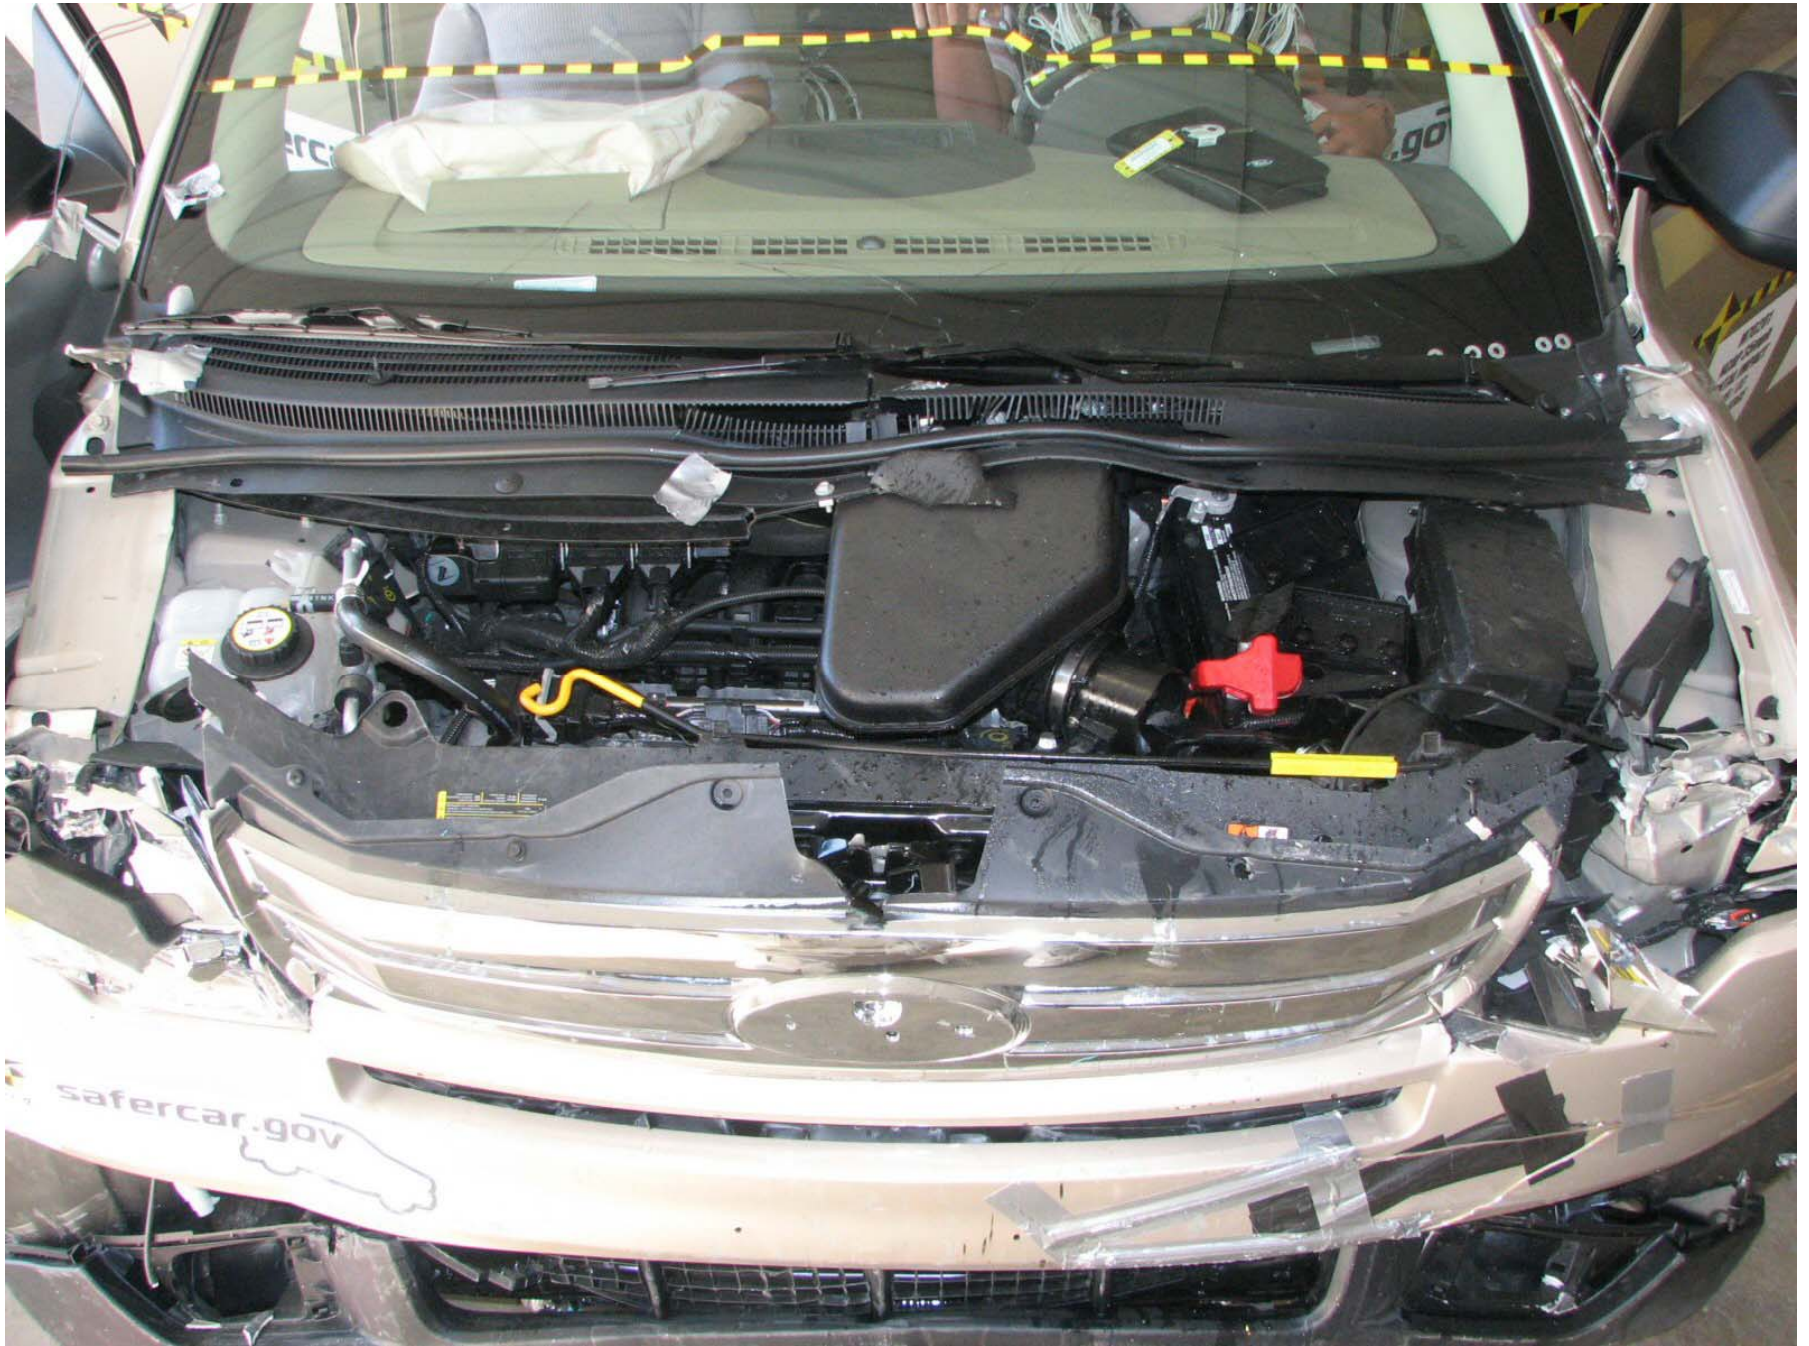
Figure A-21: Post-Test Engine Compartment (Vehicle Moved)

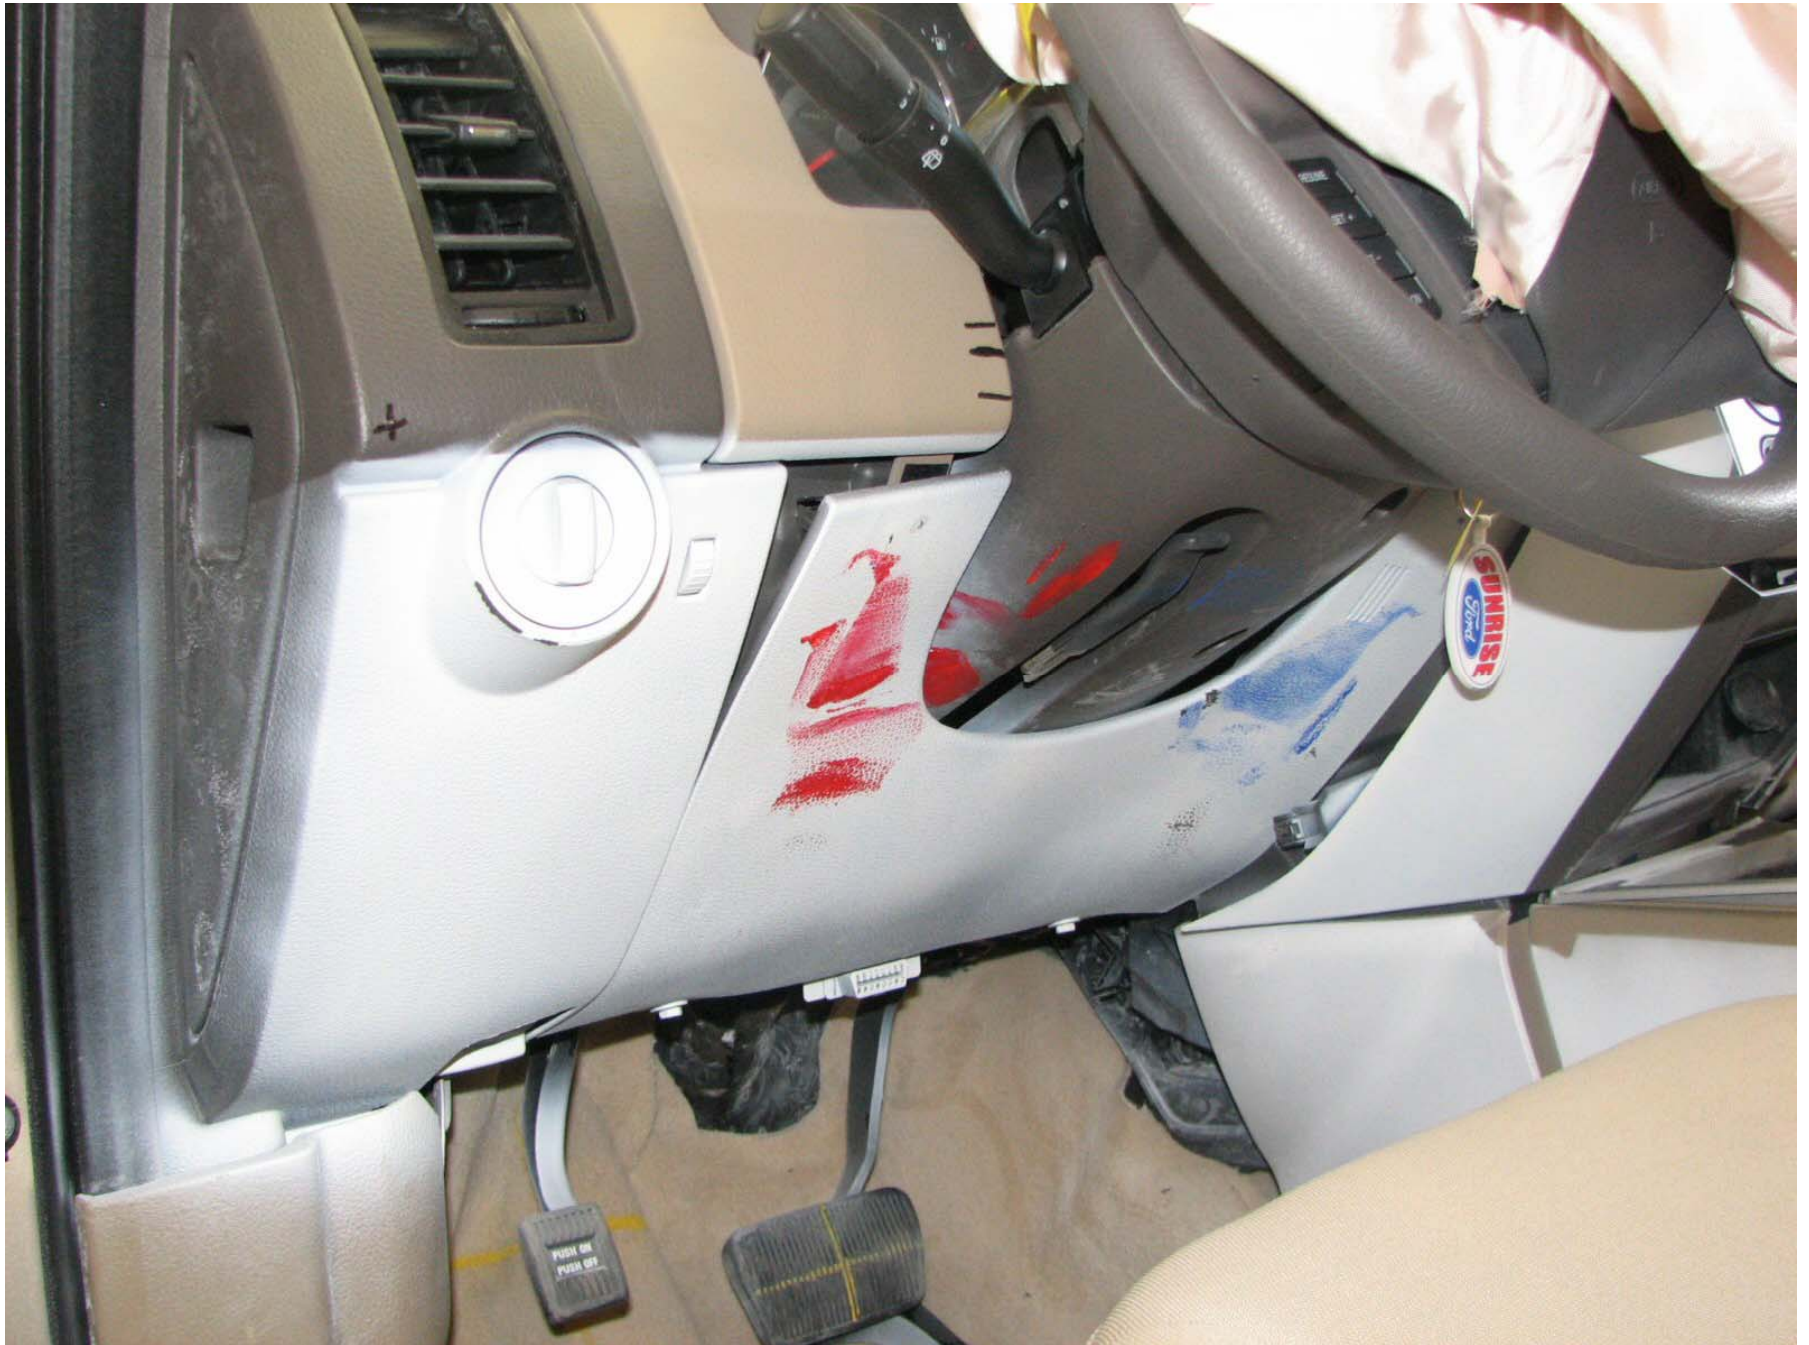
Figure A-39: Post-Test Driver Side Knee Bolster

The driver's visible contact points were as follows: The driver ATD's head and chest contacted the airbag and the abdomen had no contact. Both knees contacted the knee bolster.

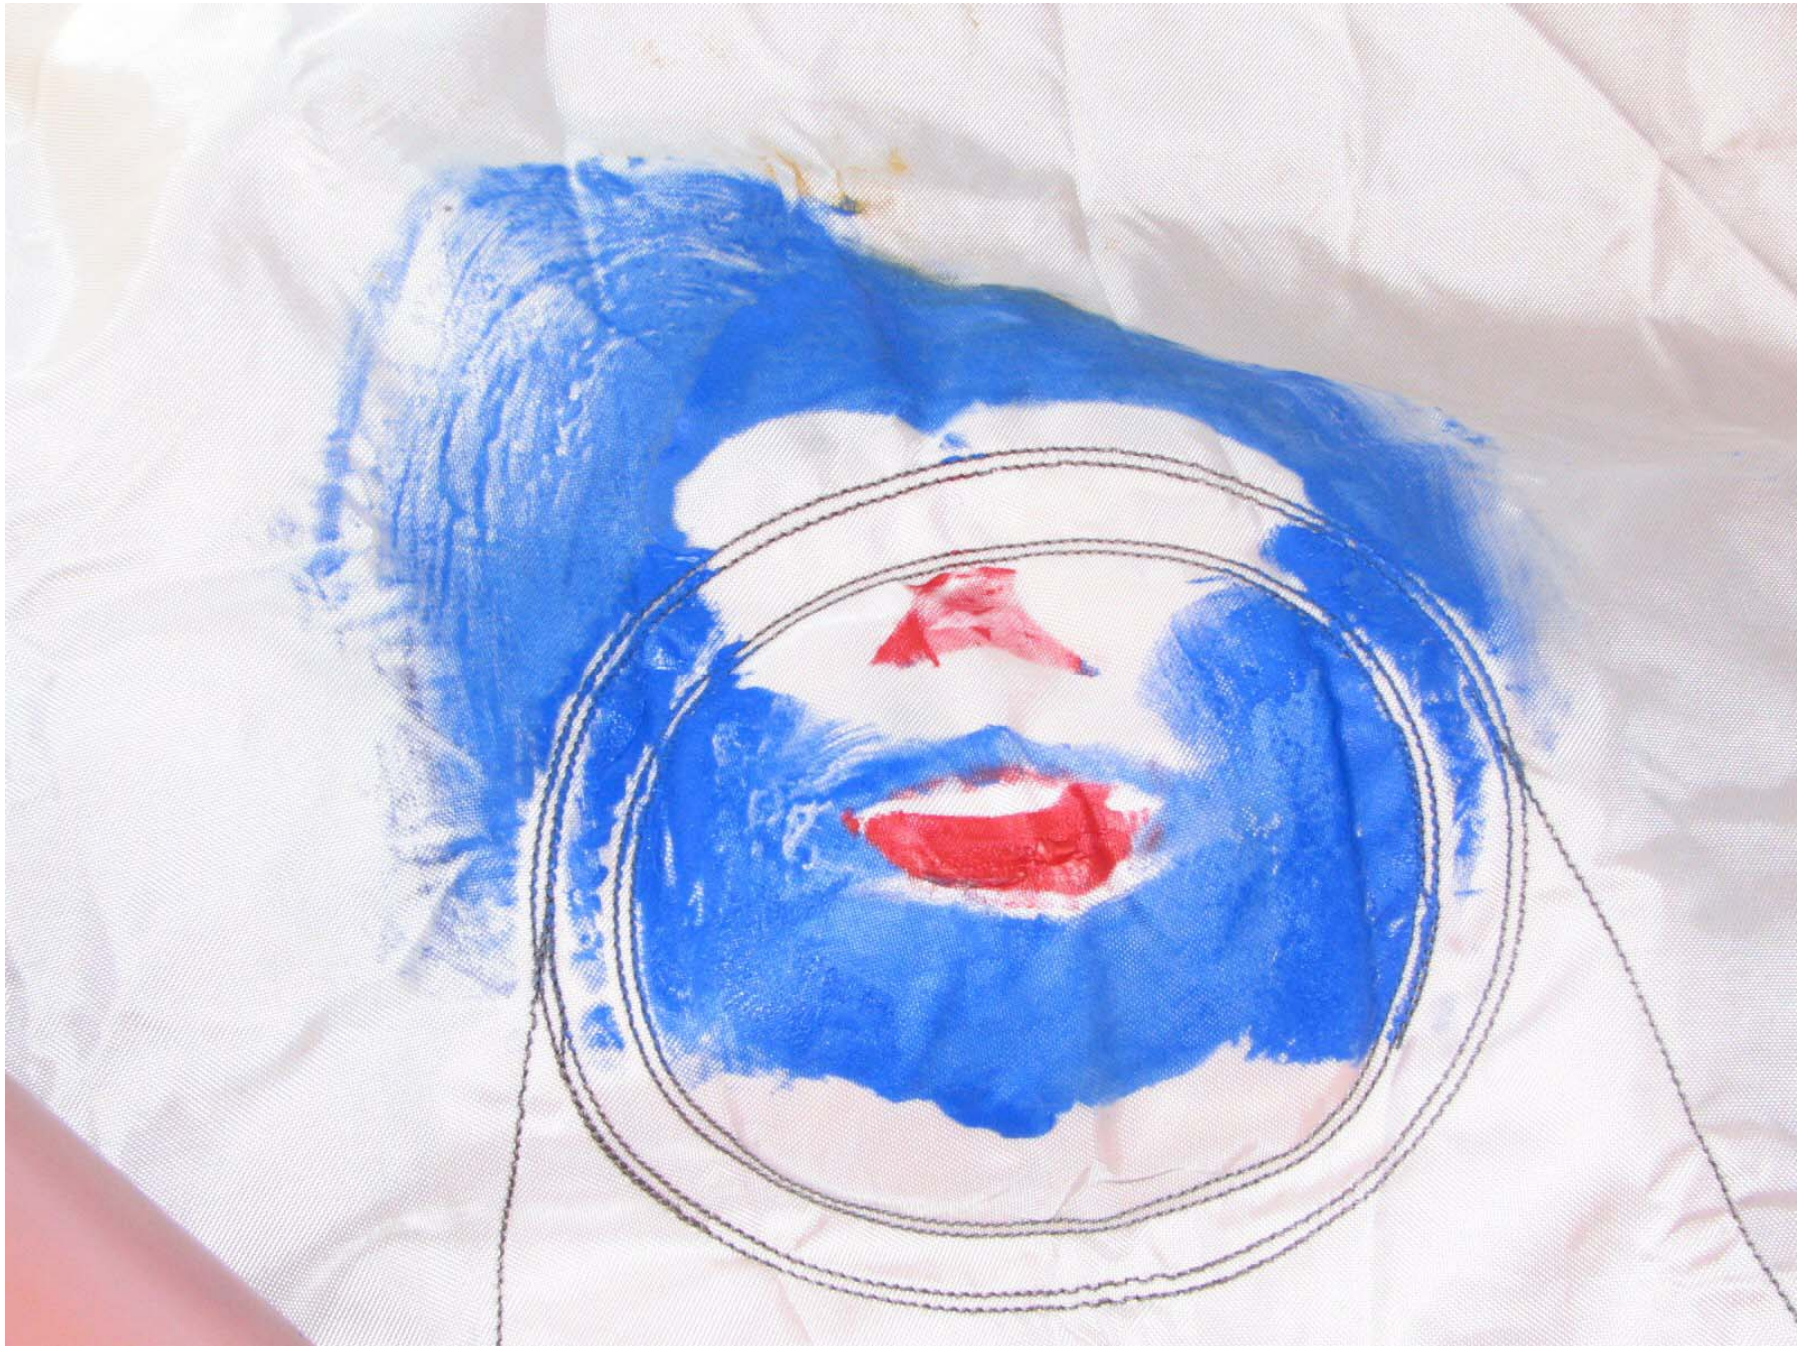
Figure A-43: Post-Test Driver Dummy Airbag Contact

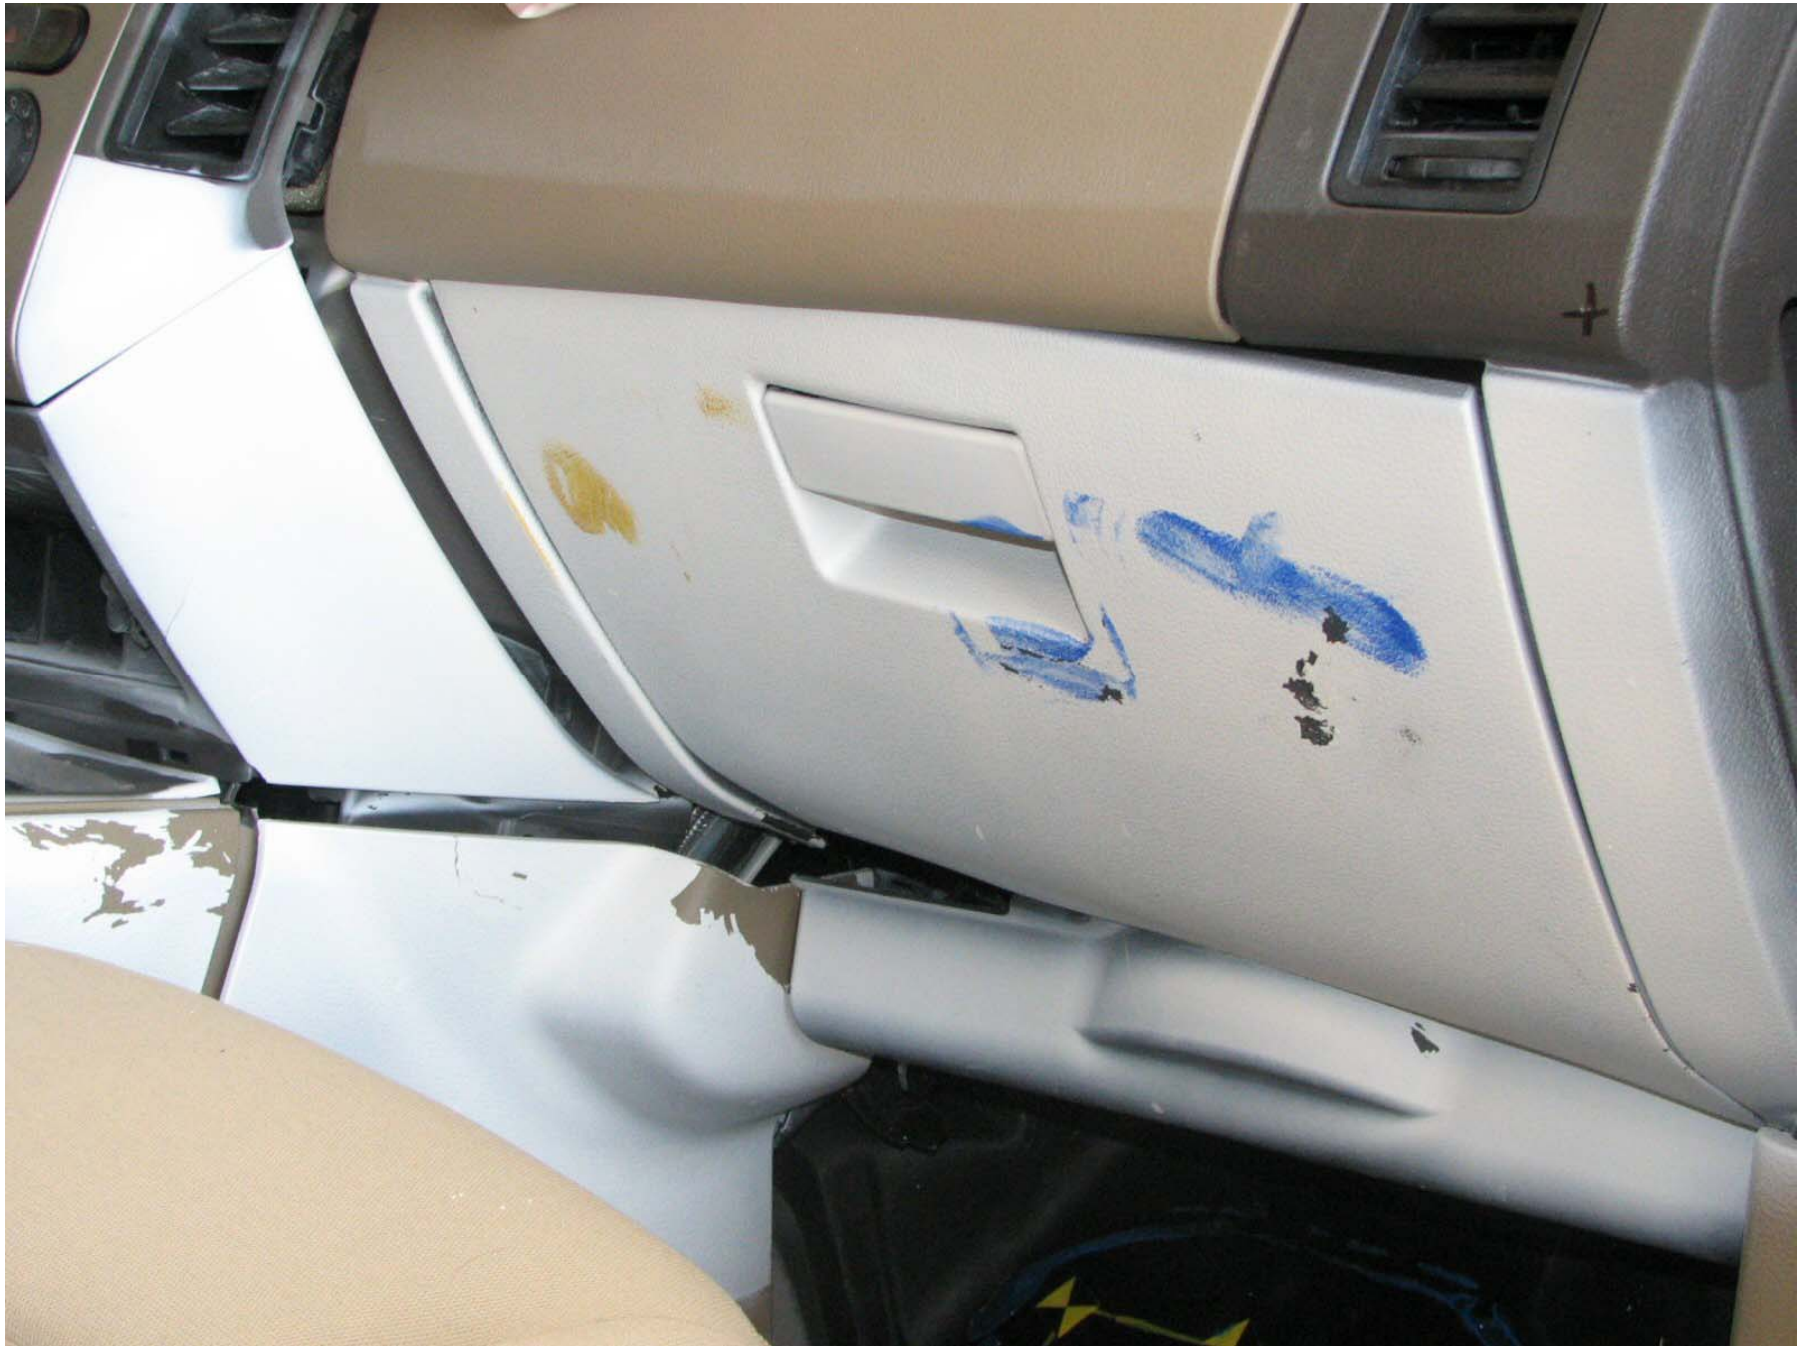
Figure A-53: Post-Test Passenger Side Glove Box

The passenger's visible contact points were as follows: The passenger ATD's head, chest and abdomen contacted the airbag. Both knees contacted the glove box.

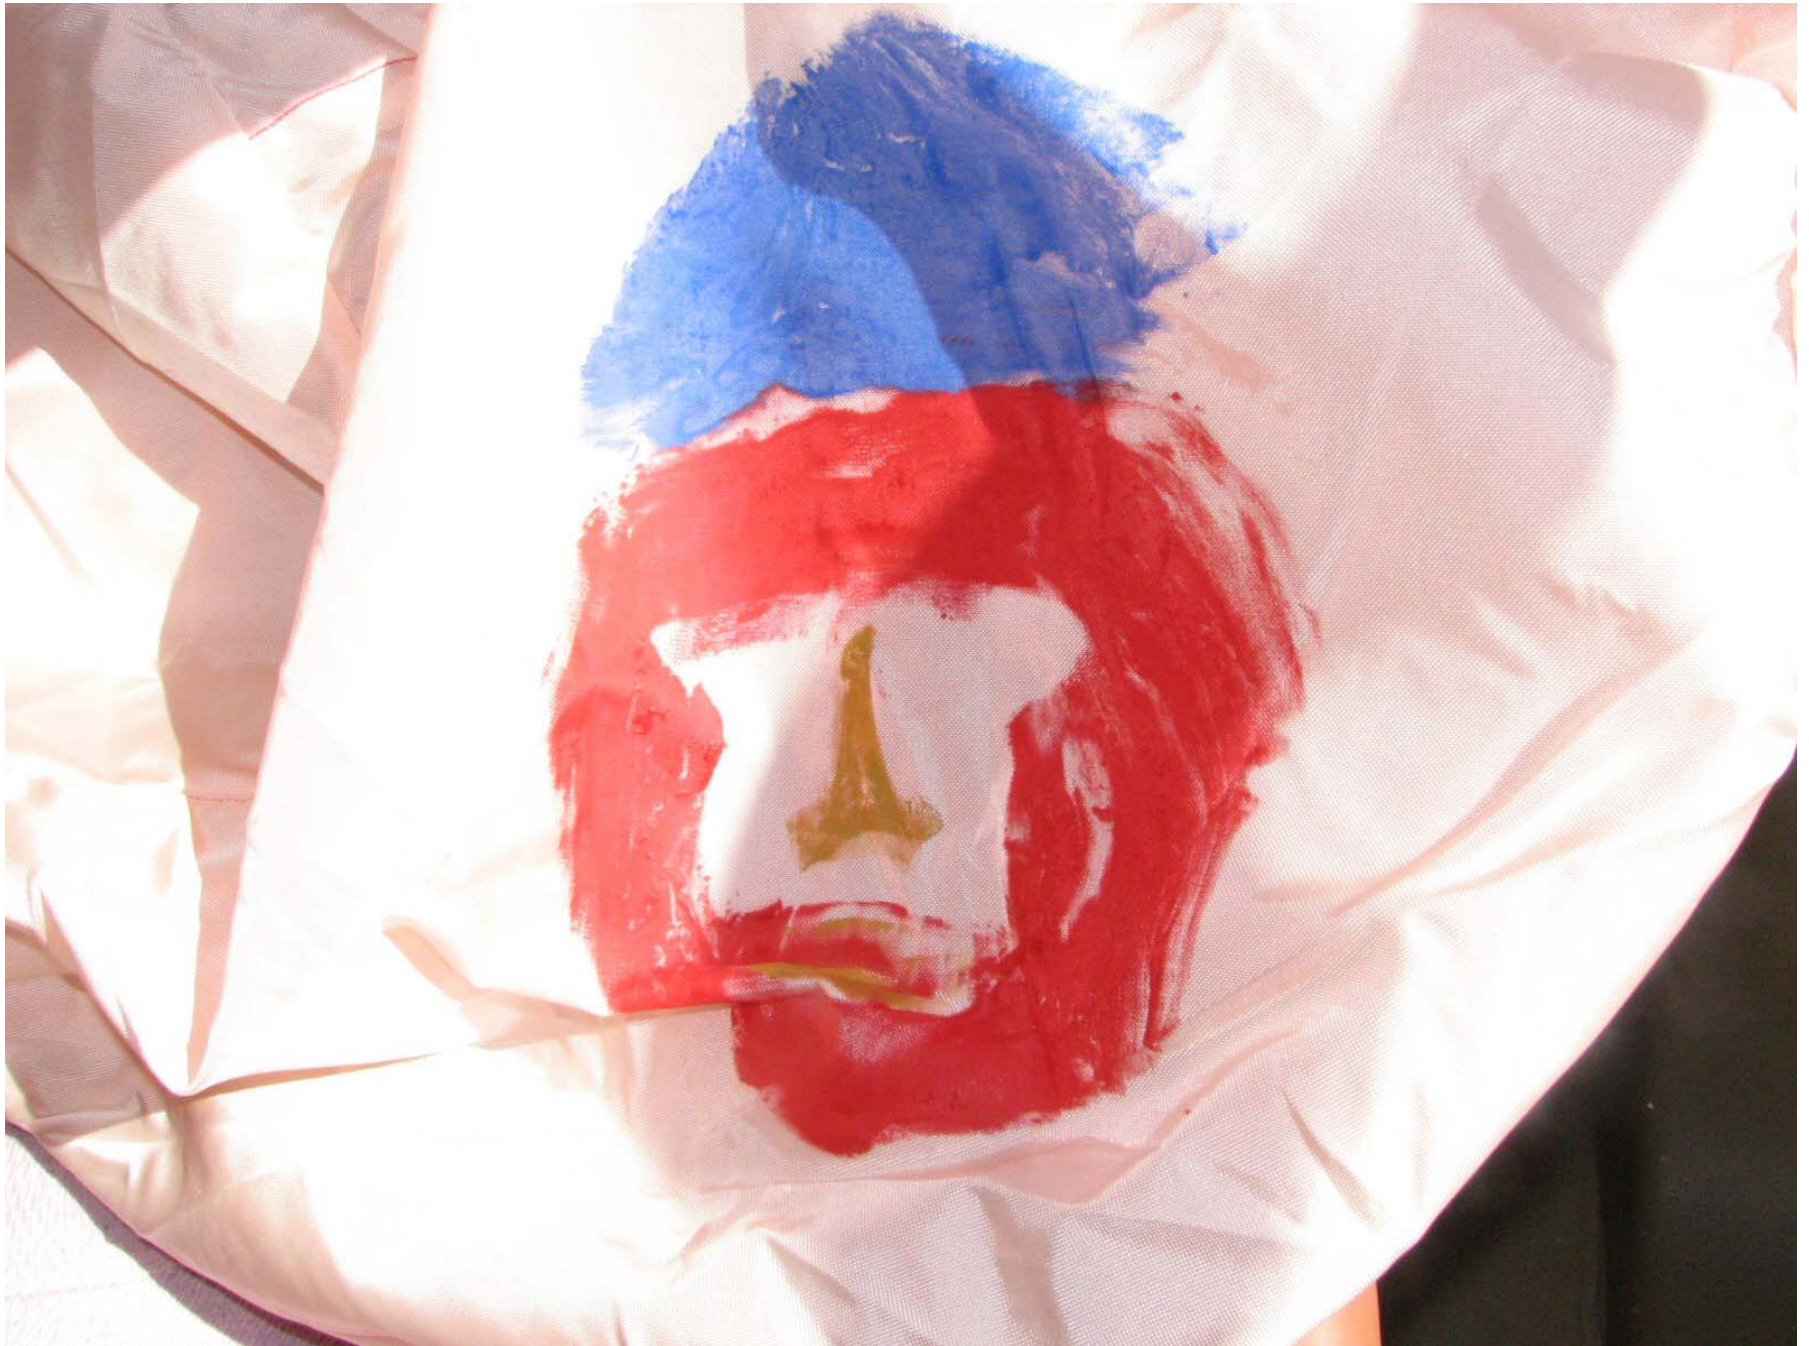
Figure A-57: Post-Test Passenger Dummy Airbag Contact
