**NEW CAR ASSESSMENT PROGRAM  
FRONTAL BARRIER IMPACT TEST**

**FORD MOTOR COMPANY  
2007 FORD EDGE SE AWD  
5-DOOR MPV**

**NHTSA NUMBER: M70201**

**FINAL REPORT**

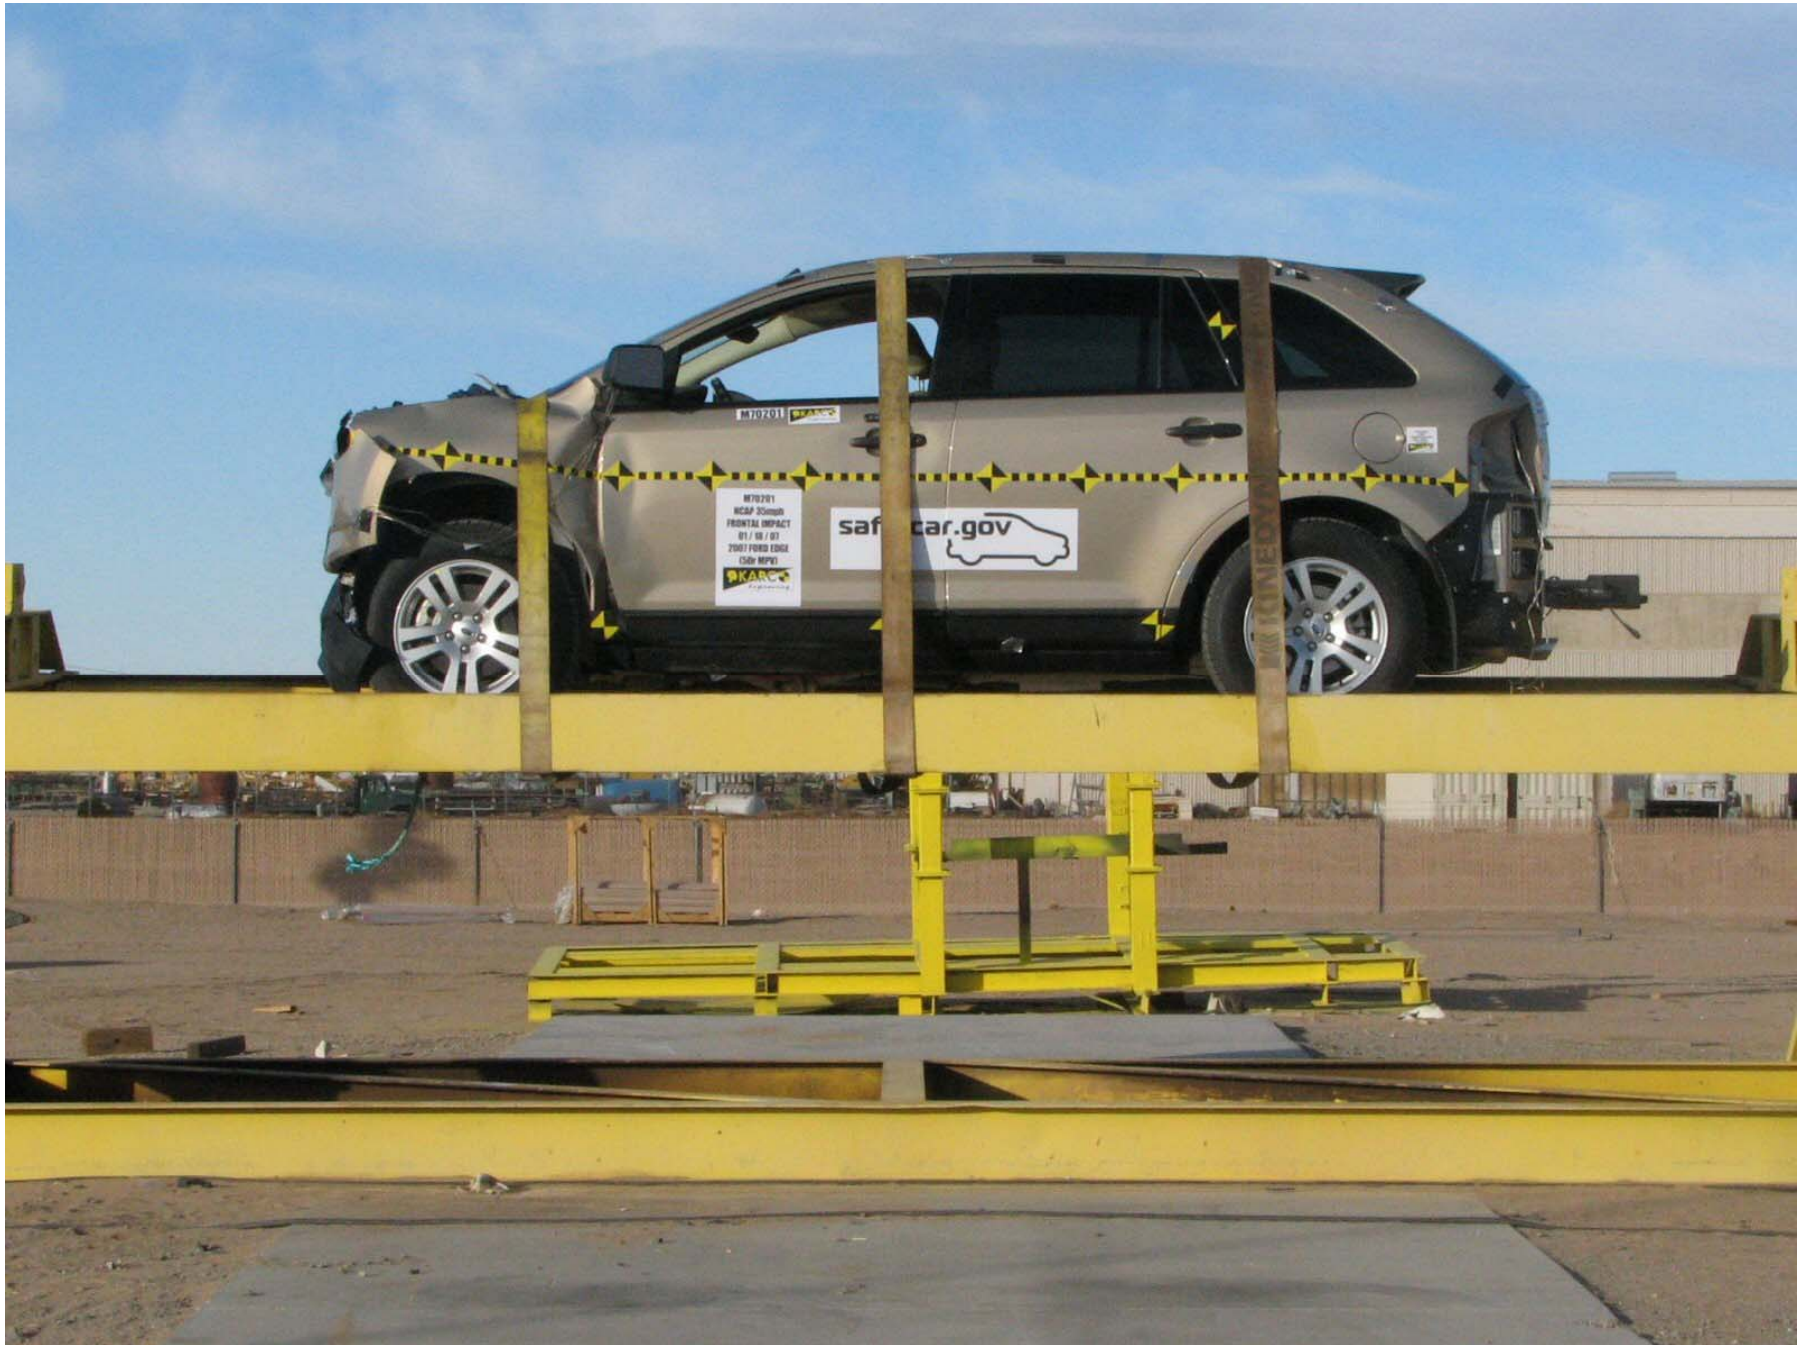
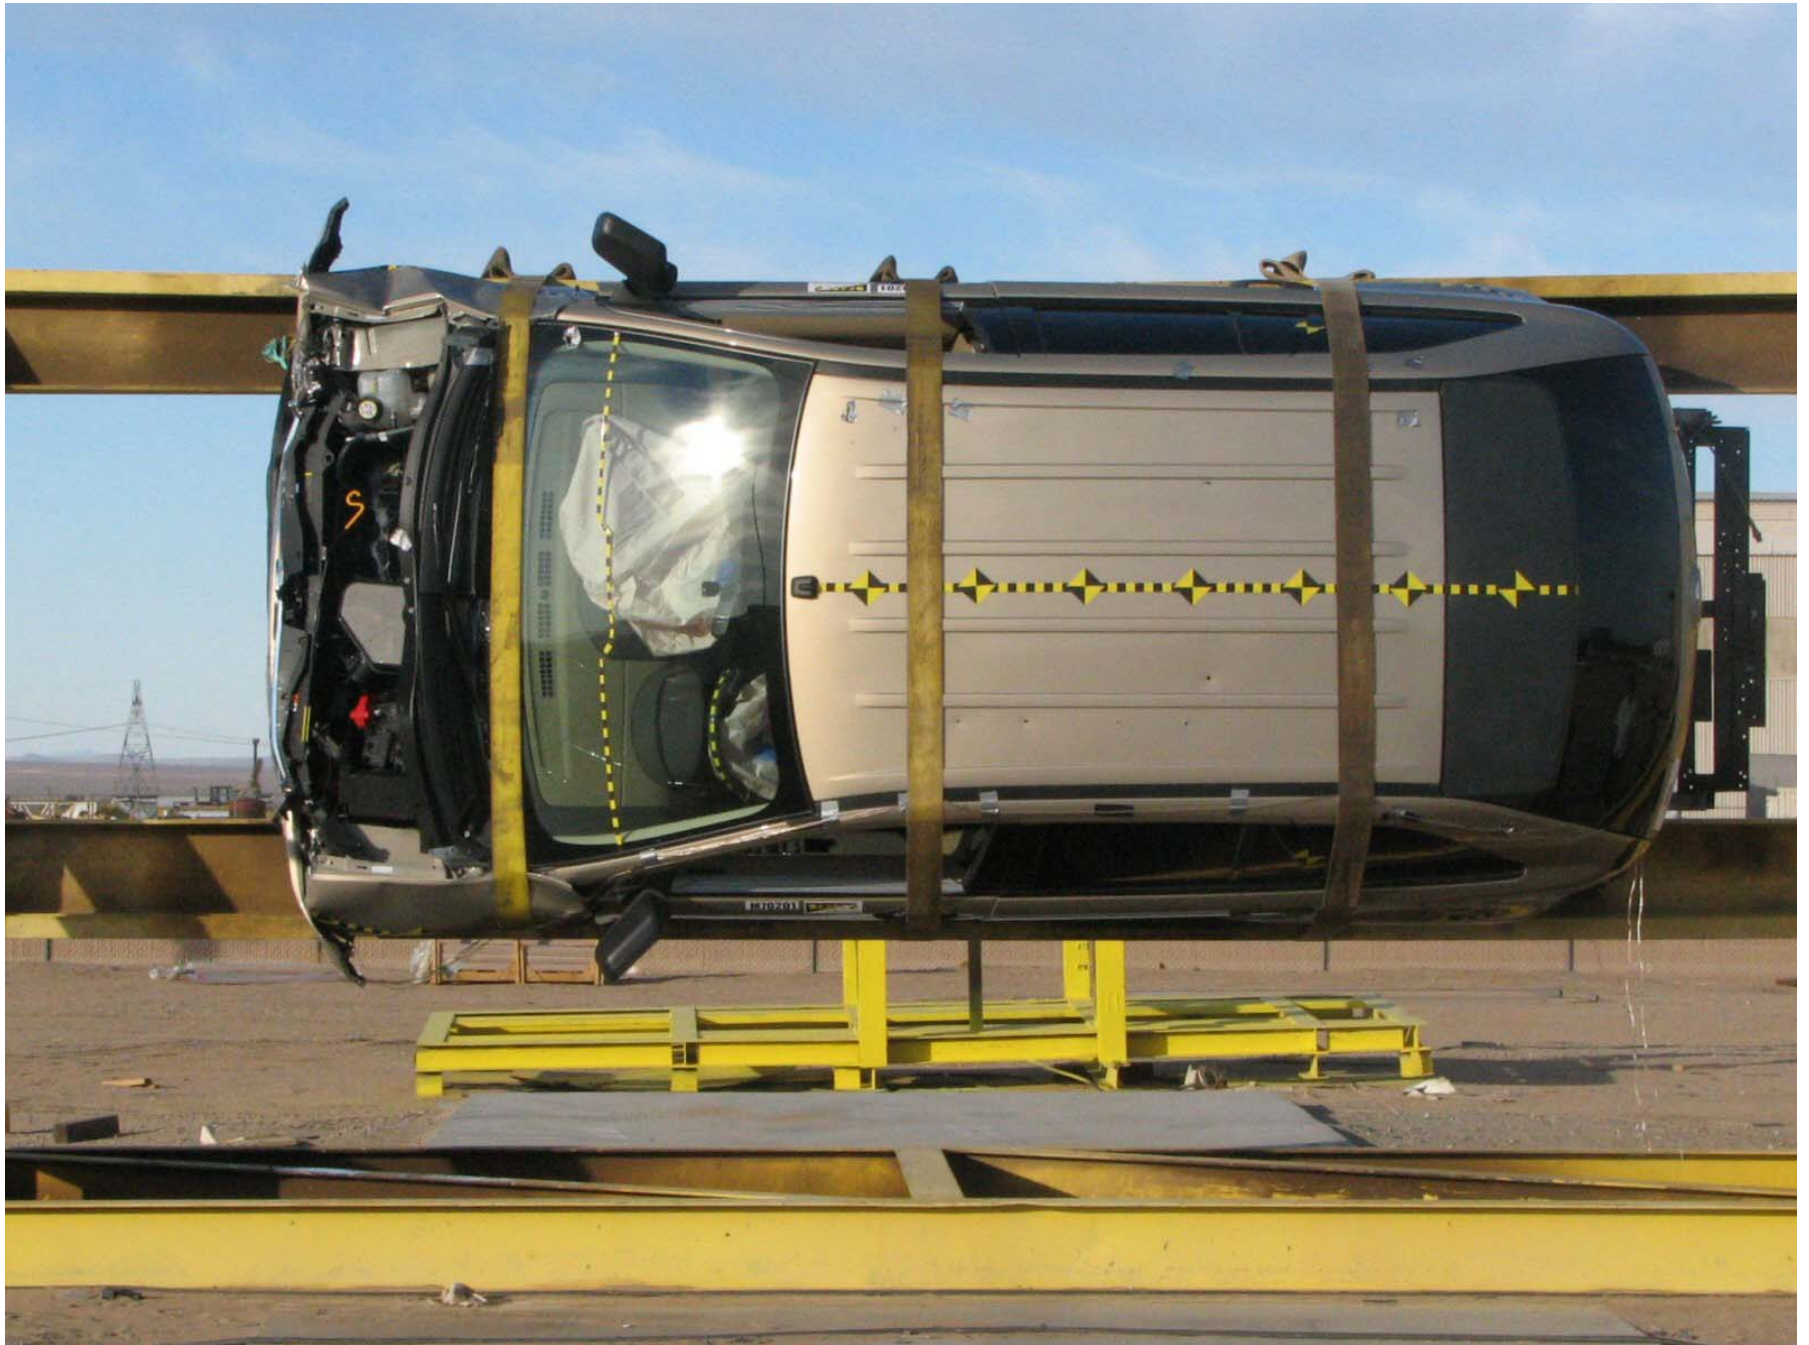
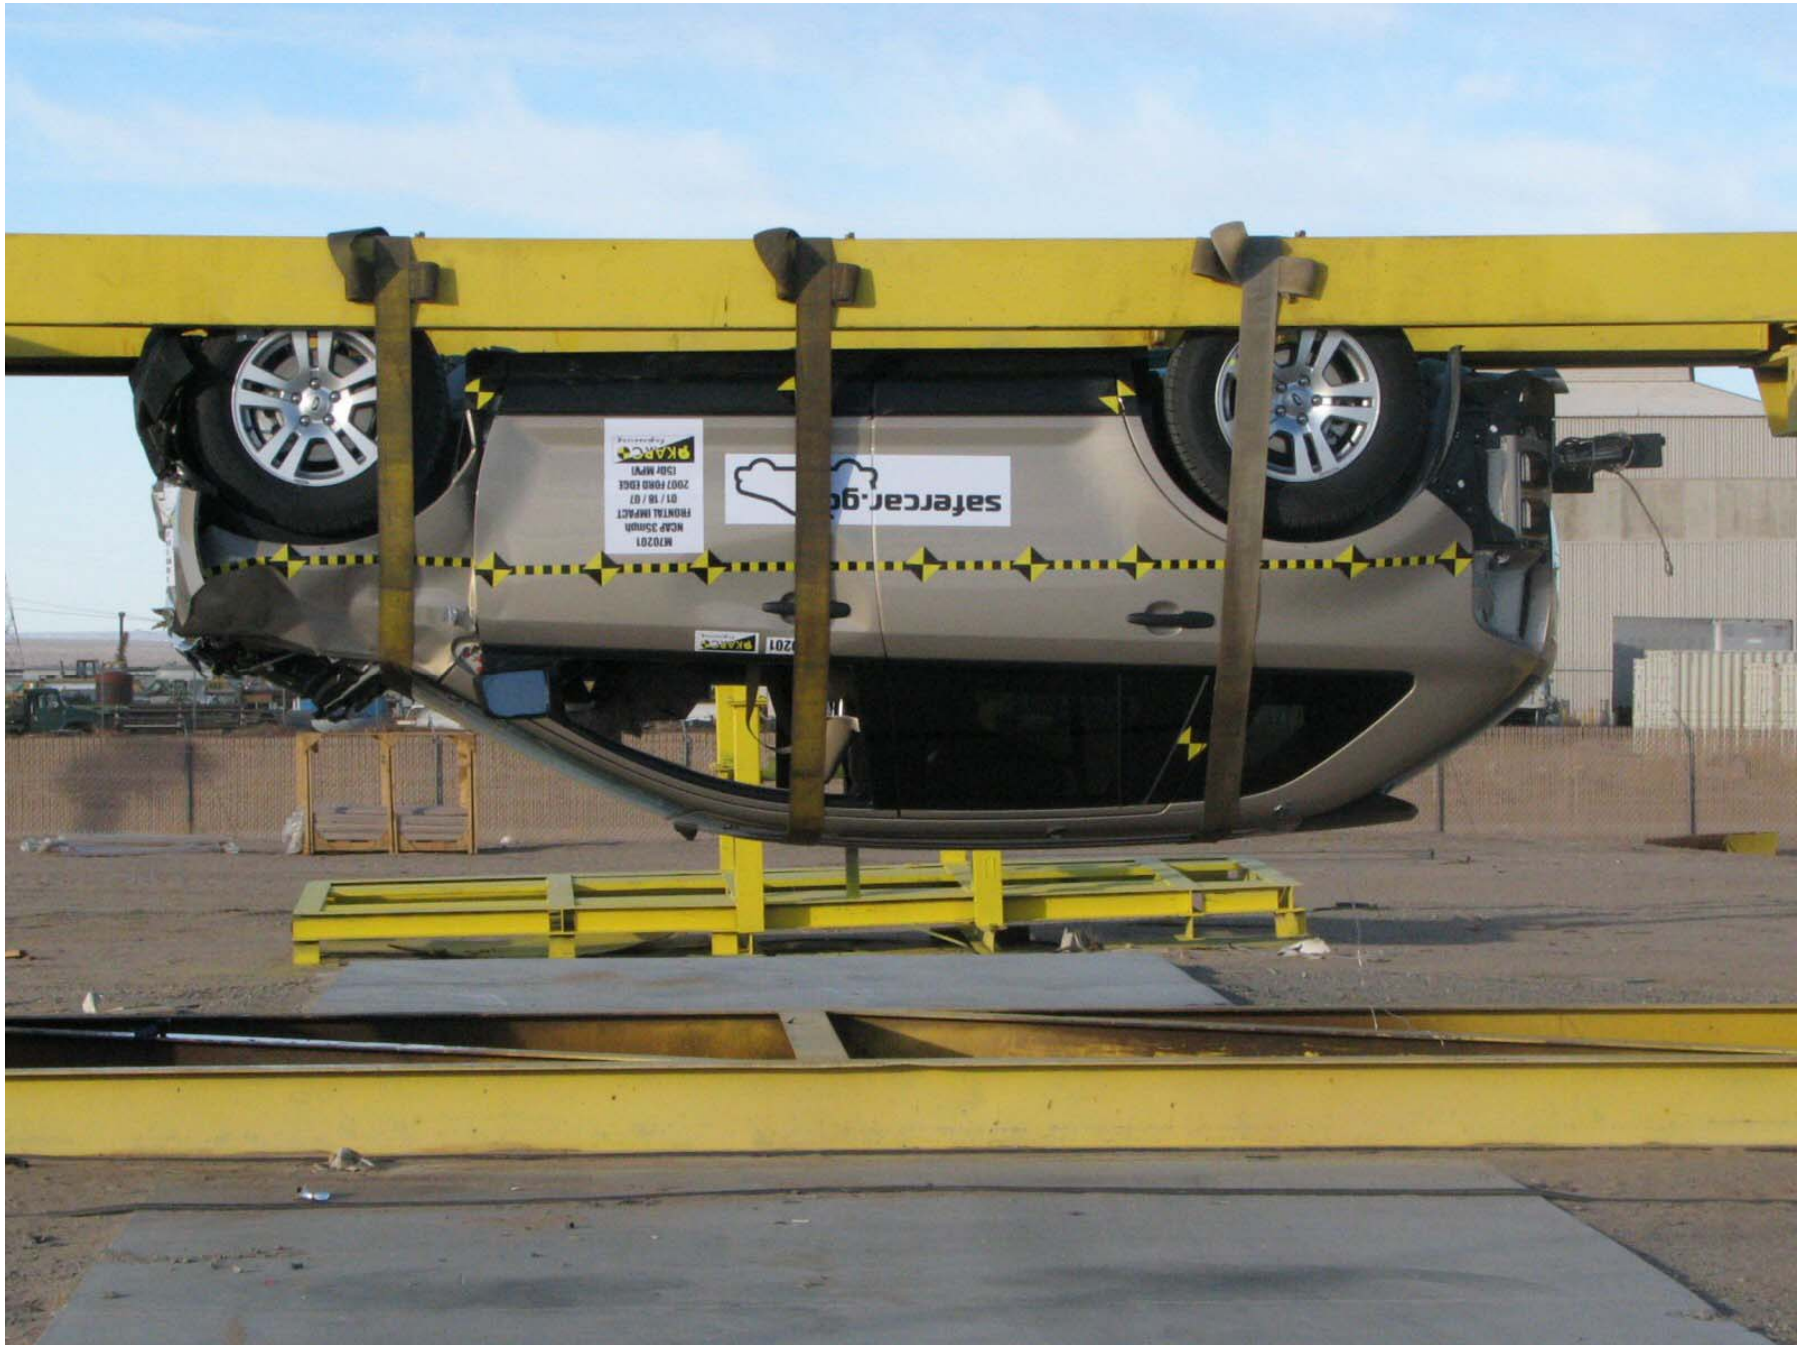
Figure A-58: Vehicle on Rollover Device (0°)

Figure A-59: Vehicle on Rollover Device (90°)

Figure A-60: Vehicle on Rollover Device (180°)

Figure A-61: Vehicle on Rollover Device (270°)

1. The specified fixture rollover rate for each 90° of rotation is 60 to 120 seconds.
2. The position hold time at each position is 300 seconds (minimum).
3. No solvent leakage occurred during rollover.

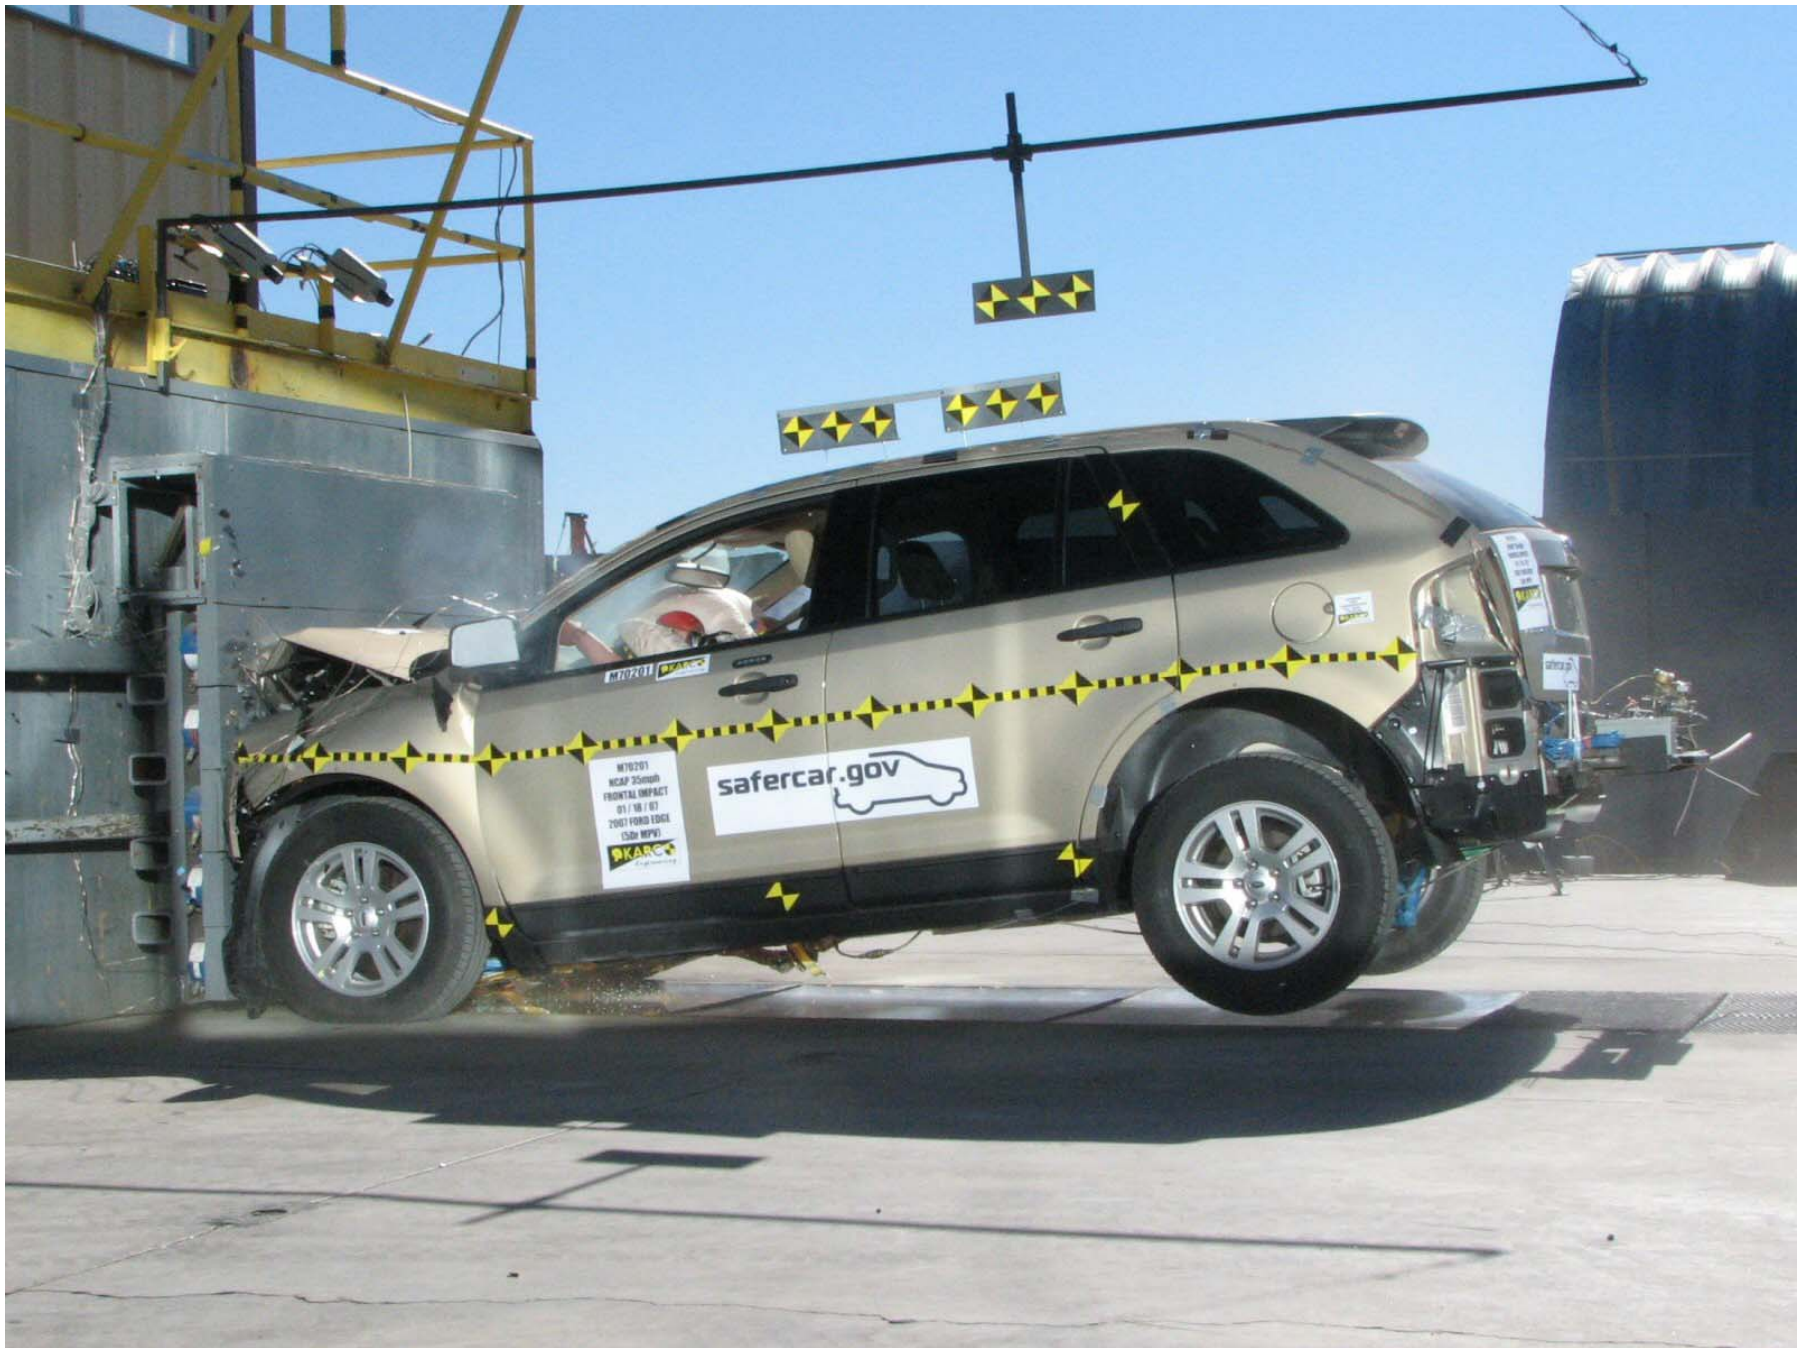
Figure A-62: Vehicle Impact

A load cell barrier consisting of 45 load cells was impacted by a 2007 Ford Edge SE AWD 5-Door MPV at a velocity of 55.94 km/h. The test was performed at Karco Engineering, LLC on January 18, 2007.
