**REPORT NUMBER: SNCAP-CAL-07-07**

**NEW CAR ASSESSMENT PROGRAM  
SIDE IMPACT TEST**

**GENERAL MOTORS CORP.  
2007 SATURN OUTLOOK  
4-DOOR SUV**

**FINAL REPORT**

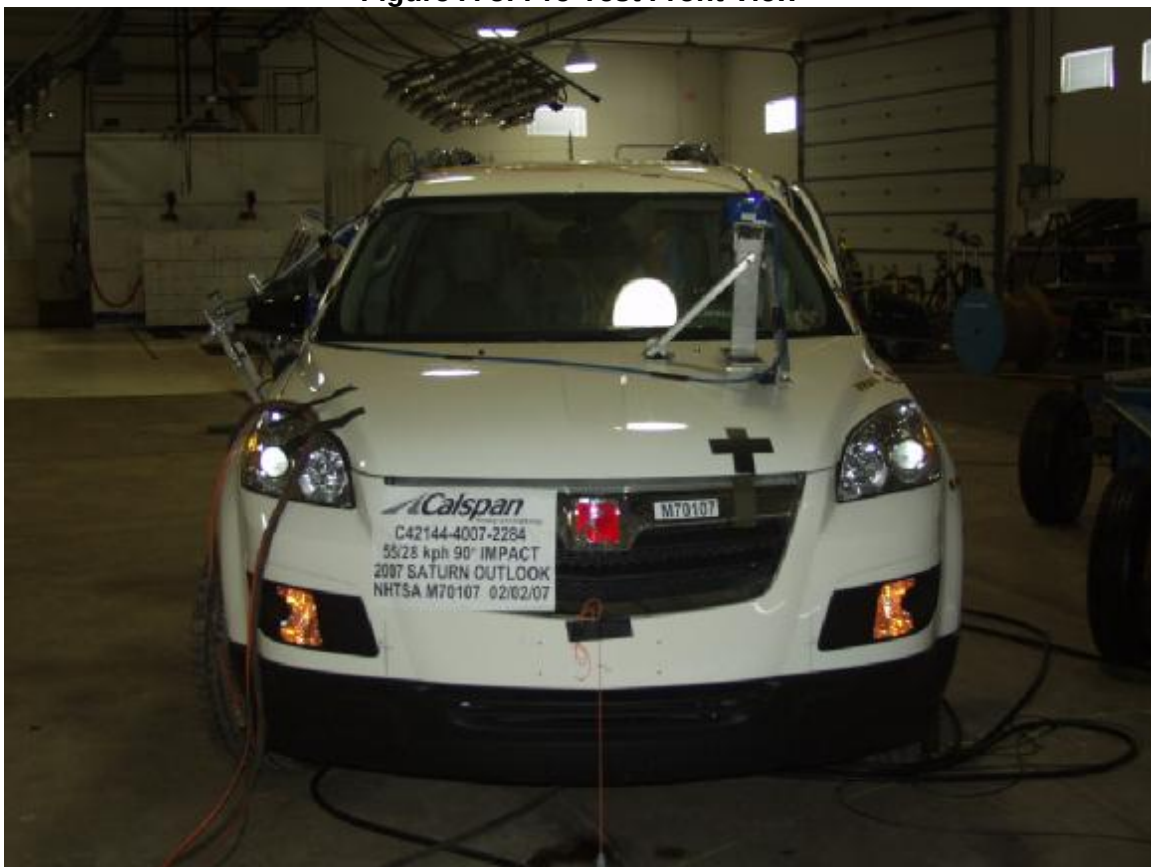
Figure A-6: Post-Test Front View

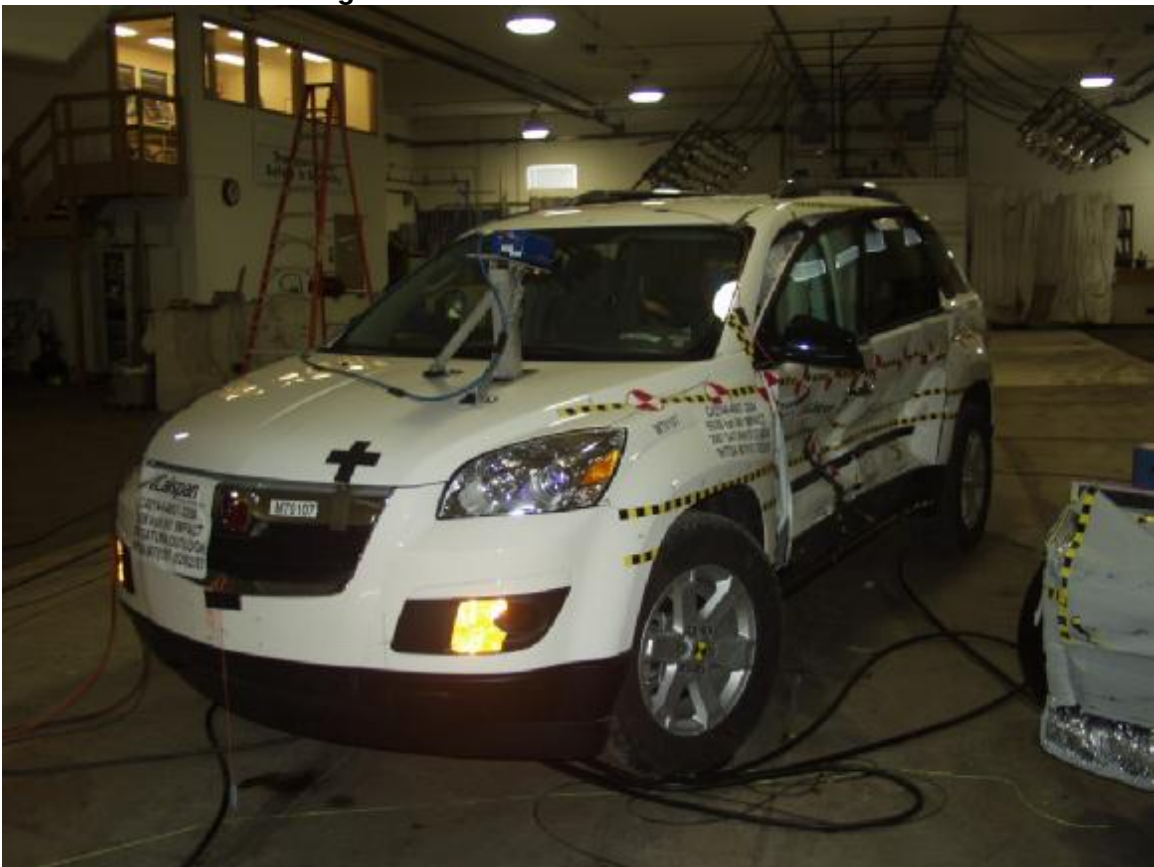
Figure A-8: Post-Test Left Front  $\frac{3}{4}$  View

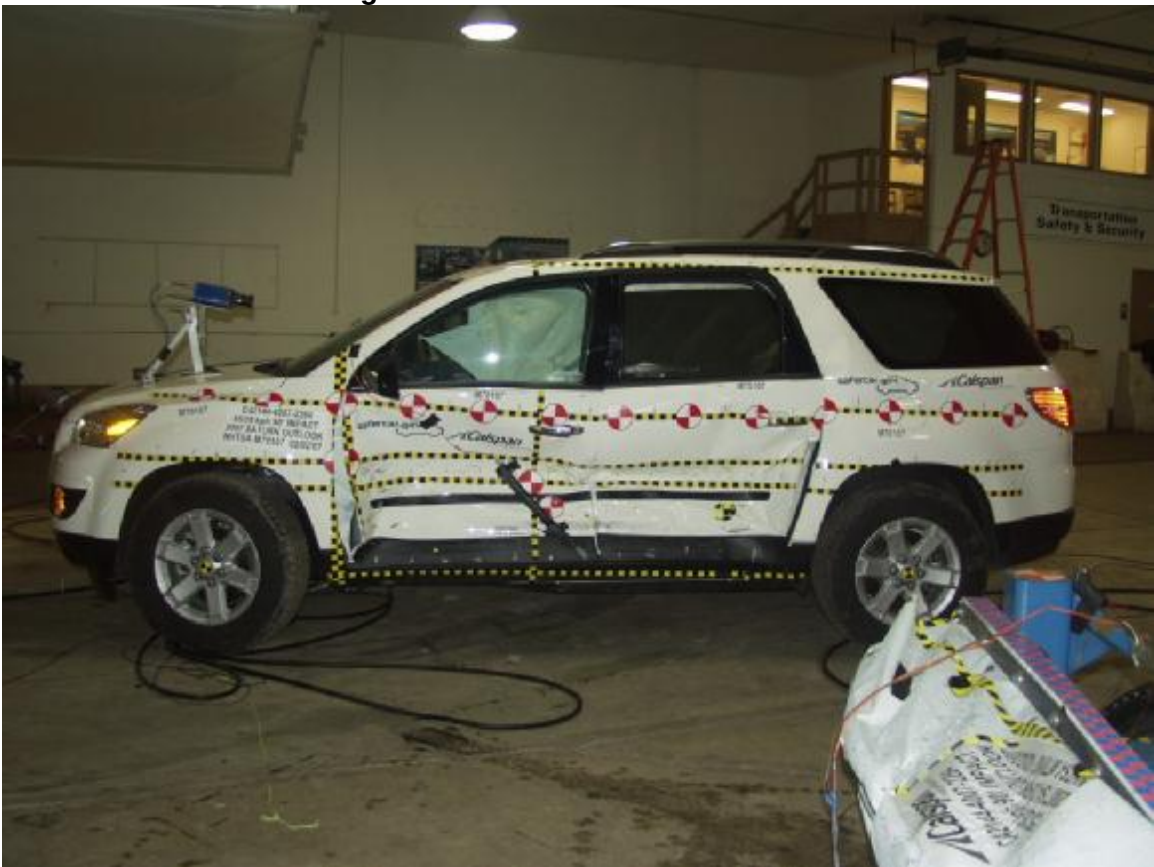
Figure A-10: Post-Test Left Side View

The test vehicle sustained a maximum static crush of 222 mm at level 2, 1500 mm rearward of the left vertical impact point. The driver and passenger SID/HII's, Serial Nos. 906 and 905 respectively, were calibrated just prior to this test.

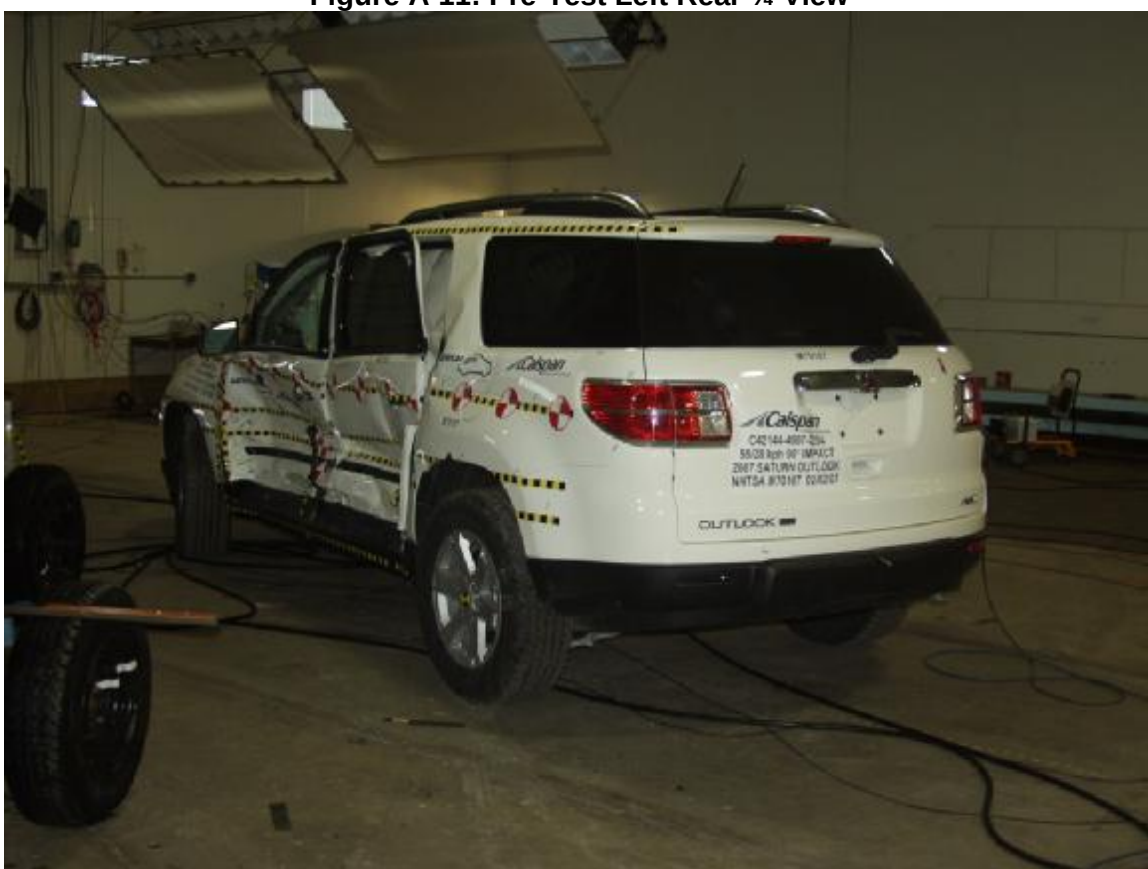
**Figure A-12: Post-Test Left Rear  $\frac{3}{4}$  View**

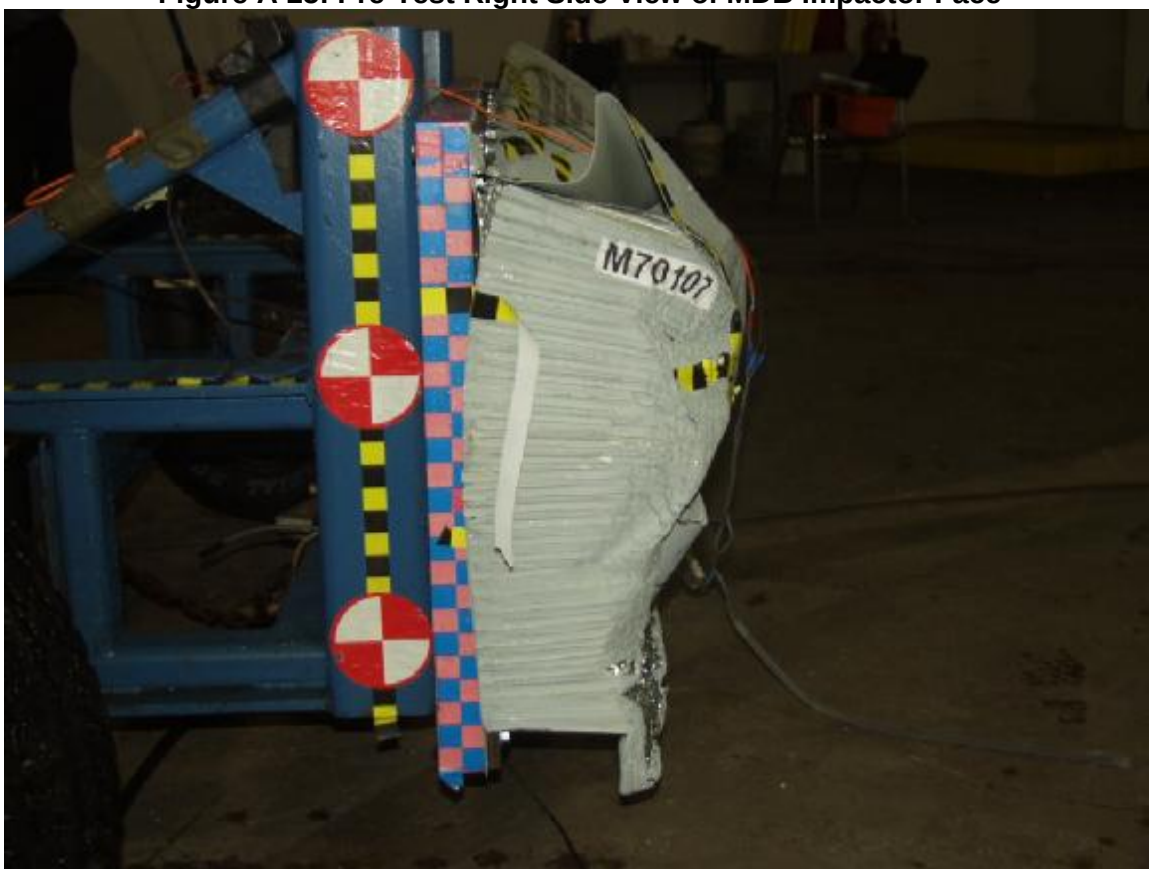
**Figure A-26: Post-Test Right Side View of MDB Impactor Face**

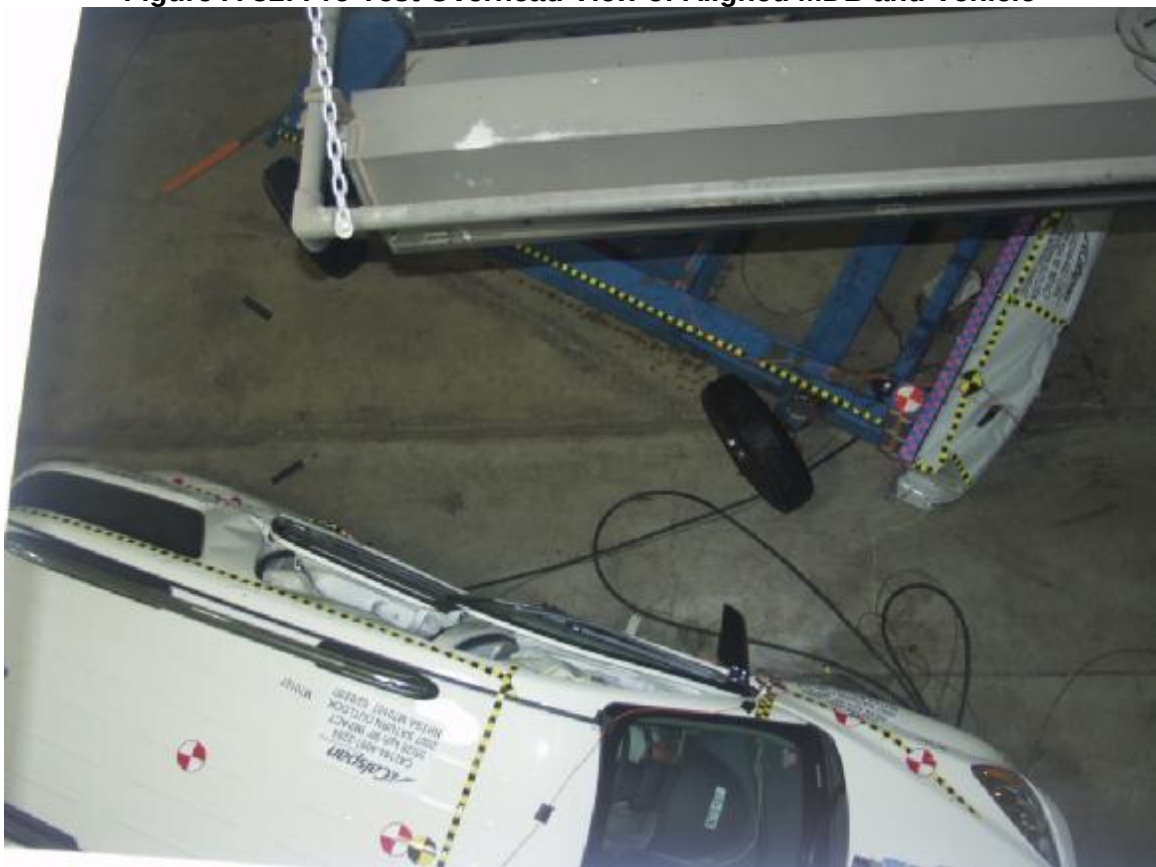
**Figure A-32: Post-Test Overhead View of MDB and Vehicle**

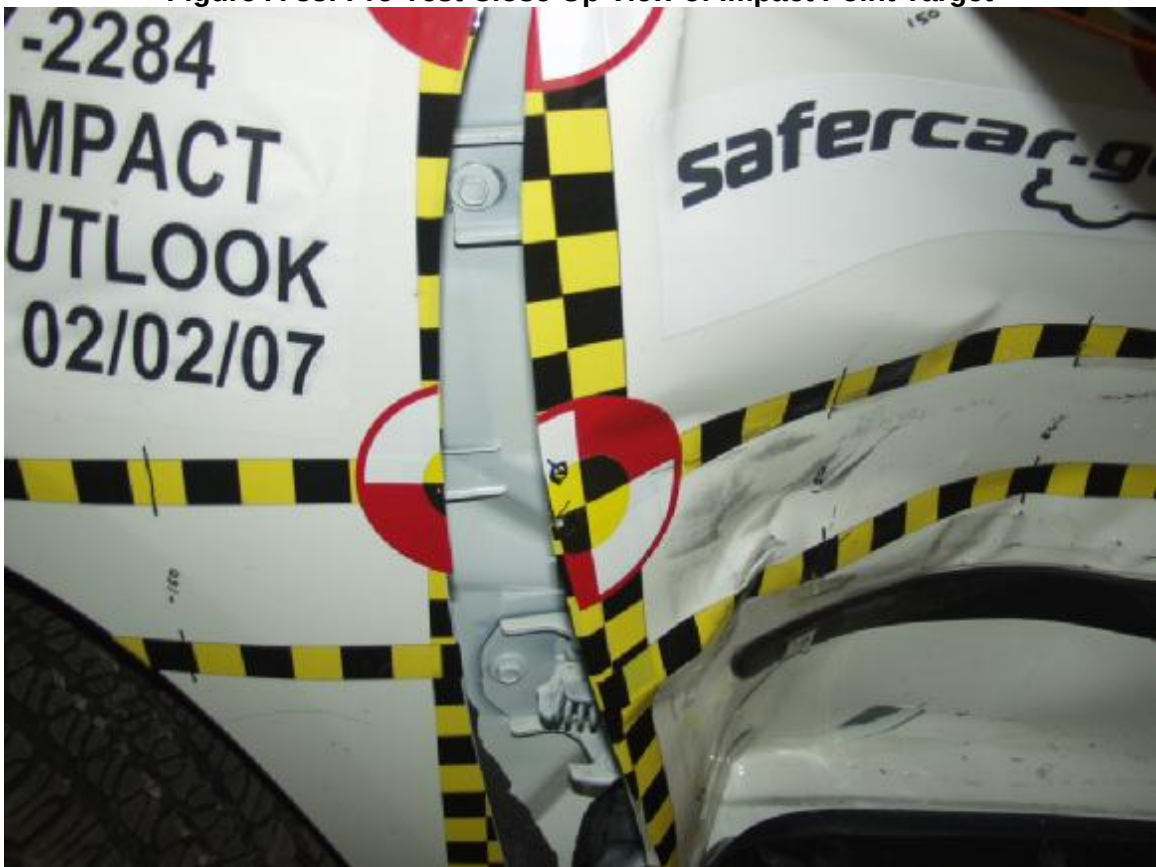
Figure A-34: Post-Test Close-Up View of Impact Point Target

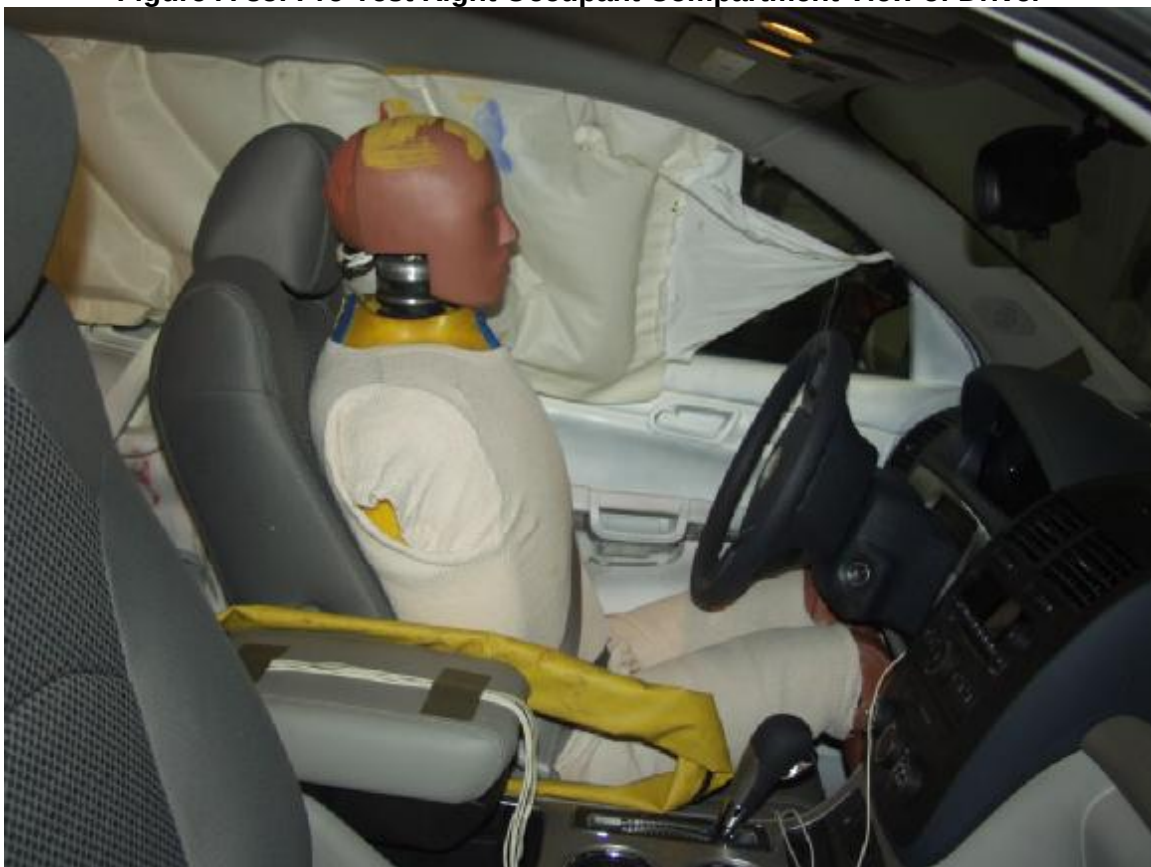
**Figure A-36: Post-Test Right Occupant Compartment View of Driver**

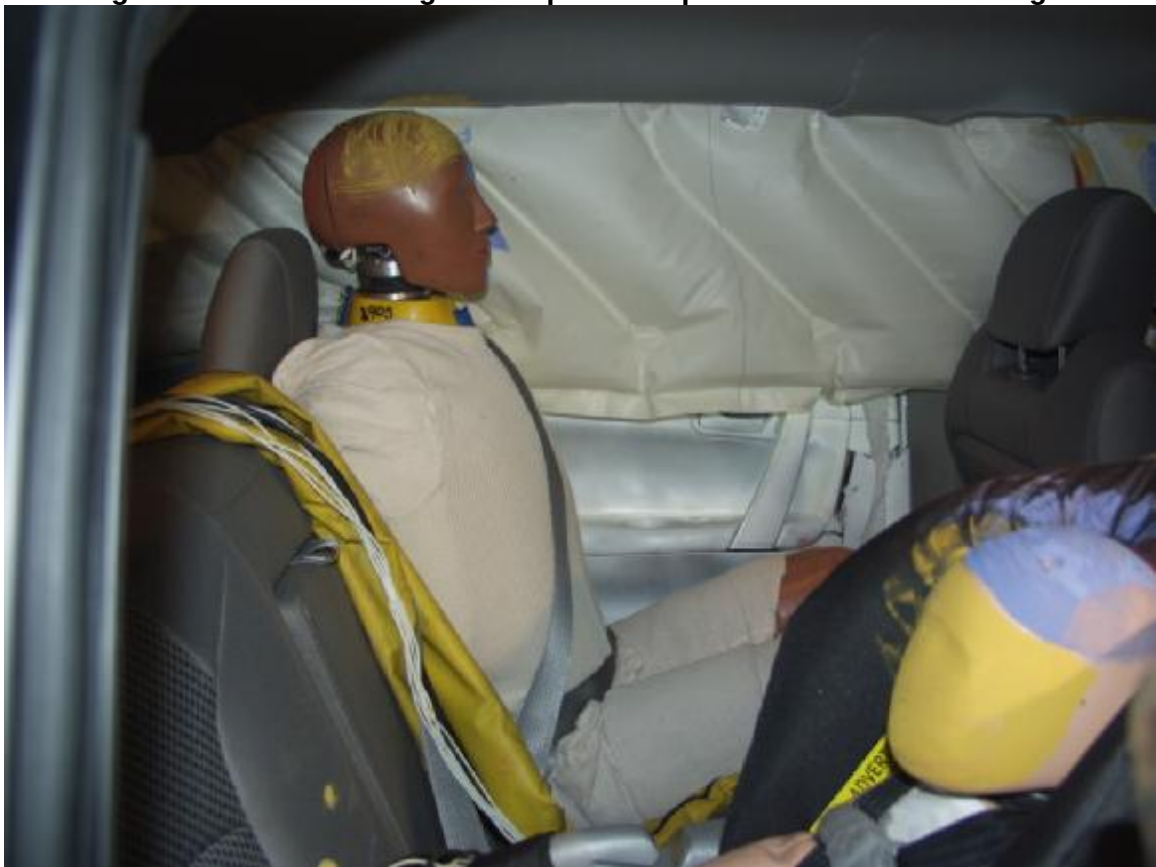
**Figure A-38: Post-Test Right Occupant Compartment View of Passenger**

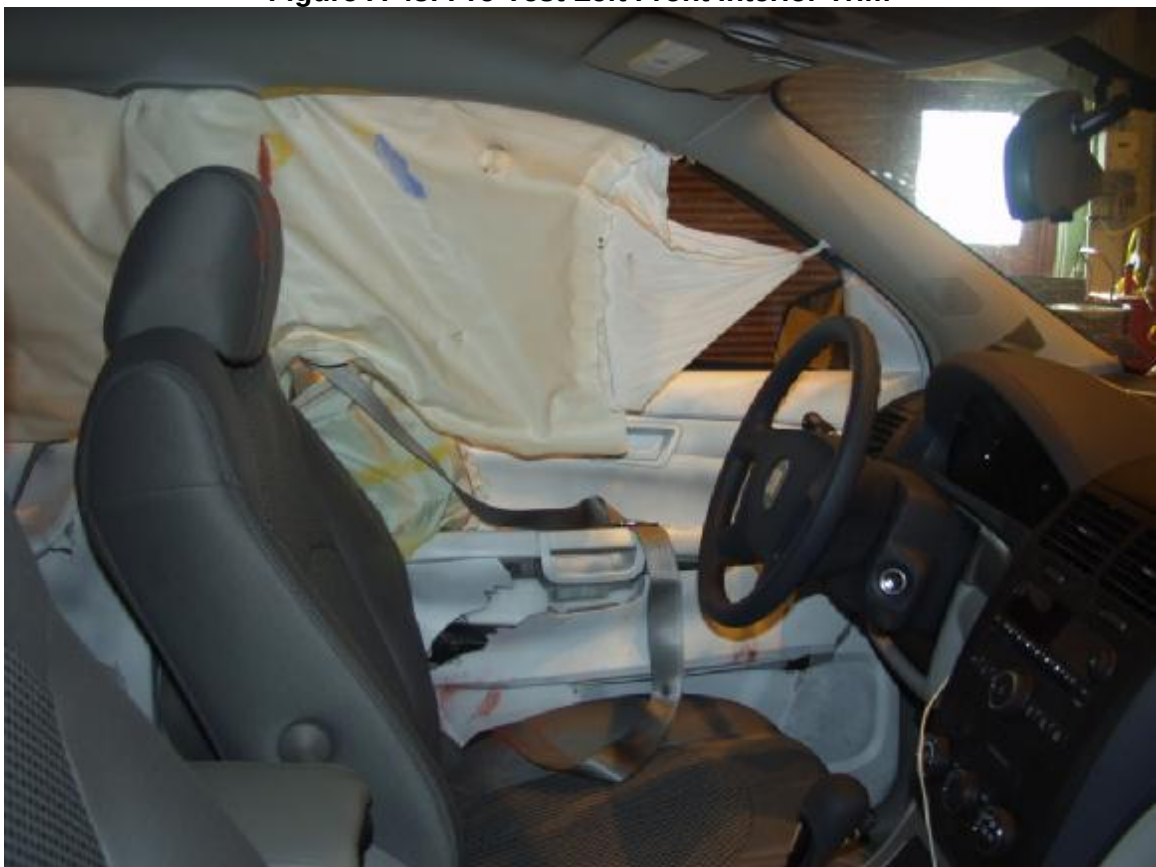
**Figure A-44: Post-Test Left Front Interior Trim**

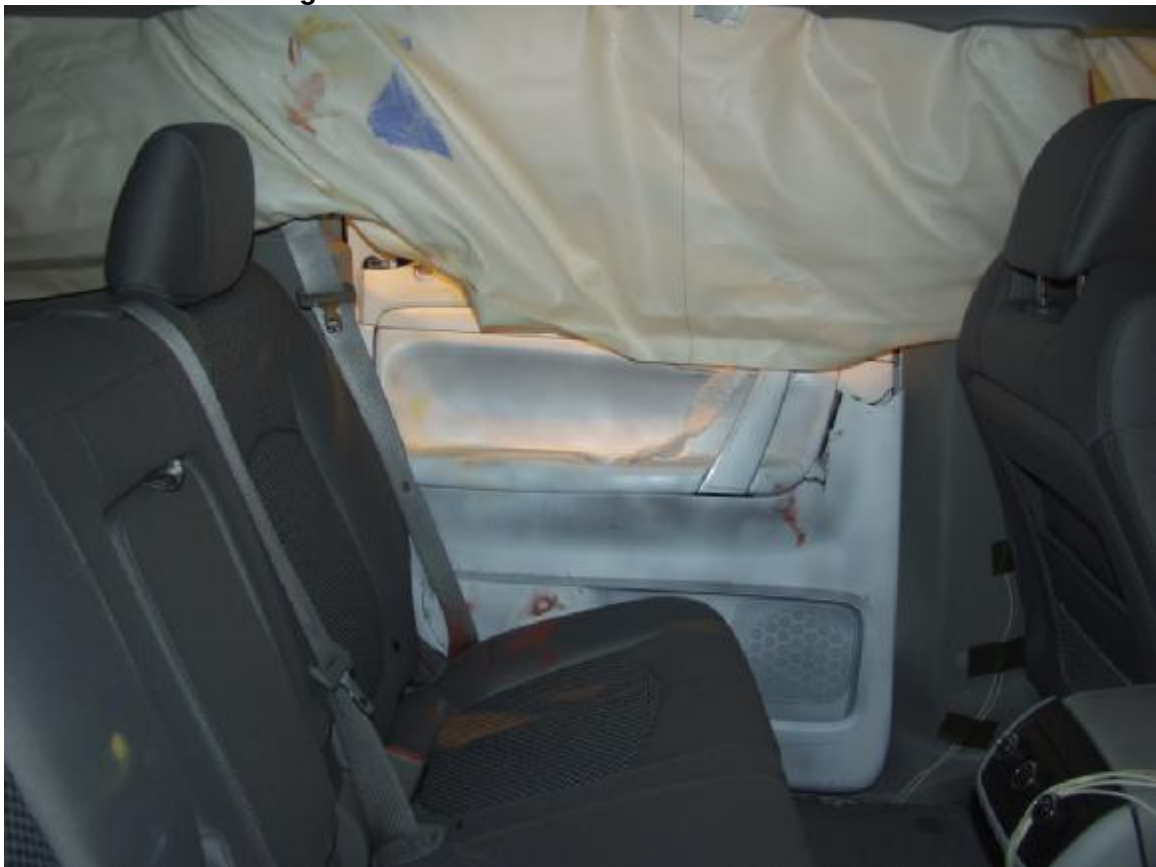
**Figure A-46: Post-Test Left Rear Interior Trim**

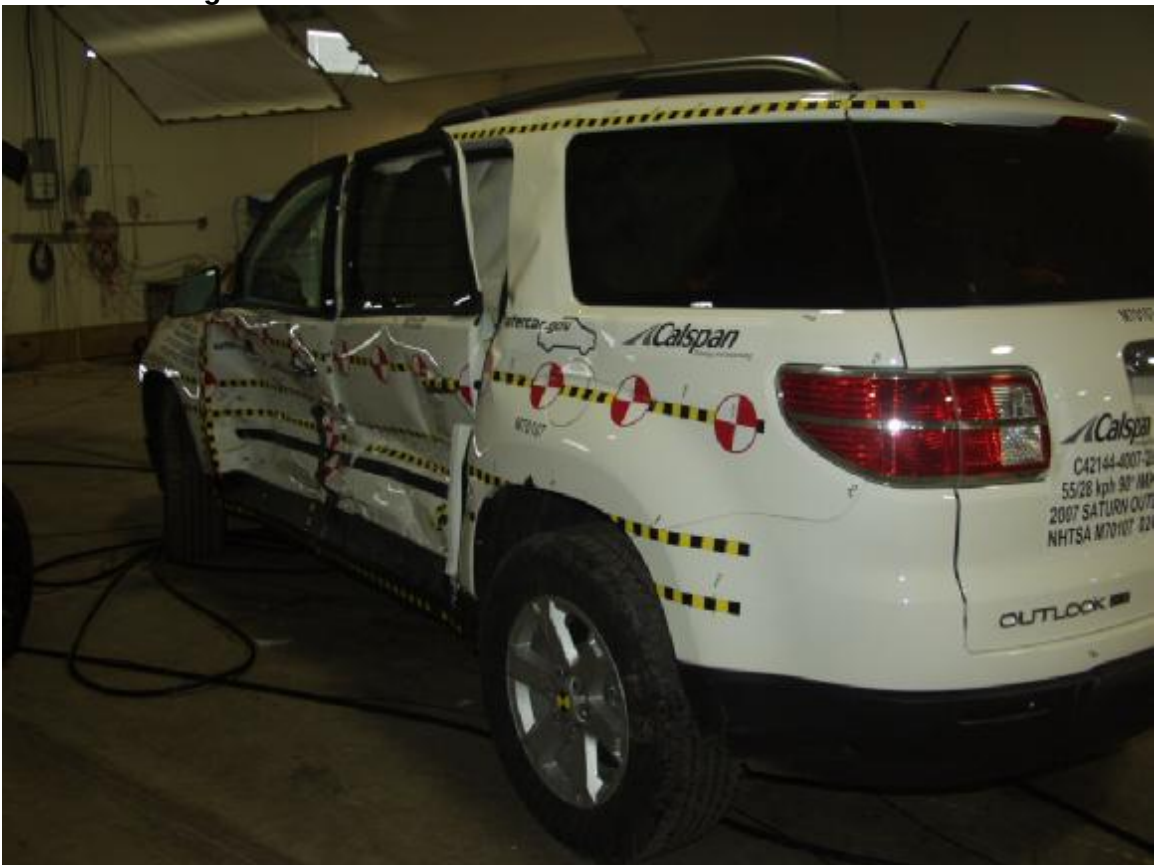
Figure A-50: Post-Test Left Rear  $\frac{3}{4}$  View of Left Side Doors
