REPORT NUMBER: CAL-07-10

**NEW CAR ASSESSMENT PROGRAM (NCAP)  
FRONTAL BARRIER IMPACT TEST**

TOYOTA MOTOR MANUFACTURING, TEXAS INC.  
2007 TOYOTA TUNDRA  
2-DOOR PICK-UP

FINAL REPORT

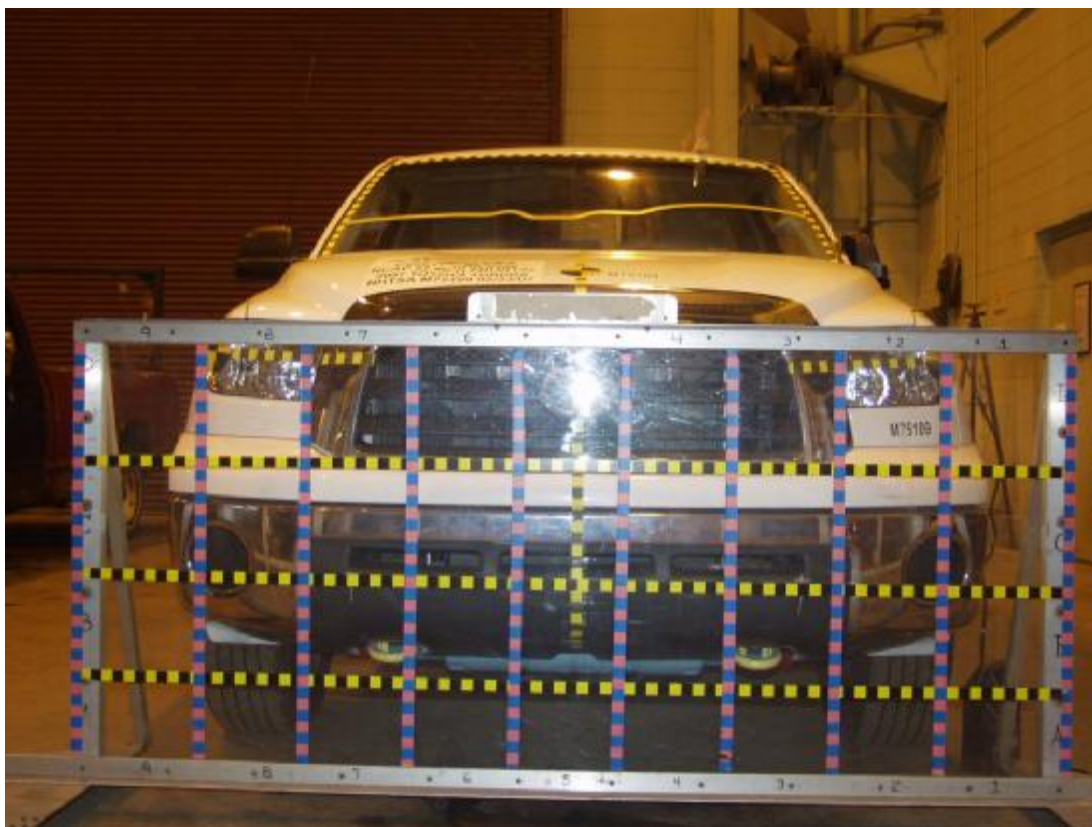
**Figure A-1: Load Cell Locations**

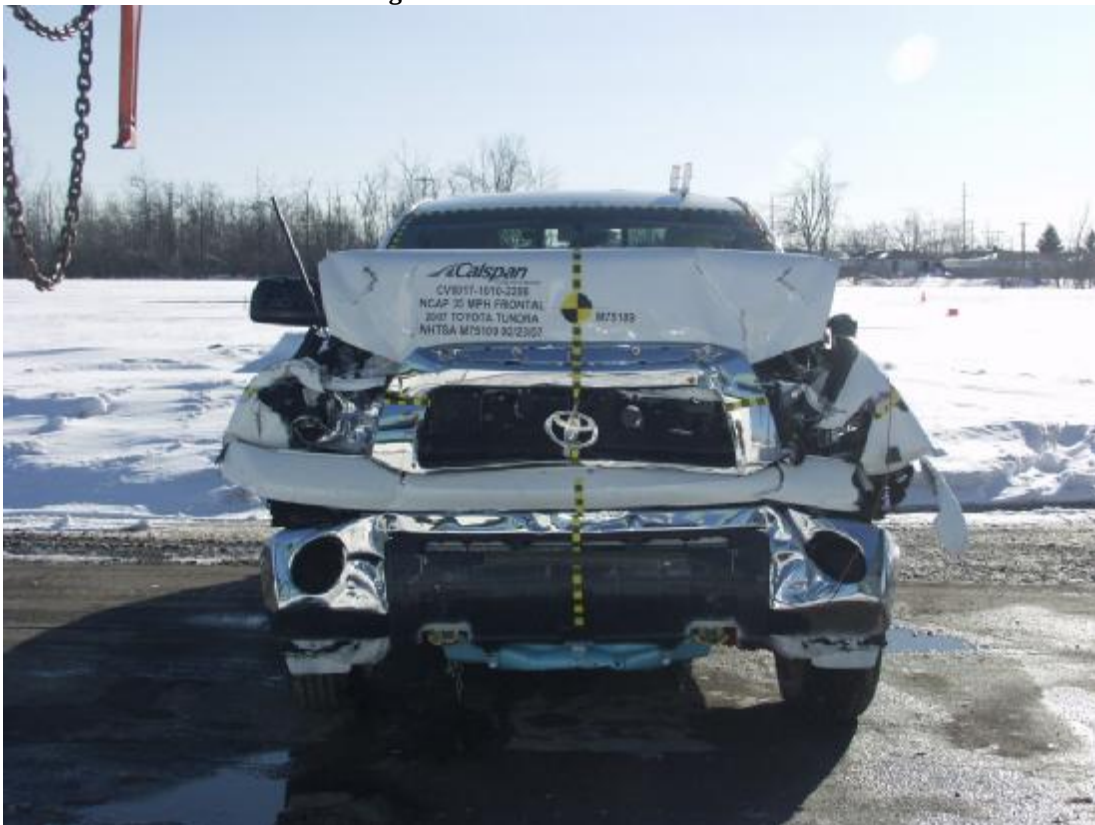
**Figure A-7: Post-Test Front View**

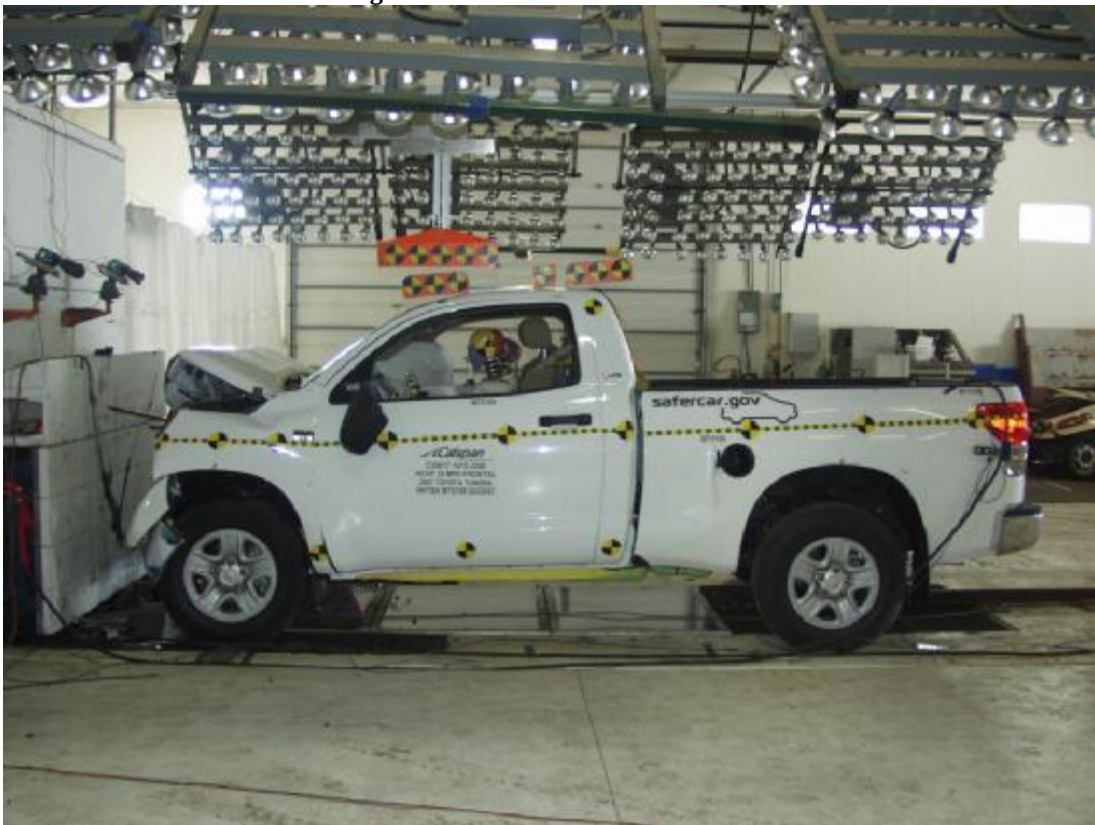
Figure A-9: Post-Test Left Side View

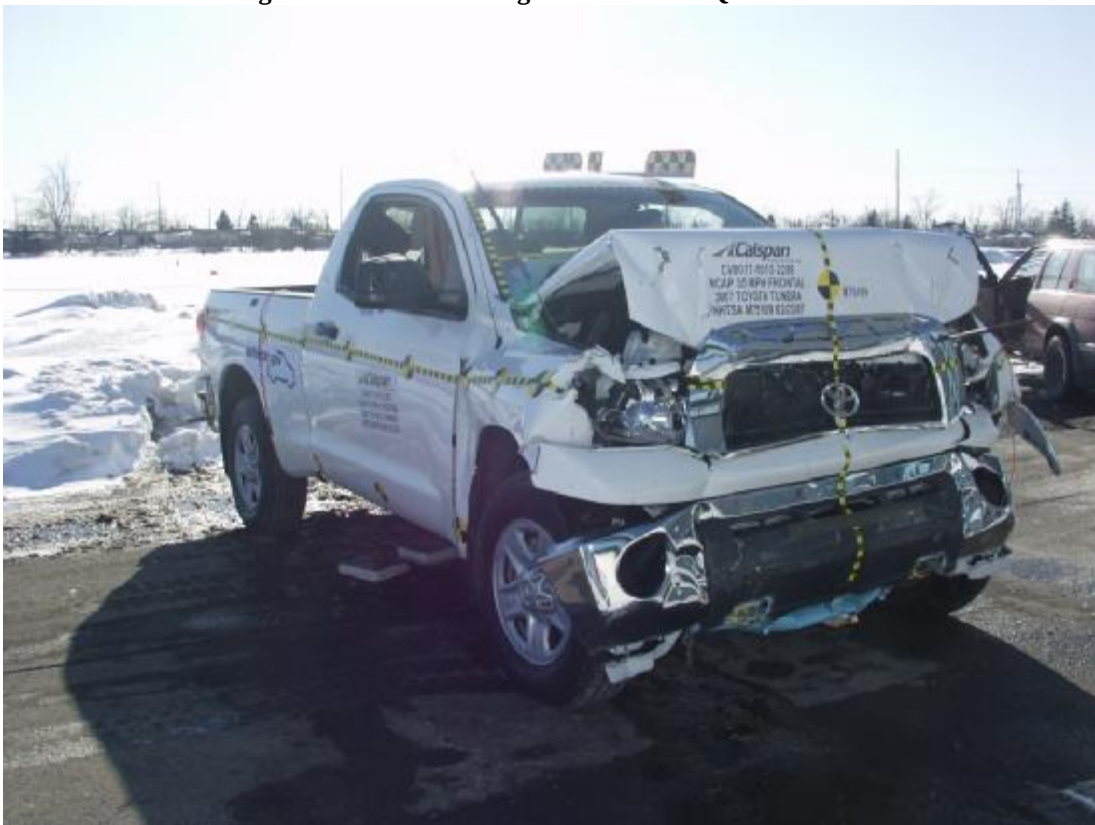
**Figure A-13: Post-Test Right Front Three-Quarter View**

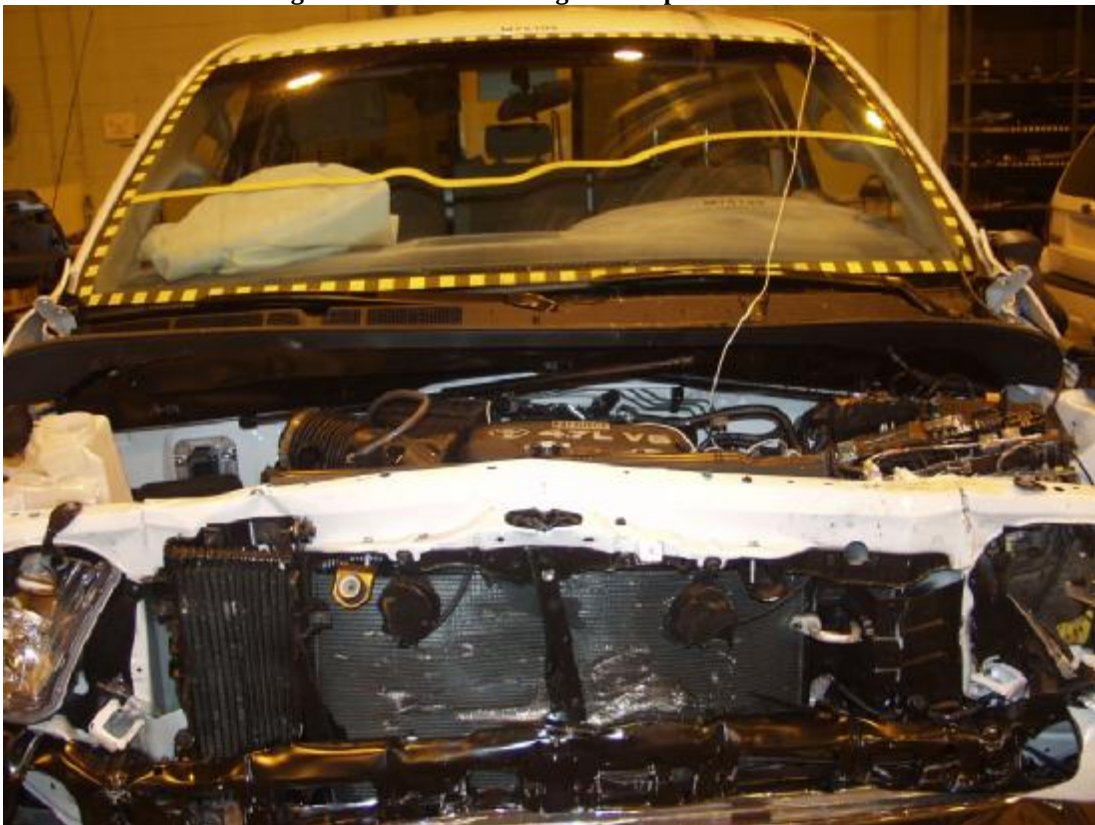
**Figure A-21: Post-Test Engine Compartment View**

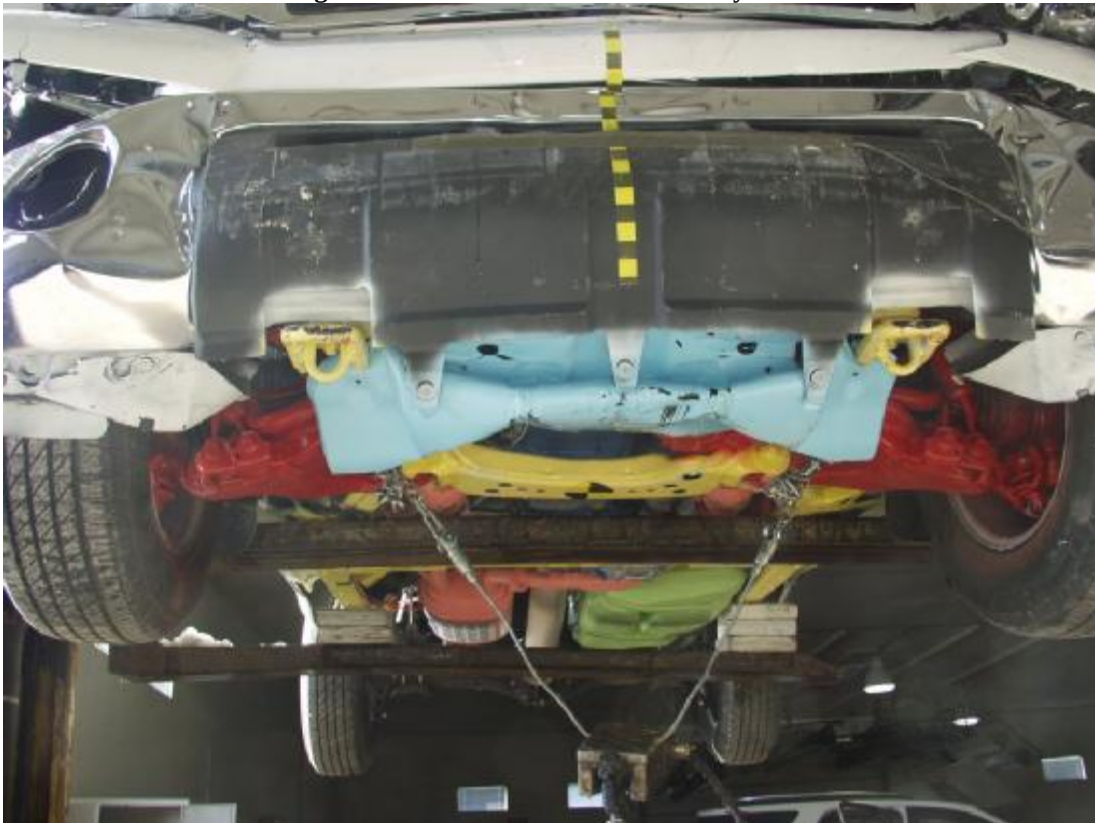
**Figure A-25: Post-Test Front Underbody View**

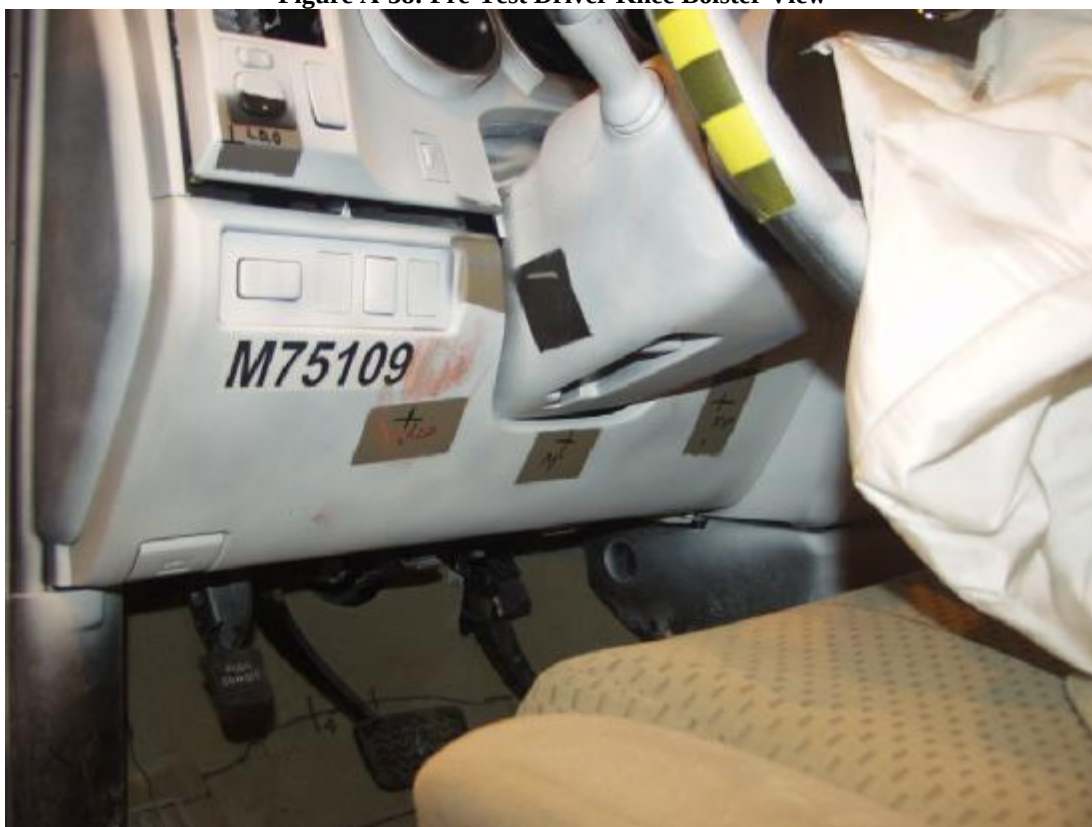
**Figure A-39: Post-Test Driver Knee Bolster View**

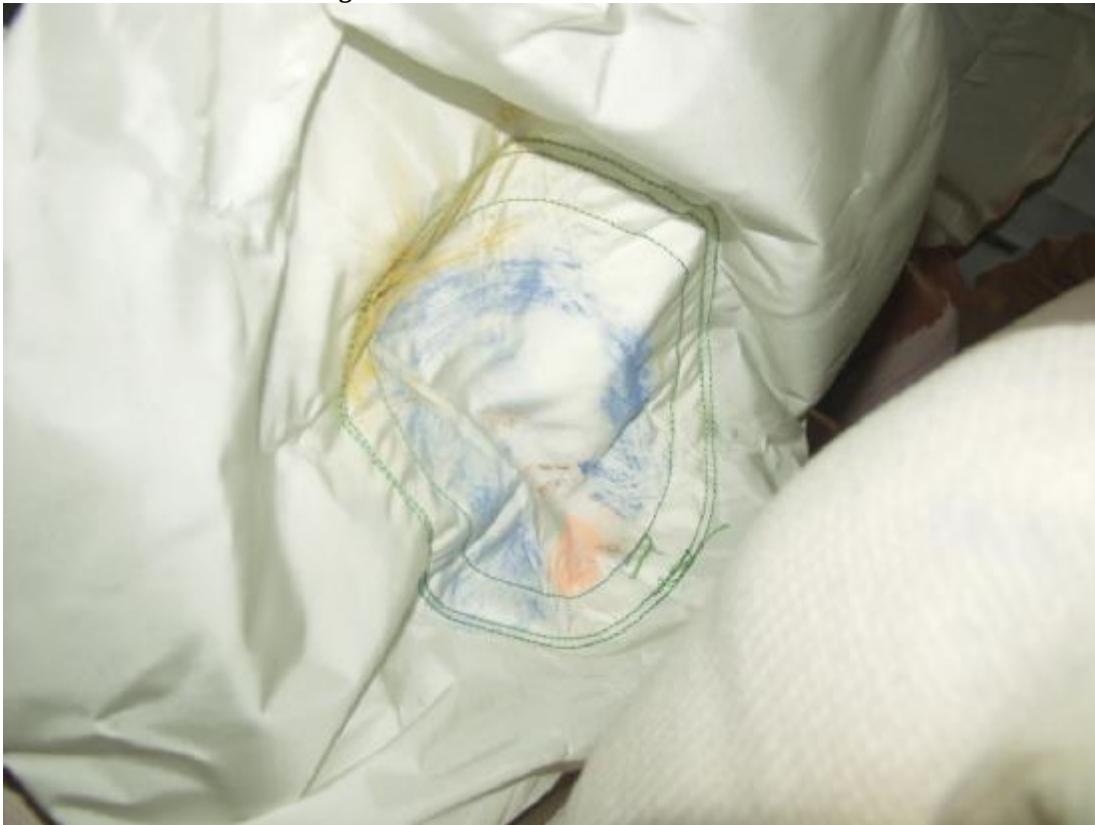
**Figure A-43: Post-Test Driver Contact to Airbag**

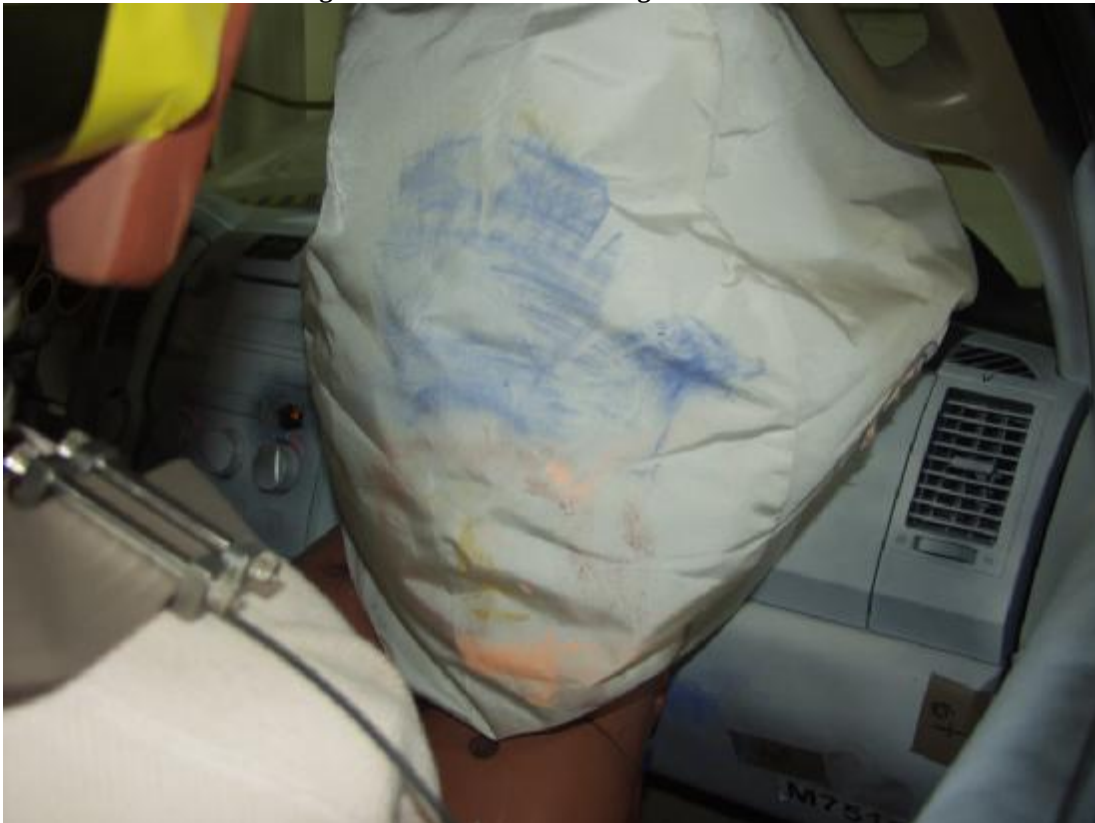
**Figure A-57: Post-Test Passenger Contact to Airbag**
