REPORT NUMBER: CAL-07-11

**NEW CAR ASSESSMENT PROGRAM (NCAP)
FRONTAL BARRIER IMPACT TEST**

DAIMLER CHRYSLER CORPORATION
2007 JEEP PATRIOT
MPV

CALSPAN TEST NUMBER: 8806-NCAP-11

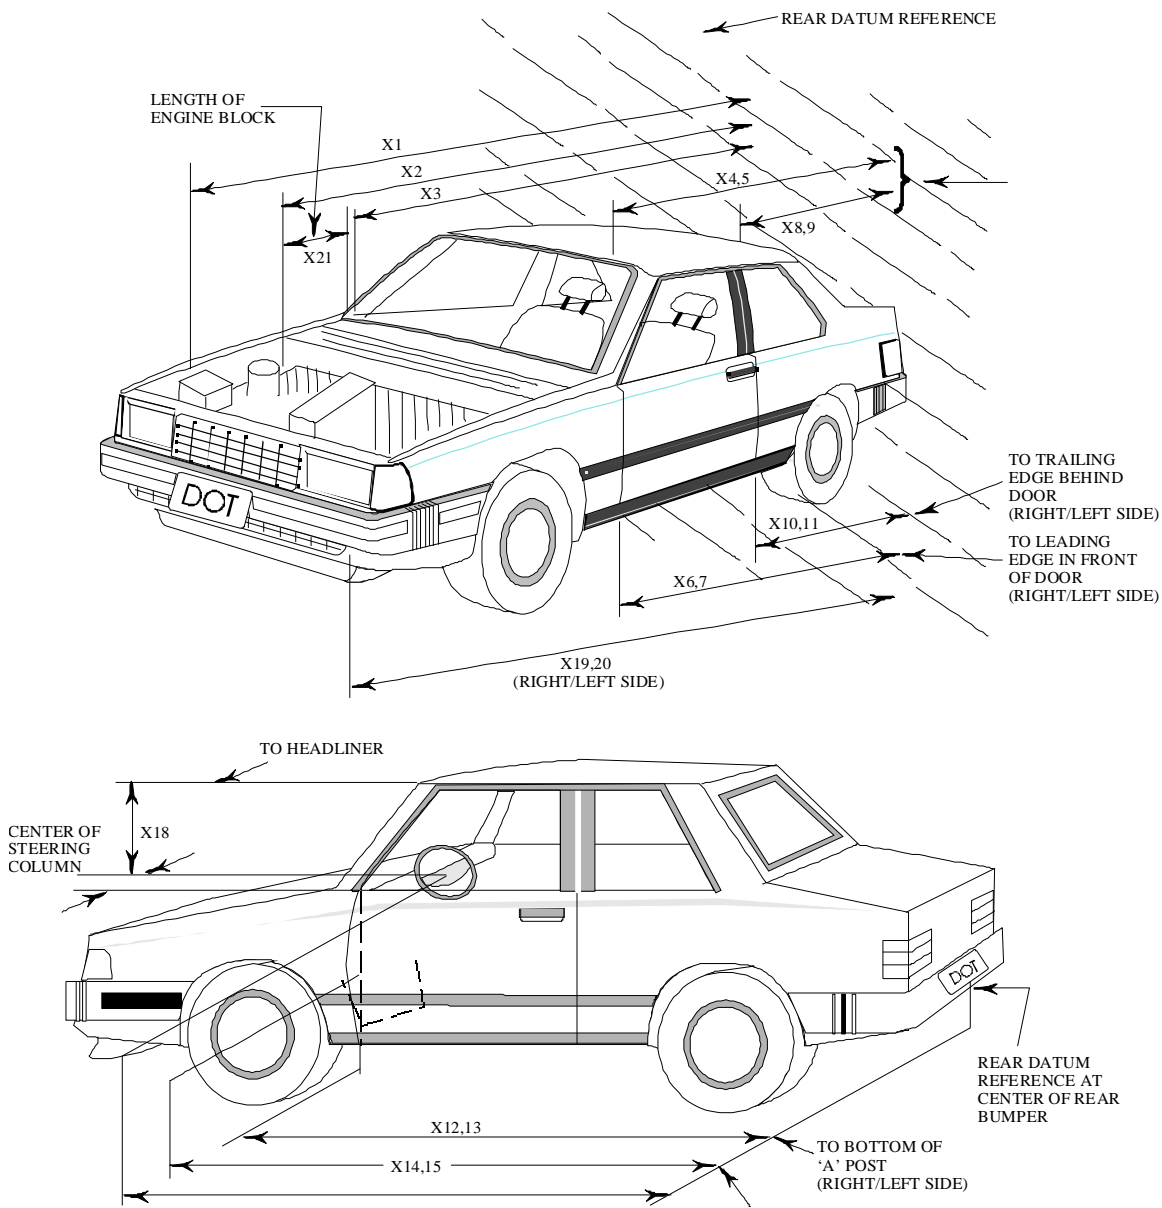
DATA SHEET NO. 10
TEST VEHICLE MEASUREMENTS

Elements	Pre-Test (mm)
1	Total length	4413
2	Total Width	1757
3	Bumper Top Height	638
4	Bumper Bottom Height	500
5	Longitudinal Member Top Height	602
6	Distance Between Longitudinal Members	1000
7	Longitudinal Member Width	57
8	Engine top height	900
9	Engine bottom height	219
10	Engine and gearbox width	585
11	Front bumper-engine distance	450
12	Front shock absorber fixing height	947
13	Bonnet leading edge height	984
14	Front shock absorber fixing width	1110
15	Front bumper – front axle distance	883
16	Front axle – A pillar distance	938
17	A-pillar – B pillar distance	613
18	B-pillar – rear axle distance	1086
19	B-pillar – C Pillar distance	826
20	Roof sill bottom height	1518
21	Roof sill top height	1601
22	Floor sill bottom height	261
23	Floor sill top height	396

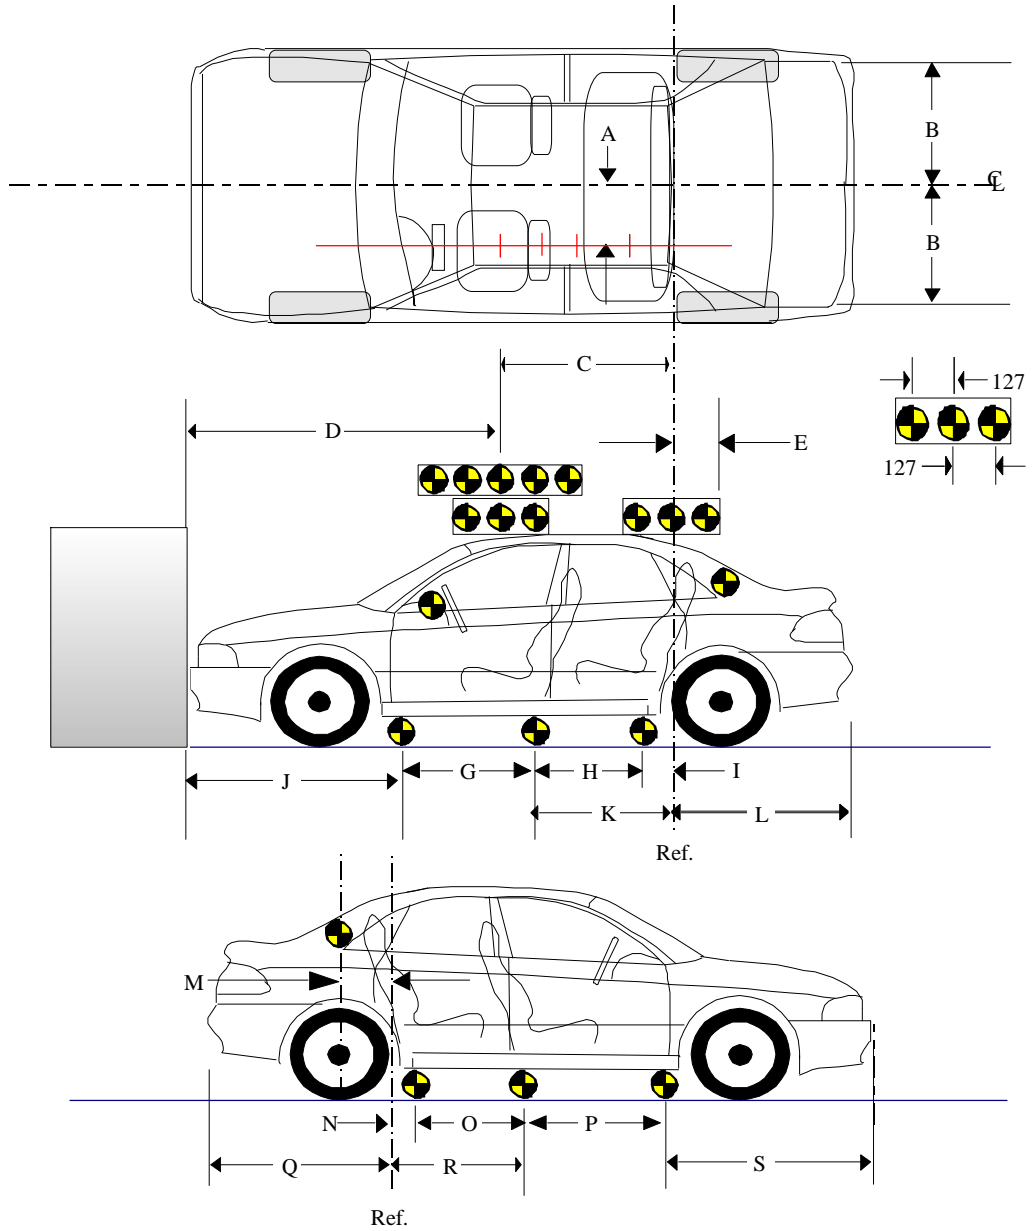
(Dimensions in millimeters)

A	389
B	647
C	910
D	2261
E	773
F	1497
G	788
H	778
I	126
J	1475
K	904
L	1246
M	774
N	119
O	789
P	787
Q	1242
R	908
S	1475

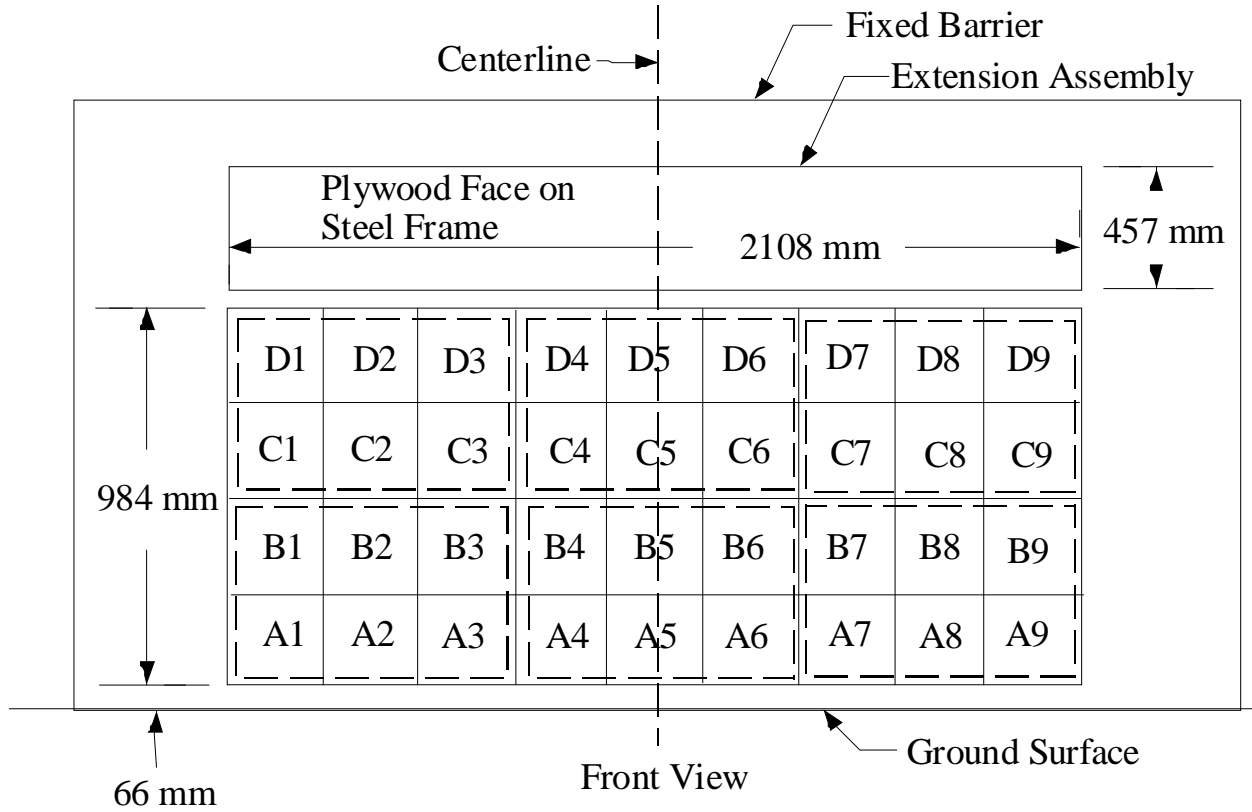
DATA SHEET NO.14
LOAD CELL LOCATIONS ON FIXED BARRIER

36 Load Cells
4 Rows
9 Columns

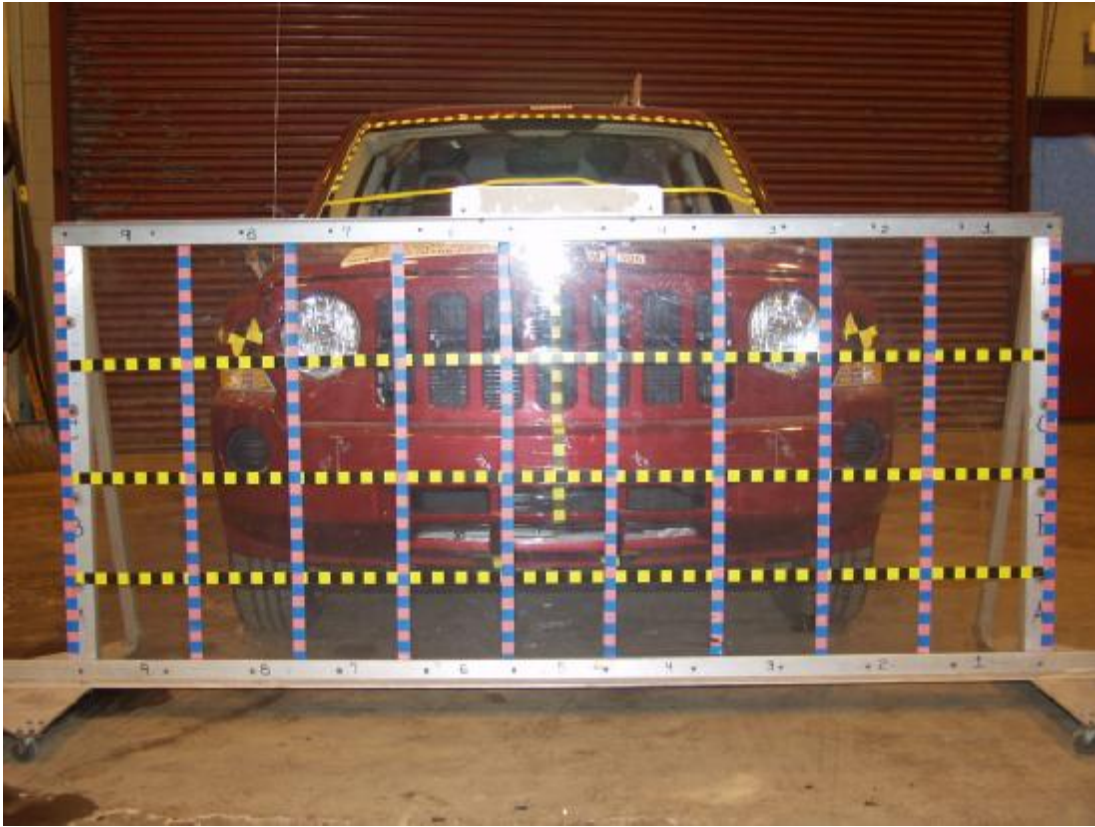
Figure A-1: Load Cell Locations

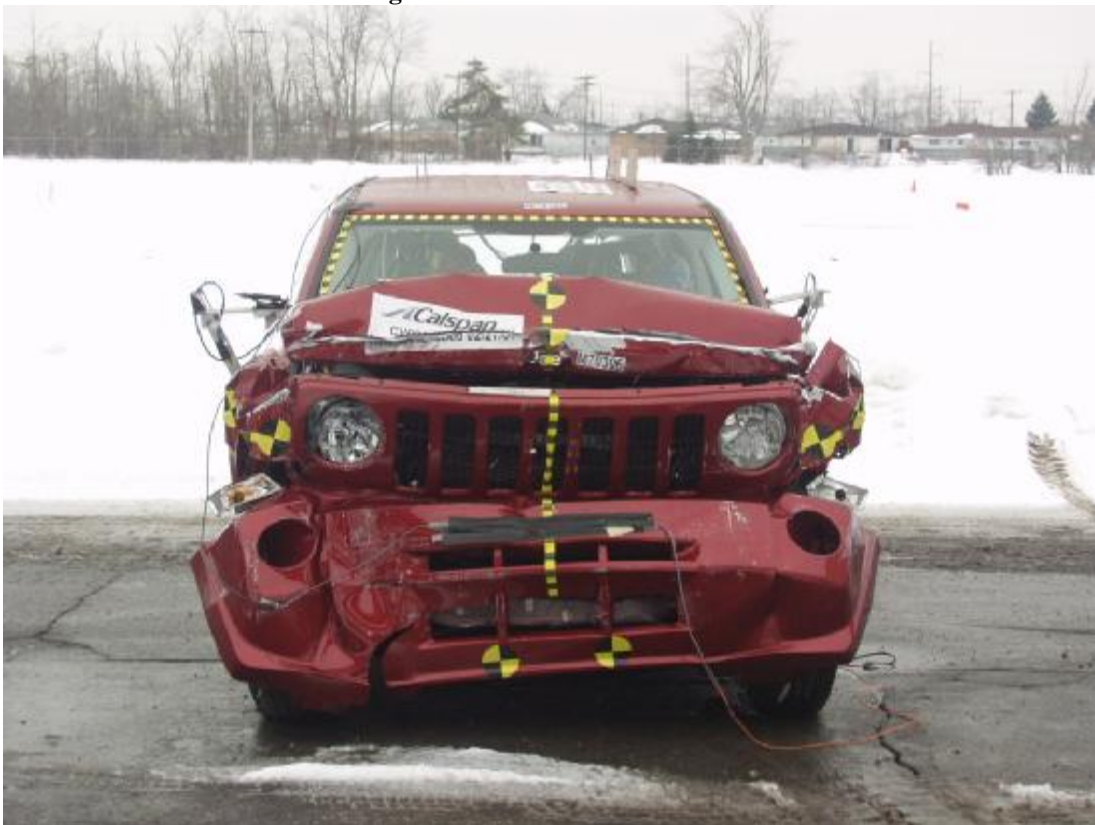
Figure A-7: Post-Test Front View

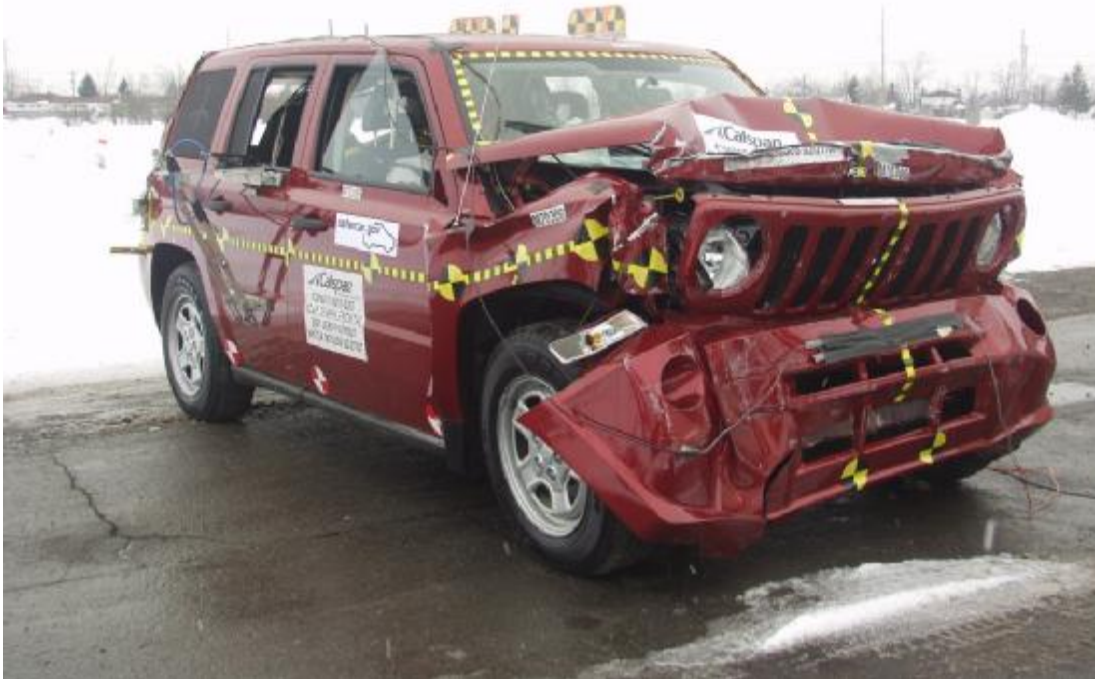
Figure A-13: Post-Test Right Front Three-Quarter View

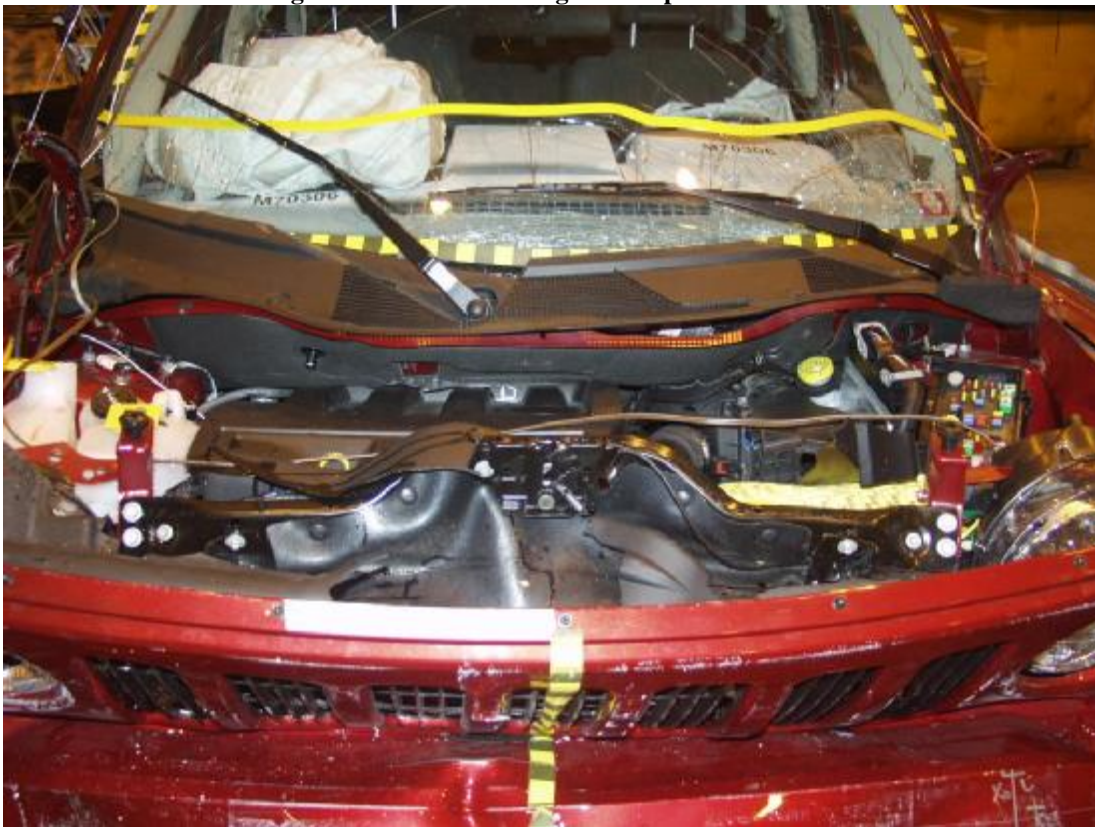
Figure A-21: Post-Test Engine Compartment View

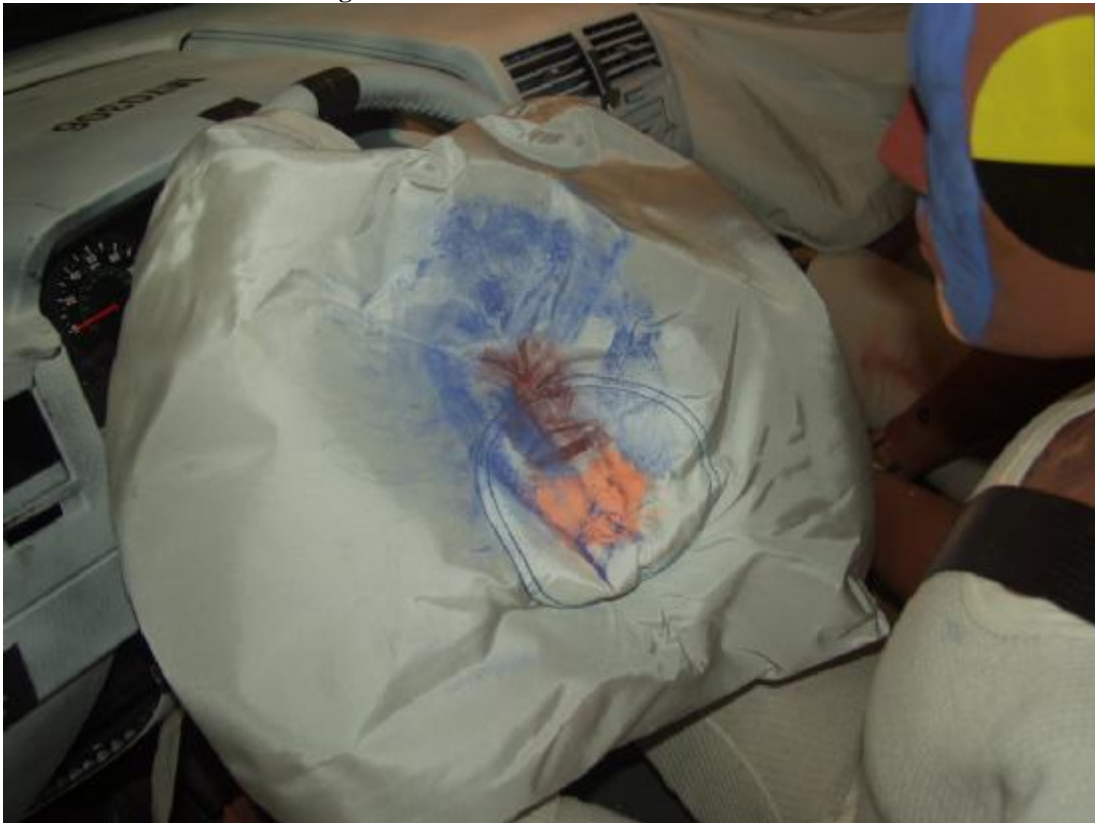
Figure A-43: Post-Test Driver Contact to Airbag

DRIVER	PASSENGER
ATD Type:	Part 572E	Part 572E
Restraint System:	Seatbelt, Airbag, Knee Bolster	Seatbelt, Airbag, Knee Bolster
Head Contact:	The face to the center of the airbag	Airbag / Back of head to headrest / Side of head to side rail entry handle
Abdomen Contact:	None	None
Chest Contact:	Airbag	Airbag
Left Knee Contact:	Knee Bolster	Glove Box
Right Knee Contact:	Knee Bolster	Glove Box

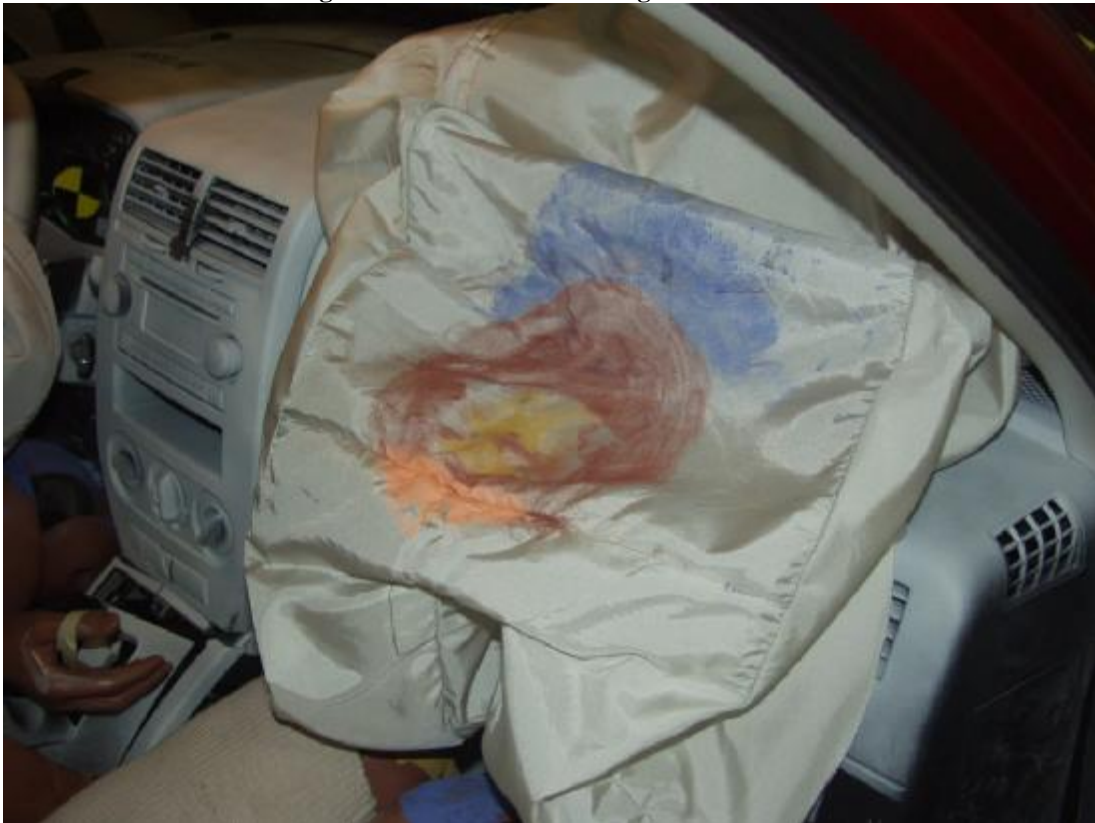
Figure A-57: Post-Test Passenger Contact to Airbag
