REPORT NUMBER TR-P27083-01-NC

**NEW CAR ASSESSMENT PROGRAM
FRONTAL BARRIER IMPACT TEST**

**HYUNDAI MOTOR COMPANY
2007 HYUNDAI VERACRUZ
5-DOOR MPV**

FINAL REPORT

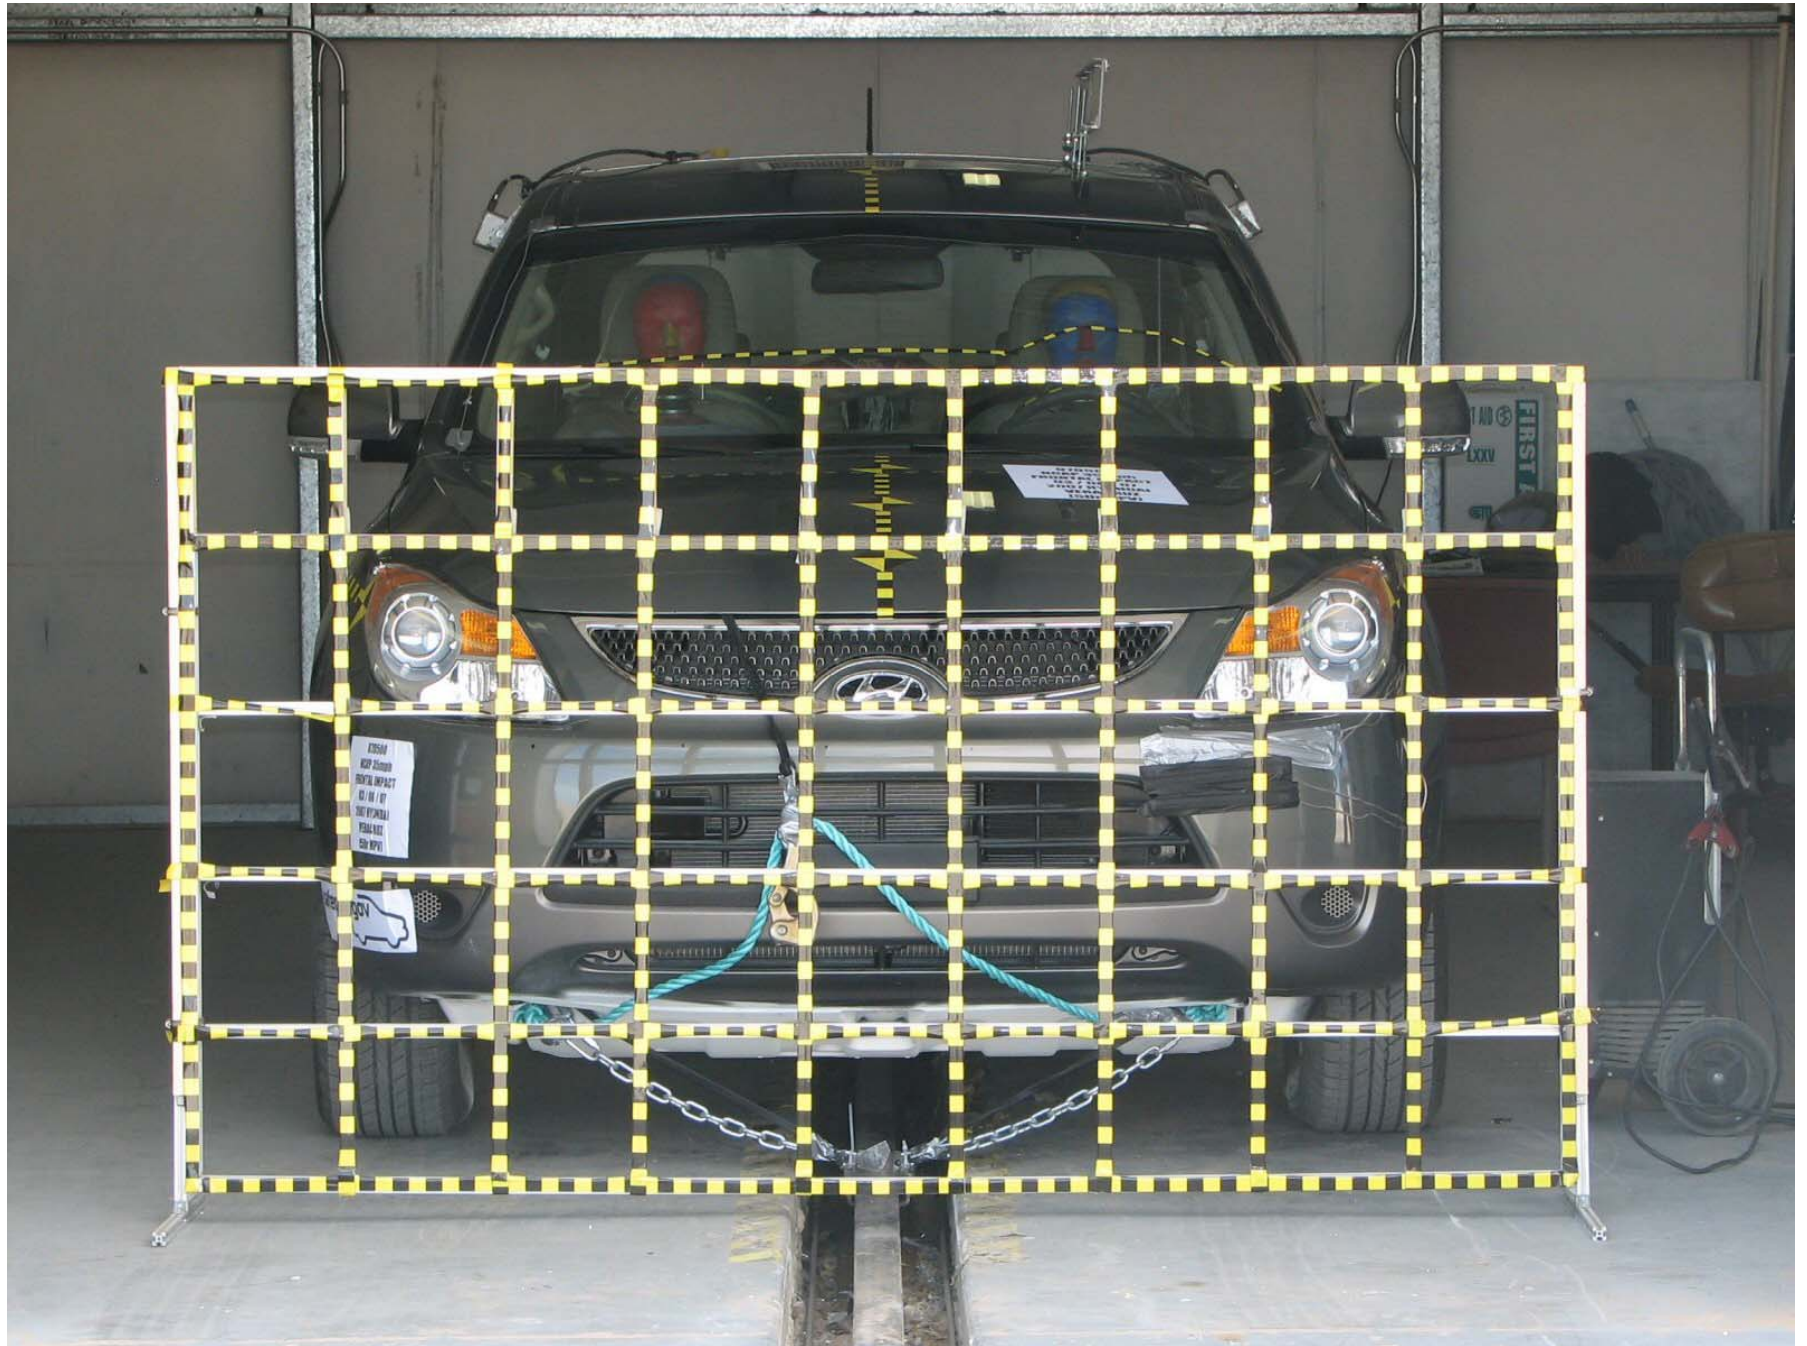
Figure A-1: Load Cell Location

A load cell barrier consisting of 36 load cells was impacted by a 2007 Hyundai Veracruz 5-Door MPV at a velocity of 55.70 km/h. The test was performed at Karco Engineering, LLC on March 6, 2007.

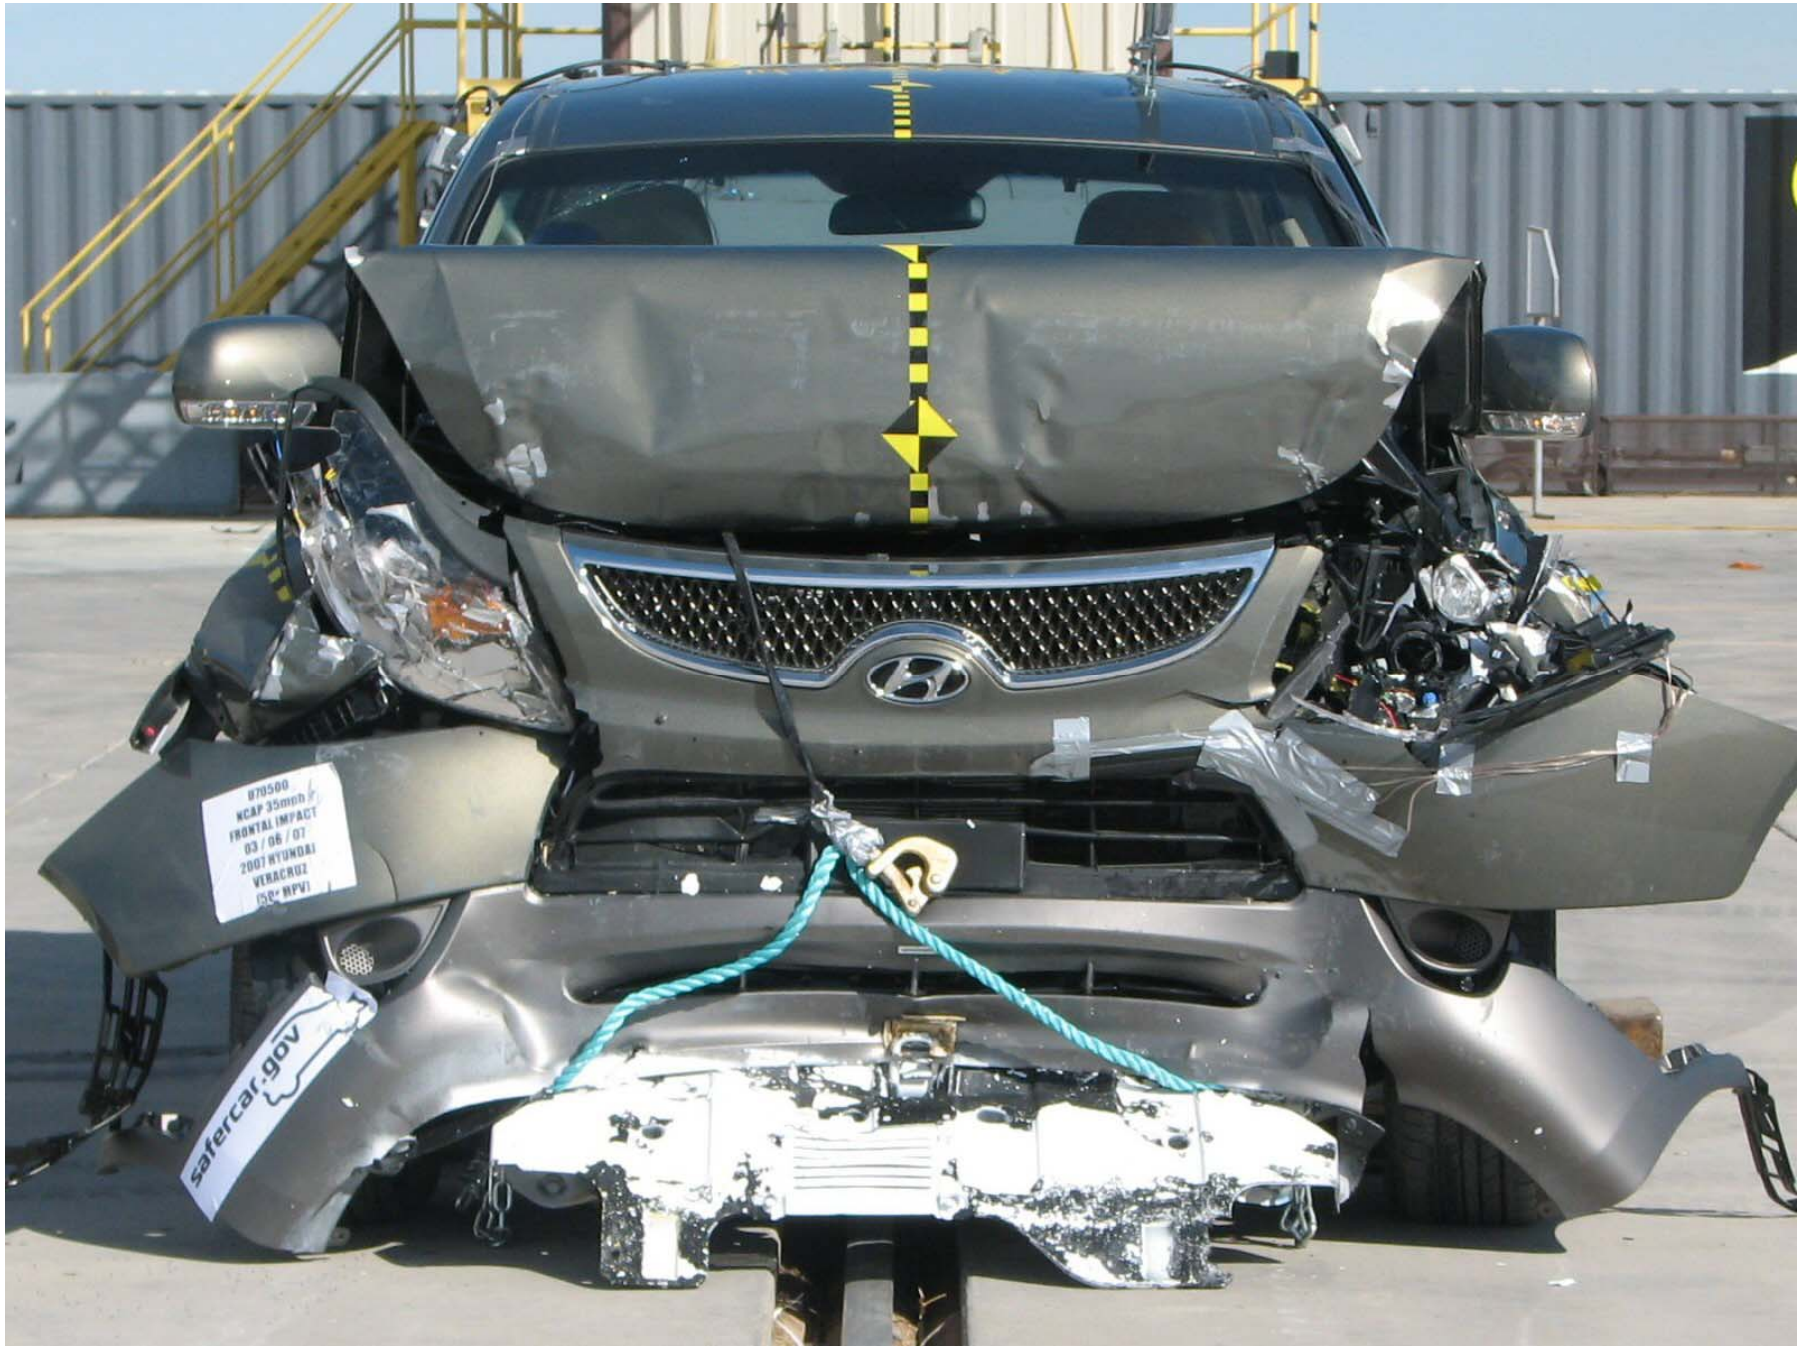
Figure A-7: Post-Test Front View (Vehicle Moved)

The maximum static crush of the vehicle was 609 mm at the vehicle's centerline and both the driver and the passenger side doors remained closed and latched during the impact event and were operable after the impact.

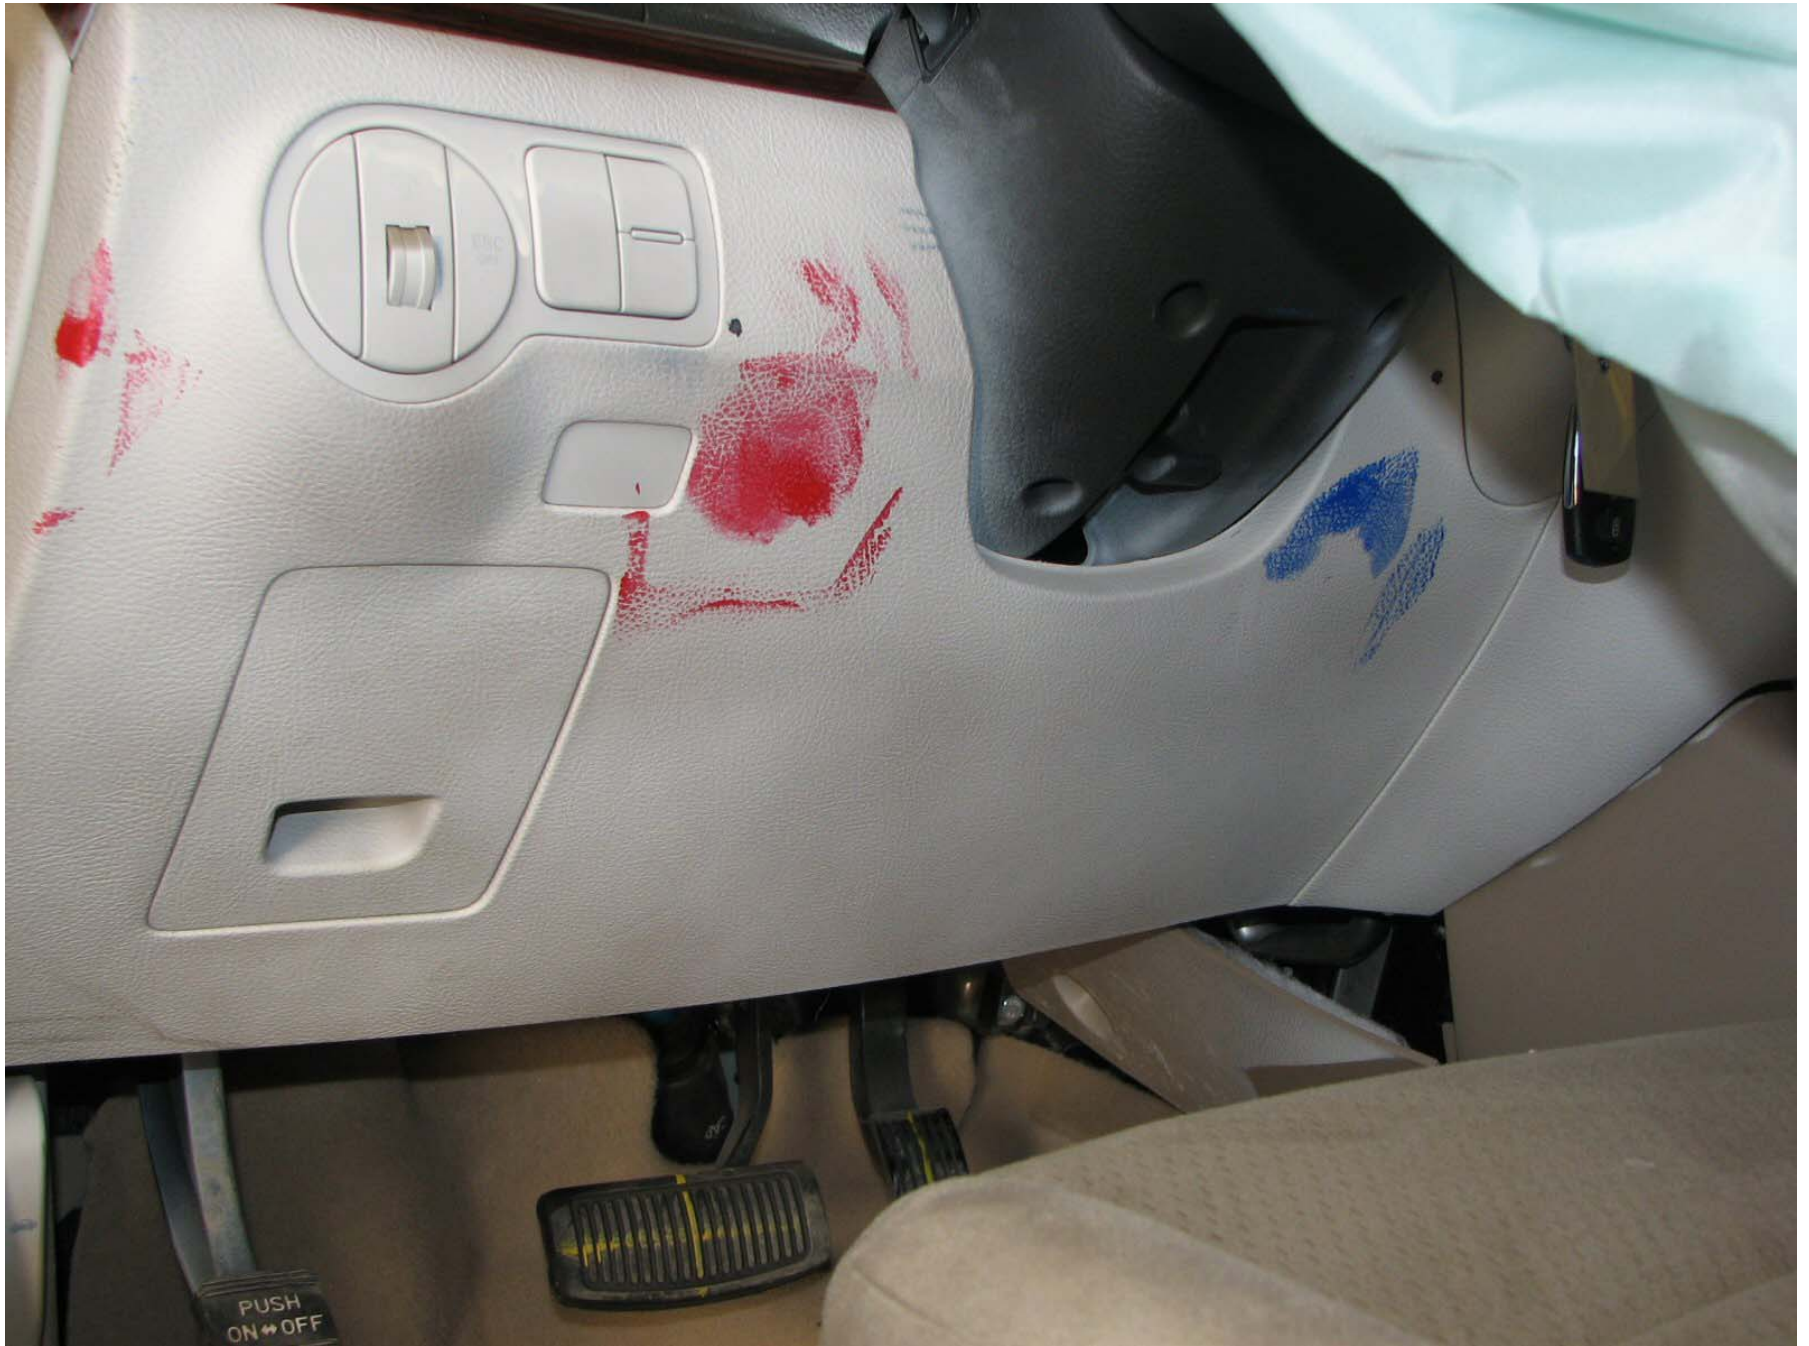
Figure A-39: Post-Test Driver Side Knee Bolster

The driver's visible contact points were as follows: The driver ATD's head and chest contacted the airbag and the abdomen had no contact. Both knees contacted the knee bolster.

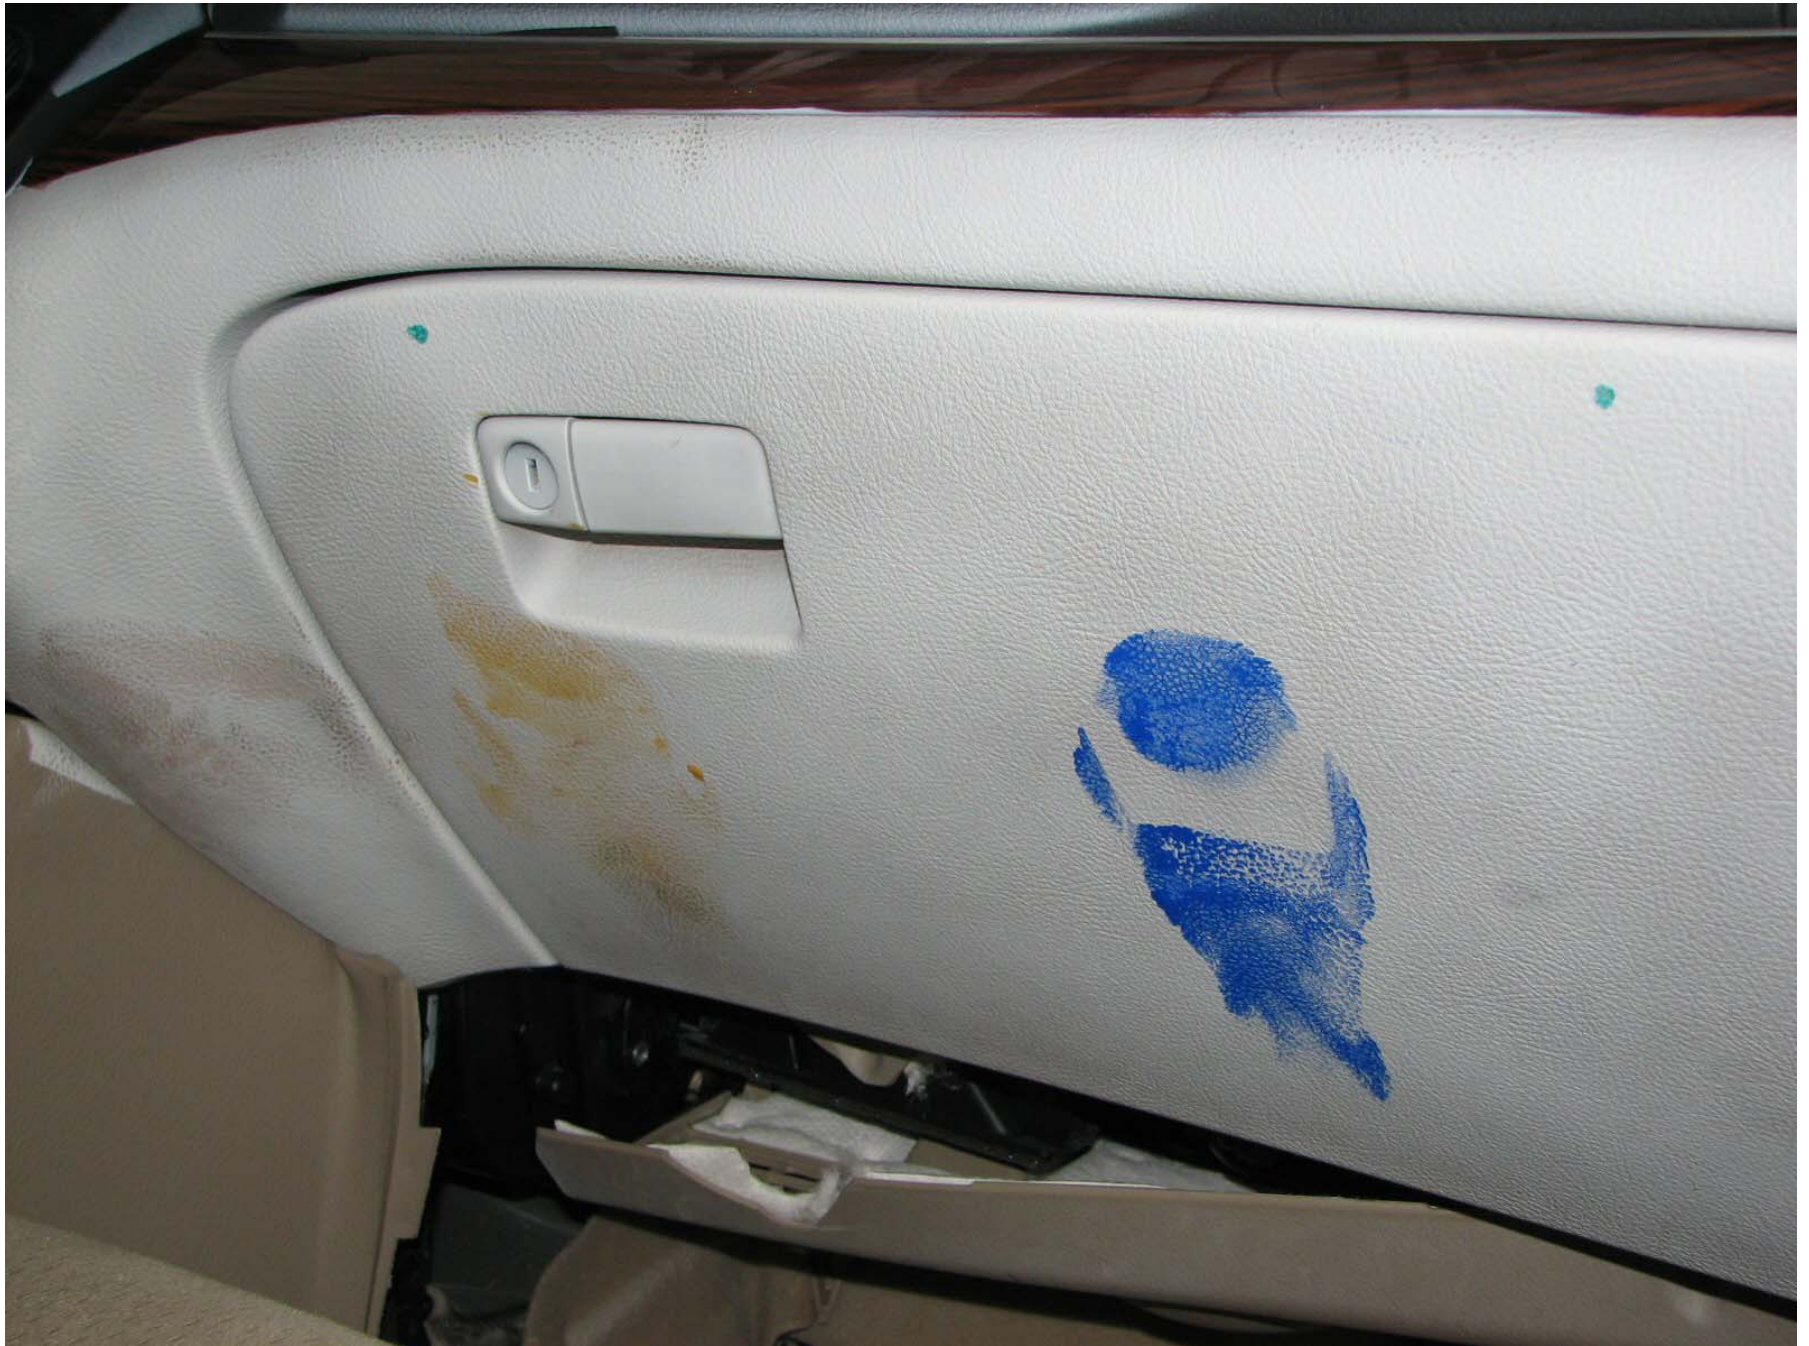
Figure A-53: Post-Test Passenger Side Glove Box

The passenger's visible contact points were as follows: The passenger ATD's head, and chest contacted the airbag. Both knees contacted the glove box.

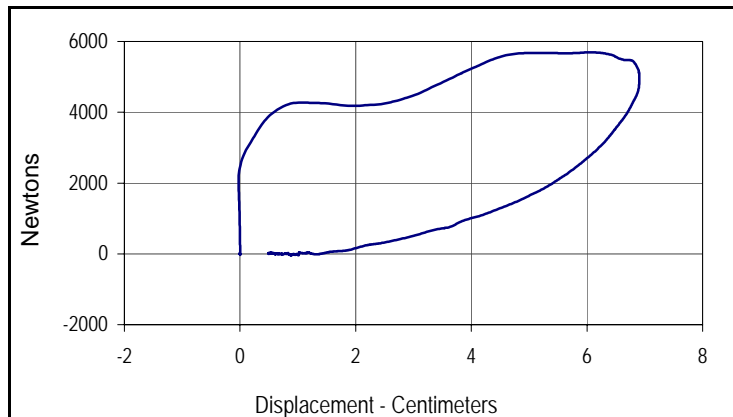
Tested Parameter	Units	Specification	Result	Pass/Fail
Laboratory Temperature	°C	20.6 to 22.2	21.1	Pass
Laboratory Relative Humidity	%	10 to 70	30	Pass
Probe Velocity	m/s	6.58 to 6.82	6.76	Pass
Peak Probe Force	Newtons	5159 to 5893	5694	Pass
Peak Sternum Deflection	CM	6.35 to 7.26	6.90	Pass
Internal Hysteresis	%	69 to 85	76.8	Pass
Overall Test Results				Pass

Curve Description			
Probe Force vs. Chest Deflection			
CURNO	Type	SAE Class	Hysteresis
001	FIL	180	76.8
Peak Probe Force		Peak Chest Deflection	
5694		6.90
