REPORT NUMBER: SNCAP-CAL-07-08

**NEW CAR ASSESSMENT PROGRAM
SIDE IMPACT TEST**

**FORD MOTOR COMPANY
2008 FORD ESCAPE
MPV**

NHTSA NUMBER: M80201

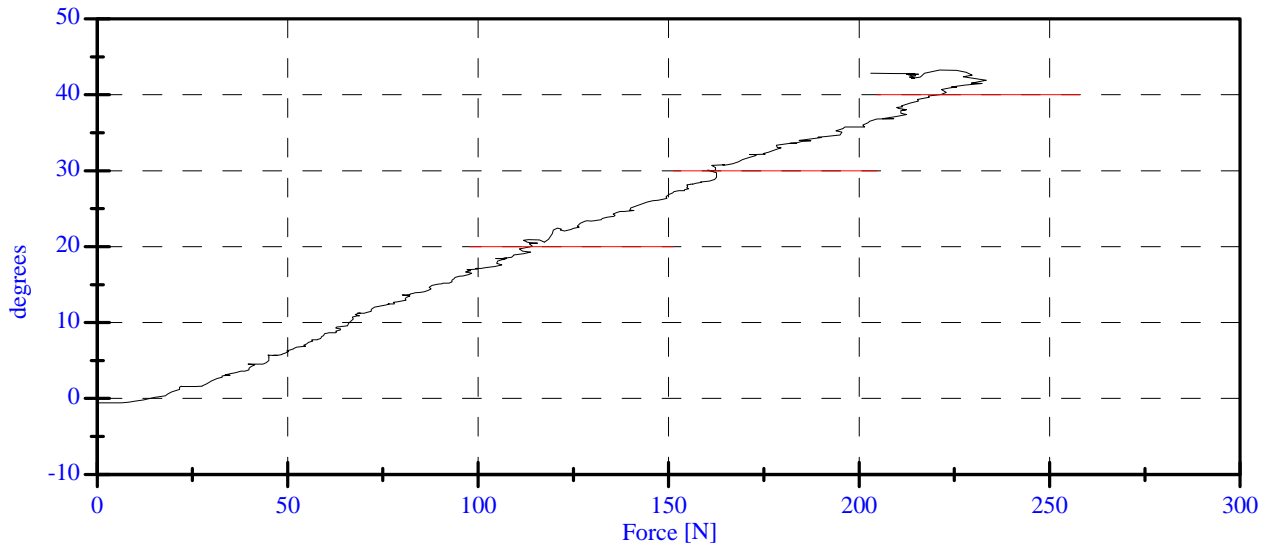
LUMBAR SPINE FLEXION TEST

<u>TEST PARAMETER</u>	<u>SPECIFICATION</u>	<u>TEST RESULTS</u>	<u>STATUS</u>
Lab Temperature:	18.9-25.5 C	21.1 C	Passed
Lab Humidity:	10-70 %	33.00 %	Passed
Force at 0 Deg:	0.00-26.69 N	15.02 N	Passed
Force at 20 Deg:	97.86-151.24 N	114.26 N	Passed
Force at 30 Deg:	151.24-204.62 N	161.79 N	Passed
Force at 40 Deg:	204.62-258.00 N	221.33 N	Passed
Return Angle	12 Deg Max	1.33 deg	Passed
