**REPORT NUMBER TR-P27001-09-NC**

**NEW CAR ASSESSMENT PROGRAM  
FRONTAL BARRIER IMPACT TEST**

**TOYOTA MOTOR MANUFACTURING  
2007 TOYOTA TUNDRA CREWMAX SR5  
4-DOOR TRUCK**

**NHTSA NUMBER: M75106**

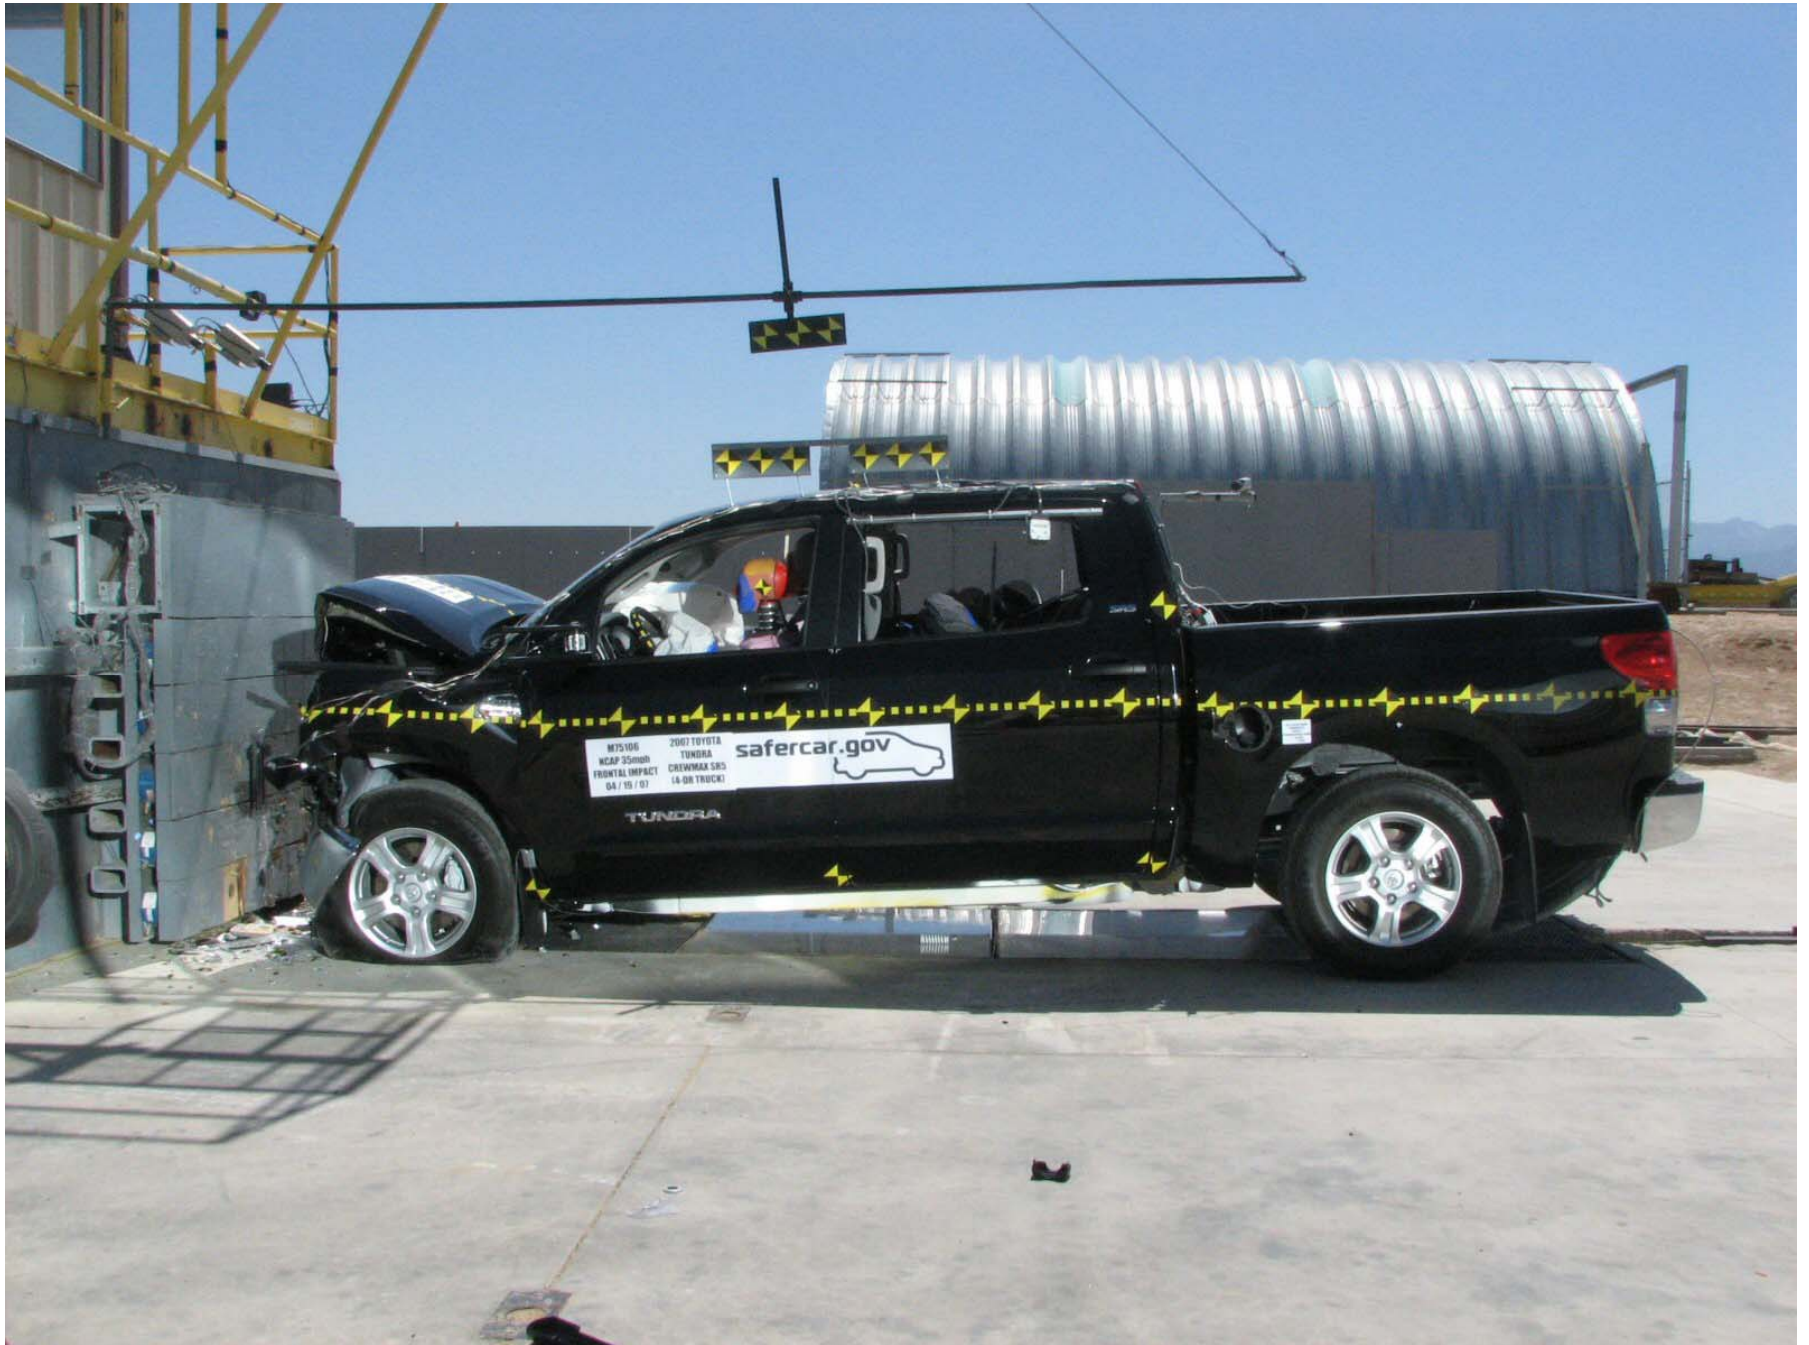
Figure A-9: Post-Test Left Side View

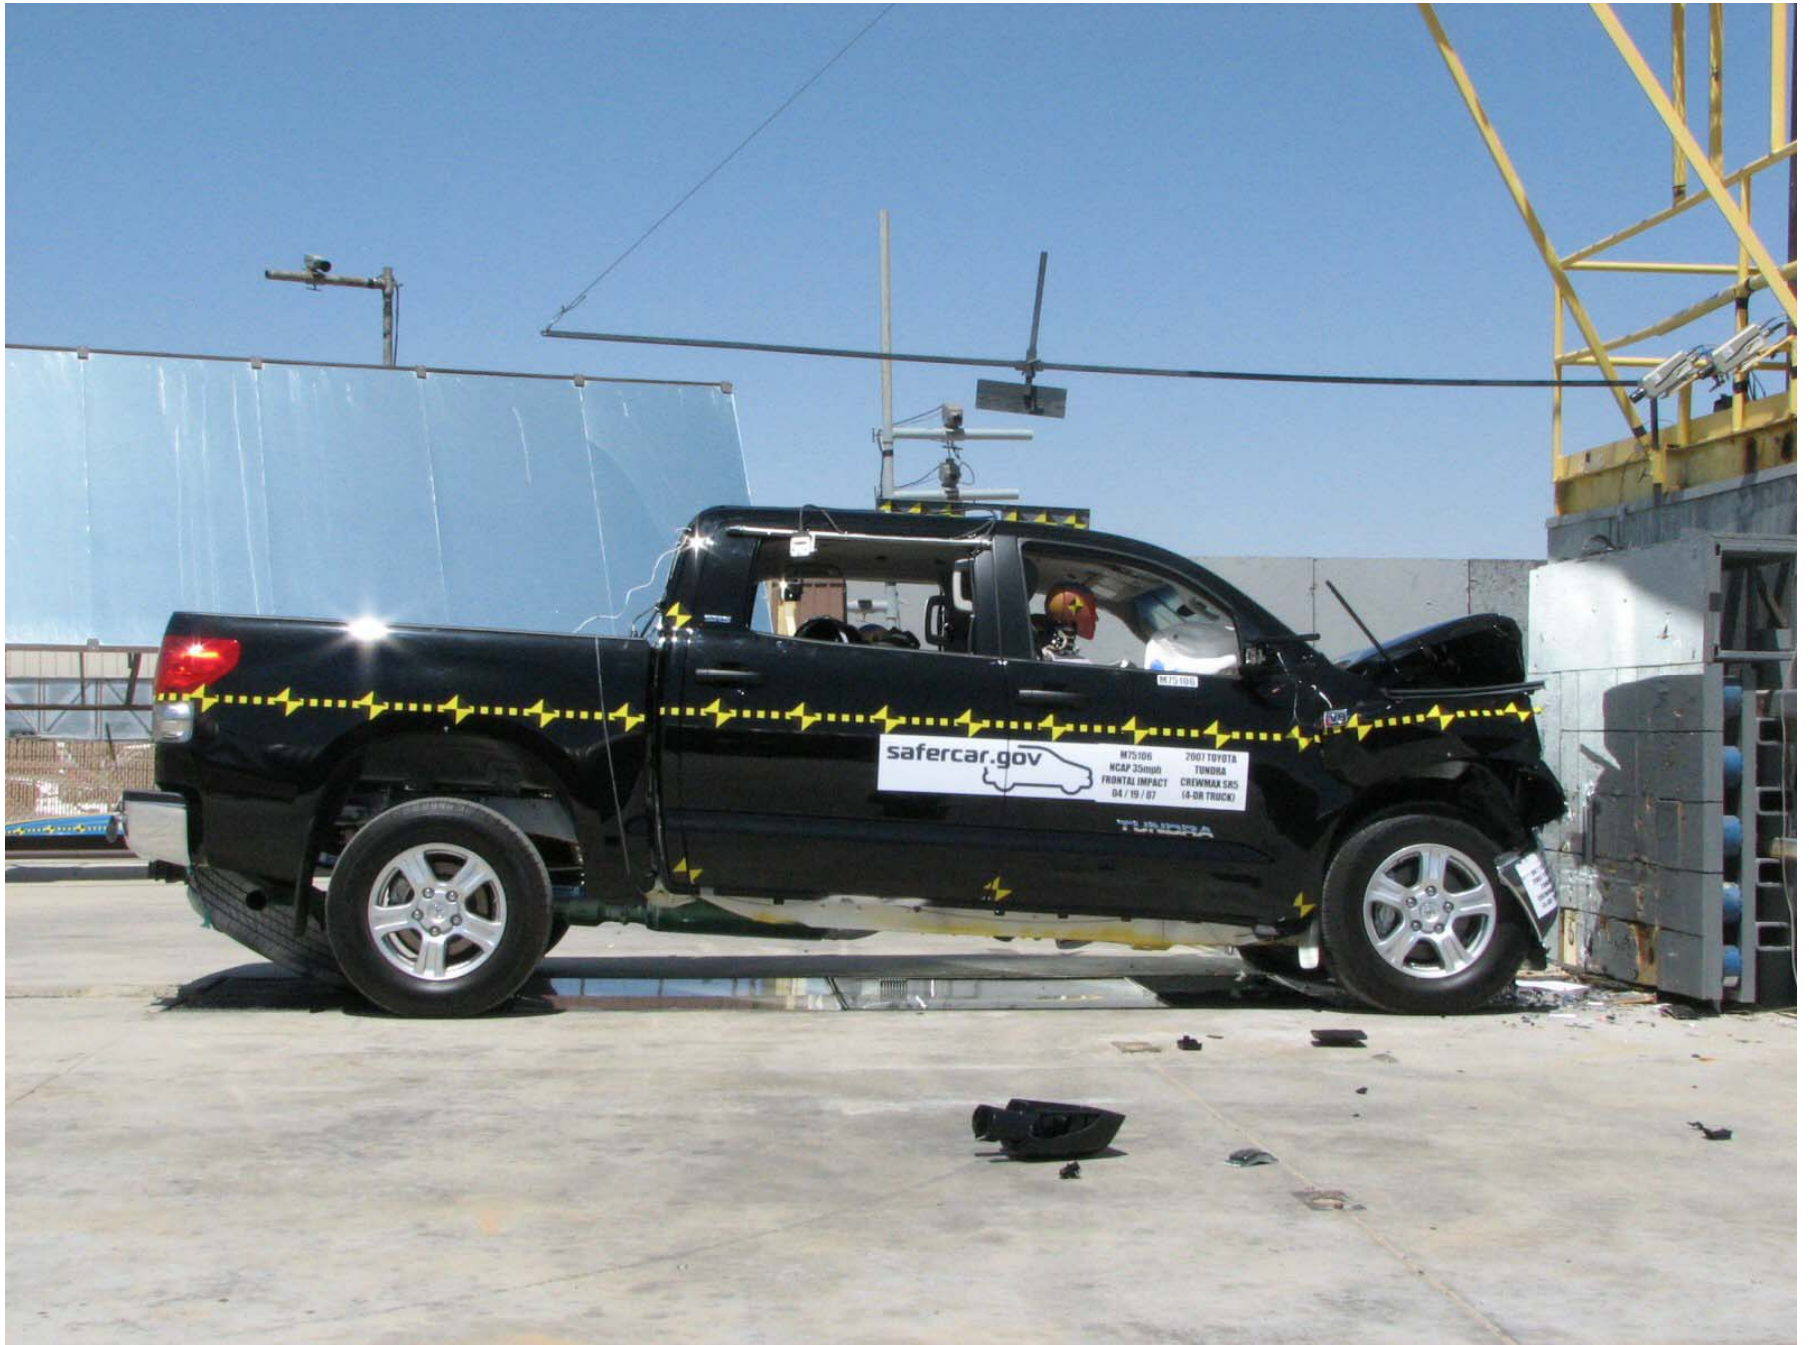
Figure A-11: Post-Test Right Side View

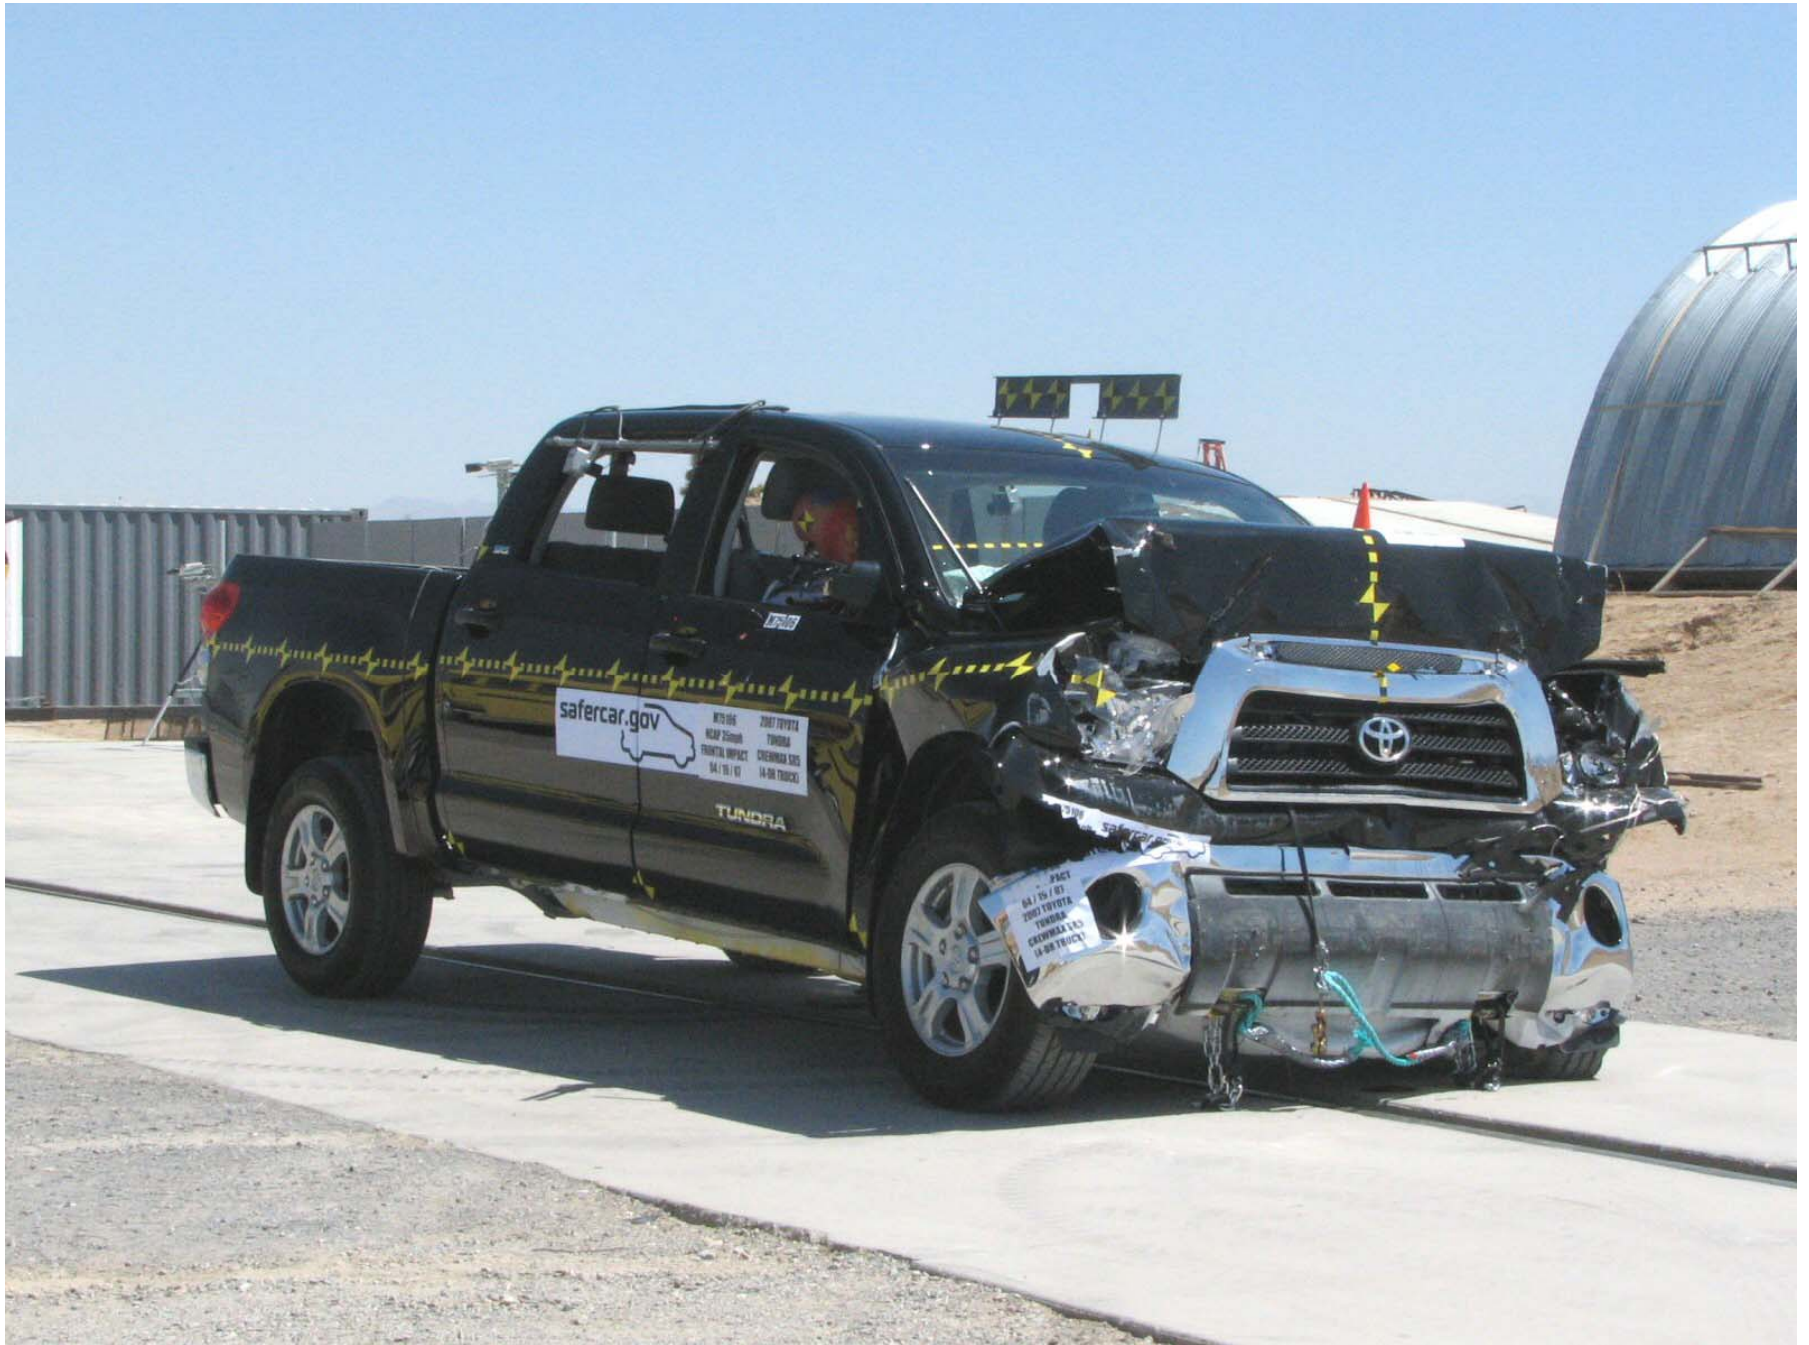
Figure A-13: Post-Test Right Front ¾ View (Vehicle Moved)

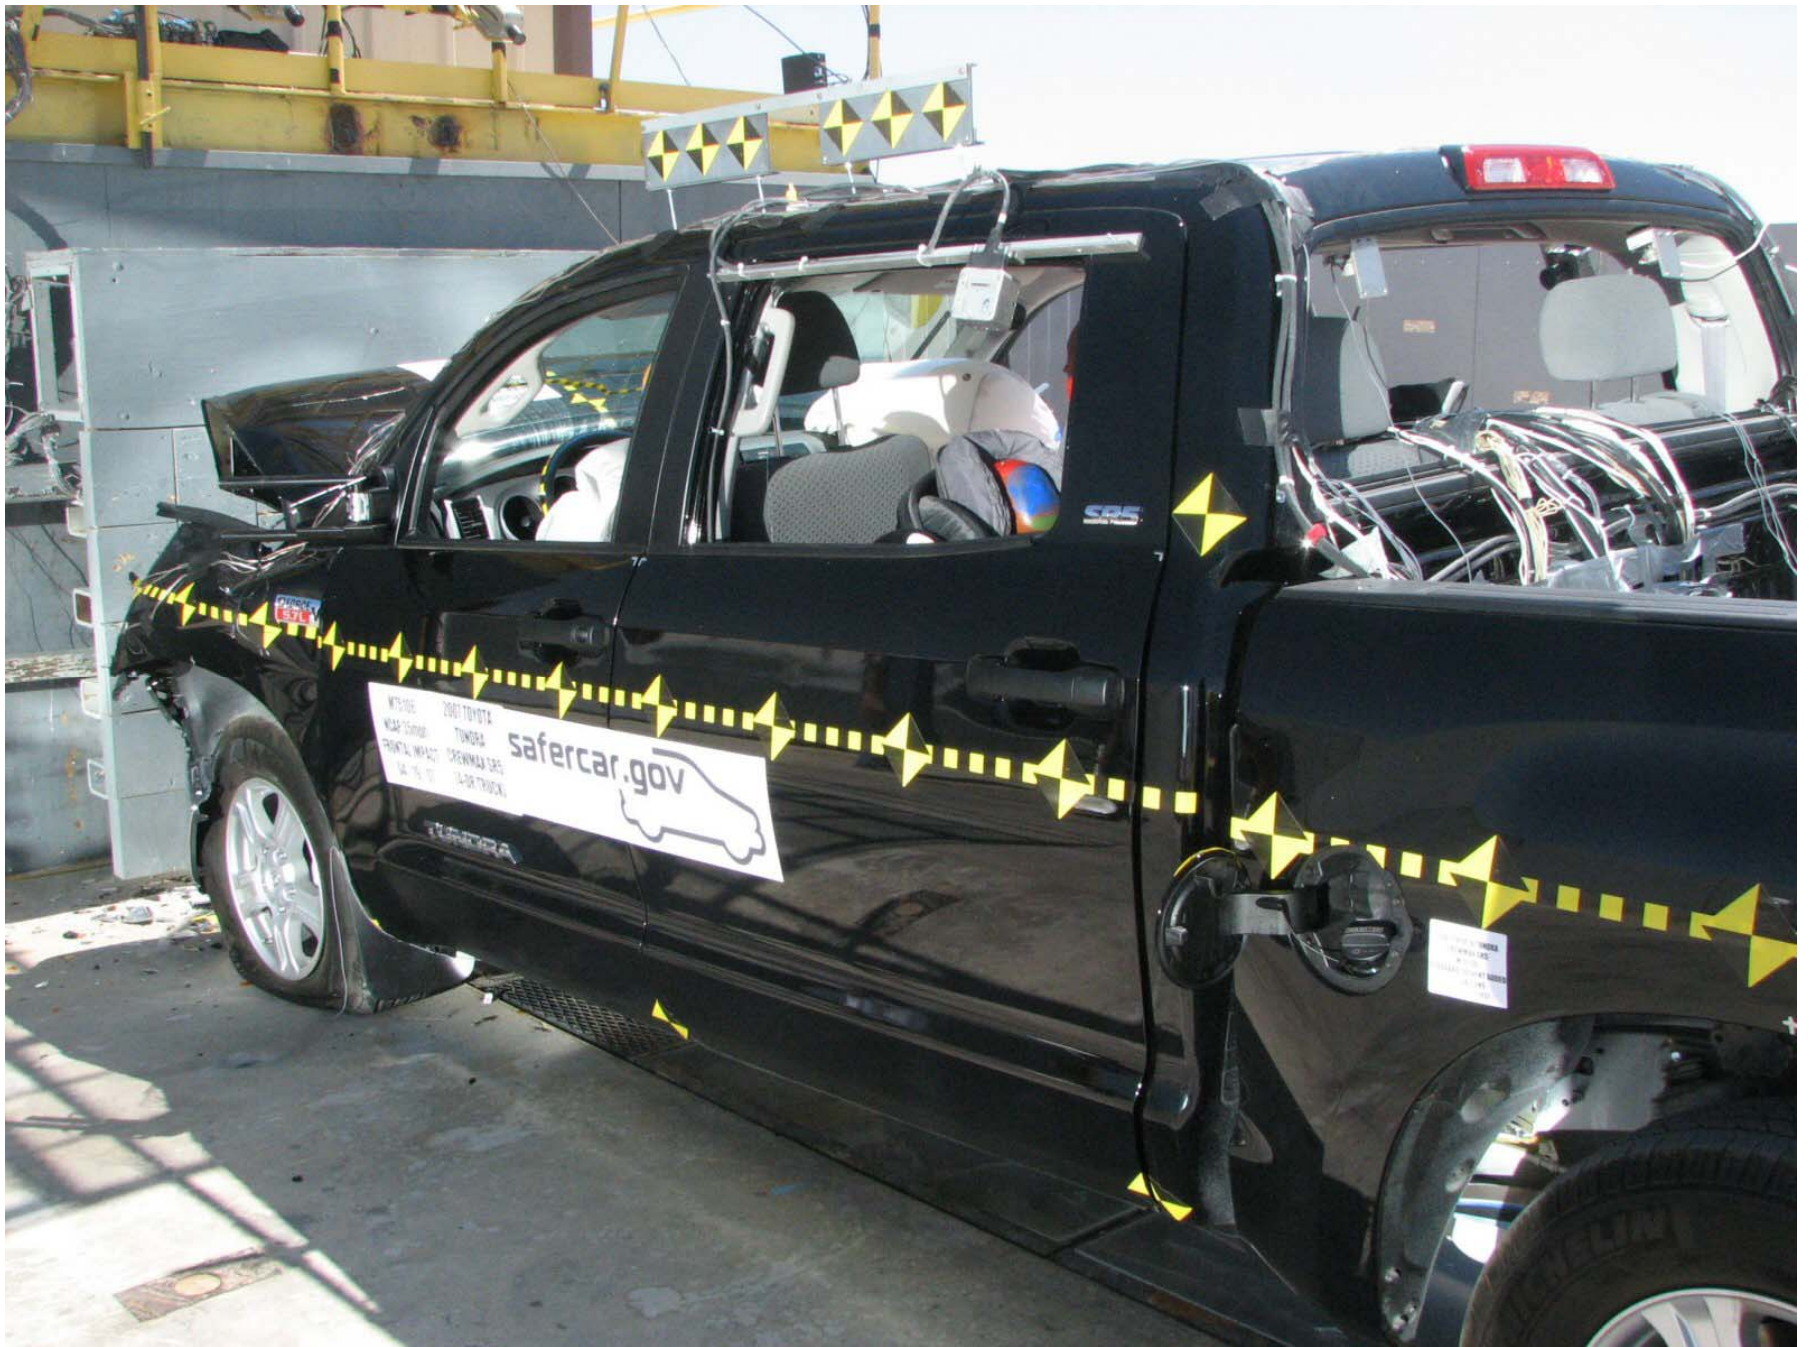
Figure A-16: Post-Test Left Side ¾ View of Doors After Impact

The maximum static crush of the vehicle was 473 mm at crush zone 3 (left side of bumper) and both the driver and the passenger side doors remained closed and latched during the impact event and were operable after the impact.

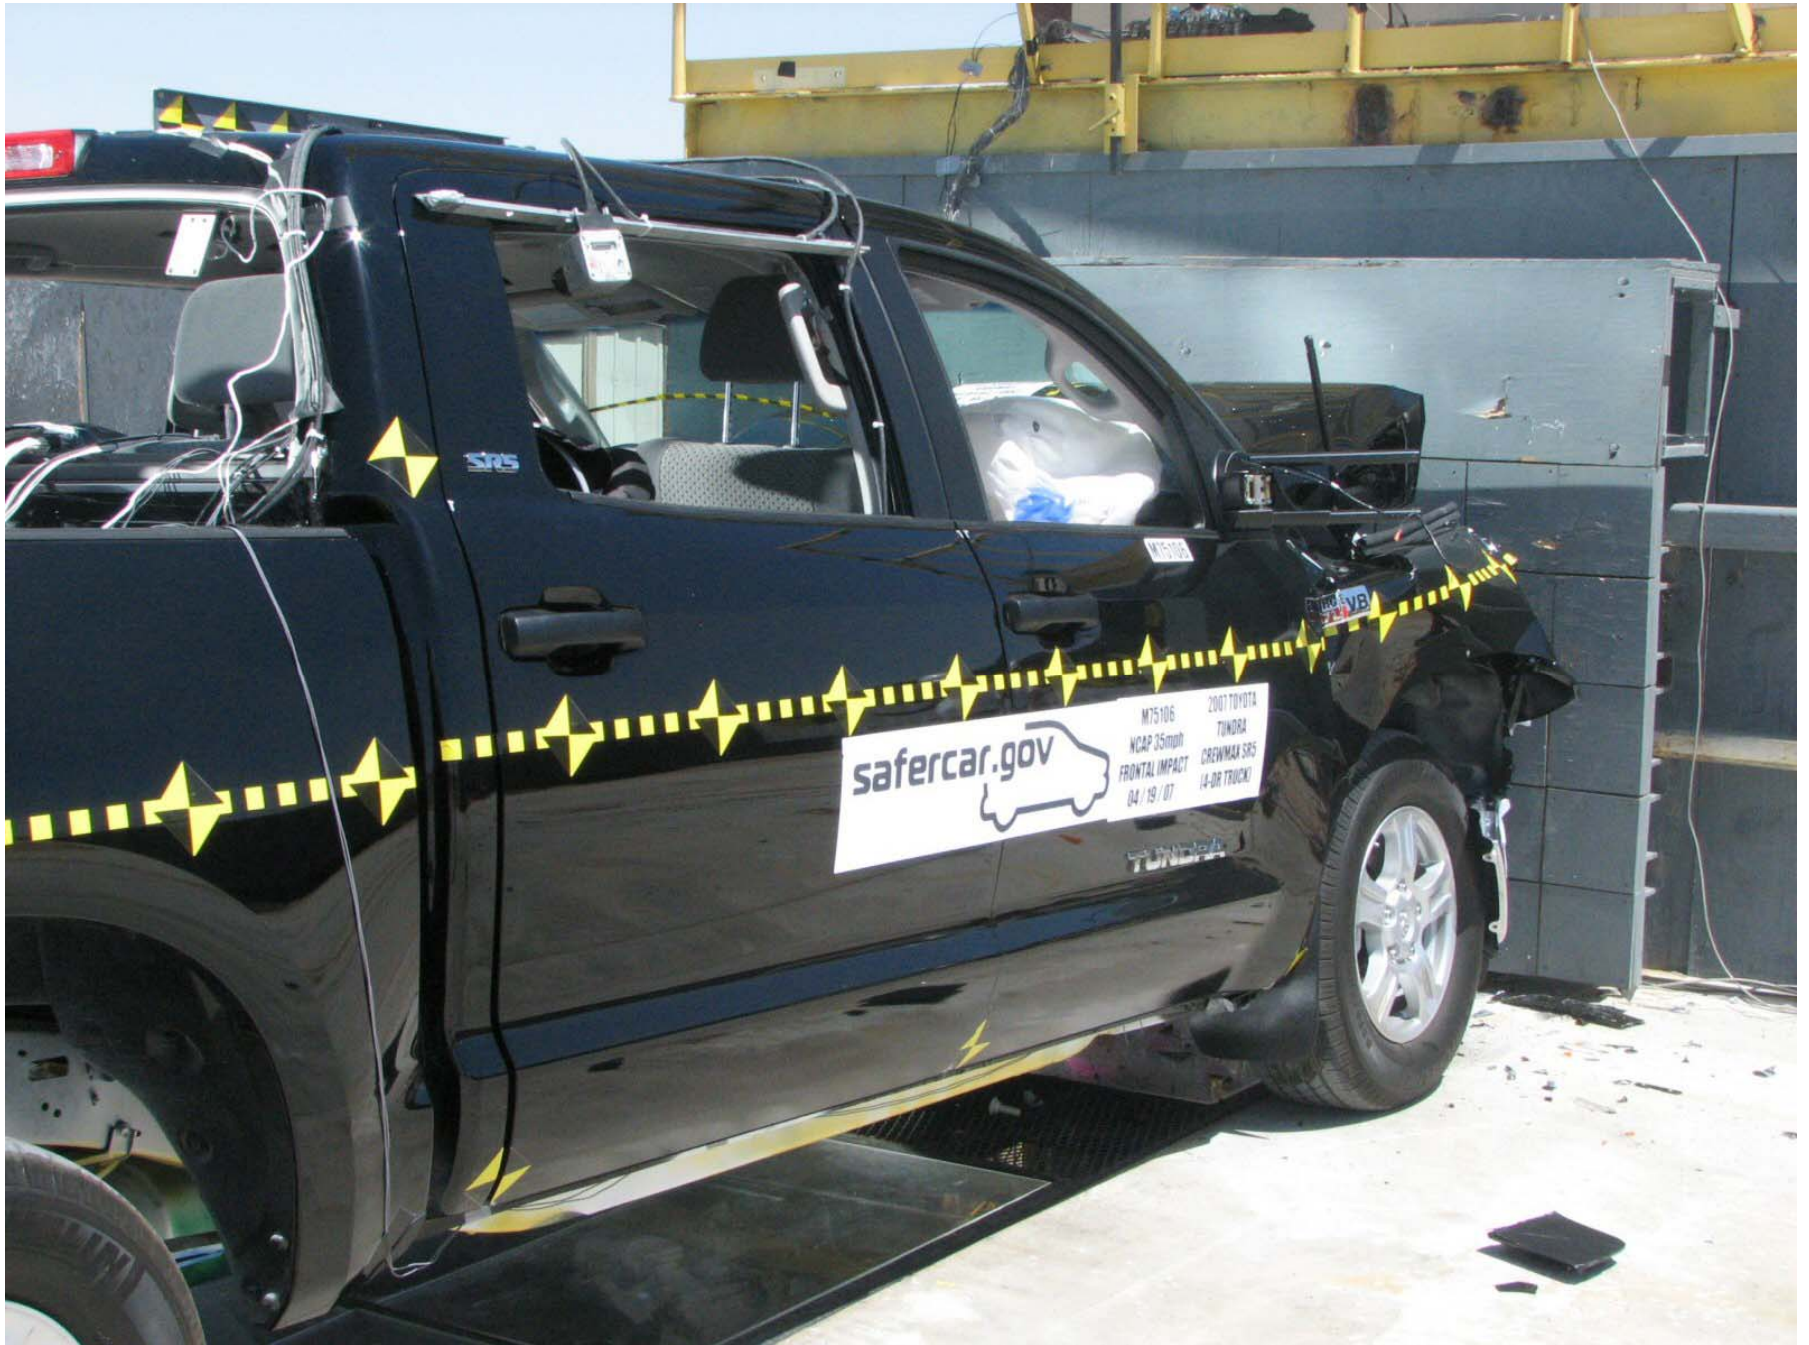
Figure A-17: Post-Test Right Side  $\frac{3}{4}$  View of Doors After Impact

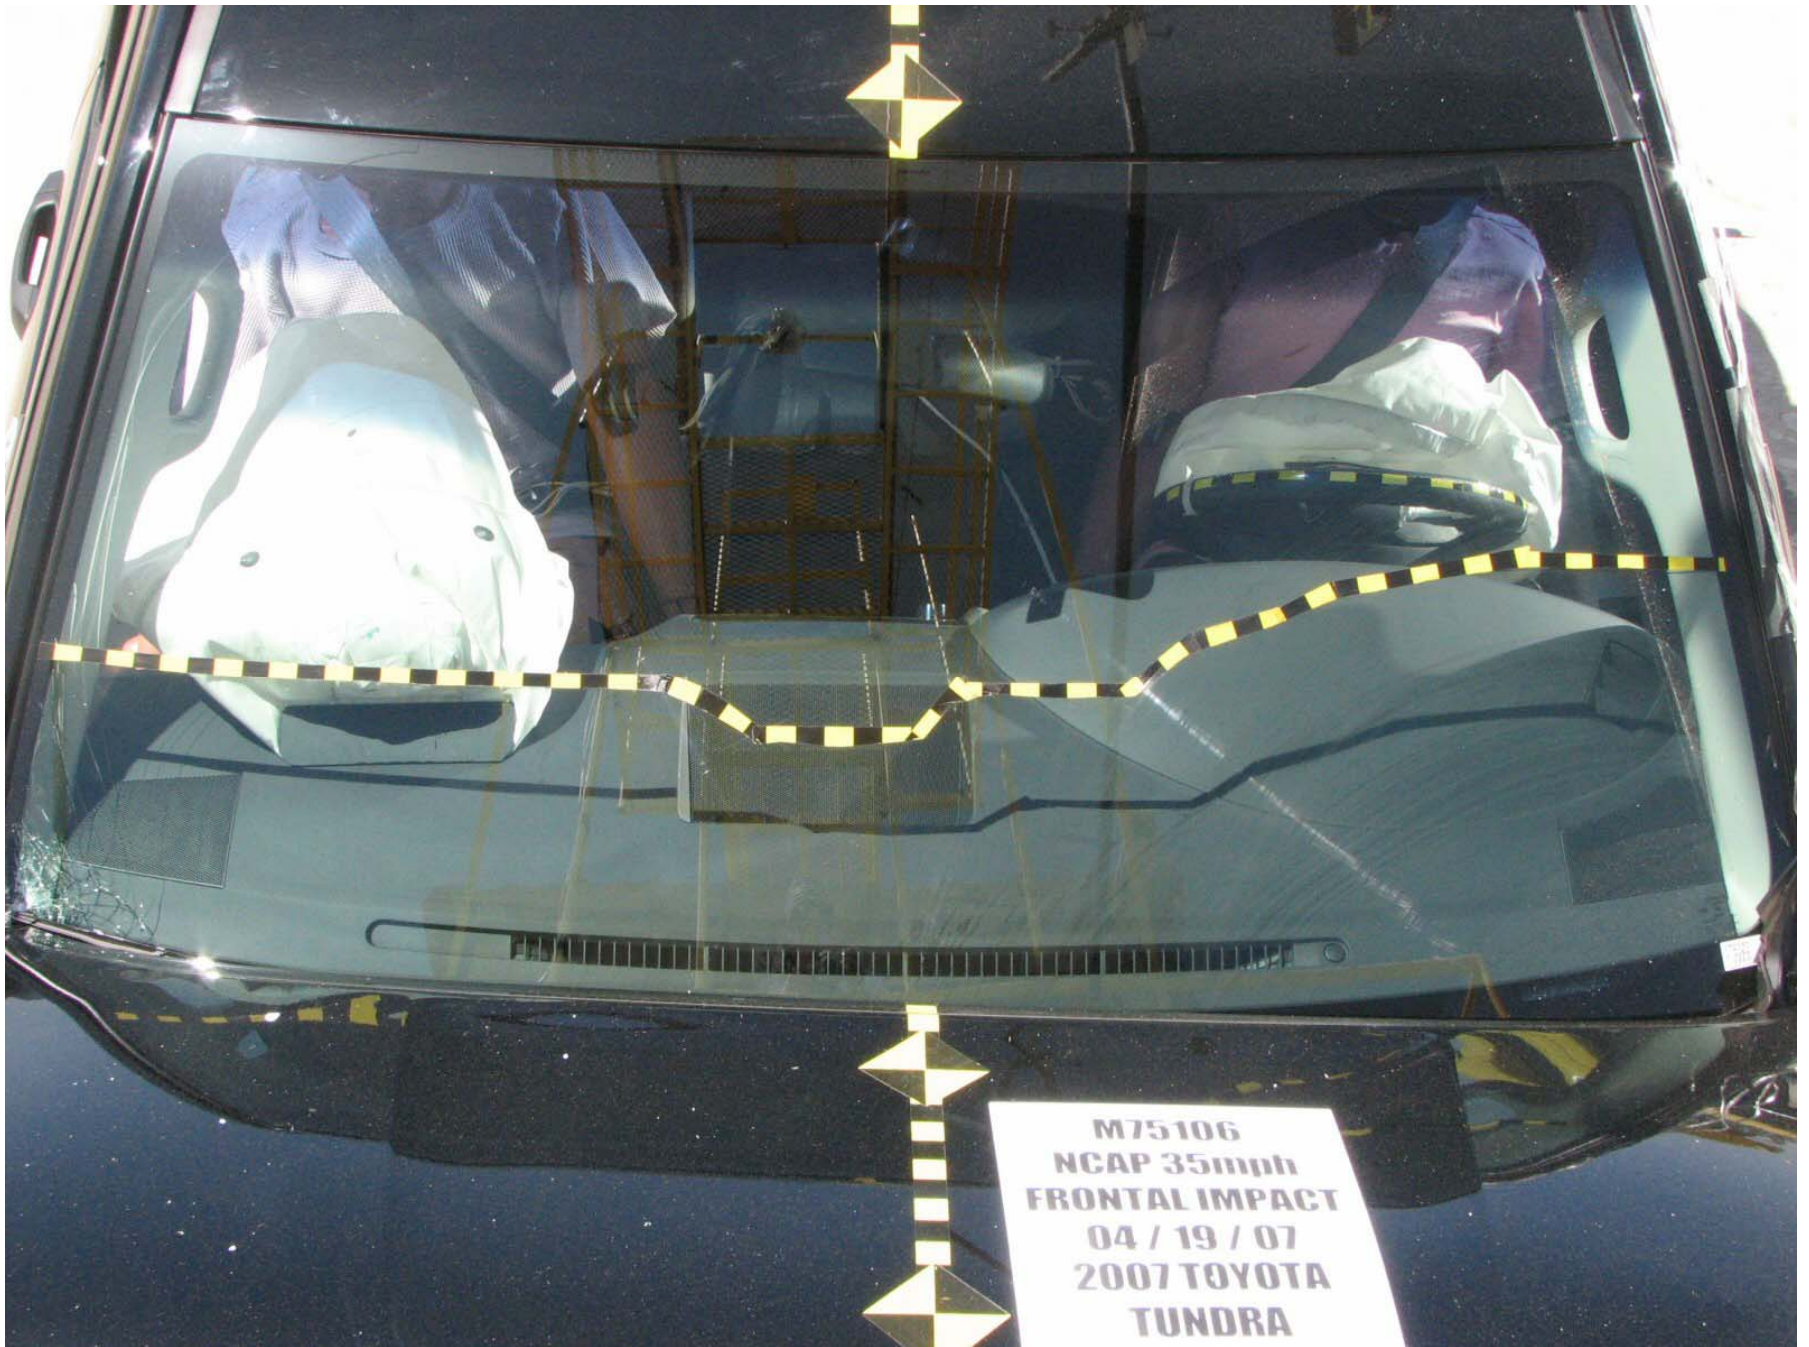
Figure A-19: Post-Test Windshield

There was 100 percent windshield retention and there was no intrusion into the protected zone of the windshield during the impact event. There was no stoddard solvent leakage after the event or during any phase of the static rollover.

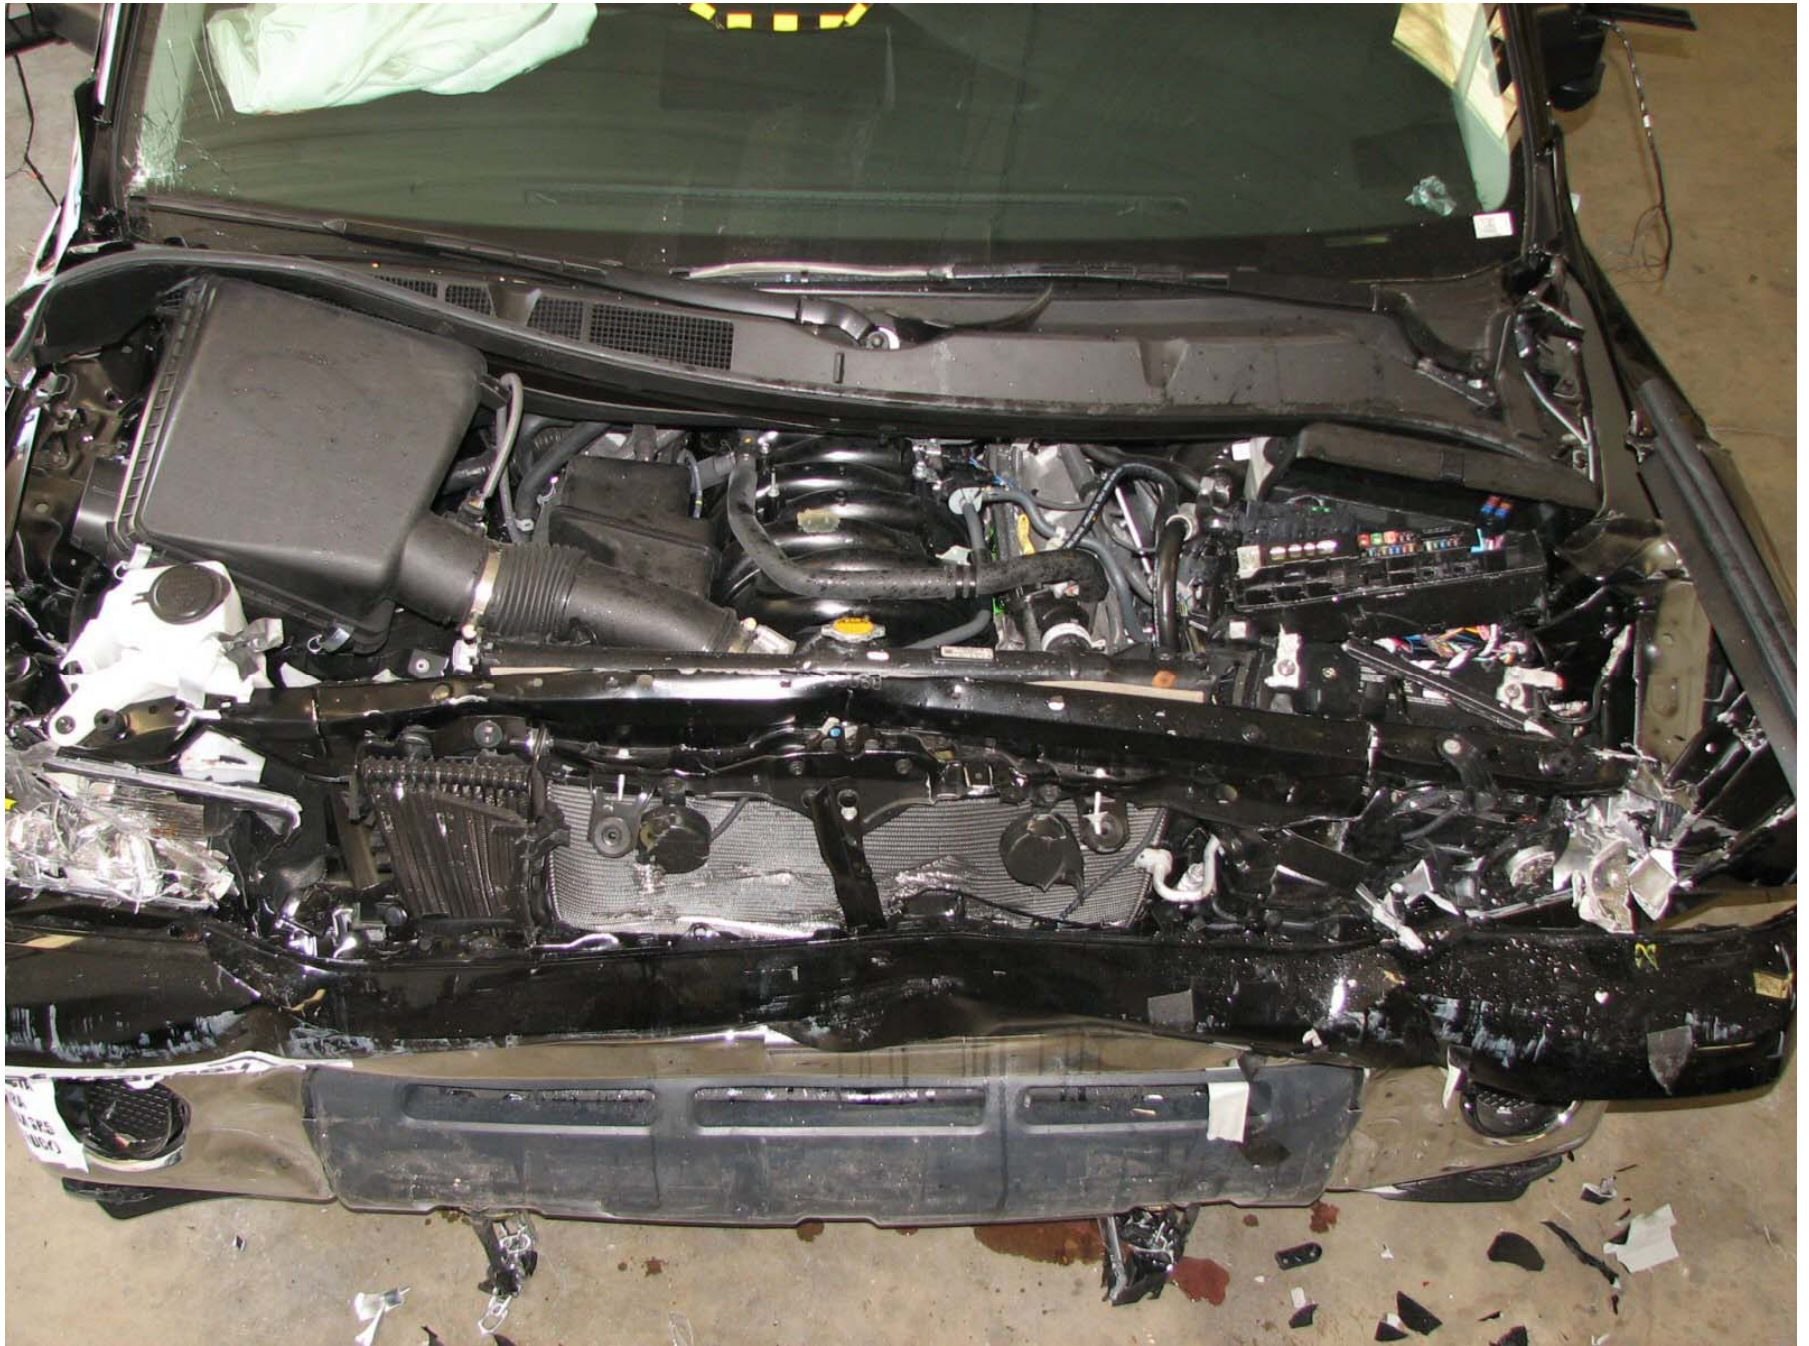
Figure A-21: Post-Test Engine Compartment (Vehicle Moved)

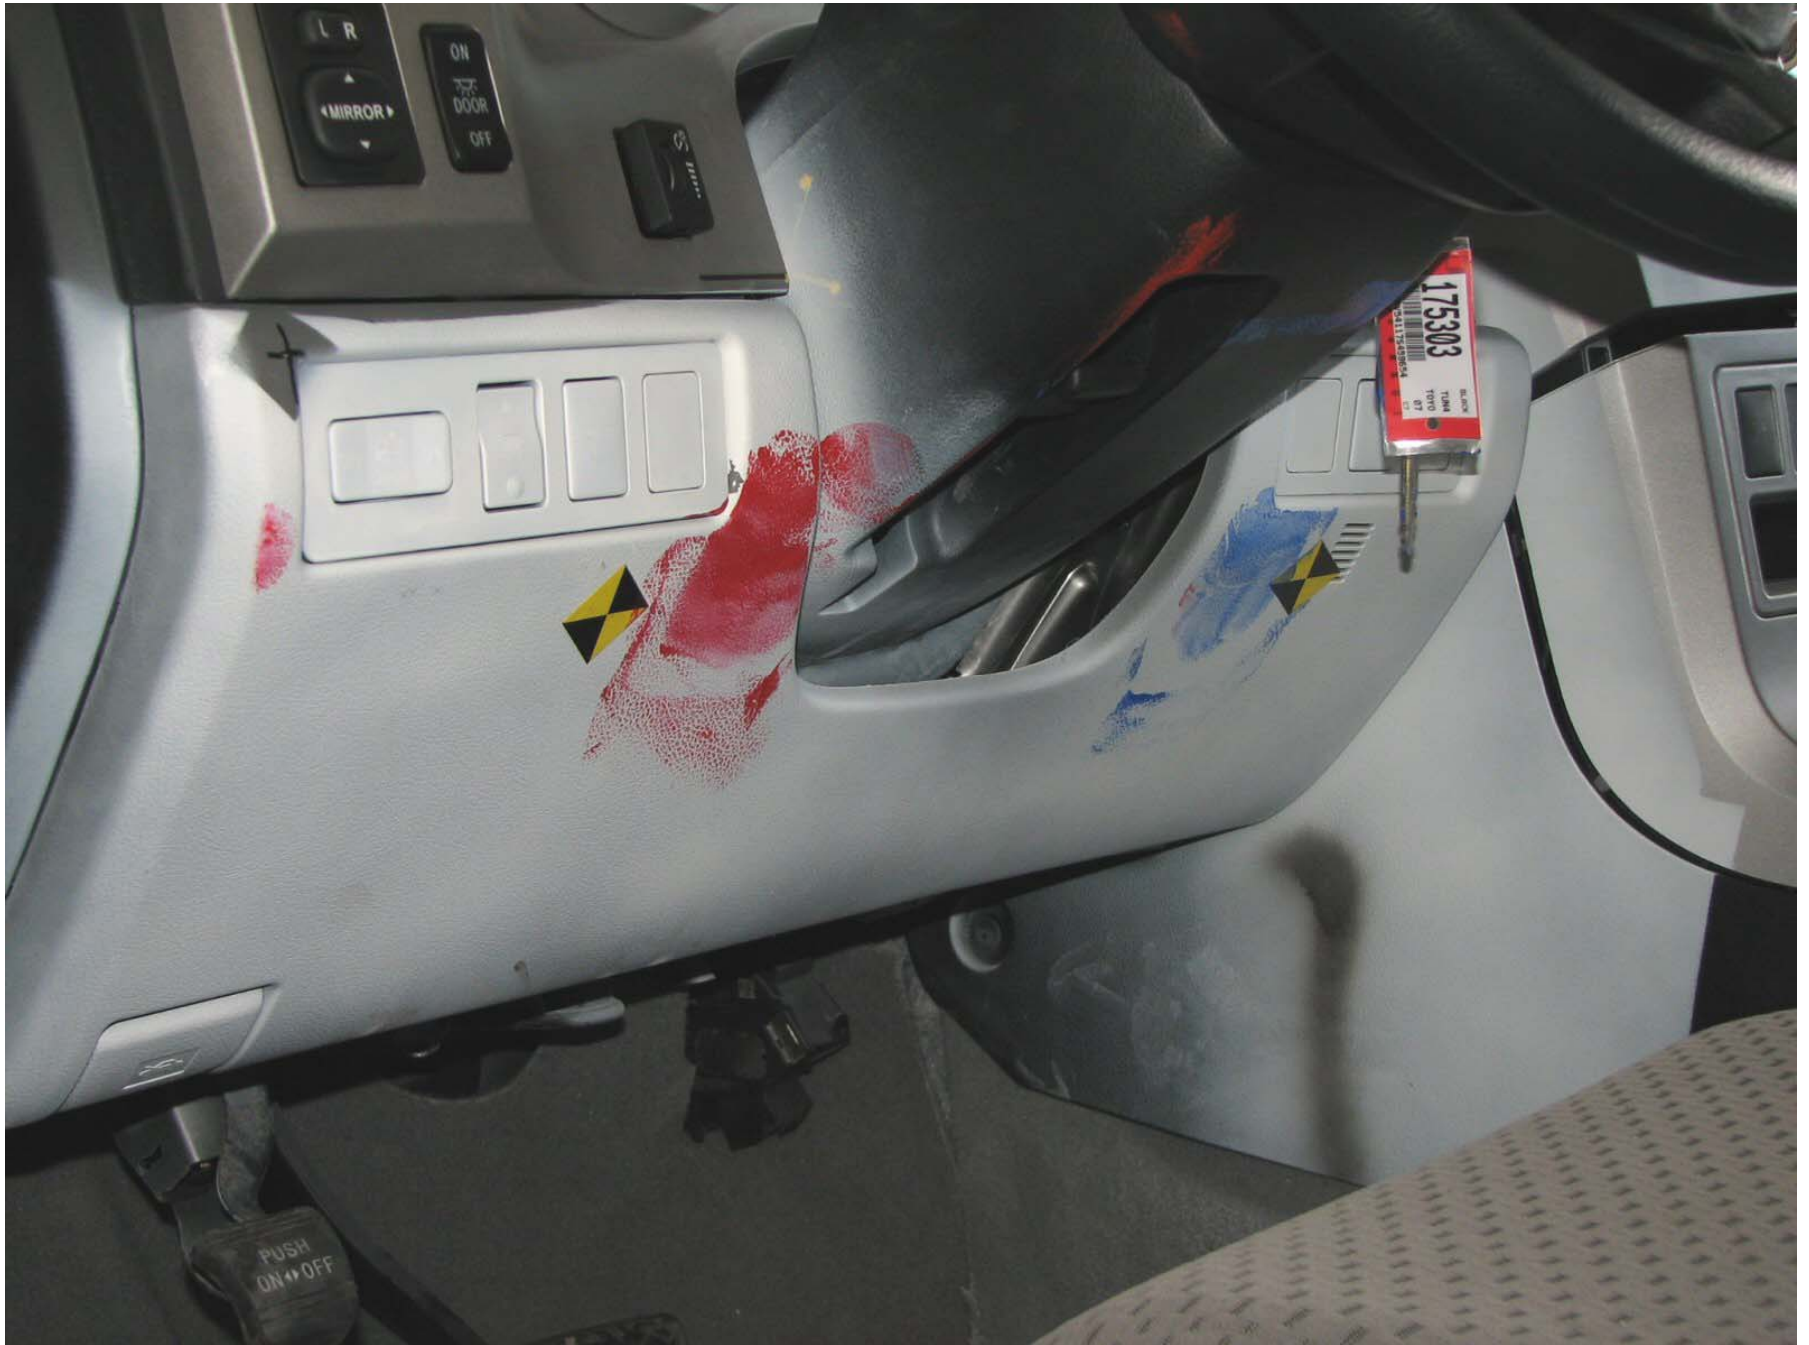
Figure A-39: Post-Test Driver Side Knee Bolster

The driver's visible contact points were as follows: The driver ATD's head and chest contacted the airbag and the abdomen had no contact. Both knees contacted the knee bolster.

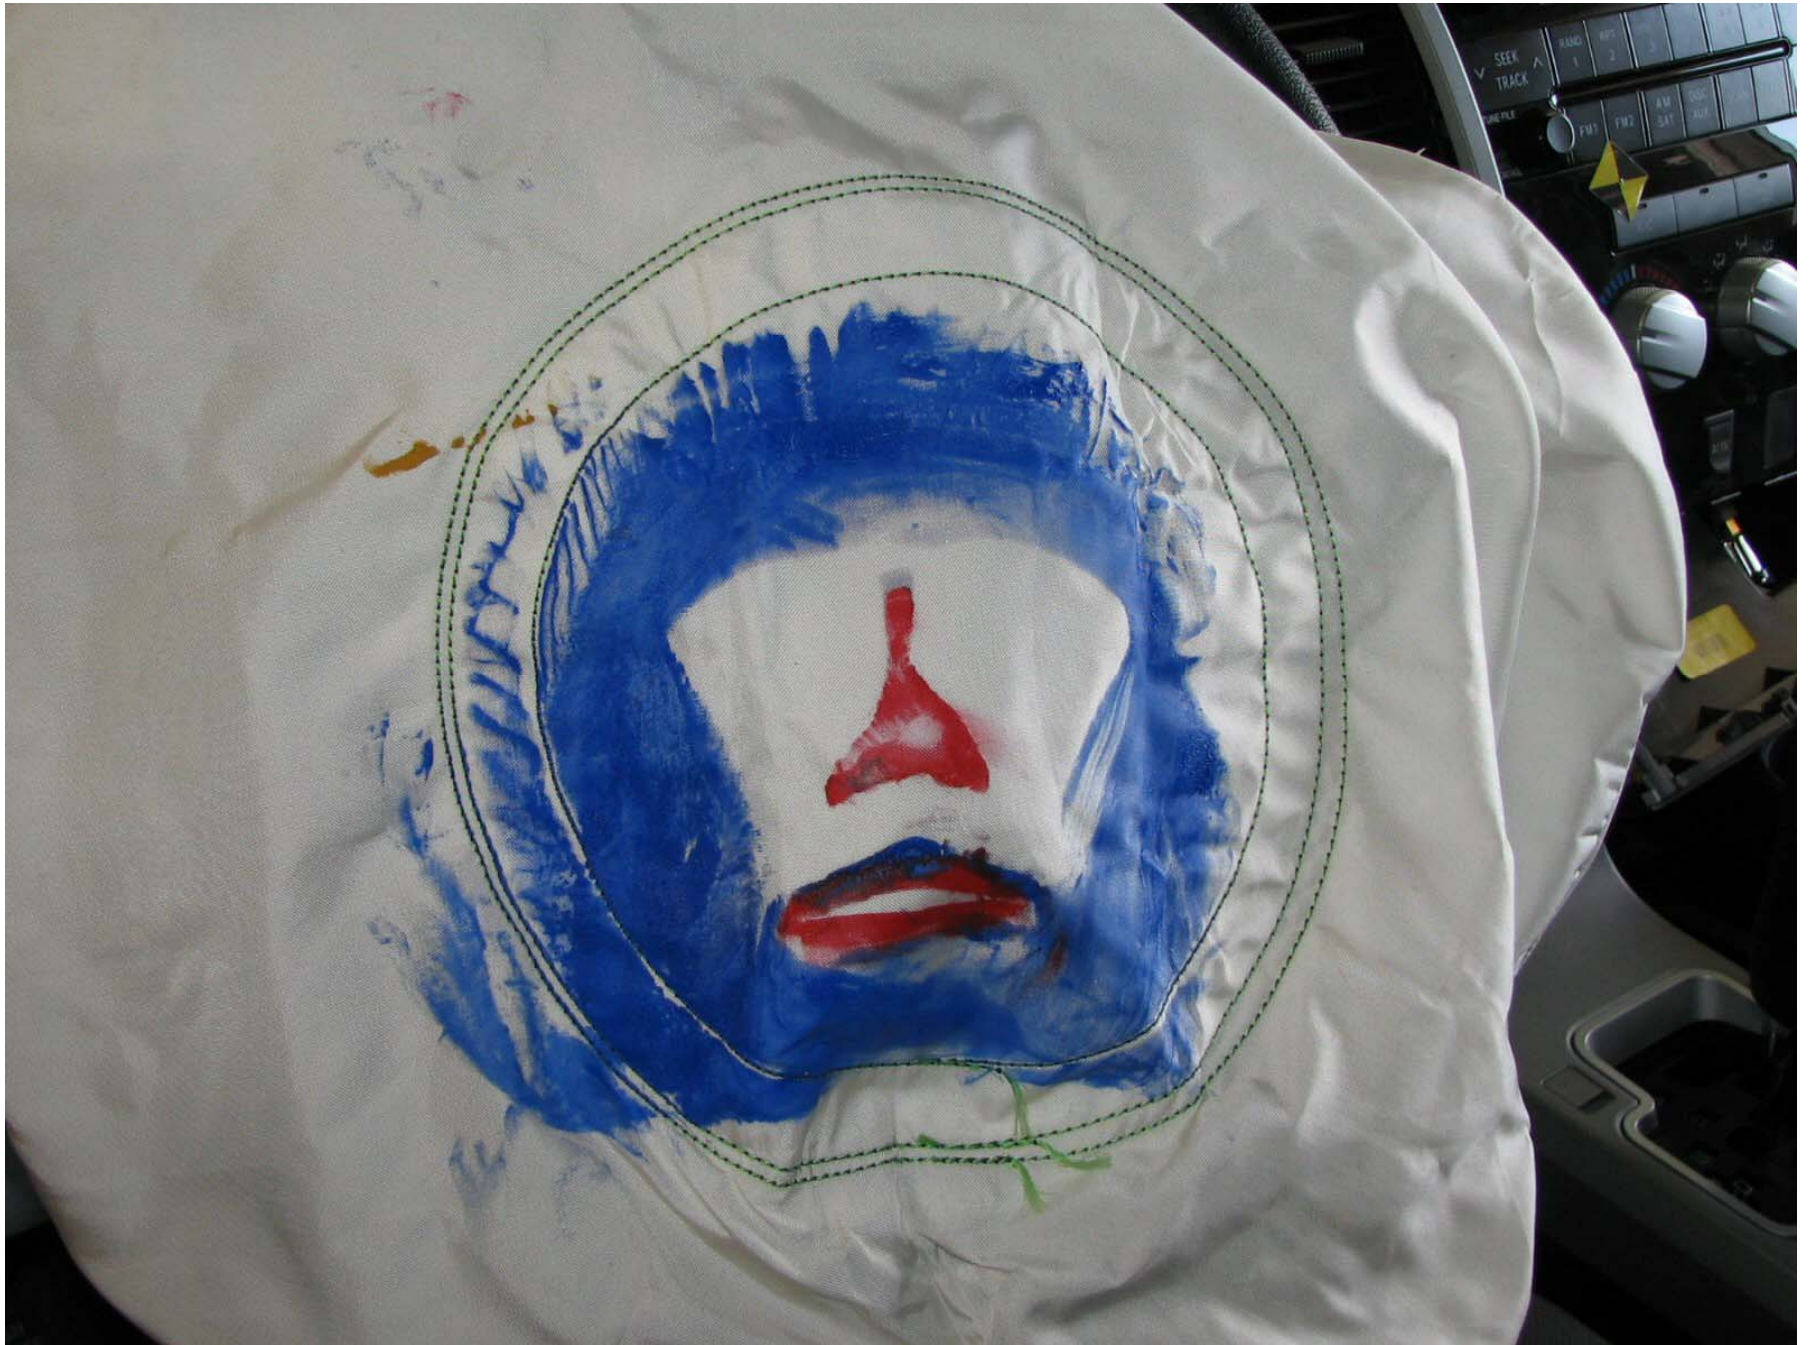
Figure A-43: Post-Test Driver Dummy Airbag Contact
