**REPORT NUMBER TR-P27001-09-NC**

**NEW CAR ASSESSMENT PROGRAM  
FRONTAL BARRIER IMPACT TEST**

**TOYOTA MOTOR MANUFACTURING  
2007 TOYOTA TUNDRA CREWMAX SR5  
4-DOOR TRUCK**

**NHTSA NUMBER: M75106**

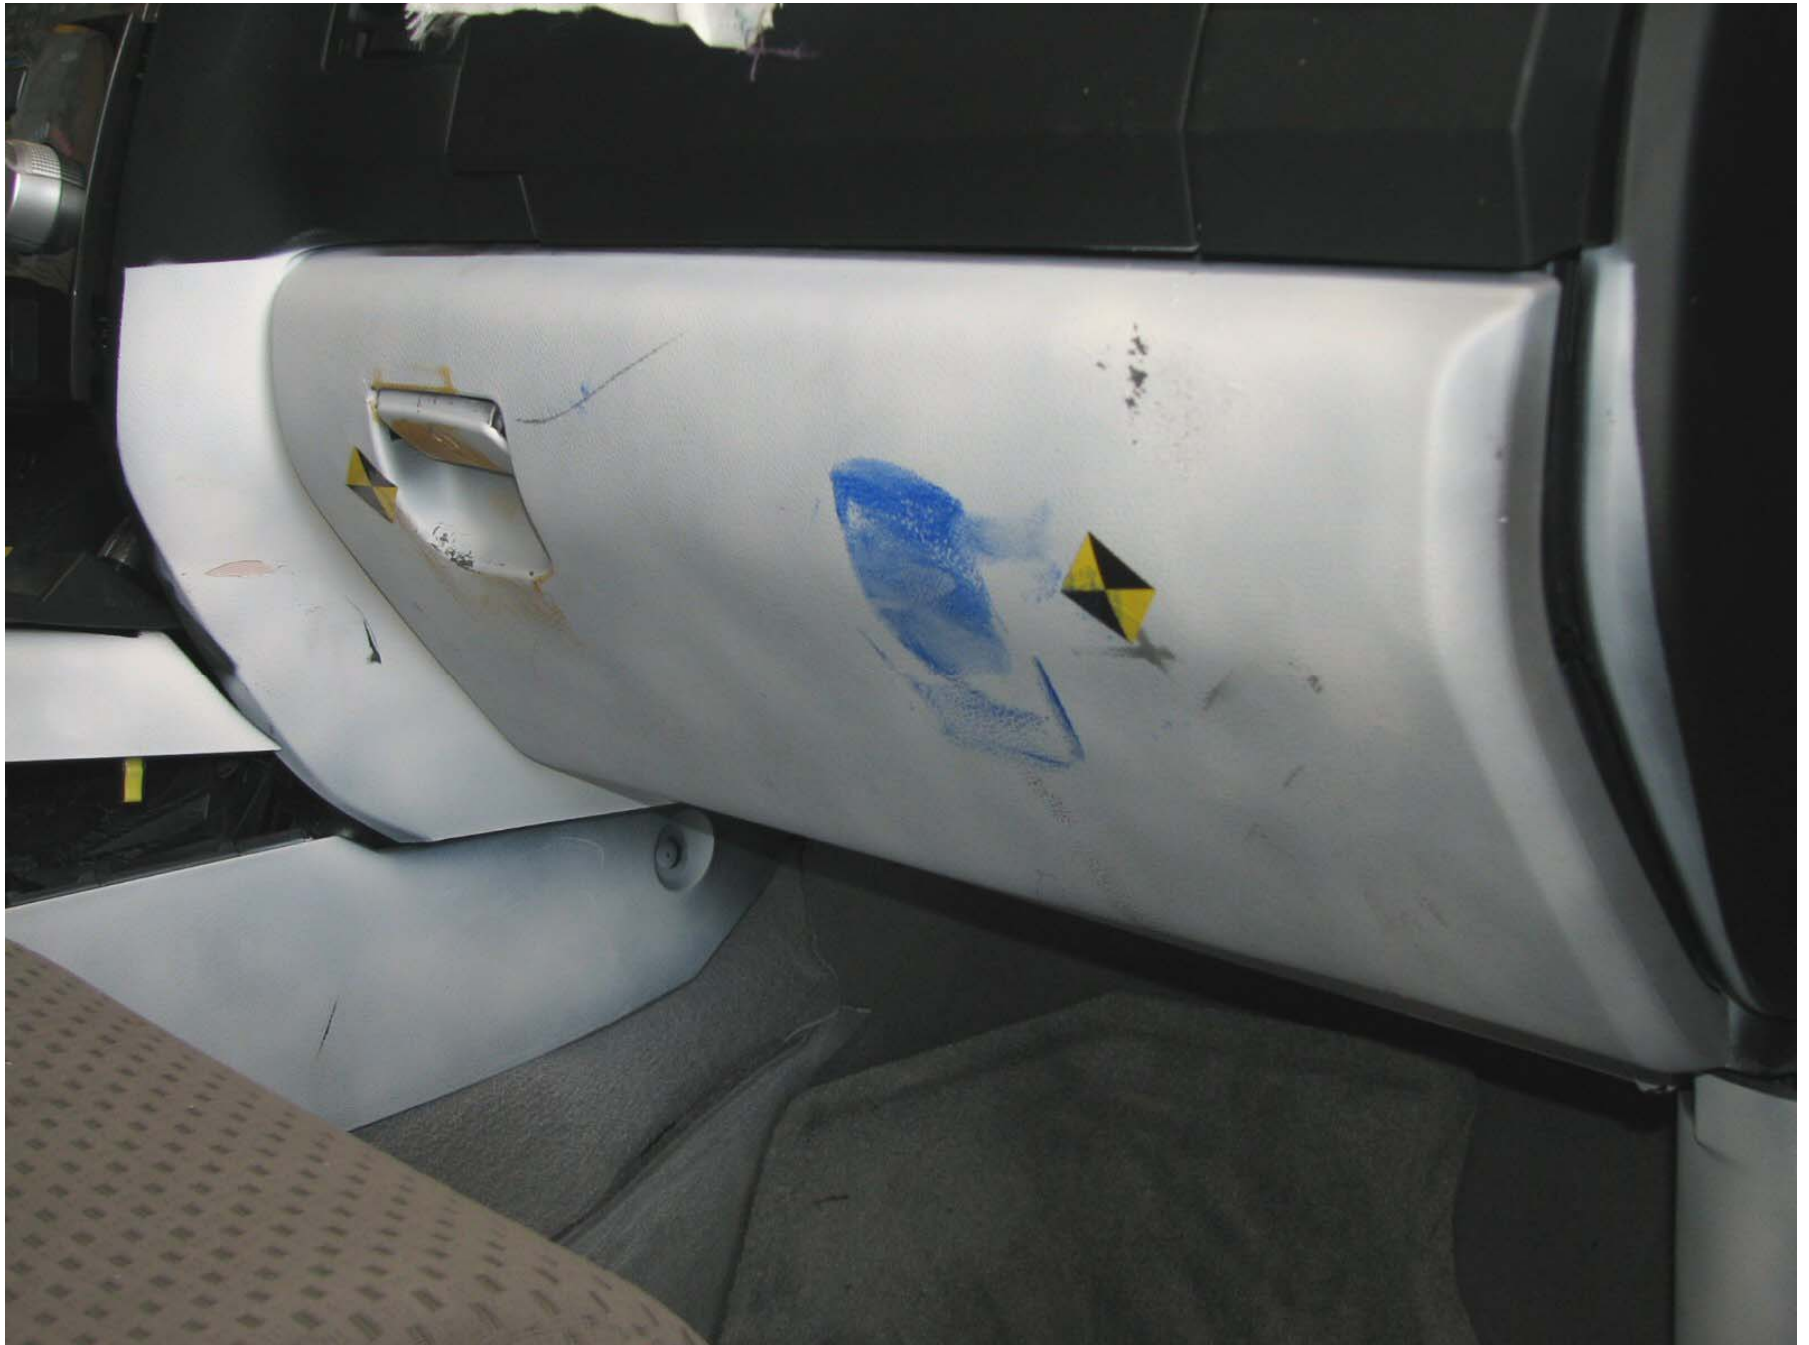
Figure A-53: Post-Test Passenger Side Glove Box

The passenger's visible contact points were as follows: The passenger ATD's head and chest contacted the airbag. Both knees contacted the glove box.

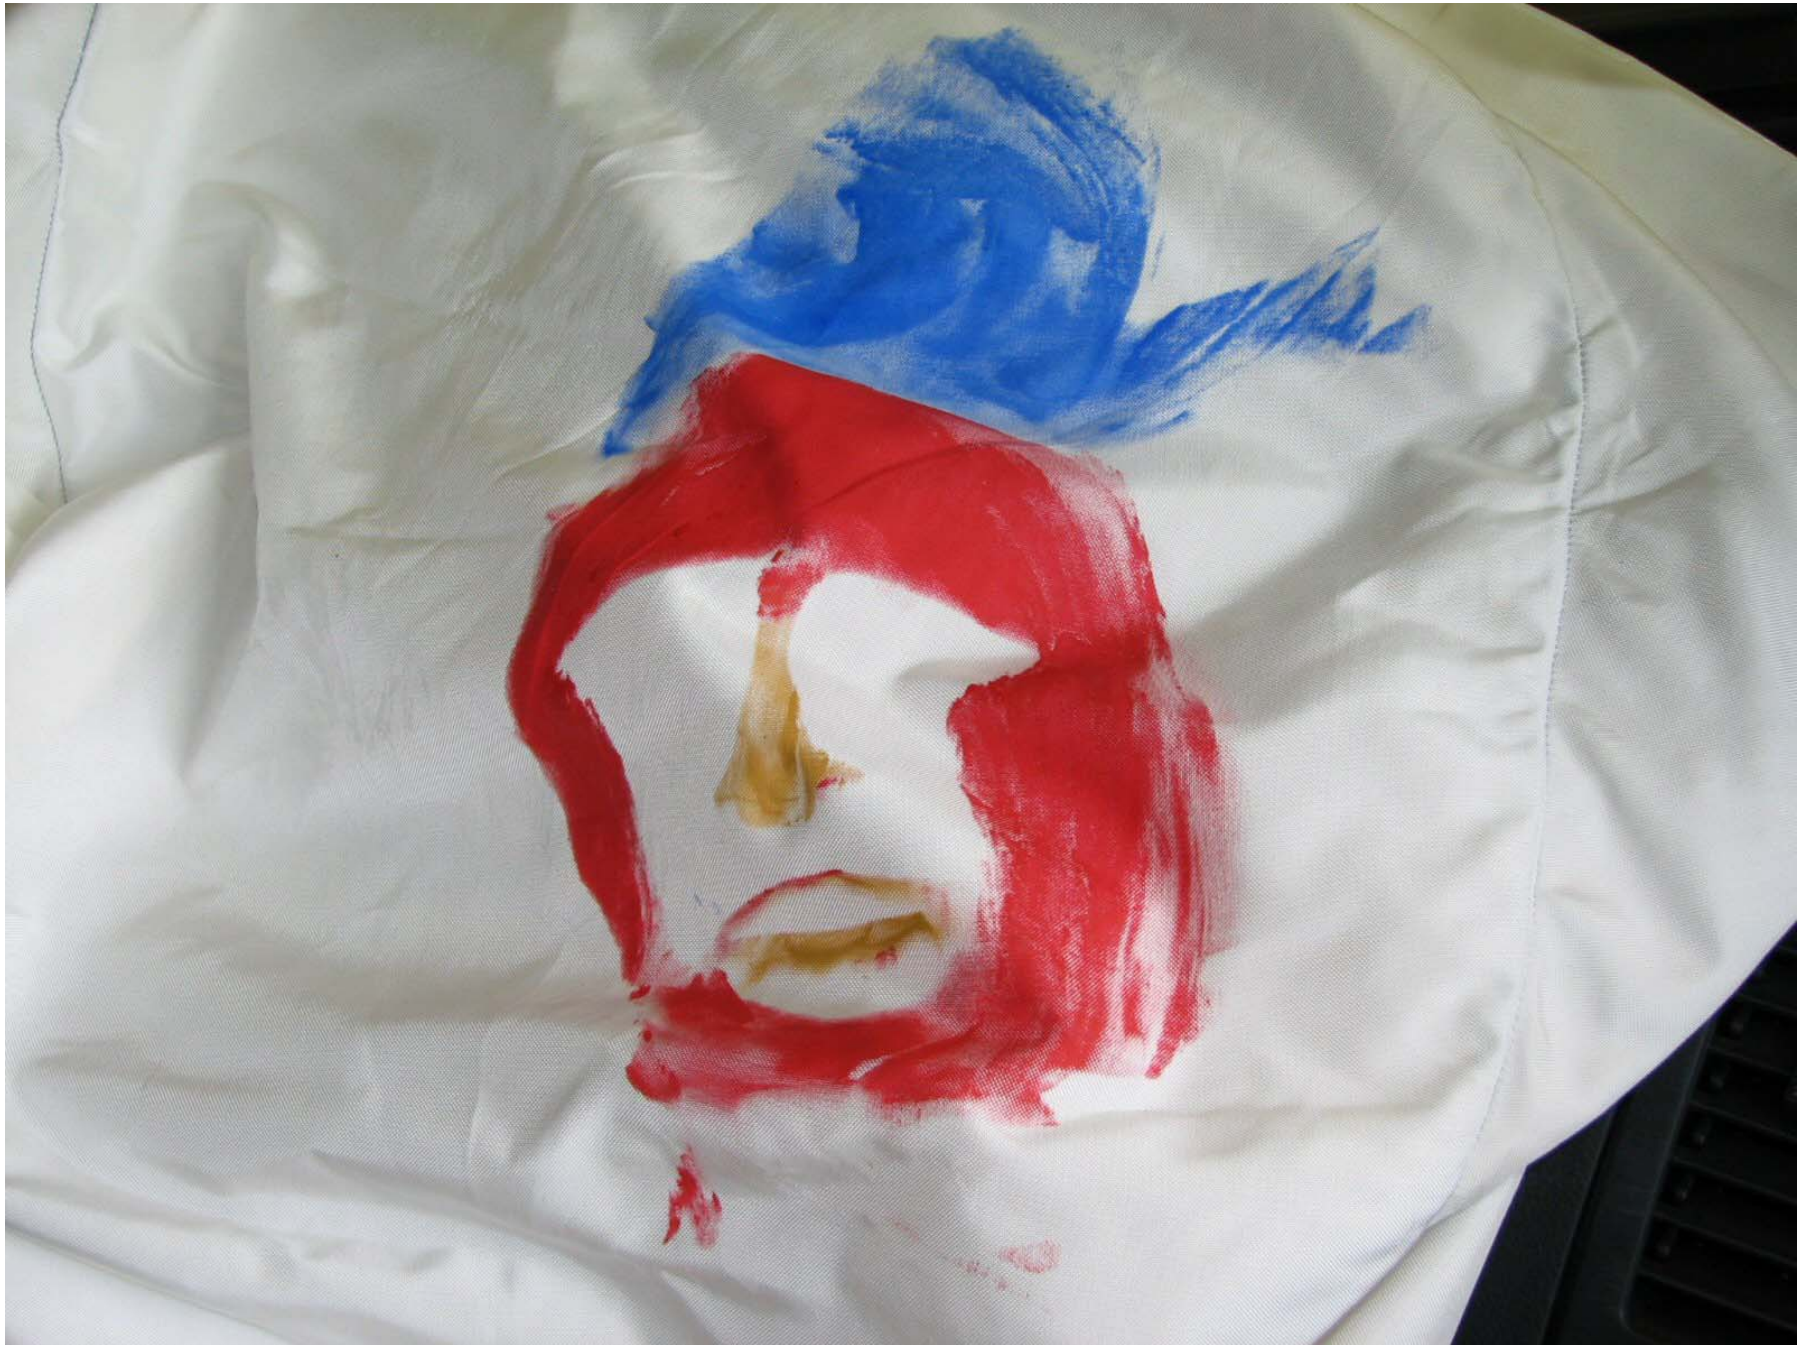
Figure A-57: Post-Test Passenger Dummy Airbag Contact

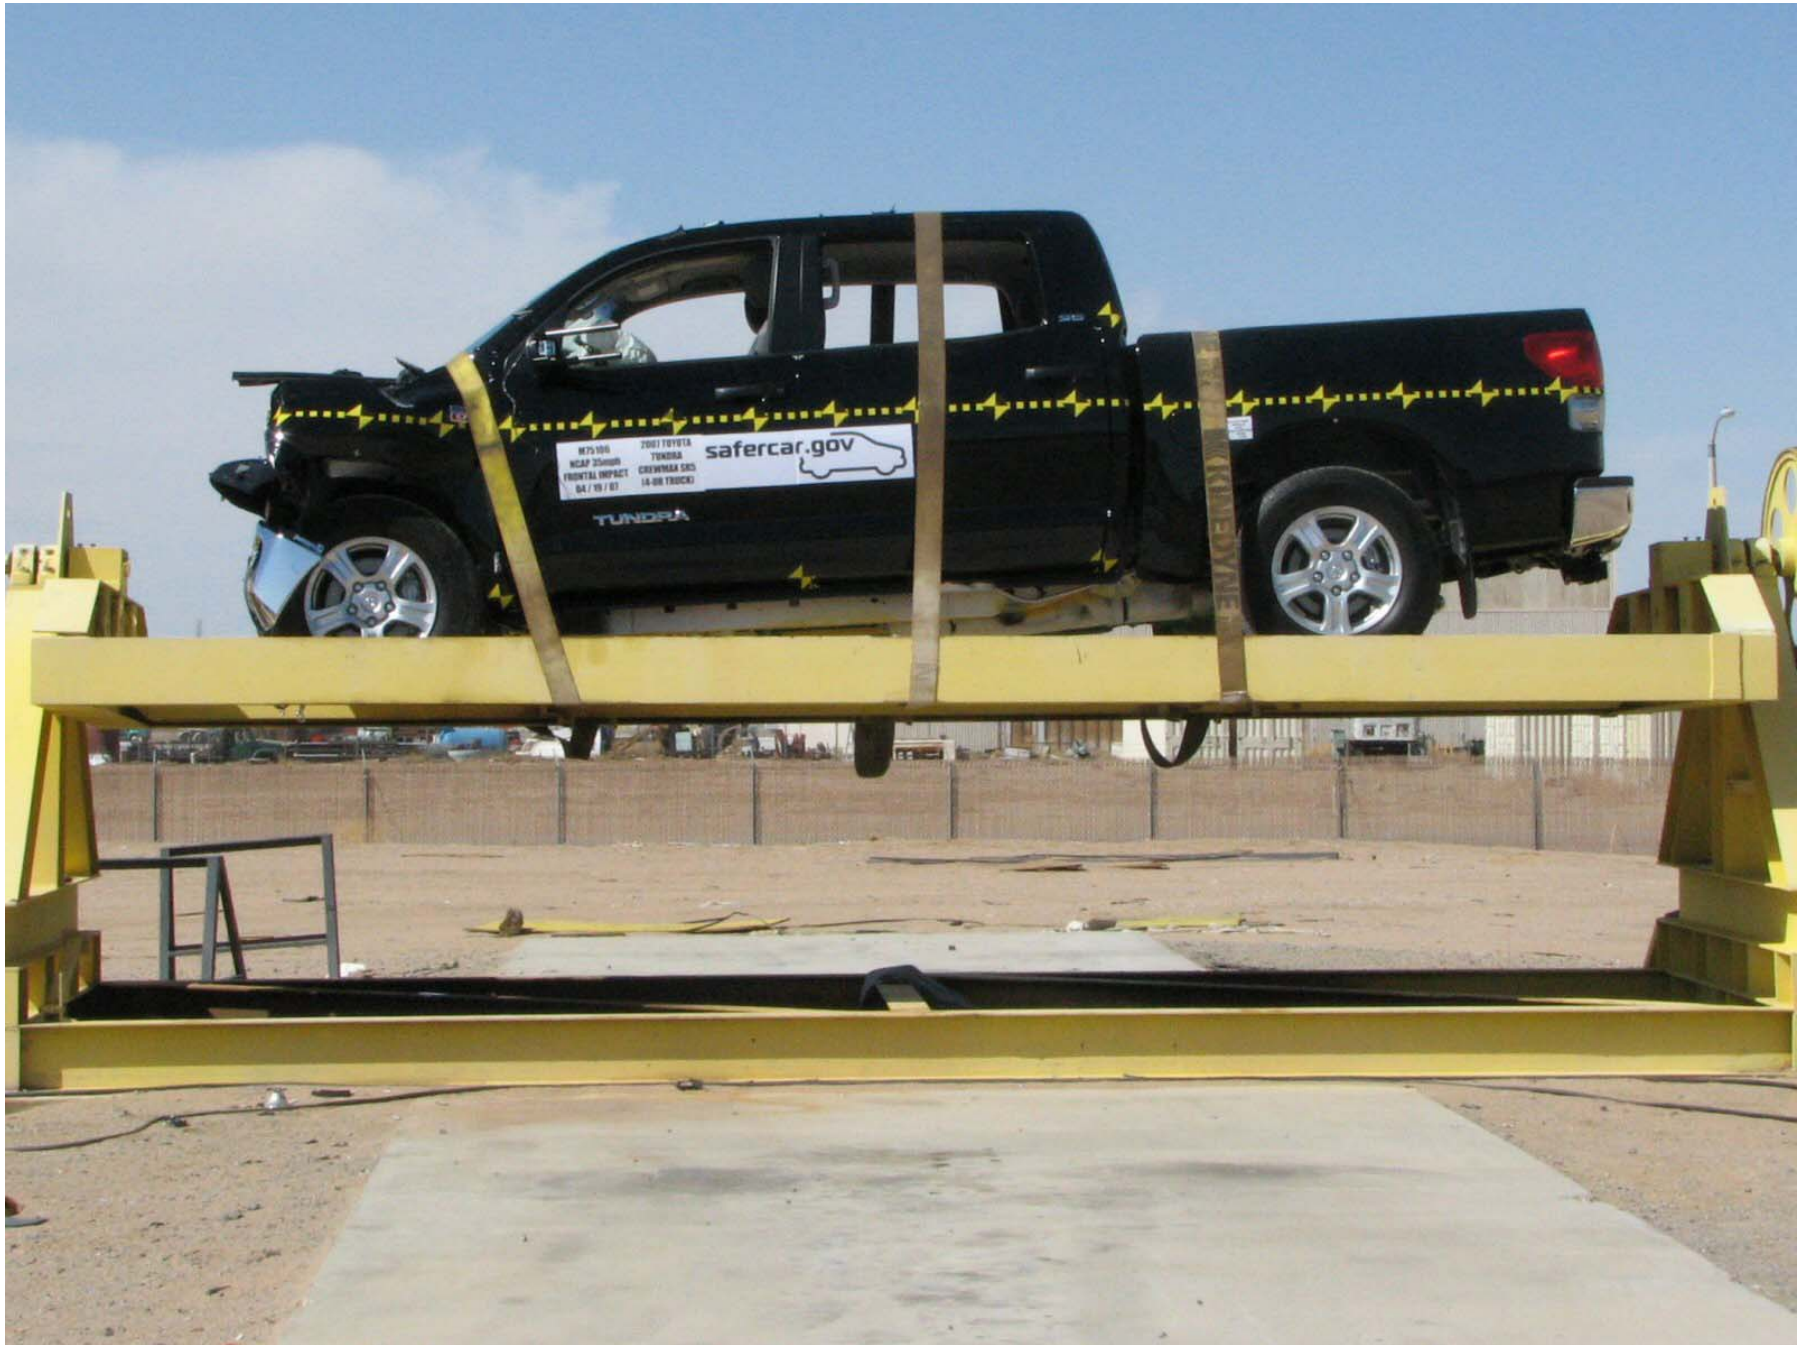
Figure A-58: Vehicle on Rollover Device (0°)

1. The specified fixture rollover rate for each 90° of rotation is 60 to 120 seconds.
2. The position hold time at each position is 300 seconds (minimum).
3. No solvent leakage occurred during rollover.

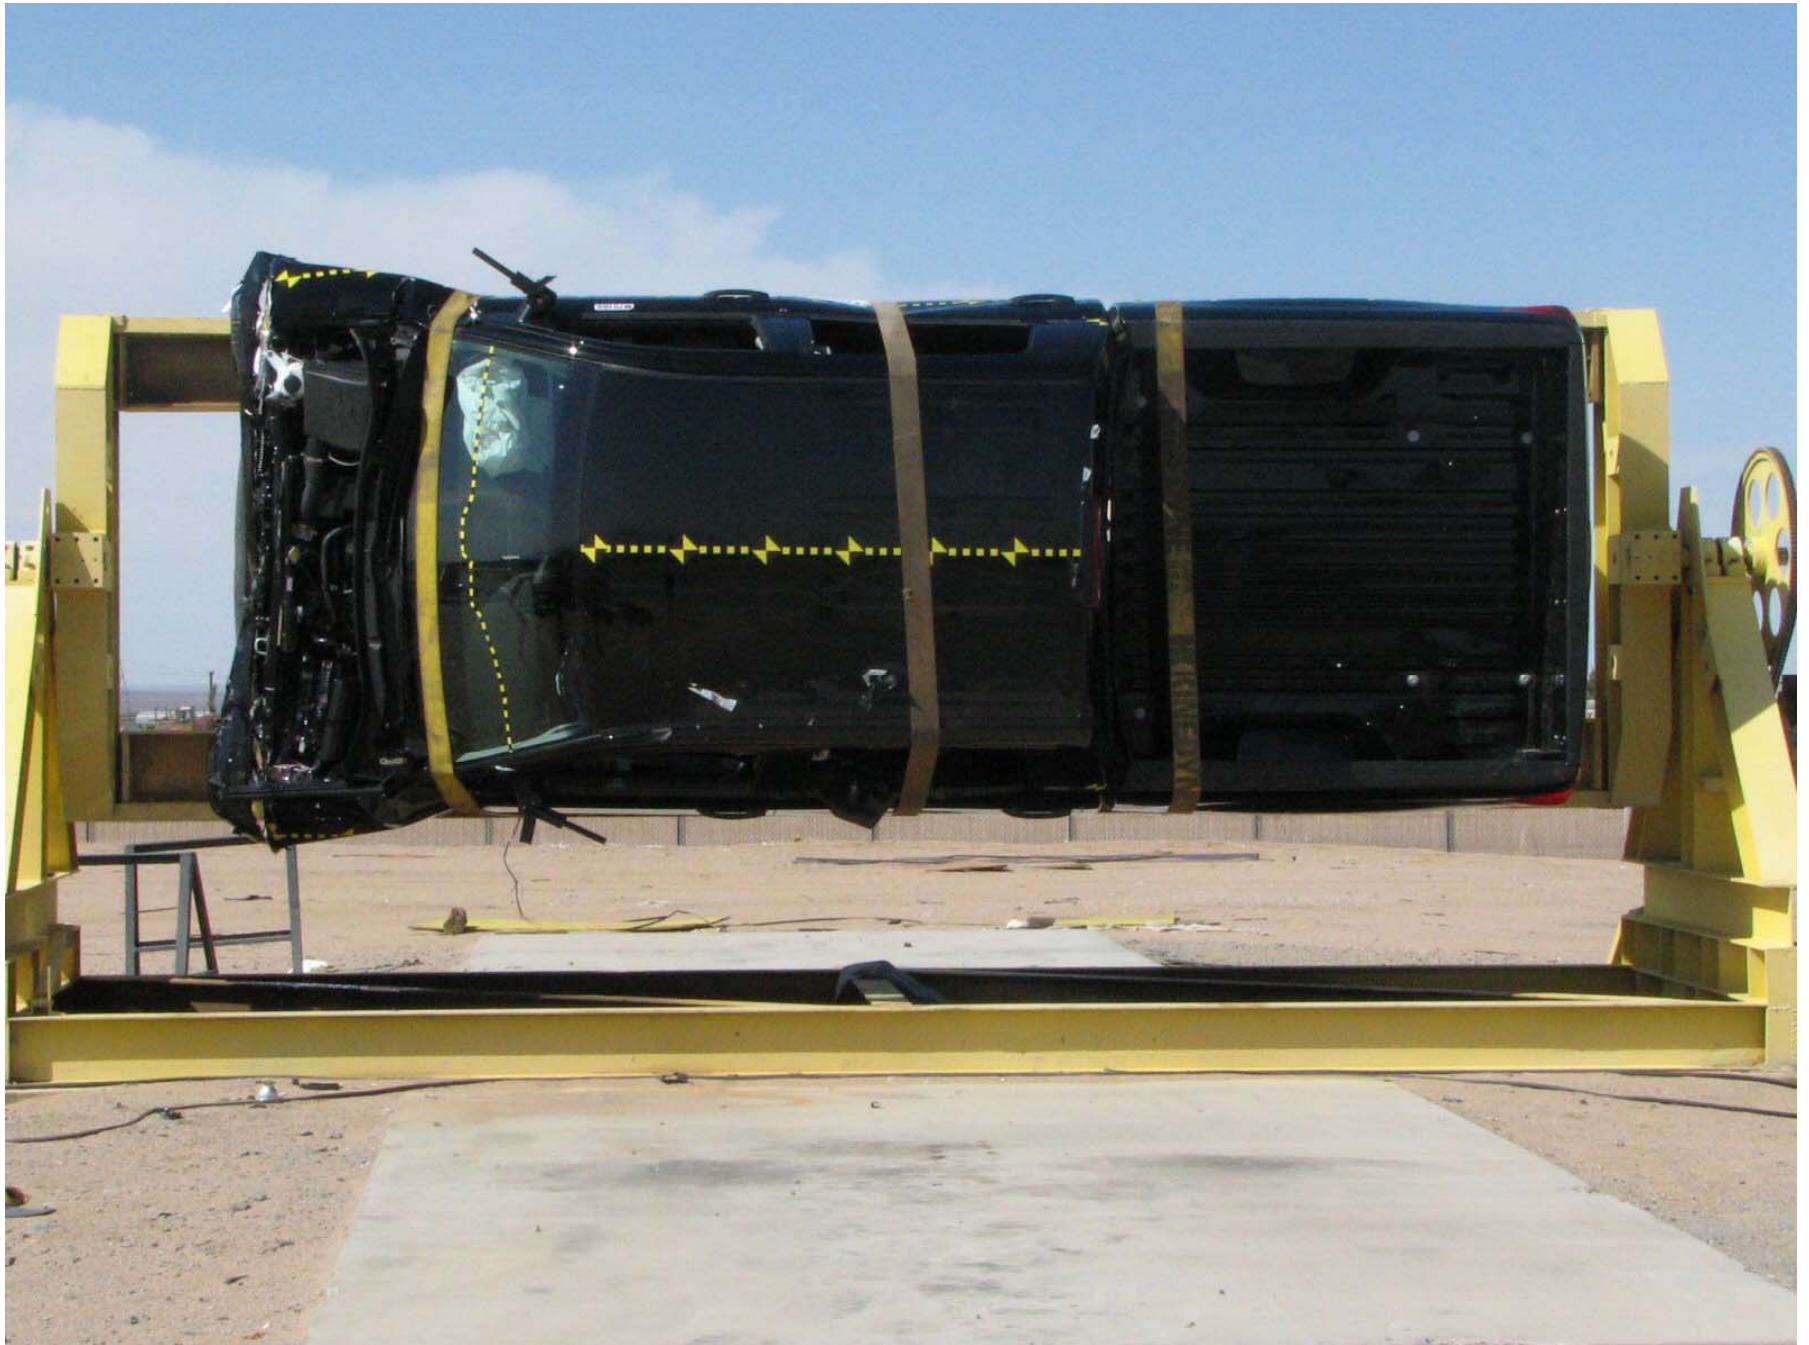
Figure A-59: Vehicle on Rollover Device (90°)

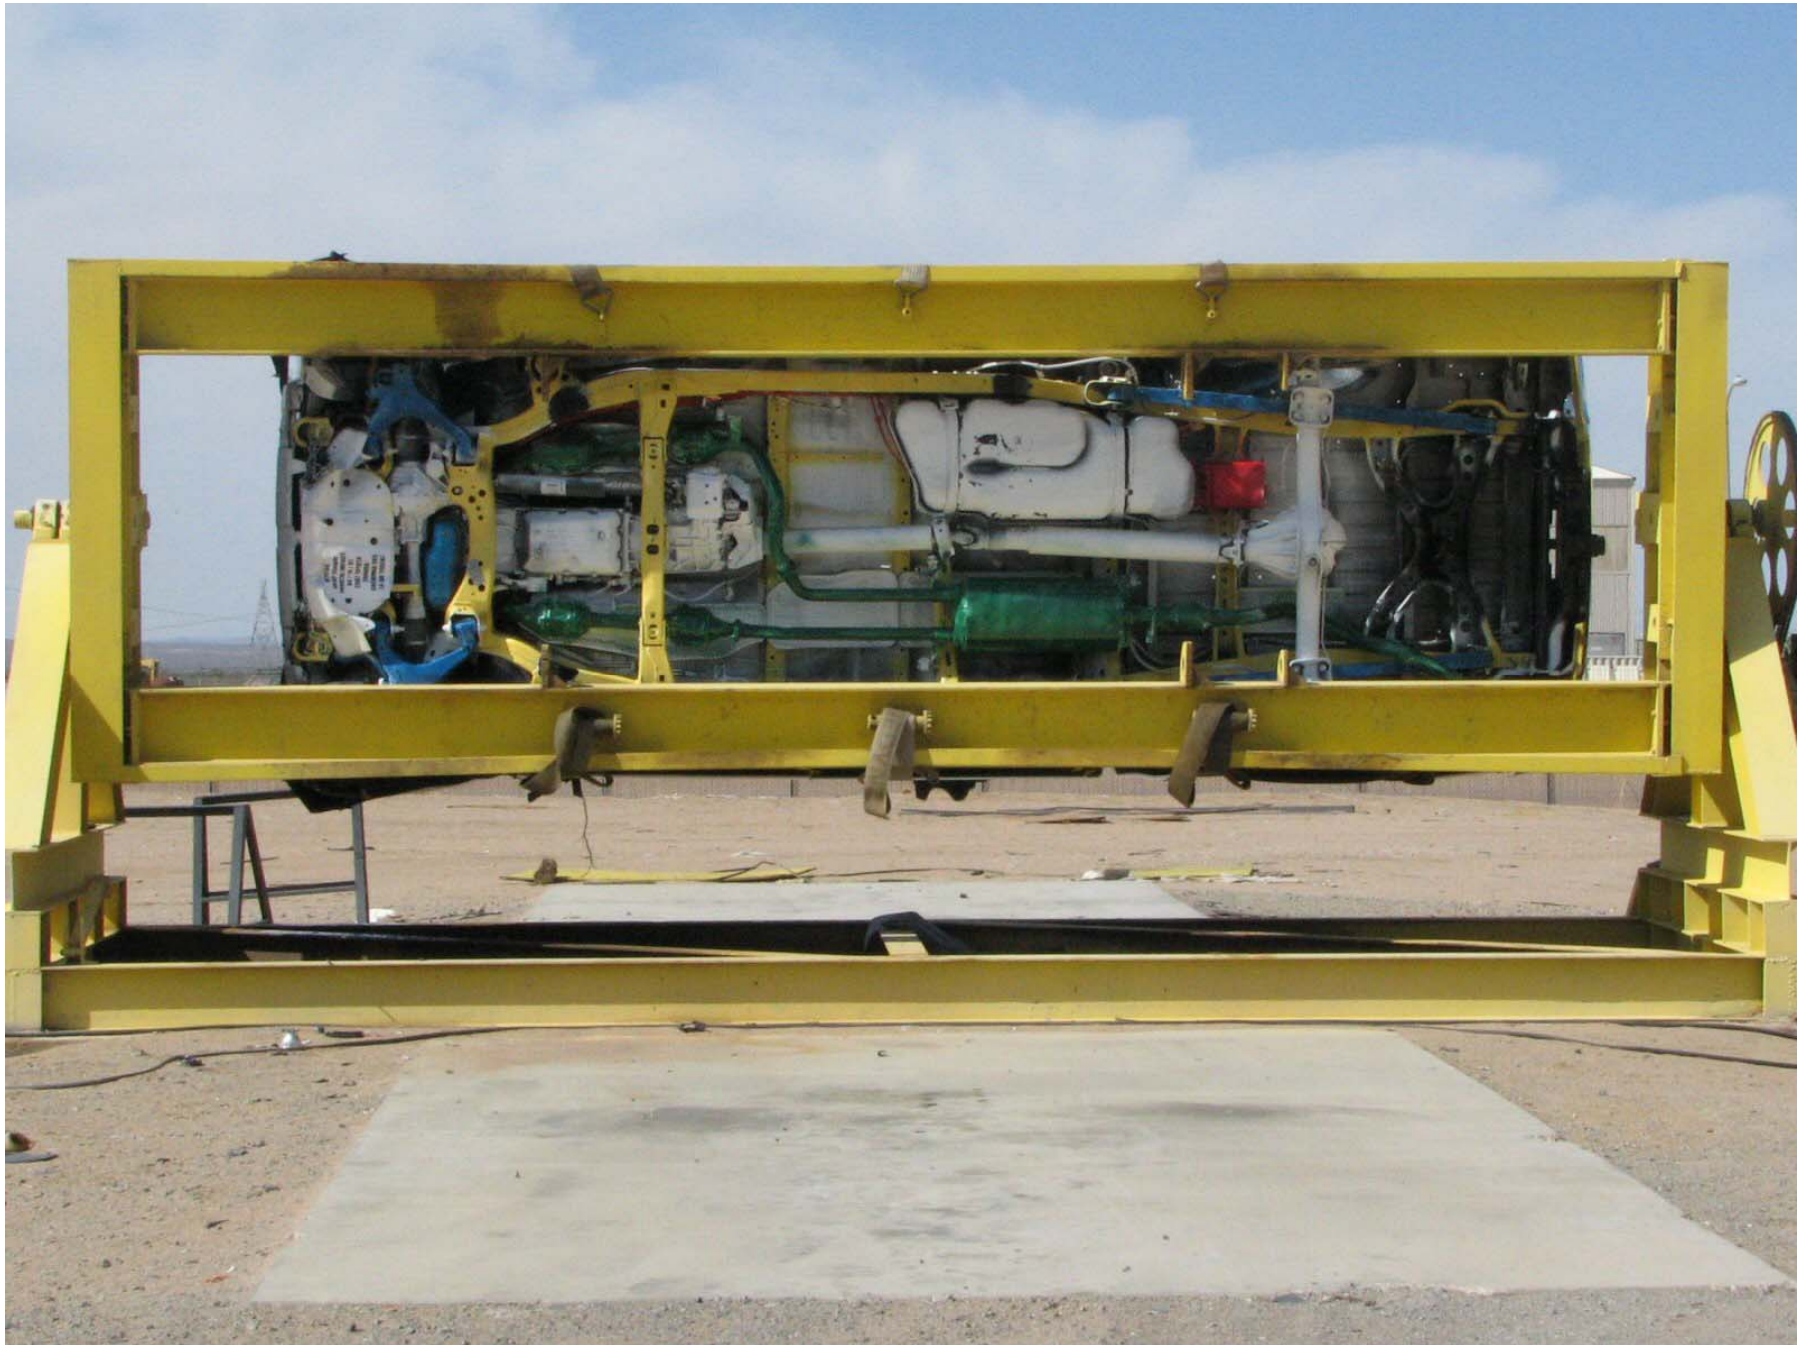
Figure A-61: Vehicle on Rollover Device (270°)

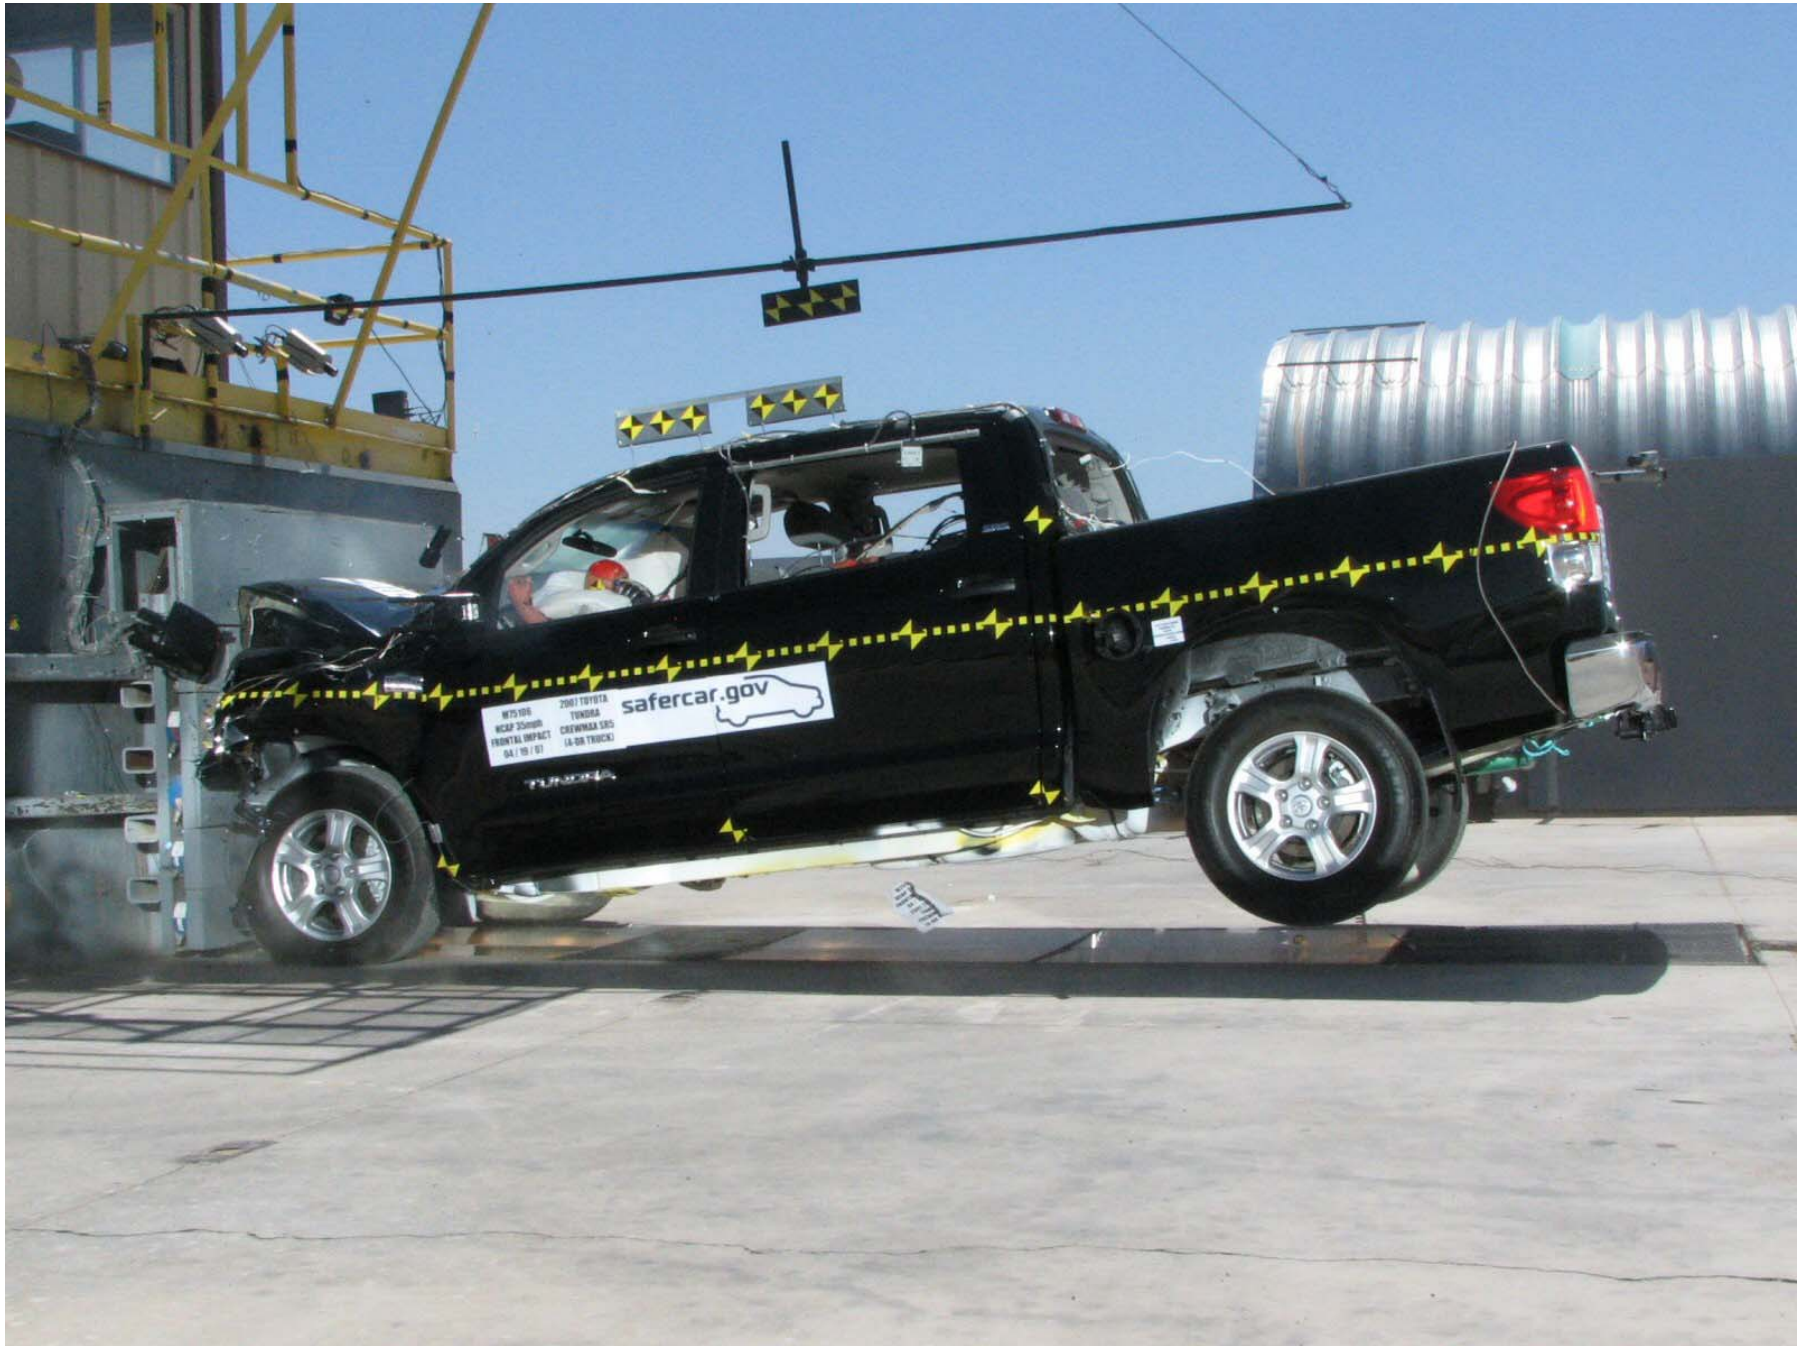
Figure A-62: Vehicle Impact

A load cell barrier consisting of 45 load cells was impacted by a 2007 Toyota Tundra CrewMax SR5 4-Door Truck at a velocity of 56.21 km/h. The test was performed at Karco Engineering, LLC on April 19, 2007.
