**REPORT NUMBER TR-P27121-01-NC**

**NEW CAR ASSESSMENT PROGRAM  
FRONTAL BARRIER IMPACT TEST**

**GENERAL MOTORS CORPORATION  
2007 SAAB 9-3  
4-DOOR SEDAN**

**NHTSA NUMBER: A70100**

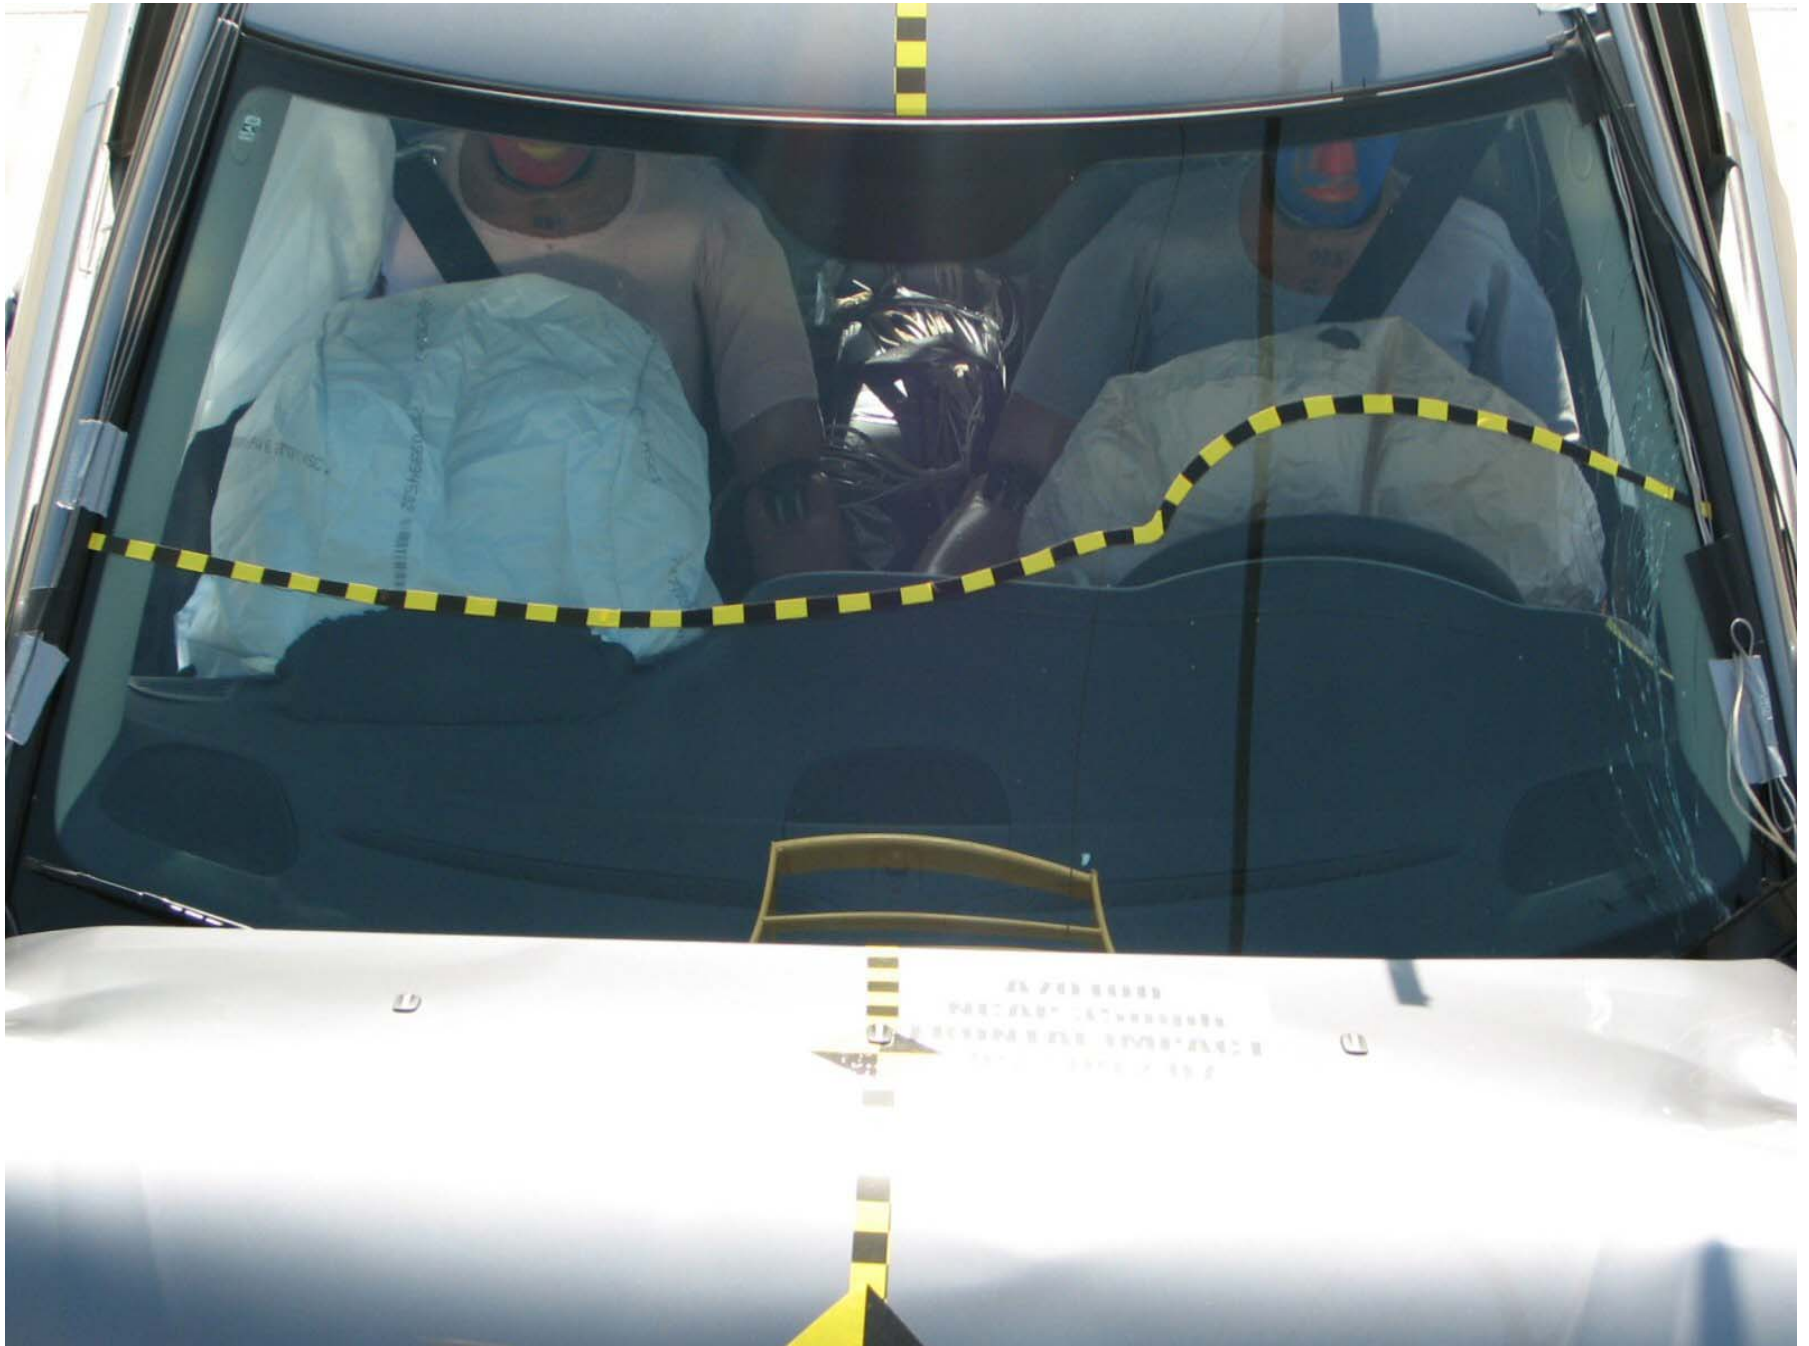
Figure A-19: Post-Test Windshield

There was 100 percent windshield retention and there was no intrusion into the protected zone of the windshield during the impact event. There was no stoddard solvent leakage after the event or during any phase of the static rollover.

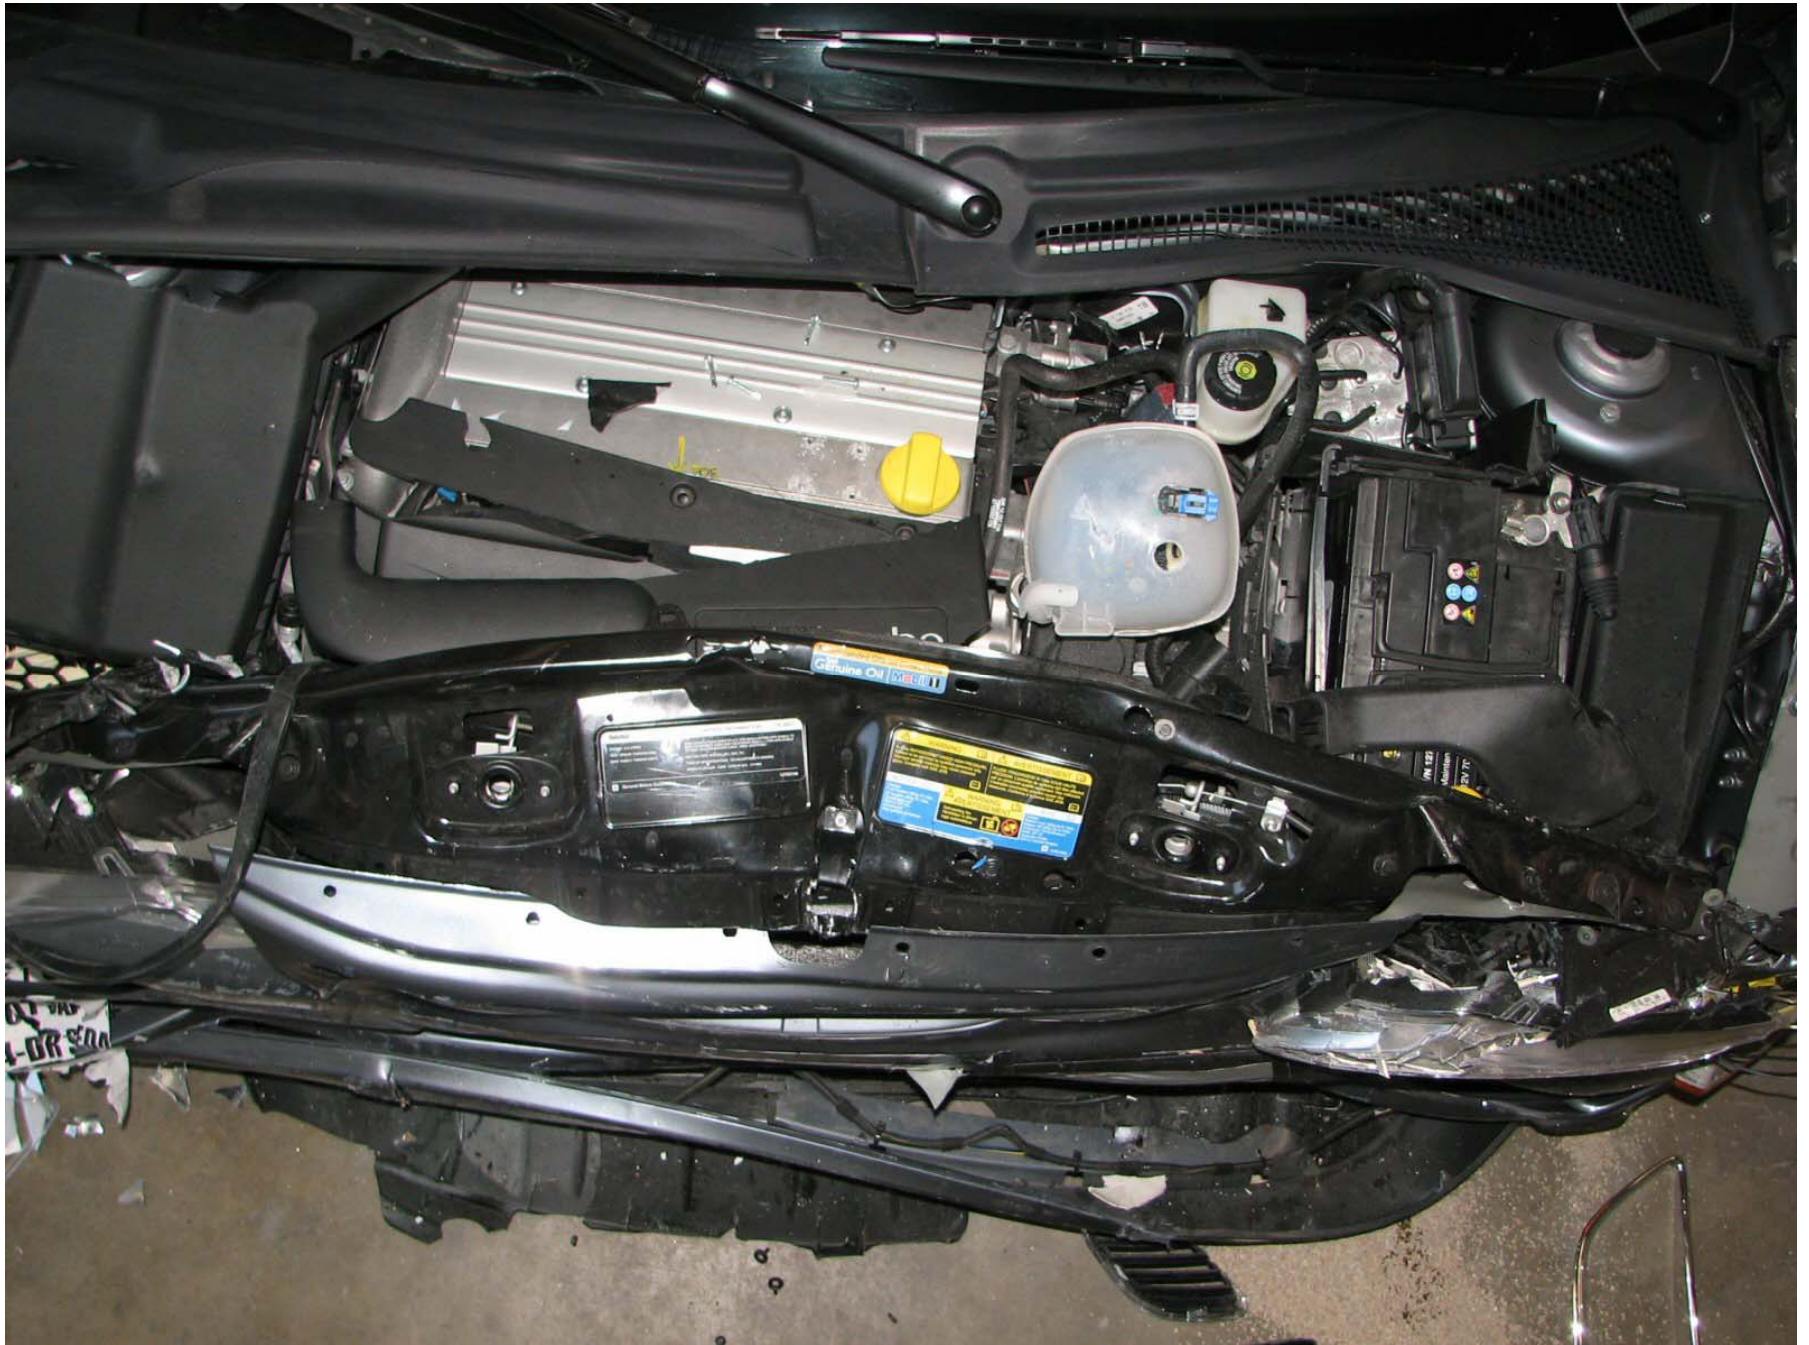
Figure A-21: Post-Test Engine Compartment (Vehicle Moved)

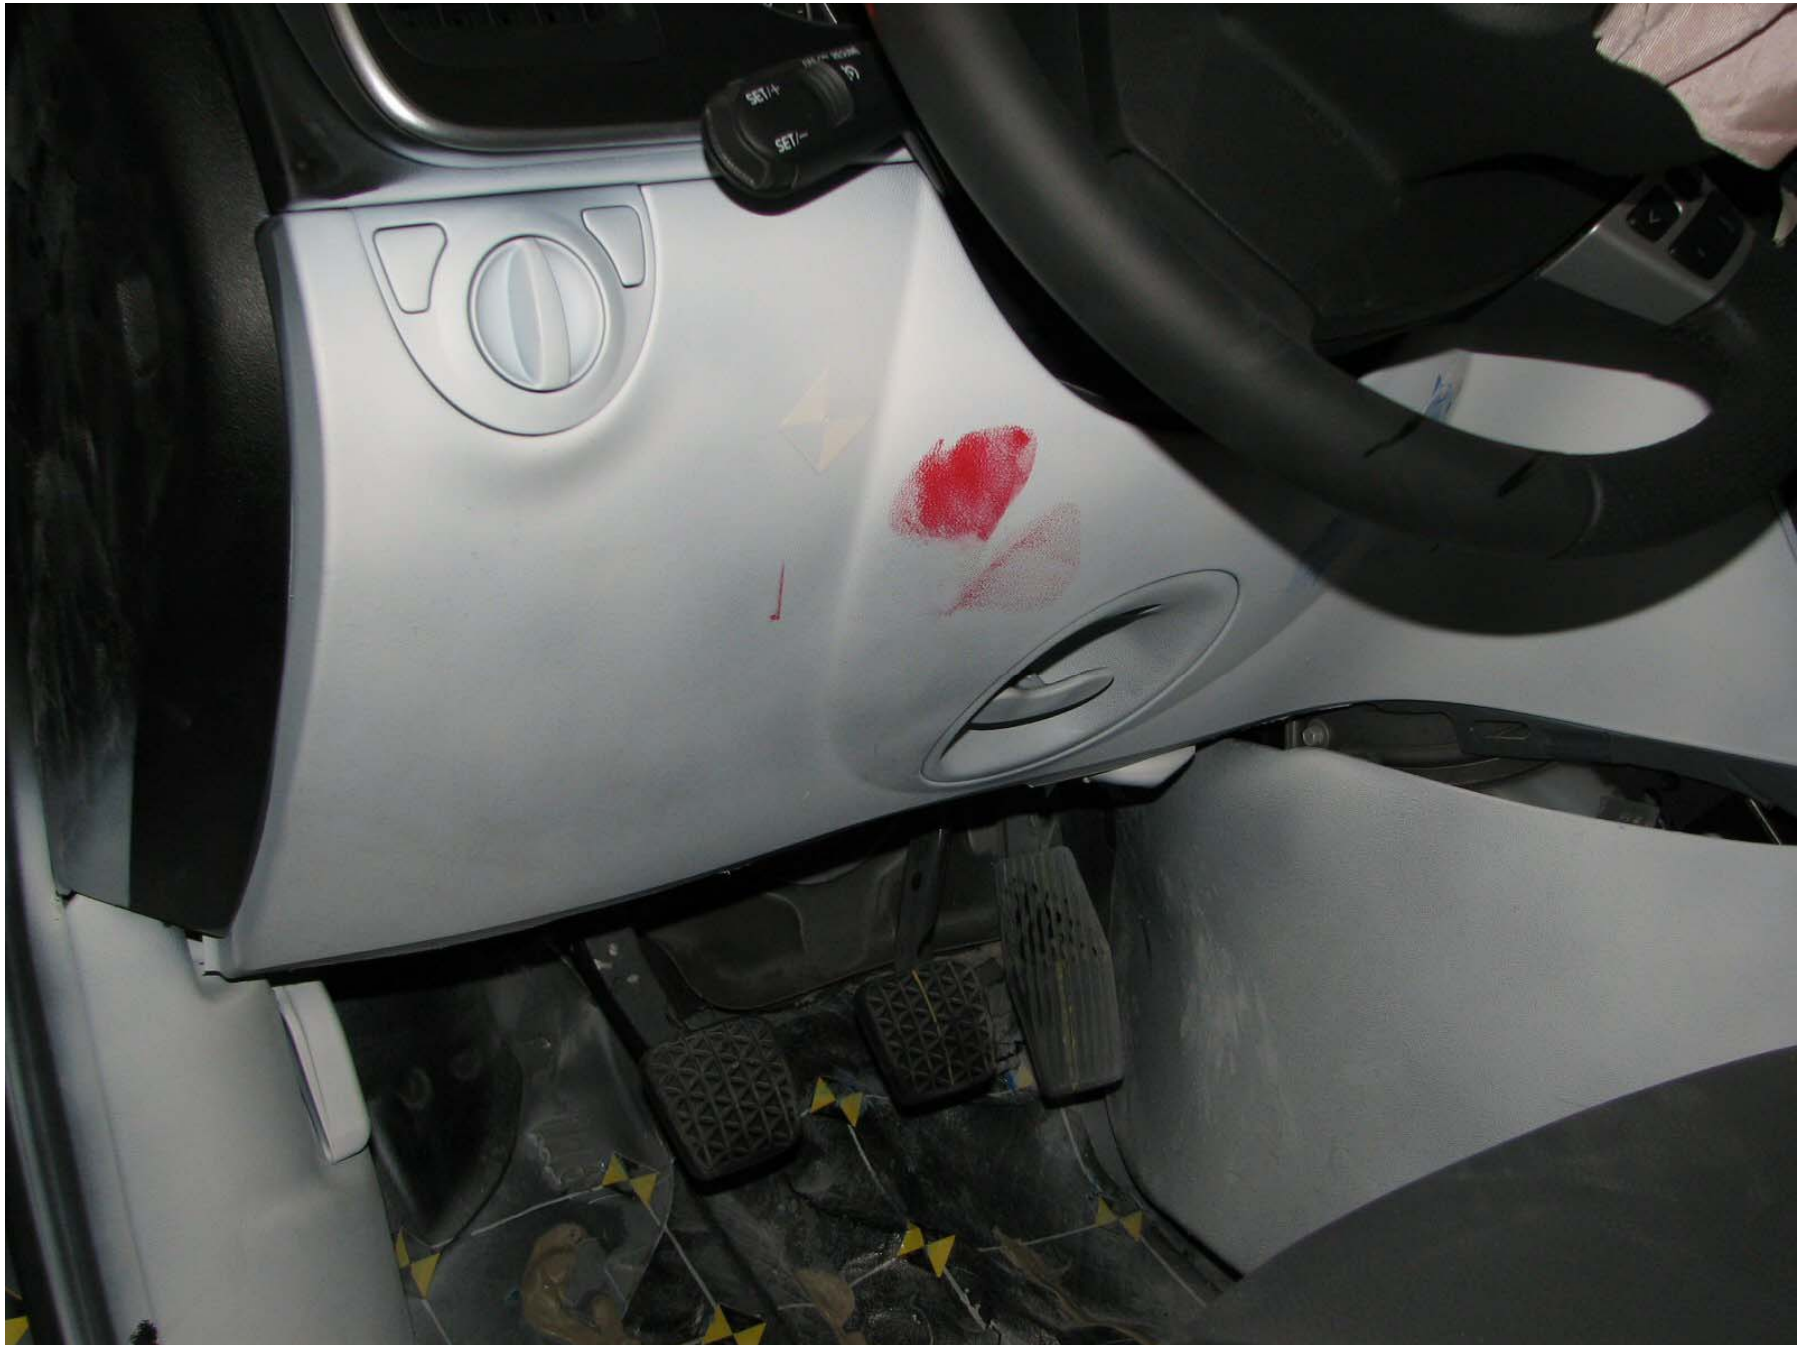
Figure A-39: Post-Test Driver Side Knee Bolster

The driver's visible contact points were as follows: The driver ATD's head and chest contacted the airbag and the abdomen had no contact. Both knees contacted the knee bolster.

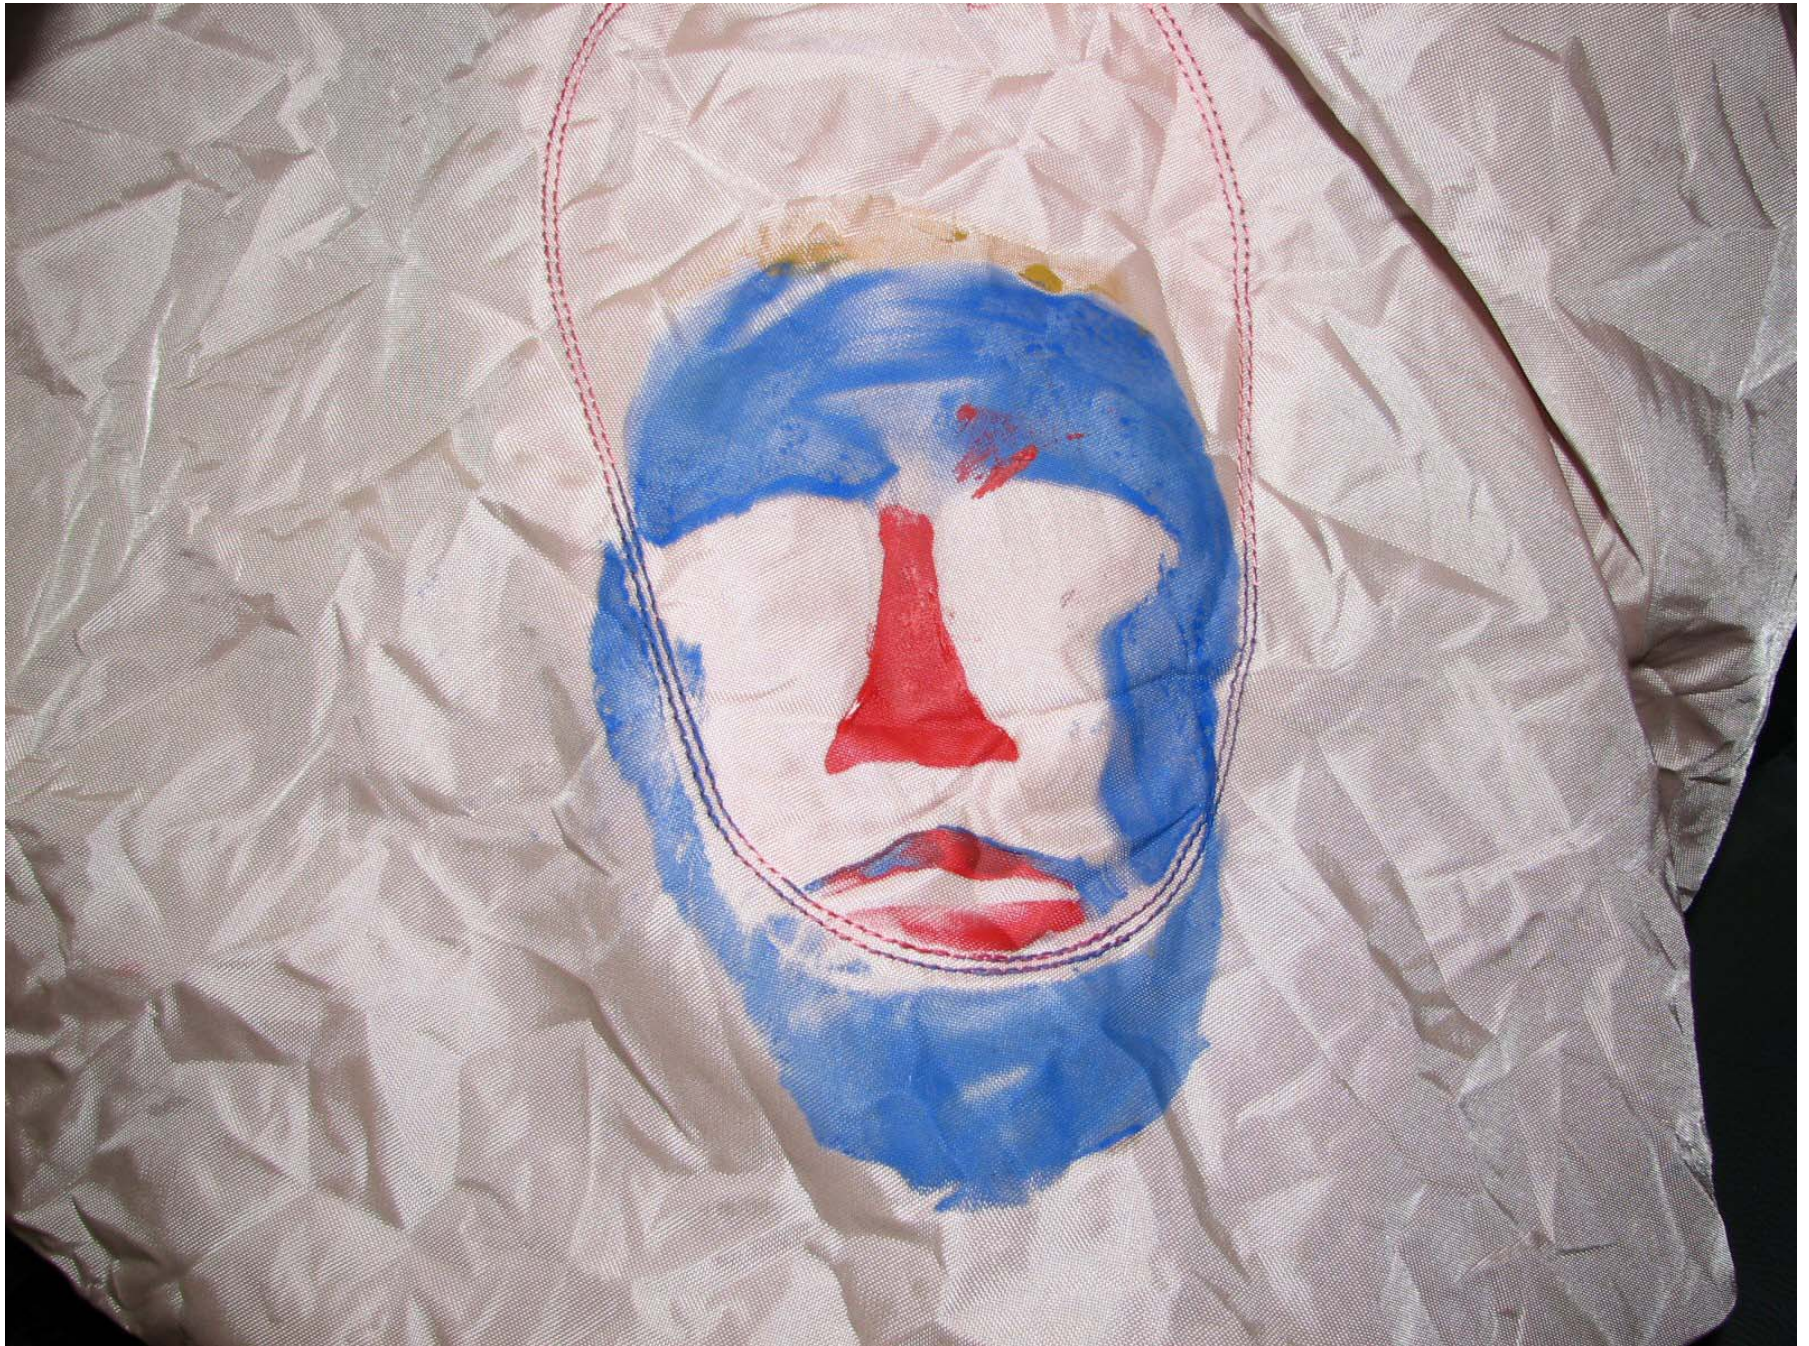
Figure A-43: Post-Test Driver Dummy Airbag Contact

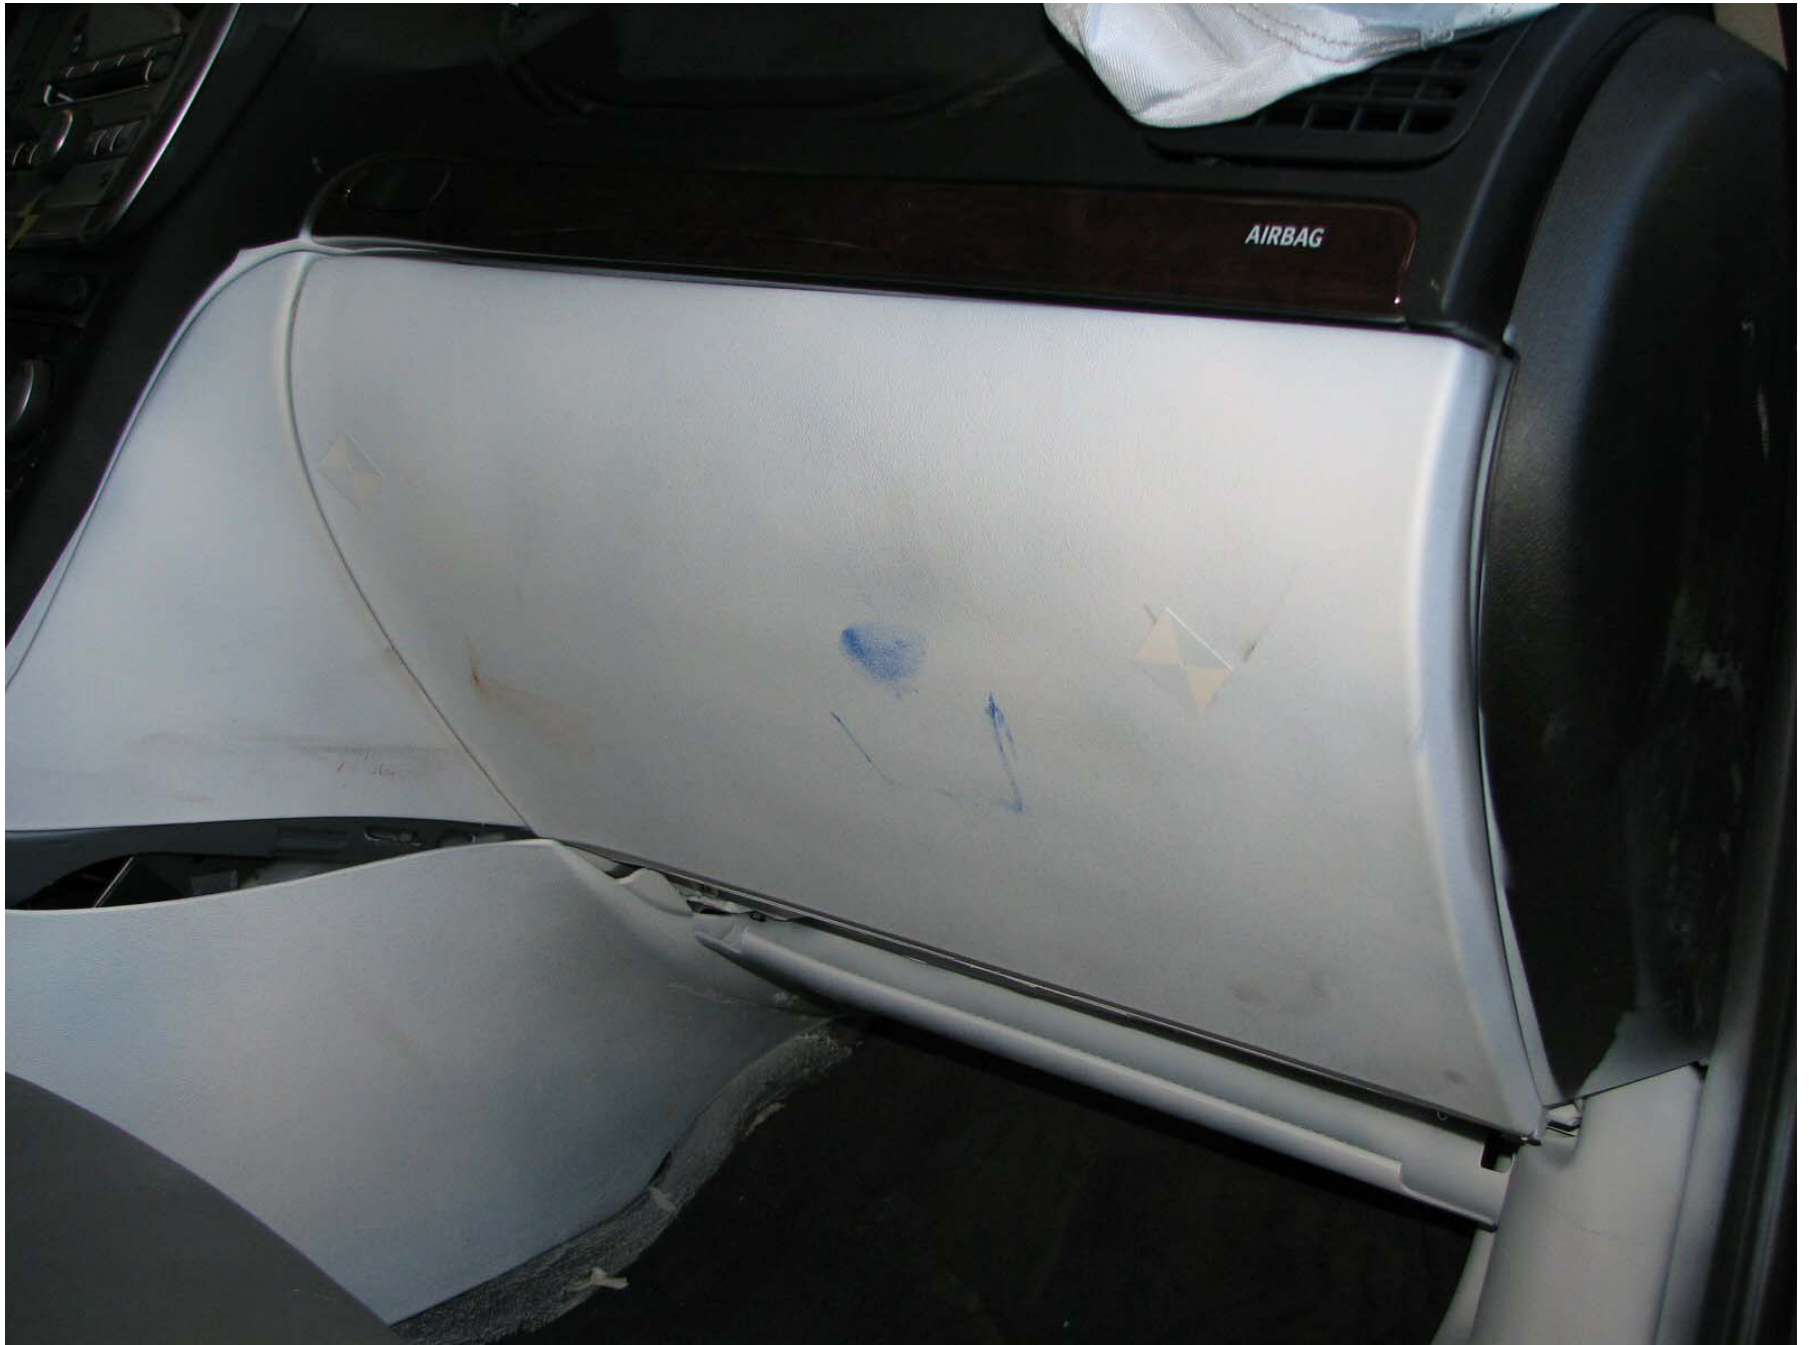
Figure A-53: Post-Test Passenger Side Glove Box

The passenger's visible contact points were as follows: The passenger ATD's head and chest contacted the airbag. Both knees contacted the glove box.

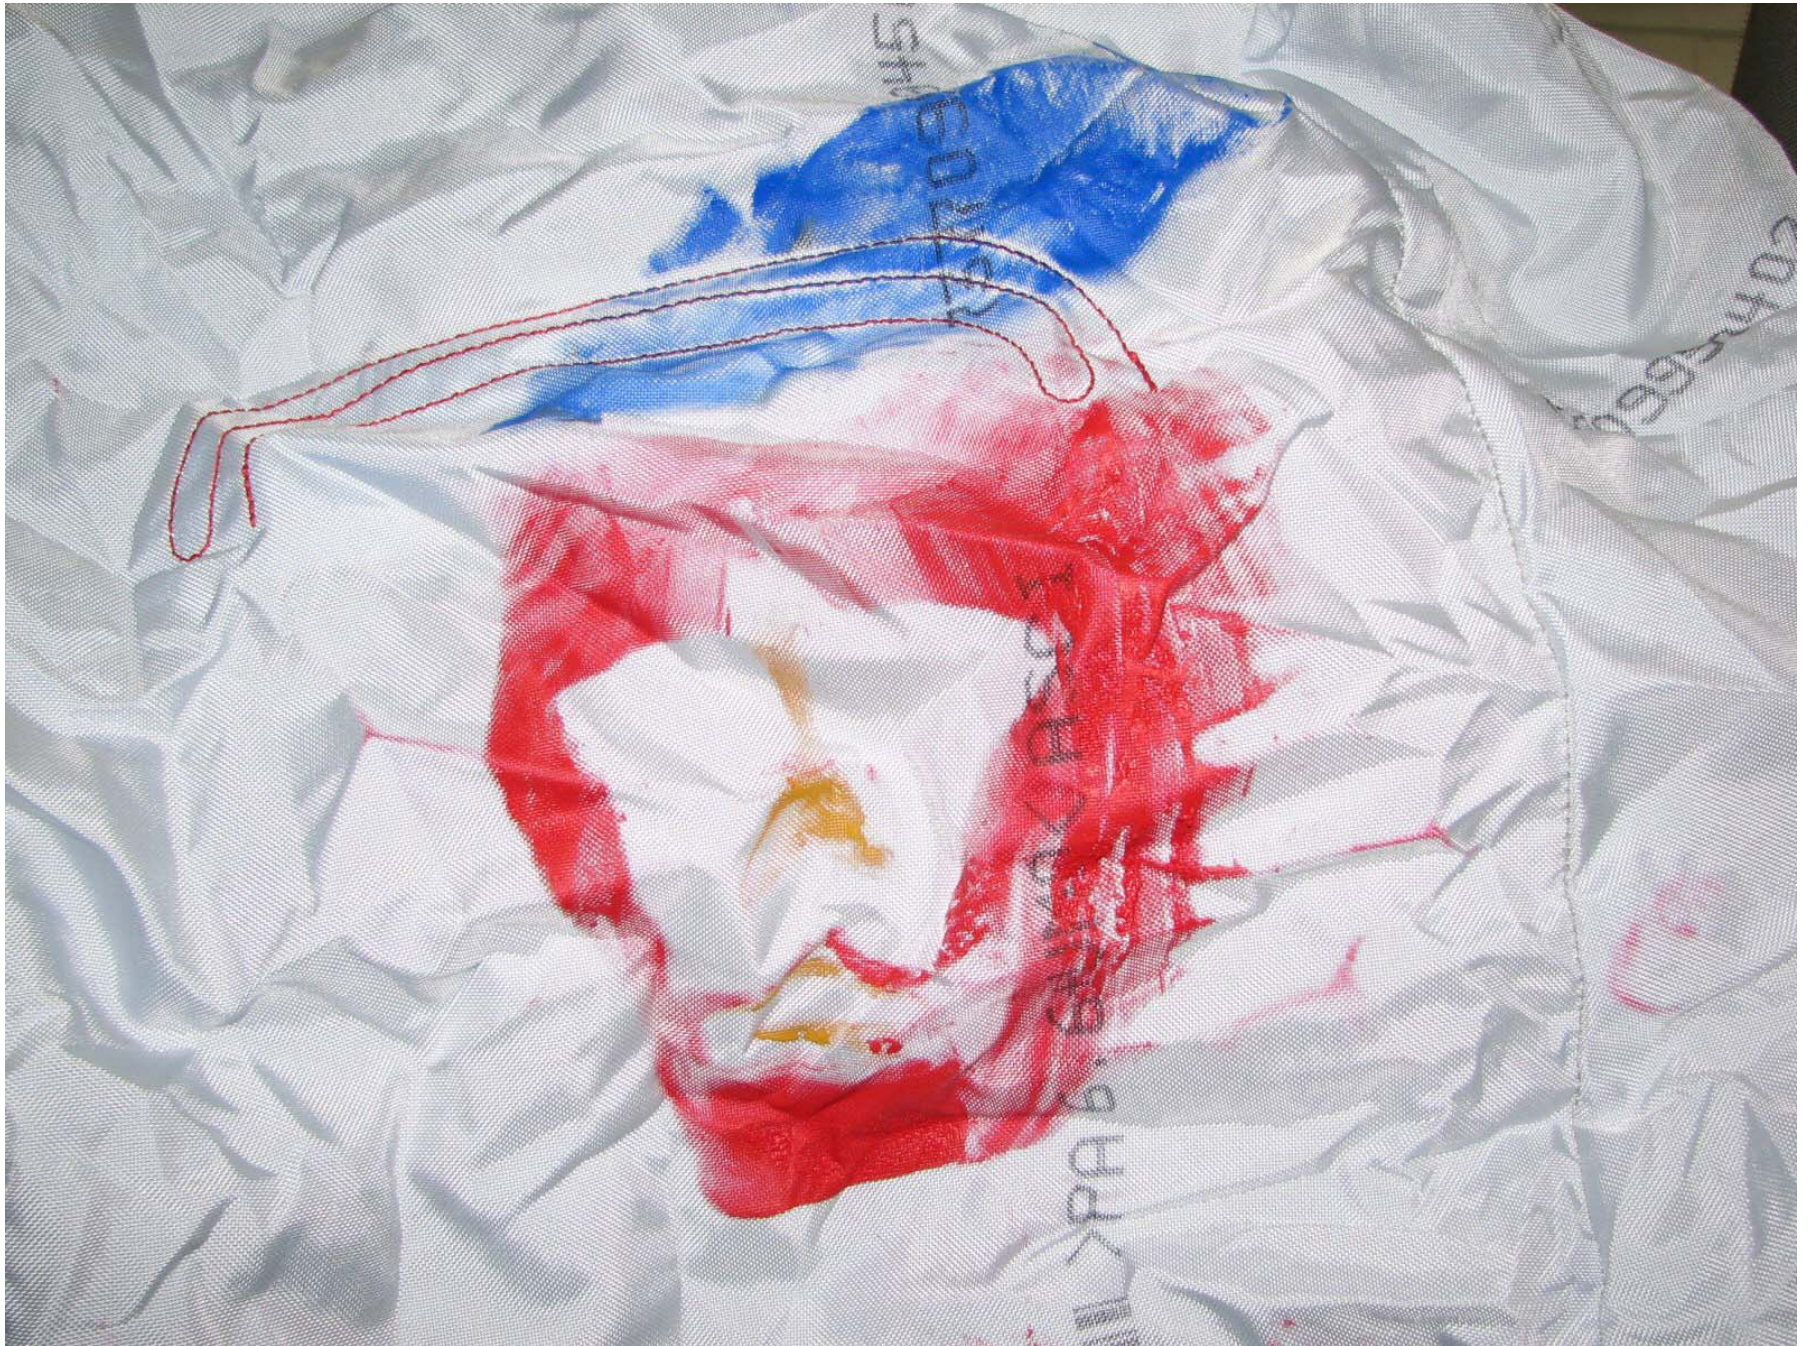
Figure A-57: Post-Test Passenger Dummy Airbag Contact

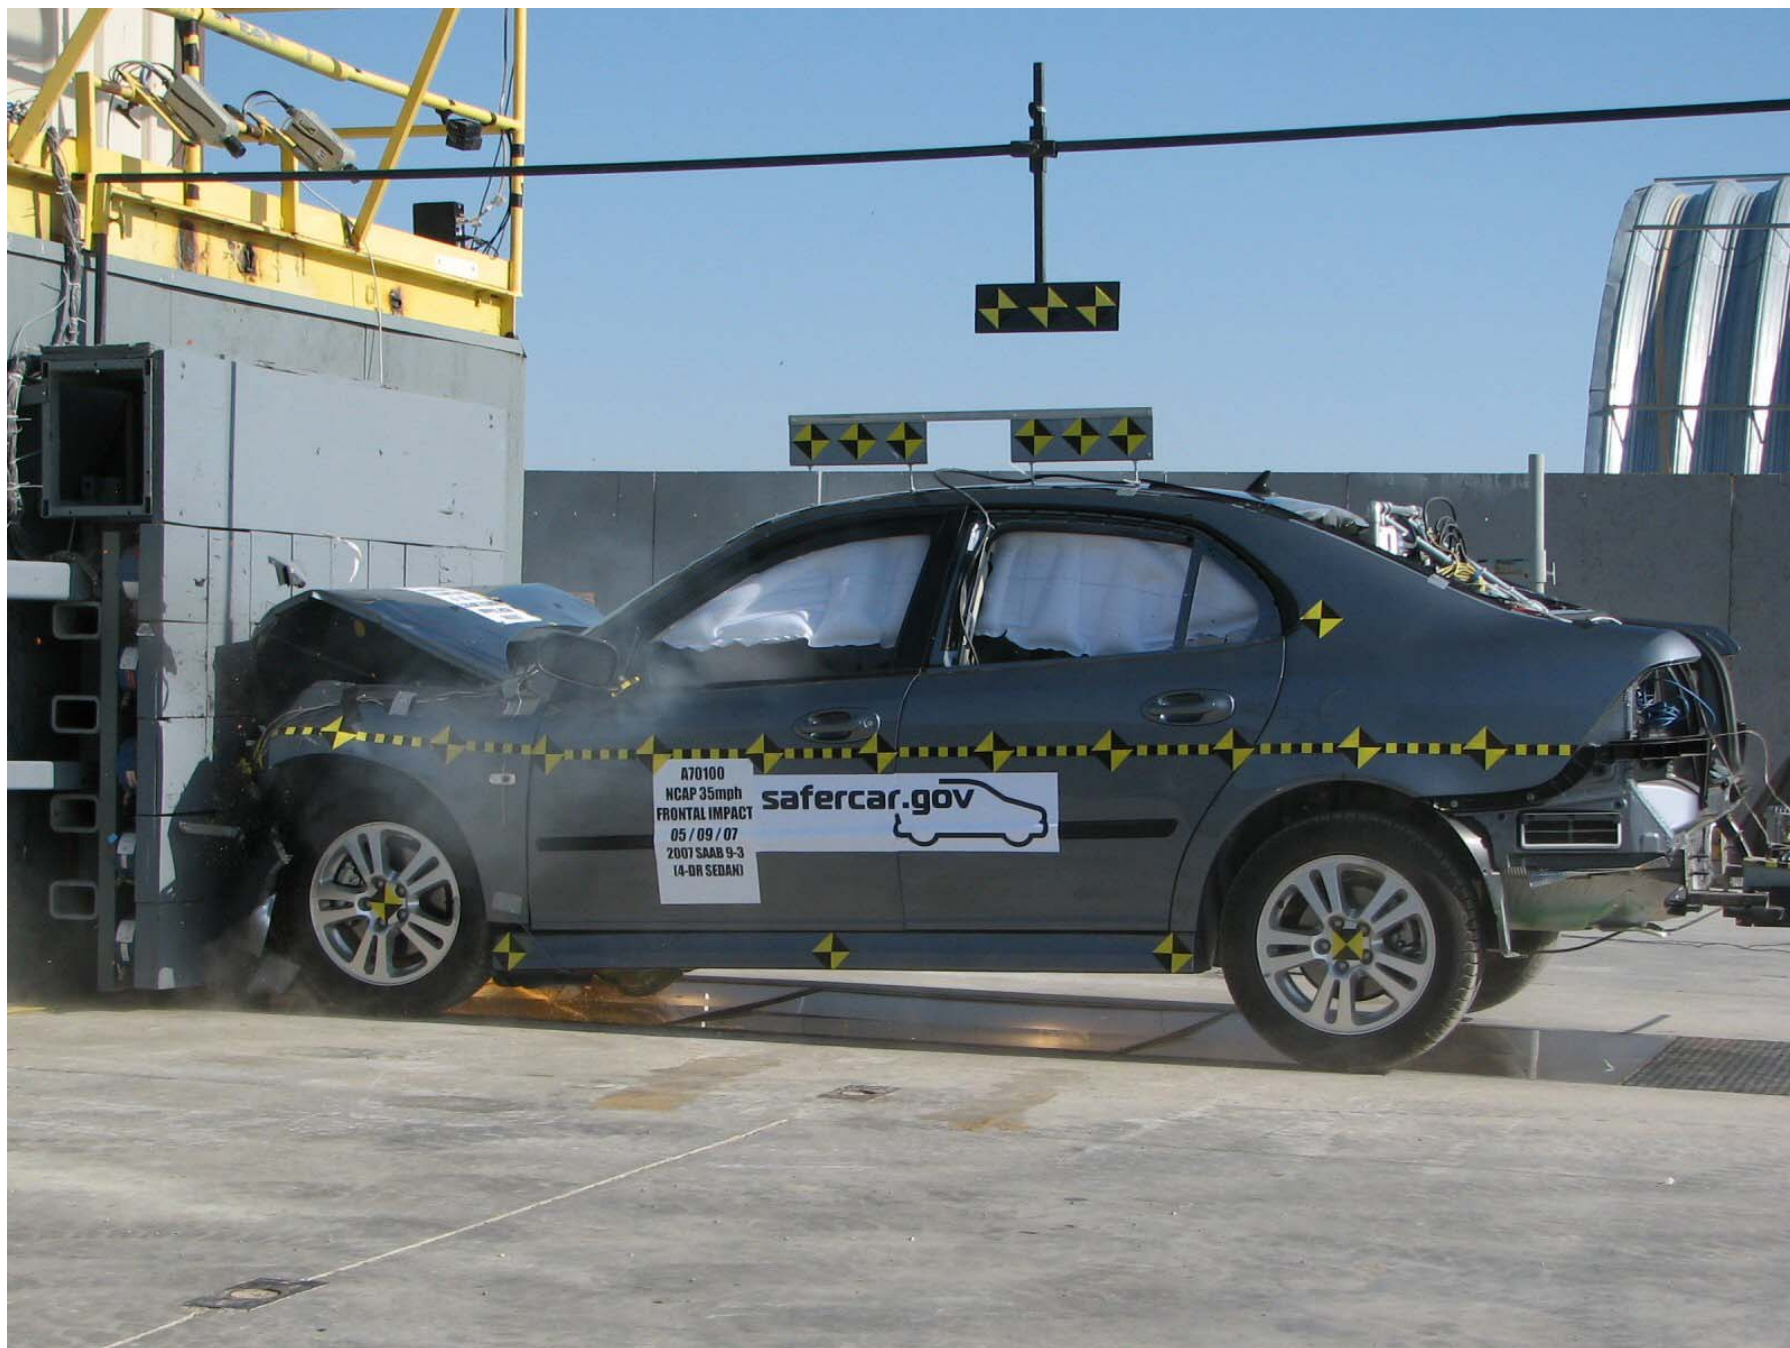
Figure A-62: Vehicle Impact

A load cell barrier consisting of 36 load cells was impacted by a 2007 Saab 9-3 4-Door Sedan at a velocity of 55.80 km/h. The test was performed at Karco Engineering, LLC on May 9, 2007.
