REPORT NUMBER TR-P27125-01-NC

**NEW CAR ASSESSMENT PROGRAM
SIDE IMPACT TEST**

**GENERAL MOTORS CORPORATION
2007 PONTIAC VIBE
4-DOOR**

NHTSA NUMBER: G70113

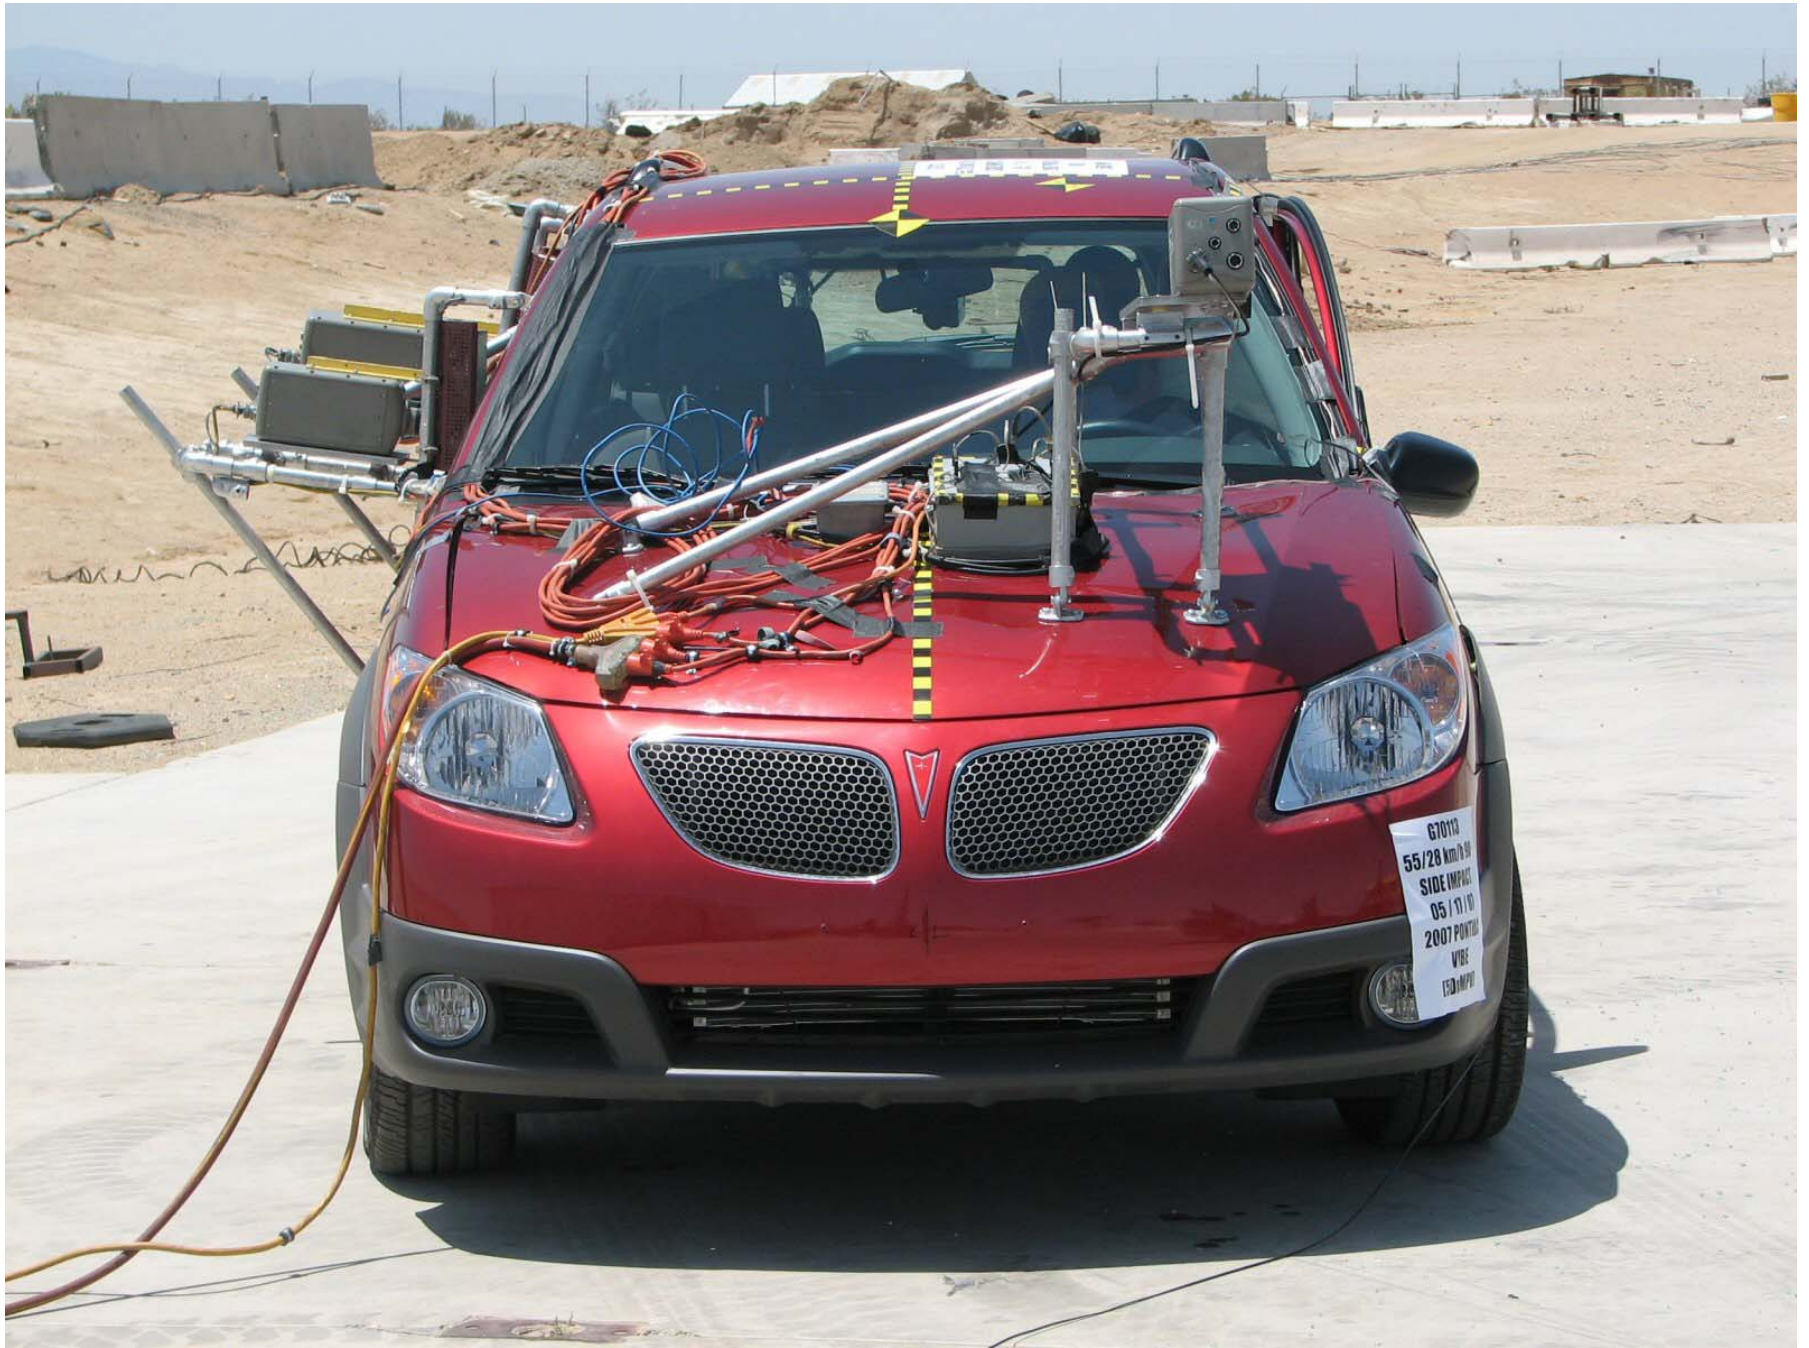
Figure A-6: Post-Test Front View

The driver and passenger doors remained closed during impact. The test vehicle sustained a maximum static crush of 308 mm at level 2, 1350 mm rearward of the left vertical impact point. The driver SID/Hybrid III, Serial No. 275 and the passenger SID/Hybrid III, Serial No. 274 were calibrated prior to this test. The SID/Hybrid III injury criteria is summarized as follows:

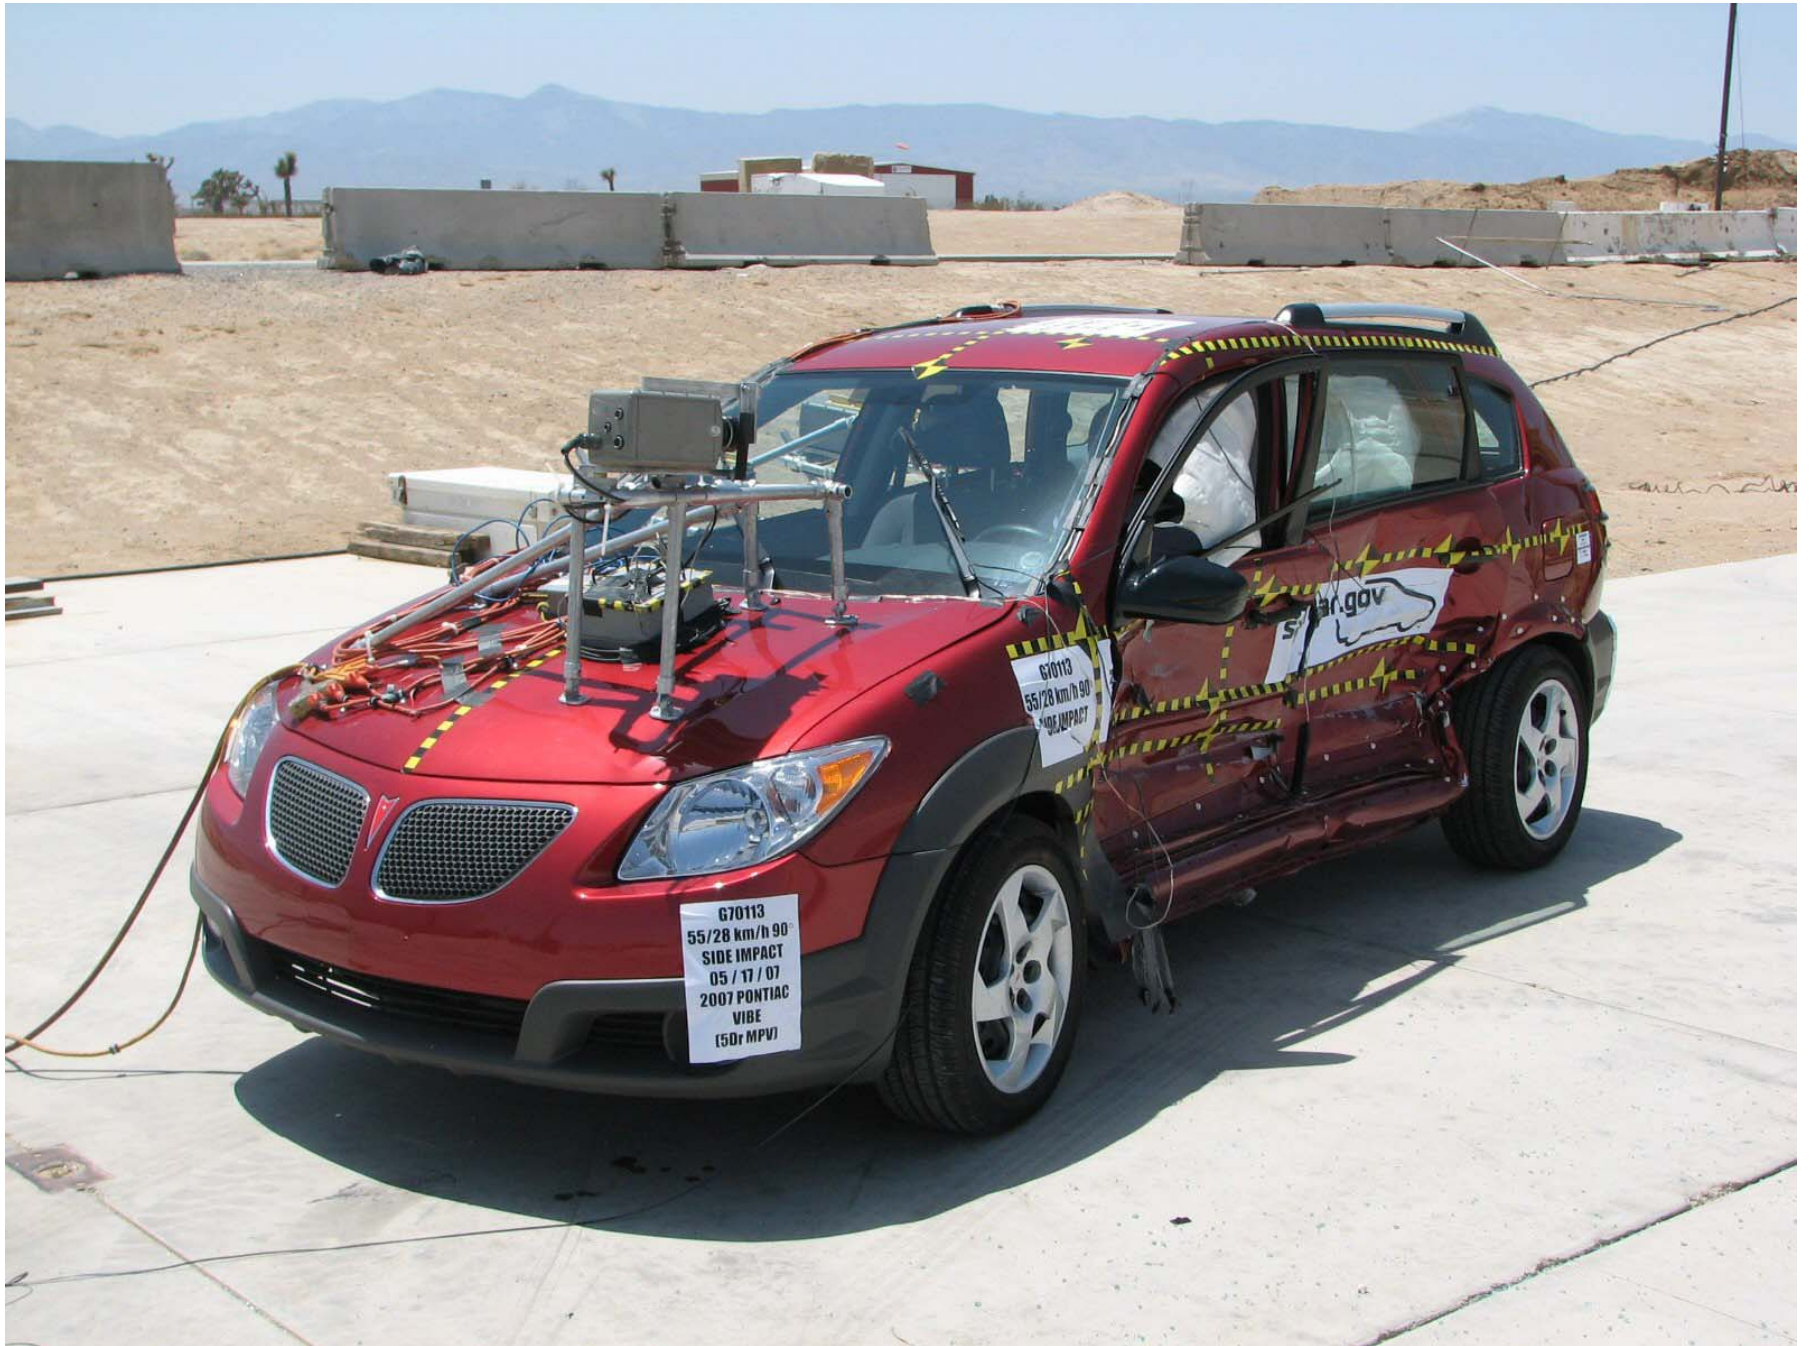
Figure A-8: Post-Test Left Front 3/4 View

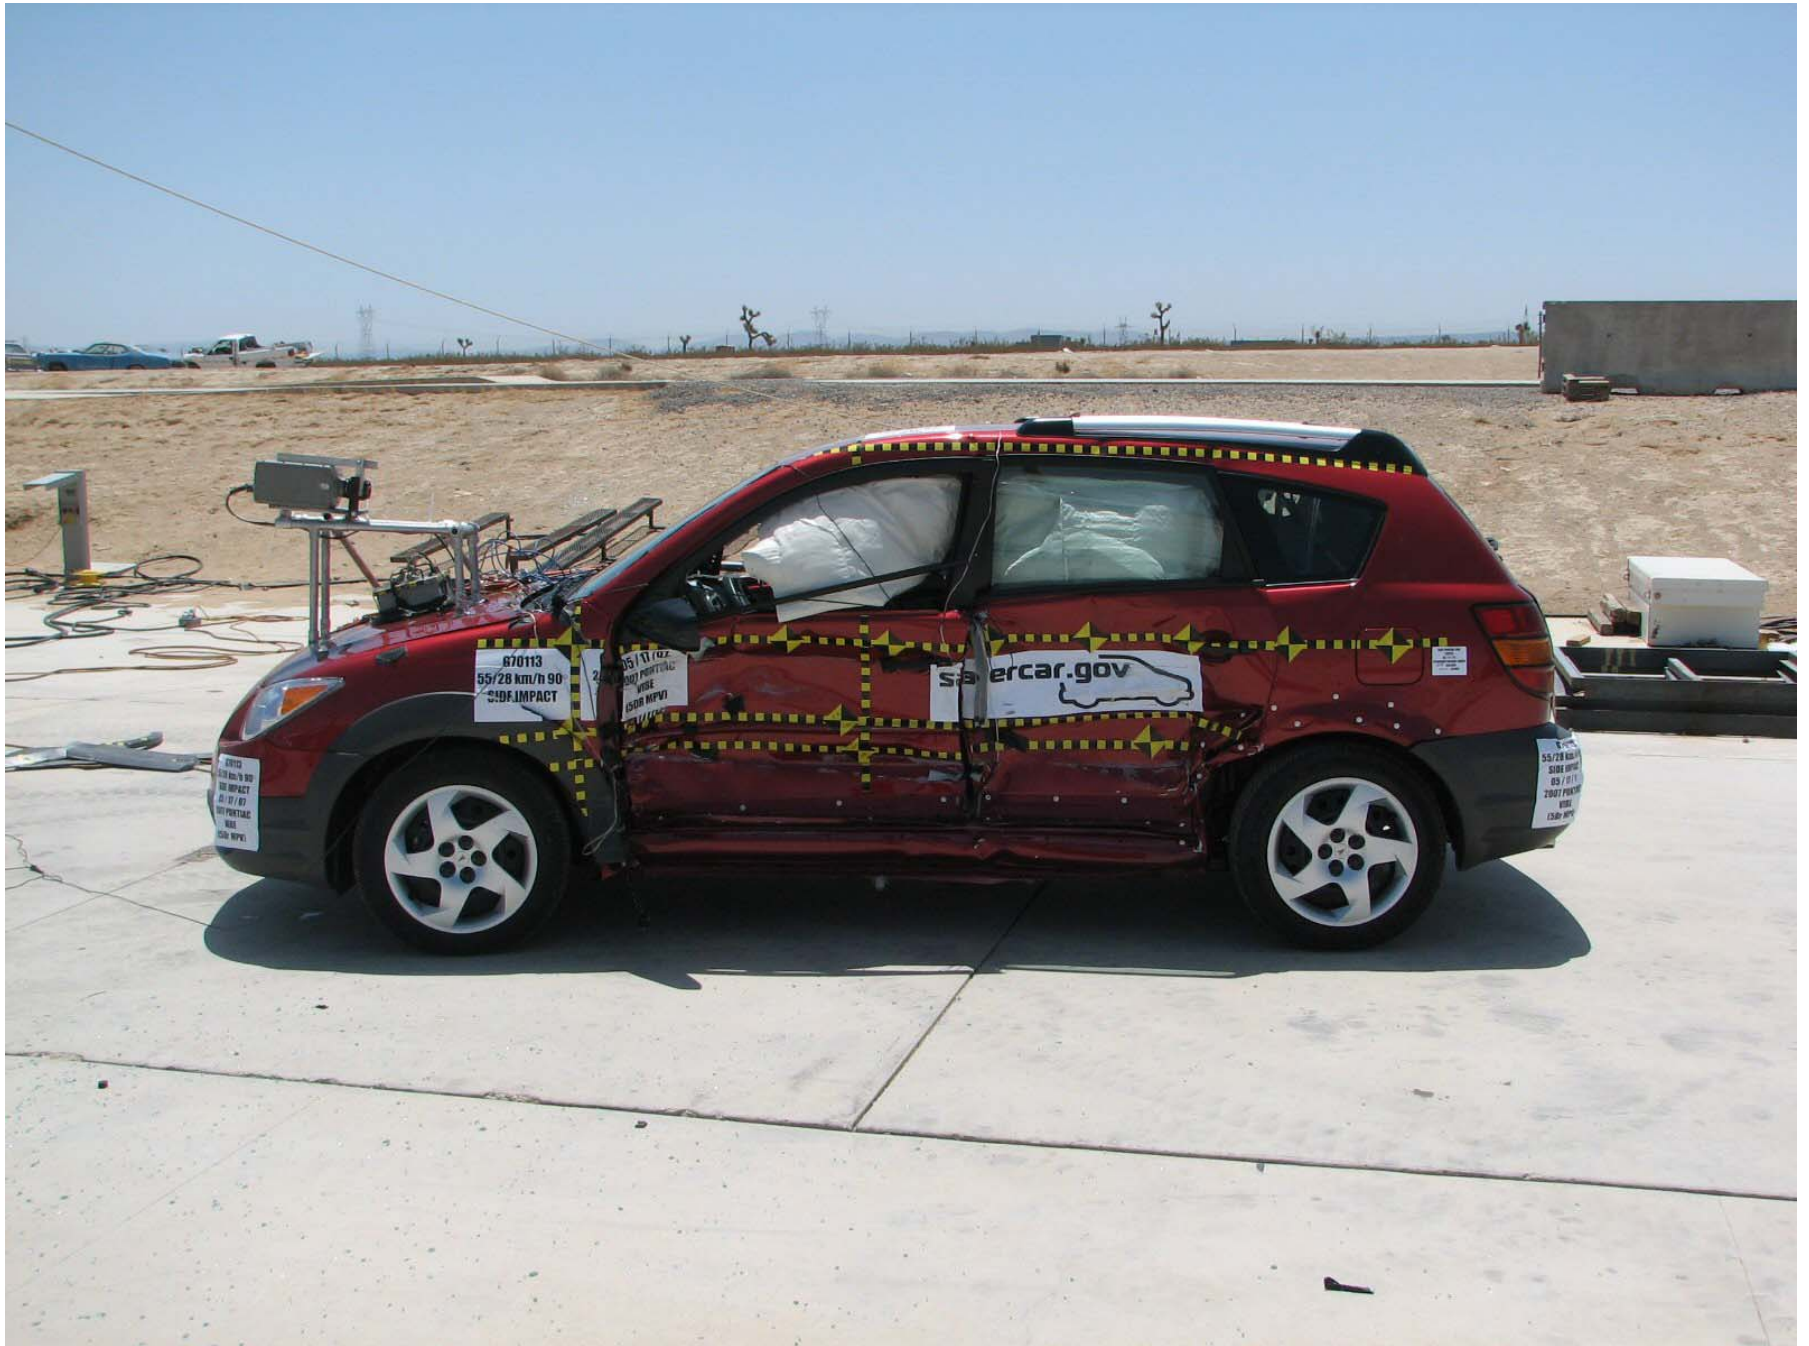
Figure A-10: Post-Test Left Side View

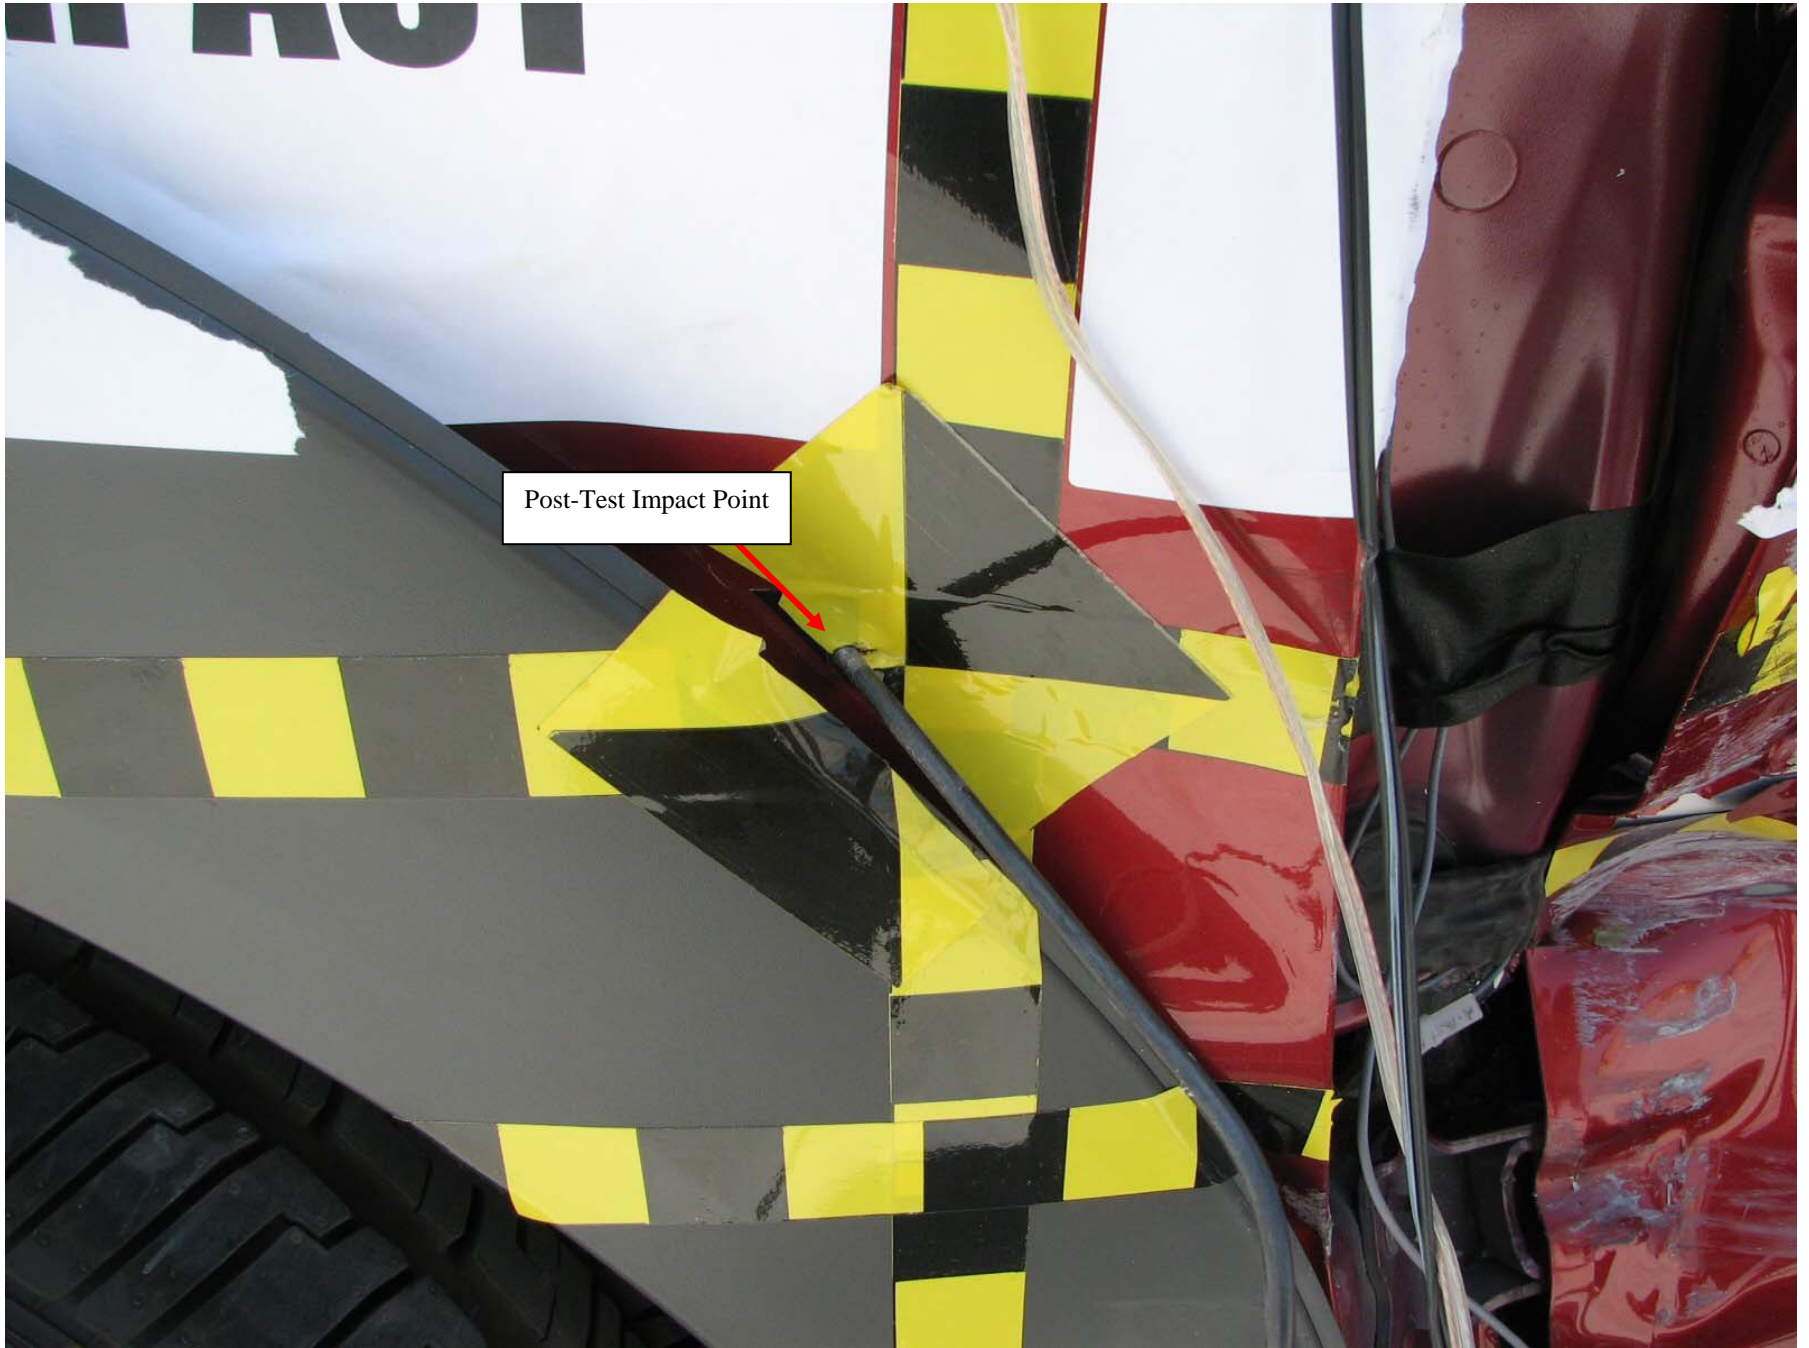
Figure A-26: Post-Test Left Impact Point

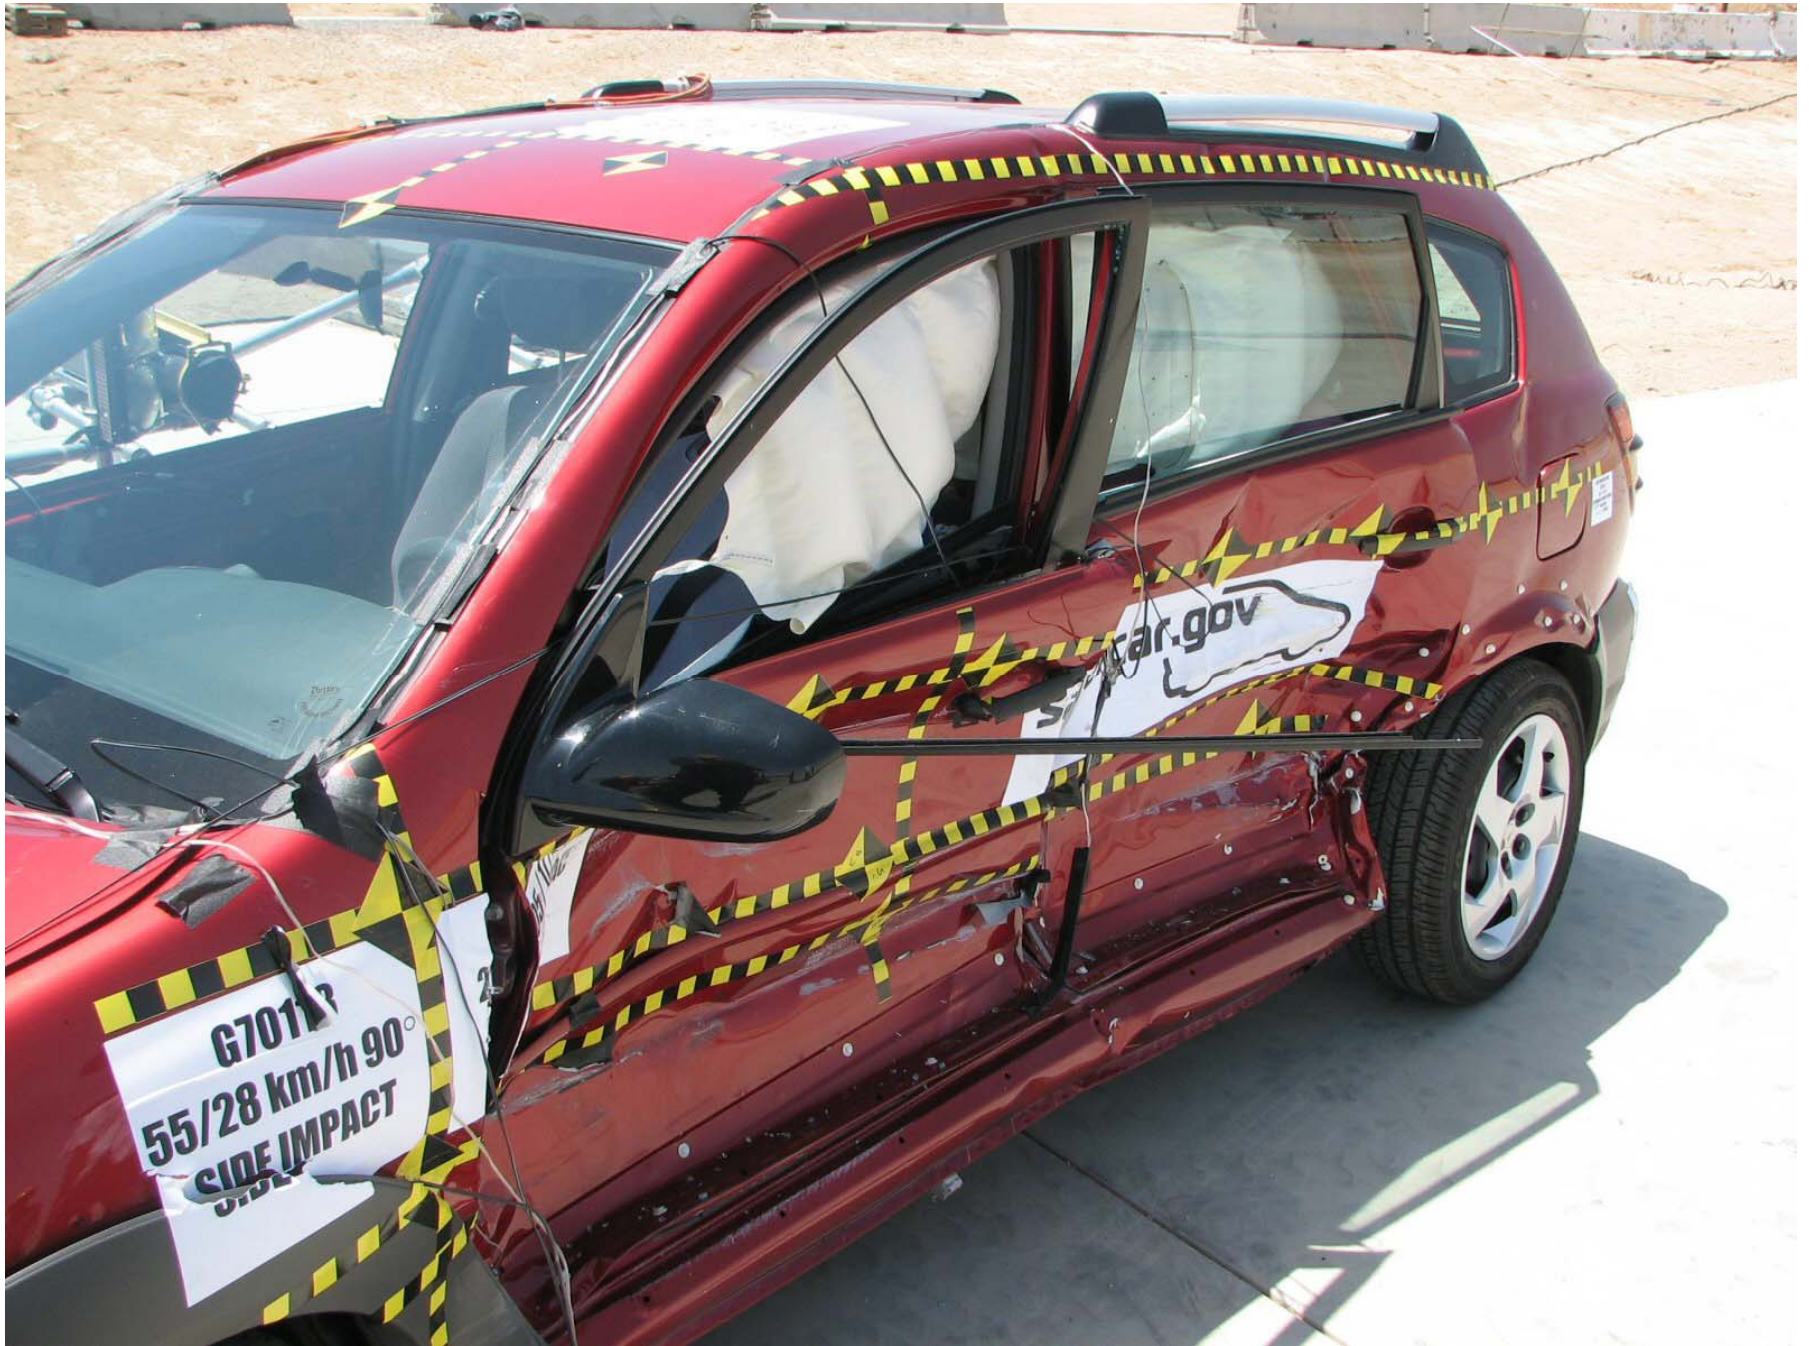
Figure A-28: Post-Test Front ¾ View of Left Side Door

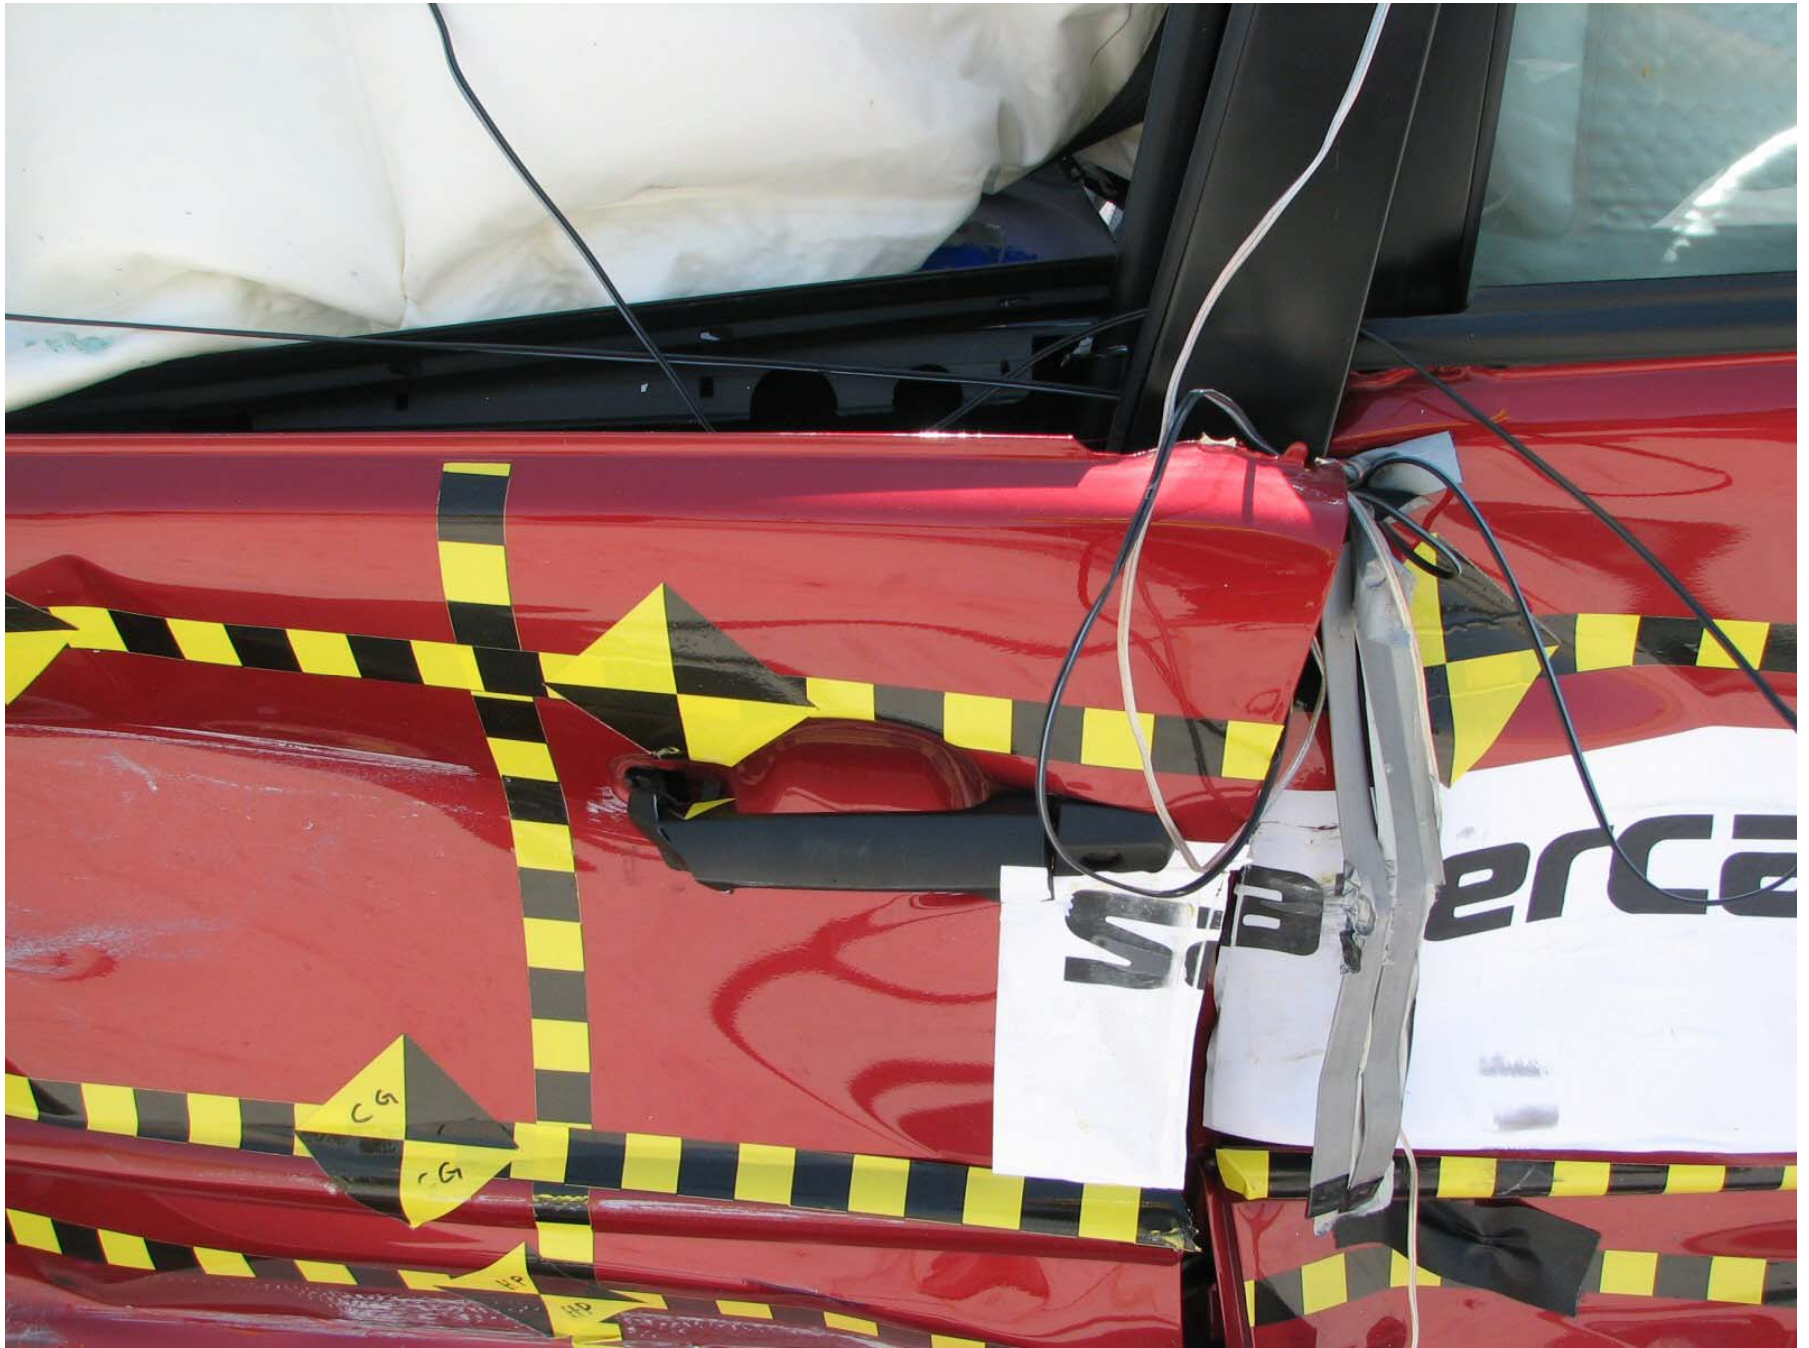
Figure A-32: Post-Test Left Front Door

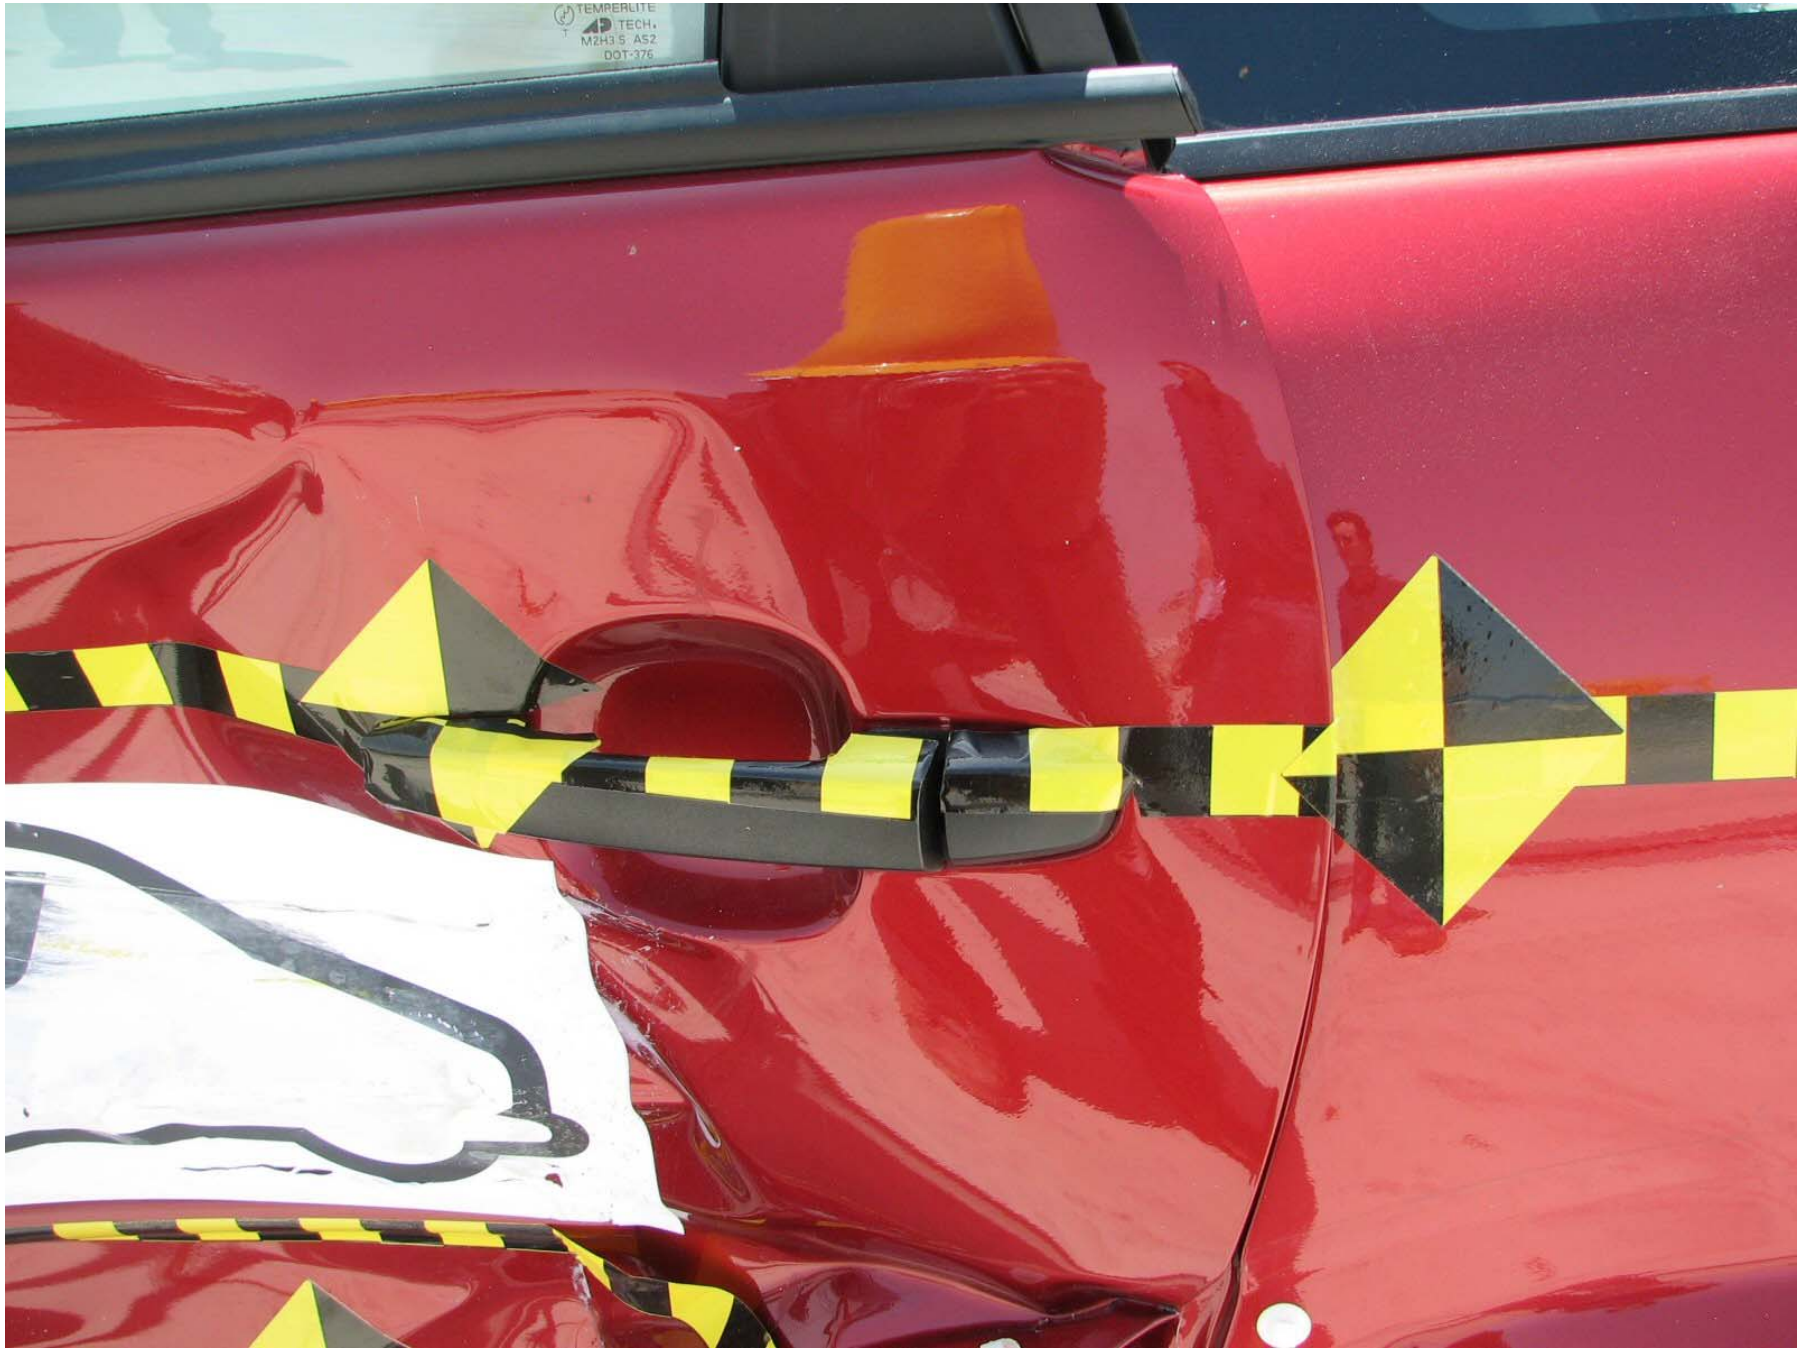
Figure A-34: Post-Test Left Rear Door

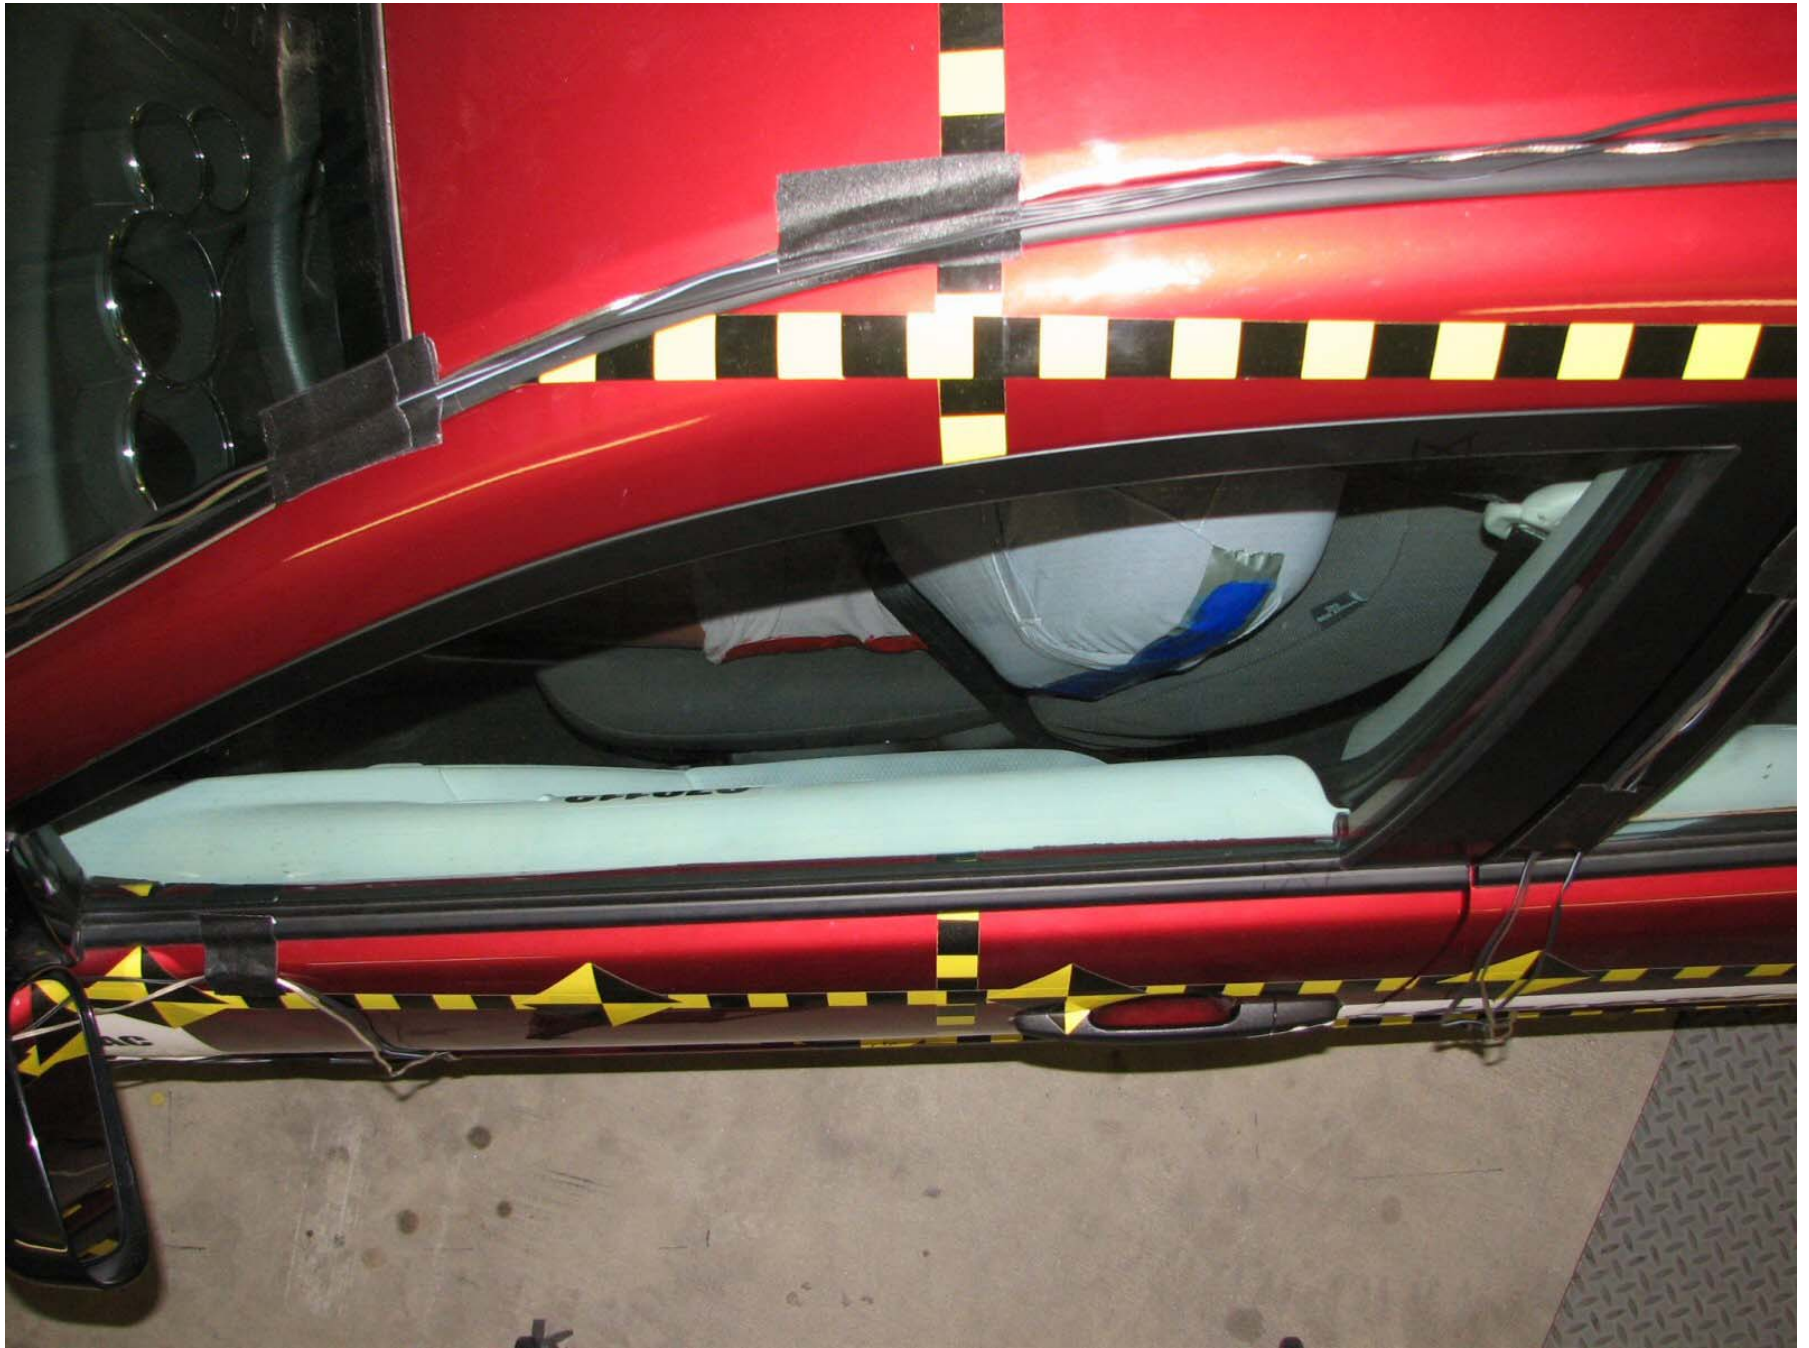
Figure A-38: Pre-Test Driver Dummy Clearance From Door

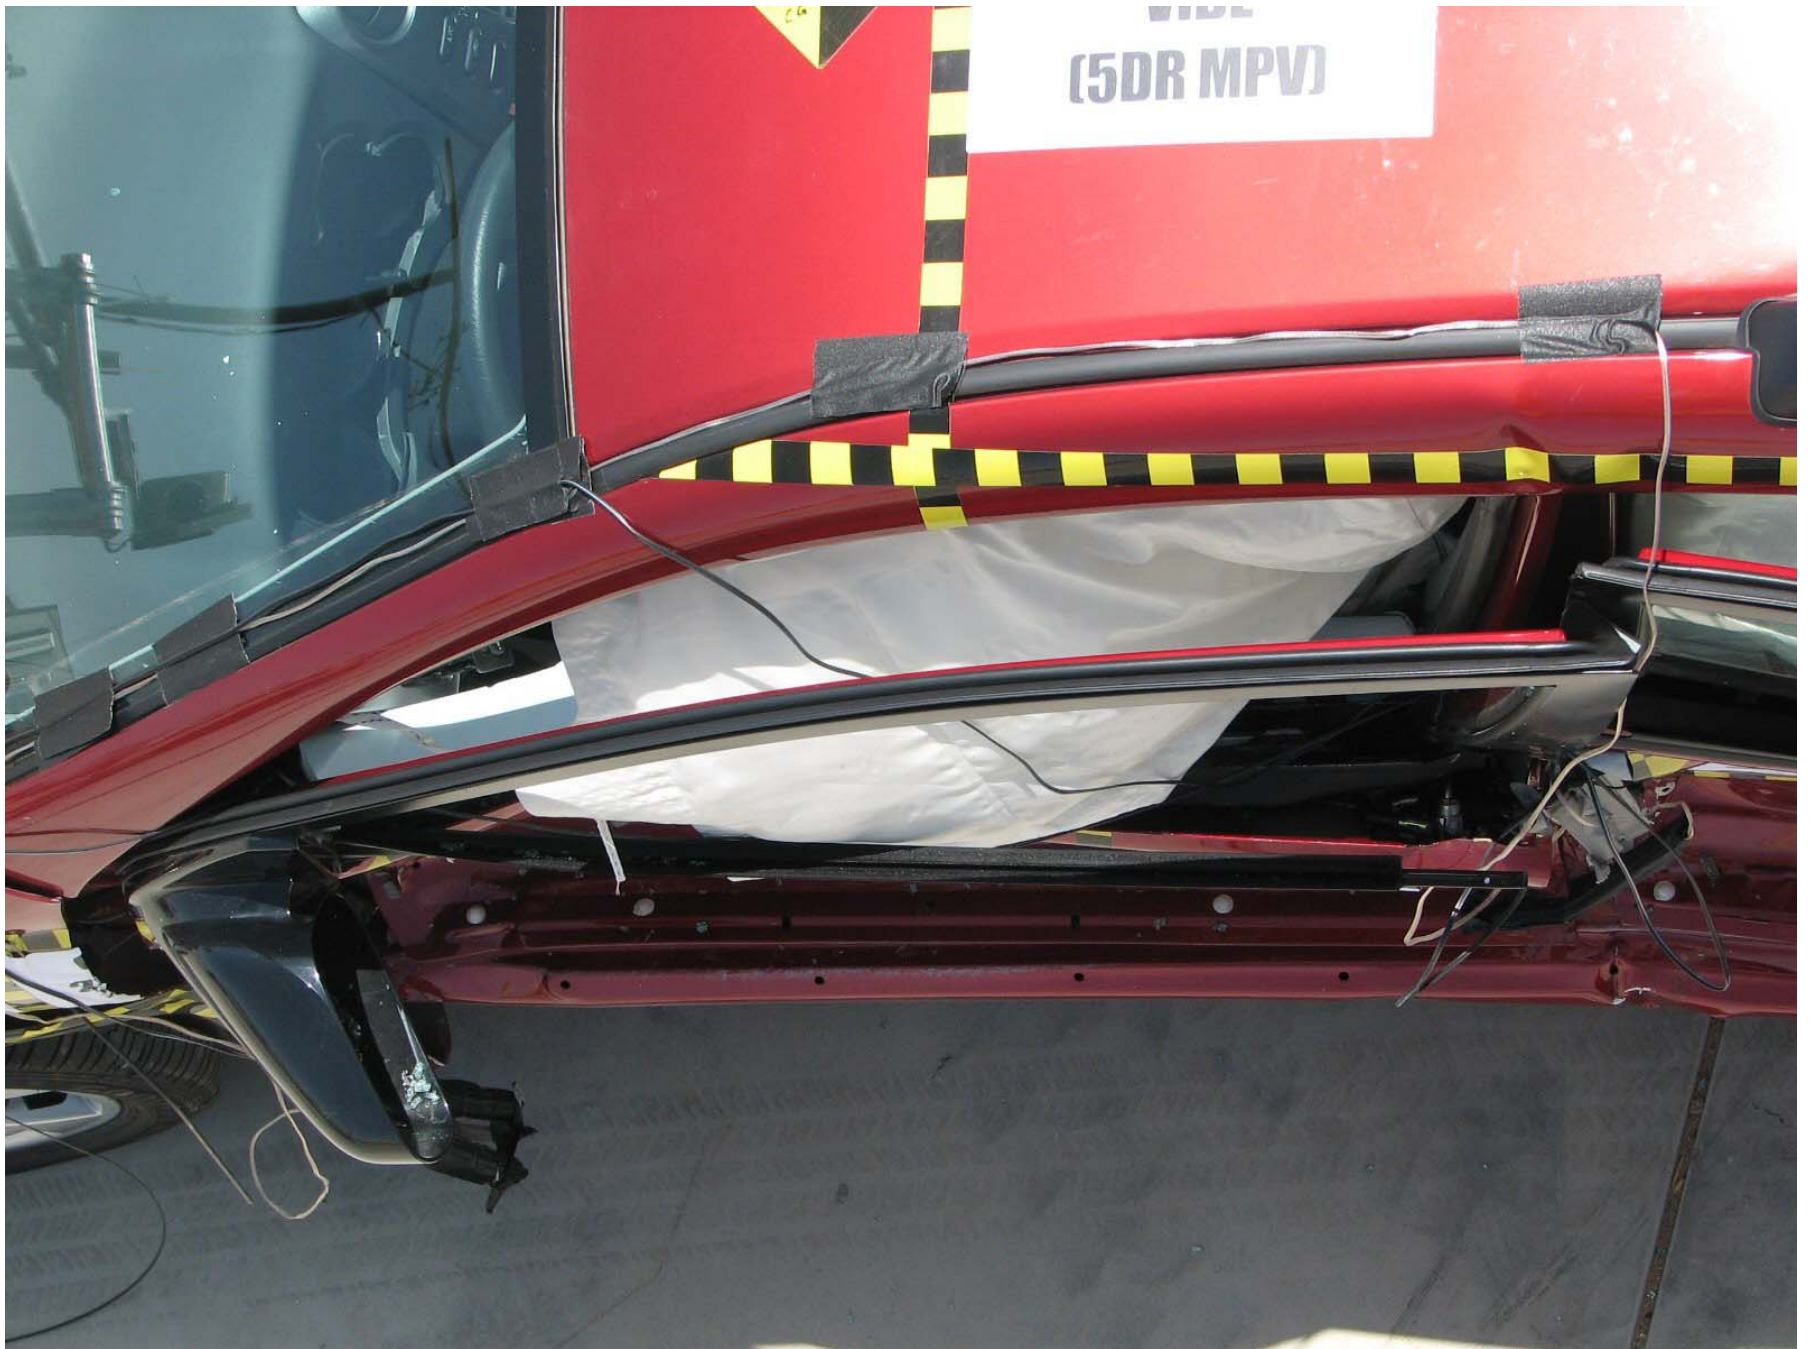
Figure A-39: Post-Test Driver Dummy Clearance From Door
