REPORT NUMBER TR-P27125-01-NC

**NEW CAR ASSESSMENT PROGRAM
SIDE IMPACT TEST**

**GENERAL MOTORS CORPORATION
2007 PONTIAC VIBE
4-DOOR**

NHTSA NUMBER: G70113

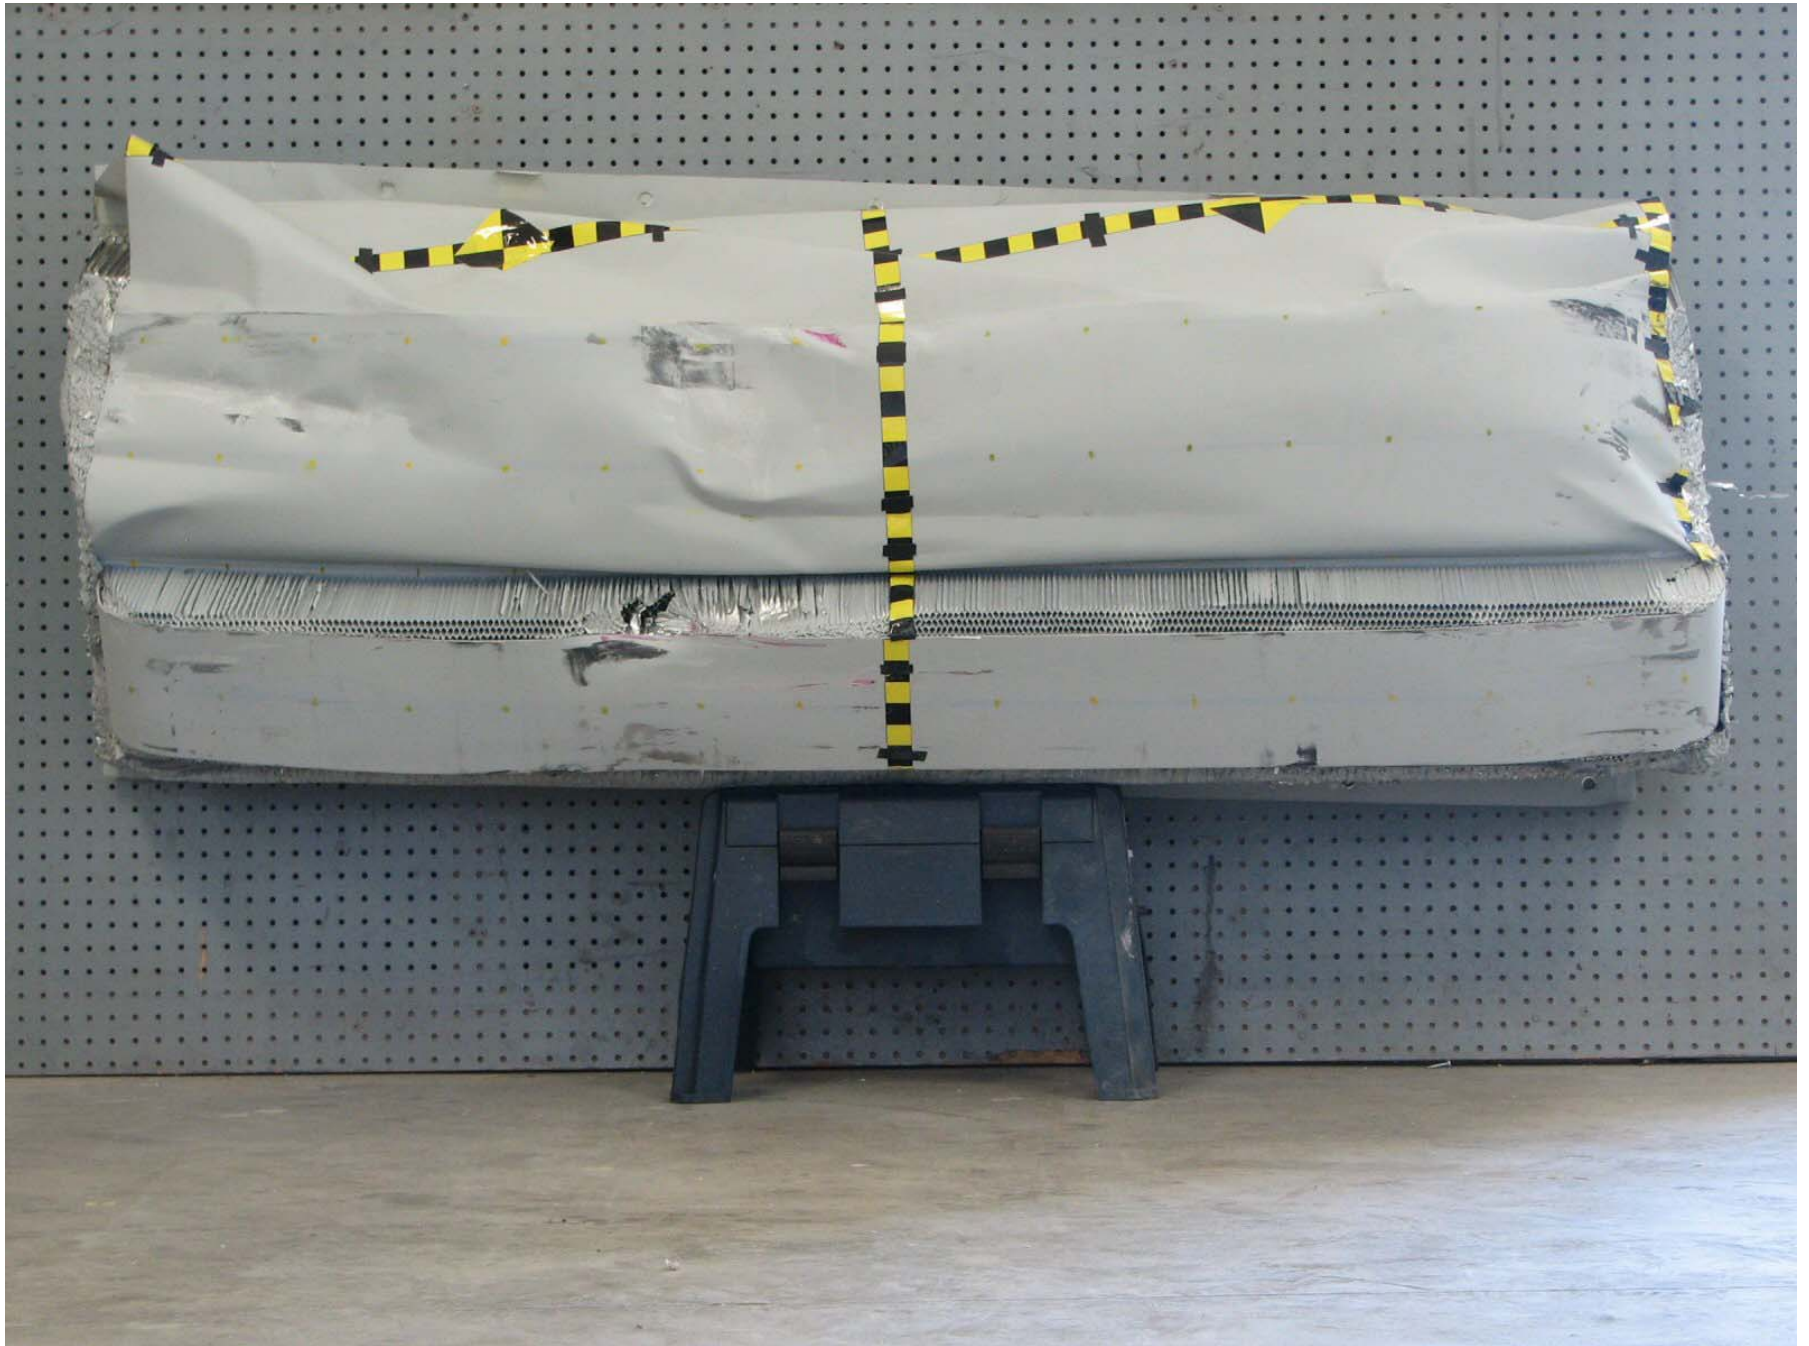
Figure A-54: Post-Test Front View of Deformable Barrier

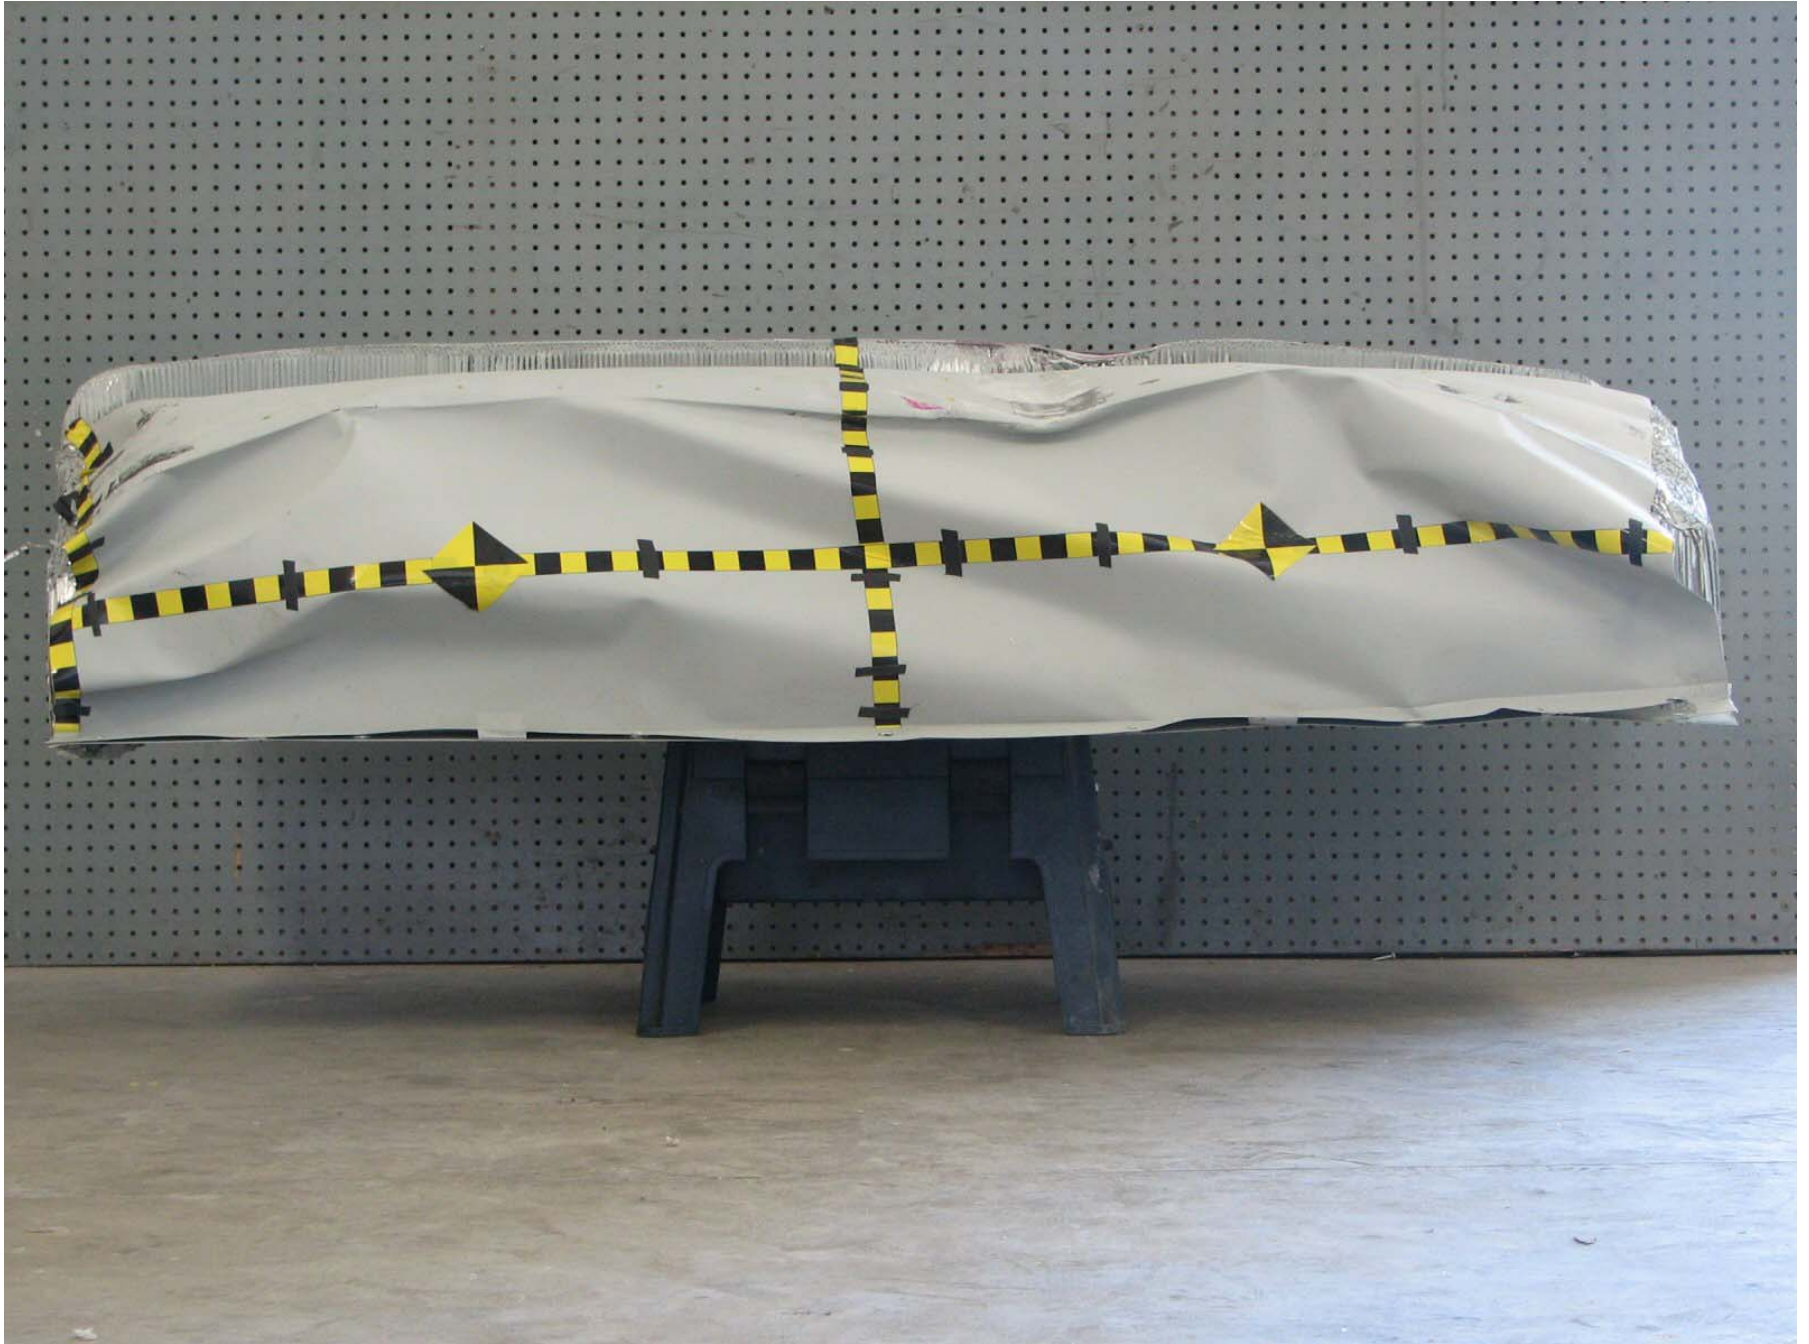
Figure A-56: Post-Test Top View of Deformable Barrier

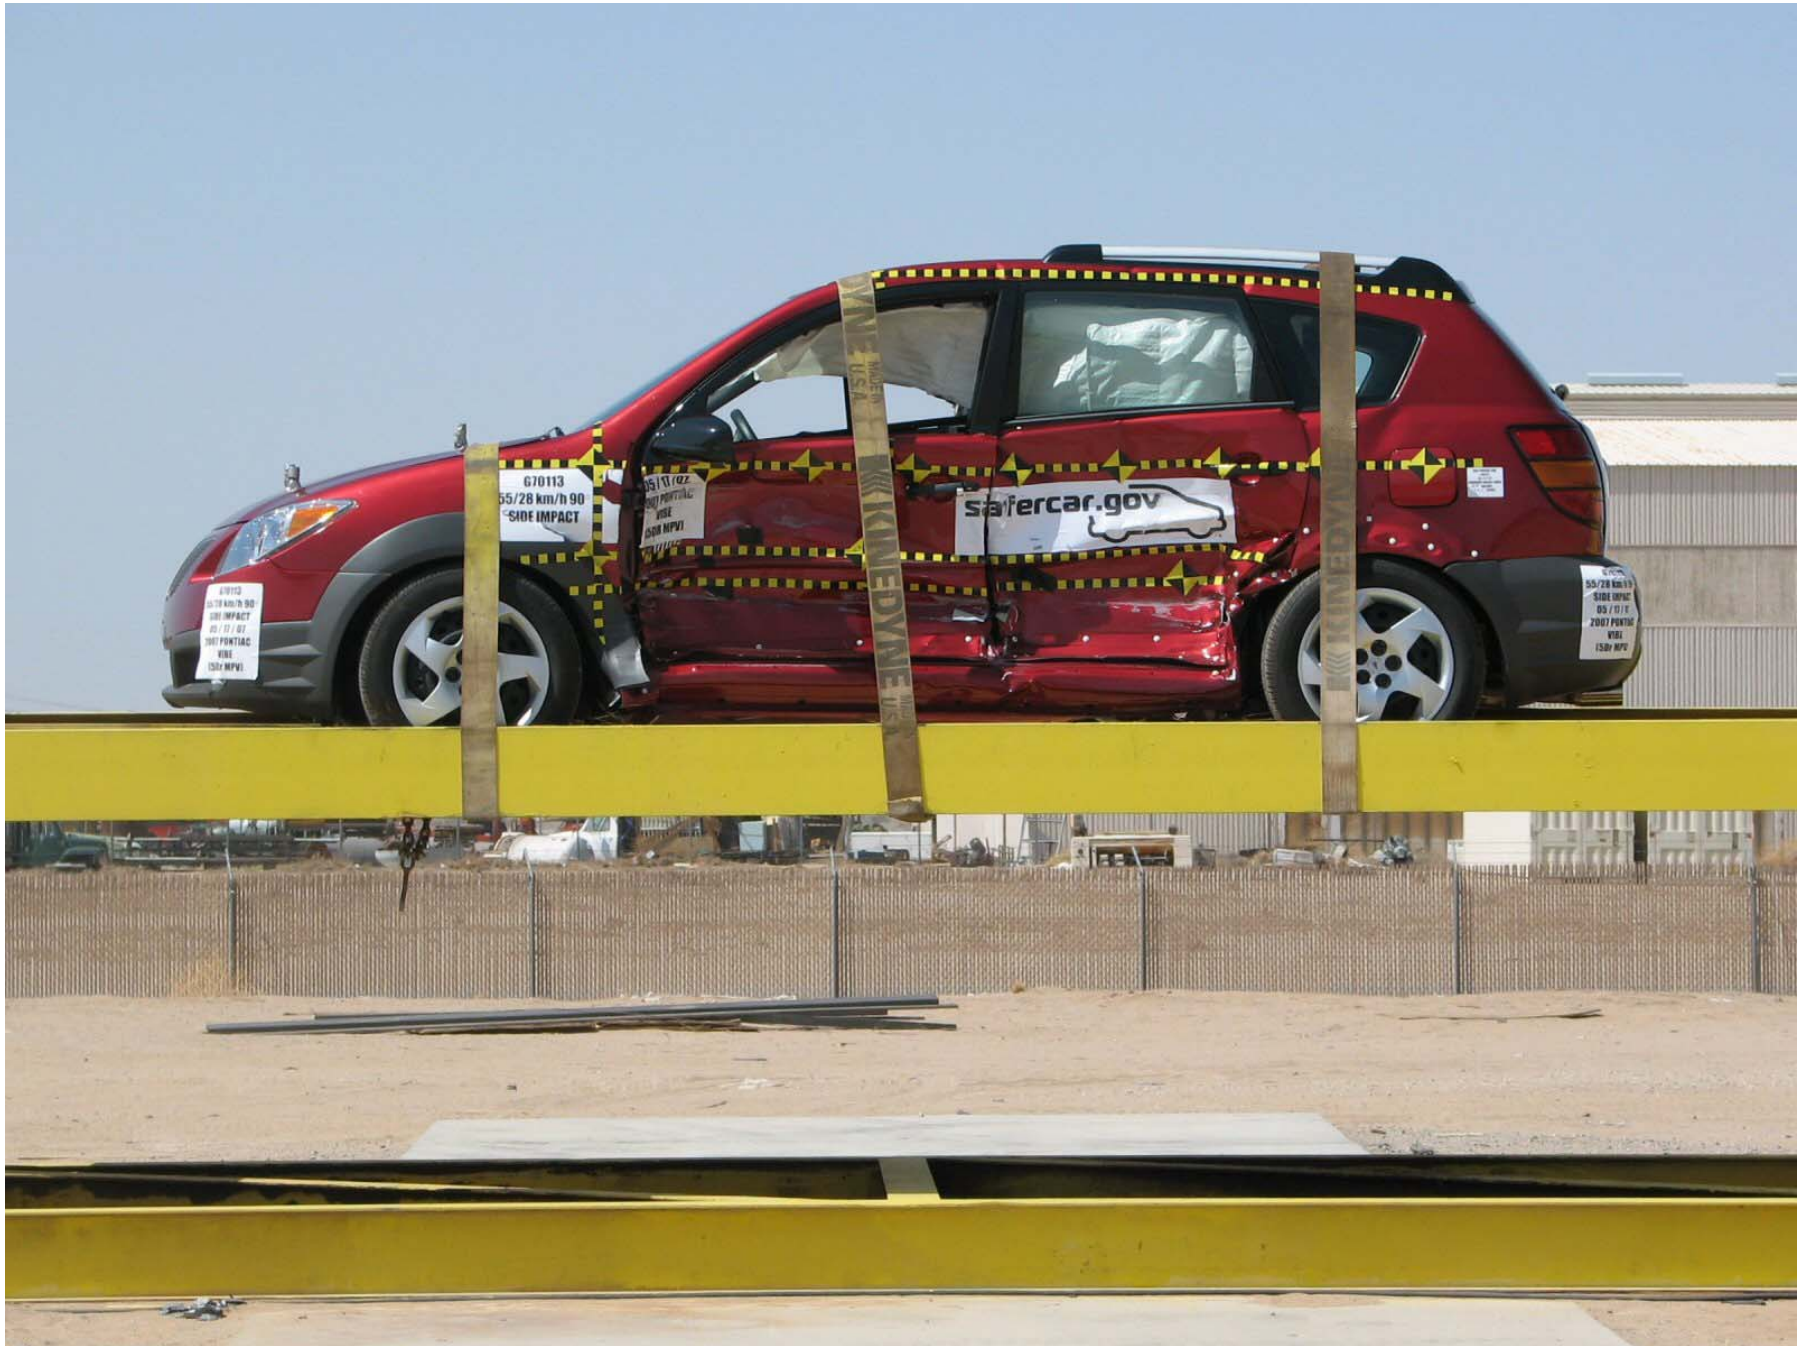
Figure A-61: Vehicle on Rollover Device (0°)

1. The specified fixture rollover rate for each 90° of rotation is 60 to 120 seconds.
2. The position hold time at each position is 300 seconds (minimum).
3. Details of Stoddard Solvent spillage locations.
No solvent leakage occurred during static rollover testing.

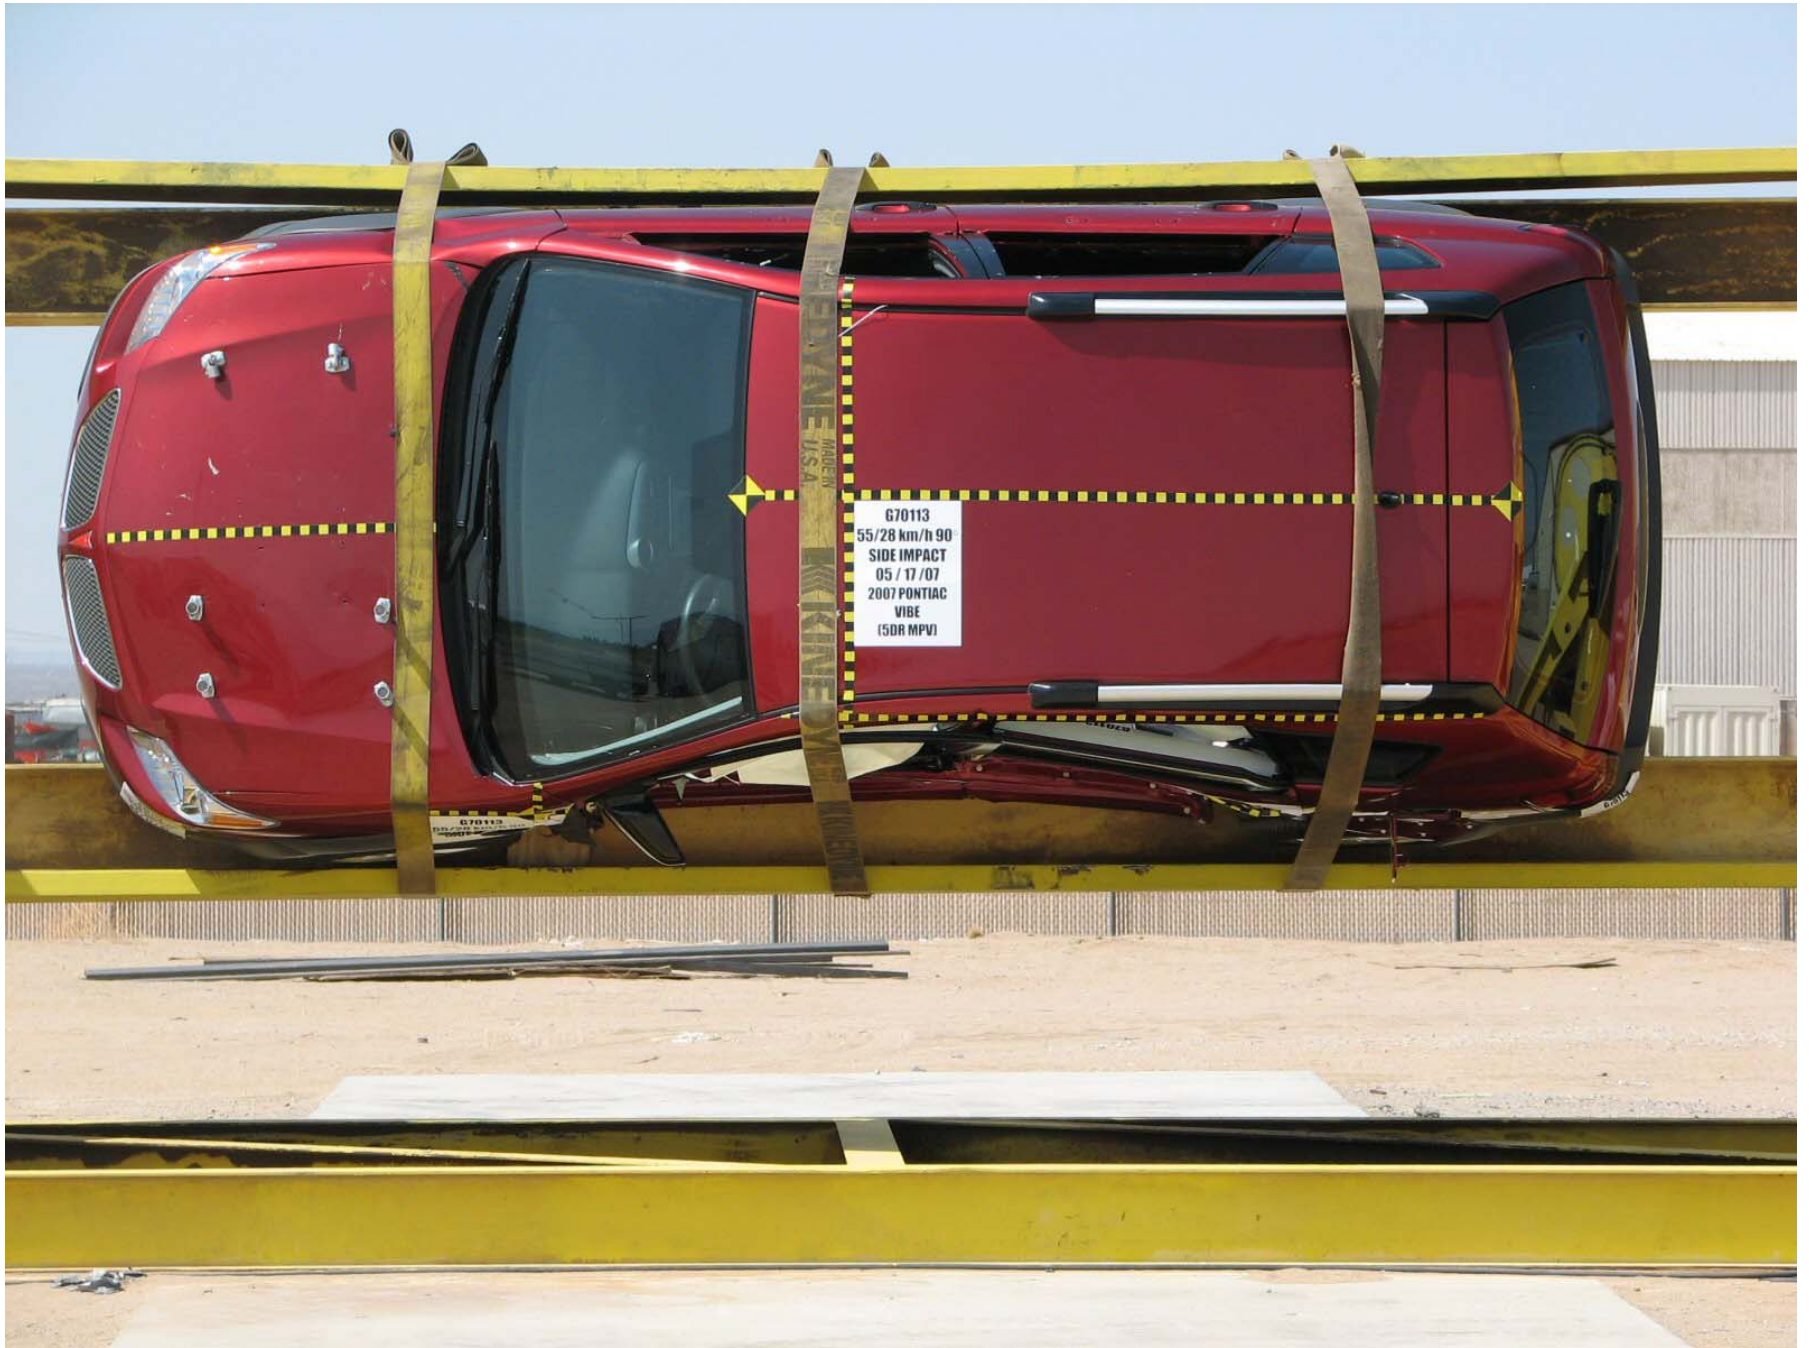
Figure A-62: Vehicle on Rollover Device (90°)

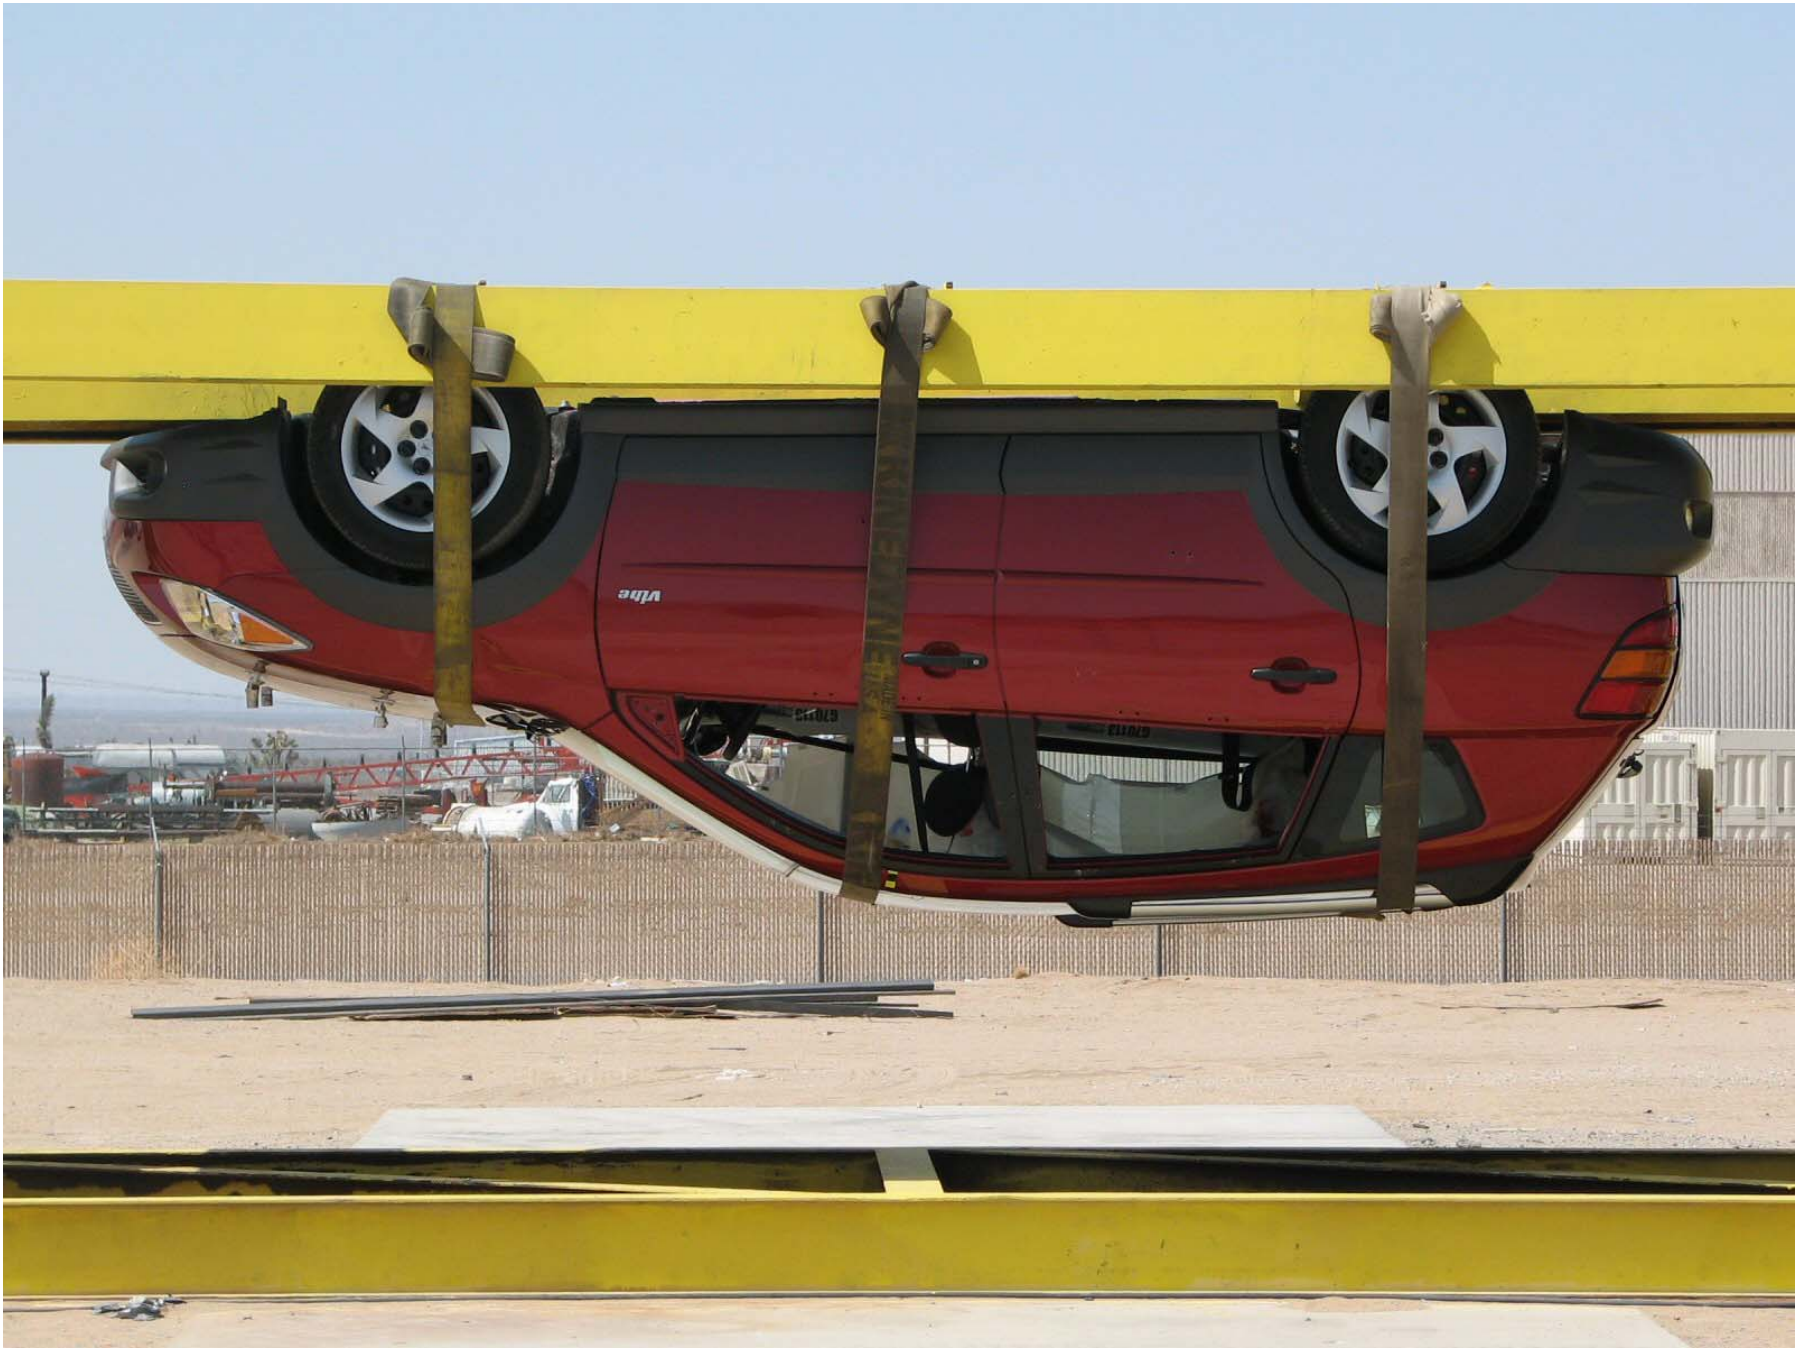
Figure A-63: Vehicle on Rollover Device (180°)

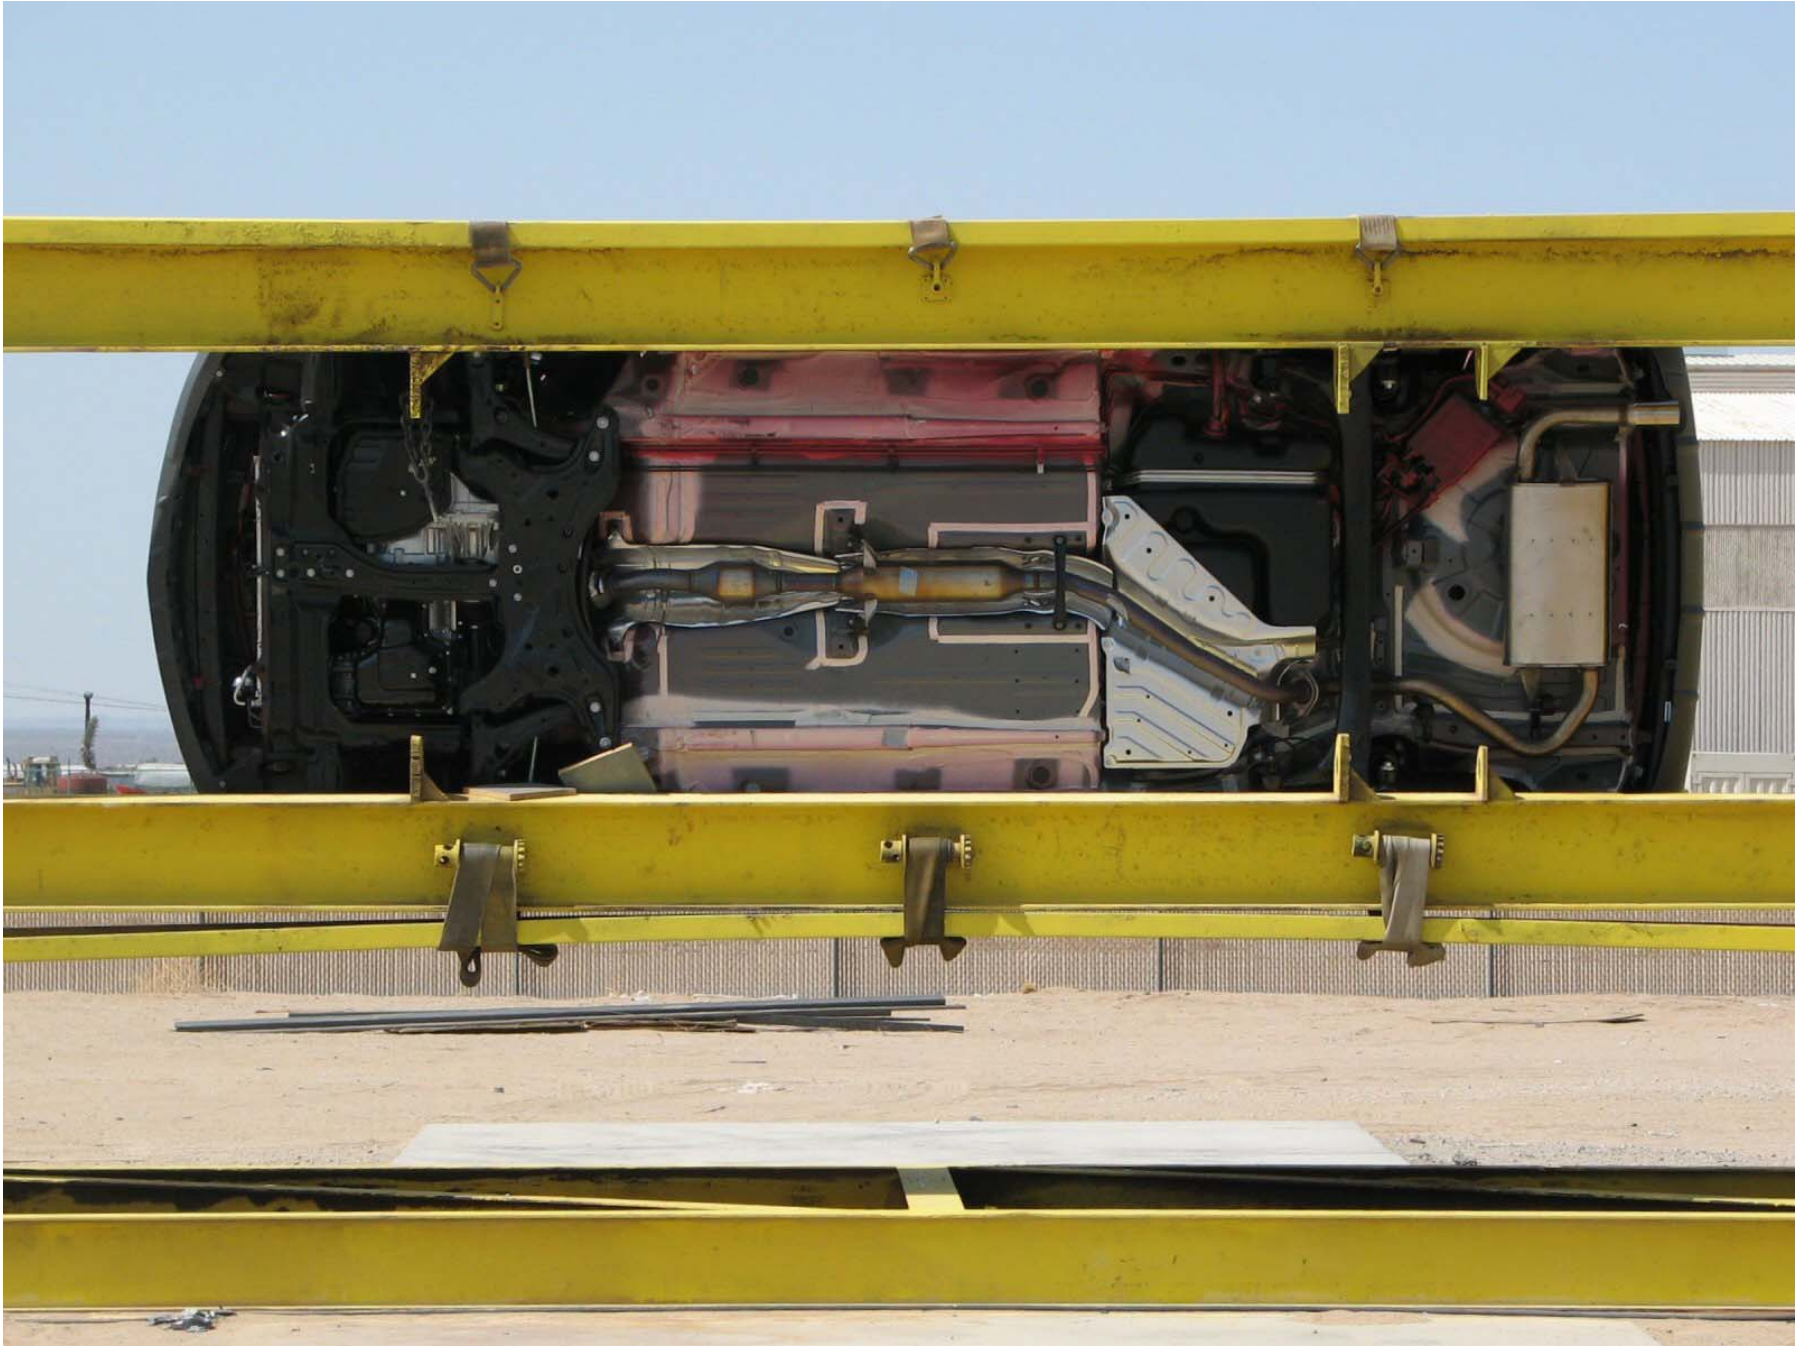
Figure A-64: Vehicle on Rollover Device (270°)
