**REPORT NUMBER: NCAPSIDE-MGA-2007-006**

**NEW CAR ASSESSMENT PROGRAM  
SIDE IMPACT TEST**

**CAMI AUTOMOTIVE INC.  
2008 SUZUKI XL7  
NHTSA NUMBER: X80501**

**PREPARED BY:  
MGA RESEARCH CORPORATION  
5000 WARREN ROAD  
BURLINGTON, WI 53105**

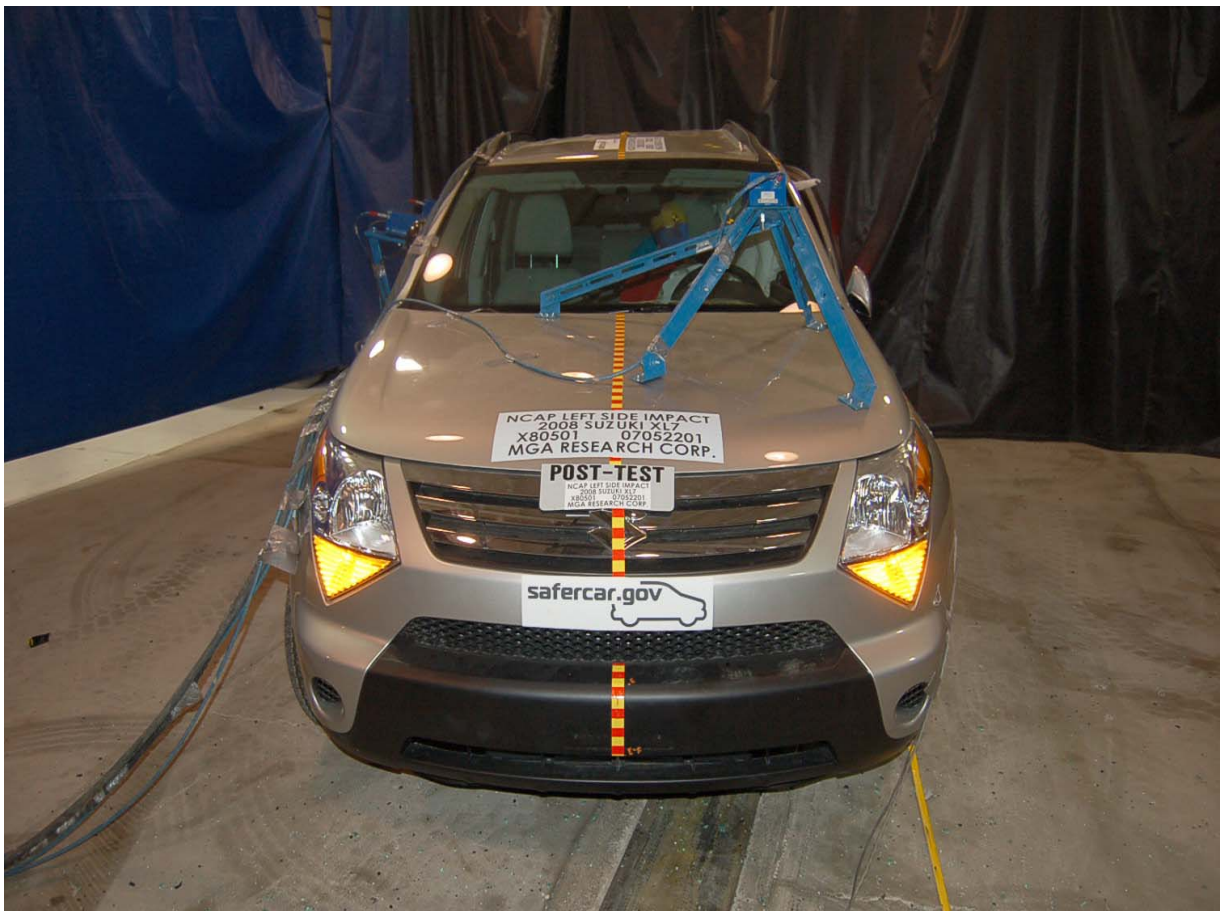
Post-Test Front View

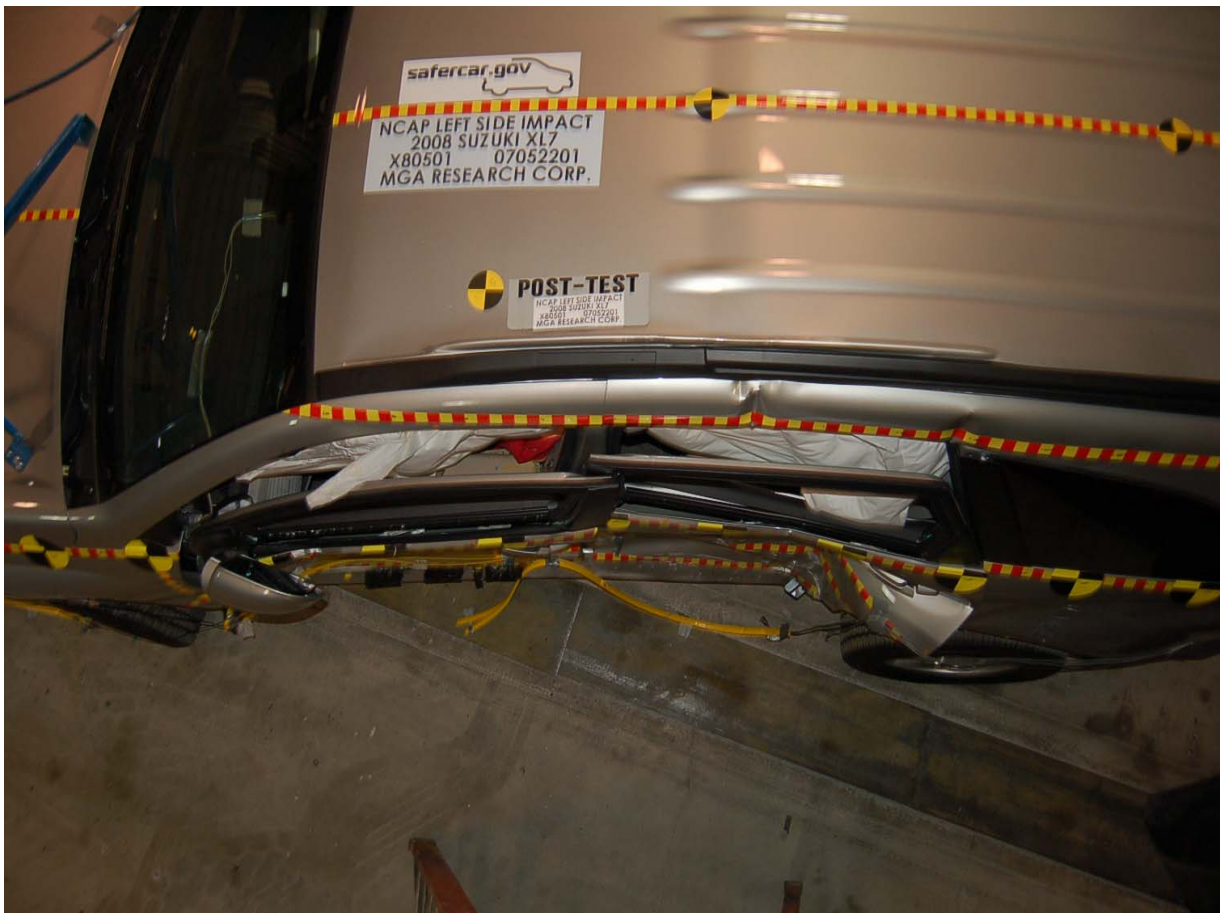
Post-Test Overhead View

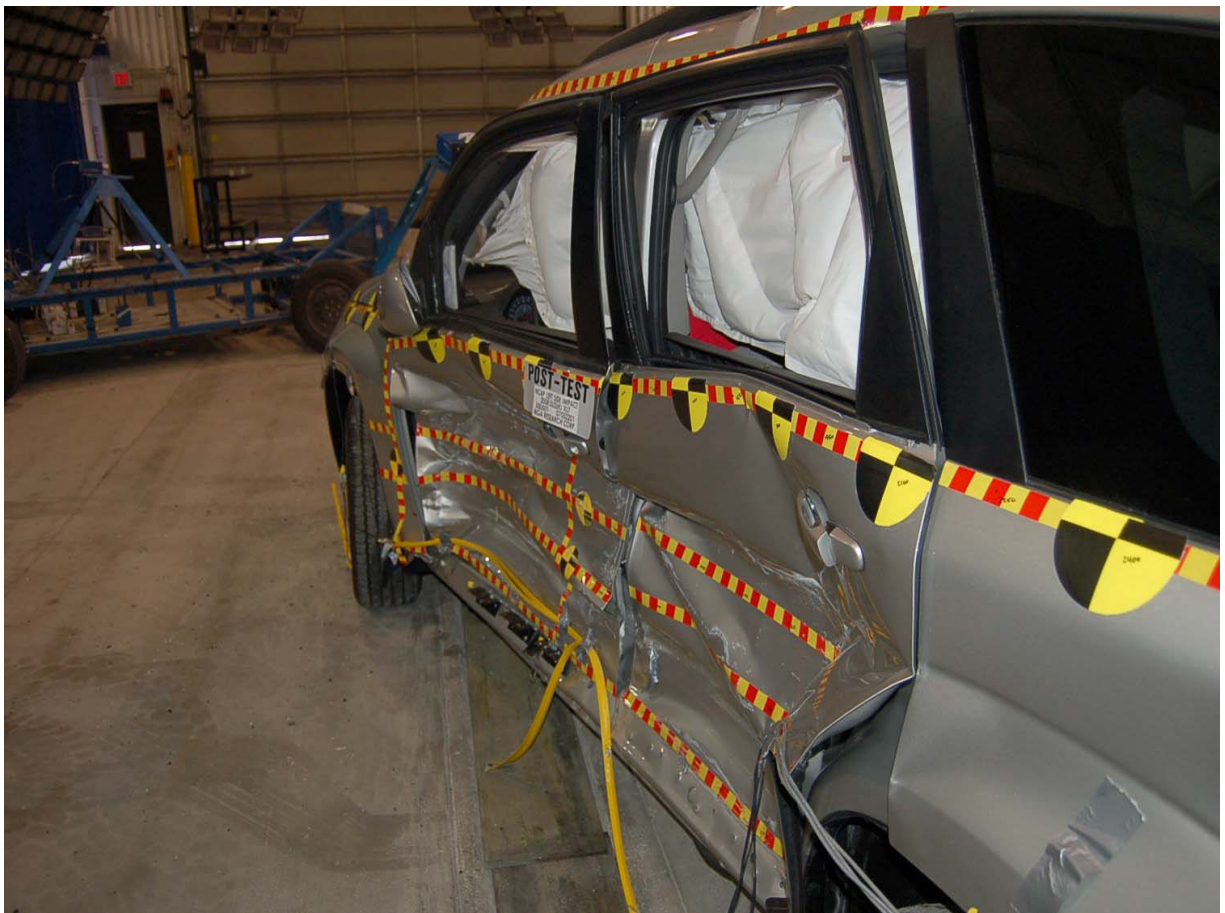
Post-Test Rear  $\frac{3}{4}$  View of Left Side Doors

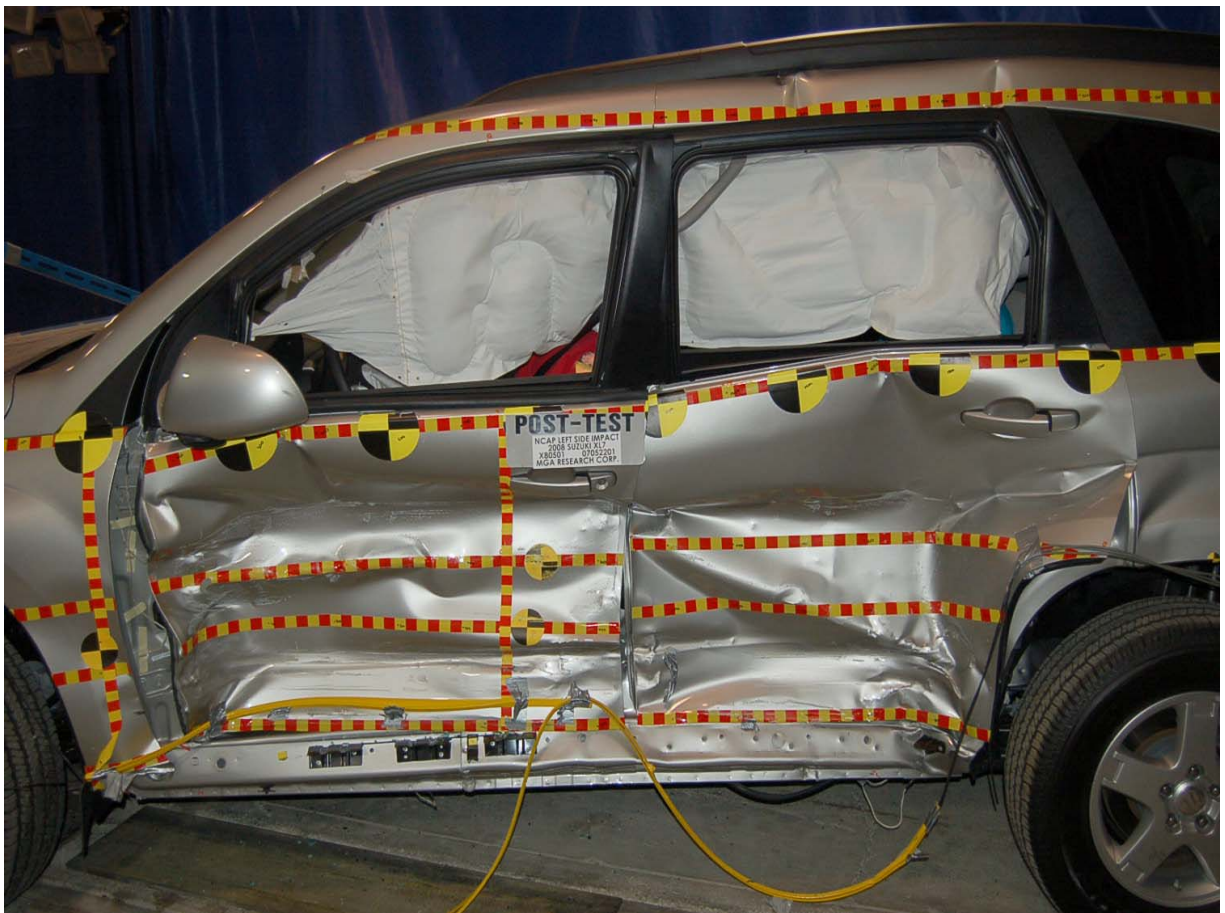
Post-Test Left Side Impact Close-up

The test vehicle sustained a maximum static crush of 315 mm at level 3, 1500 mm rearward of the vertical impact point. The driver and passenger SID/HIIs, Serial Nos. 271 and 904 respectively, were calibrated just prior to this test.

| Critical Areas of Performance | Observations and Conclusions |
|---|---|
| Window Damage | Left front and left rear windows broke |

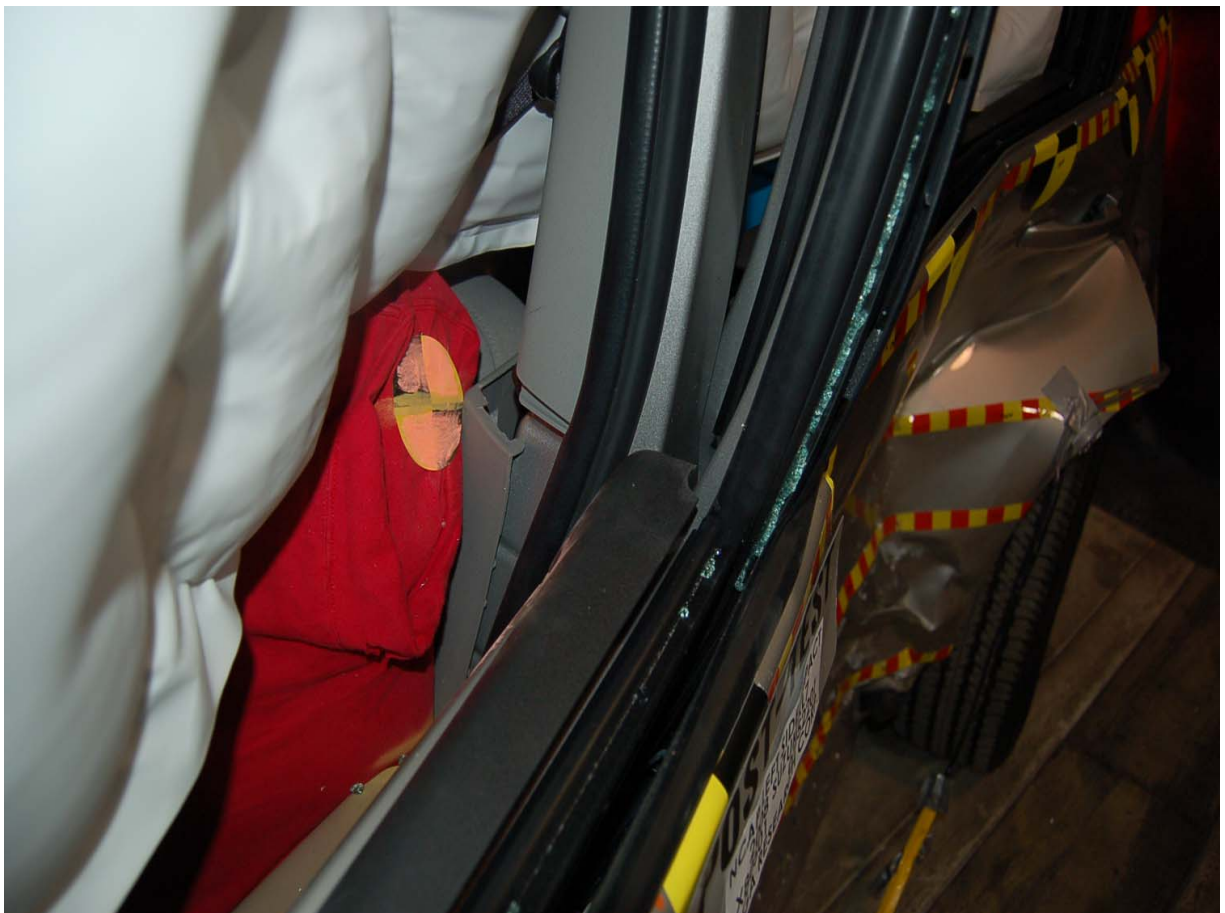
Post-Test Driver Dummy Clearance From Door

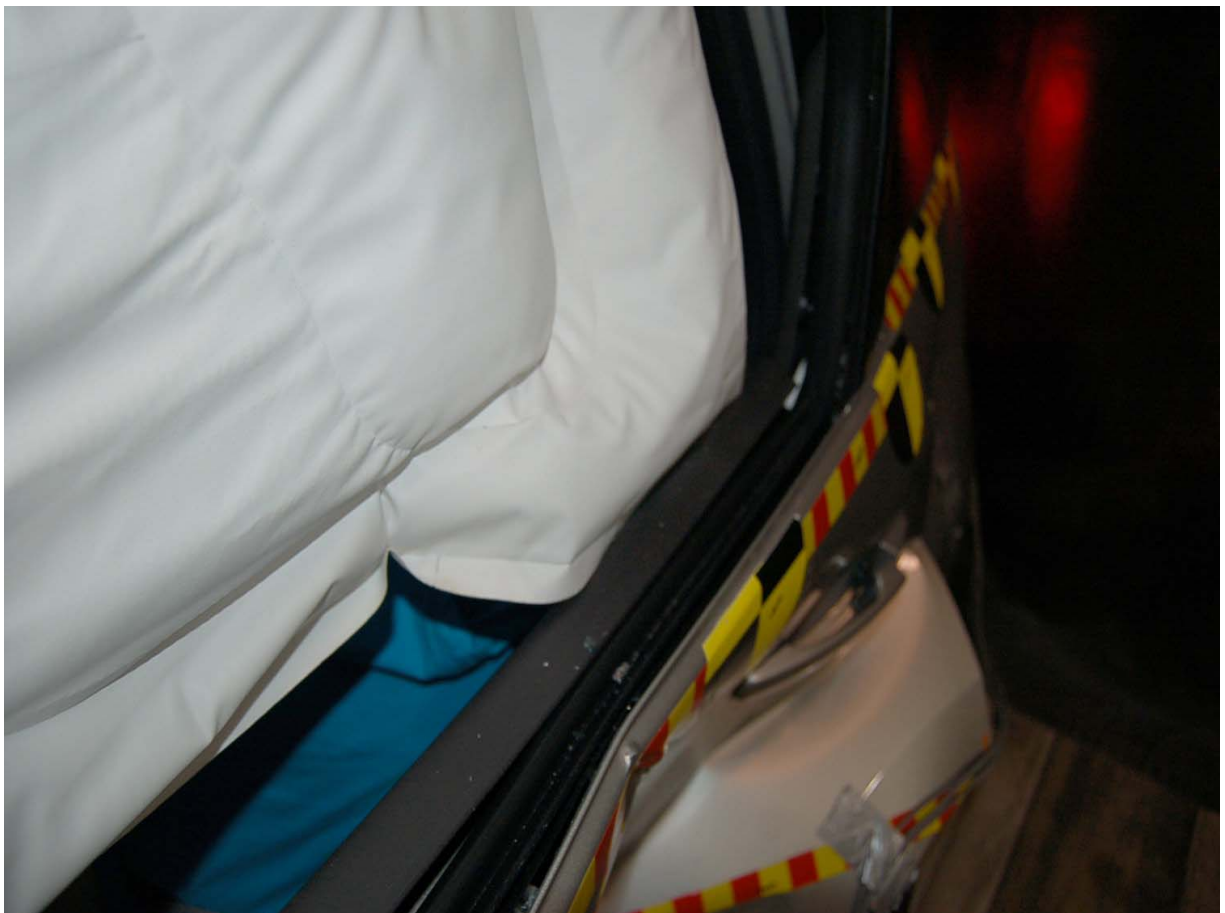
Post-Test Passenger Dummy Clearance From Door

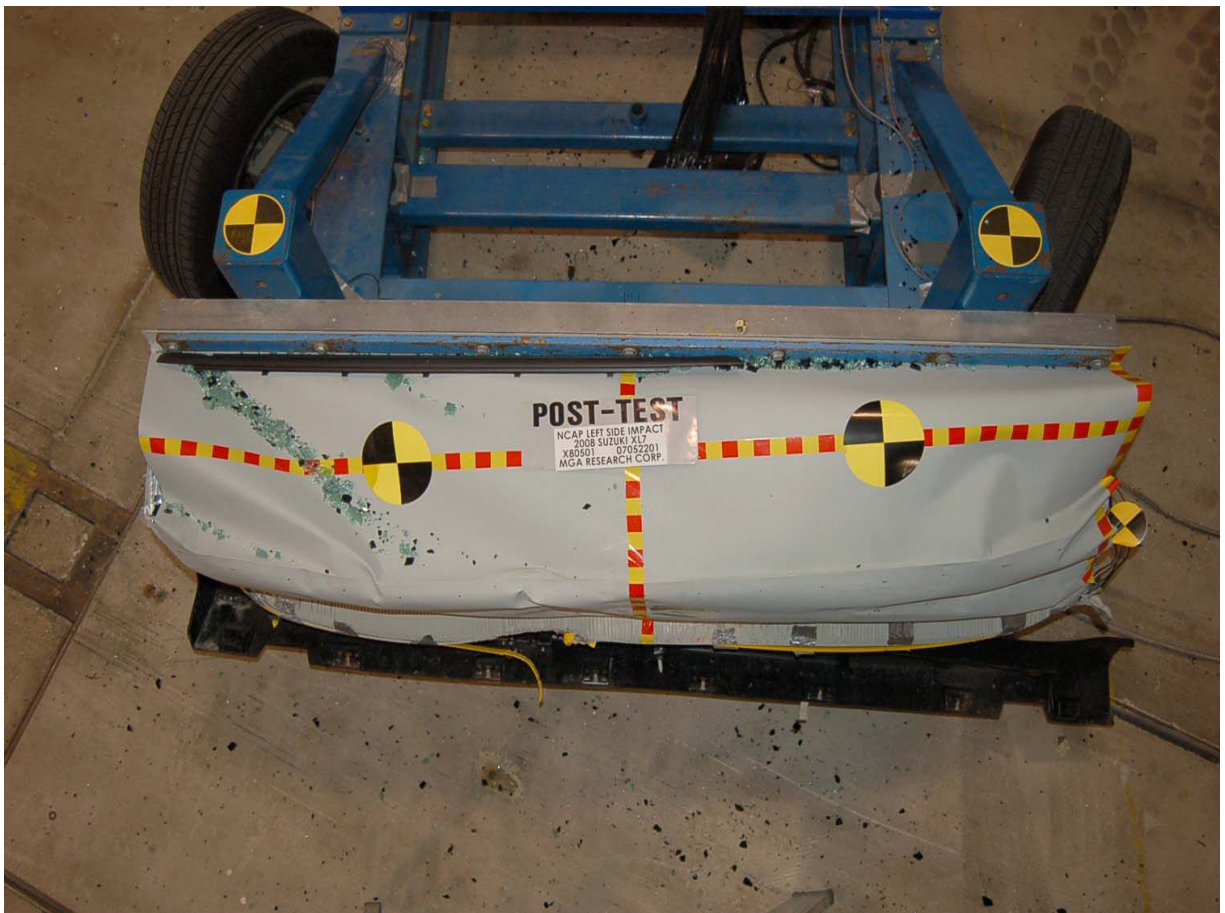
Post-Test Top View of Deformable Barrier

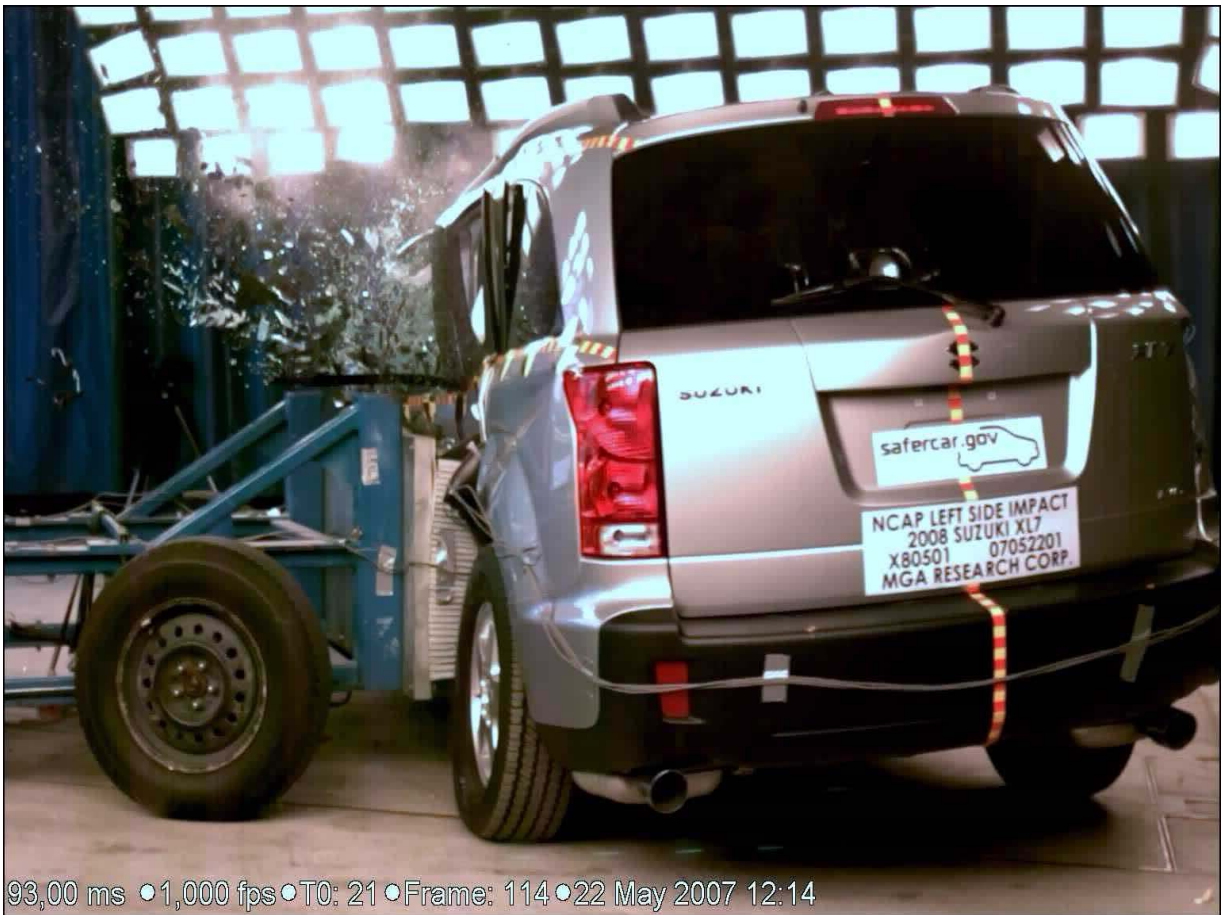
93,00 ms • 1,000 fps • T0: 21 • Frame: 114 • 22 May 2007 12:14

Vehicle Impact

A model year 2008 Suzuki XL7 was impacted on the left (driver's) side by a Moving Deformable Barrier (MDB) which was moving forward in a 27° crabbed position to the tow road guidance system at a velocity of 62.0 km/h. The specified impact velocity range is from 61.1 to 62.7 km/h. The test (target) vehicle was stationary and positioned 63° to the line of forward motion. The weight of the vehicle as tested was 2107.9 kg and the test weight of the MDB was 1360.8 kg. The test was conducted at MGA Research Corporation in Burlington, Wisconsin, on May 22, 2007.

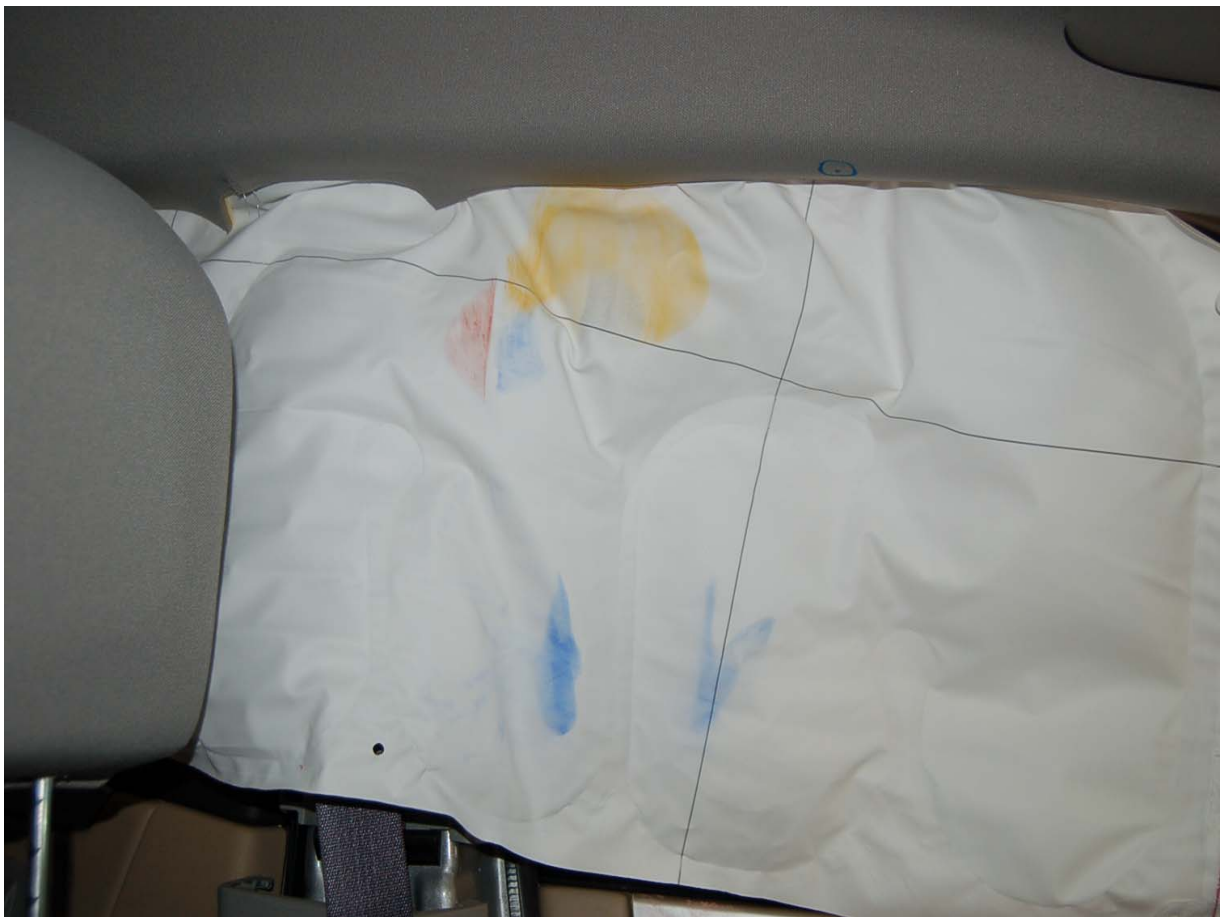
Post-Test Driver Dummy Head Contact

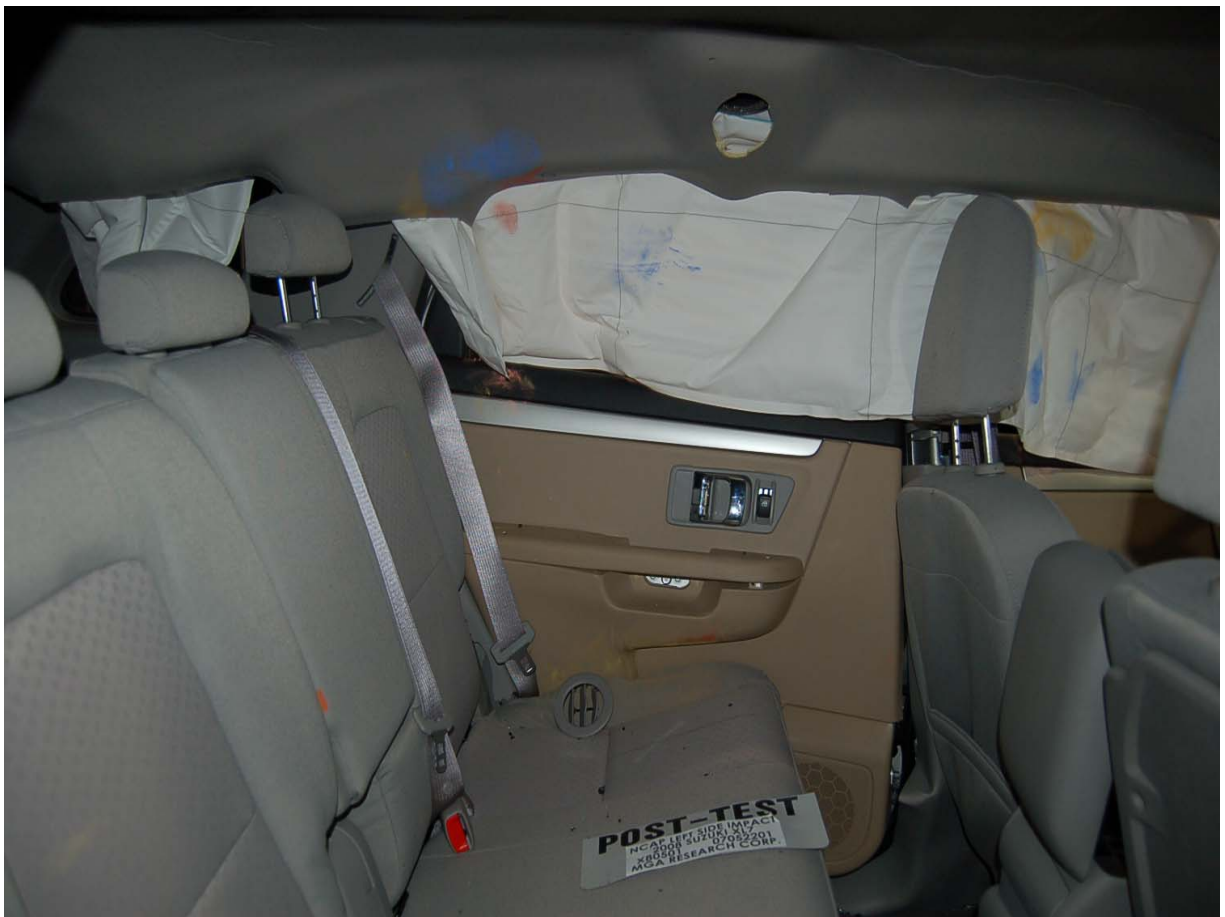
Post-Test Passenger Dummy Contact
