**REPORT NUMBER TR-P27127-01-NC**

**NEW CAR ASSESSMENT PROGRAM  
SIDE IMPACT TEST**

**GENERAL MOTORS CORPORATION  
2007 PONTIAC G6  
2-DOOR COUPE**

**NHTSA NUMBER: G70112**

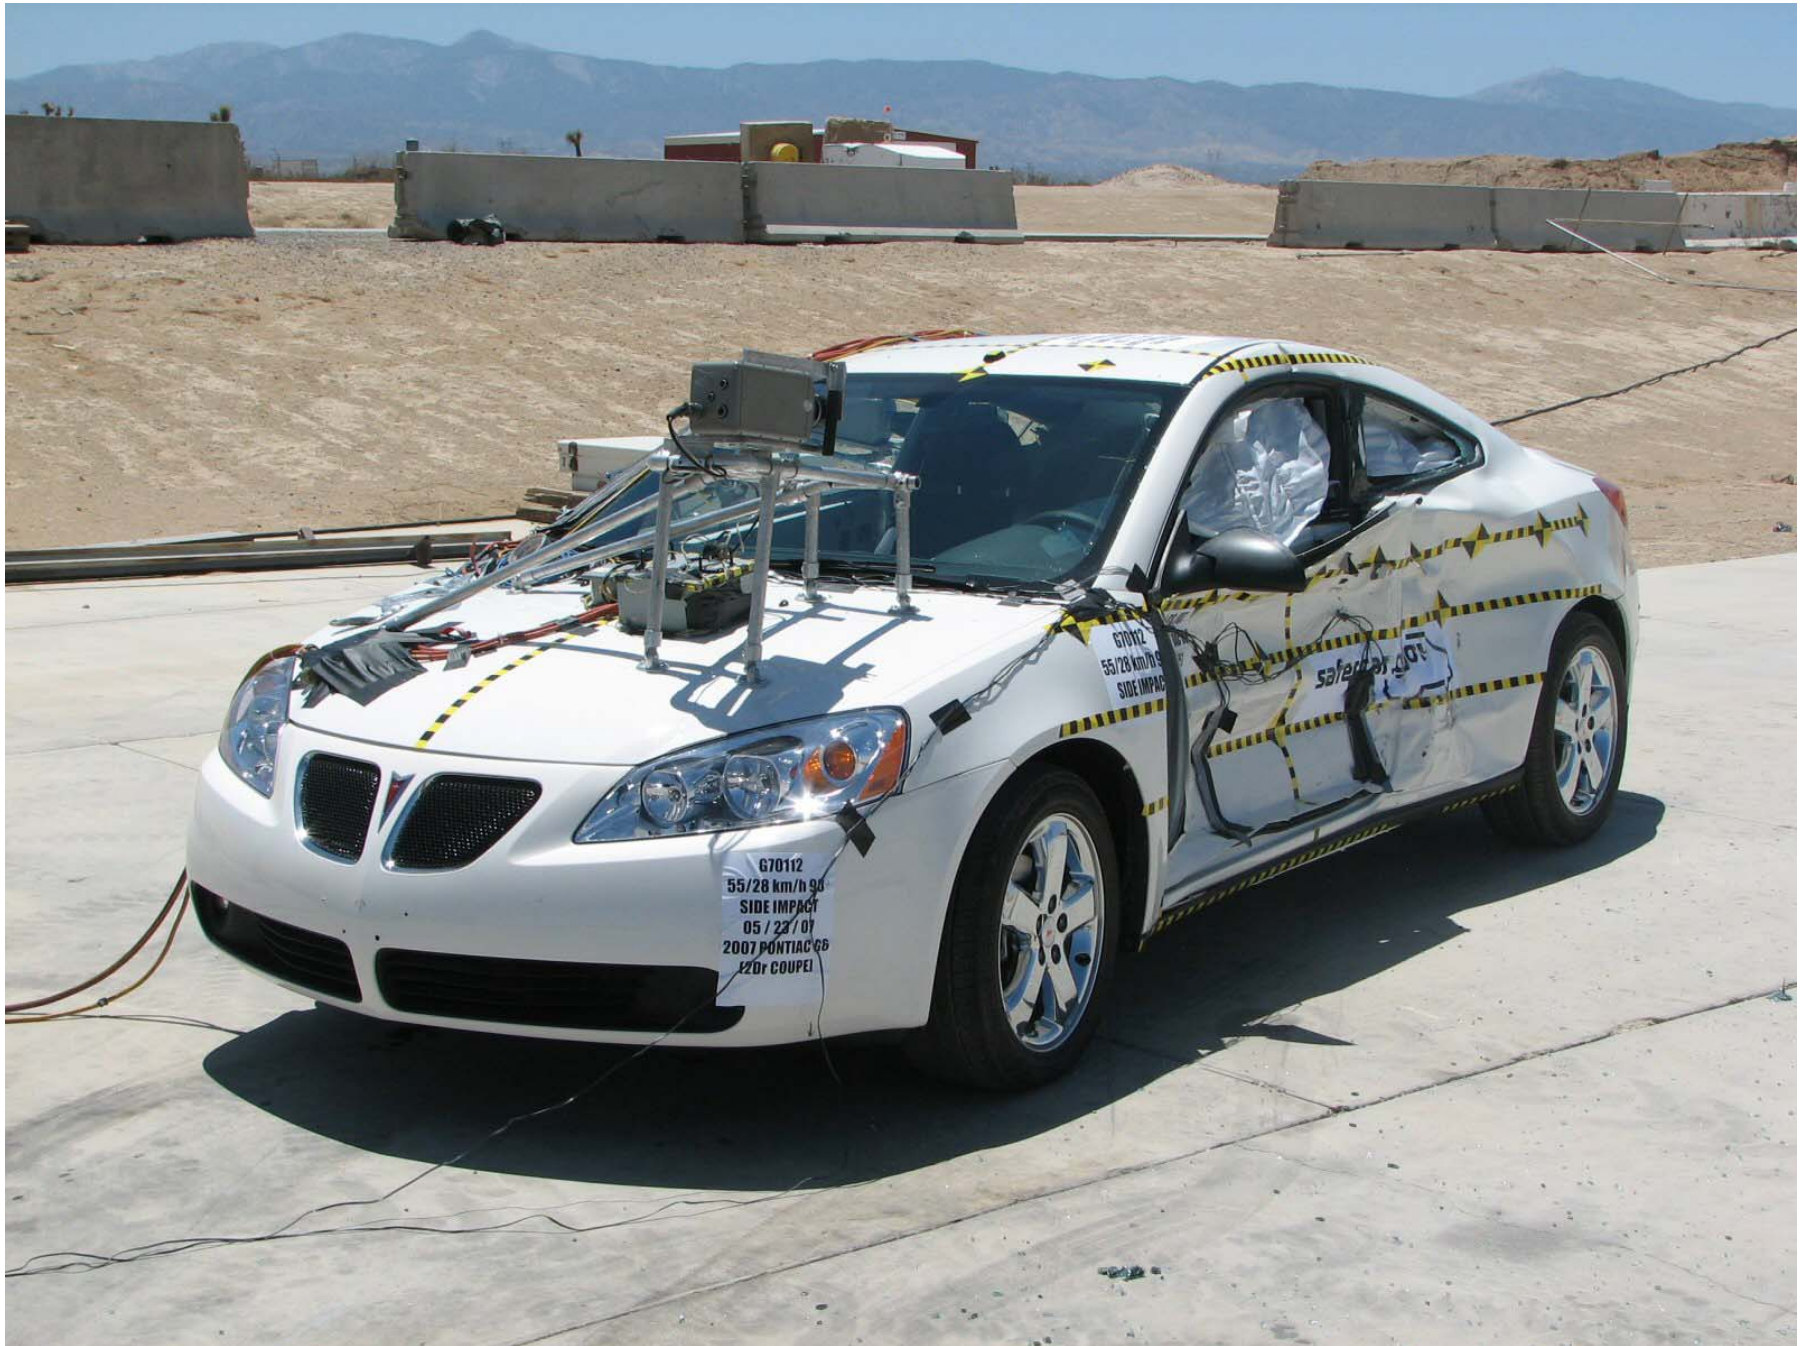
Figure A-8: Post-Test Left Front  $\frac{3}{4}$  View

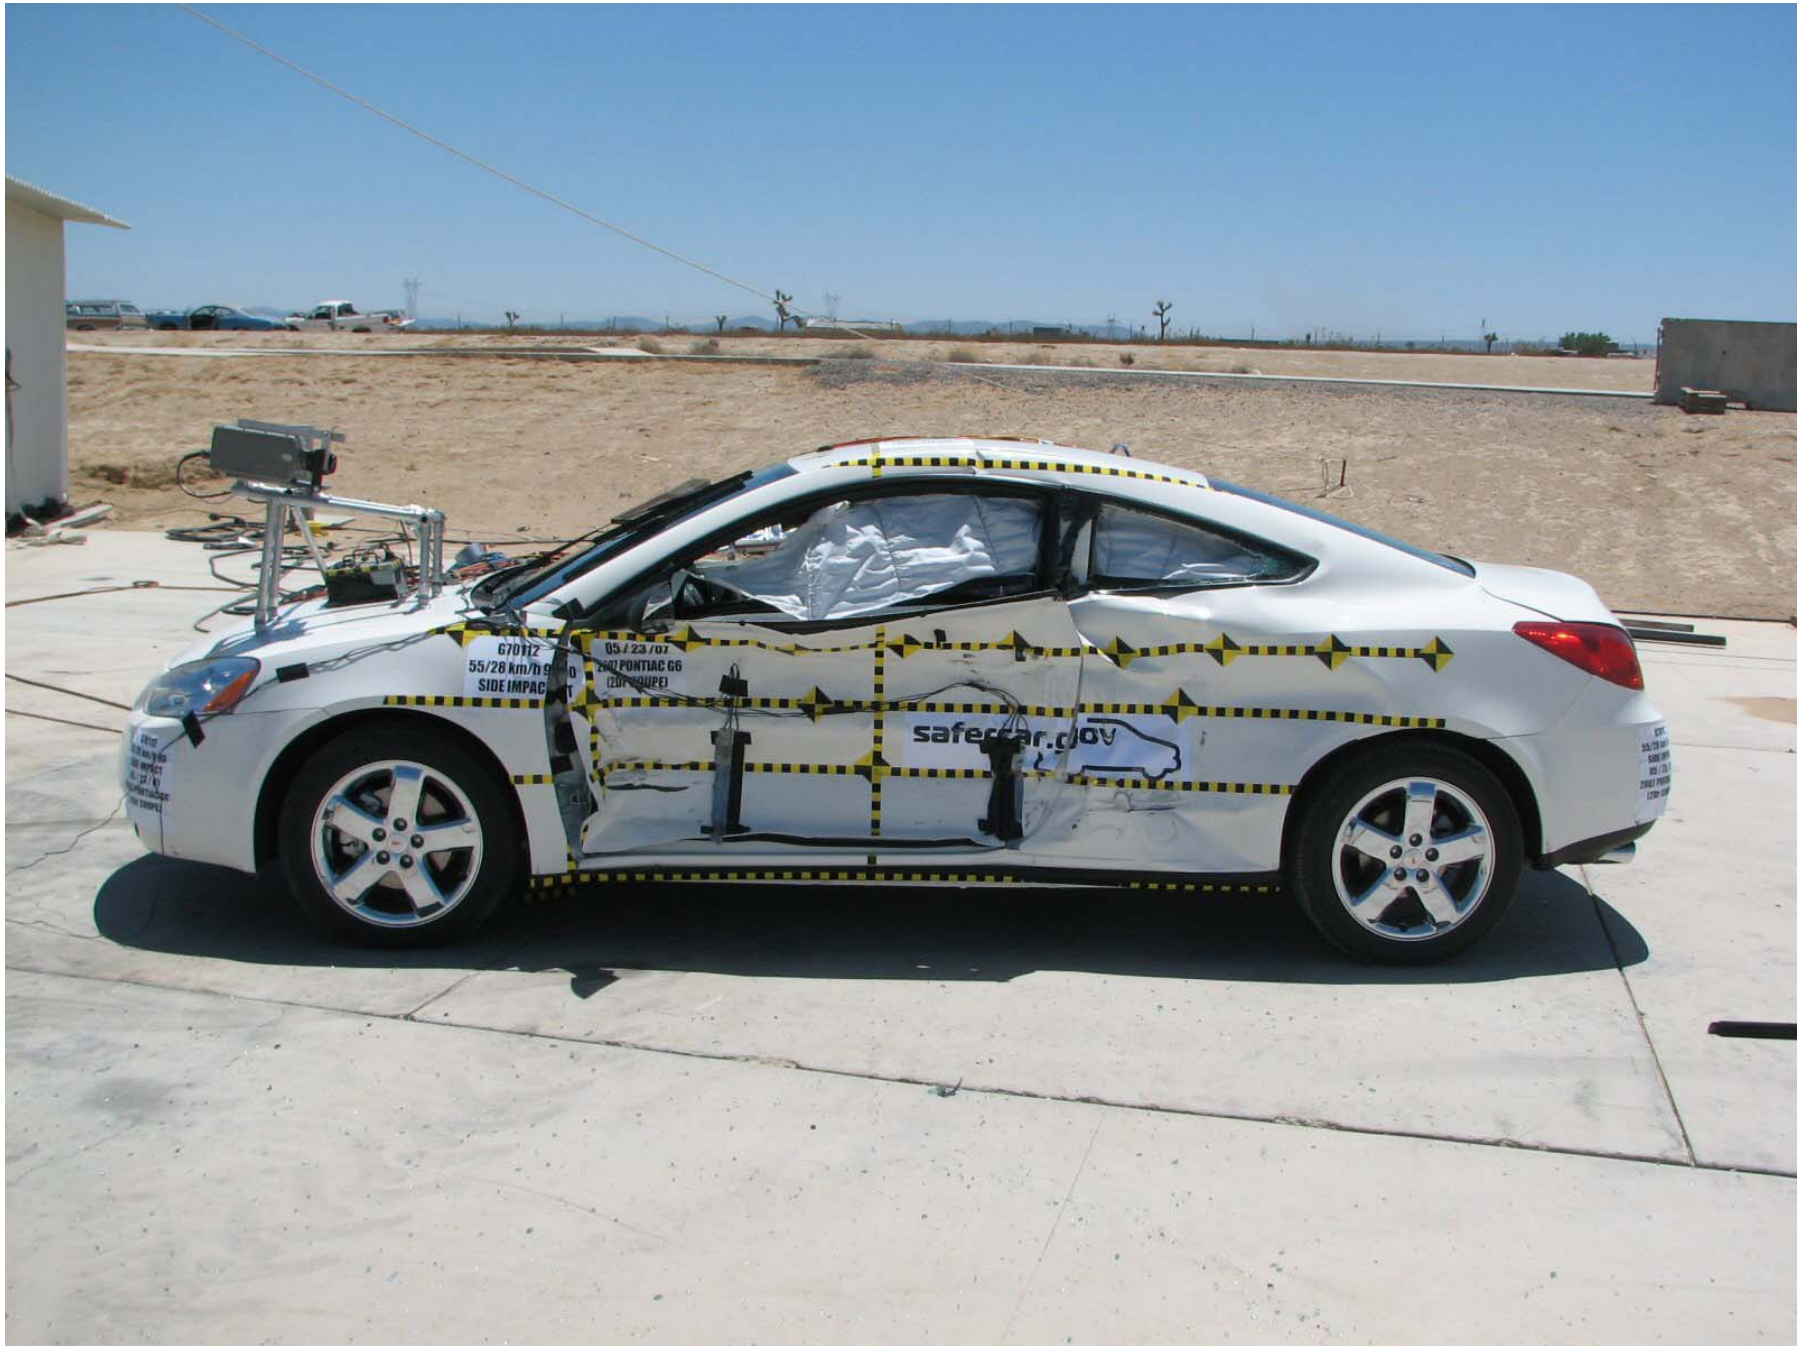
Figure A-10: Post-Test Left Side View

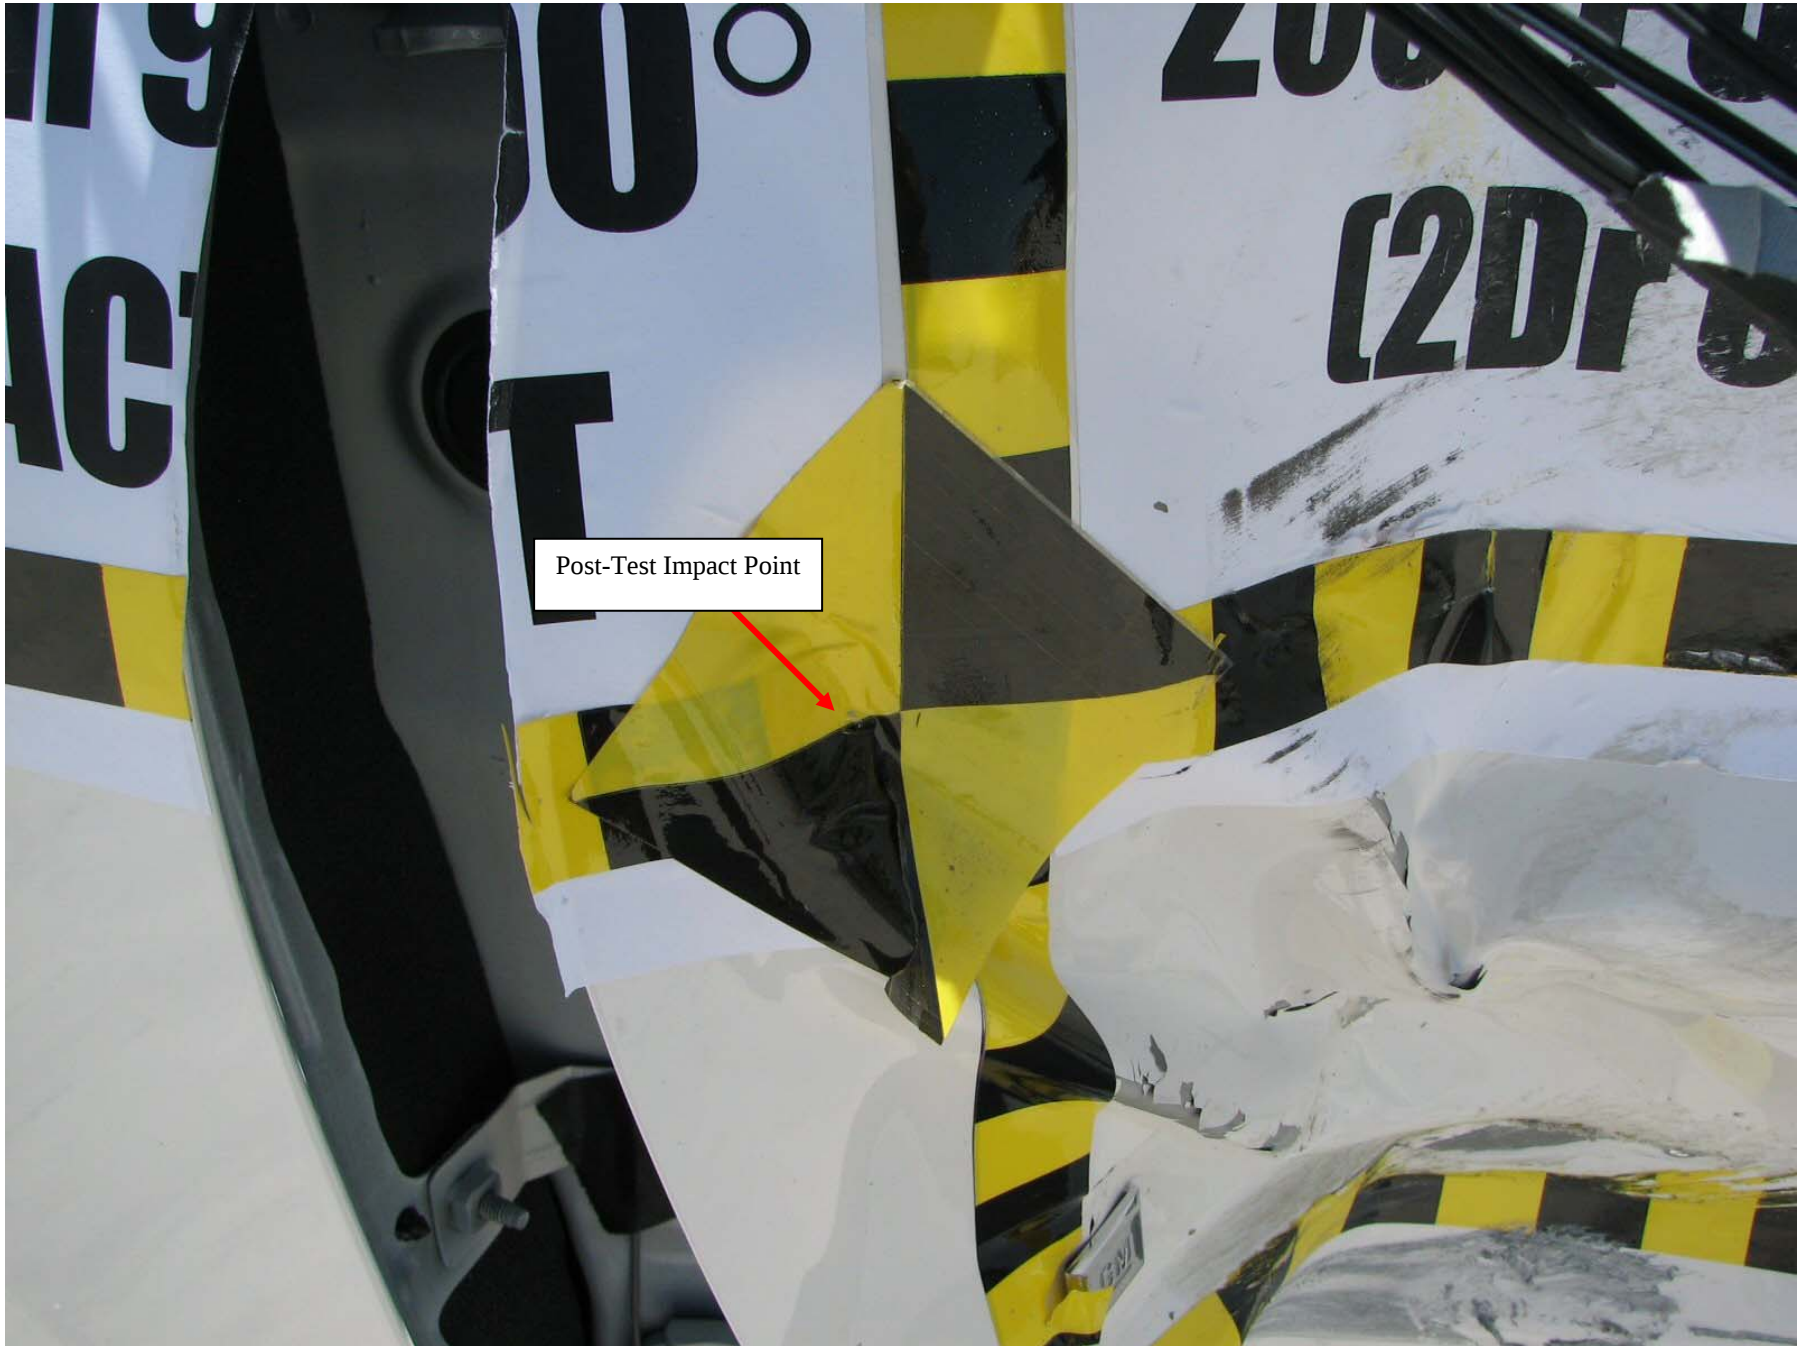
Figure A-26: Post-Test Left Impact Point

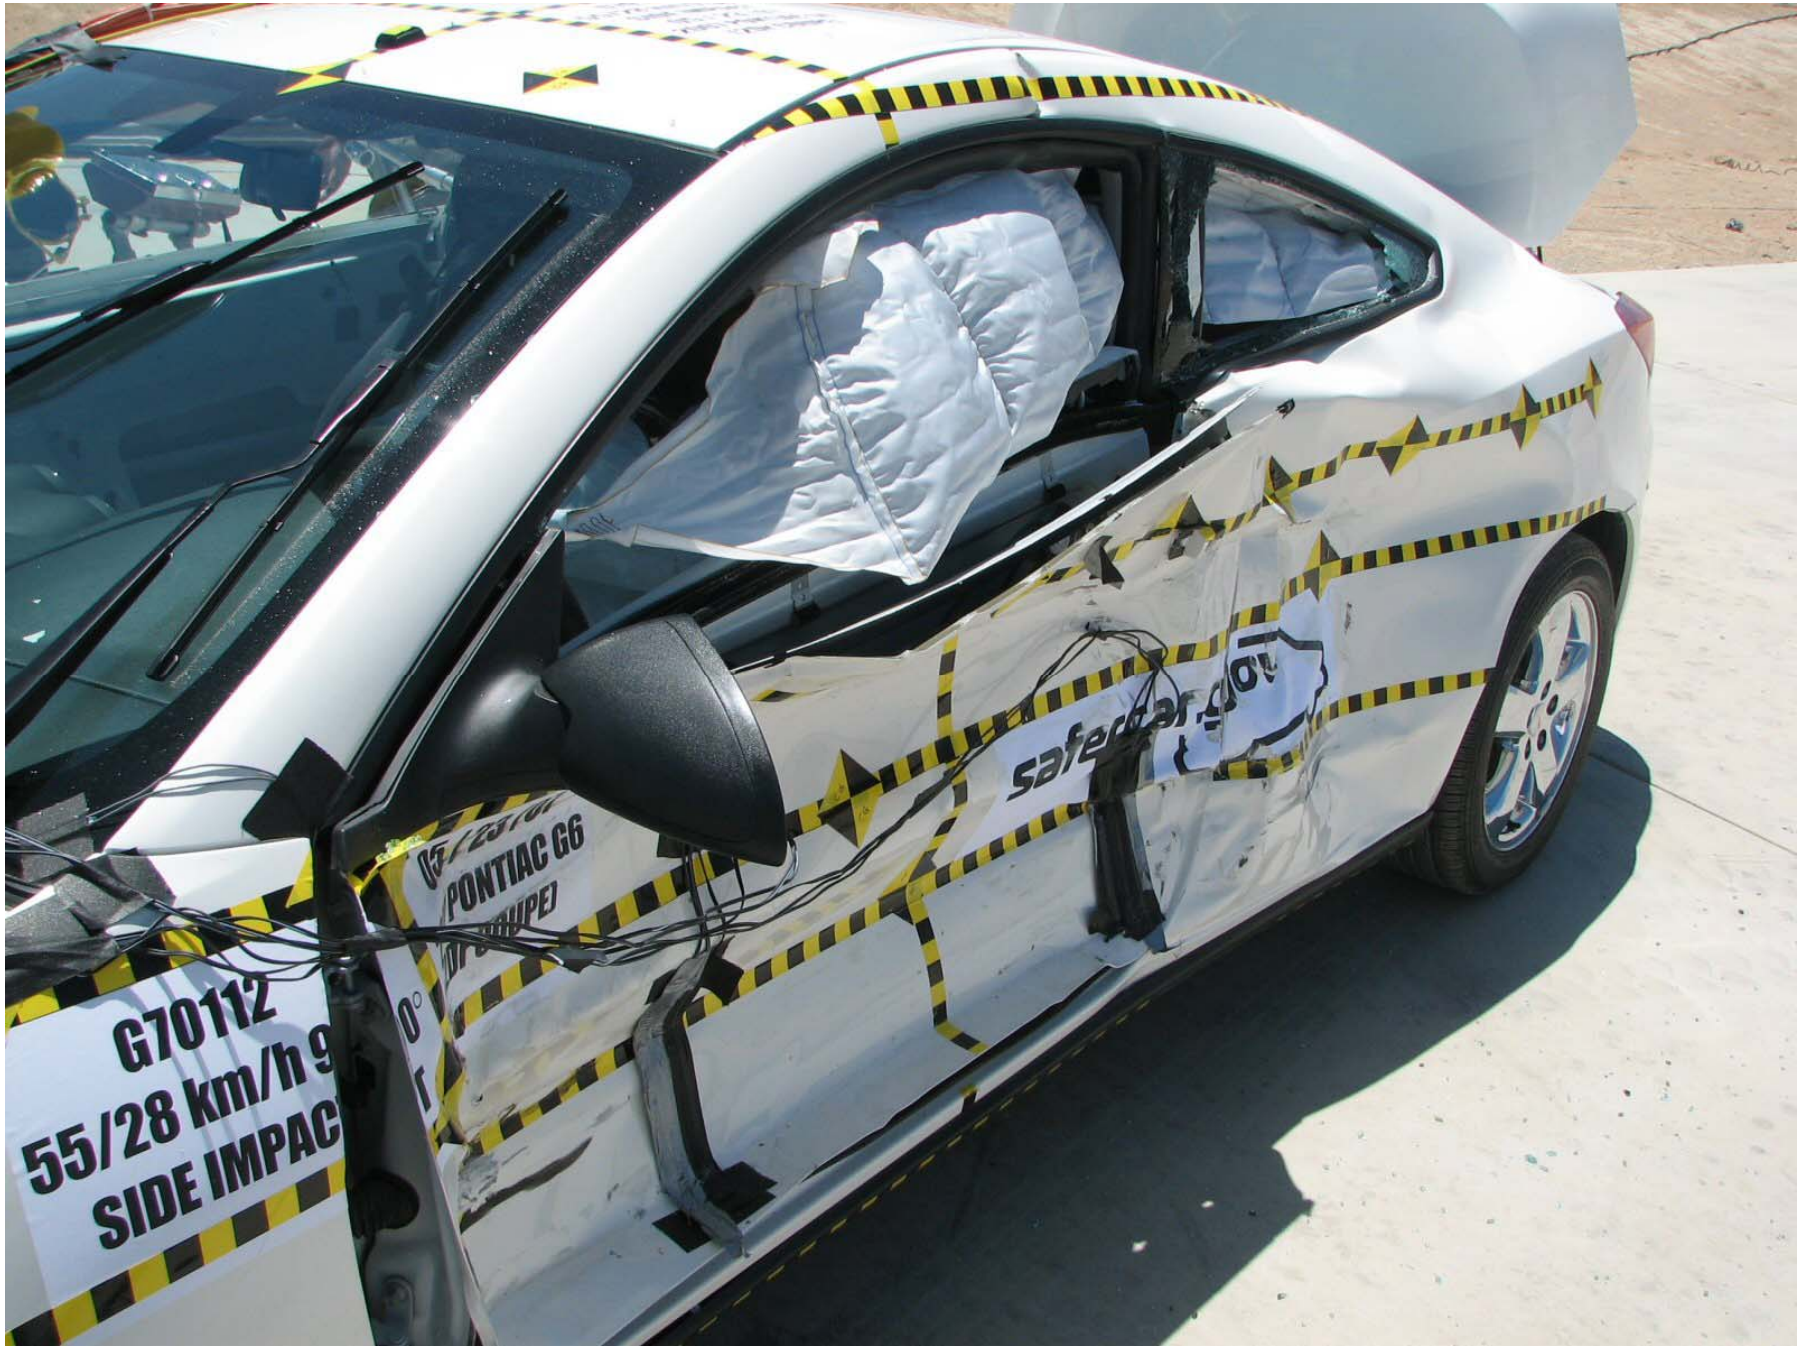
Figure A-28: Post-Test Front  $\frac{3}{4}$  View of Left Side Door

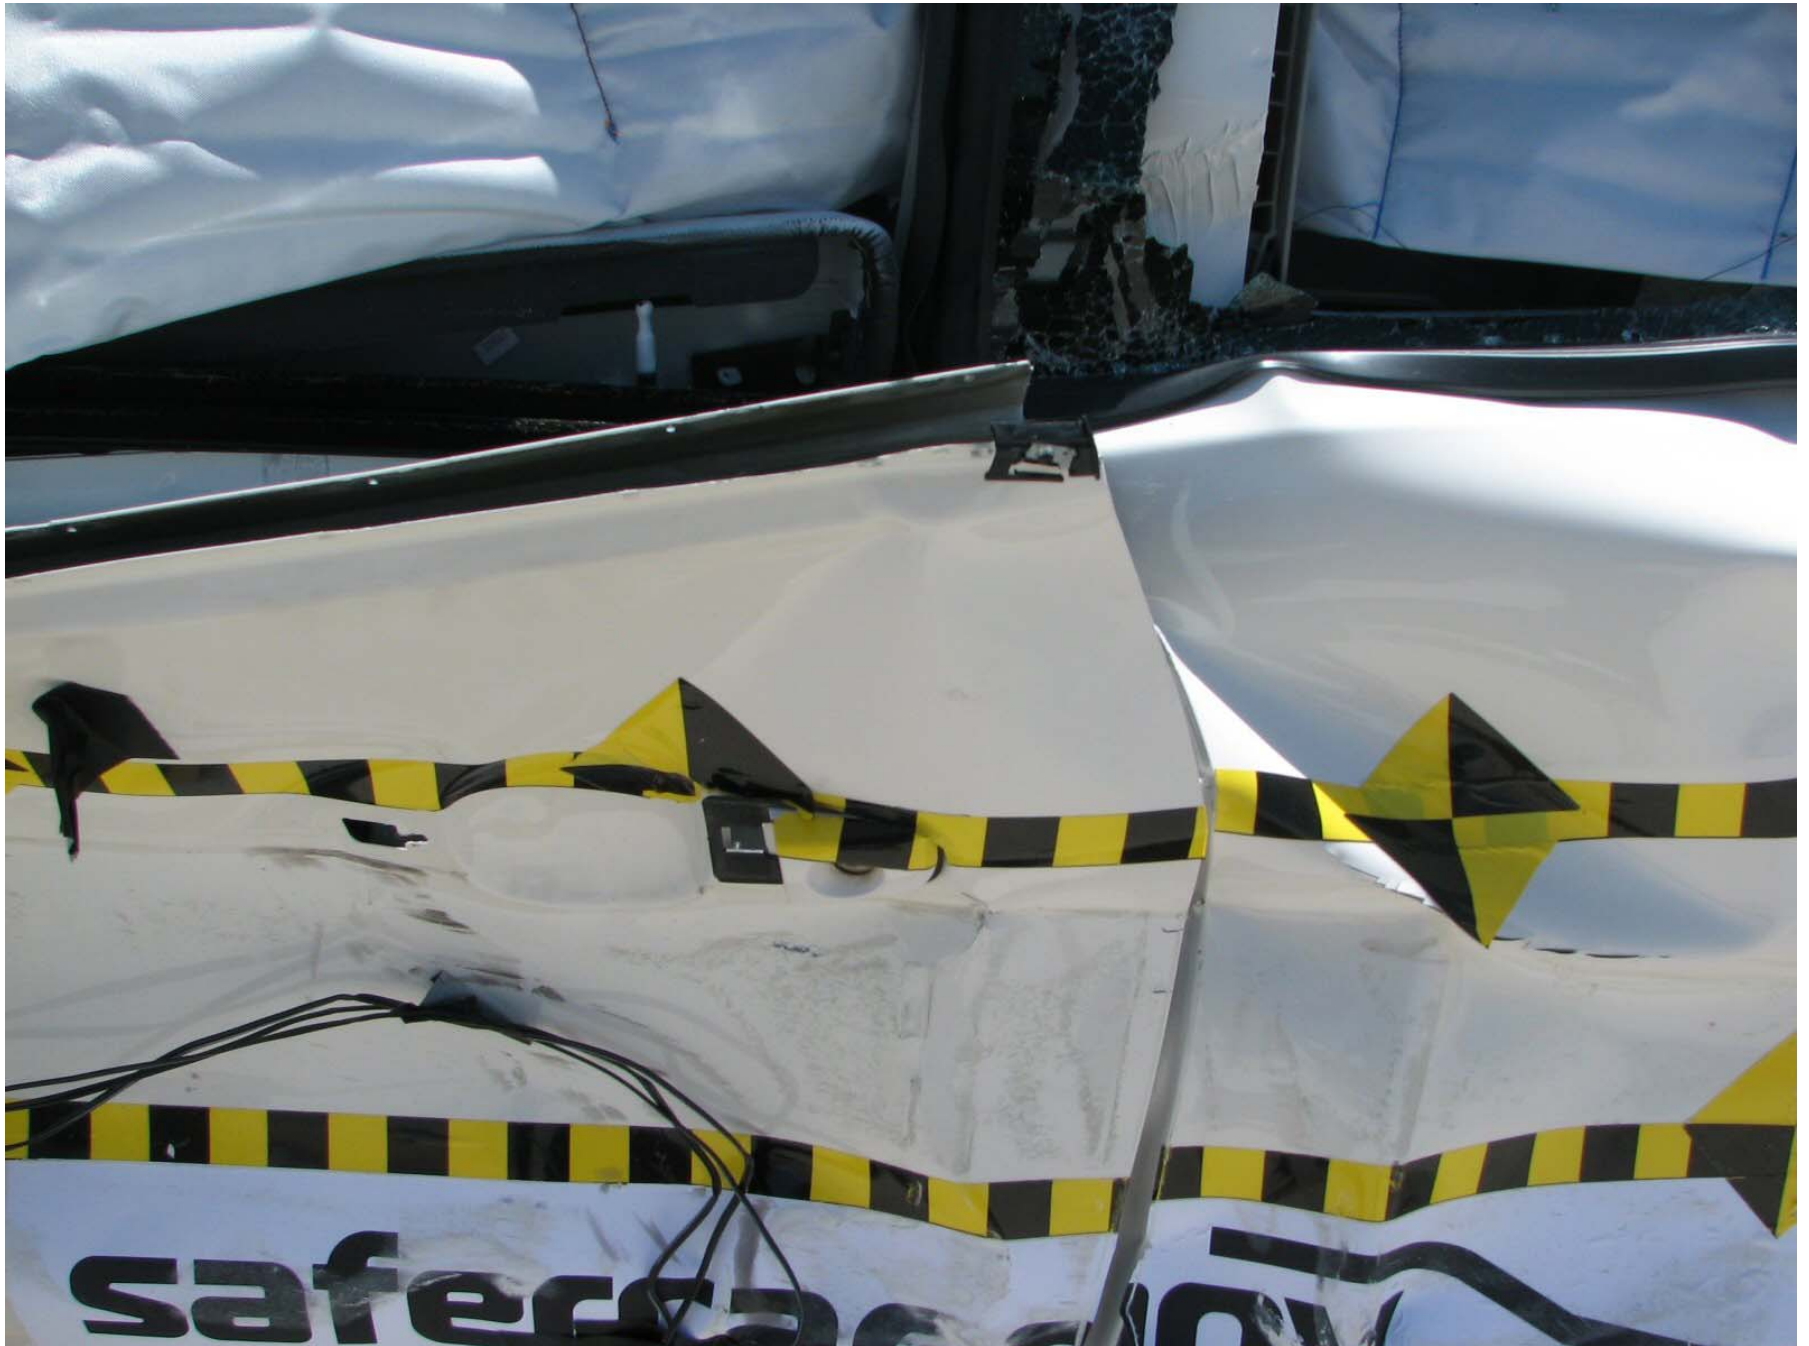
Figure A-32: Post-Test Left Front Door

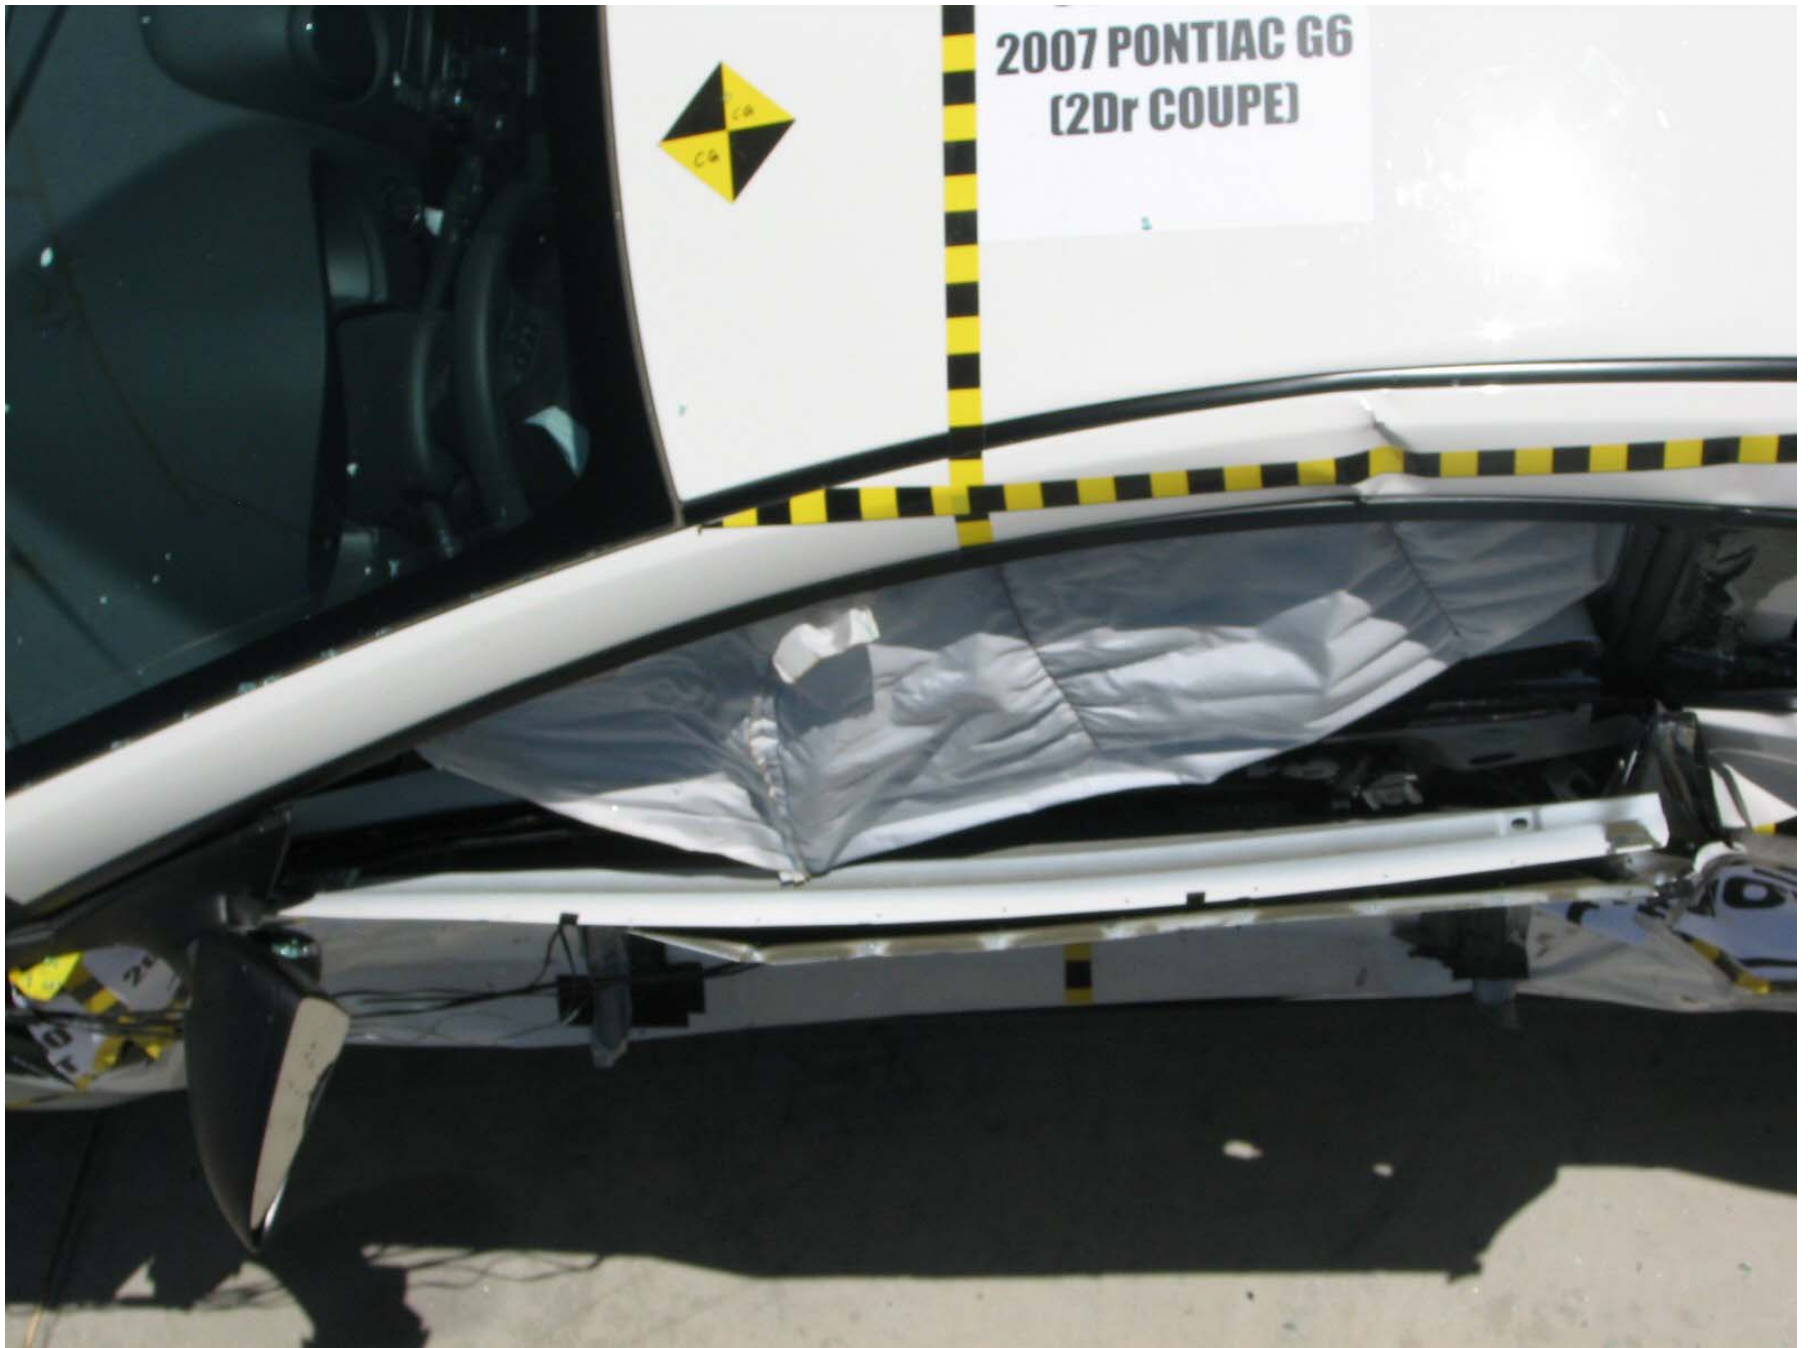
Figure A-39: Post-Test Driver Dummy Clearance From Door

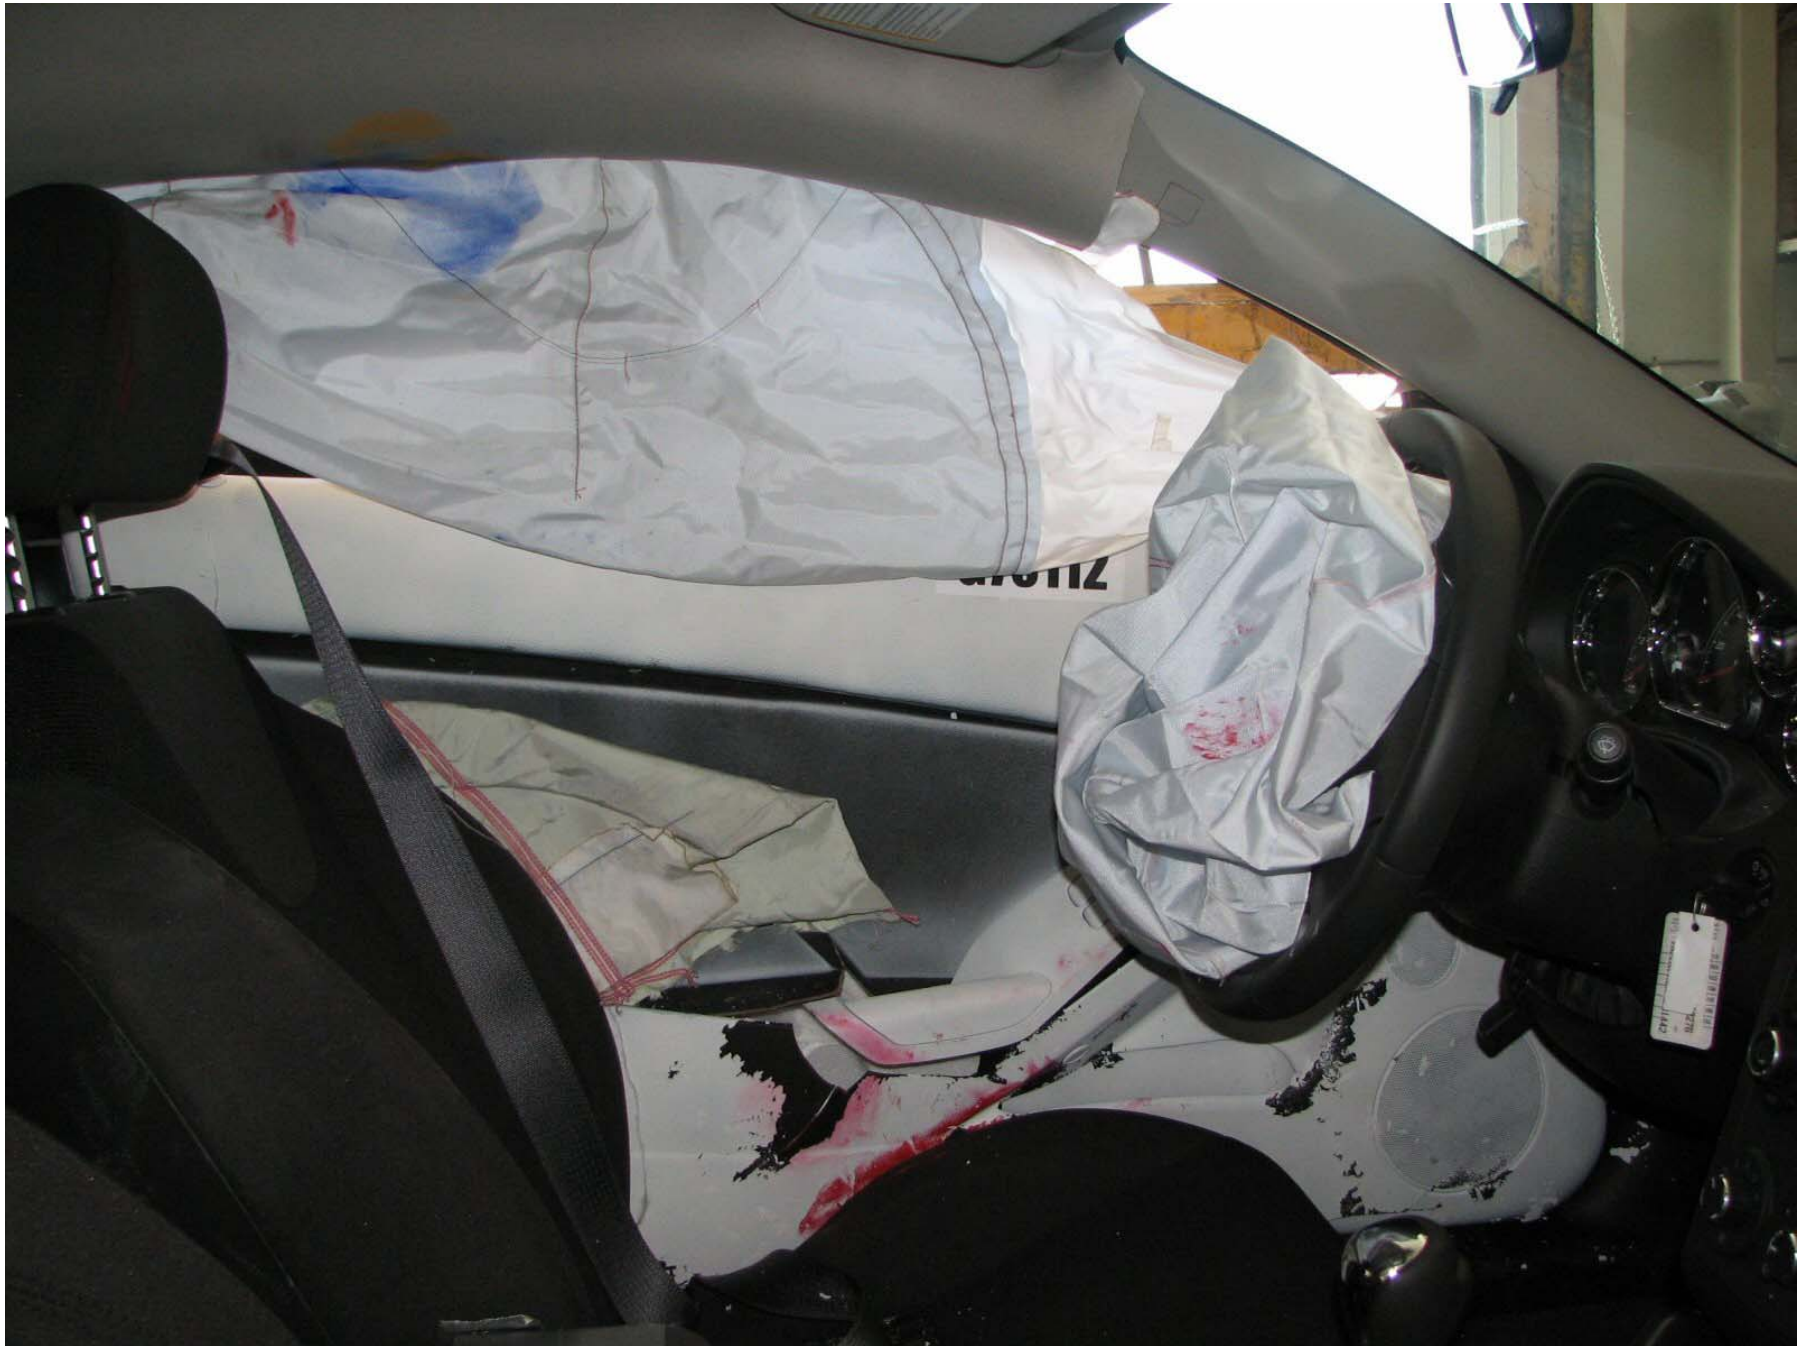
Figure A-43: Post-Test Front Door Panel (Interior)

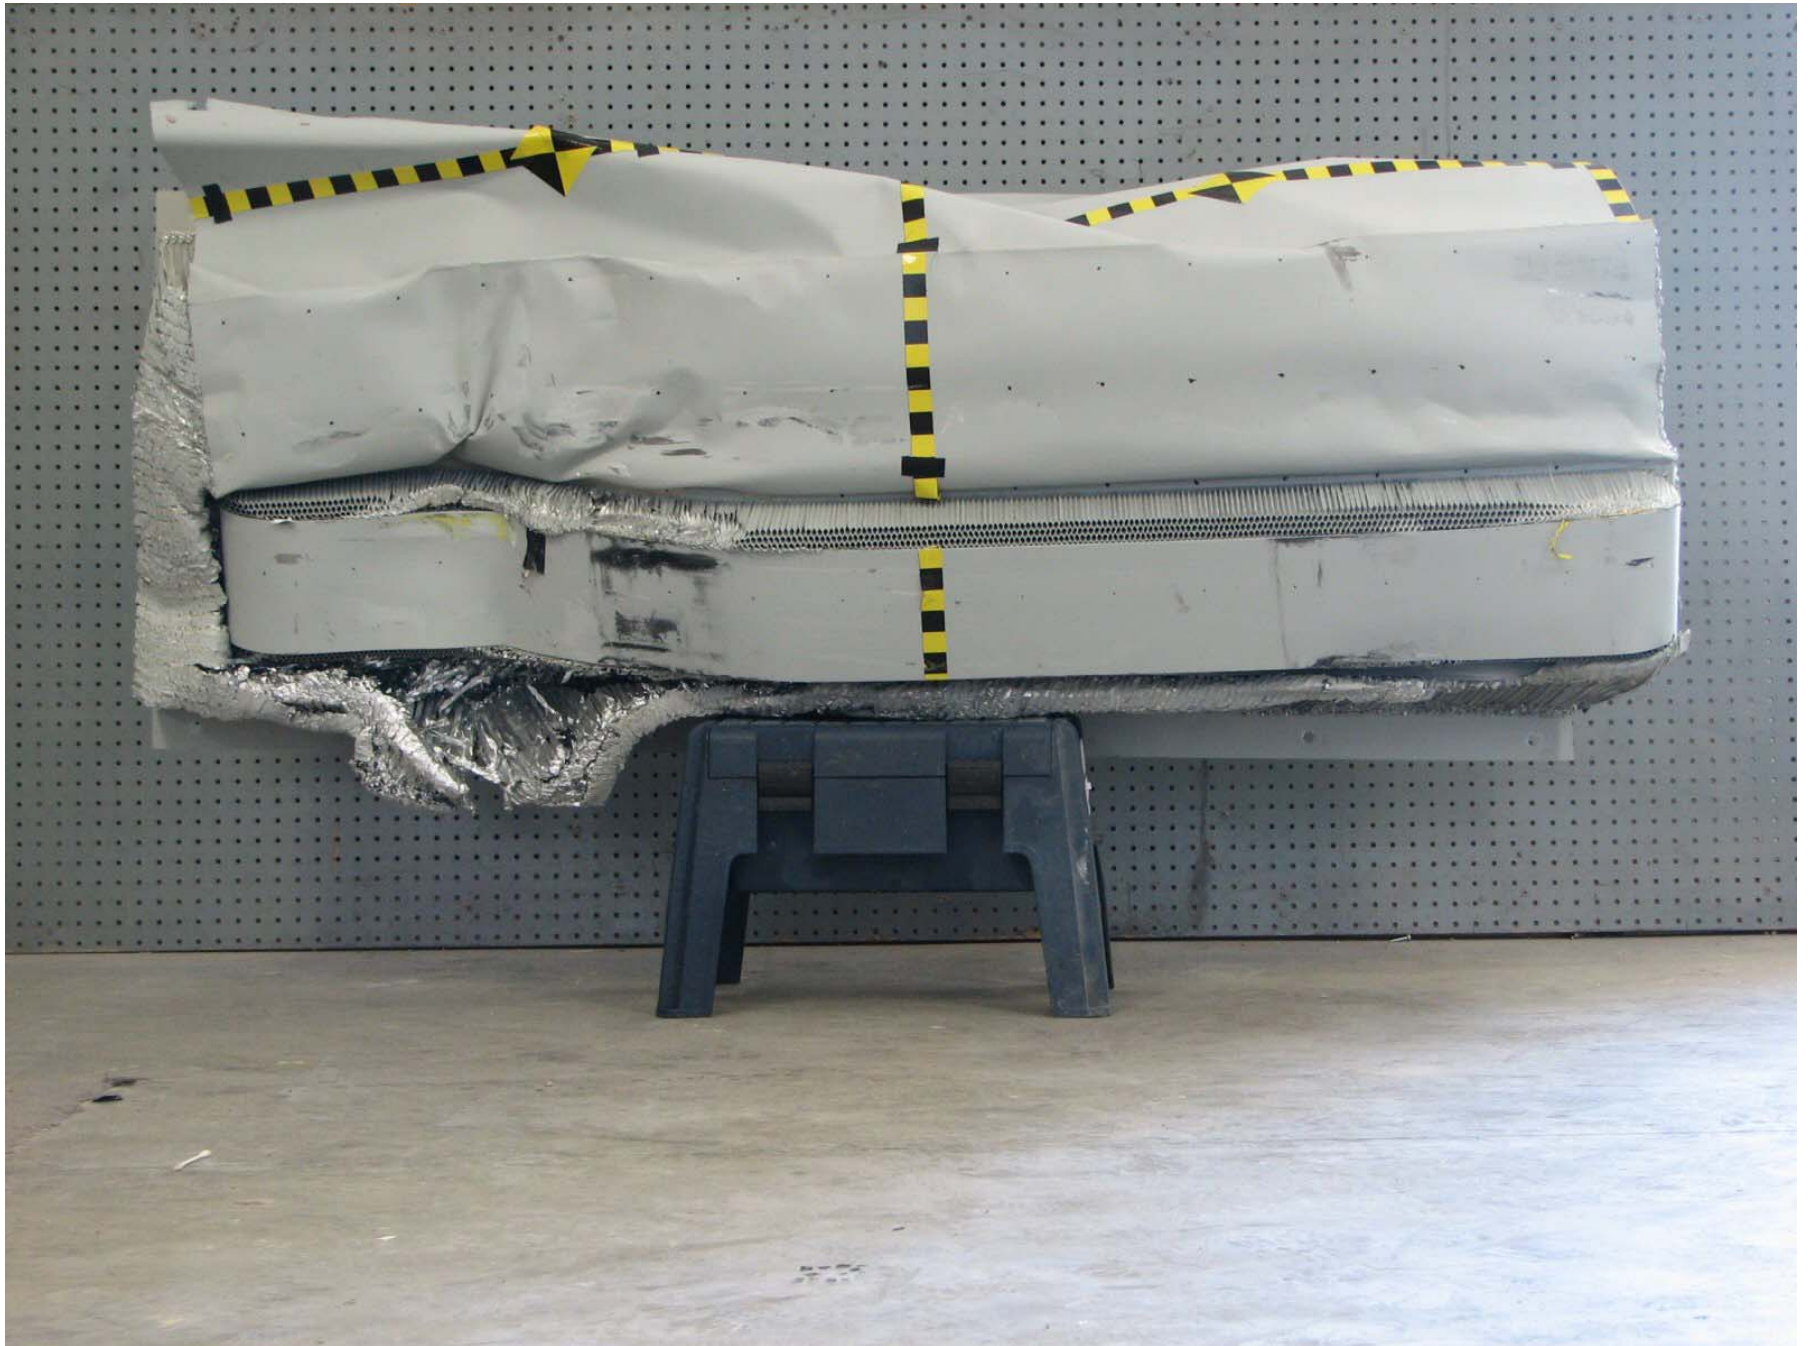
Figure A-54: Post-Test Front View of Deformable Barrier

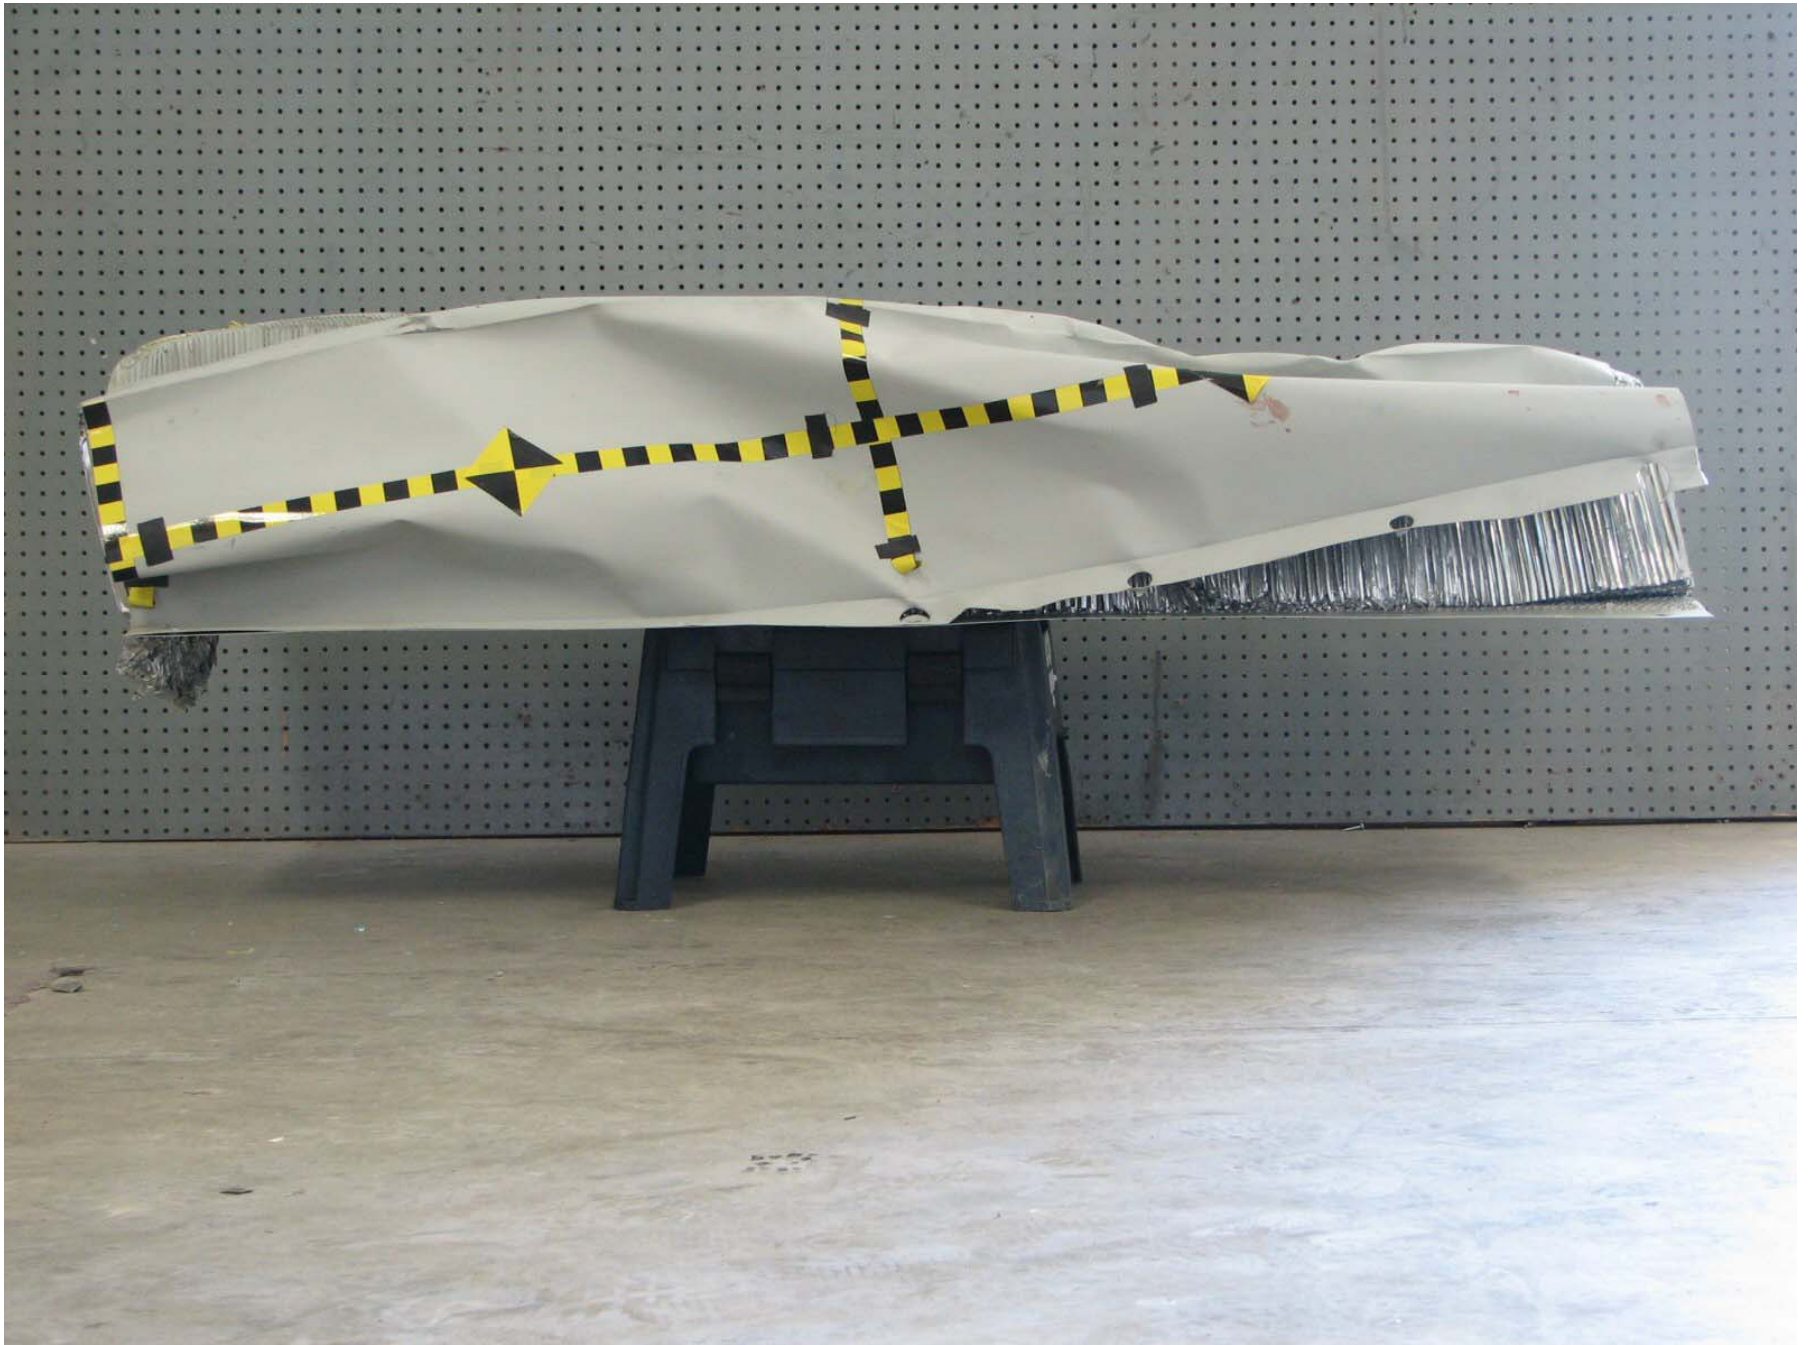
Figure A-56: Post-Test Top View of Deformable Barrier
